MUNICIPALITY OF
West Grey

Municipality of West Grey
Bridge Prioritization Program

February 2025

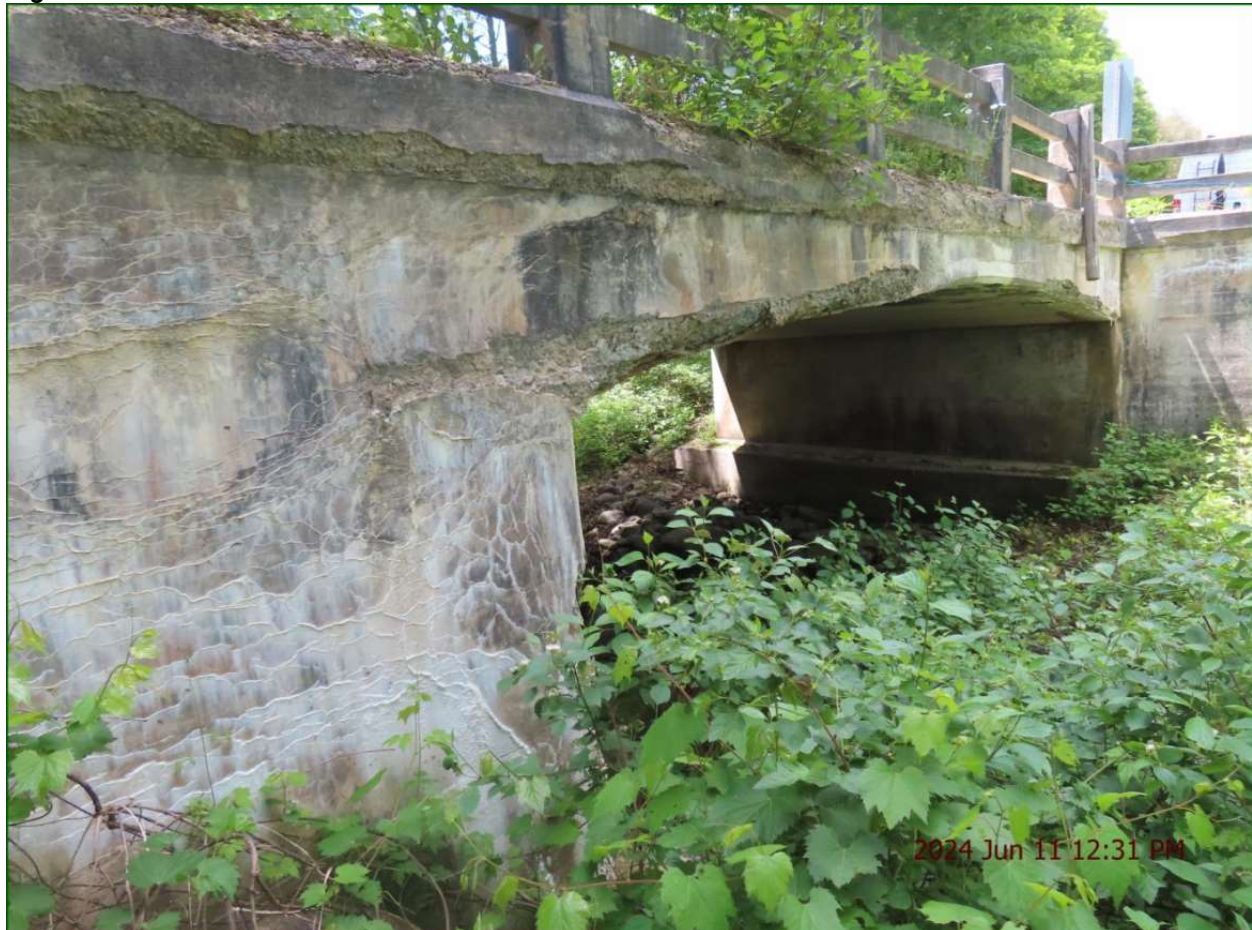
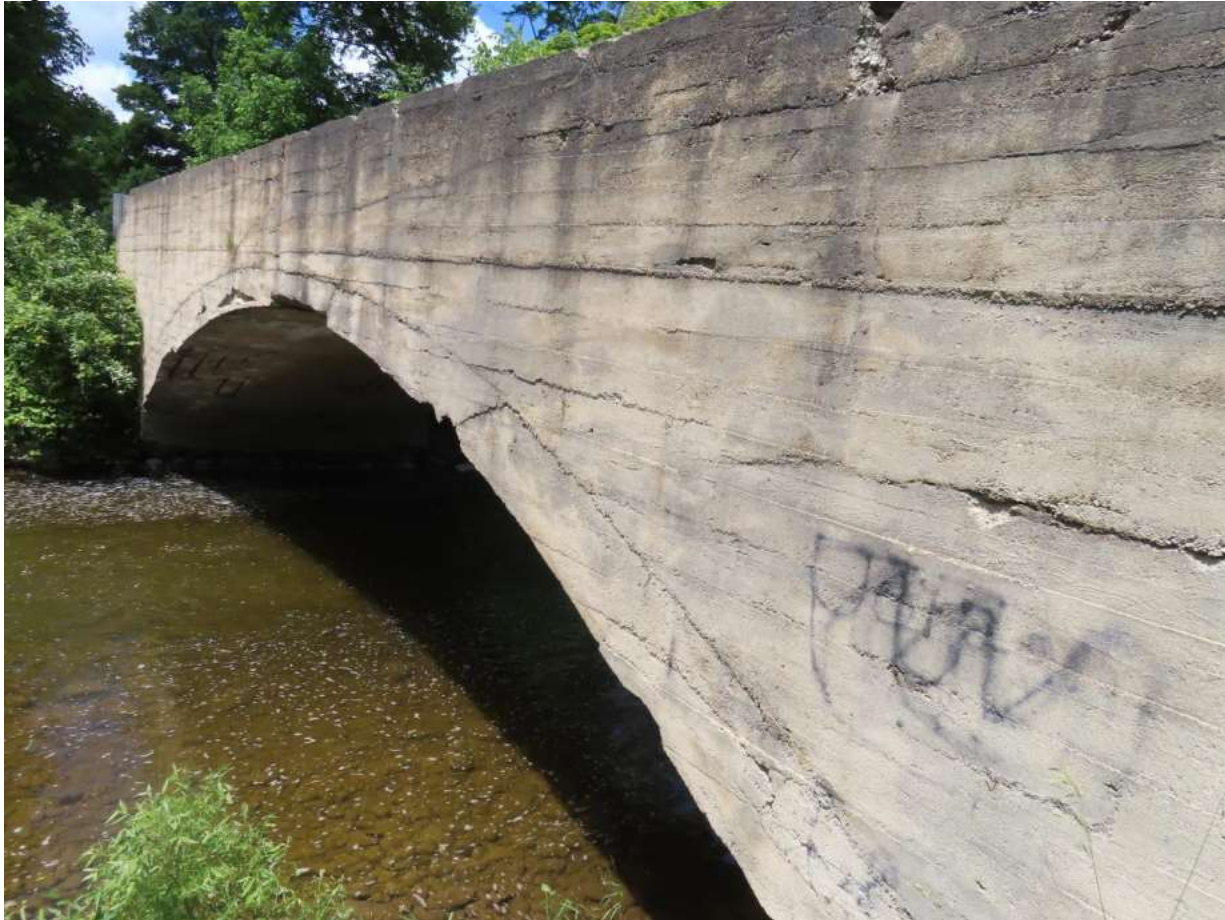
Figure 4.01: North Elevation View of Structure G-037

The high scores for these two structures were primarily attributed to the localized flooding known to occur on this road segment during spring snow melt. The flooding has the potential to isolate residents from the transportation network with Structure G-038 now closed and Structure G-037 in an advanced state of deterioration. In the event of localized flooding, there are no detour options available to landowners on this road segments. Rehabilitation is not viable for these structures and they both require full replacement.

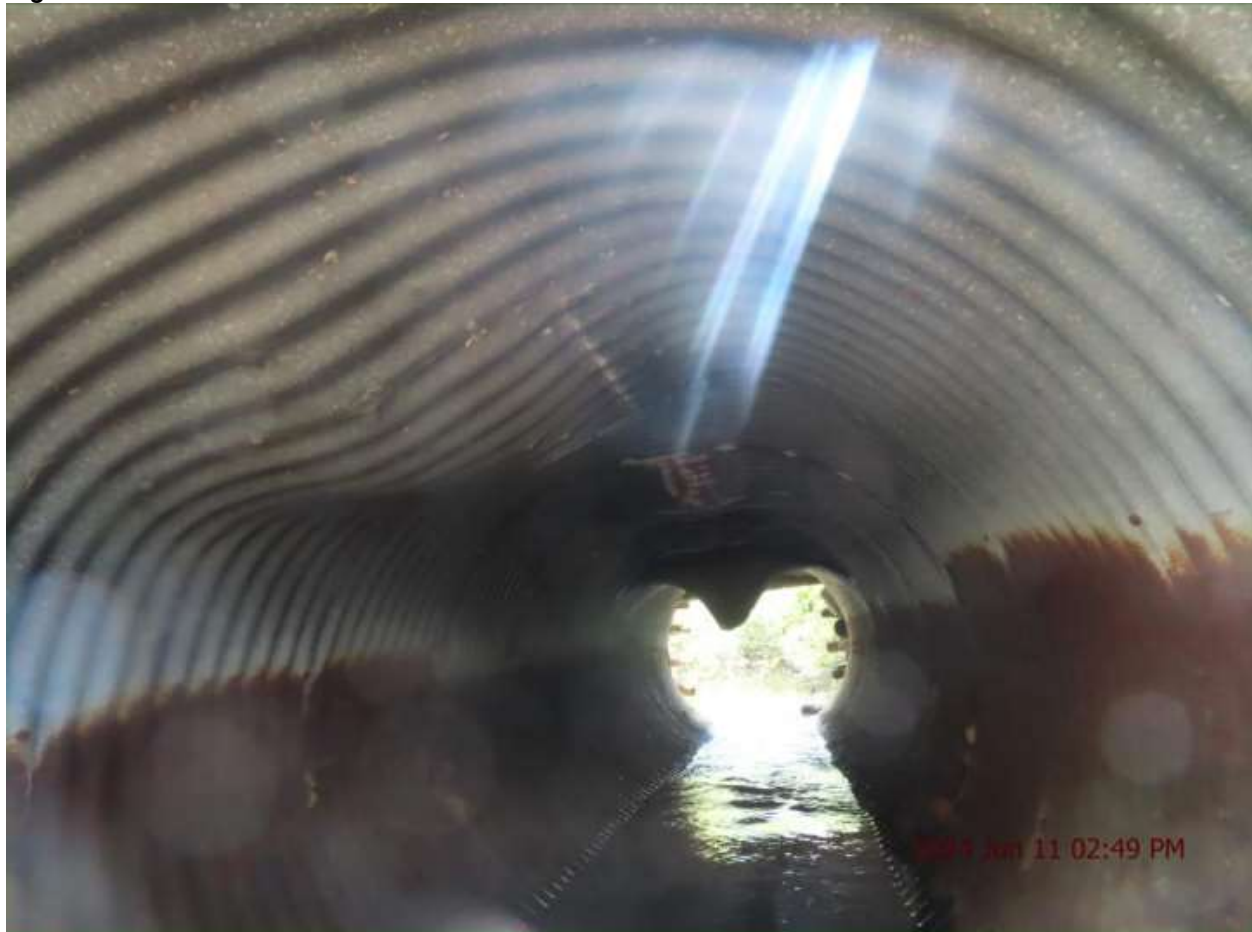
Figure 4.03: EG-001 Structure Failure

Structure EG-001 presents a unique scenario in which the segment of Stone Hill Road is not a through road and provides access to two properties beyond the culvert. Therefore, this culvert must be in functioning condition for these properties to maintain access to the transportation network. This culvert still is still open, however, has zero years of service remaining, based on the 2024 OSIM inspection.

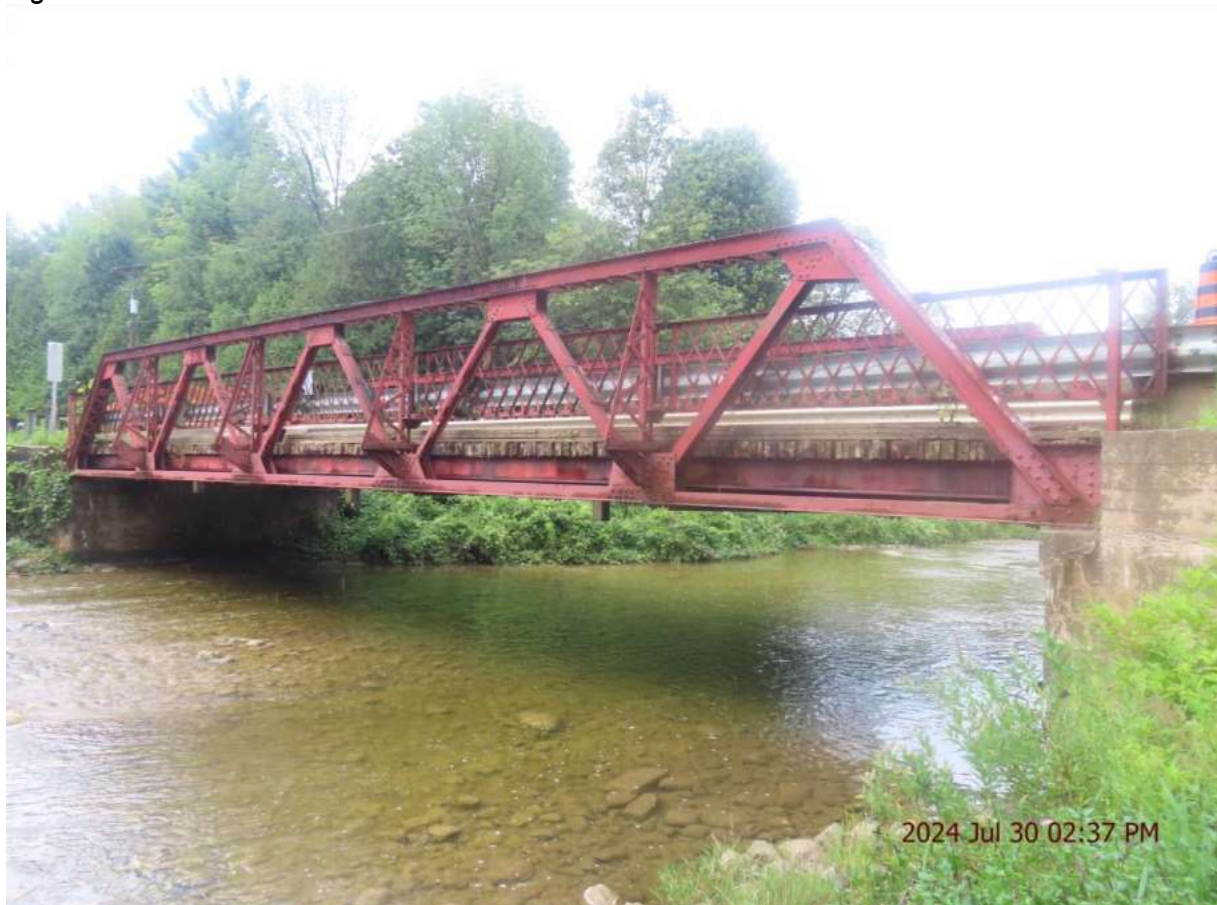
Figure 4.04: South Elevation View of Structure N-051

Concession 18 serves as a major east-west route through the Municipality of West Grey, indicative by the high volume of daily traffic. Over 7.0 minutes have been added for the Change in Emergency Response Time, when accounting for both segments of an EMS route, with the required closure of this structure. Detour length is also relatively longer than most structures analyzed in this program. With Structure N-051 currently closed, it ranks 3rd on the priority list just below G-037 and G-038, due to Concession 18's significance to the overall transportation network.

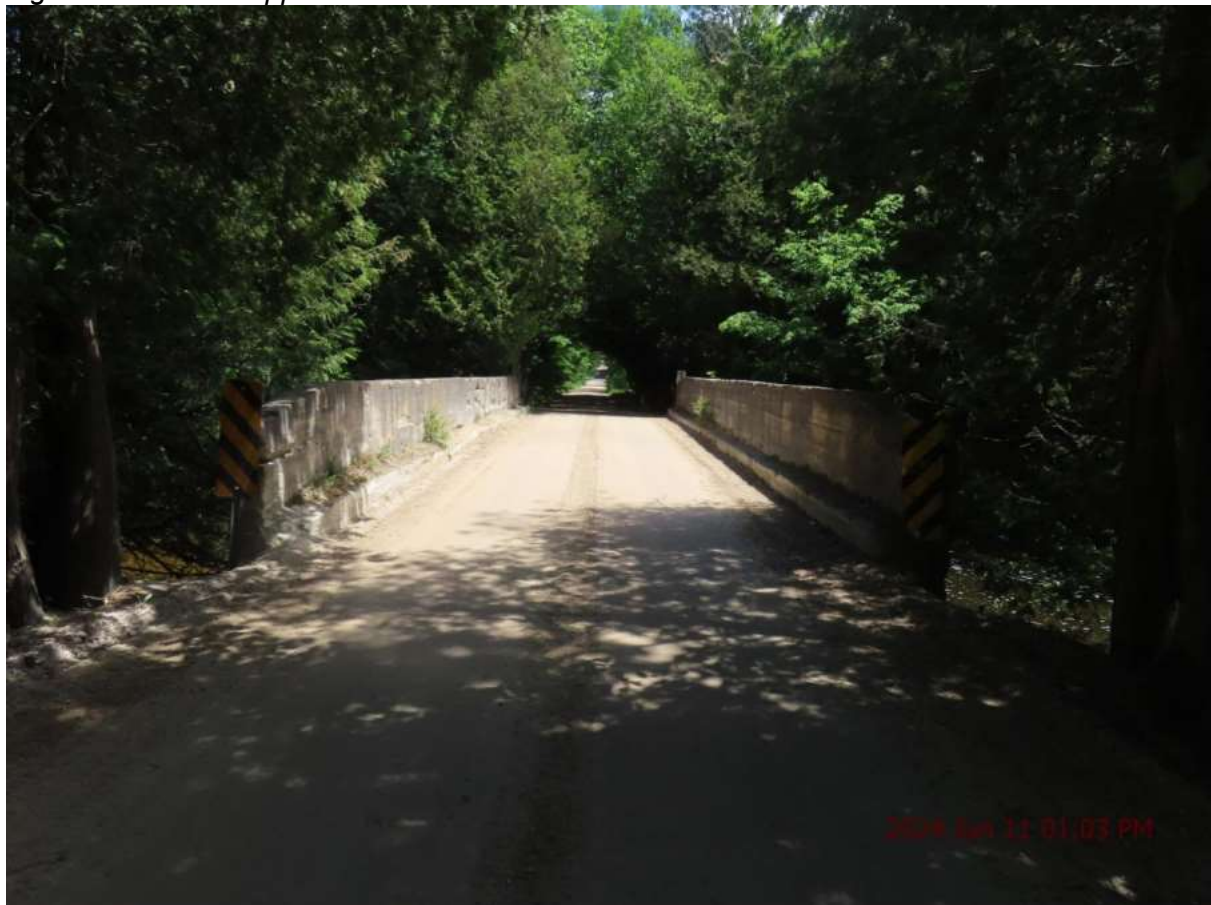
Figure 4.05: West Approach View of Structure G-044

Structure G-044 experiences a low volume of daily traffic relative to other structures in the Municipality. While this segment of North Line does not function as a major thoroughfare, the closure of this culvert significantly lengthens the response time from EMS by over 10.0 minutes when accounting for both segments of the emergency response route. The closure also results in a lengthy detour distance relative to other structures analyzed for landowners on North Line. As mentioned previously in Section 4.4, the decision and initiation of the engineering process to replace Structure G-044 precedes this *Bridge Prioritization Program*, however, as indicated by this analysis, it is an important structure for maintaining service to landowners on this segment of North Line.

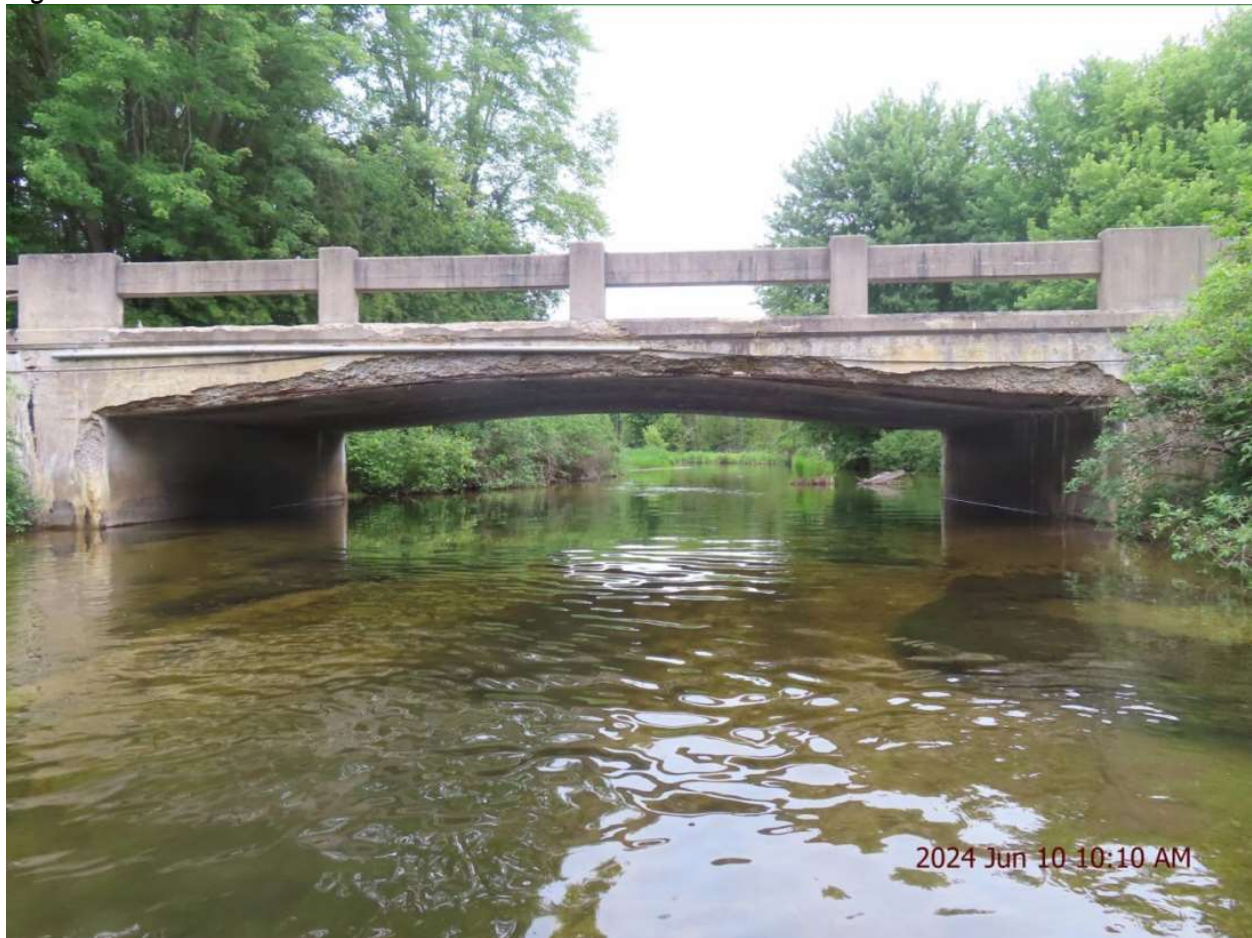
Figure 4.06: South Elevation View of Structure B-003

As indicated by high volumes of daily vehicular traffic, Concession 6 NDR serves as an east-west throughfare in the former Township of Bentick. Structure B-003 scored relatively high for Total Risk of Asset Failure due to its remaining years service life and the implications its closure will have on local traffic patterns and the overall transportation network.

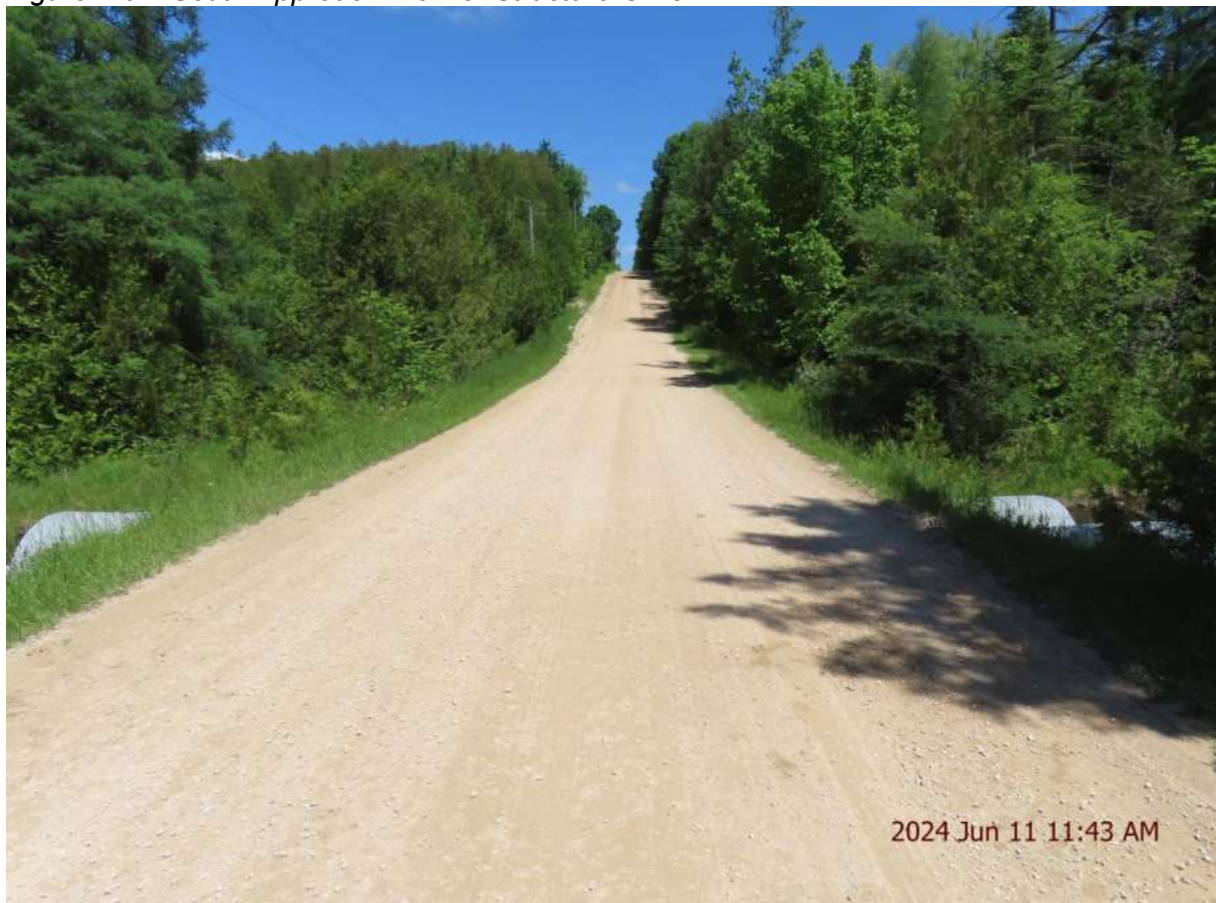
Figure 4.07: South Approach View of Structure G-132

Similar to Structure EG-001, Structure G-132 presents the same scenario in which the segment of road is not a through road (dead-end) and provides access to two properties. Therefore, this culvert must be in functional condition for these properties to maintain access to the transportation network. This culvert still has two years of service remaining and is proposed to be replaced prior to required closure from structural deterioration to avoid the isolation of properties.

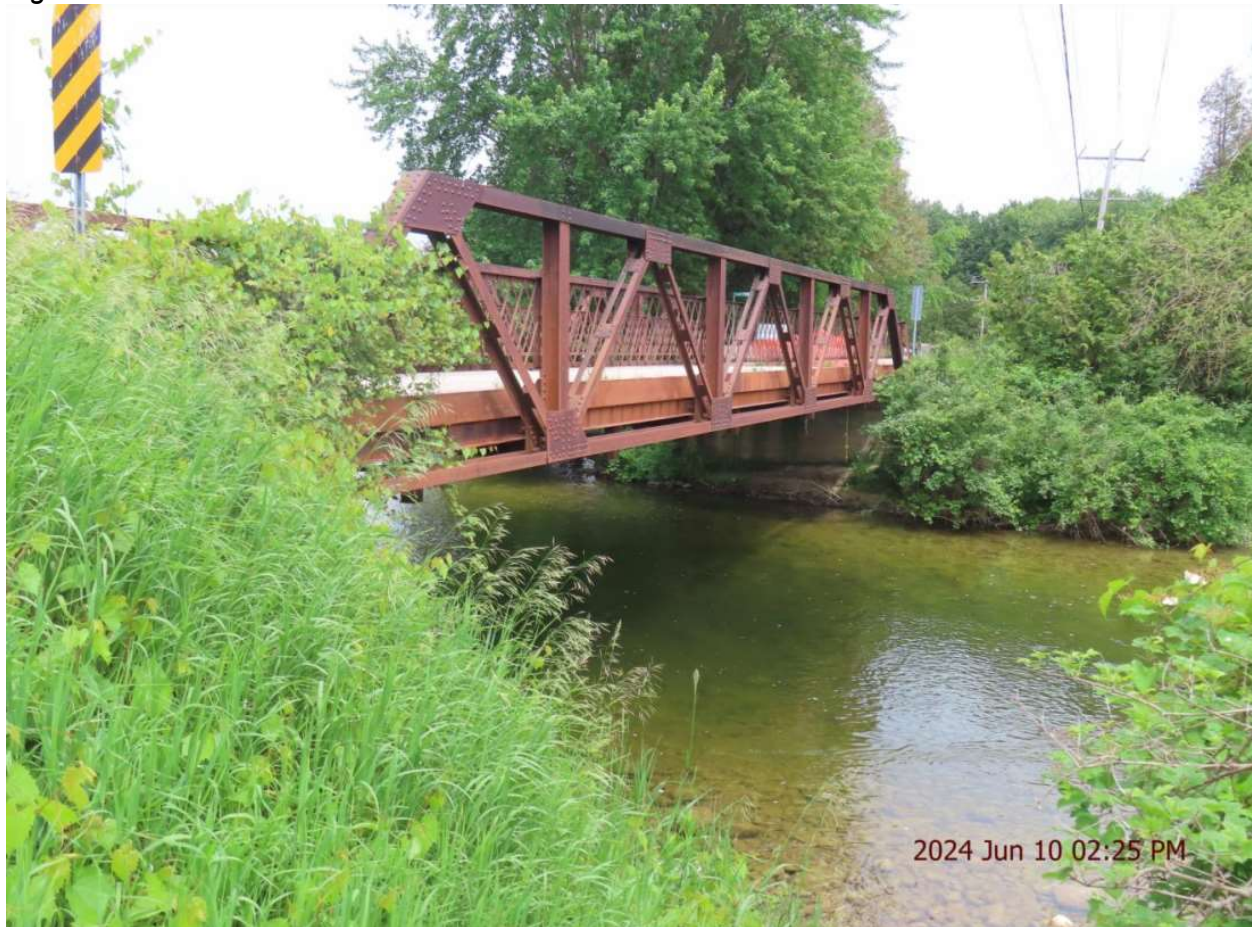
Figure 4.08: South Elevation View of Structure B-020

Although Kennedy Bridge has been closed since 2015, traffic volumes in 2016 displayed over 900 vehicles daily travelling on the segment west of Grey Road 3 on Concession 2, which is one of the highest traffic volumes in the Municipality. While traffic data from 2016 is not available east of Grey Road 3 within the same road segment as Kennedy Bridge, ongoing and updated ADT volumes by the Municipality have the potential to analyze the use of Concession 2 as a major thoroughfare and may indicate the need for the re-opening of Kennedy Bridge. For consistency and completeness and based on the high traffic counts recorded on adjacent and surrounding road segments from the structure an assumption of 953 ADT volume was used when evaluating B-020.

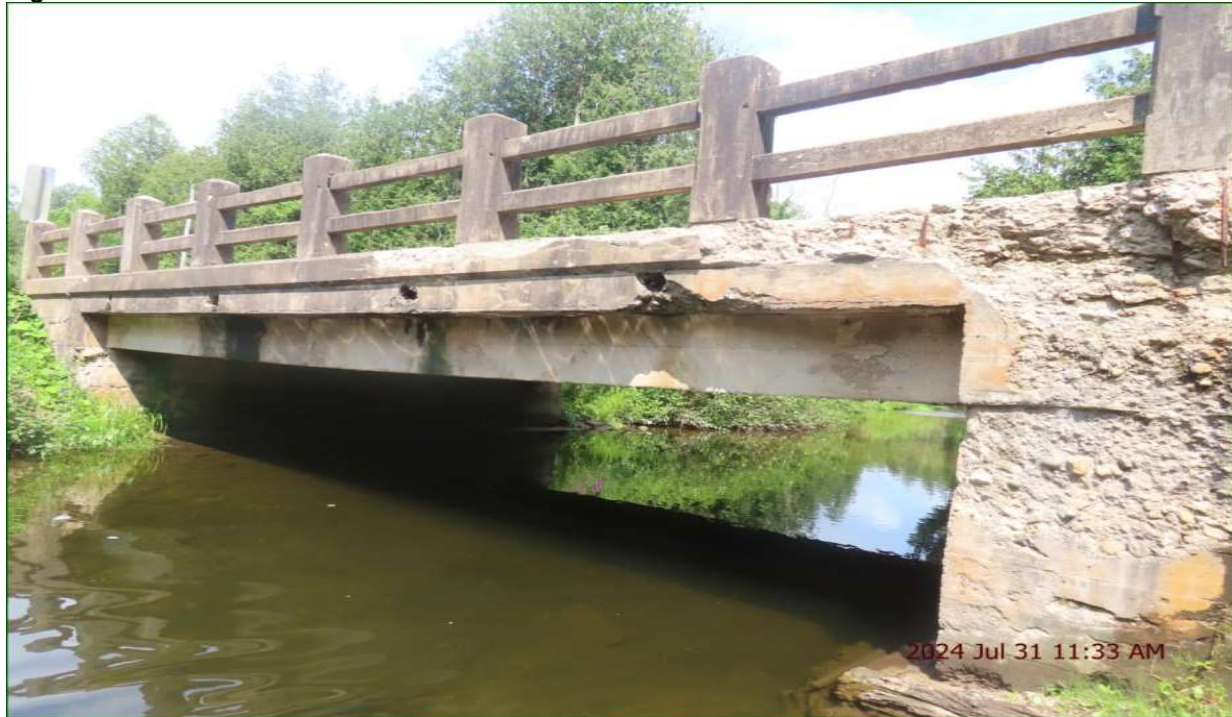
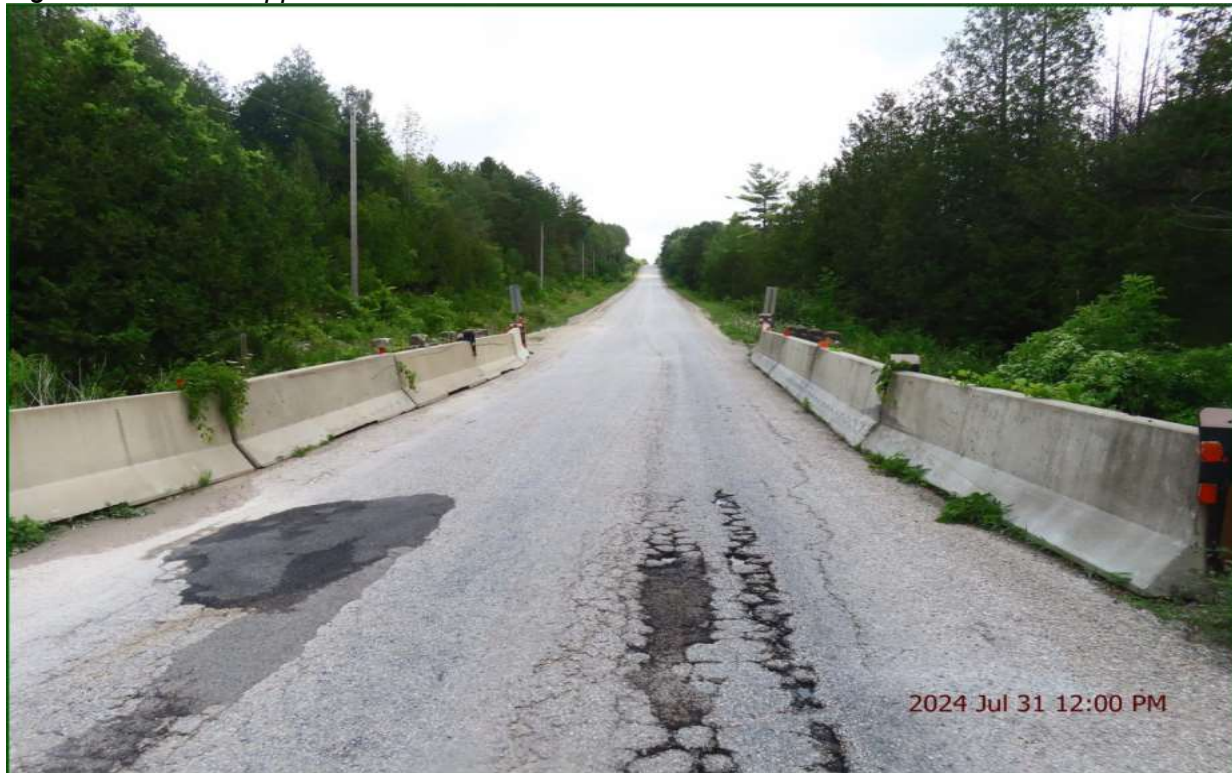
Figure 4.09: South Elevation View of Structure N-058

These structures scored among the highest for Total Risk of Asset Failure, attributed to the large volume of daily vehicular road users on Concession 12, which serves as a major east-west thoroughfare in the Municipality. While change in emergency response times were relatively unaffected for these individual structures, a scenario requiring closure due to structure deterioration on Concession 12 has the potential to significantly alter traffic patterns in West Grey. These two structures appear at the bottom of the priority list due to the number of years of service life remaining compared to those at the top of the priority list, despite their high scores for Total Risk of Asset Failure.

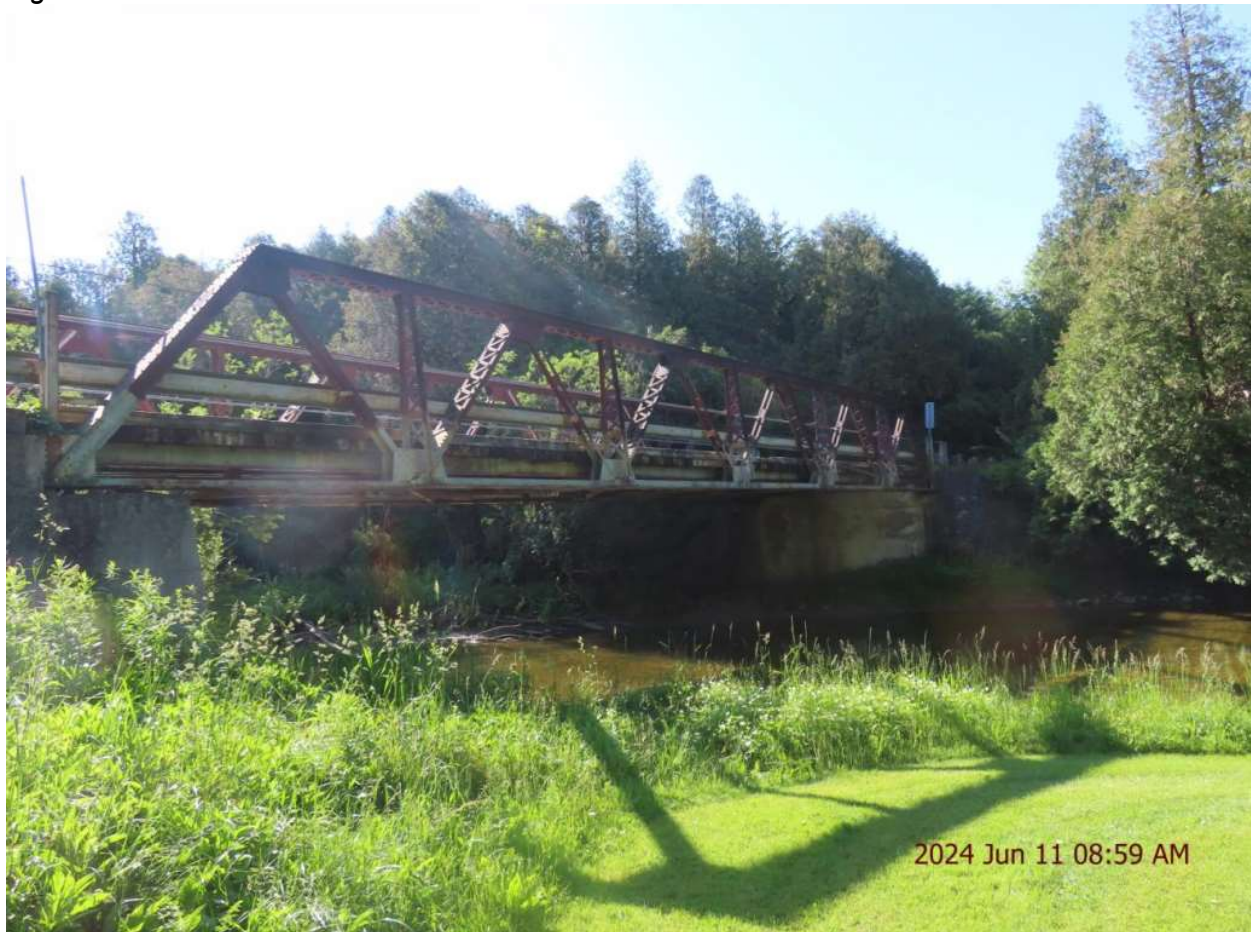
Figure 4.11: West Elevation View of Structure B-025

Structure B-025 experiences a low volume of daily traffic with respect to other structures and their respective road segments in the Municipality and offers a low level of service given the few properties on this road segment. The low volume of road users is attributed to the fact that Side Road 10 is relatively short “local road” which services road users between Concession 2 and Normanby-Bentick Townline. Change in emergency response times are minimally impacted due to closure. For these reasons, Structure B-025 is a candidate to remain closed.

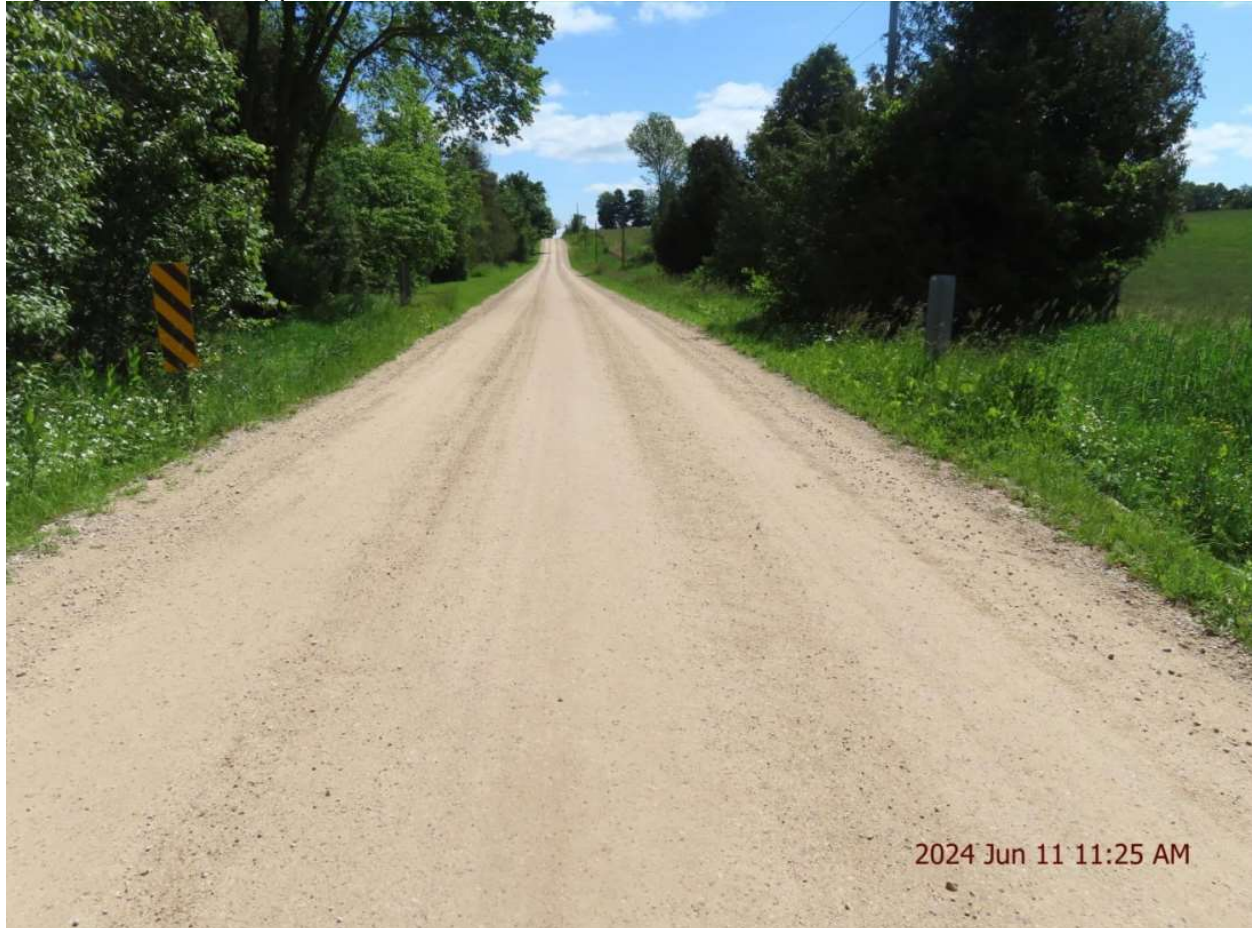
Figure 4.12: West Approach View of Structure G-133

South Line experiences a low volume of daily traffic with respect to other structures in the Municipality. Emergency response times and detour routes are also only minimally impacted relative to other structures analyzed. Due to the low volume of road users and minimal impact to landowner's services, Structure G-133 is proposed for closure at the end of its service life.

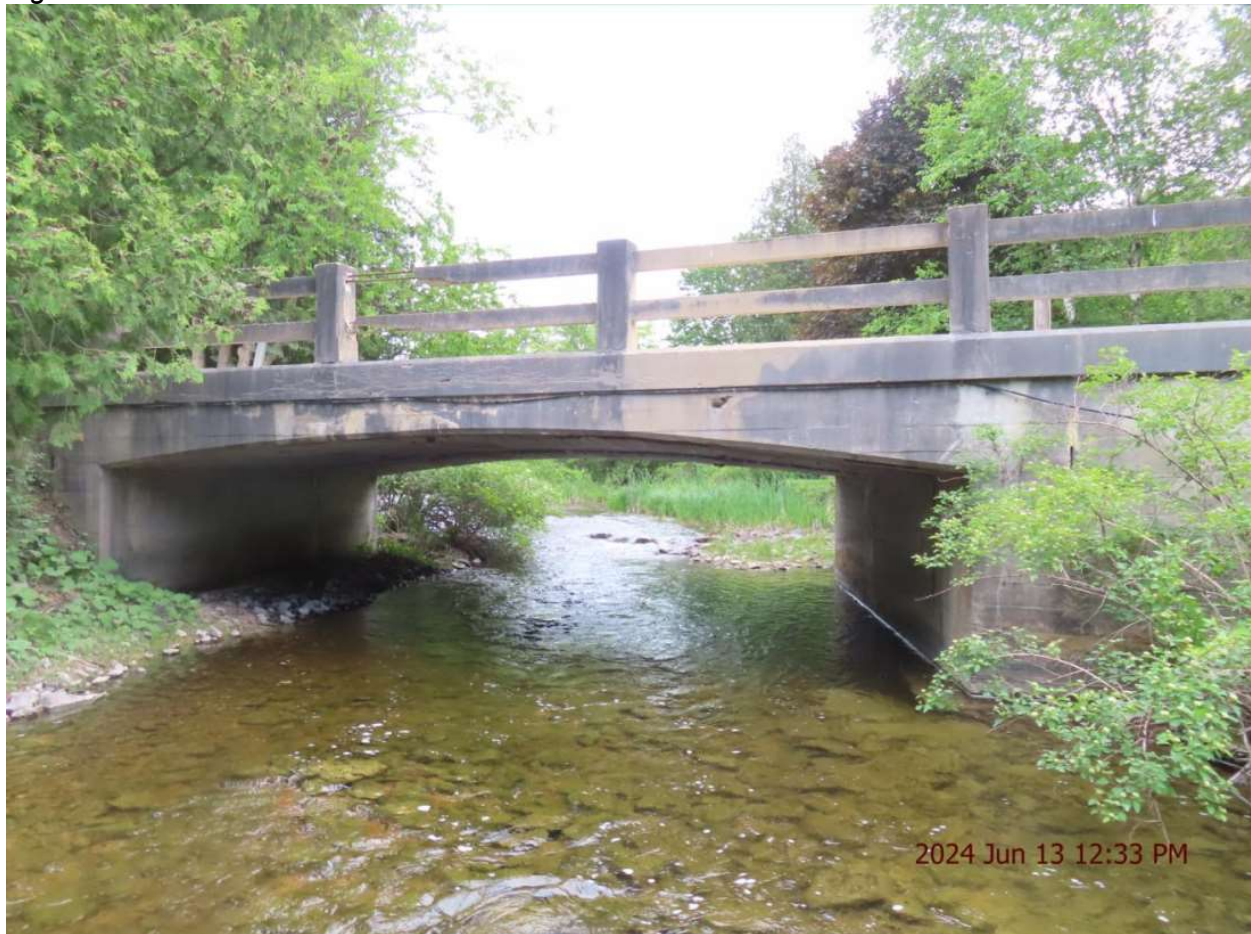
Figure 4.13: West Elevation View of Structure B-008

Structure B-008 experiences a low volume of daily traffic and contains less than ten properties located between Concession 12 and Concession 10. Baseline is discontinuous north of Concession 12 and varies in condition throughout its north/south length. Detour lengths and emergency response times are minimally affected relative to other structures analyzed. Structure B-008 is not considered critical infrastructure to maintaining the overall transportation network and is therefore proposed as a candidate for closure.

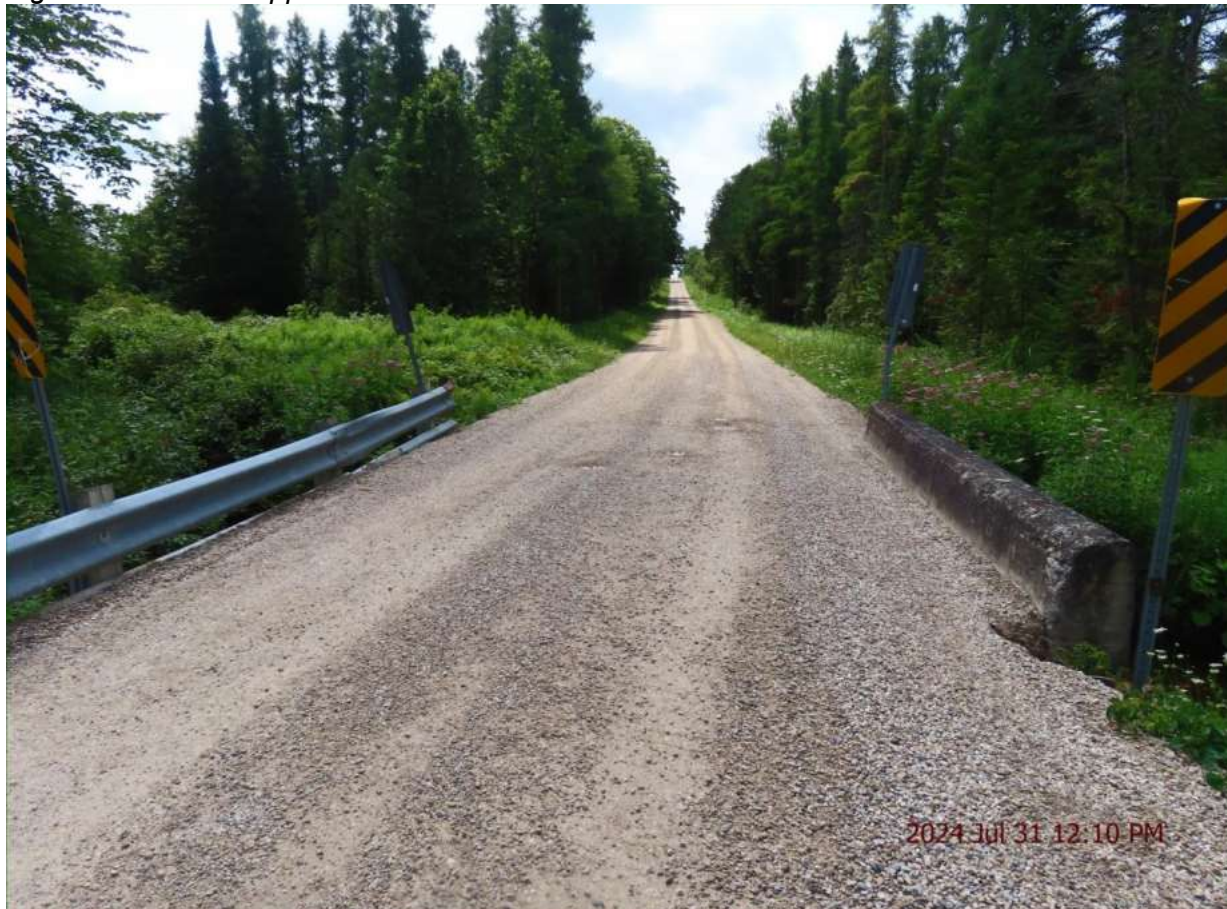
Figure 4.16: North Approach View of Structure N-188

Structure N-188 experiences a low volume of daily traffic with respect to other structures in the Municipality and has a low level of service given less than 10 properties located on Sideroad 25, between Concessions 12 and 14. With a low volume of daily vehicular traffic, combined with minimal changes to emergency response times, Structure N-188 is a candidate for closure.

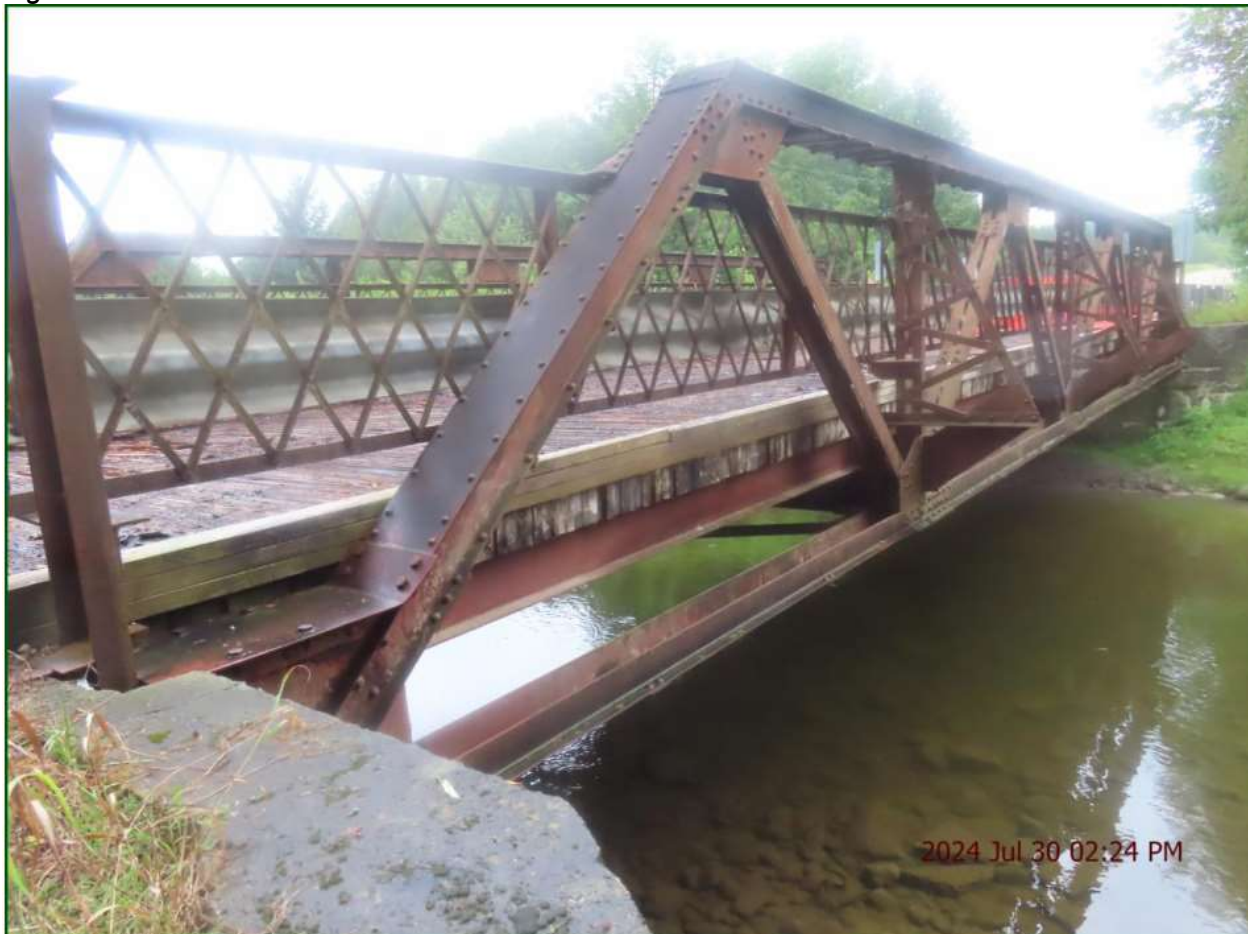
Figure 4.17: East Elevation View of Structure N-055

Structure N-055 experiences a low volume of daily traffic, relative to other structures in the Municipality and has a low service level due to the few properties located on this segment of Sideroad 20. Emergency response times are also relatively unchanged for services at the structure location. For these reasons, Structure N-055 is a candidate proposed for closure.

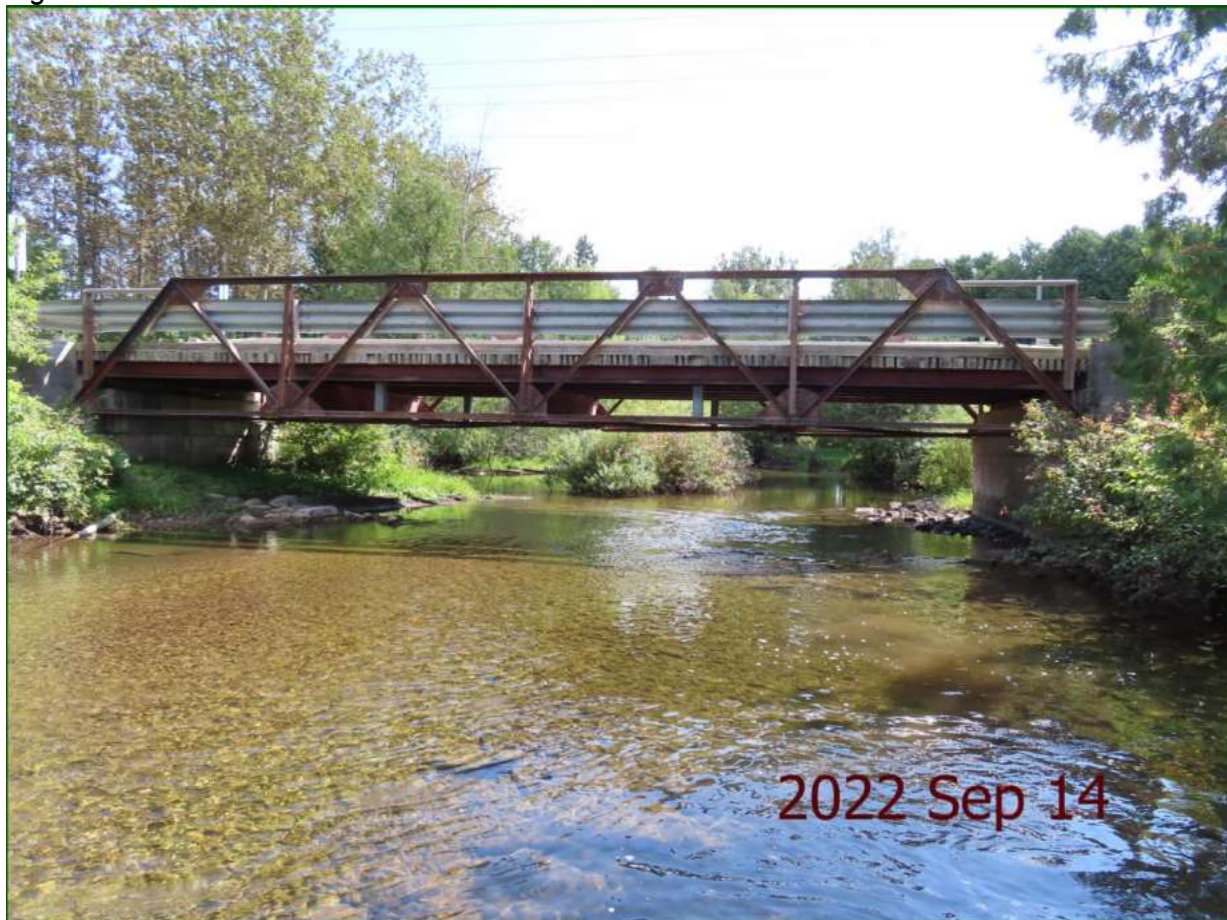
Figure 4.18: North Elevation View of Structure N-061

Concession 14 functions as an east-west traffic route through the Municipality and experiences higher volumes of daily traffic on the western segments of this road, compared to where Structure N-061 is located. Due to the low volume of daily traffic and less than 10 properties located on this road segment, as well as minimal changes to emergency response times, Structure N-061 is a candidate proposed for closure.

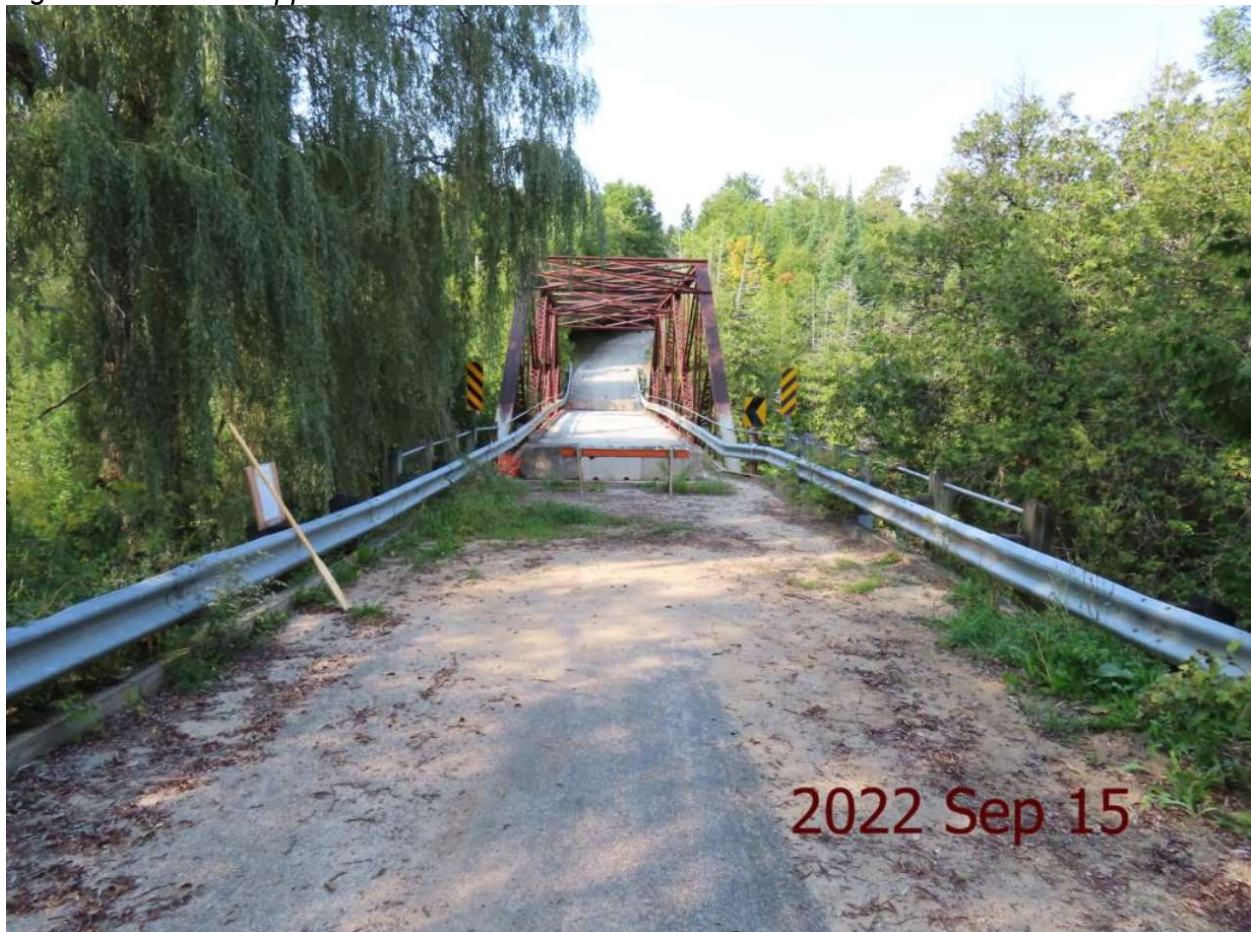
Figure 4.19: South Approach View of Structure G-033

Daily traffic volumes used as part of the analysis in this *Bridge Prioritization Program* were from 2016, prior to the closure of Traverston Bridge. With relatively minimal use from the local transportation users, indicated by low daily traffic volumes when the structure was a functioning component of the transportation network, and minimal changes to traffic patterns and emergency

response times, Structure G-033 is a candidate proposed for continued closure.

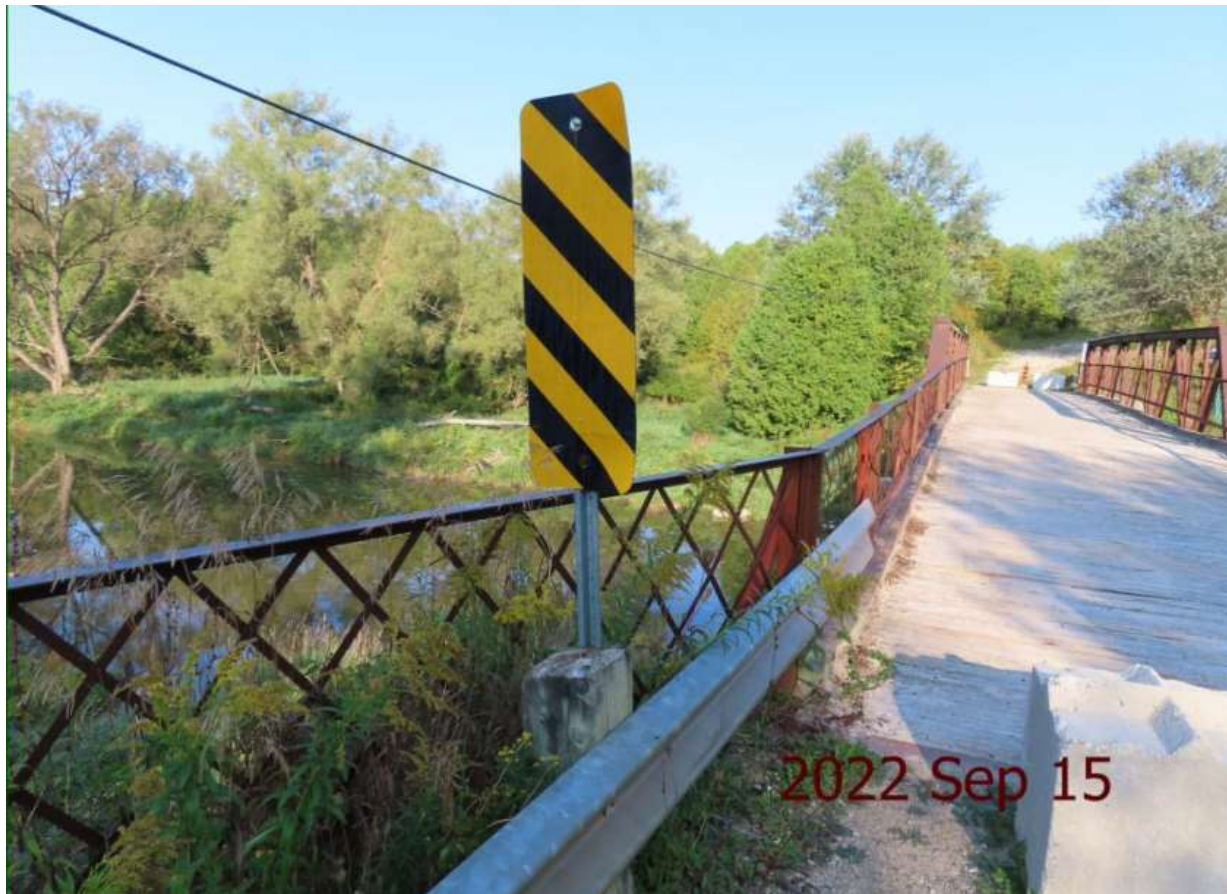
Figure 4.20: South Approach View of Structure N-070

Structure N-070 experiences a low volume of daily traffic with respect to other structures in the Municipality. It is located on Concession 2 WGR, which provides a low level of service to the properties on this road segment and is discontinuous throughout its north-south length. For these reasons, Structure N-070 is a candidate proposed for closure.
