MUNICIPALITY OF
West Grey

Municipality of West Grey
Bridge Prioritization Program

February 2025

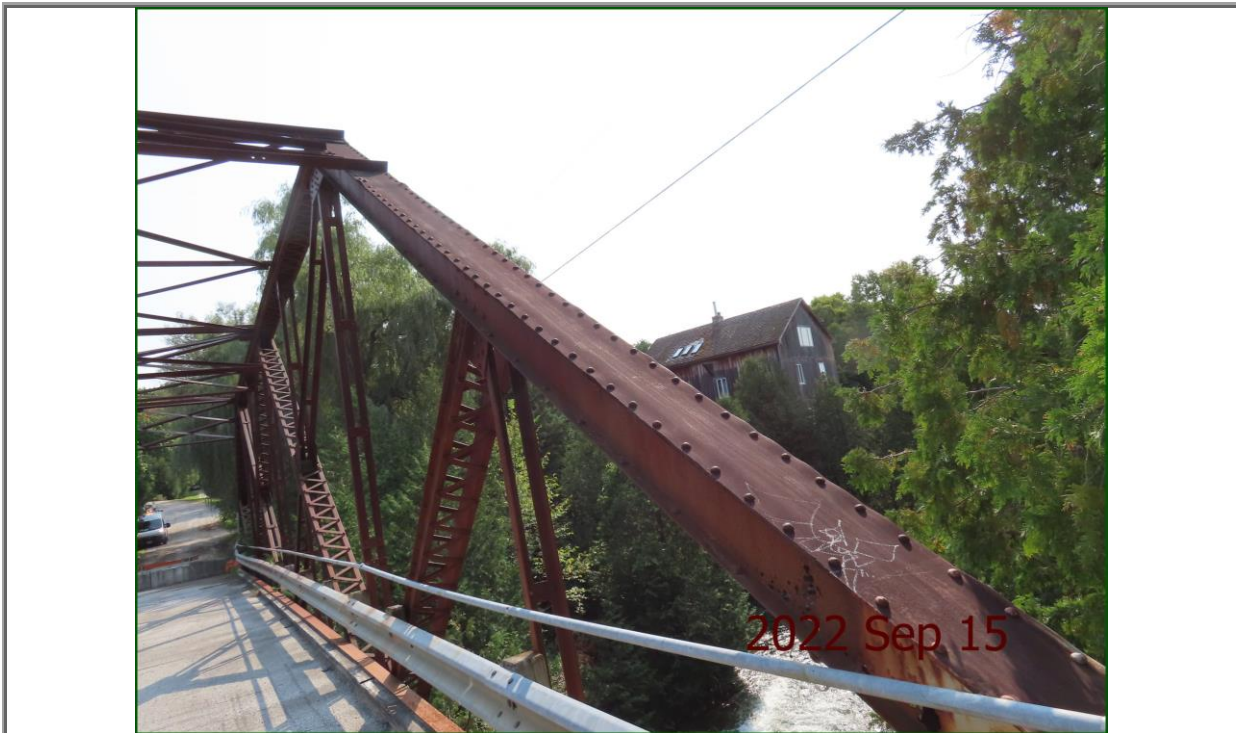
Areas of medium to severe corrosion with 100% section loss.

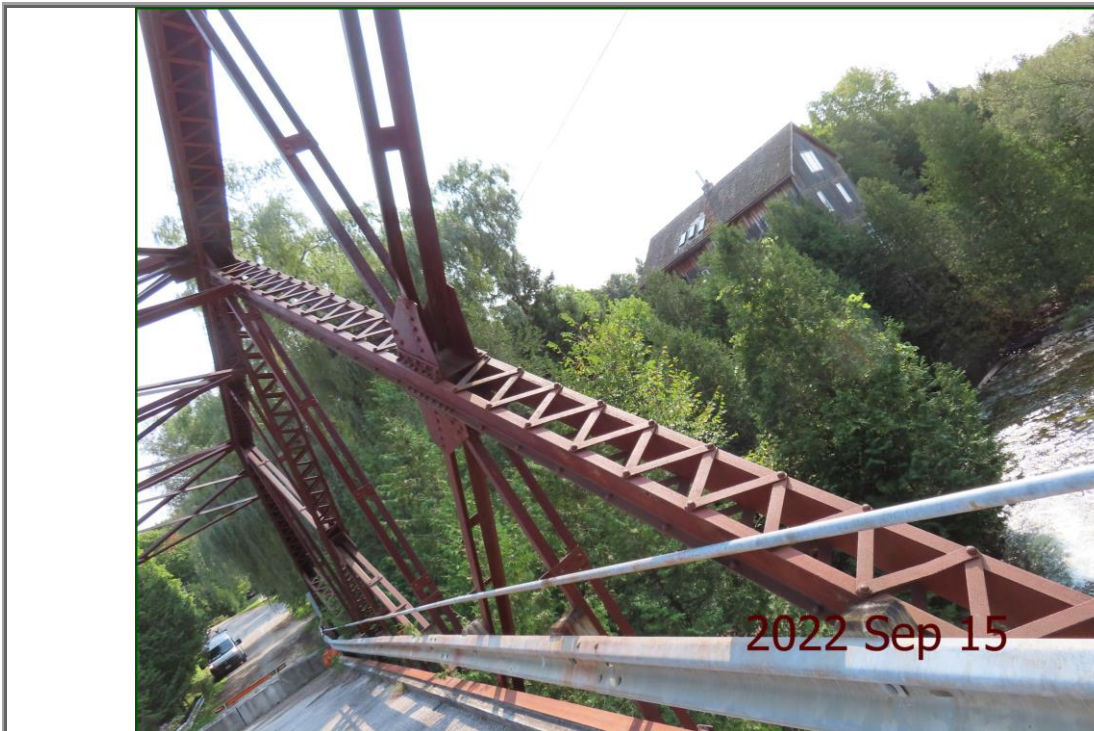
Light to moderate corrosion throughout. Impact damage on various diagonals.

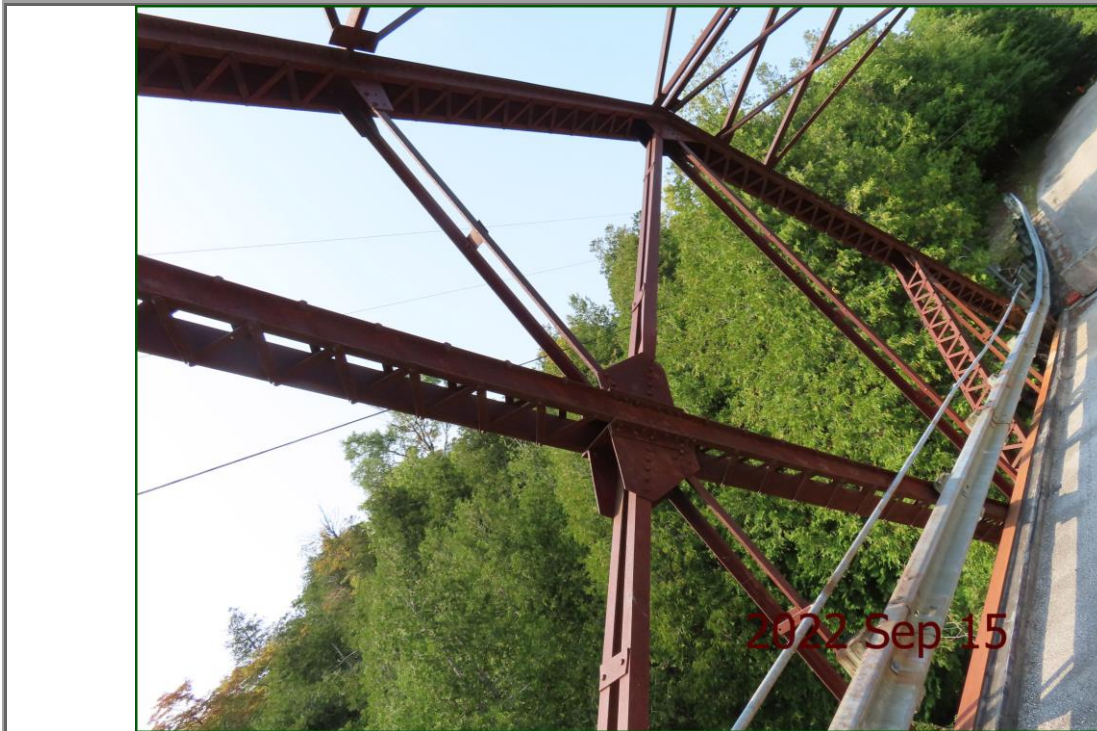
Light to moderate corrosion throughout.

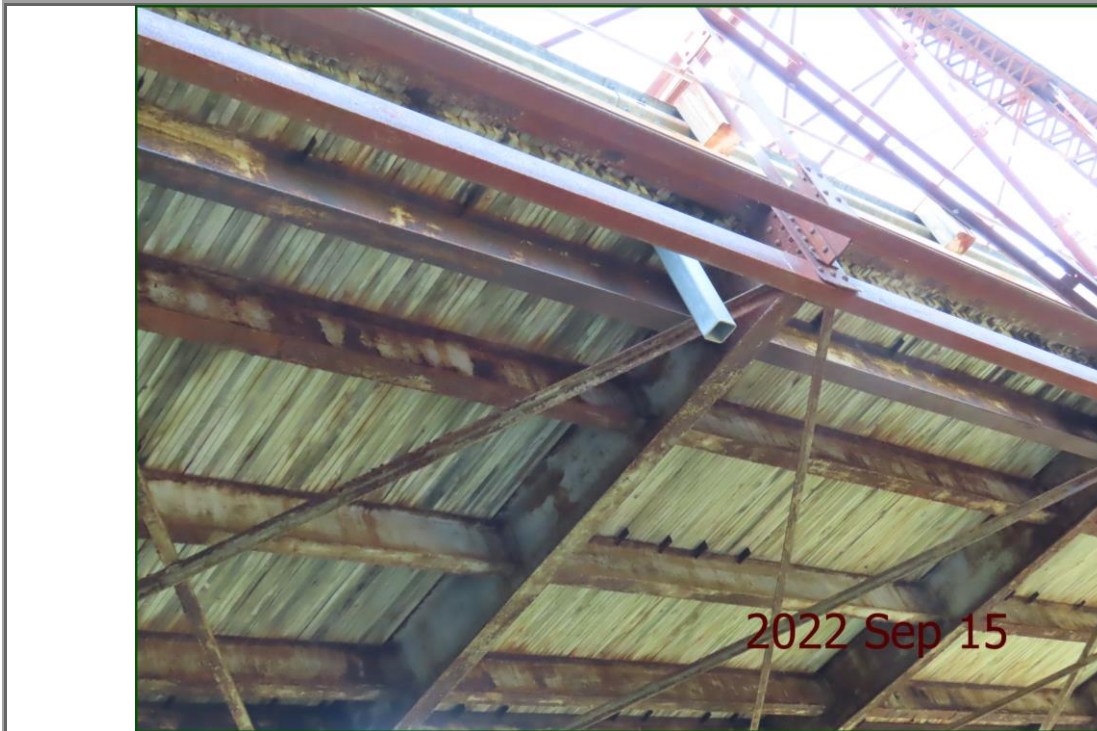
Areas of moderate to severe corrosion throughout. COUNT SEEMS OFF (TAKEN FROM PREVIOUS REPORT).

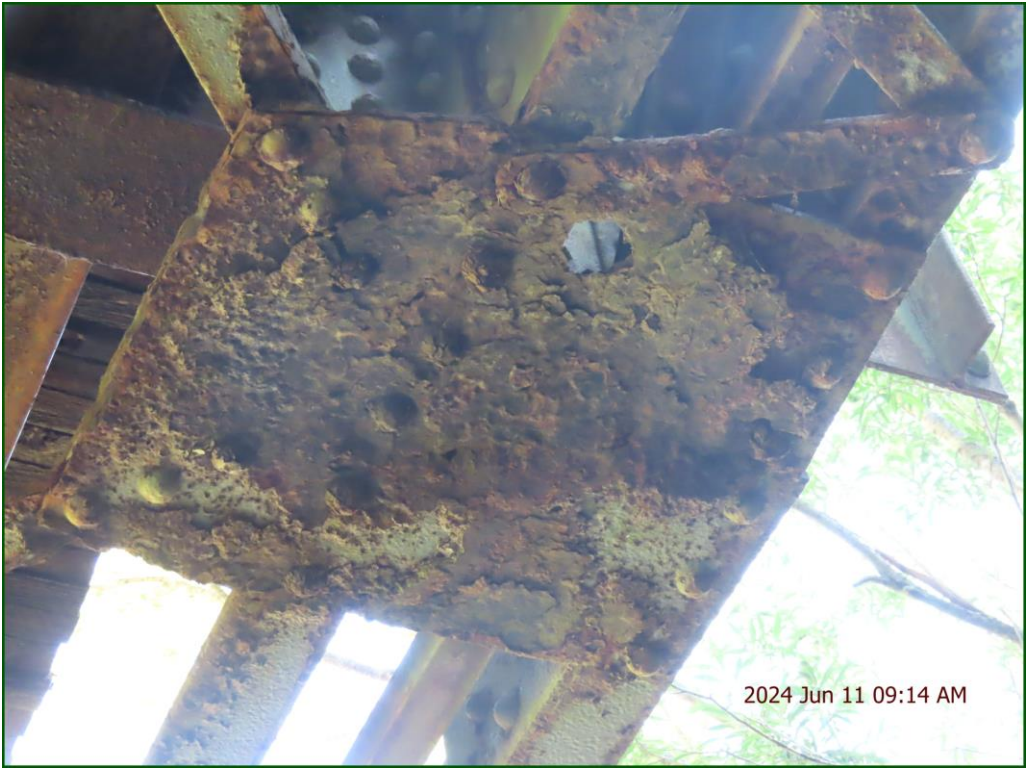
Description: Connections: Moderate to severe corrosion with areas of 100% section loss.

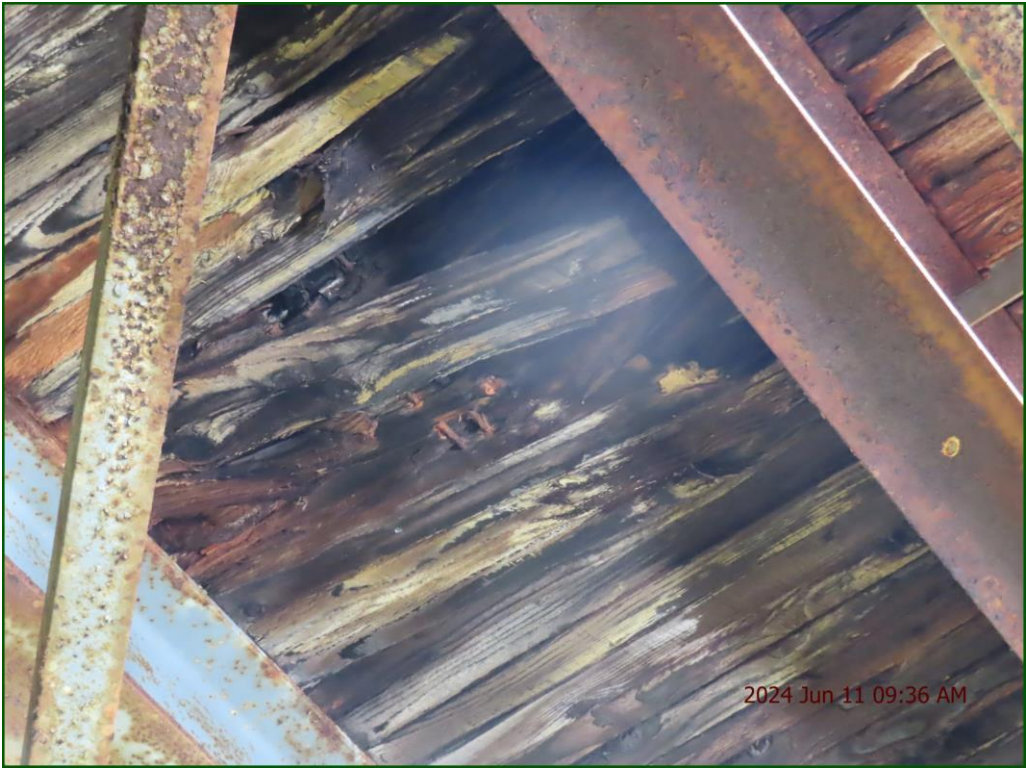
Description: Soffit: Localized area of severe rot resulting in hole in sofft (1/2).

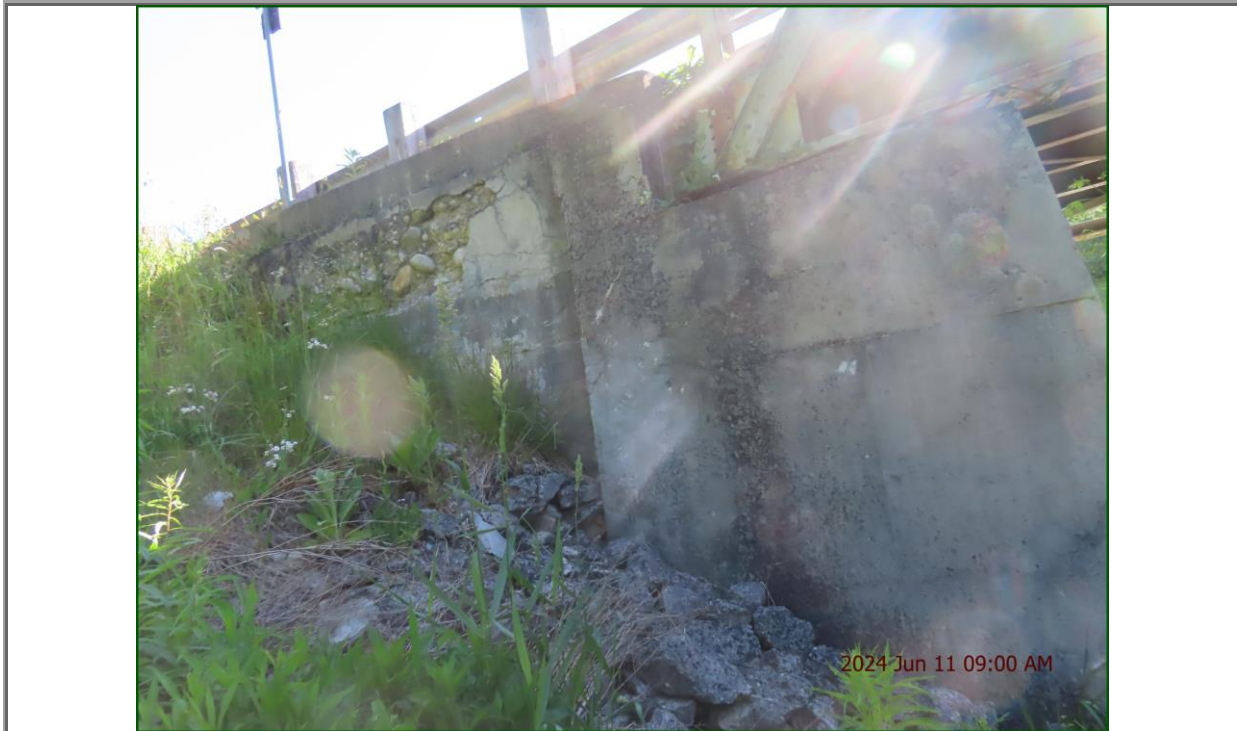
Severe spalling and disintegration. Wide cracking.

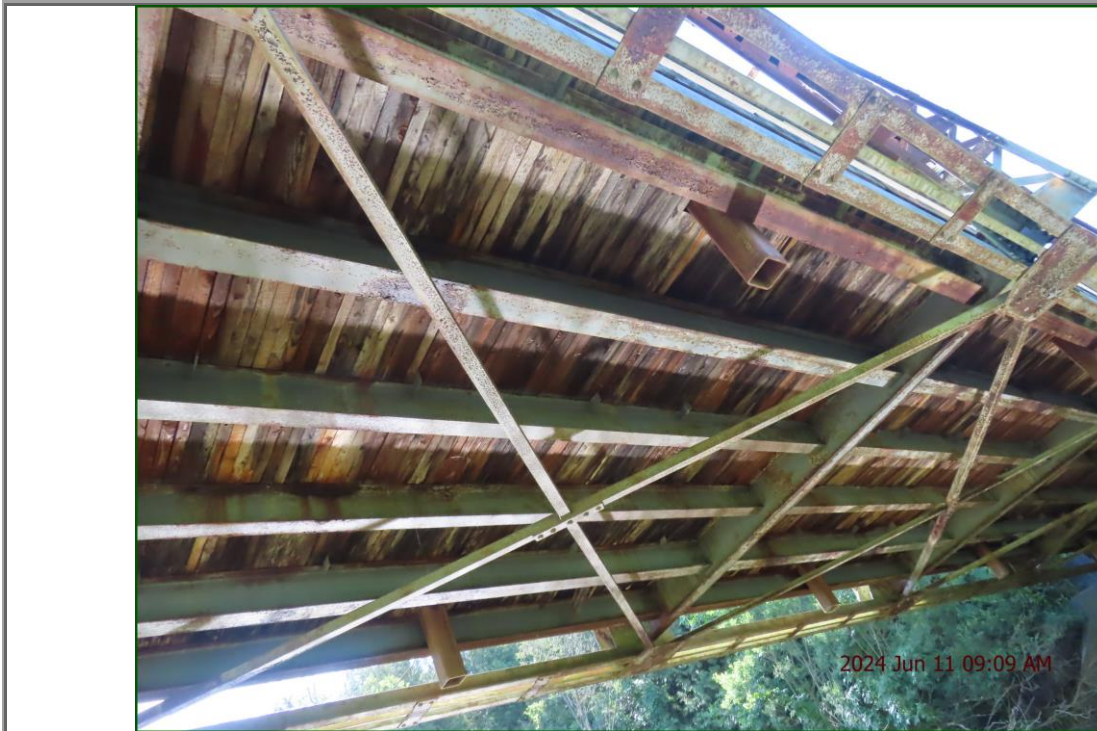
Deck soffit full of moisture, ends appear sound. Localized area of severe rot resulting in hole in soffit.

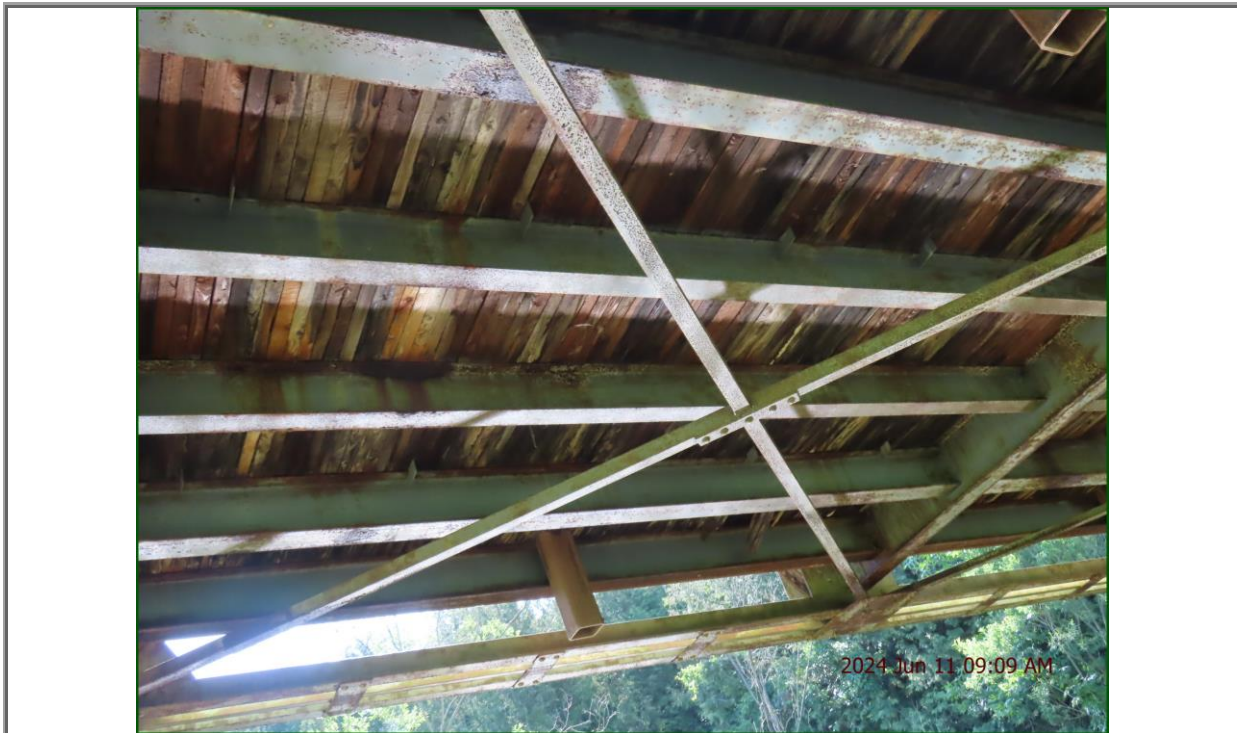
Limited inspection due to stringer ends due to height of abutments. Light to corrosion throughout.

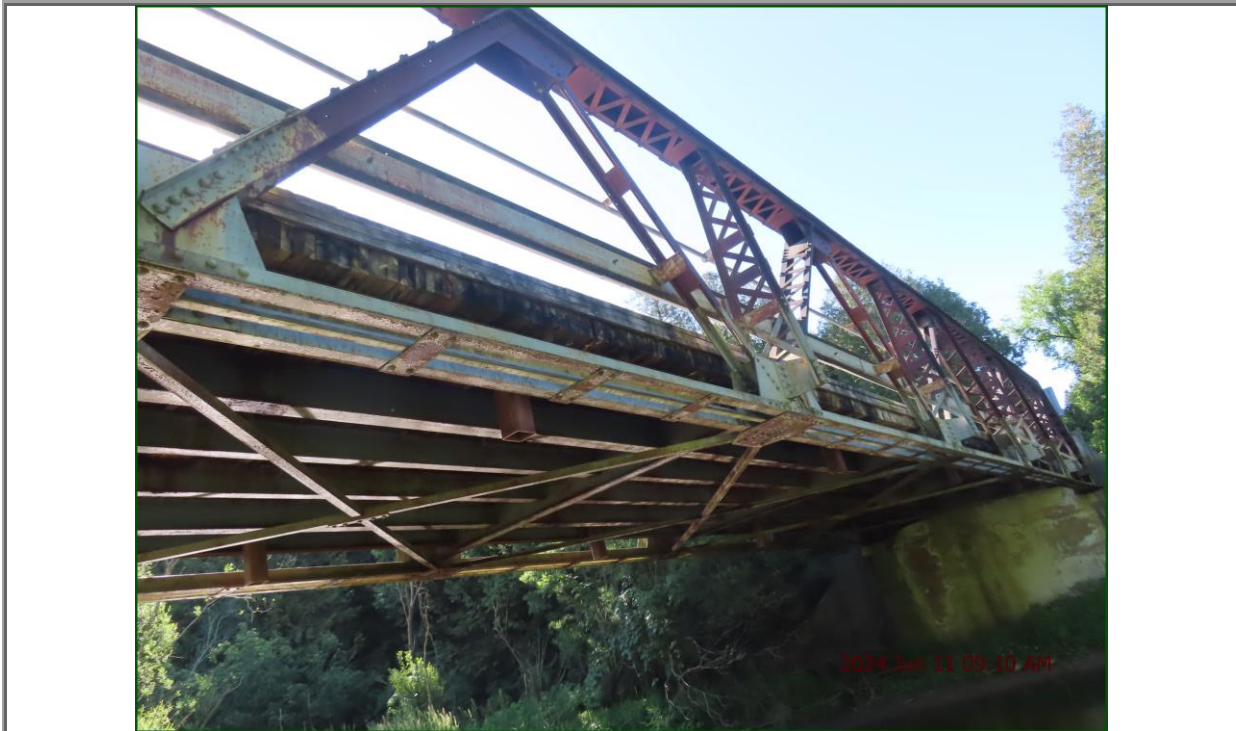
Severe corrosion at ends with areas of 50% section loss. Additional members added. Repair noted on west bottom chord.

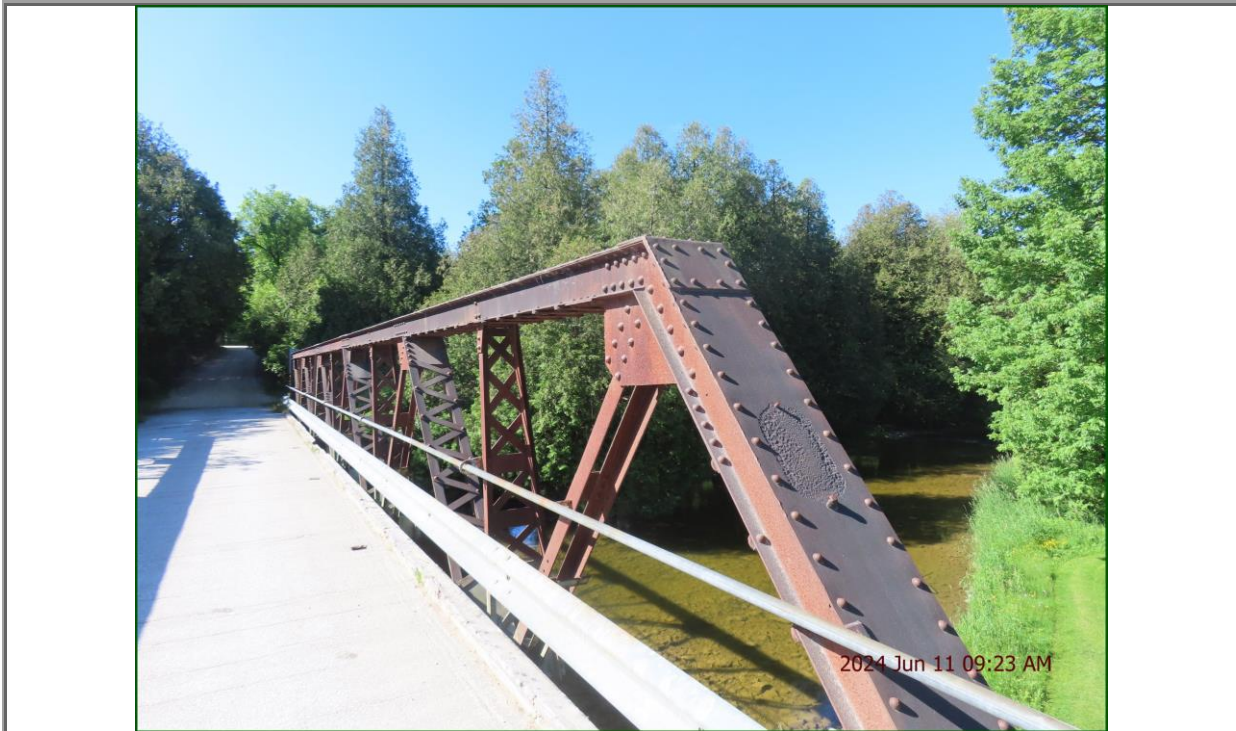
Light corrosion throughout.

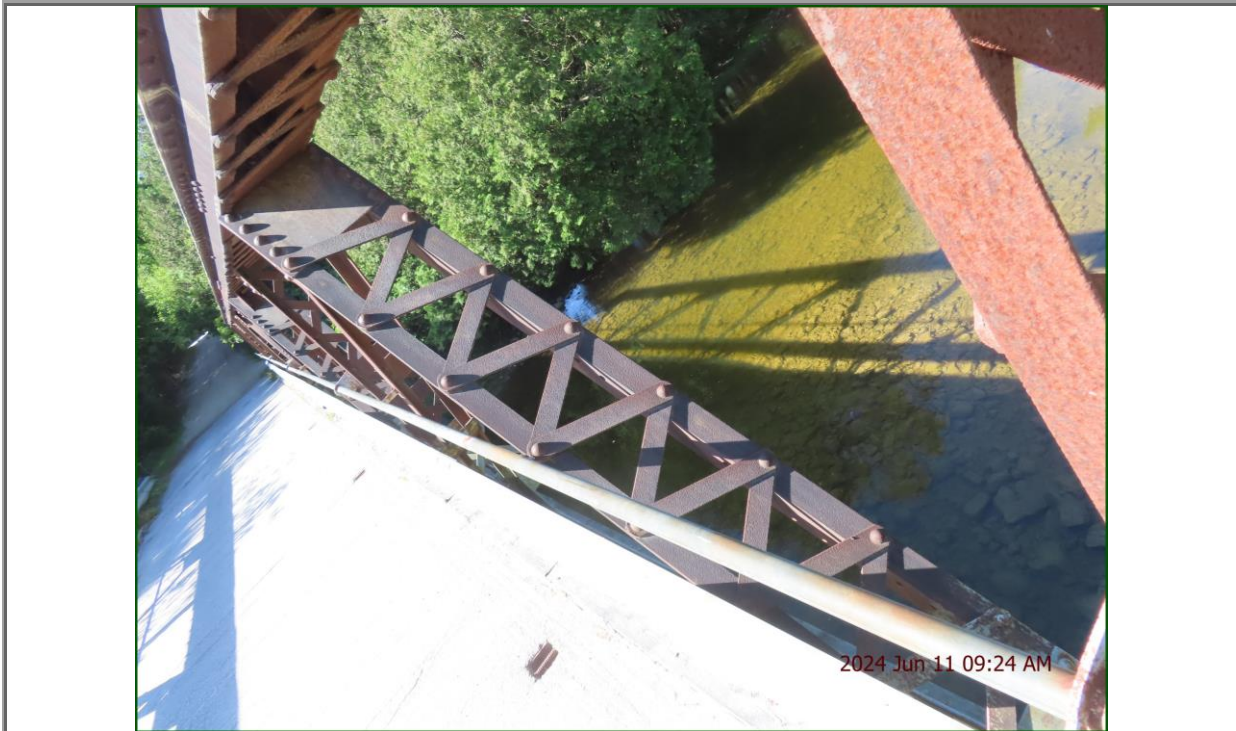
Light corrosion throughout. Railing system welded to structure. Structural steel plates welded to diagonals.

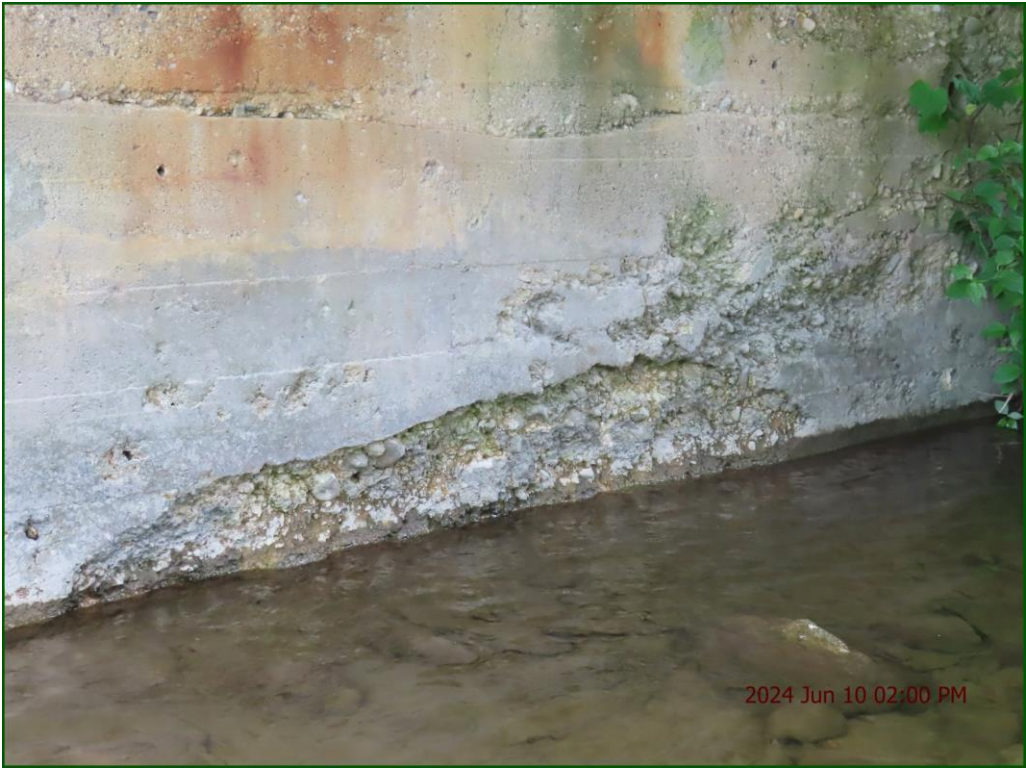
Description: Abutment Walls: Severe spalling with disintegration throughout.

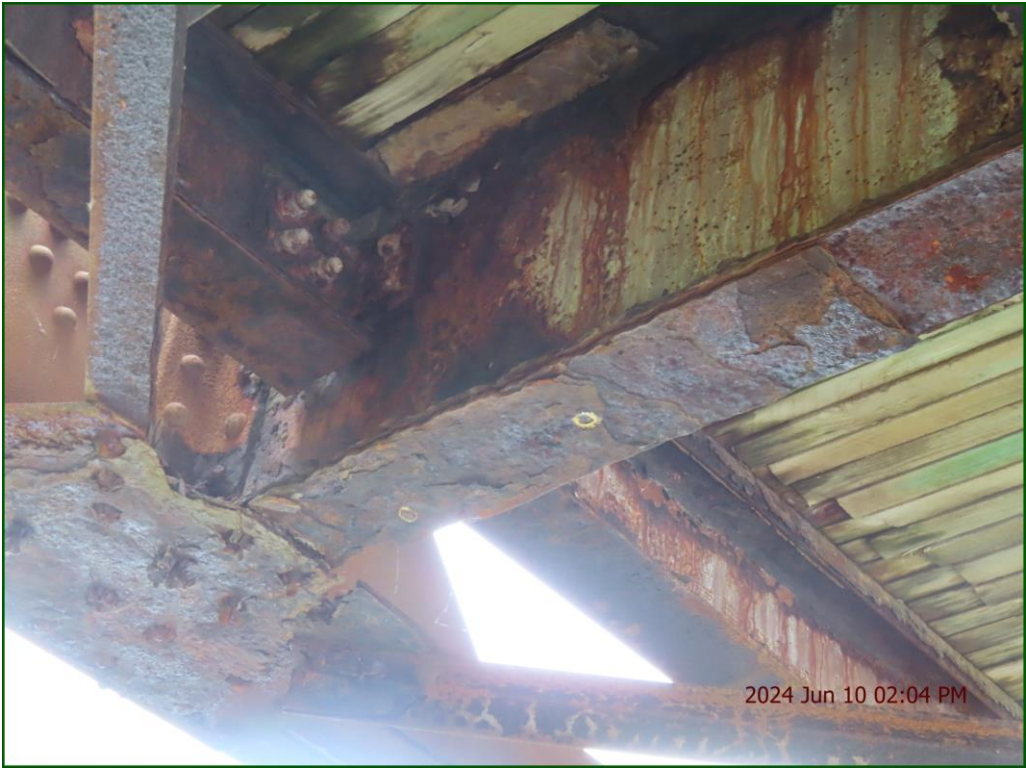
Description: Floor beams: Medium to severe corrosion at various connections to stringers (2/2).

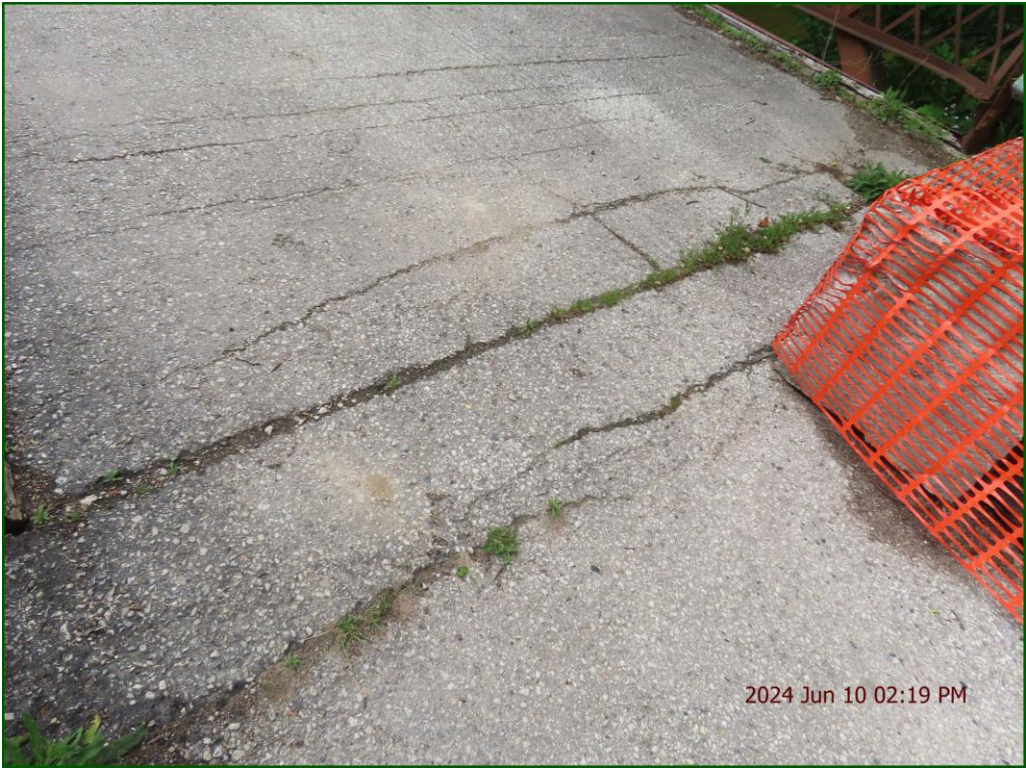
Description: Approach Wearing surface: Wide cracking along joints.

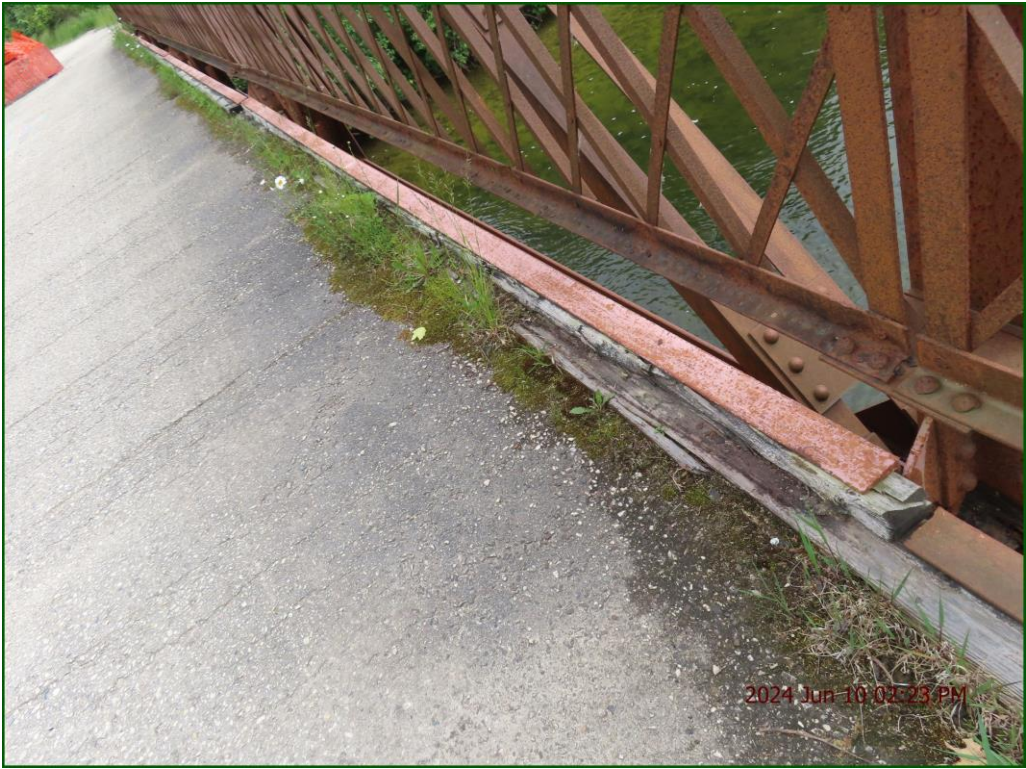
Description: Curbs: Moderate to severe rotting throughout.

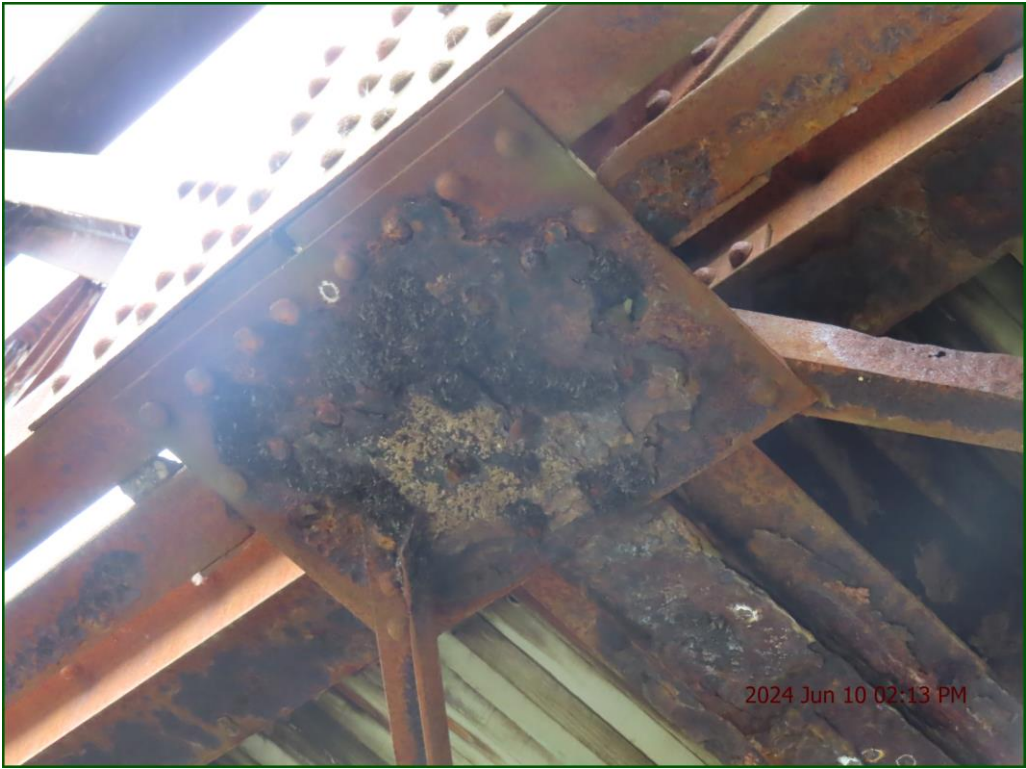
Description: Connections: Severe corrosion with areas of 100% section loss.

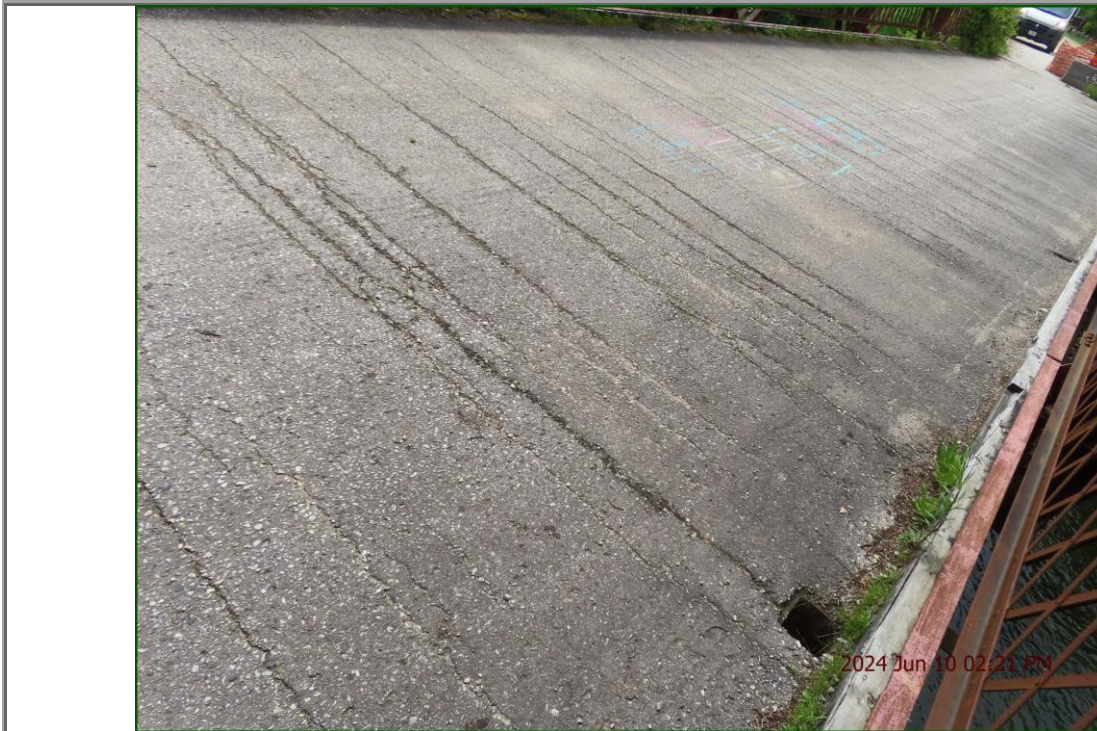
Wide transverse cracking throughout.

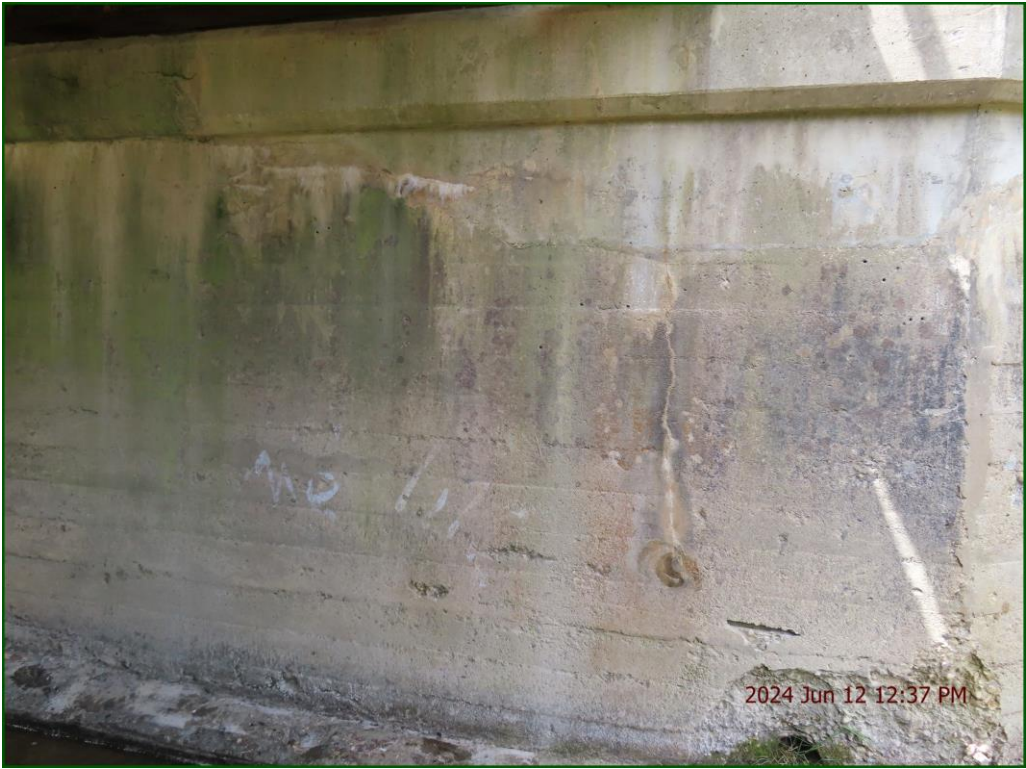
Description: Abutment walls: Light to medium vertical cracking with leachate staining throughout.

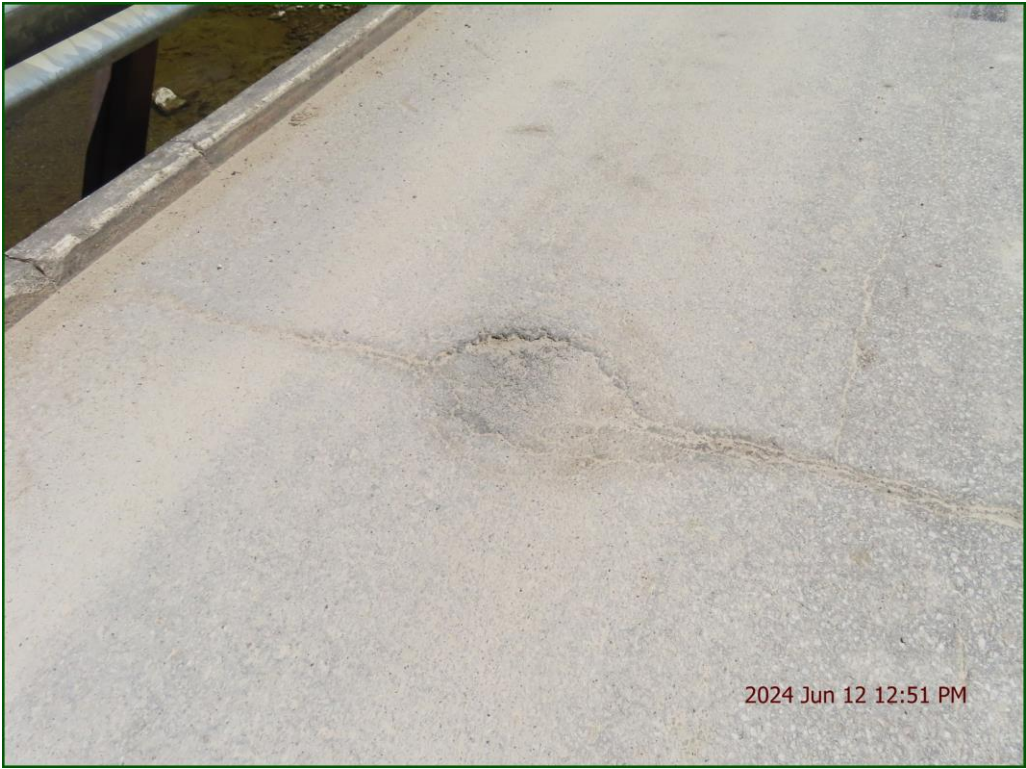
Description: Wearing surface: Moderate pothole at midspan appear to be cold patched.

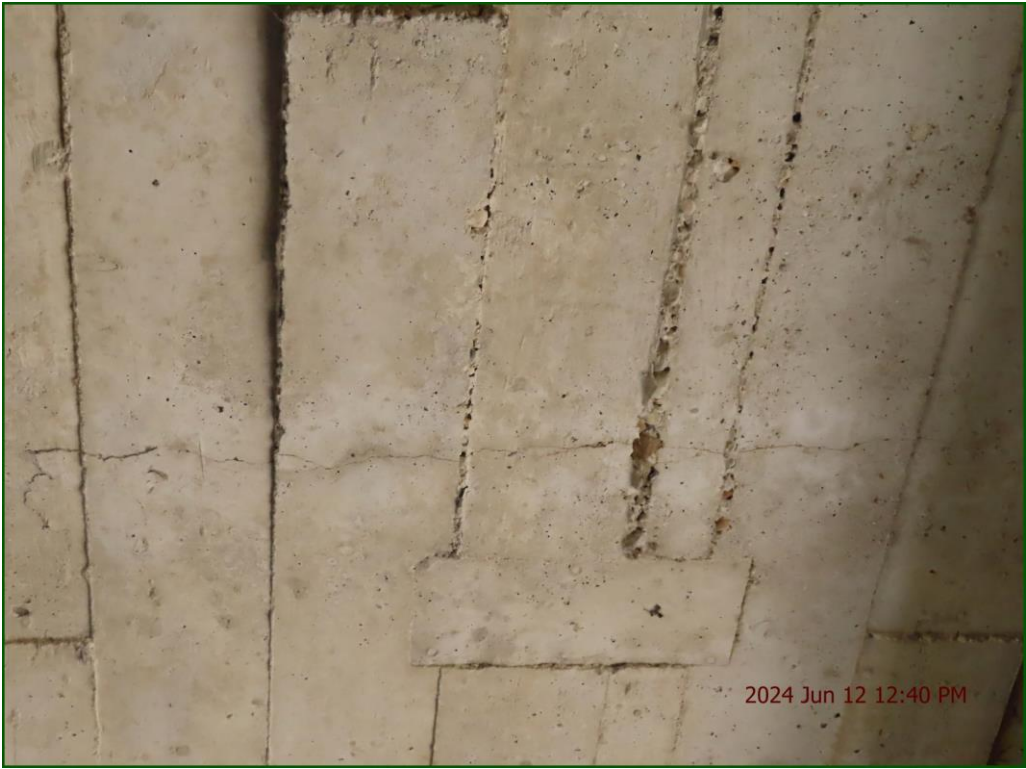
Description: Soffit: Light to medium transverse cracking throughout.

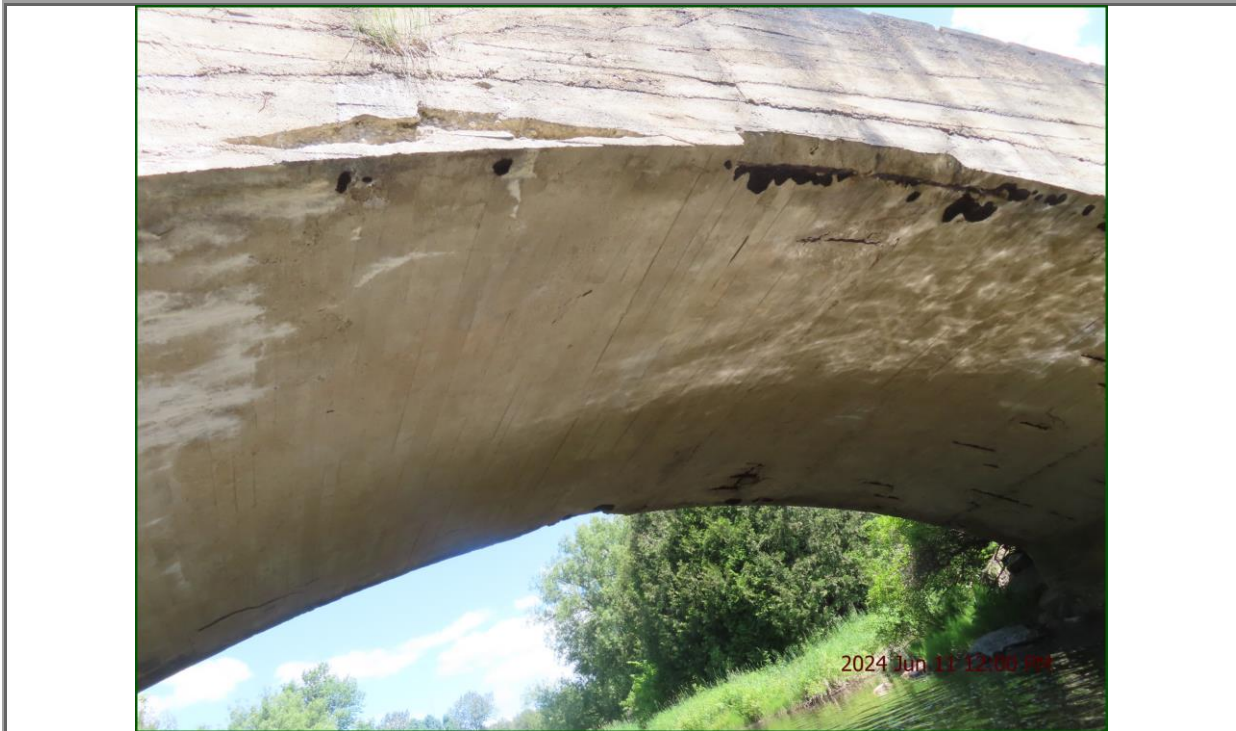
Severe spalling with exposed reinforcing throughout. Medium map cracking with leachate staining, just west of midspan. Severe disintegration throughout.

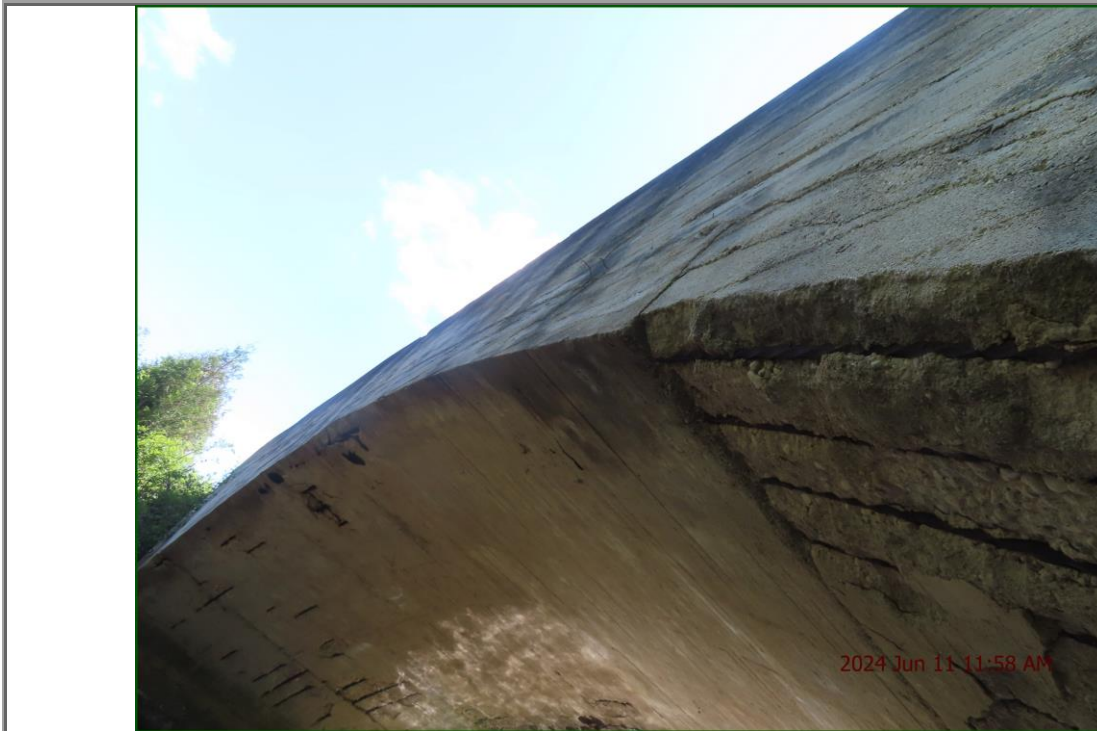
Severe spalling with exposed reinforcing throughout. Medium longitudinal cracking with leachate staining. Light to medium honeycombing throughout. Severe disintegration throughout.

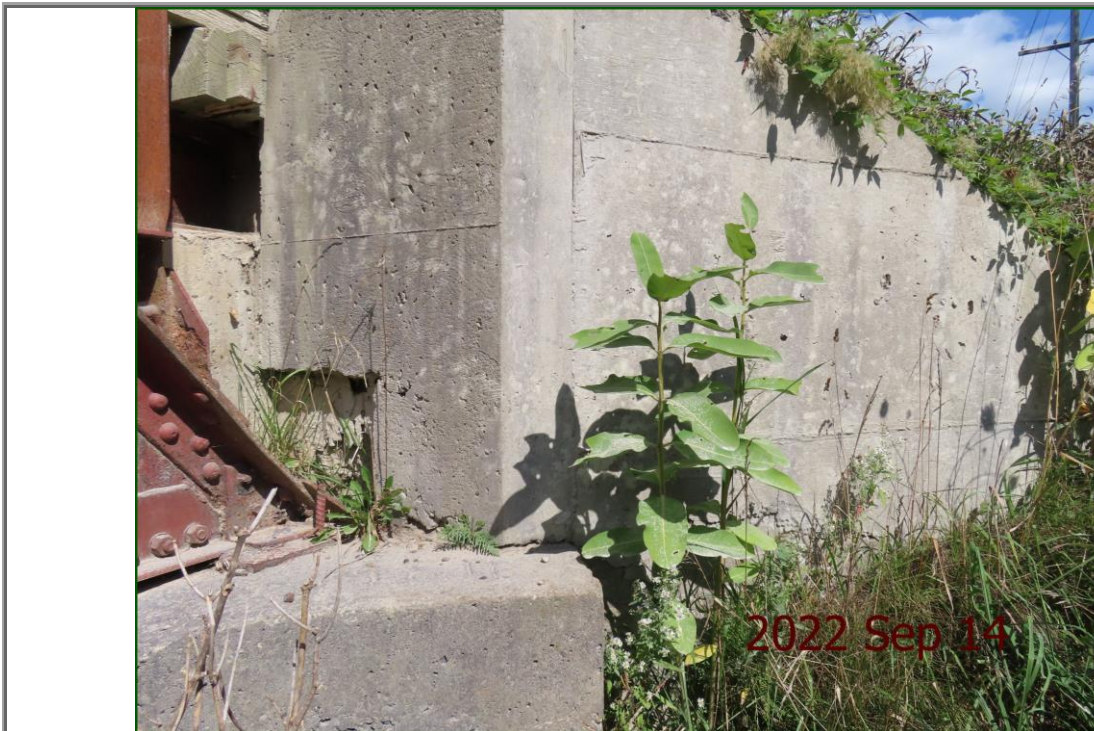
Severe spall and possible crushing.

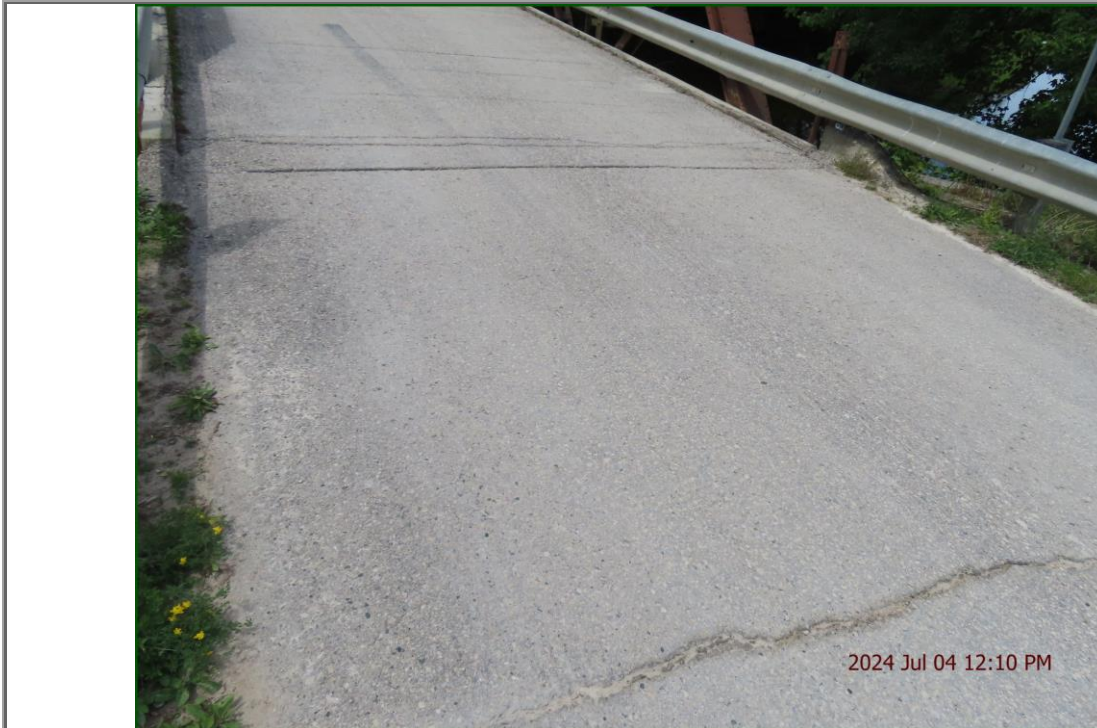
Wide transverse crack.

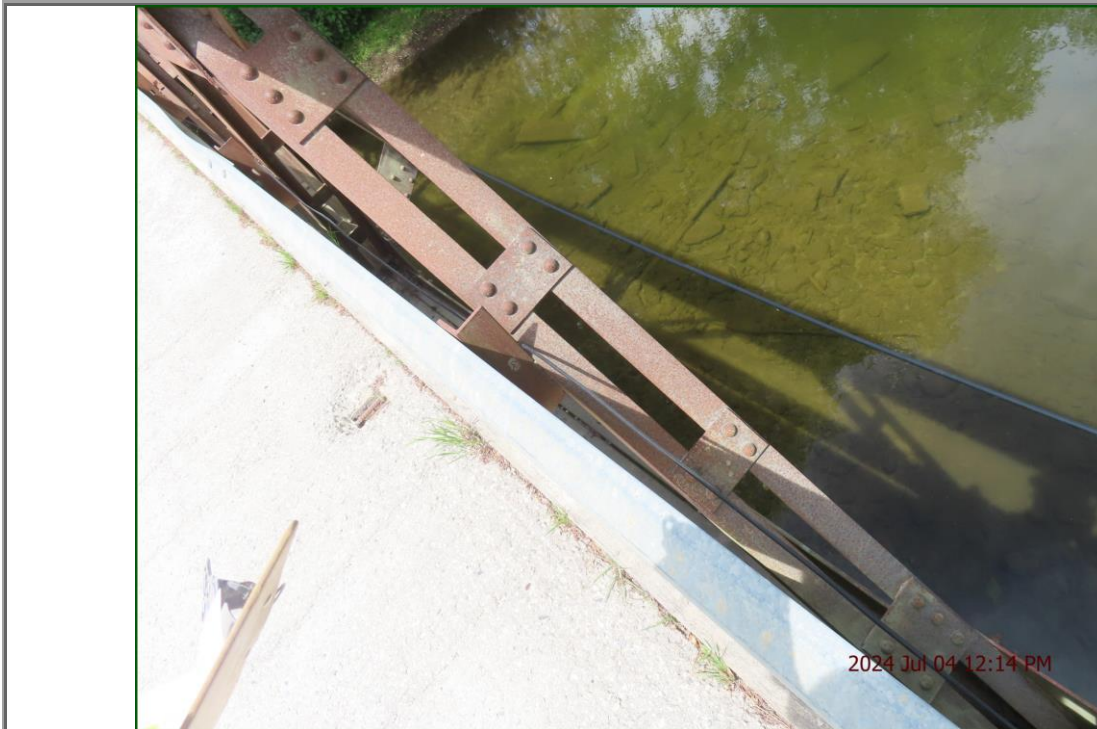
Severe impact damage resulting in bent vertical.

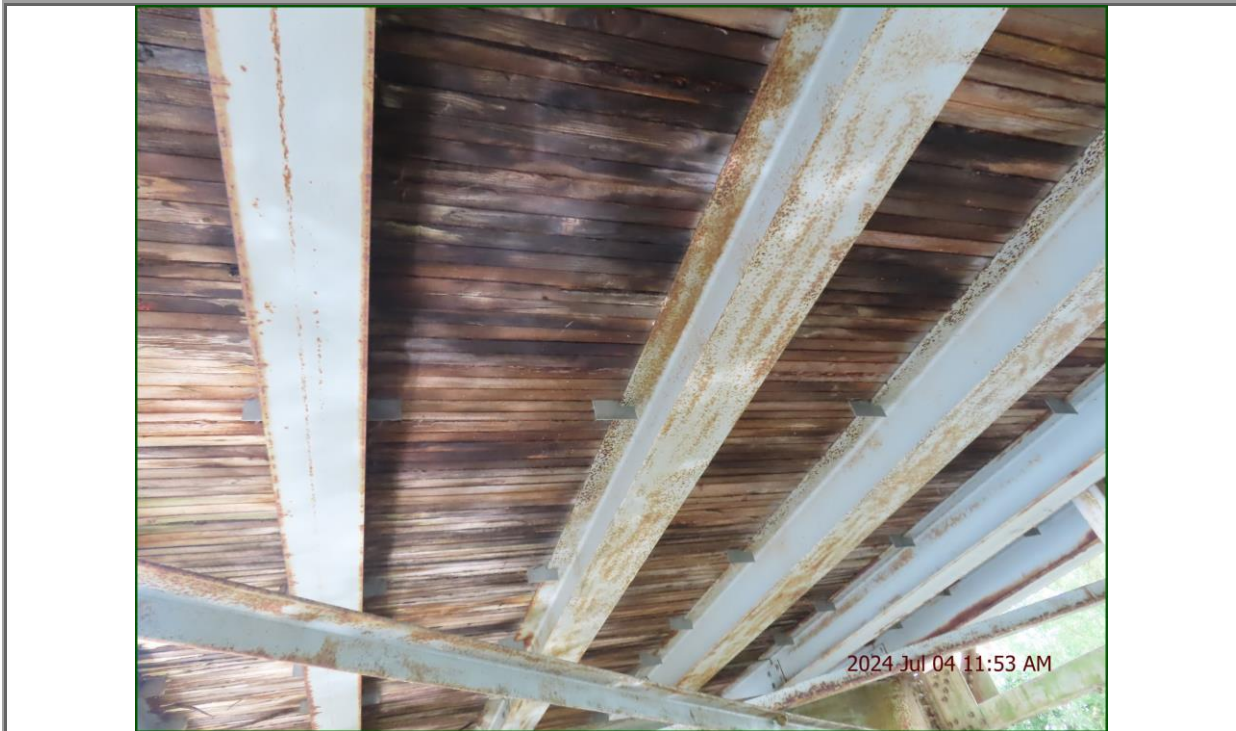
Moderate to severe rotting throughout. Severe rot SW quadrant resulting in deck/soffit failure (local).
