MUNICIPALITY OF
West Grey

Municipality of West Grey
Bridge Prioritization Program

February 2025

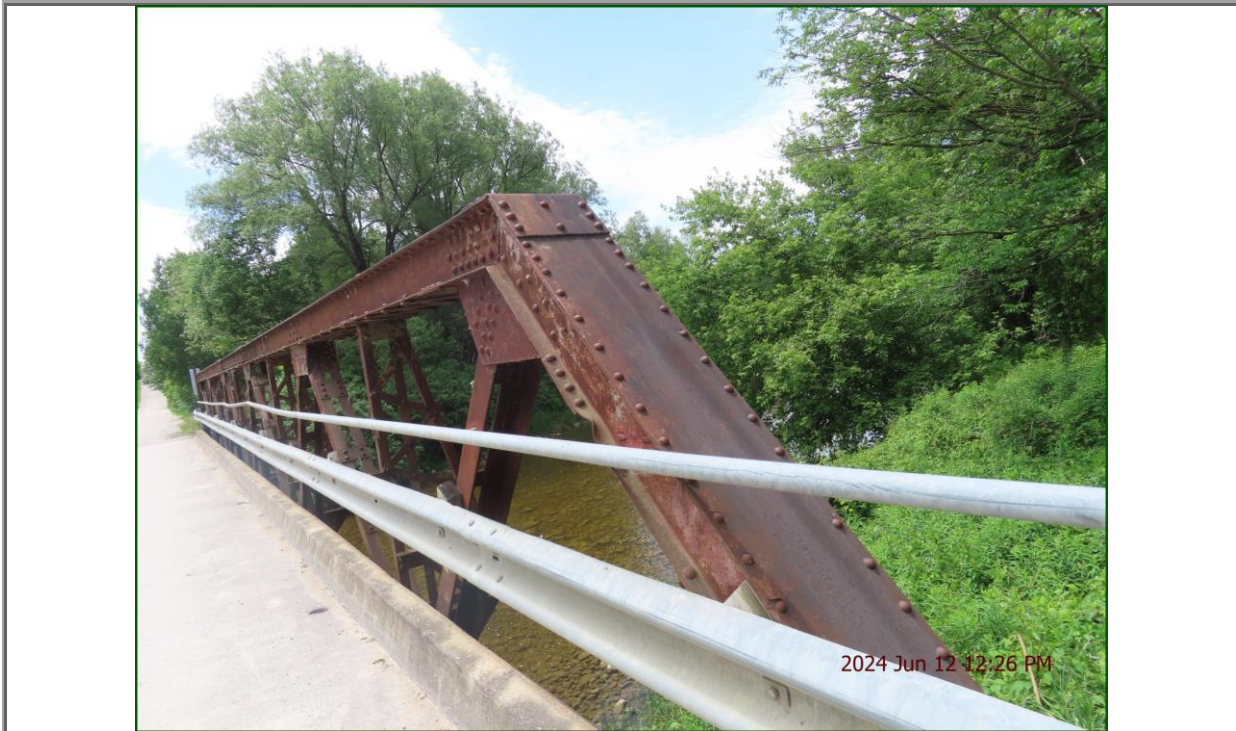
Light corrosion throughout. Areas of impact damage.

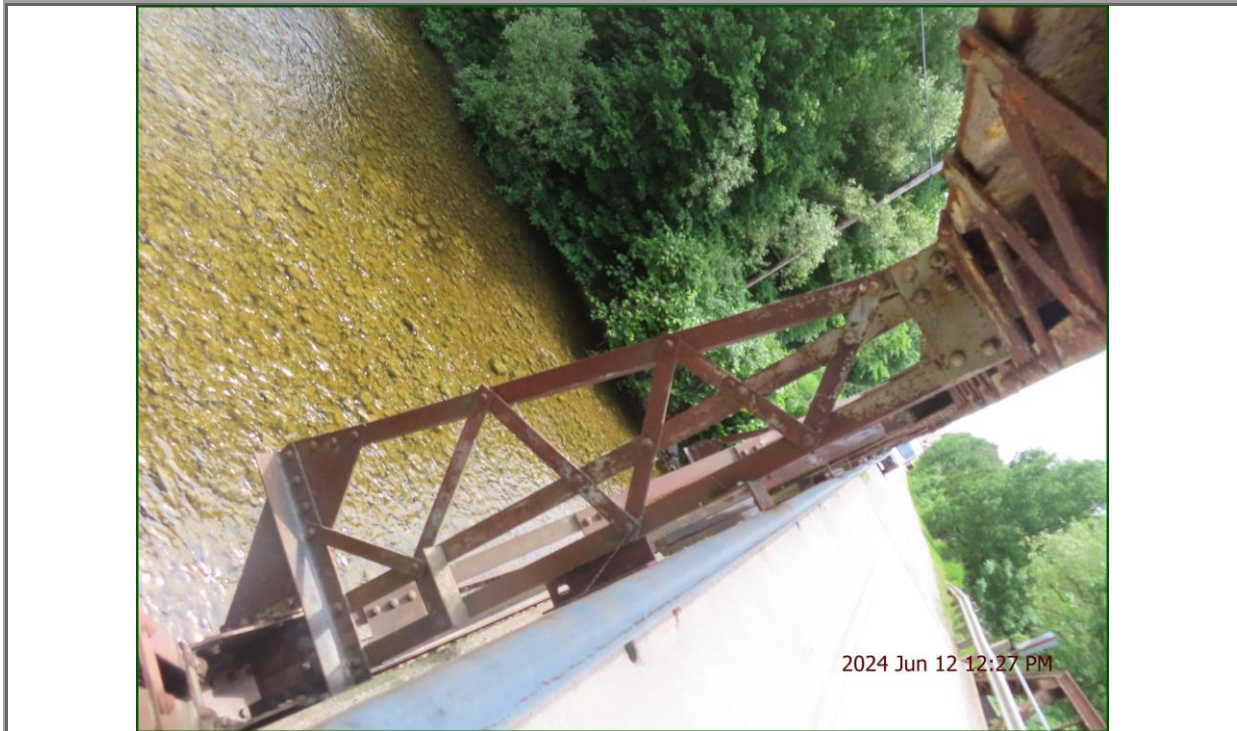
Light corrosion throughout. Moderate impact damage.

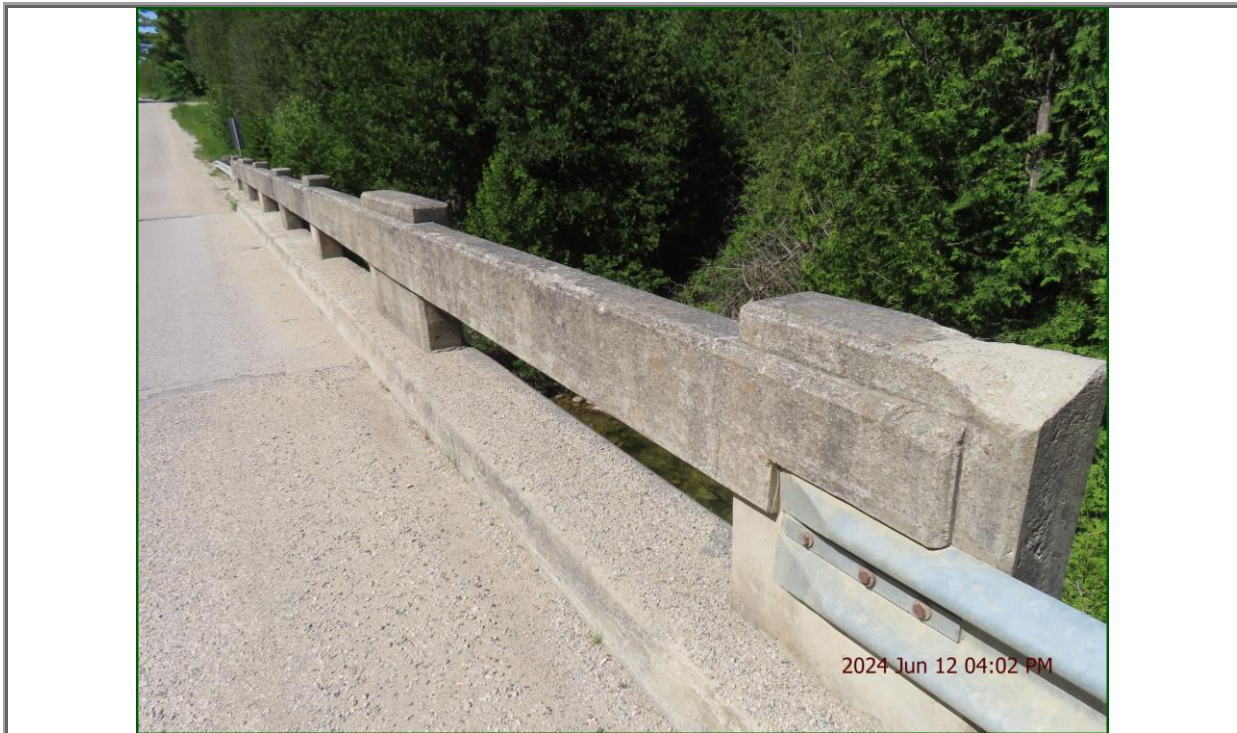
Localized shallow spall at SE corner. Light to medium vertical cracking throughout. Shallow delamination throughout.

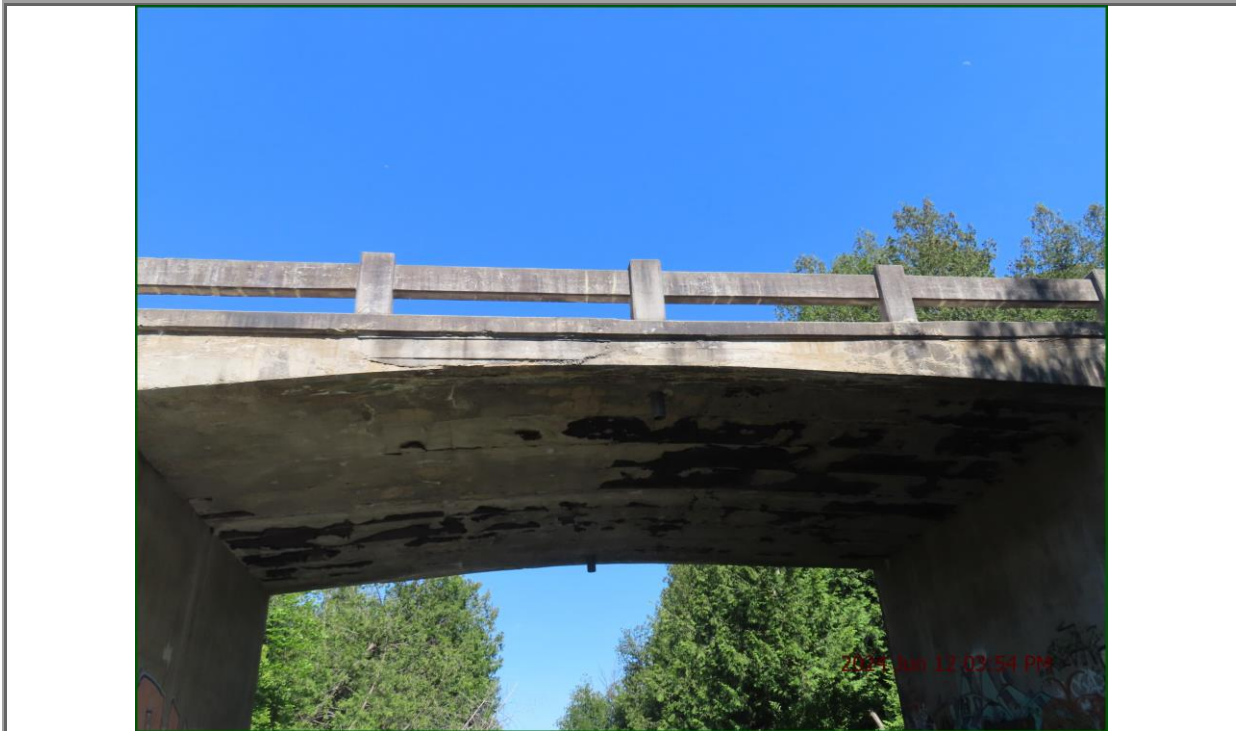
Medium to wide map cracking with leachate staining and stalactite. Moderate spalls throughout and disintegration. Moderate to severe delamination.

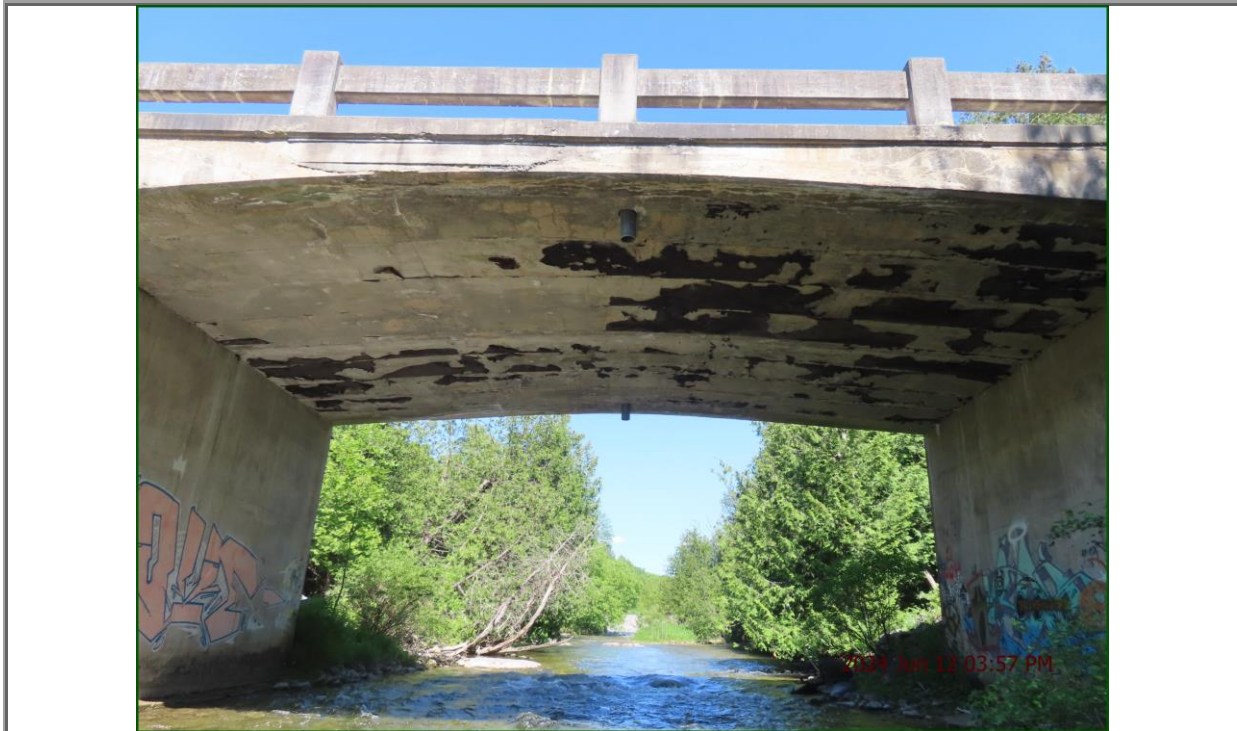
Moderate delamination. Light to moderate honeycombing. Light to medium longitudinal cracking at construction joints. Severe localized spall with exposed reinforcing at mid span.

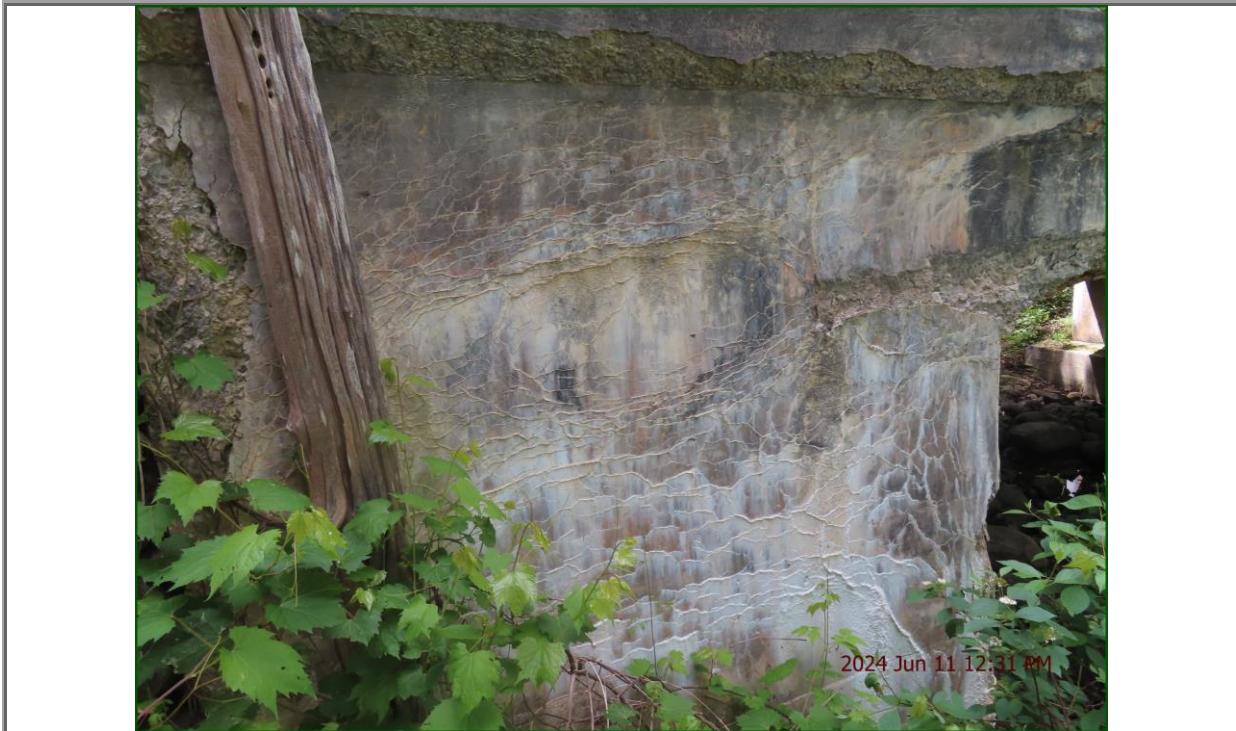
Medium to wide map cracking with leachate staining. Moderate spalling and disintegration.

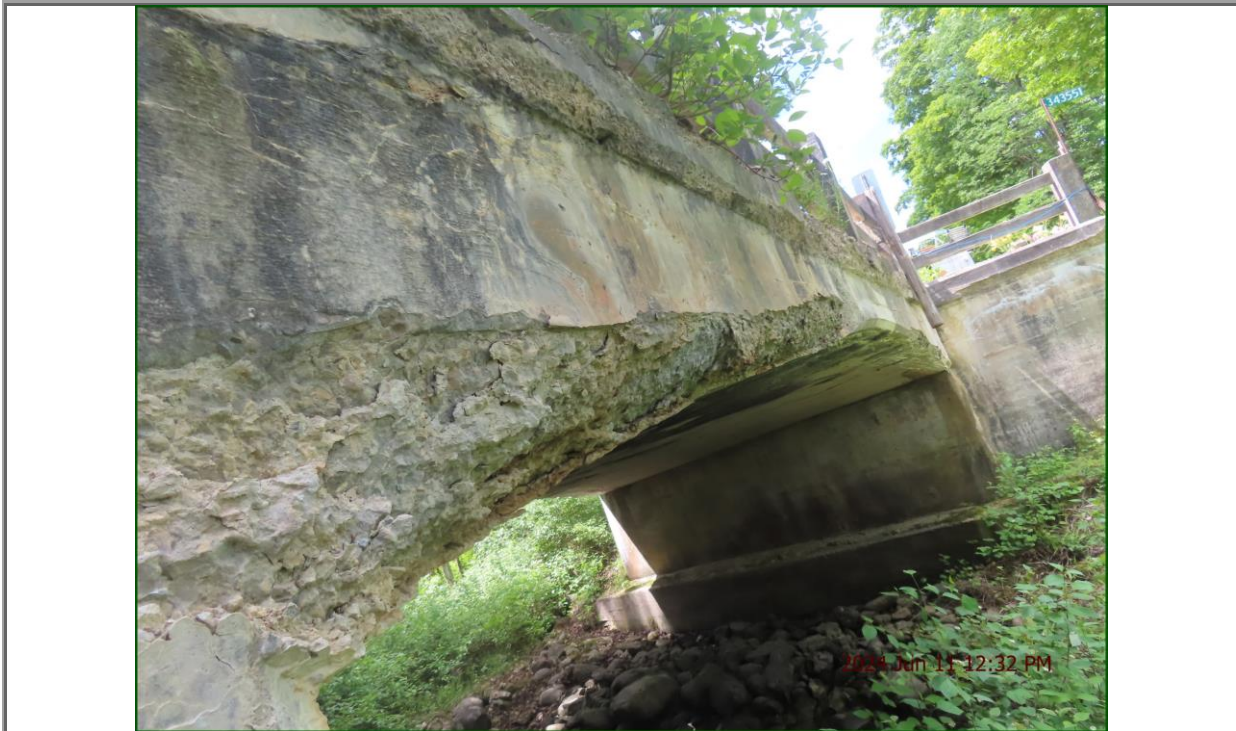
Severe disintegration throughout. Medium to wide map cracking with leachate staining. Severe spalling and disintegration with exposed reinforcing.
