OSIM Biennial Inspection Report

Concession 11/12, Lot 30

Burgess Engineering Inc

27-Aug-24

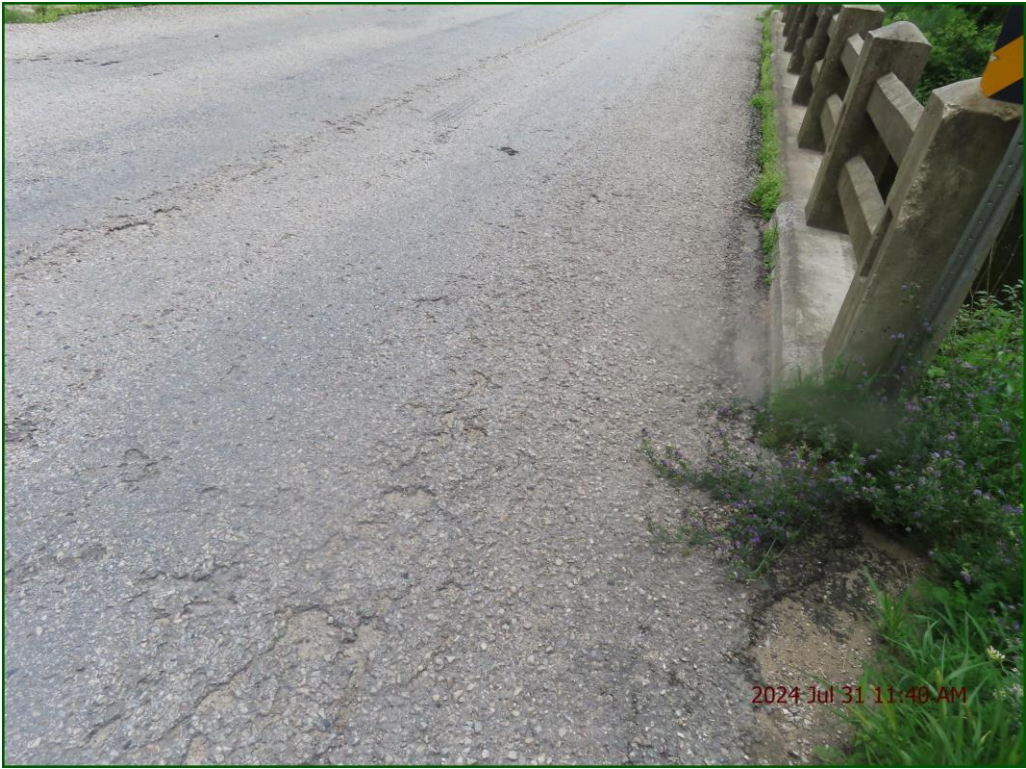
Description: Approach Wearing Surface: Severe ravelling along curline.

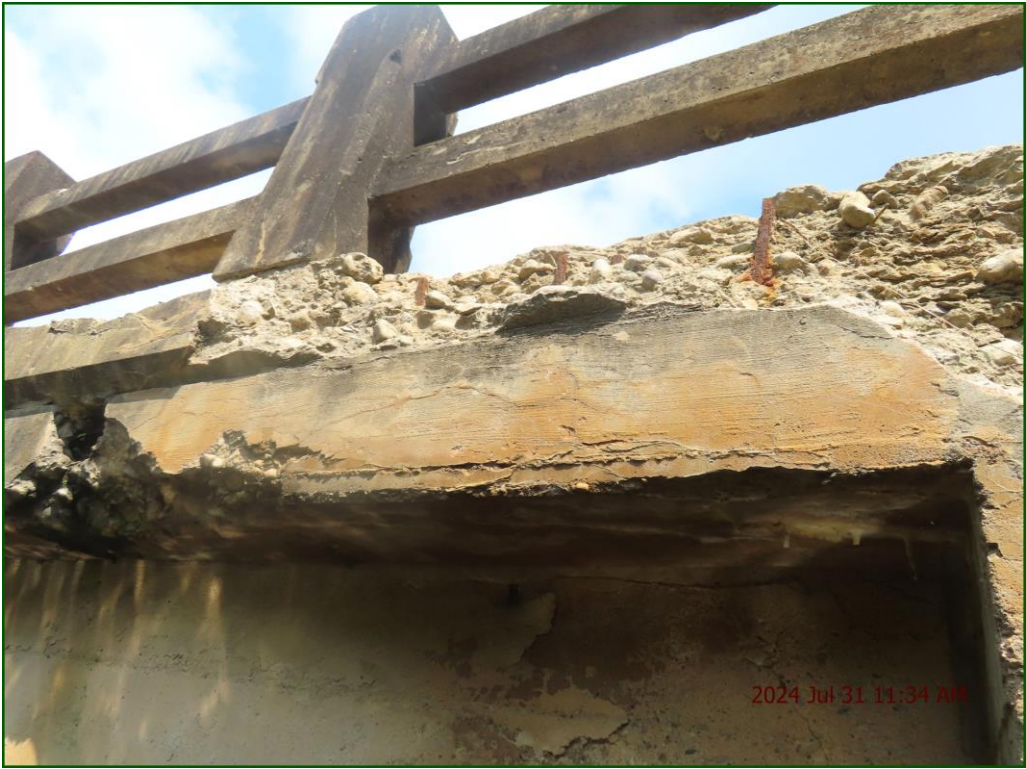
Description: Soffit (ext): Severe spalling with exposed reinforcing.

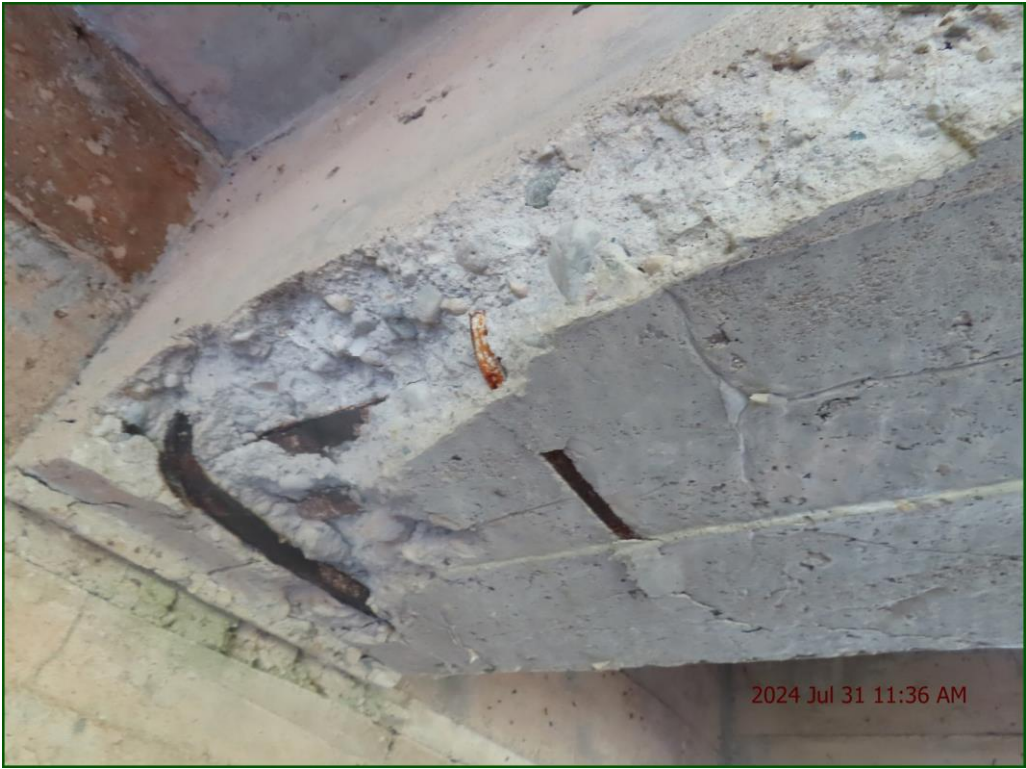
Description: Girders: Severe spall with exposed reinforcing throughout.

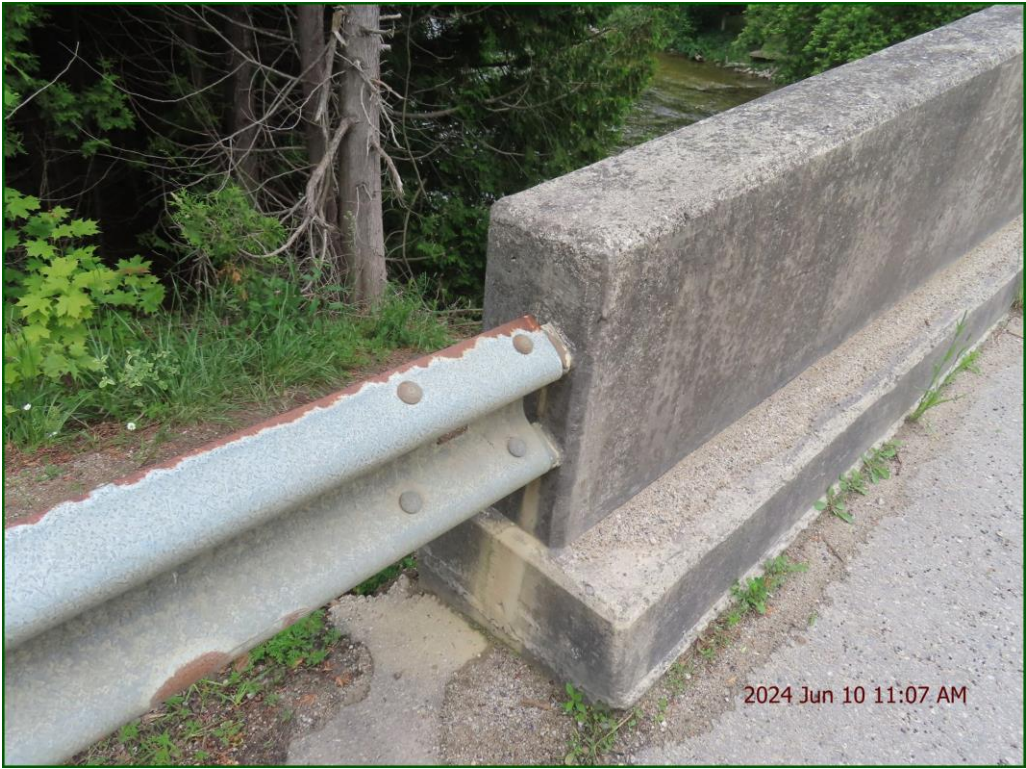
Description: Railing systems: Recommend to mount flexi beam on face of barrier.

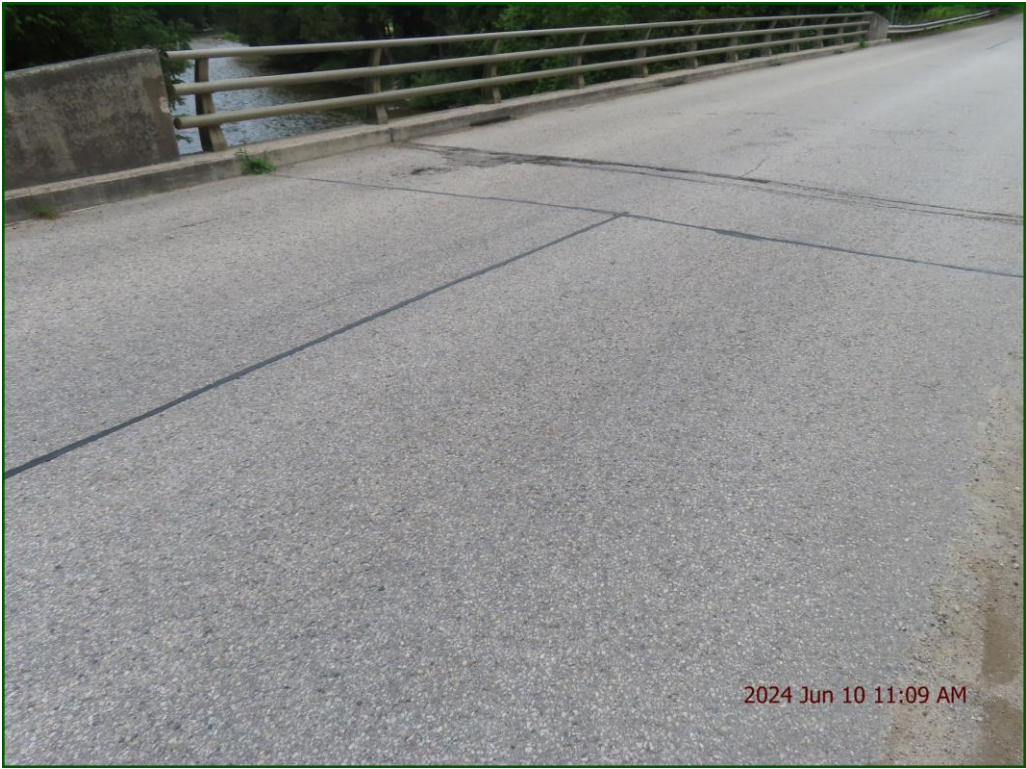
Description: Approach Wearing Surface: Joint sealing.

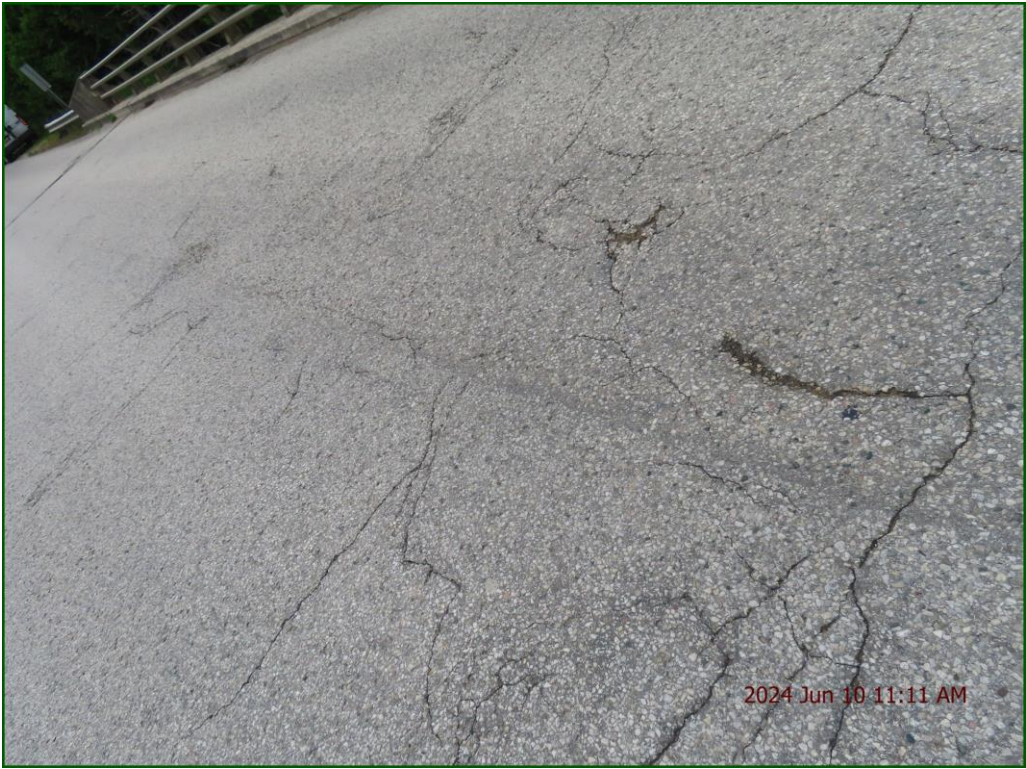
Description: Wearing Surface: Light to medium transverse cracking along joints.

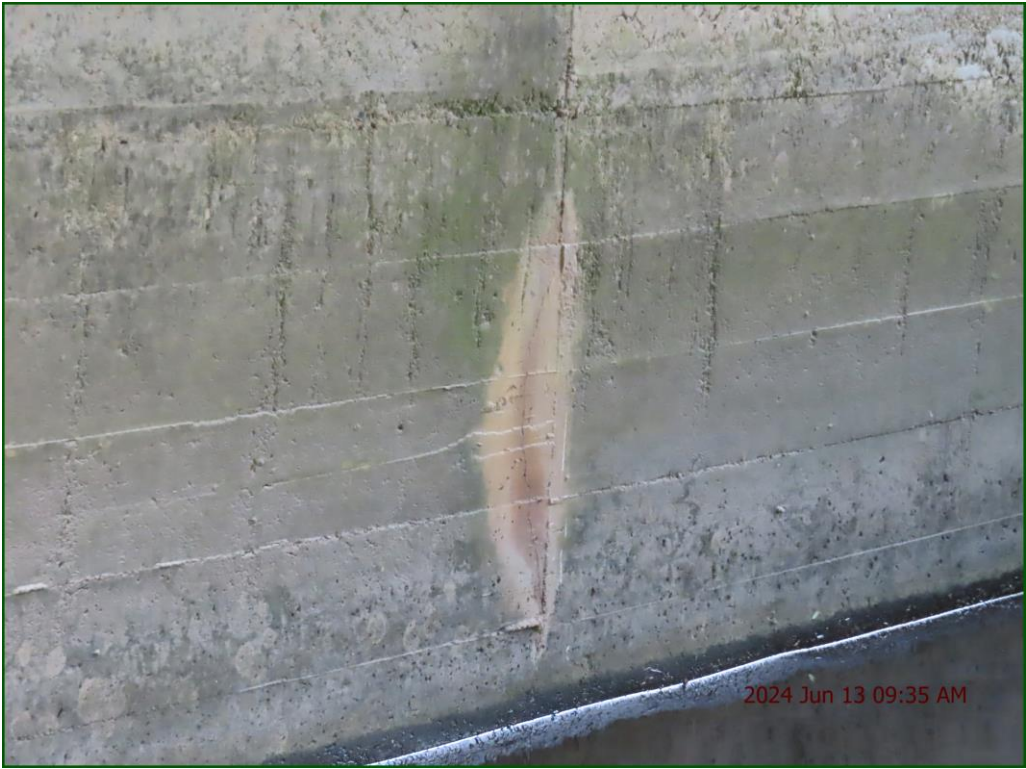
Description: Abutment walls: Light to medium vertical crack midspan on west abutment.

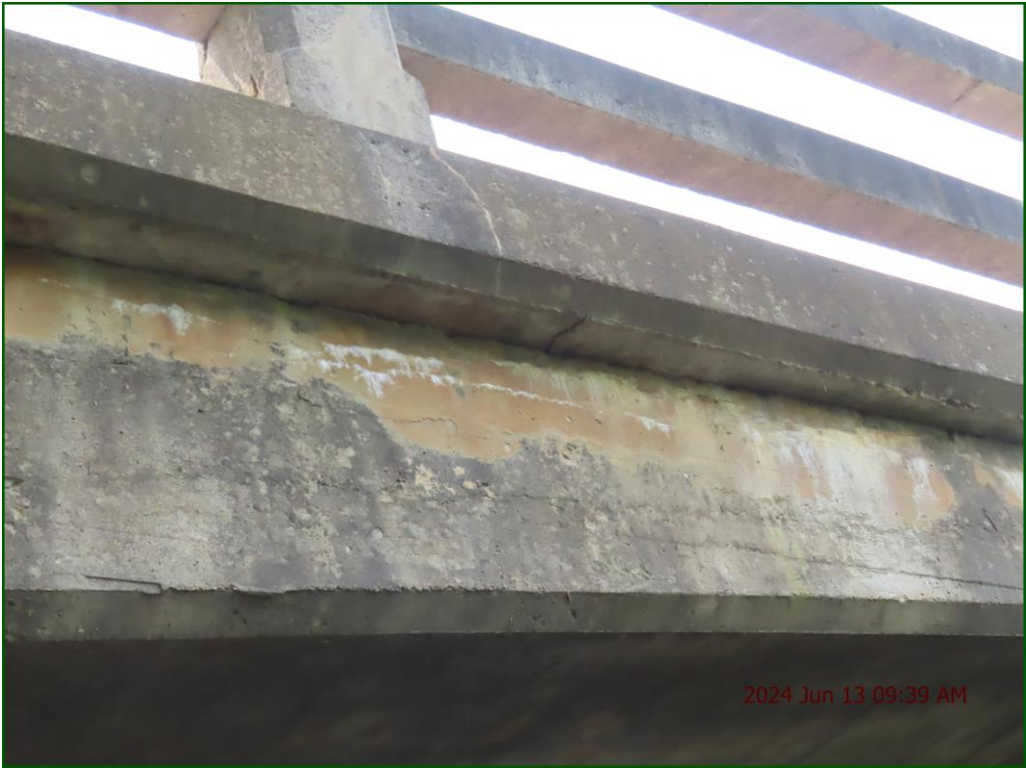
Description: Soffit (ext): Light to medium horizontal cracks with leachate staining.

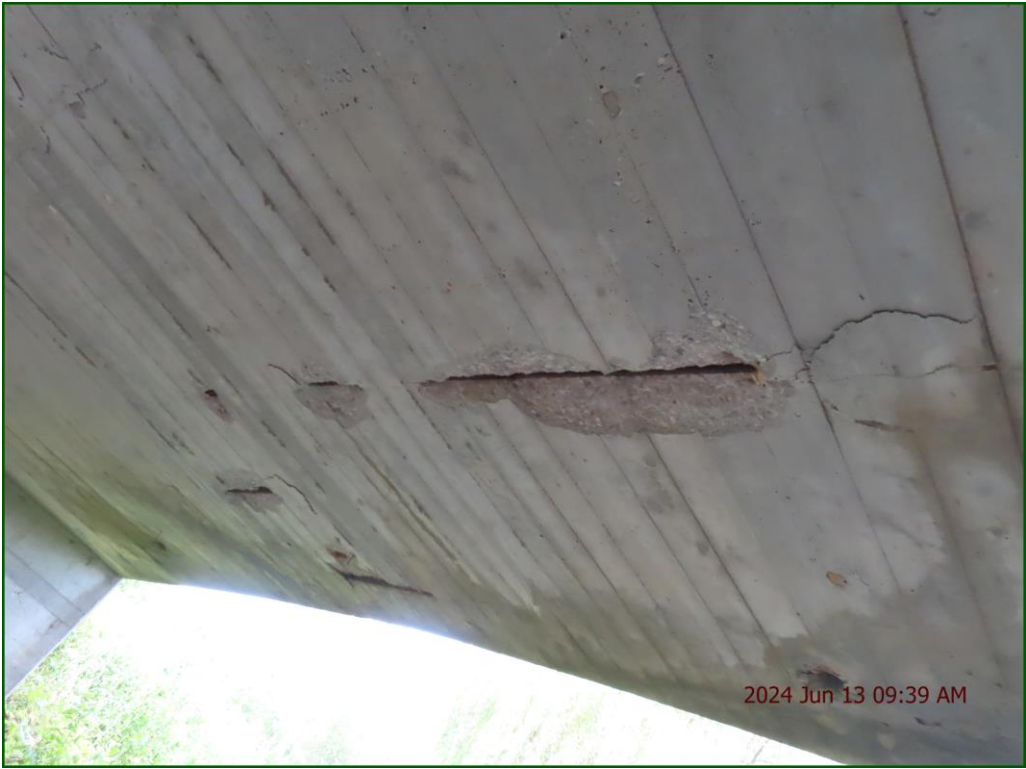
Description: Soffit (int): Light spalling with exposed reinforcing throughout.

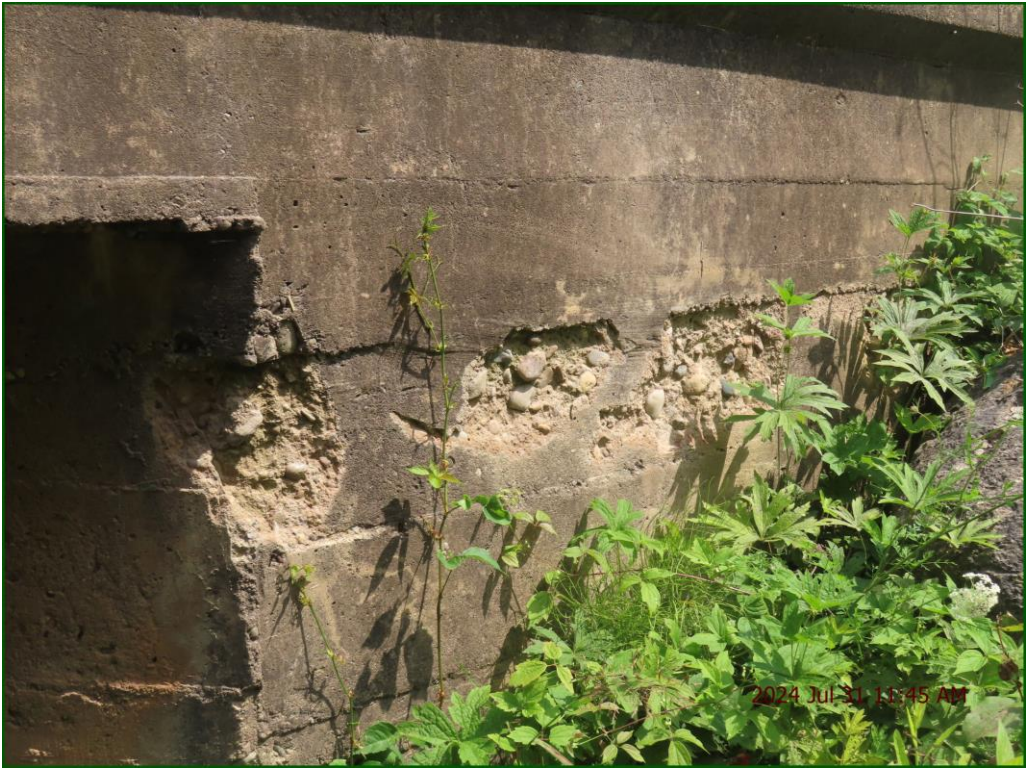
Description: Wingwalls: Light spalling with disintegration.

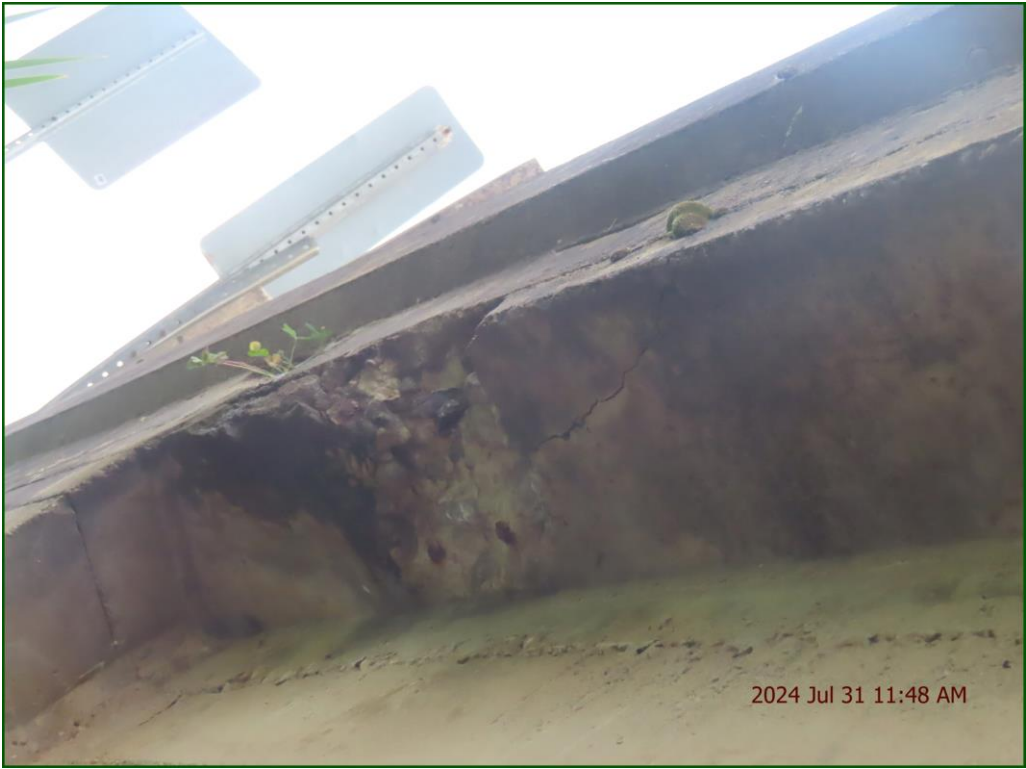
Description: Soffit: Severe spalling and disintegration with exposed reinforcing.

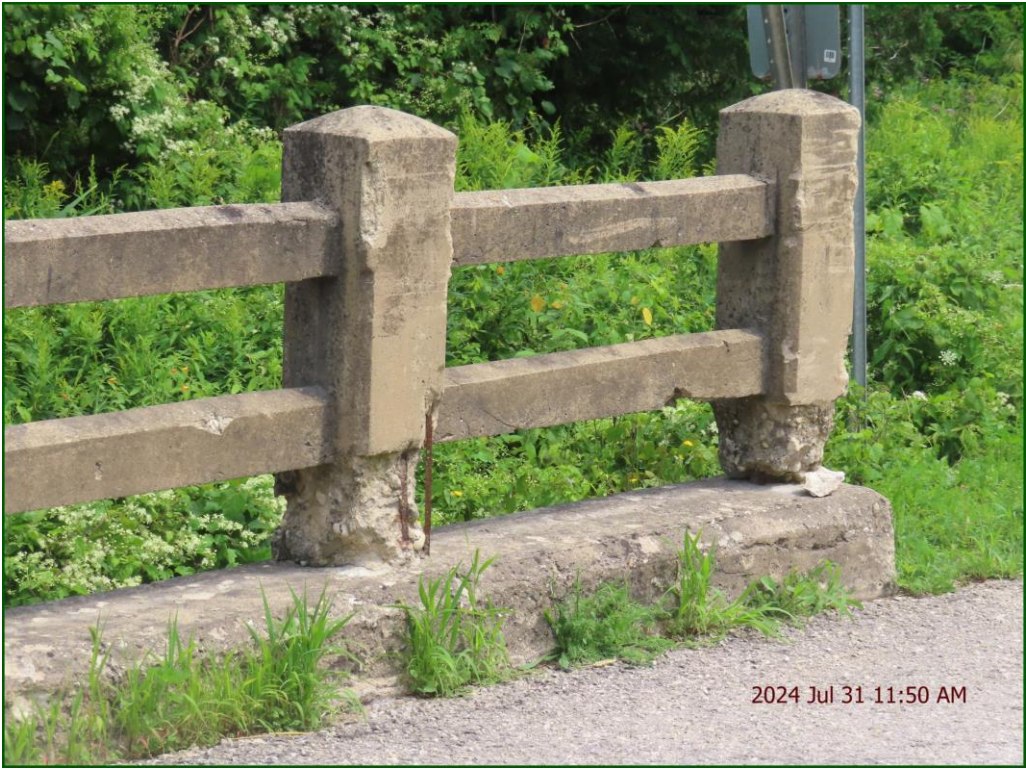
Description: Approach Railing System: Severe spalling and disintegration at base of posts.

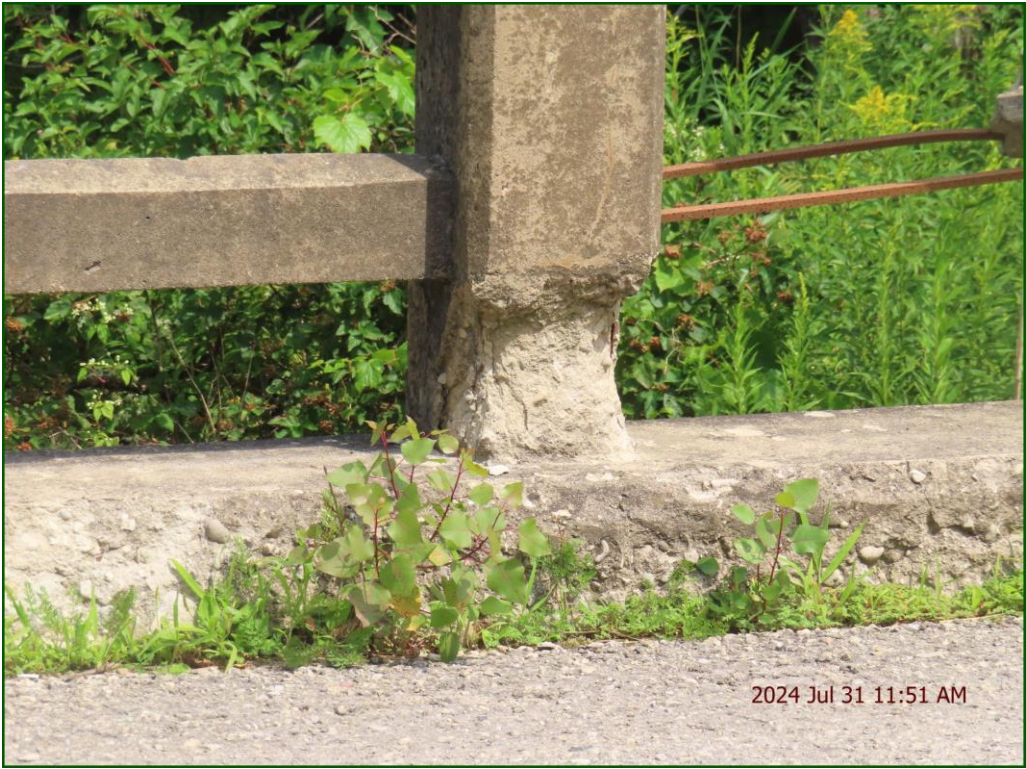
Description: Railing System: Severe spalling and disintegration of bases and railing.

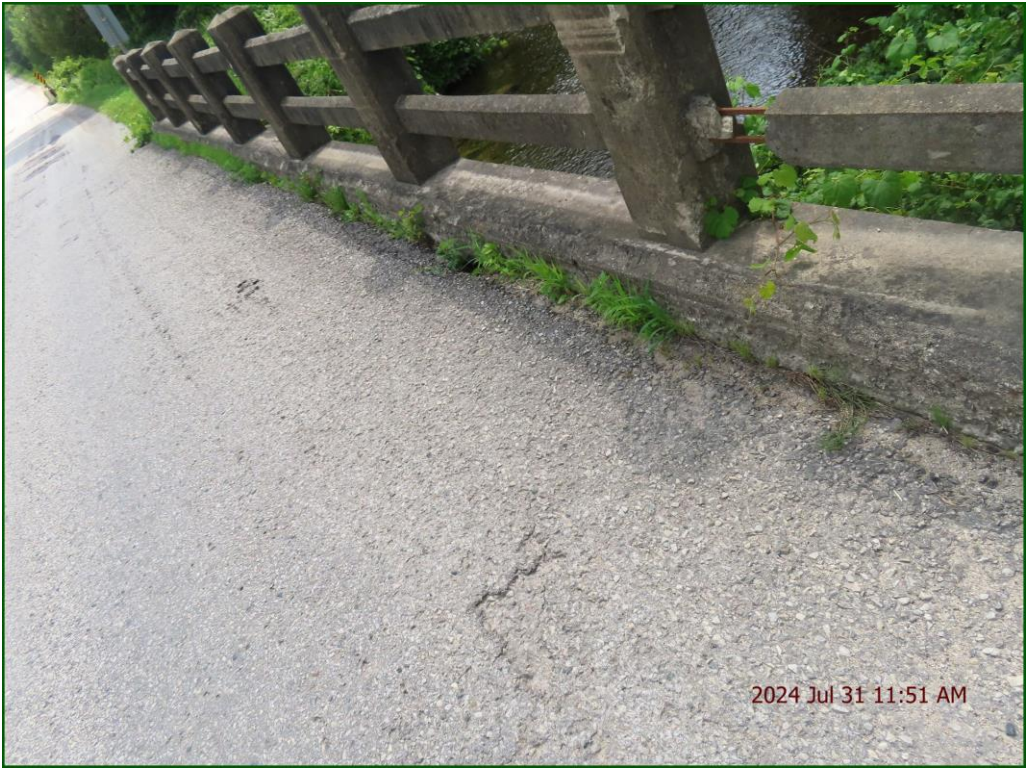
Description: Wearing Surface: Moderate ravelling along curbline and centreline.

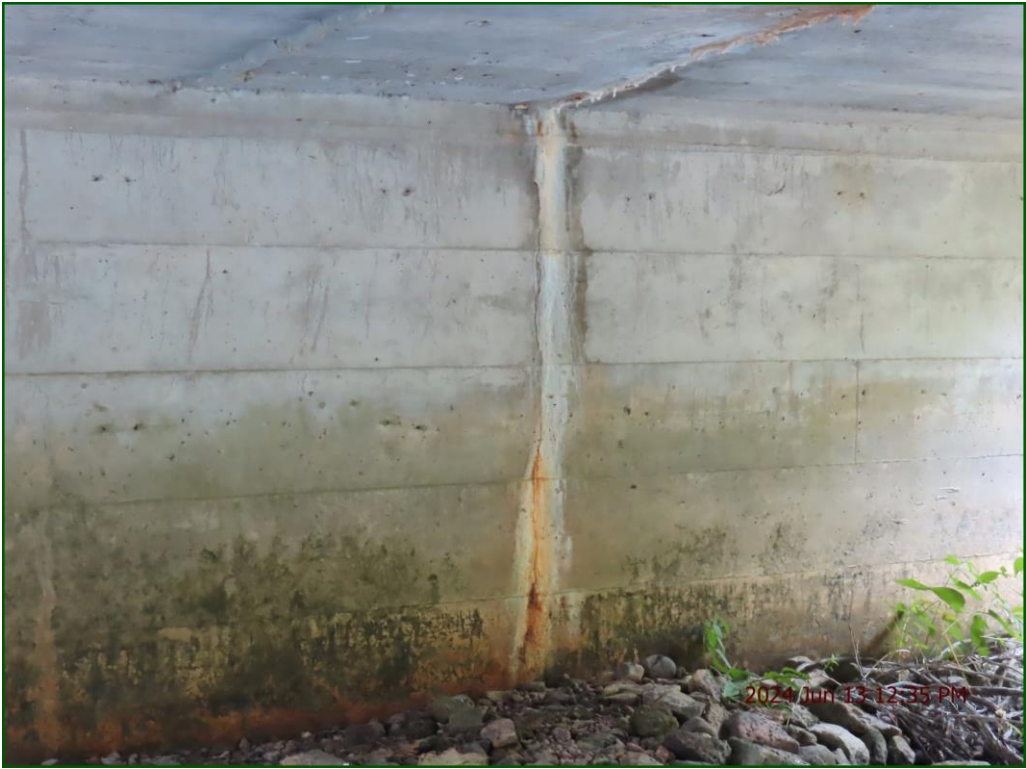
Description: Abutment walls: Medium vertical cracking with leachate staining.

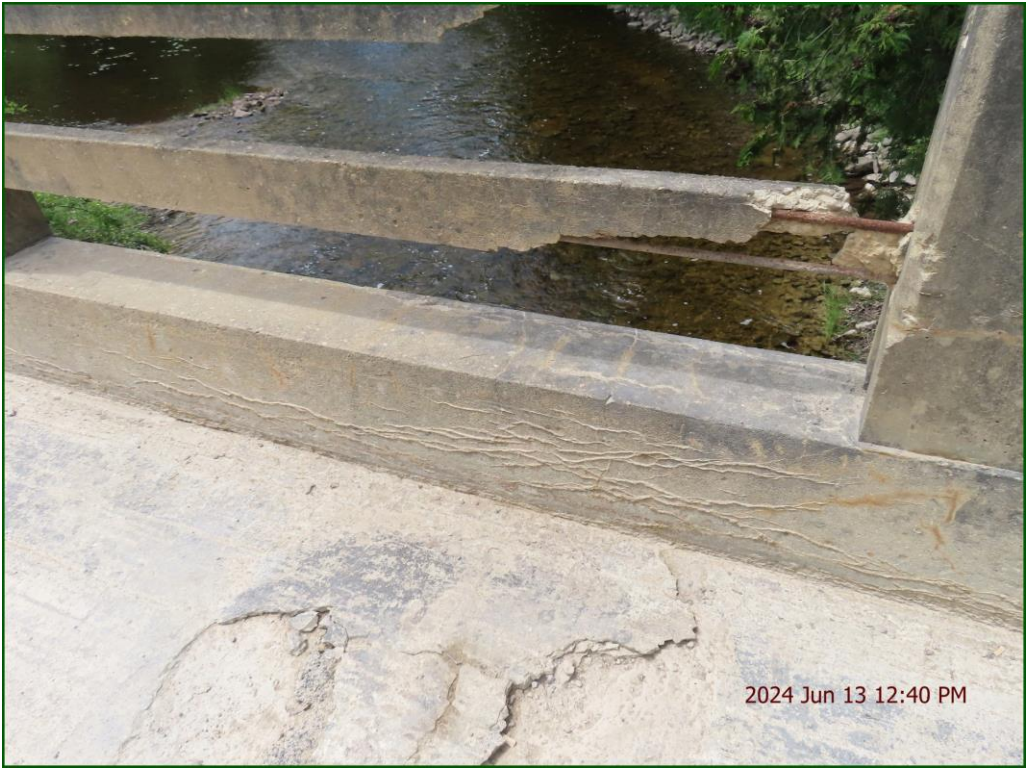
Description: Curbs: Shallow delamination with medium map cracking and leachate staining.

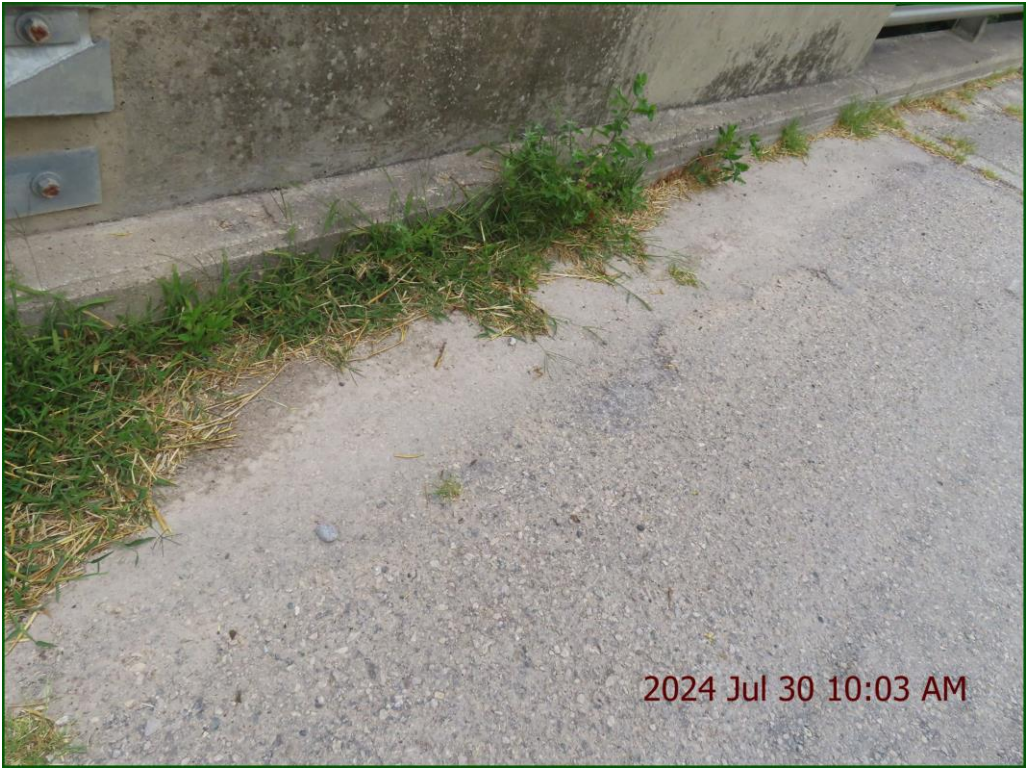
Description: Approach Wearing surface: Moderate ravelling along curbline.

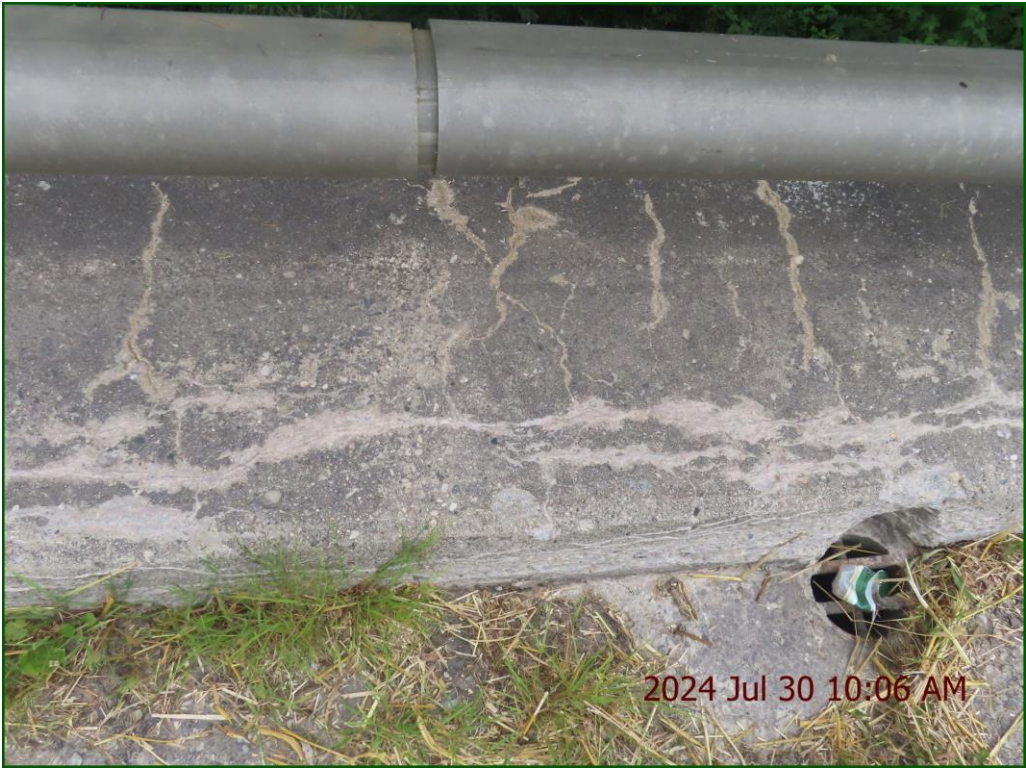
Description: Curbs: Medium to wide cracking with wetness staining throughout (2/2).

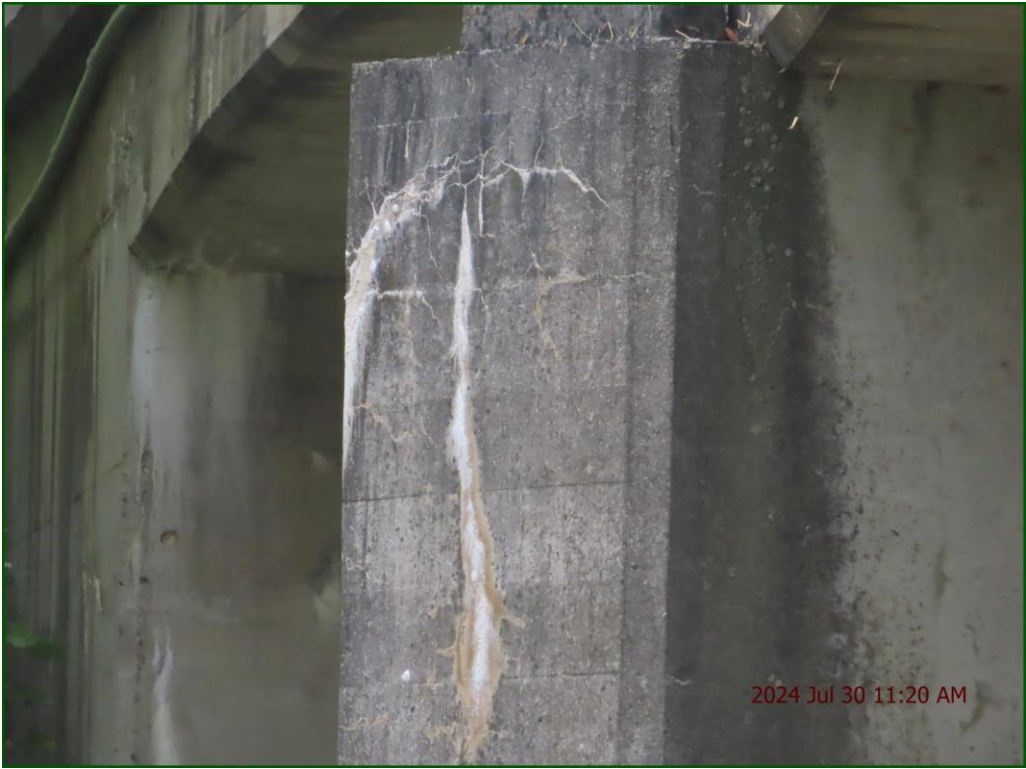
Description: Shafts/Columns/Pile Bents: Medium to wide cracking with leachate staining throughout.

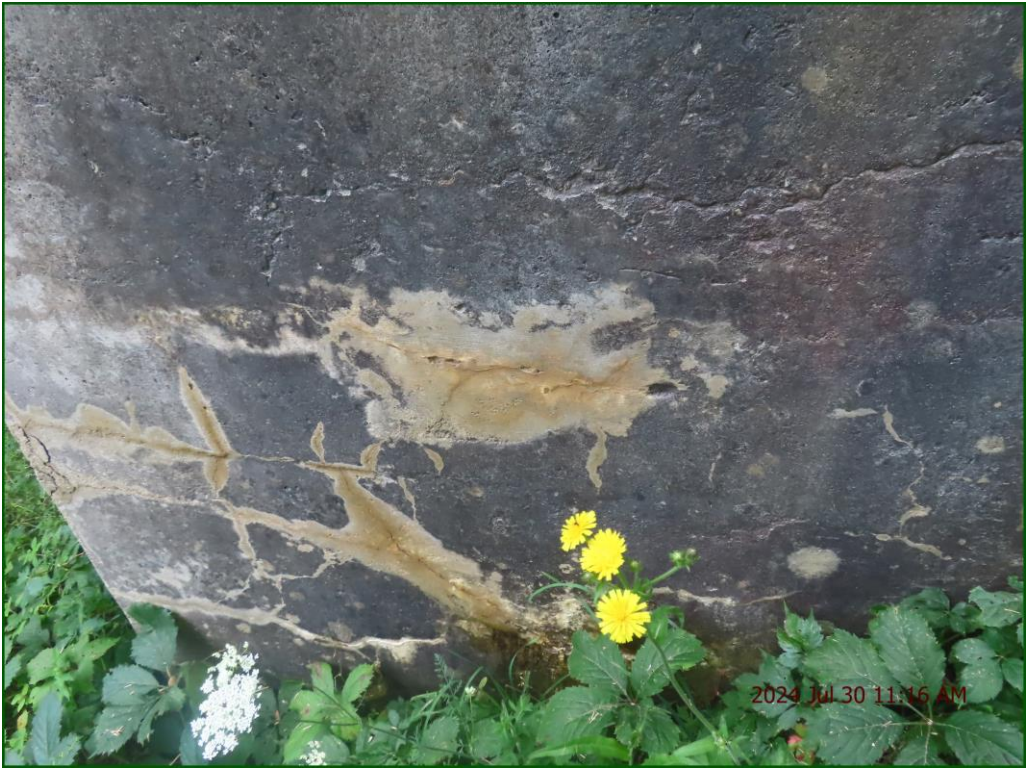
Description: Wingwalls: Light to medium cracking with leachate staining.

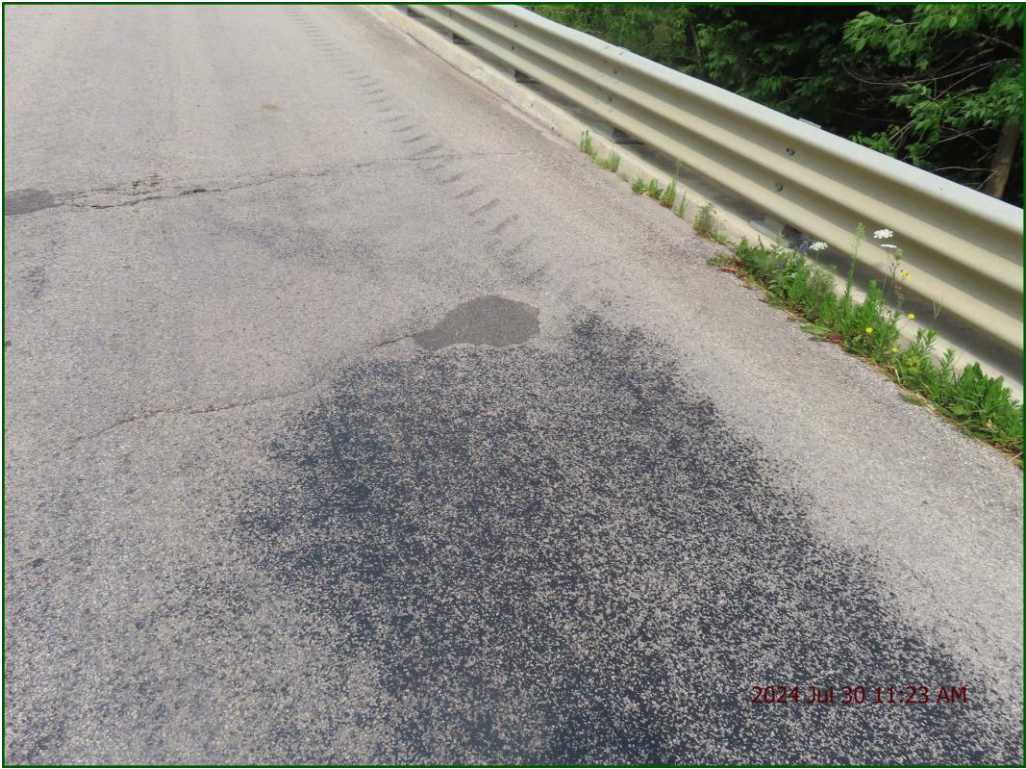
Description: Approach Wearing Surface: Minor potholing throughout.

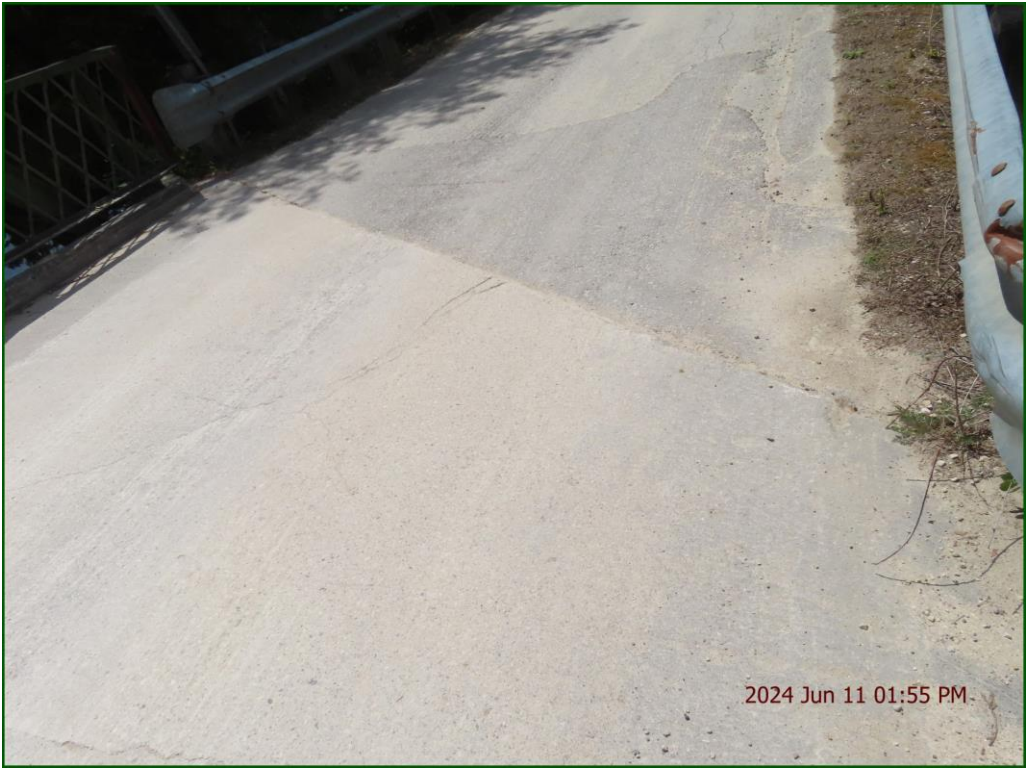
Description: Concrete end dams: West side paved over.

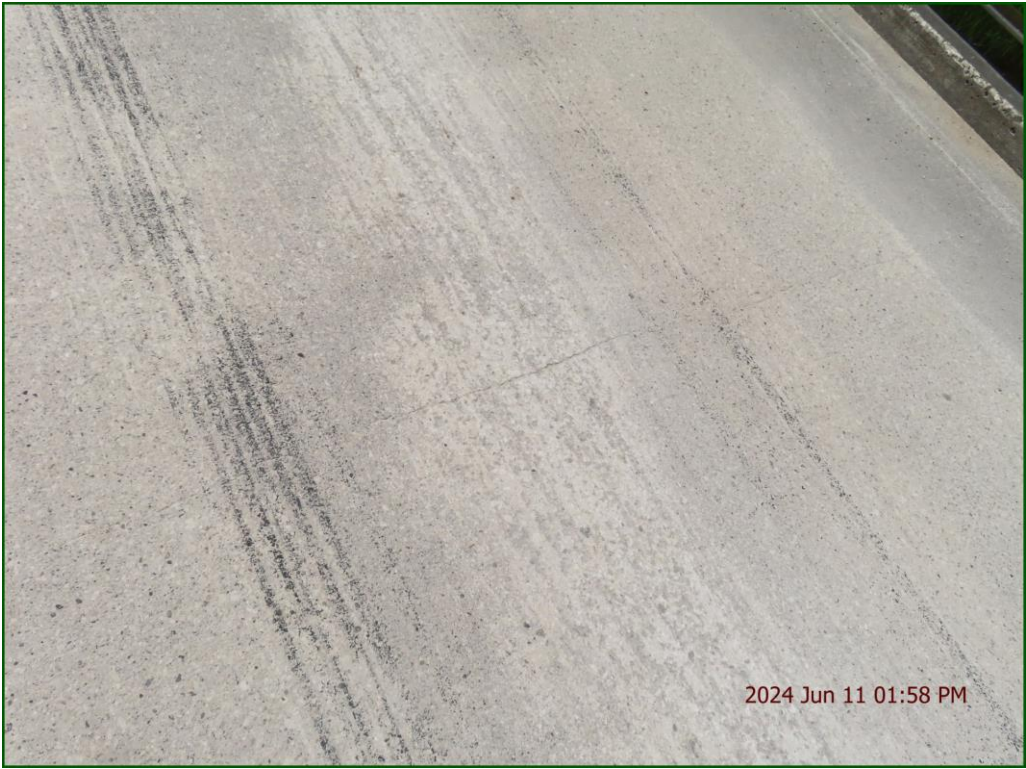
Description: Deck top: Medium transverse crack.

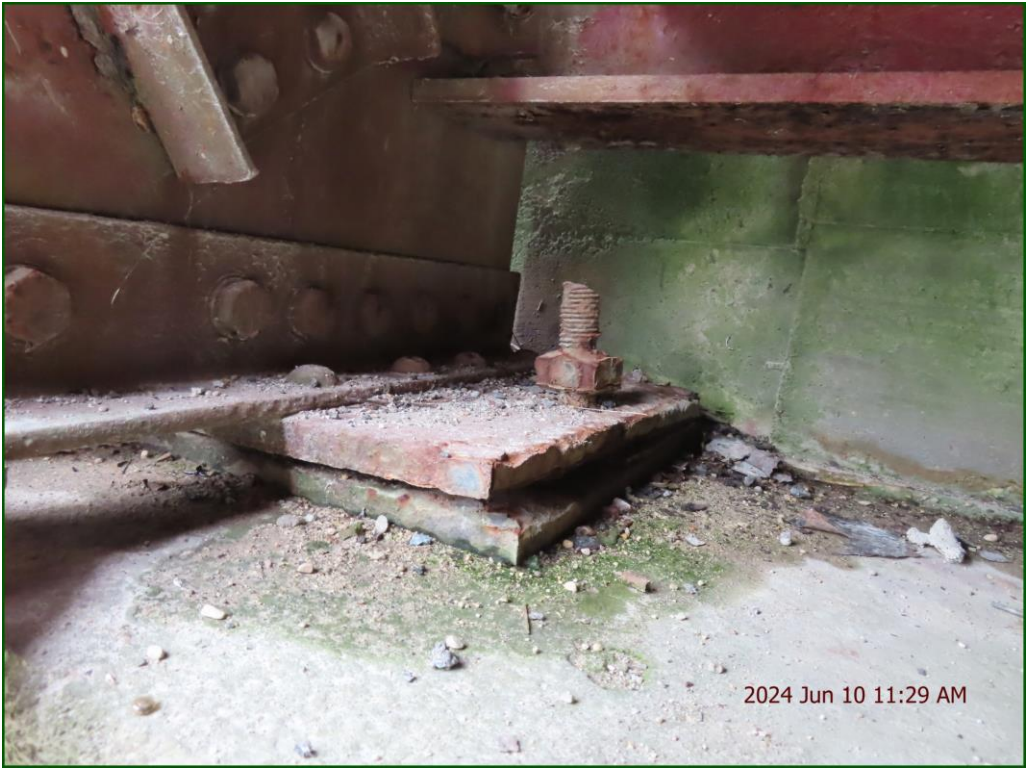
Description: Bearings: Medium corrosion at both east bearings.

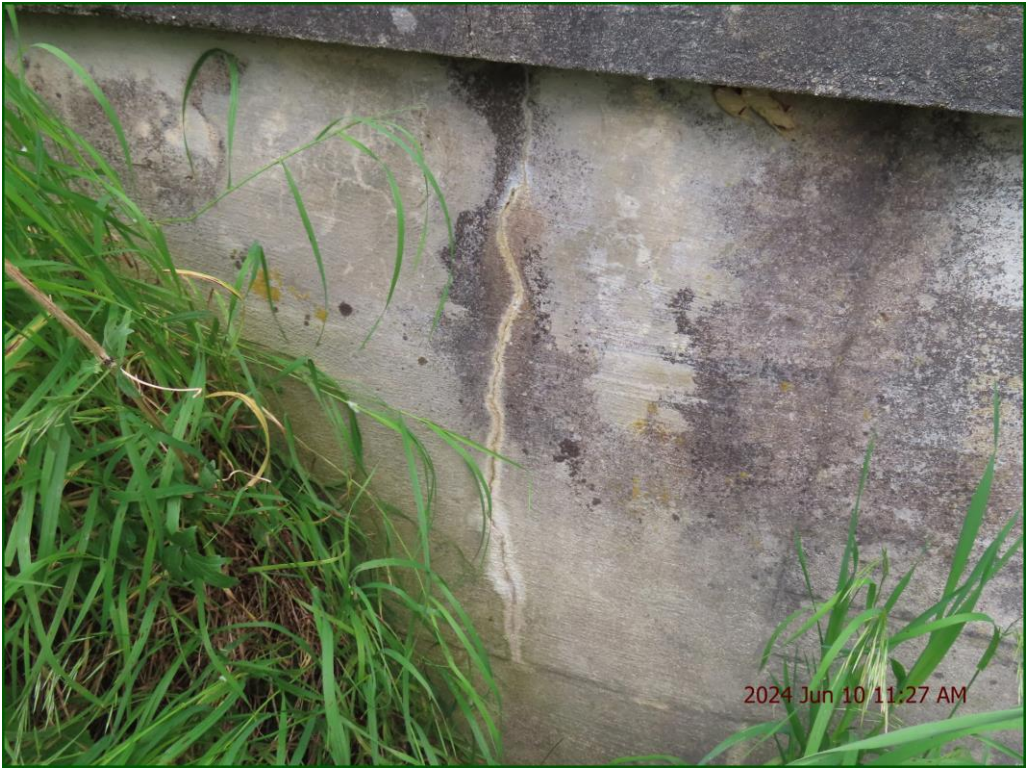
Description: Wingwalls: Light to medium vertical cracking with leachate staining.
