Element Inspection

Date of Inspection:	31-Jul-24
Name of Inspector:	Andrew Burgess, P.Eng. & Joel Ziegler CET
Equipment Used:	Sounding hammer, measuring equipment, GPS
Weather Conditions:	Sunny
Temperature:	23
Special Notes:	Bridge is in good condition, showing no signs of structural distress.

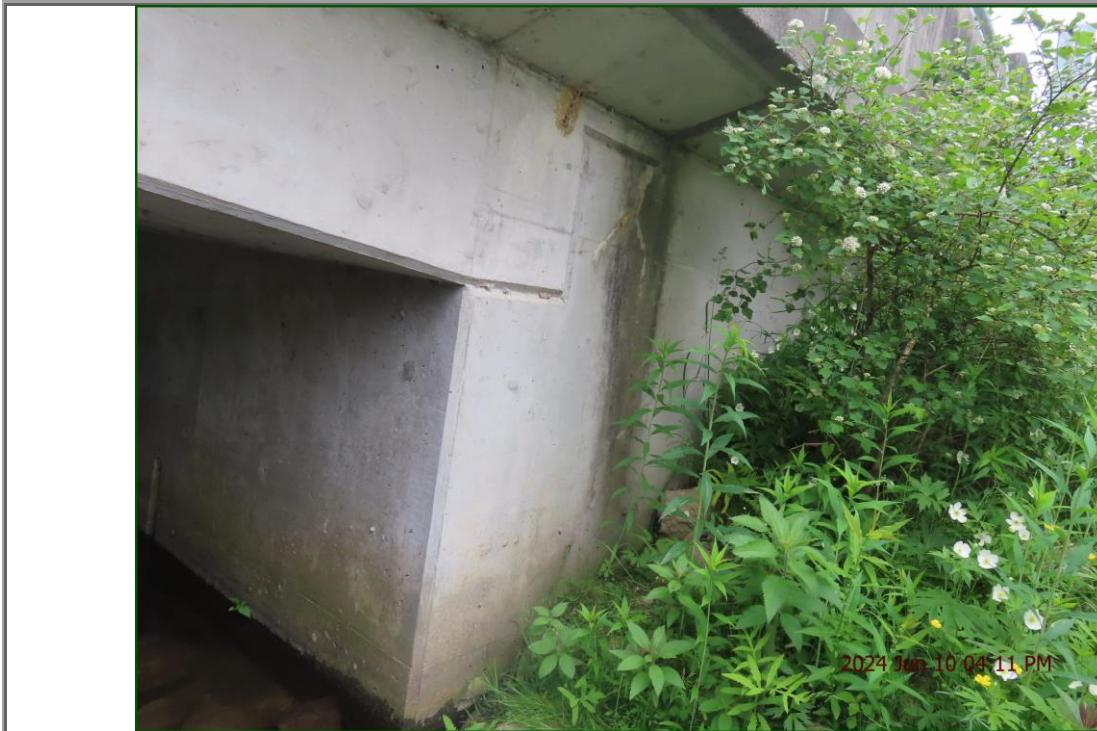
Medium to wide cracking with leachate staining.

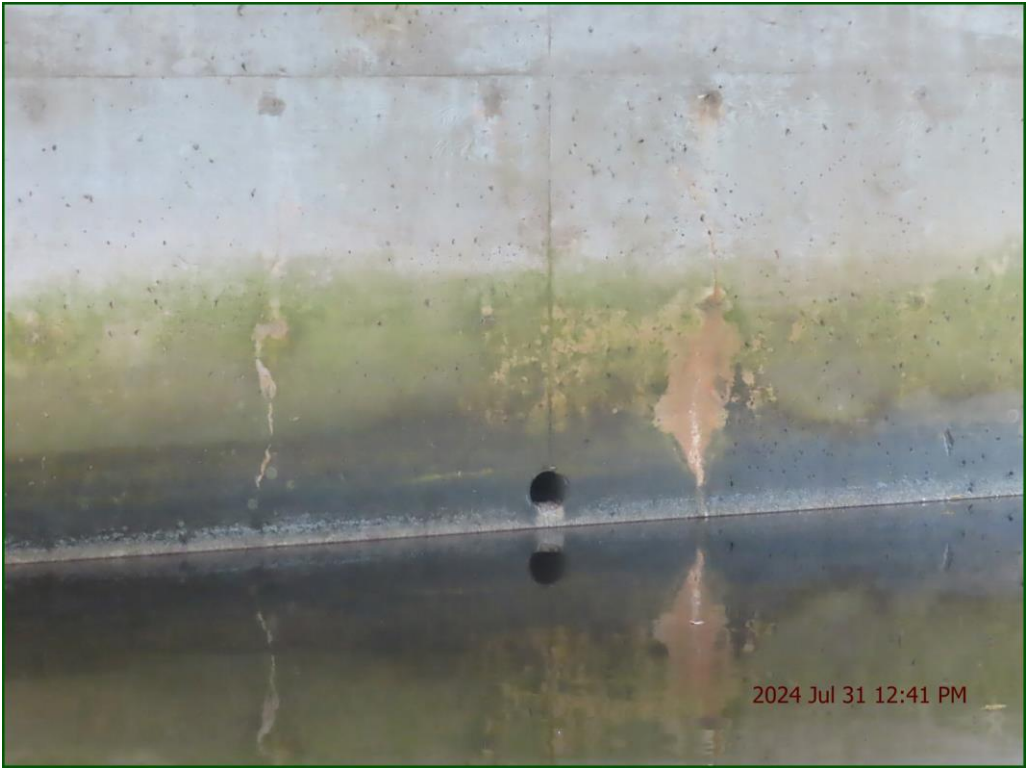
Description: Abutment Walls: Light to medium vertical cracking with leachate staining.

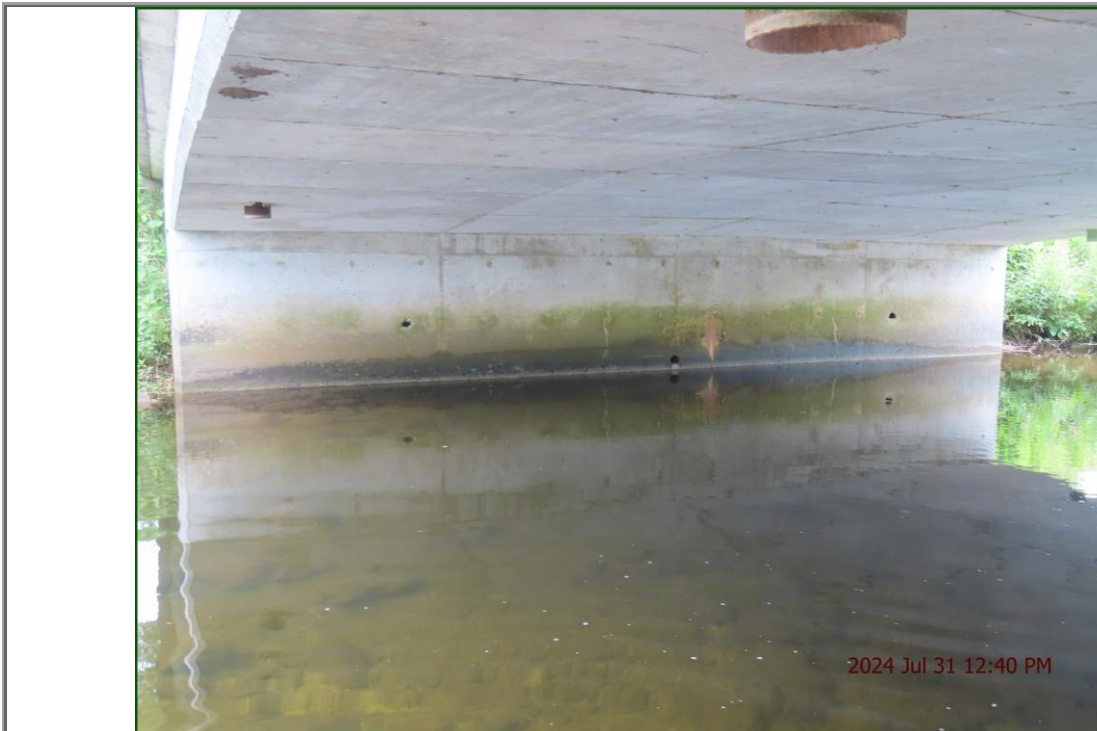
Light to medium vertical cracking with leachate staining.

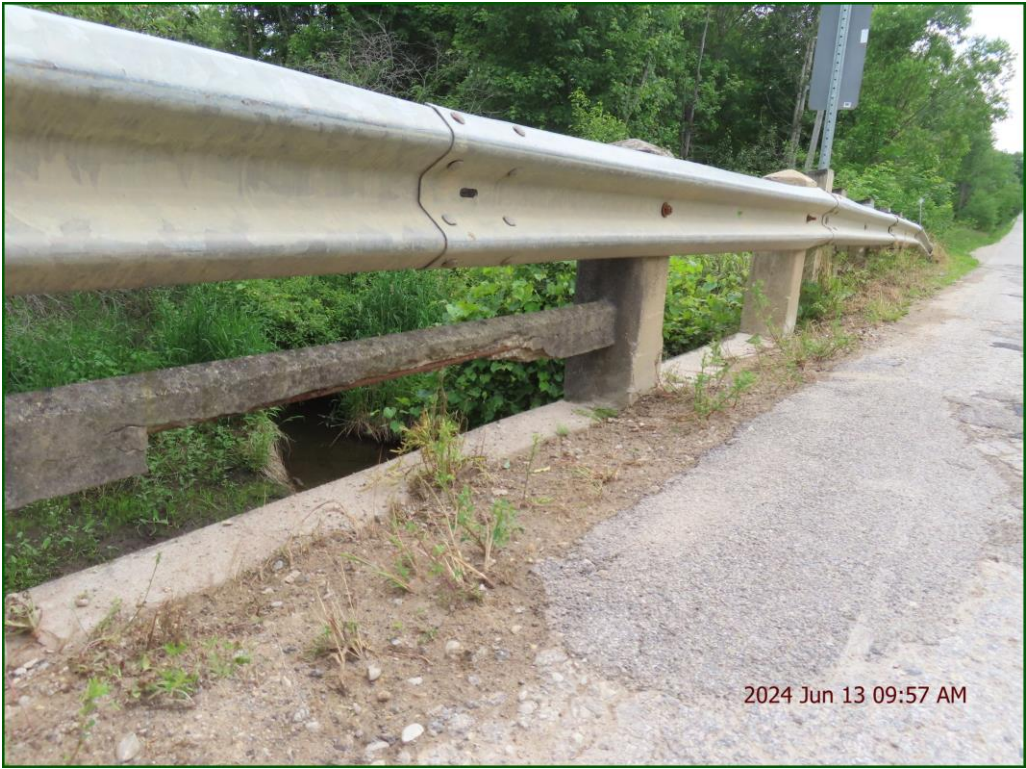
Description: Railing systems: Original rail disintegration with areas of 100% section loss.

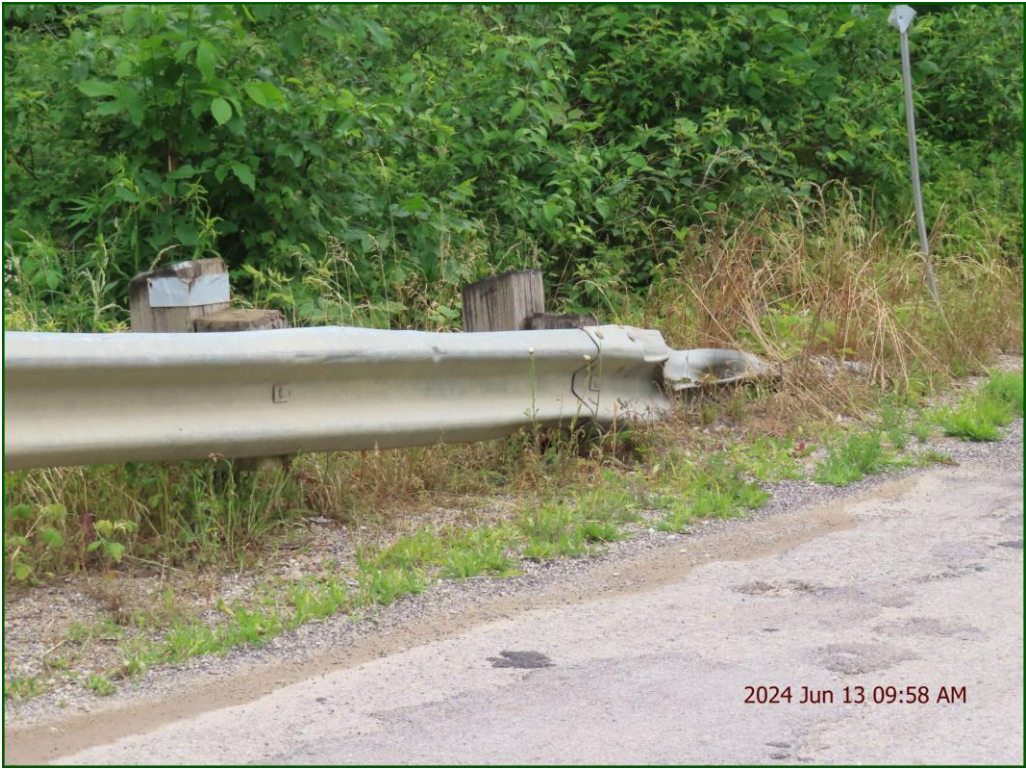
Description: Railing Systems: Moderate impact damage at NE quadrant.

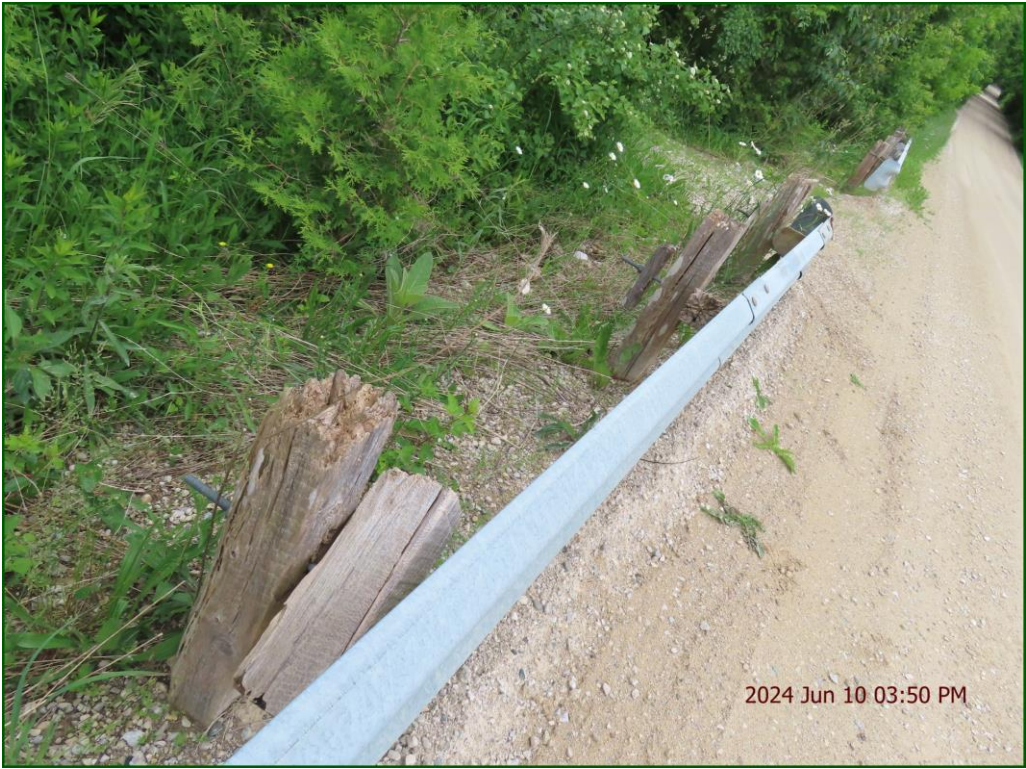
Description: Railing Systems: Moderate to severe rotting in timber posts.

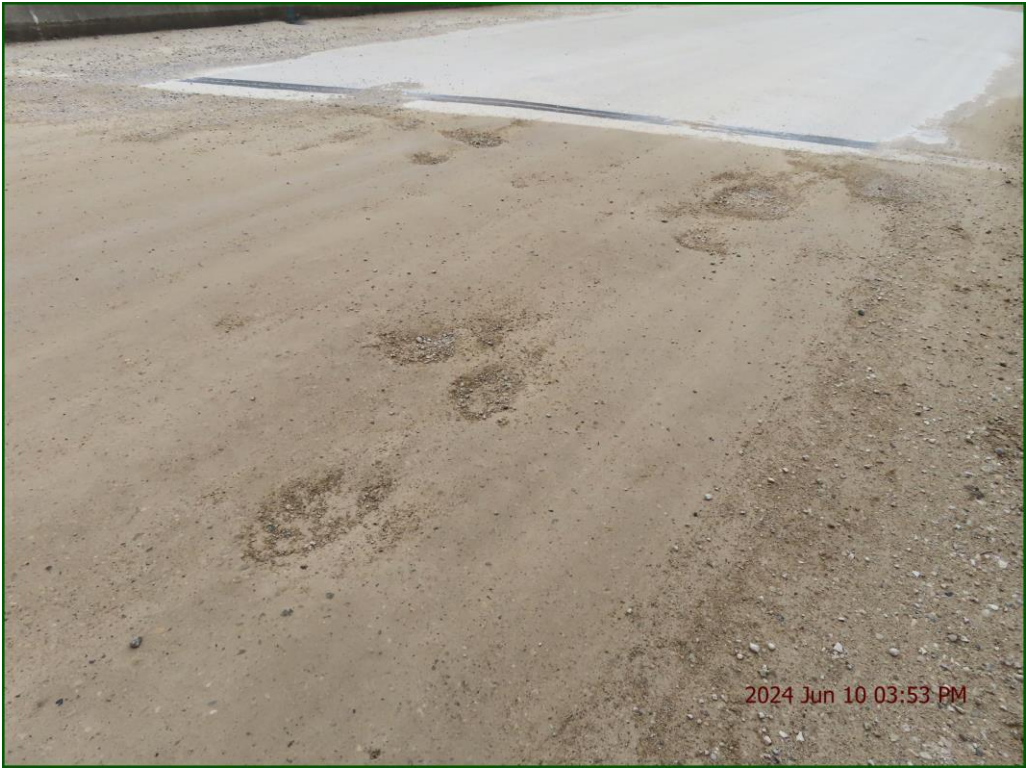
Description: Approach Wearing surface: Moderate to severe potholing throughout.

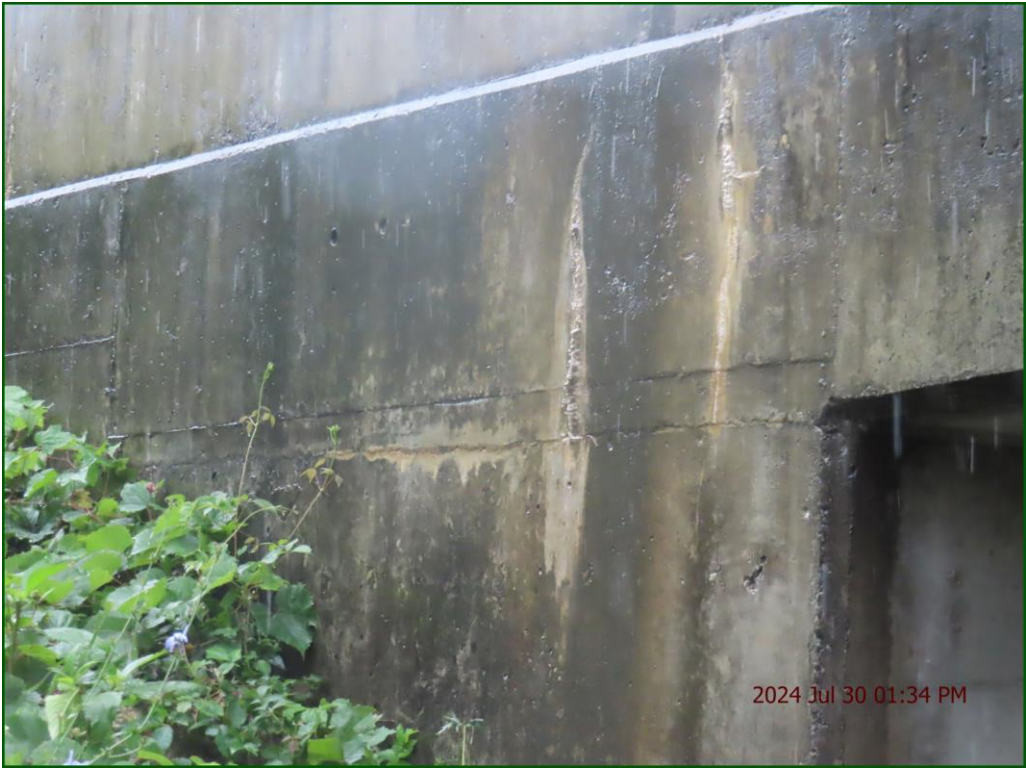
Description: Wingwalls: Light to medium vertical crack with leachate staining.

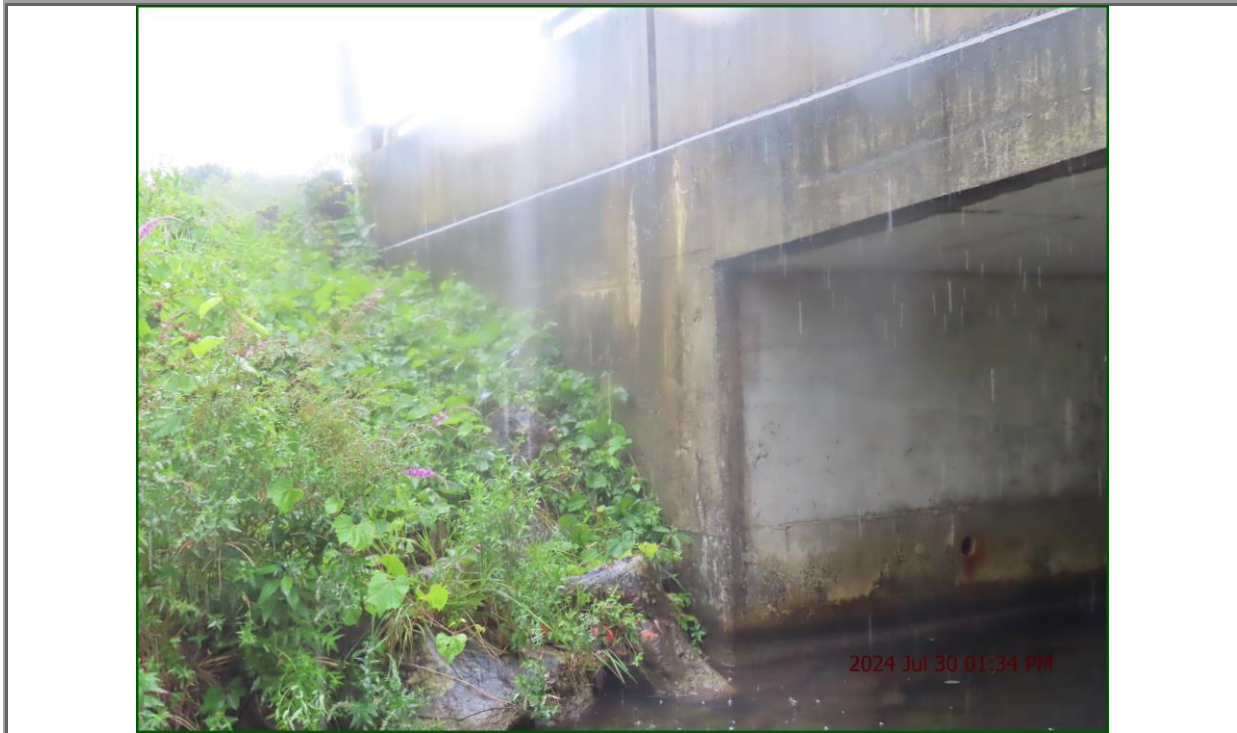
Light to medium vertical crack with leachate staining.

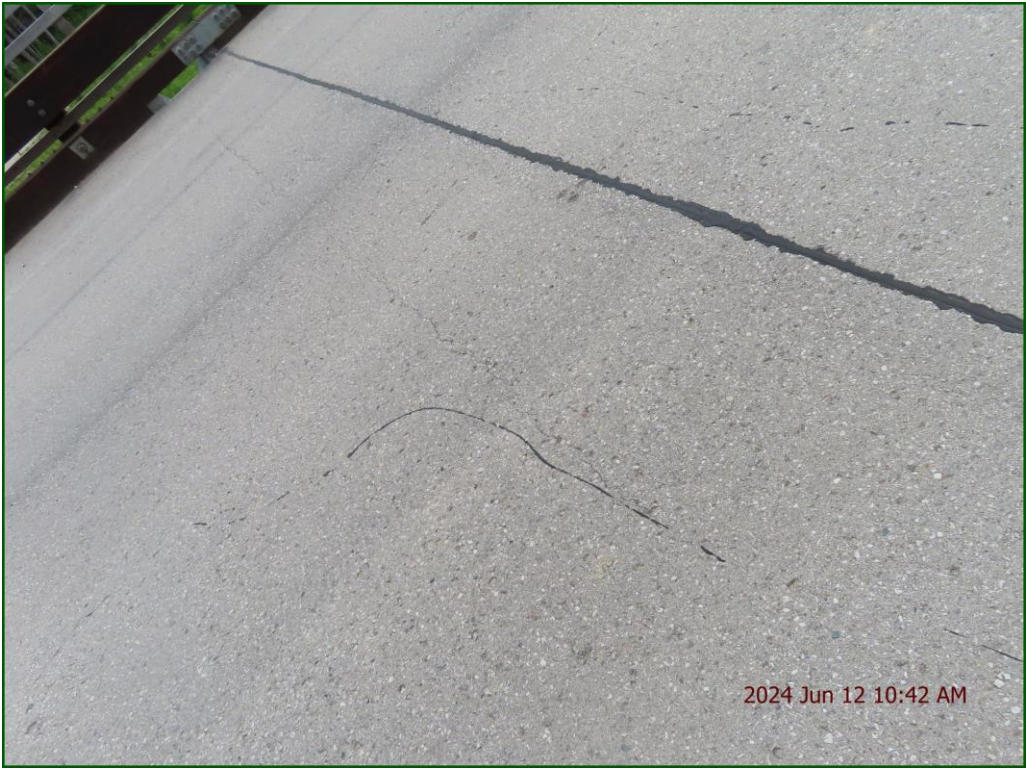
Description: Approach Wearing surface: Narrow transverse crack.

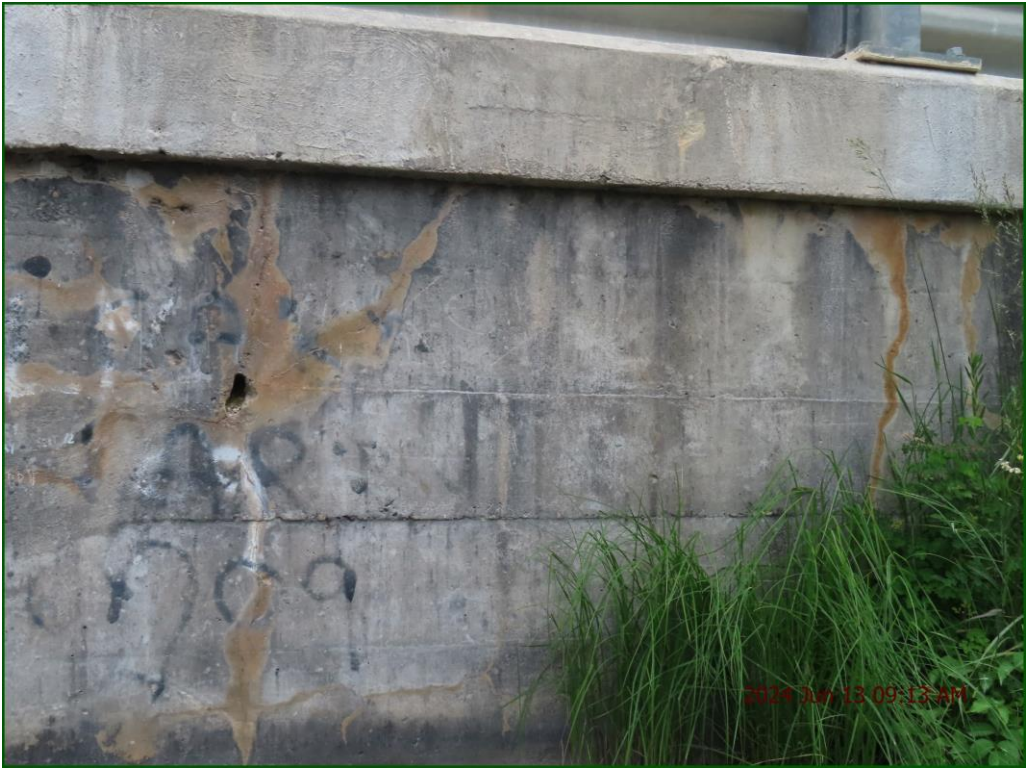
Description: Wingwalls: Light to medium vertical cracking with leachate staining.

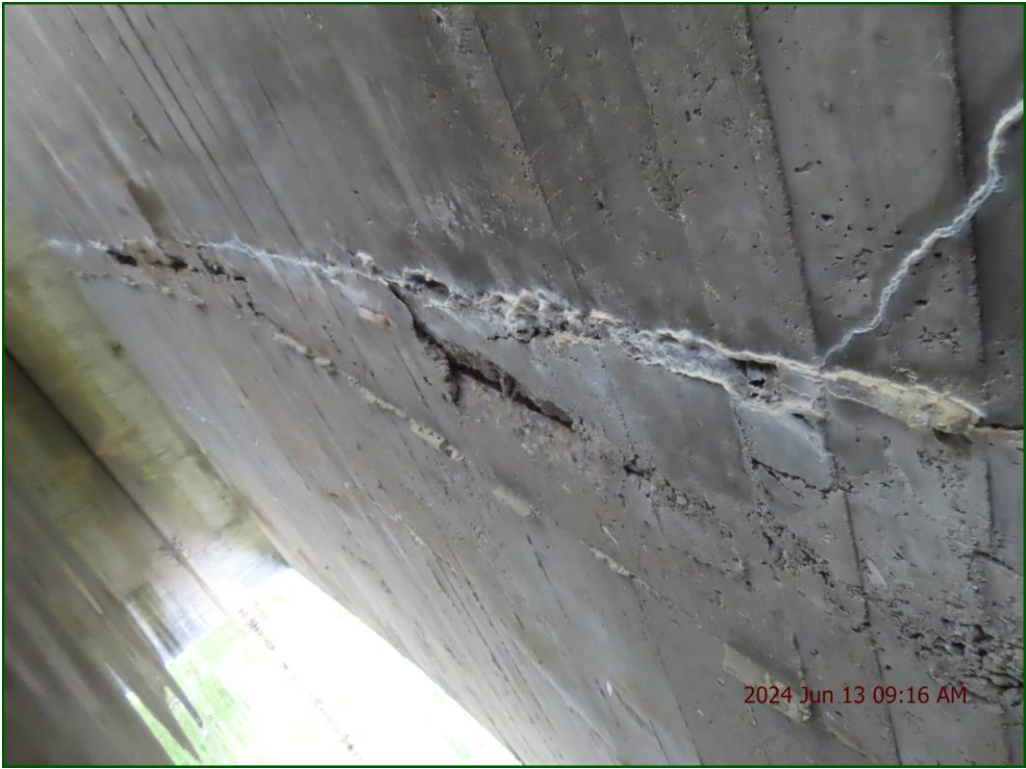
Description: Soffit (int): Medium to wide longitudinal cracking with leachate staining and stalactite.

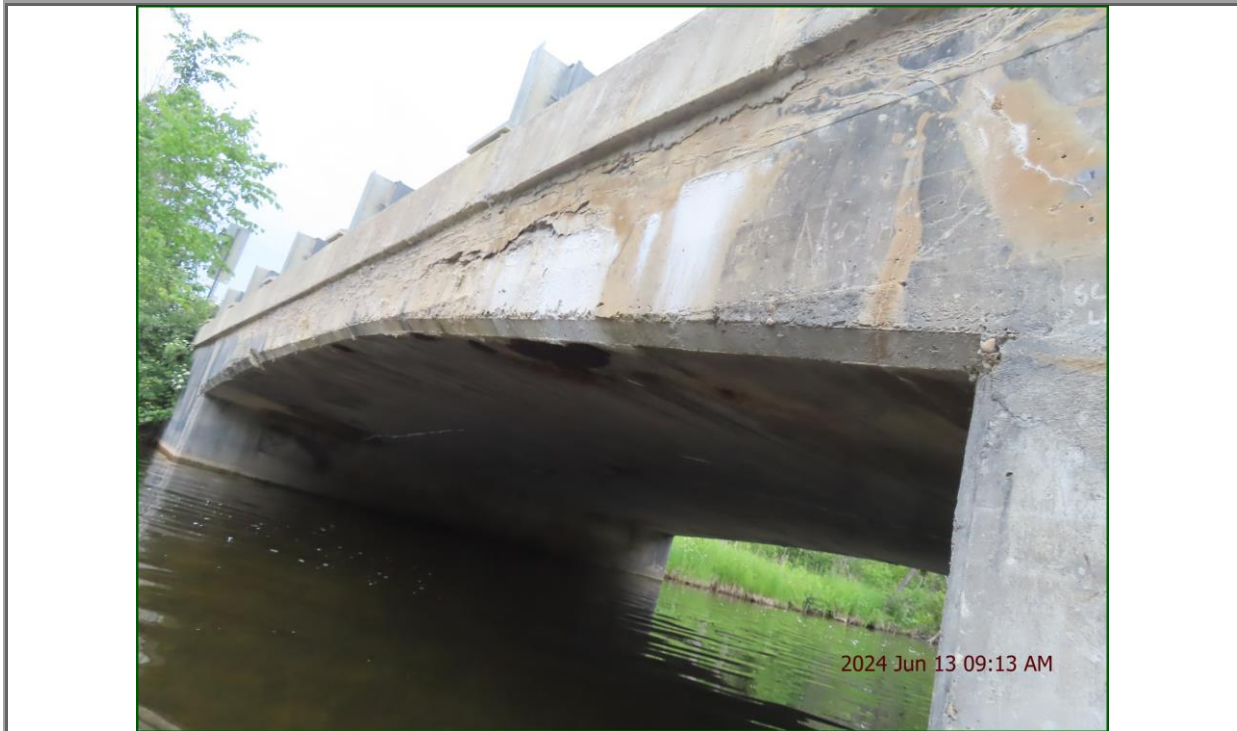
Moderate to severe delamination throughout. Severe spalling on south. Light to medium horizontal cracking with leachate staining.

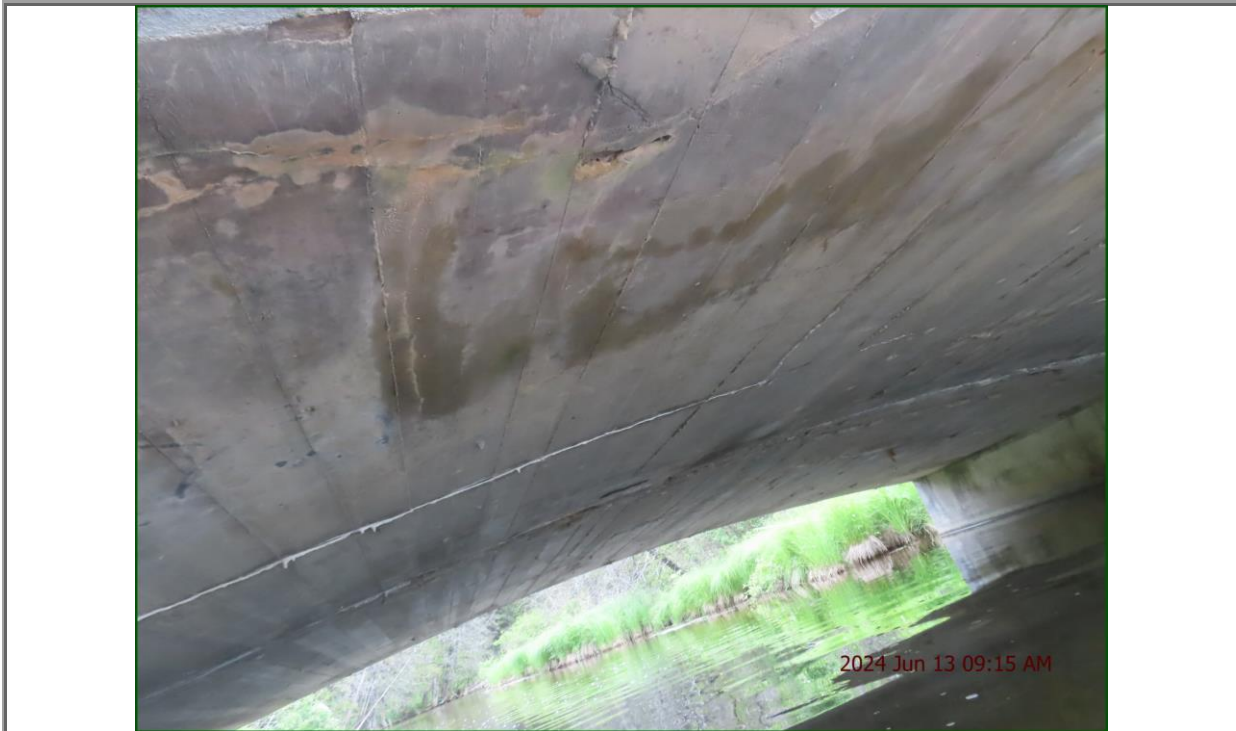
Medium to wide longitudinal cracking with leachate staining and stalactite. Severe spalling with exposed reinforcing throughout.

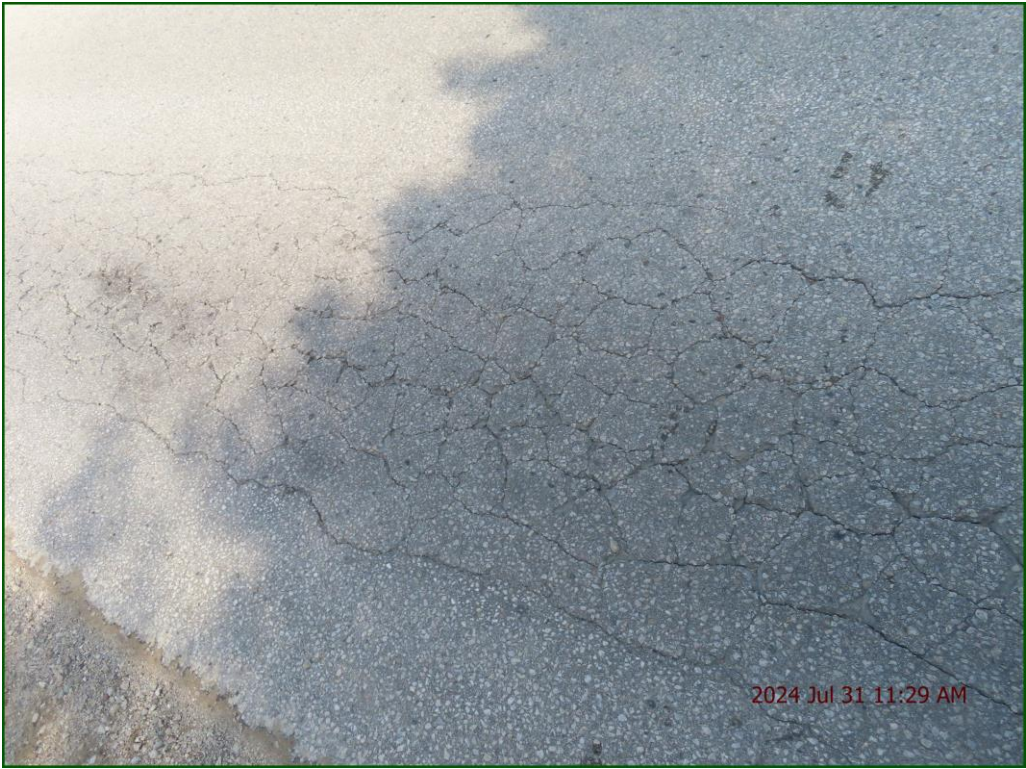
Description: Wearing Surface: Light alligator cracking along road edge.

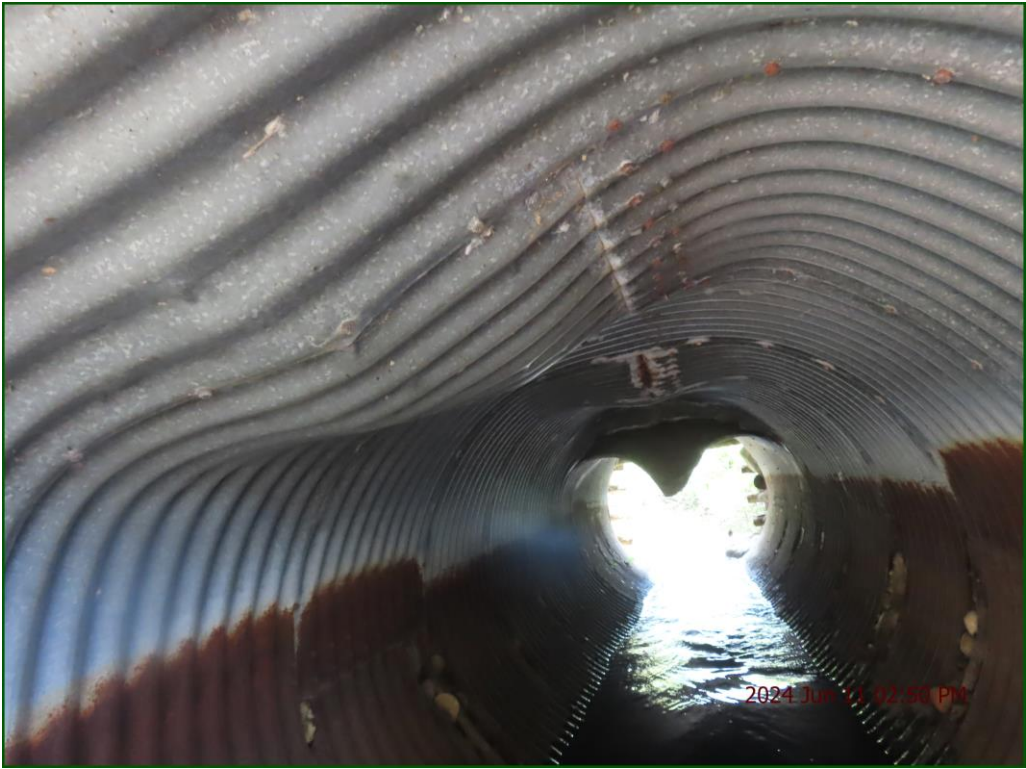
Description: Barrel: Severe sag at mid barrel and north side of barrel.

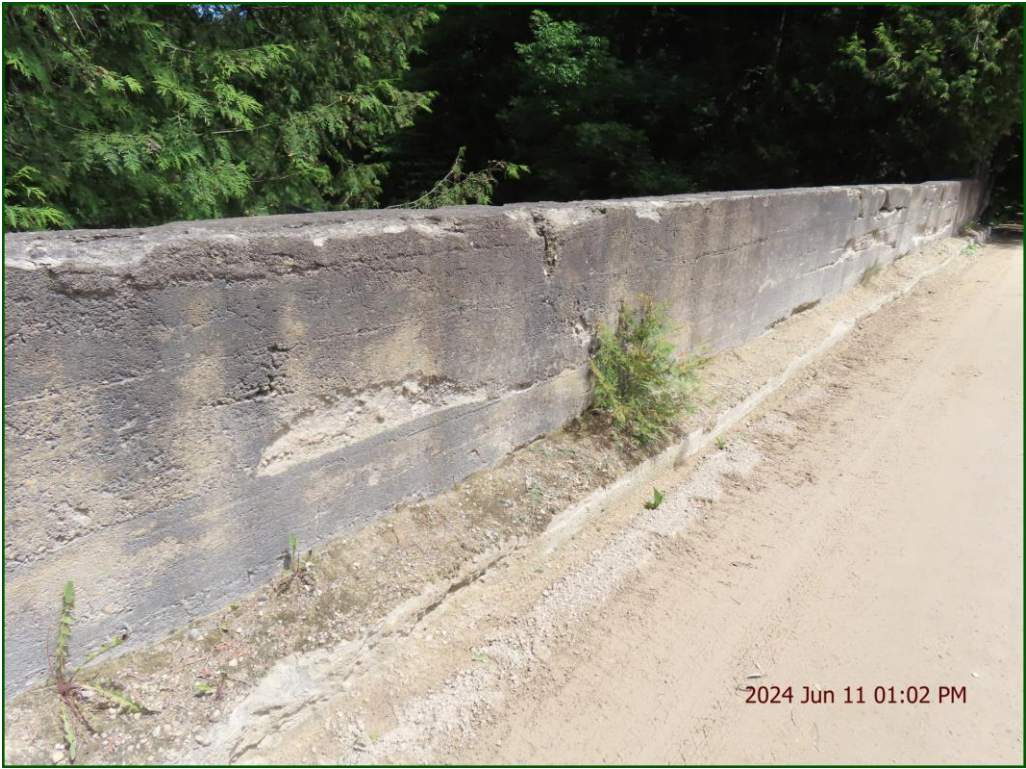
Description: Barrier/Parapet walls: Severe spalling and disintegration throughout.

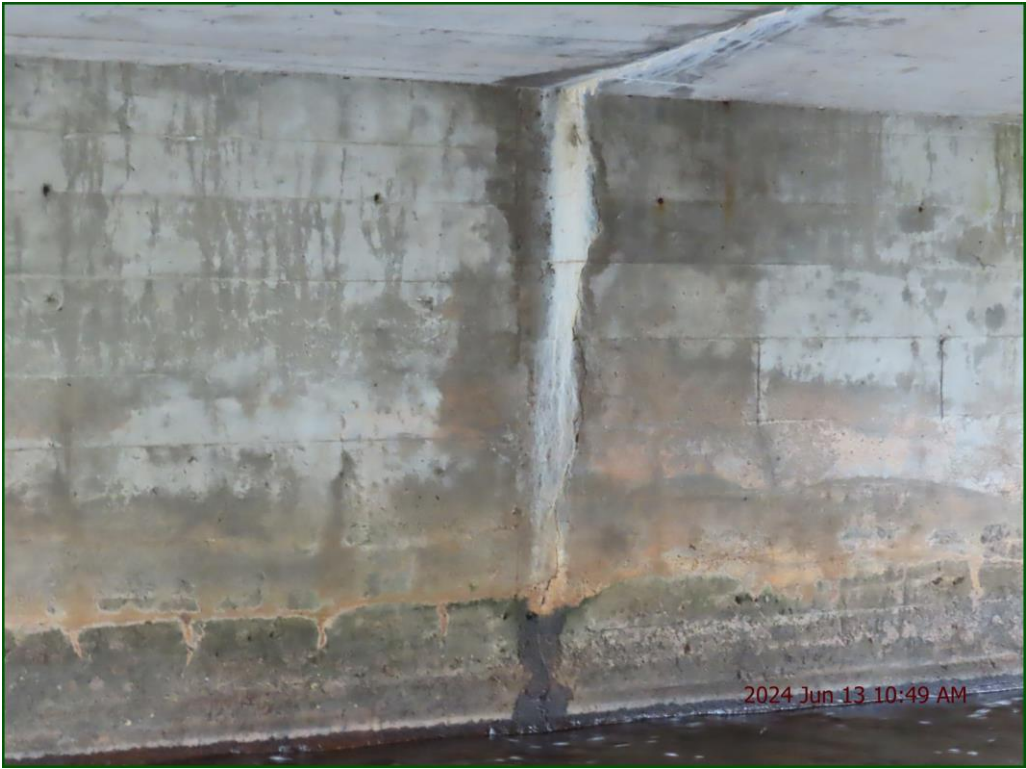
Description: Abutment walls: Light to medium vertical cracking with leachate staining.

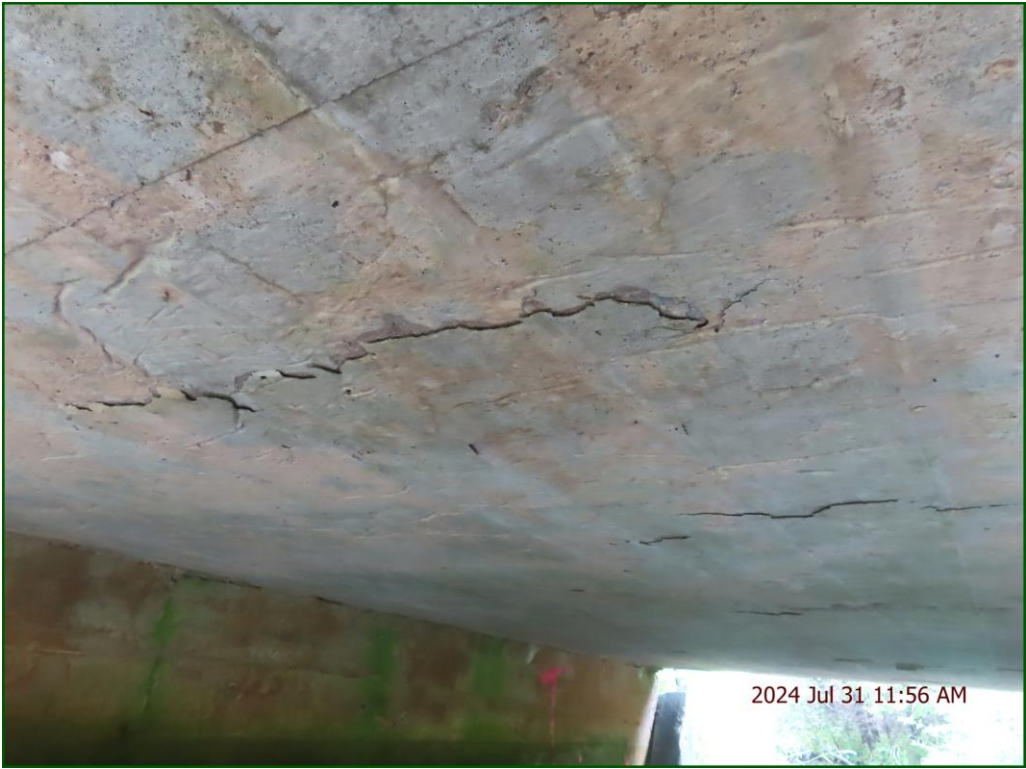
Description: Barrel: Moderate delamination.

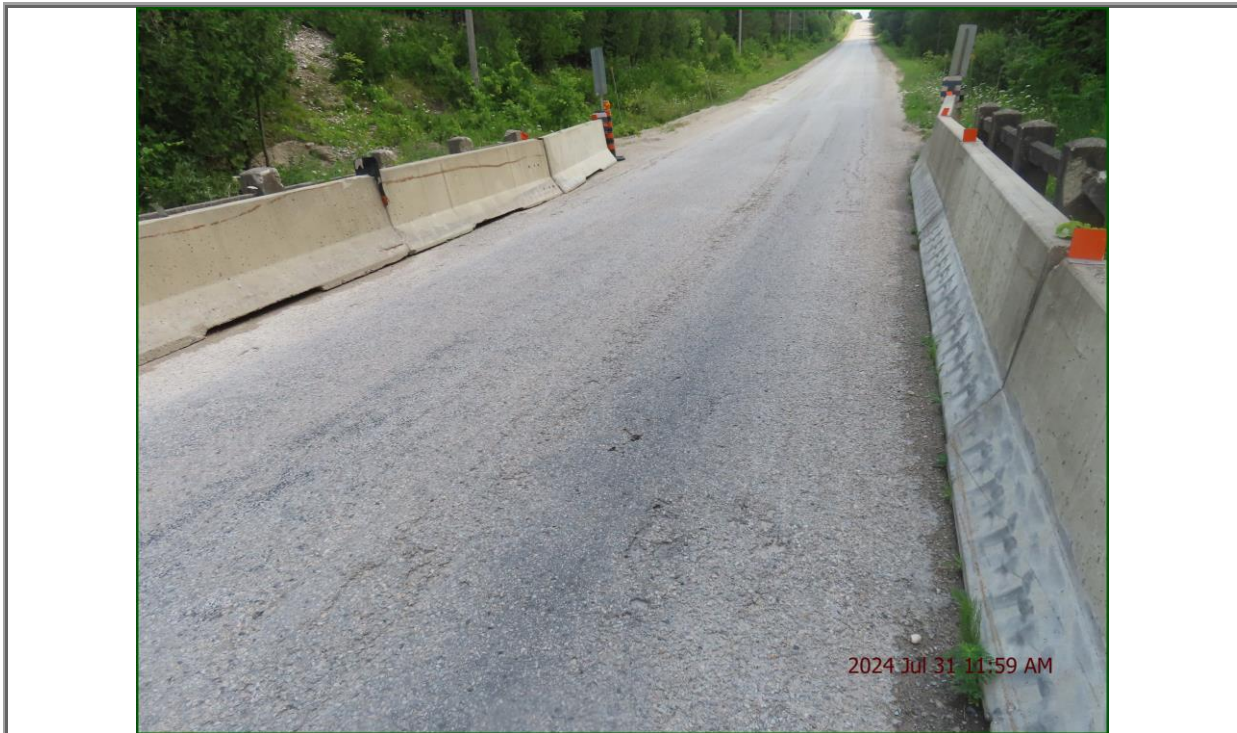
Moderate ravelling along curblines. Medium to wide longitudinal cracking.

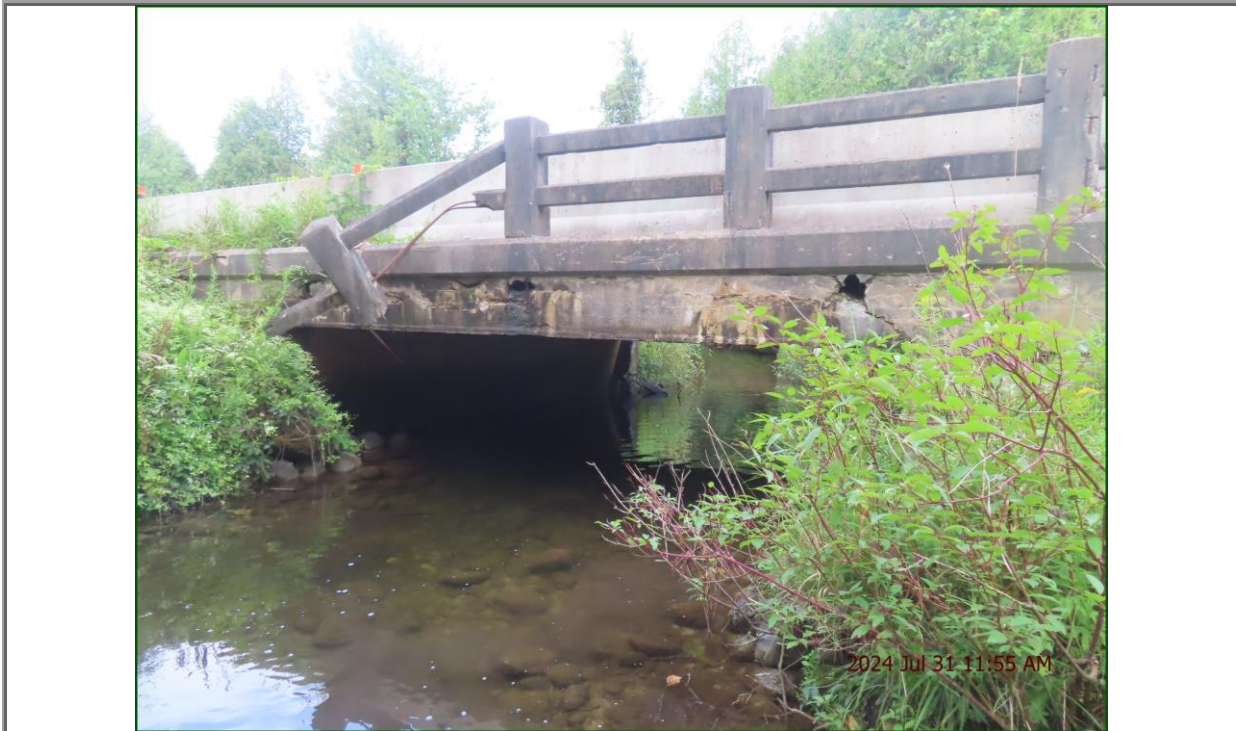
Severe delamination and disintegration. Medium to wide cracking with leachate staining.

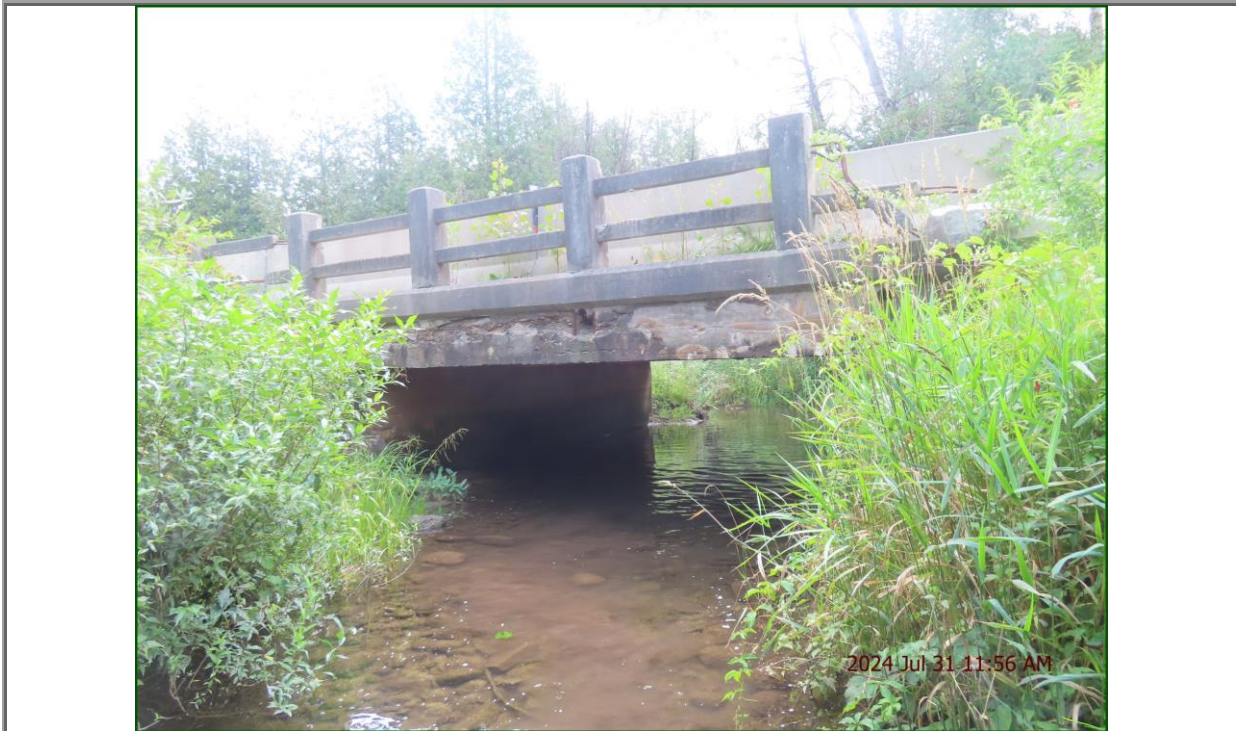
Severe spalling and disintegration with exposed reinforcing.

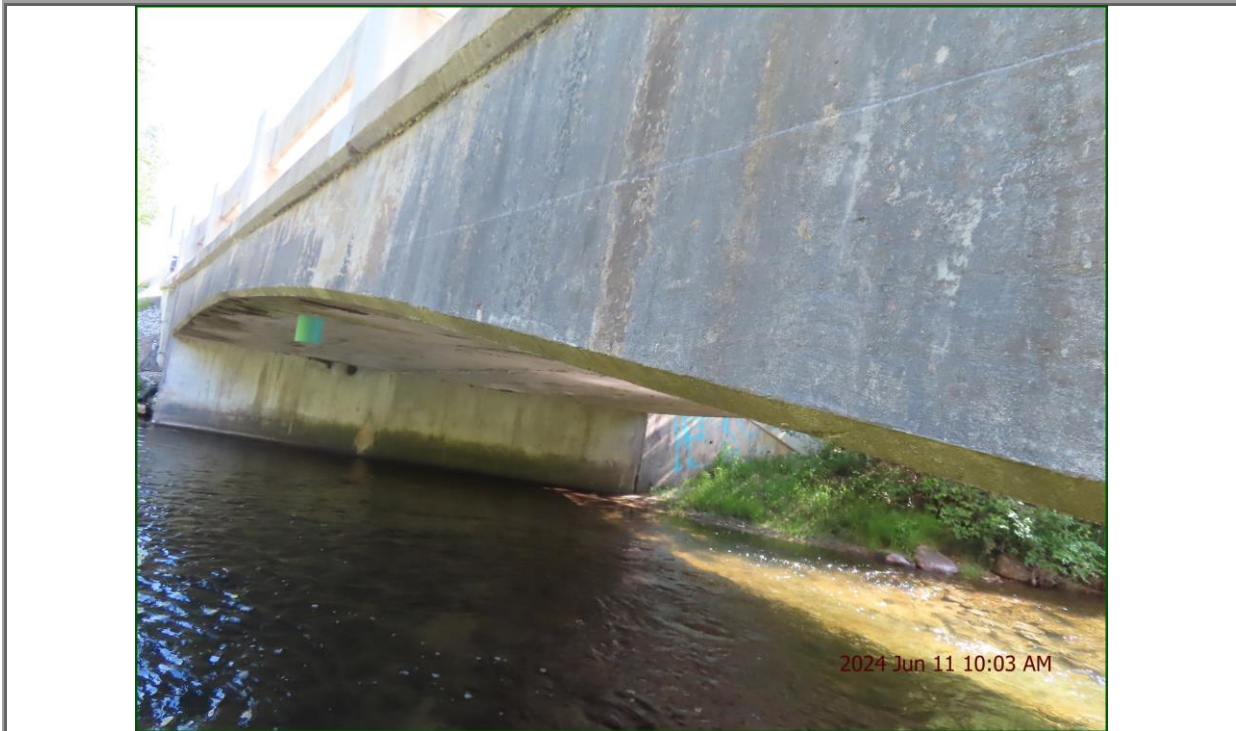
Light to medium cracking with leachate staining throughout.

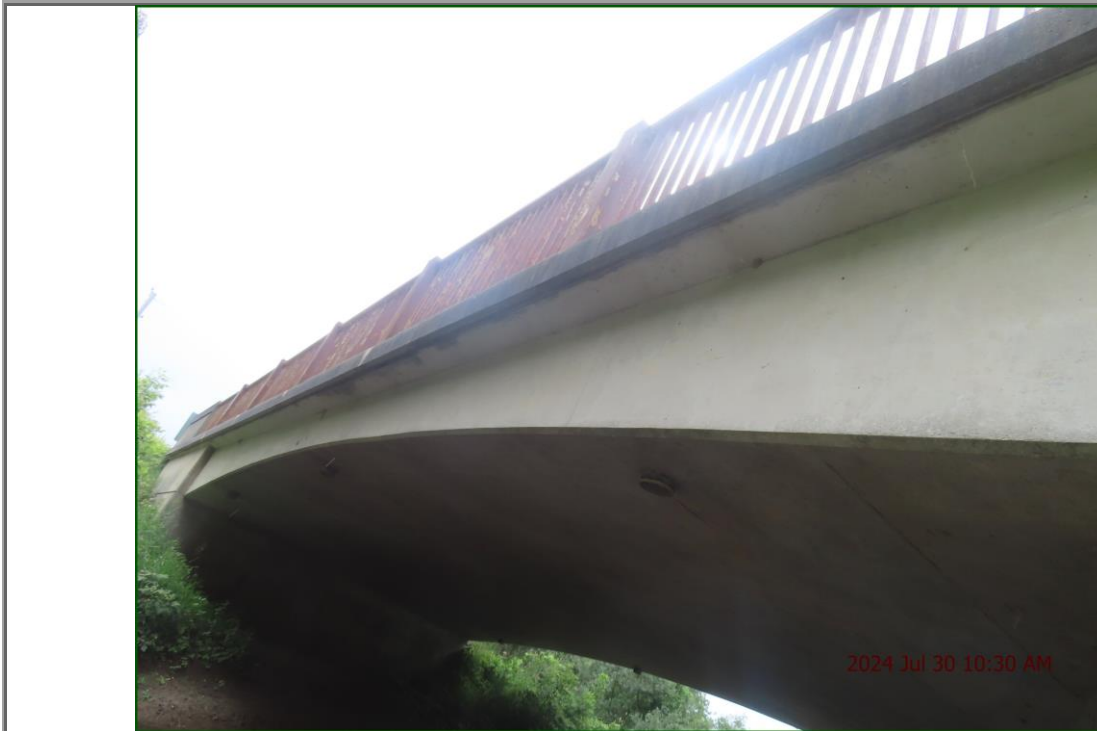
Light to medium cracking with leachate staining at posts locations.

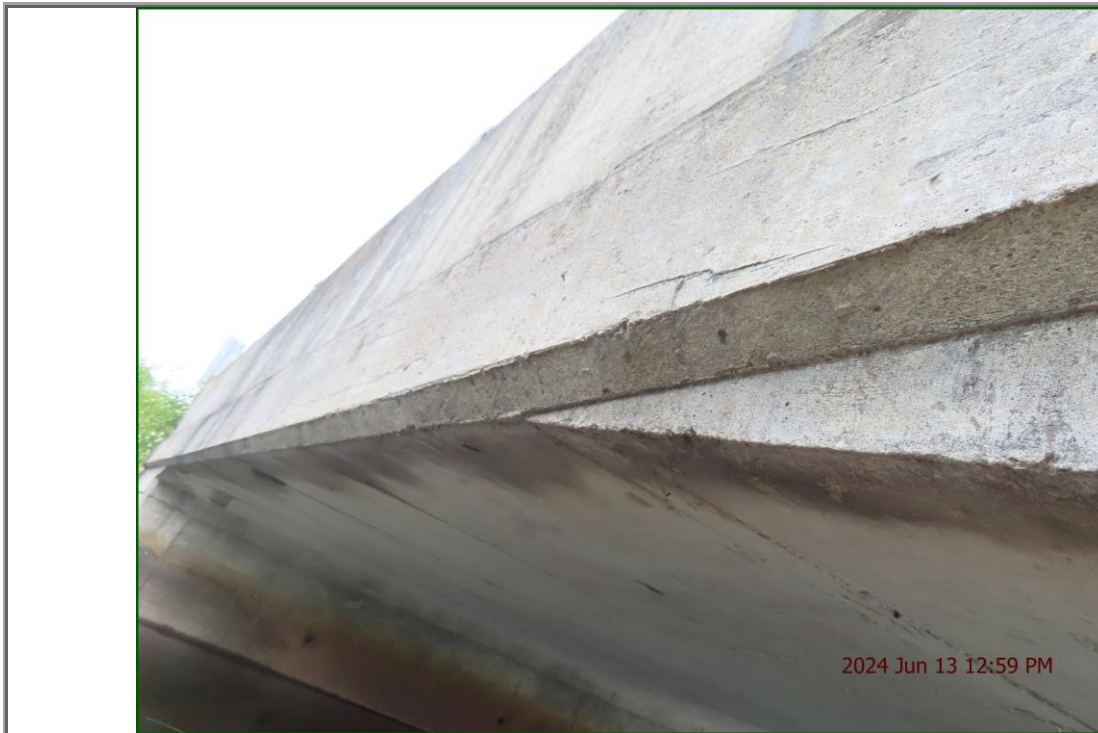
Light vertical cracking with leachate staining throughout.

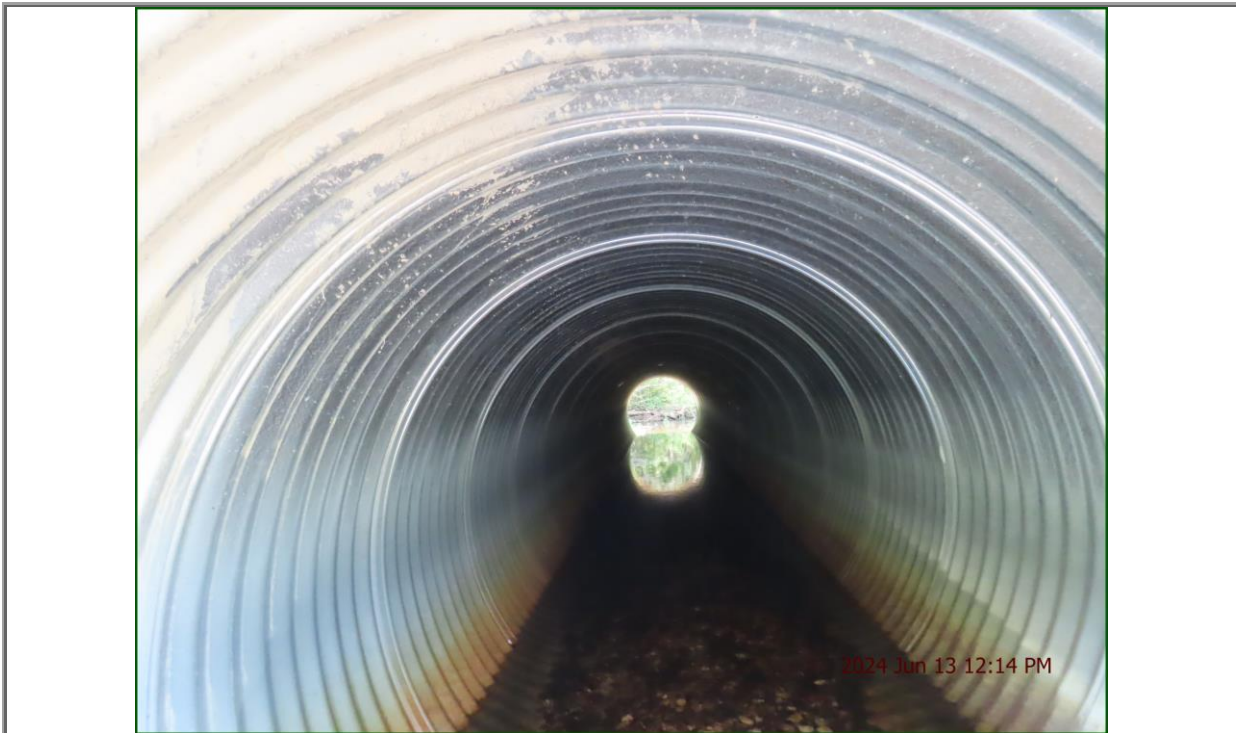
Minor deformations throughout.
