May 17, 2024
Our File: 224002-1

Re: Slope Review
Durham Heights Bible Retreat
423018 Rocky Saugeen Road
Municipality of West Grey

This letter report provides a review of the current slope conditions and comments on the proposed development.

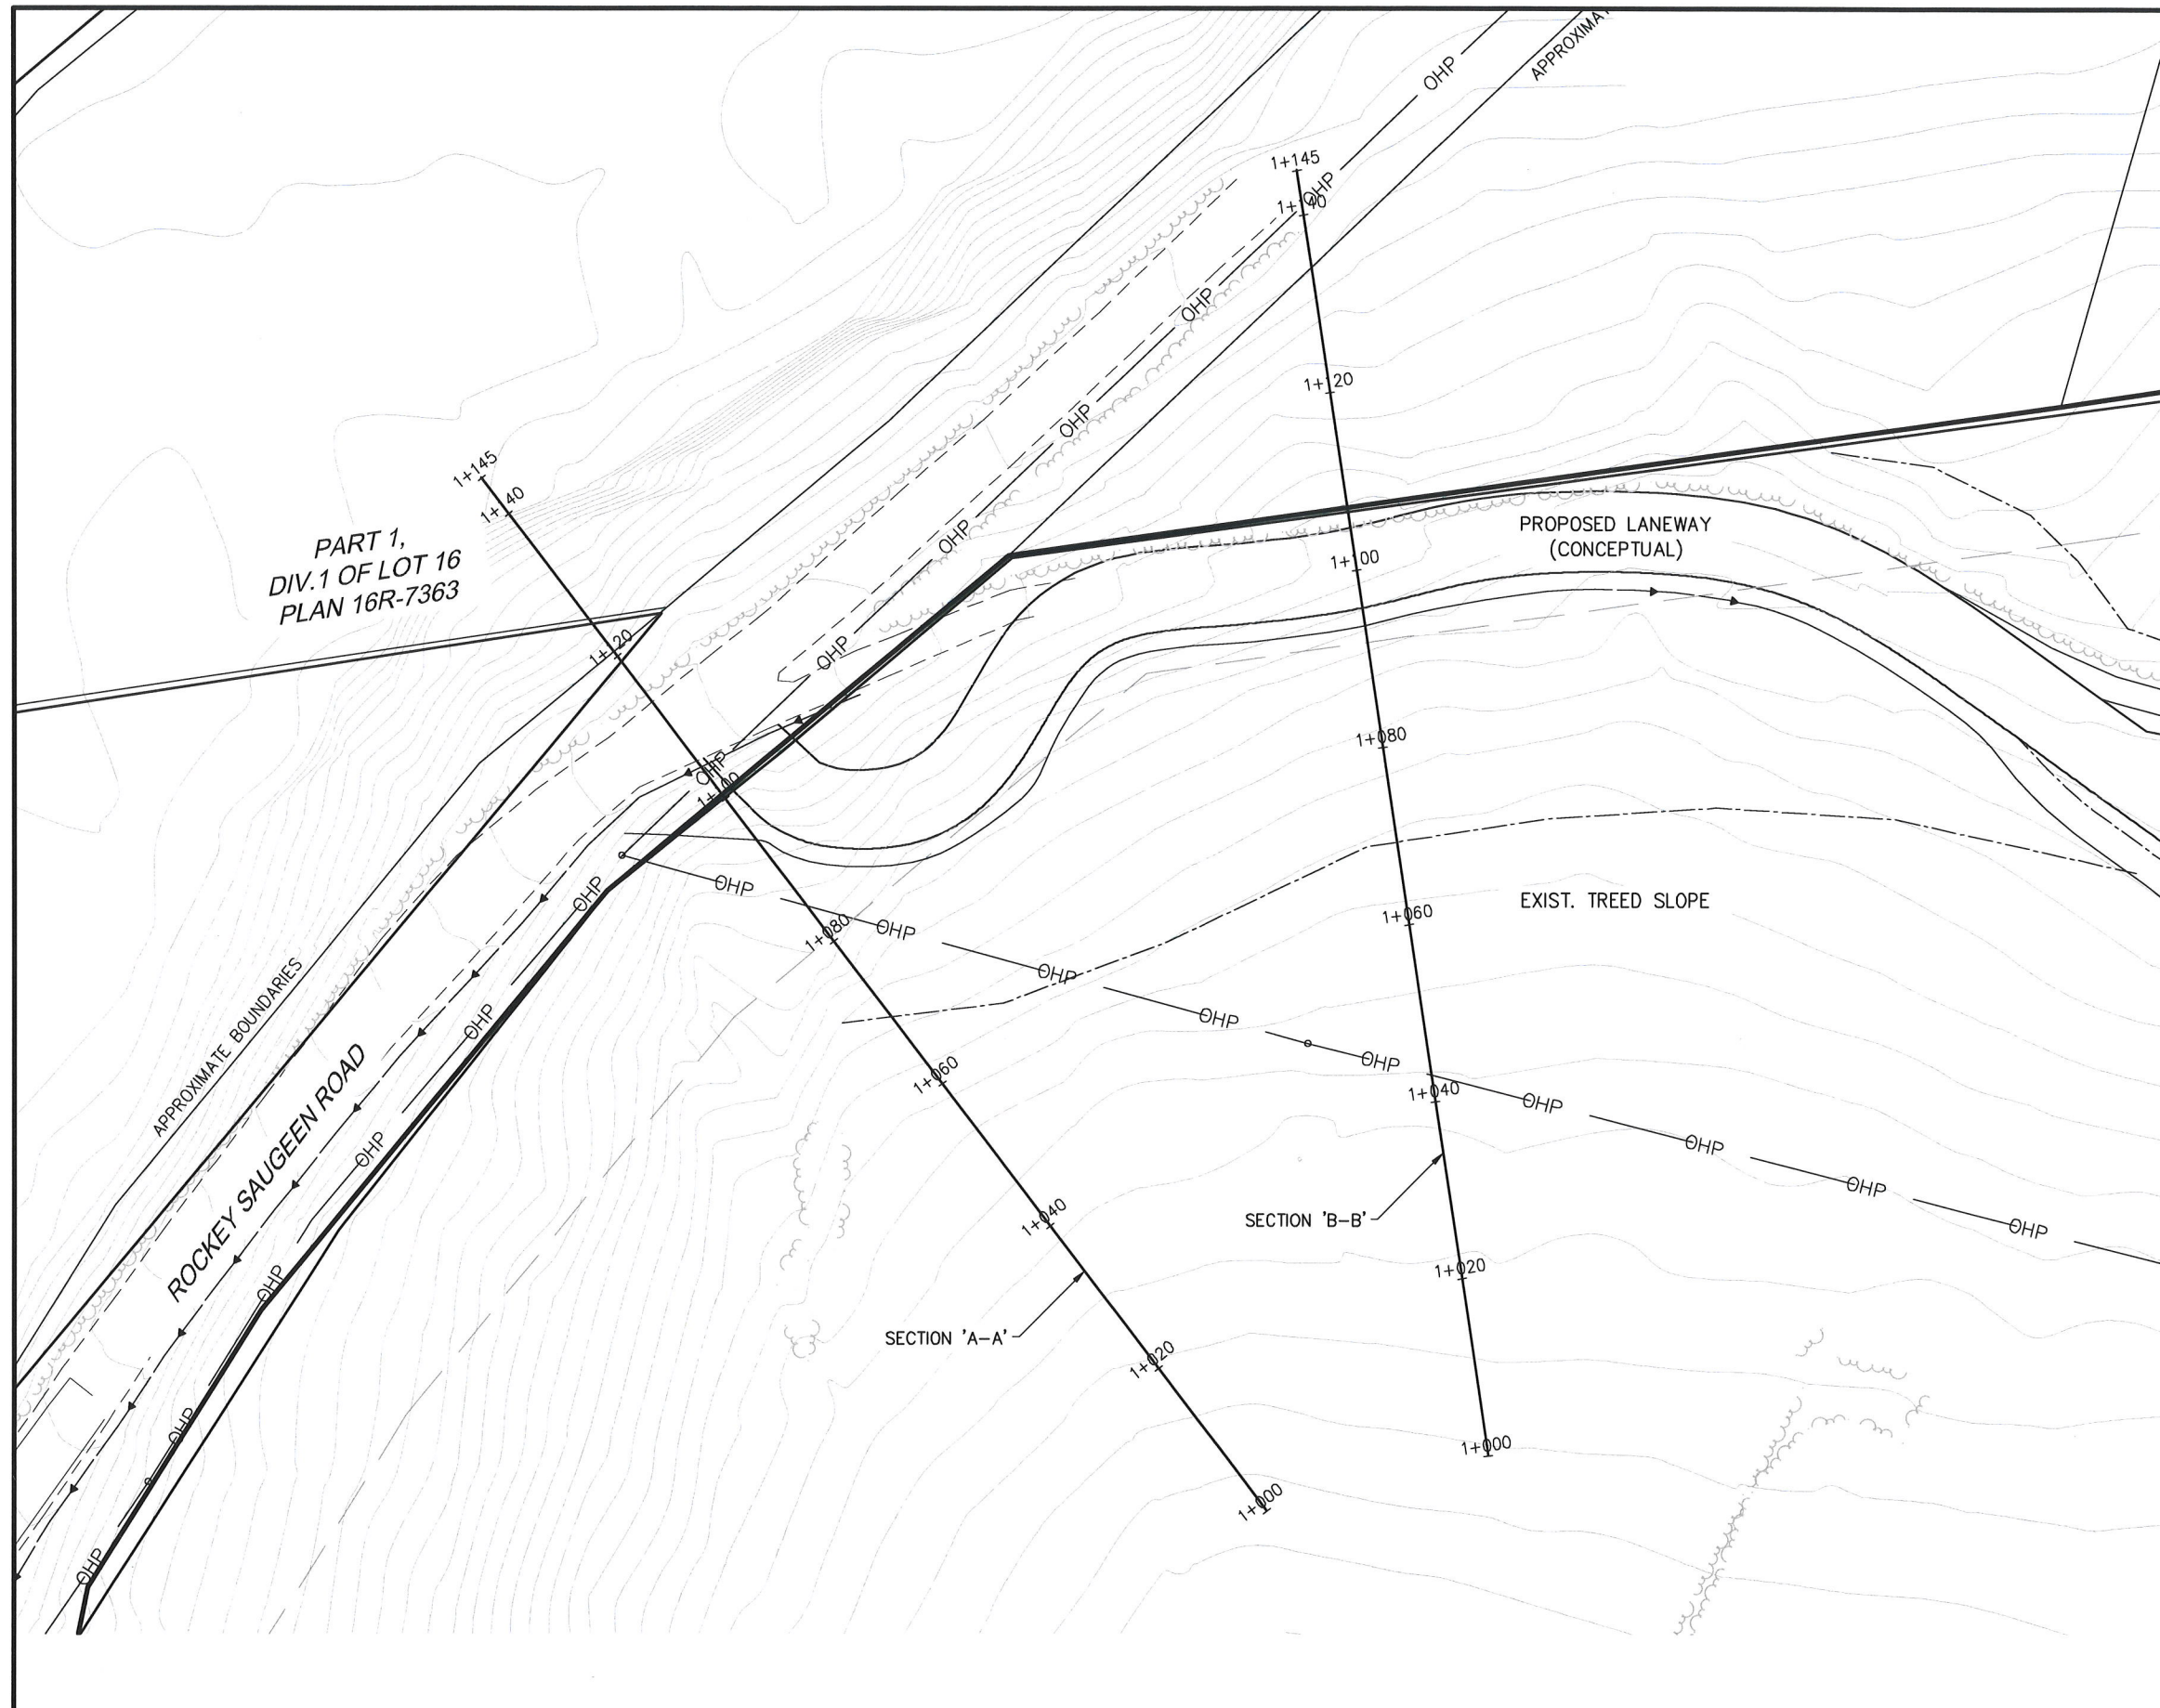
The undersigned visited the site to review the slope conditions on April 12, 2024. A previous topographical survey had been completed, with the focus on the subject area to the south of Rocky Saugeen Road. For the purposes of this review, these are considered two general areas of the slope being reviewed and the areas are represented by Section A-A and Section B-B.

The background subsurface information gathered in combination with the topographical survey information, base map contouring and on-site observations was used to conduct preliminary slope condition review. The cross-section locations are identified on Figure No. 1 and the cross-sections are shown on Figure No. 2.

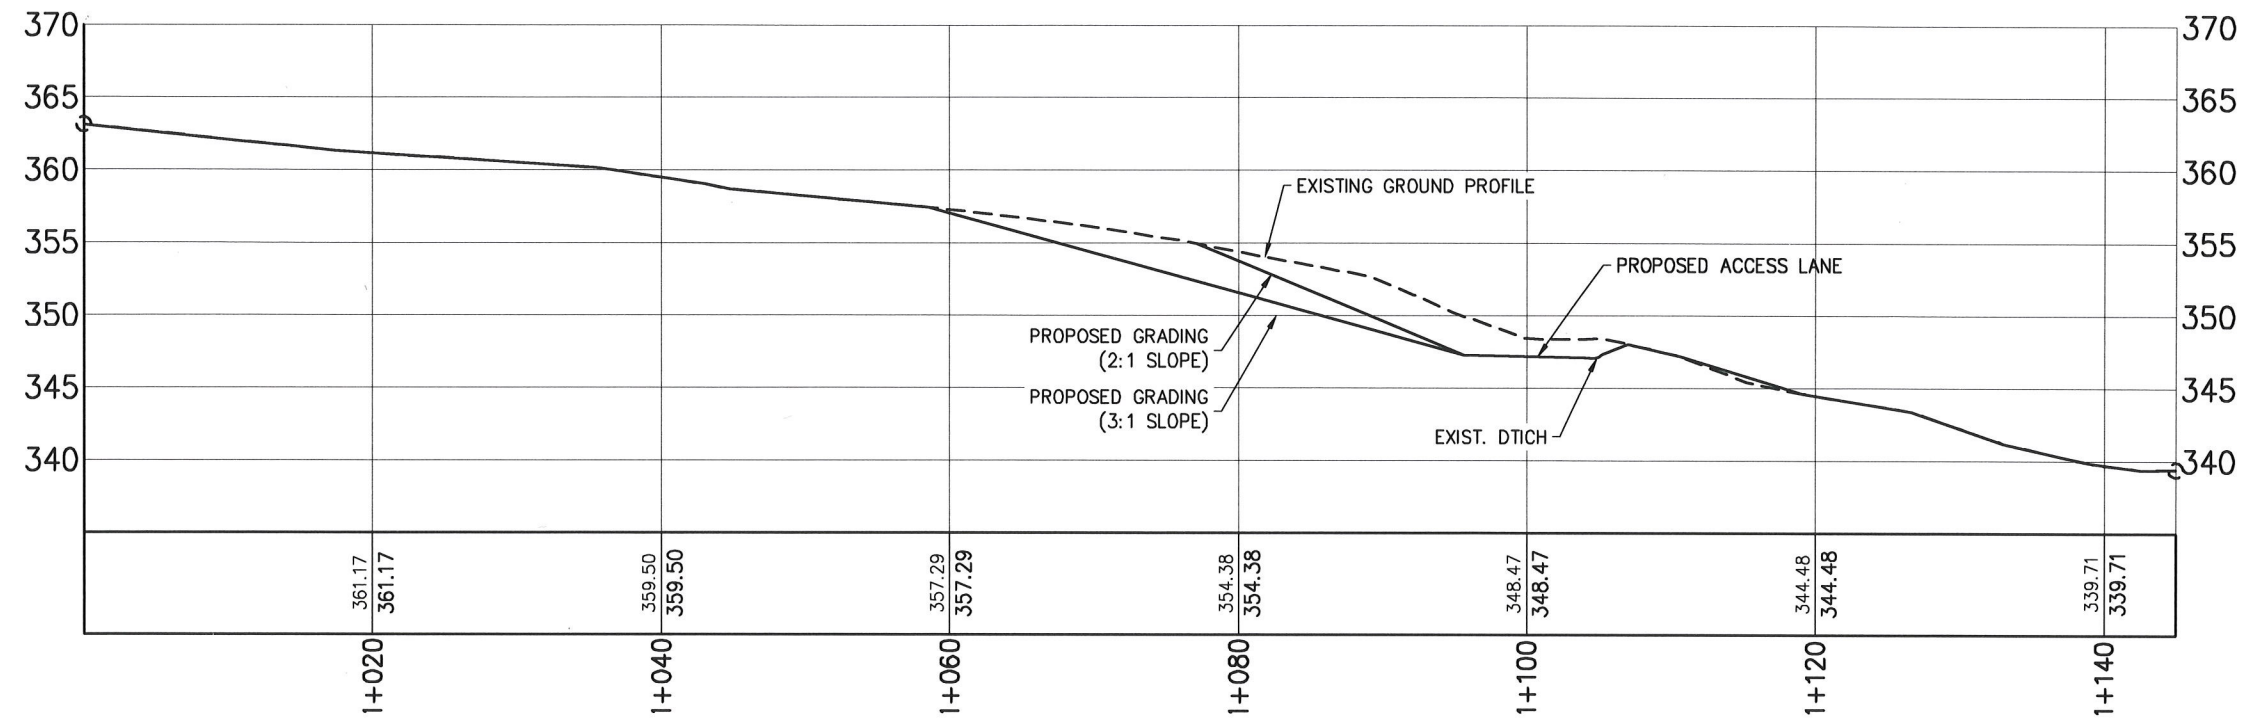
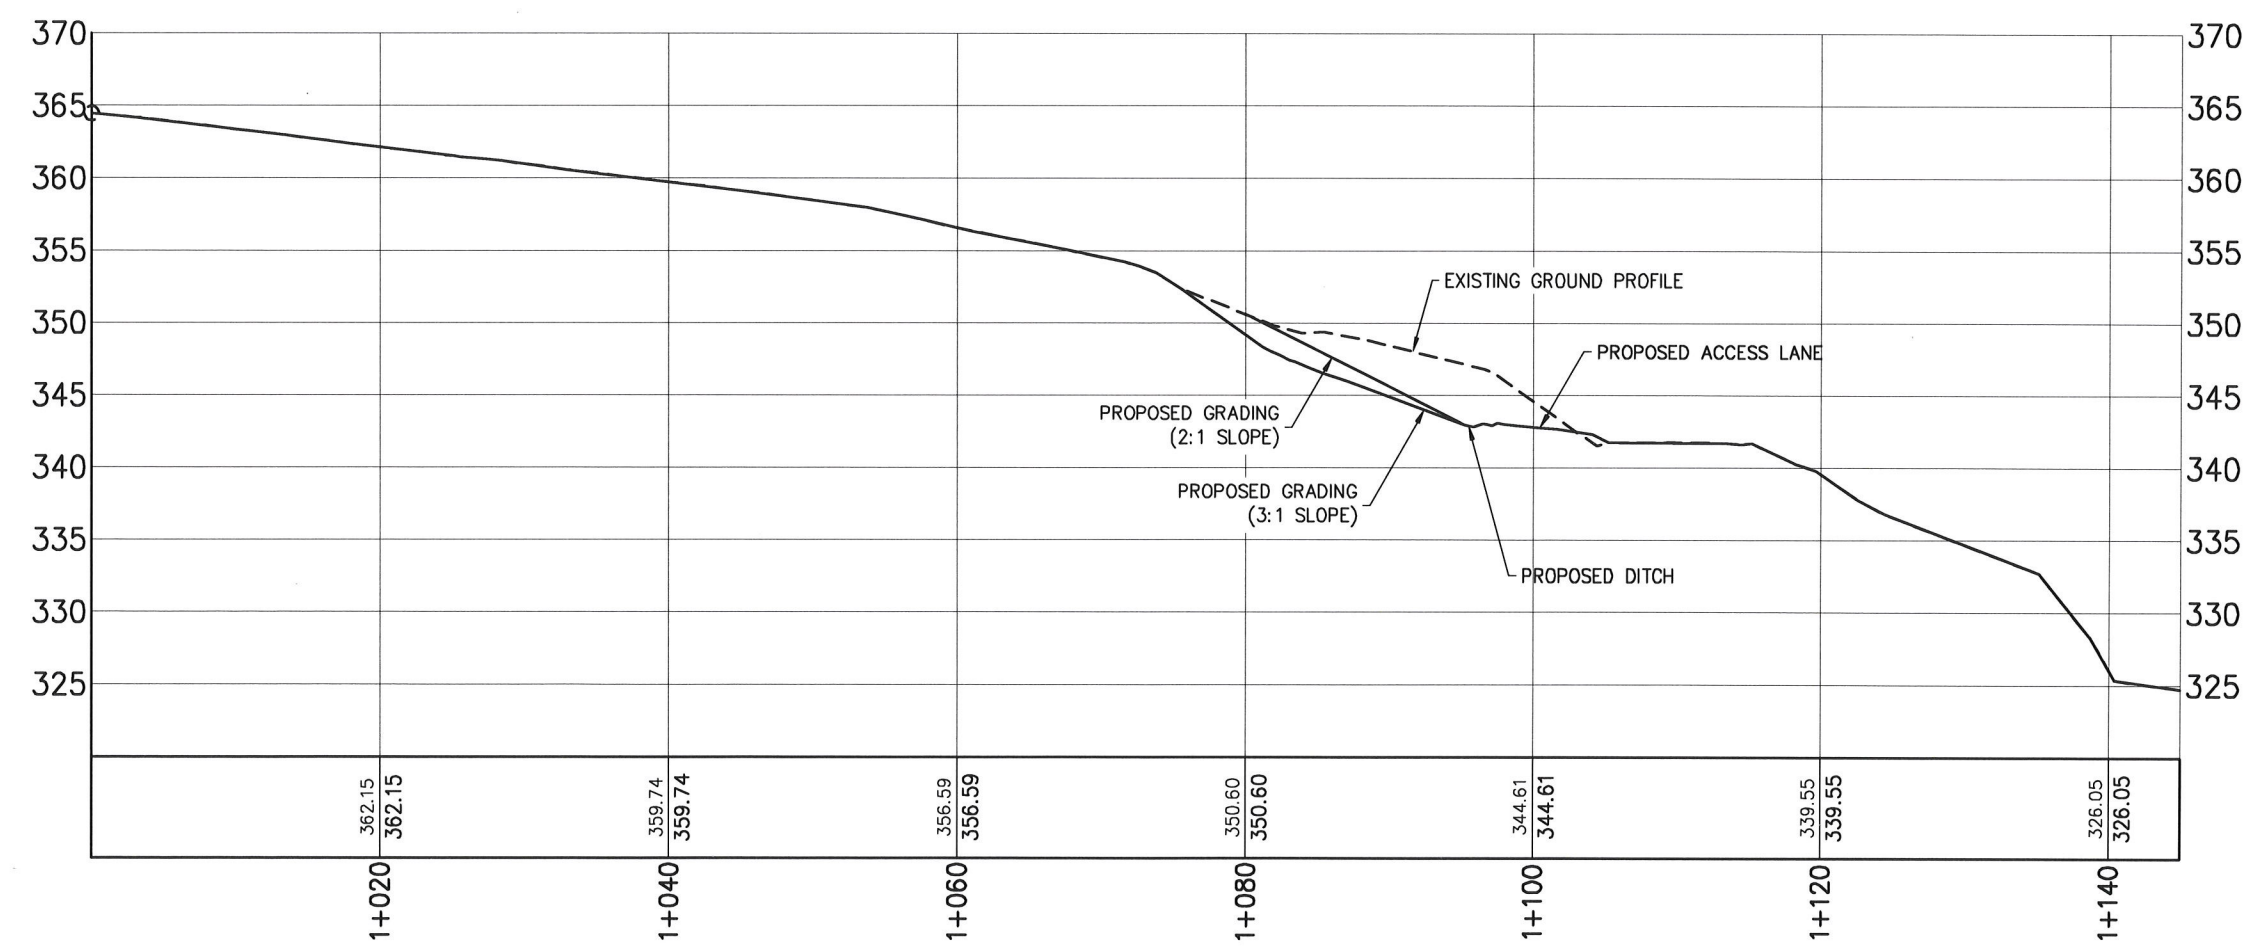
Figure No. 2

Section A-A cuts through the slope to the on the north and south side of Rocky Saugeen Road. The top of the slope along this section is near elevation 365m and the bottom of the slope is near elevation 325m, with the overall height of approximately 40m. The upper portion of the slope is at an inclination of 9° to 18°. The slope then has an over-steepened section on the south side of Rocky Saugeen Road, transitioning to an inclination of 35°. On the north side of Rocky Saugeen Road, the slope is at an inclination of 25°, down towards a vertical rock face that is approximately 8 to 10m in height. Below the rock face is relatively flat, with low lying marshy land and the Rock Saugeen River approximately 30m from the base of the slope.

Section B-B is through the slope on the north and south side of the access laneway to the proposed site. This slope is at an inclination of 7° at the top, and transitions to 16° on the south side of the access laneway and 17° on the north side.

On April 12th, during the site visit to review the current condition of the slope, general measurements of the slope inclinations were recorded and found to be generally consistent with the desktop study of the slope. The slopes are well treed, with mainly mature trees and both deciduous and coniferous tree growth. The over-steepened section along the south side of Rocky Saugeen Road and the access laneway features no tree growth and minimal vegetative cover, with the sand and gravel subsurface exposed along the section. As such, there was some evidence of localized erosion of the sand and gravel along Rocky Saugeen Road. No seepage of groundwater was evident along the sections of the slope observed.

Based on the above noted observations and slope measurements, the Slope Stability Rating Chart (Table 8.1) from the Ministry of Natural Resources (MNR) Geotechnical Principles for Stable Slopes Guidelines was used to evaluate the slope and determine the potential investigation requirements. The scoring of slope based on the parameters of the Chart is attached to this letter report. The total rating value was determined to be 22, which corresponds to a Low Potential for Slope Instability based on the existing conditions of the slope.
