Final Dam Inspection Report

Durham Upper Dam and Dyke

**Municipality of West Grey,
County of Grey, Ontario**

D.M. Wills Project Number 22-5540

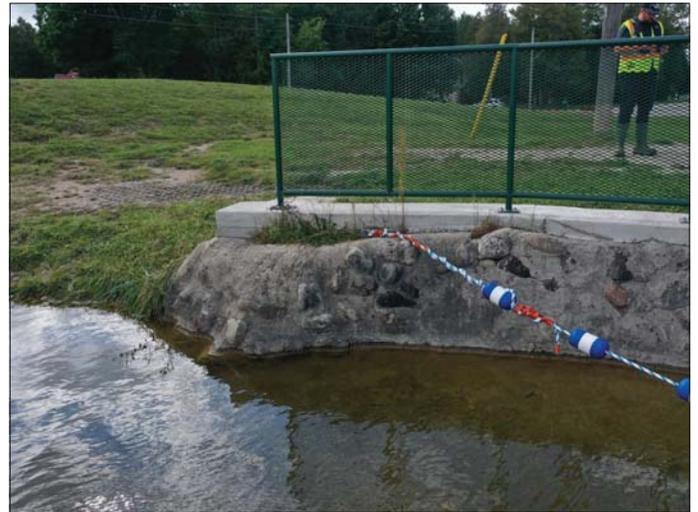
Photo 2 - September 19, 2022
Durham Upper Dam and Dyke
Right Side Buoy Line Anchor

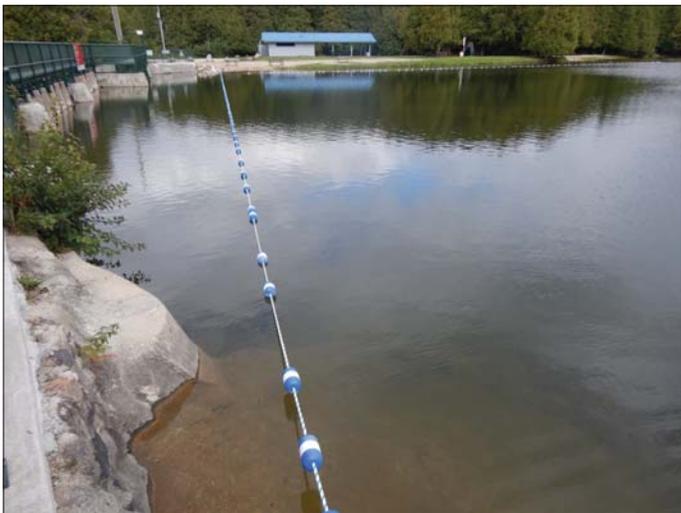
Photo 3 - September 19, 2022
Durham Upper Dam and Dyke
Buoy Line from Right Bank

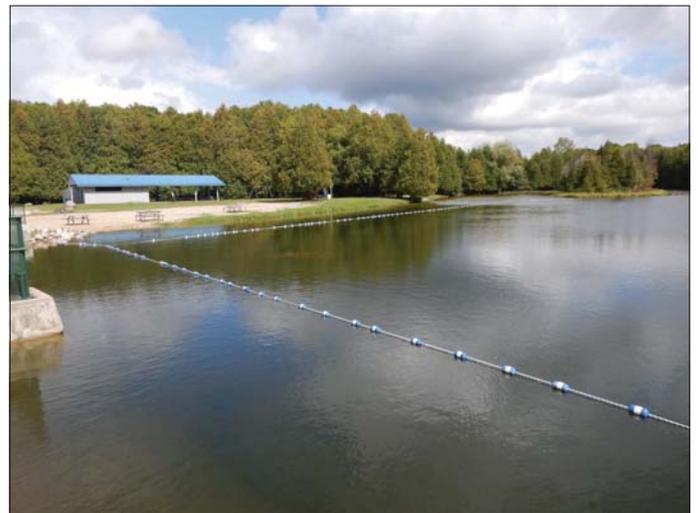
Photo 4 - September 19, 2022
Durham Upper Dam and Dyke
Buoy Line from Walkway

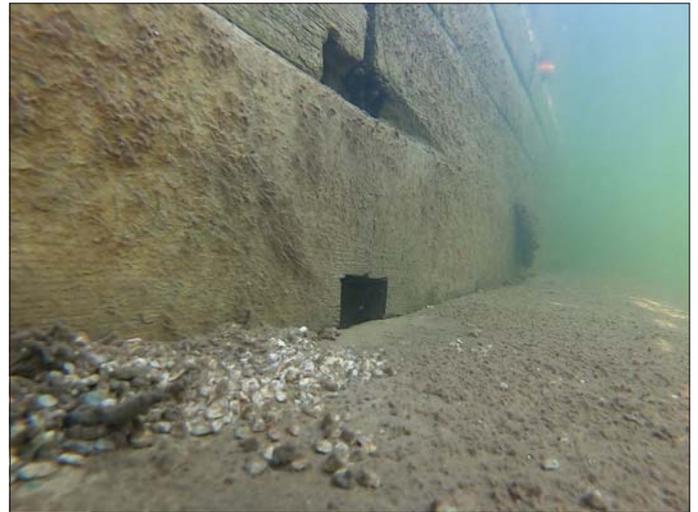
Photo 14 - September 19, 2022
Durham Upper Dam and Dyke
Stoplogs in Sluiceway 5

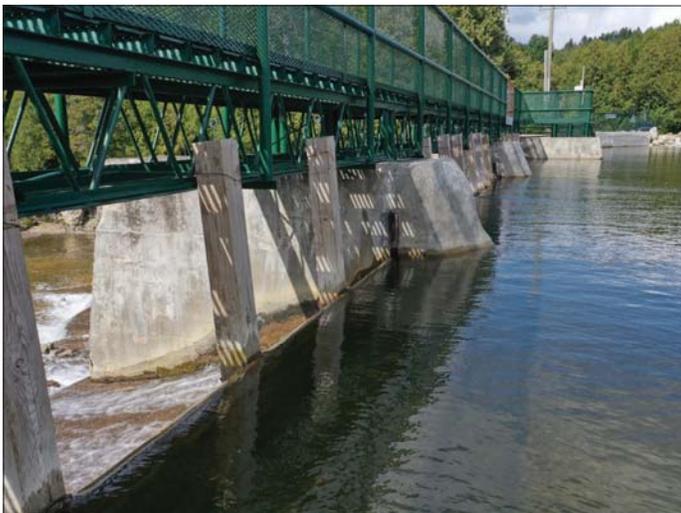
Photo 15 - September 19, 2022
Durham Upper Dam and Dyke
Right Side of Pier 4

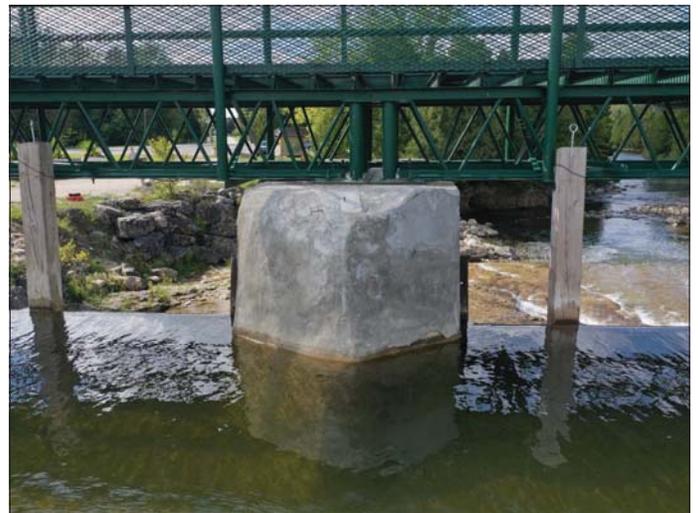
Photo 16 - September 19, 2022
Durham Upper Dam and Dyke
Upstream Side of Pier 4

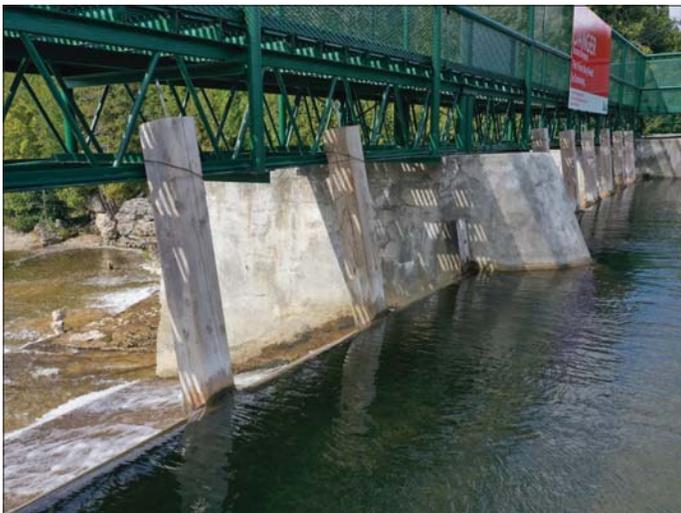
Photo 21 - September 19, 2022
Durham Upper Dam and Dyke
Right Side of Pier 3

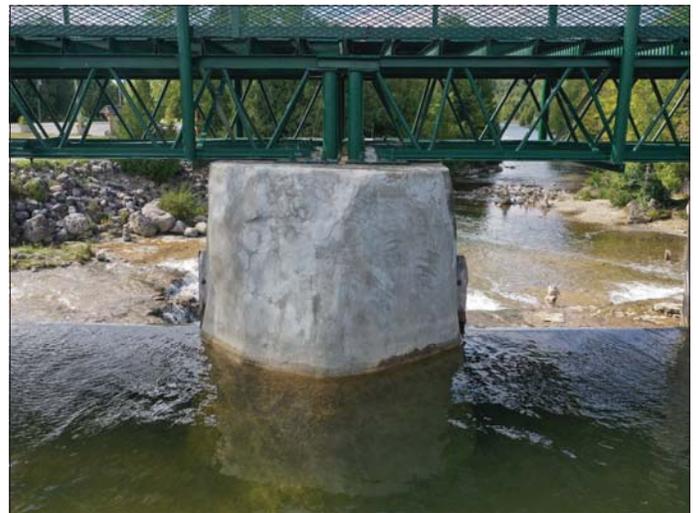
Photo 22 - September 19, 2022
Durham Upper Dam and Dyke
Upstream Side of Pier 3
