Final Dam Inspection Report

Durham Lower Dam and Dyke

**Municipality of West Grey,
County of Grey, Ontario**

D.M. Wills Project Number 22-5540

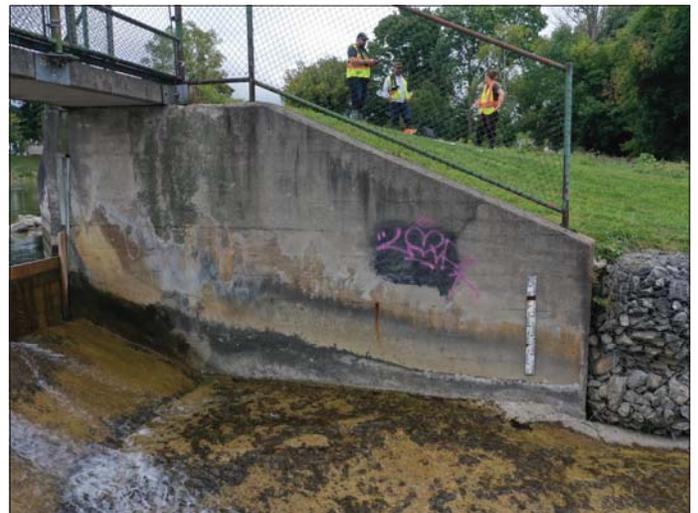
Photo 3 - September 19, 2022
Durham Lower Dam and Dyke

Gabion Baskets on Downstream Right Side of Dam

5. Monitor the gabion baskets on the downstream right side of the dam to check for movement and deterioration and undertake repairs as required.	The gabion baskets on the downstream right side of the dam show signs of deterioration.	Ongoing	\$0	It is assumed that this would be completed by SVCA staff as part of their regular duties. Costs to replace the gabion basket retaining wall could be in the \$5,000 range.

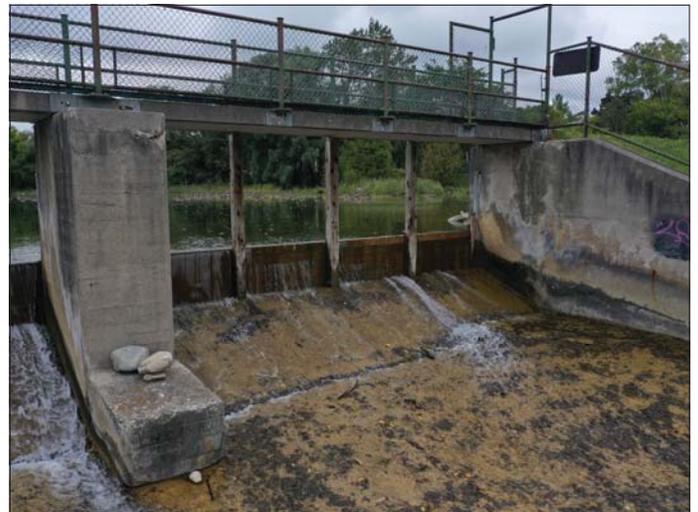
Photo 5 - September 19, 2022
Durham Lower Dam and Dyke

Staff Gauge on Downstream Right Wingwall

Minor Maintenance				
8. Replace the staff gauge on the downstream side of the dam and install a staff gauge on the upstream side of the dam.	The staff gauge on the downstream side of the dam is in poor condition and there is no staff gauge on the upstream side of the dam.	High	\$2,000	It is assumed that this would be completed by SVCA staff as part of their regular duties with purchased materials.
Major Maintenance

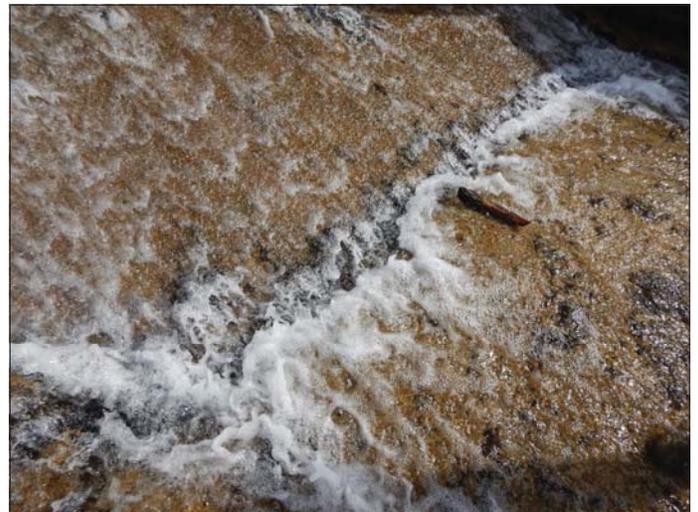
Photo 11 - September 19, 2022
Durham Lower Dam and Dyke
Stoplogs in Sluiceway 4

stoplogs. The stoplogs and posts are exhibiting light weathering, rot, and decay, consistent with the environment in which they are being used.

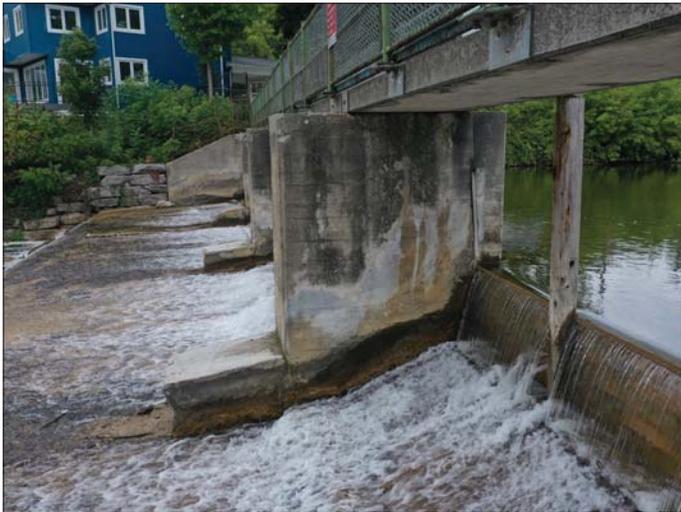
Photo 12 - September 19, 2022
Durham Lower Dam and Dyke
Crack in Apron Below Sluiceway 4

9. Complete patching and repairs to the concrete piers, deck, abutments, and apron.	The concrete sections of the dam are showing signs of deterioration and repairs will ultimately be required to preserve the service life of the structure.	Medium	\$250,000	It is assumed that the SVCA would retain a qualified contractor to undertake this work. The cost estimate includes a detailed concrete condition assessment and detailed design by a professional engineer.

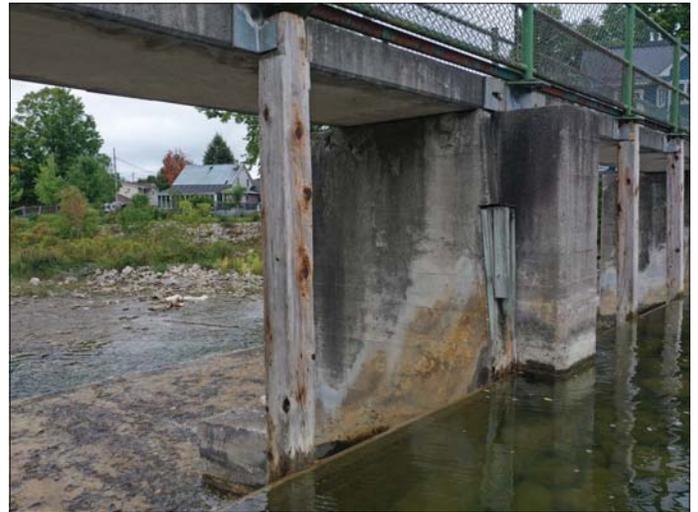
Photo 37 - September 19, 2022
Durham Lower Dam and Dyke

Stoplogs on Upstream Side of Sluiceway 5

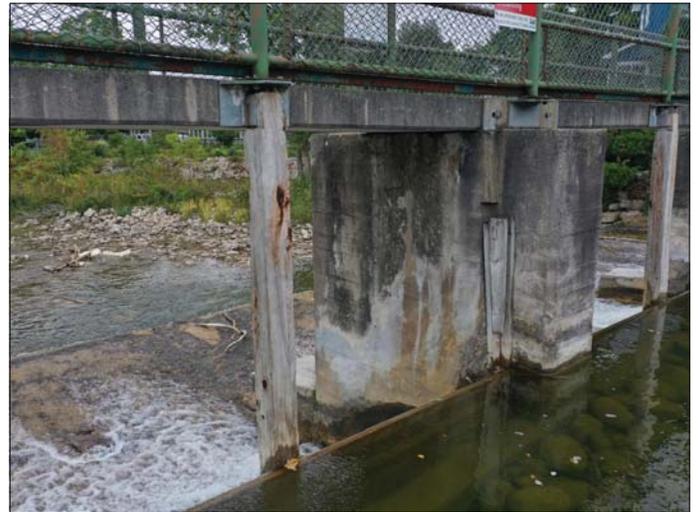
Photo 43 - September 19, 2022
Durham Lower Dam and Dyke

Stoplogs on Upstream Side of Sluiceway 4

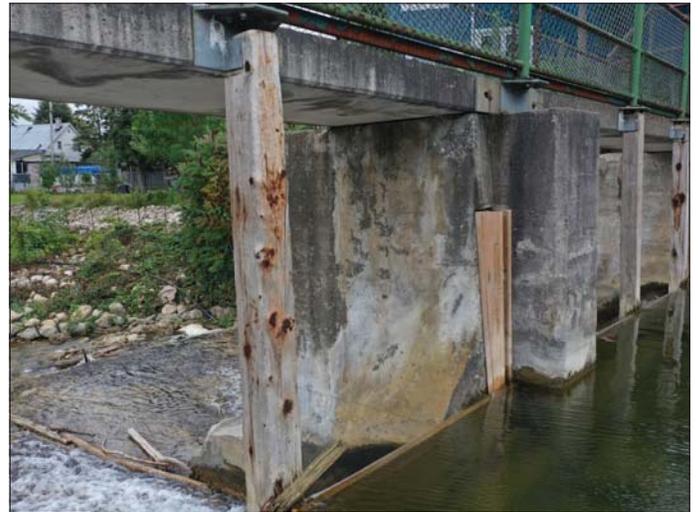
Photo 55 - September 19, 2022
Durham Lower Dam and Dyke

Stoplogs on Upstream Side of Sluiceway 2

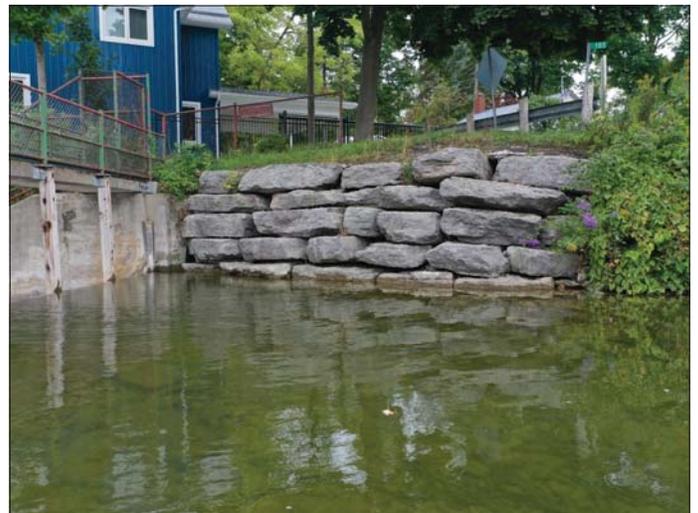
Photo 64 - September 19, 2022
Durham Lower Dam and Dyke

Stone Retaining Wall on Upstream Left Bank

4. Monitor the armour stone retaining walls on the upstream and downstream left sides of the dam to check for movement and deterioration and undertake repairs as required.	The armour stone retaining walls on the upstream and downstream sides of the dam show some signs of deterioration.	Ongoing	\$0	It is assumed that this would be completed by SVCA staff as part of their regular duties. Costs to replace the armour stone retaining walls could be in the \$10,000 range.

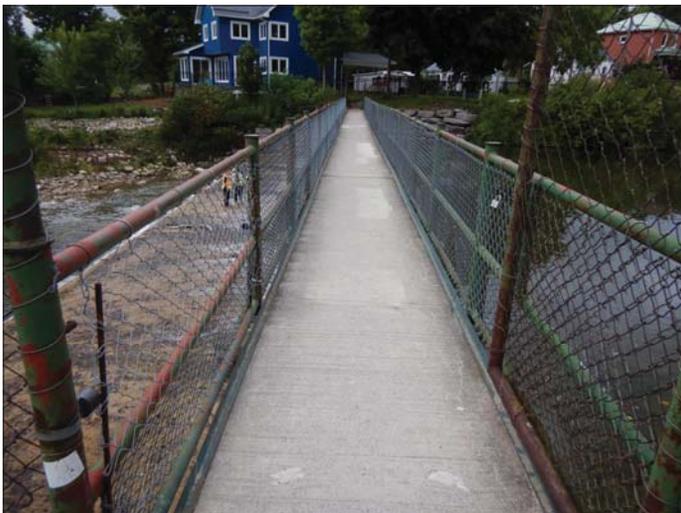
Photo 74 - September 19, 2022
Durham Lower Dam and Dyke
Right Facing Public Safety Sign

There are small (18 inch by 24 inch) public safety signs mounted to the railings on the upstream and downstream sides of the dam. The signs read “DANGER, NO TRESPASSING, Access Beyond This Point May Result in Drowning” and includes the old SVCA logo as well as the address of the dam and instructions to call 911 in an emergency. The signs are in good condition; however, they are not the correct signs for facing upstream and downstream.

Recommendation	Description of Deficiency	Priority	Estimated Cost	Additional Comments
Public Safety				
7. Complete a Public Safety Risk Assessment and prepare a Public Safety Plan for the Durham Lower Dam and implement appropriate public safety measures (i.e. railings, fencing, signage, public safety boom/buoys). This work should be completed in accordance with the Best Management Practices for Public Safety Around Dams (MNR, 2011) and the Guidelines for Public Safety Around Dams (CDA, 2011).	There is no Public Safety Risk Assessment or Public Safety Plan for the Durham Lower Dam and it is evident that there is a significant public presence at the site.	High	\$15,000	The cost estimate assumes that the SVCA would retain the services of a qualified consulting engineering firm to complete this work; however, this could be completed by SVCA staff if they have the appropriate knowledge and experience. The appropriate public safety measures and their costs would be identified as part of the Public Safety Risk Assessment.
