Date of Inspection:	30-Jul-24
Name of Inspector:	Andrew Burgess, P.Eng. & Joel Ziegler CET
Equipment Used:	Sounding hammer, measuring equipment, GPS
Weather Conditions:	Cloudy
Temperature:	23
Special Notes:	Bridge is in good condition, showing no signs of structural distress.

Year Built:	1979	Contract Number When Built:	
Latest Biennial Inspection:	September 14, 2022	Latest Specialized Inspection:	
Latest Structure Rating:	75.0	Latest Structure Condition:	
RehabHistory:			
Regional Priority Number:		Programmed Work Year:	
NatureOfProgramWork:

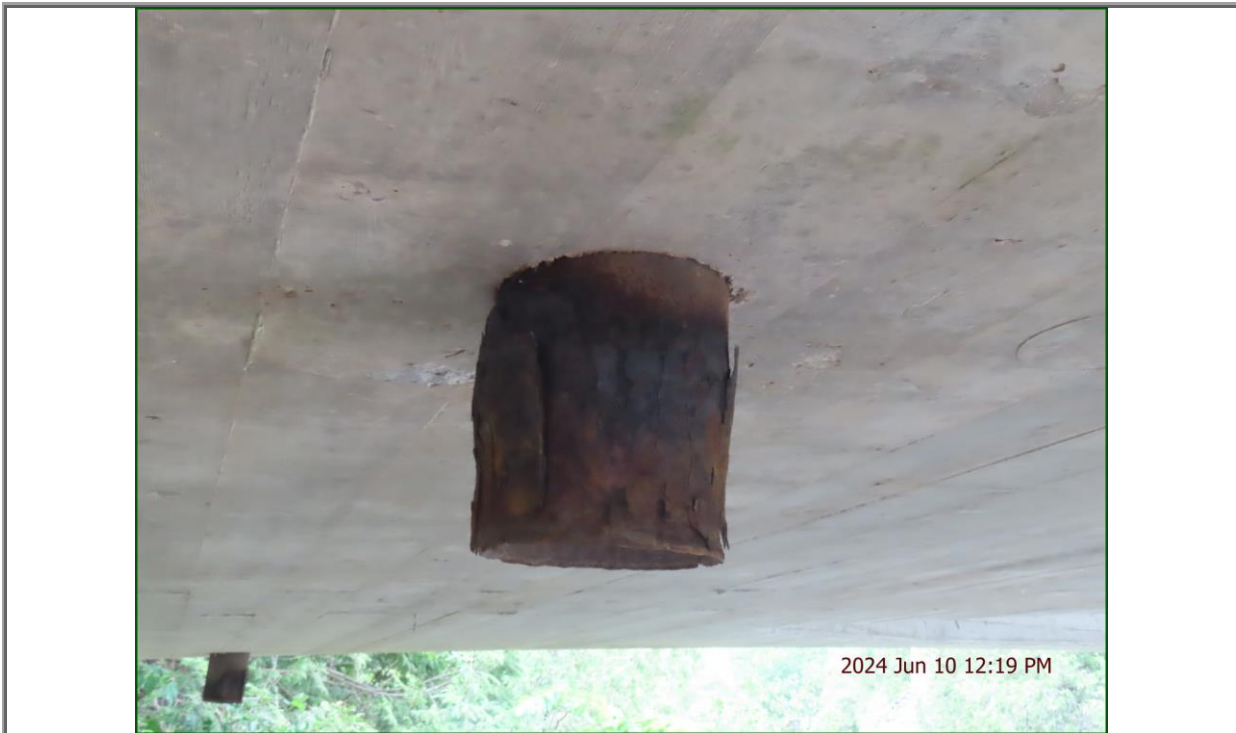
Medium corrosion throughout.

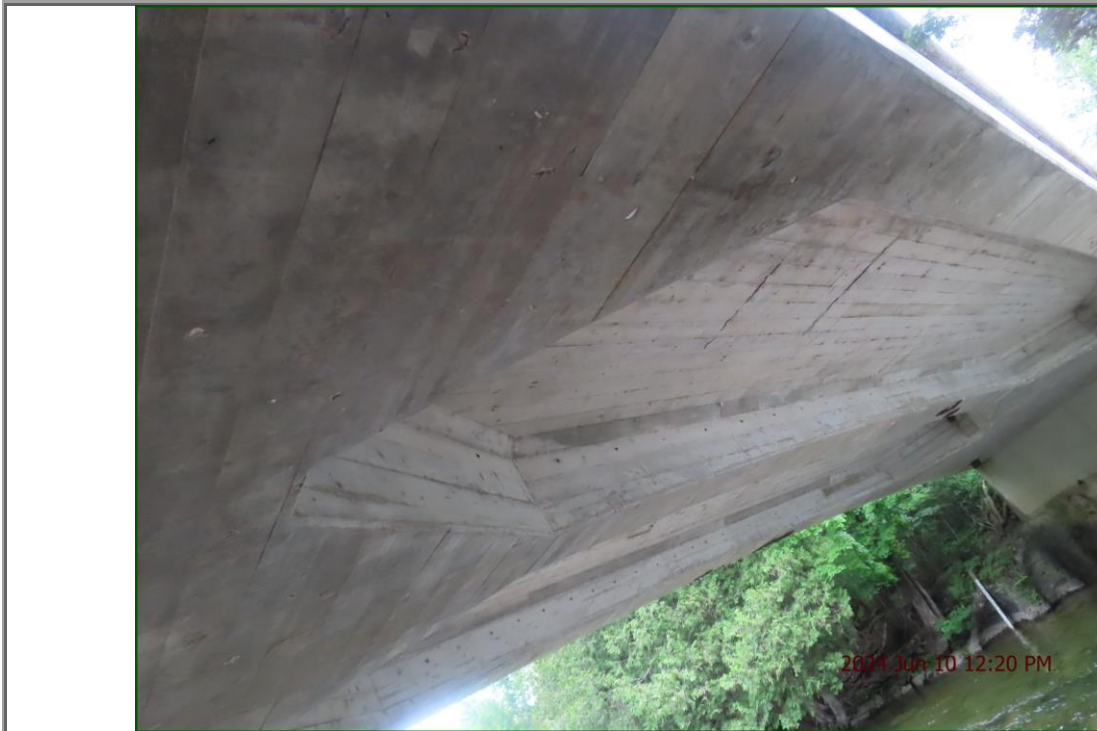
Light spalling with exposed reinforcing.

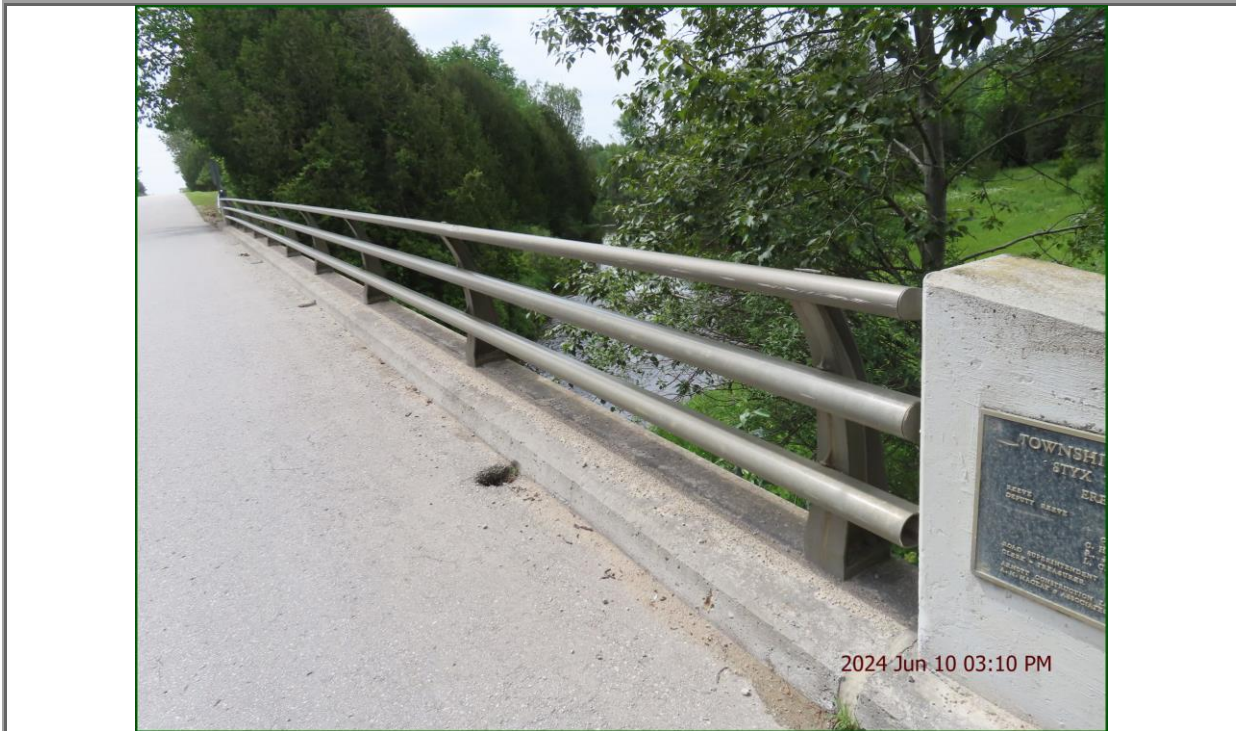
Minor impact damage.

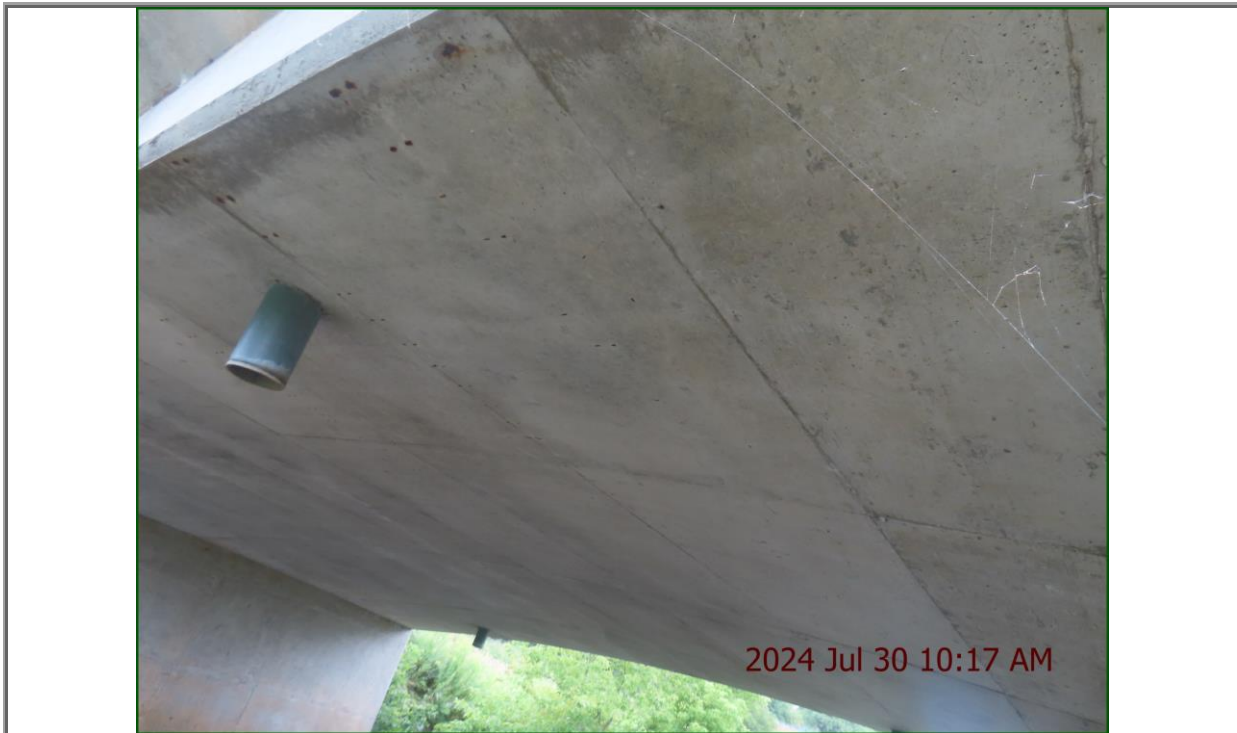
Light to medium longitudinal crack with leachate staining.

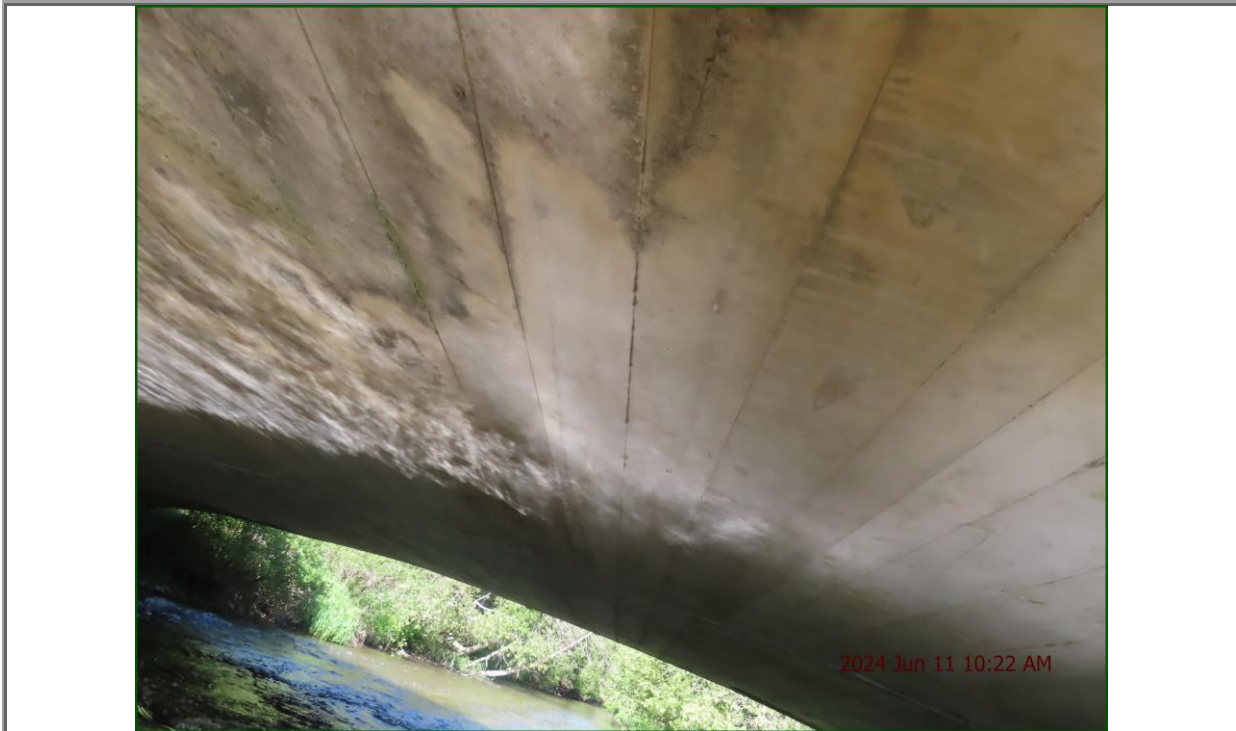
Medium to wide transverse crack with leachate staining. Shallow delamination along construction joint.

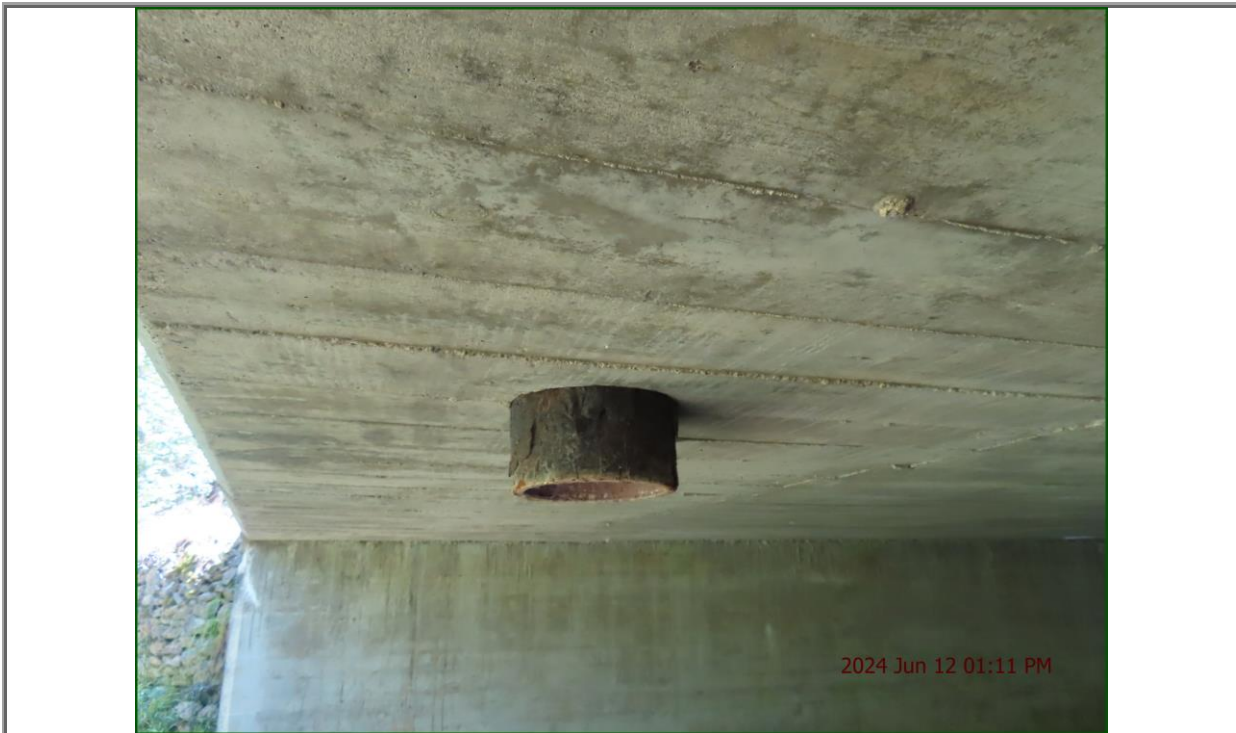
Light corrosion typical.

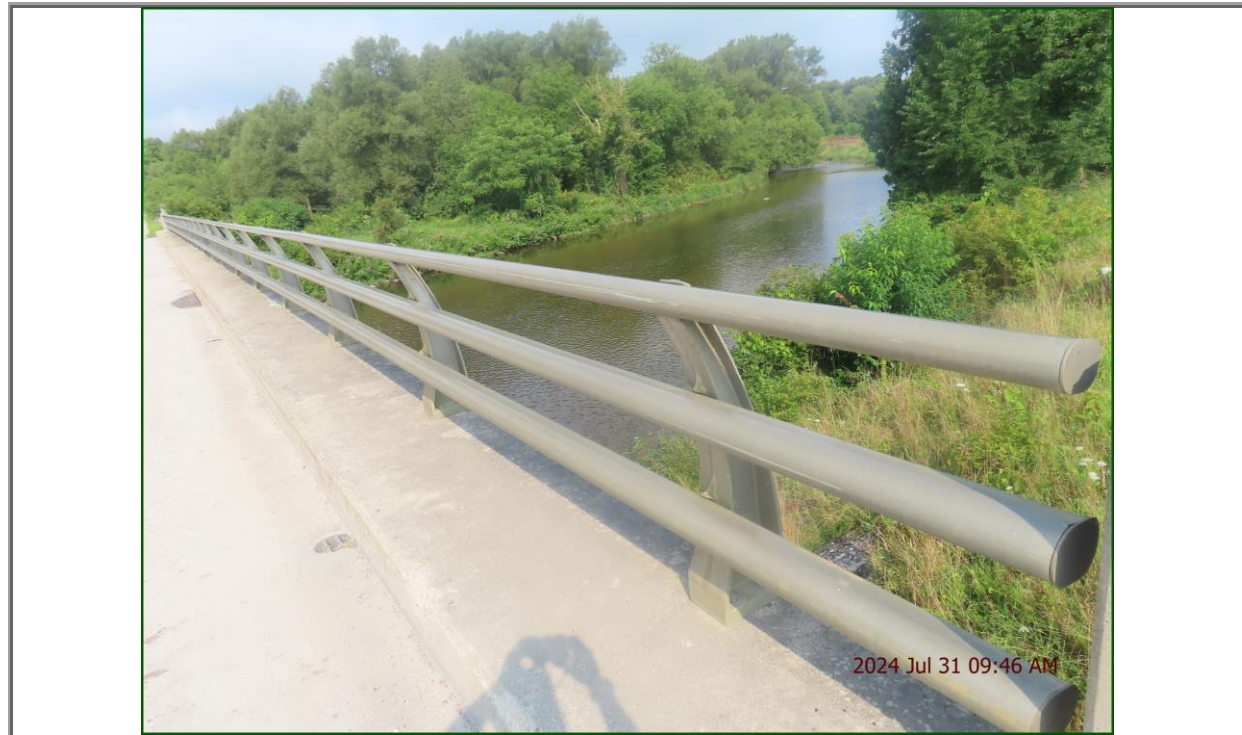
General Comments:
Minor impact damage throughout.

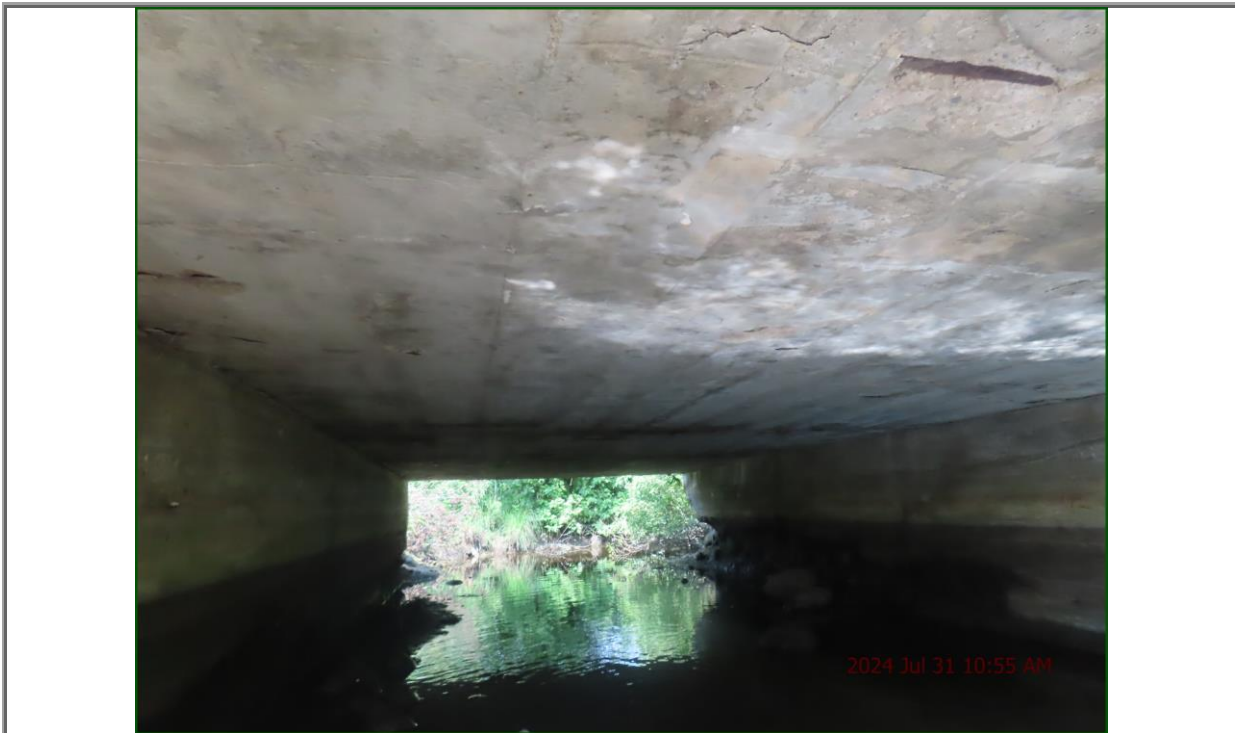
Severe spalling with exposed reinforcing throughout. Severe scaling. Severe disintegration along waterline, has undermined culvert. Wide vertical cracks propegating from spalling.

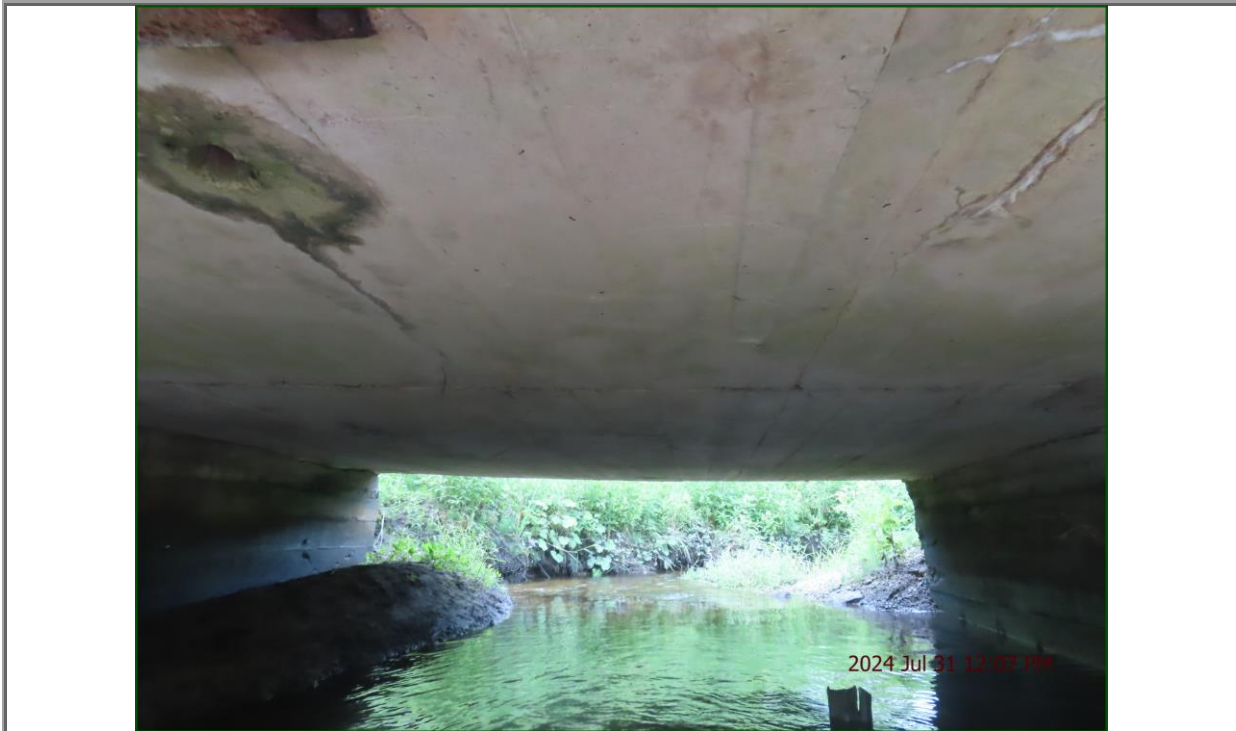
Severe spalling and disintegration. Medium to wide cracking with leachate staining throughout. Severe spalling and disintegration (undermining).

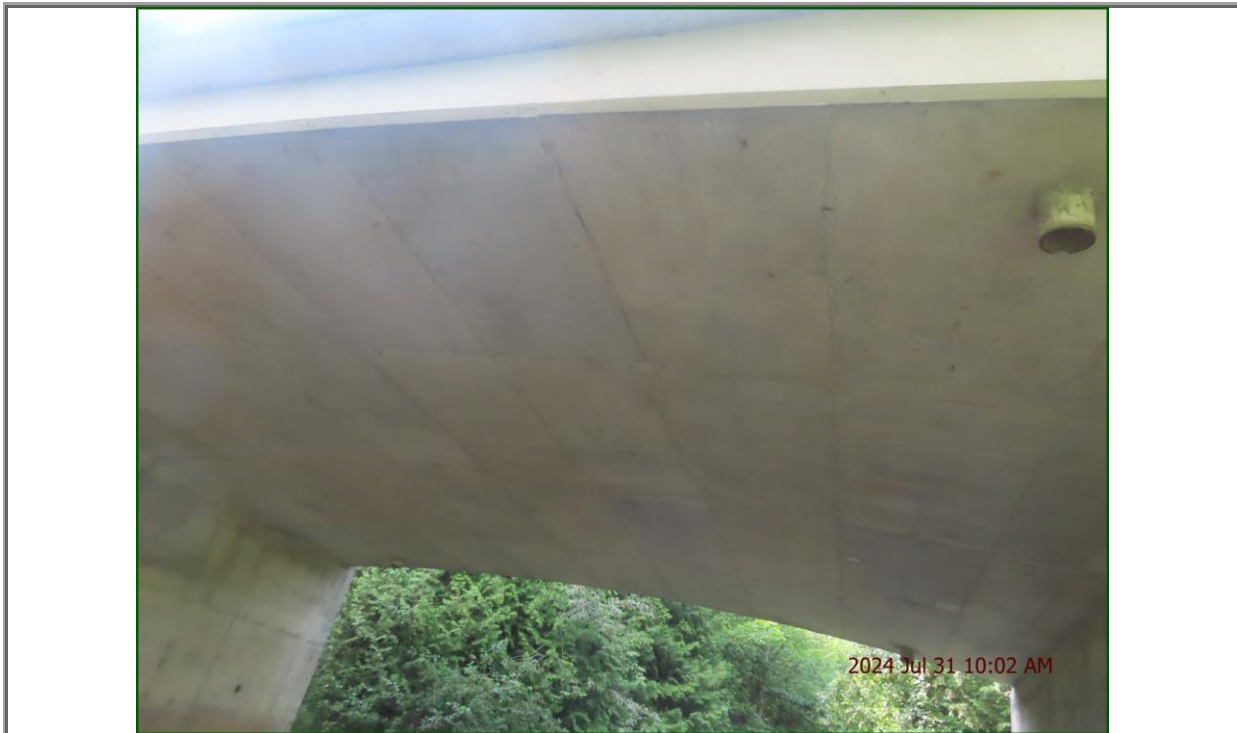
Light to medium longitudinal cracking with leachate staining.

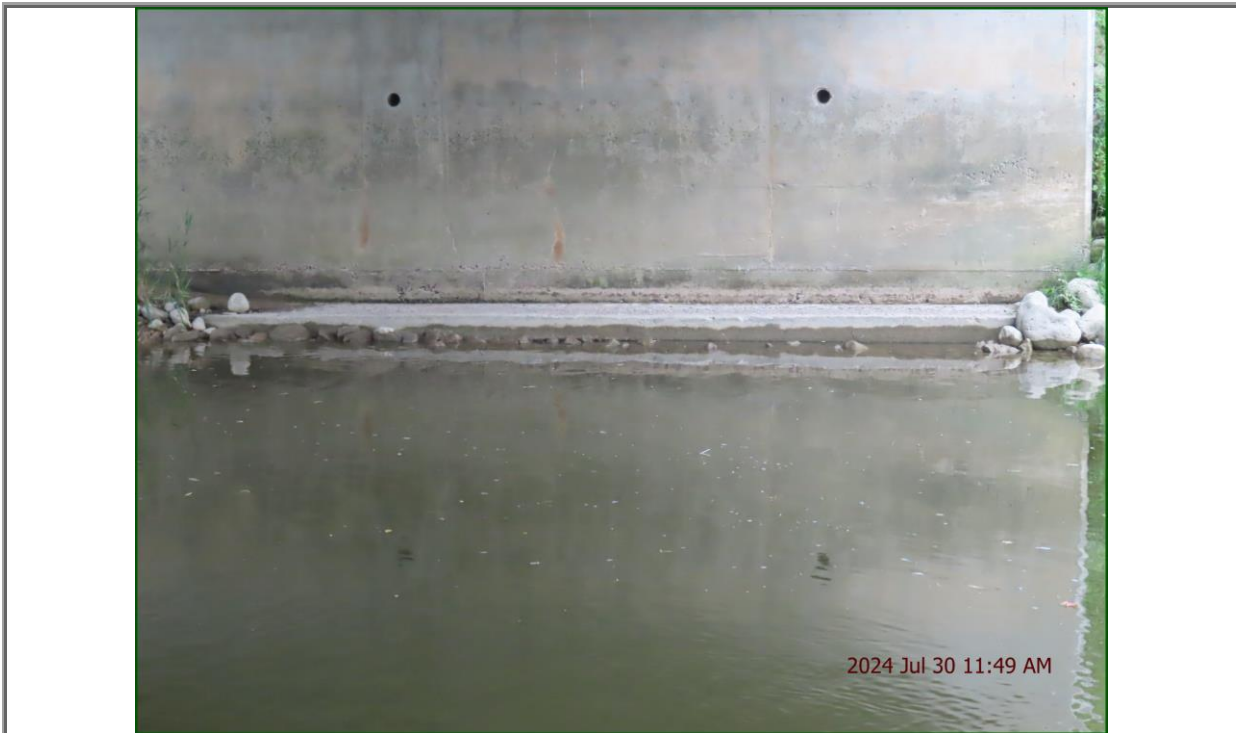
No signs of settlement.

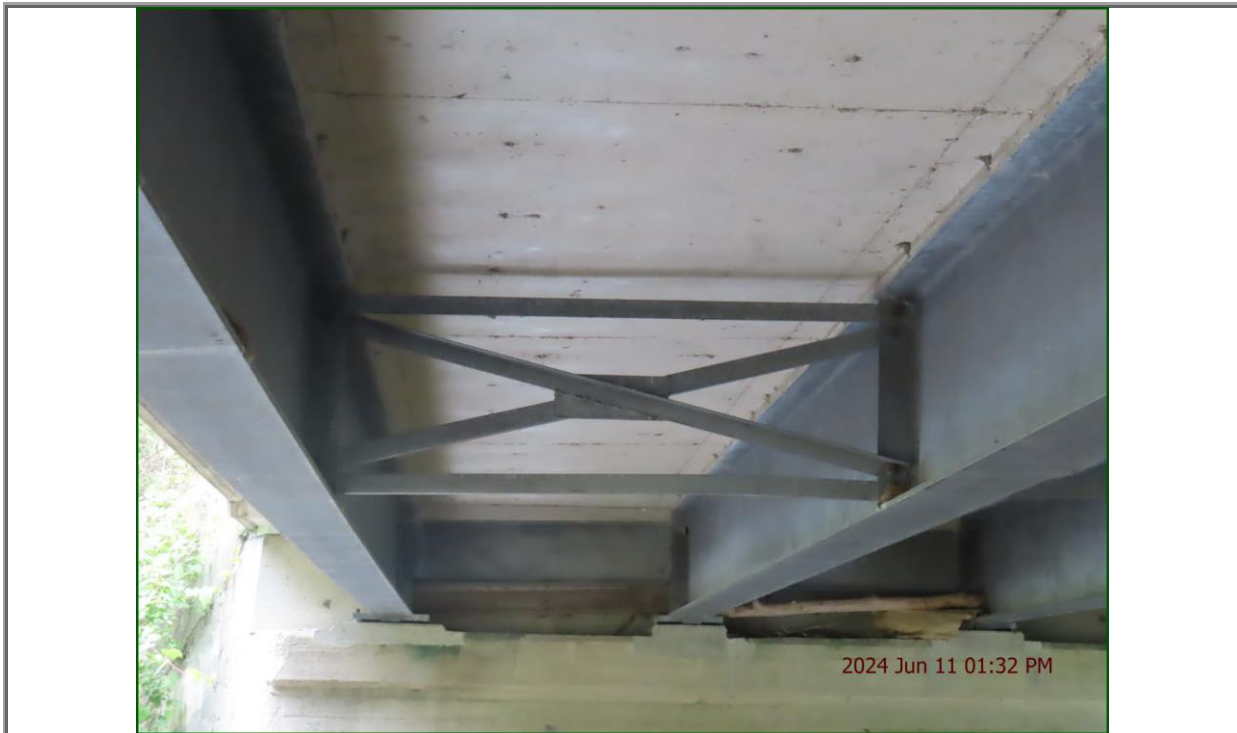
Impact damage.

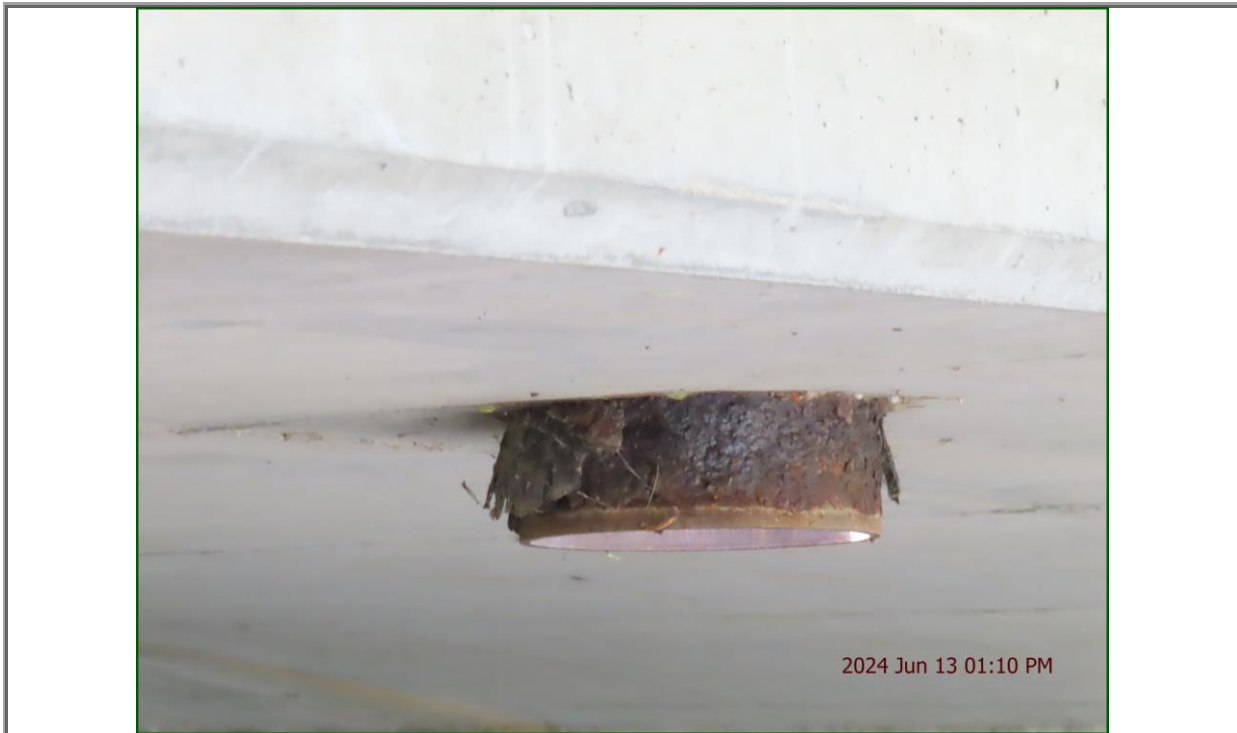
Medium corrosion.

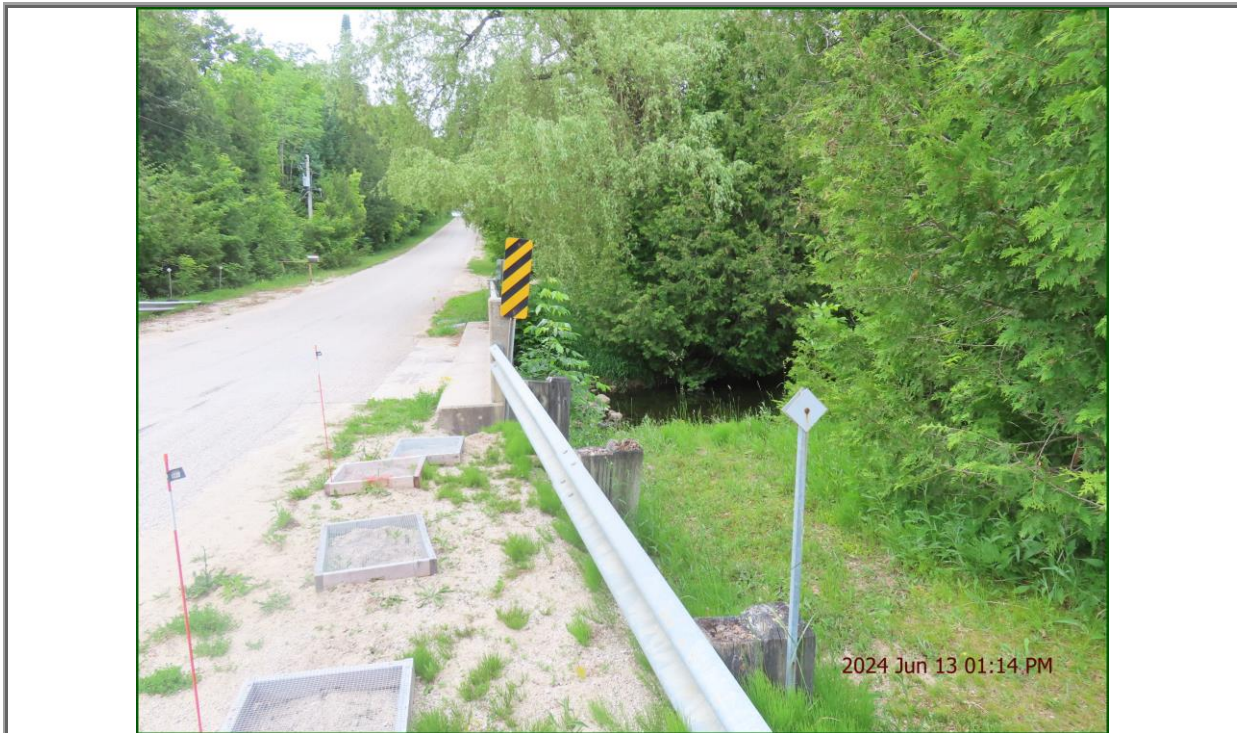
Minor erosion at NE quadrant.

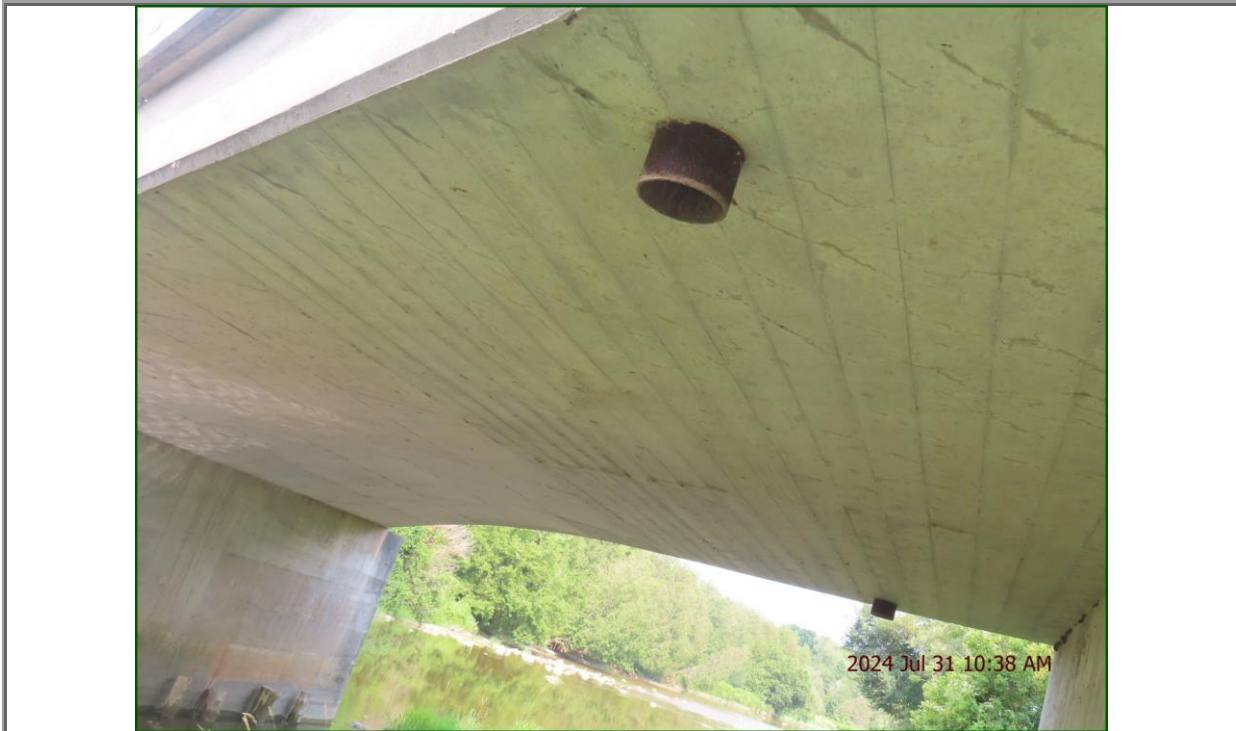
Various hairline cracks with wetness staining.
