Municipality of West Grey Structure G-044 and G-033 Bridge

Schedule B Municipal Class Environmental Assessment

Public Information
Centre No.1

June 6, 2024

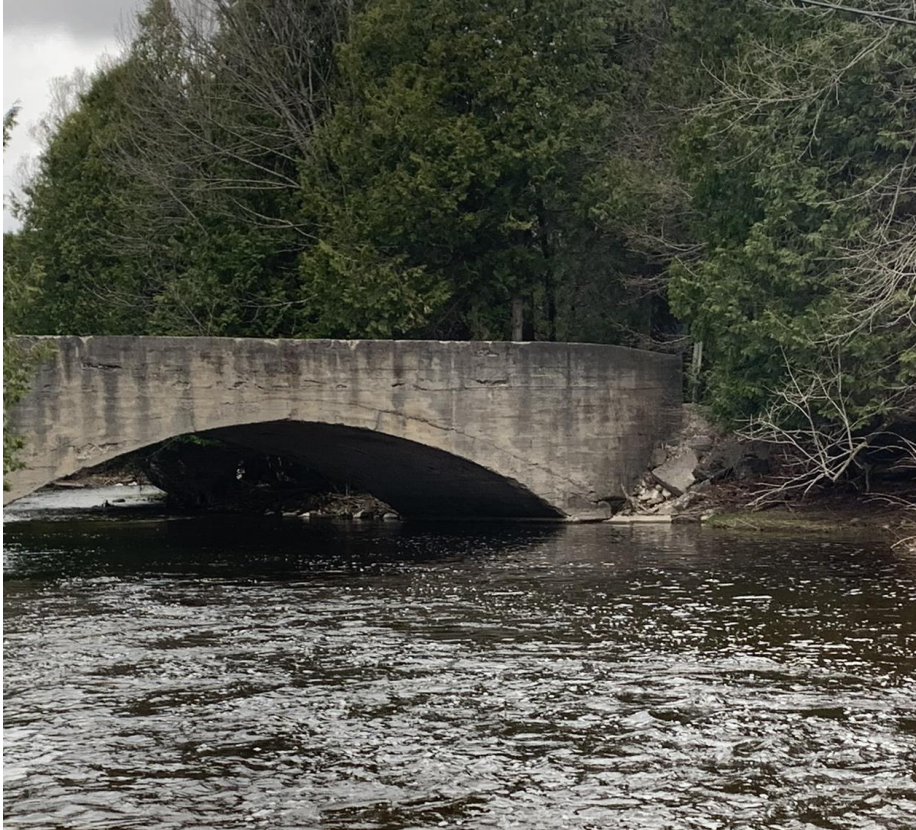
Northline is a narrow gravel road with typically steep side slopes down into the roadside ditches. The existing structure comprises a concrete arch structure with an approximate span of 15.0 m. It is also approximately 4.3 m from the gravel surface over the bridge deck to the river bottom. Frequent pieces of concrete slabs and stacked boulders were observed at the outside edges of the bridge approaches.

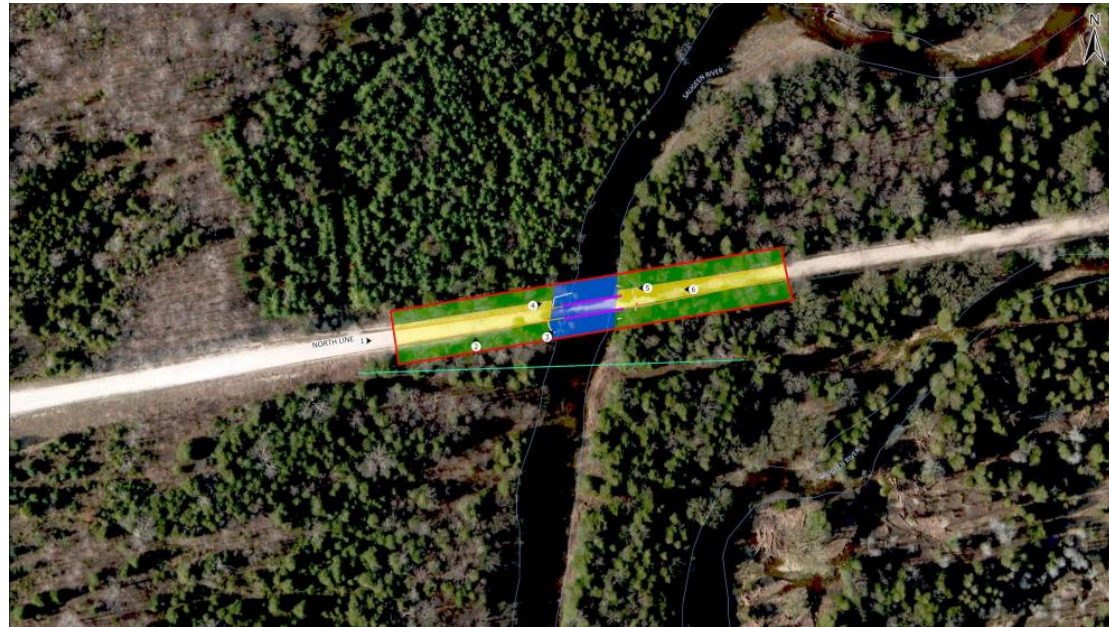
Structure G-044

Yellow – Previously disturbed locations

Blue – Water course

Green – Undisturbed locations (archaeological potential)

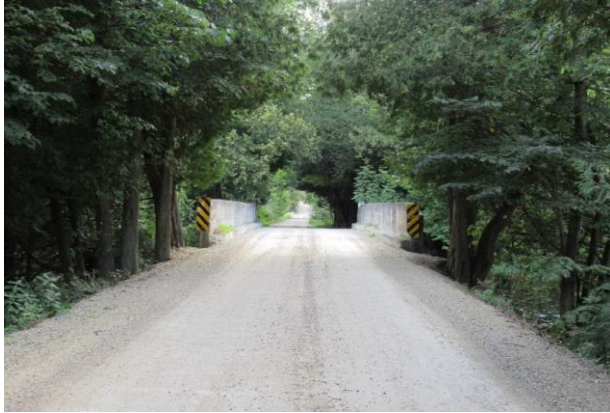
View of Structure from West Approach

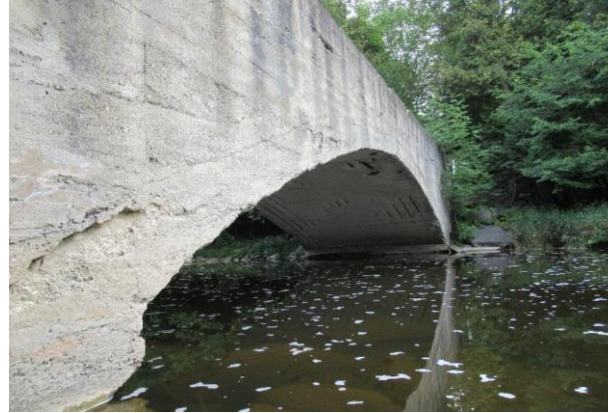
View of Structure Elevation

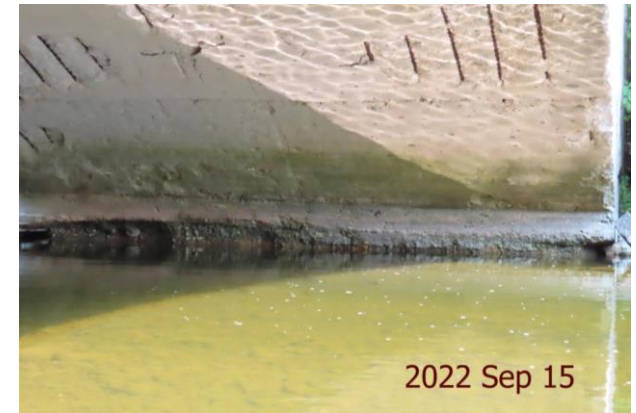
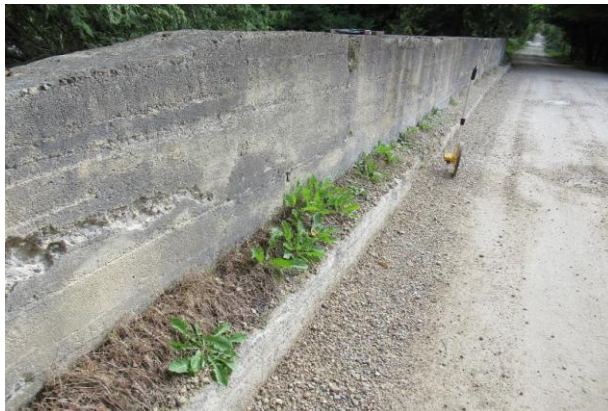
Delamination Along Parapet Wall and Vegetation and Debris on Curb

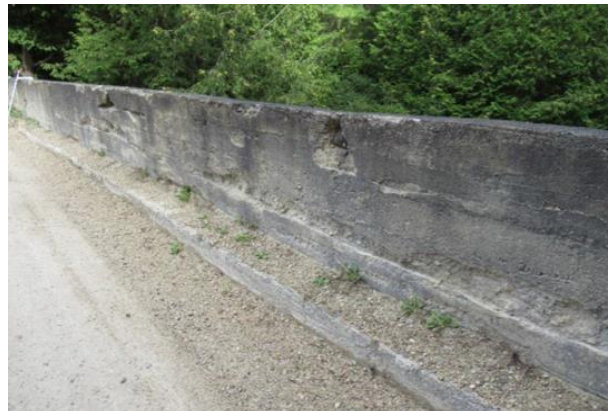
Deterioration of Parapet Wall

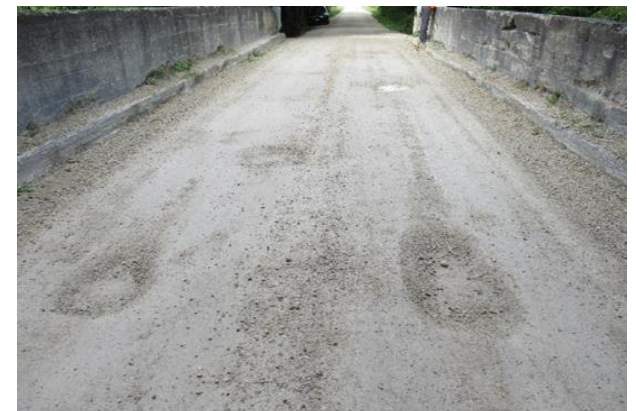
Potholes and Wheel Path
Rutting on Structure Wearing
Surface

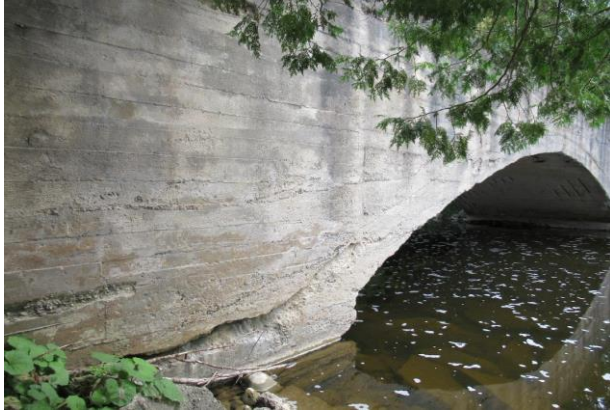
Score in Wingwall

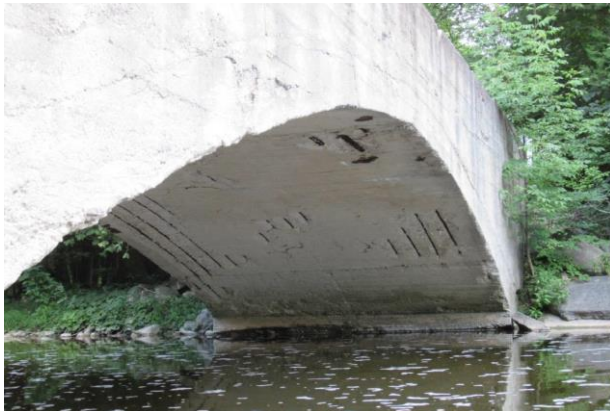
View of Exterior and Interior Soffit with Spalling and Exposed Rebar

Structure G-044 is in a state of disrepair and recent 2023 OSIM inspection report indicates there is severe concrete spalling and disintegration to multiple bridge components and therefore, recommended for replacement to reduce the risk to bridge users and maintain public access through Northline Road.

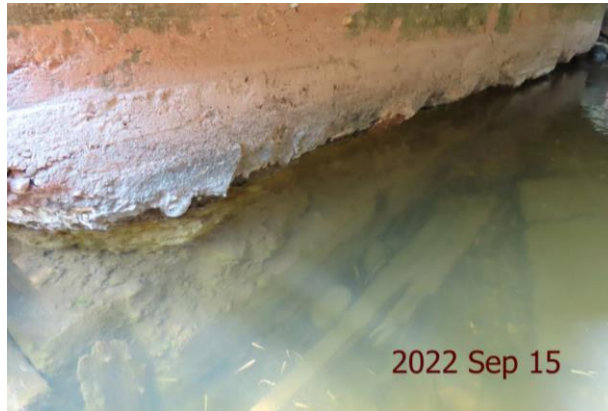
Barrel: Severe scouring and disintegration at waterline

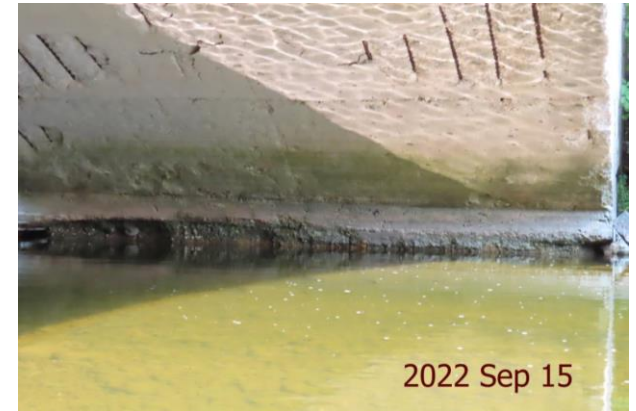
Barrel: Severe scouring and disintegration at waterline

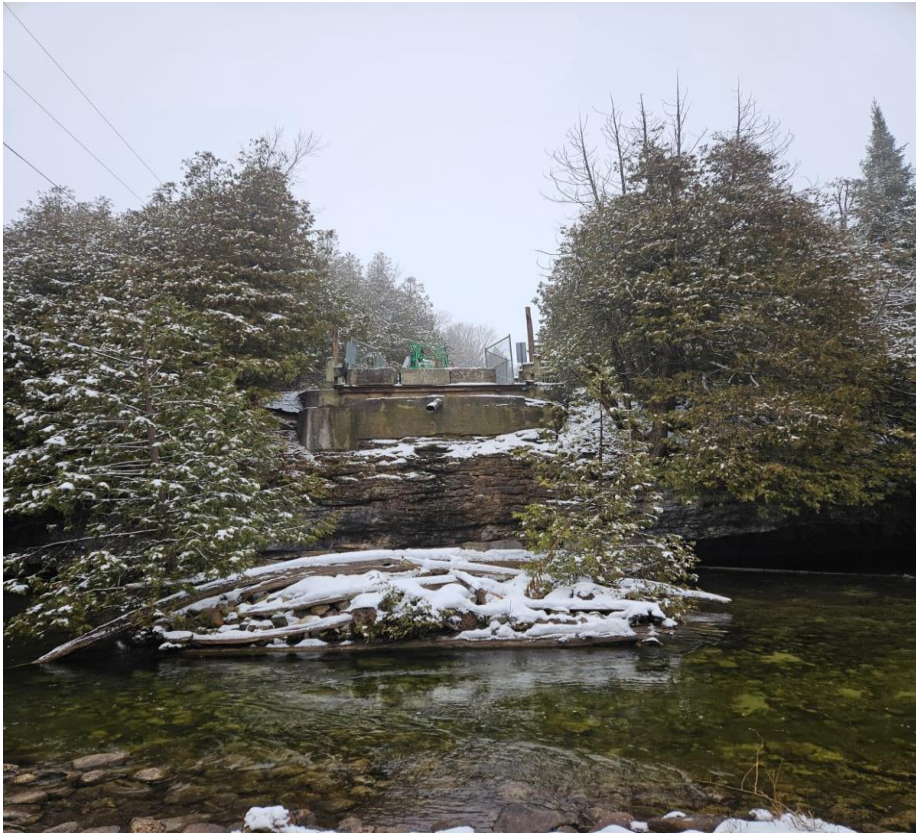
Traverston is a narrow asphalt road with typically deep side slopes down into the roadside ditches. It is considered a local road, allowing traffic from arterial roads, Concession Road 8 and Grey Road 12, to access the few residential properties situated on Traverston Road. In the winter of 2023, Structure G-033 was removed due to structural deficiencies.

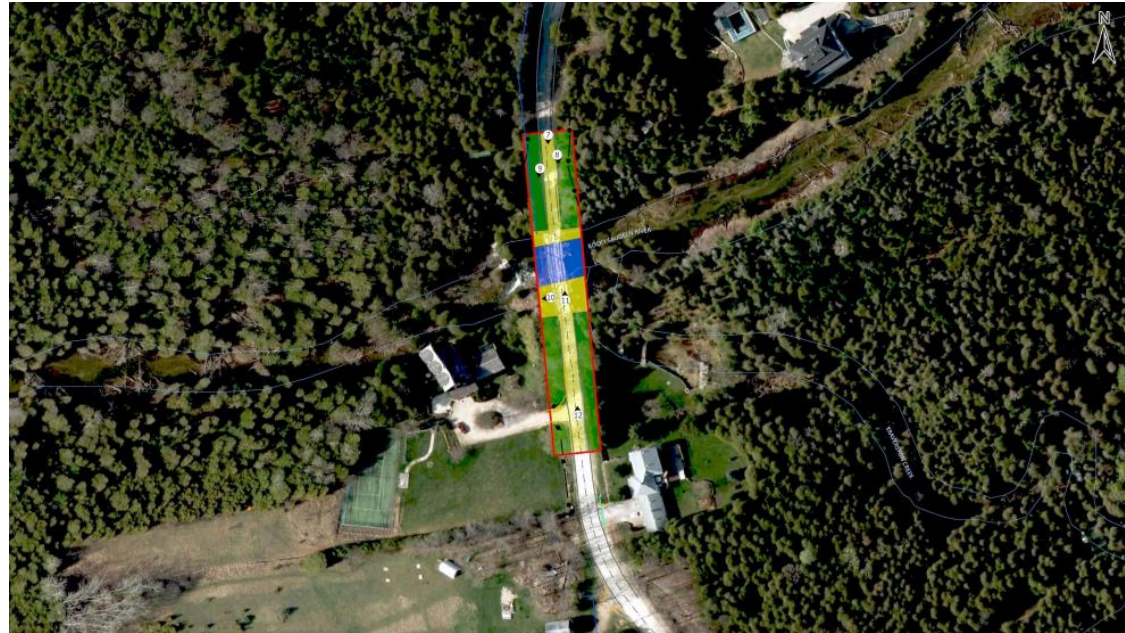
Structure G-033

- Yellow – Previously disturbed locations
- Blue – Water course
- Green – Undisturbed locations (archaeological potential)

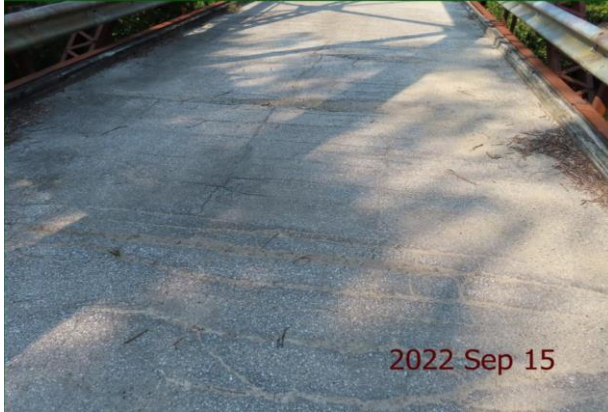
Medium to Wide Transverse Cracks Throughout Approach

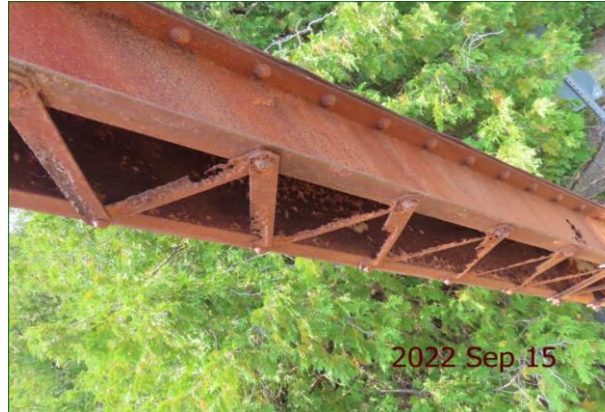
Severe Corrosion and 100% Section Loss

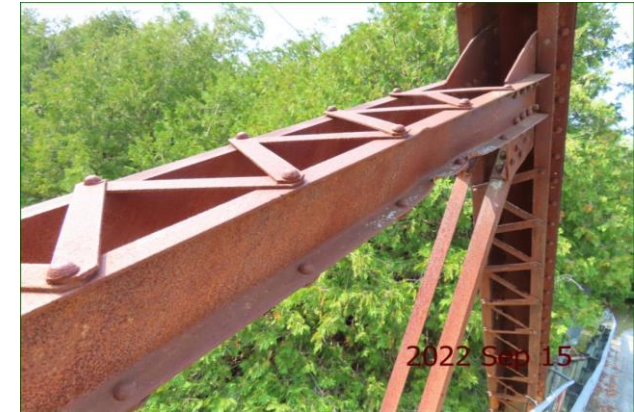
Impact Damage on Diagonals

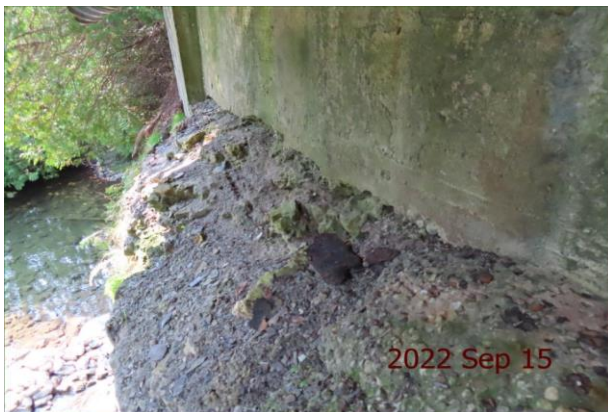
Severe Scouring and Disintegration Along Bottom of Abutment

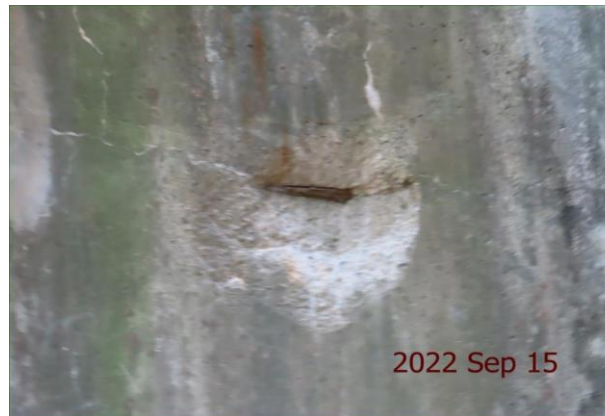
Severe Spall with Exposed Reinforcement

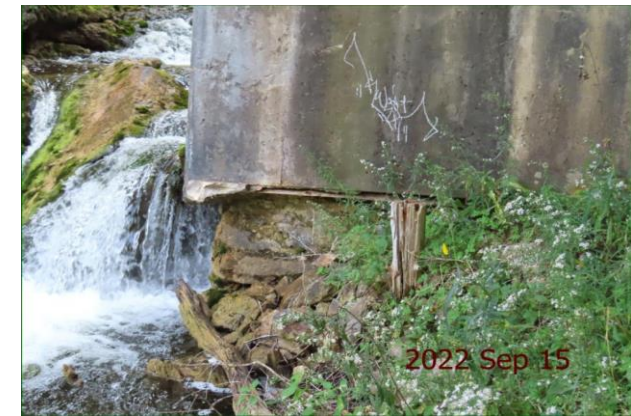
Partial Foundation Exposed and Disintegrated, Undermined.

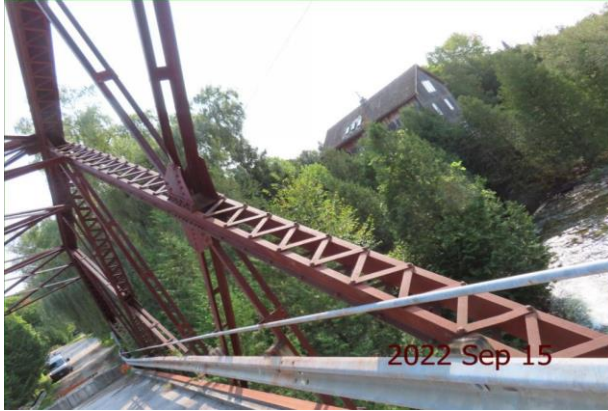
Corrosion and Impact Damage to Diagonals

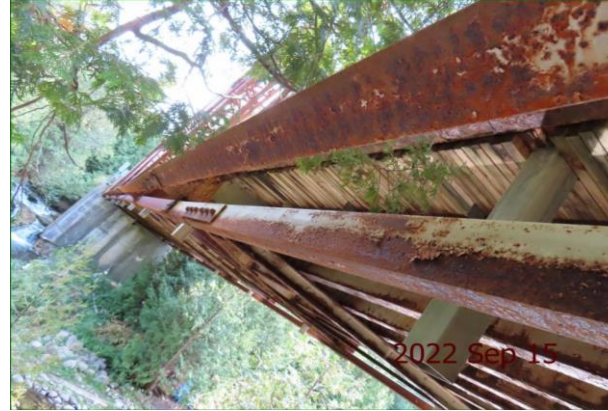
Severed Member

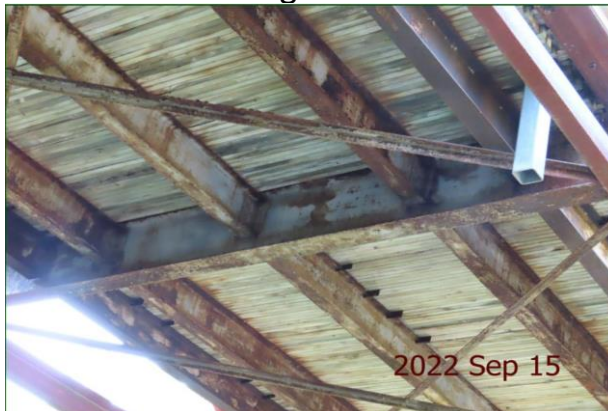
Severe Corrosion at Ends on Floor Beam

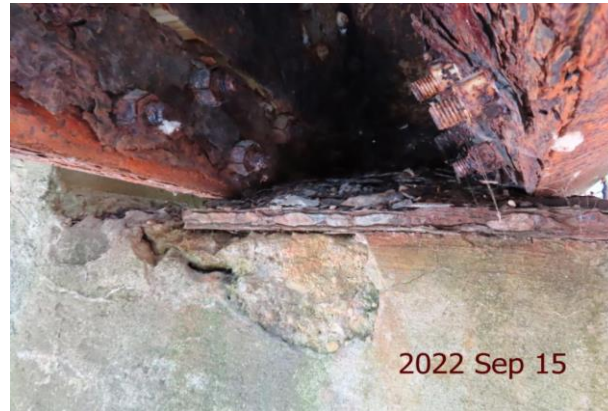
Medium to Severe Corrosion Throughout Bearings

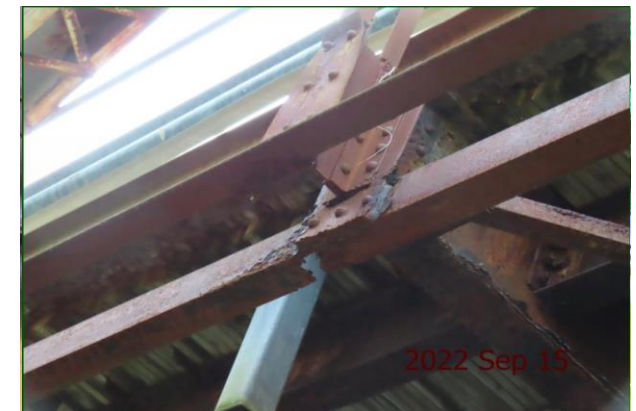
Severe corrosion and Severed Bottom Chord
