MUNICIPALITY OF
West Grey

Municipality of West Grey
Bridge Prioritization Program

February 2025

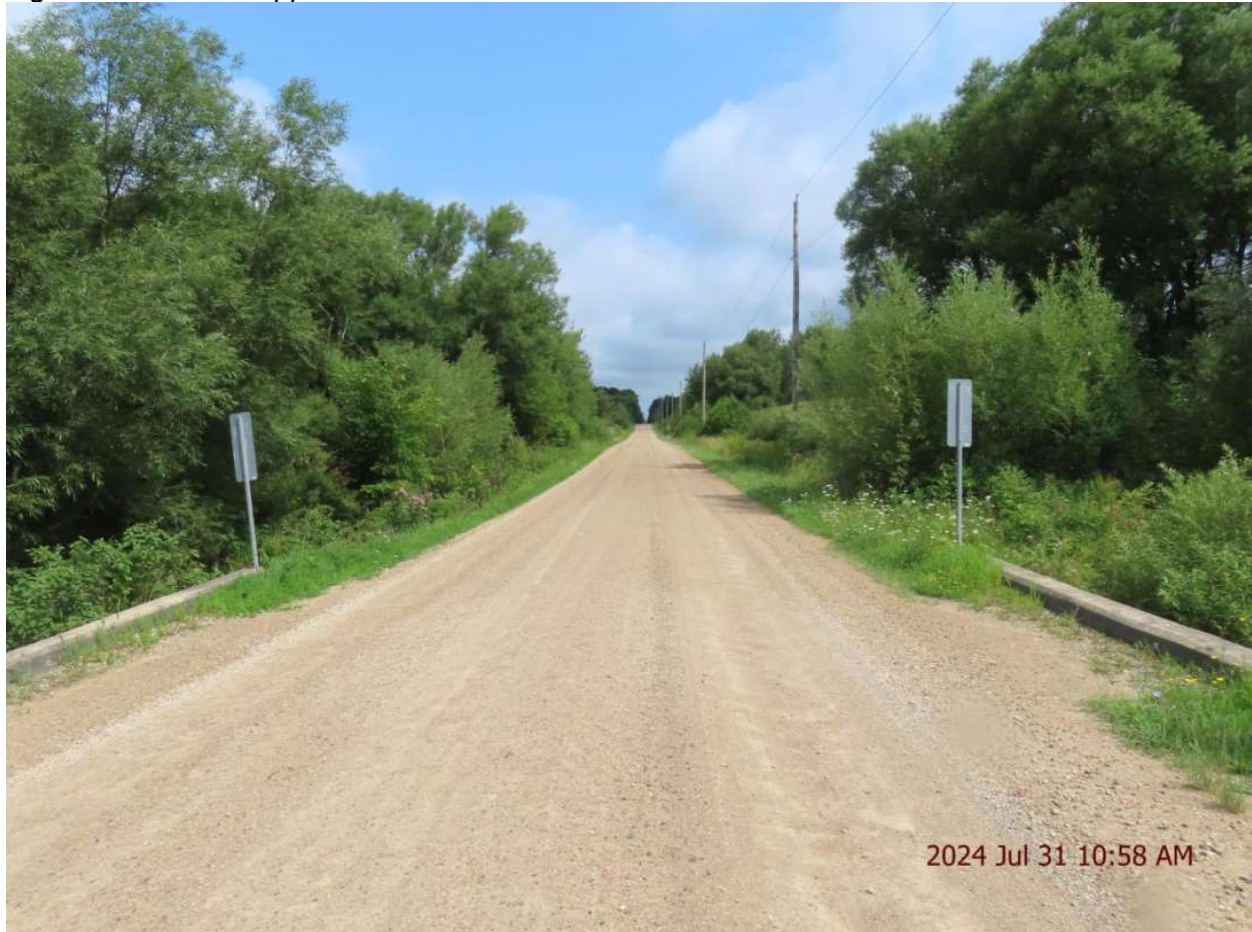
Figure 4.14: South Approach View of Structure N-184

Structures N-184 and N-185 are located on Sideroad 25 between Grey Road 9 and Concession 8 in the former Township of Normanby. Structure N-184 received a score of 7.58 and Structure N-185 received a score of 7.85 out of a possible 20 for Total Consequence of Asset Closure/Failure. Both structures were constructed in 1950, with repairs completed periodically. The structures span approximately 9 metres each and are rigid frame concrete culverts overlain by granular fill. Given the current condition of Structure N-184 and N-185 outlined in the 2024 OSIM reports, rehabilitation is not an option.

Structures N-184 and N-185 experience a low volume of daily traffic with respect to other structures in the Municipality, as it is located on Sideroad 25, which has a low level of service given the few residents that reside on this segment of the road. Structure detour lengths and emergency response times are not significantly impacted. For these reasons, Structures N-184 and N-185 are proposed candidates for closure at the end of their service life.
