MUNICIPALITY OF
West Grey

Municipality of West Grey
Bridge Prioritization Program

February 2025

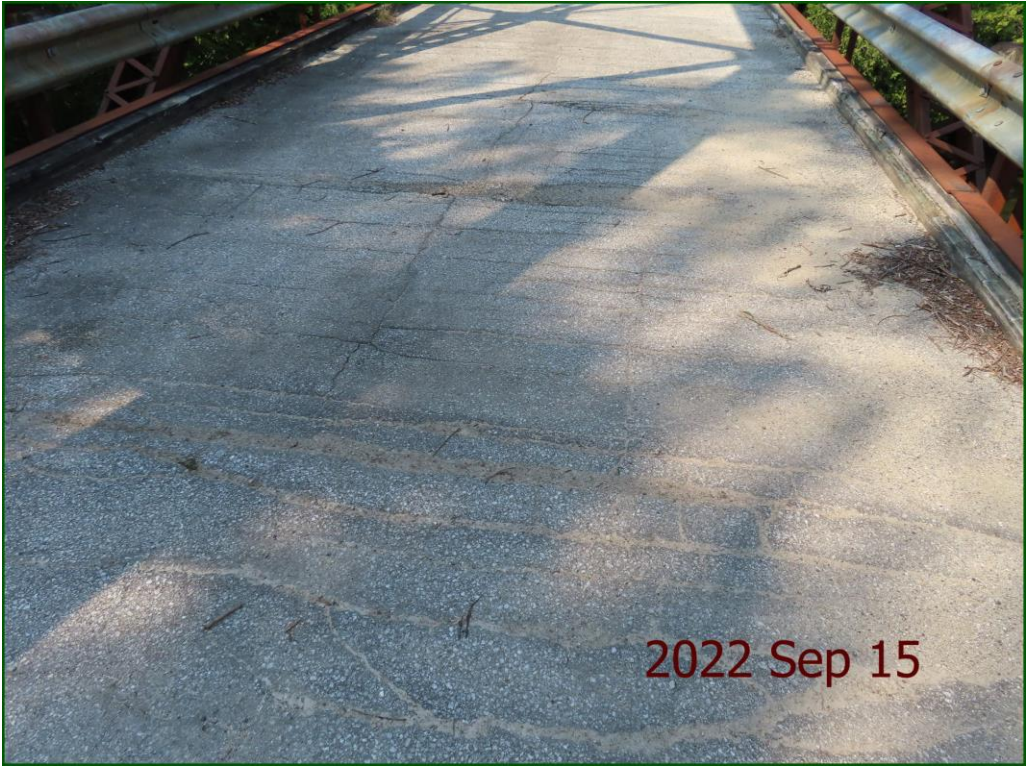
Description: Wearing surface: Medium to wide transverse cracks throughout.

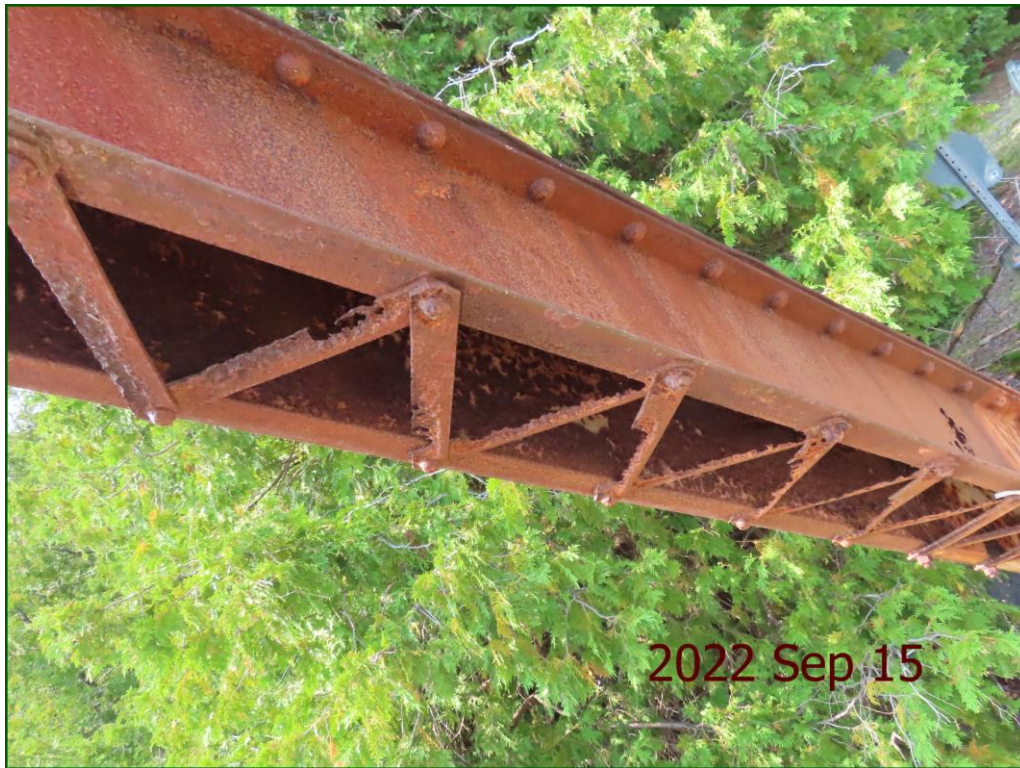
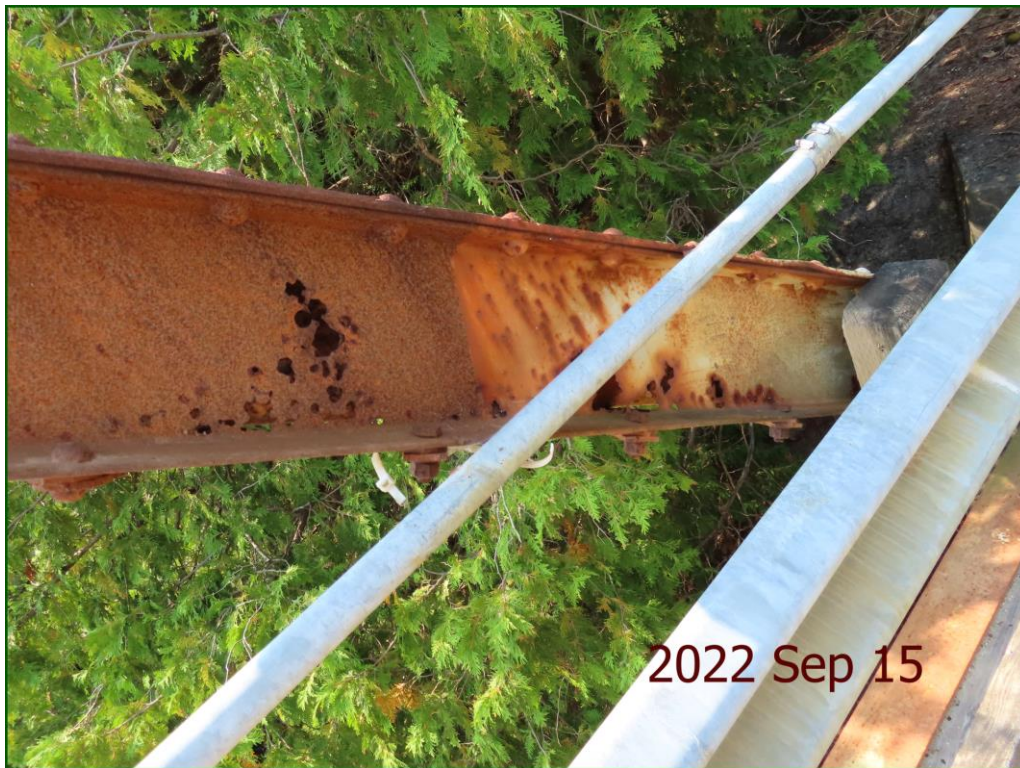
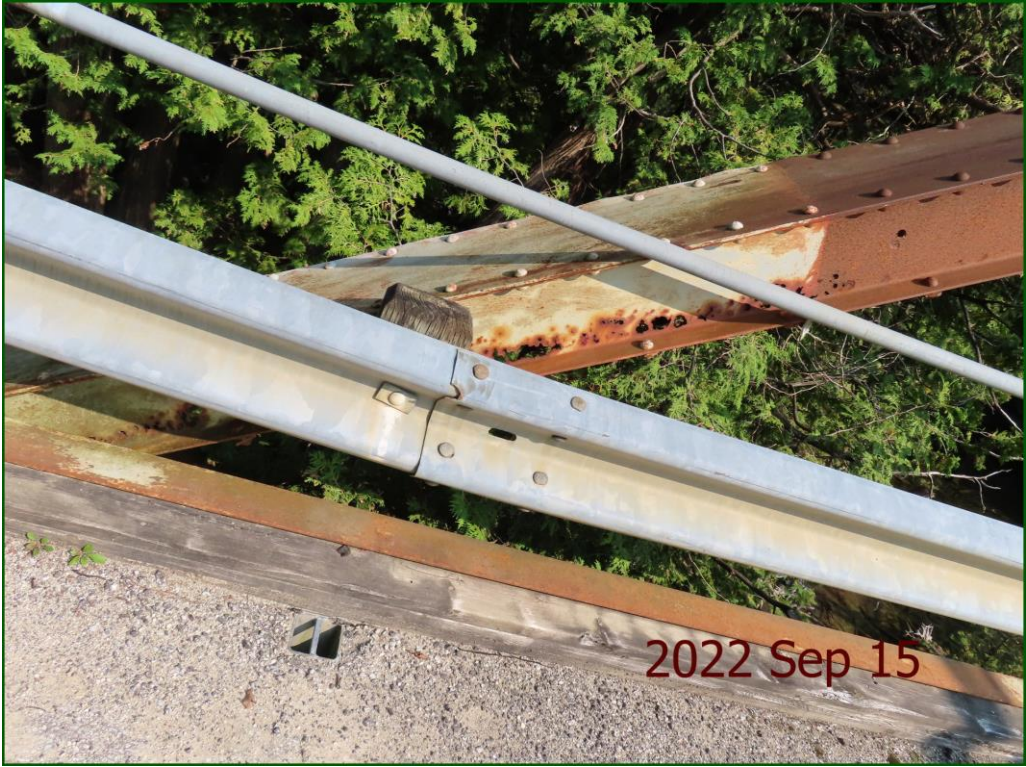
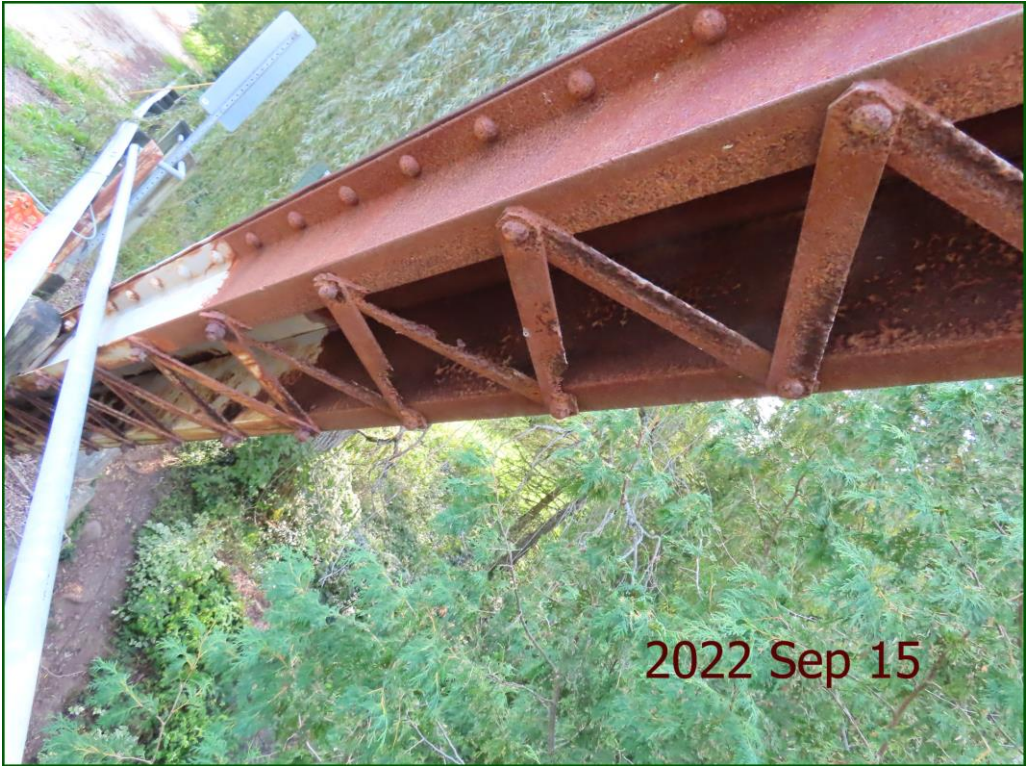
Description: Top chords: Areas of medium to severe corrosion with 100% section loss. (1/4)

Description: Top chords: Areas of medium to severe corrosion with 100% section loss. (2/4)

Description: Top chords: Areas of medium to severe corrosion with 100% section loss. (3/4)

Description: Top chords: Areas of medium to severe corrosion with 100% section loss. (4/4)

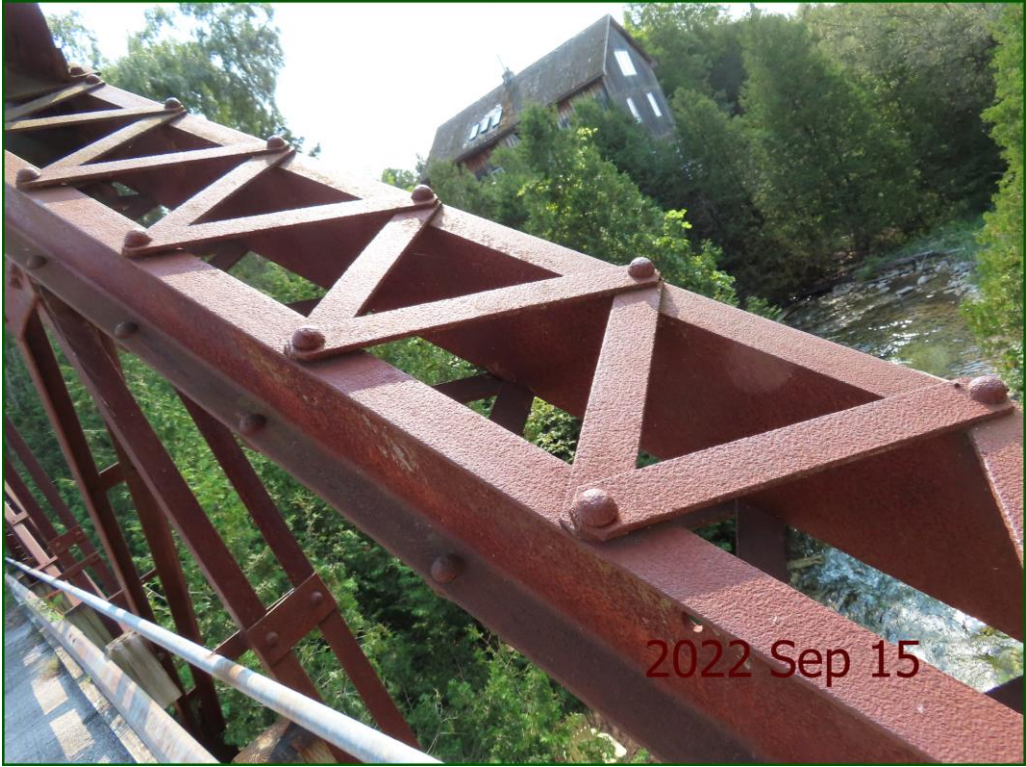
Description: Diagonals: Light to medium corrosion throughout.

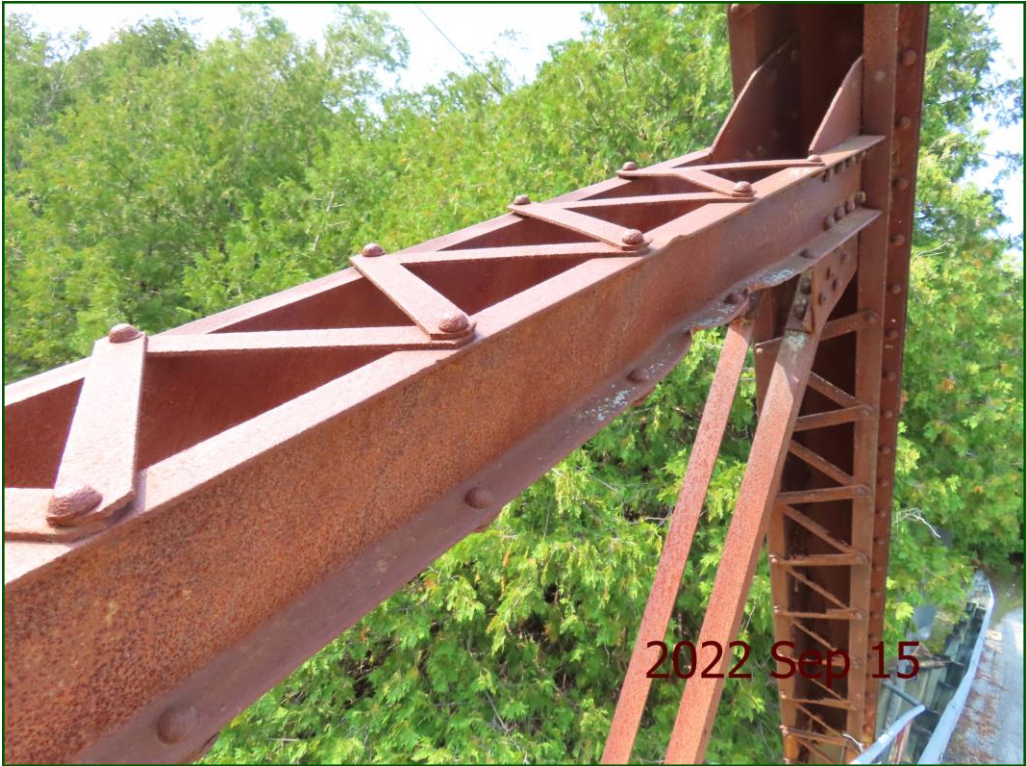
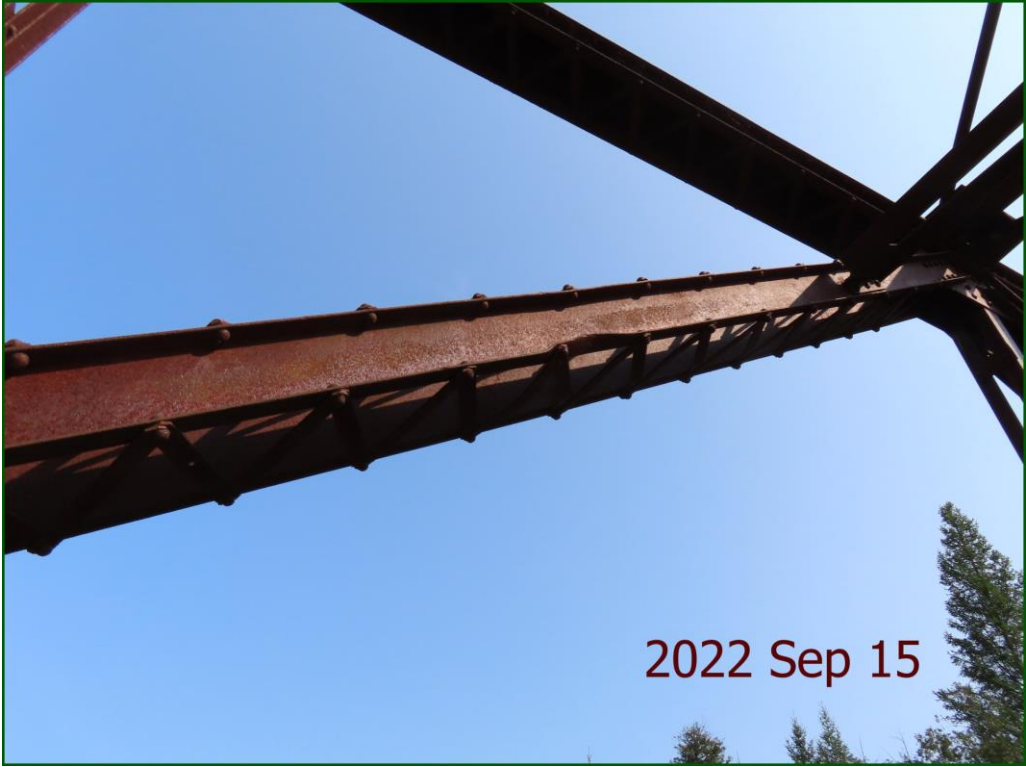
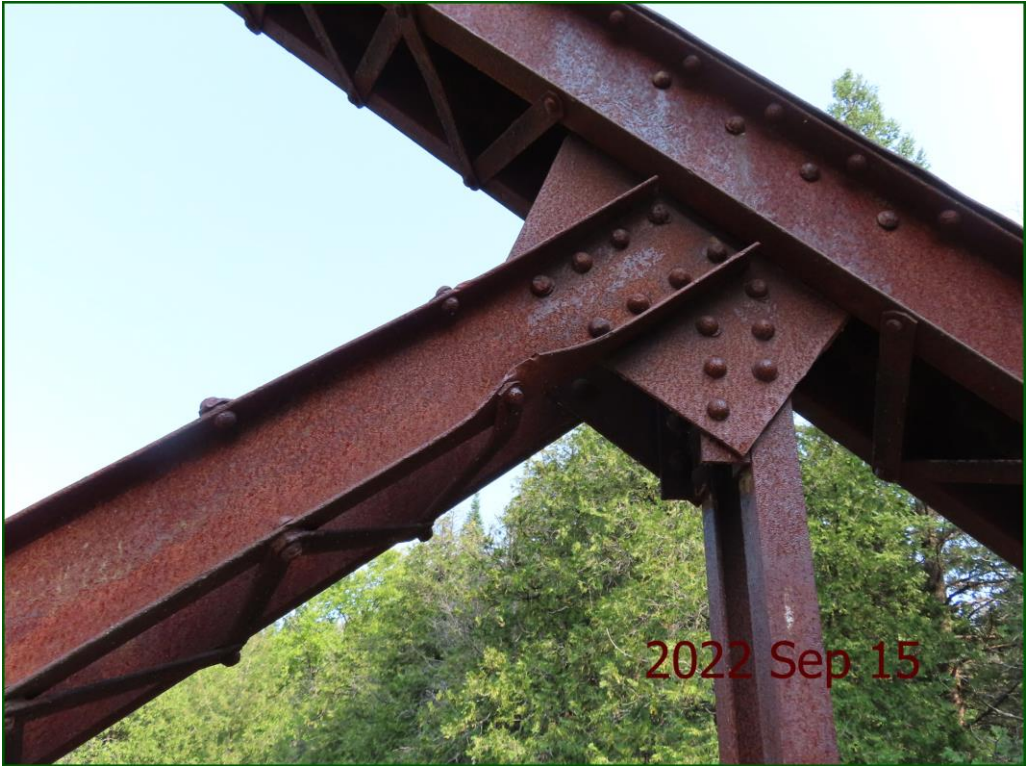
Description: Diagonals: Impact damage on various diagonals. (1/3)

Description: Diagonals: Impact damage on various diagonals. (2/3)

Description: Diagonals: Impact damage on various diagonals. (3/3)

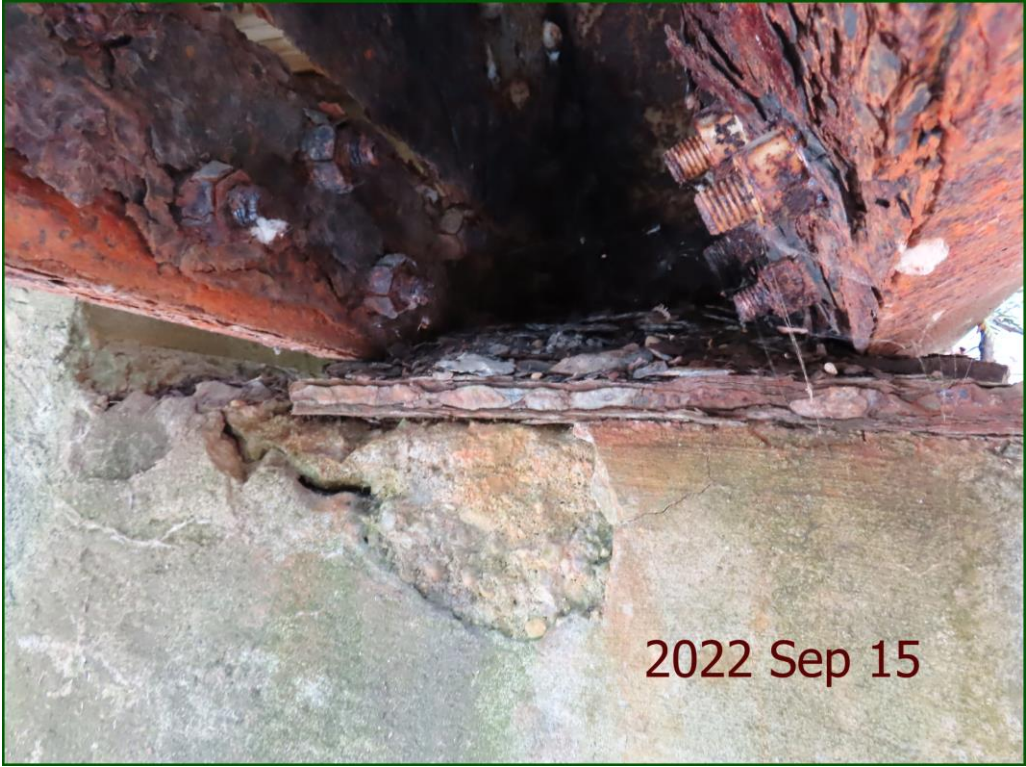
Description: Bearings: Medium to severe corossion throughout.

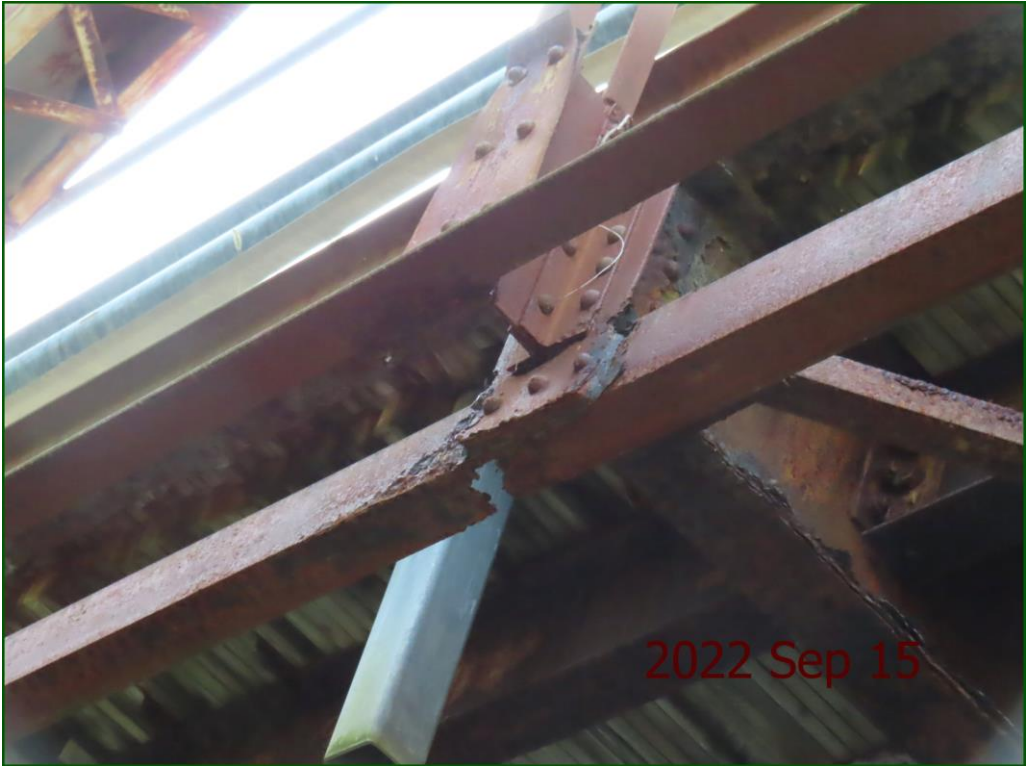
Description: Bottom chord: Very severe corrosion throughout member has been severed.

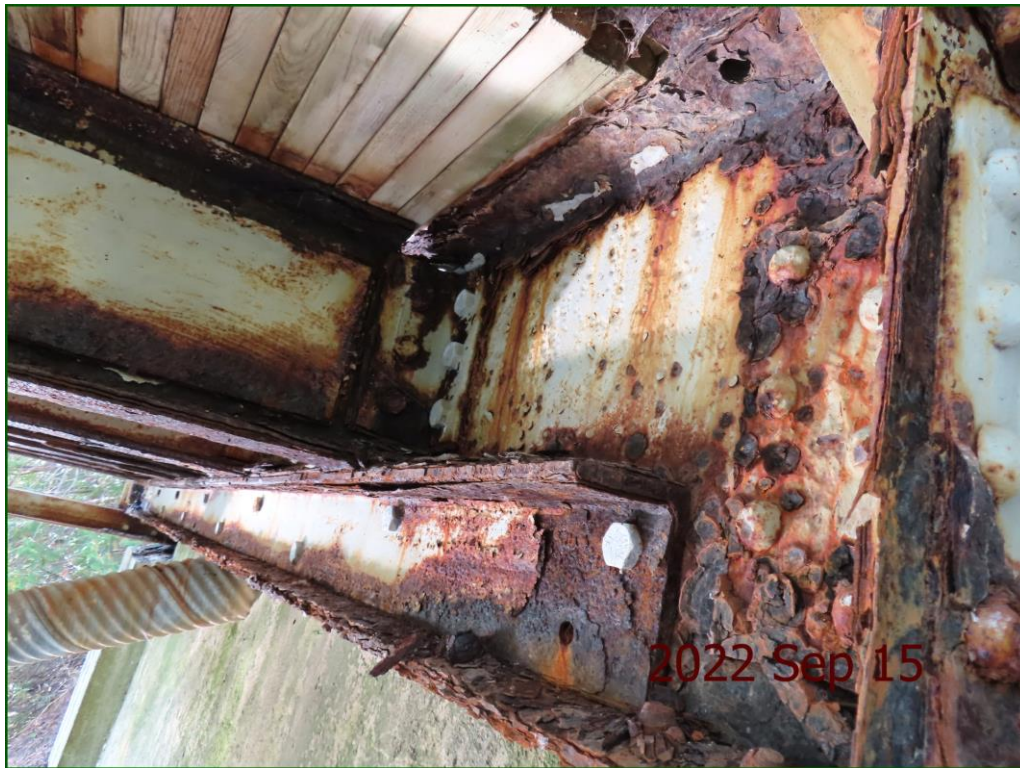
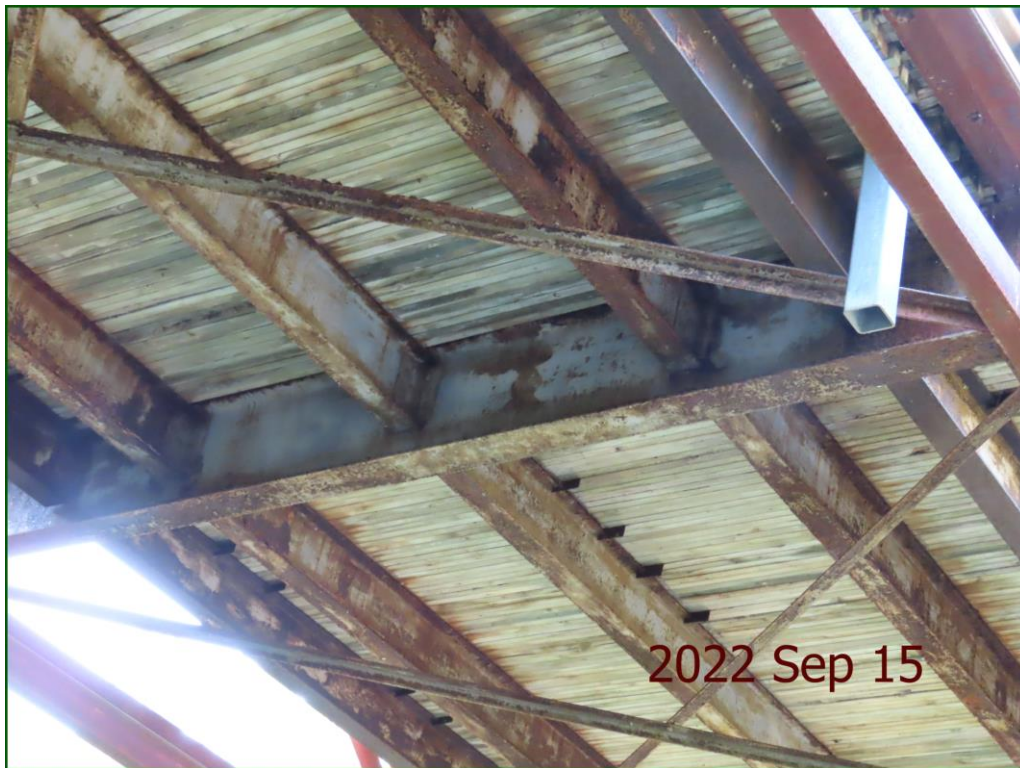
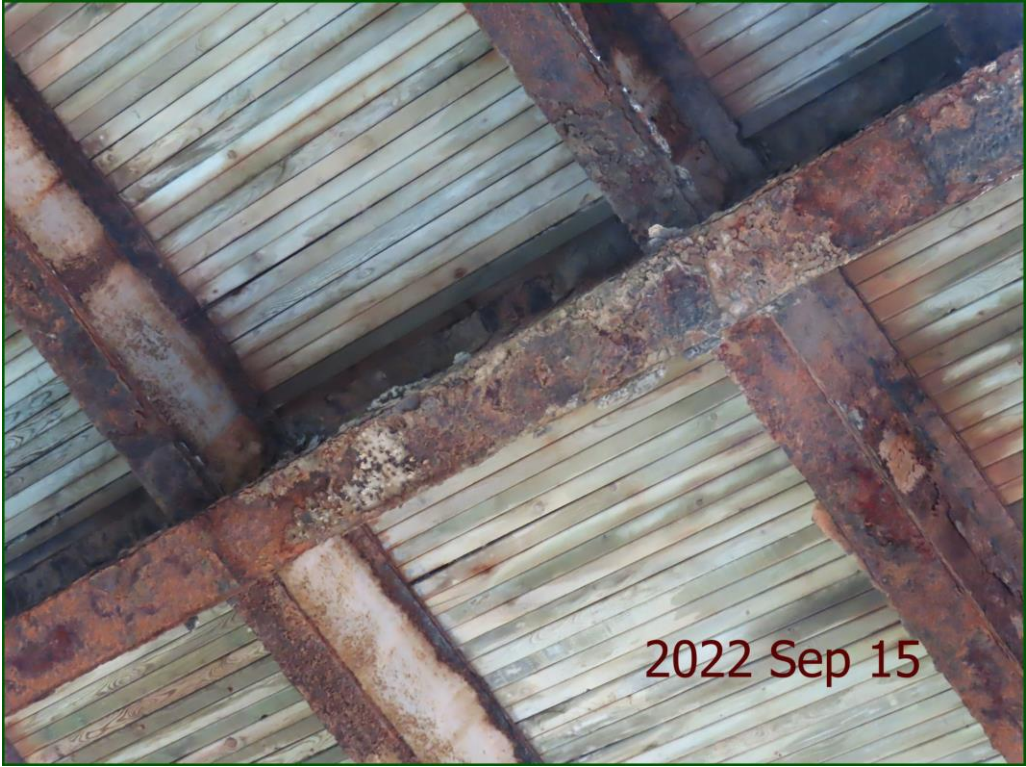
Description: Floor beams: Severe corrosion at ends. (1/3)

Description: Floor beams: Severe corrosion at ends. (2/3)

Description: Floor beams: Severe corrosion at ends. (3/3)

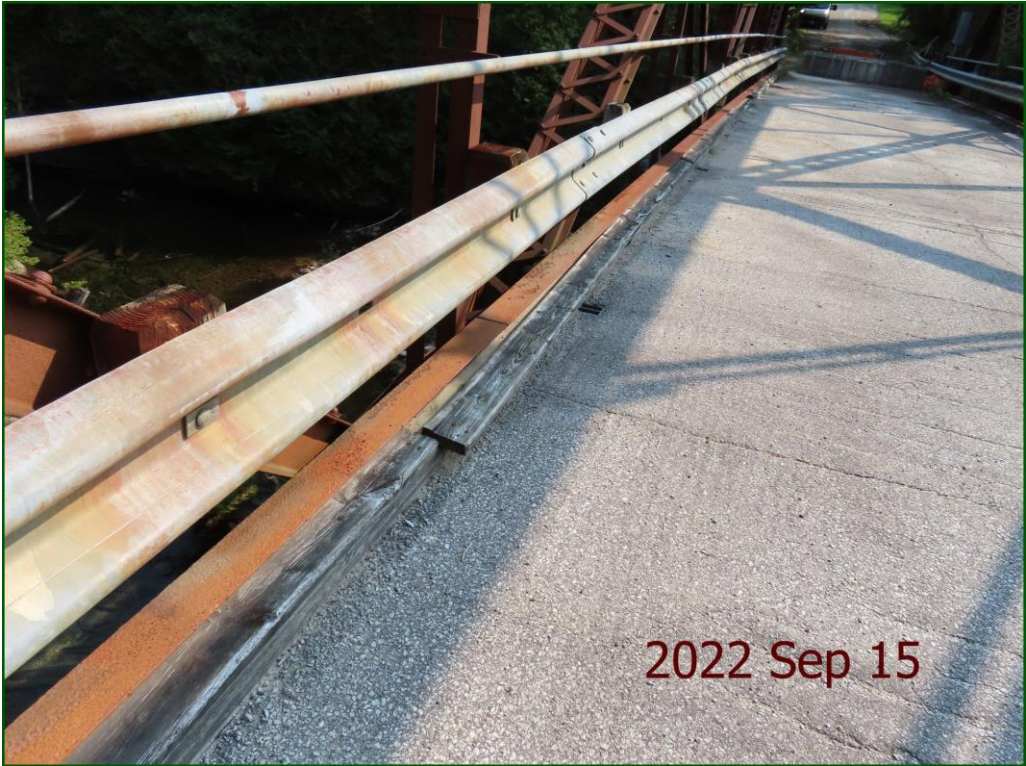
Description: Curbs: Impact damage throughout.

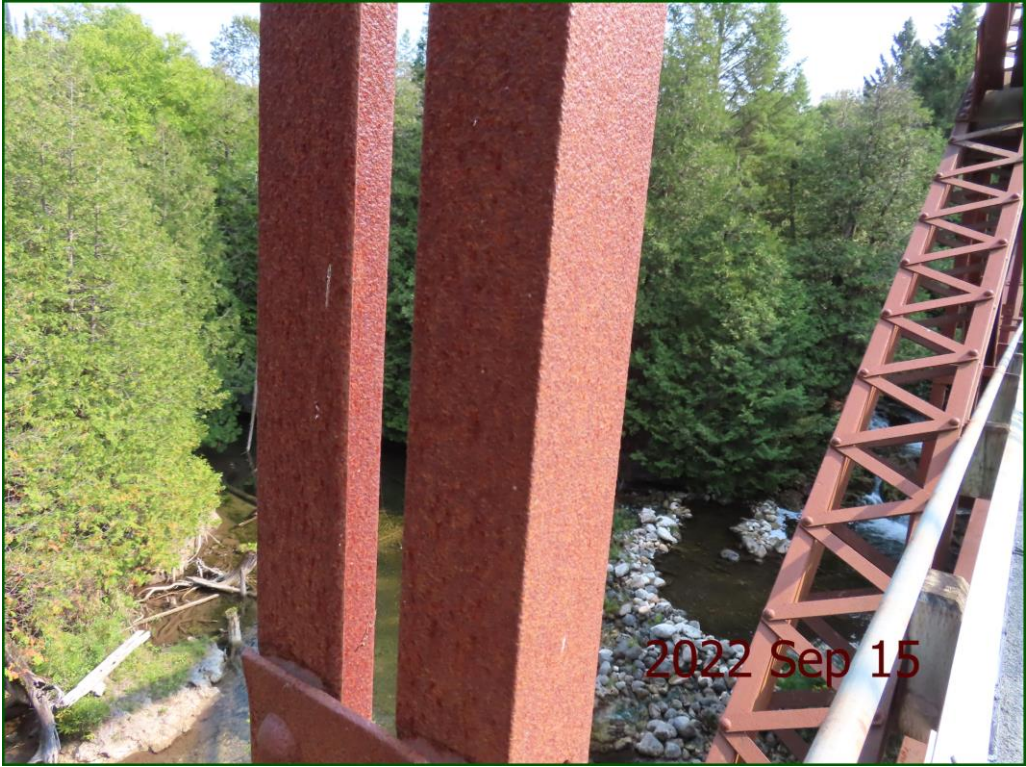
Description: Verticals: Light to medium corrosion throughout.

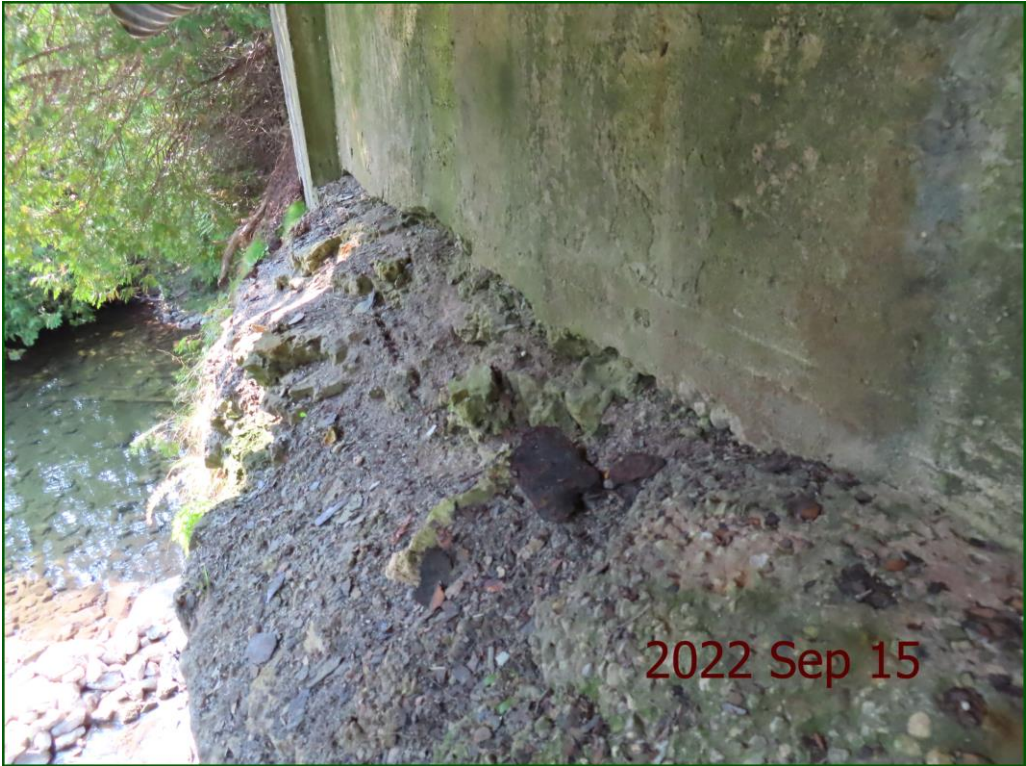
Description: Abutment walls: Severe scouring and disintegration along bottom of abutment.

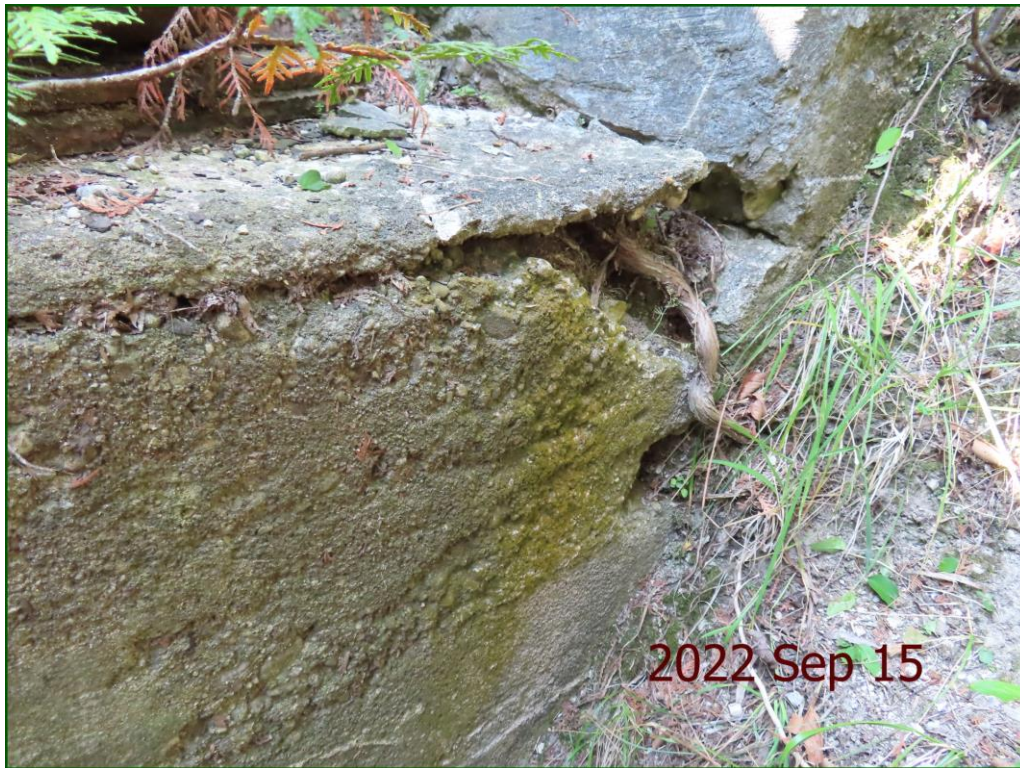
Description: Abutment walls: Moderate spalling with disintegration.

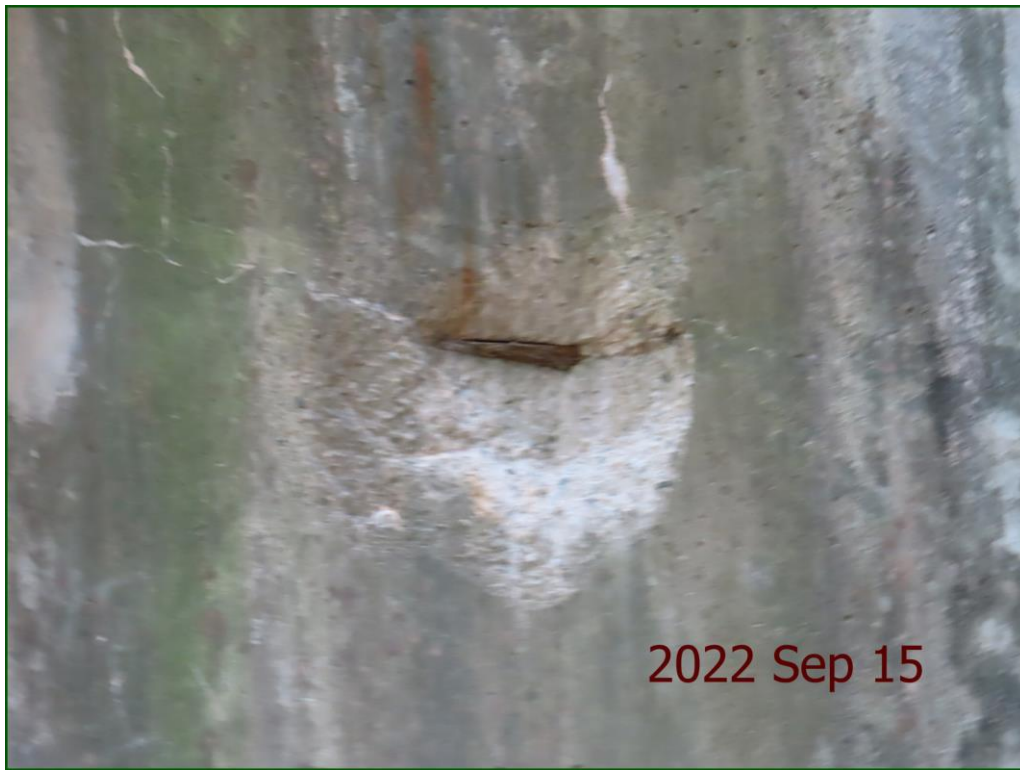
Description: Abutment walls: Severe spall with exposed reinforcement.

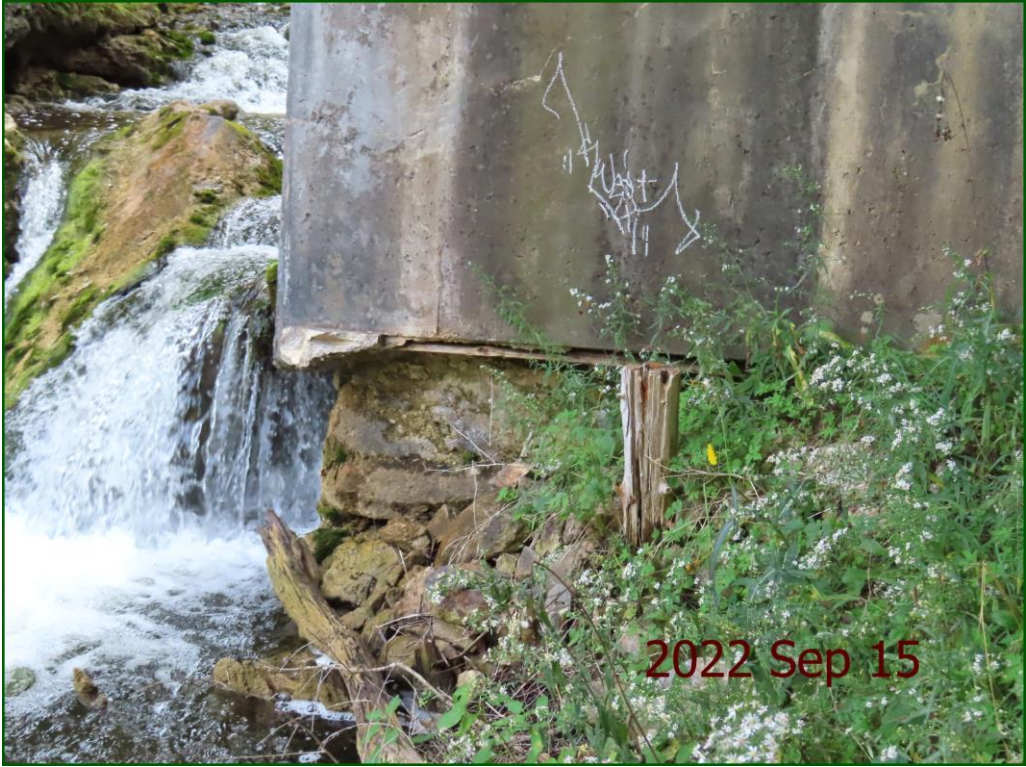
Description: Abutment walls: Partial foundation exposed and disintegrated, undermined.

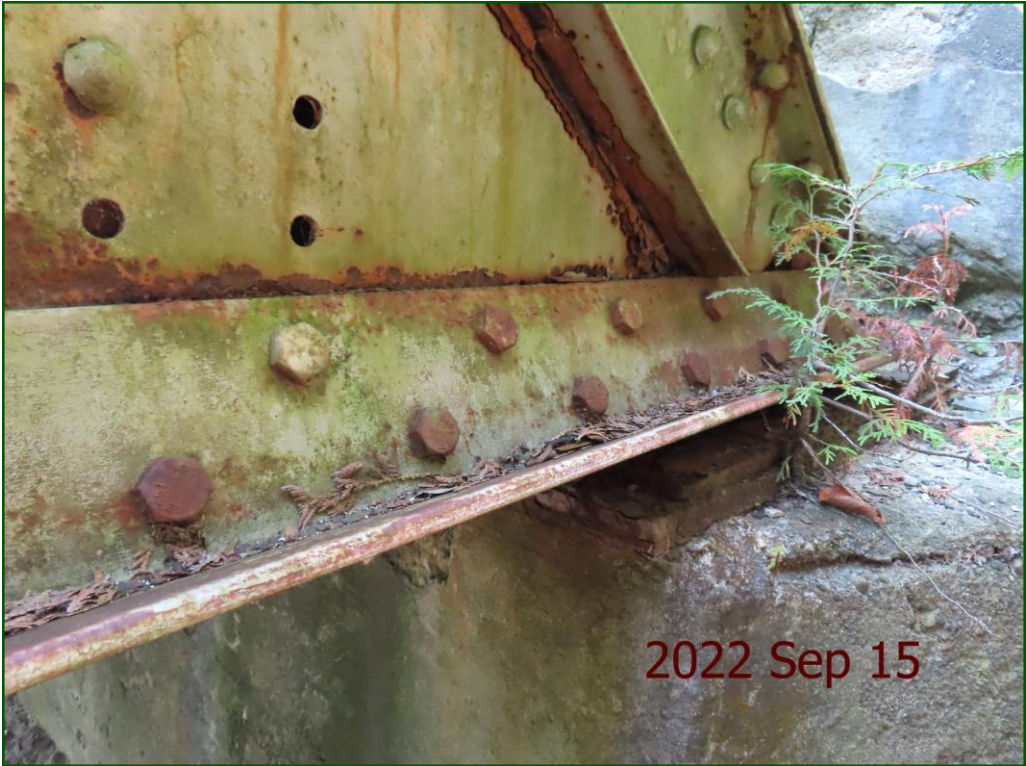
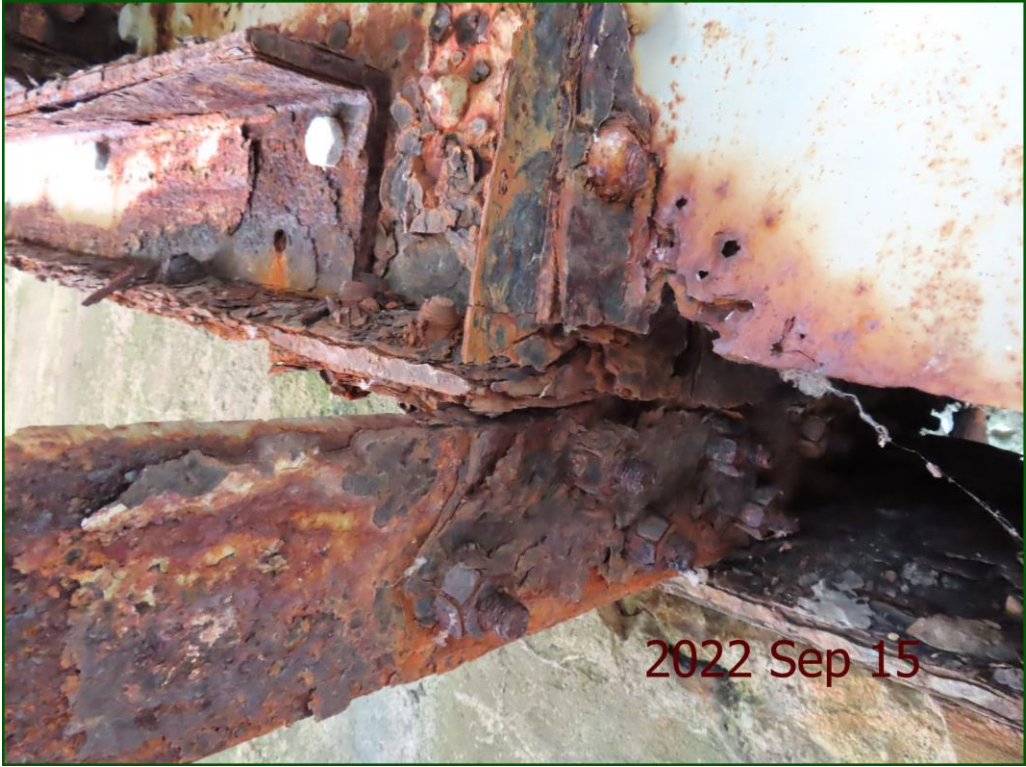
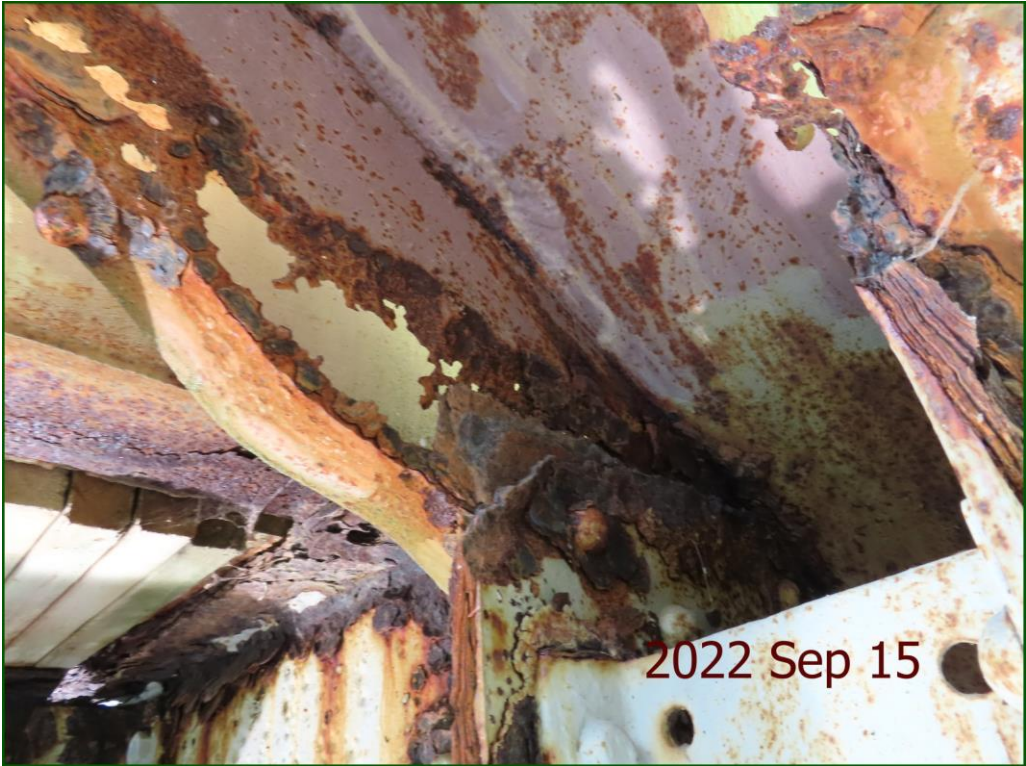
Description: Connections: Very severe corrosion and bottom chord connection to top chord.

Description: Connections: Very severe corossion and bottom chord connection to top chord.

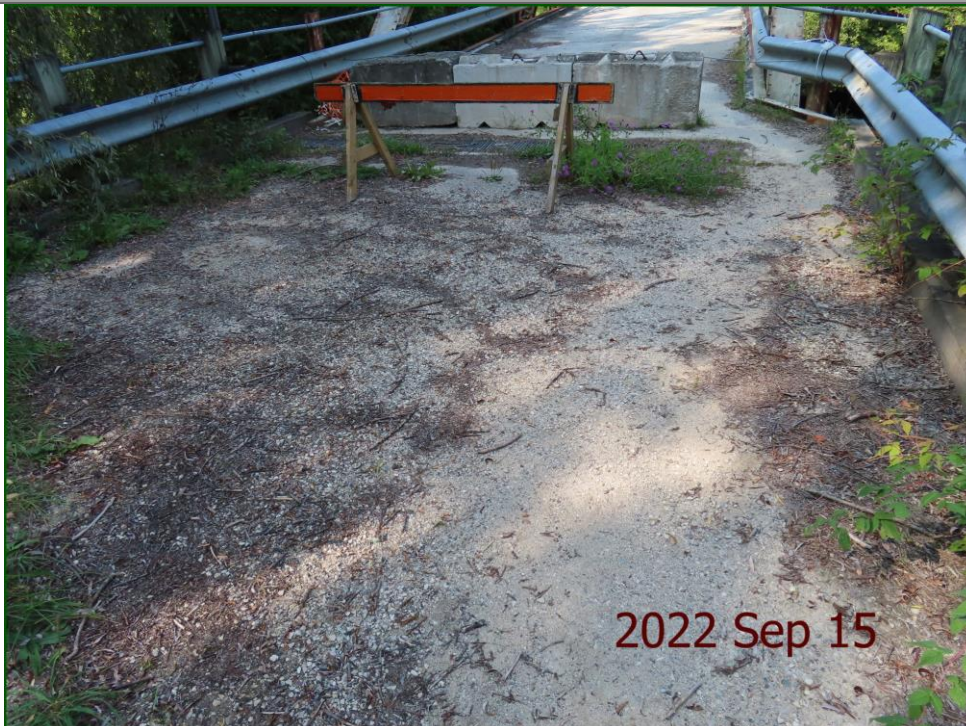
Debris covering entire wearing surface.

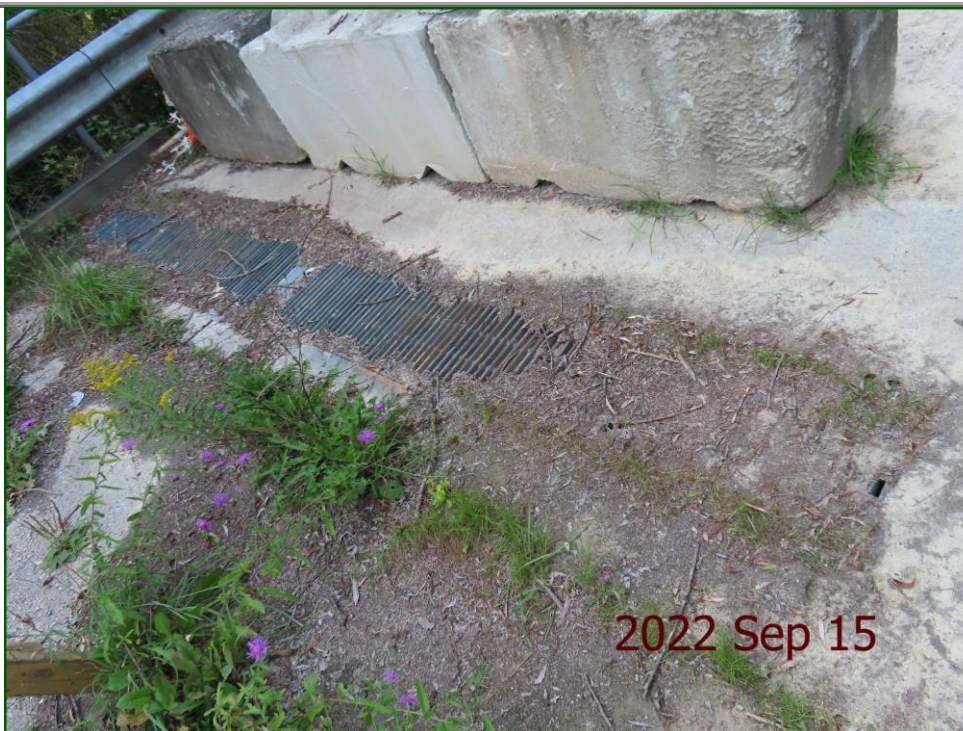
Grate partially covered by cedament.

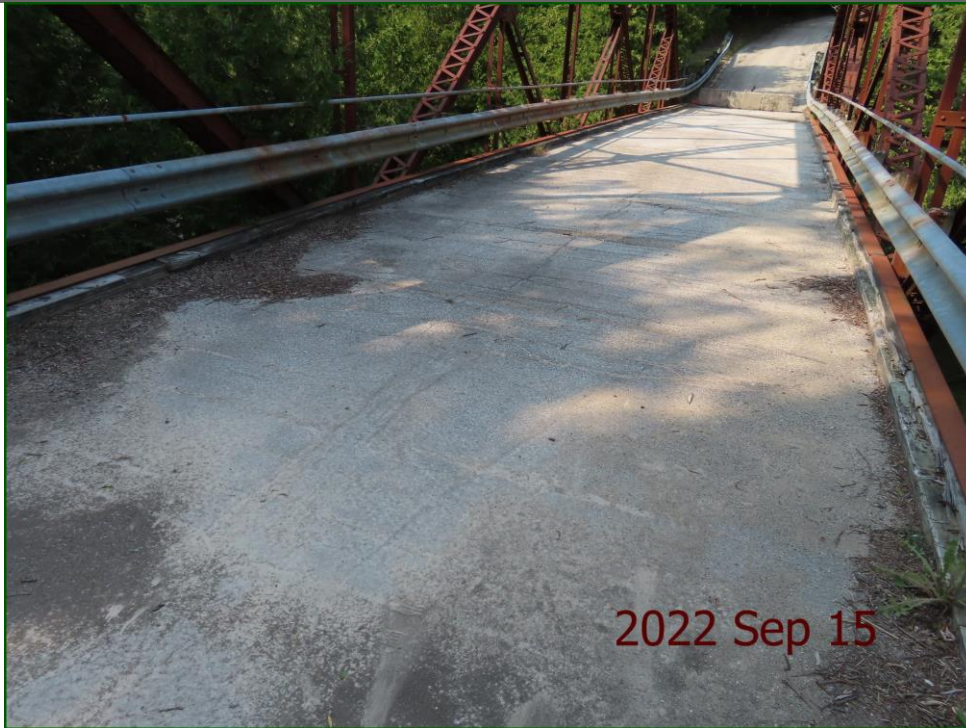
Medium to wide transverse cracks throughout.

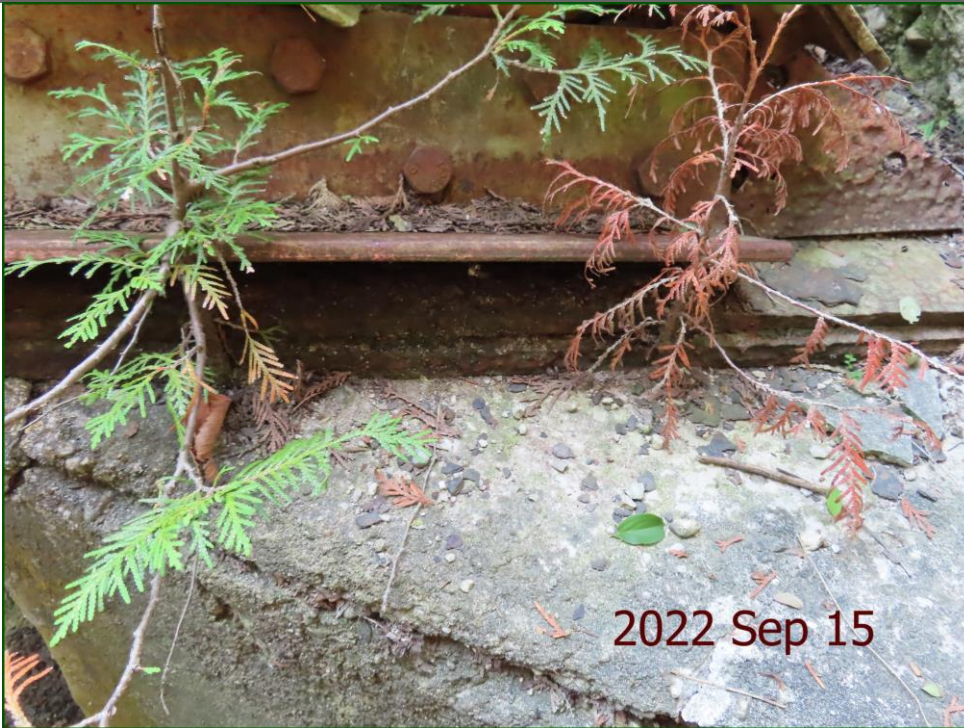
Moderate to severe corrosion throughout.

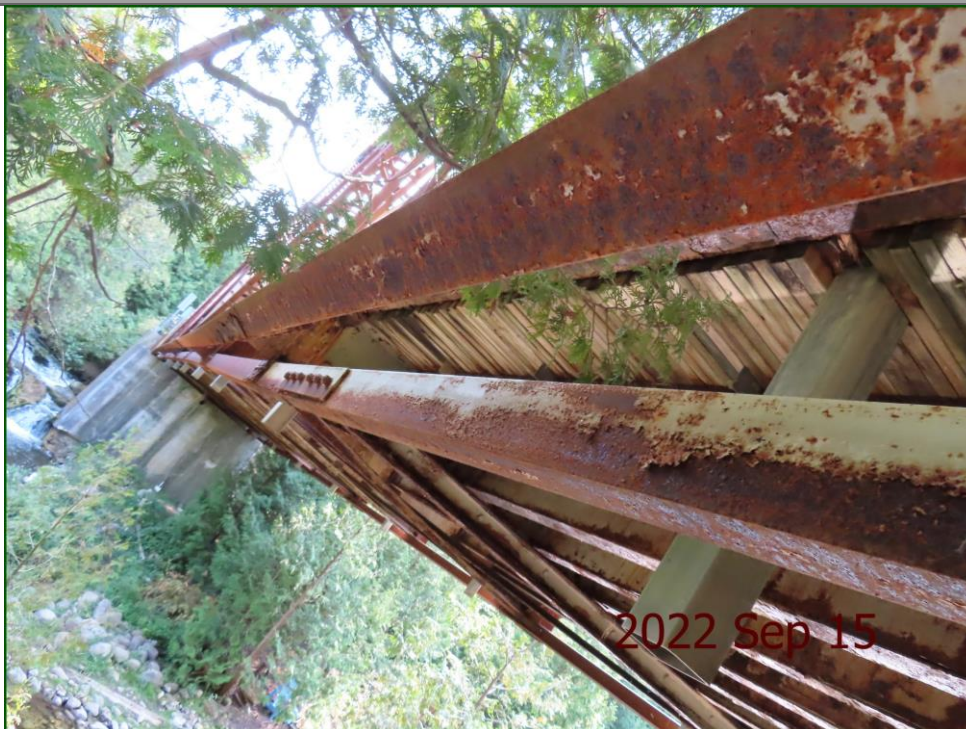
Very severe corrosion throughout resulting in locations where member has been severed.

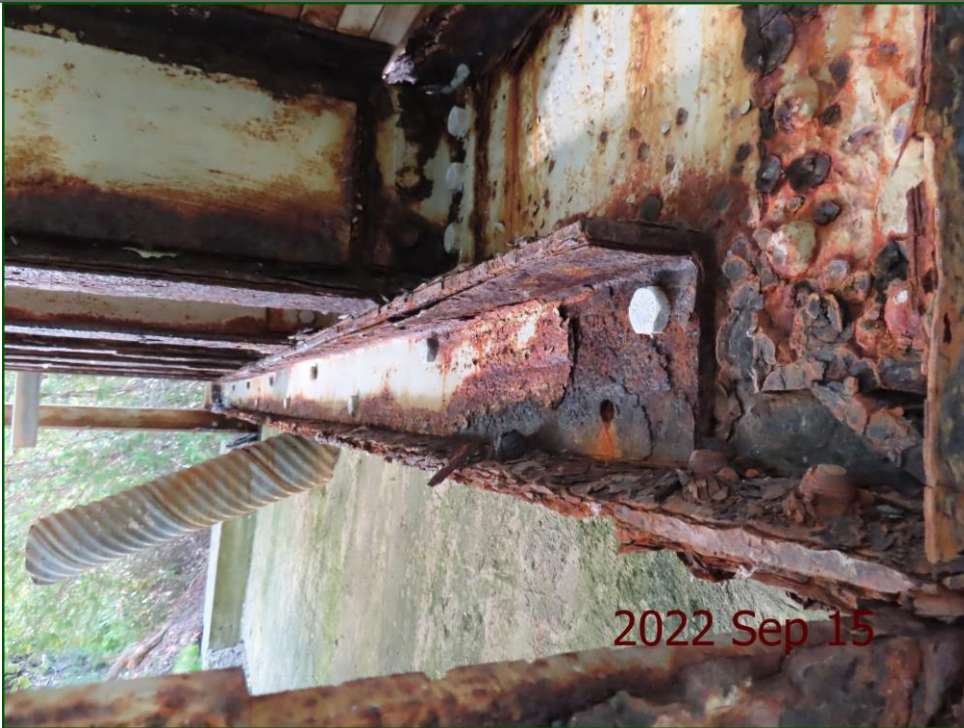
Severe corrossion at ends.
