MUNICIPALITY OF
West Grey

Municipality of West Grey
Bridge Prioritization Program

February 2025

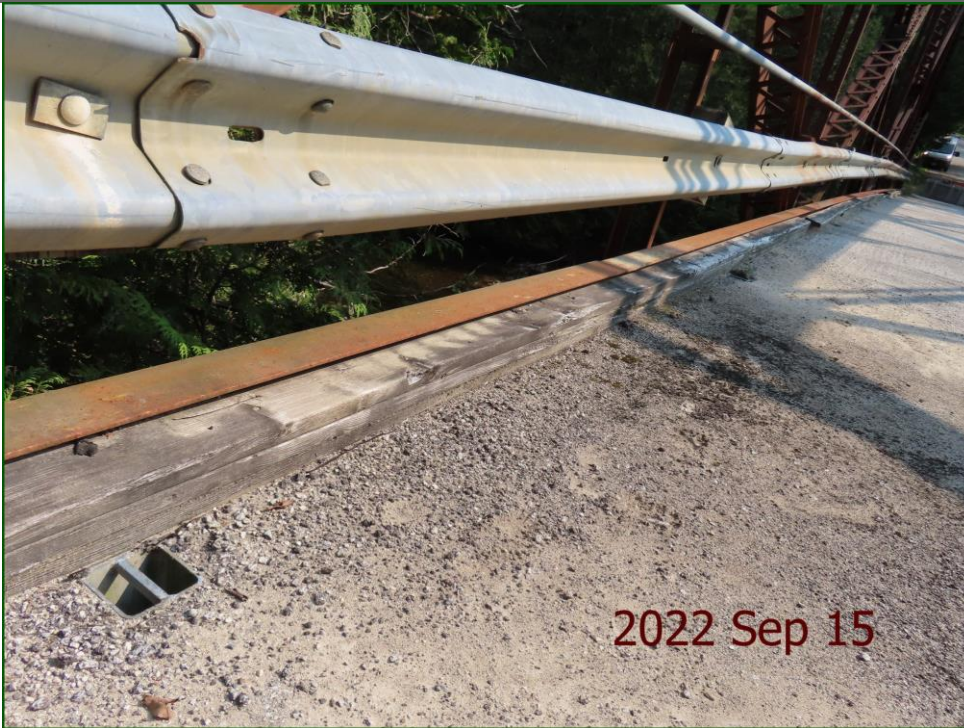
Impact damage throughout.

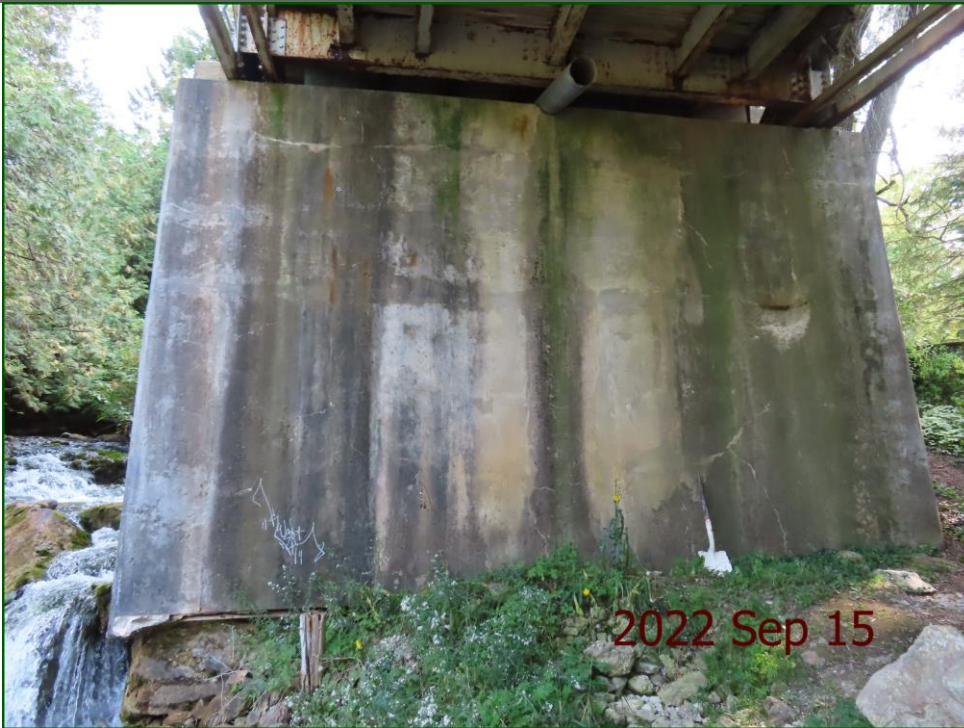
Severe scouring and disintegration along bottom of abutment. Moderate spalling with disintegration. Severe spall with exposed reinforcement. Partial foundation exposed and disintegrated, undermining abutment.

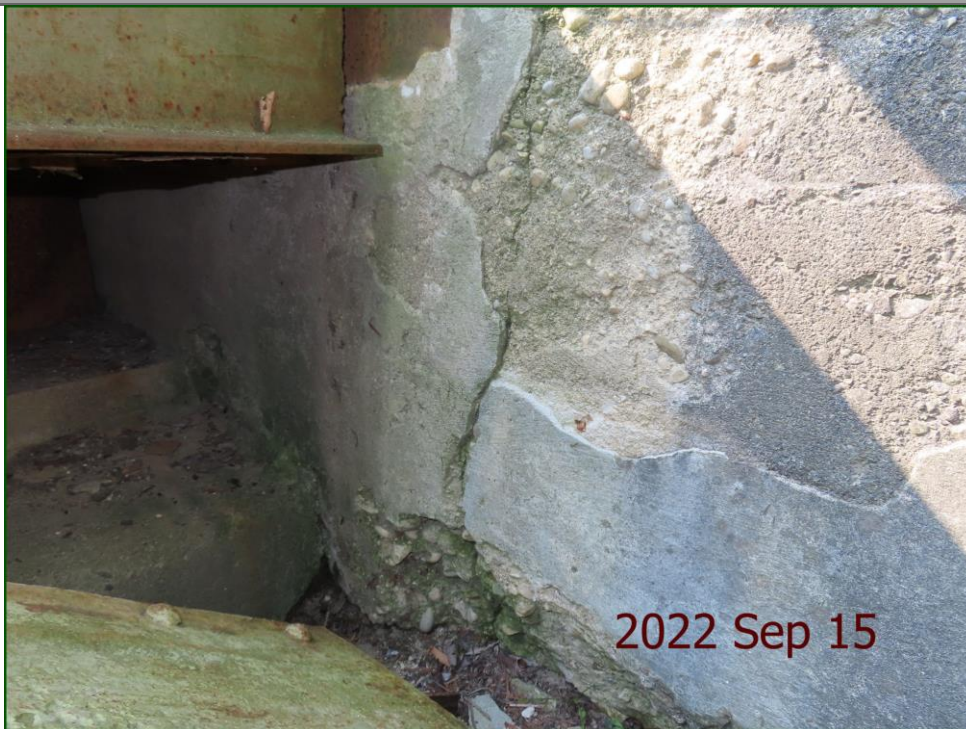
Severe spalling and disintegration.

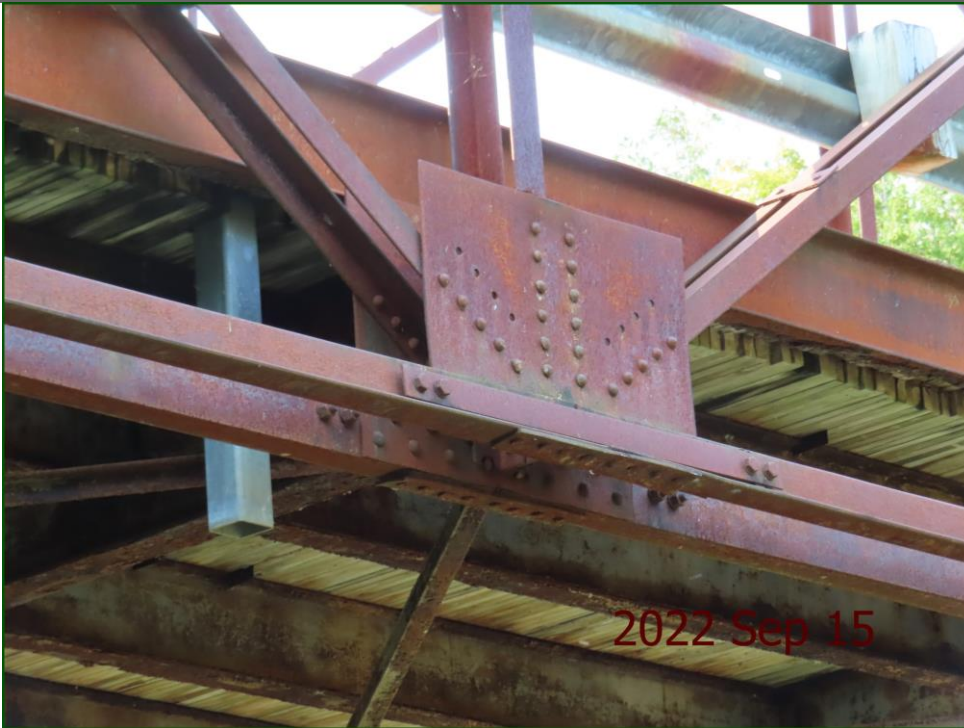
Very severe corrosion and bottom chord connection to top chord failing.

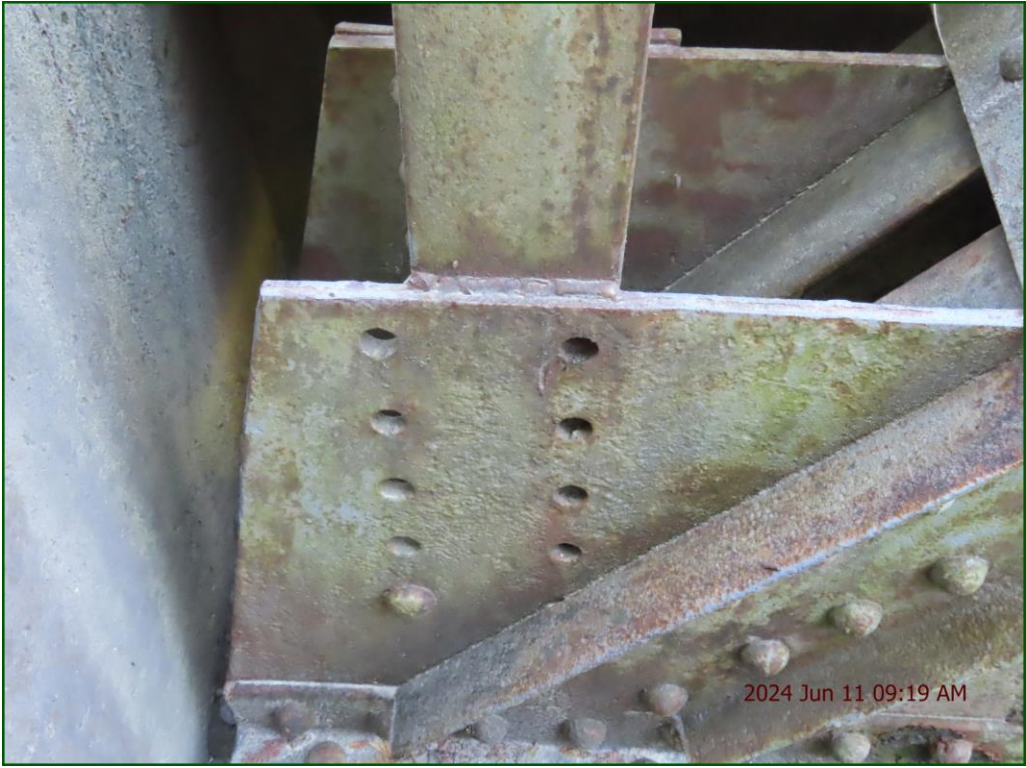
Description: Connections: Missing bolts at SE replaced by welding.

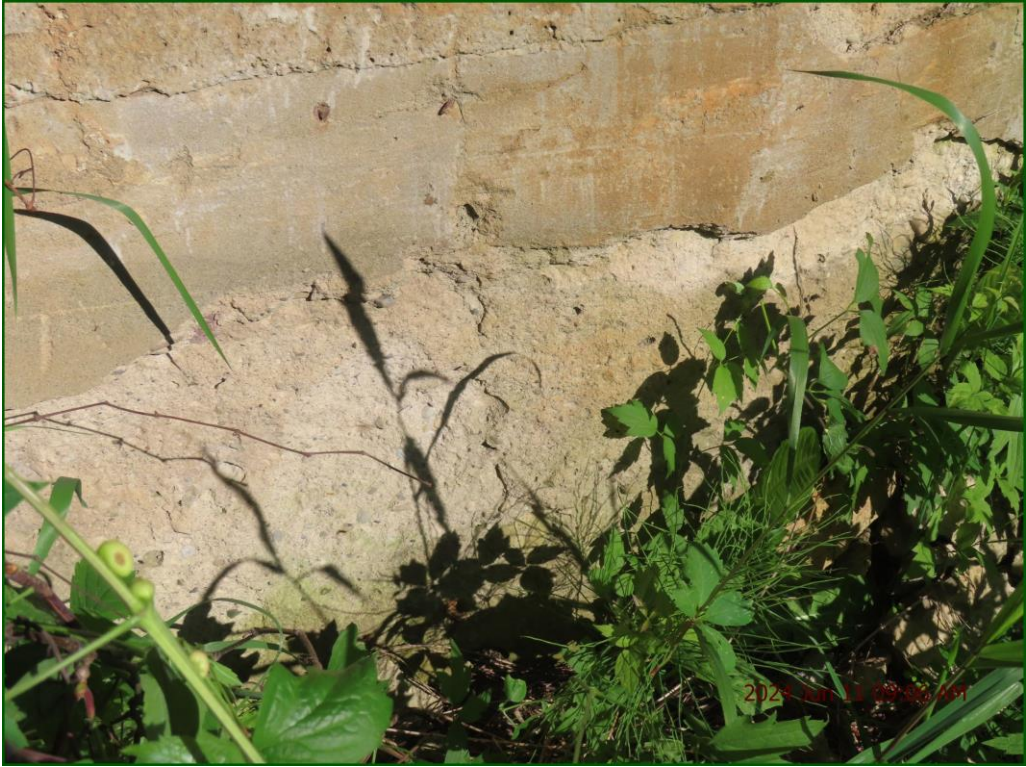
Description: Abutment Walls: Medium to severe delamination and disintegration along bottom.

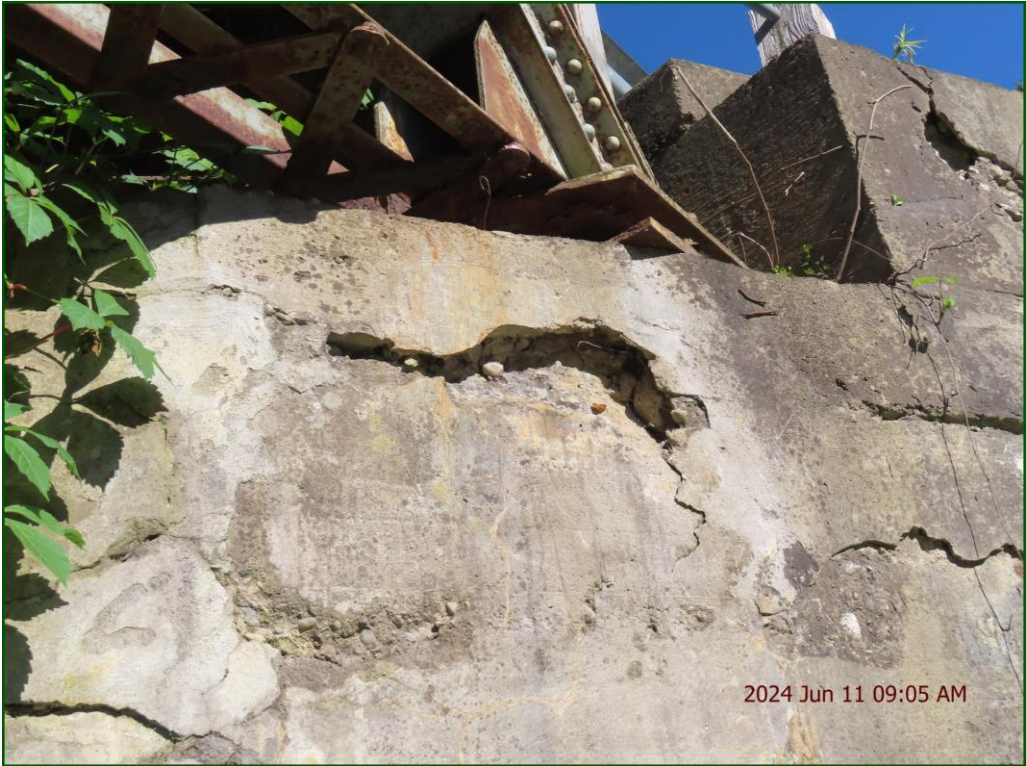
Description: Abutment walls: Possible crushing at bearings.

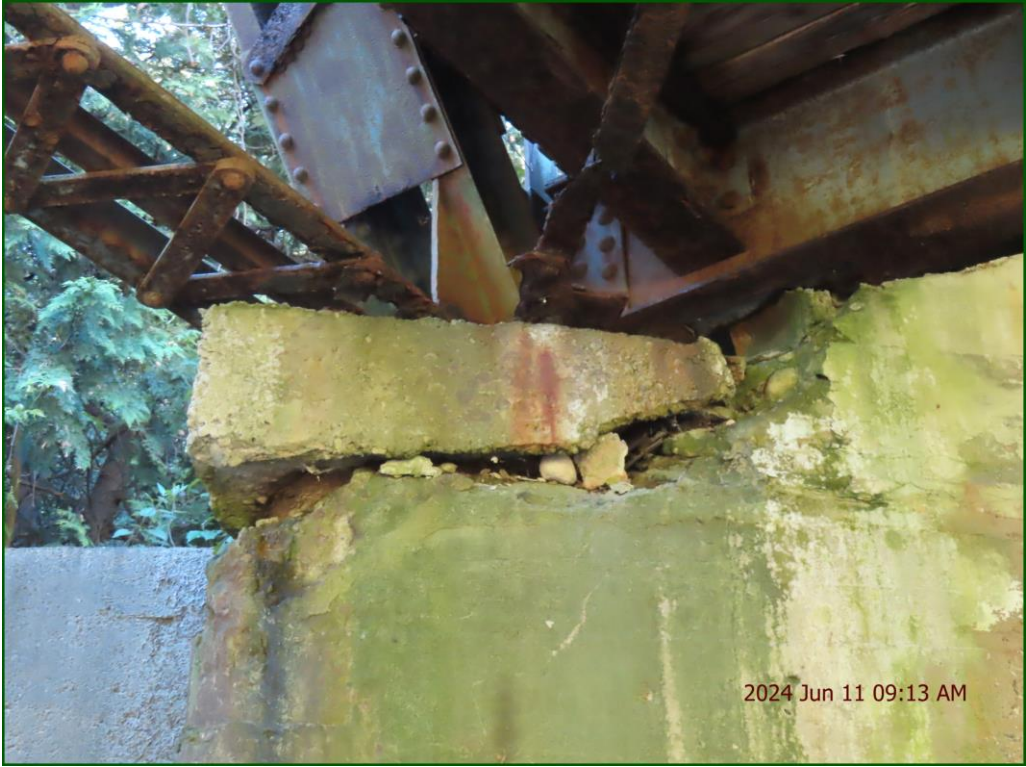
Description: Abutment walls: Severe spalling and crushing at bearing plate.

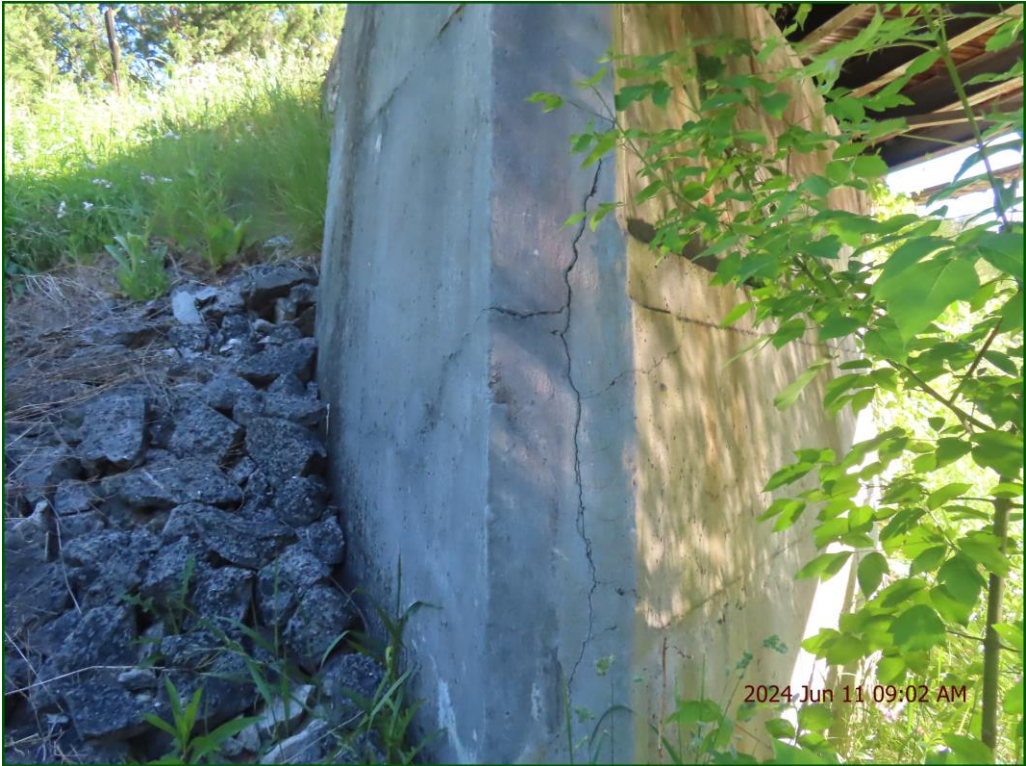
Description: Abutment walls: Wide vertical crack.

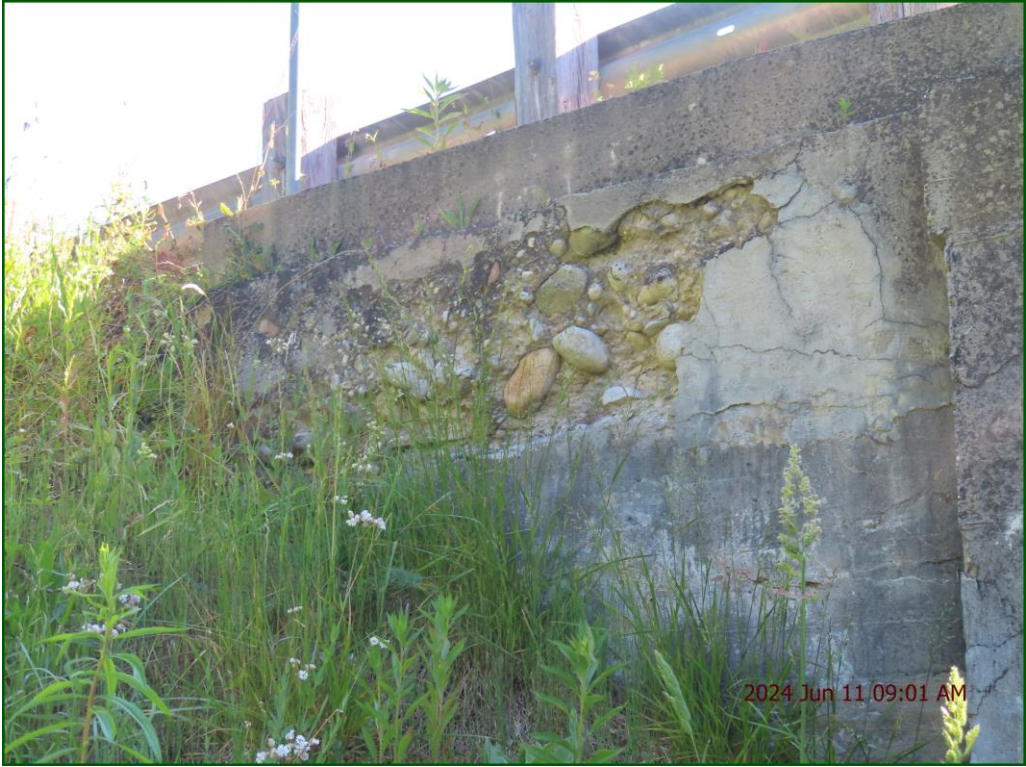
Description: Wingwalls: Severe spalling and disintegration.

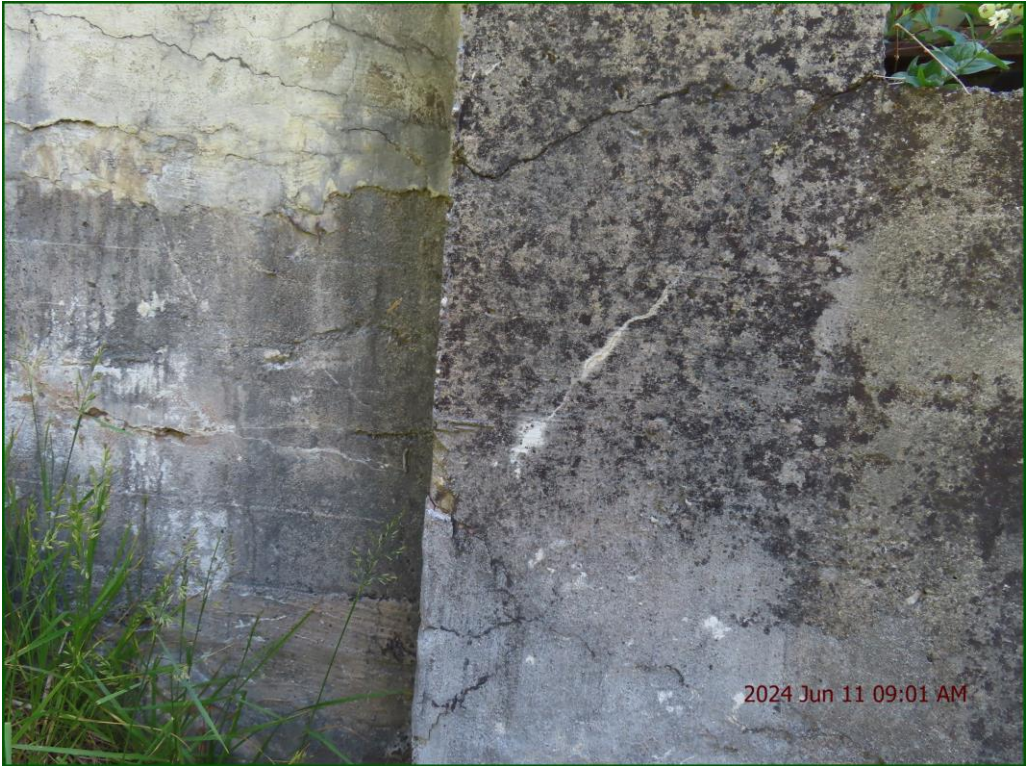
Description: Wingwalls: Wide cracking.

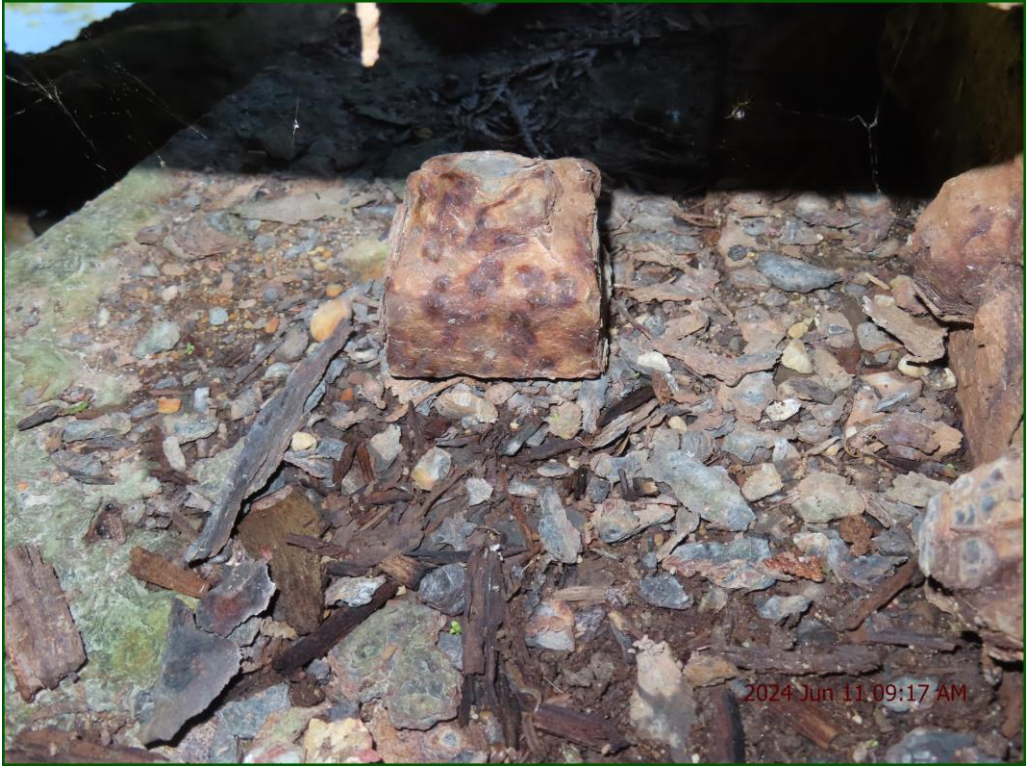
Description: Bearings: Severe corrosion in connection bolts.

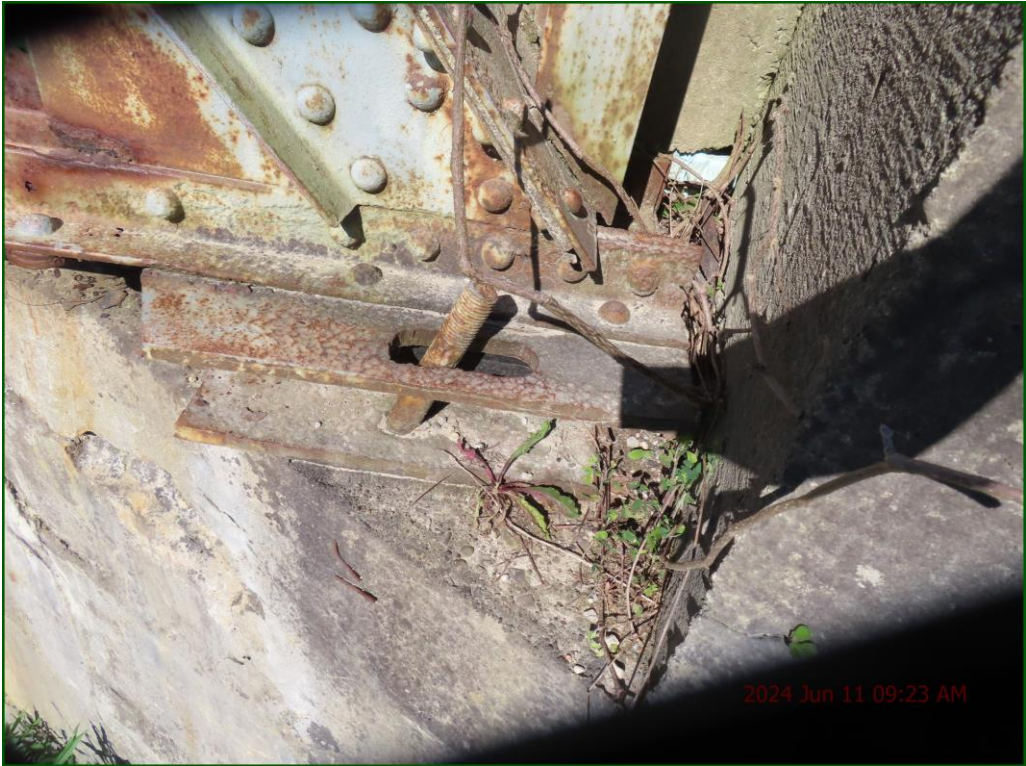
Description: Bearings: 1 bearing elastomeric at North East.

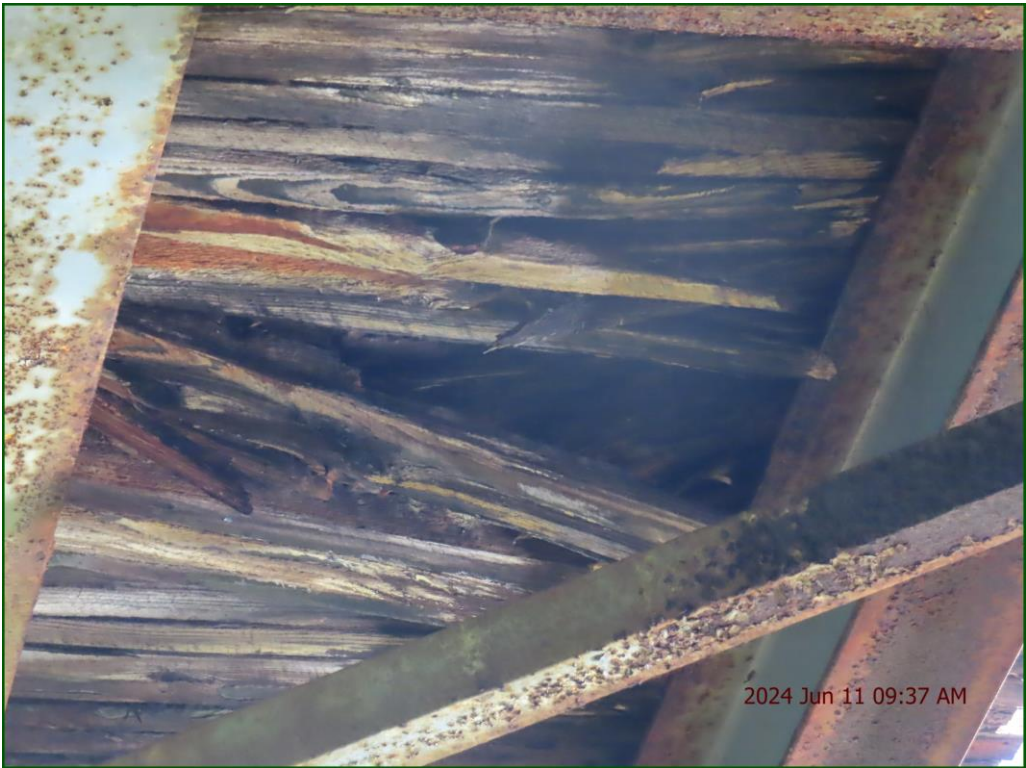
Description: Soffit: Localized area of severe rot resulting in hole in sofft (2/2).

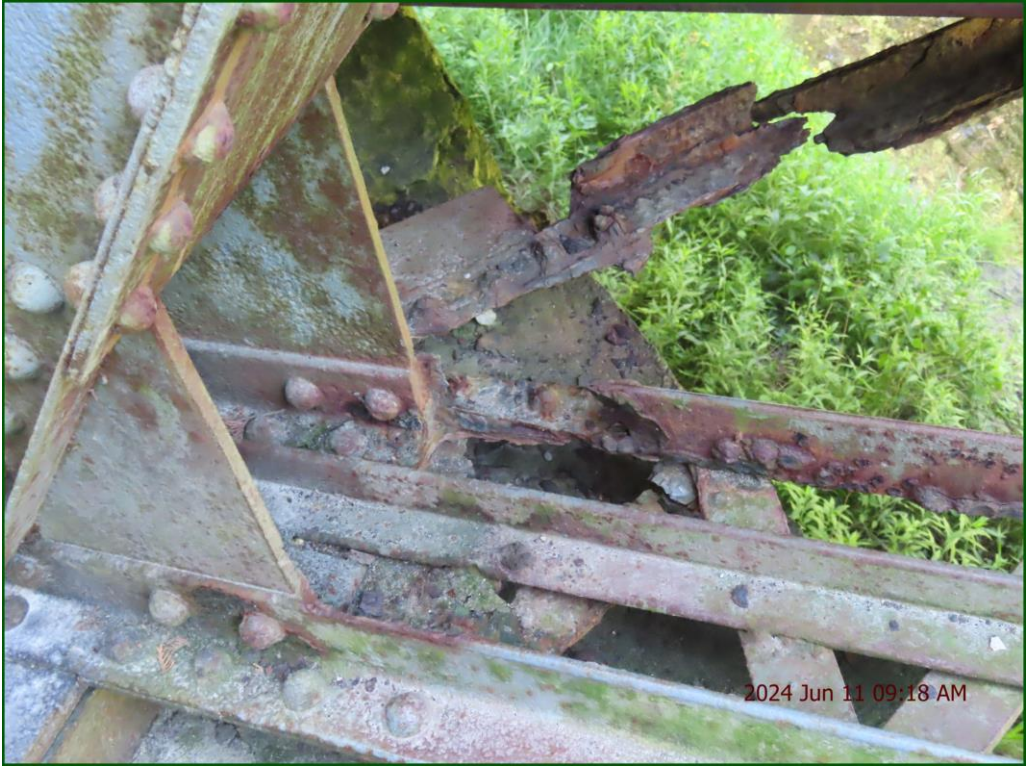
Description: Bottom chord: Severe corrosion at ends with areas of 50% section loss.

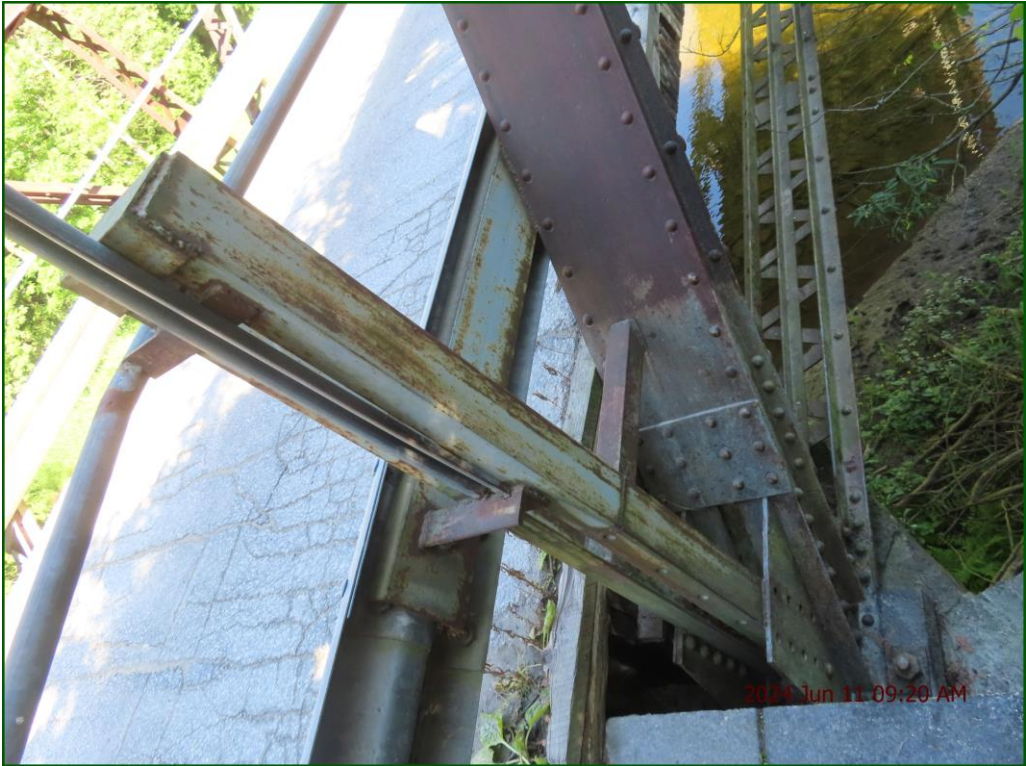
Description: Bottom chord: Additional members added.

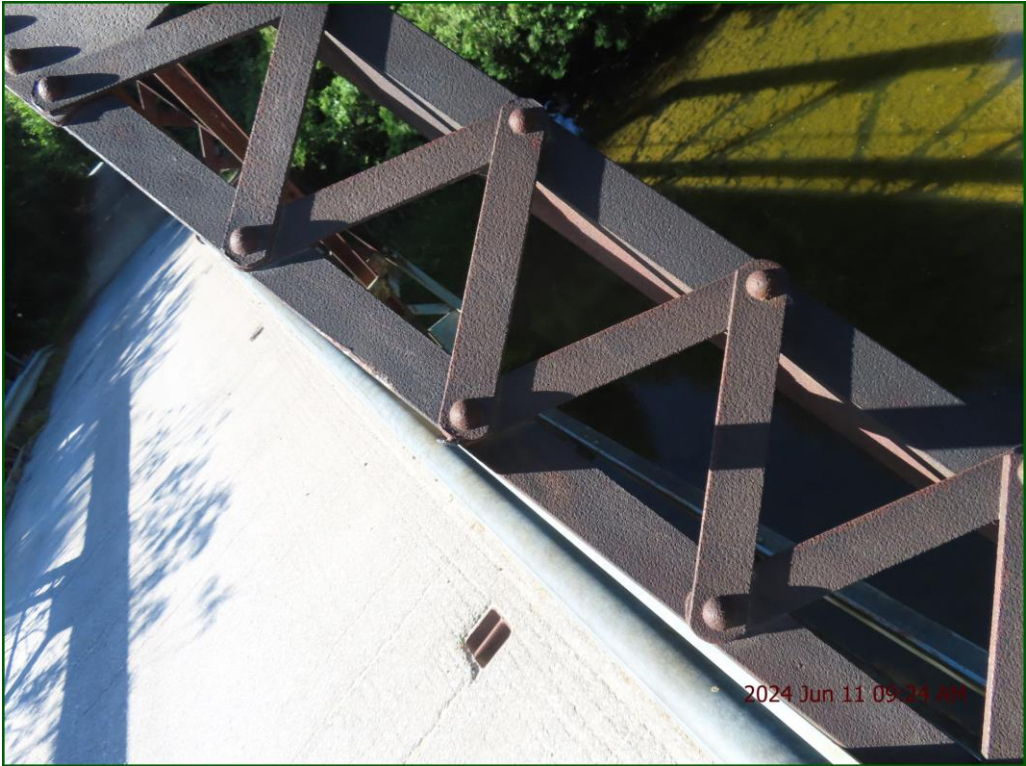
Description: Verticals/diagonals: Railing system welded to structure.

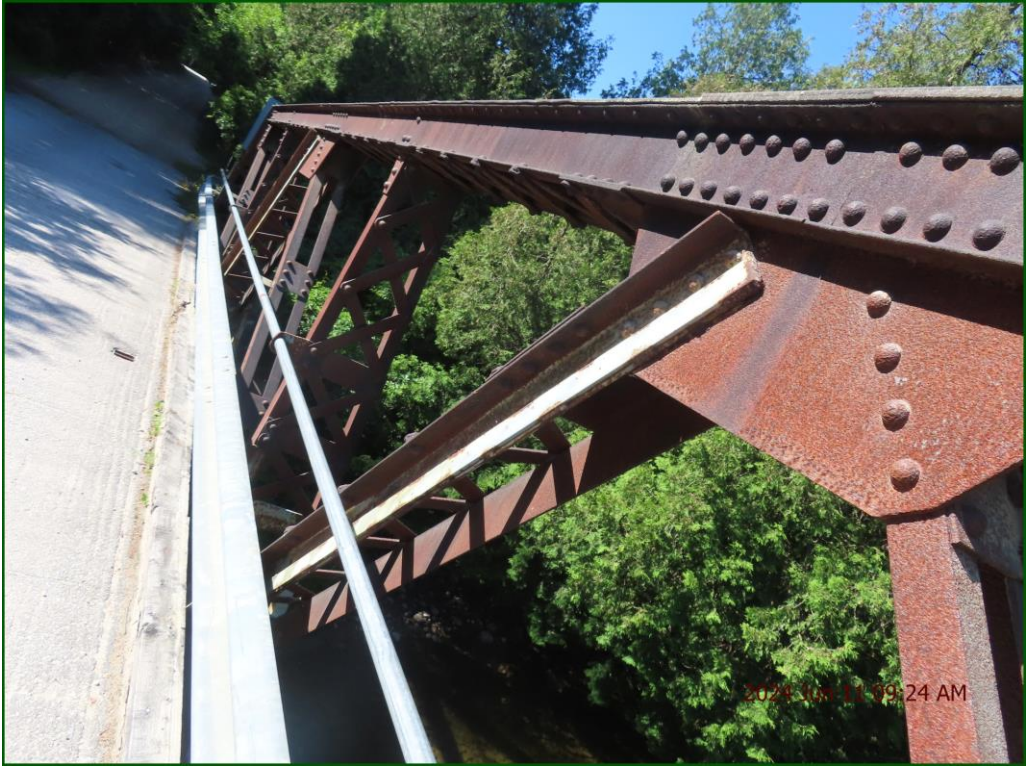
Description: Verticals/diagonals: Structural steel plates welded to diagonals.

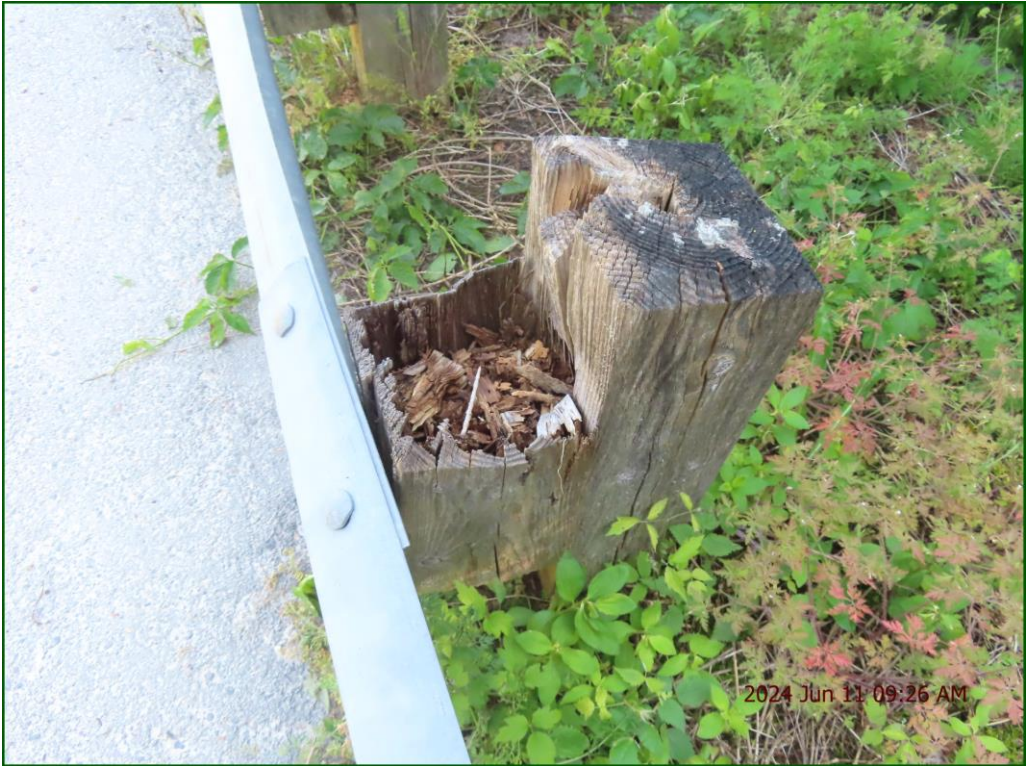
Description: Railing system: Severe rotting.

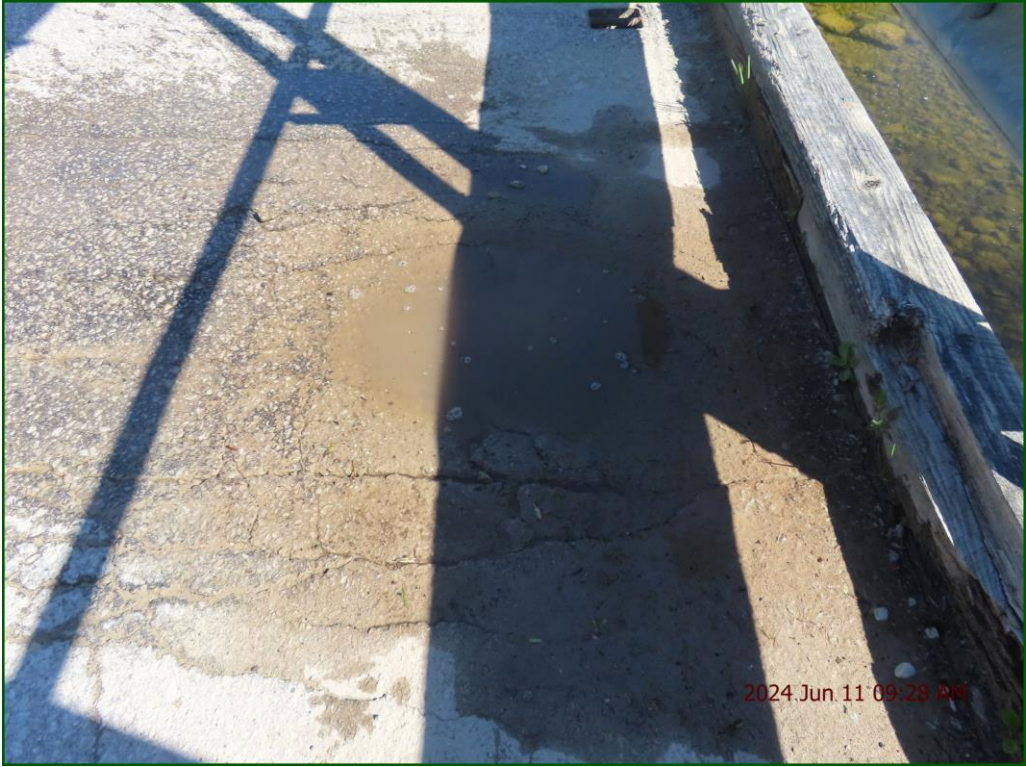
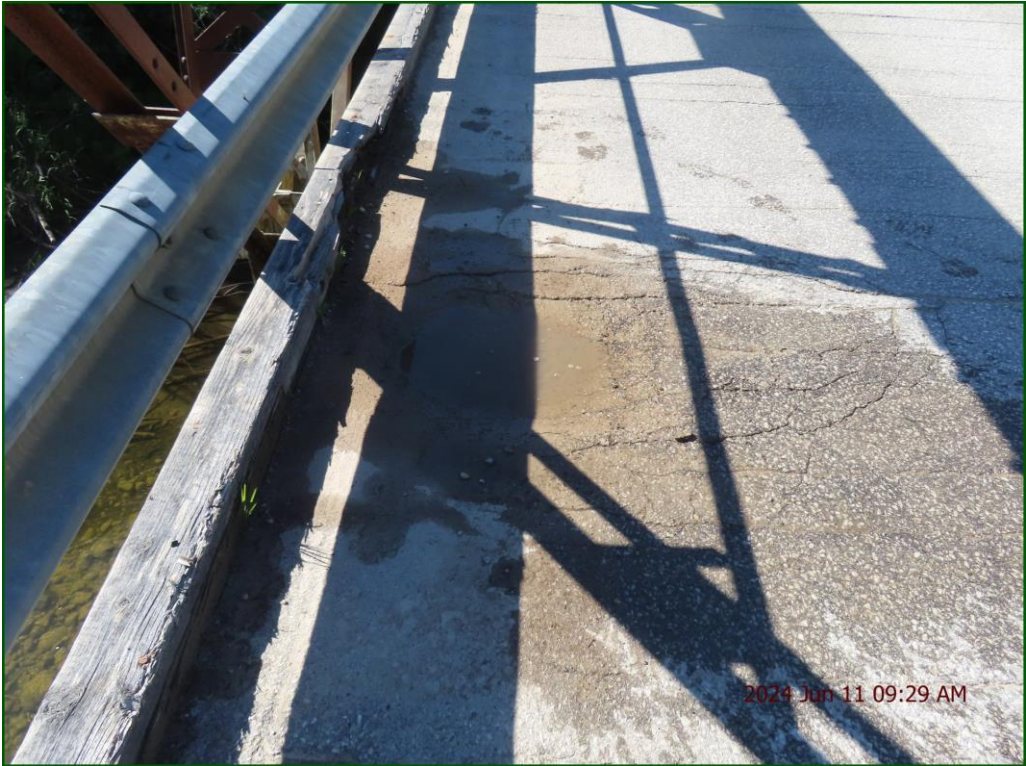
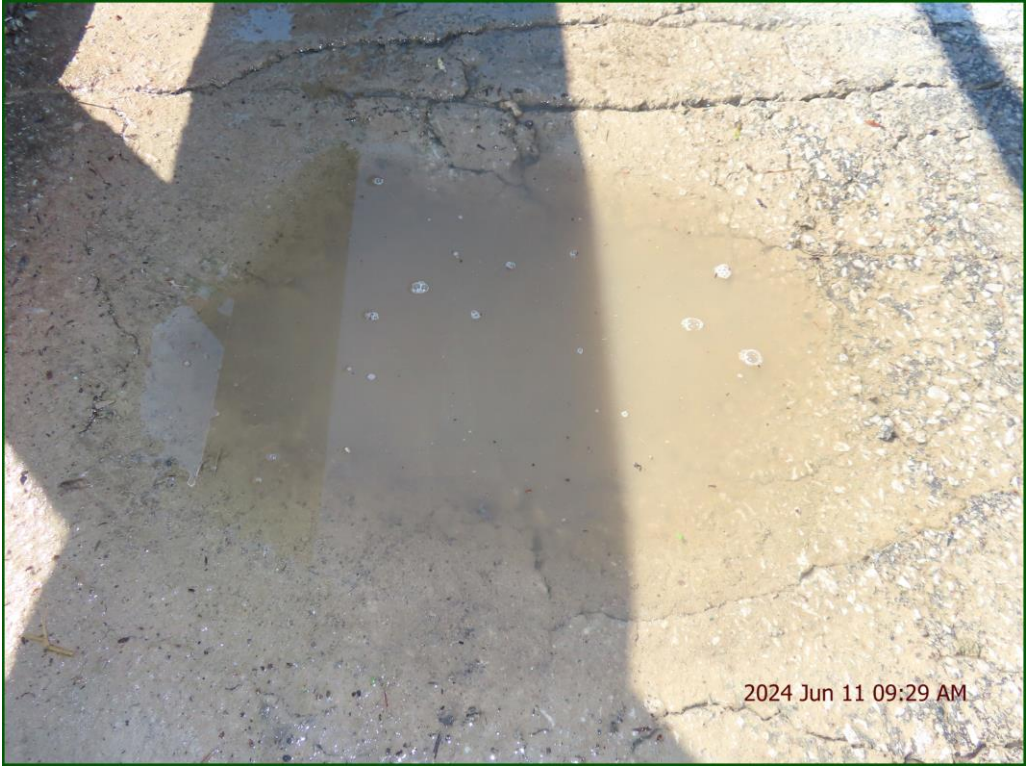
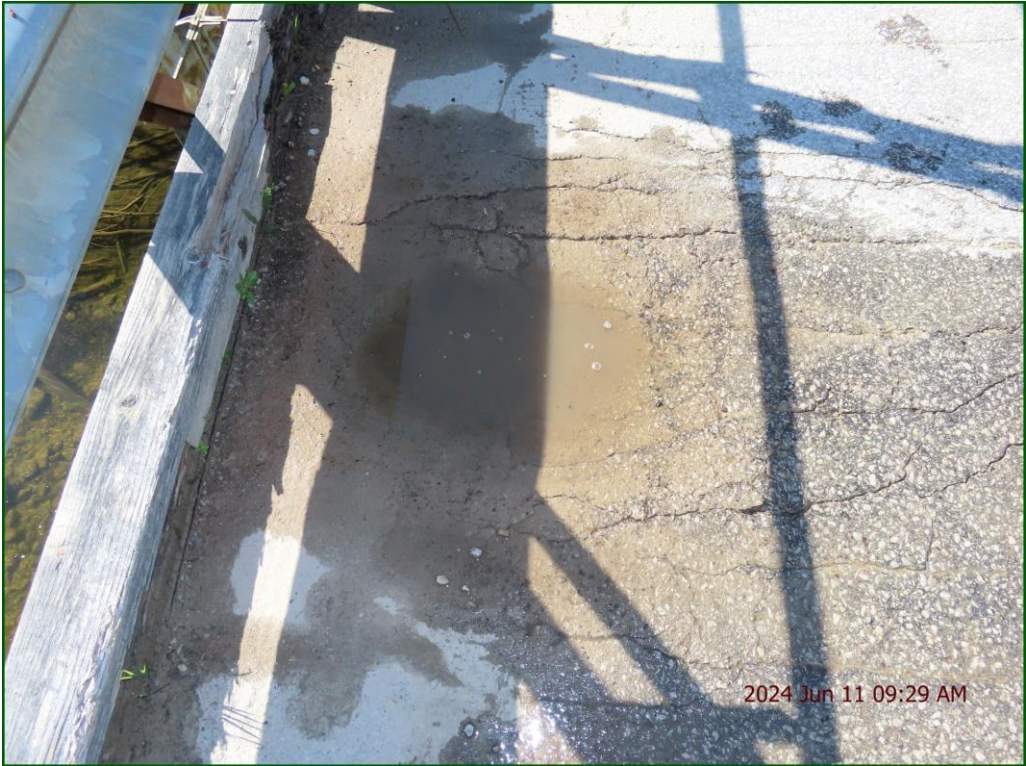
Description: Wearing surface: Severe pothole at midspan (1/4).

Description: Wearing surface: Severe pothole at midspan (2/4).

Description: Wearing surface: Severe pothole at midspan (3/4).

Description: Wearing surface: Severe pothole at midspan (4/4).

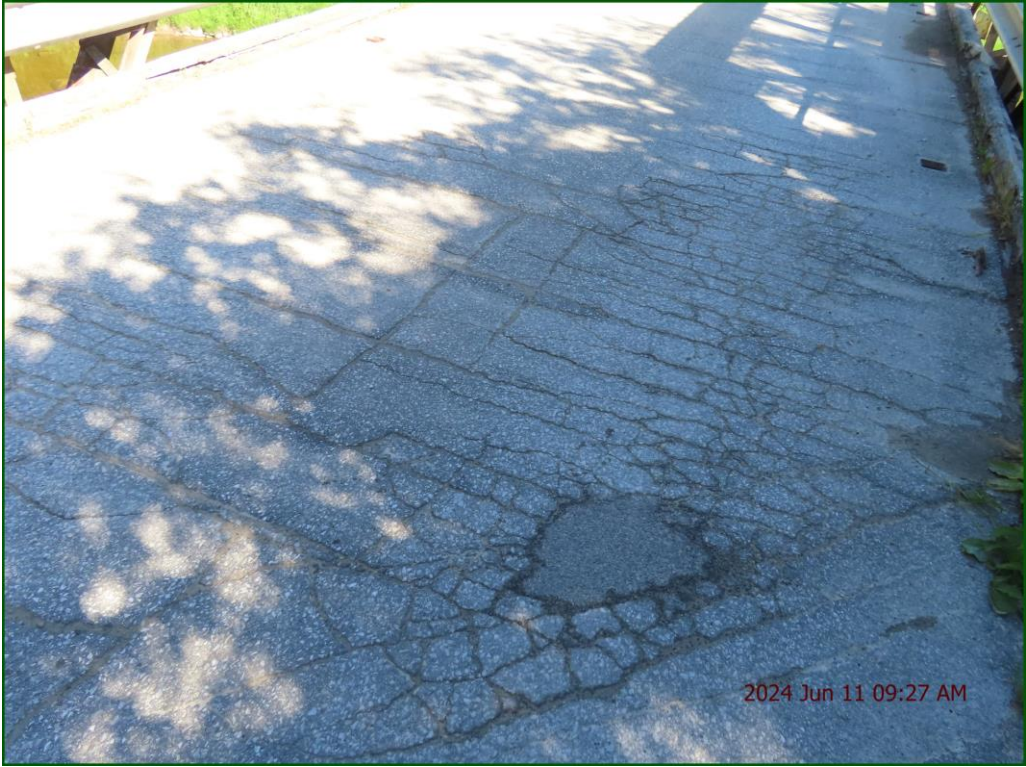
Description: Wearing surface: Severe alligator cracking throughout.

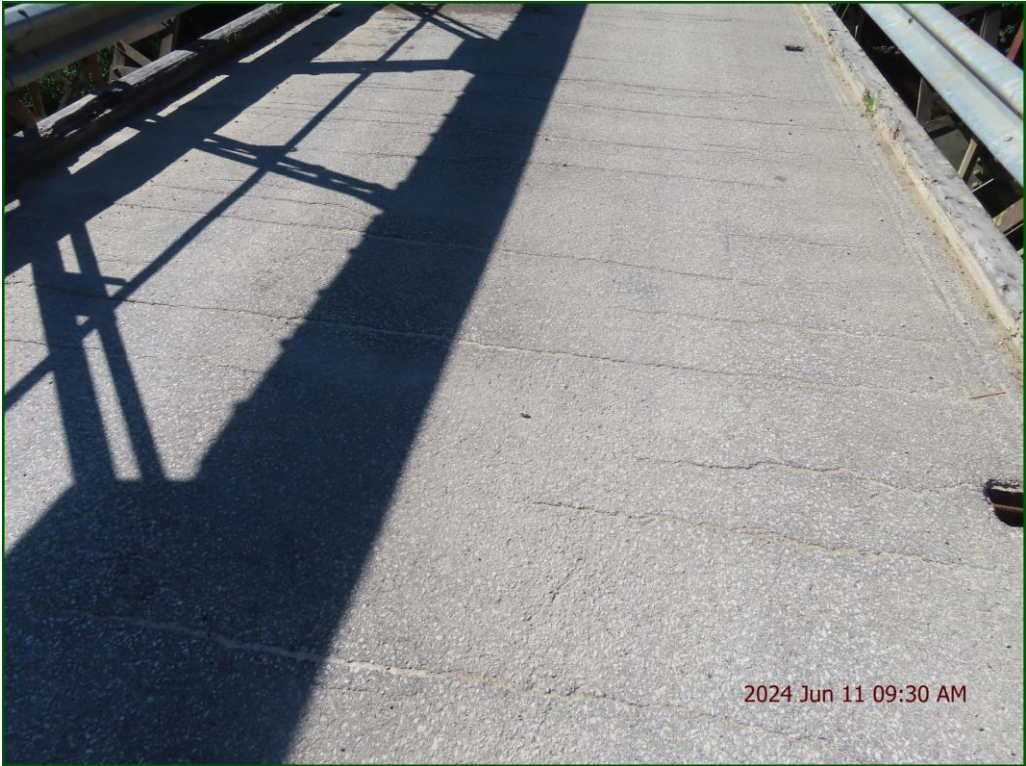
Description: Wearing surface: Wide transverse cracking throughout.

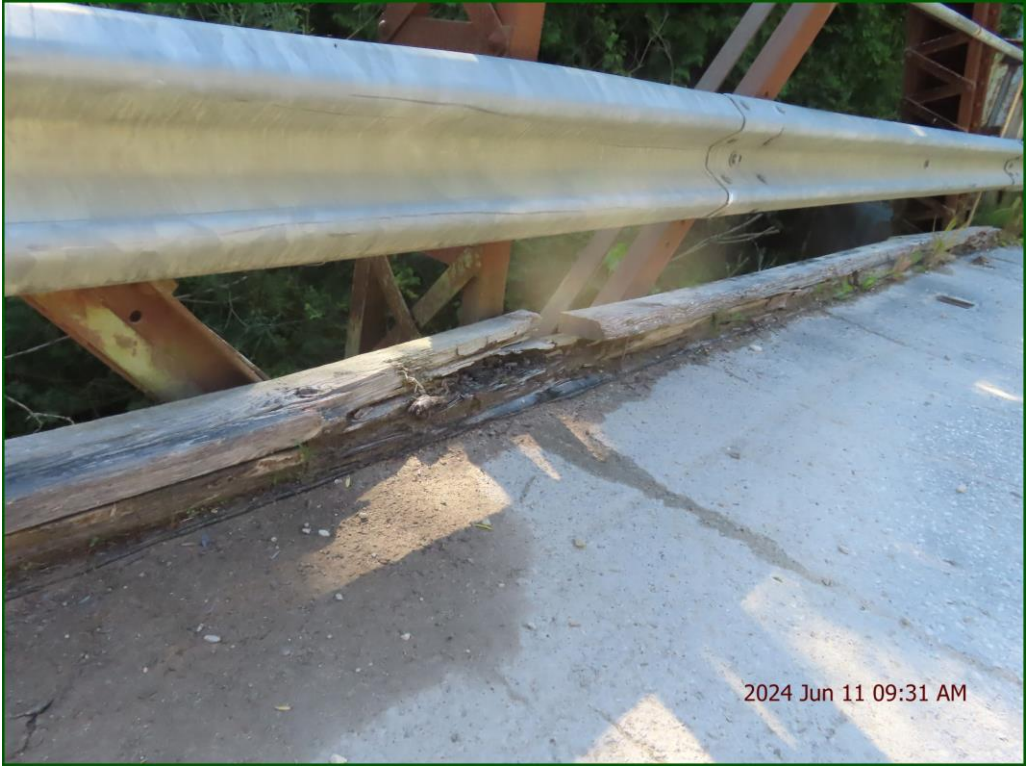
Description: Curbs: Medium to severe rotting throughout with some areas of complete section loss.

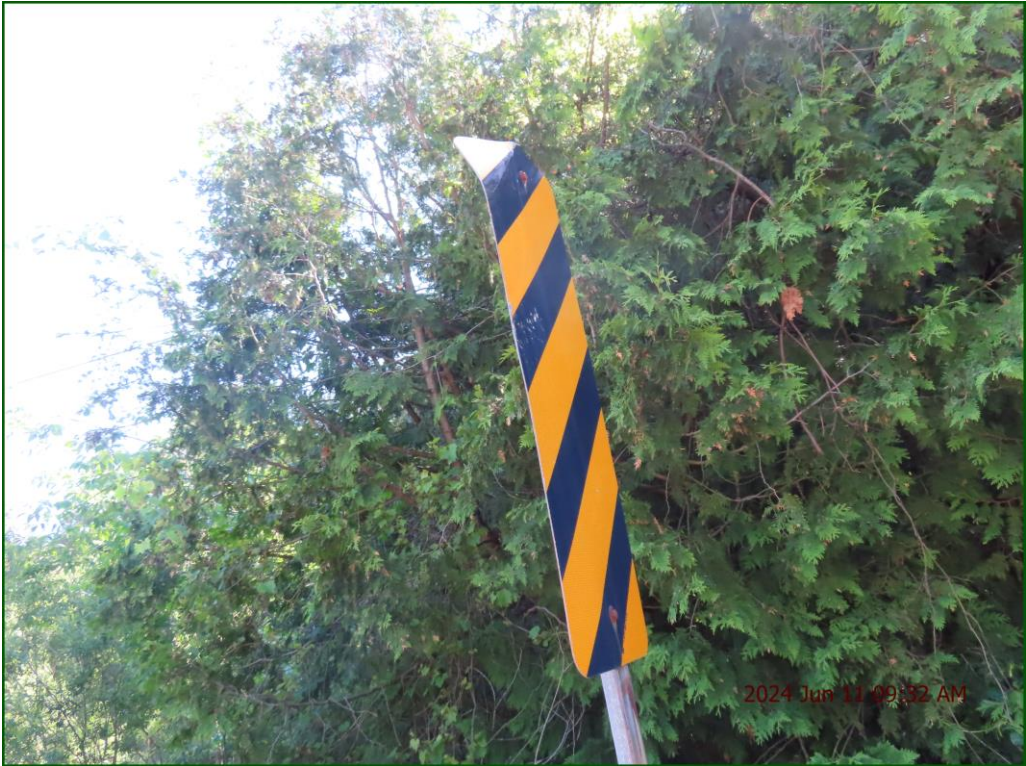
Description: Signs: Minor impact damage on various signs.

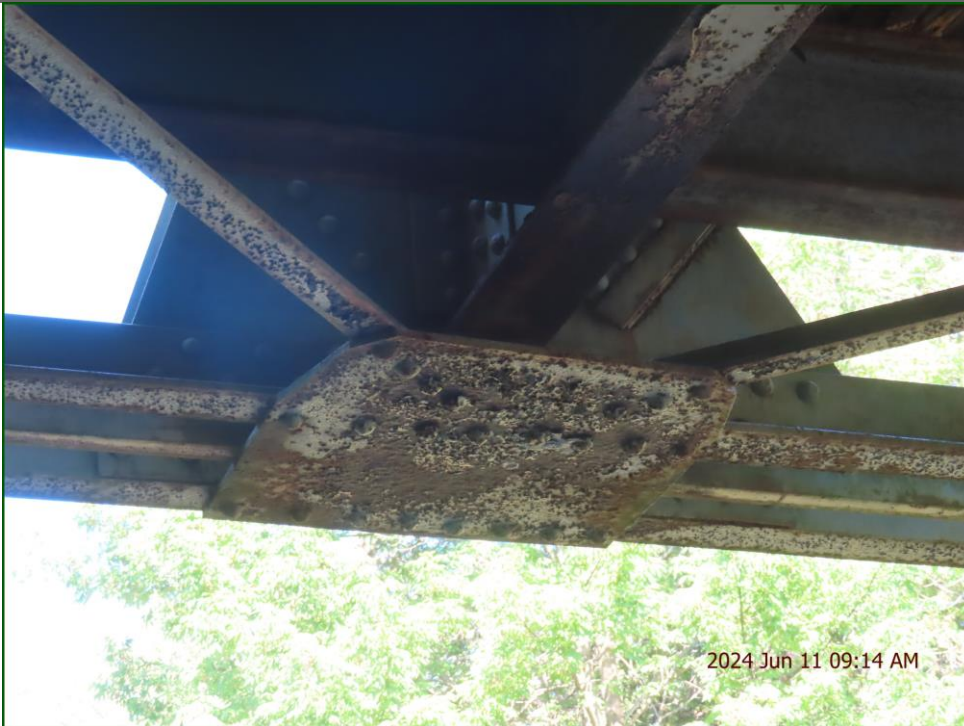
Moderate to severe corrosion with areas of 100% section loss. Missing bolts at SE replaced by welding.

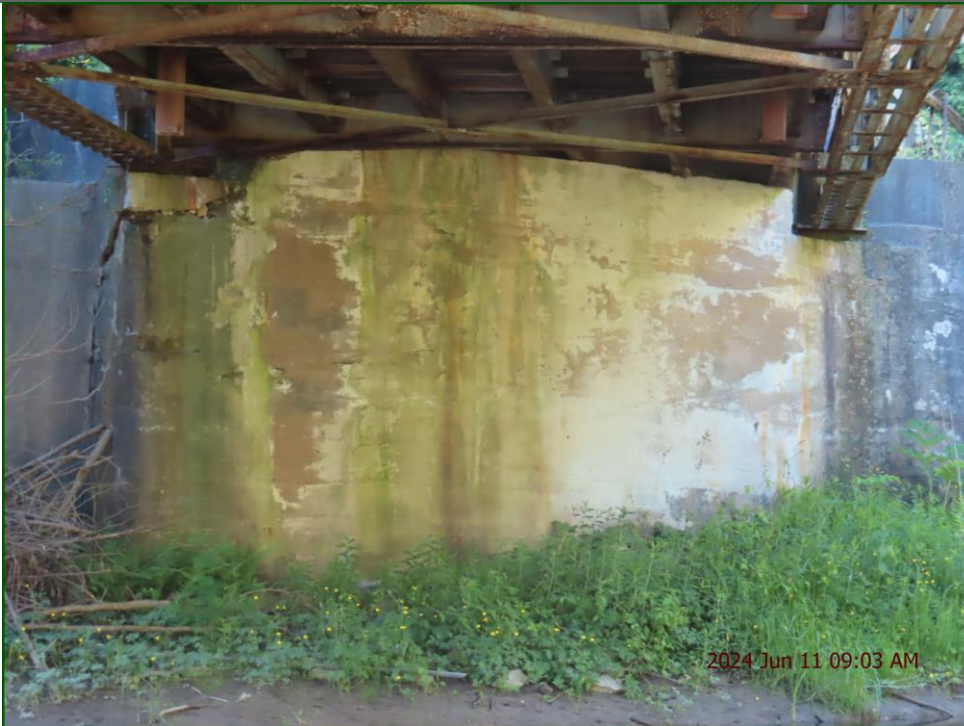
Medium to severe delamination and disintegration along bottom. Possible crushing at bearings. Severe spalling and crushing at bearing plate. Monitor bearing seat regions for advancing deterioration. Wide vertical crack.
