MUNICIPALITY OF
West Grey

Municipality of West Grey
Bridge Prioritization Program

February 2025

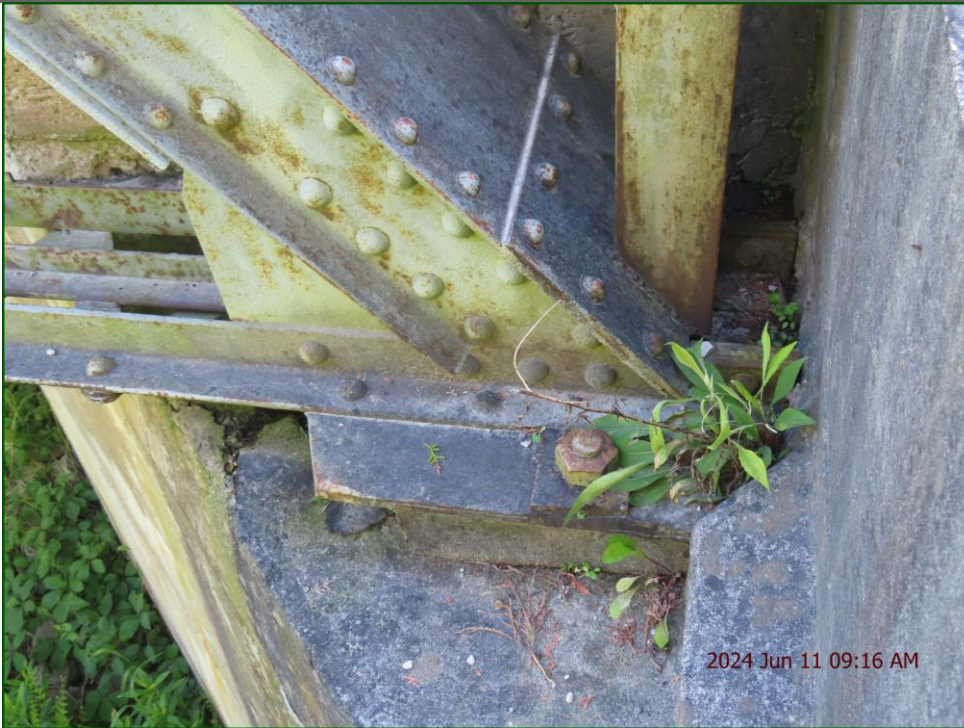
Severe corrosion in connection bolts. 1 bearing elastomeric at North East.

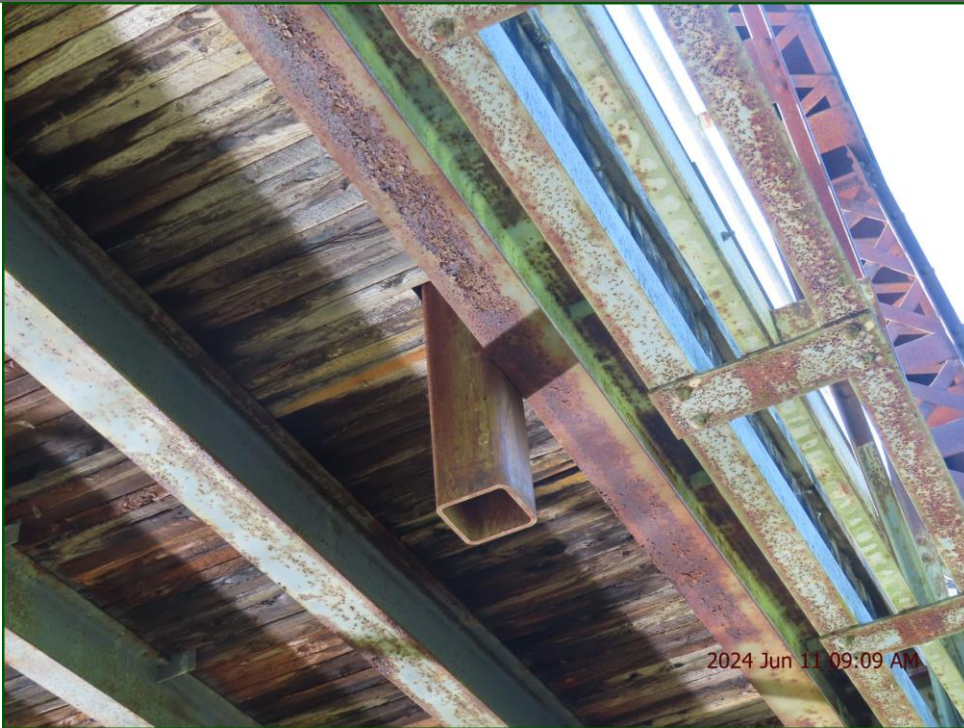
Light corrosion throughout.

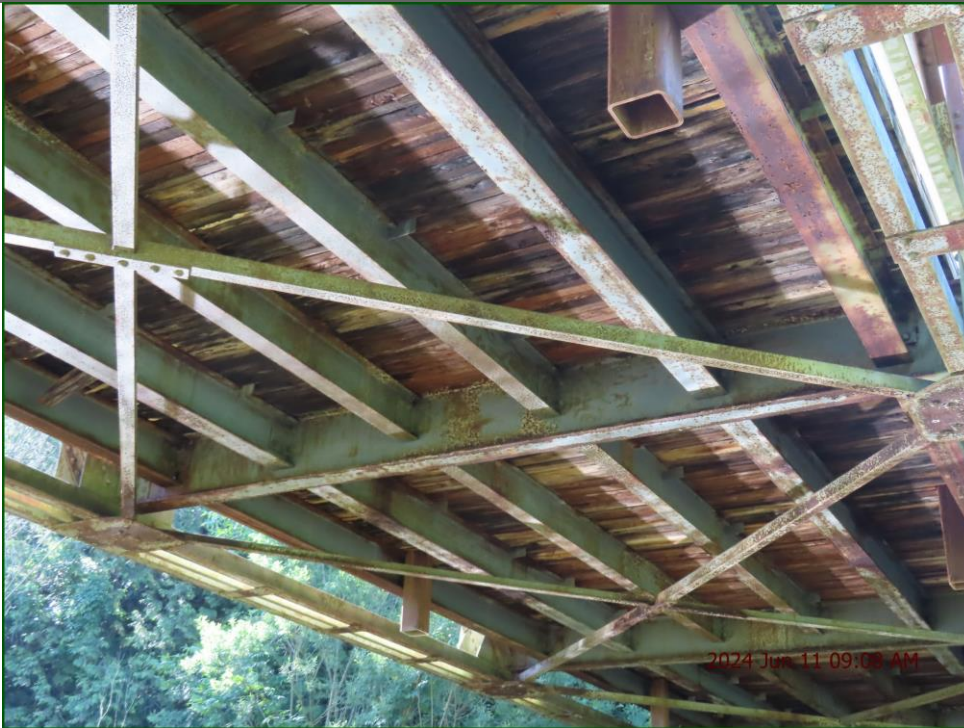
Light corrosion throughout. Limited inspection of floor beams above abutment.

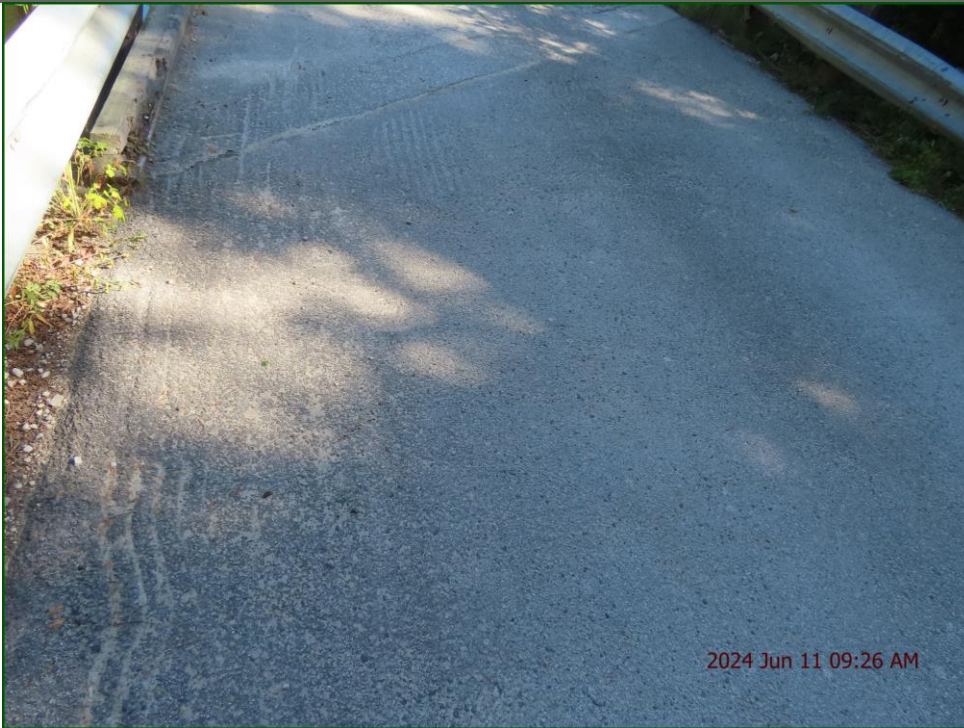
No signs of settlement.

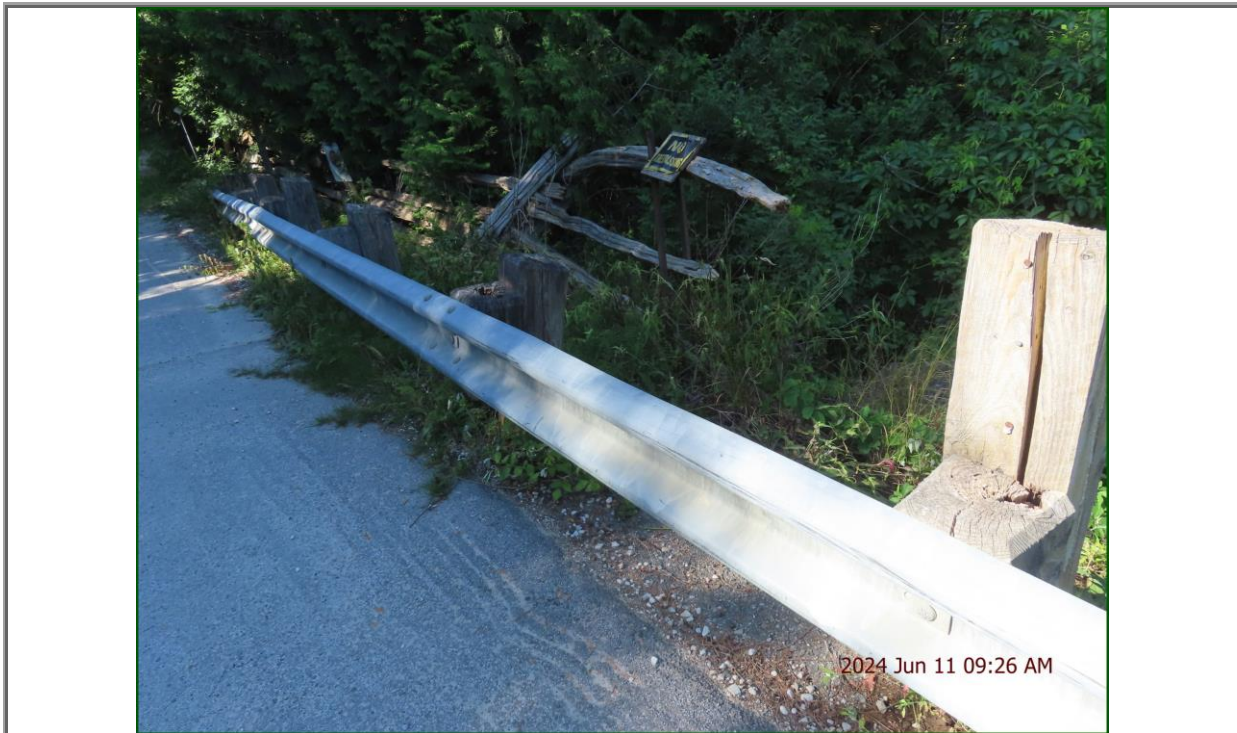
Severe rotting.

Element Group:	<input type="text" value="Approaches"/>	Site Number:	<input type="text" value="B-025"/>
Element Name:	<input type="text" value="Railing system"/>	Width:	<input type="text" value="0"/> m
Element type:	<input type="text" value="Flexi beam with timber posts"/>	Height:	<input type="text" value="0.65"/> m
Sub-element:	<input type="text"/>	Length:	<input type="text" value="5"/> m
Material:	<input type="text" value="Steel"/>	Count:	<input type="text" value="4"/>
Location:	<input type="text"/>	Total Quantity:	<input type="text" value="20"/>
Environment:	<input type="text" value="Severe"/>	Not inspected:	<input type="checkbox"/>
Perform. deficiencies:	<input type="text" value="None"/>	Maintenance Type:	<input type="text" value="Structural"/>
Maint needs:	<input type="text" value="Repair guide rail protection"/>	Maint. Time Period:	<input type="text" value="1 Year"/>

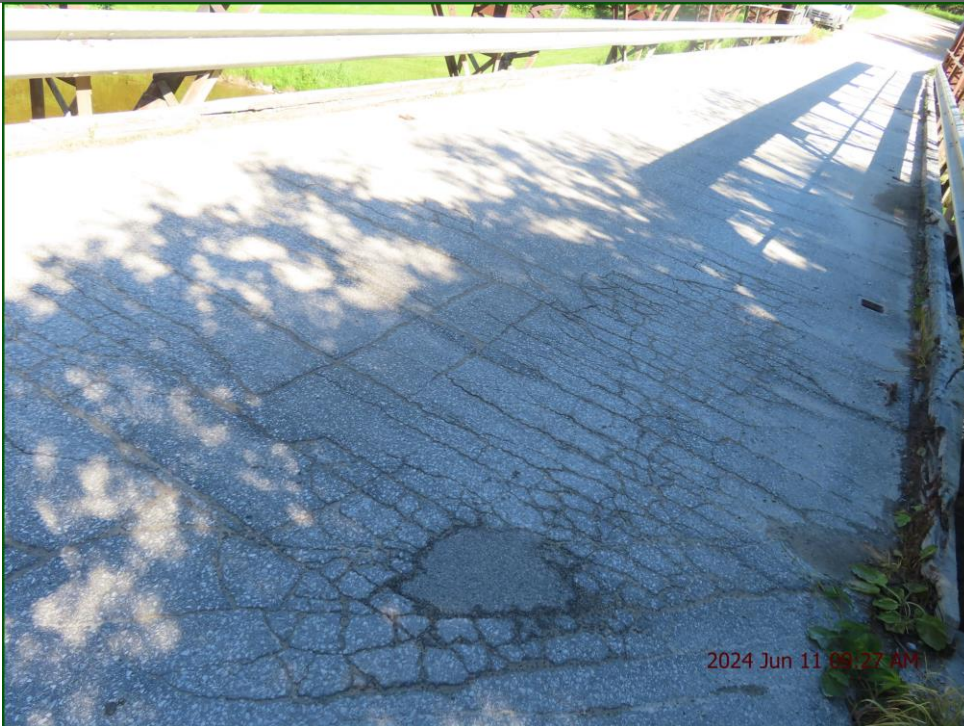
Severe pothole at midspan possibly suggesting rot of wooden soffit, bottom of pothole feels punky. Severe alligator cracking throughout. Wide transverse cracking throughout.

Element Group:	Decks	Site Number:	B-025
Element Name:	Wearing surface	Width:	4.1 m
Element type:		Height:	m
Sub-element:		Length:	28.96 m
Material:	Asphalt	Count:	
Location:		Total Quantity:	119 sqm
Environment:	Severe	Not inspected:	<input type="checkbox"/>
Perform. deficiencies:	None	Maintenance Type:	Structural
Maint needs:	Asphalt Repairs	Maint. Time Period:	1 Year

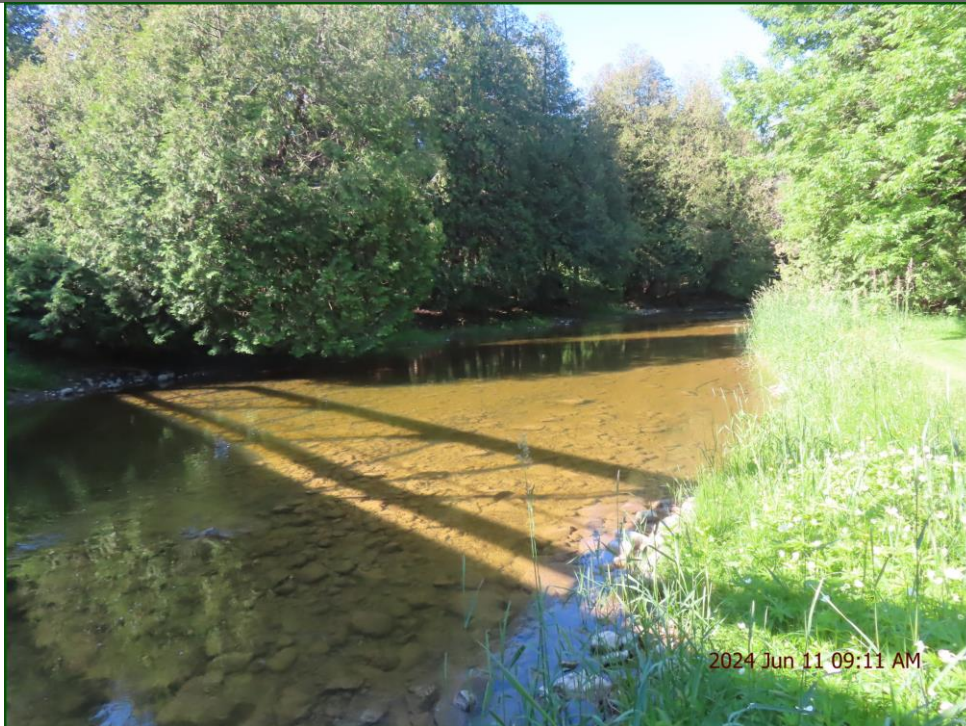
Heavy flow at time of inspection.

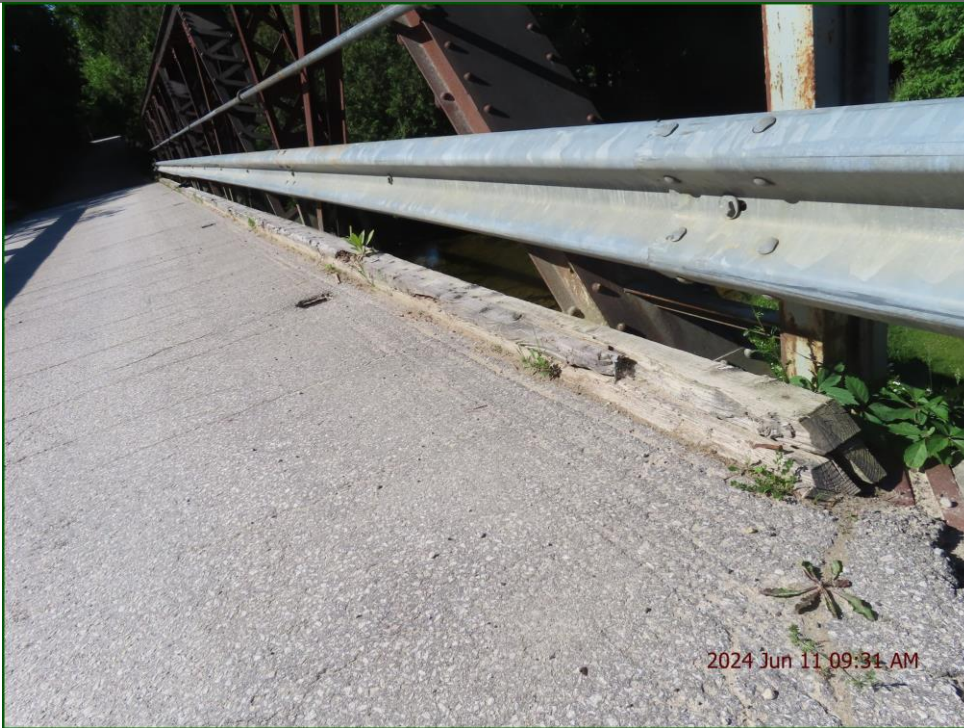
Medium to severe rotting throughout with some areas of complete section loss.

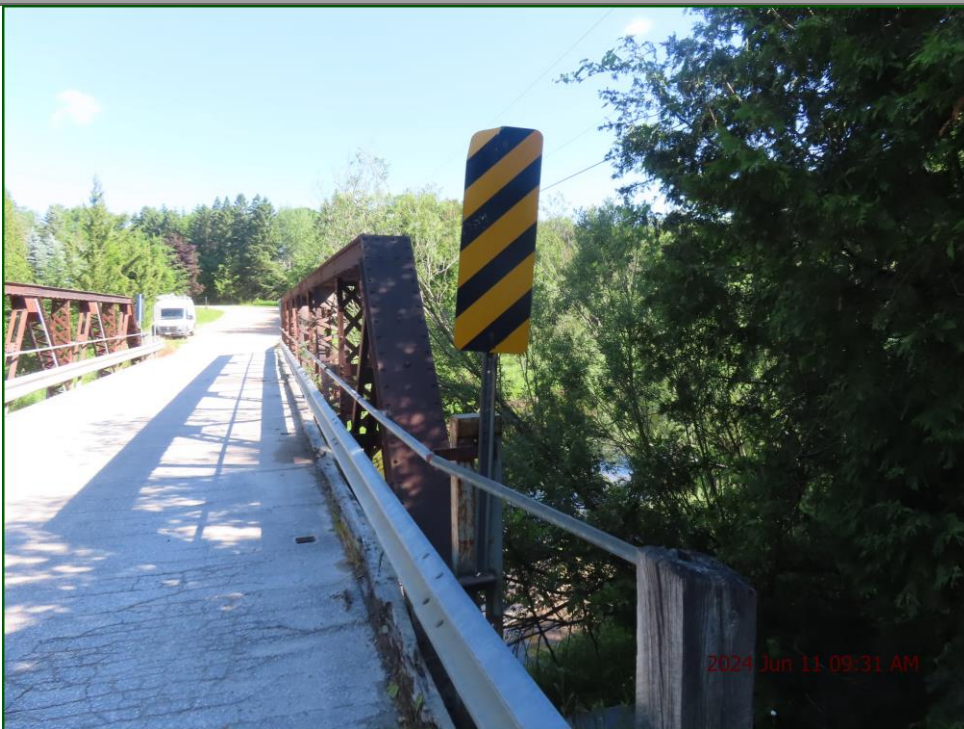
Minor impact damage on various signs.

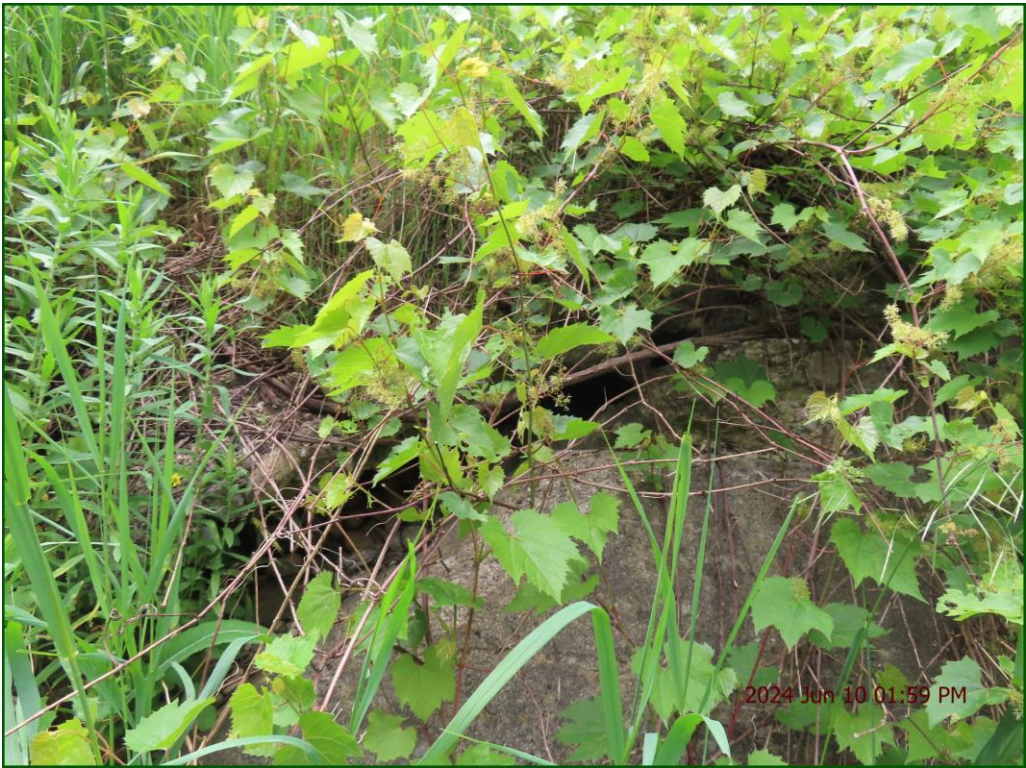
Description: Wingwalls: Severe spalling with disintegration throughout (1/2).

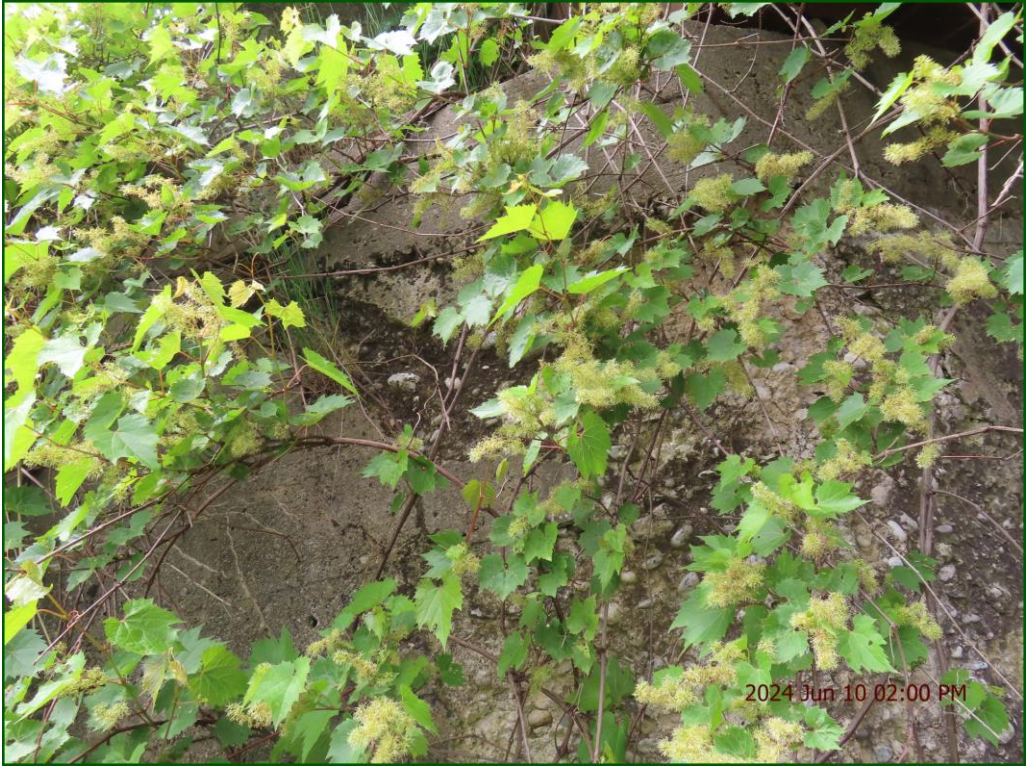
Description: Wingwalls: Severe spalling with disintegration throughout (2/2).

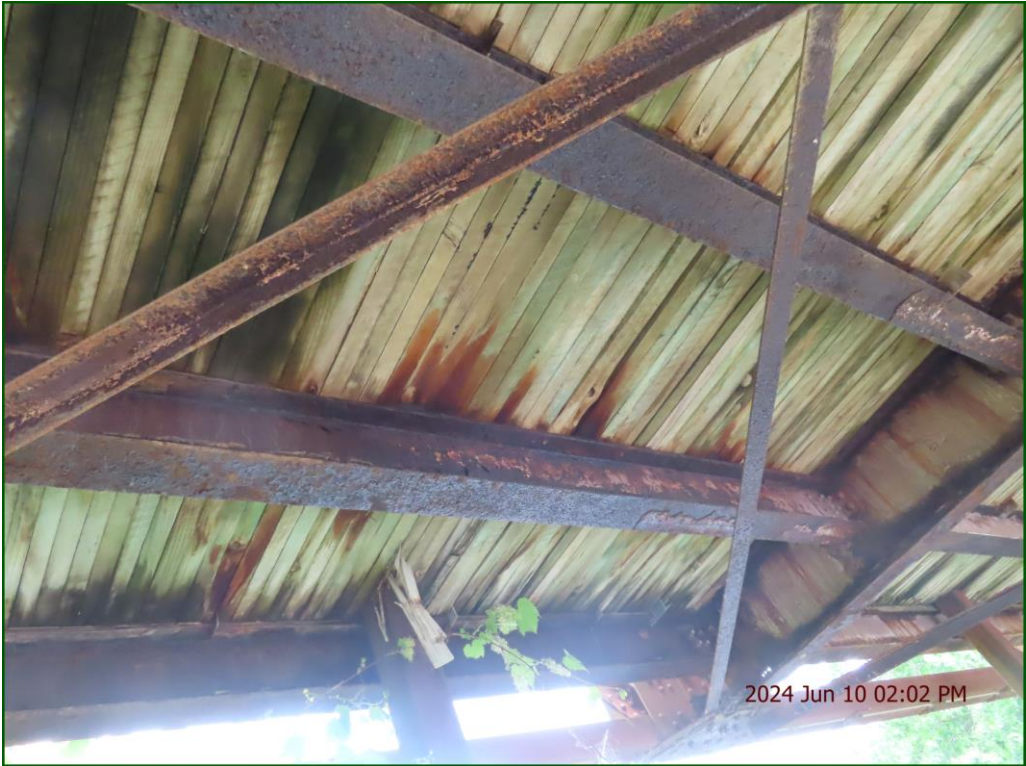
Description: Soffit: Light rotting throughout.

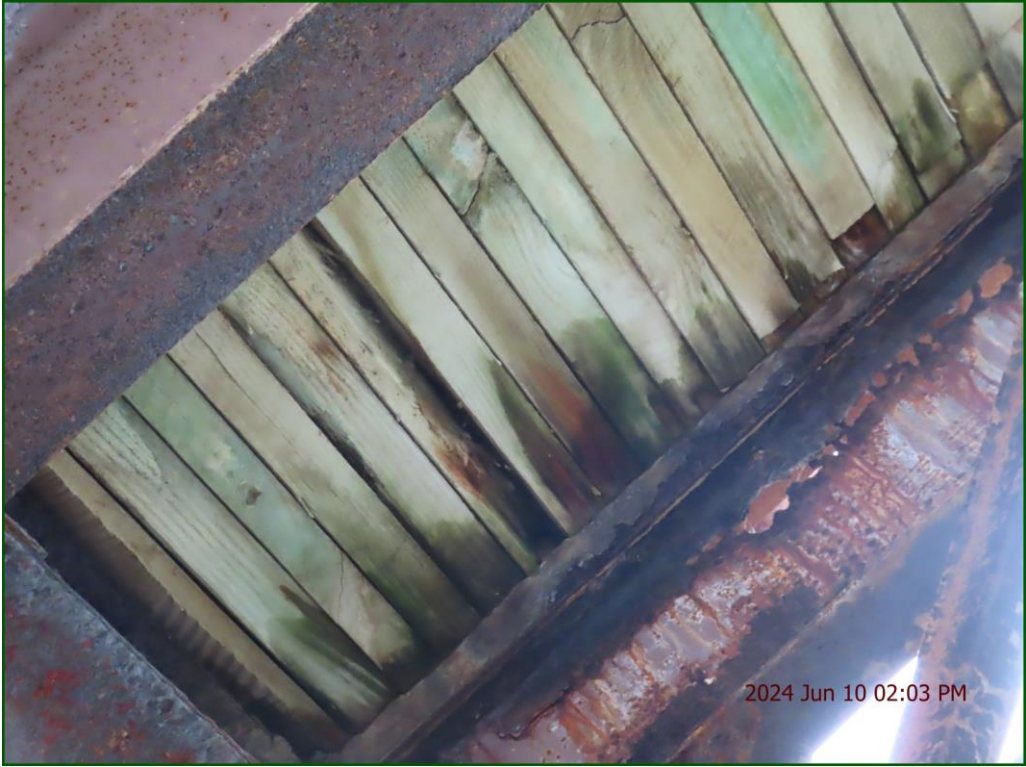
Description: Soffit: Areas of localized severe rot.

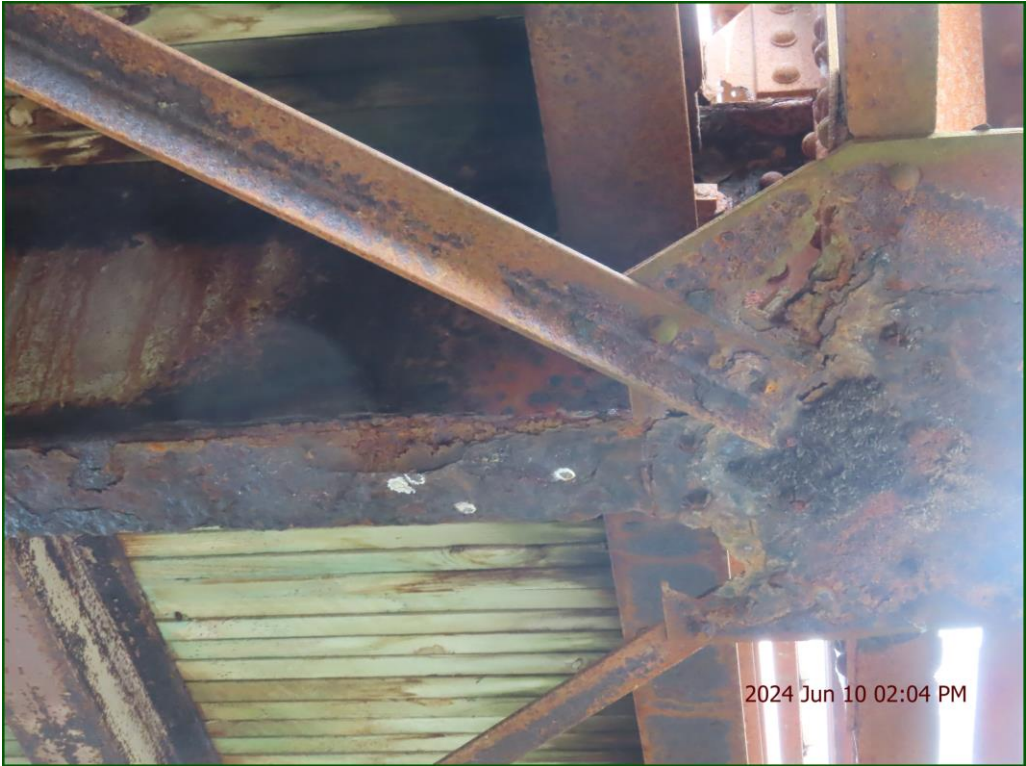
Description: Floor beams: Medium to severe corrosion at various connections to stringers (1/2).

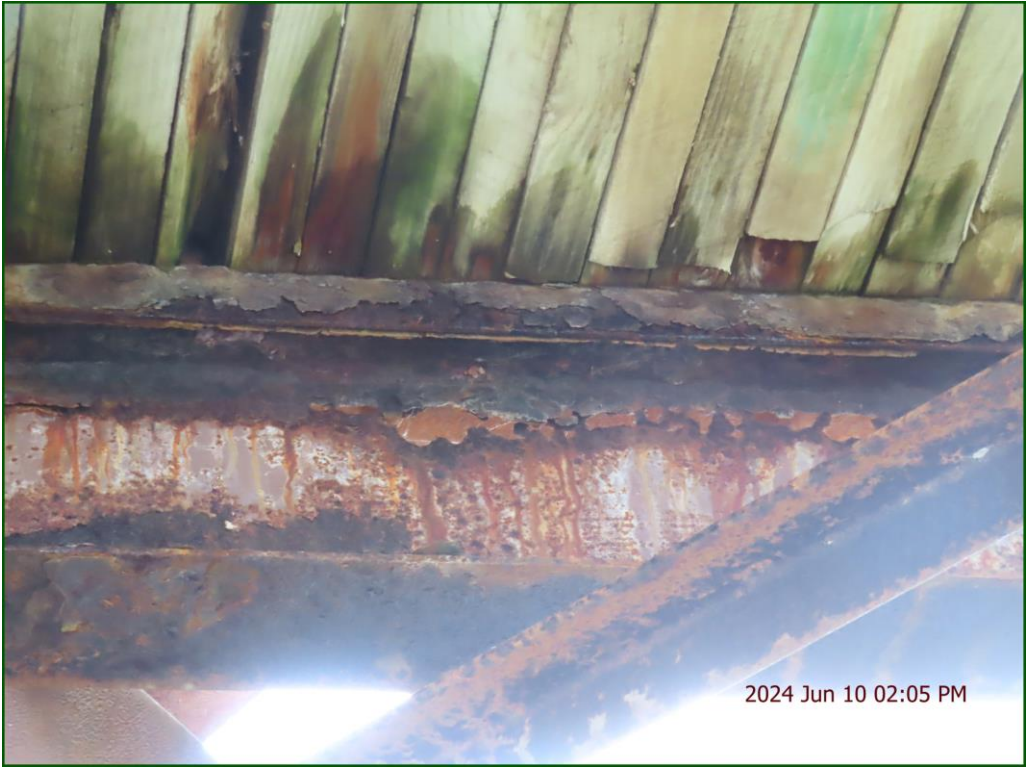
Description: Stringers: Medium to severe corrosion throughout with areas of section loss.

Medium to severe corrosion throughout with areas of section loss.

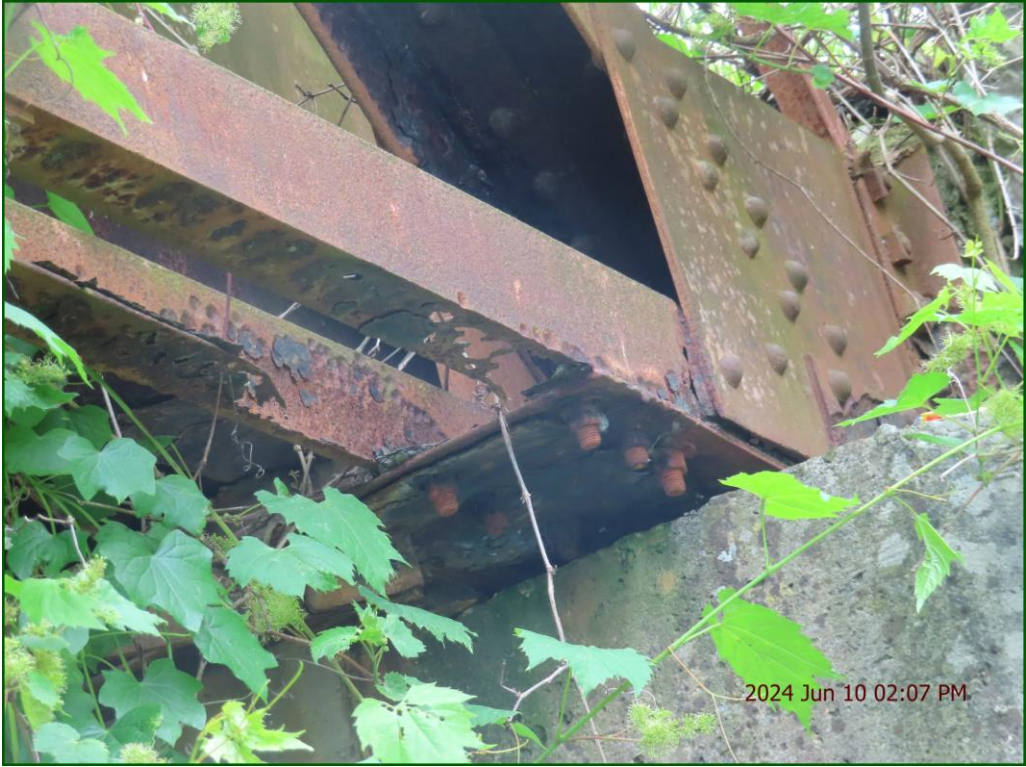
Description: Bottom chord: Severe corrosion of chords at ends and connection locations.

Severe corrosion of chords at ends and connection locations.

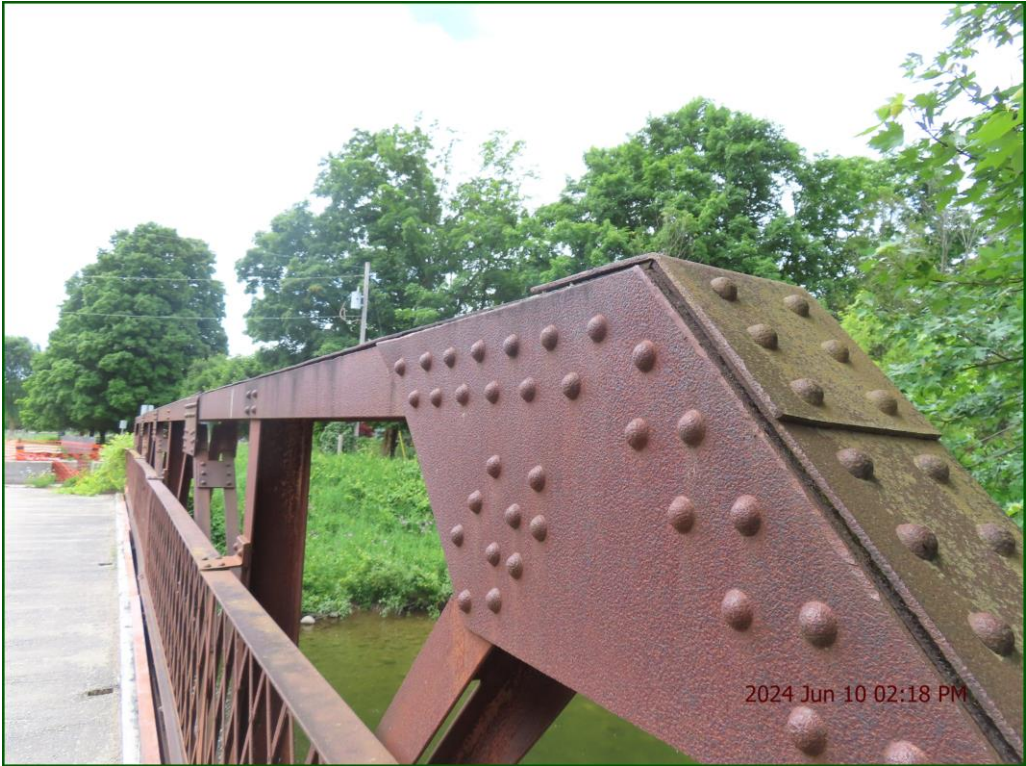
Description: Top chords: Warping in top chord due to bolts missing at one point in time.

Light corrosion throughout. Warping in top chord due to bolts missing at one point in time.

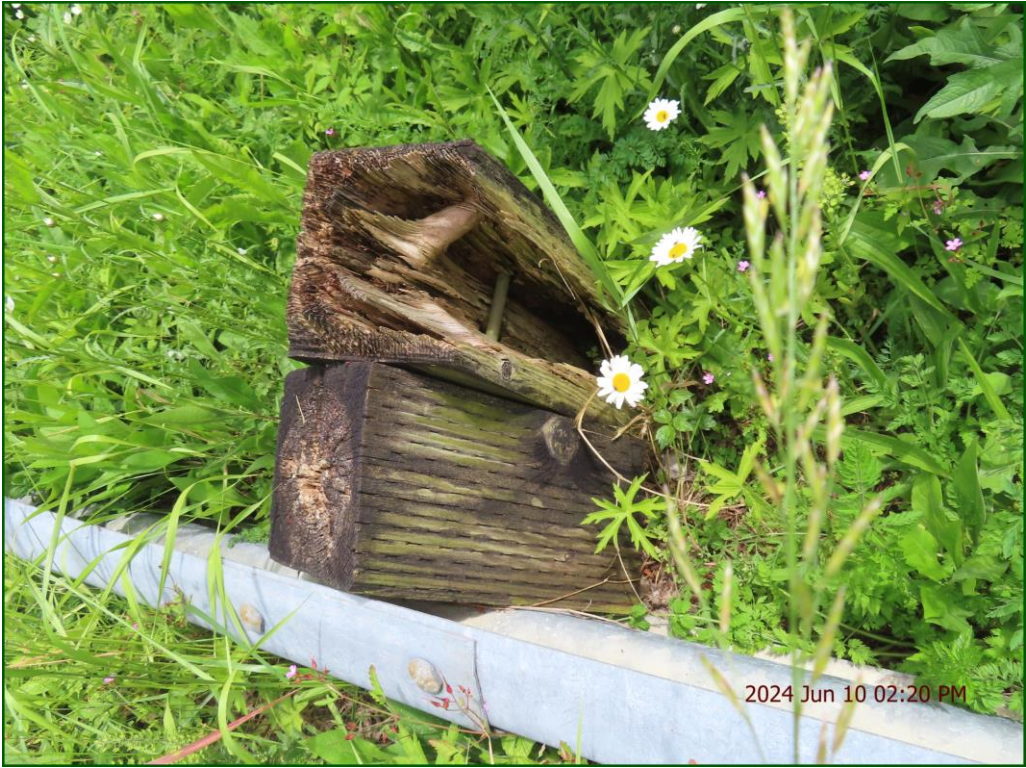
Description: Railing system: Severe rotting throughout.

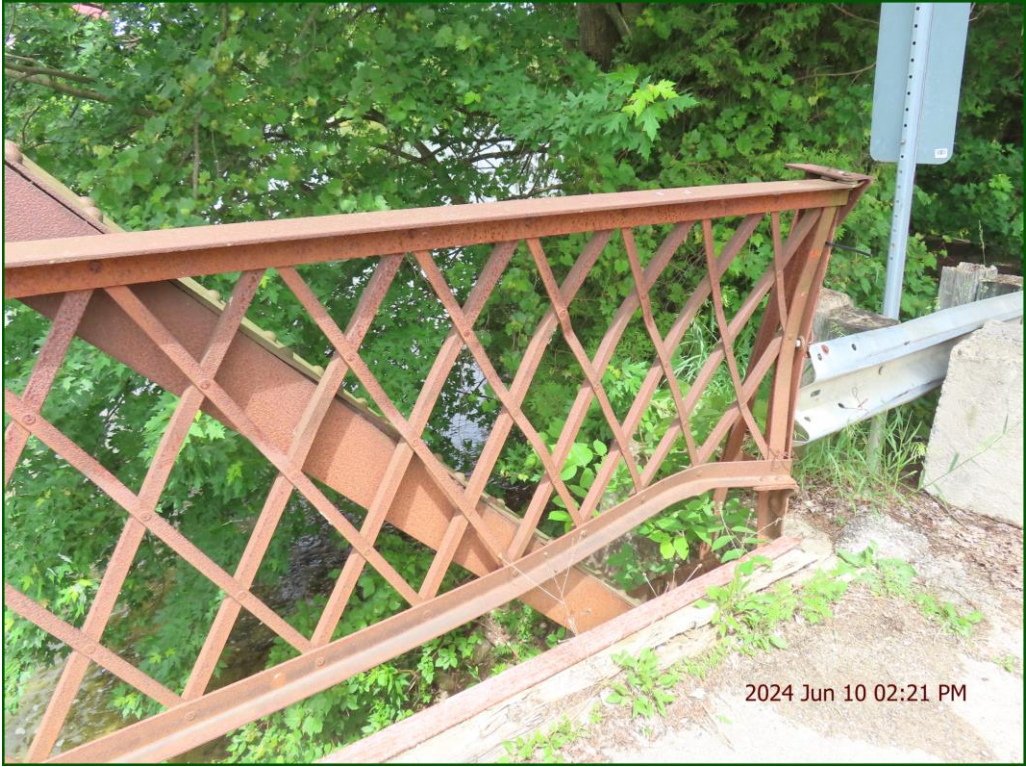
Description: Railing system: Severe impact damage throughout.

Severe impact damage throughout.

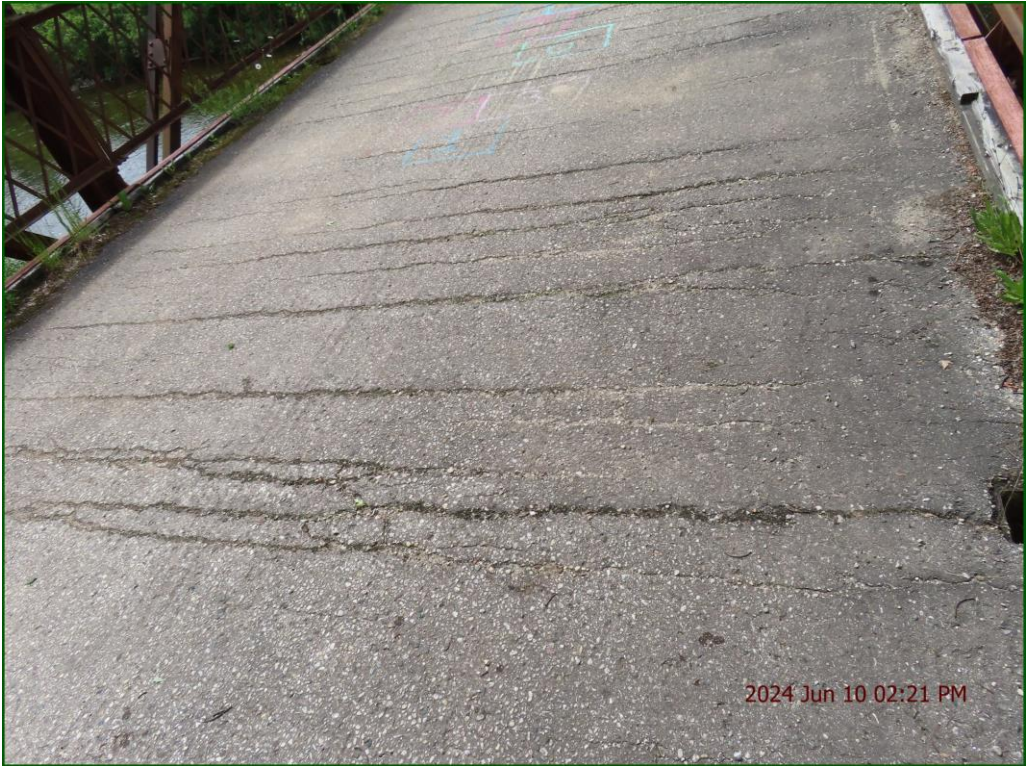
Description: Wearing surface: Wide transverse cracking throughout.

Wide transverse cracking throughout.

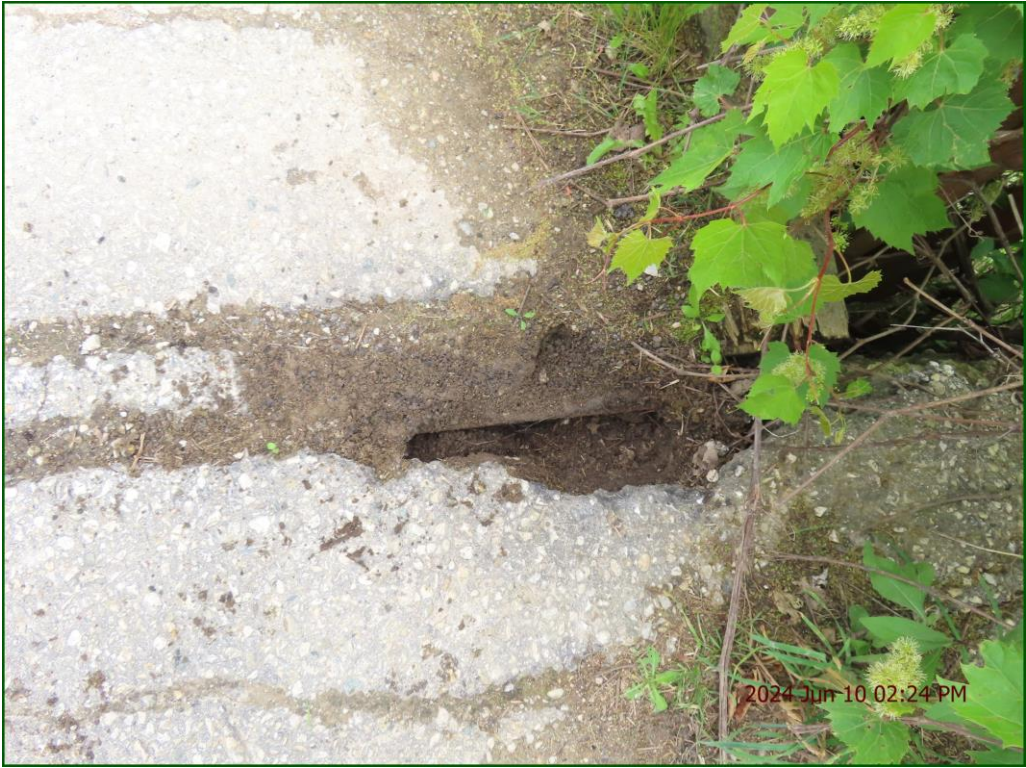
Description: Seals: Areas of joint failure at corner resulting in erosion of bridge.

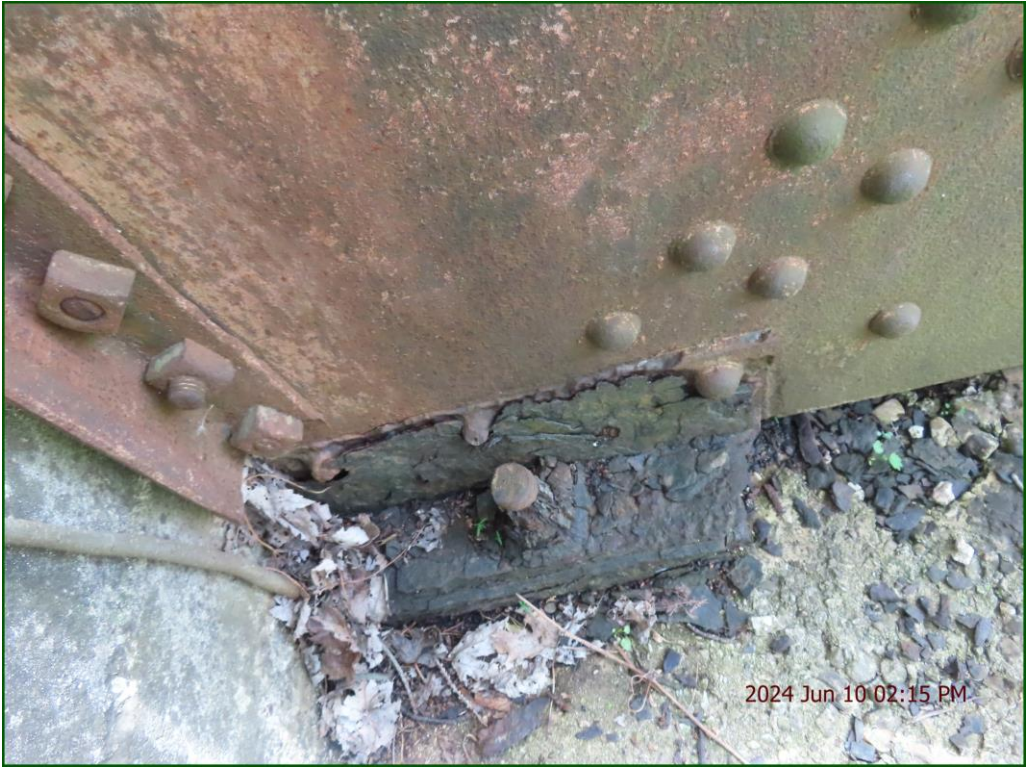
Description: Bearings: Severe corrosion.

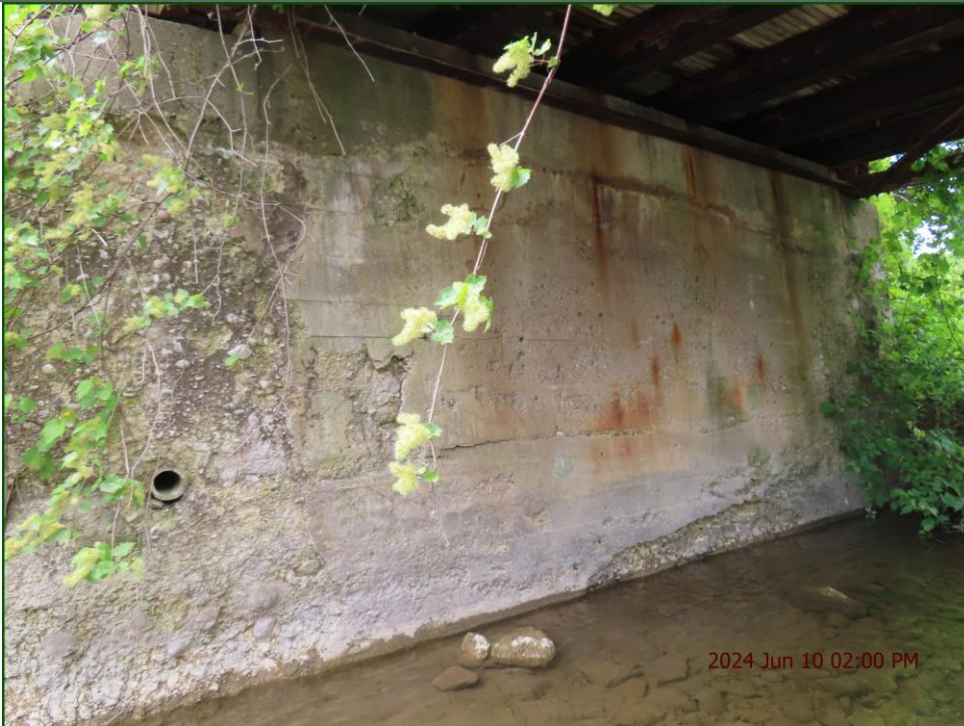
Severe spalling with disintegration throughout.

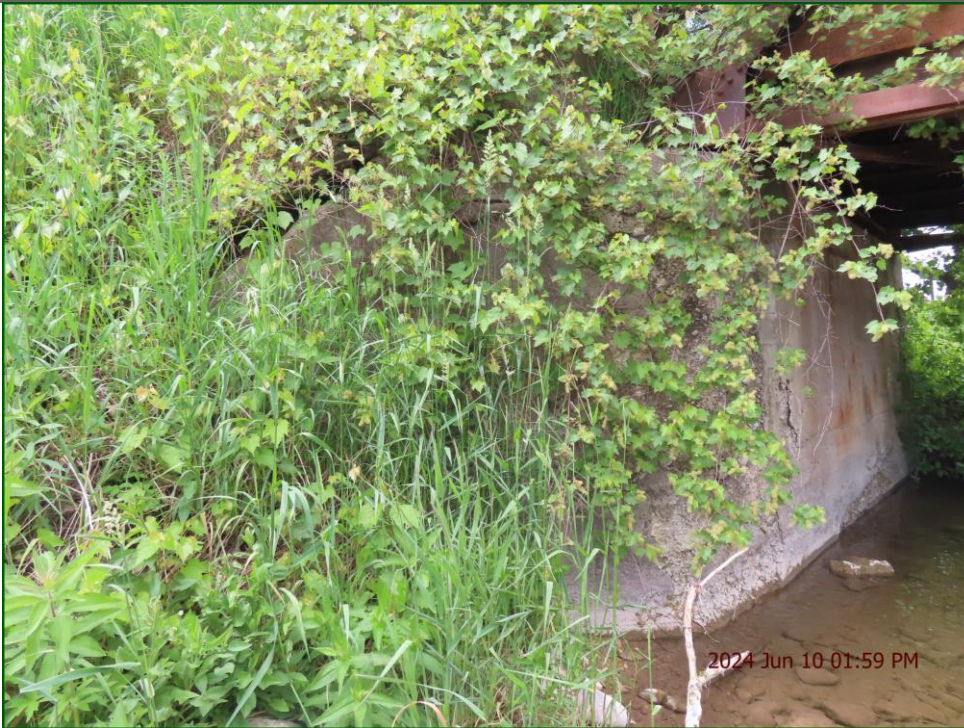
Severe spalling with disintegration throughout.

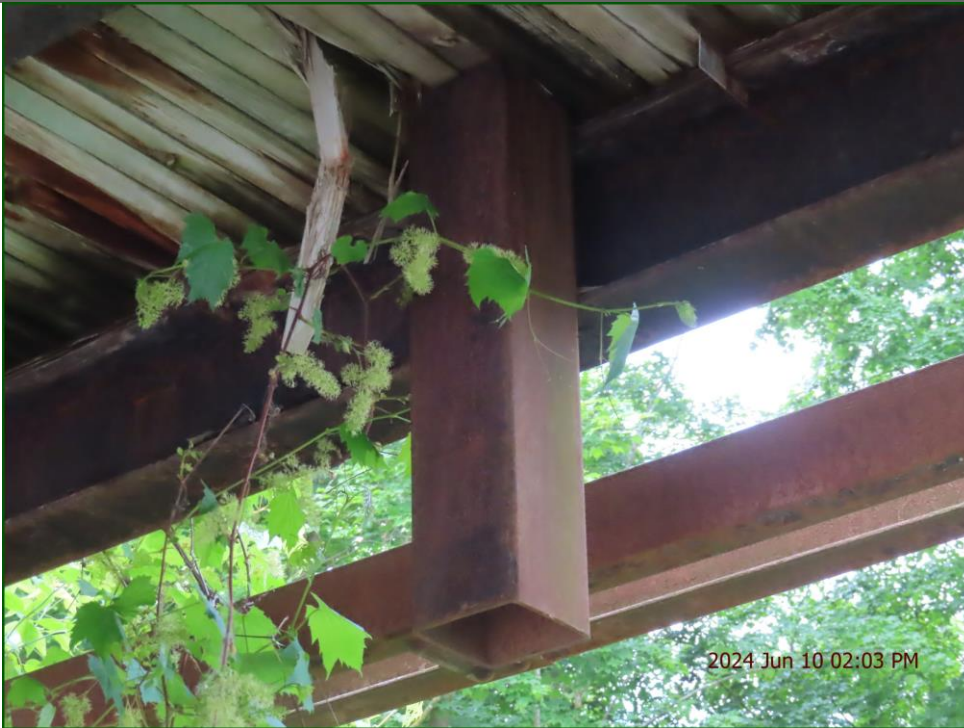
Light corrosion throughout.

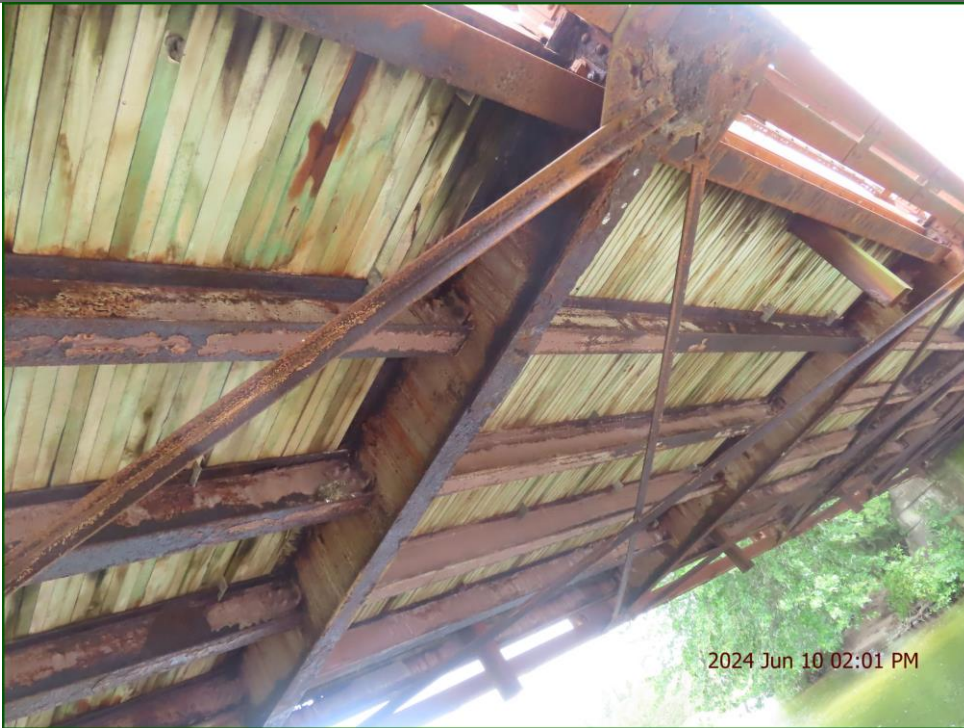
Light rotting throughout. Areas of localized severe rot.

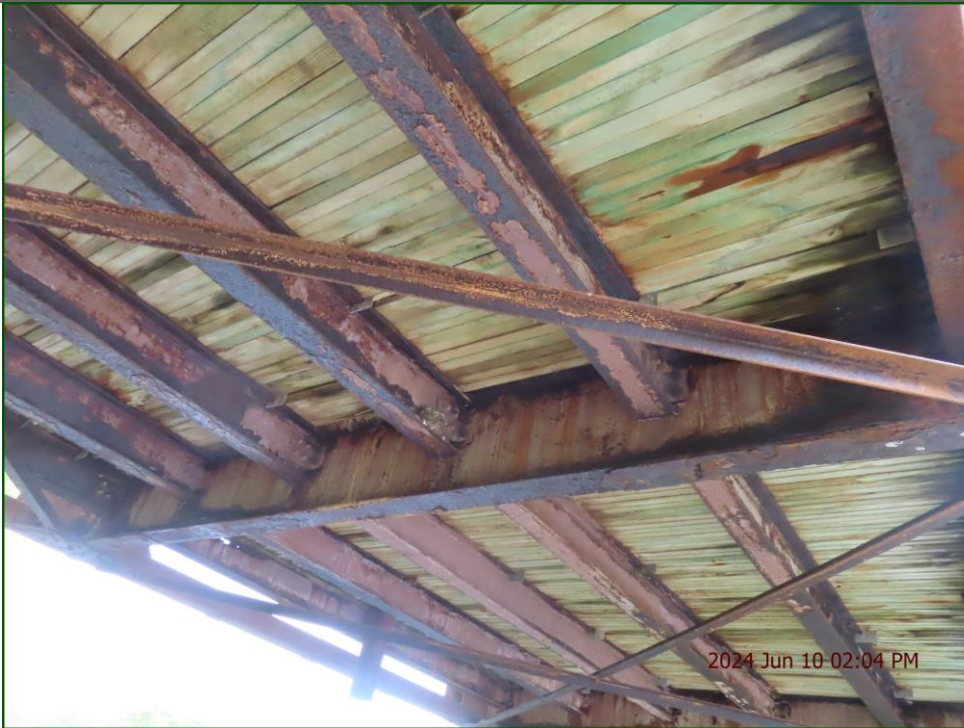
Medium to severe corrosion at various connections to stringers with areas of perforations.

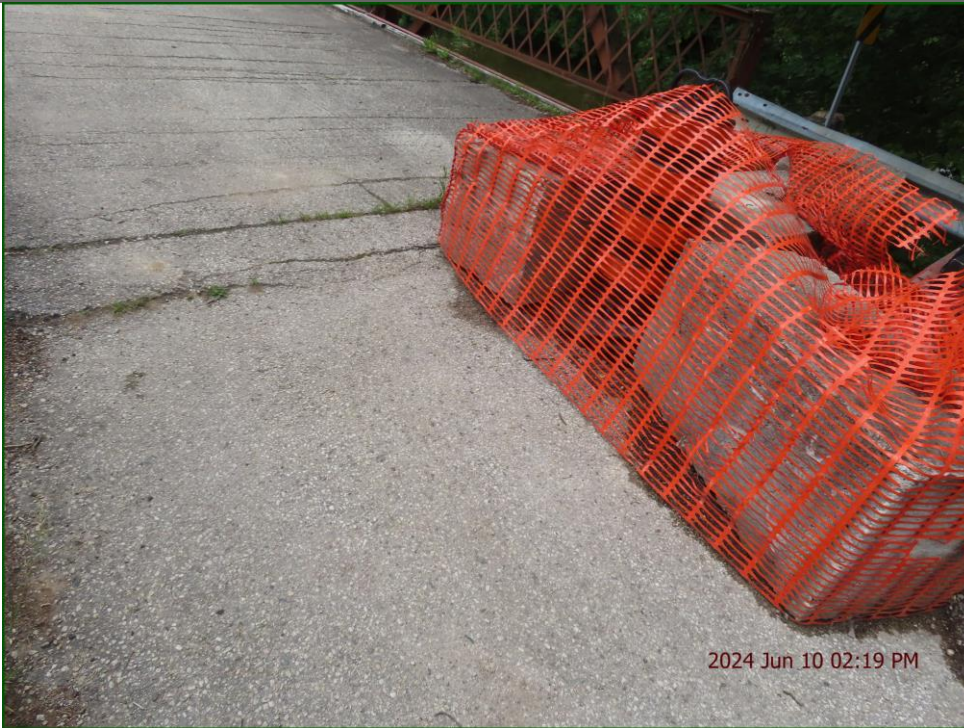
Wide cracking along joints.

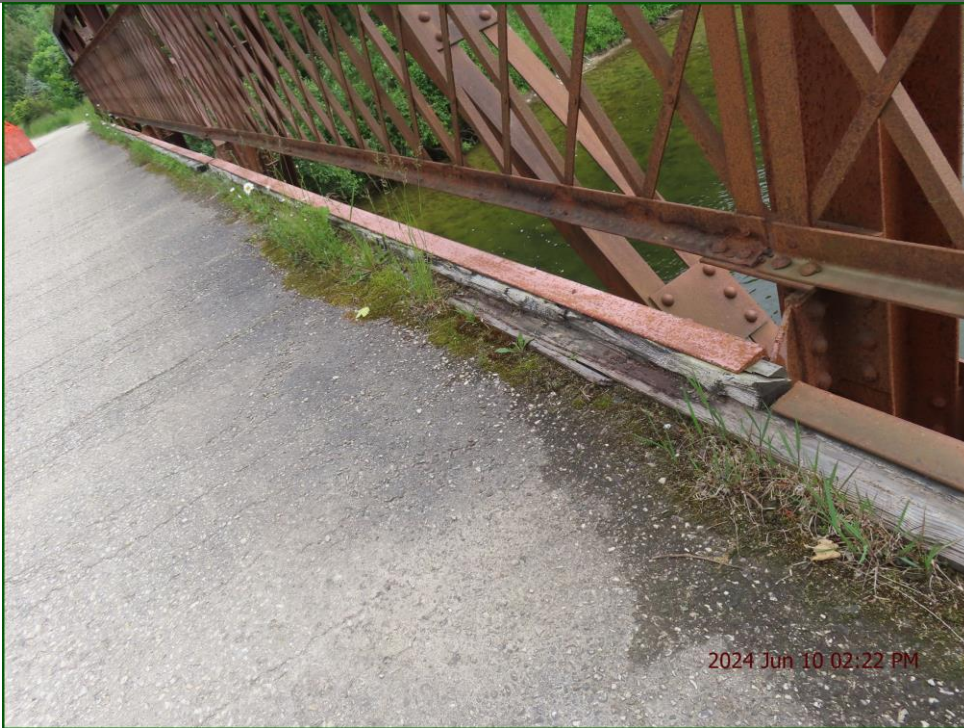
Moderate to severe rotting throughout.

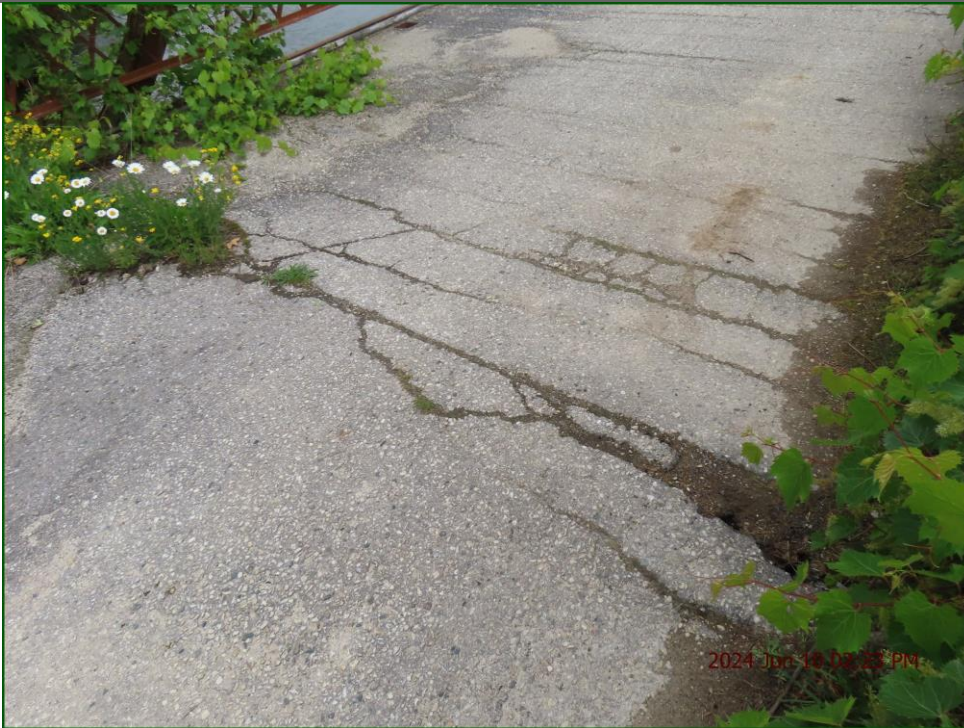
Areas of joint failure at corner resulting in erosion of bridge.
