MUNICIPALITY OF
West Grey

Municipality of West Grey
Bridge Prioritization Program

February 2025

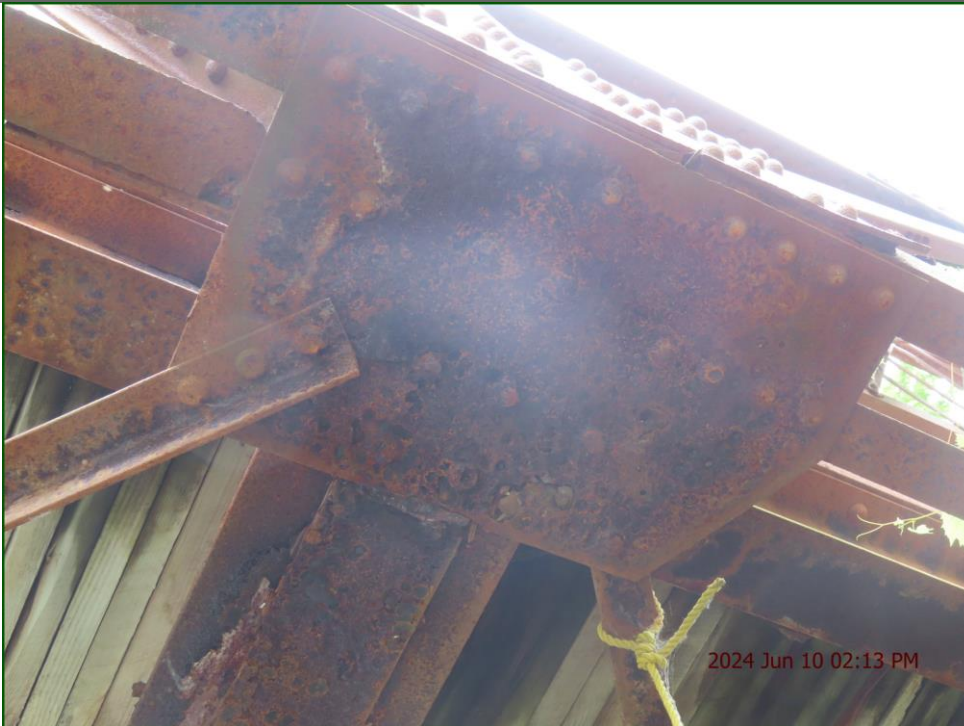
Severe corrosion with areas of 100% section loss.

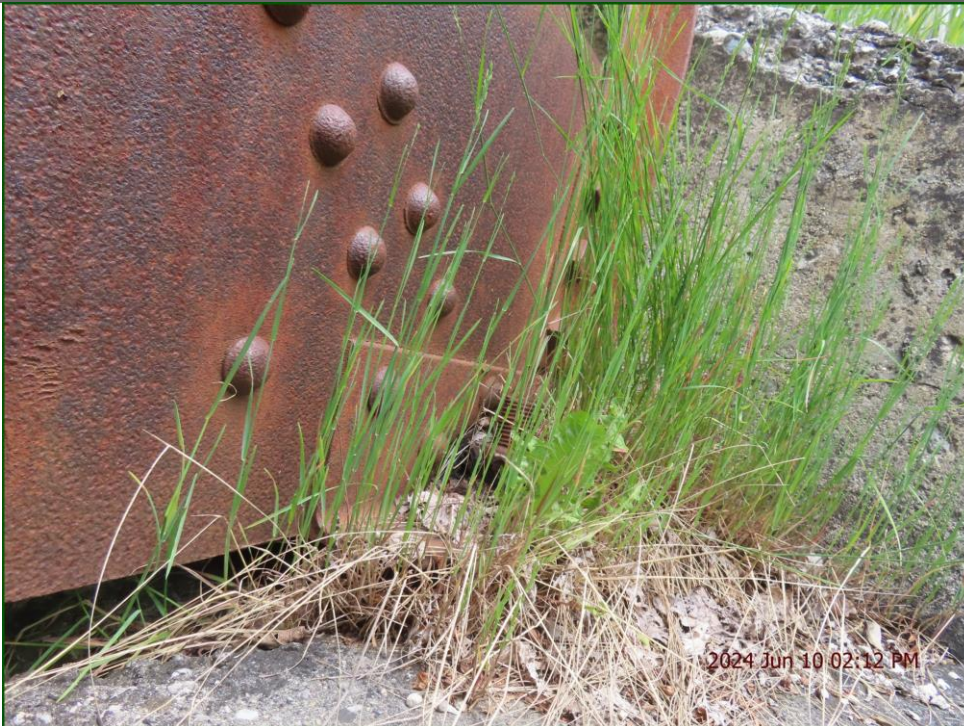
Limited inspection of west bearings. Severe corrosion.

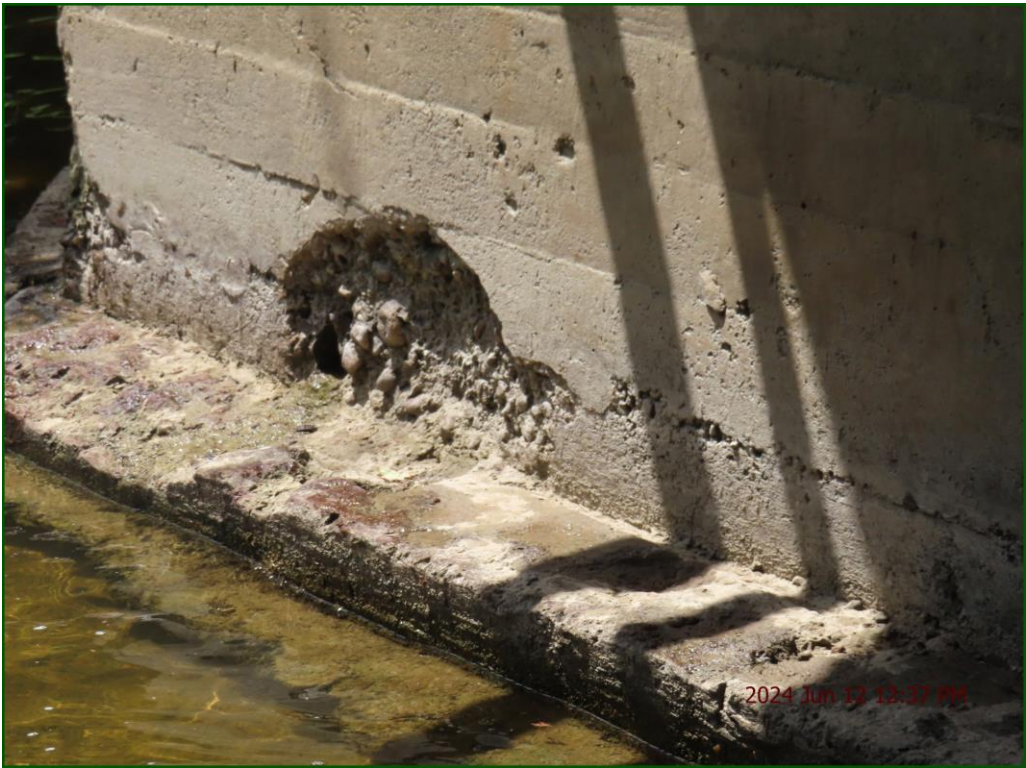
Description: Wingwalls: Light to medium map cracking with leachate staining.

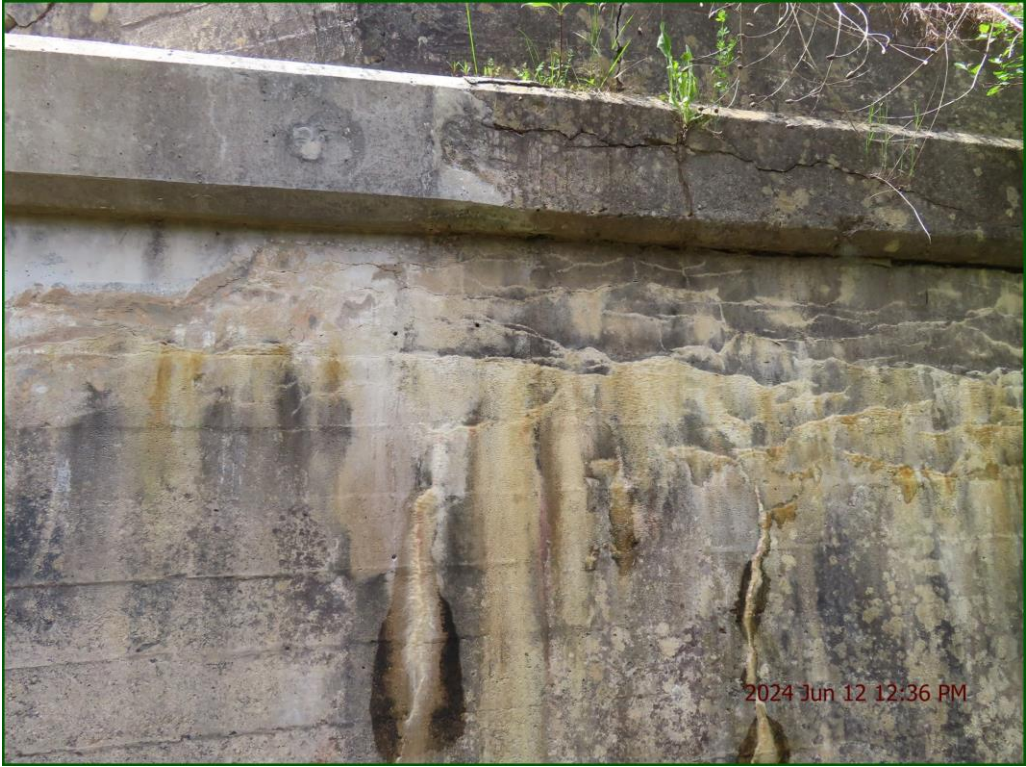
Description: Wingwalls: Severe spalling and disintegration at SW quadrant.

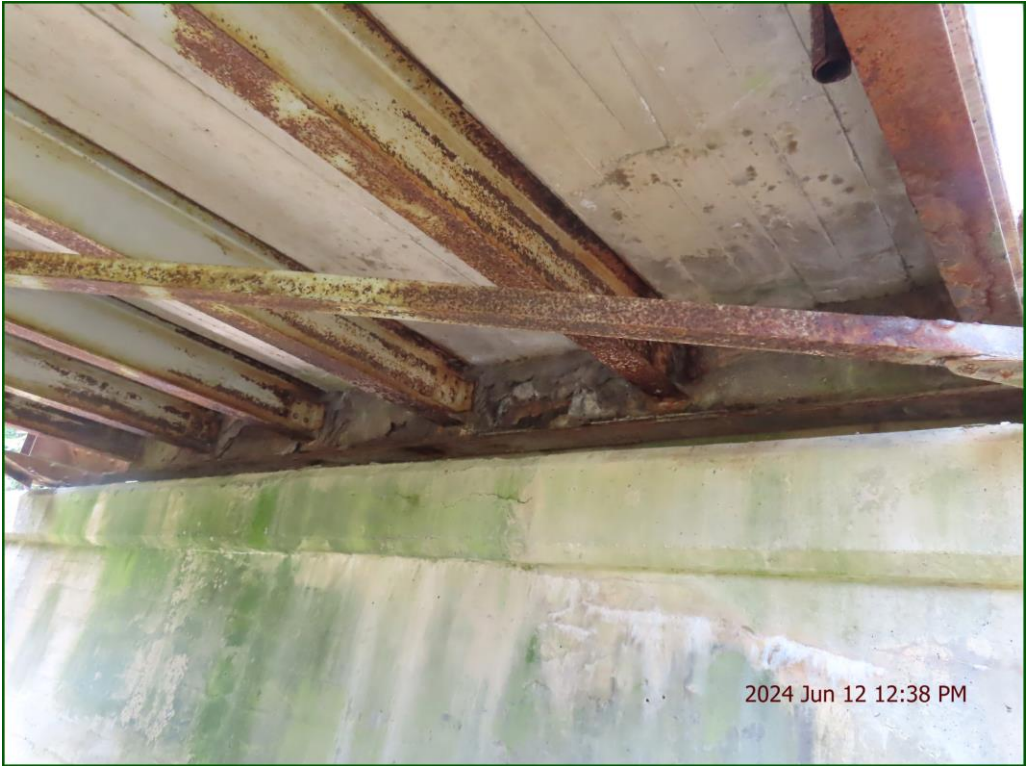
Description: Floor beams: Medium to severe corrosion of beams below joints (2/2).

Medium to severe corrosion of beams below joints. Recommend replace end floor beams.

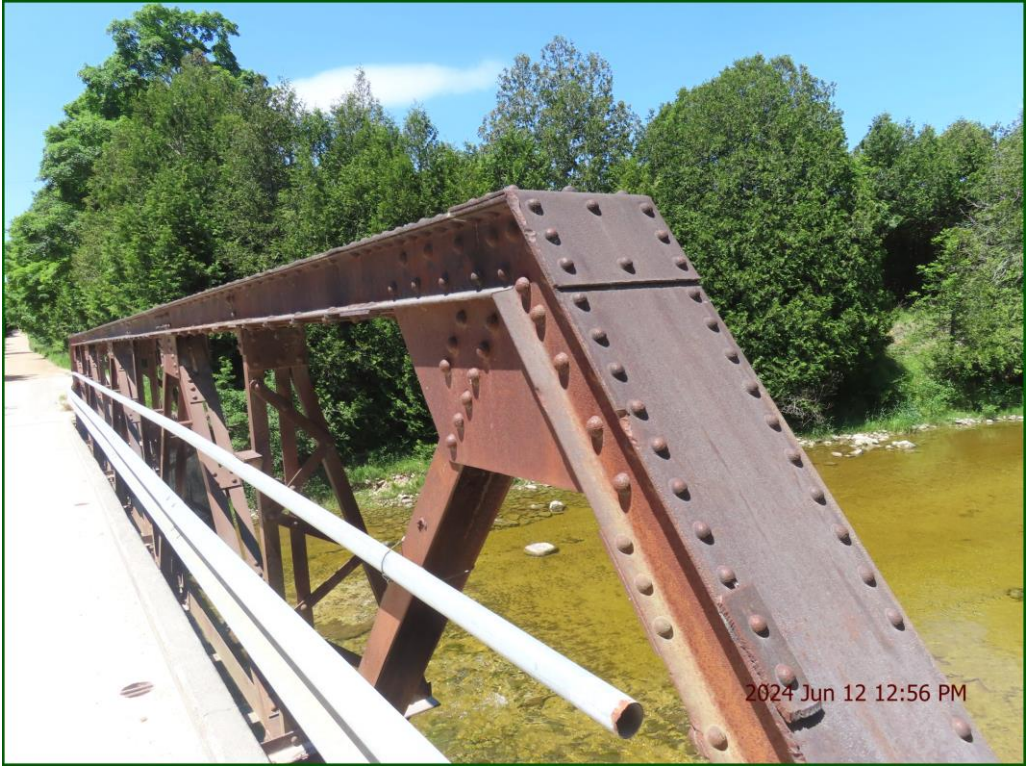
Description: Bottom chord: Medium to severe corrosion at NW with areas of 100% section loss.

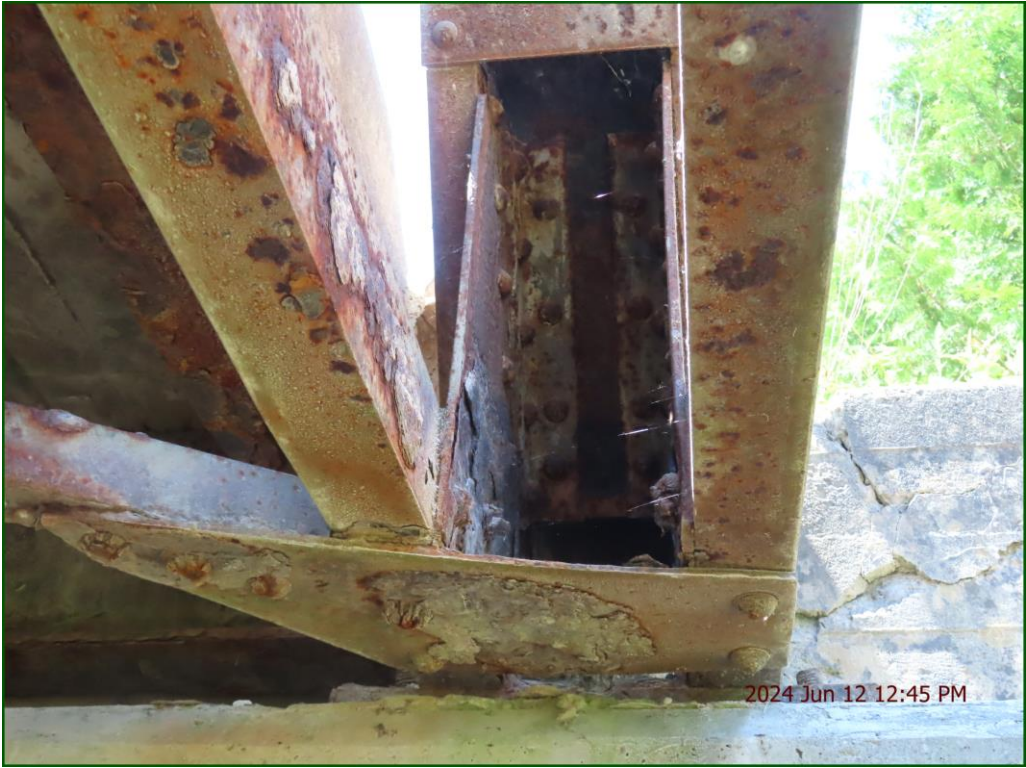
Description: Verticals/diagonals: Areas of severe corrosion with perforation.

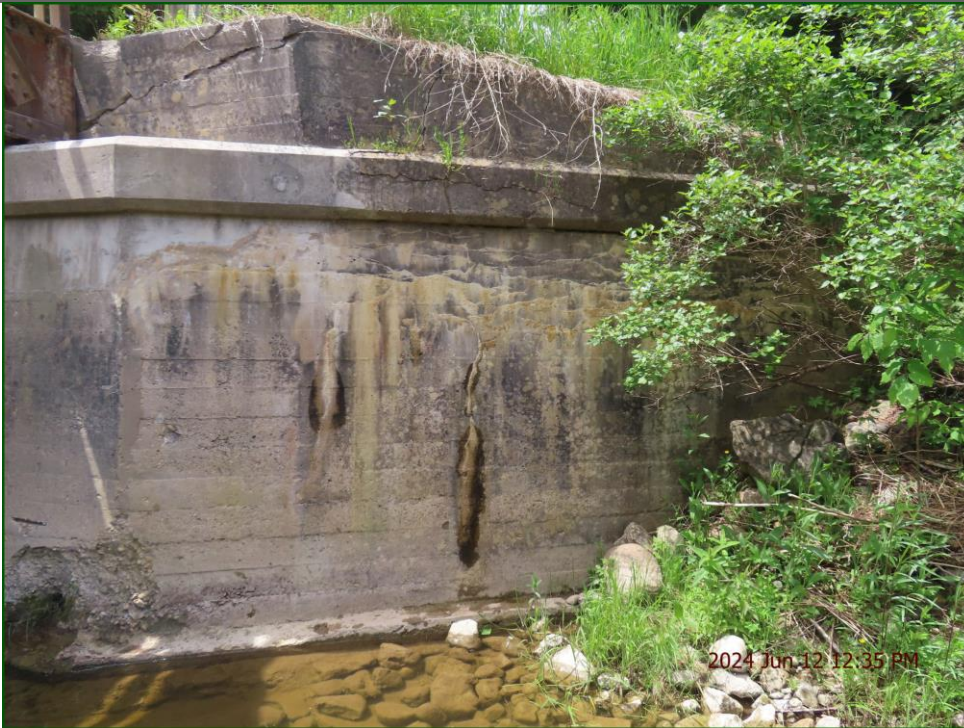
Light to medium map cracking with leachate staining. Severe spalling and disintegration at SW quadrant.

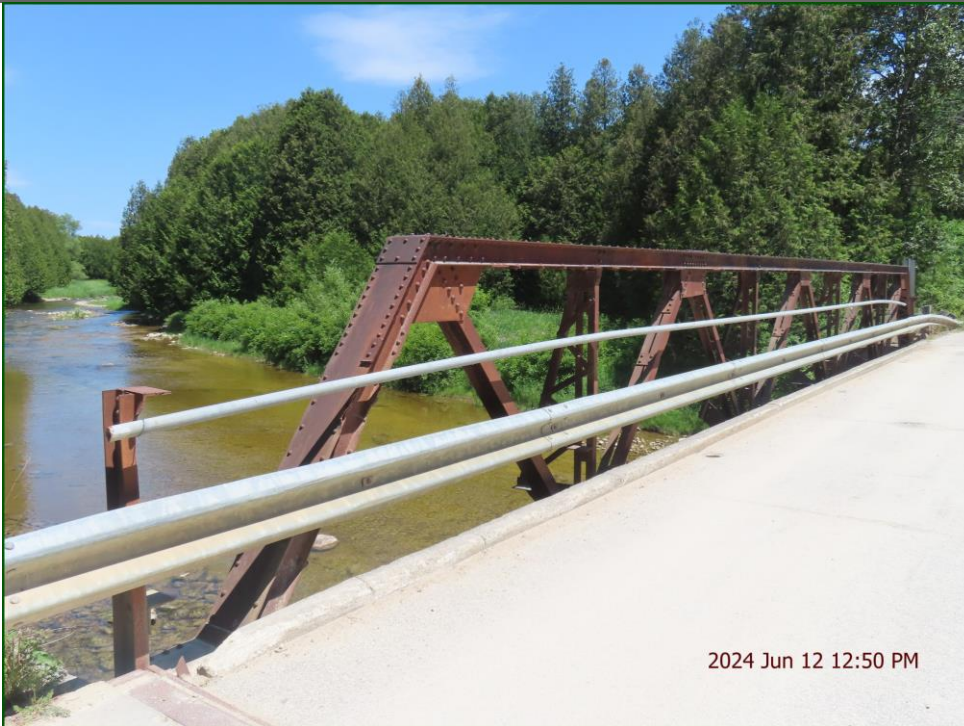
Description: Hand railings: Severe impact damage and missing hand railing on south side.

Severe impact damage and missing hand railing on south side.

Element Group:	Barriers	Site Number:	G-040
Element Name:	Hand railings	Width:	0 m
Element type:		Height:	0 m
Sub-element:		Length:	16.6 m
Material:	Steel	Count:	2
Location:		Total Quantity:	33 m
Environment:	Severe	Not inspected:	<input type="checkbox"/>
Perform. deficiencies:		Maintenance Type:	Structural
Maint needs:	Hand rail repairs	Maint. Time Period:	2 Year

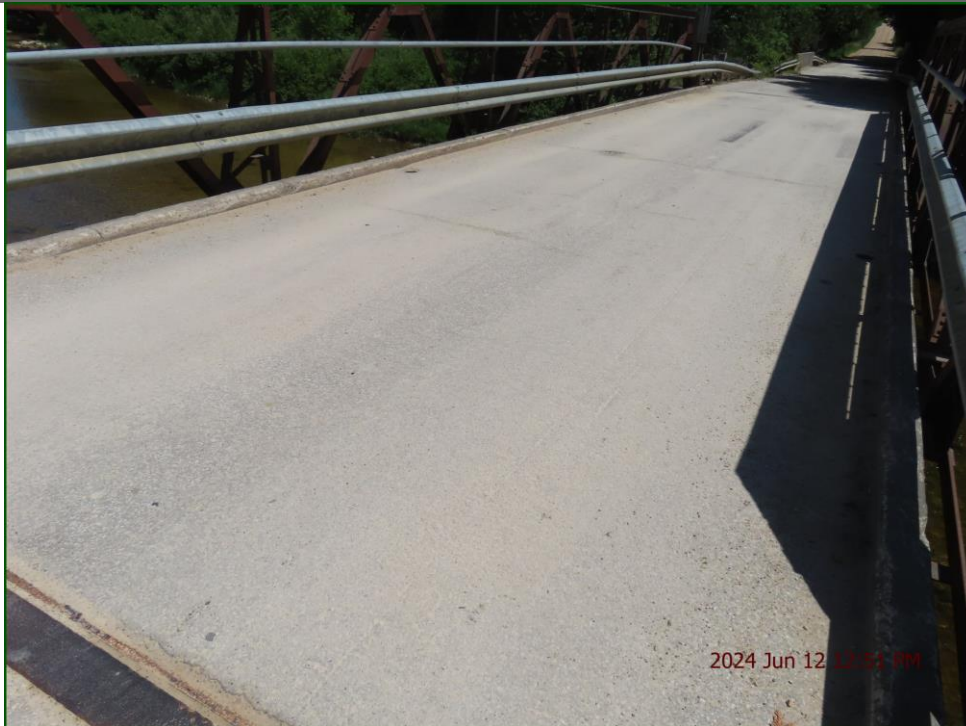
Shallow potholes throughout. Moderate pothole at midspan appear to be cold patched. Light to medium transverse cracks.

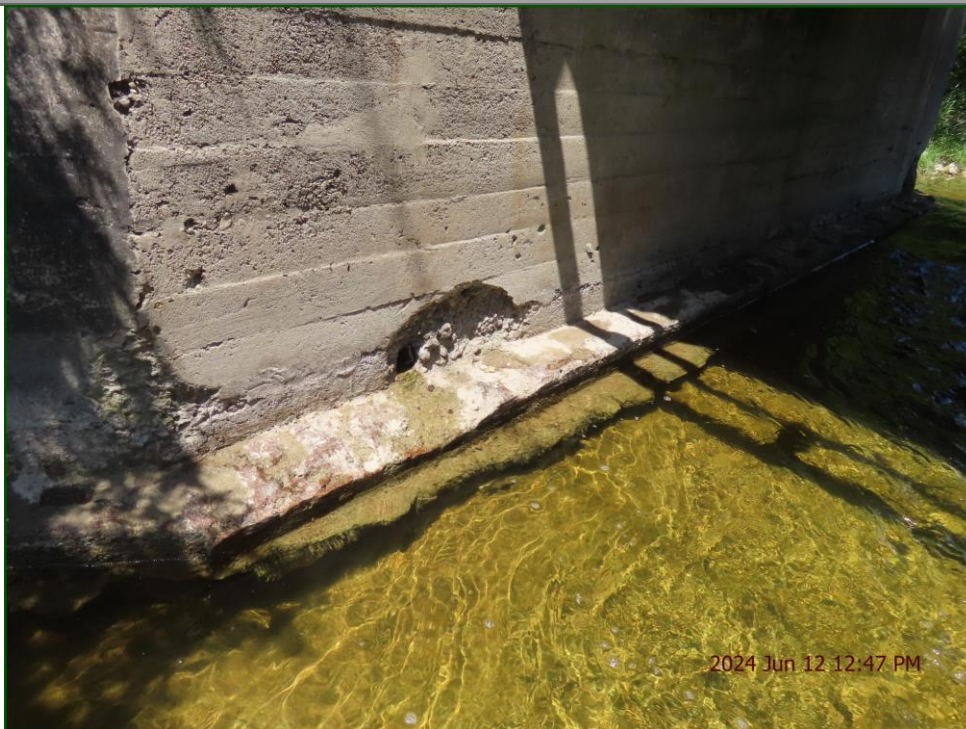
Minor scouring throughout.

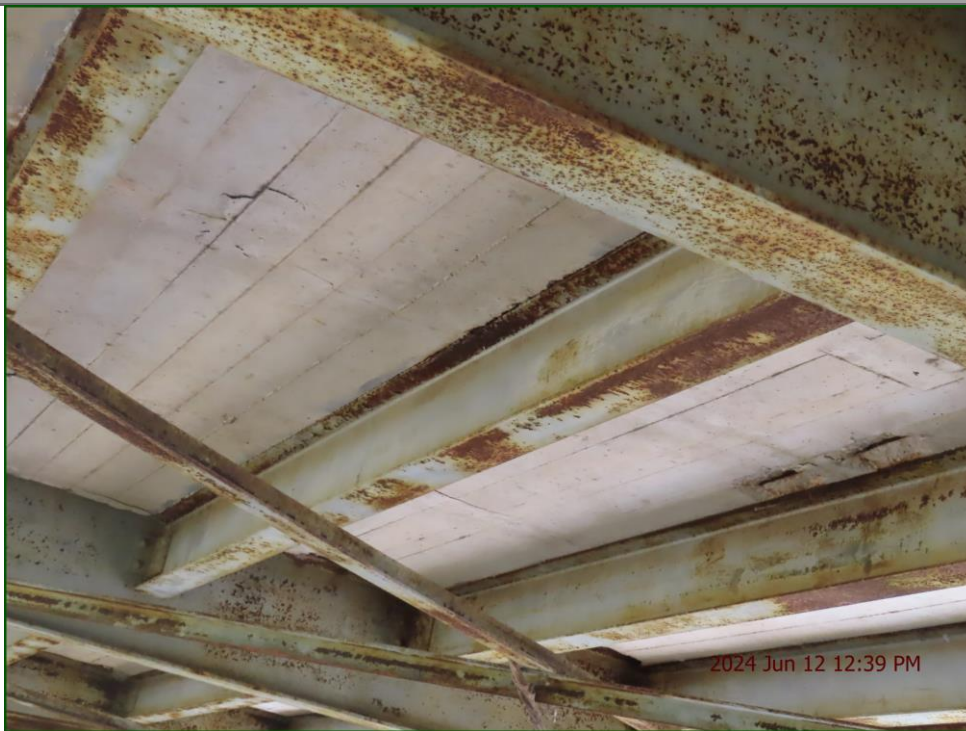
Description: Stringers: Medium corrosion below joints.

Light corrosion throughout. Medium corrosion below joints.

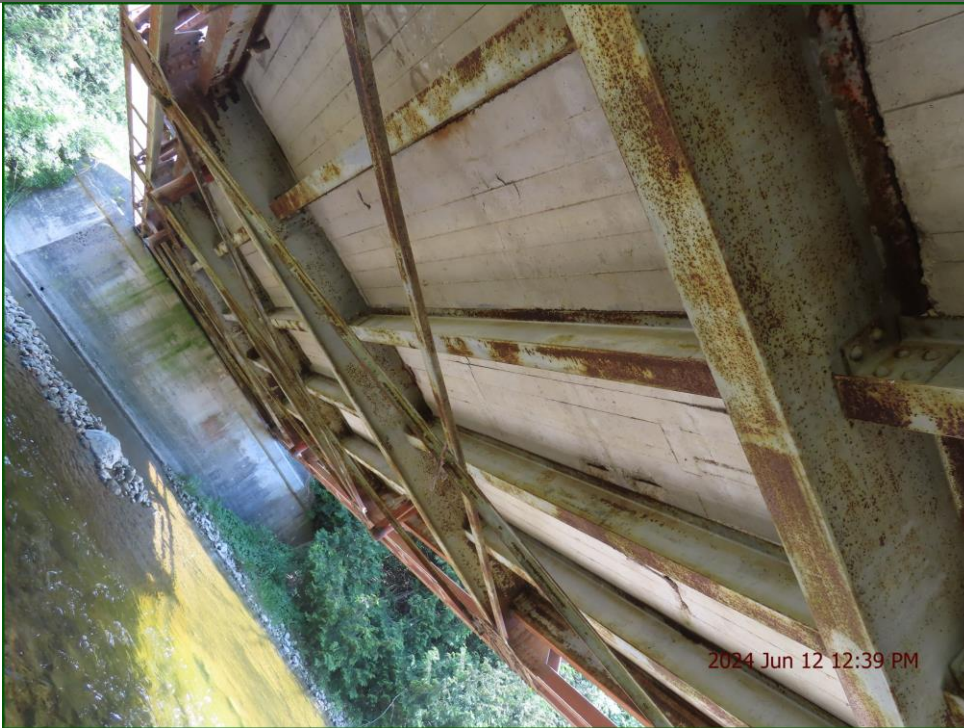
Description: Soffit: Light to medium transverse cracking throughout.

Light to medium transverse cracking throughout. Medium to severe delamination with exposed reinforcing throughout.

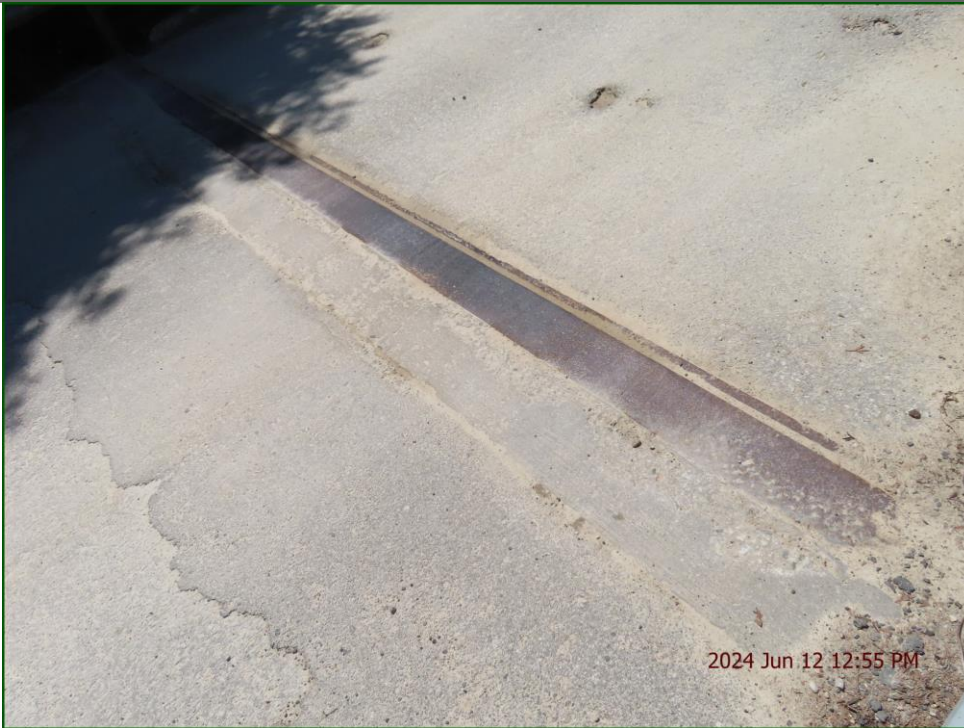
Open joint causing advancing floor beam deterioration.

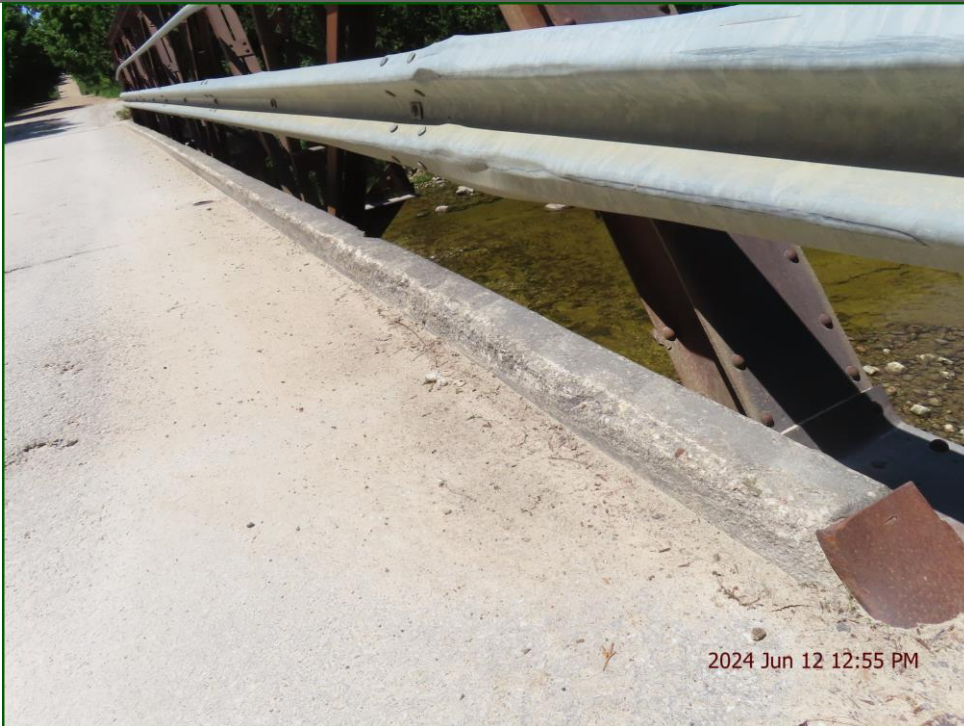
Description: Curbs: Light to medium horizontal and vertical cracking throughout.

Light to medium horizontal and vertical cracking throughout.

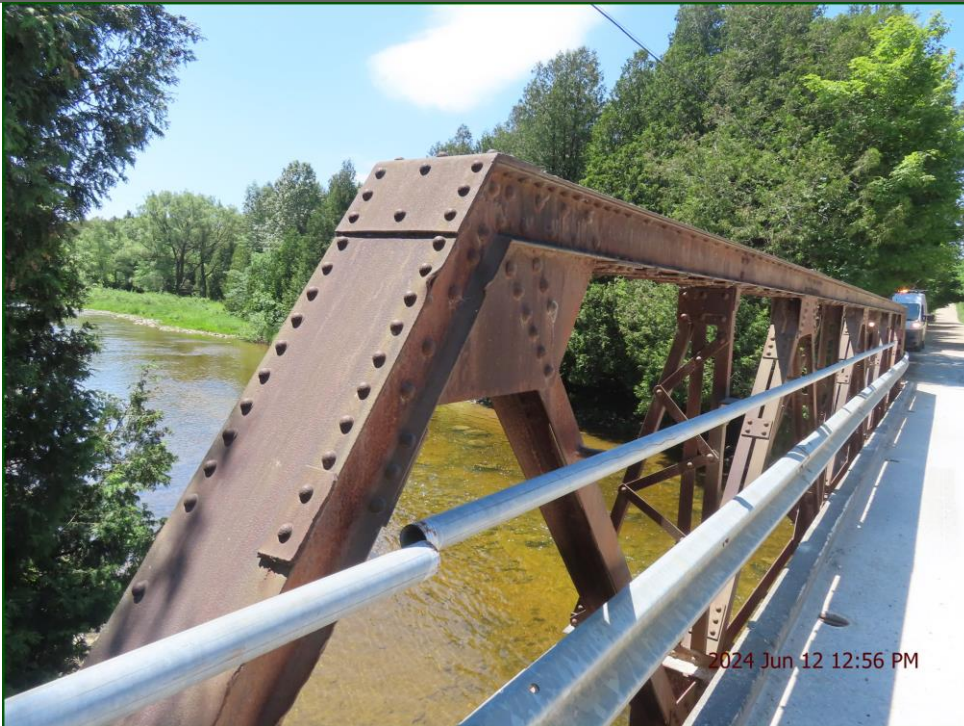
Description: Top chords: Minor impact damage throughout.

Minor impact damage throughout. Light corrosion throughout.

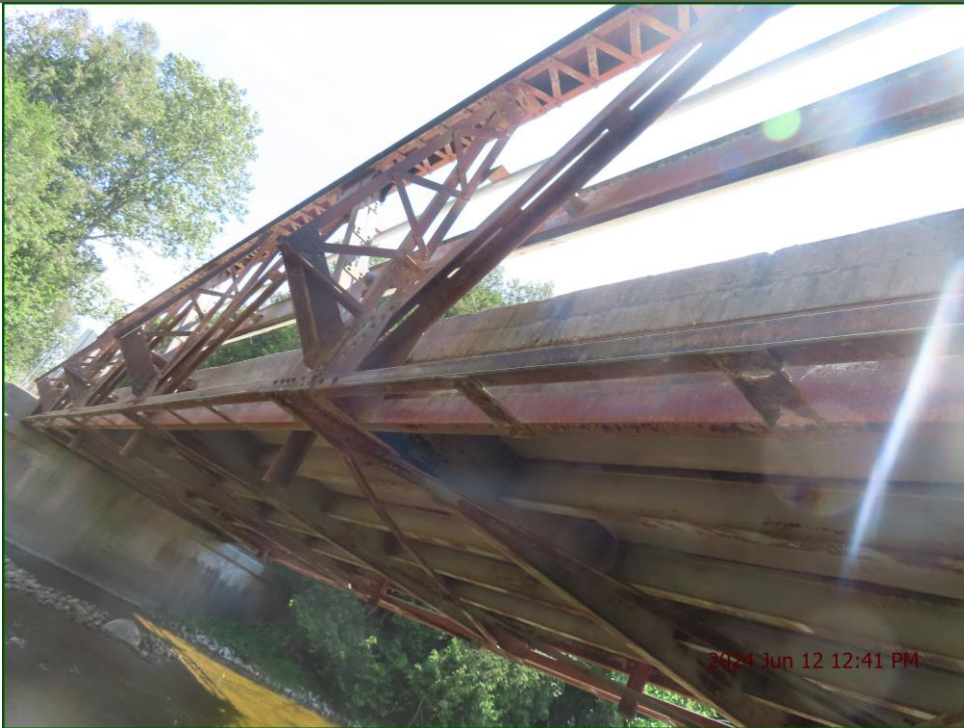
Light corrosion throughout. Medium corrosion at NW with areas of 100% section loss.

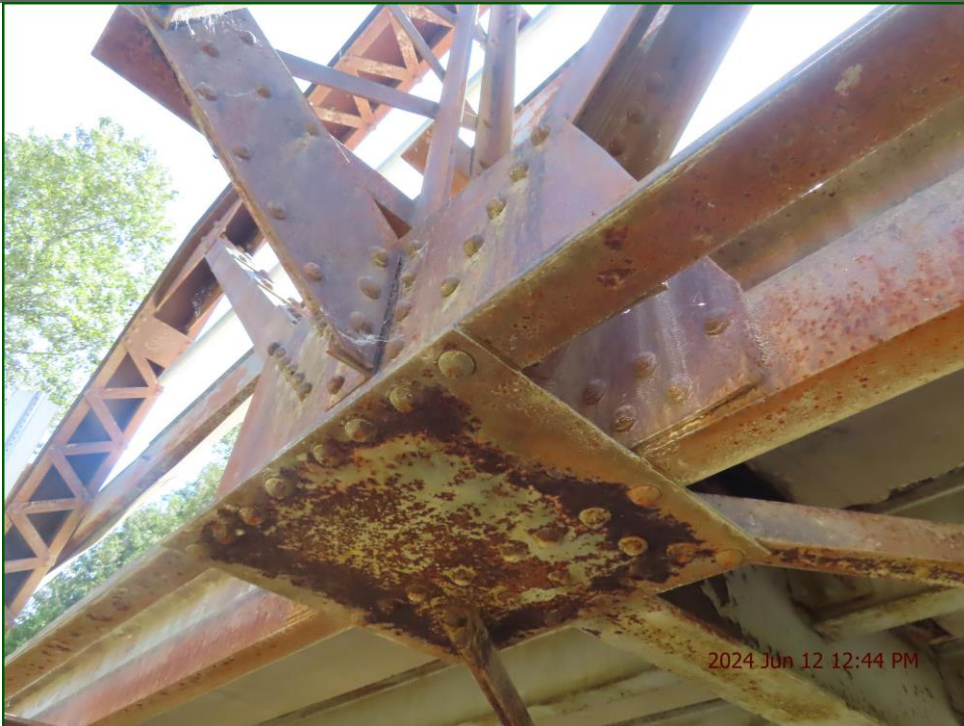
Description: Connections: Medium corrosion at various connections.

Light corrosion throughout. Medium corrosion at various connections.

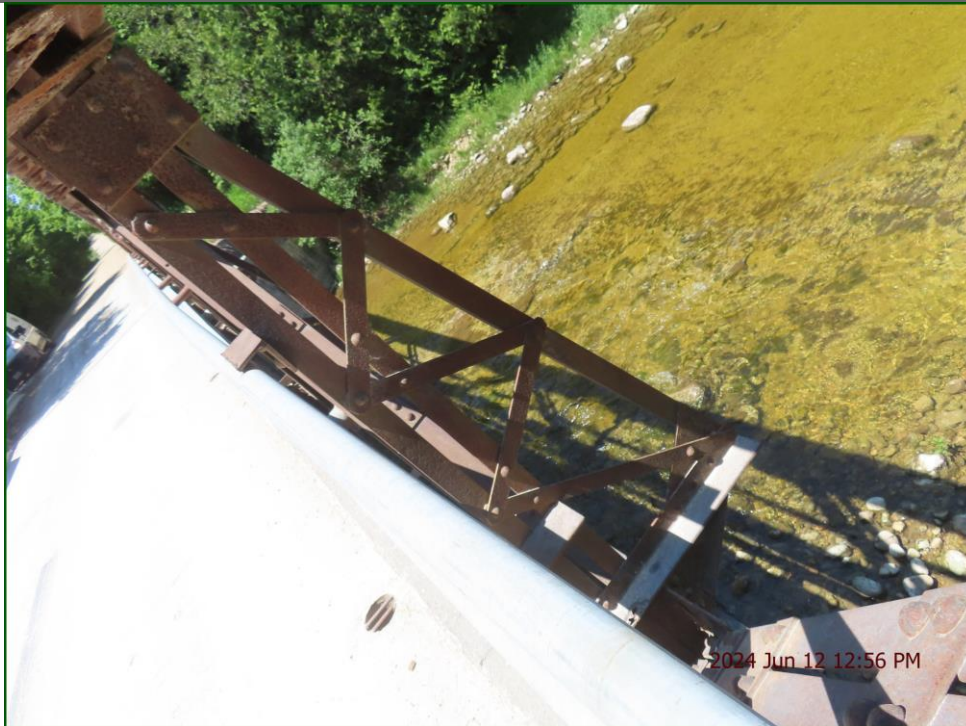
Light corrosion throughout. Areas of severe corrosion with perforation.

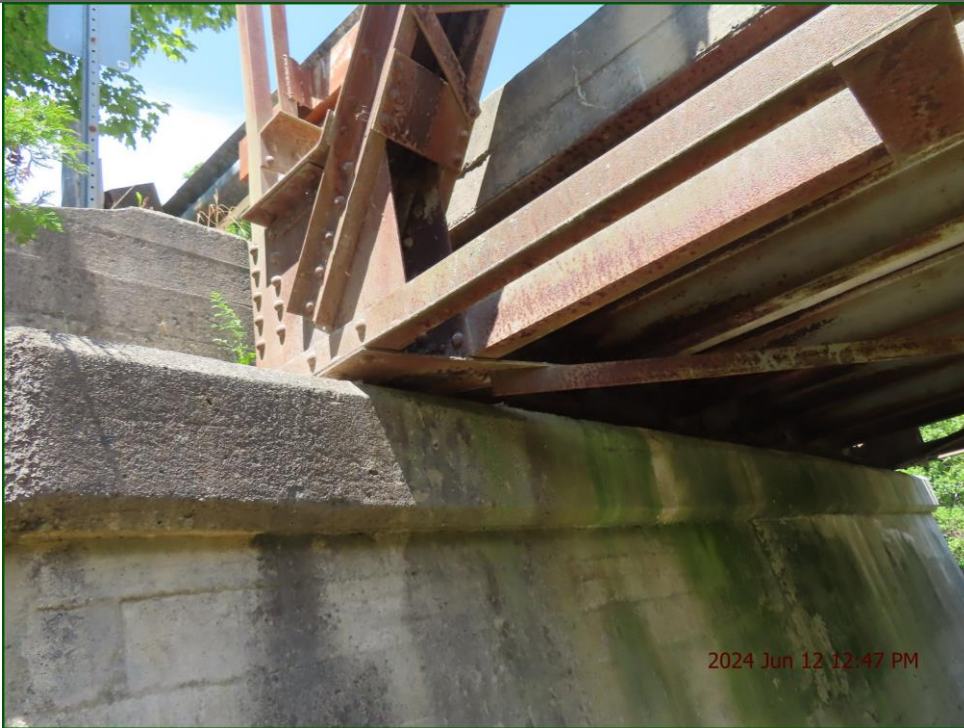
Limited inspection due to floor beams.

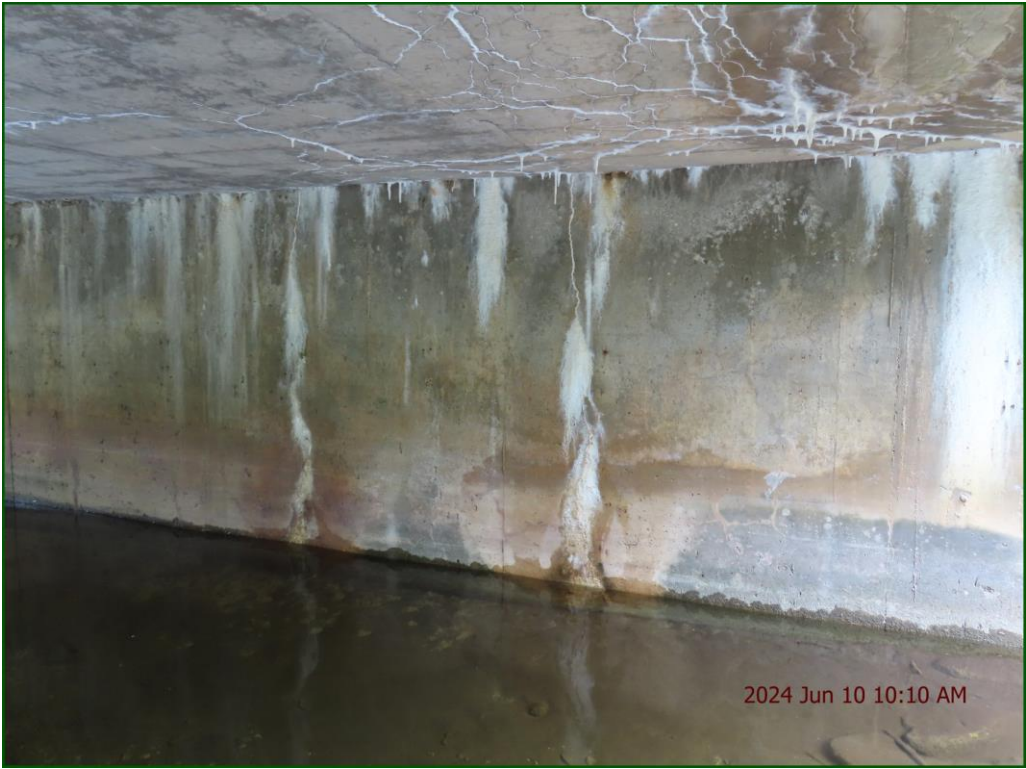
Description: Abutment Walls: Medium to wide vertical cracks with leachate staining.

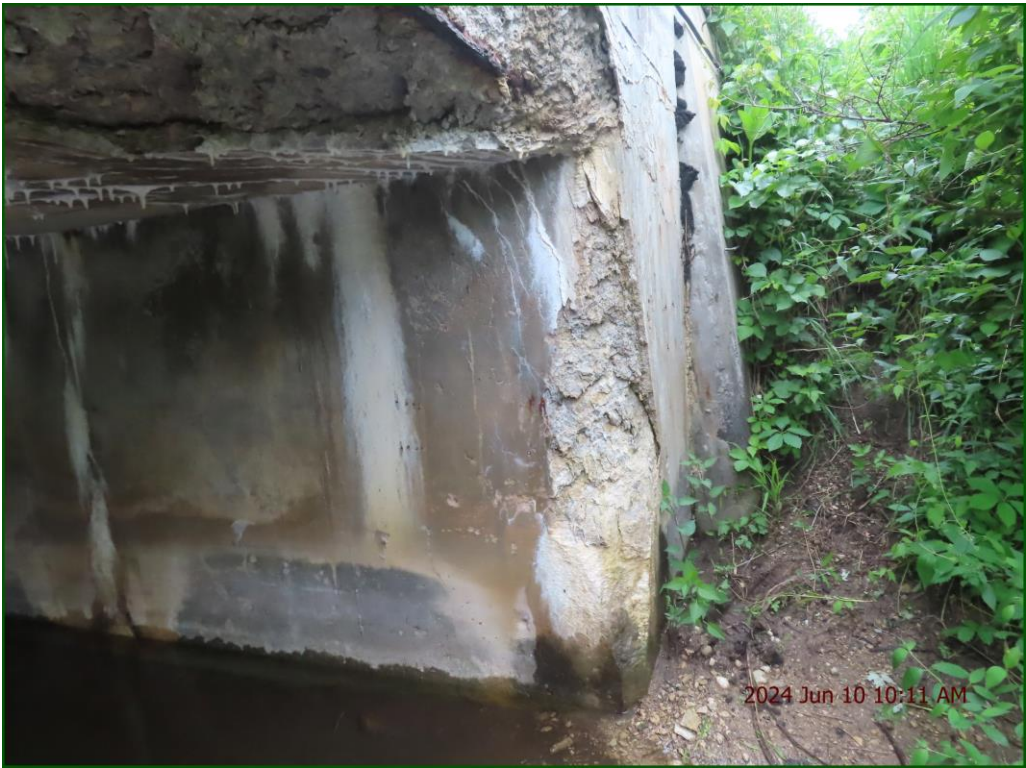
Description: Abutment Walls: Severe spalling on corners.

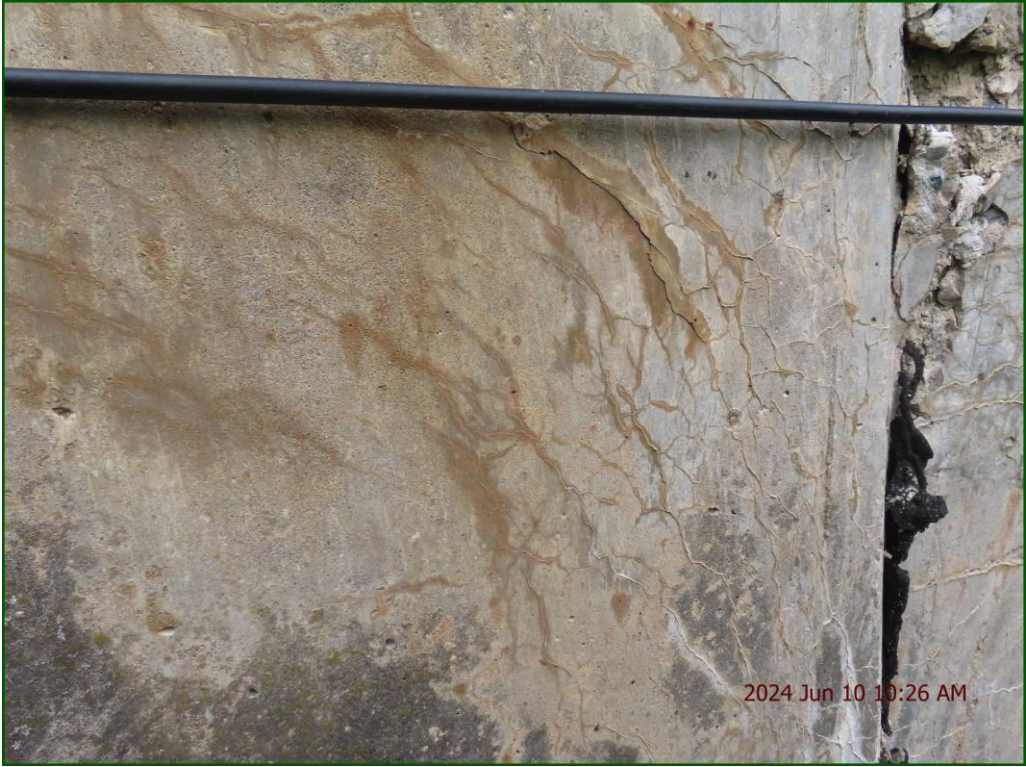
Description: Wingwalls: Light to medium cracking with leachate staining.

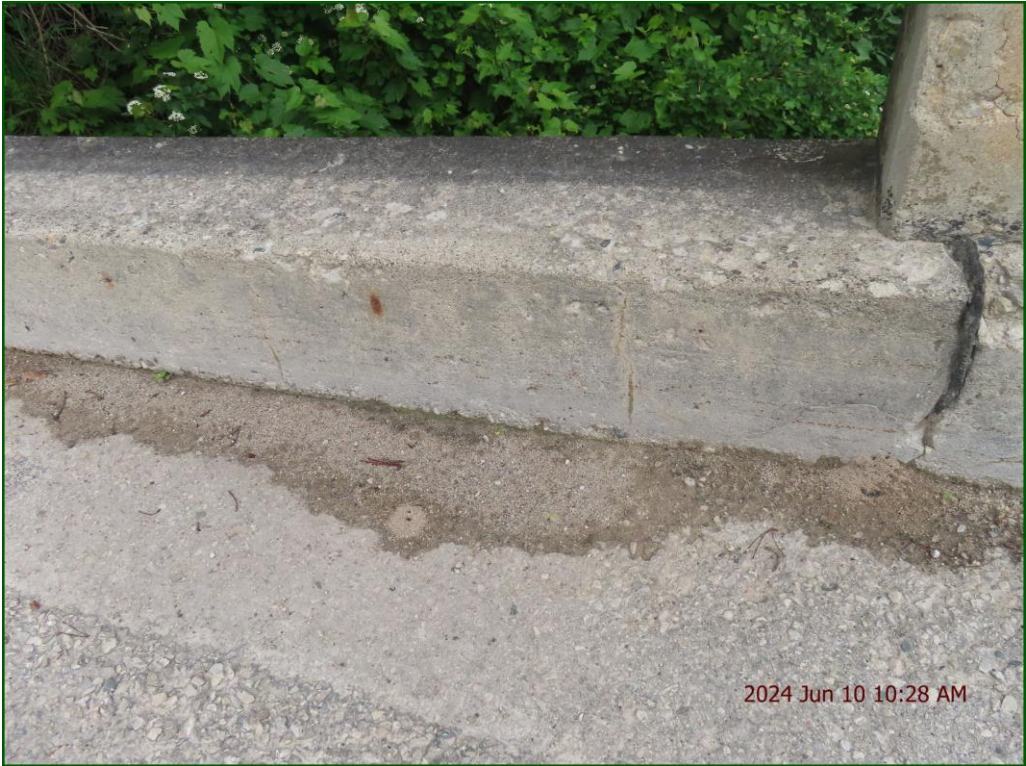
Description: Approach Curbs: Light to medium vertical cracking throughout.

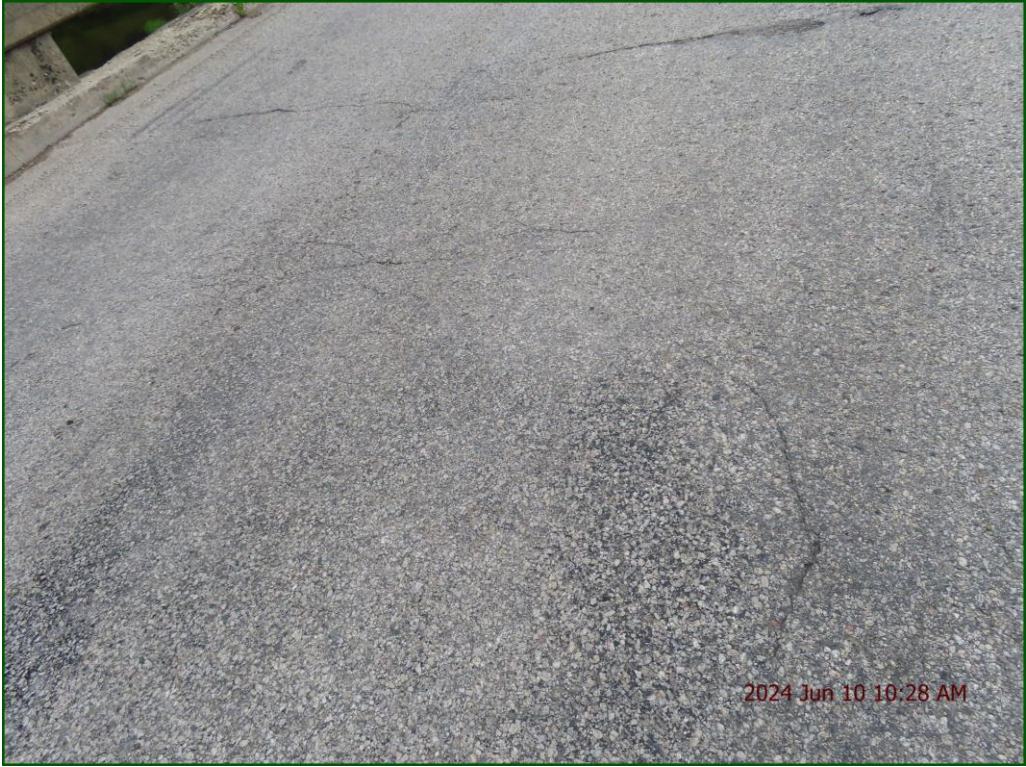
Description: Approach Wearing Surface: Light to medium map cracking.

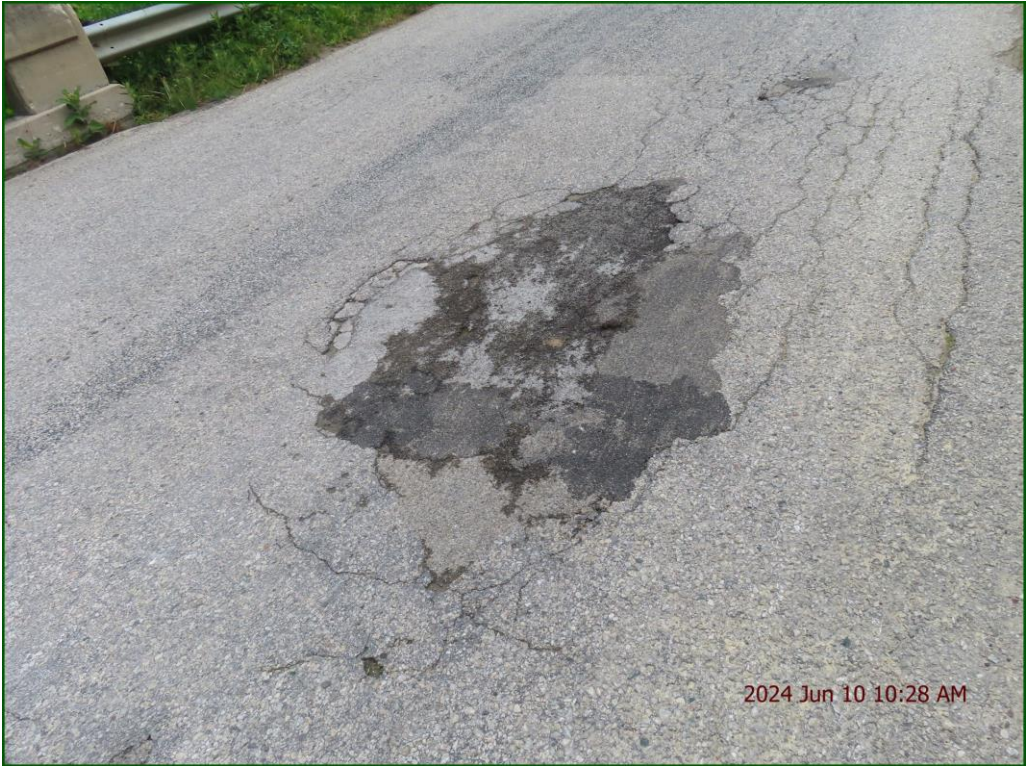
Description: Approach Wearing Surface: Light to medium potholing.

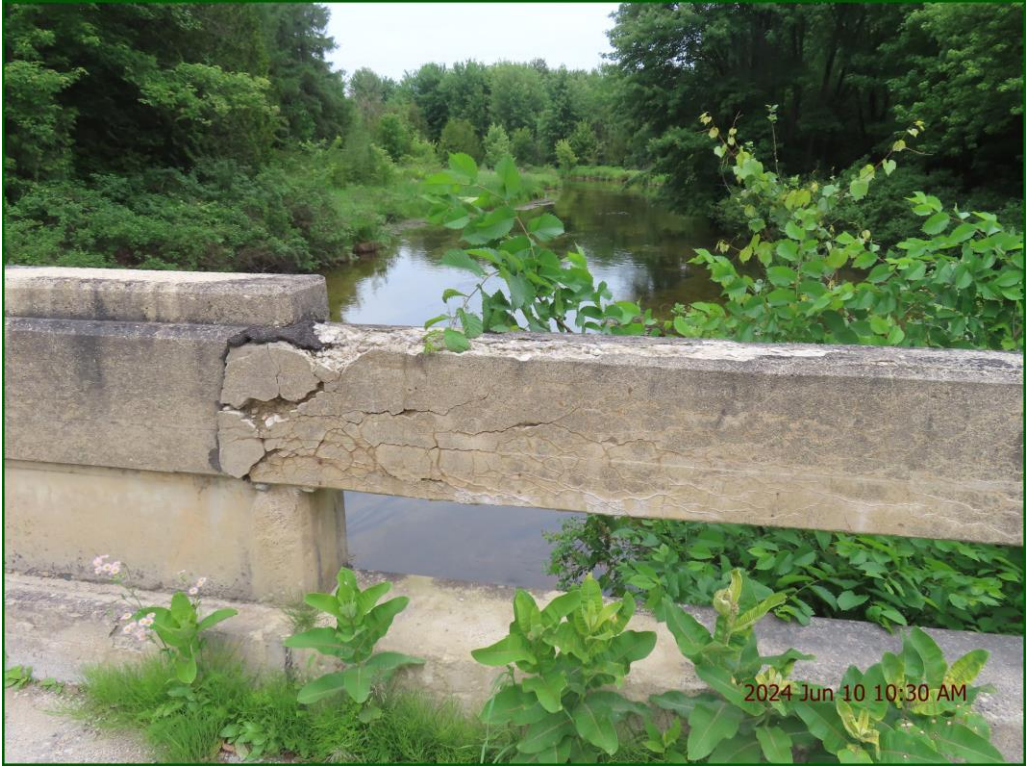
Description: Railing systems: Severe delamination and disintegration.

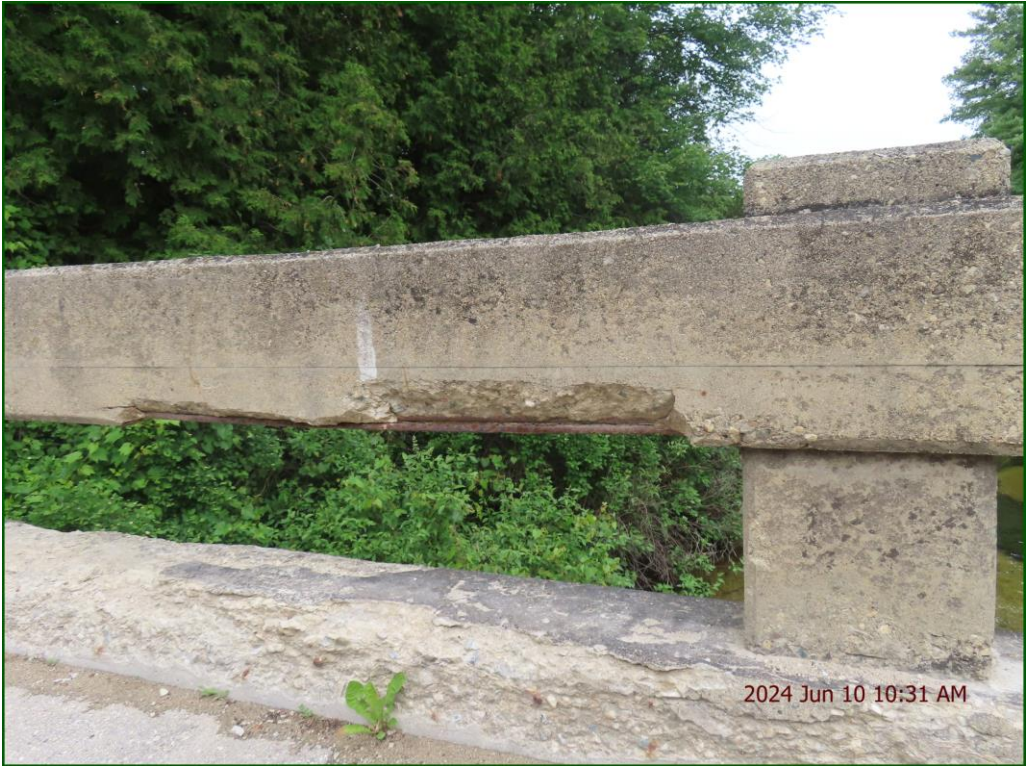
Description: Railing systems: Moderate spall on north side with exposed reinforcing.

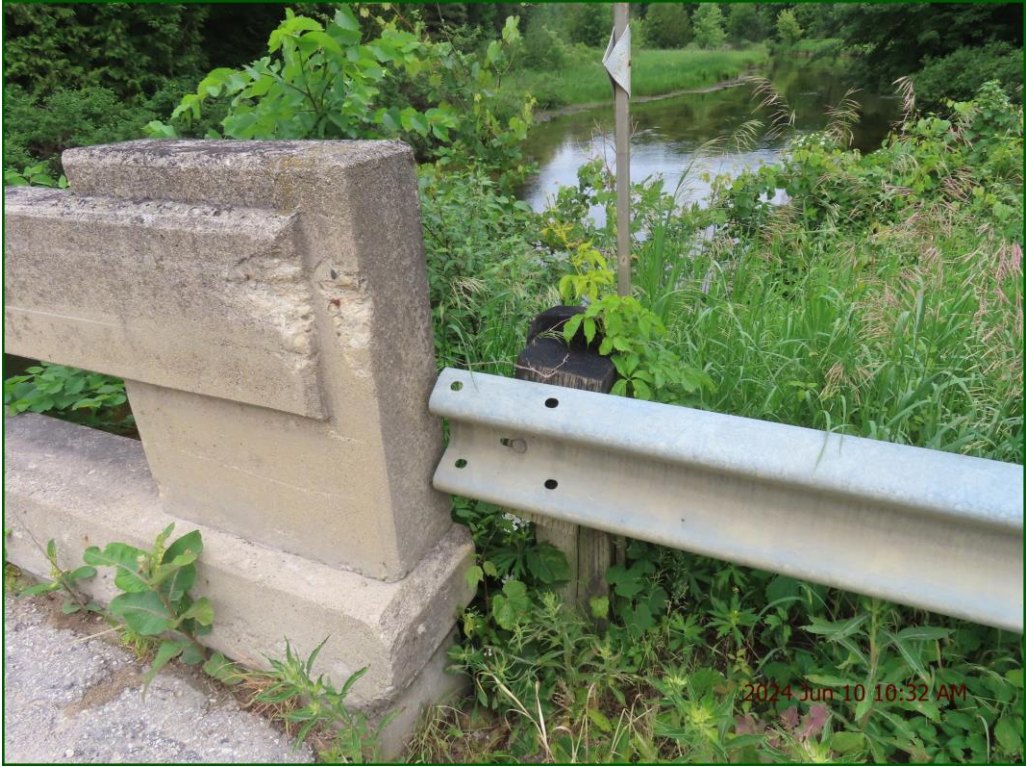
Description: Railing systems: Improper connection.

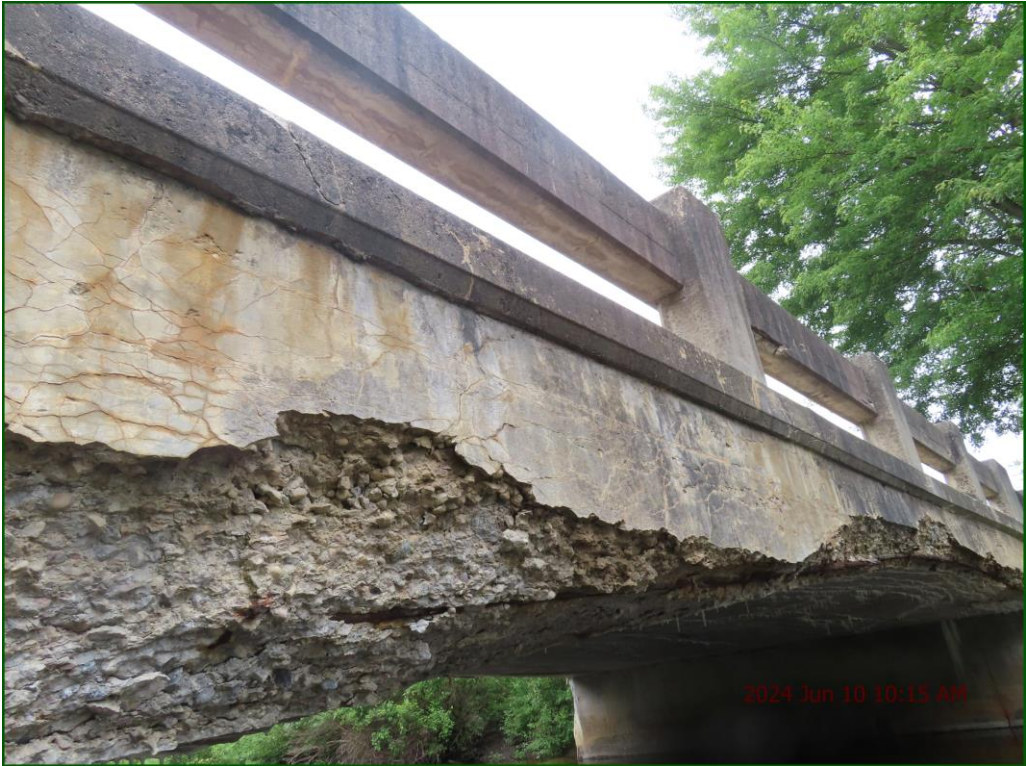
Description: Soffit (ext): Severe disintegration and spalling throughout.
