MUNICIPALITY OF
West Grey

Municipality of West Grey
Bridge Prioritization Program

February 2025

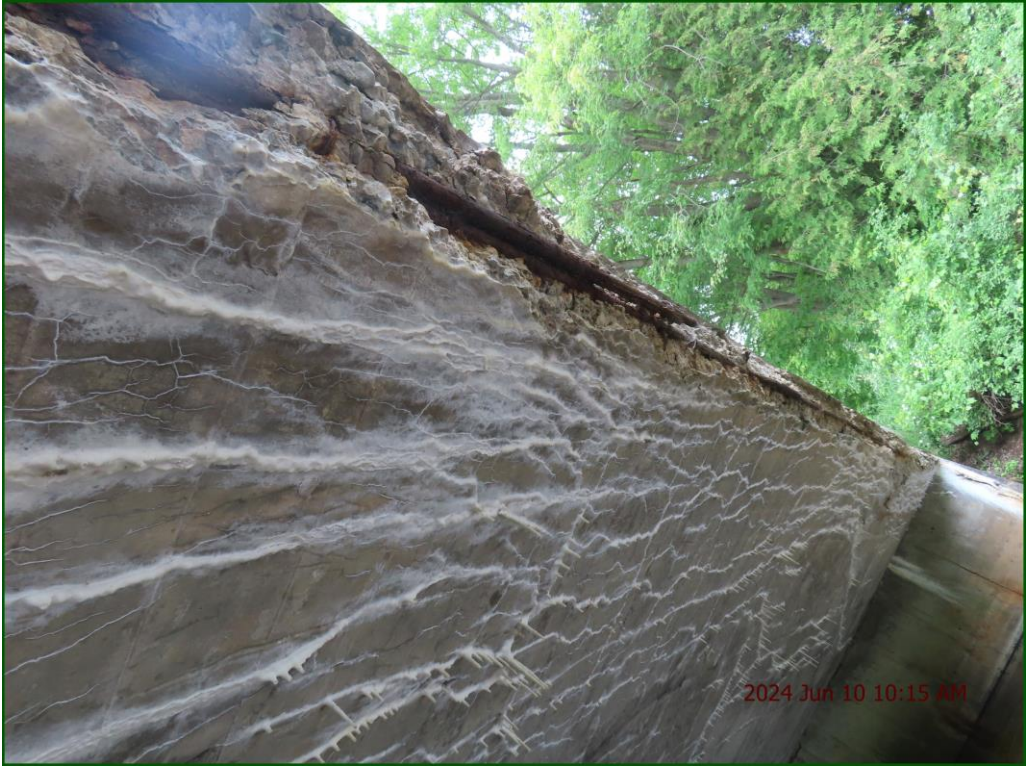
Description: Soffit (ext): Extensive map cracking with leachate staining and stalactite.

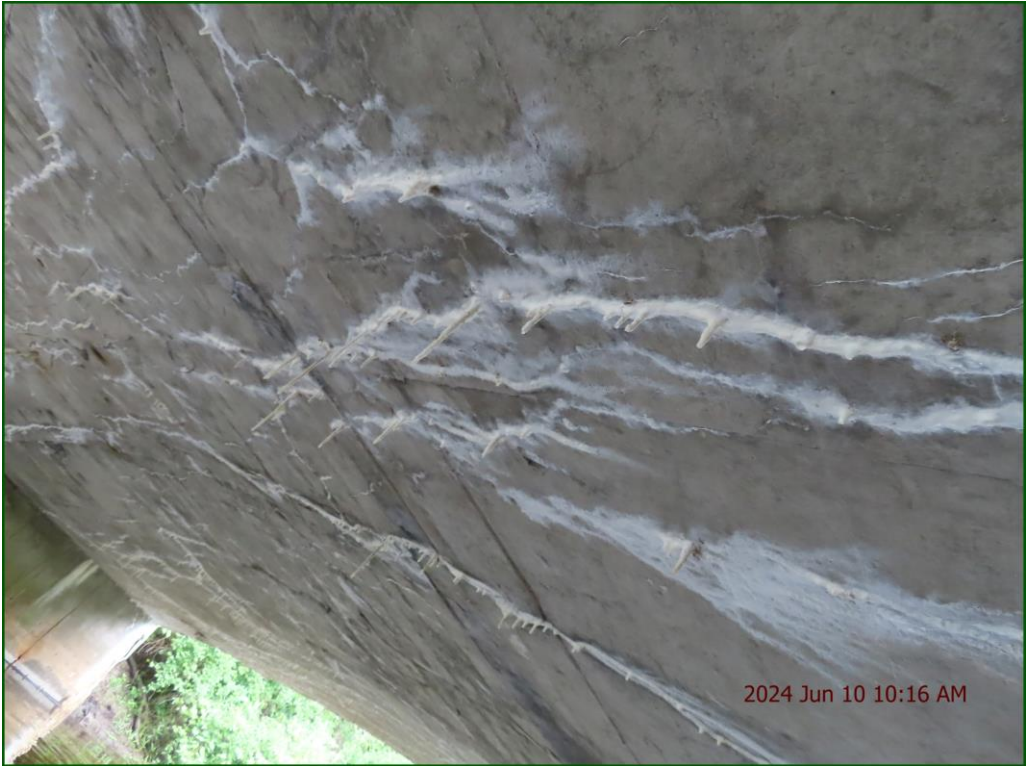
Description: Soffit (int): Medium to wide transverse and longitudinal cracking.

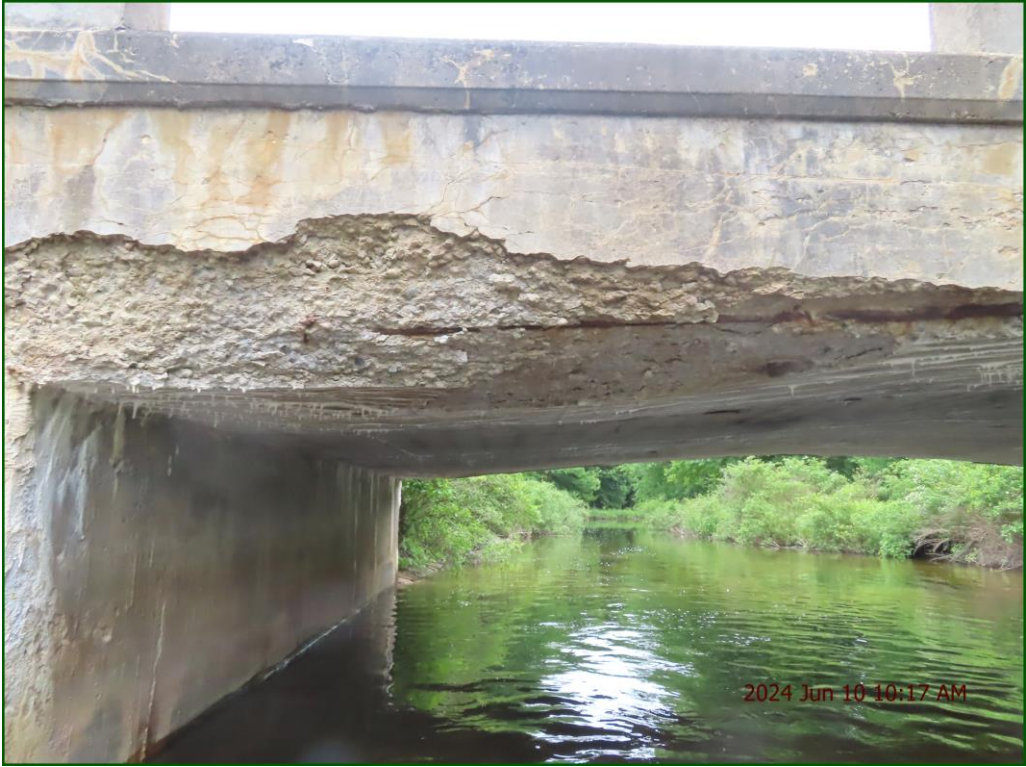
Description: Soffit (int): Possible sag at east and west ends. Possibly occurred at time of construction.

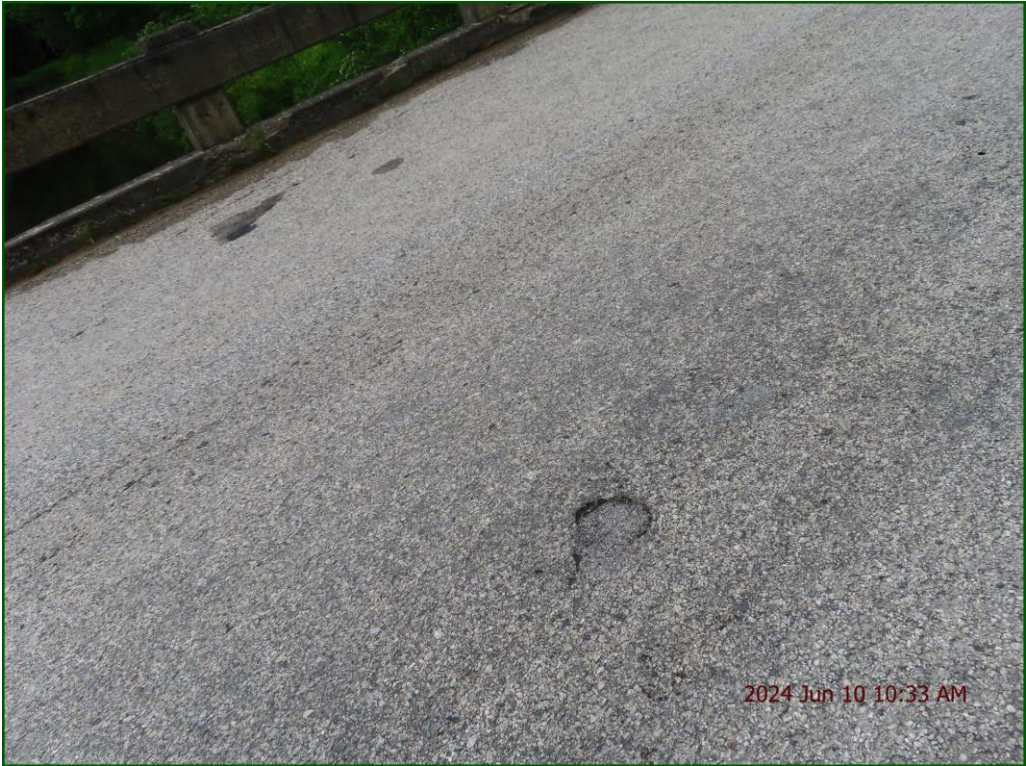
Description: Wearing Surface: Shallow potholing throughout.

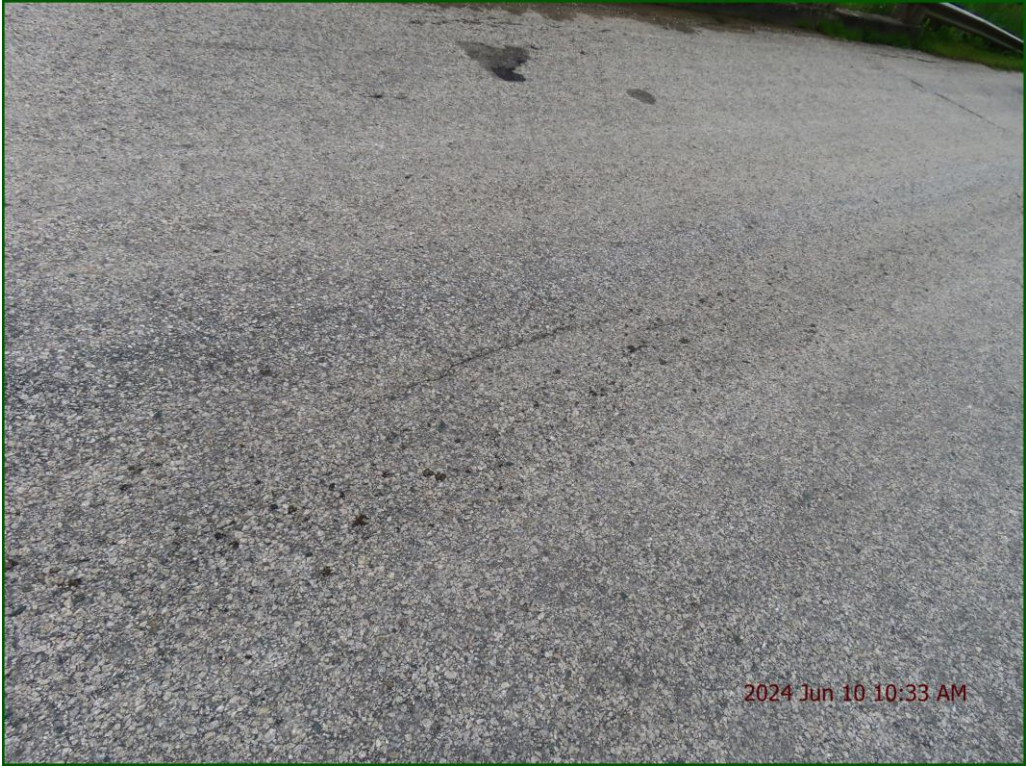
Description: Wearing Surface: Light to medium cracking along centreline.

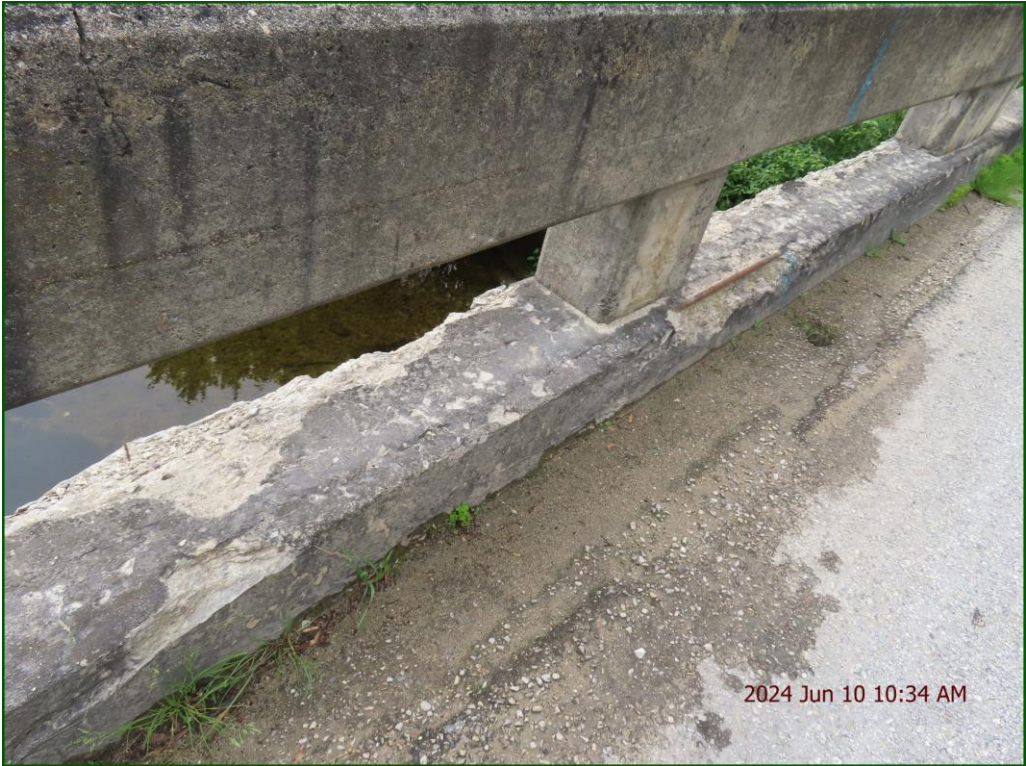
Description: Curbs: Severe spalling throughout.

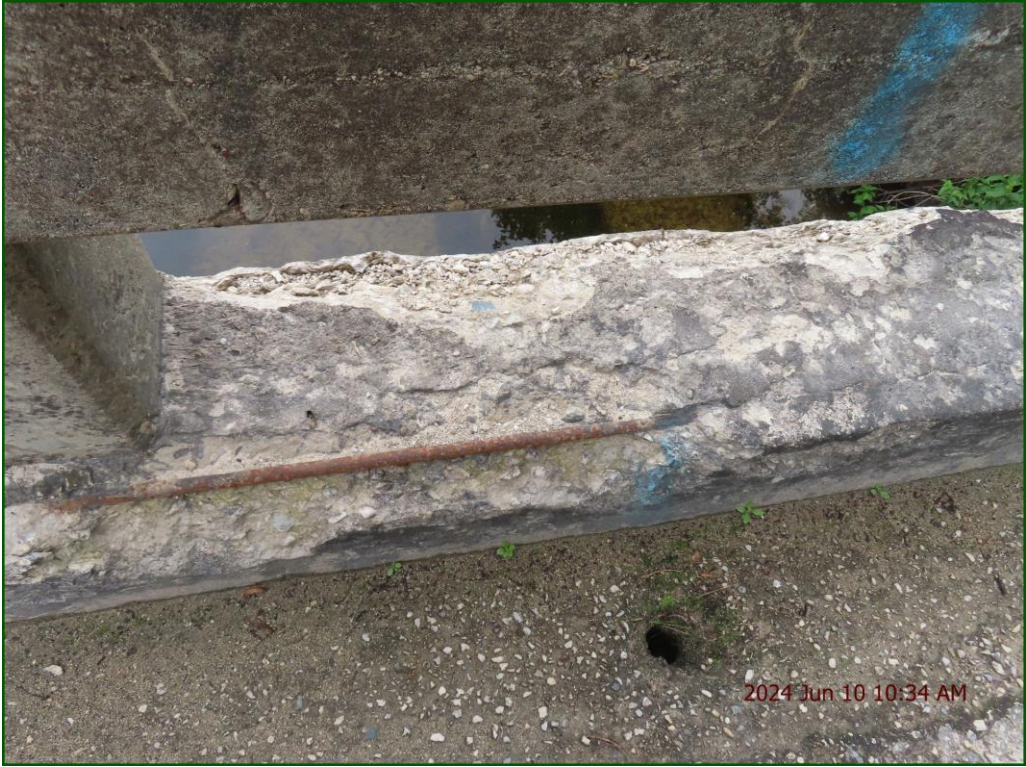
Description: Curbs: Severe disintegration with exposed reinforcing.

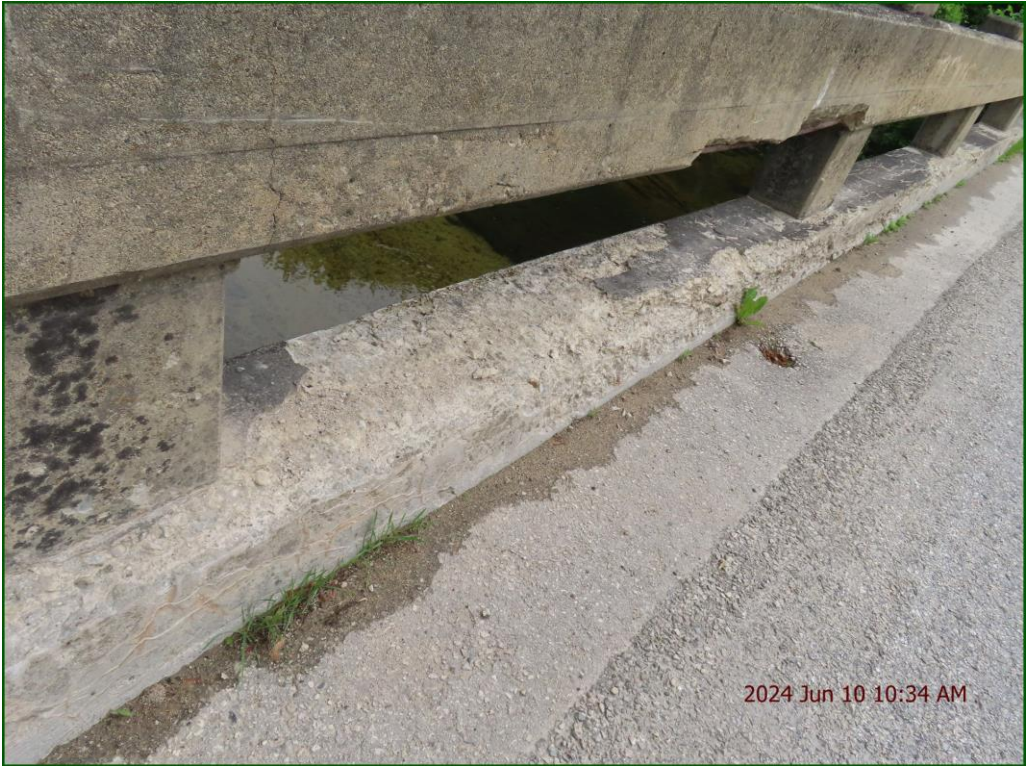
Description: Curbs: Severe delamination throughout.

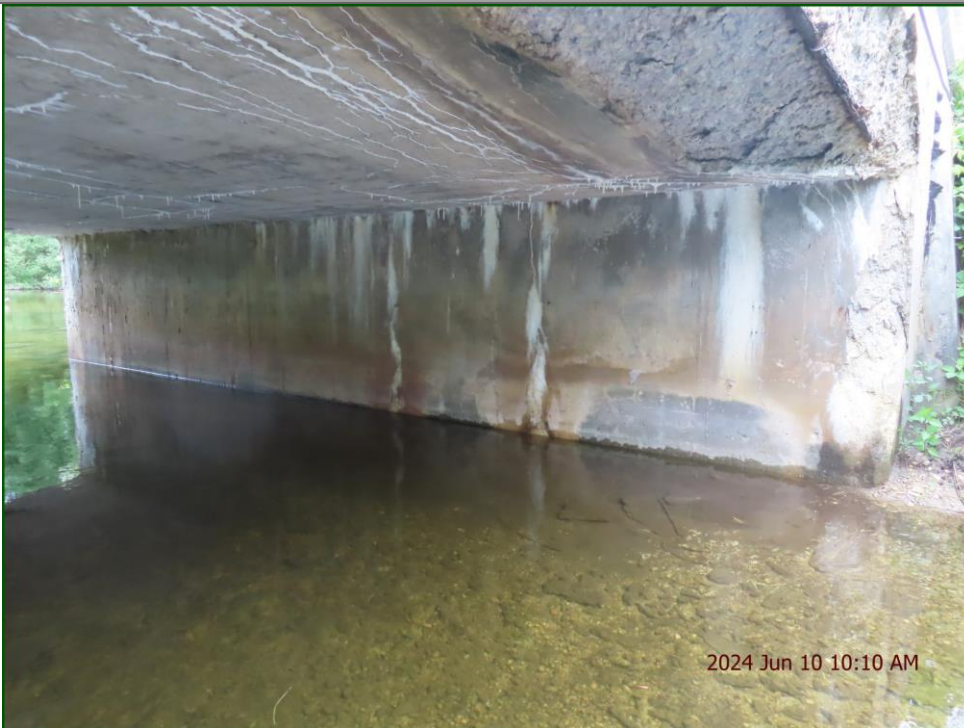
Light to medium vertical cracks with leachate staining. Light spalling on corners.

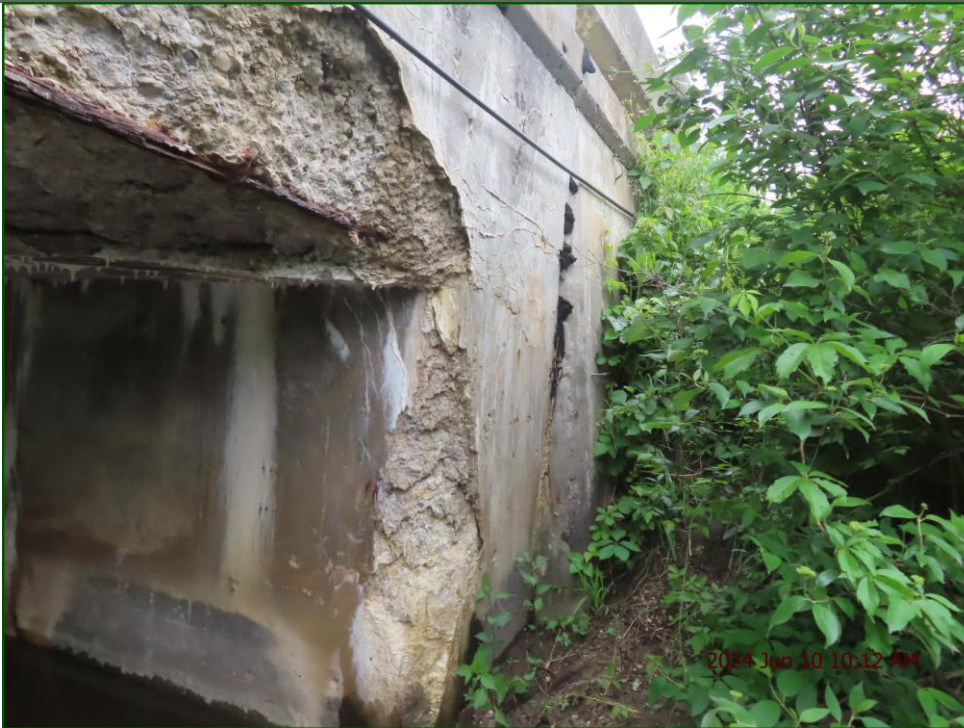
Light to medium cracking with leachate staining.

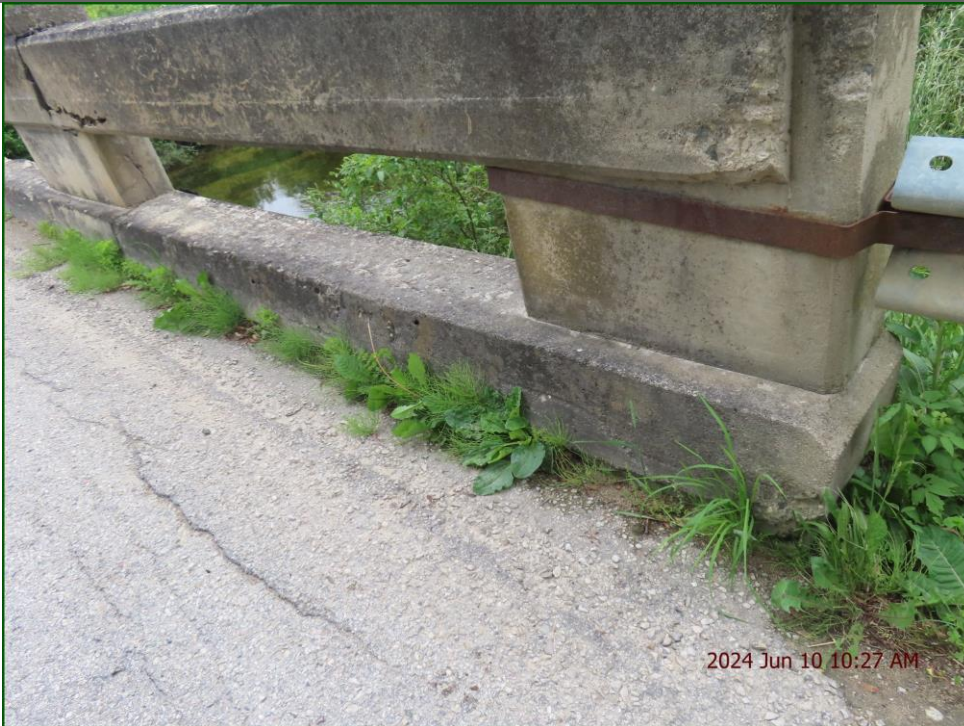
Light to medium vertical cracking throughout.

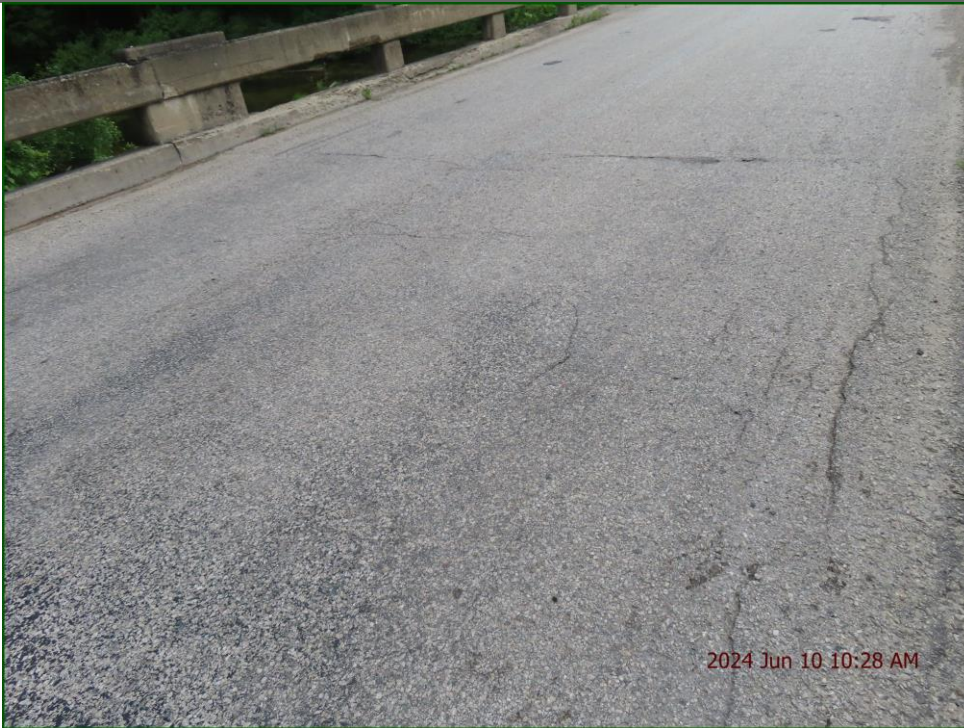
Light to medium map cracking. Light to medium potholing.

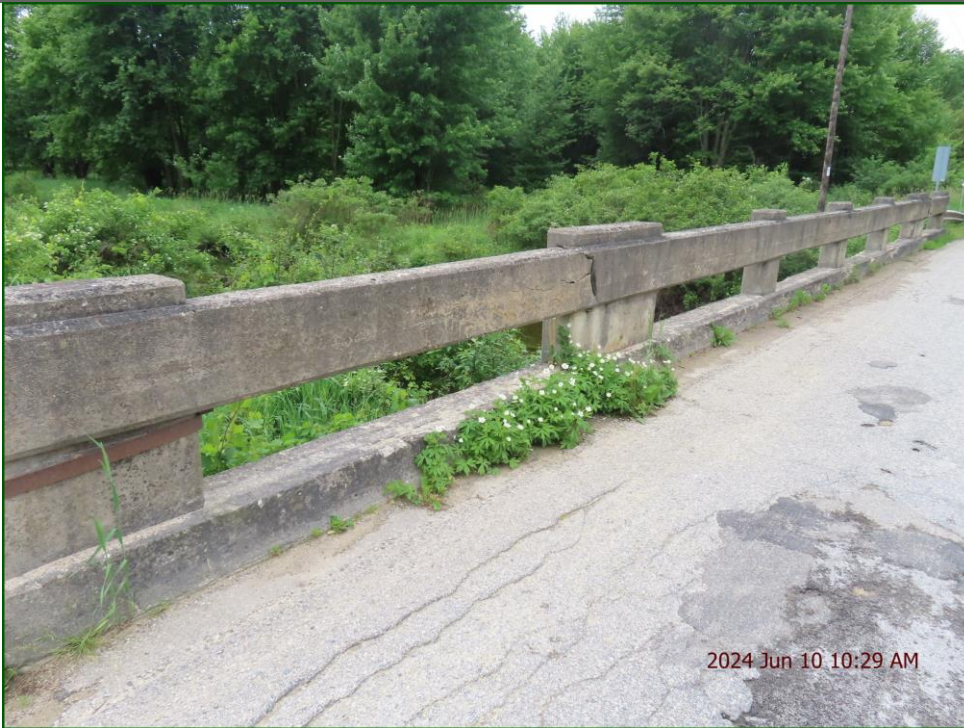
Severe delamination and disintegration. Moderate spall on north side with exposed reinforcing.

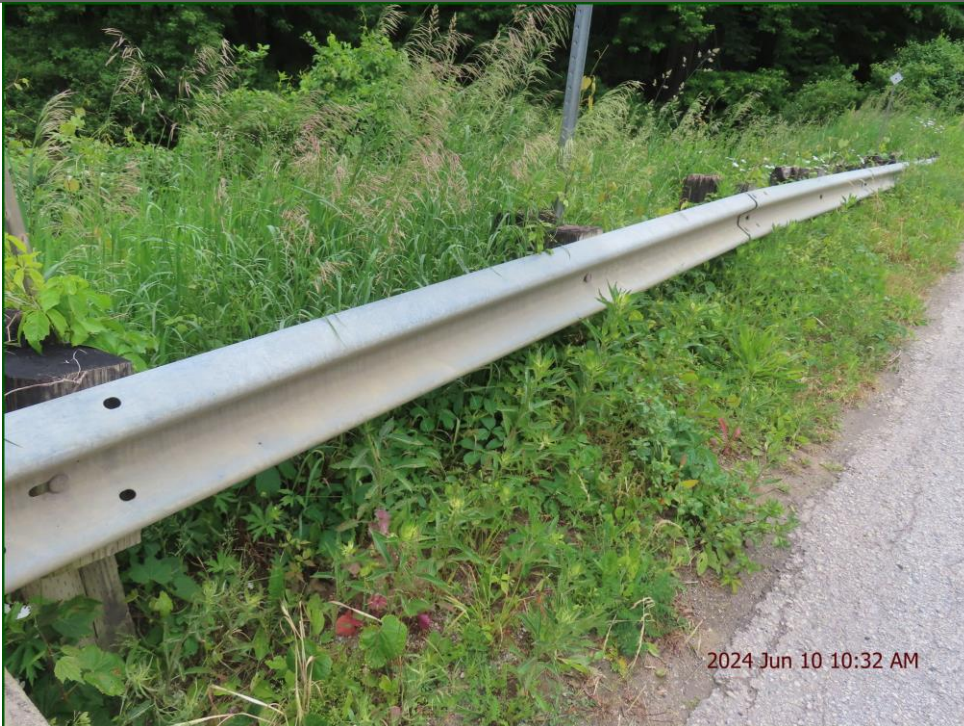
Improper connection.

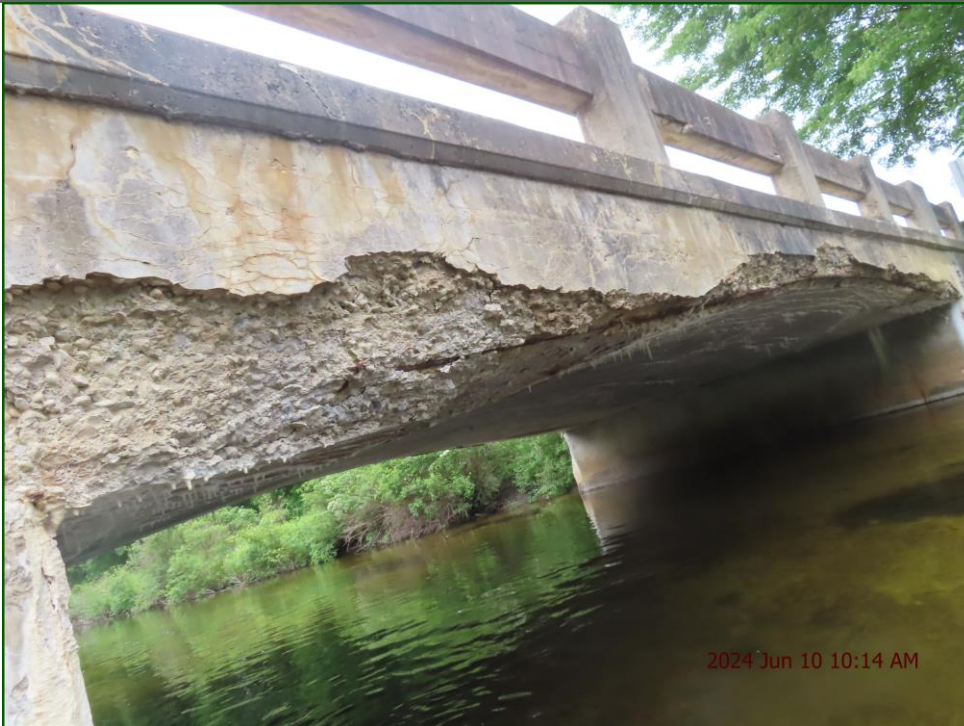
Severe disintegration and spalling throughout with exposed reinforcing. Medium map cracking with leachate staining and stalactite. Moderate to severe delamination throughout.

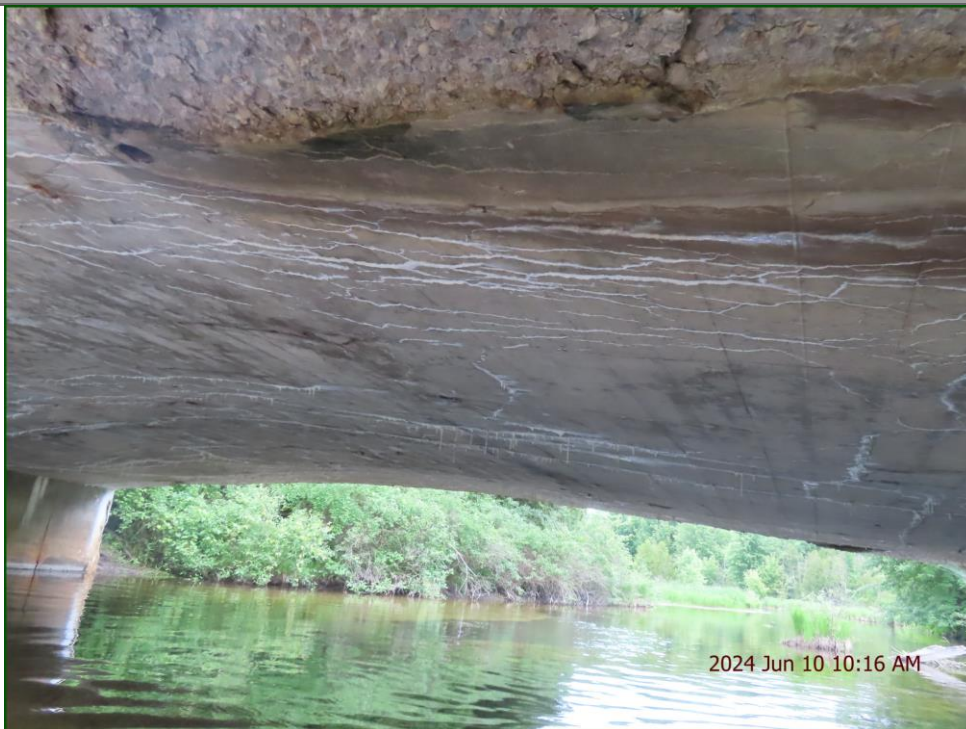
Medium to wide transverse and longitudinal cracking with leachate staining and stalactite. Possible sag at east and west ends.

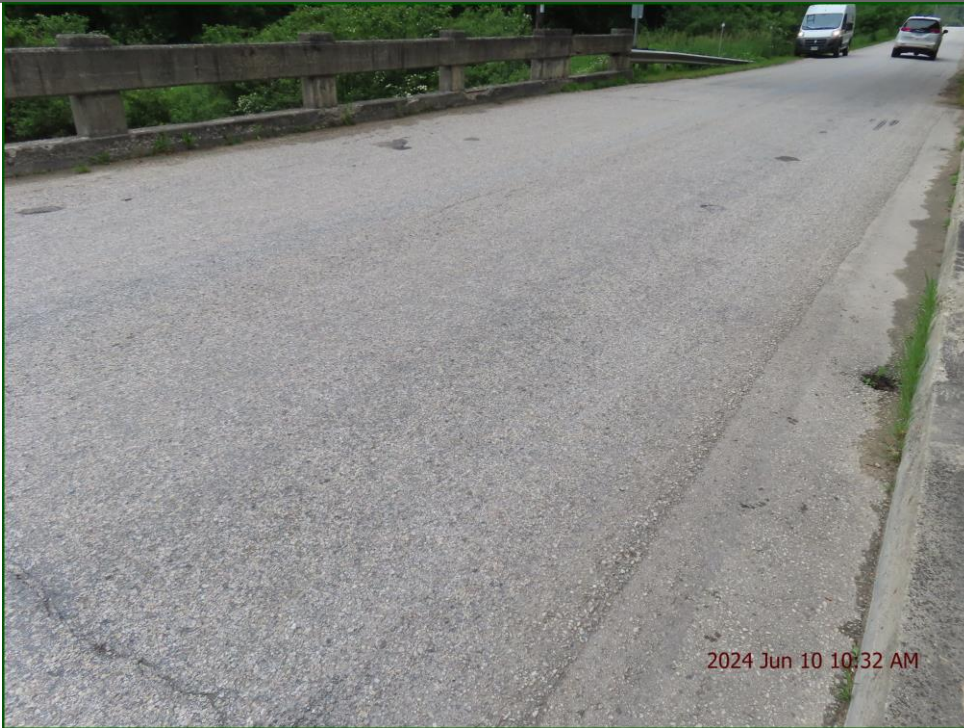
Shallow potholing throughout. Light to medium cracking along centreline.

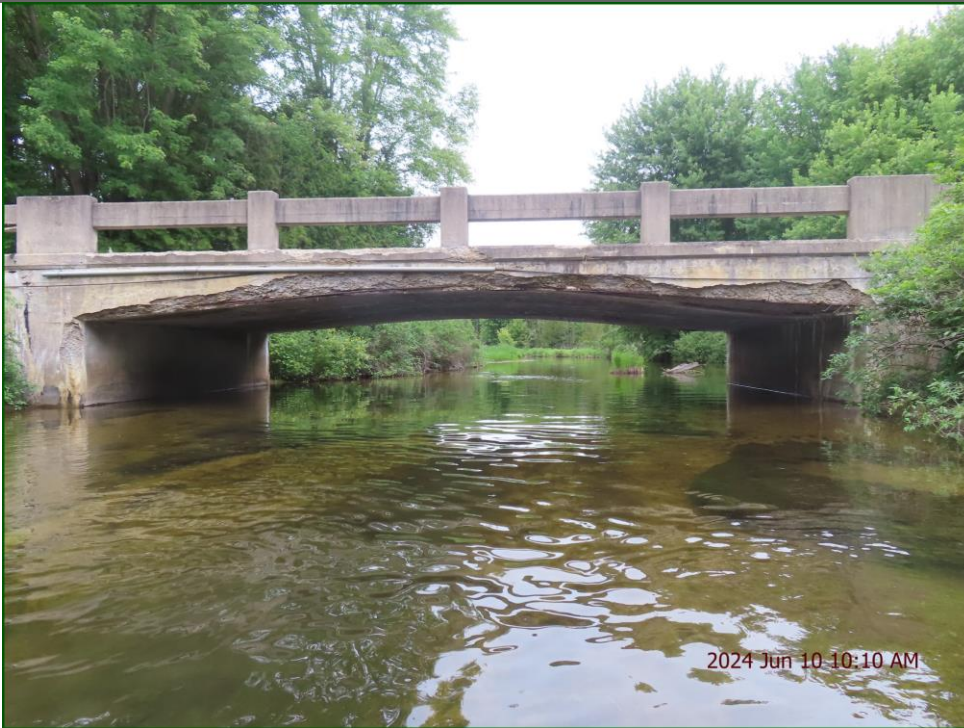
Concrete rigid frame has advanced deterioration, recommend consider complete replacement.

Rehab Needs:	<input type="text" value="Replace with Bridge (concrete)"/>	Unit Cost:	<input type="text" value="\$8000 / sq.m"/>
Rehab time period:	<input type="text" value="1 - 5 Years"/>	Estimated Cost:	<input type="text" value="\$904,000"/>
Quantity:	<input type="text" value="113"/> sq.m

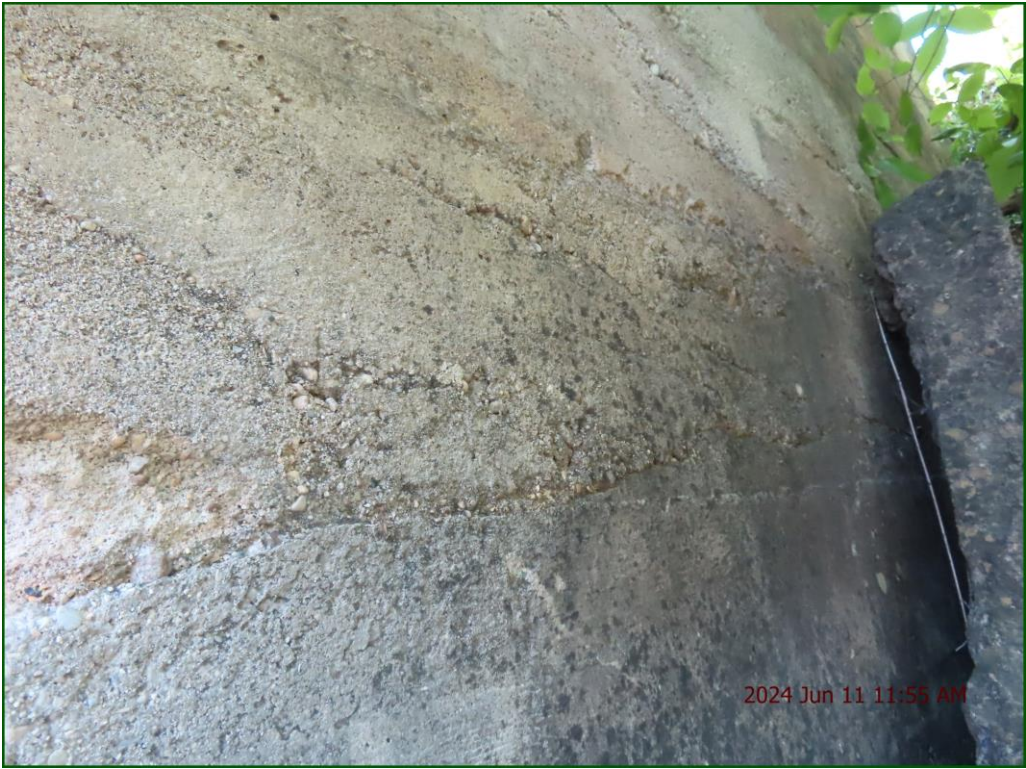
Description: Wingwalls: Light to medium honeycombing throughout.

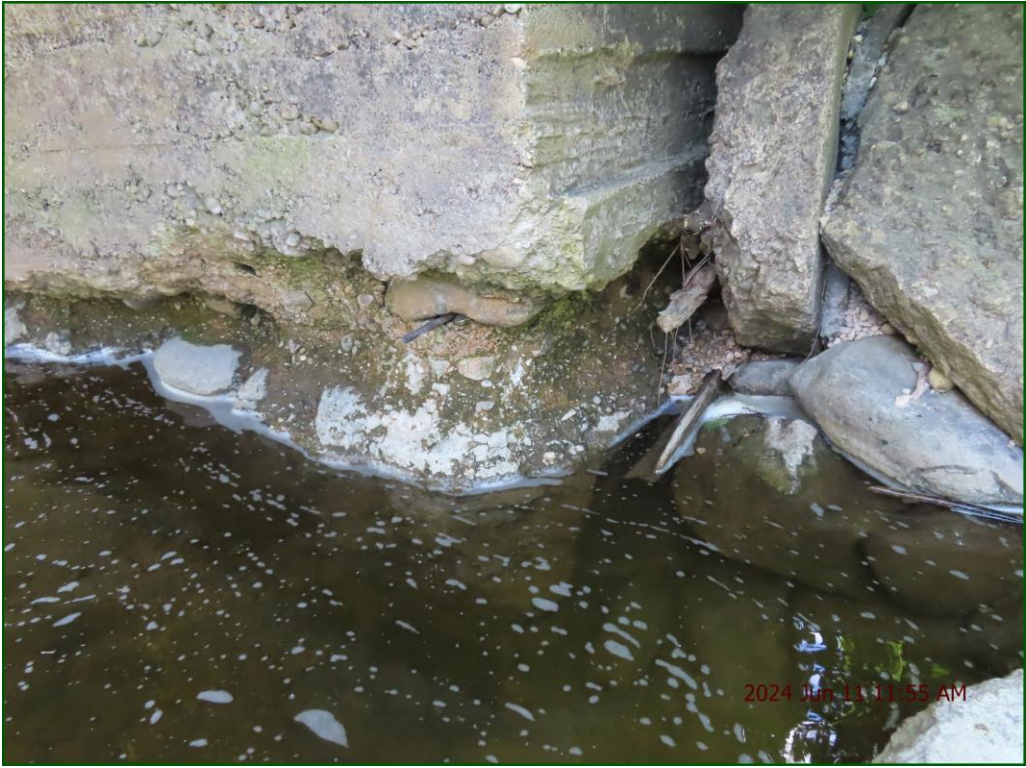
Description: Wingwalls: Severe scouring causing disintegration on west wingwalls.

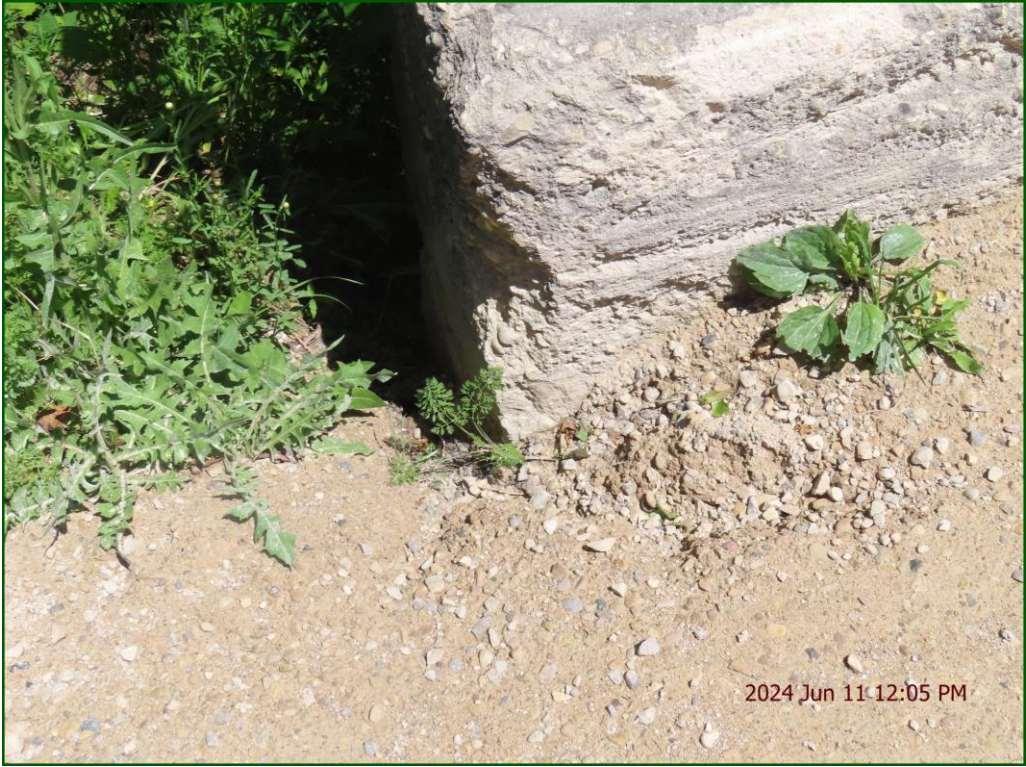
Description: Embankments: Erosion on NW quadrant.

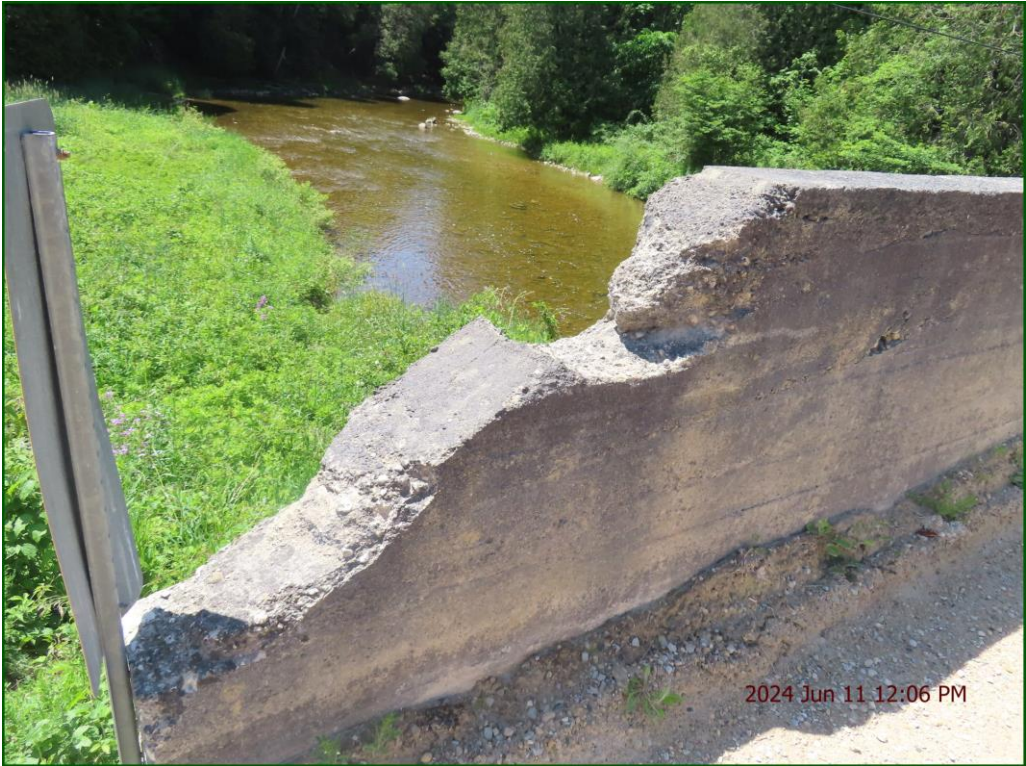
Description: Barrier/Parapet Walls: Severe spalling throughout.

Medium to severe spalling throughout. Severe disintegration throughout.

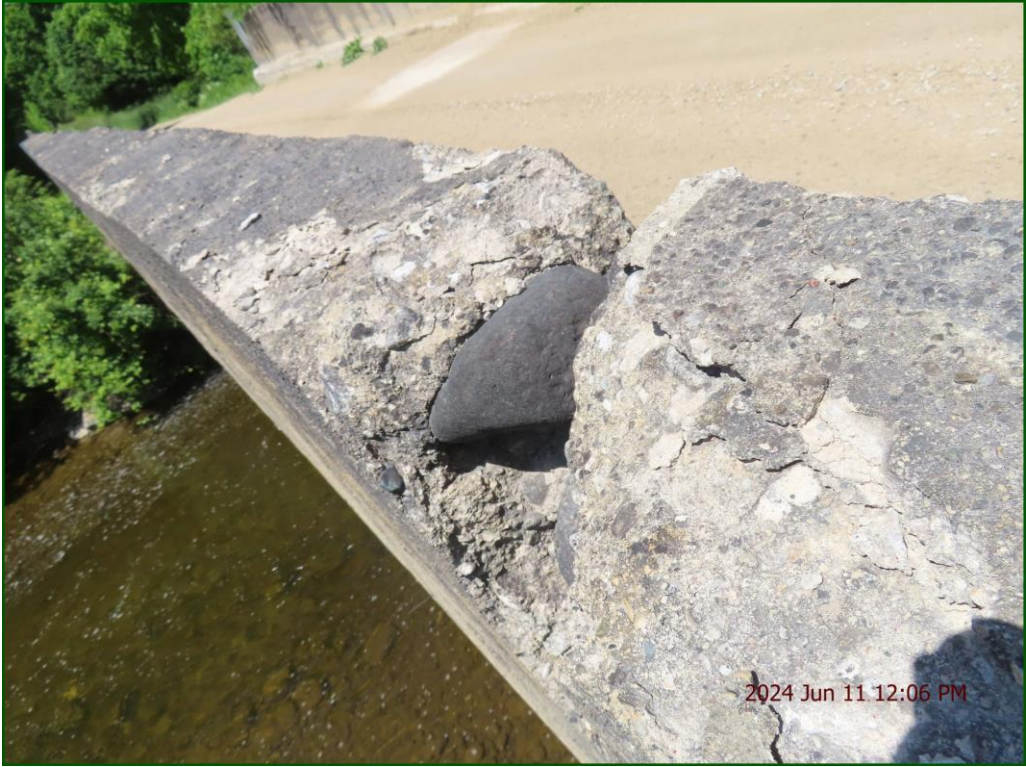
Description: Barrier/Parapet Walls: Severe disintegration throughout.

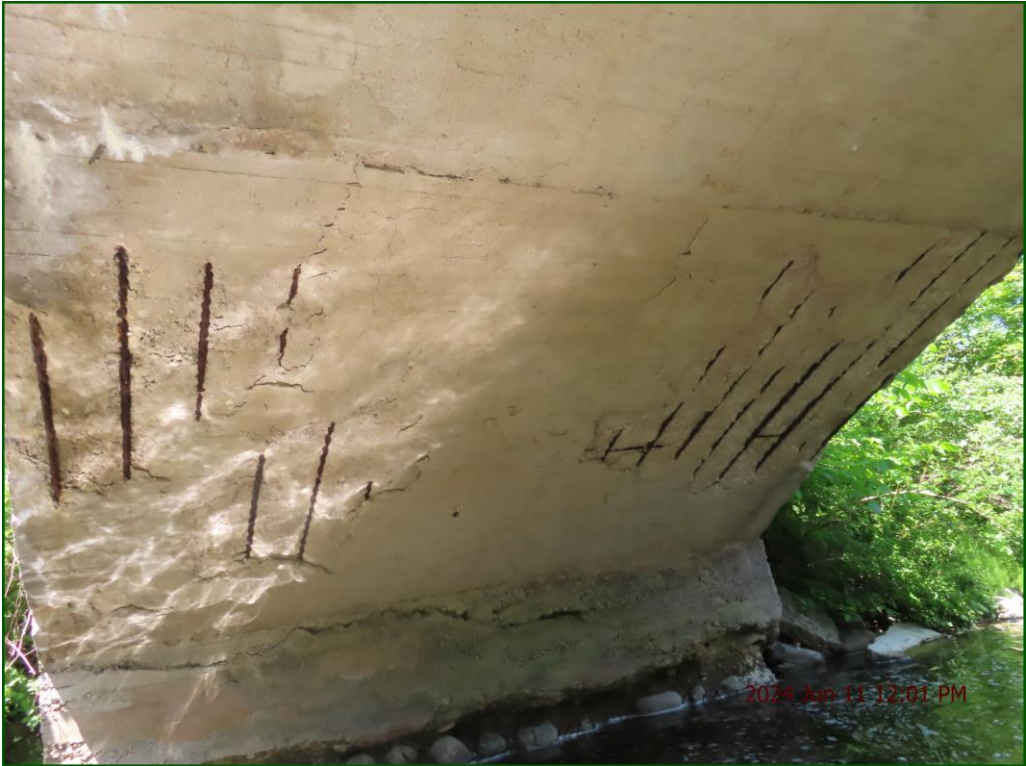
Description: Soffit (int): Severe spalling with exposed reinforcing throughout (west).

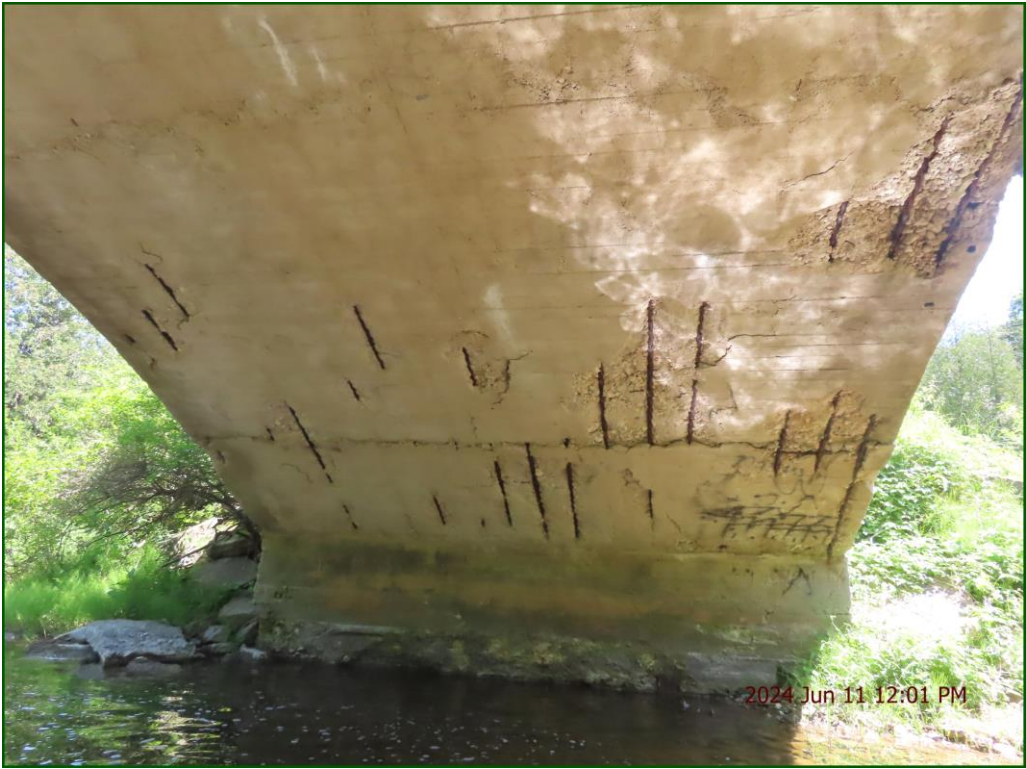
Description: Soffit (int): Severe spalling with exposed reinforcing throughout (east).

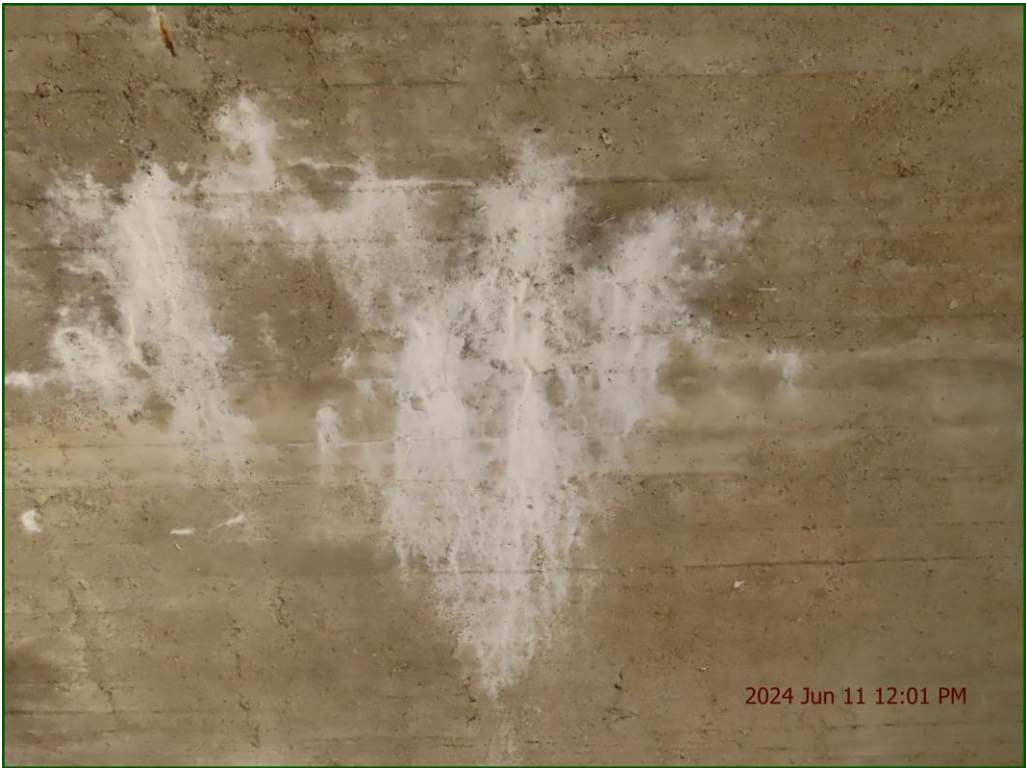
Description: Soffit (int): Medium map cracking with leachate staining, just west of midspan.

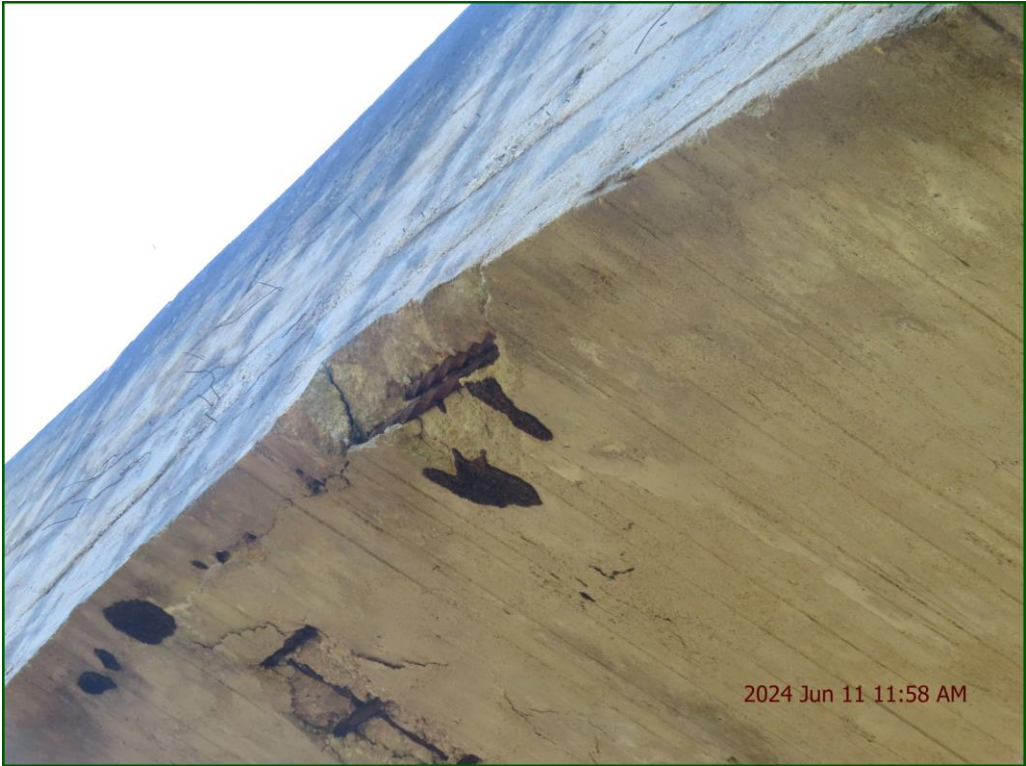
Description: Soffit (ext): Severe spalling with exposed reinforcing throughout (north) (1/3).

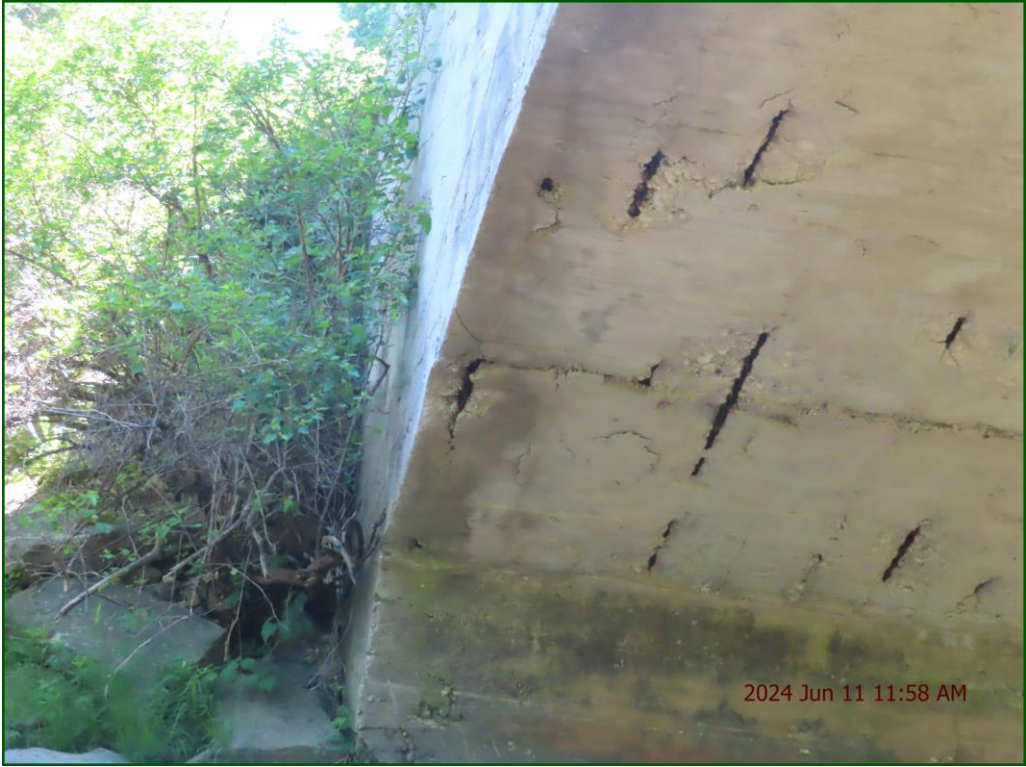
Description: Soffit (ext): Severe spalling with exposed reinforcing throughout (north) (2/3).

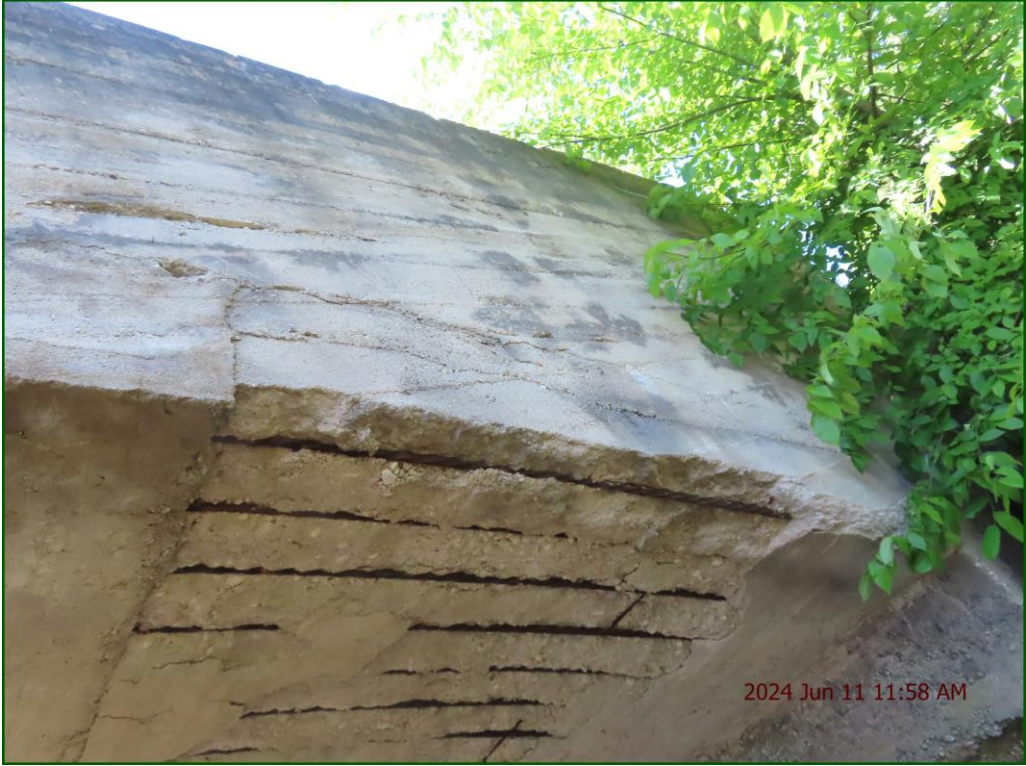
Description: Soffit (ext): Severe spalling with exposed reinforcing throughout (north) (3/3).
