MUNICIPALITY OF
West Grey

Municipality of West Grey
Bridge Prioritization Program

February 2025

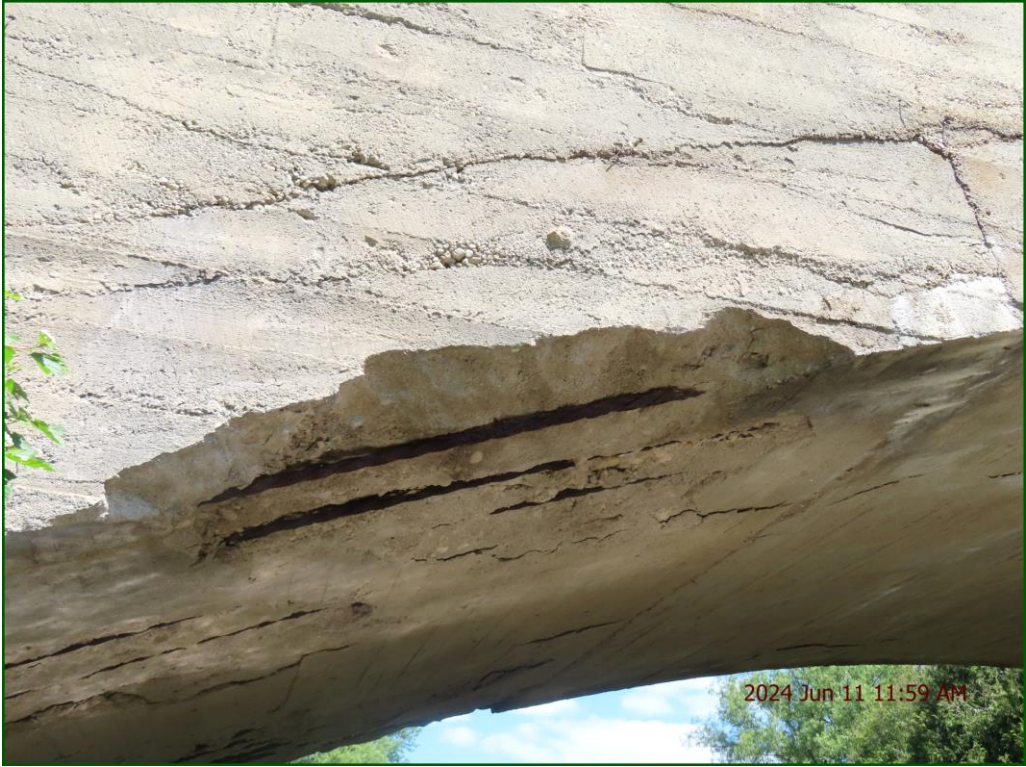
Description: Soffit (ext): Severe spalling with exposed reinforcing throughout (south) (1/2).

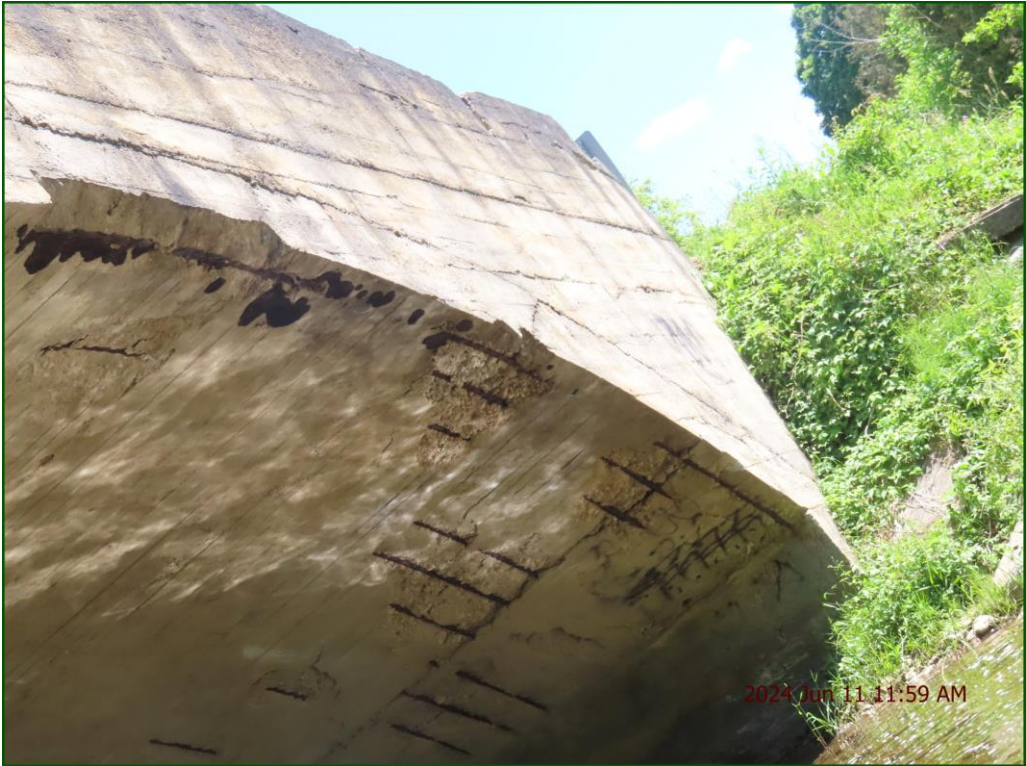
Description: Soffit (ext): Severe spalling with exposed reinforcing throughout (south) (2/2).

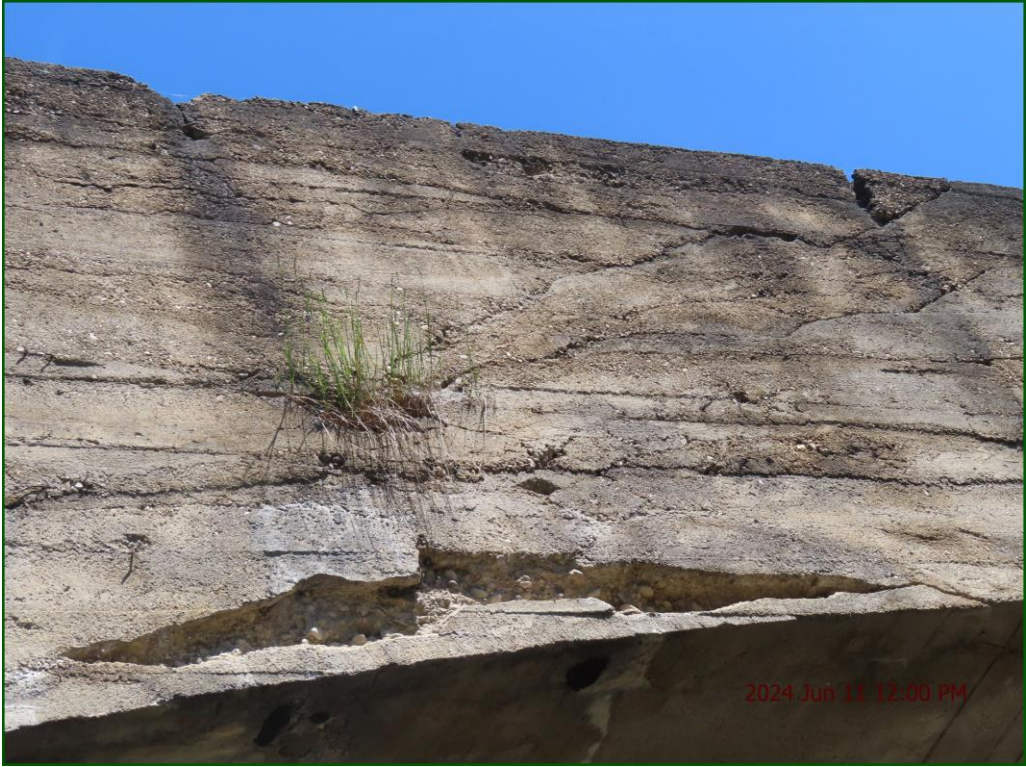
Description: Soffit (ext): Light to medium honeycombing throughout.

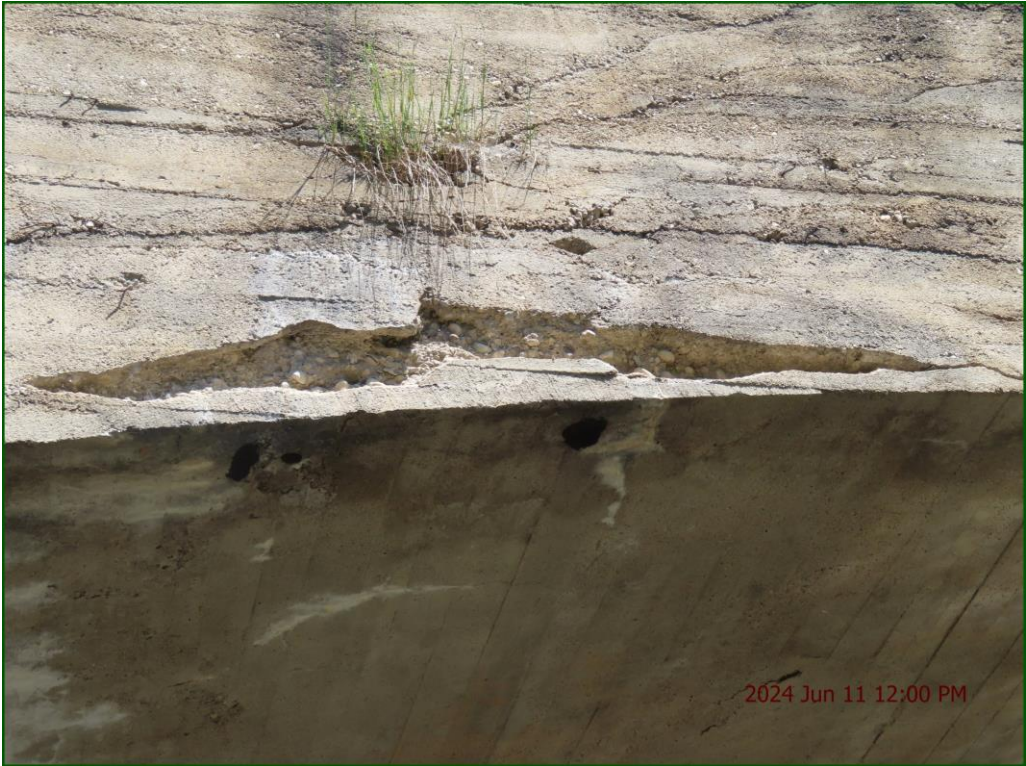
Description: Soffit (ext): Severe disintegration throughout (1/2).

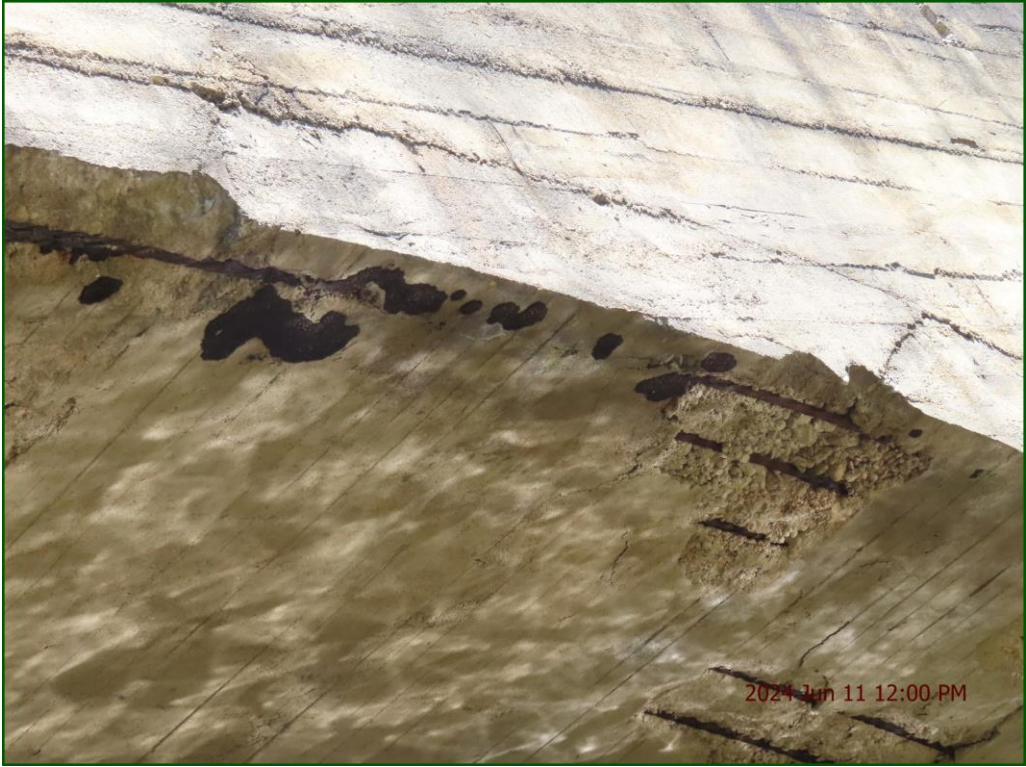
Description: Soffit (ext): Severe disintegration throughout (2/2).

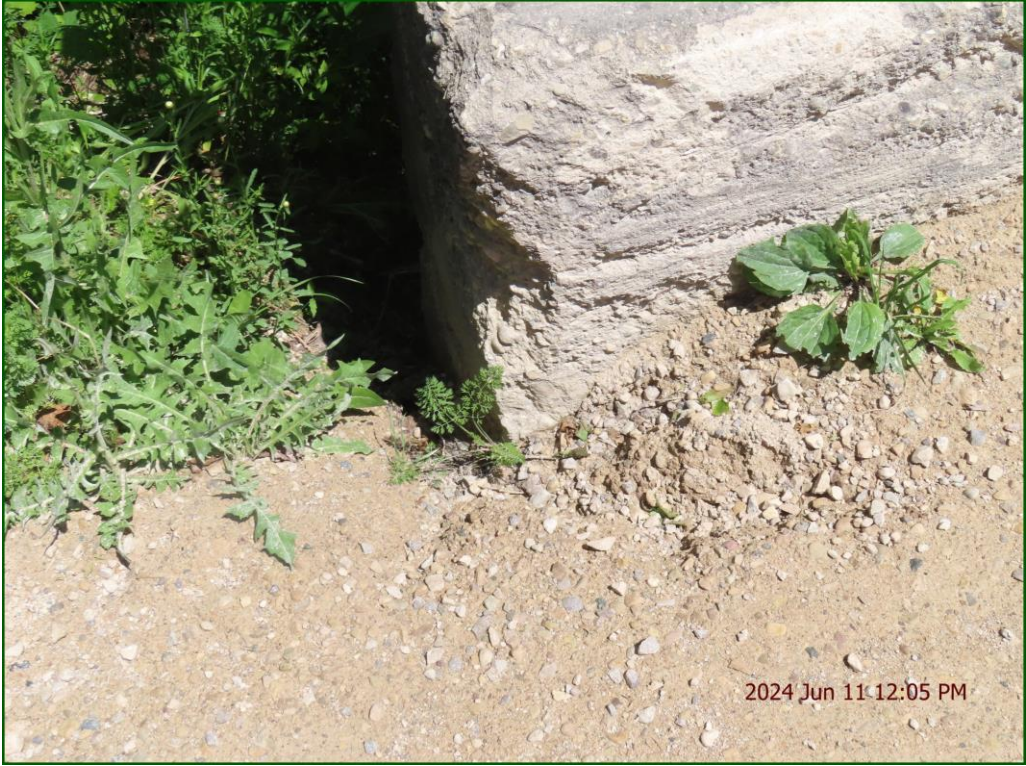
Description: Embankments: Severe erosion on NW quadrant.

Steep embankments recommend protection. Severe erosion on NW quadrant, beginning to undermine roadway.

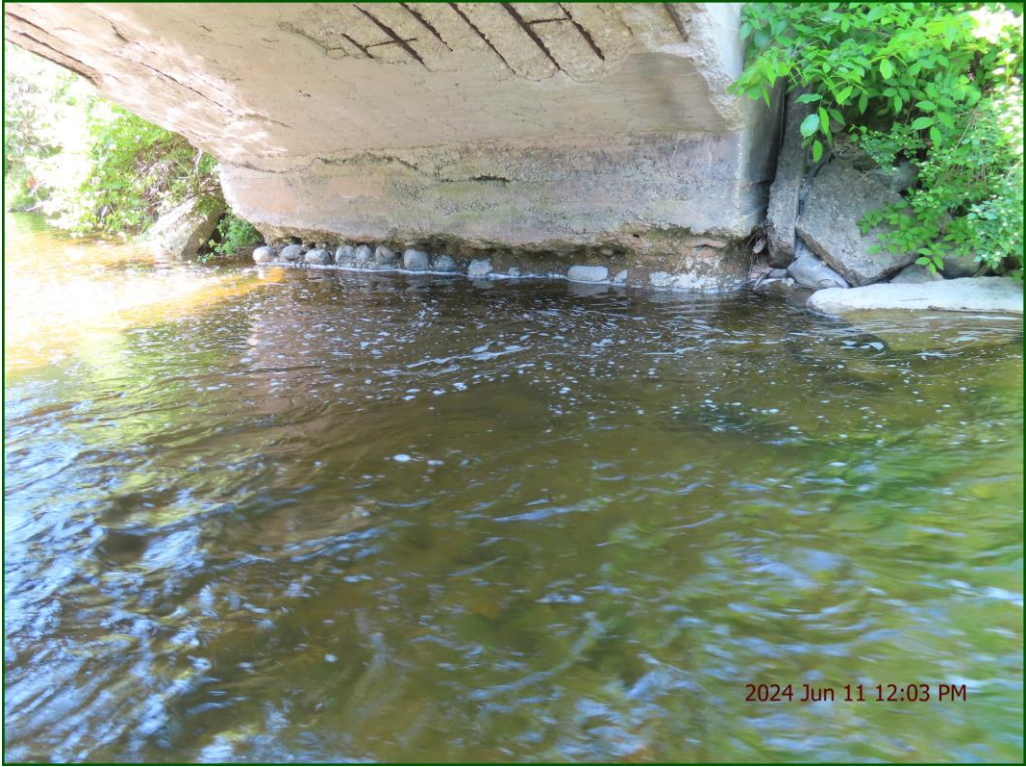
Description: S&W: Stream has been diverted to west abutment causing erosion.

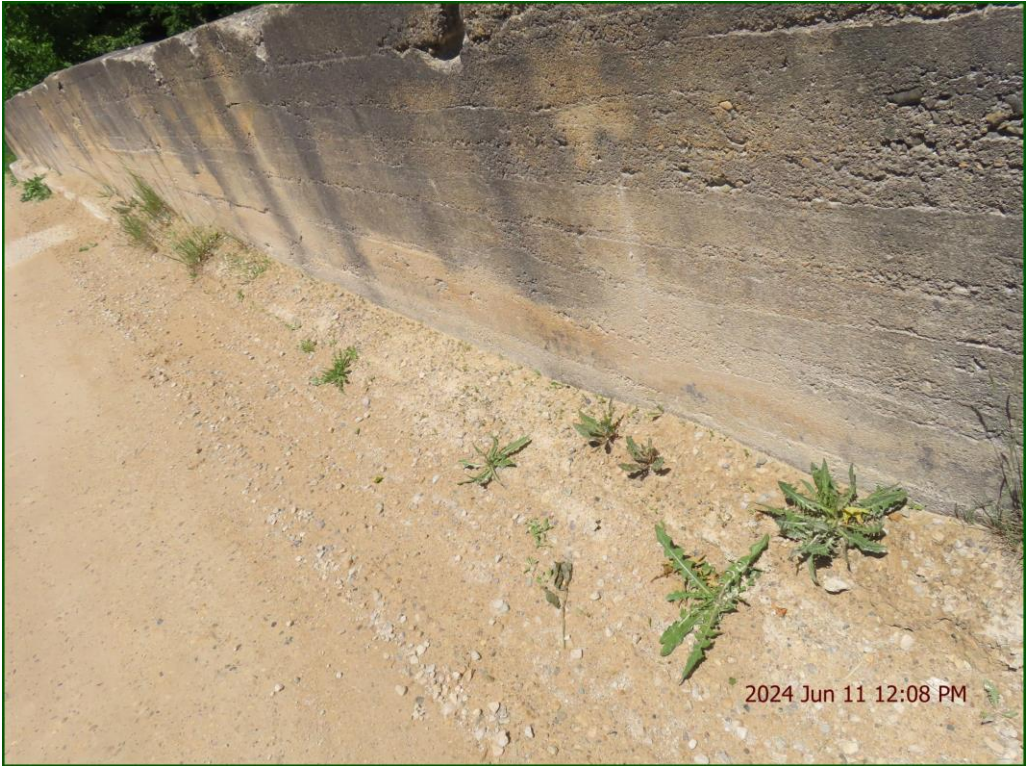
Description: Curbs: Severe spalling and disintegration throughout.

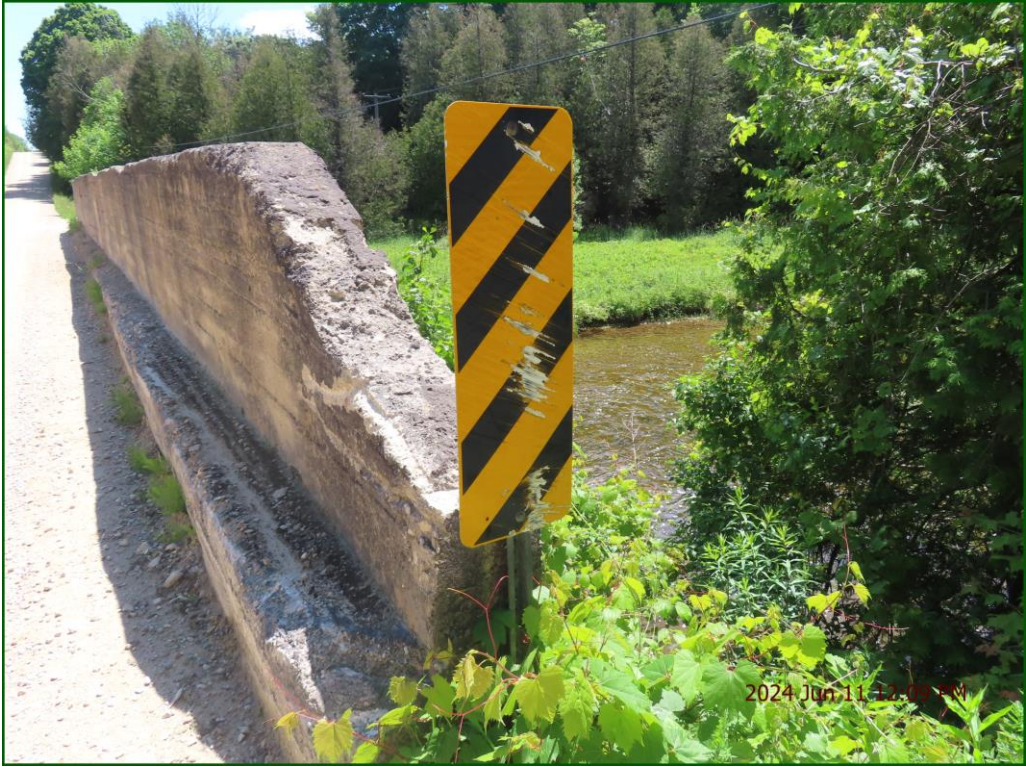
Description: Signs: Minor impact damage at SW quadrant.

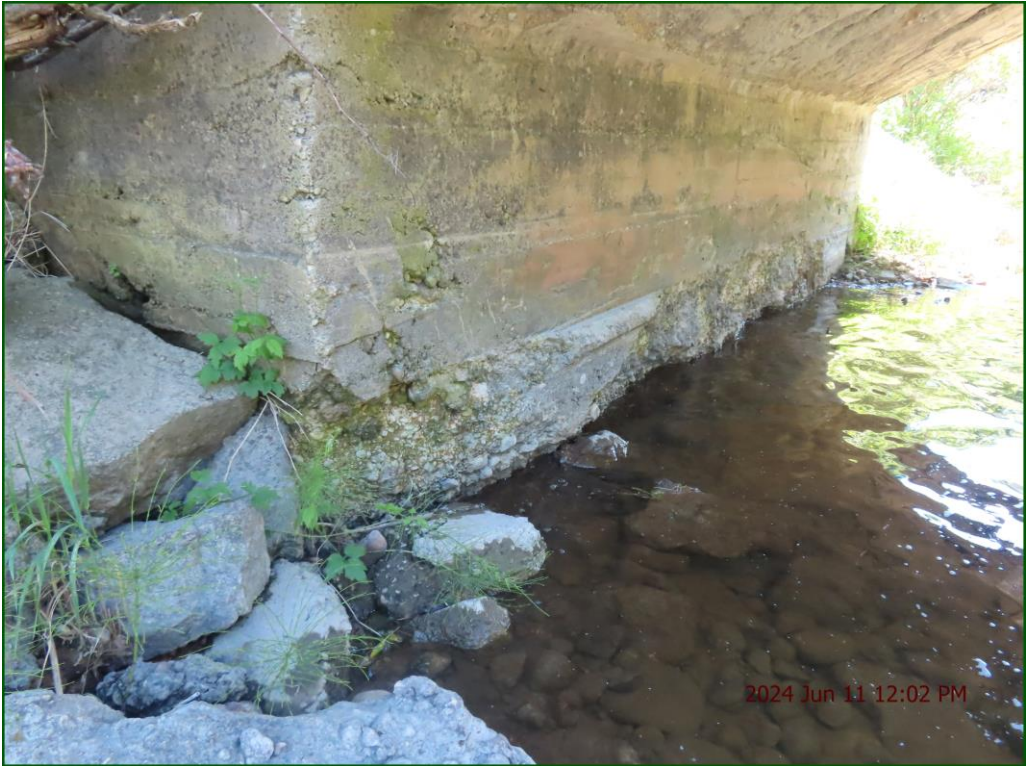
Description: Abutment Walls: Severe scouring.

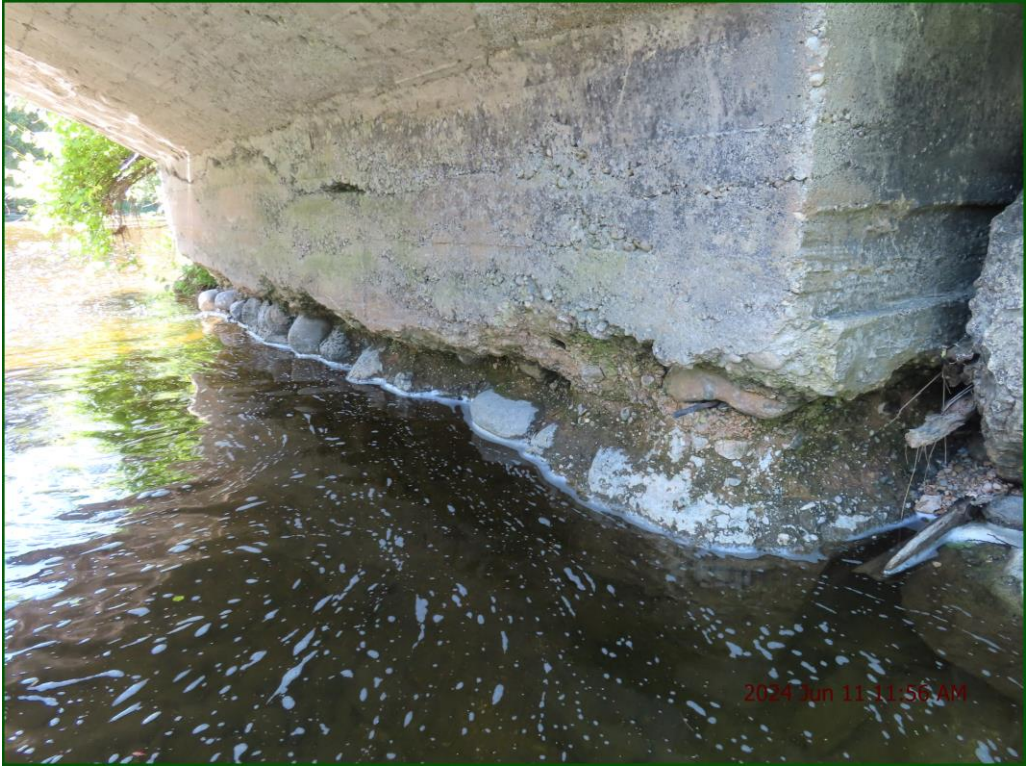
Description: Abutment Walls: Severe scouring and disintegration (1/3).

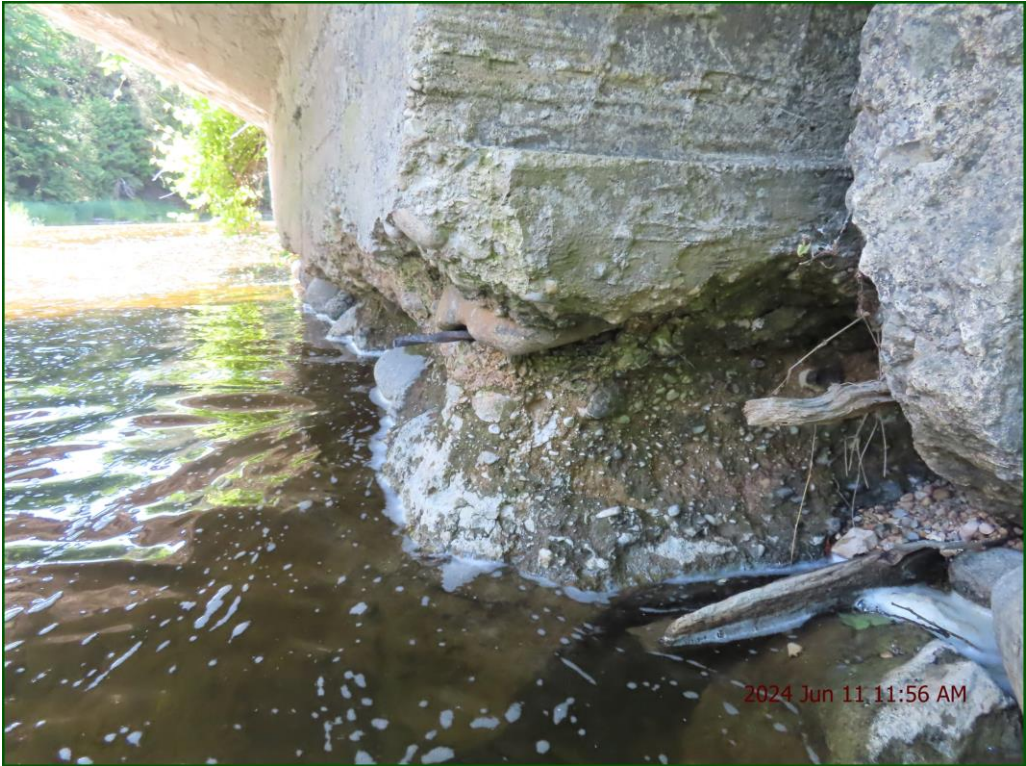
Description: Abutment Walls: Severe scouring and disintegration (2/3).

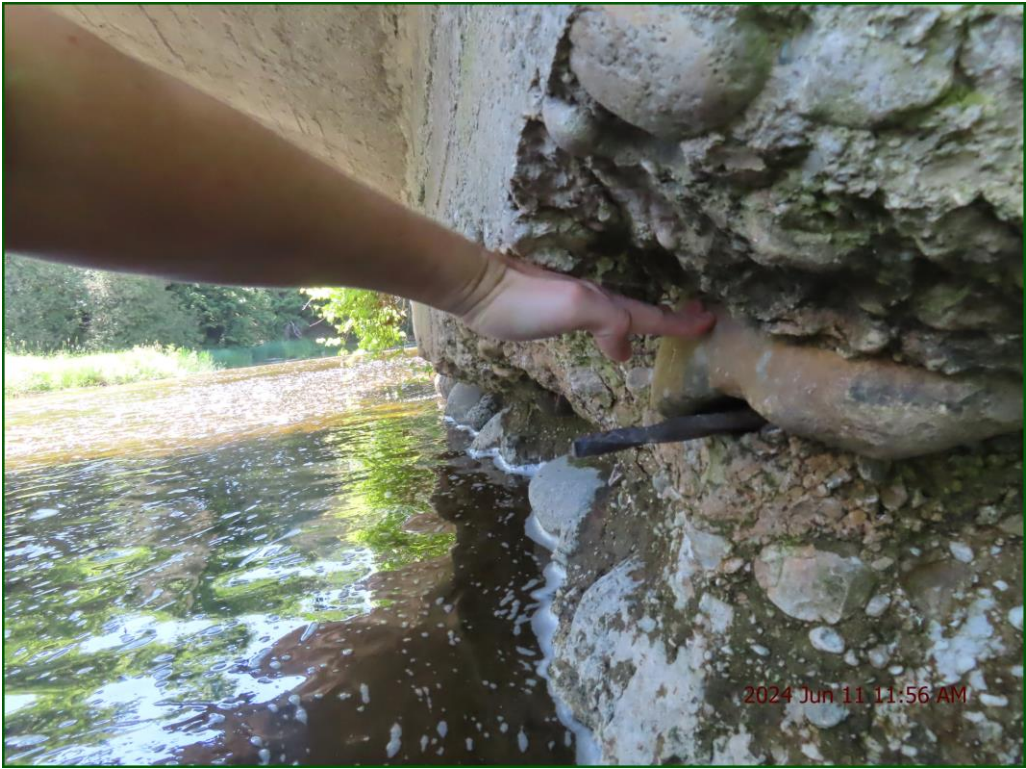
Description: Abutment Walls: Severe scouring and disintegration (3/3).

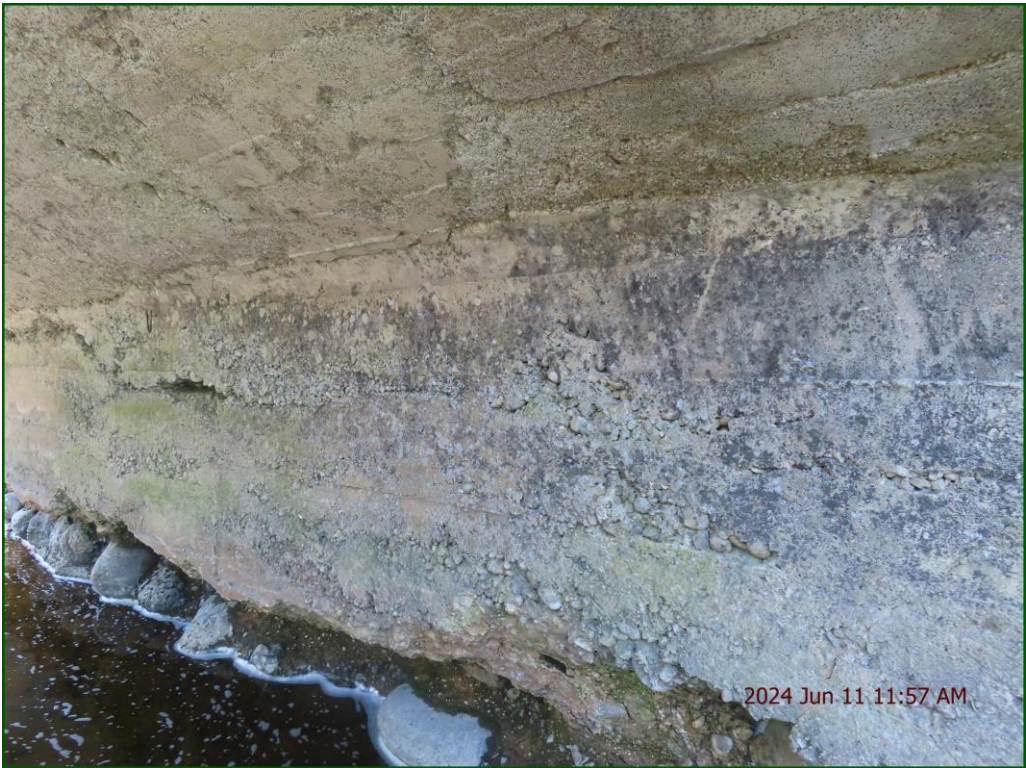
Description: Abutment Walls: Light to severe honeycombing throughout.

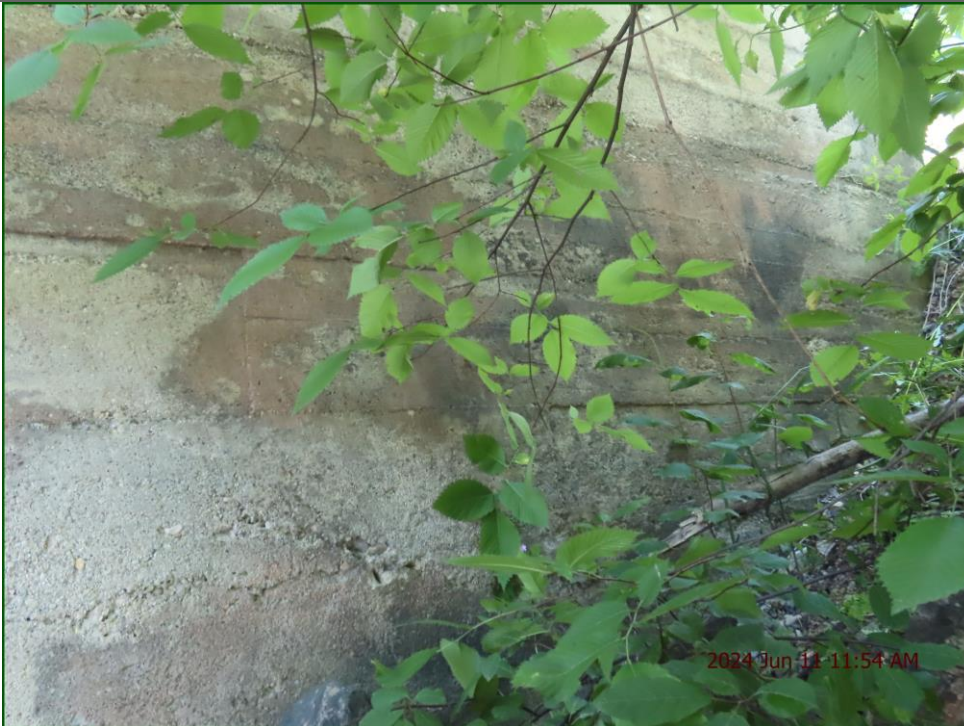
Light to medium honeycombing throughout. Severe scouring causing disintegration on west wingwalls.

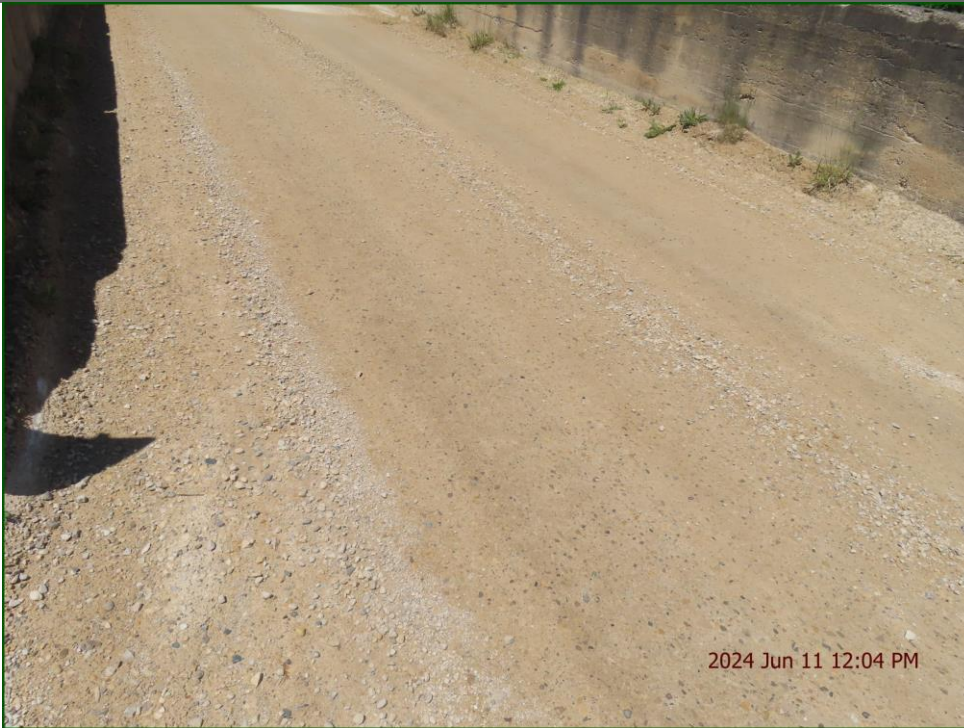
Erosion on NW quadrant encroaching on approach surface.

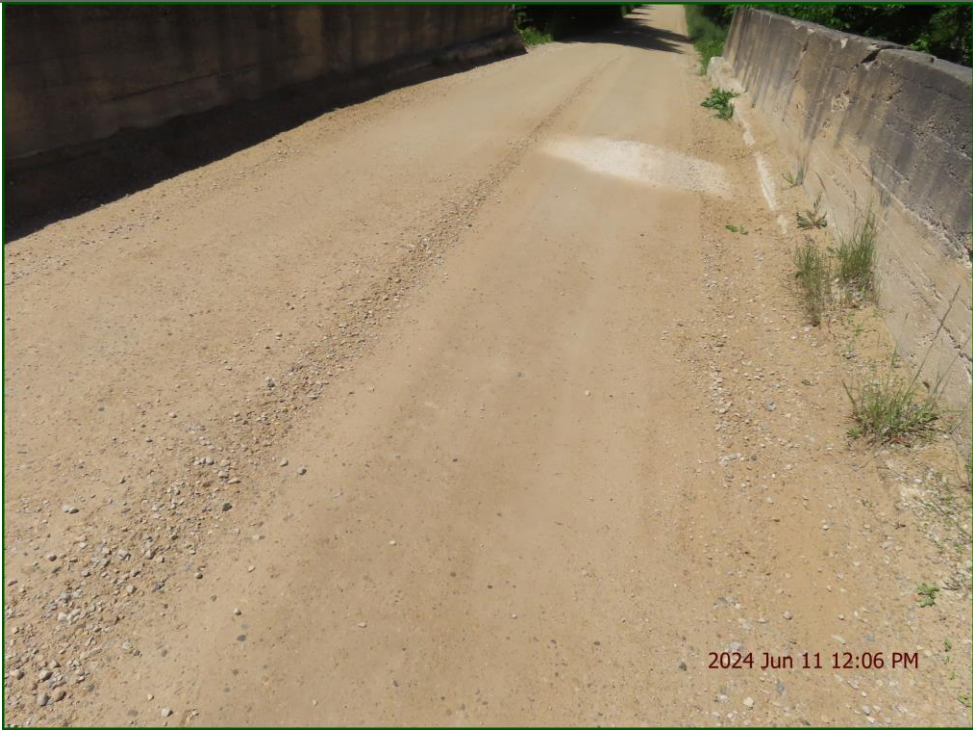
Moderate to severe potholes with localized areas of exposed deck top.

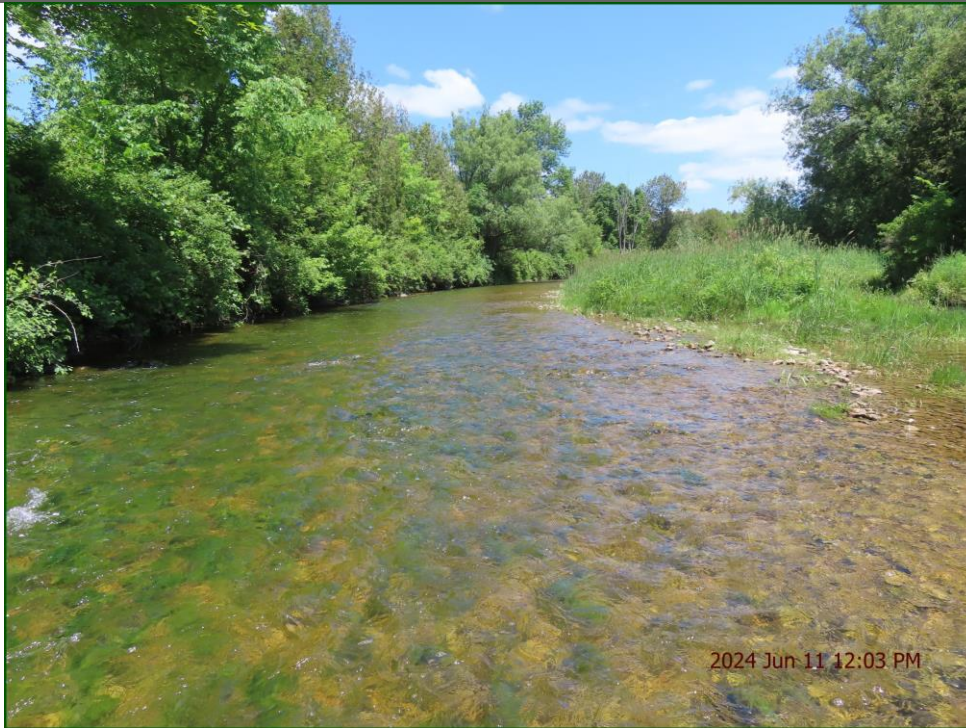
Stream has been diverted to west abutment causing erosion.

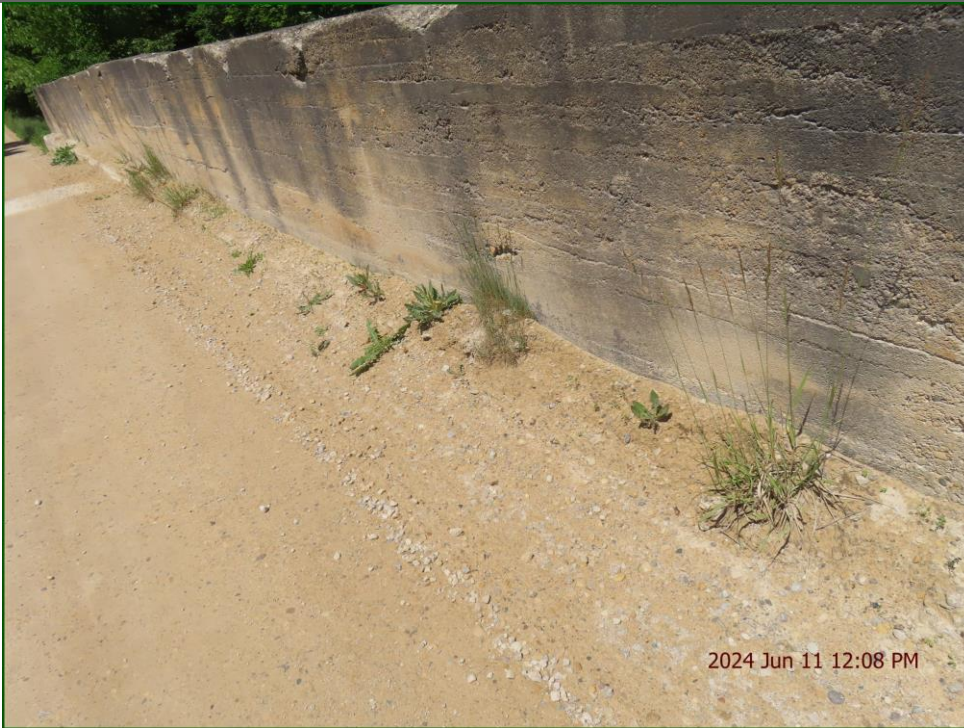
Severe spalling and disintegration throughout. Limited inspection due to gravel build up.

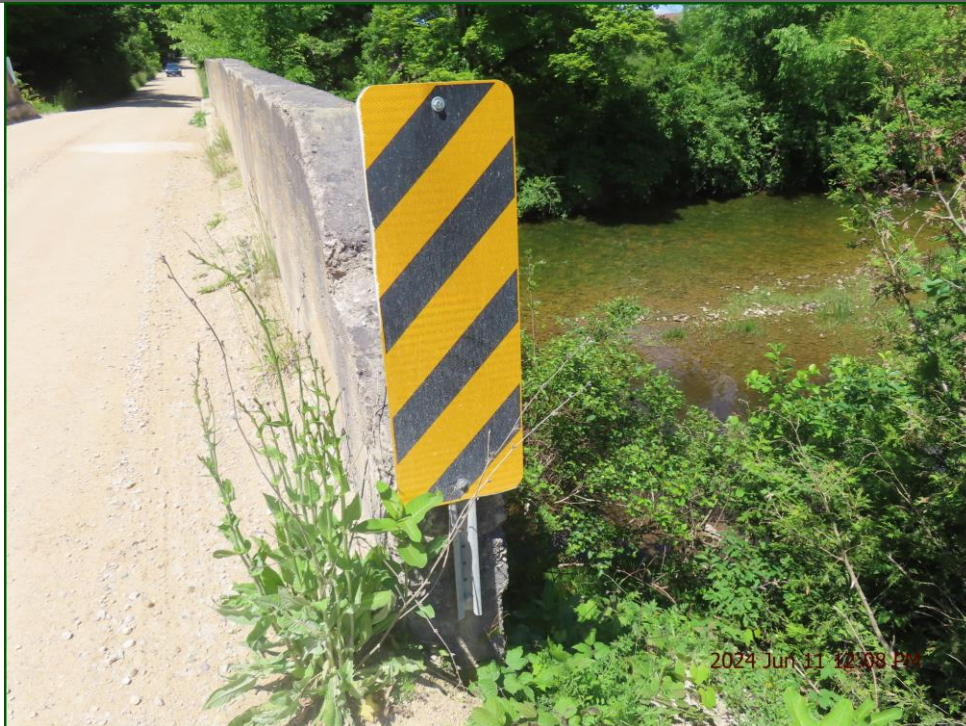
Minor impact damage at SW quadrant.

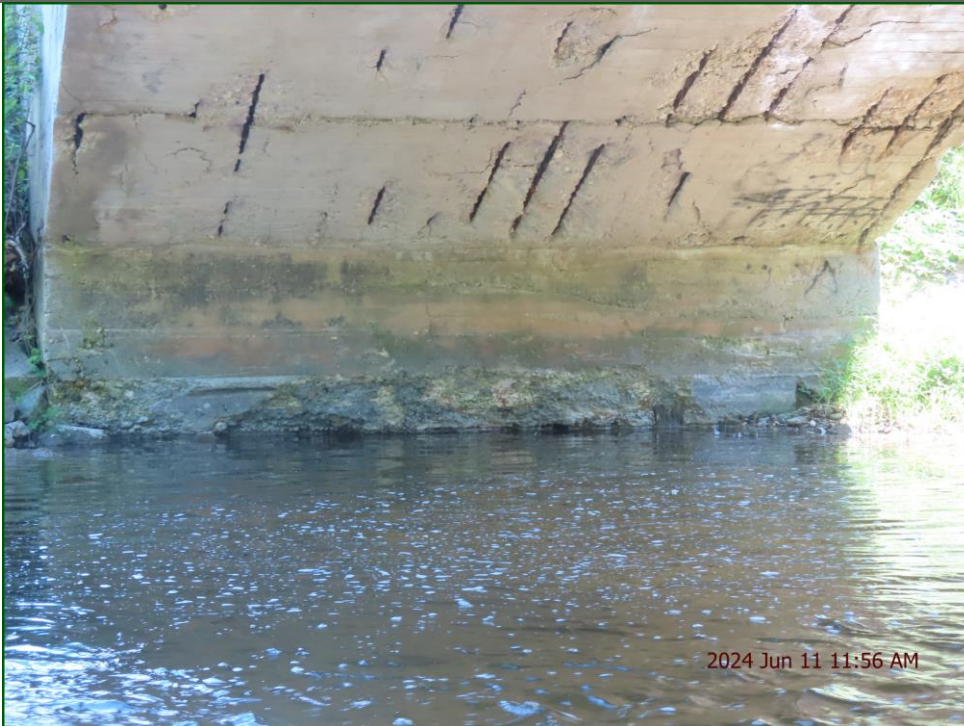
Moderate to severe scouring causing disintegration on east abutment. Severe scouring and disintegration causing west abutment to be completely undermined. Light to severe honeycombing throughout.

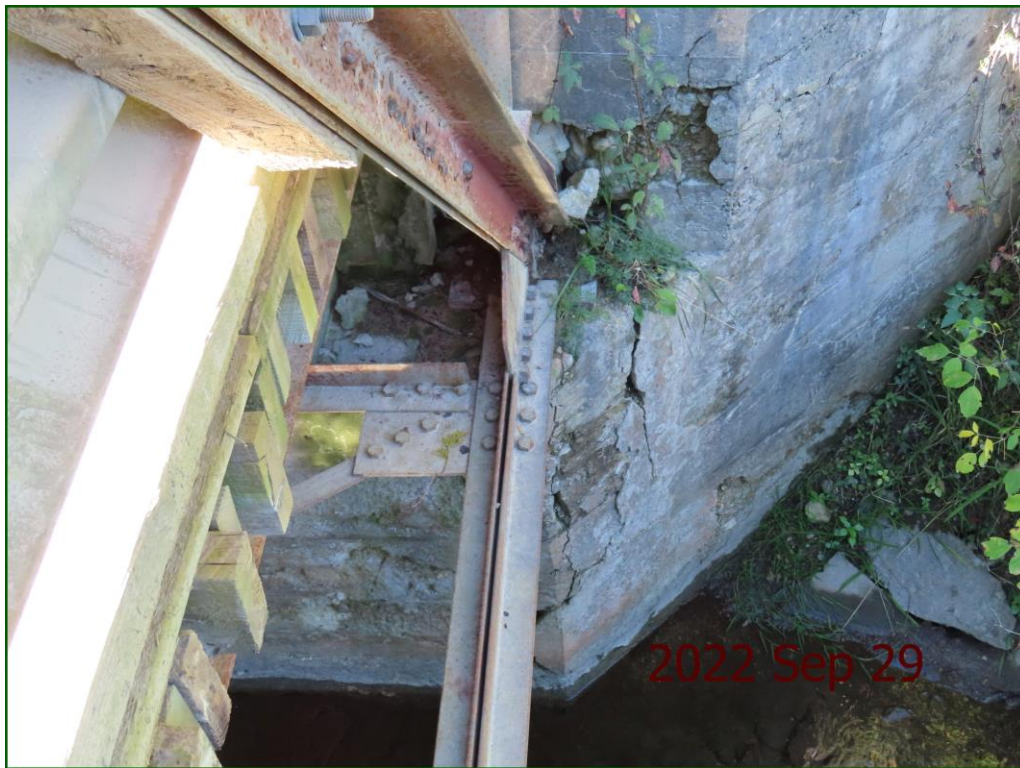
Description: Abutments: N-W Bearing seat cracking/crushing

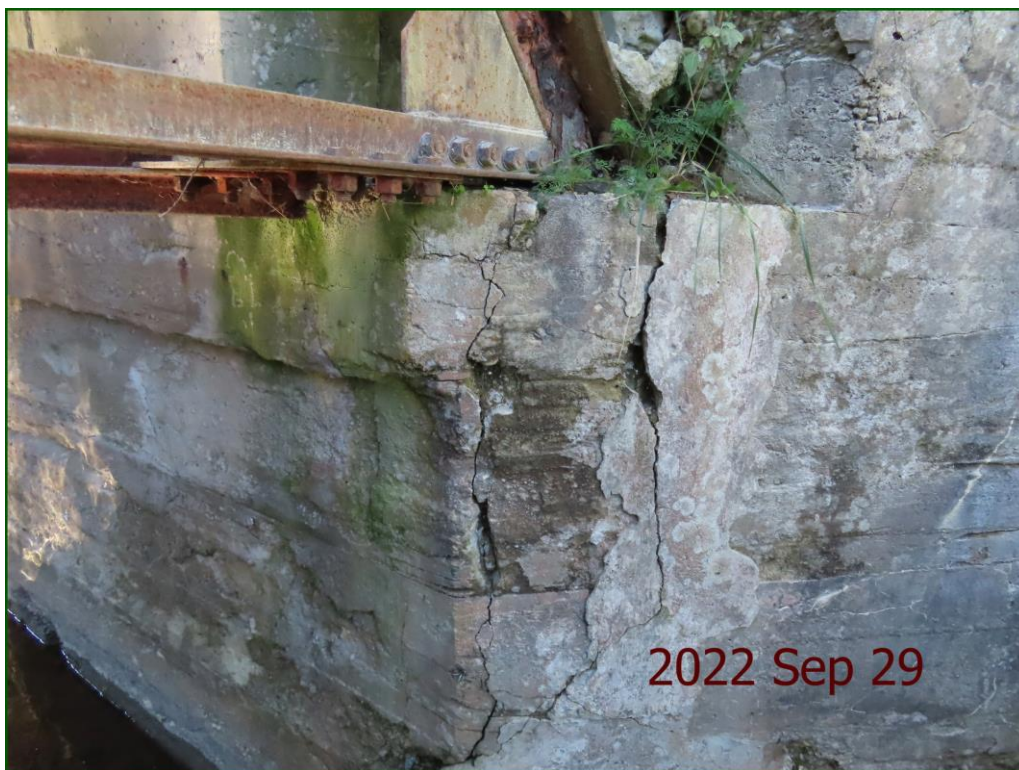
Description: Abutments: N-W Bearing seat cracking/crushing

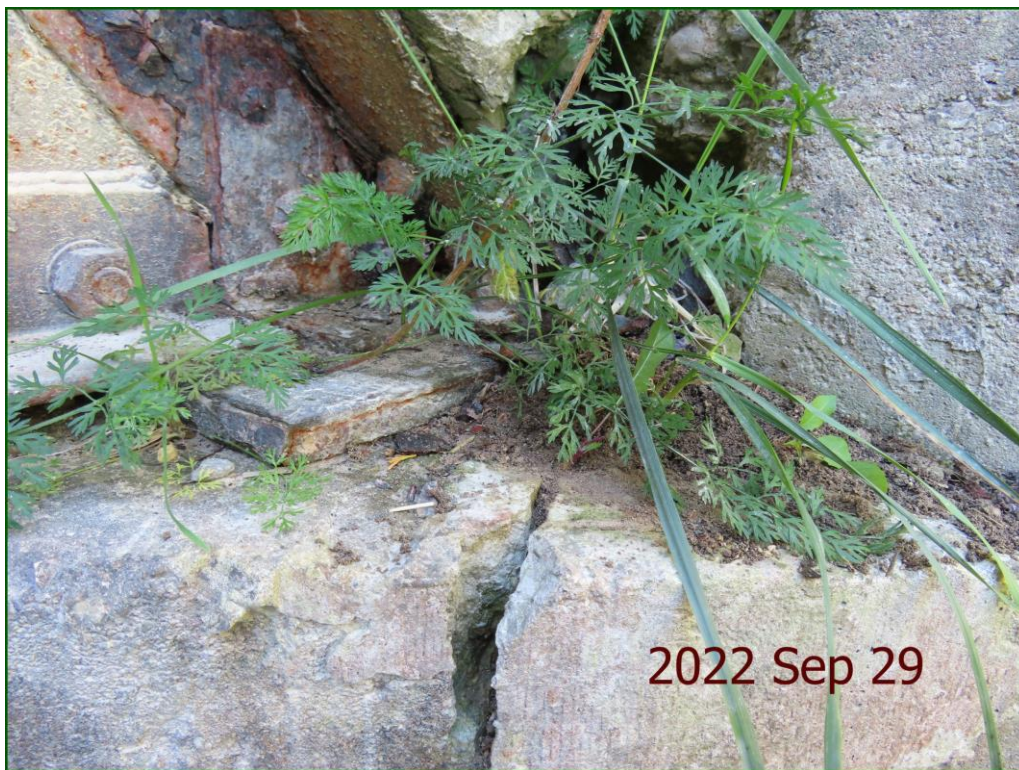
Description: Abutments: N-W Bearing seat cracking/crushing

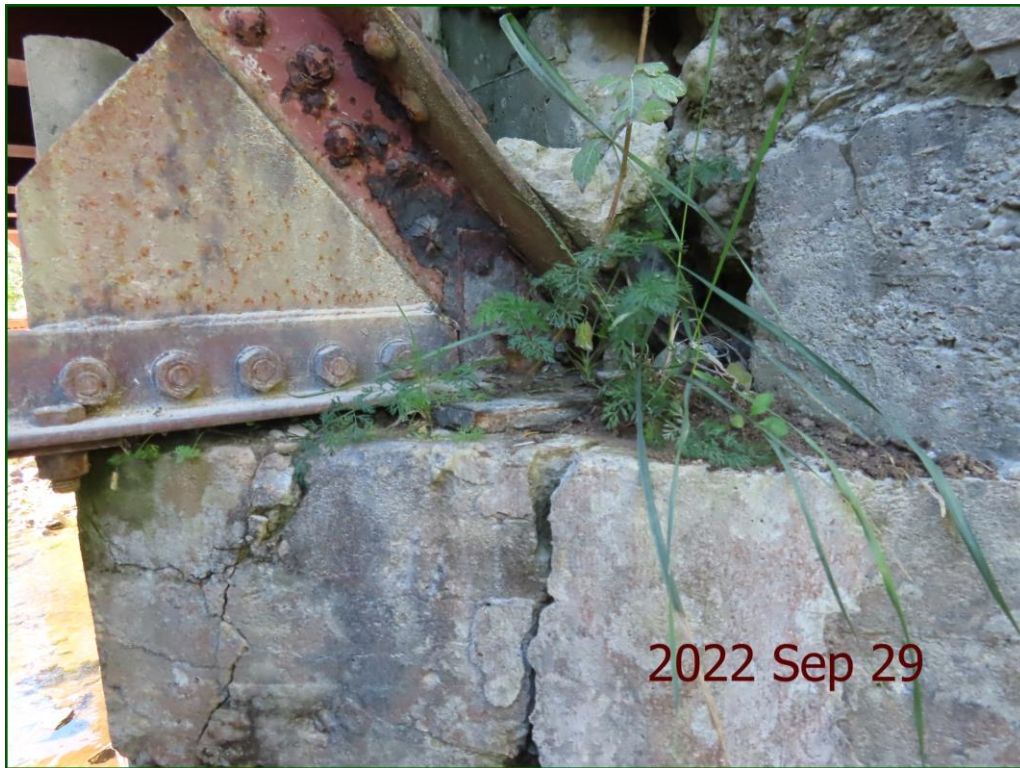
Description: Abutments: N-W Bearing seat cracking/crushing

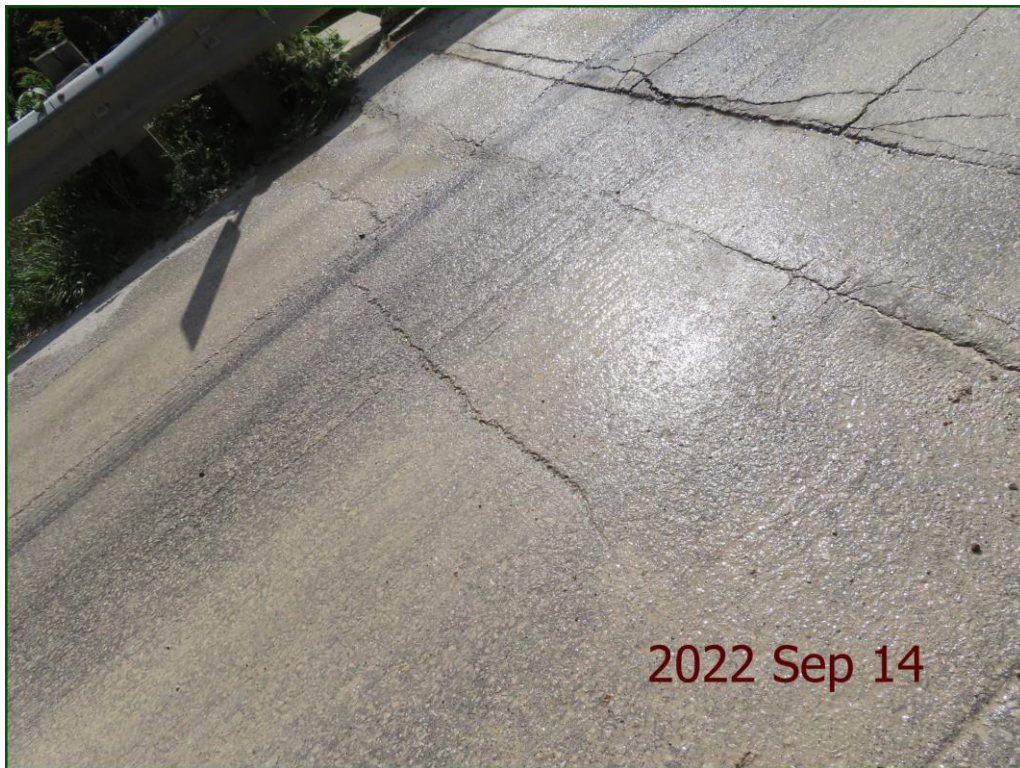
Description: Approach wearing surface: Medium transverse cracking.

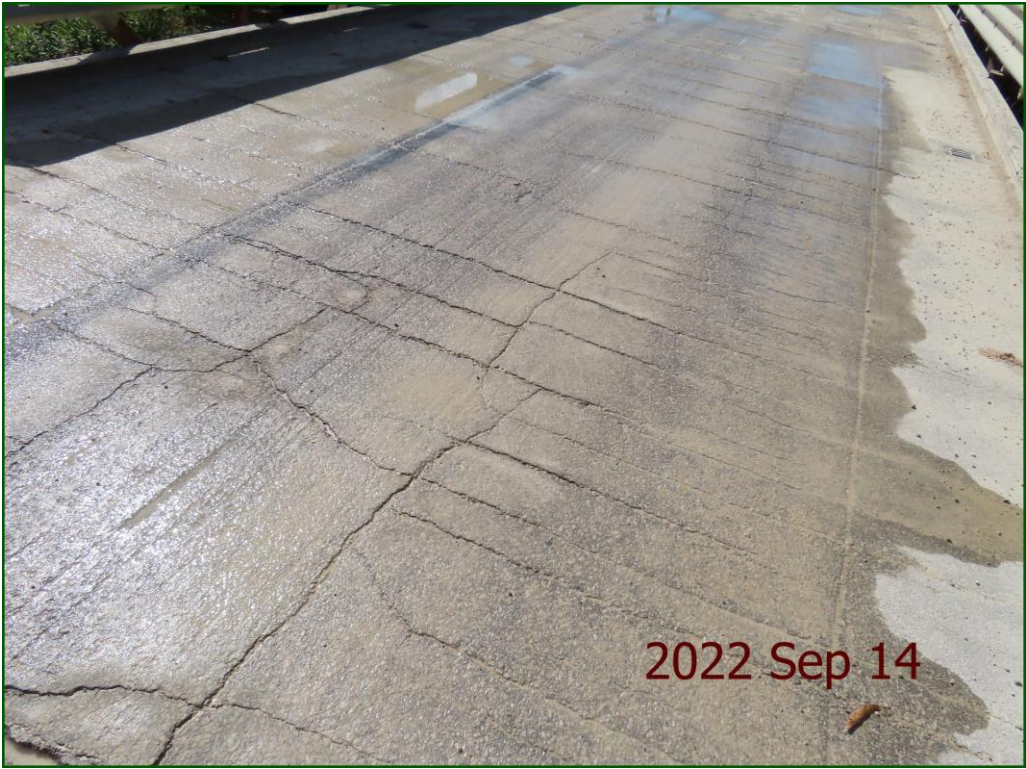
Description: Wearing surface: Medium to wide transverse and longitudinal cracking throughout.

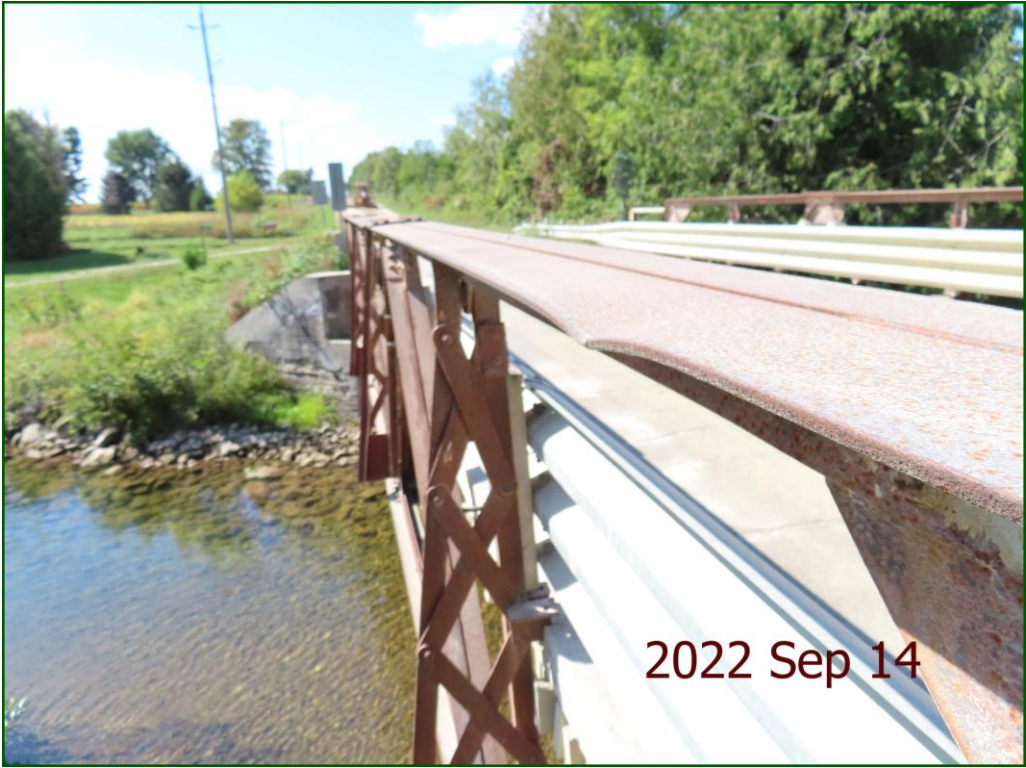
Description: Top chords: Minor impact damage.

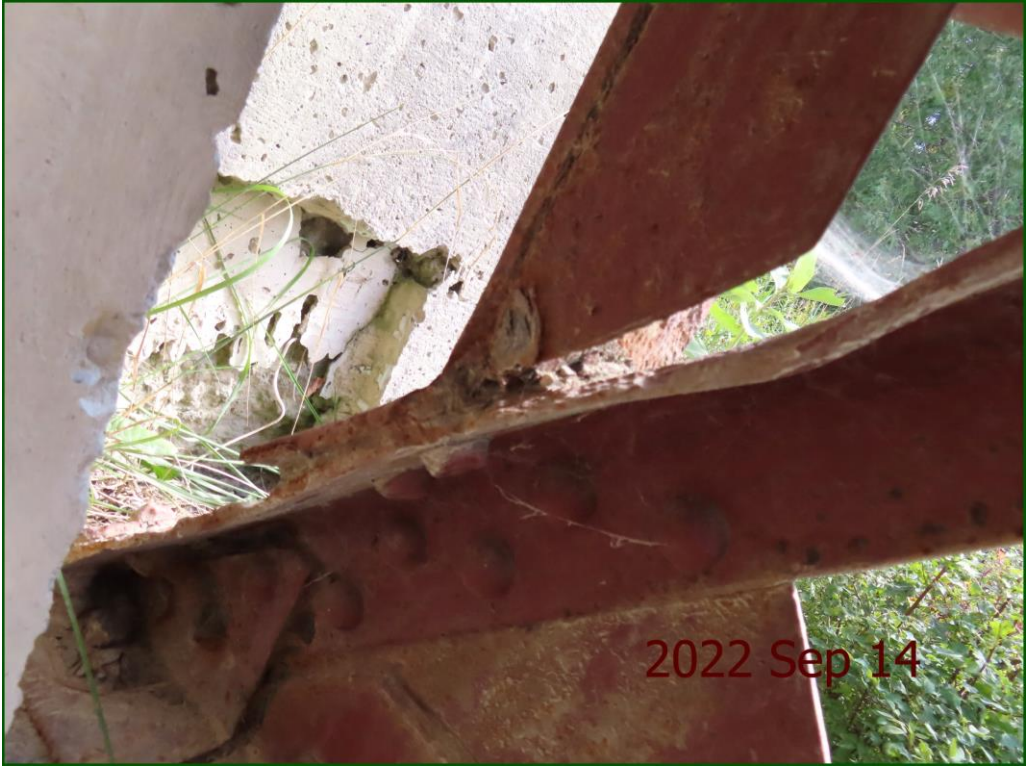
Description: Top chords: Medium corrosion with section loss at ends.
