MUNICIPALITY OF
West Grey

Municipality of West Grey
Bridge Prioritization Program

February 2025

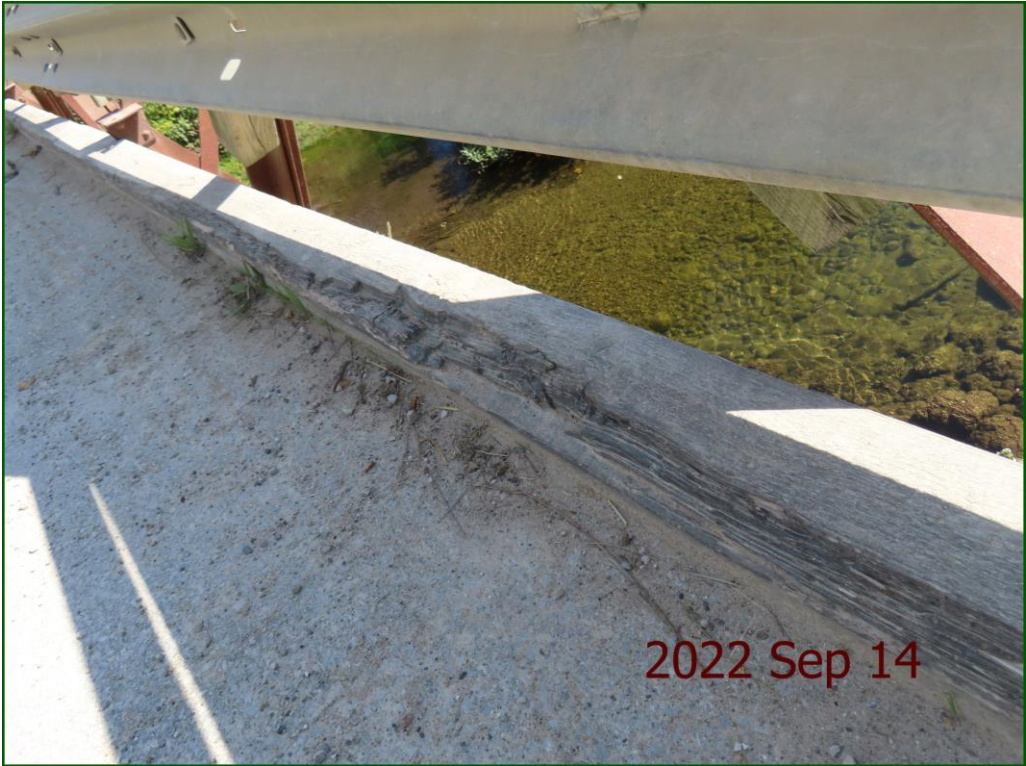
Description: Curbs: Medium abrasions throughout.

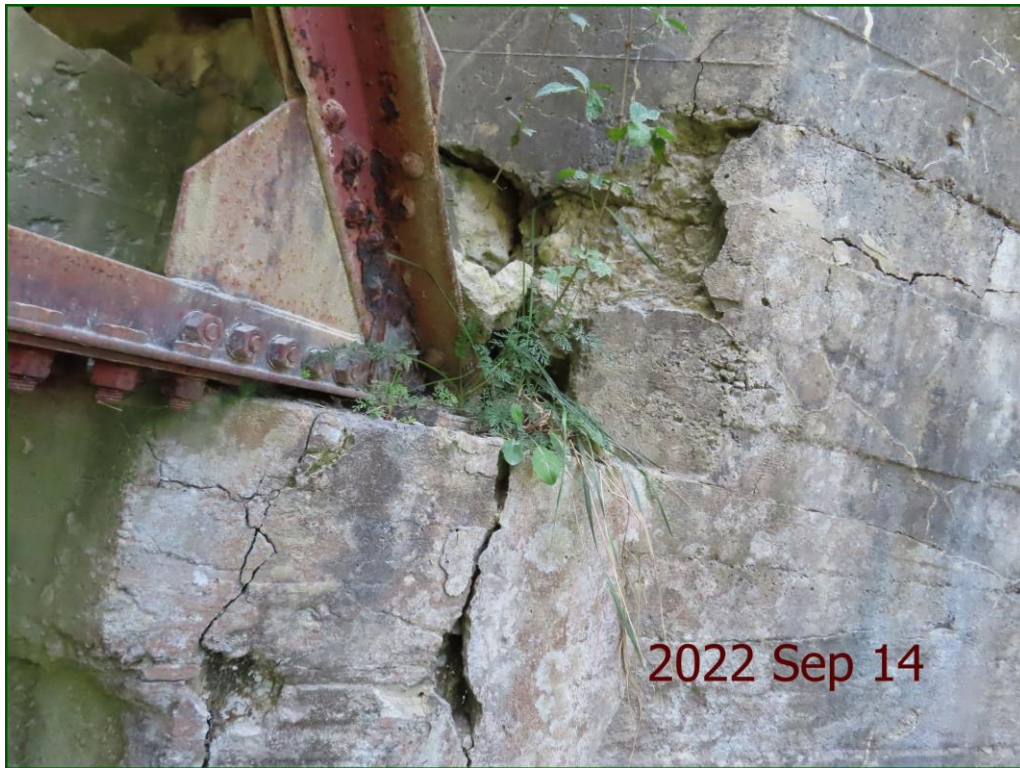
Description: Wingwalls: Severe spall and possible crushing.

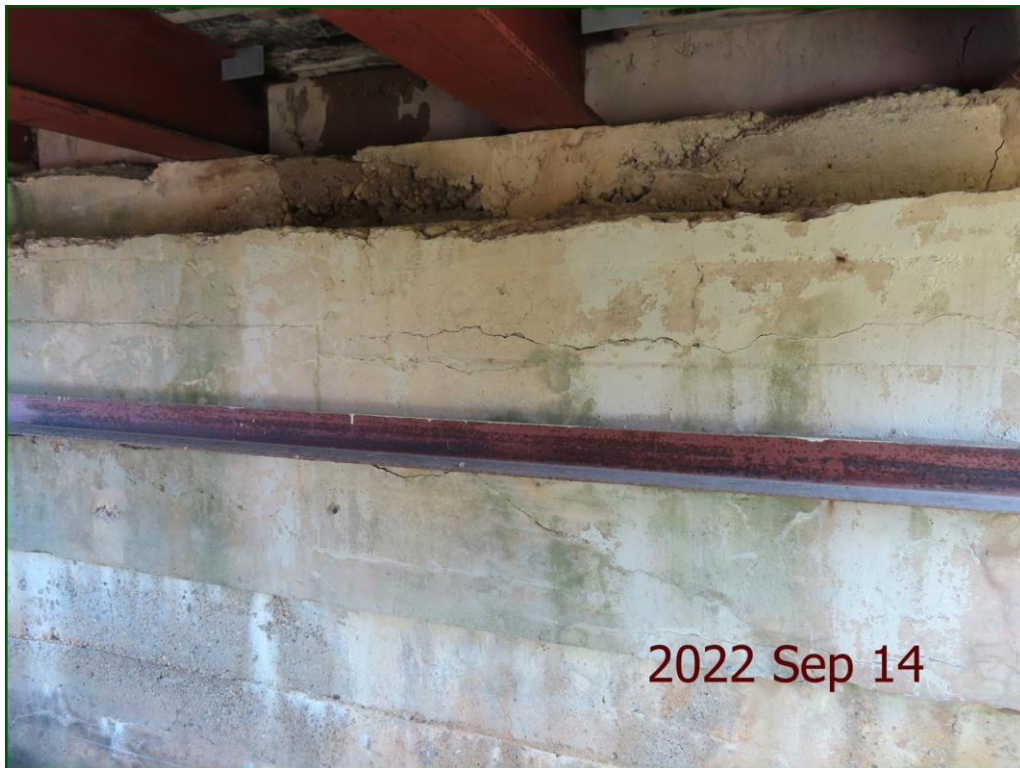
Description: Abutment walls: Medium to wide horizontal cracking.

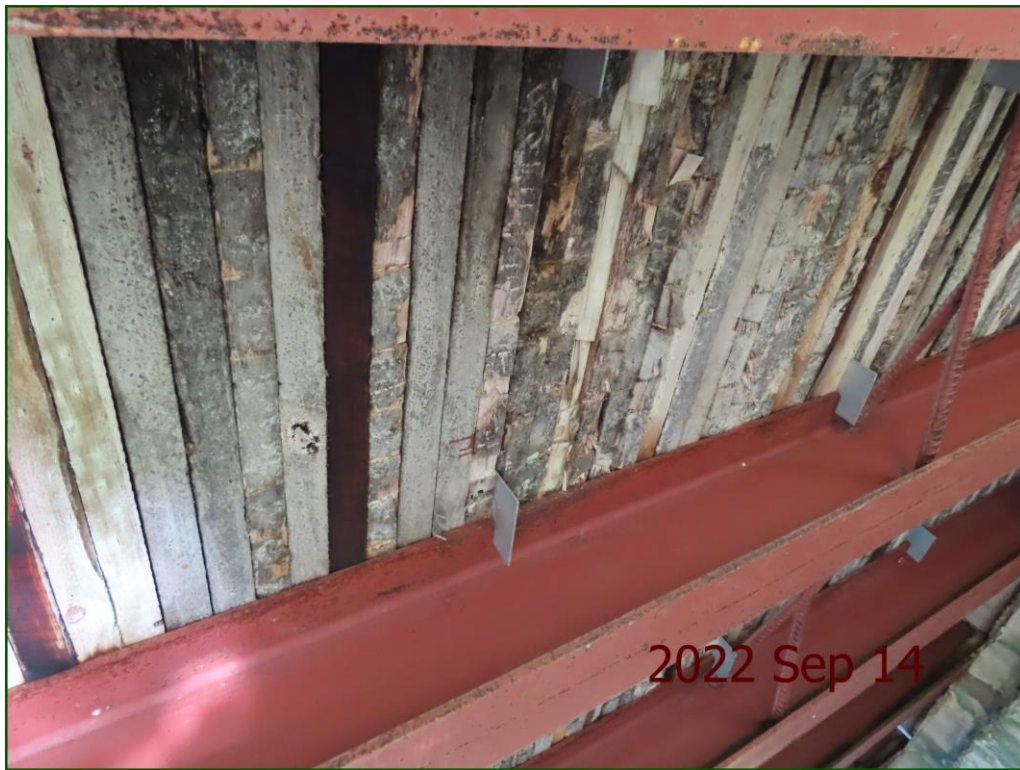
Description: Soffit: Minor abrasions throughout.

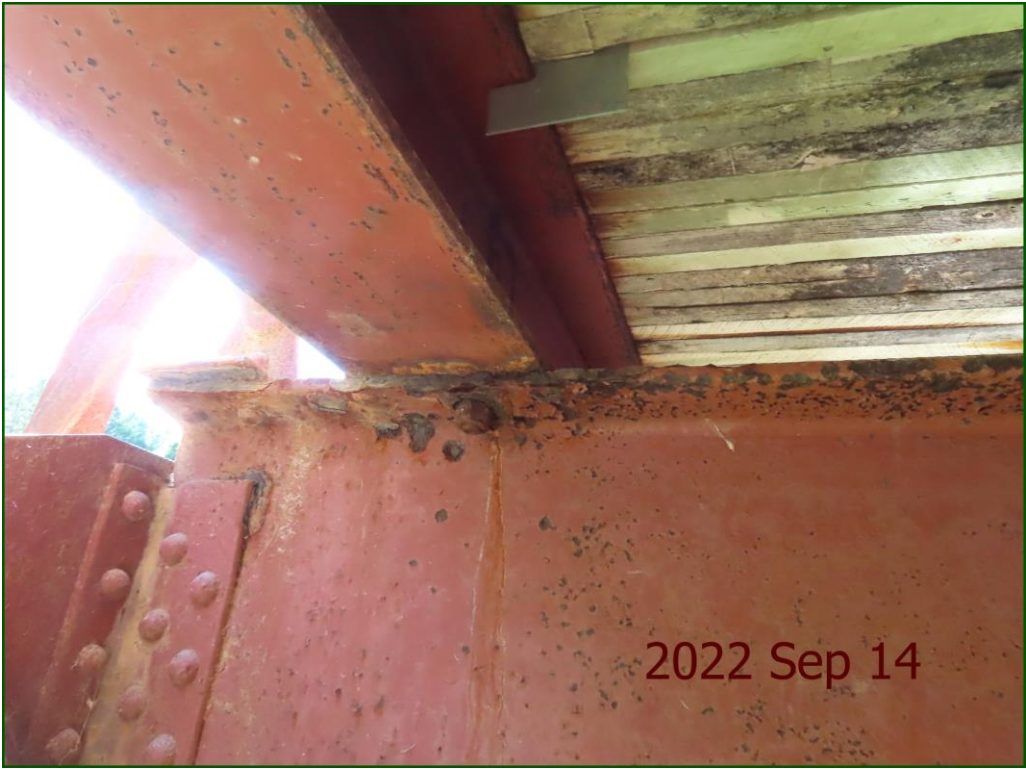
Description: Floor beams: Light to medium corrosion throughout.

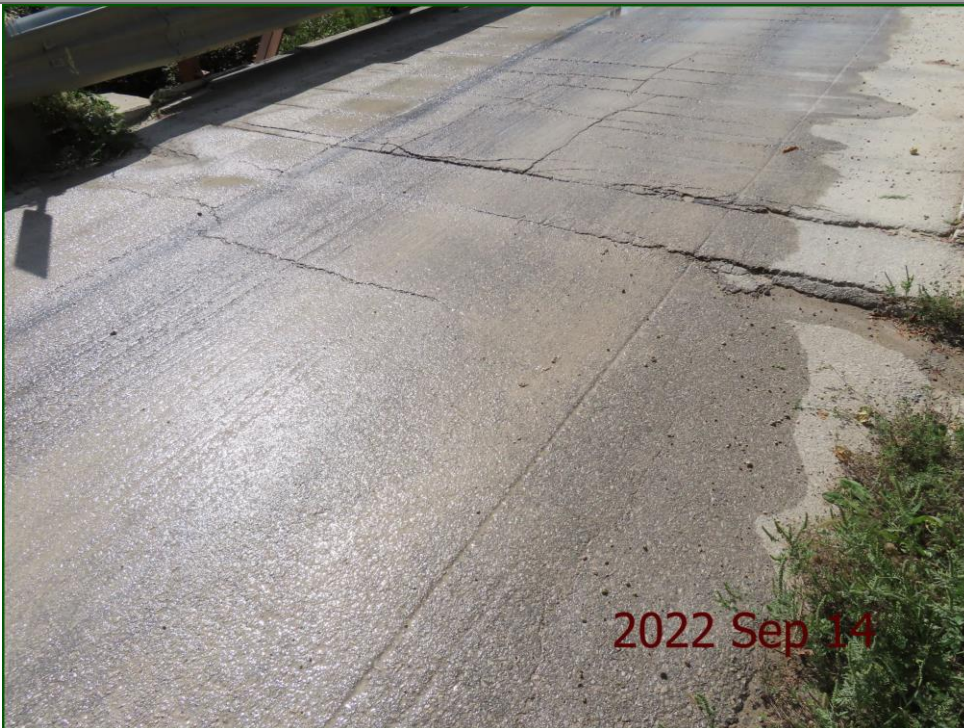
Medium transverse cracking.

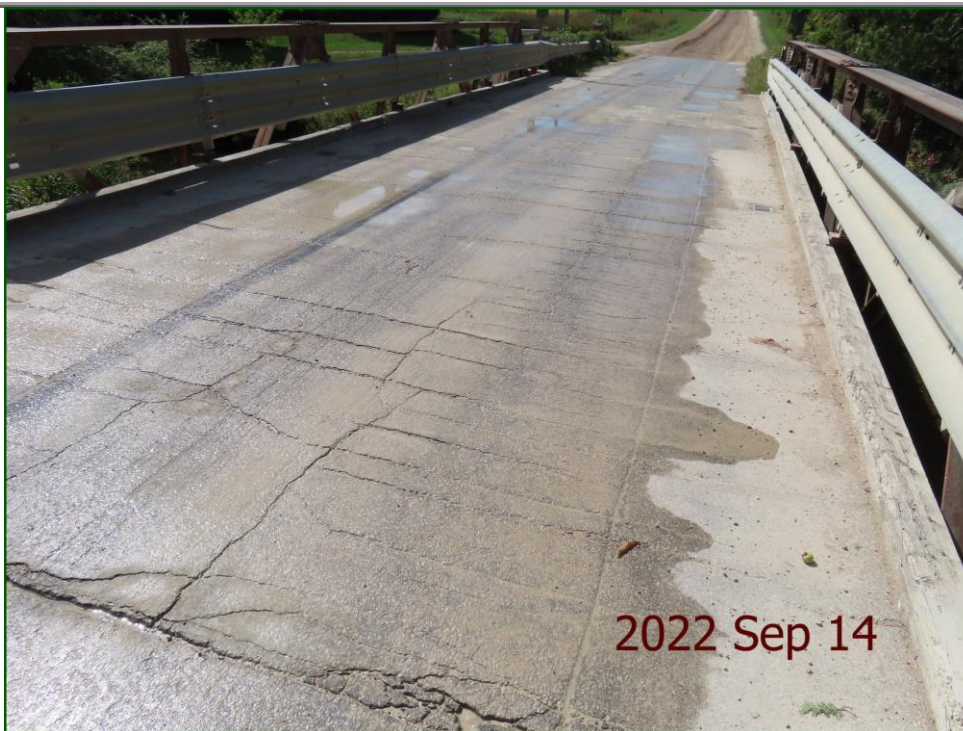
Medium to wide transverse and longitudinal cracking throughout.

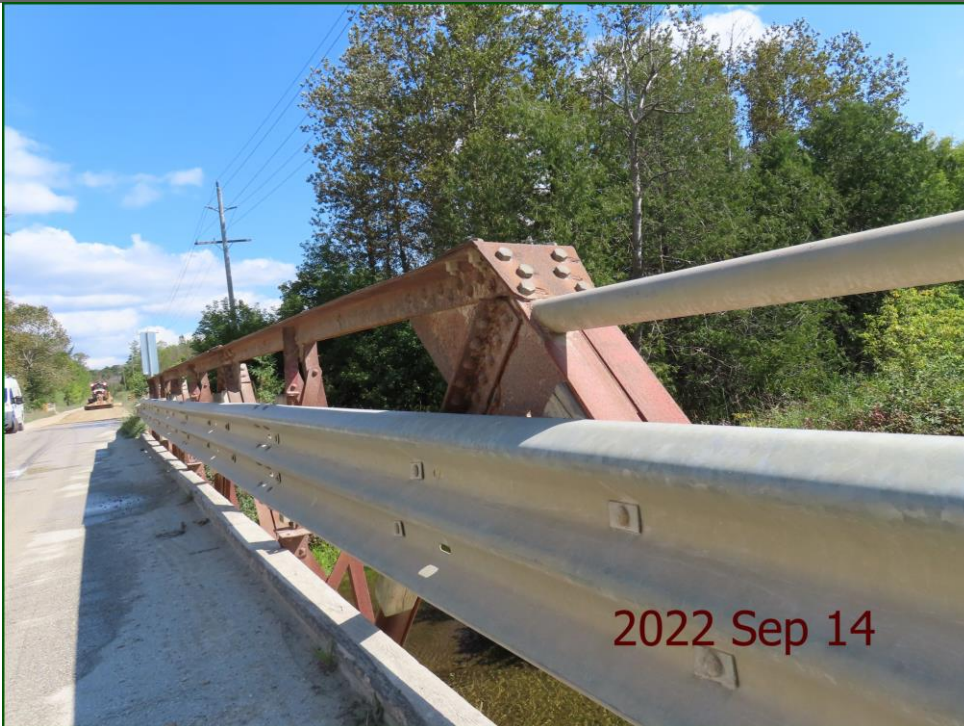
Minor impact damage. Medium corrosion with section loss at ends.

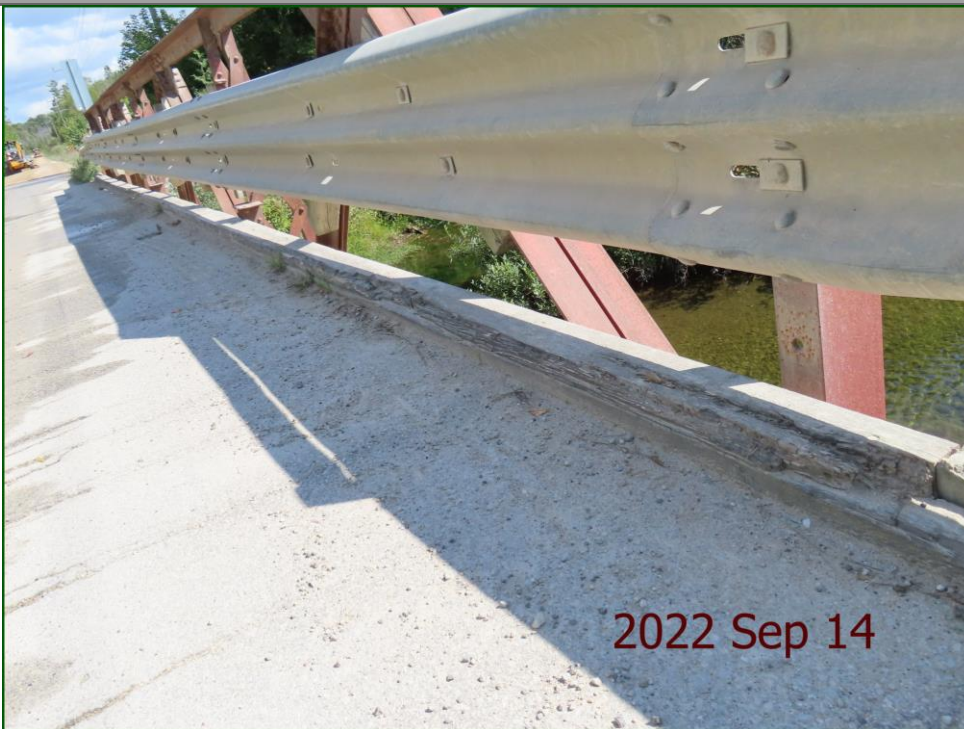
Moderate abrasions throughout.

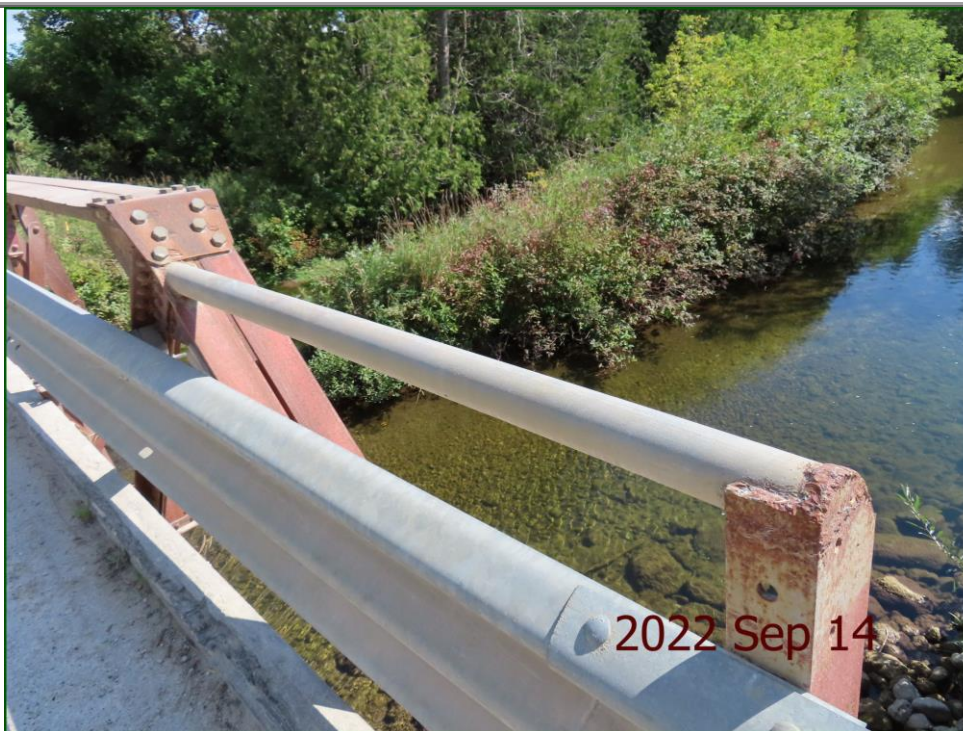
Hand railing welded to top chord, creating heat effected zone in steal.

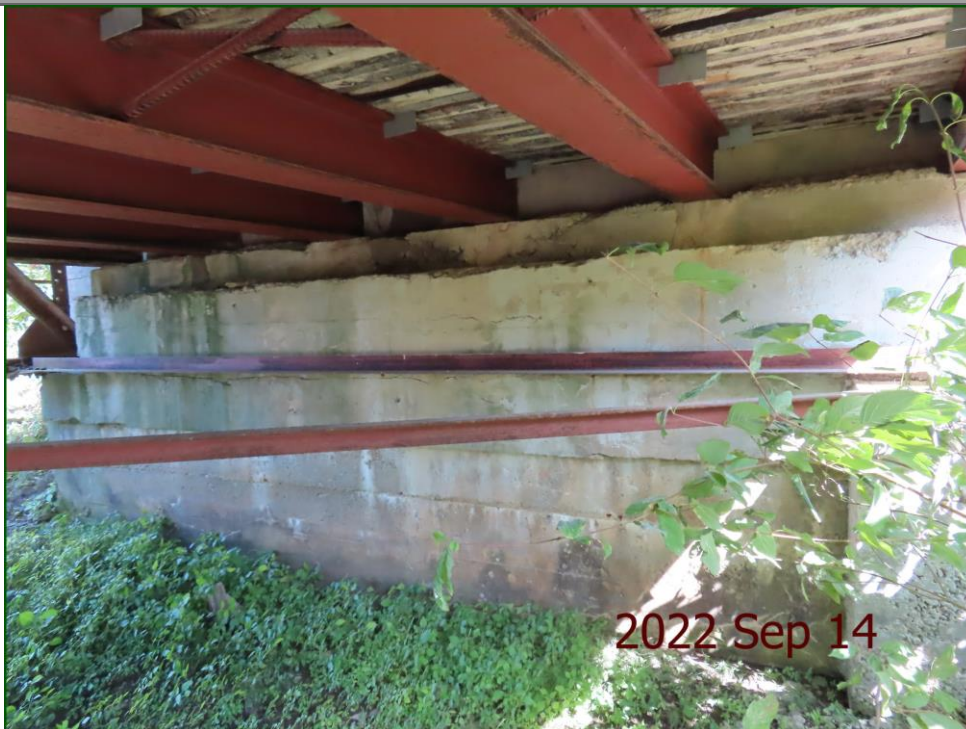
Medium to wide horizontal cracking.

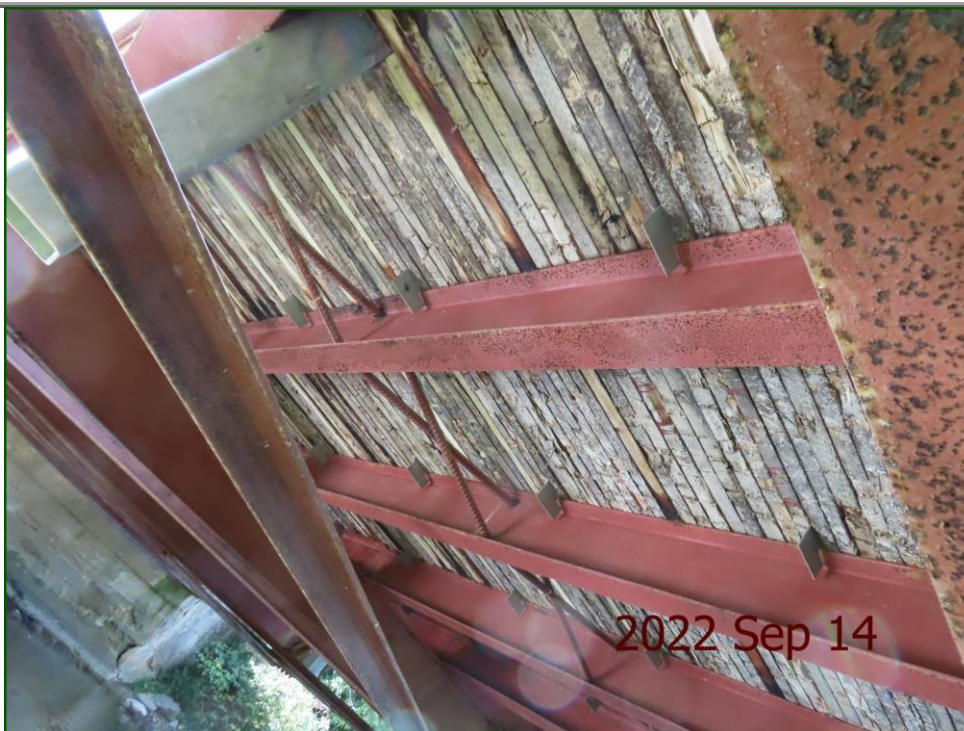
Minor abrasions throughout.

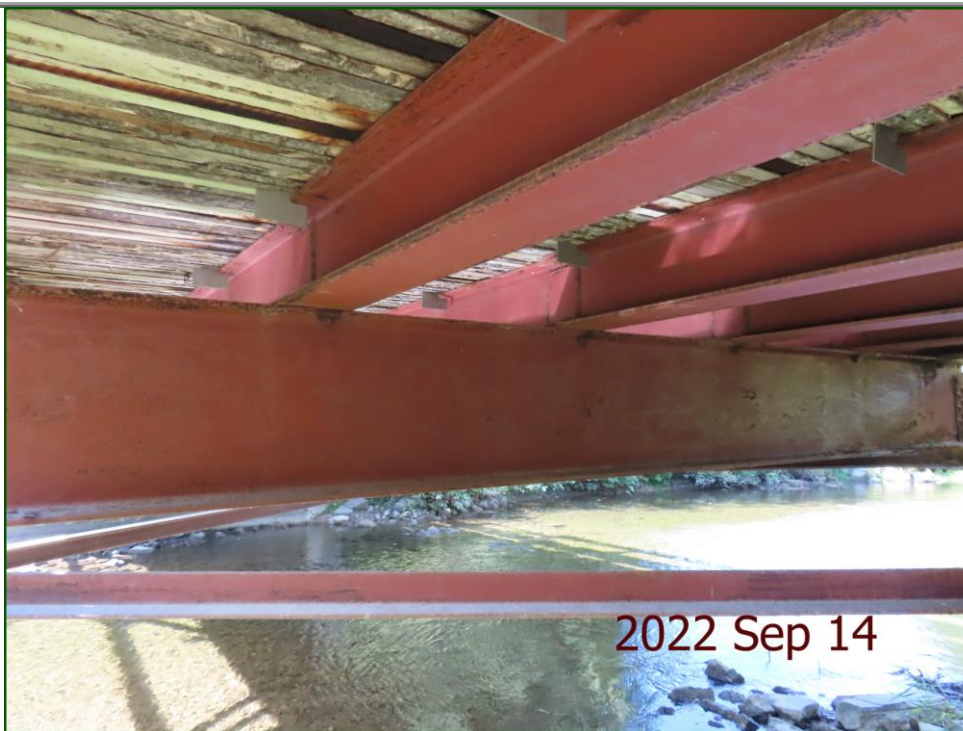
Light to medium corrosion throughout.

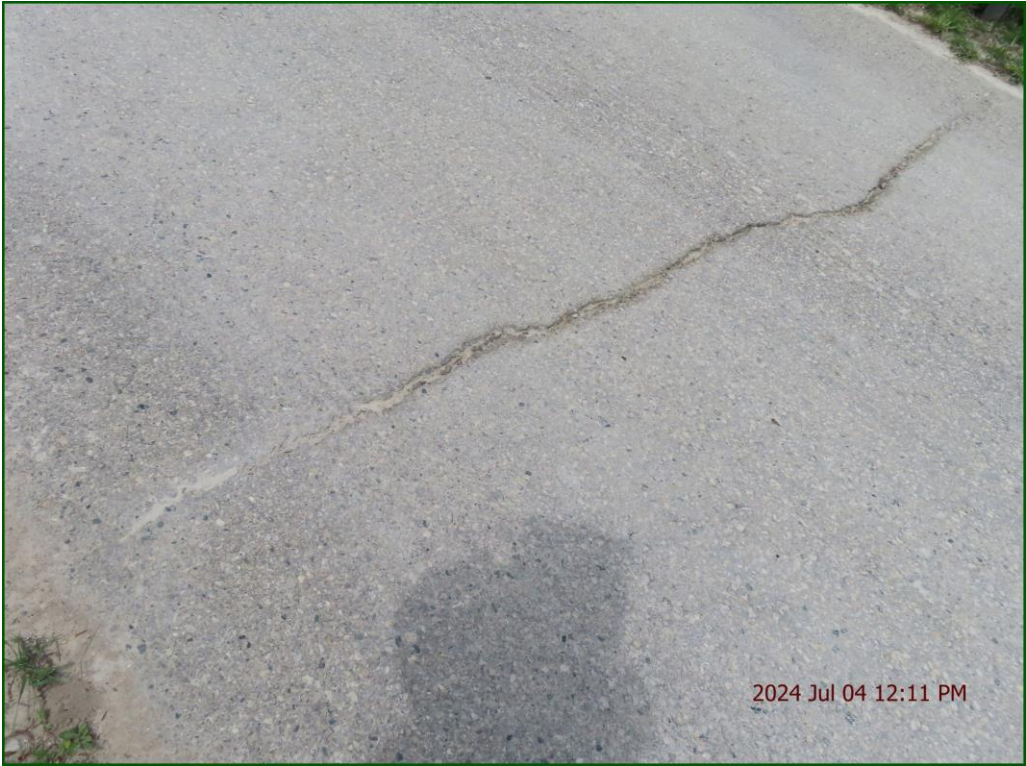
Description: Approach Wearing Surface: Wide transverse crack.

Wide transverse crack.

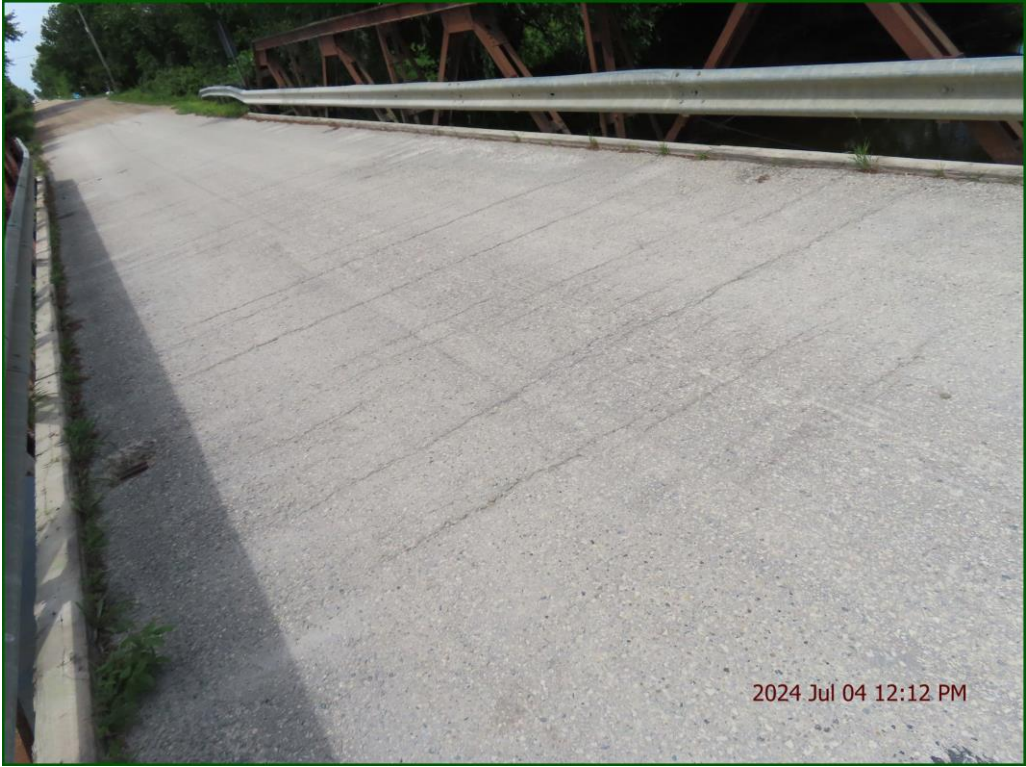
Description: Wearing Surface: Medium to wide transverse cracks throughout.

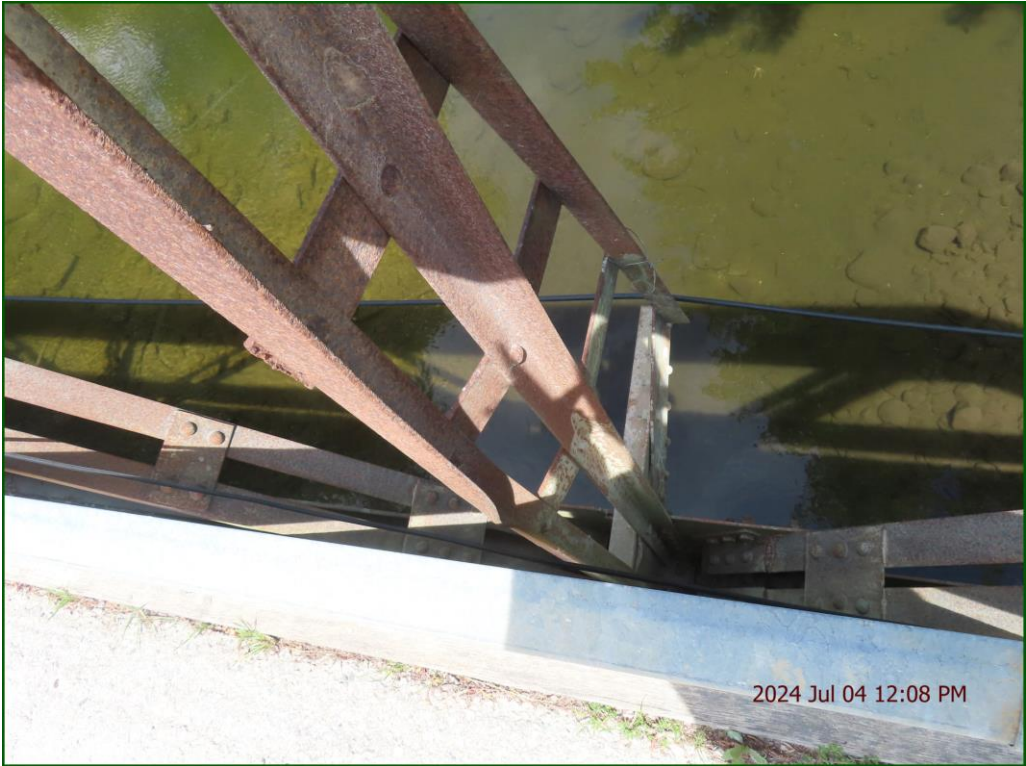
Description: Verticals: Severe impact damage resulting in bent vertical (1/2).

Severe impact damage resulting in bent vertical.

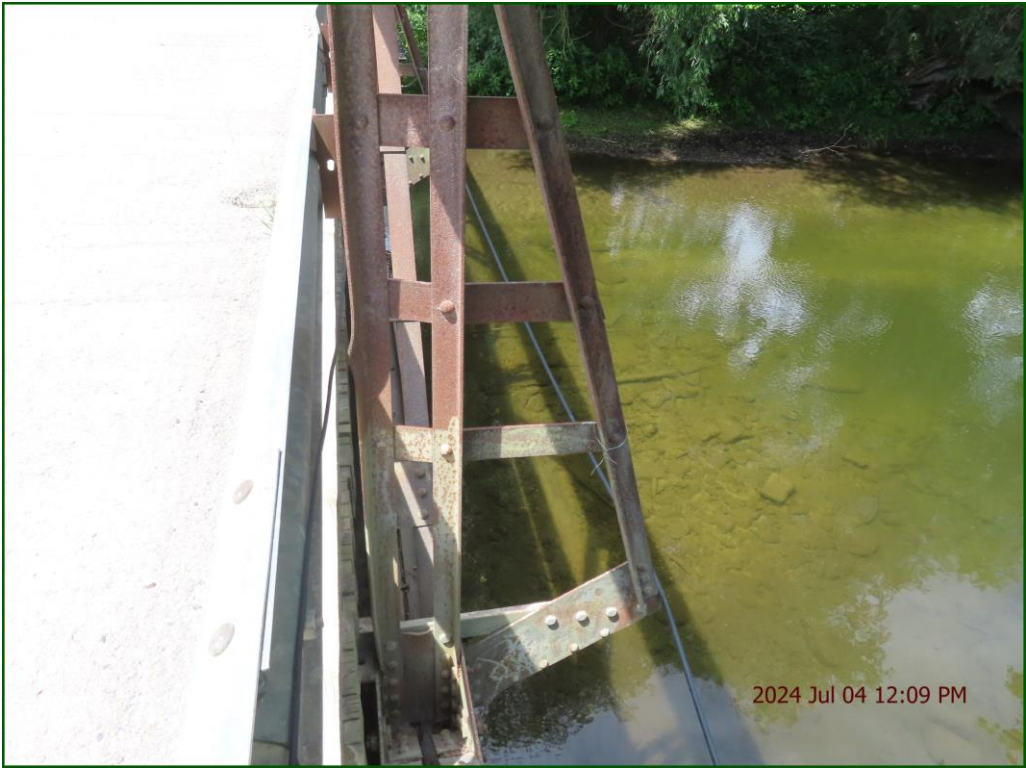
Description: Verticals: Severe impact damage resulting in bent vertical (2/2).

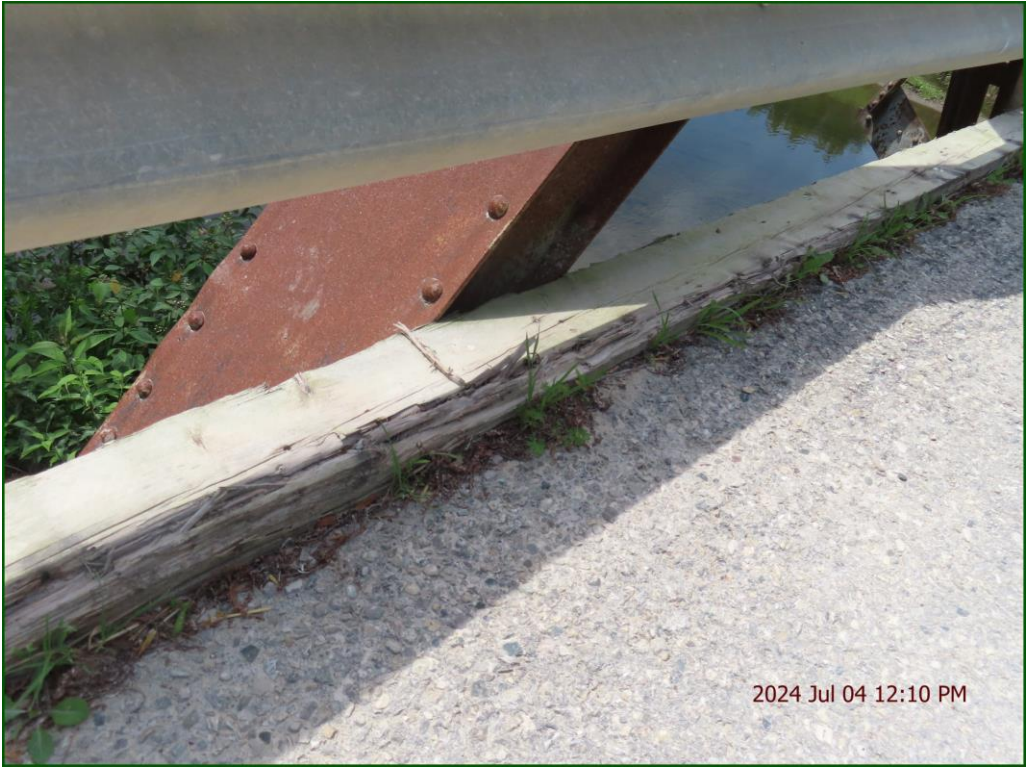
Description: Curbs: Minor abrasions throughout.

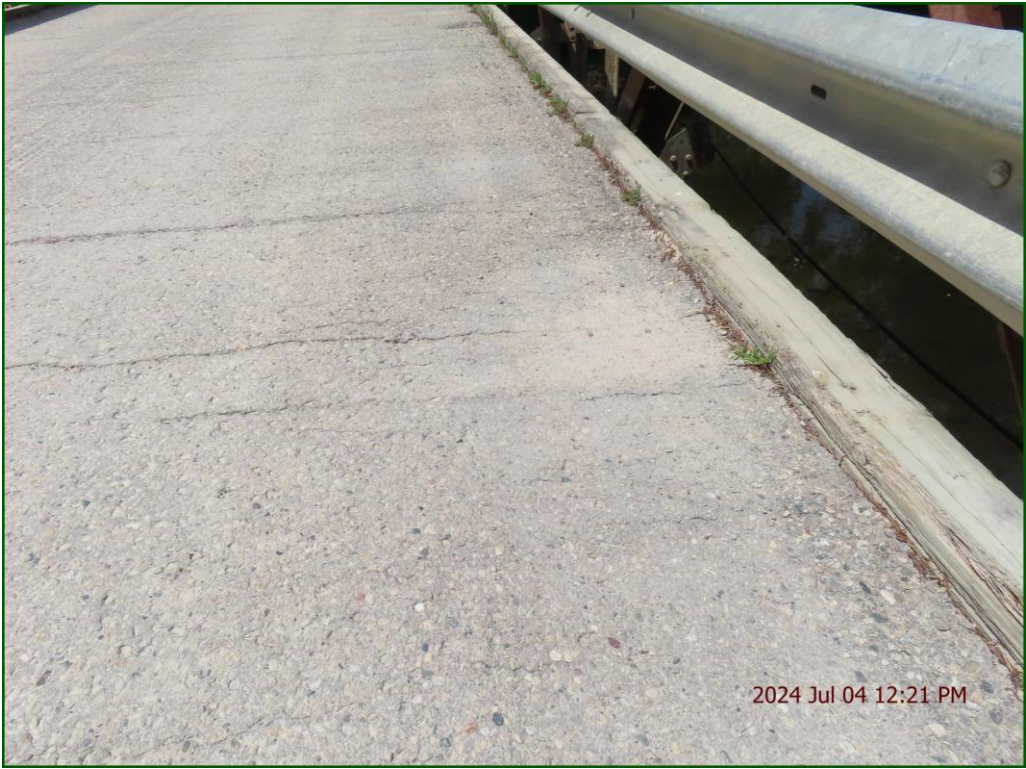
Description: Wearing Surface: Moderate to severe potholes in areas where deck/soffit has failed (1/4).

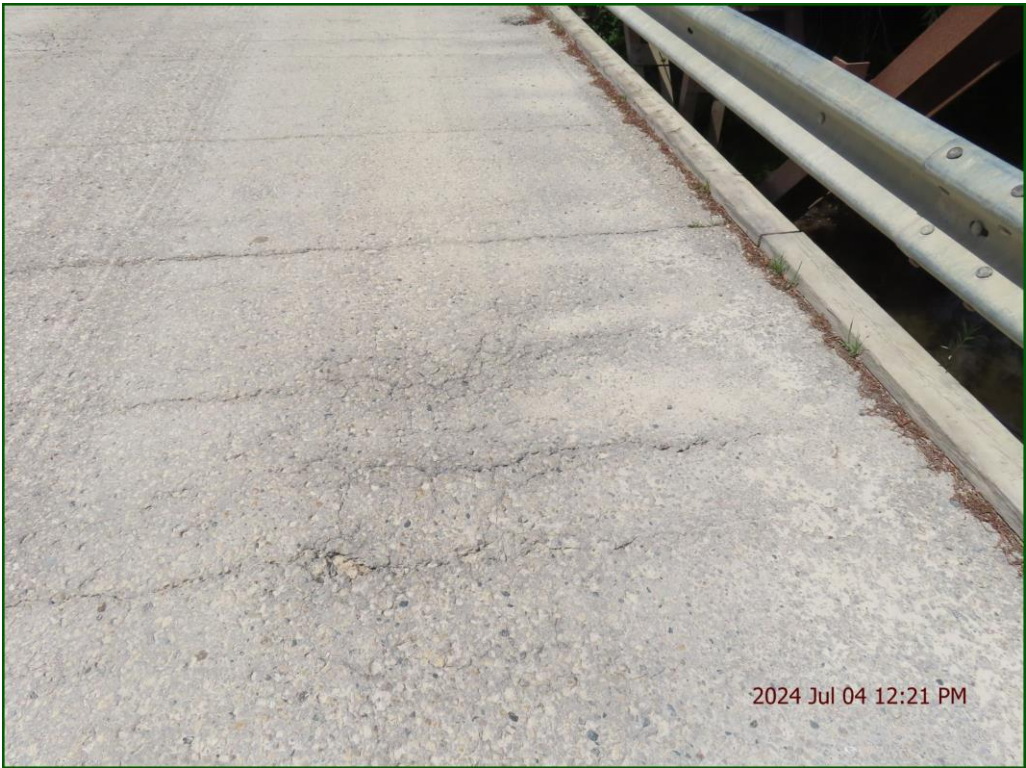
Description: Wearing Surface: Moderate to severe potholes in areas where deck/soffit has failed (2/4).

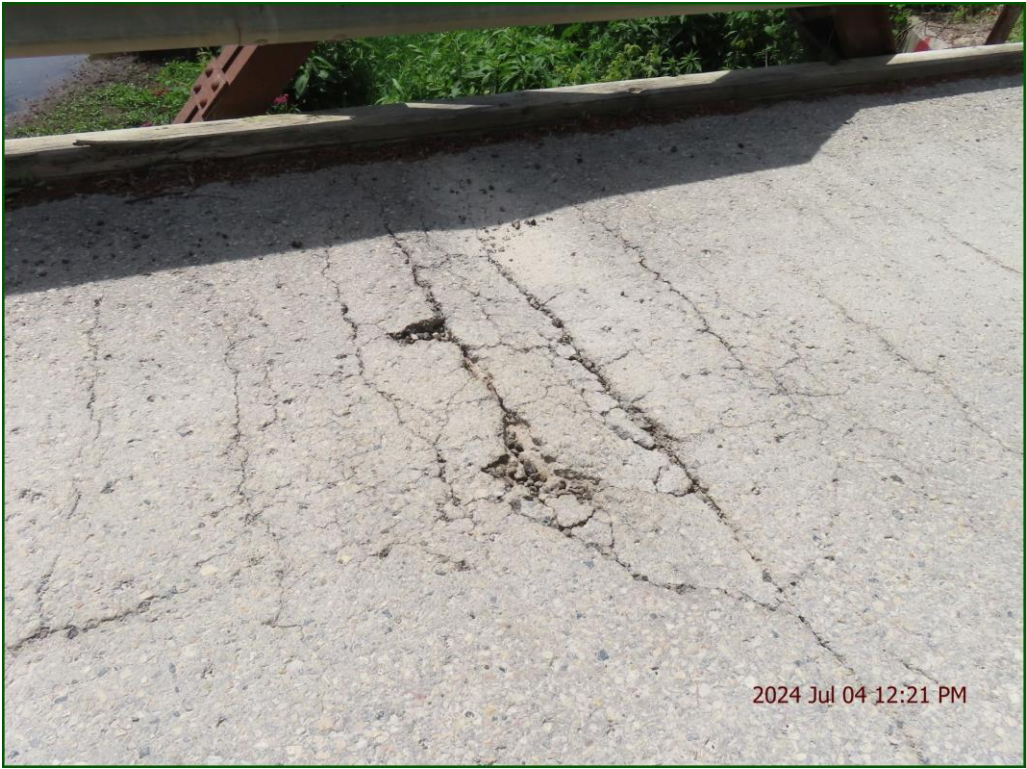
Description: Wearing Surface: Moderate to severe potholes in areas where deck/soffit has failed (3/4).

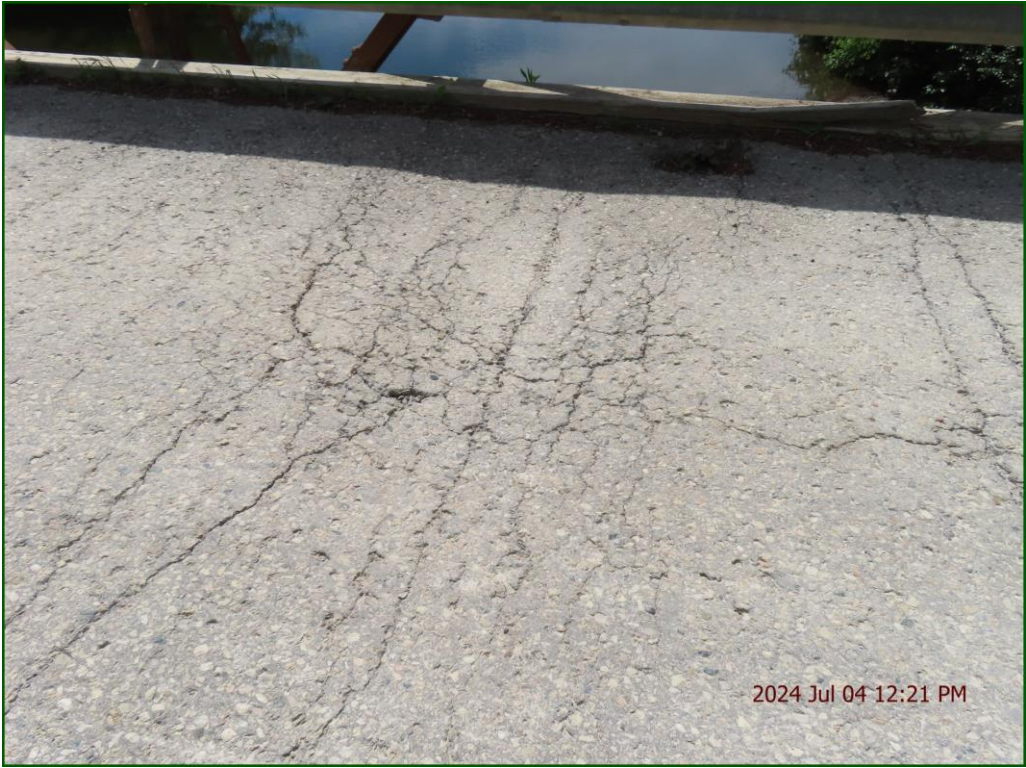
Description: Wearing Surface: Moderate to severe potholes in areas where deck/soffit has failed (4/4).

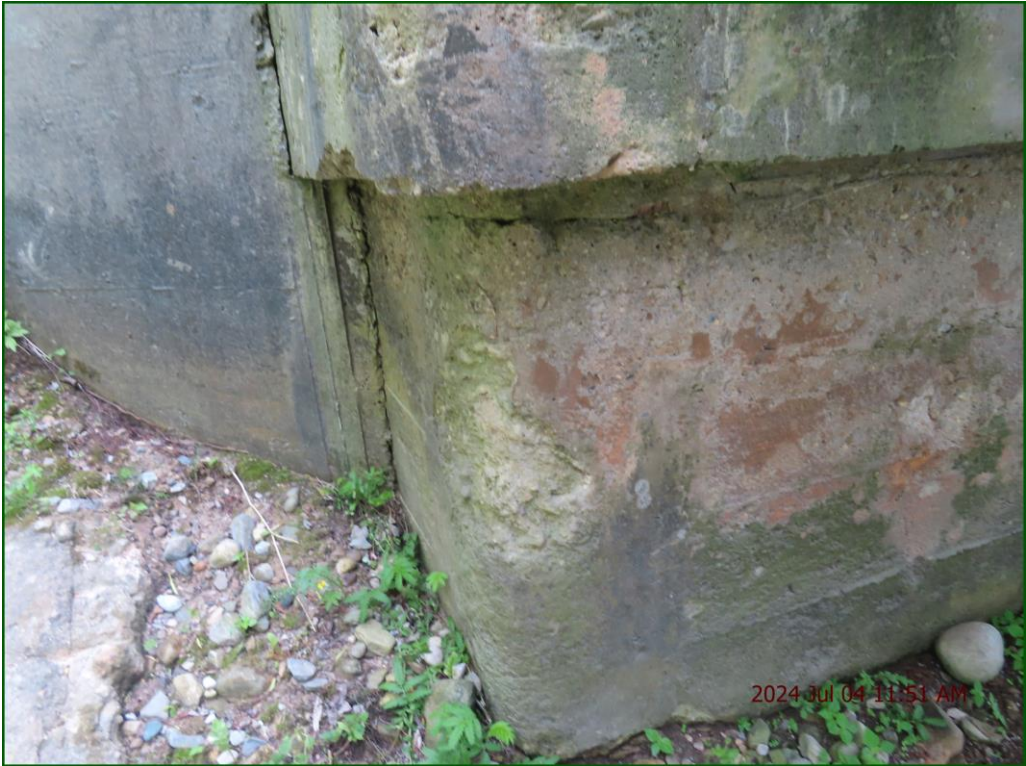
Description: Abutment Walls: Light to severe spalling throughout.

Light to severe spalling throughout.

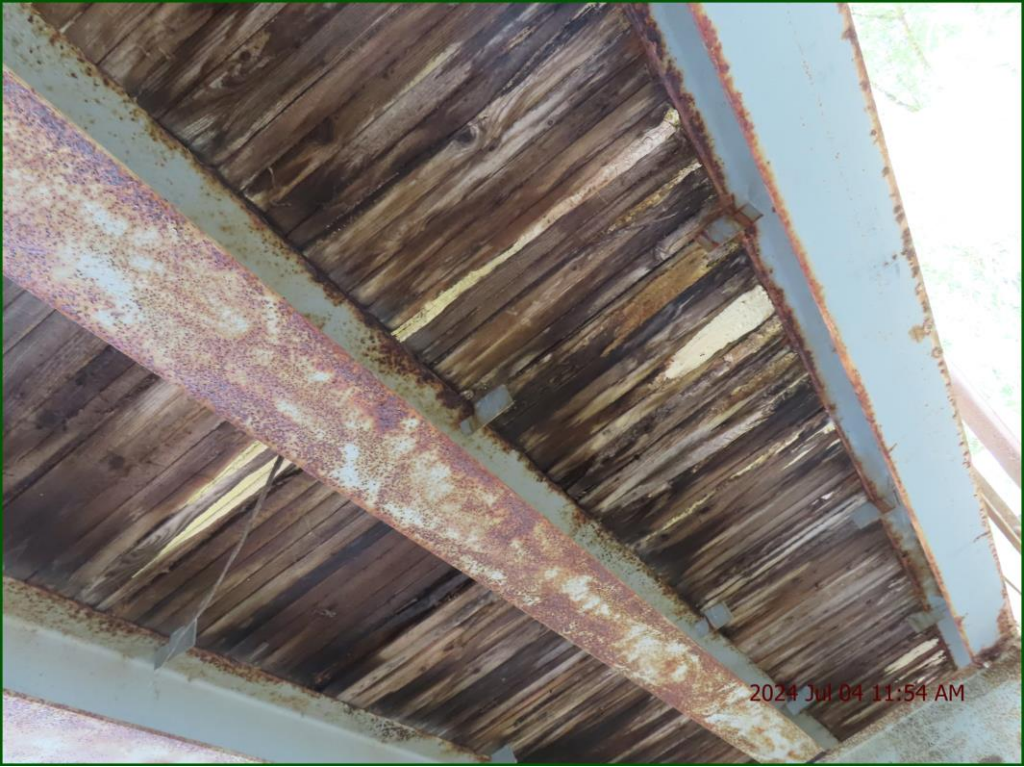
Description: Soffit: Moderate to severe rotting throughout.

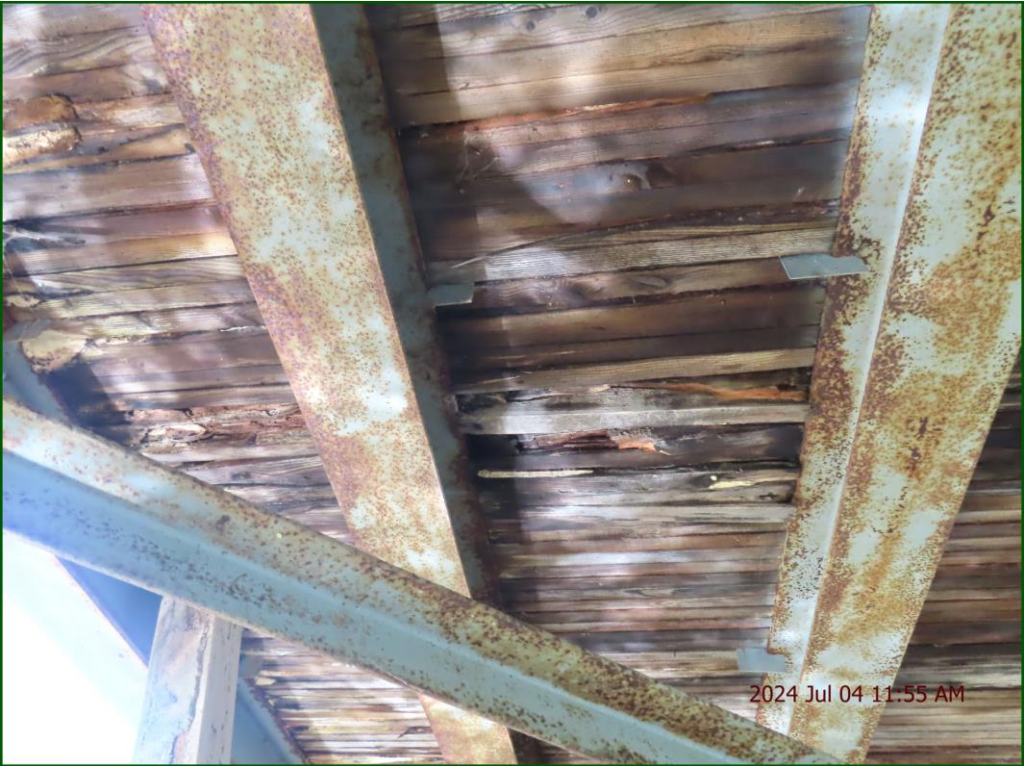
Description: Soffit: Severe rot SW quadrant resulting in deck/soffit failure (local) (1/2).

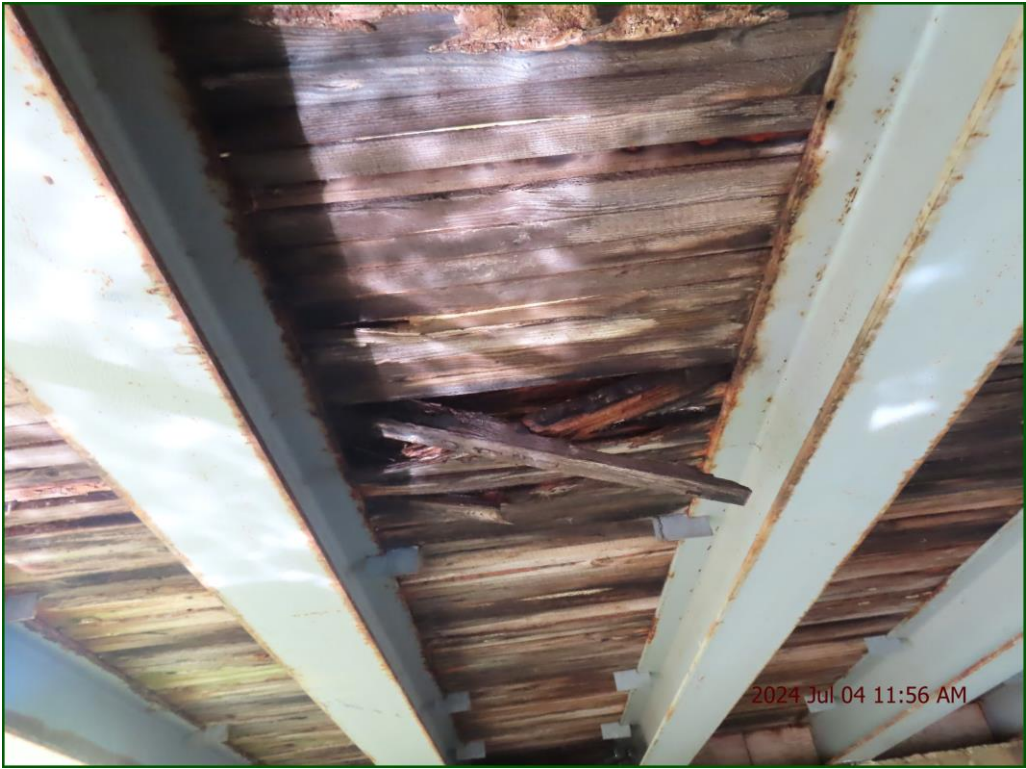
Description: Soffit: Severe rot SW quadrant resulting in deck/soffit failure (local) (2/2).

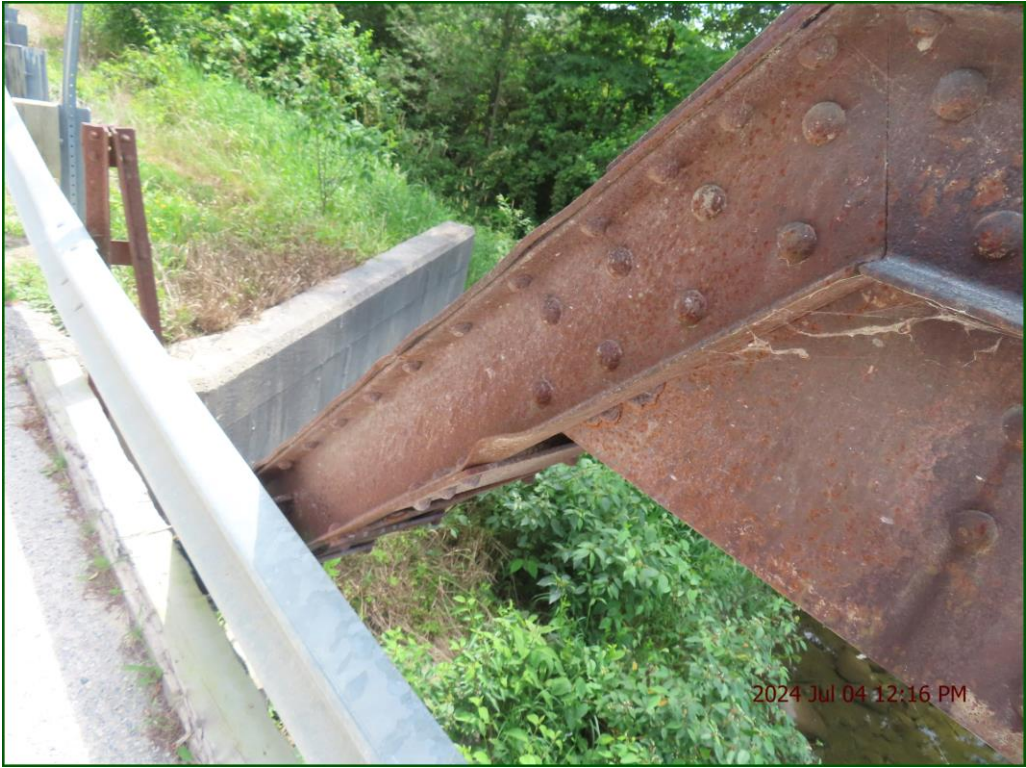
Description: Top chords: Minor impact damage.

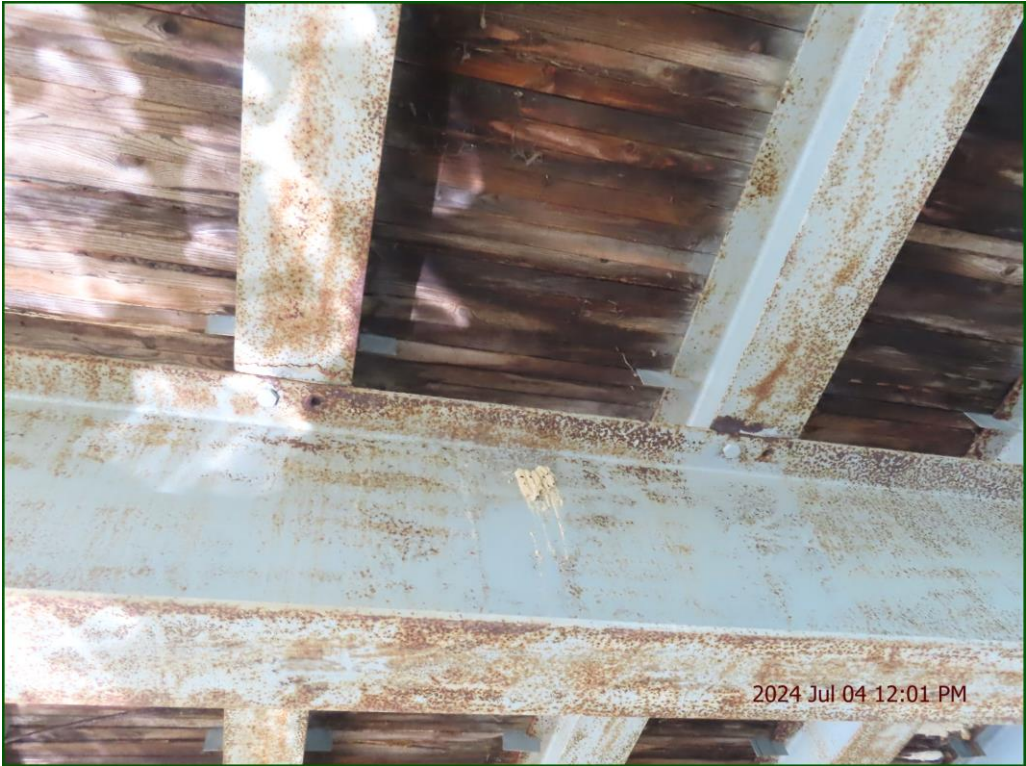
Description: Floor beams: Various missing bolts connecting floor beams to stringers, not critical.

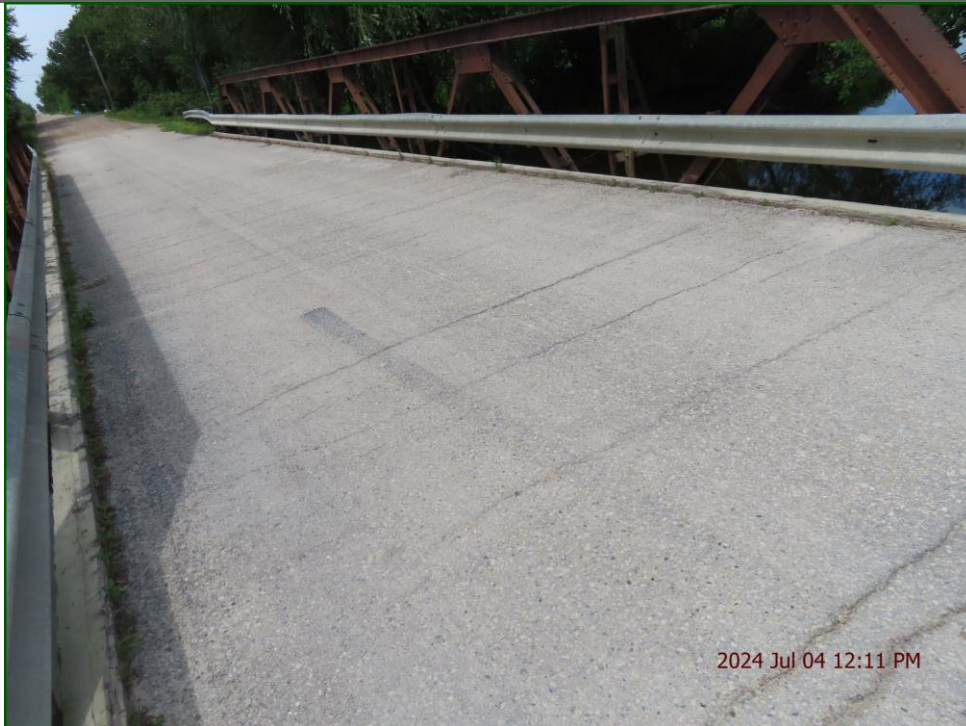
Medium to wide transverse cracks throughout. Moderate to severe potholes in areas where deck/soffit has failed, SW corner is the worst of it.

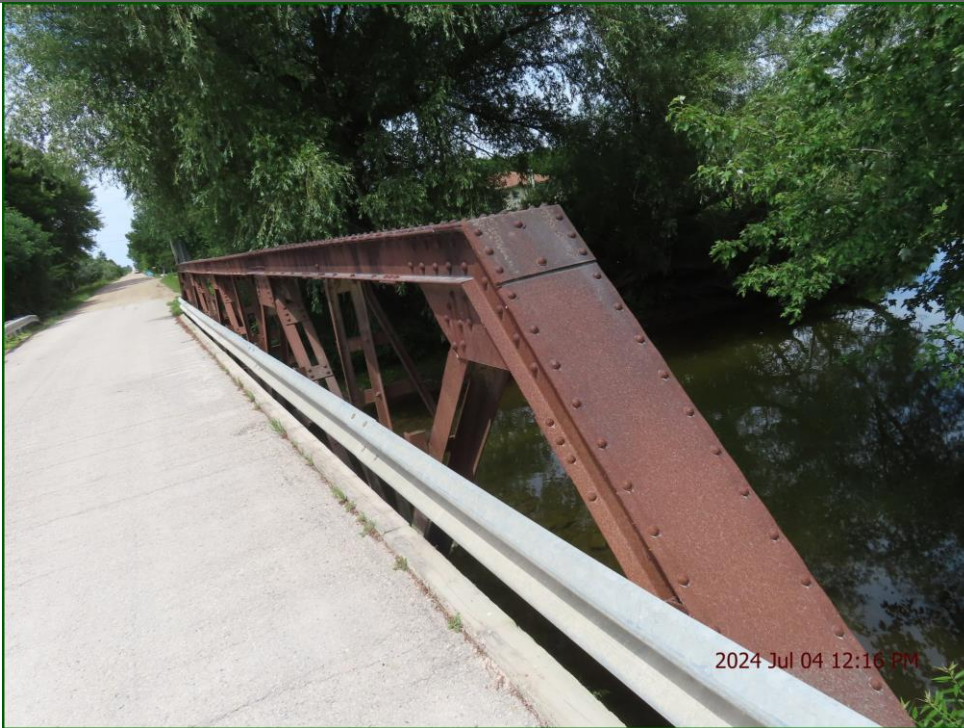
Minor abrasions throughout.
