MUNICIPALITY OF
West Grey

Municipality of West Grey
Bridge Prioritization Program

February 2025

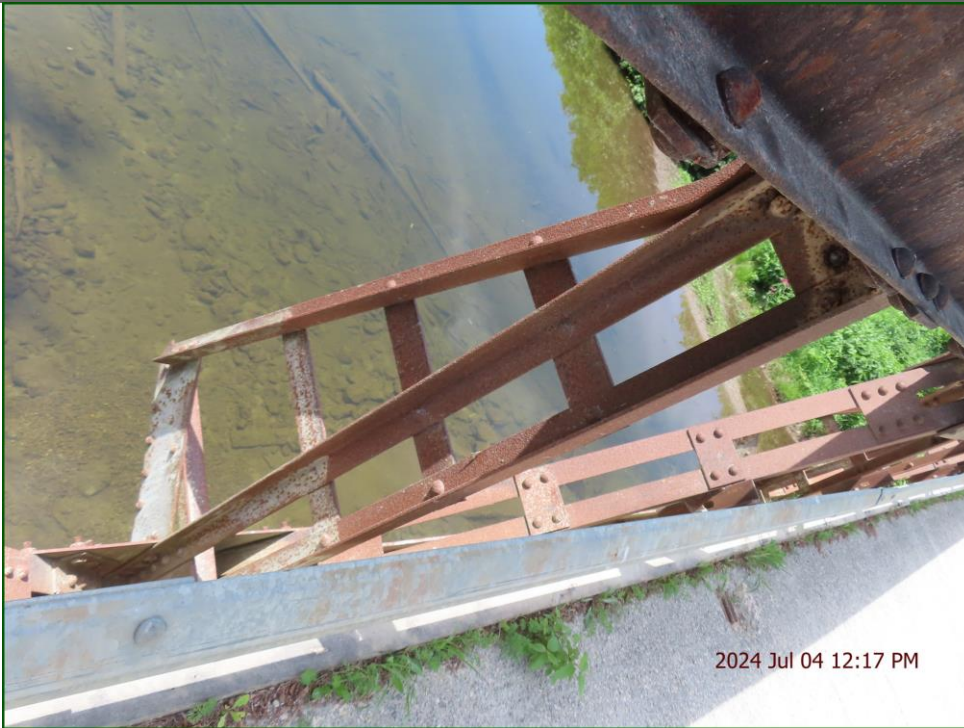
Light corrosion throughout. Minor impact damage.

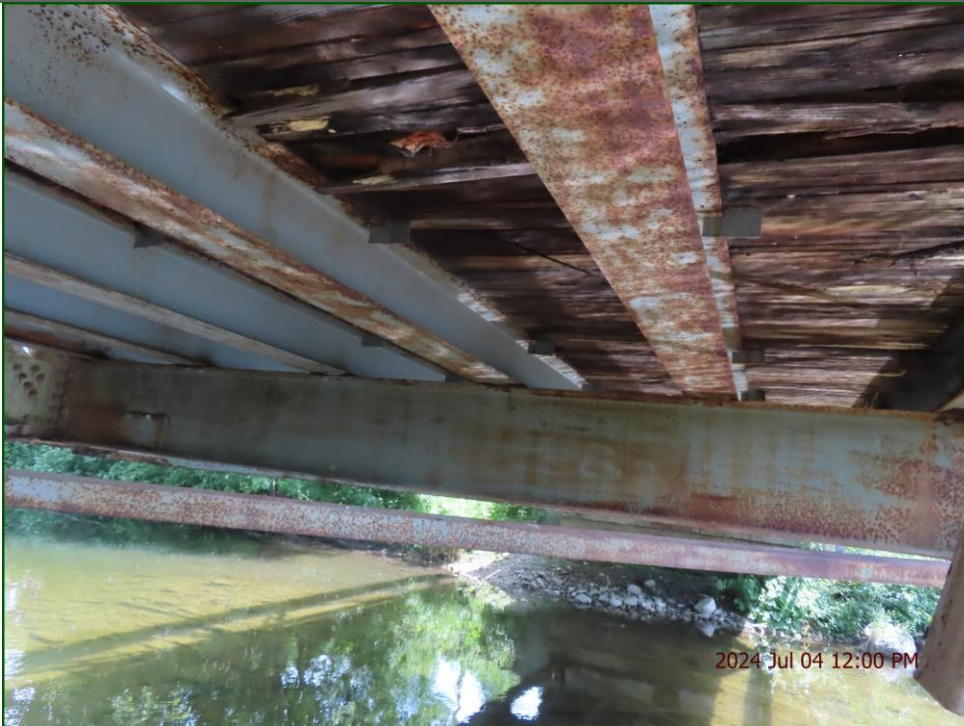
Various missing bolts connecting floor beams to stringers, not critical.

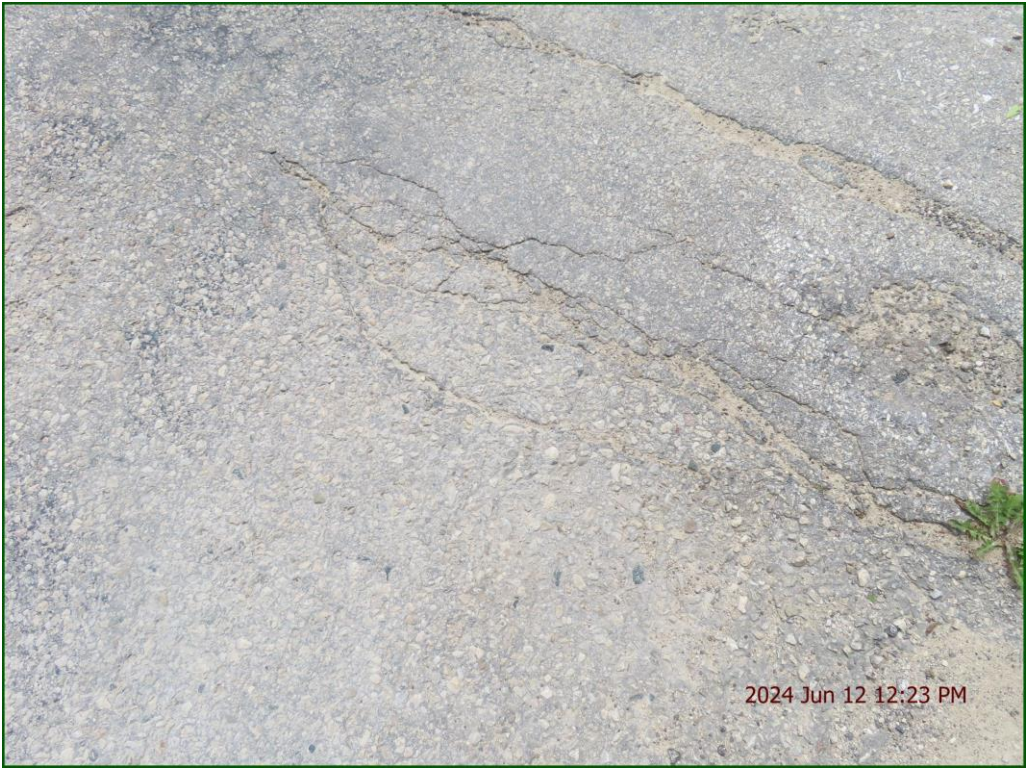
Description: Approach Wearing surface: Light to medium map cracking throughout.

Light to medium map cracking throughout. Medium to wide alligator cracking at joints.

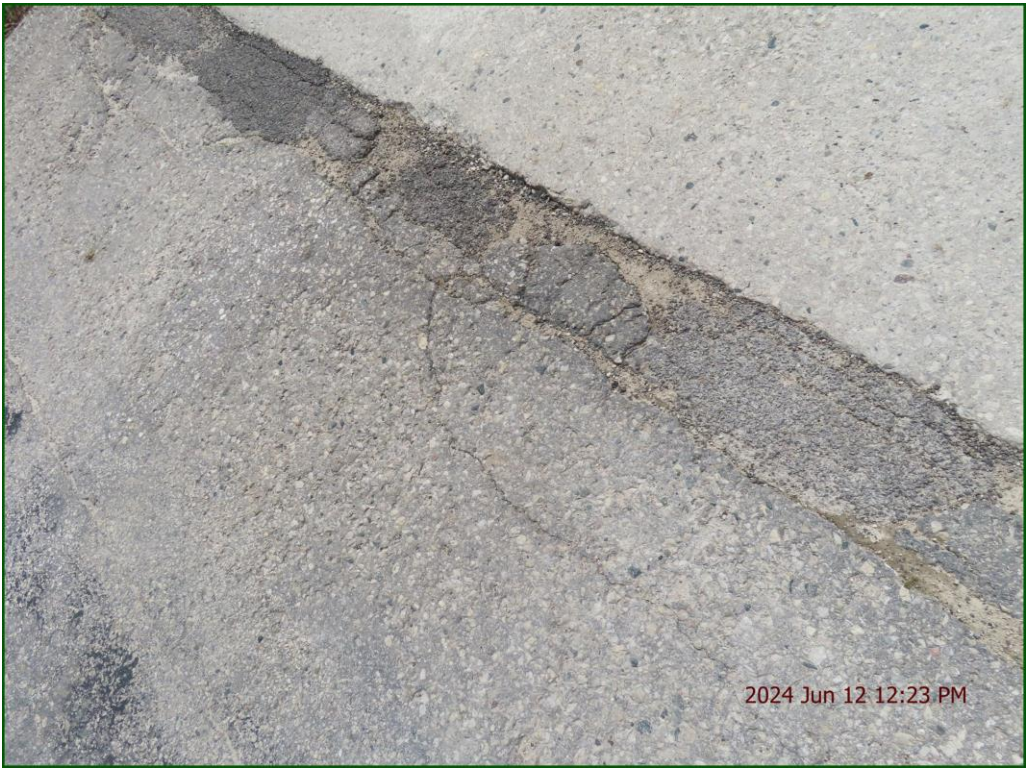
Description: Approach Wearing surface: Medium to wide alligator cracking at joints.

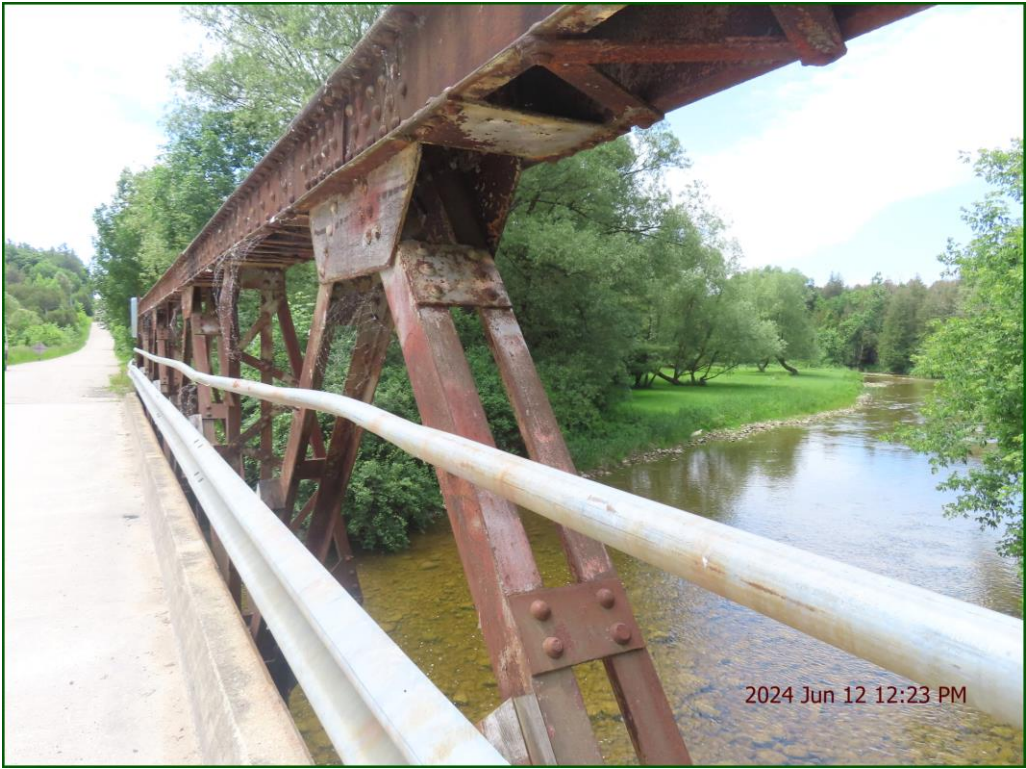
Description: Hand railings: Minor impact damage throughout.

Minor impact damage throughout.

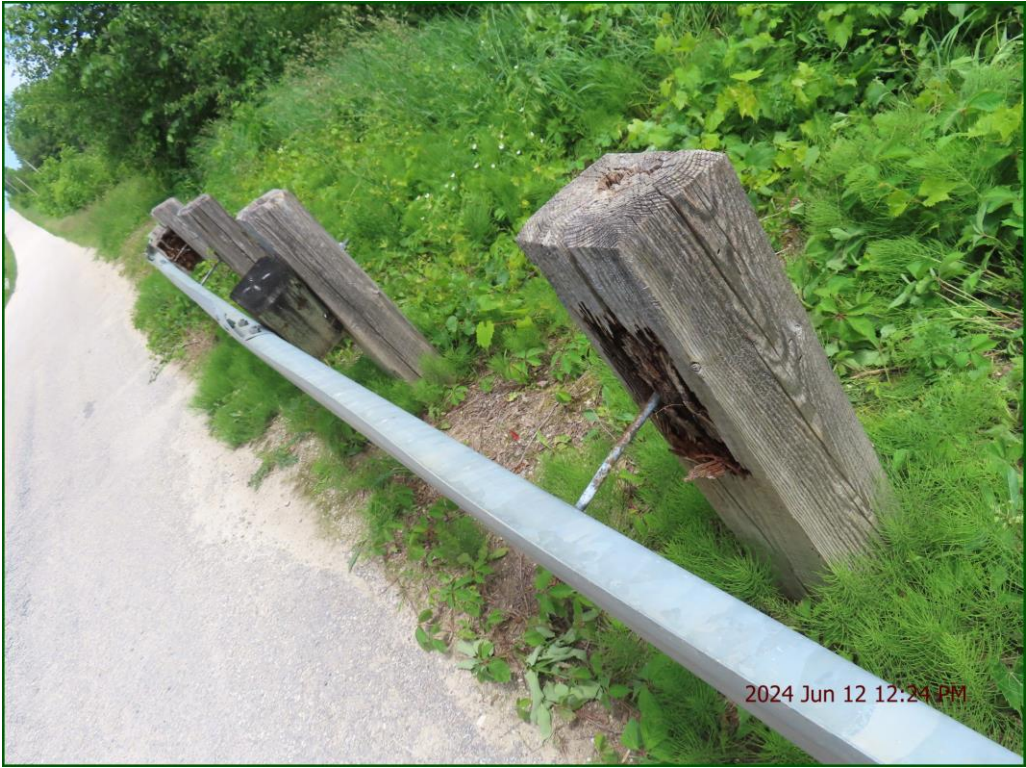
Description: Railing systems: Areas of severe rot.

Areas of severe rot.

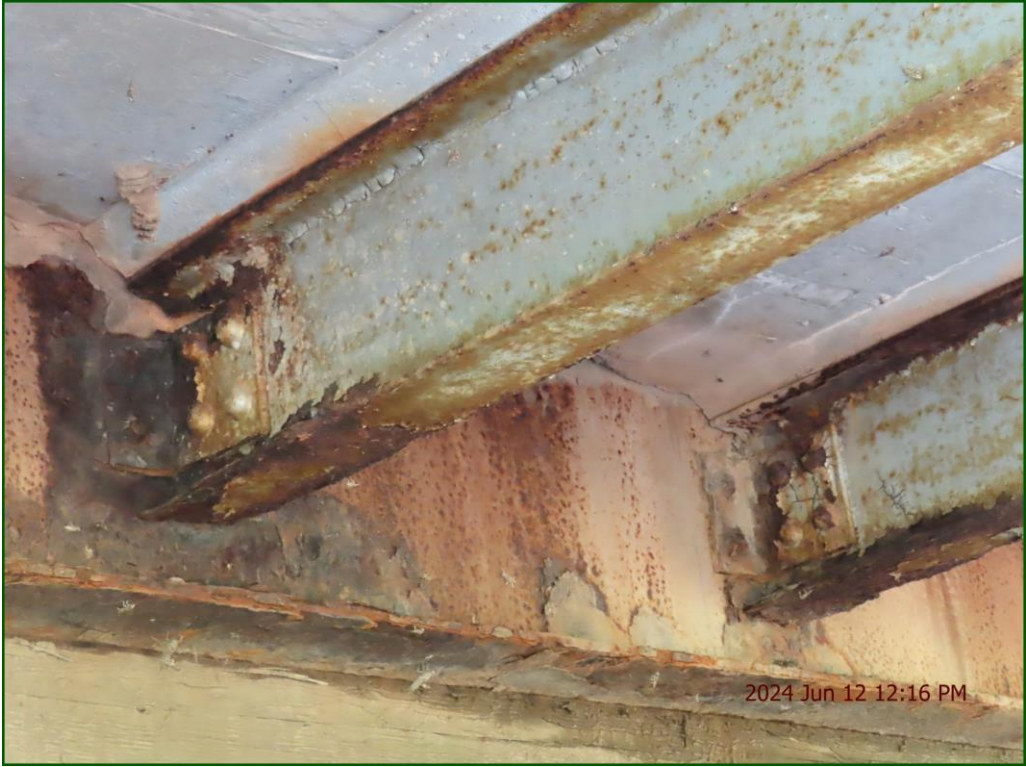
Description: Stringers: Moderate corrosion at ends.

Light corrosion throughout. Moderate corrosion at ends.

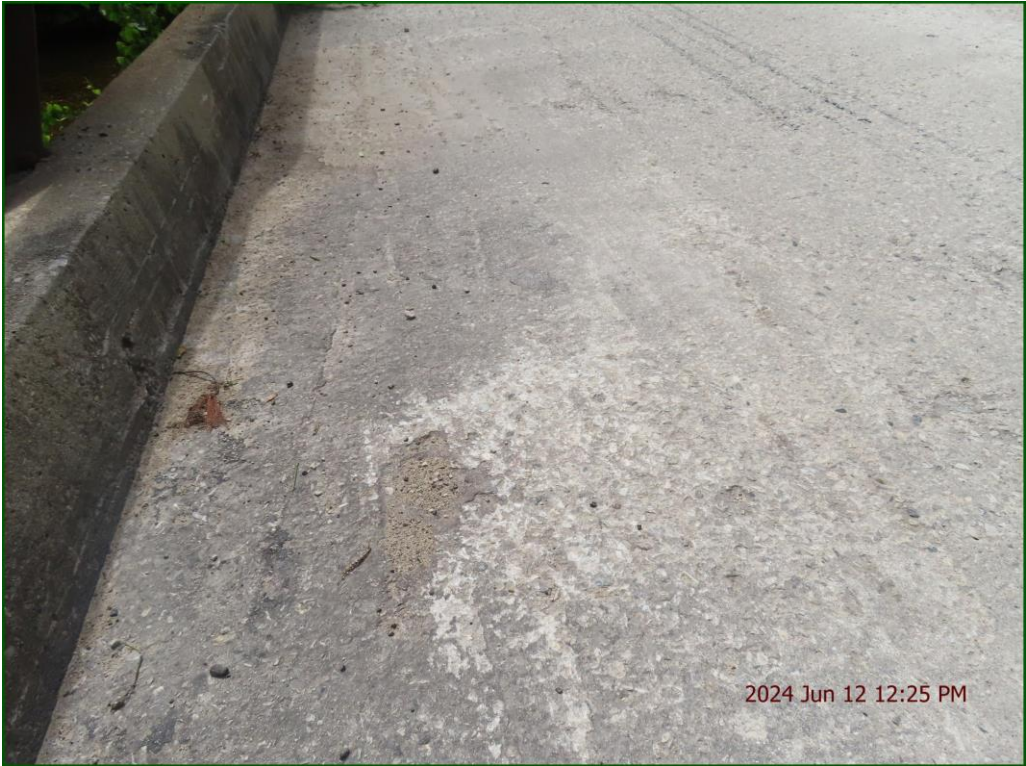
Description: Deck top: Shallow popouts throughout.

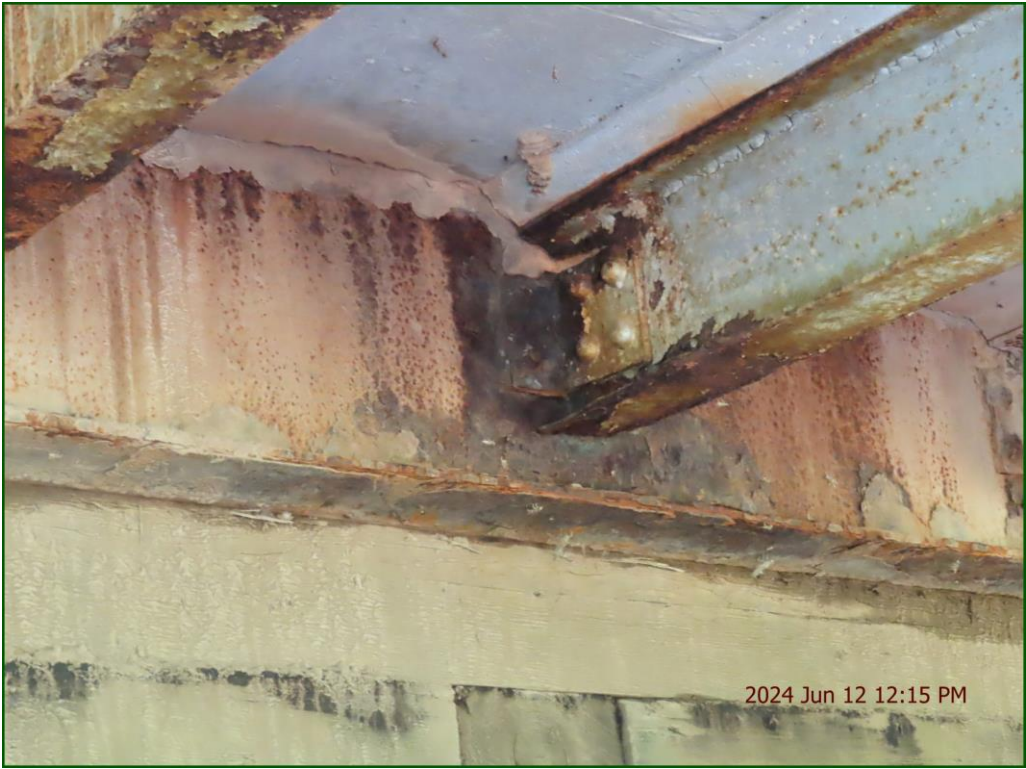
Description: Floor beams: Moderate corrosion at ends.

Light corrosion throughout. Moderate corrosion at ends.

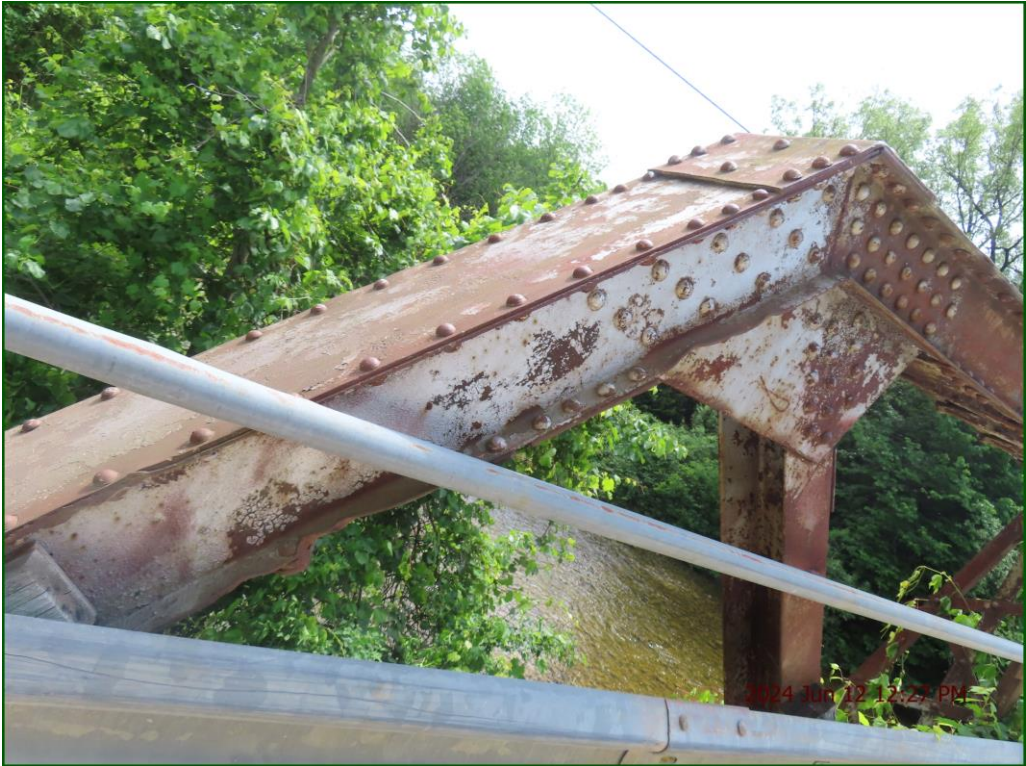
Description: Top chord: Areas of impact damage.

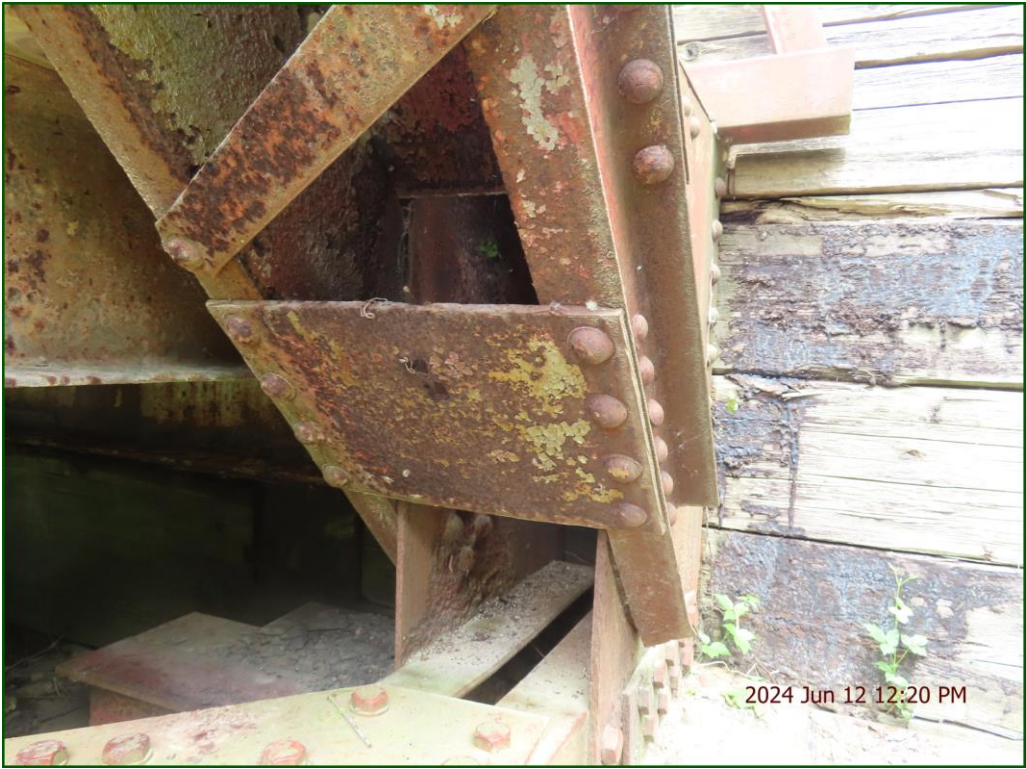
Description: Connections: Moderate to severe corrosion at ends with areas of perforation.

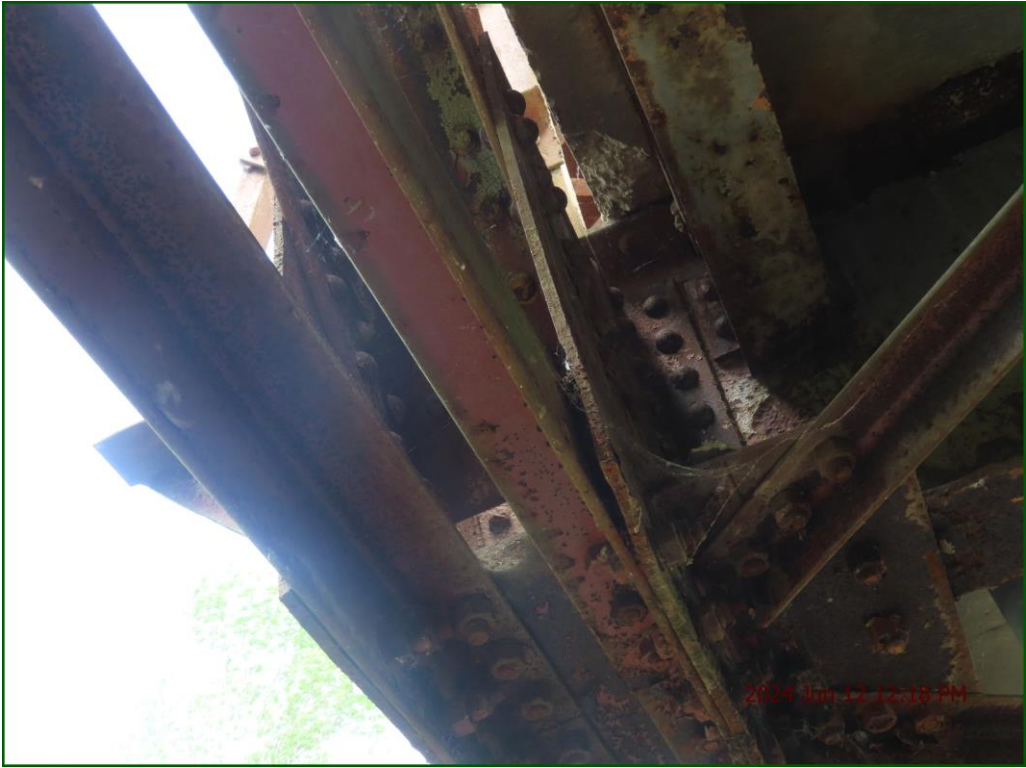
Description: Connections: Light warping on various connection plates (rust jacking).

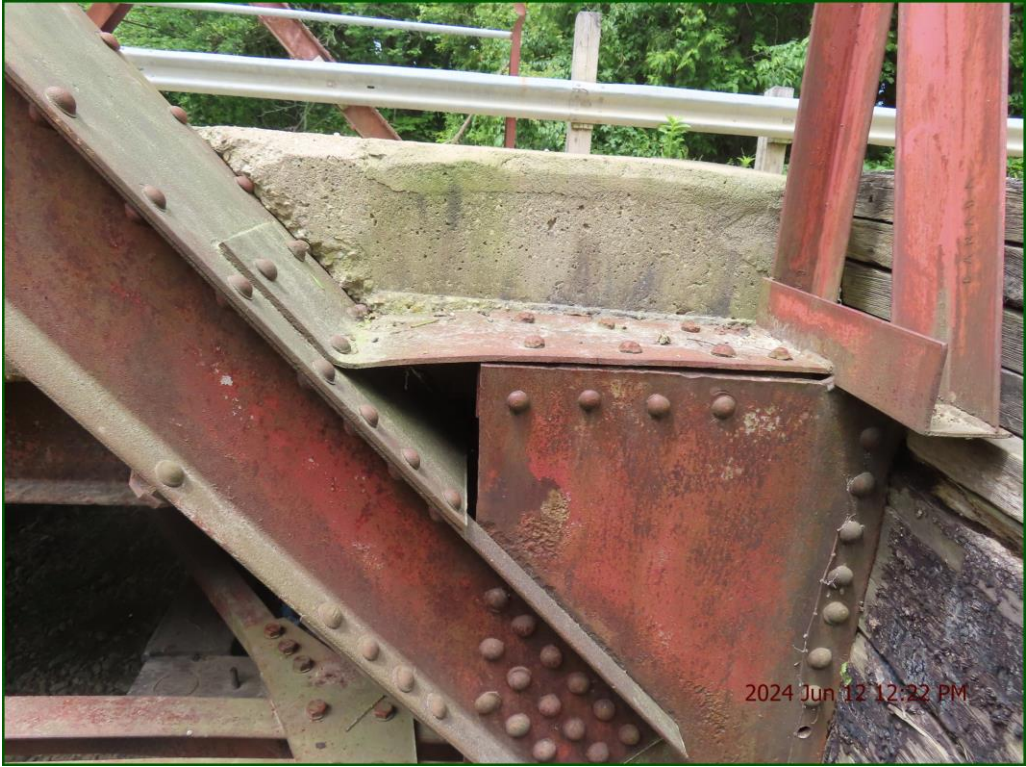
Description: Connections: End connection to chord is showing signs of warping (rust jacking).

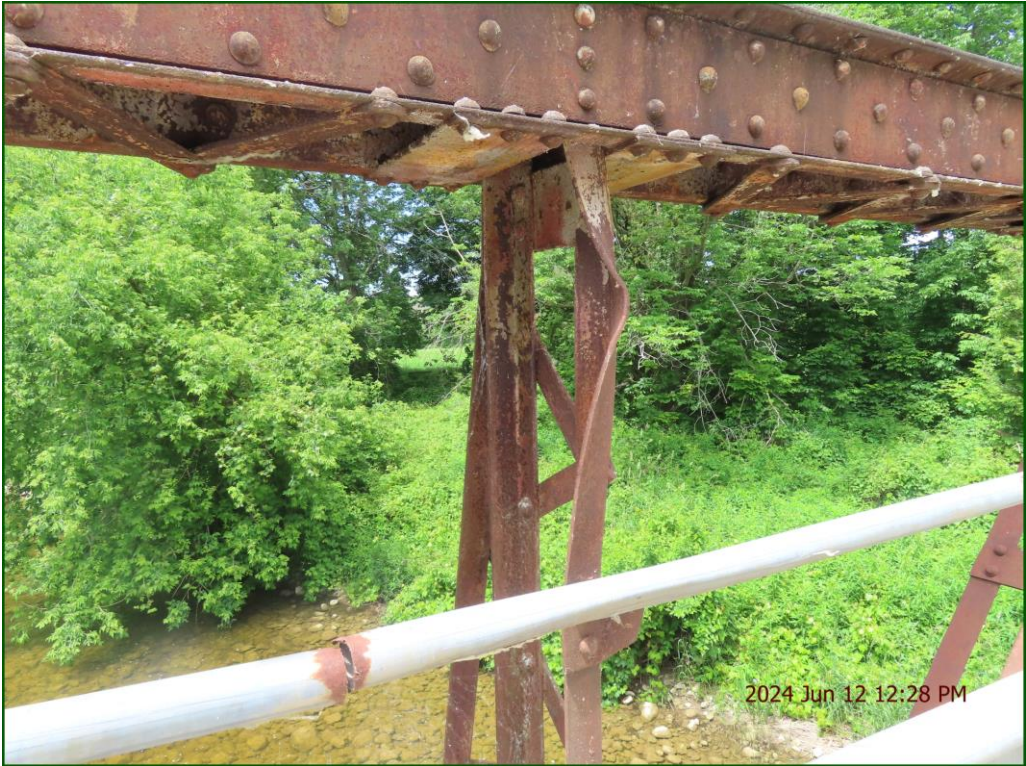
Description: Verticals/diagonals: Moderate impact damage.

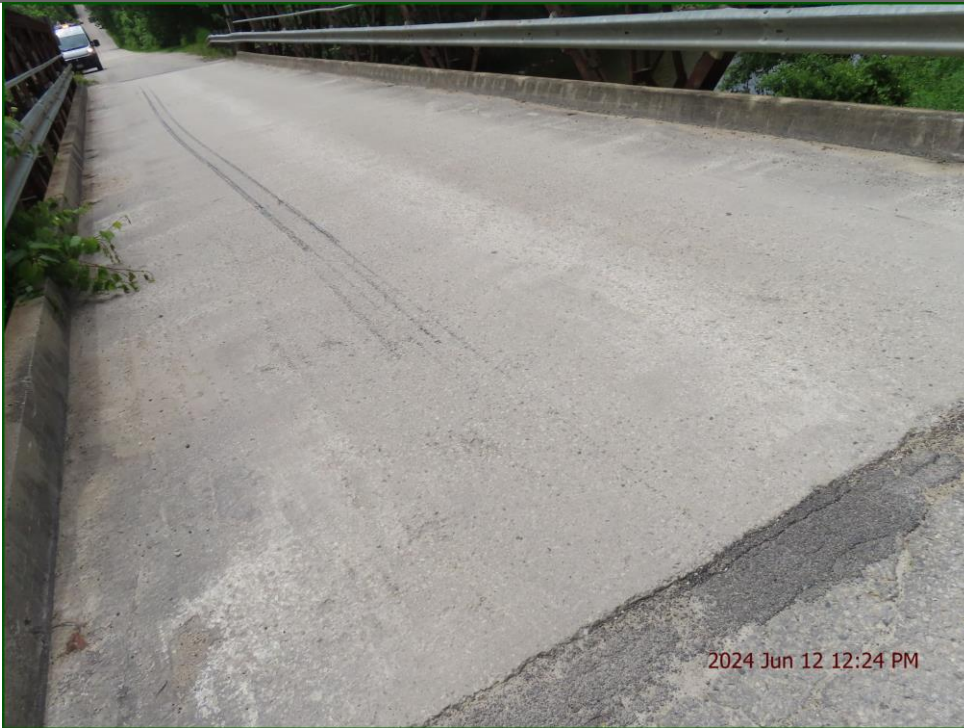
Shallow popouts throughout.

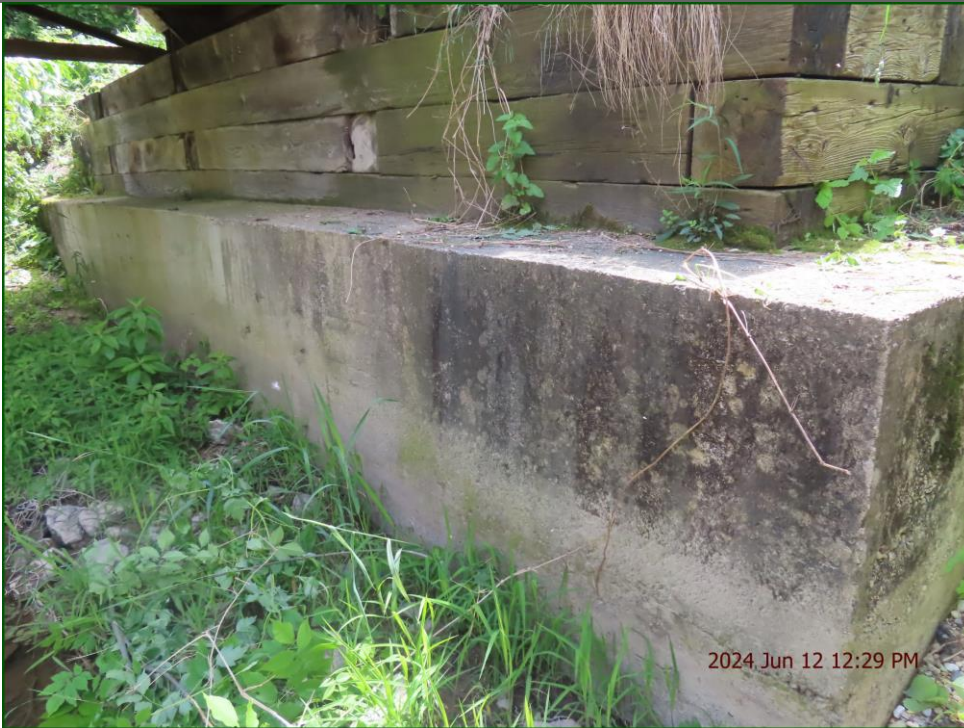
No signs of settlement.

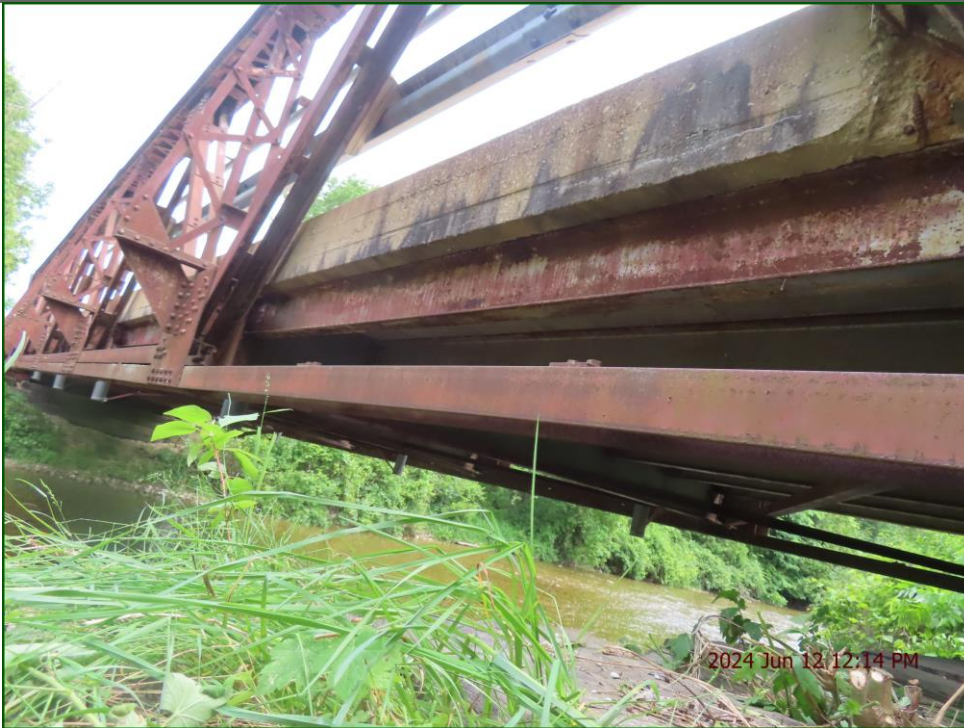
Light to medium corrosion throughout.

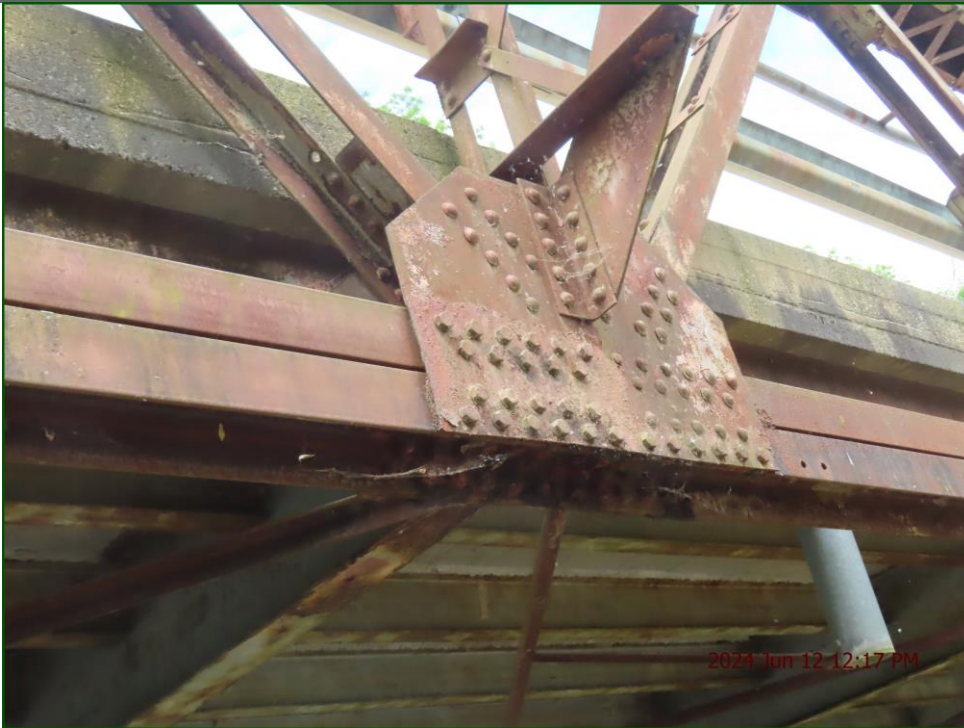
Light corrosion throughout. Moderate to severe corrosion at ends with areas of perforation. Light warping (rust jacking) on various connection plates. End connection to chord is showing signs of warping.

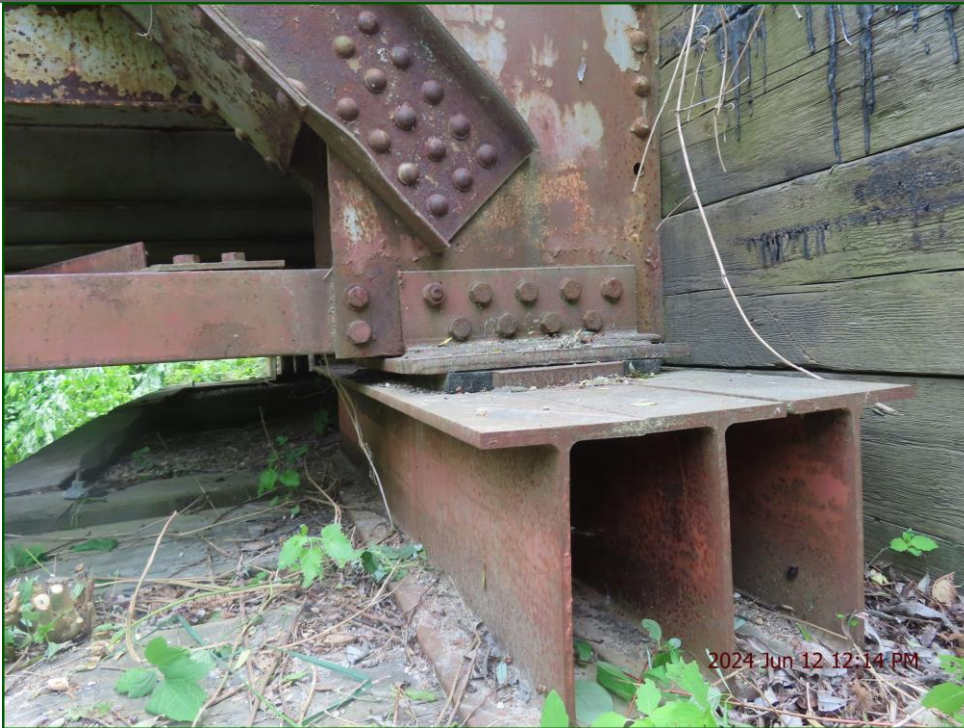
Light corrosion throughout.

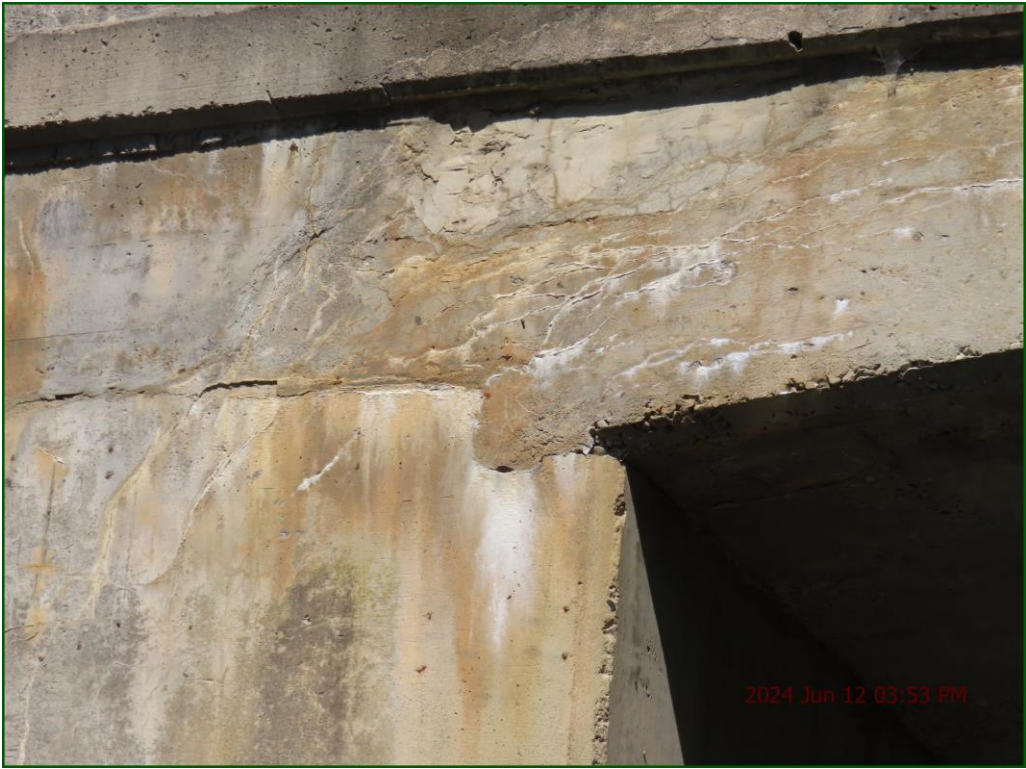
Description: Wingwalls: Light to medium map cracking with leachate staining.

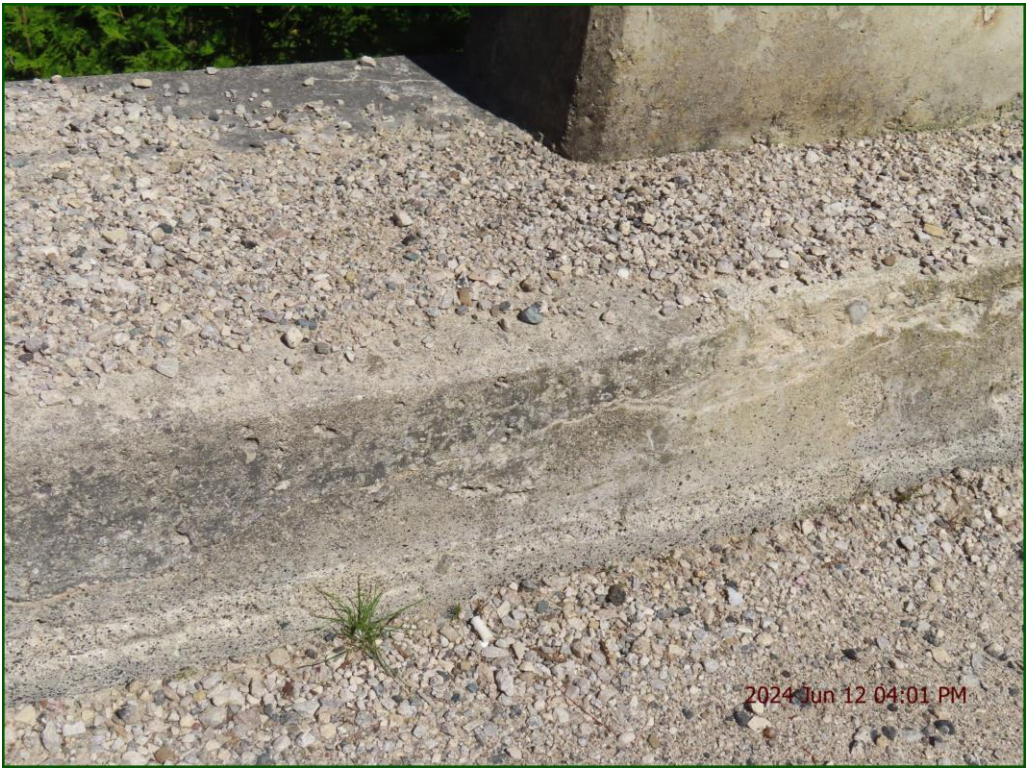
Description: Approach Curbs: Light to medium map cracking with leachate staining.

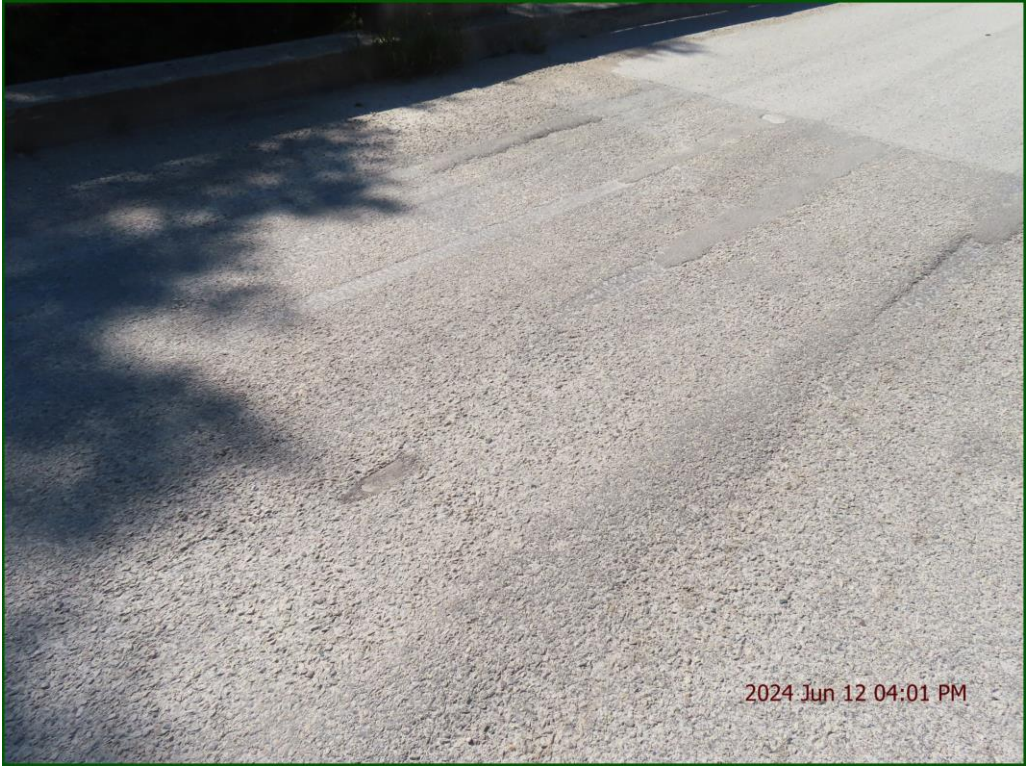
Description: Approach Wearing surface: Shallow potholes throughout.

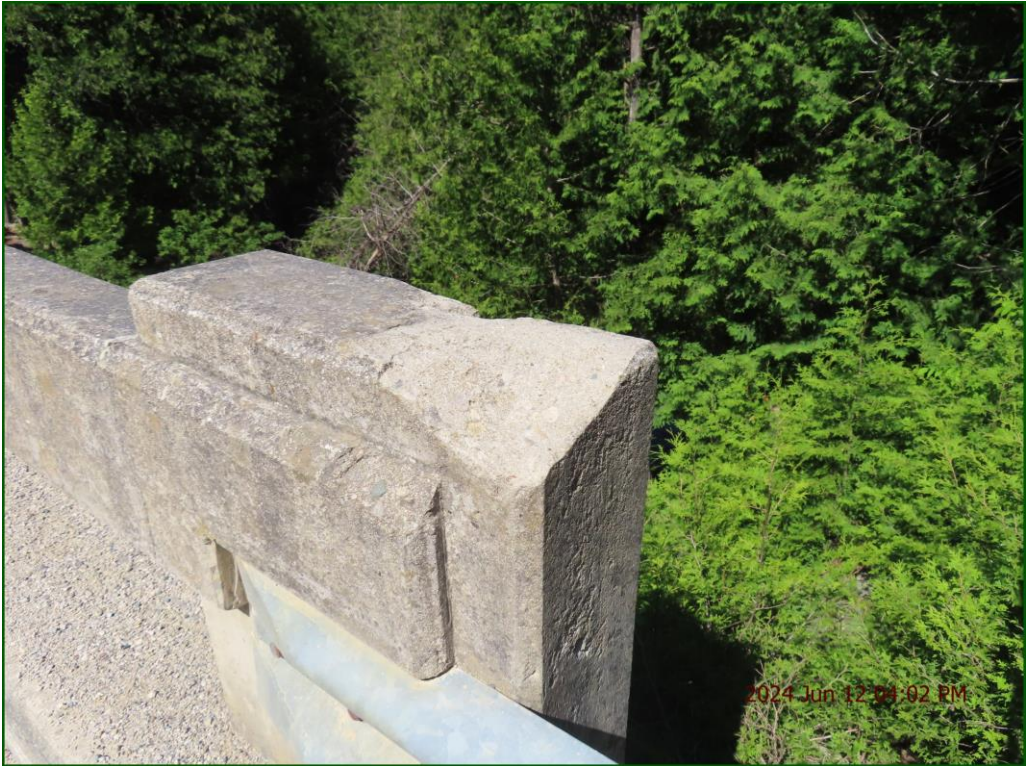
Description: Railing systems: Localized shallow spall at SE corner.

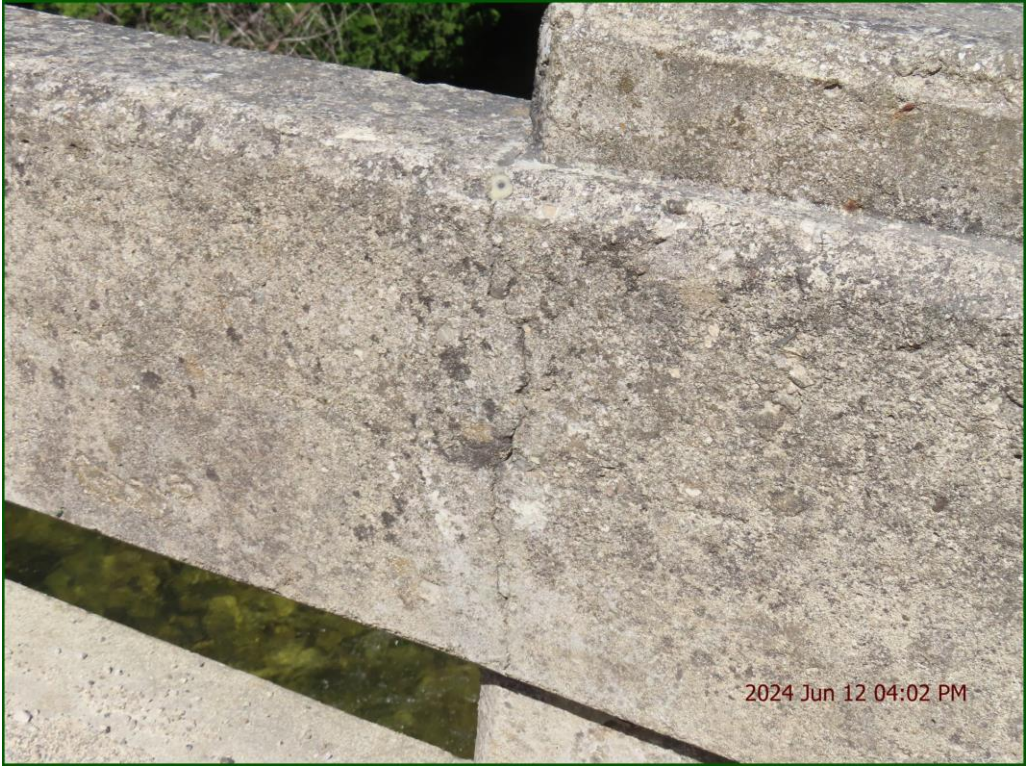
Description: Railing systems: Light to medium vertical cracking throughout.

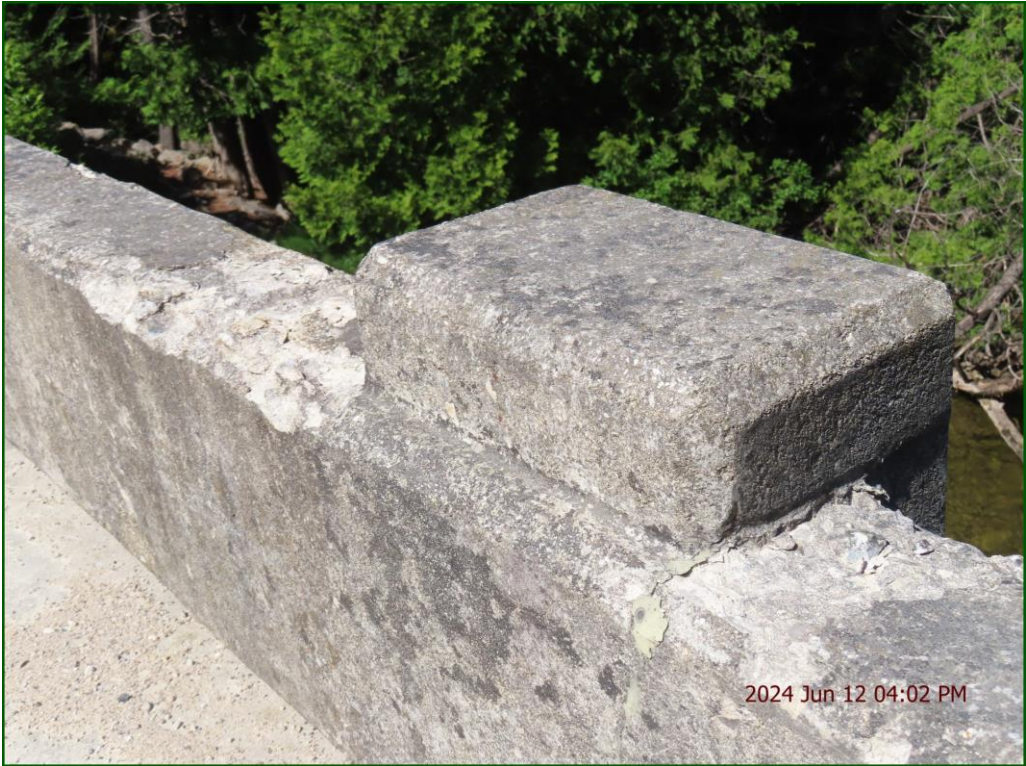
Description: Railing systems: Shallow delamination throughout.

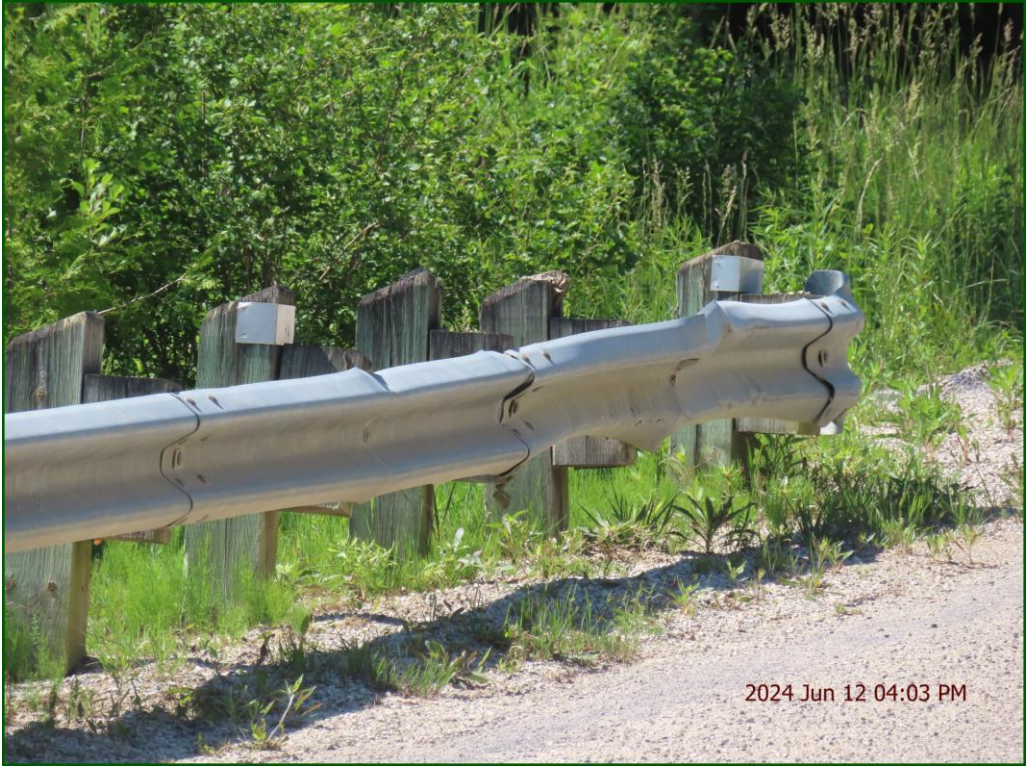
Description: Railing Systems: Severe impact damage on NW quadrant.

Severe impact damage on NW quadrant.

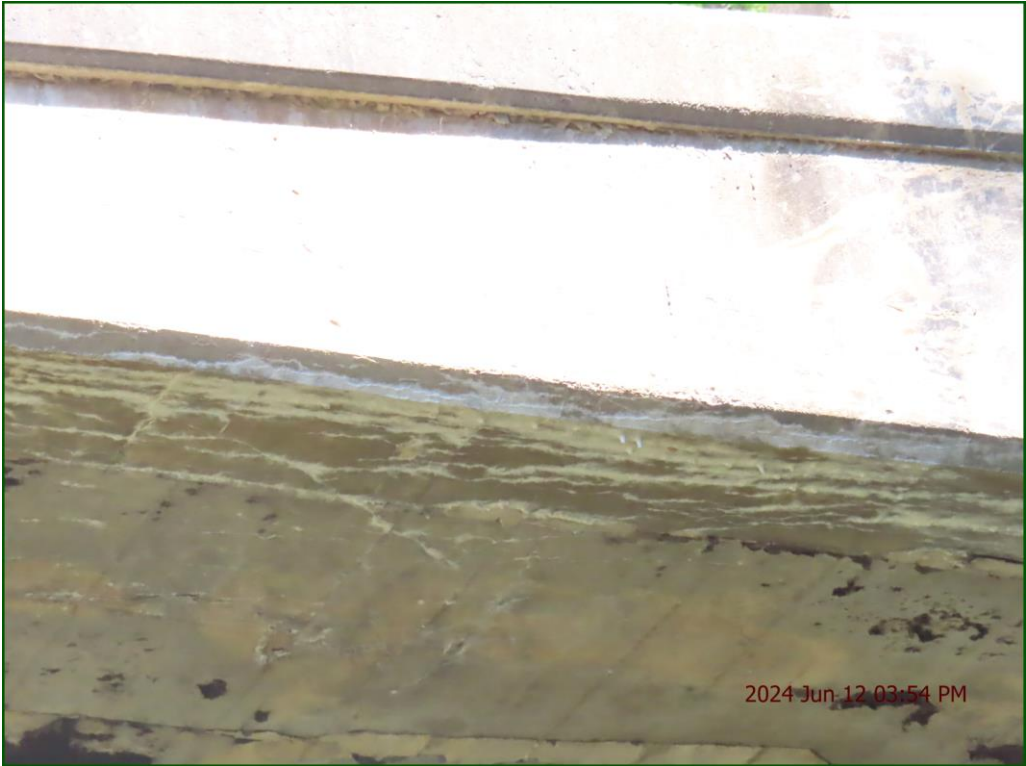
Description: Soffit (ext): Medium to wide map cracking with leachate staining and stalactite.

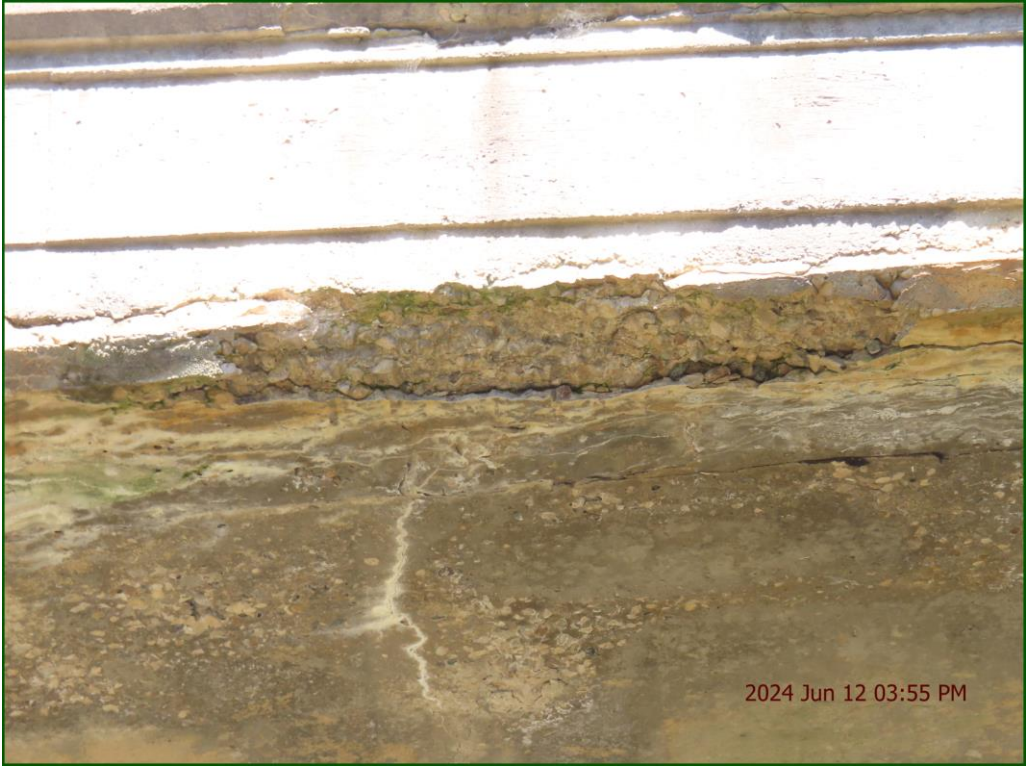
Description: Soffit (ext): Moderate spalls throughout and disintegration.

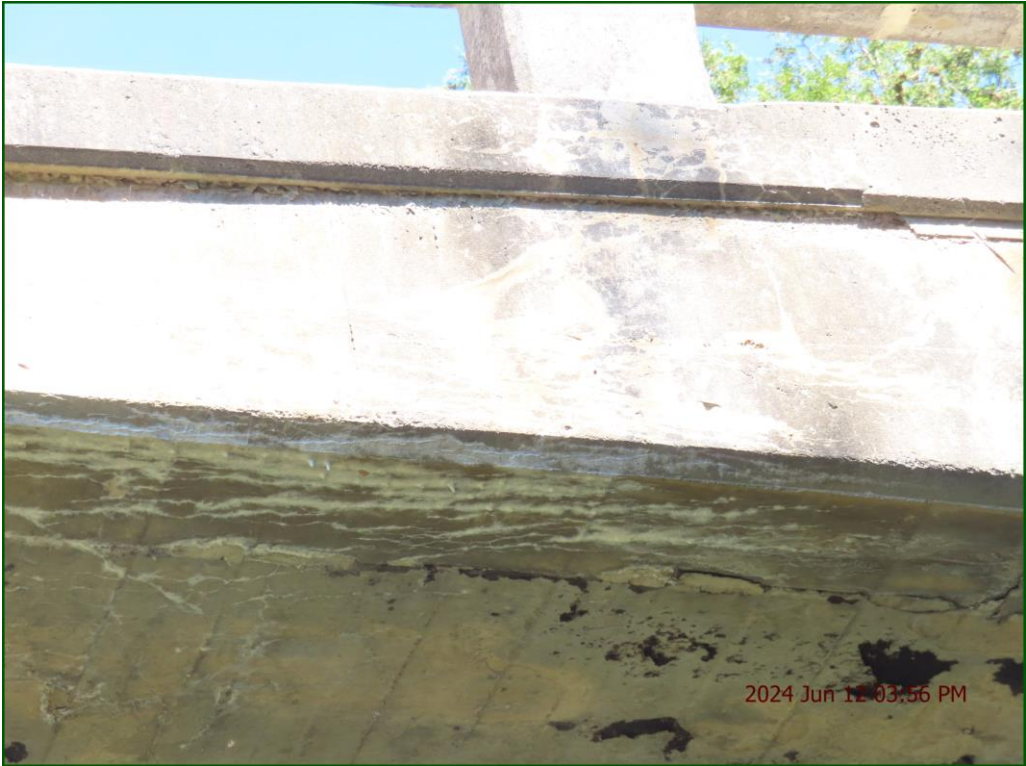
Description: Soffit (ext): Moderate to severe delamination.
