MUNICIPALITY OF
West Grey

Municipality of West Grey
Bridge Prioritization Program

February 2025

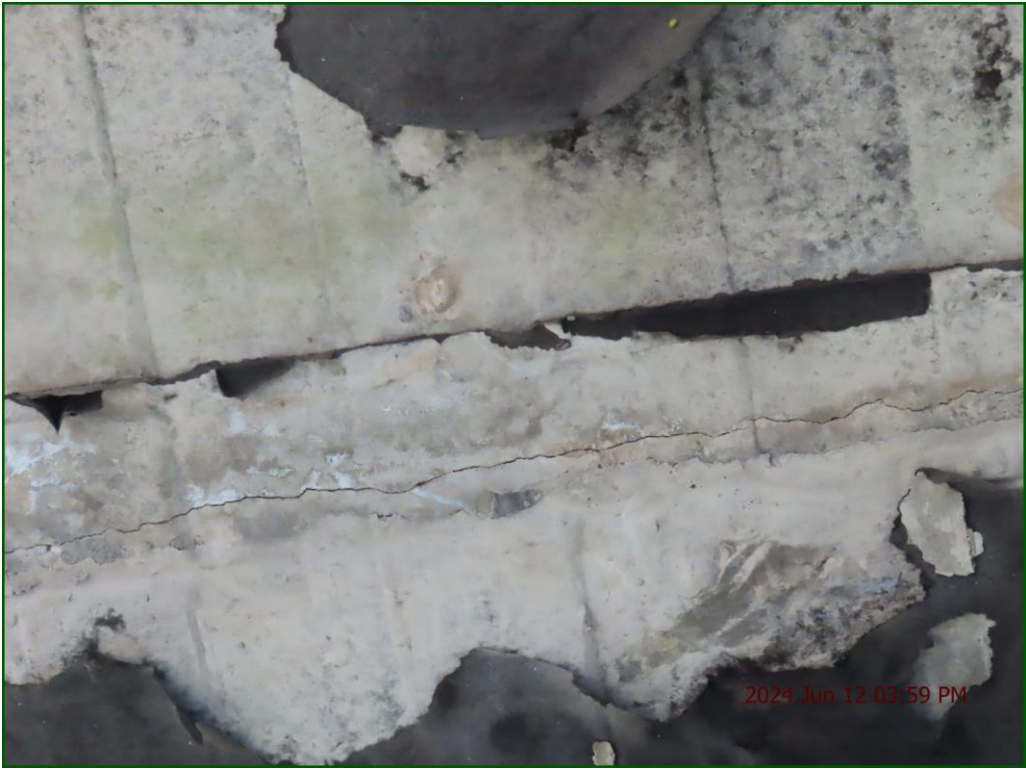
Description: Soffit (int): Moderate delamination.

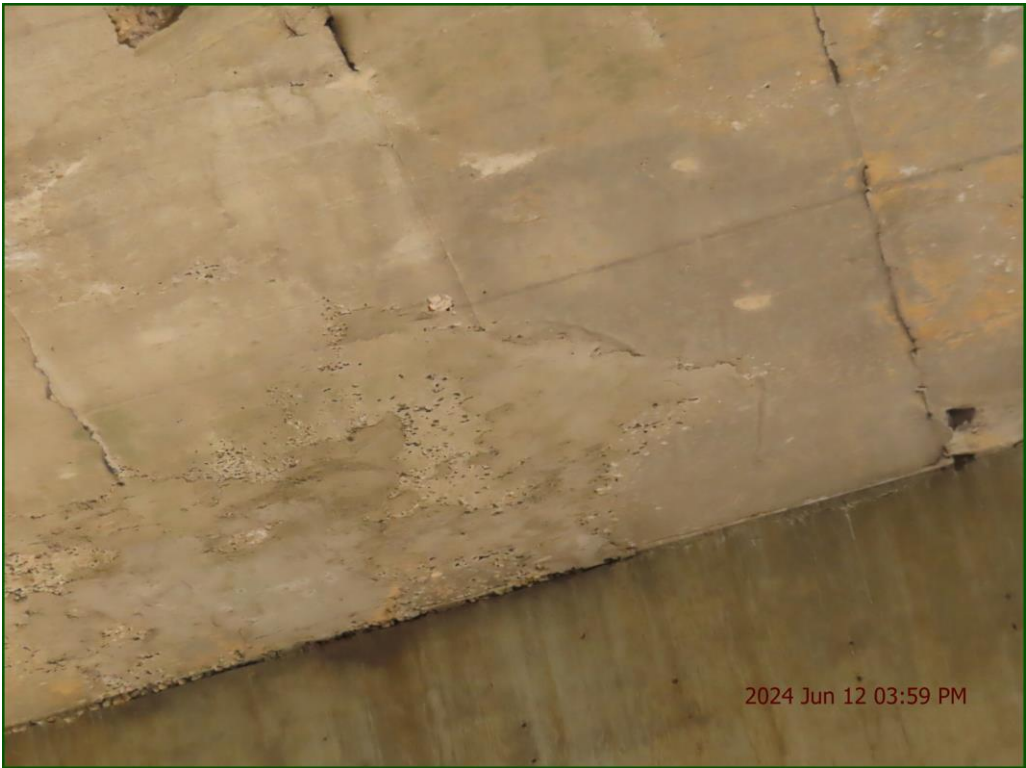
Description: Soffit (int): Light to moderate honeycombing.

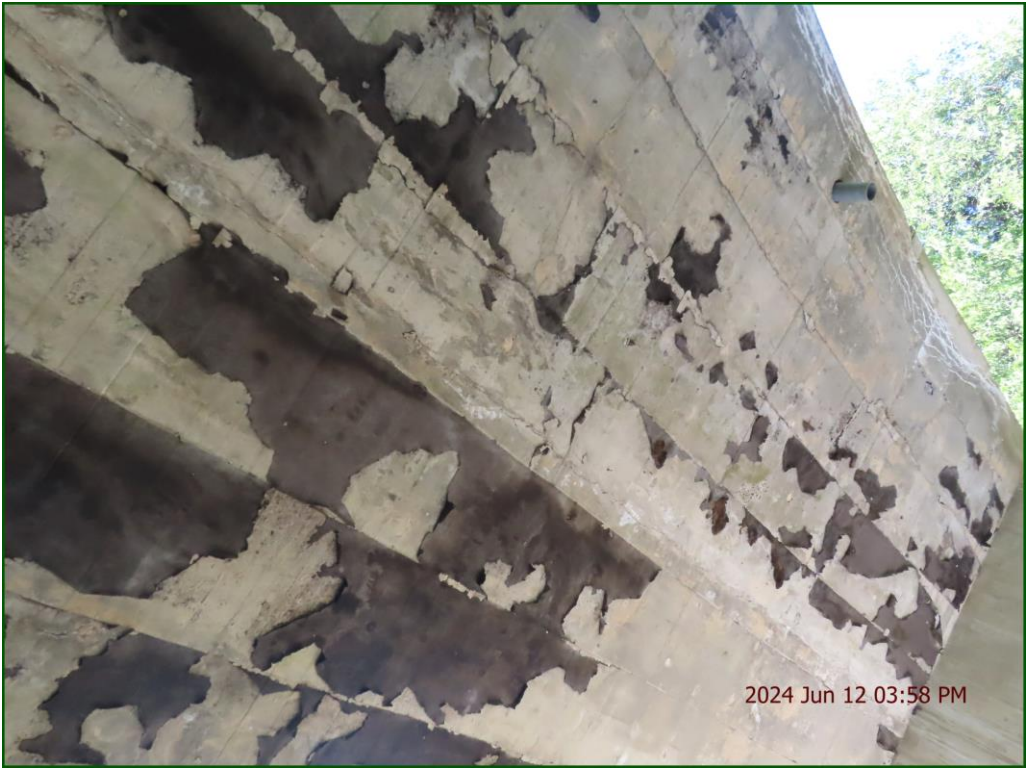
Description: Soffit (int): Light to medium longitudinal cracking at construction joints.

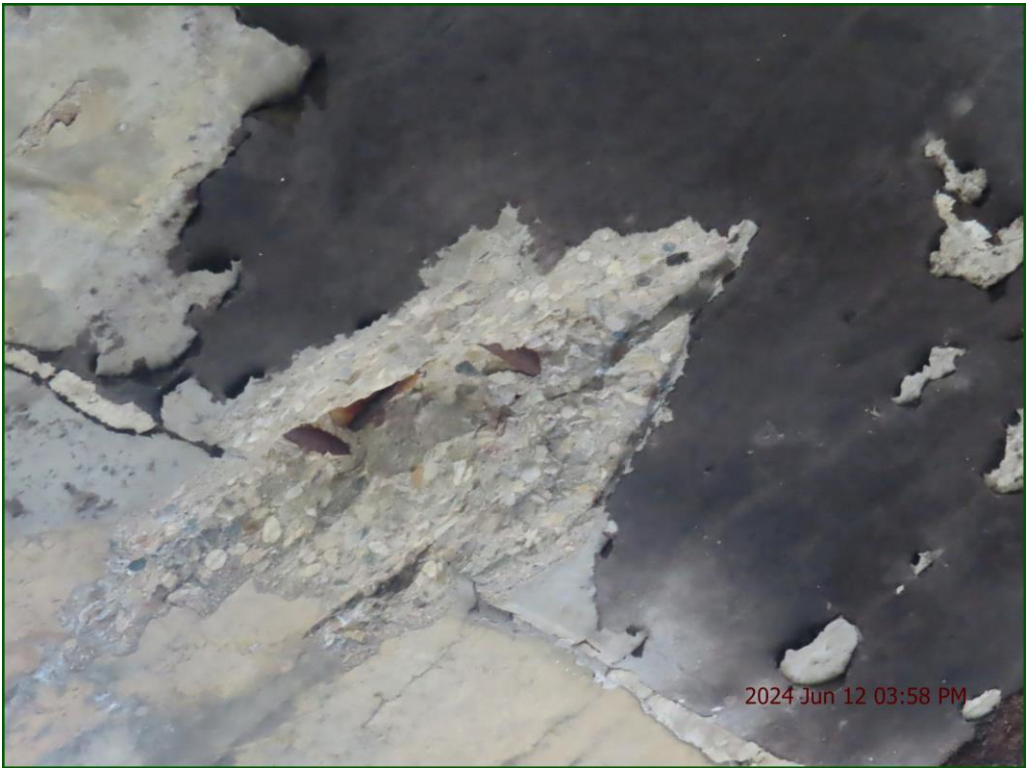
Description: Soffit (int): Severe localized spall with exposed reinforcing at mid span.

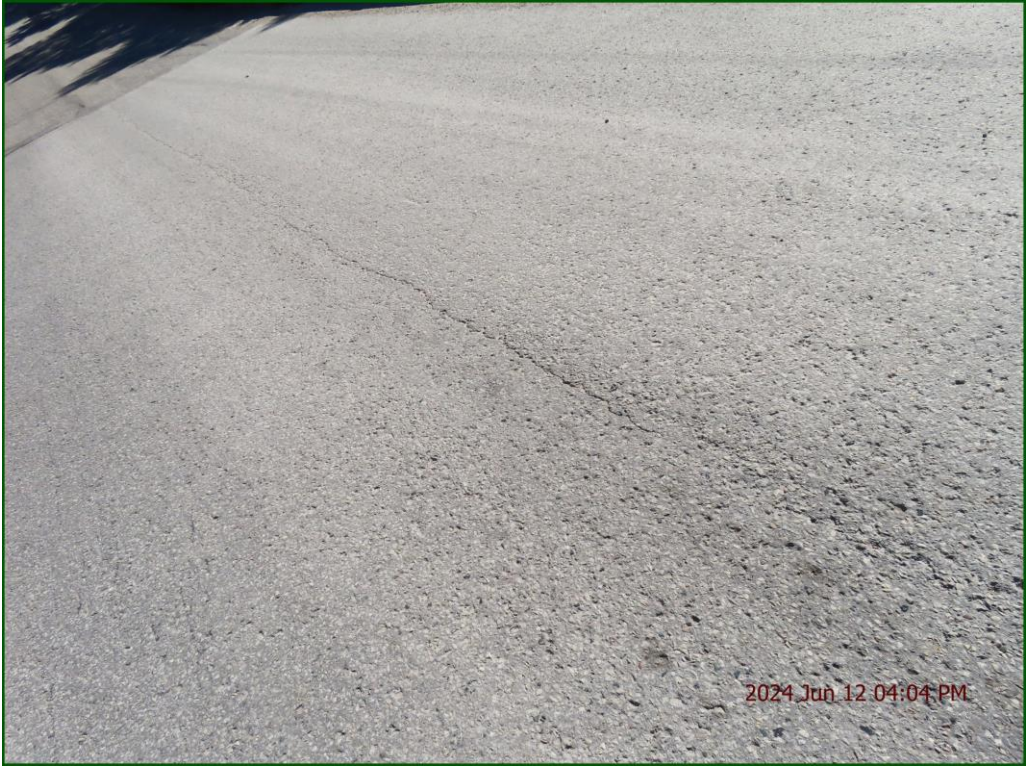
Description: Wearing Surface: Light longitudinal crack at centre line.

Light longitudinal crack at centre line.

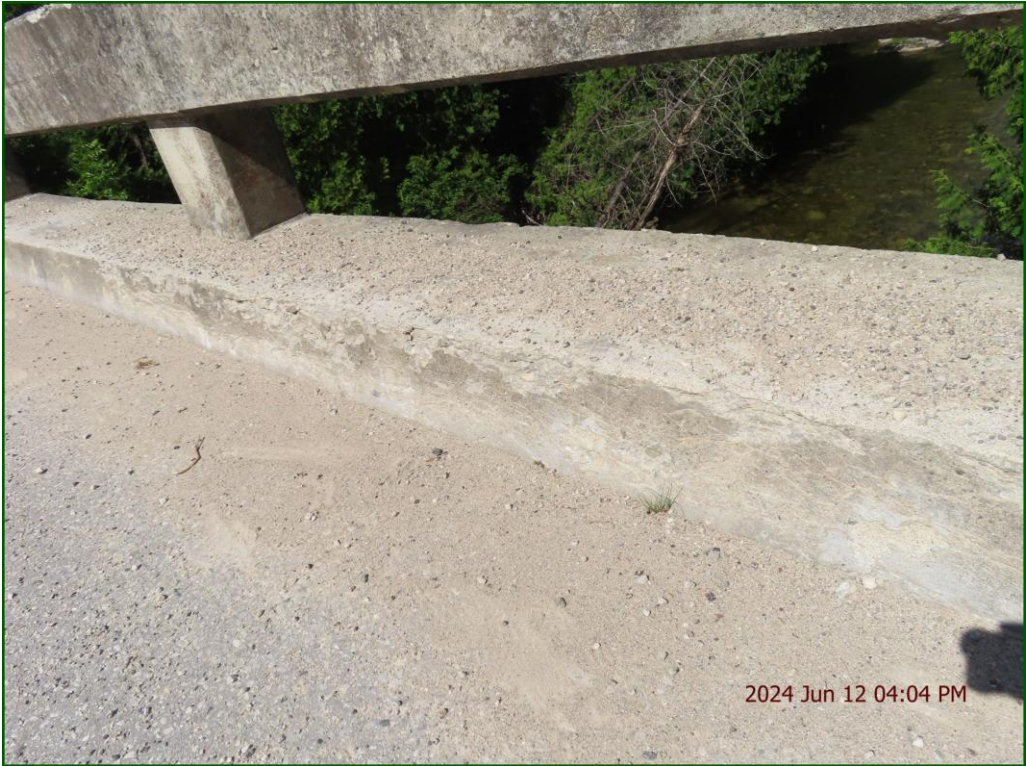
Description: Curbs: Shallow delaminations with light map cracking throughout.

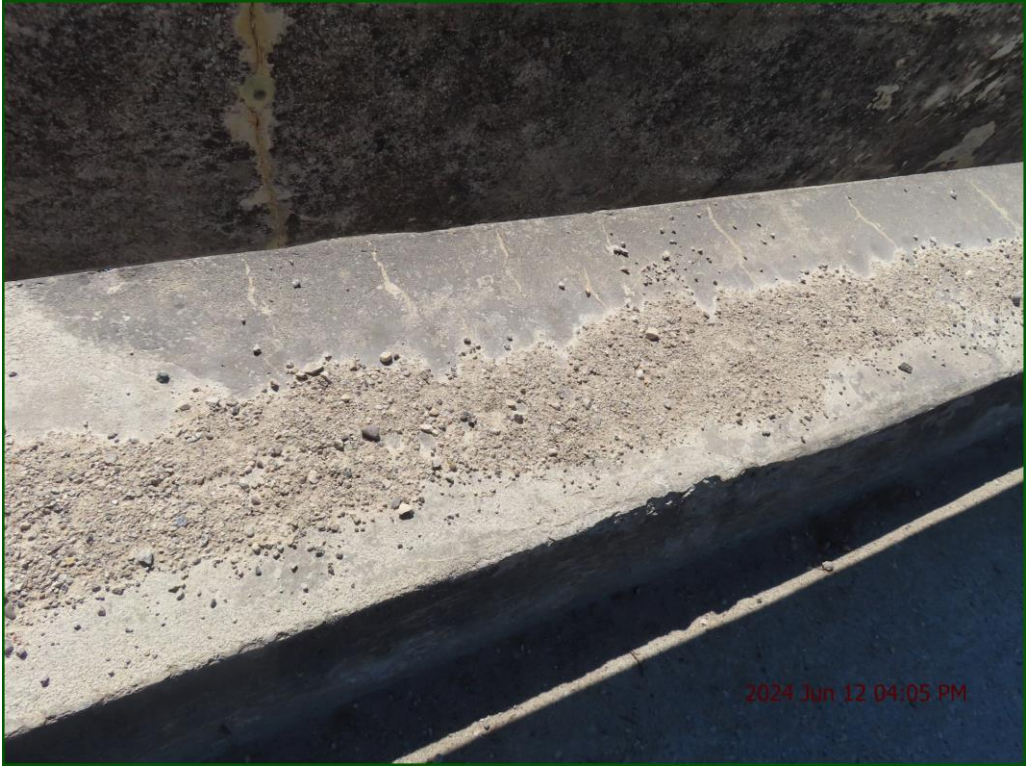
Description: Curbs: Medium longitudinal cracks throughout.

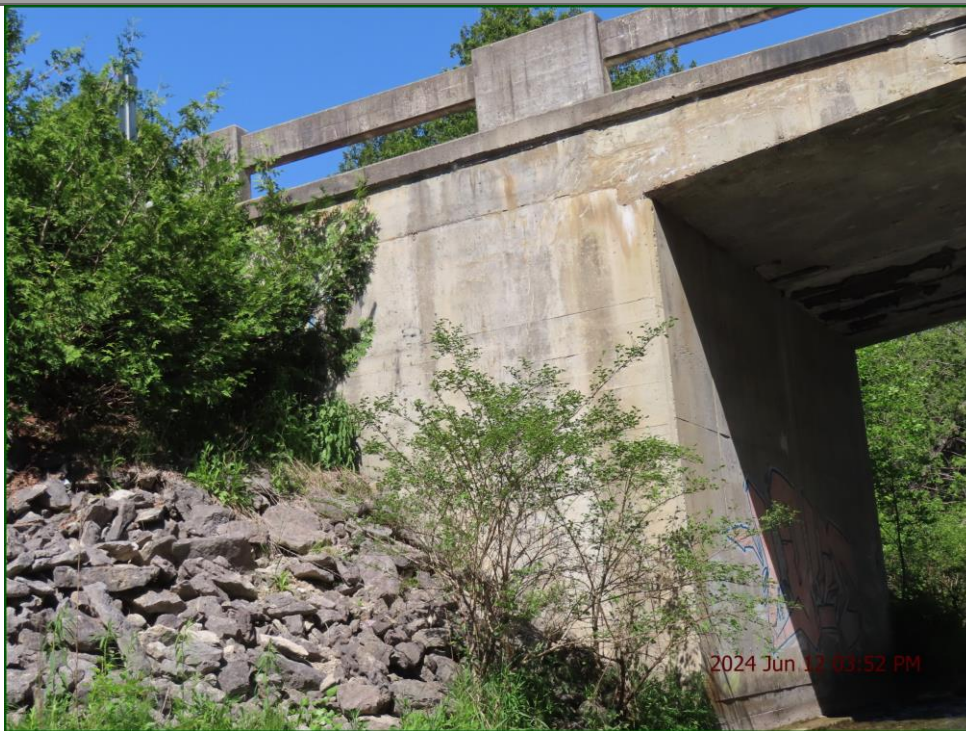
Light to medium map cracking with leachate staining.

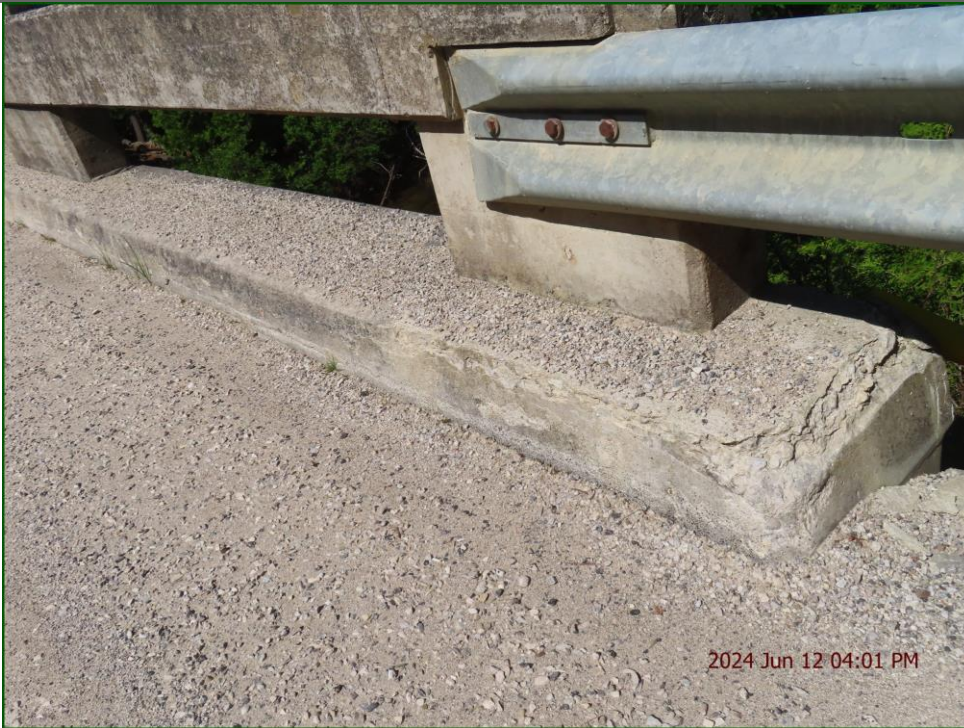
Light to medium map cracking with leachate staining.

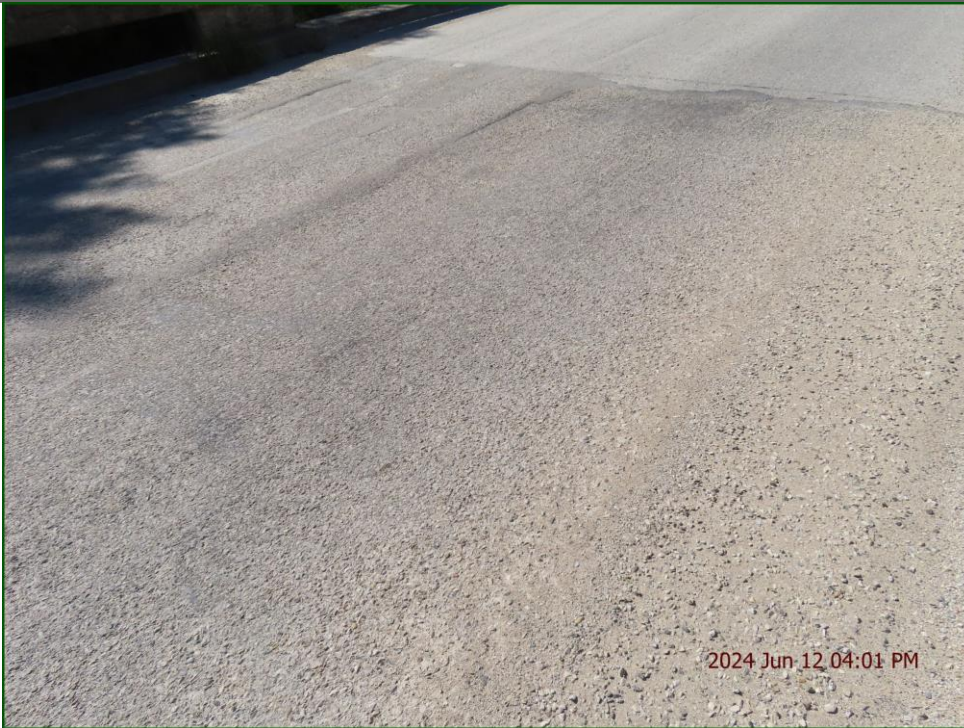
Shallow potholes throughout.

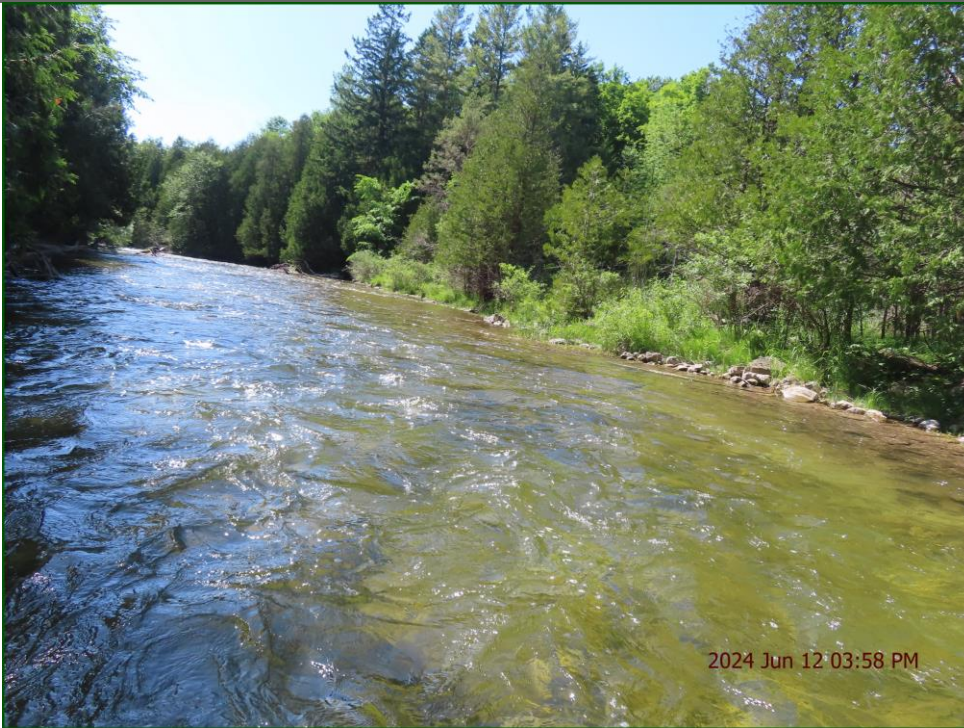
Heavy flow at time of inspection.

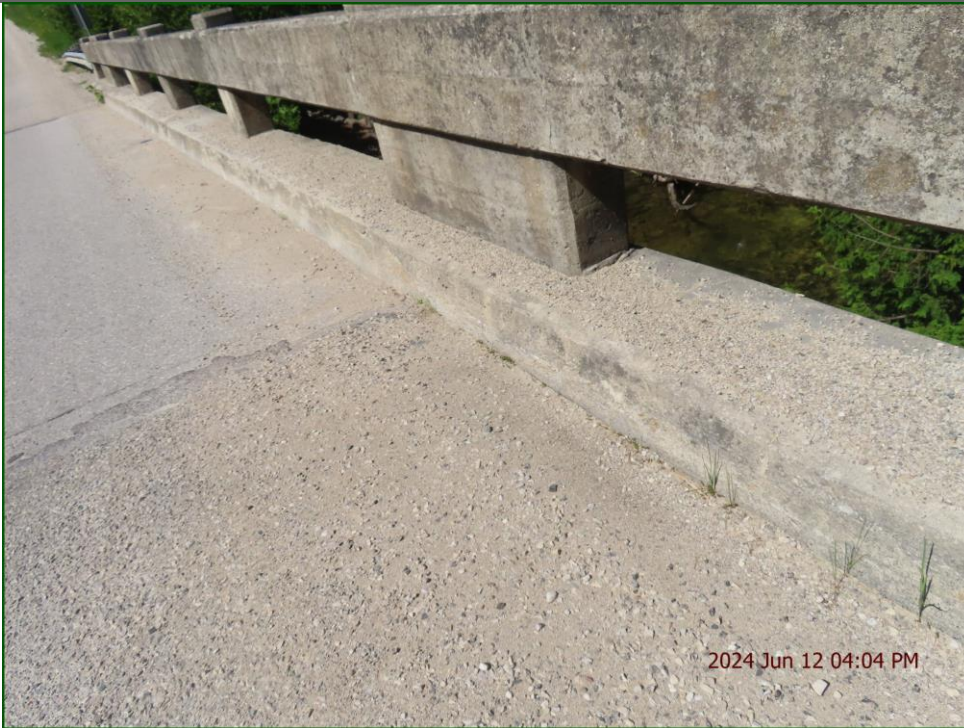
Shallow delaminations with light map cracking throughout. Medium longitudinal cracks throughout.

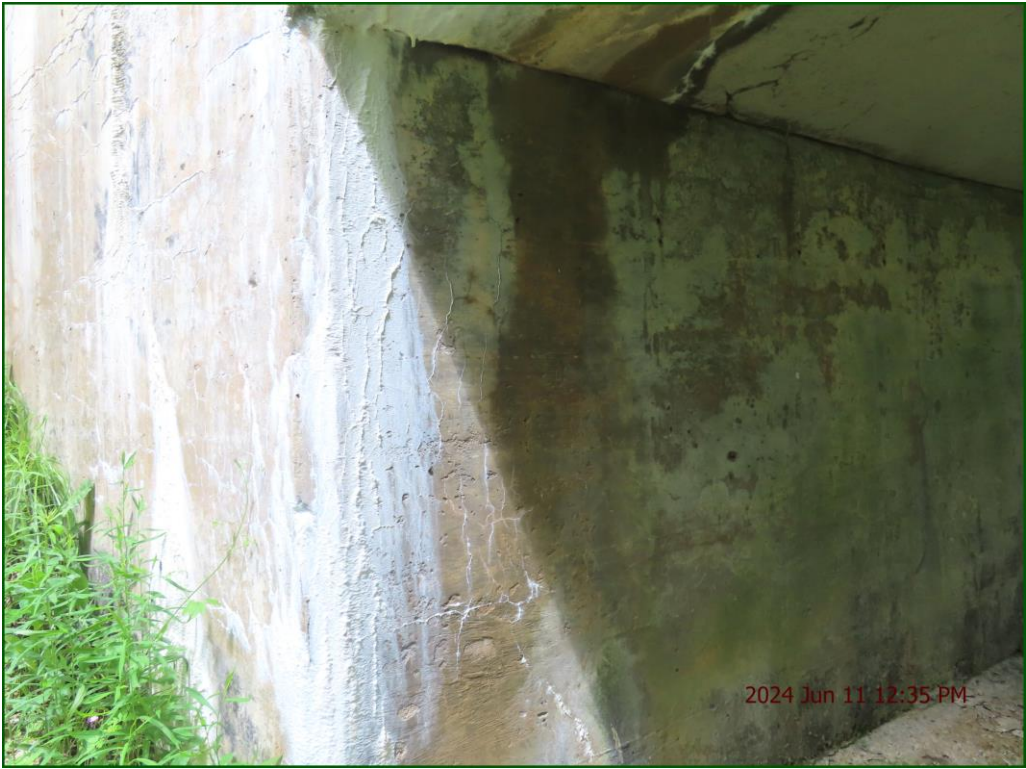
Description: Abutment walls: Medium vertical cracks with leachate staining.

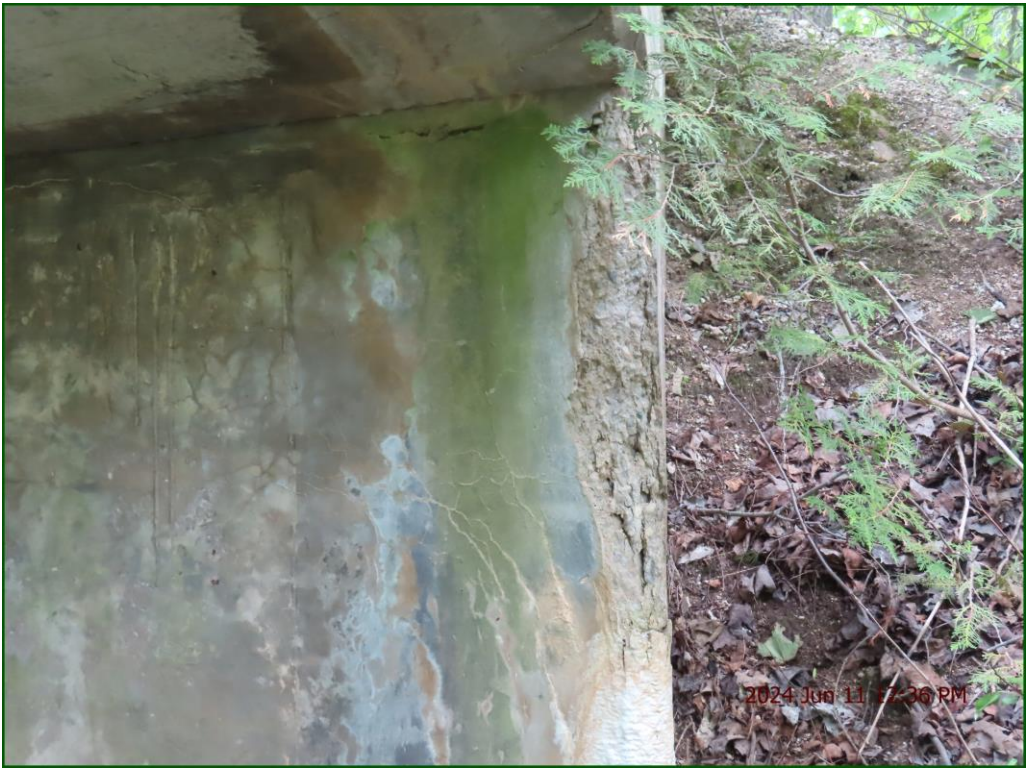
Description: Abutment walls: Moderate delamination at NE and SE quadrants.

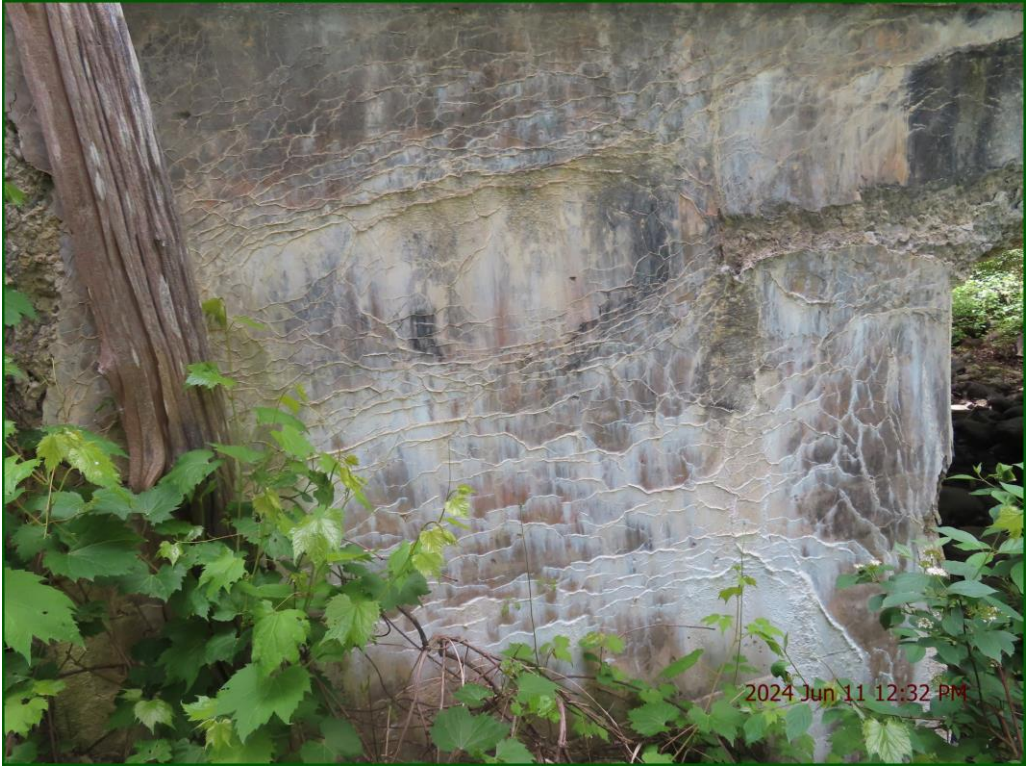
Description: Wingwalls: Medium to wide map cracking with leachate staining.

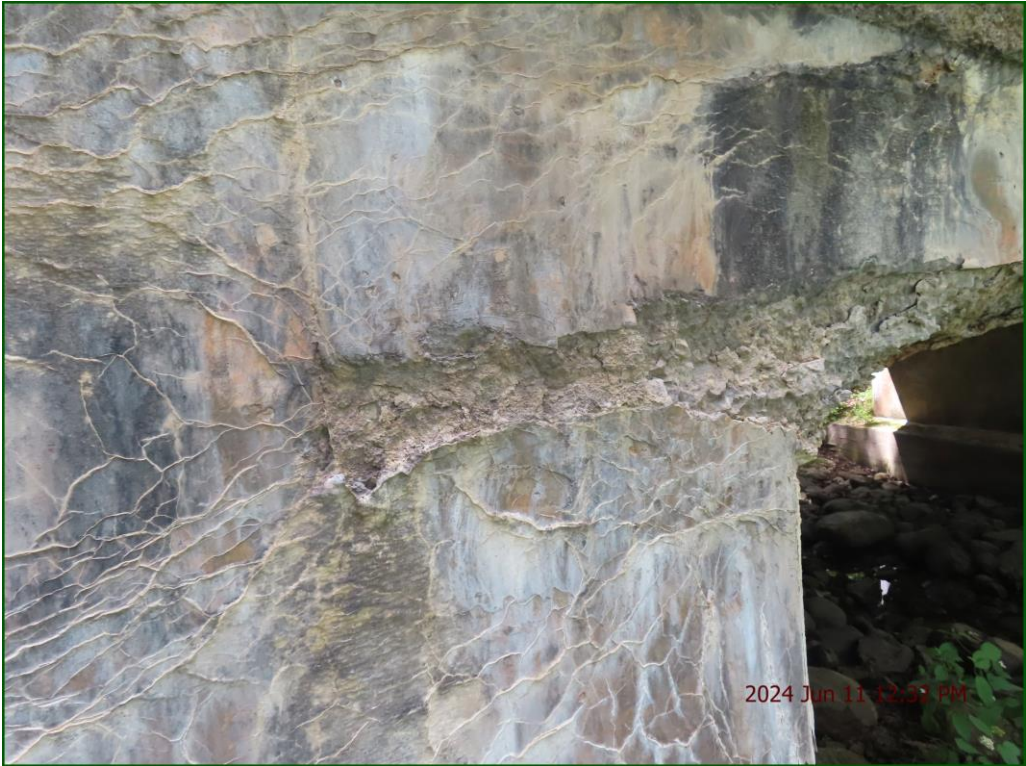
Description: Wingwalls: Moderate spalling and disintegration.

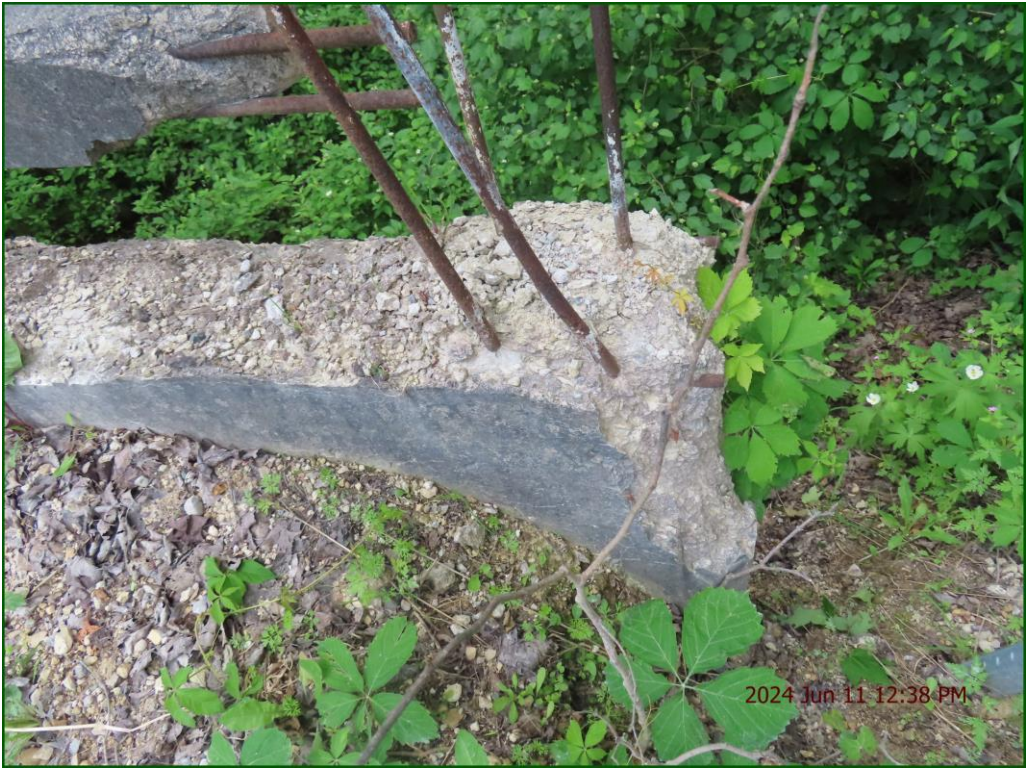
Description: Approach curbs: Severe disintegration throughout.

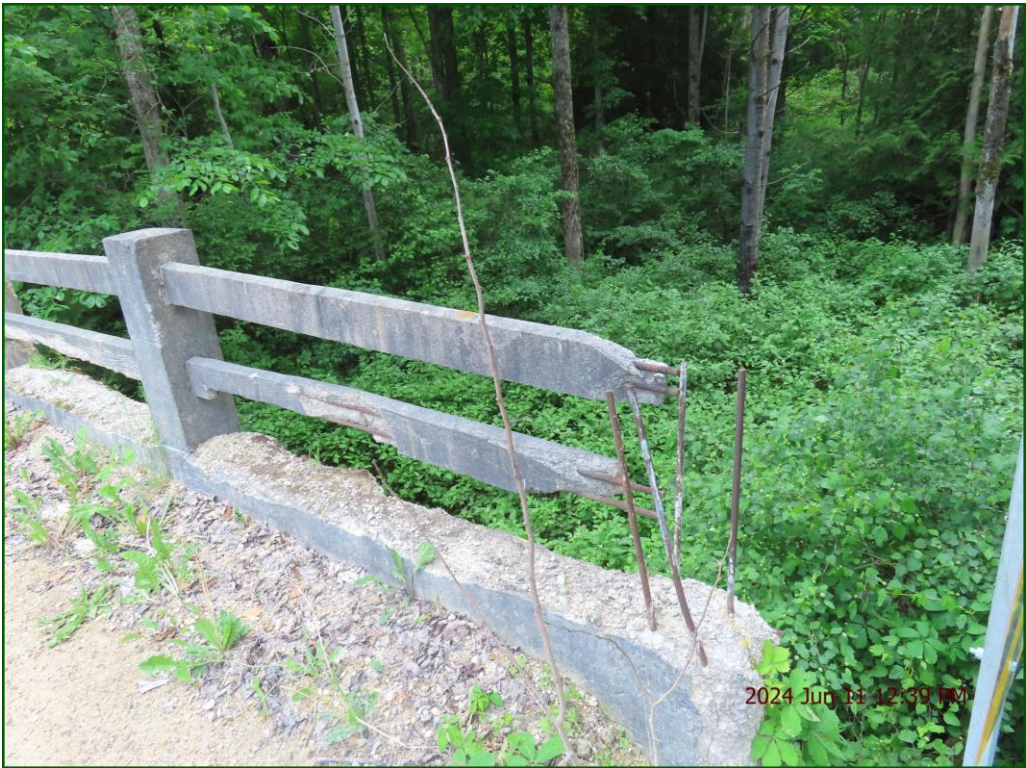
Description: Railing systems: Severe disintegration throughout with localized areas of 100% section loss.

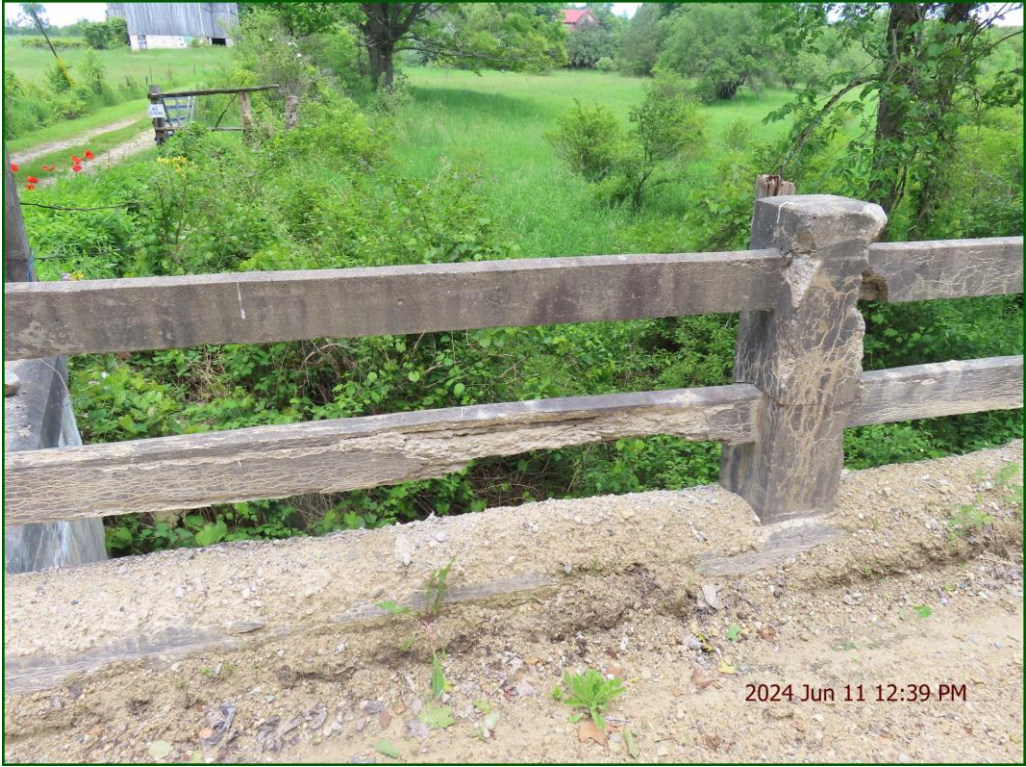
Description: Railing systems: Light to medium map cracking with leachate staining throughout.

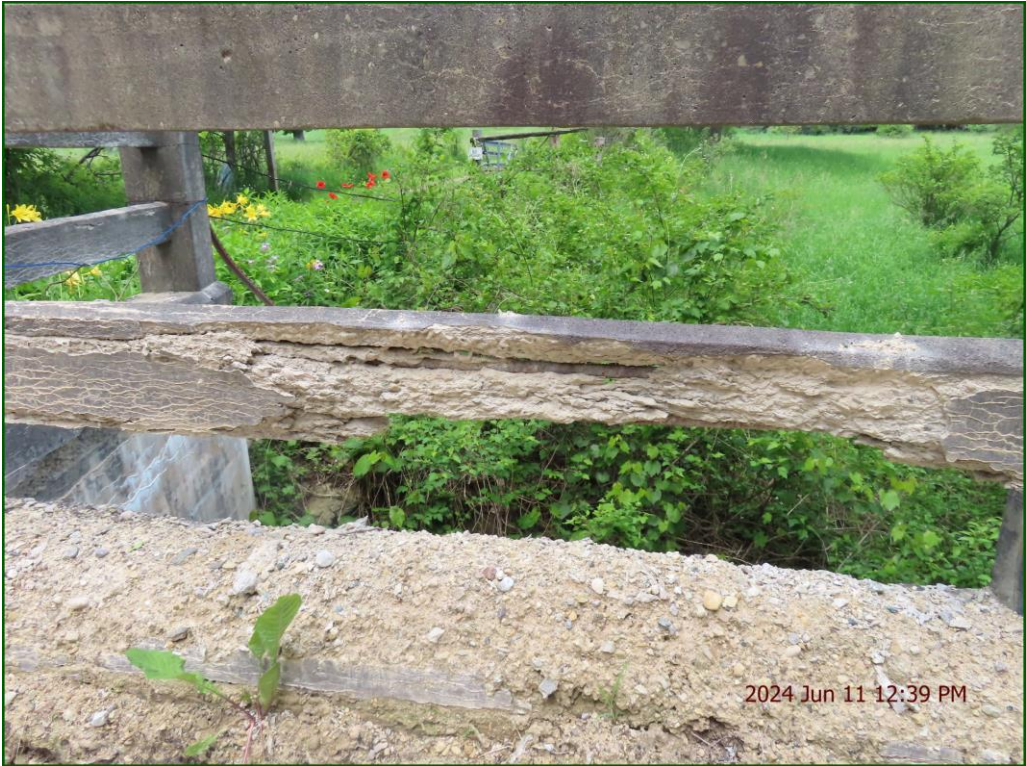
Description: Railing systems: Severe spalling with exposed reinforcing throughout.

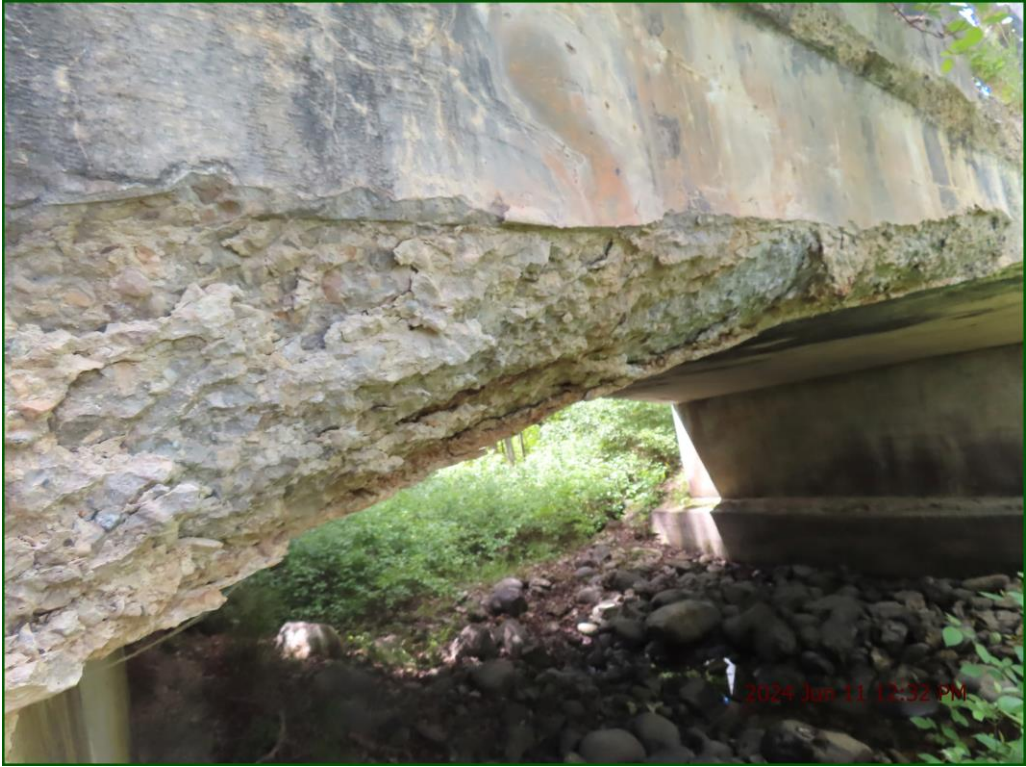
Description: Soffit (ext): Severe disintegration throughout.

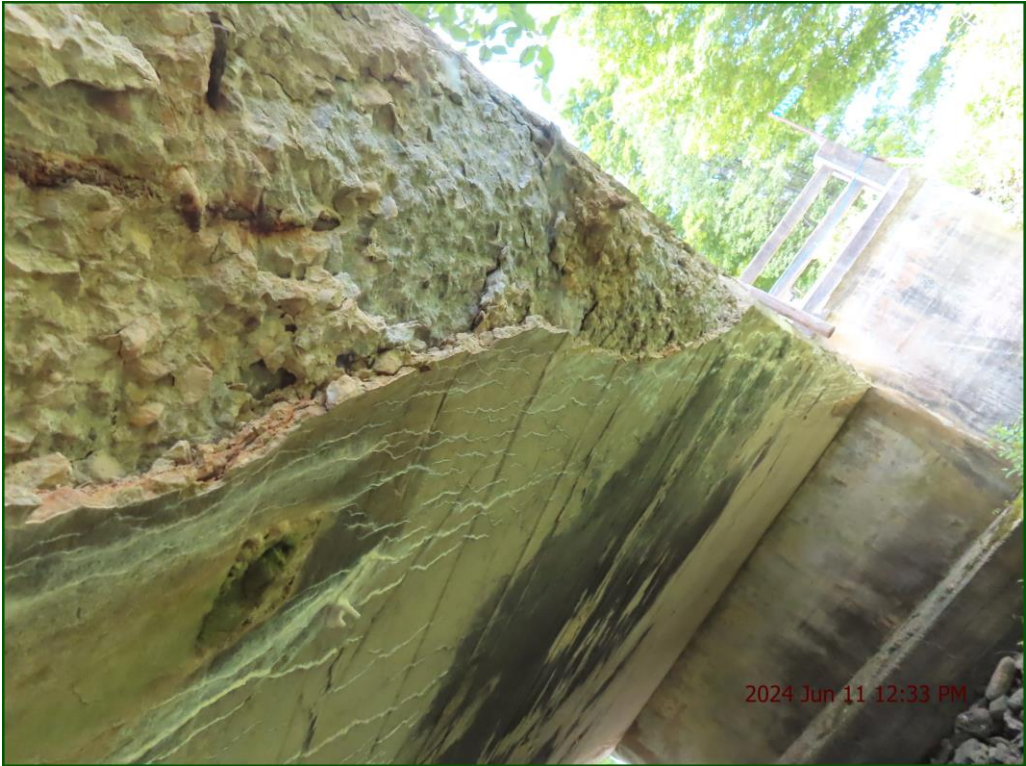
Description: Soffit (ext): Medium to wide map cracking with leachate staining.

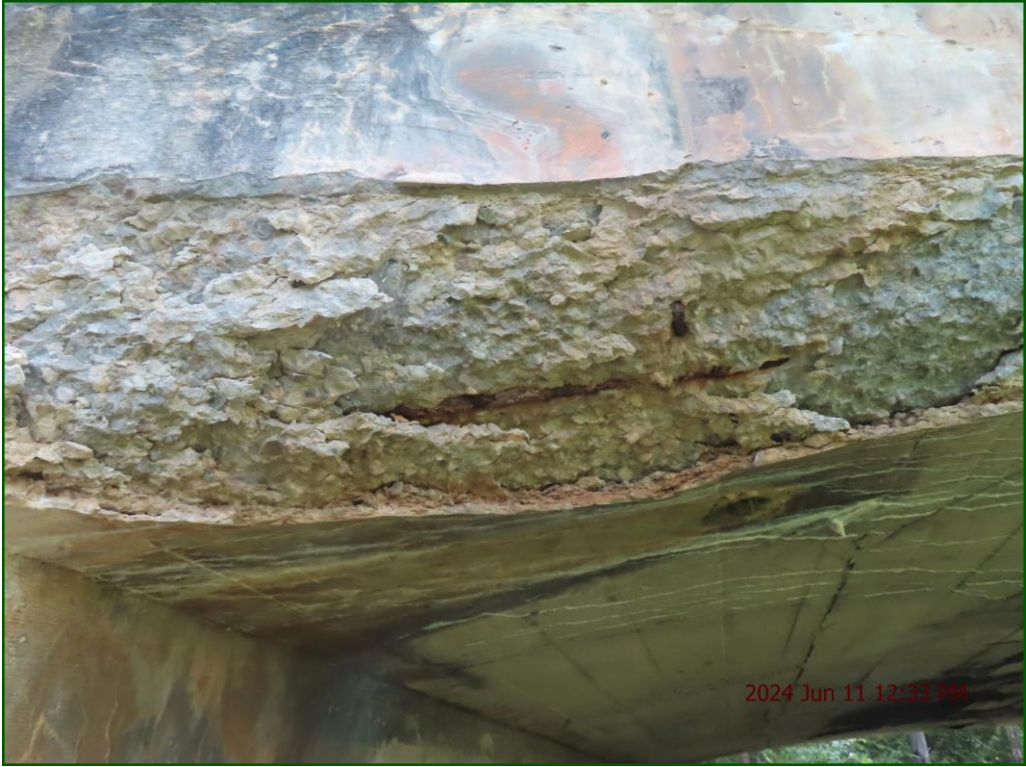
Description: Soffit (ext): Severe spalling and disintegration with exposed reinforcing.

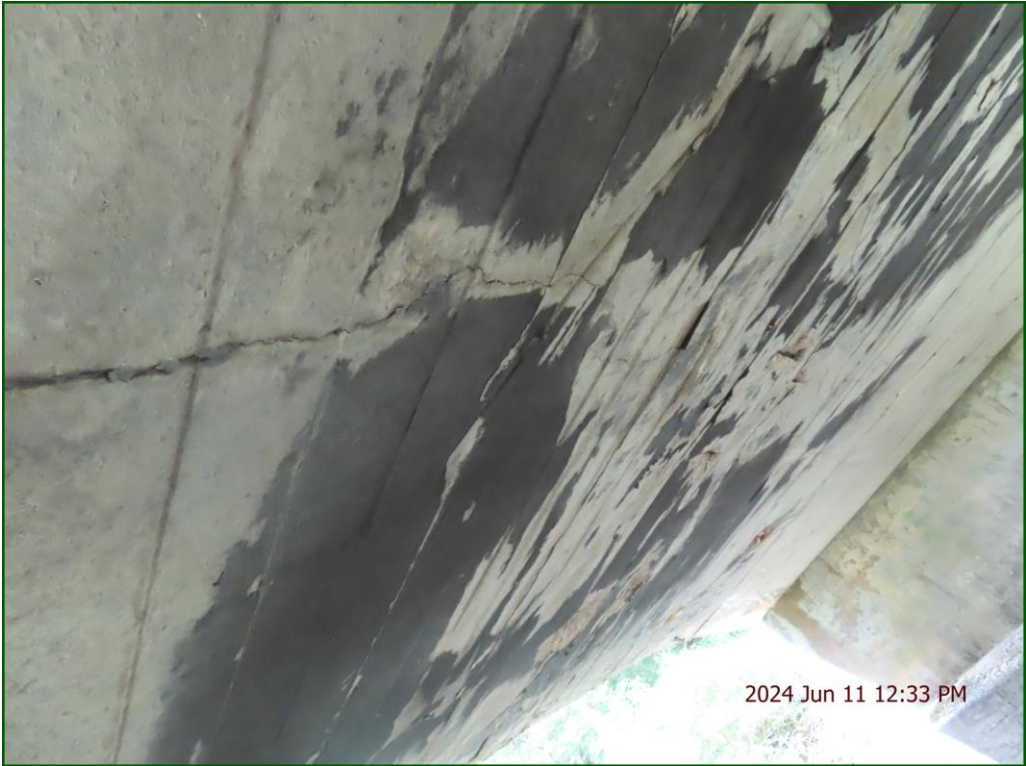
Description: Soffit (int): Four medium transverse cracks along entire width.

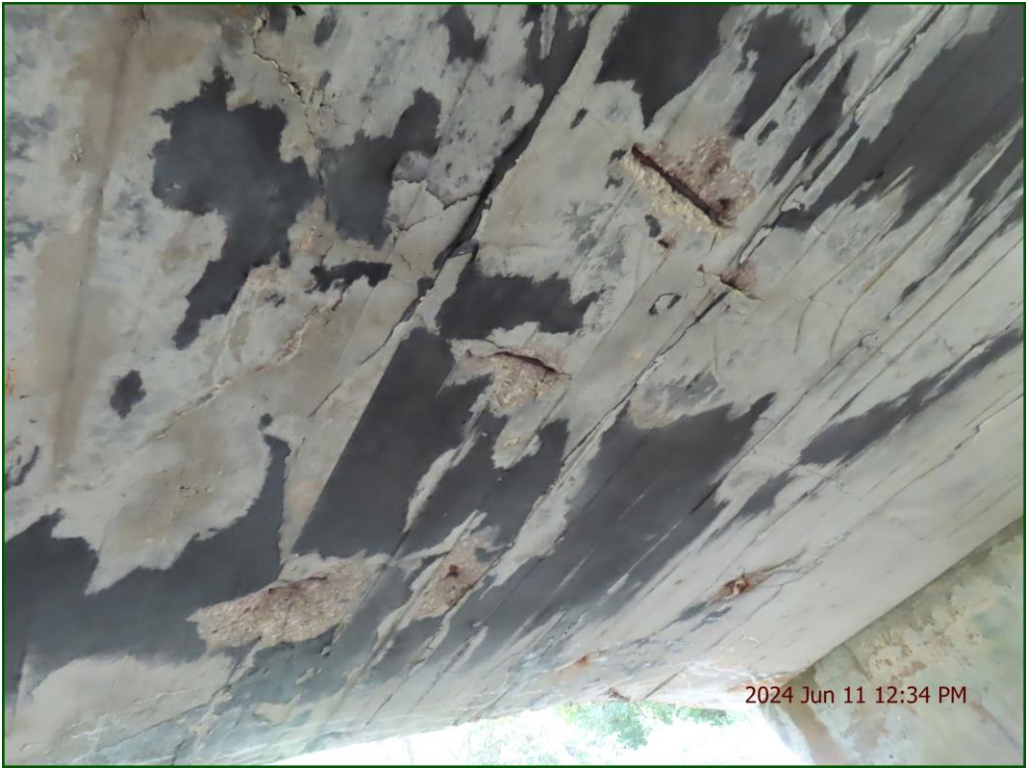
Description: Soffit (int): Moderate to severe spalling with exposed reinforcing throughout.

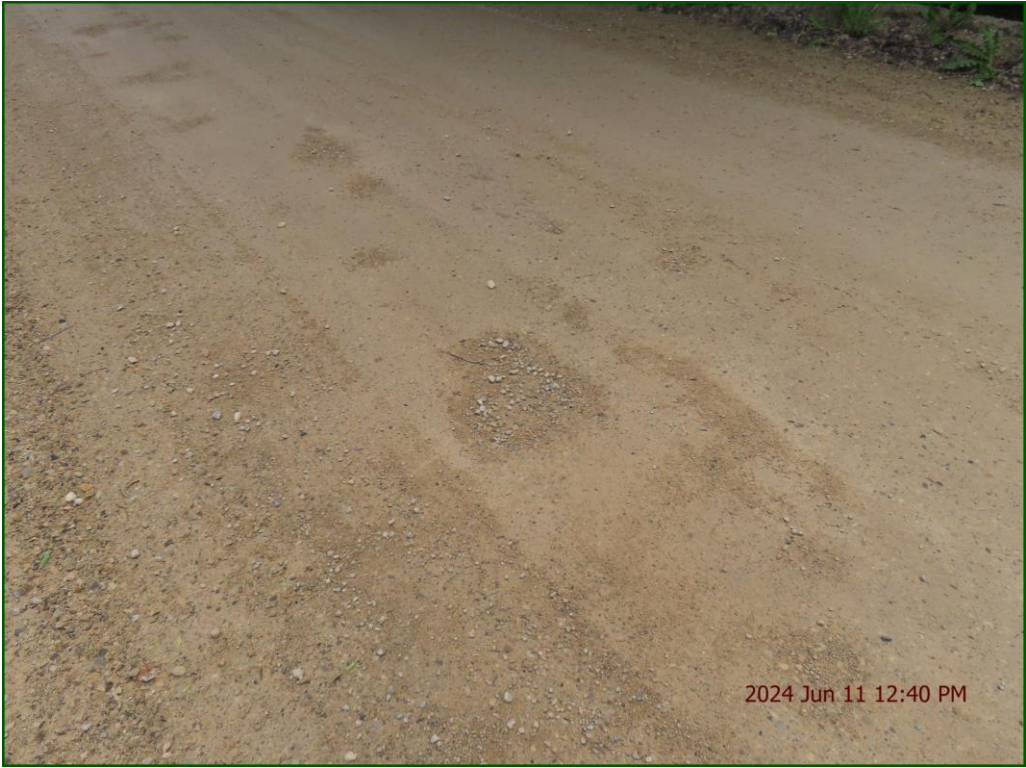
Description: Wearing Surface: Moderate potholing throughout.

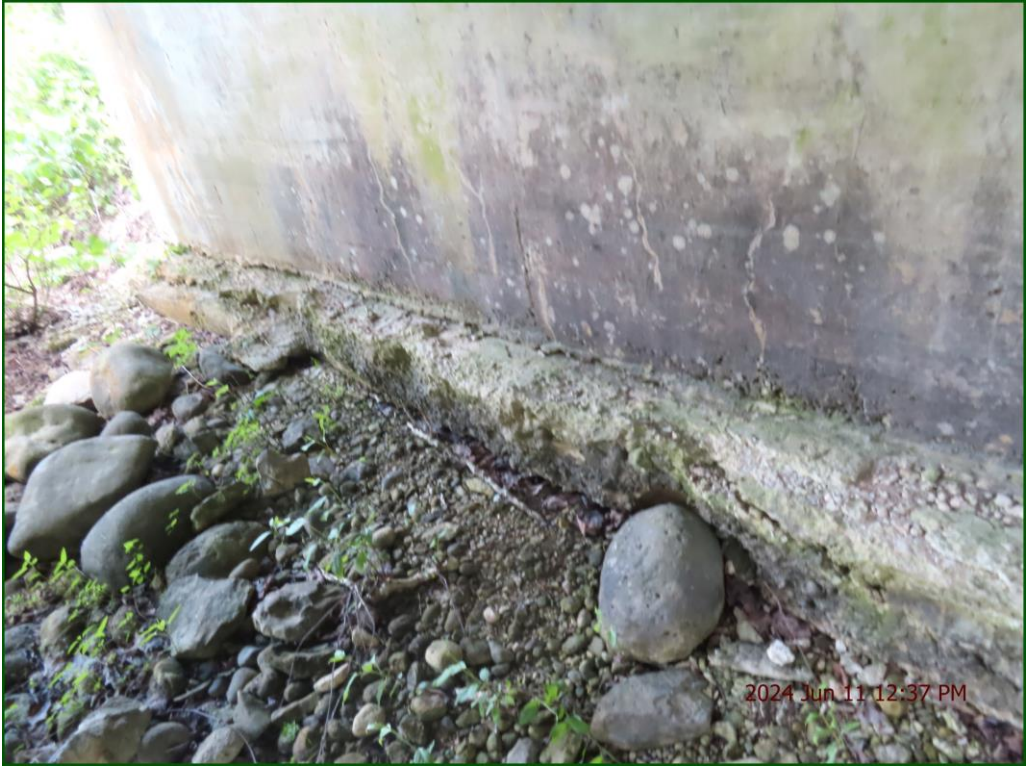
Description: Foundation: Severe deterioration on east footing.

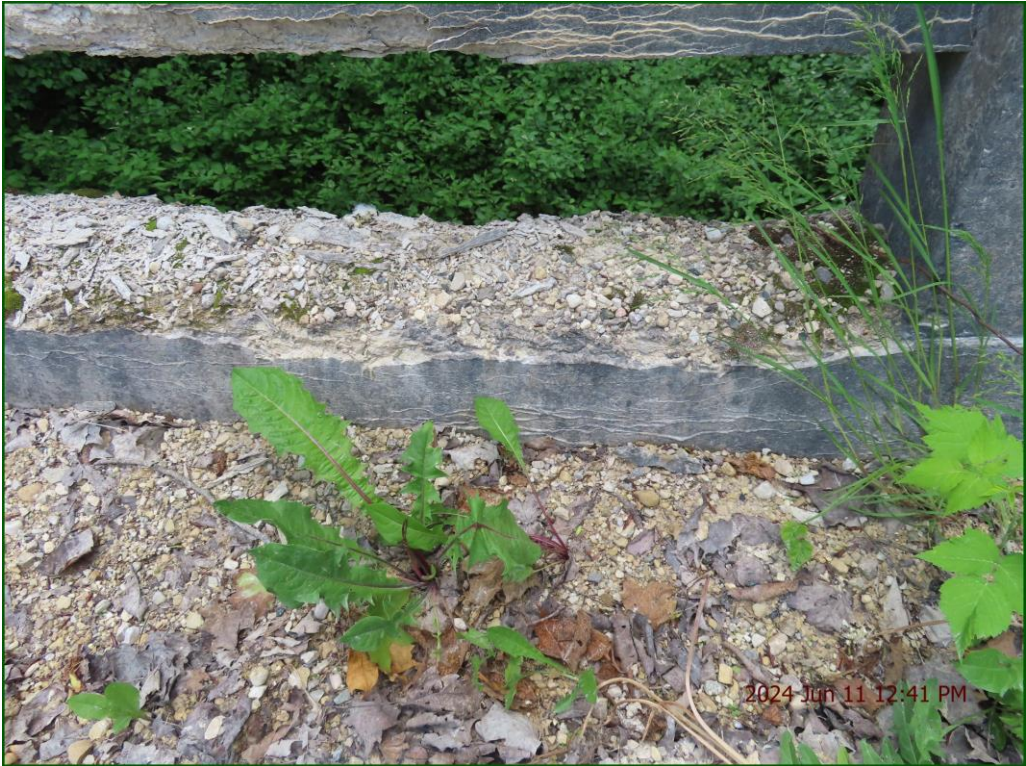
Description: Curbs: Light to medium map cracking throughout.

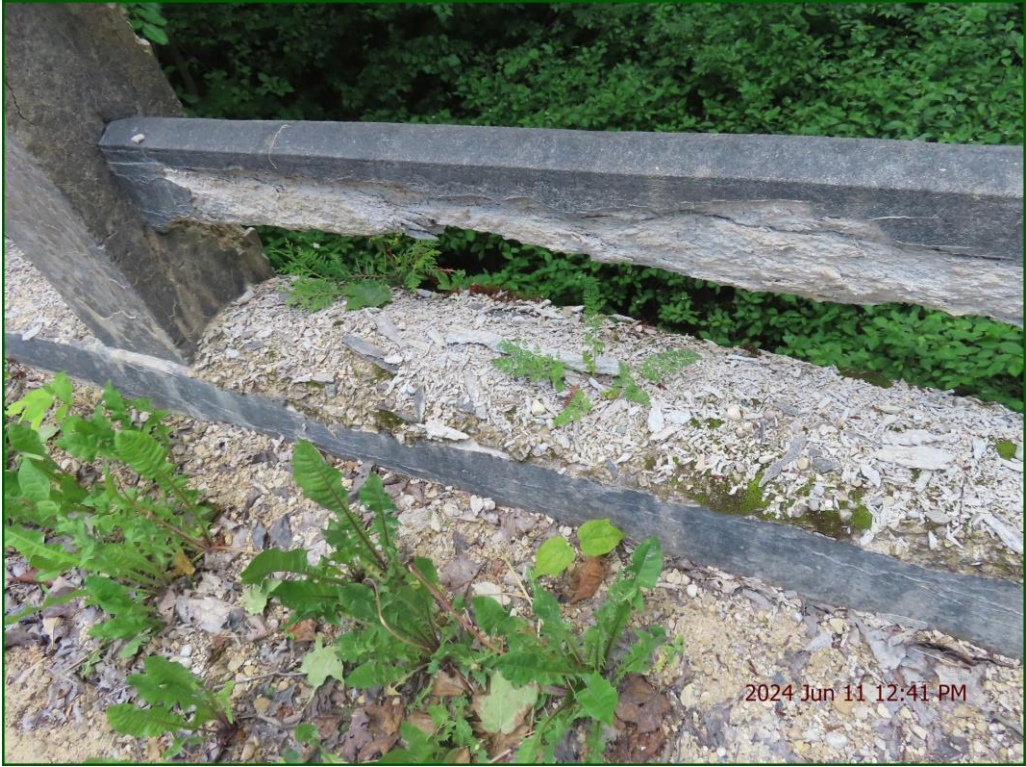
Description: Curbs: Severe disintegration throughout.
