MUNICIPALITY OF
West Grey

Municipality of West Grey
Bridge Prioritization Program

February 2025

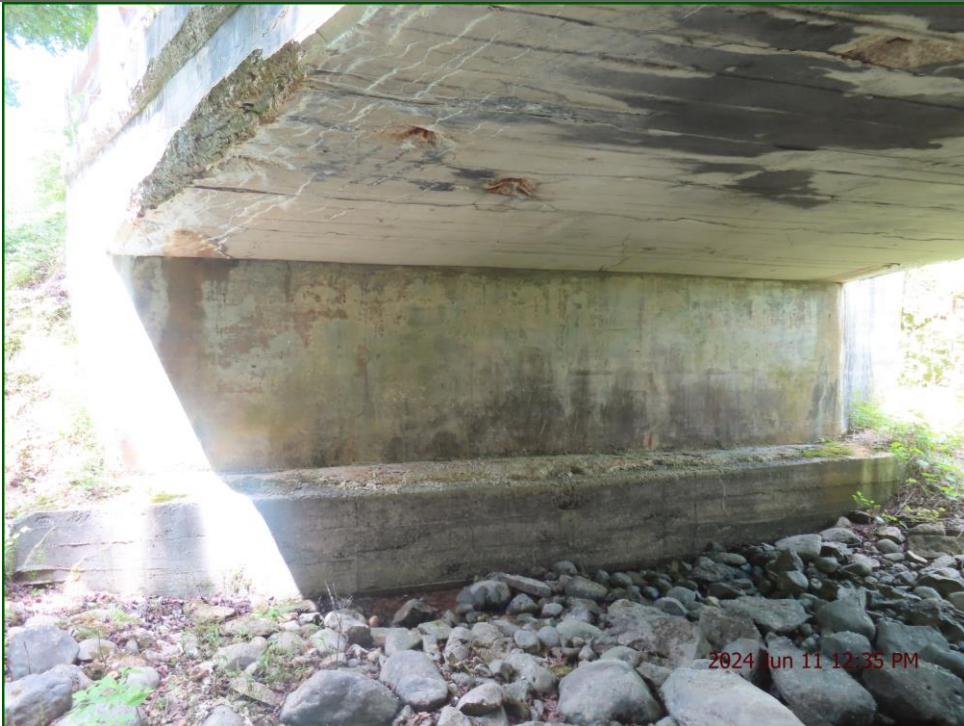
Medium vertical cracks with leachate staining. Moderate delamination at NE and SE quadrants.

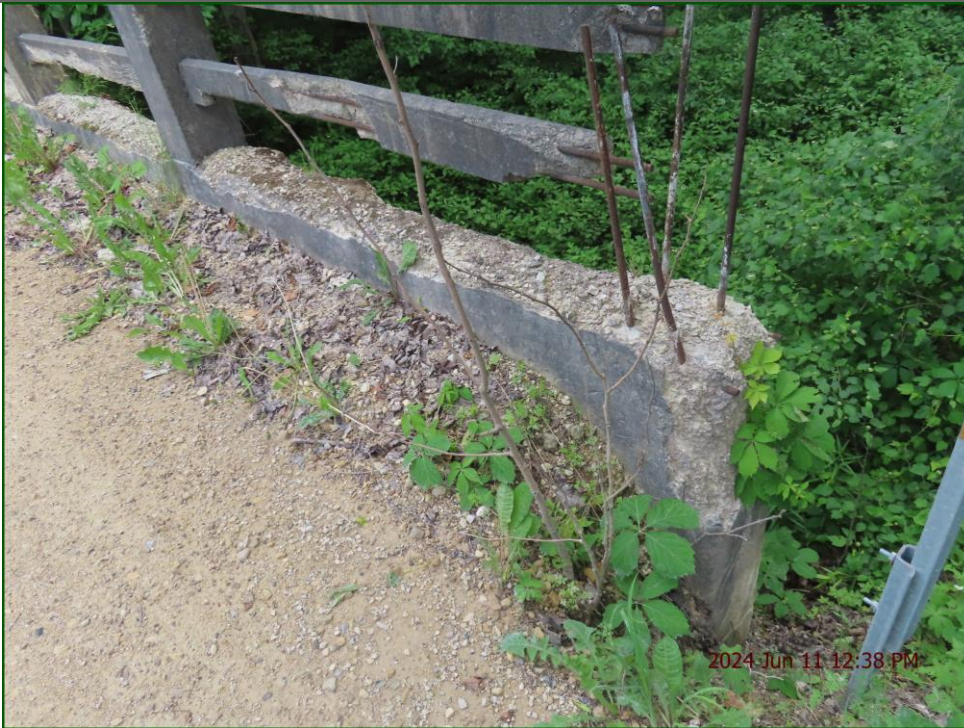
Severe disintegration throughout.

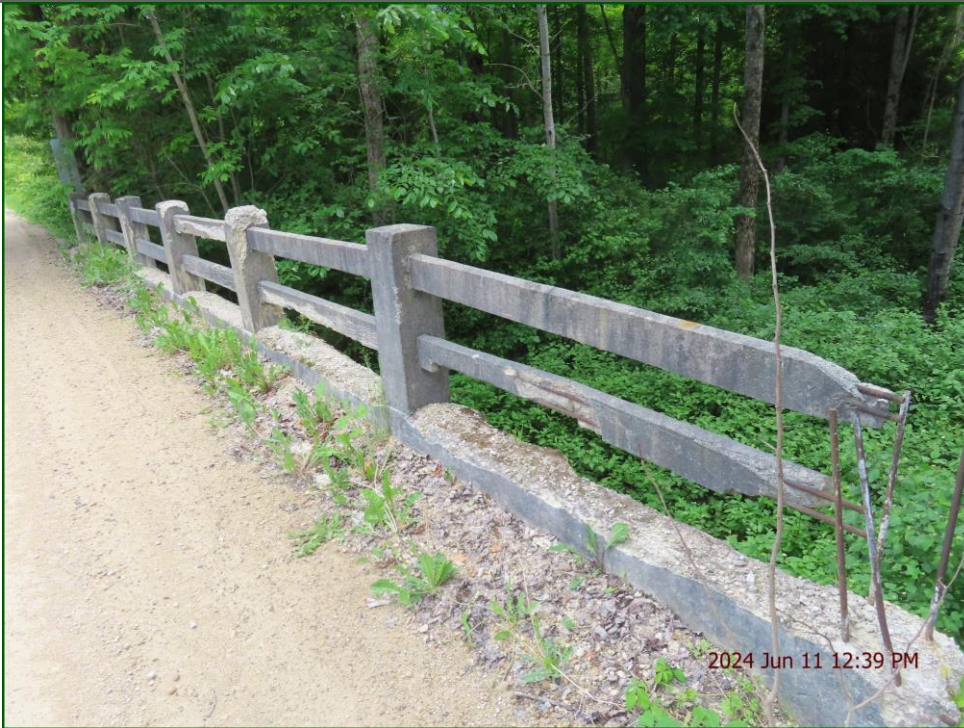
Severe disintegration throughout with localized areas of 100% section loss. Light to medium map cracking with leachate staining throughout. Severe spalling with exposed reinforcing throughout.

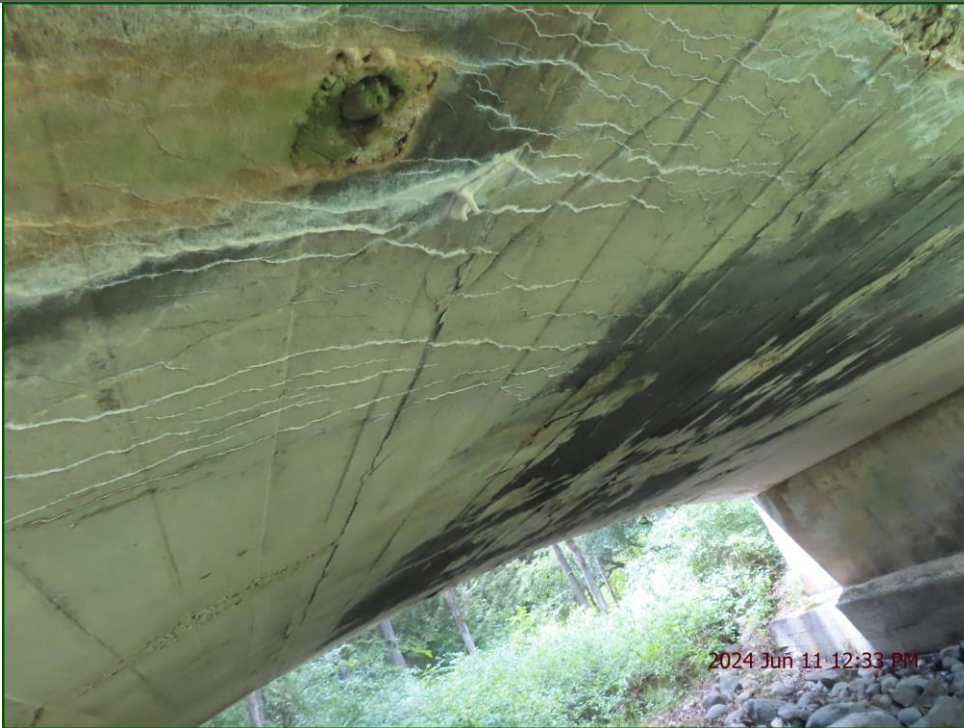
Four medium transverse cracks along entire width. Moderate to severe spalling with exposed reinforcing throughout.

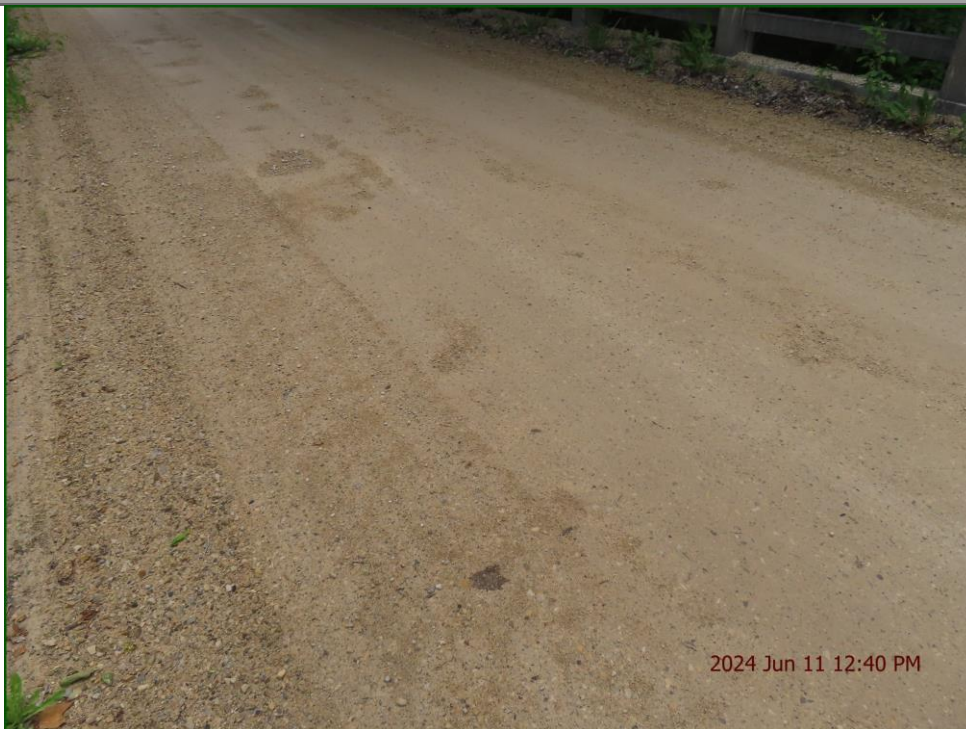
Moderate potholing throughout.

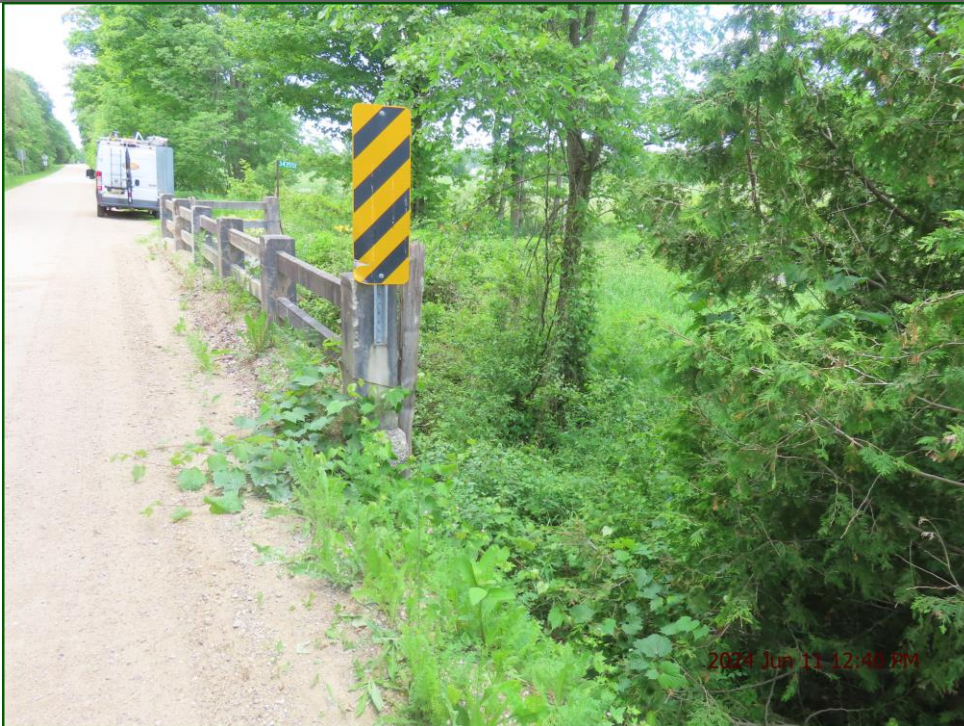
Steep embankments recommend protection.

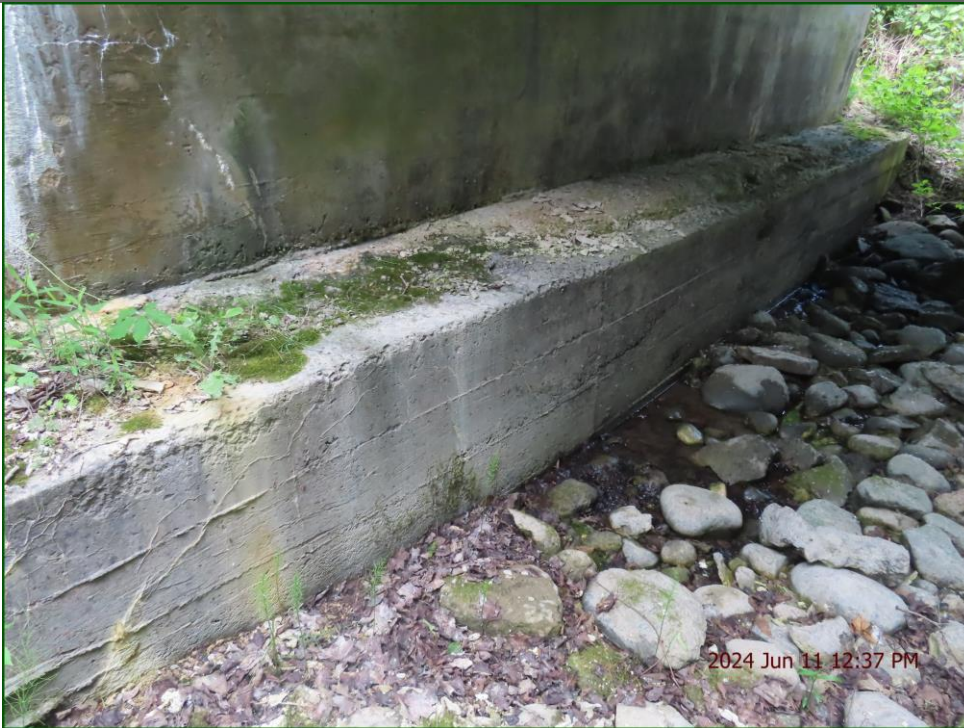
Severe deterioration on east footing.

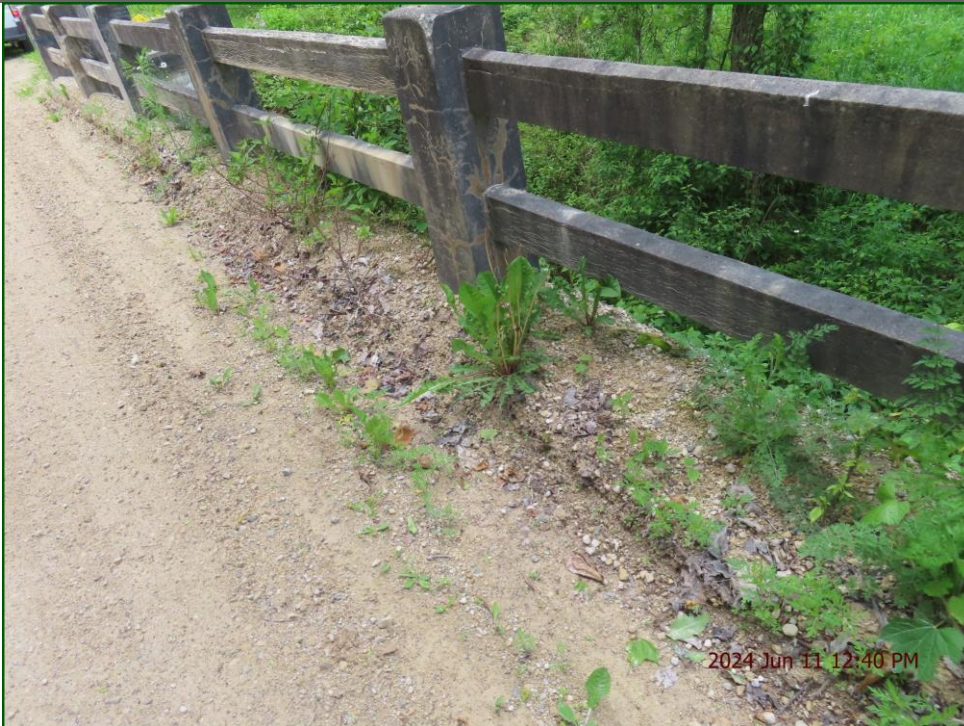
Light to medium map cracking throughout. Severe disintegration throughout. Limited inspection due to gravel build up.

Element Group:	Sidewalks/ curbs	Site Number:	G-037
Element Name:	Curbs	Width:	0.33 m
Element type:		Height:	0.2 m
Sub-element:		Length:	9.75 m
Material:	Cast-in-place Concrete	Count:	2
Location:	On deck	Total Quantity:	10 m
Environment:	Severe	Not inspected:	<input type="checkbox"/>
Perform. deficiencies:		Maintenance Type:	Routine
Maint needs:	Bridge cleaning	Maint. Time Period:	1 Year

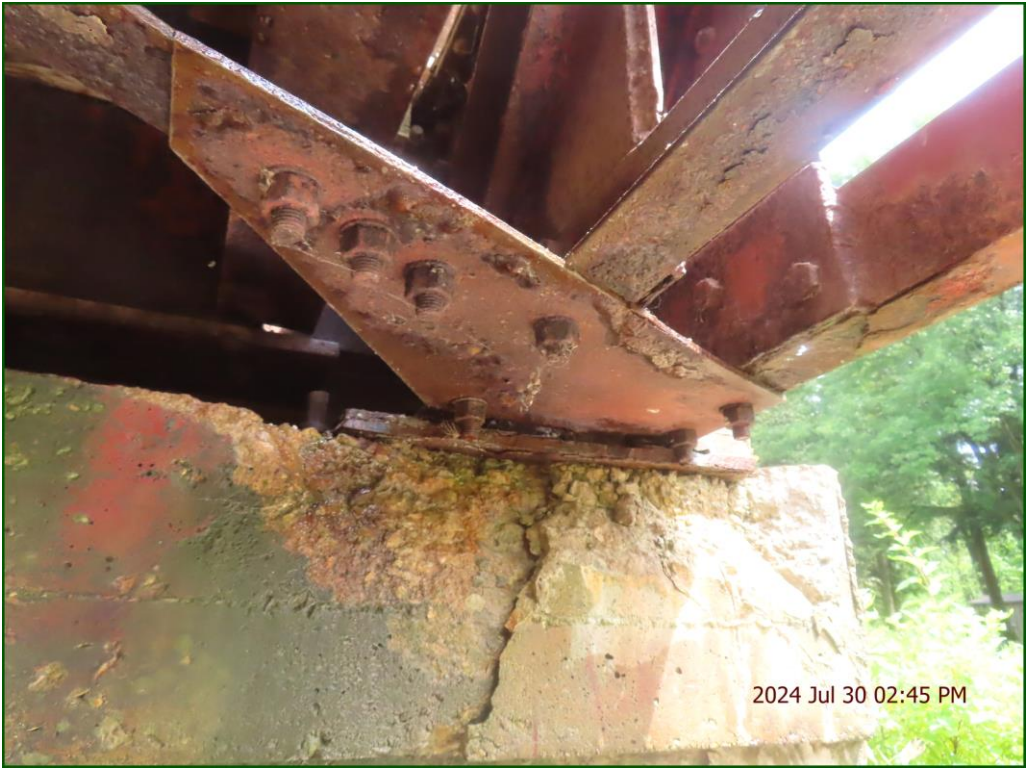
Description: Bearings: Severe corrosion throughout.

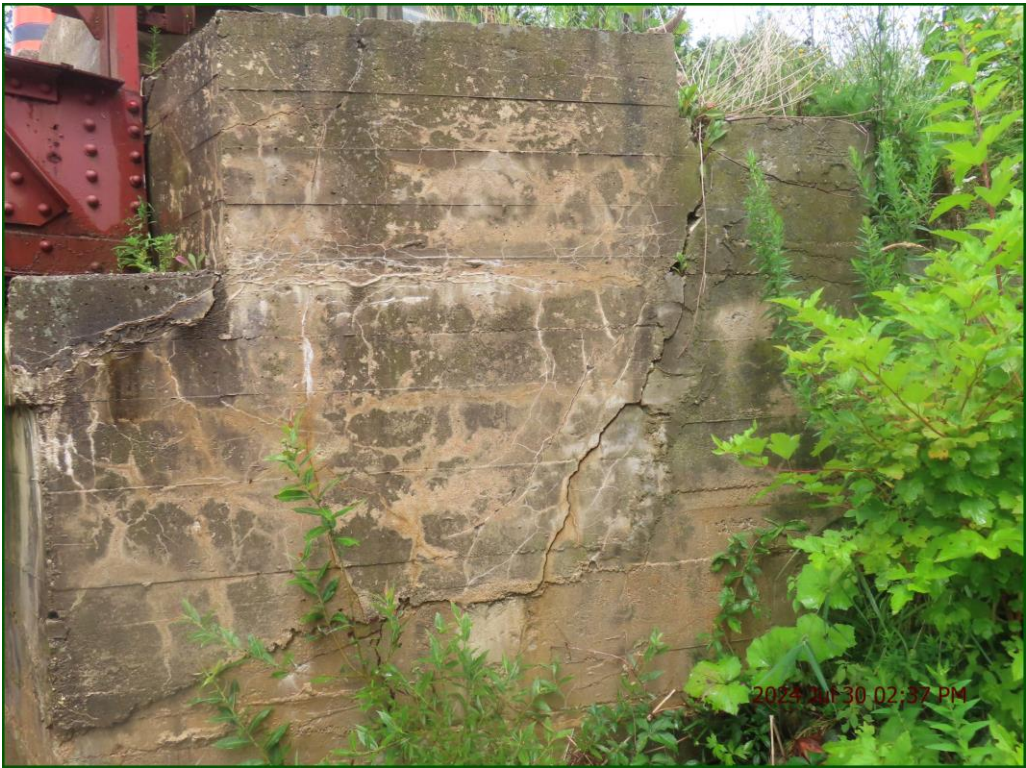
Description: Wingwalls: Wide crack and separation from abutment walls.

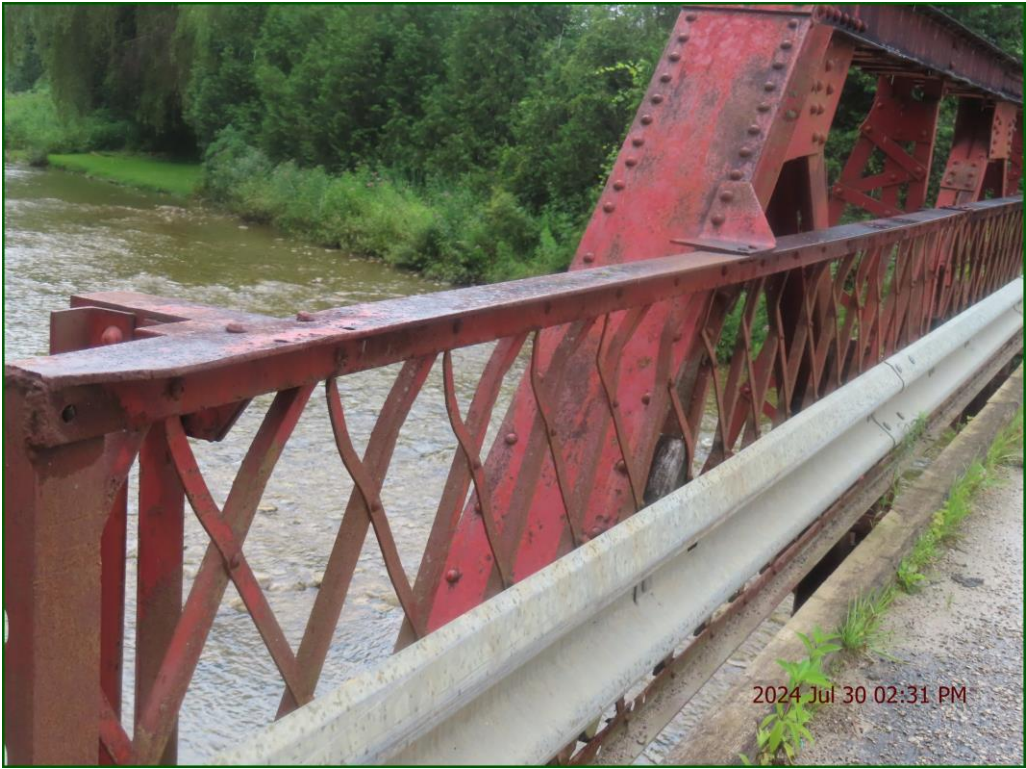
Description: Railing Systems: Localized areas of impact damage.

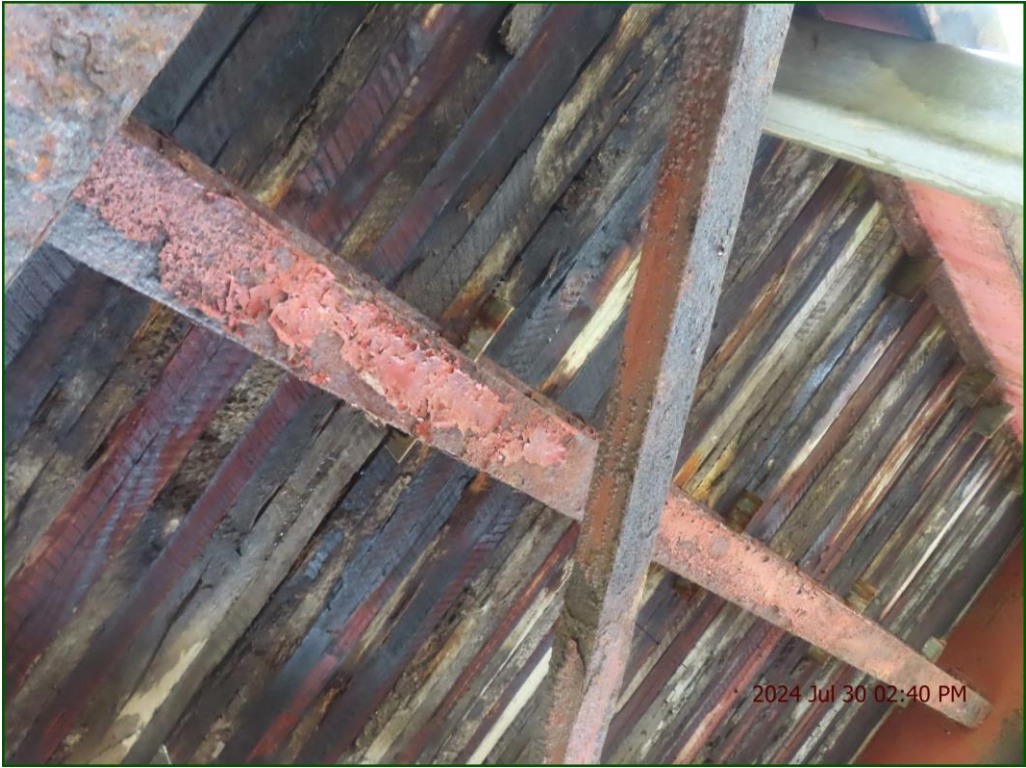
Description: Stringers: Light to medium corrosion in bottom flange areas and end connections (1/2).

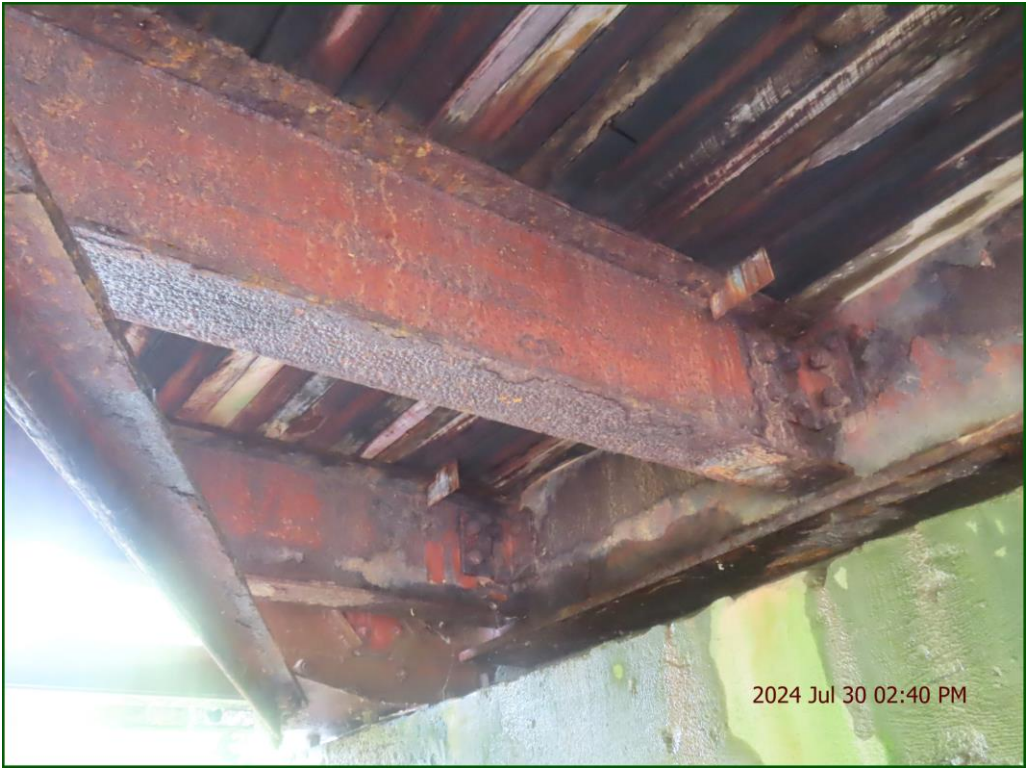
Description: Stringers: Light to medium corrosion in bottom flange areas and end connections (2/2).

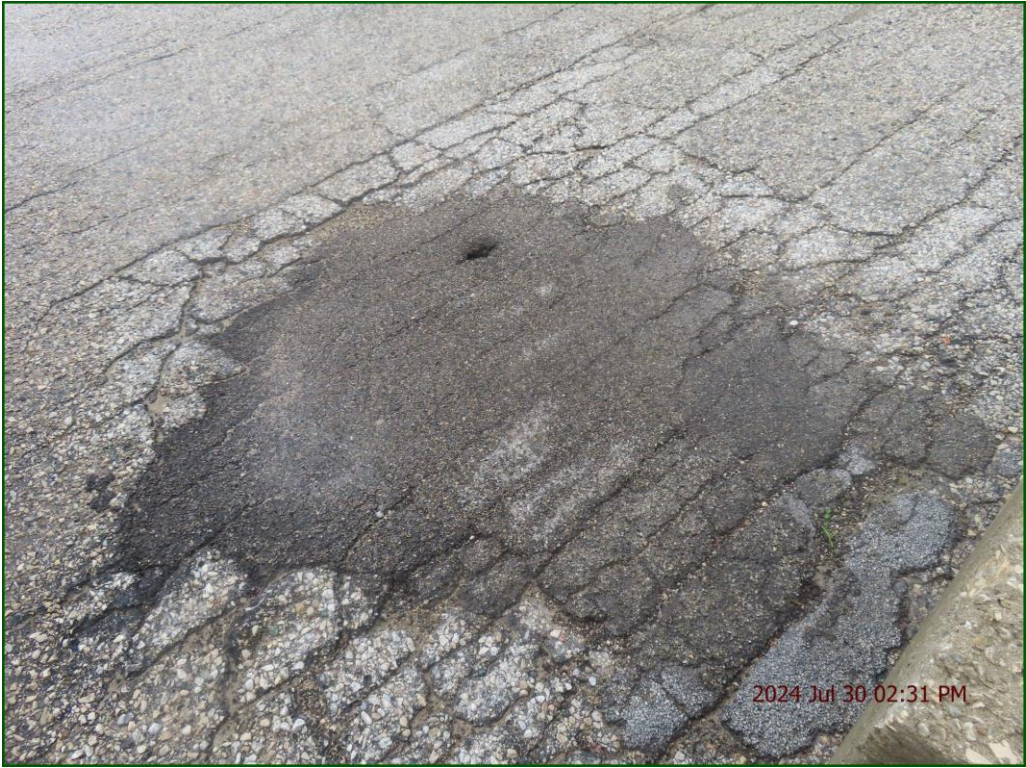
Description: Wearing Surface: Asphalt break up due to flexible deck system.

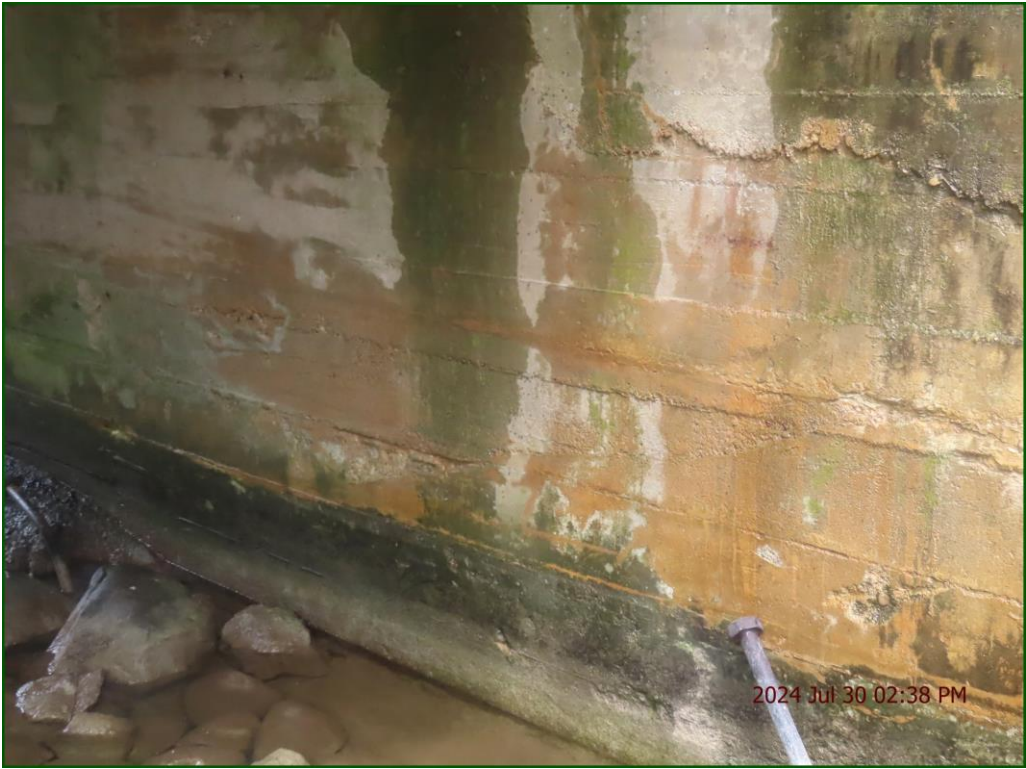
Description: Abutment Walls: Shallow to medium scaling throughout.

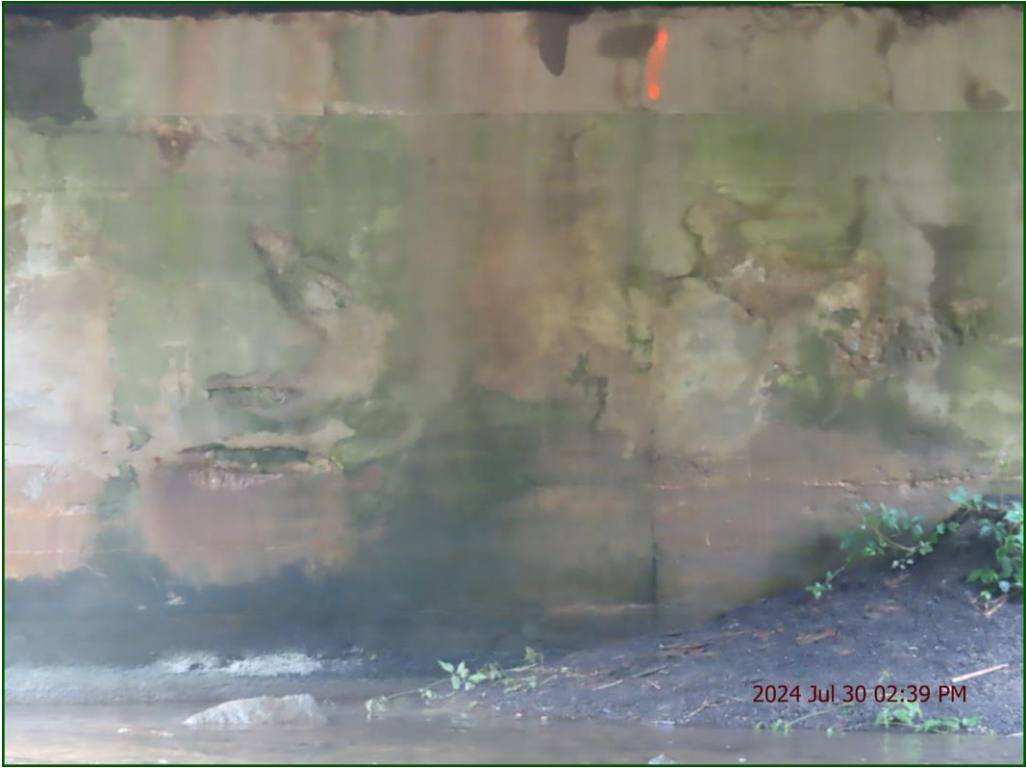
Description: Abutment Walls: Crack at construction joint, not critical.

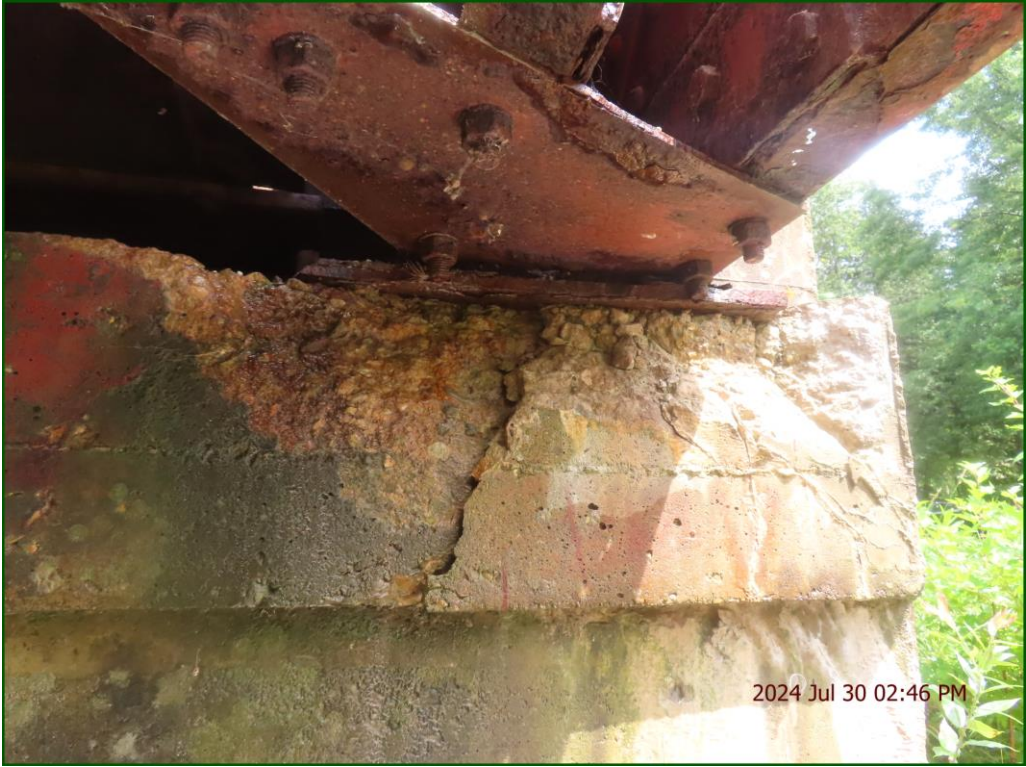
Description: Abutment Walls: Possible crushing under south east bearing.

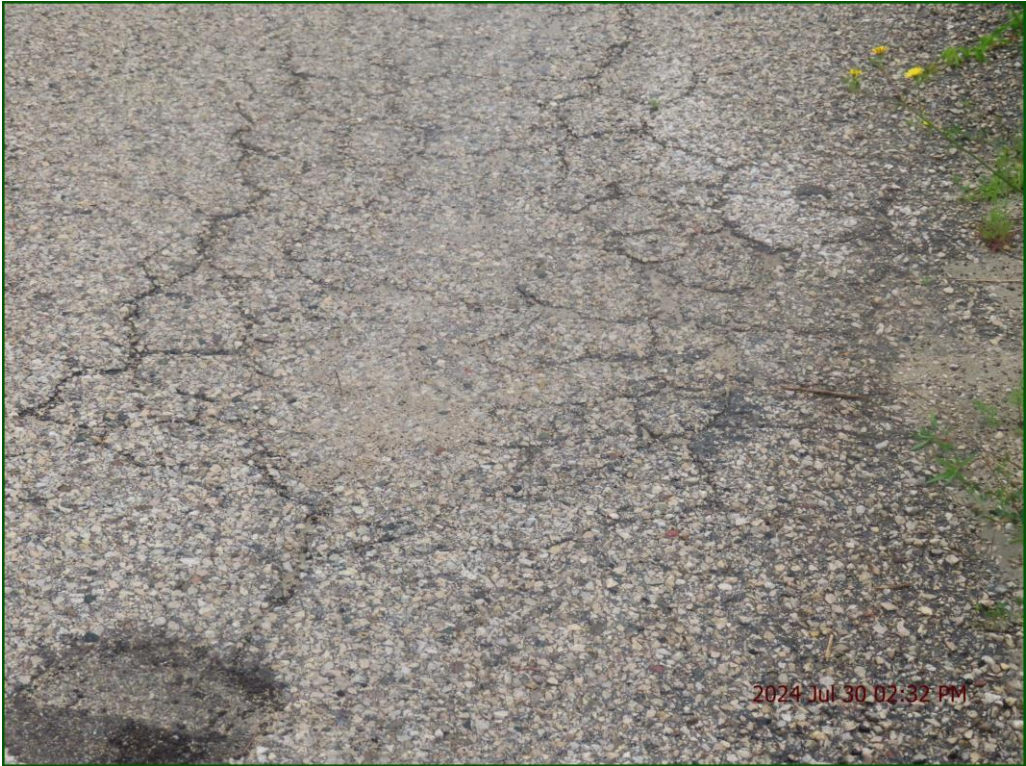
Description: Approach Wearing Surface: Narrow map cracking and raveling.

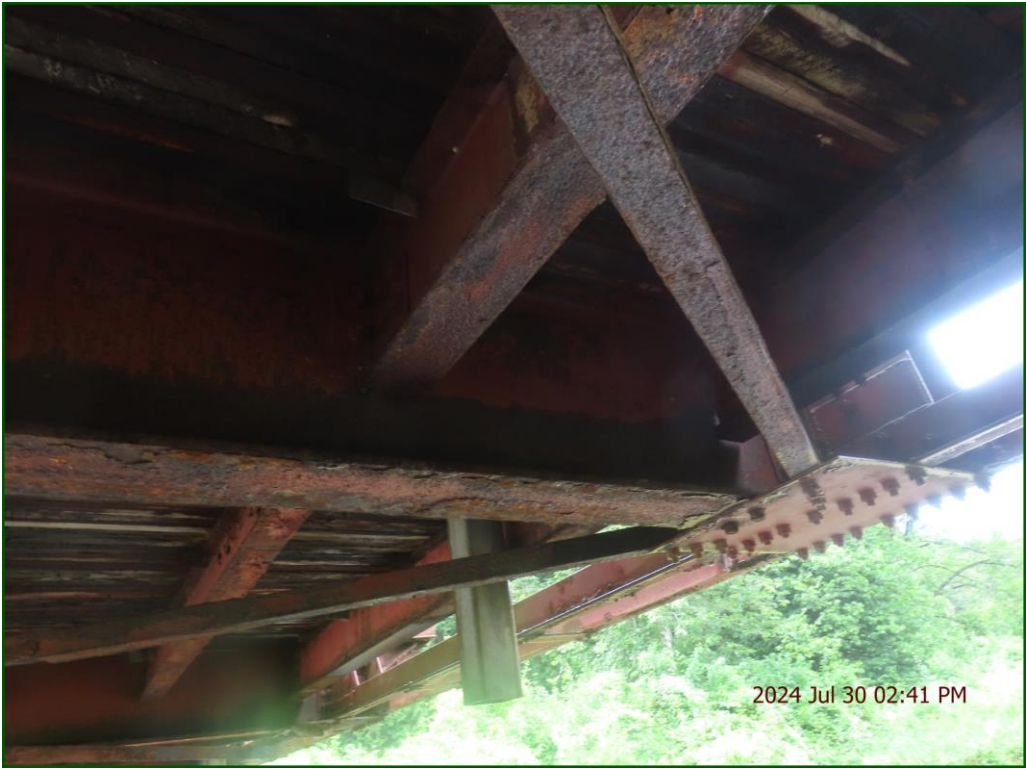
Description: Floor beams: Light to medium corrosion throughout.

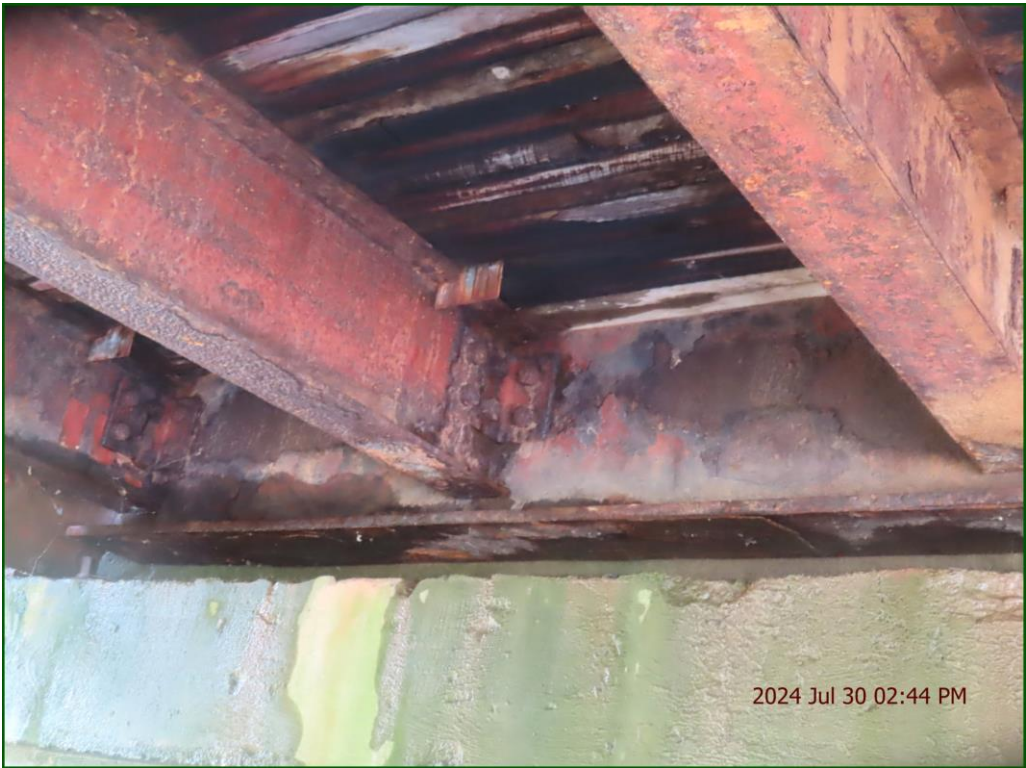
Description: Floor Beams: Medium to severe corrosion in end floor beams.

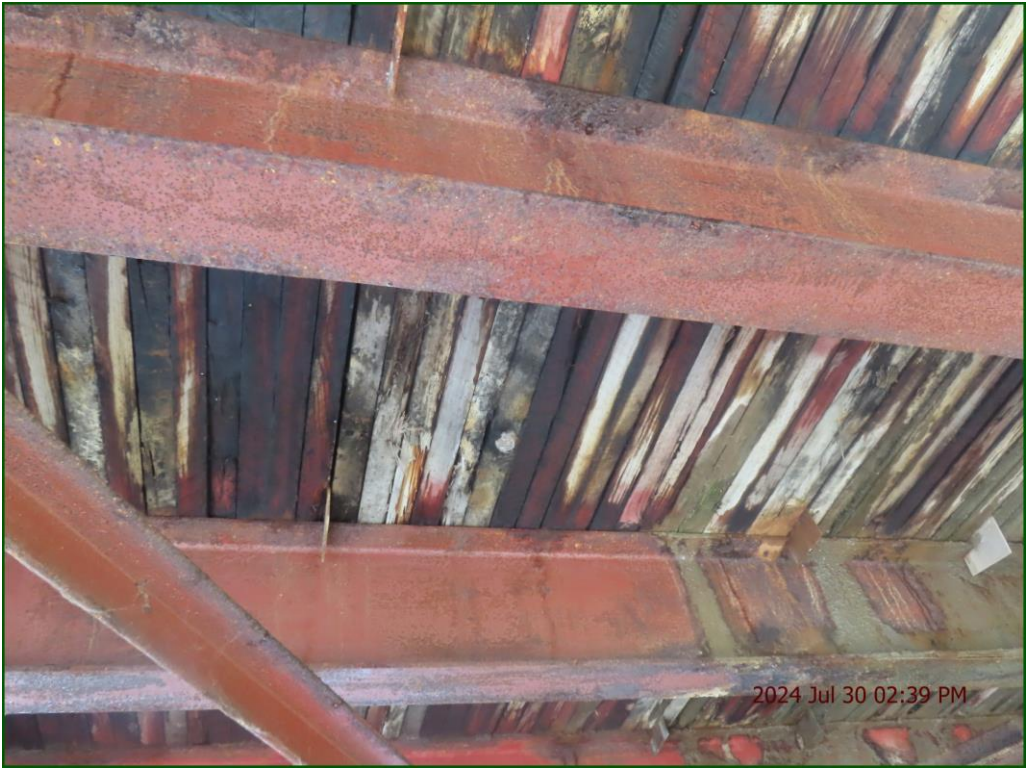
Description: Soffit: Moderate to severe rotting throughout.

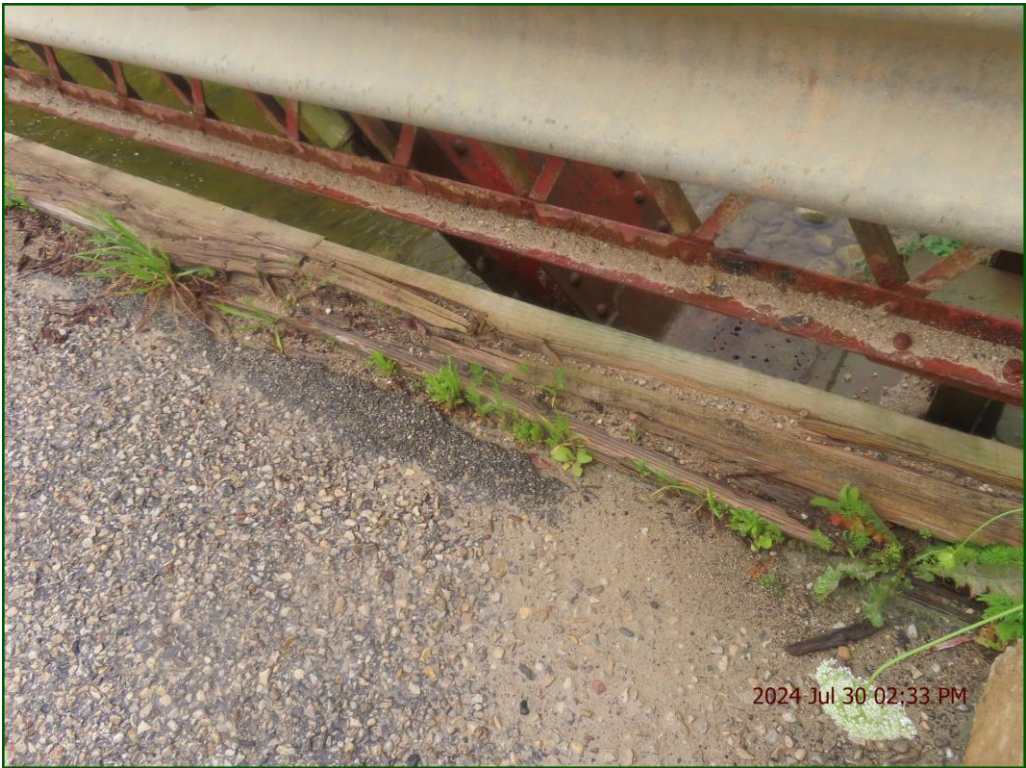
Description: Curbs: Localized severe abrasion and rot.

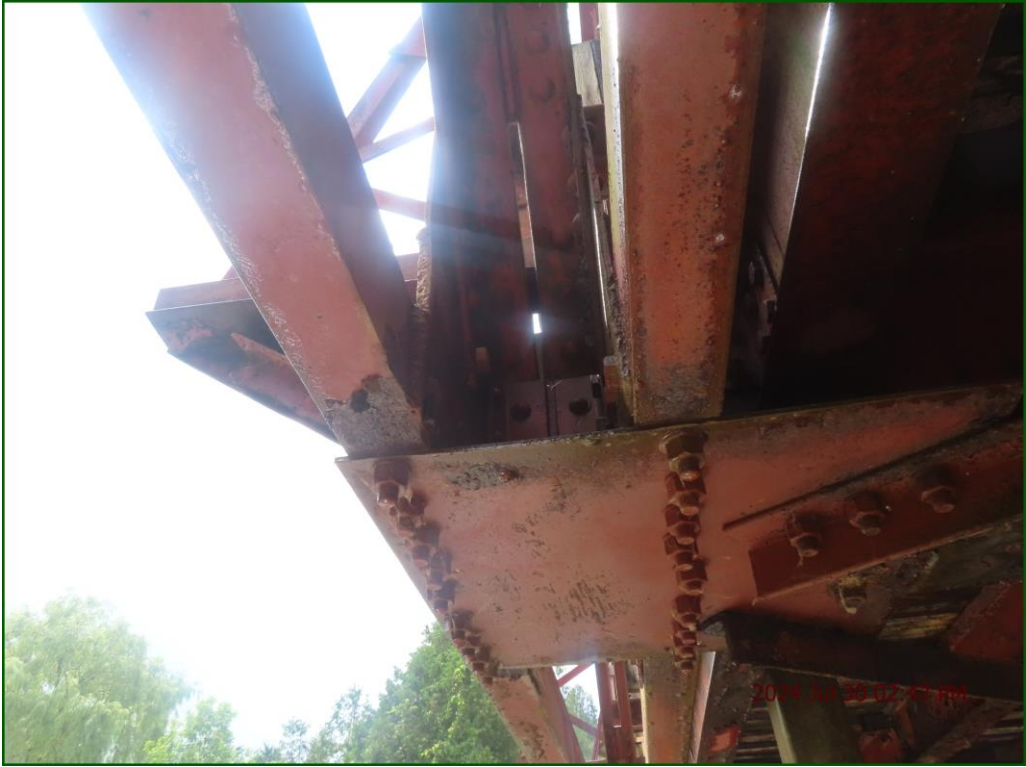
Description: Bottom Chord: Localized medium corrosion connections.

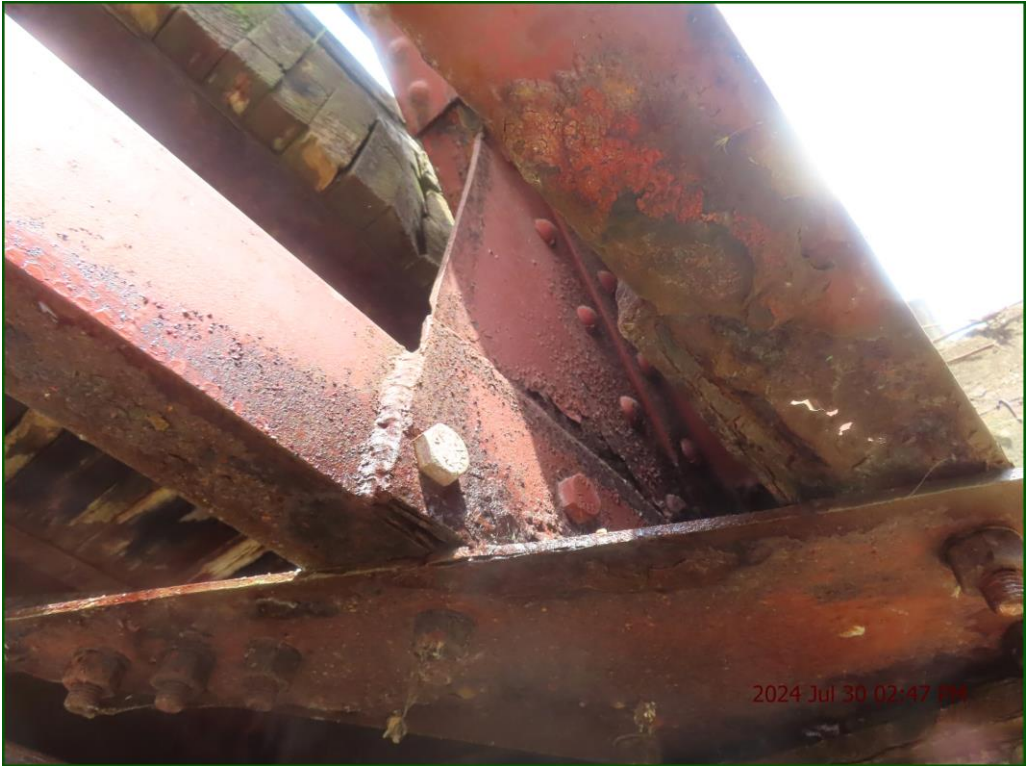
Description: Bottom Chord: Localized severe corrosion at bearing seats.

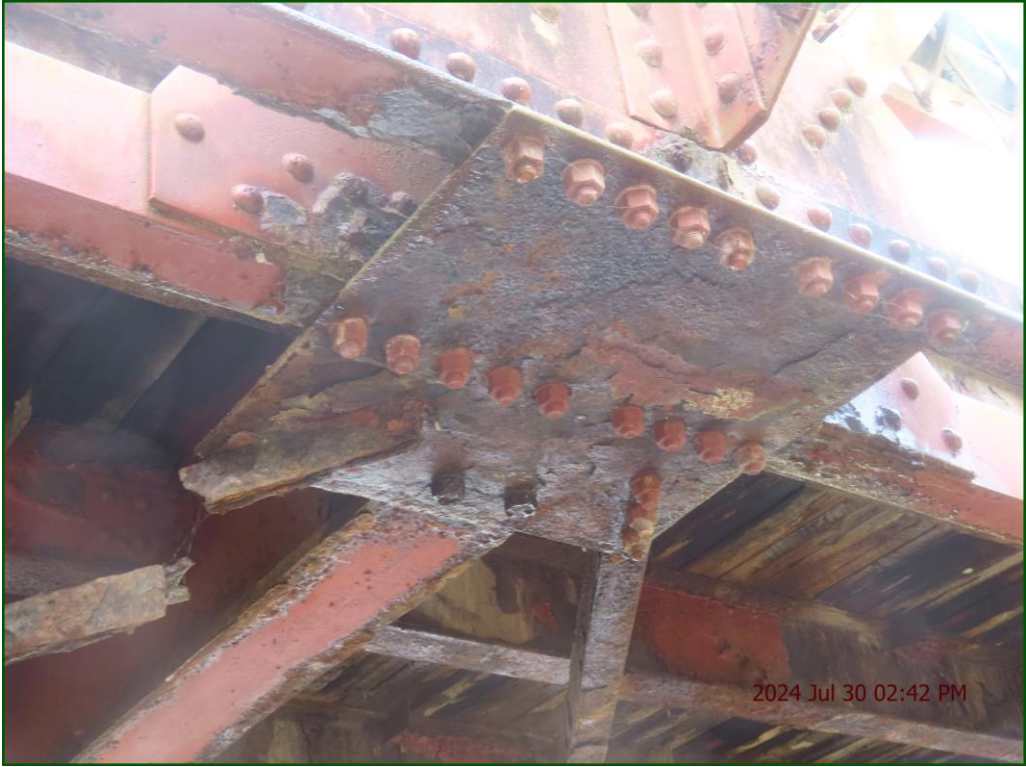
Description: Connections: Localized severe corrosion at outrigger and truss ends.

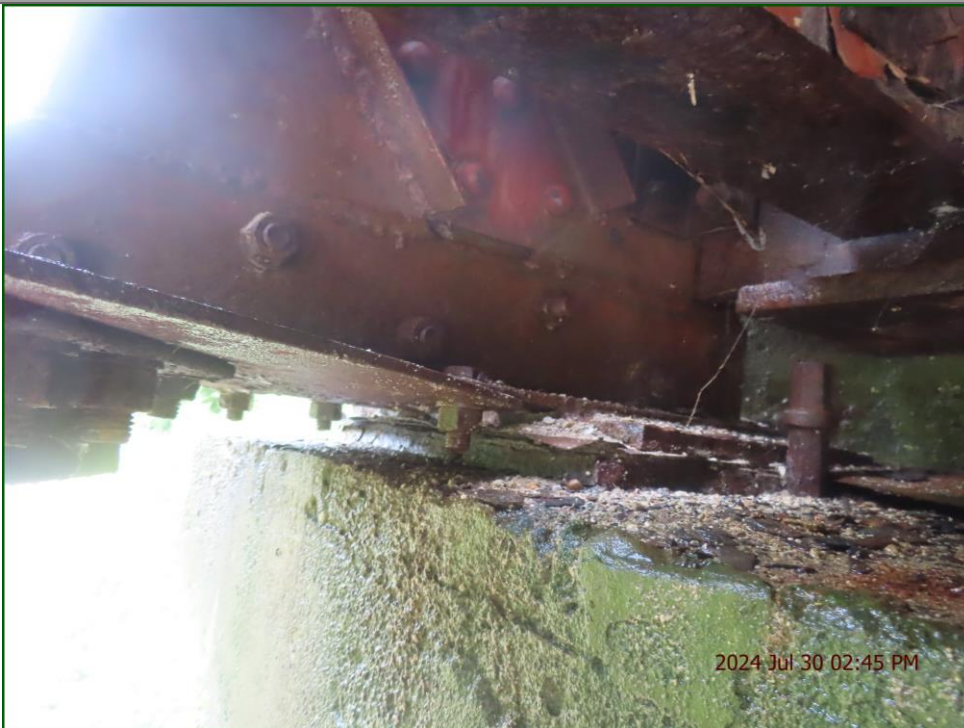
Severe corrosion throughout. Likely seized, not critical.

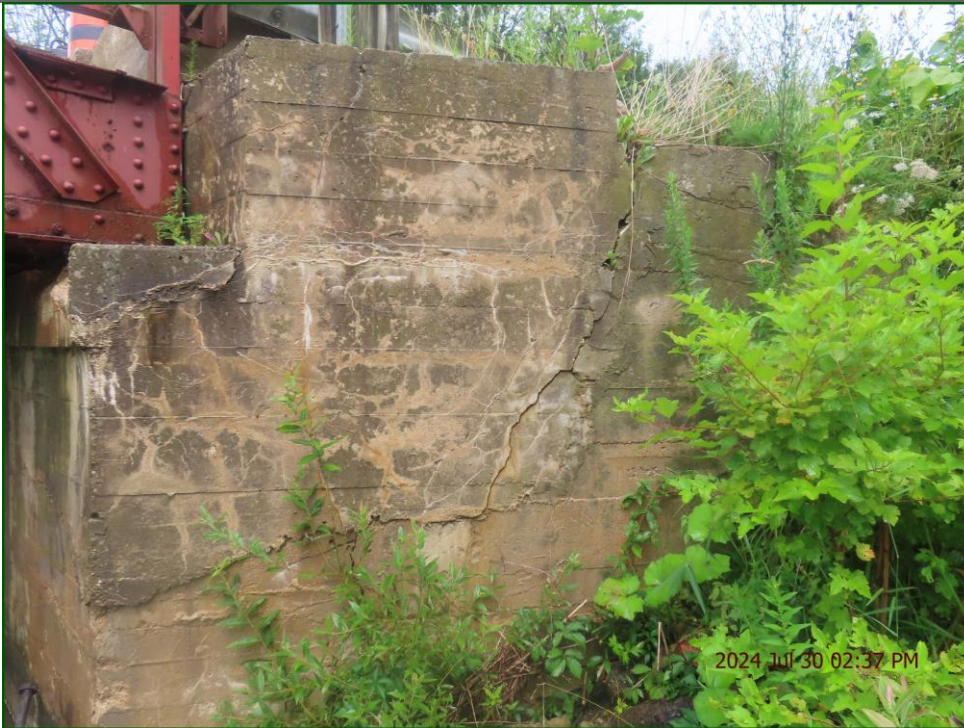
Wide crack and separation from abutment walls, monitor further movement.

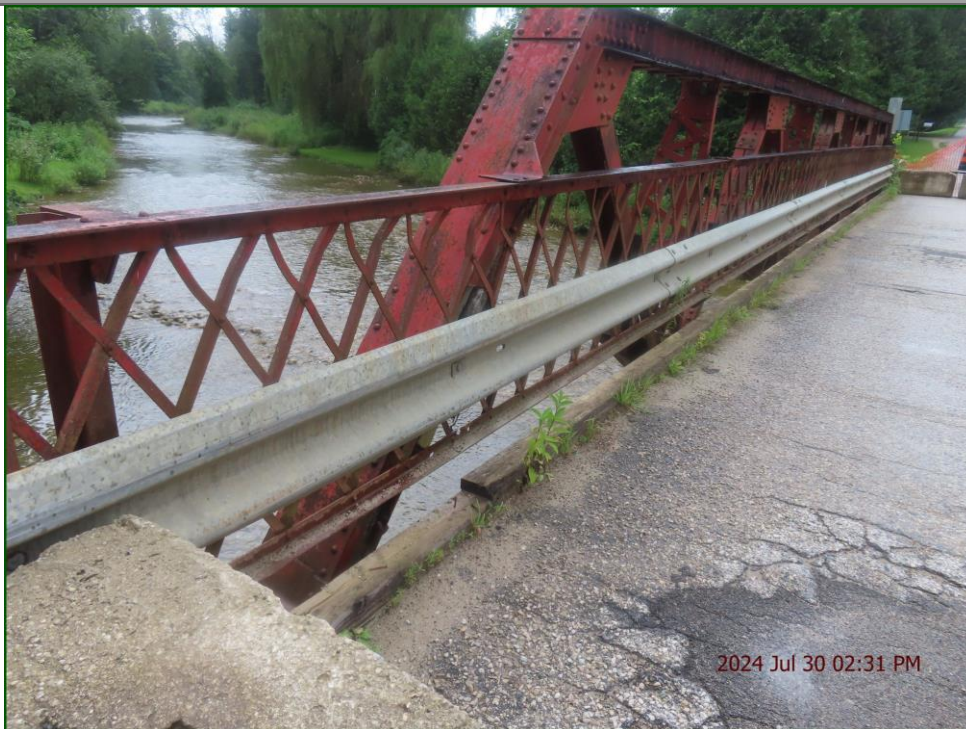
Localized areas of impact damage.

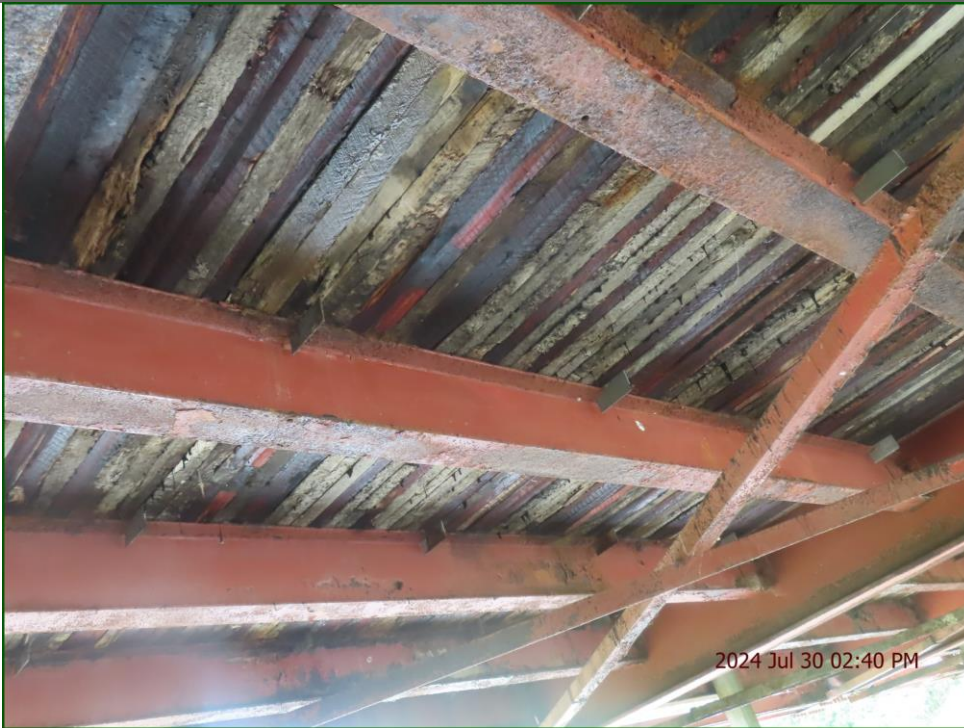
Light to medium corrosion in bottom flange areas and end connections.

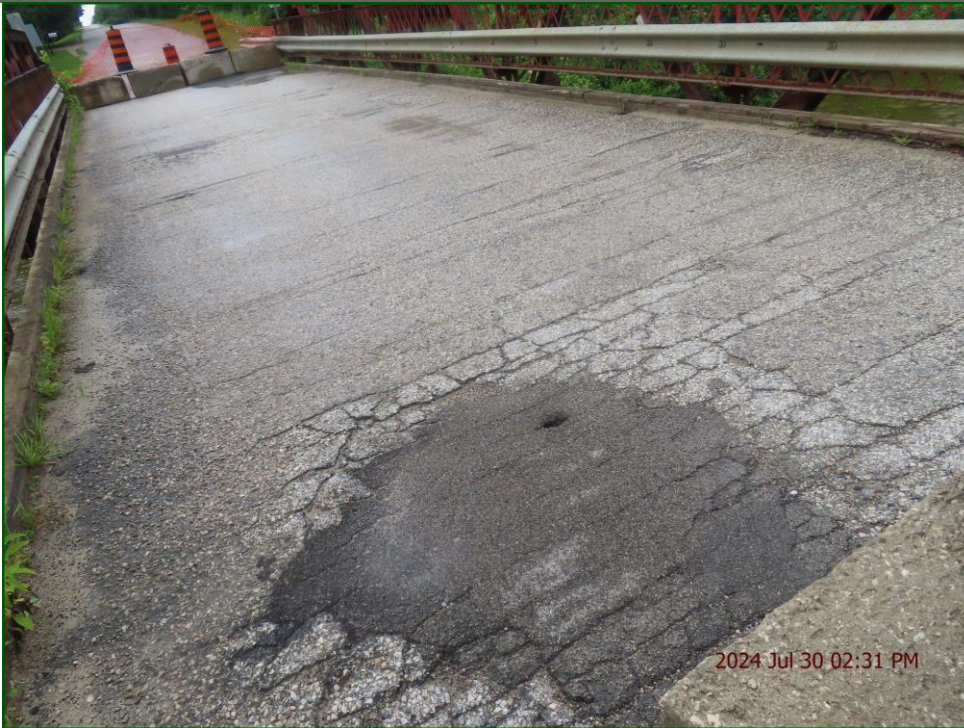
Asphalt break up due to flexible deck system. Not a structural issue.
