MUNICIPALITY OF
West Grey

Municipality of West Grey
Bridge Prioritization Program

February 2025

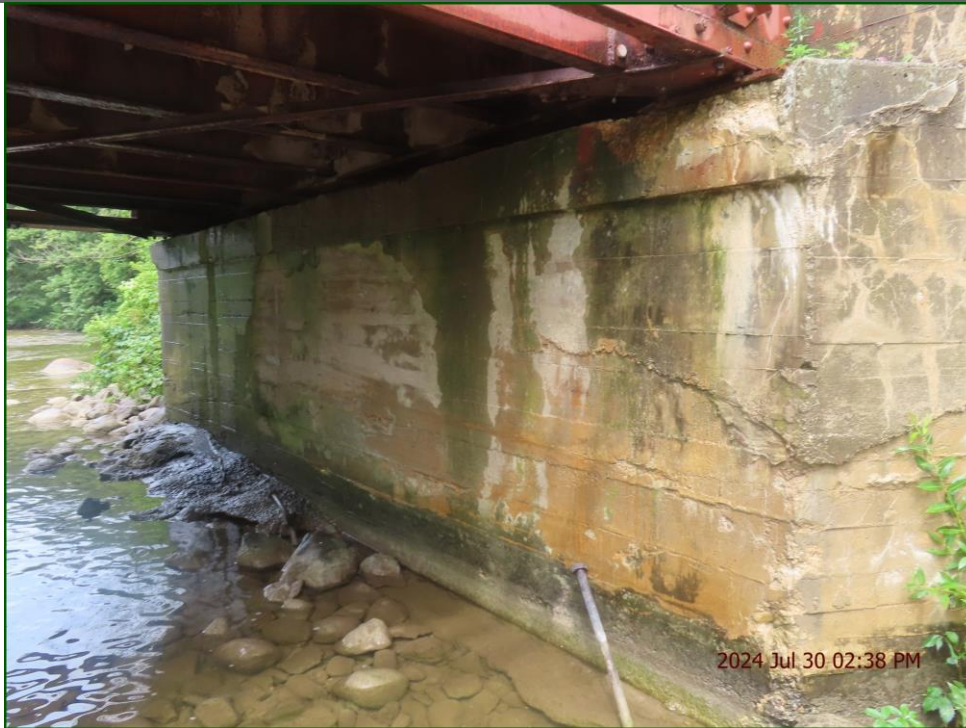
Shallow to medium scaling throughout. Crack at construction joint, not critical. Possible crushing under south east bearing.

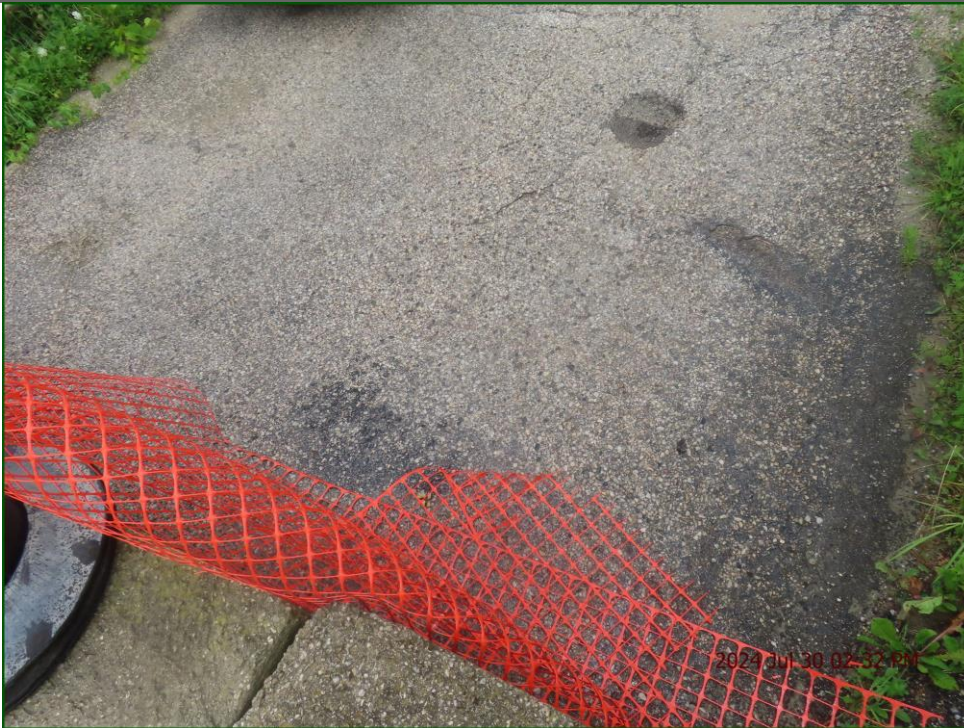
Minor settlement. Wide cracking at deck joint region, covered by concrete barriers. Narrow map cracking and raveling.

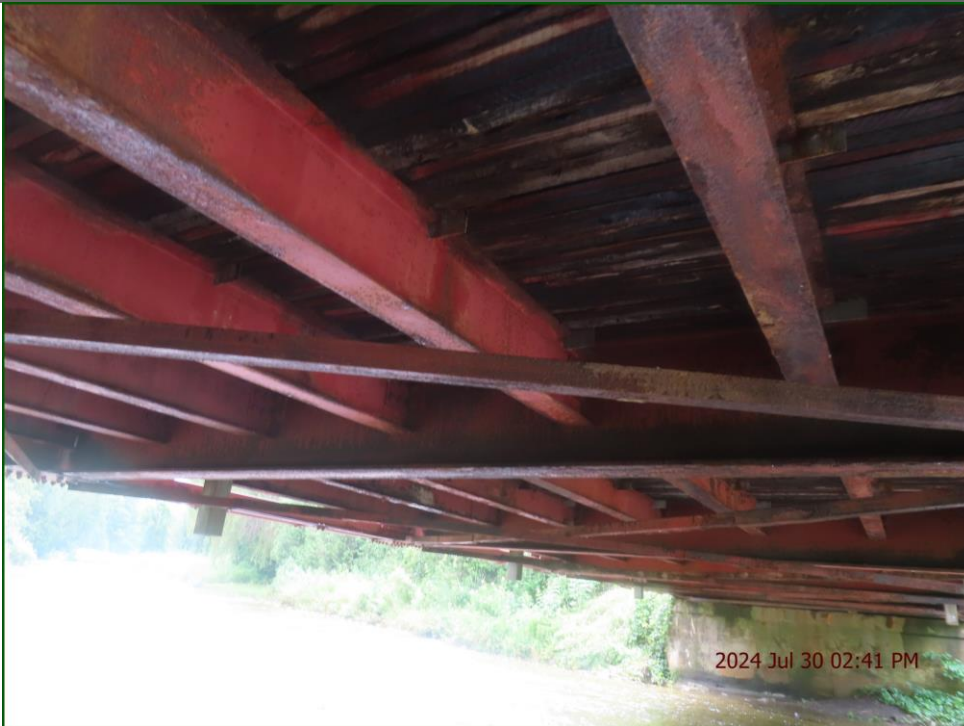
Light to medium corrosion throughout. Medium to severe corrosion in end floor beams.

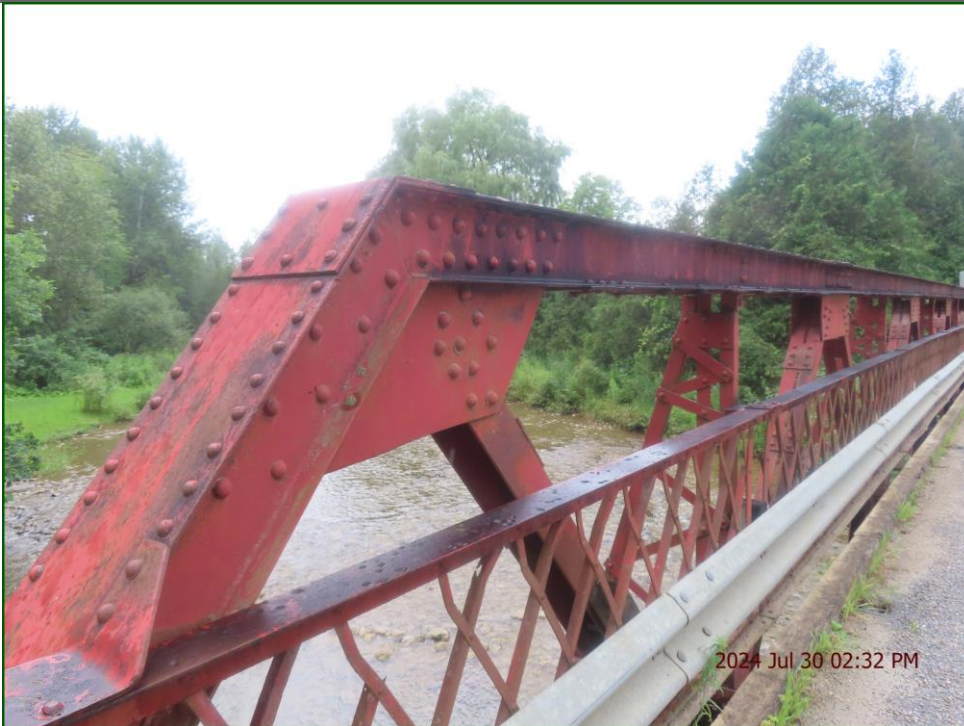
Areas of total coating breakdown, worse in deck system. Re-coating not recommended.

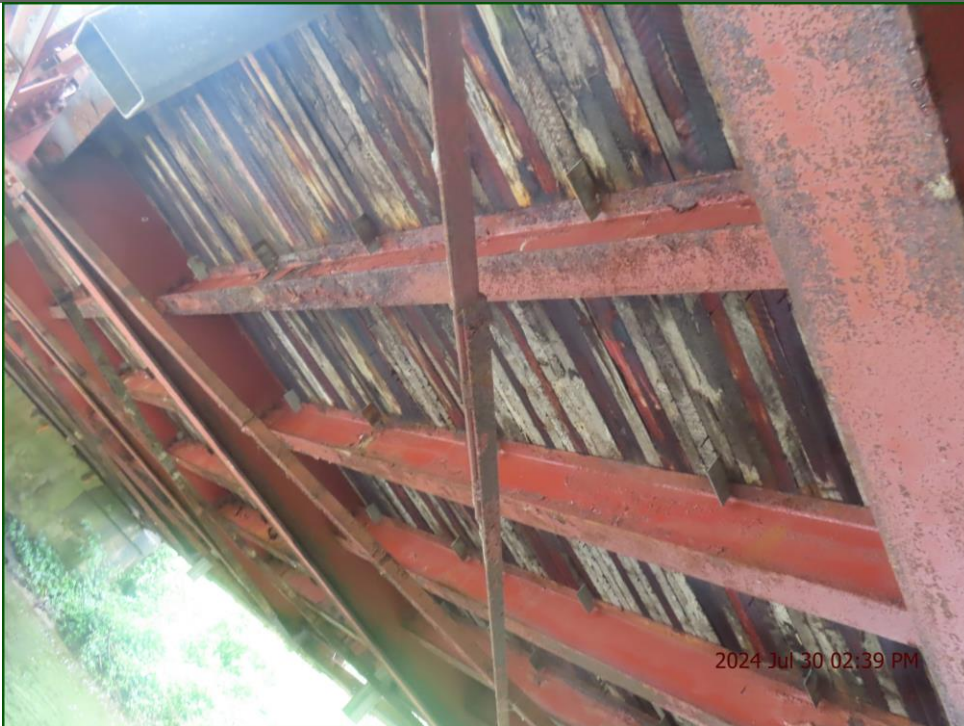
Moderate to severe rotting throughout.

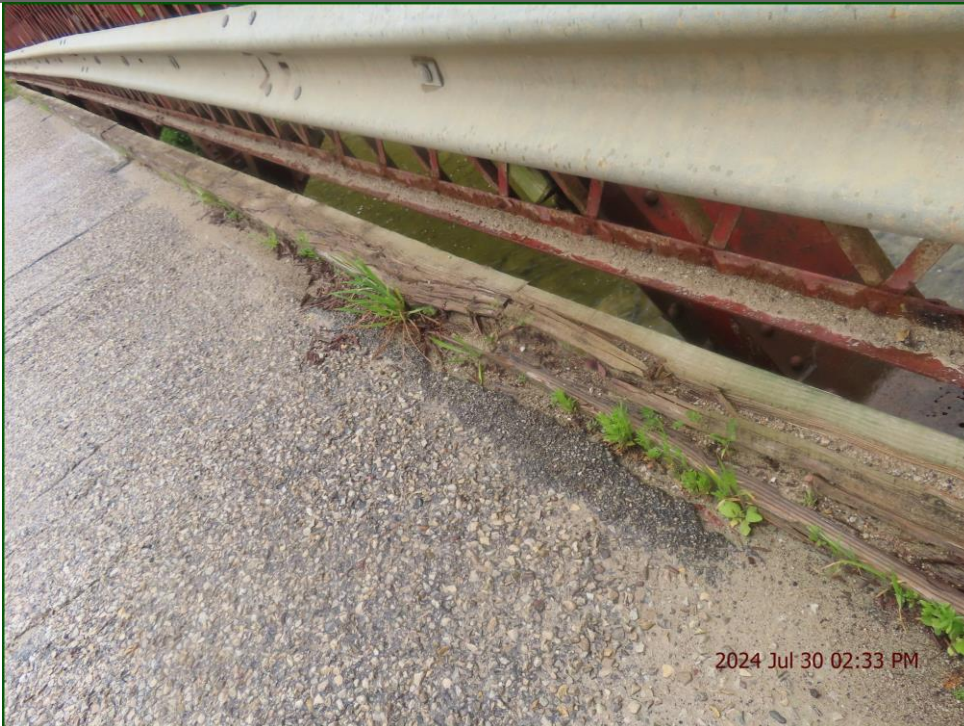
Localized severe abrasion and rot.

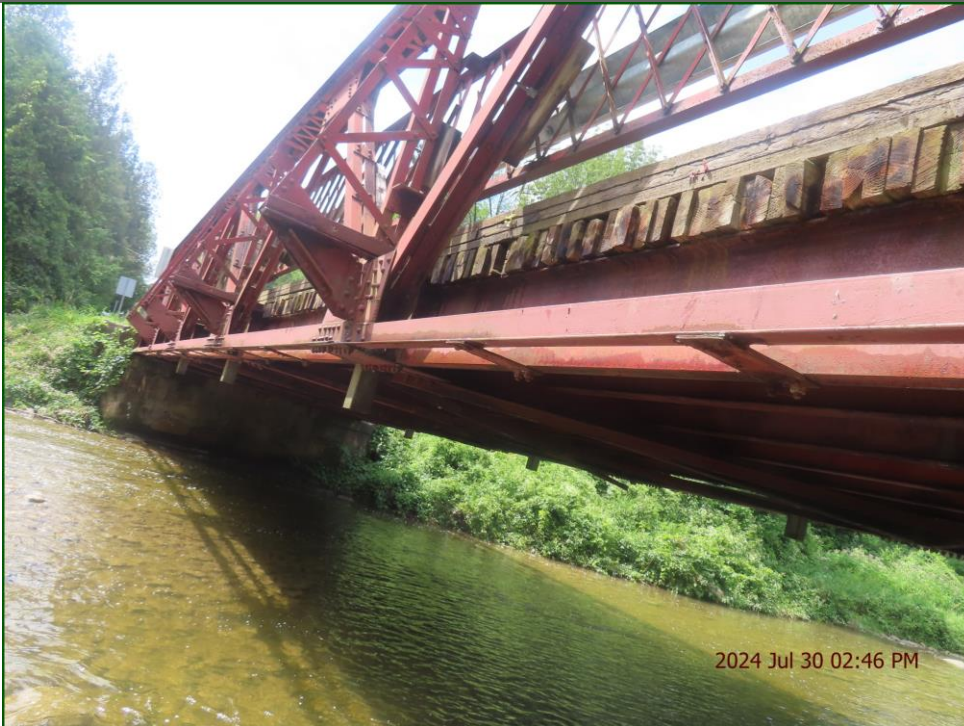
Generally in good condition. Localized medium corrosion connections. Localized severe corrosion at bearing seats.

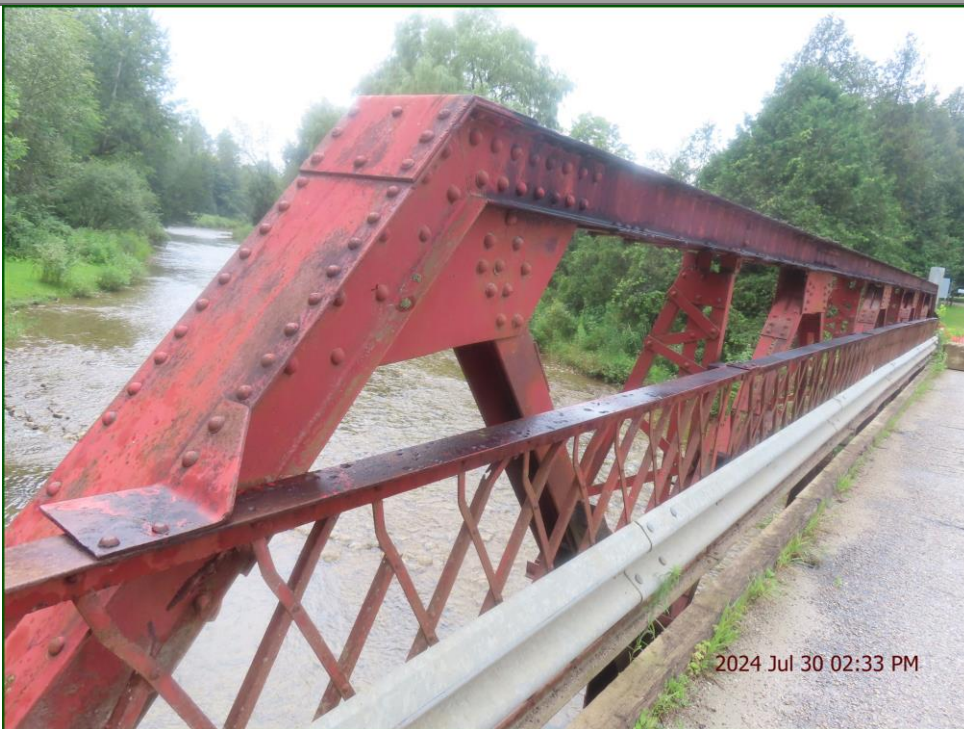
Light corrosion. Top chords are in good alignment.
