OSIM Biennial Inspection Report

Concession 11/12, Lot 30

Burgess Engineering Inc

27-Aug-24

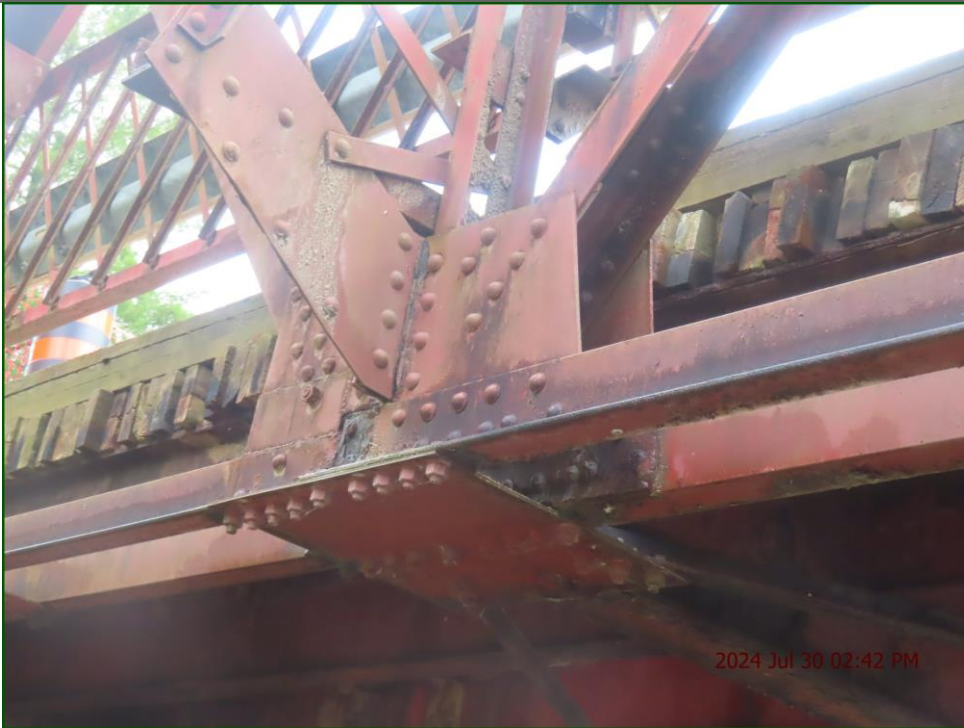
Localized severe corrosion at outrigger and truss ends.

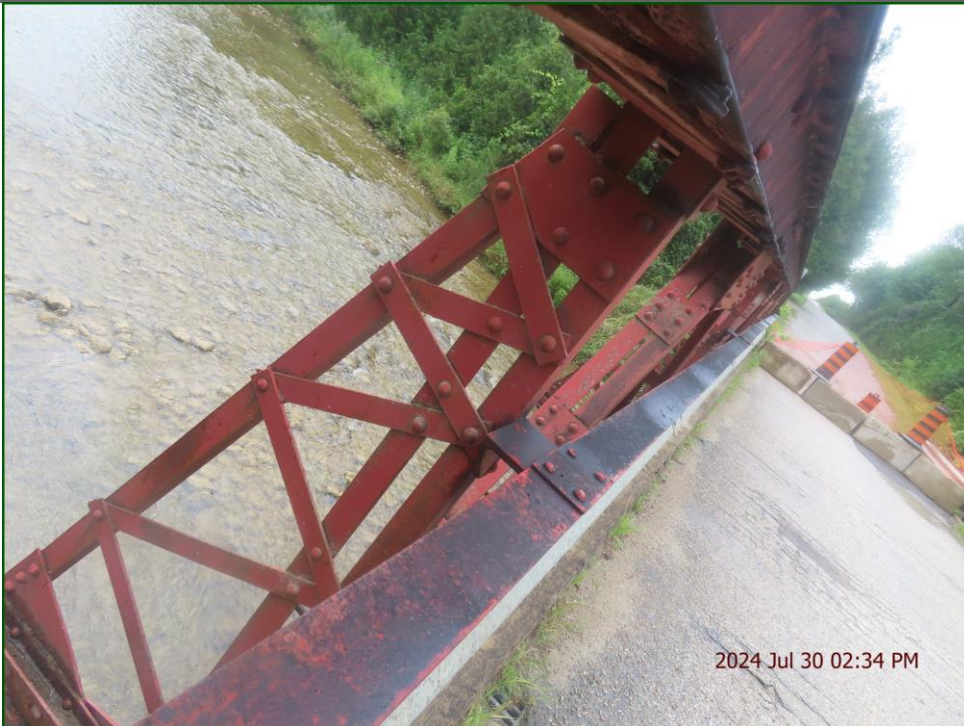
Light corrosion. Localized impact in end diagonal (N-W).

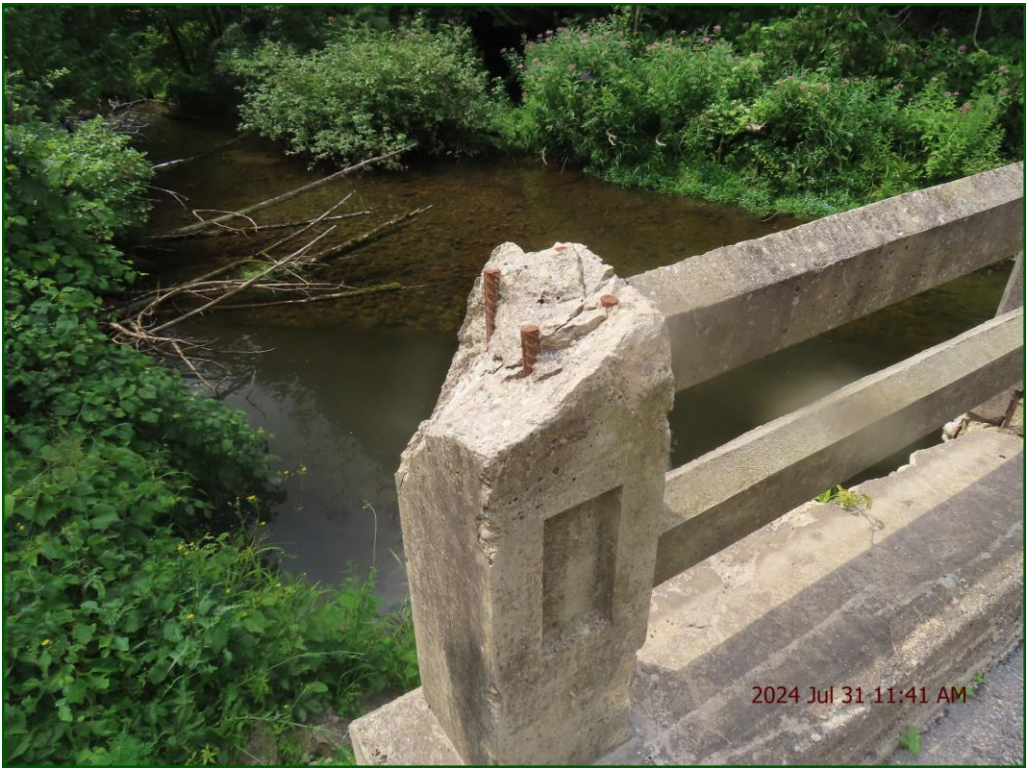
Description: Approach Railing System: Severe spall with exposed reinforcing on SE corner.

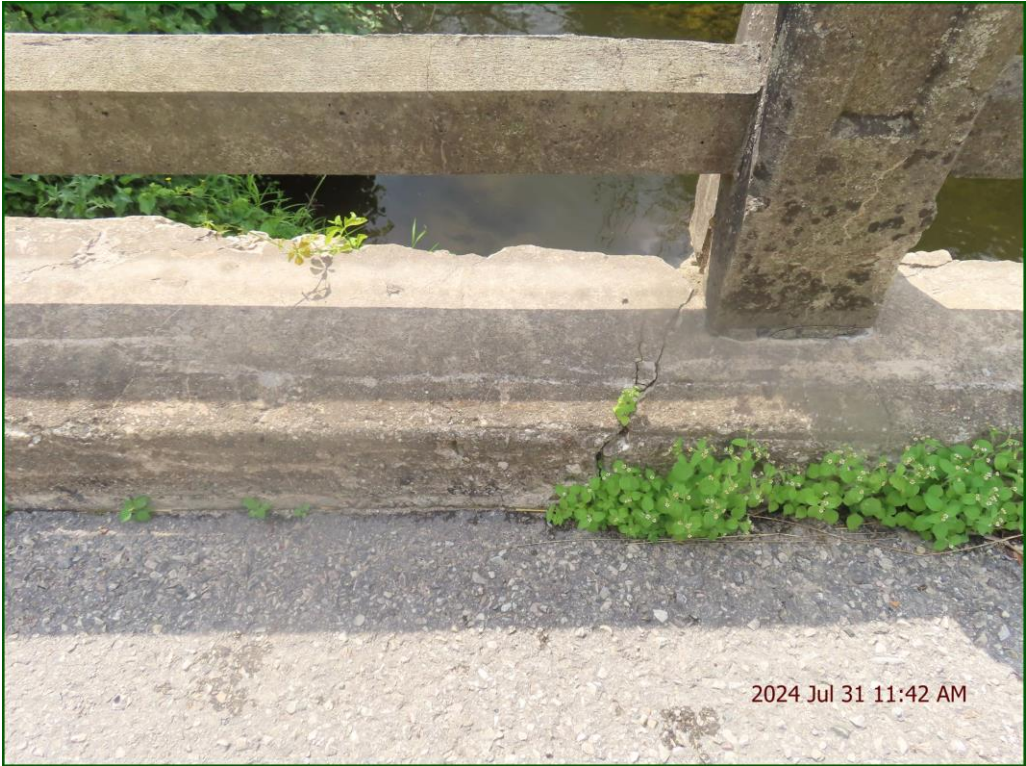
Description: Approach Curbs: Wide cracking throughout.

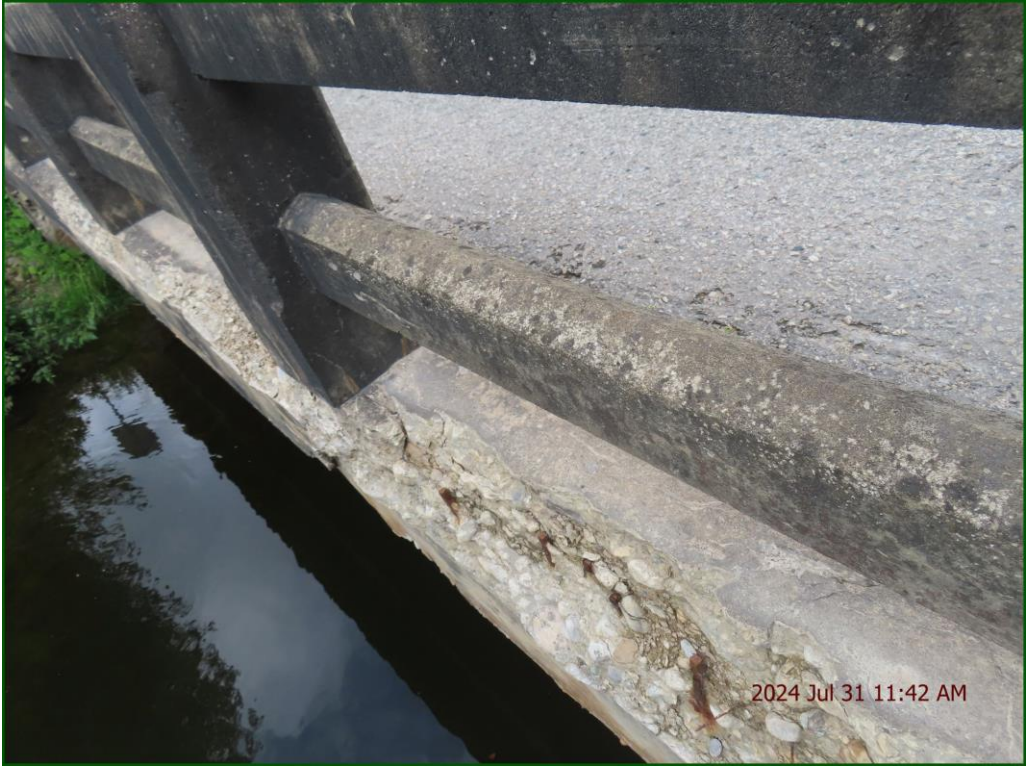
Description: Curbs: Concrete disintegration throughout.

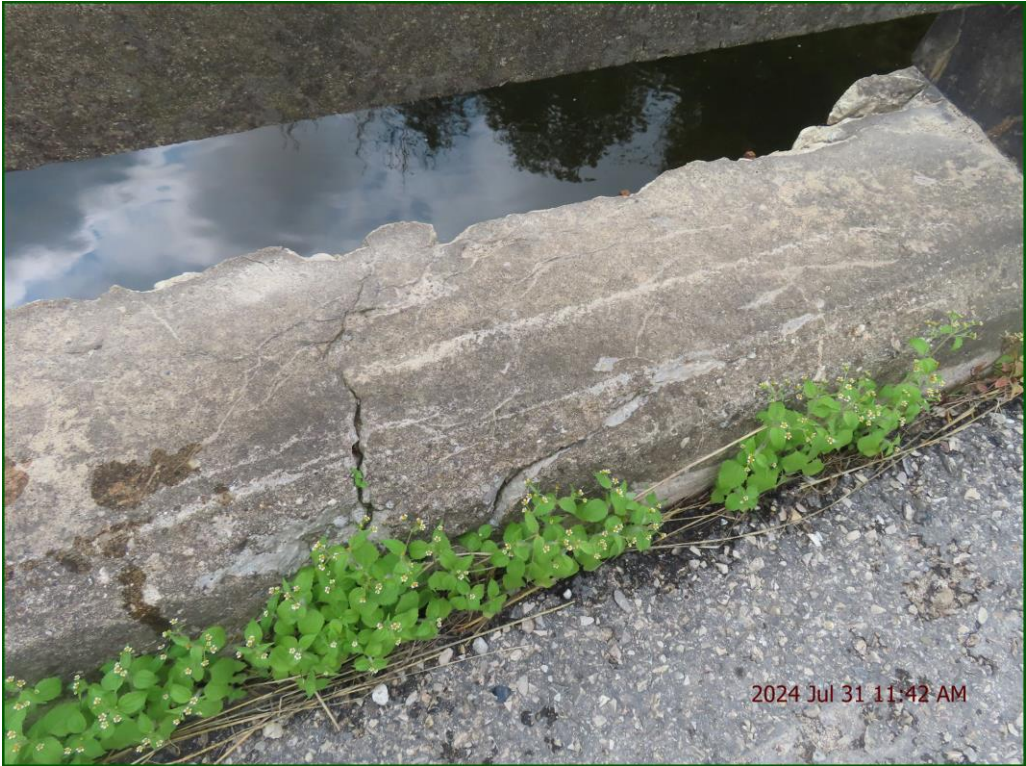
Description: Curbs: Wide cracking throughout.

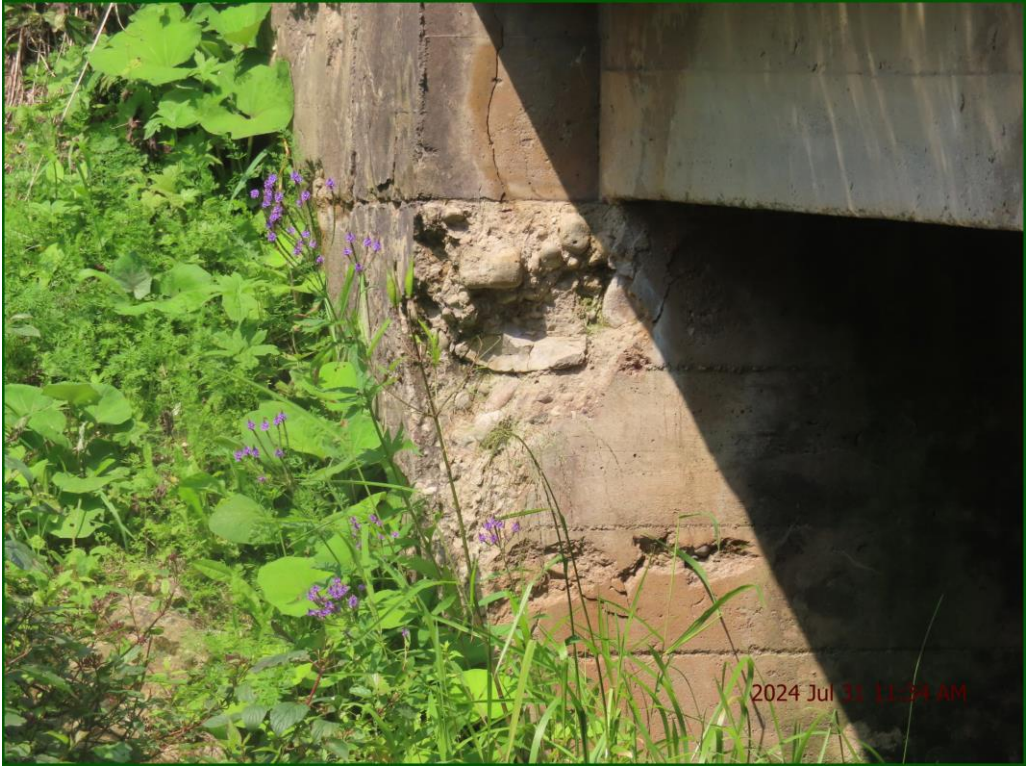
Description: Wingwalls: Moderate spalling throughout.

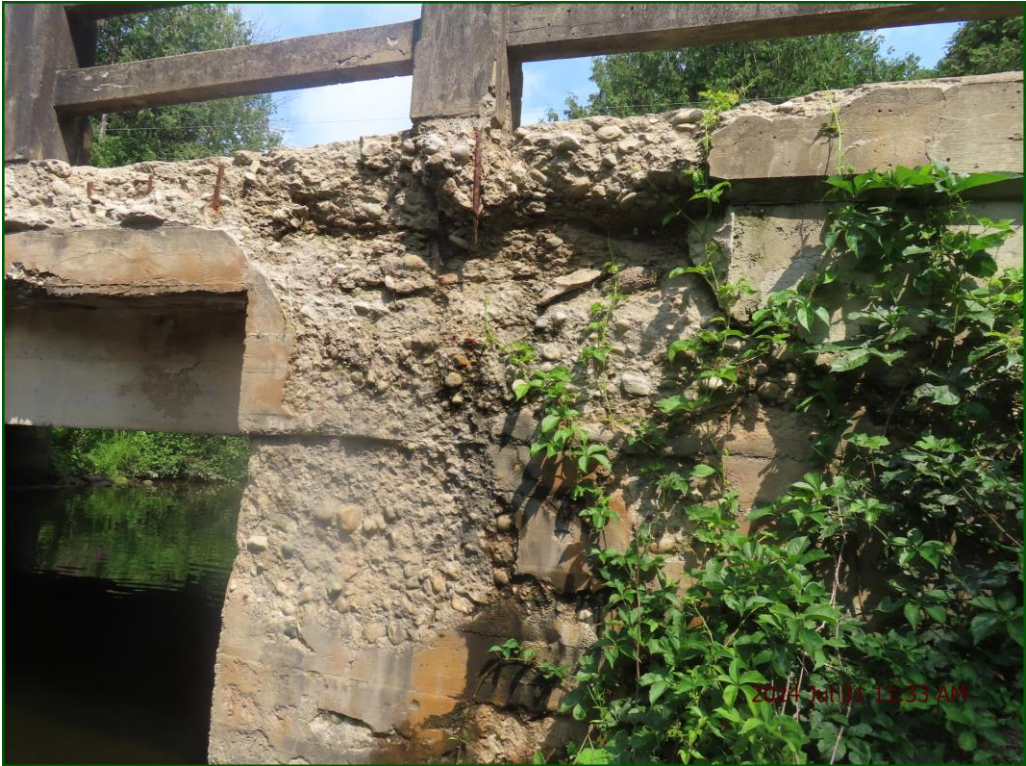
Description: Wingwalls: Severe spalling with exposed reinforcing on south-east quadrant.

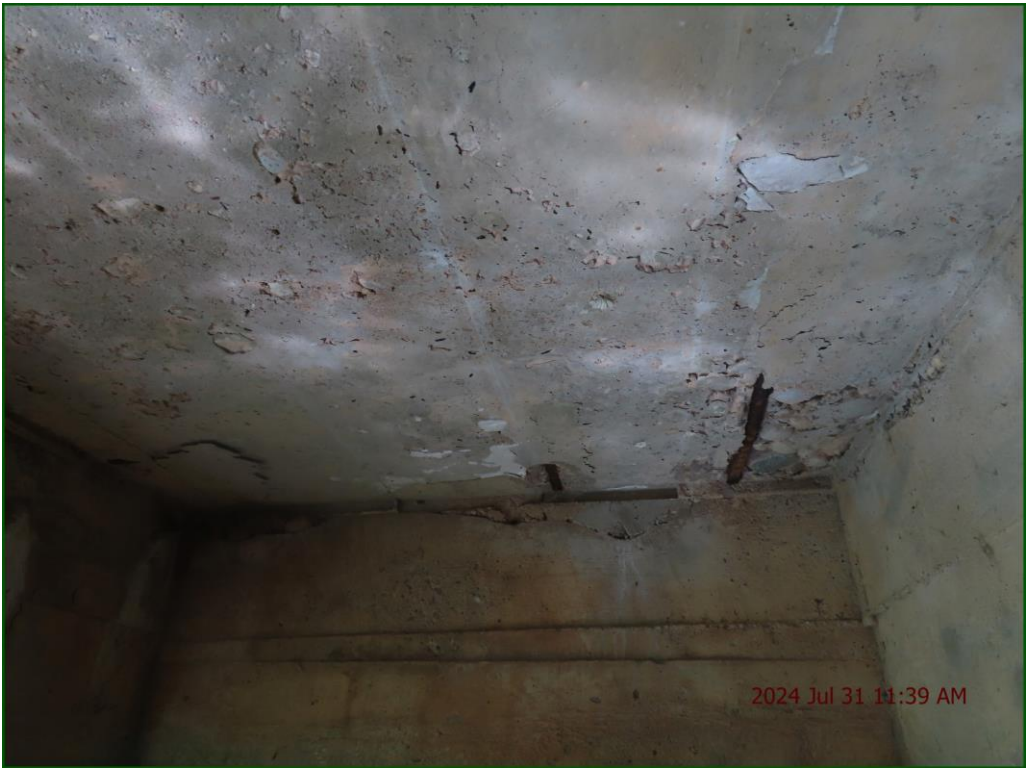
Description: Soffit (int): Severe delamination with exposed reinforcing.

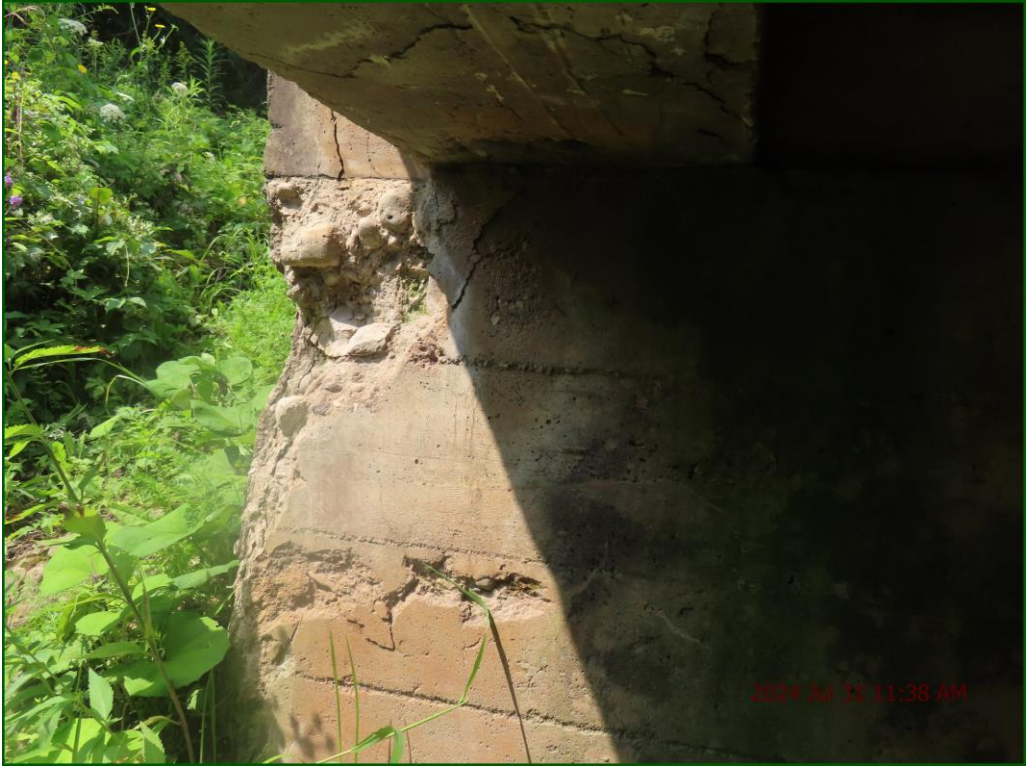
Description: Abutment Walls: Moderate spalling.

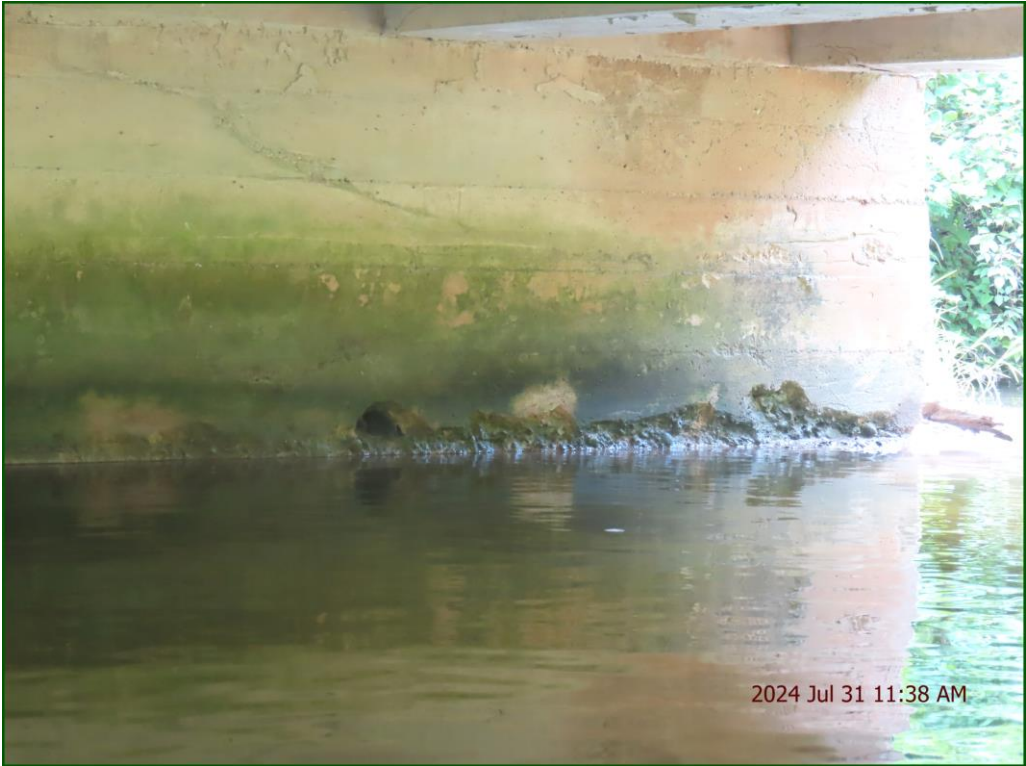
Description: Abutment Walls: Severe scouring and disintegration.

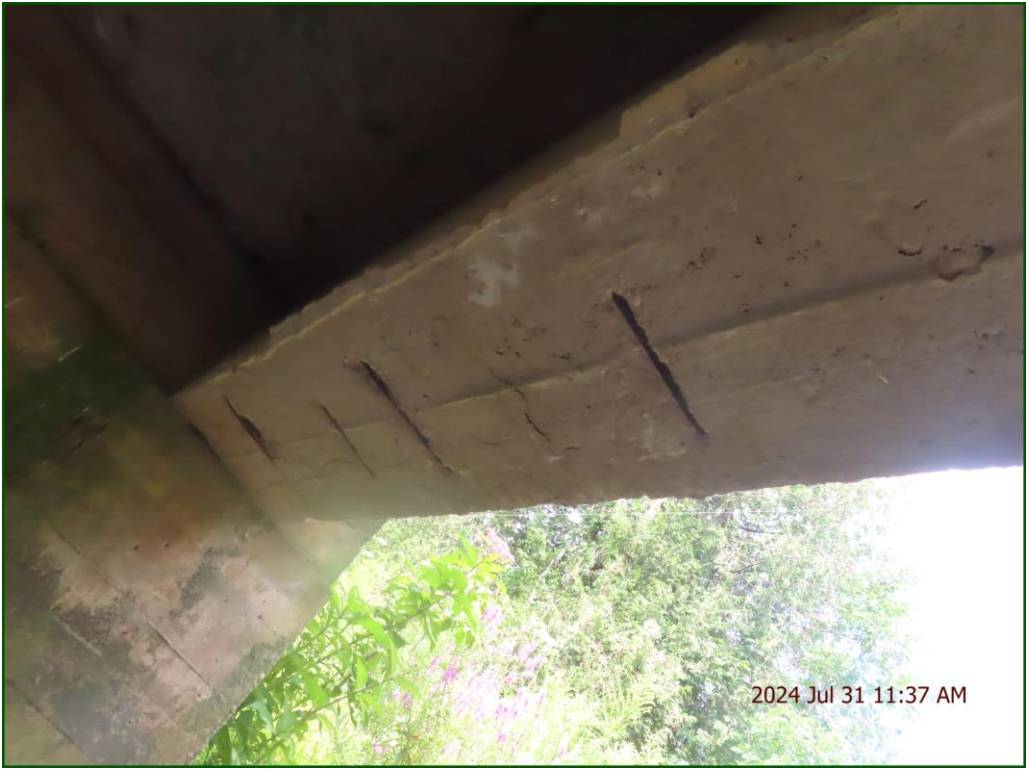
Description: Girders: Severe delamination with exposed reinforcing throughout.

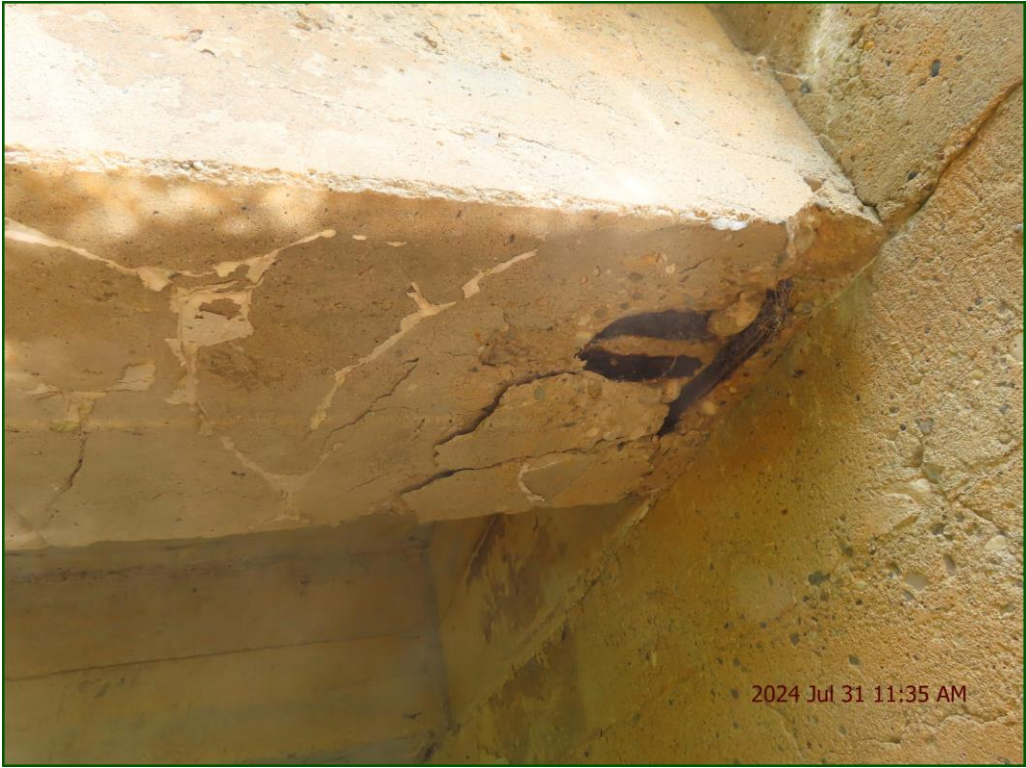
Description: Girders: Delamination at various t-beam ends.

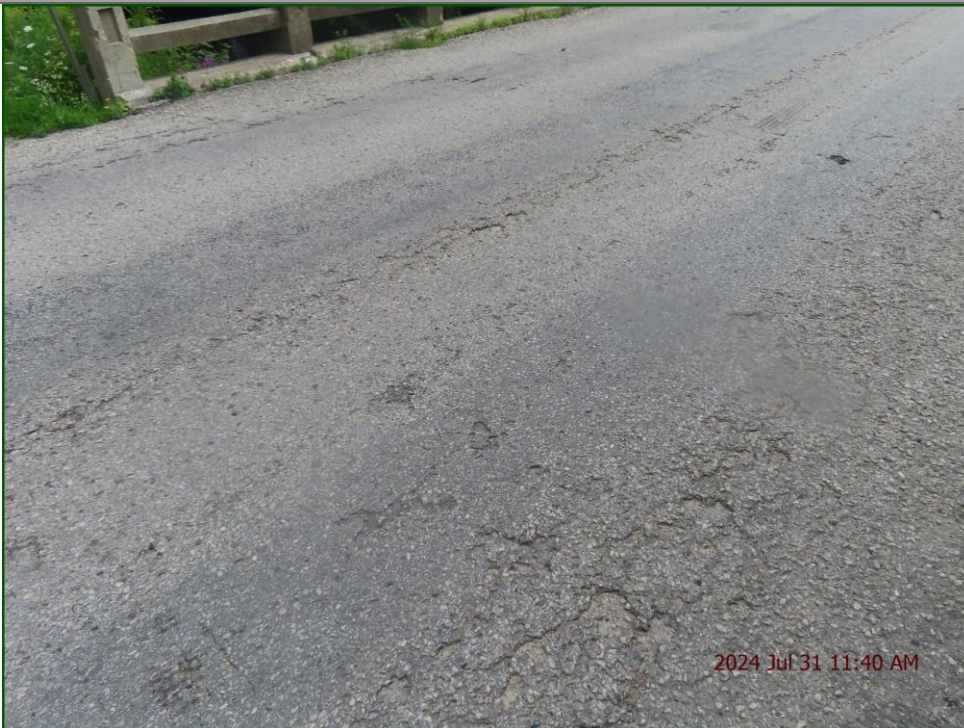
Severe ravelling along curline.

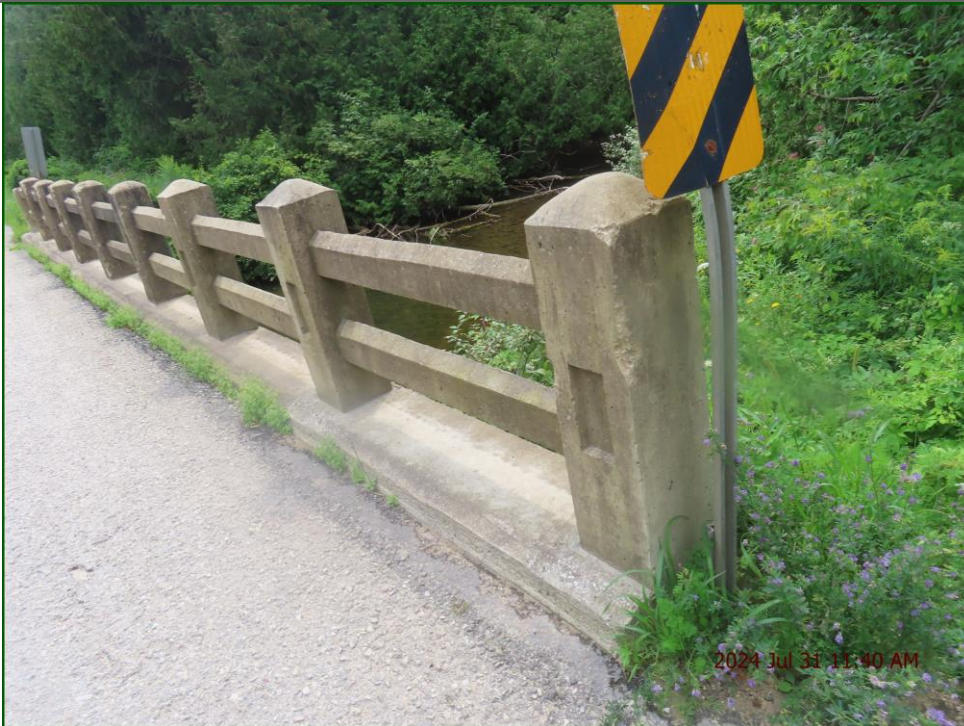
Severe spall with exposed reinforcing on south-east corner.

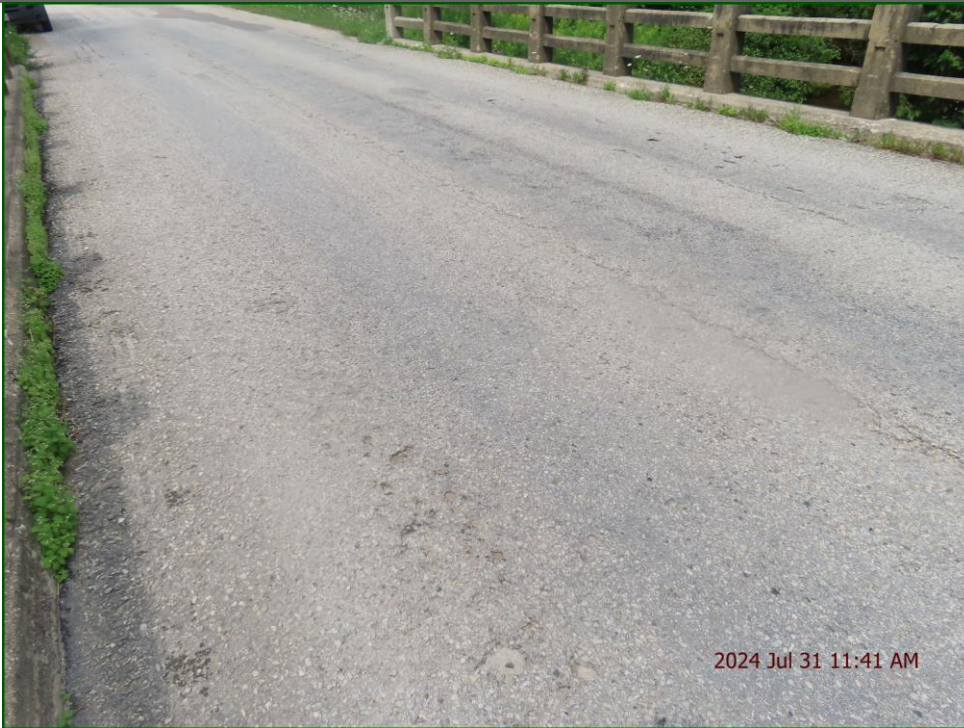
Severe ravelling along curblines.

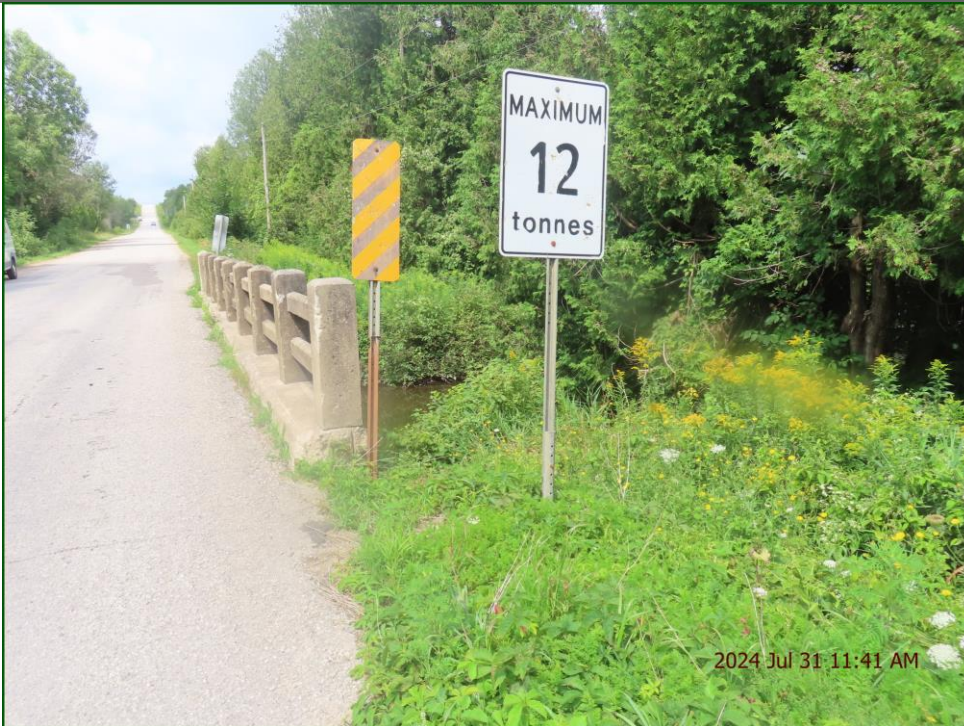
Steep embankments recommend approach protection.

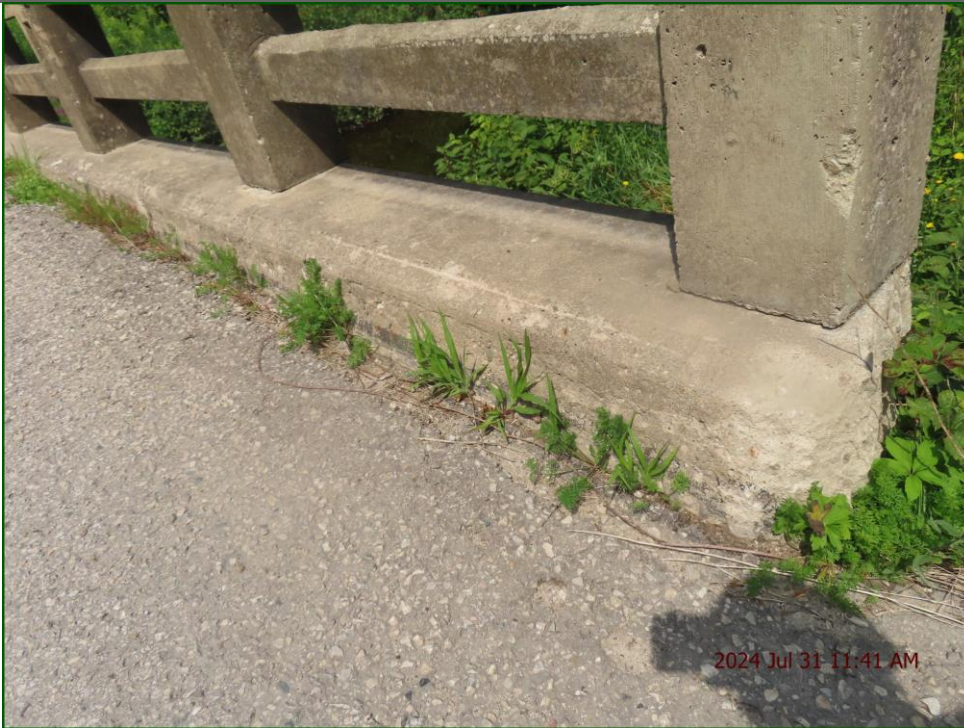
Wide cracking throughout.

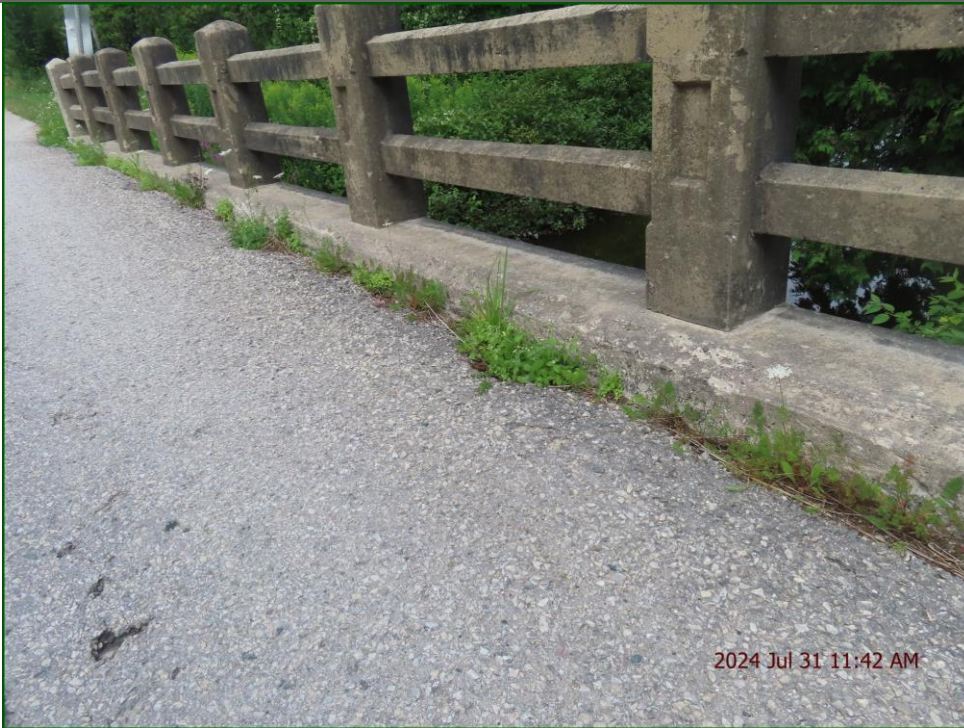
Concrete disintegration throughout. Wide cracking throughout.

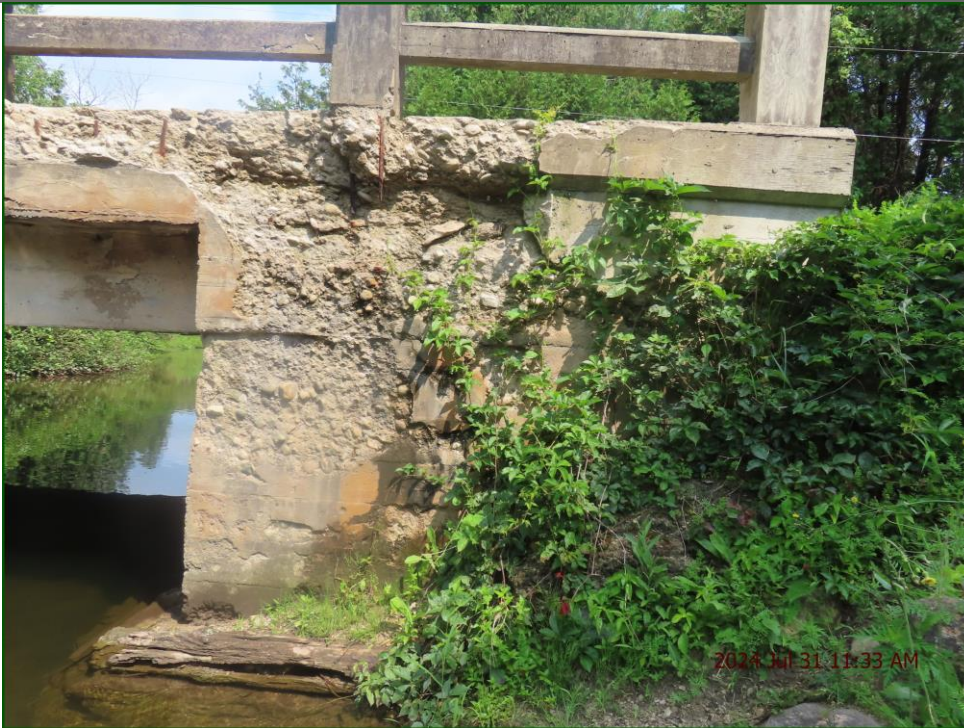
Moderate spalling throughout. Severe spalling with exposed reinforcing on south-east quadrant.

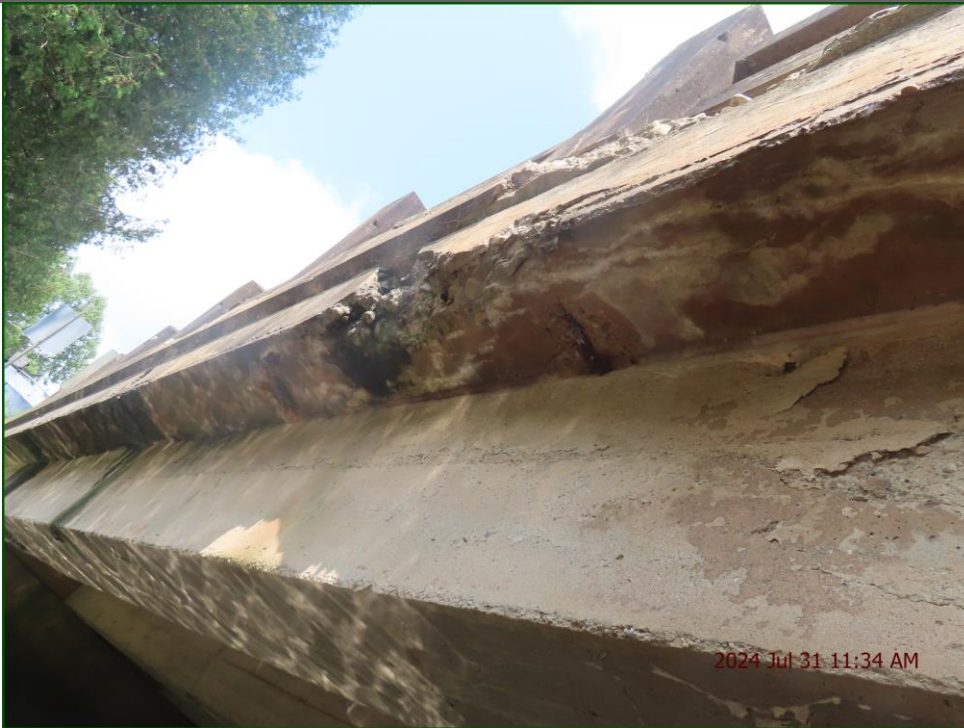
Severe delamination with exposed reinforcing throughout. Severe spalling with exposed reinforcing.

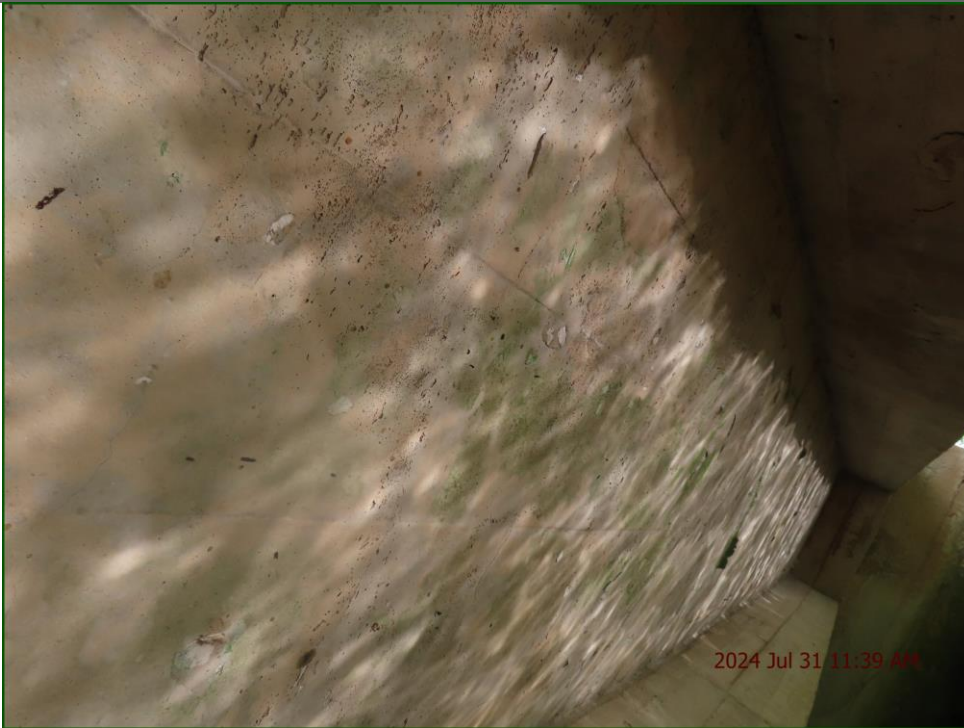
Severe delamination with exposed reinforcing.

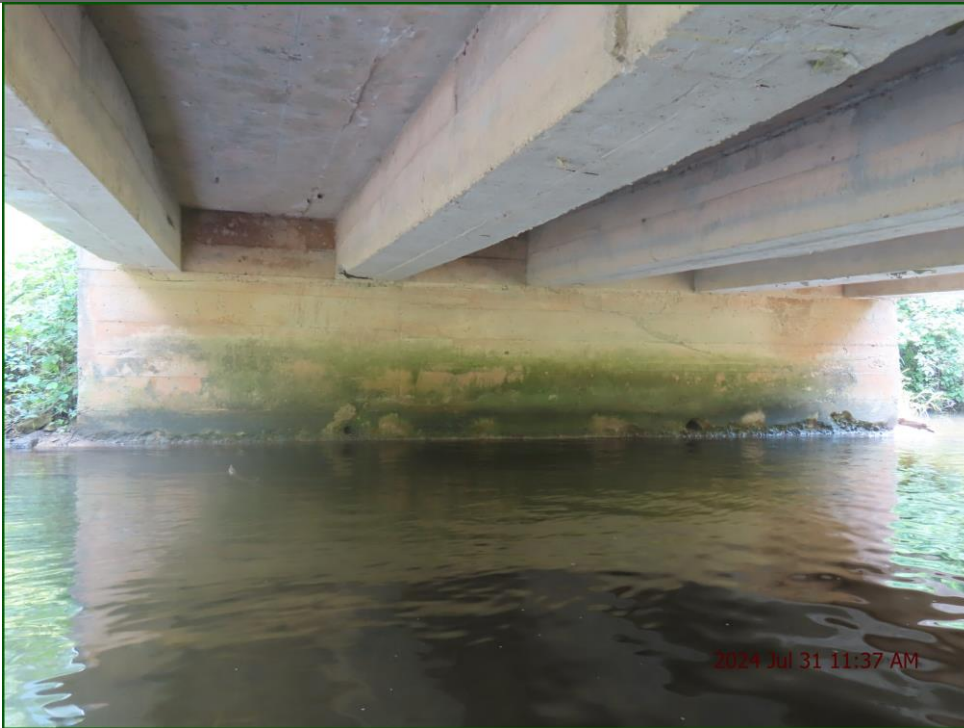
Moderate spalling. Severe scouring and disintegration.

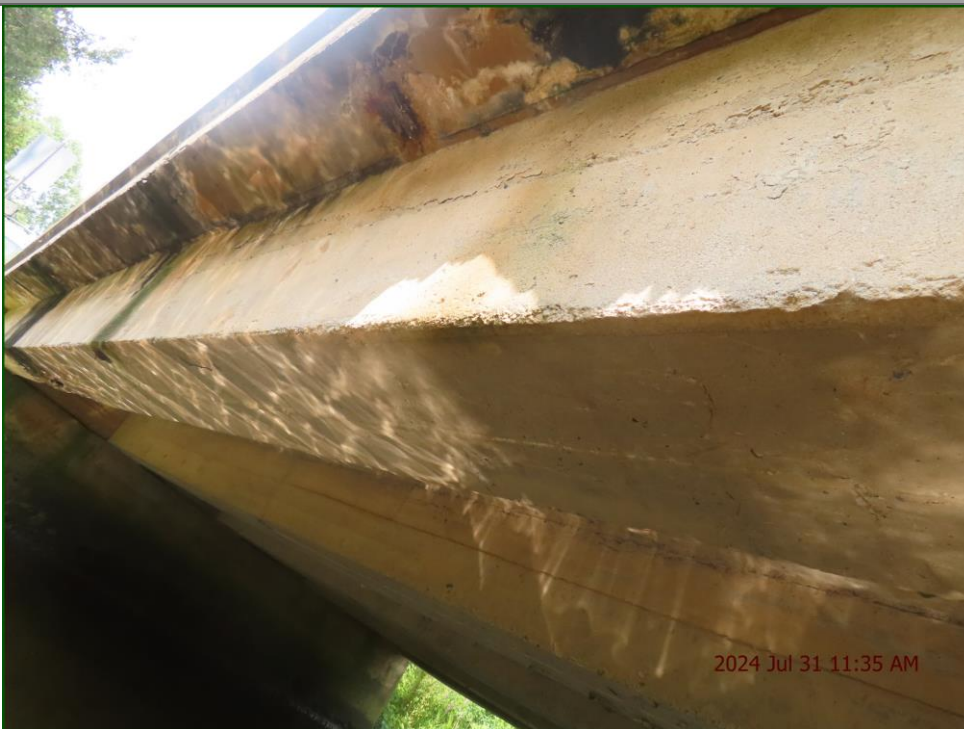
Severe delamination with exposed reinforcing throughout. Delamination at various t-beam ends. Severe spall with exposed reinforcing throughout.

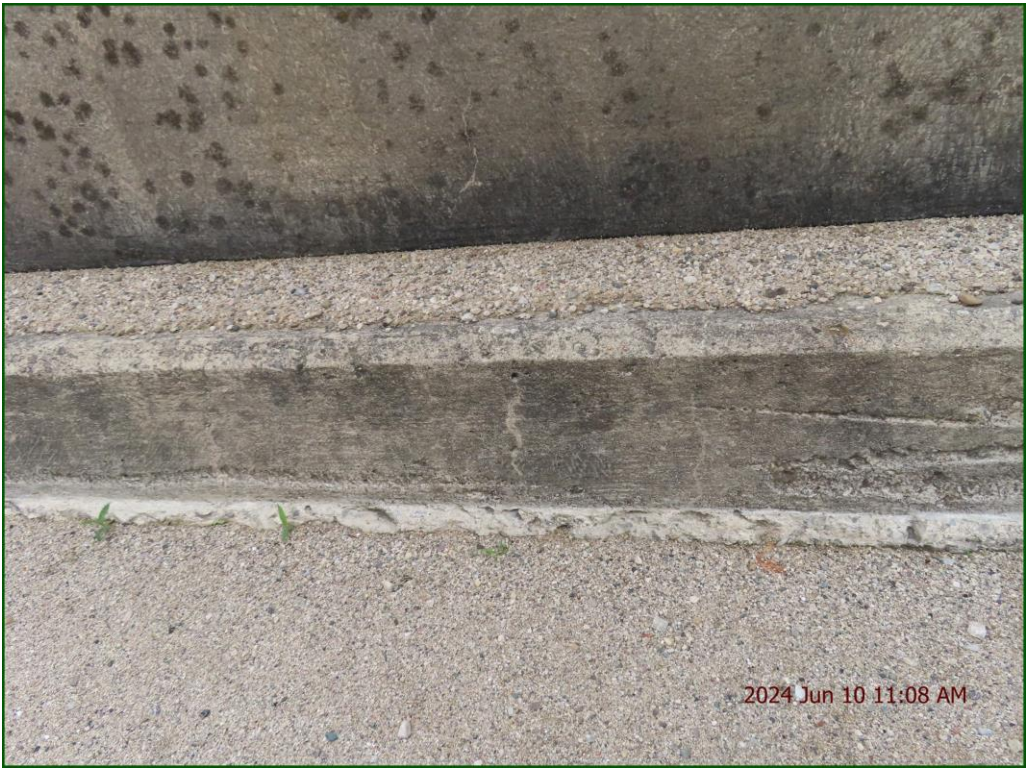
Description: Approach Curbs: Light vertical cracks throughout.

Light vertical cracks throughout.

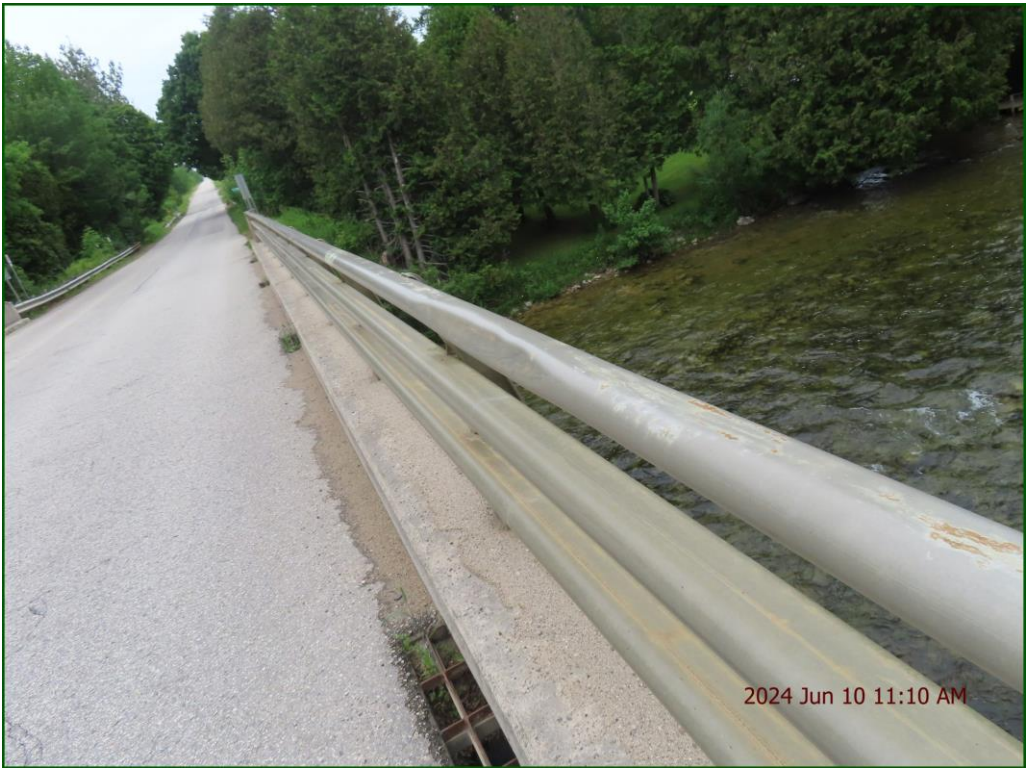
Description: Railing Systems: Minor impact damage.

Minor impact damage.

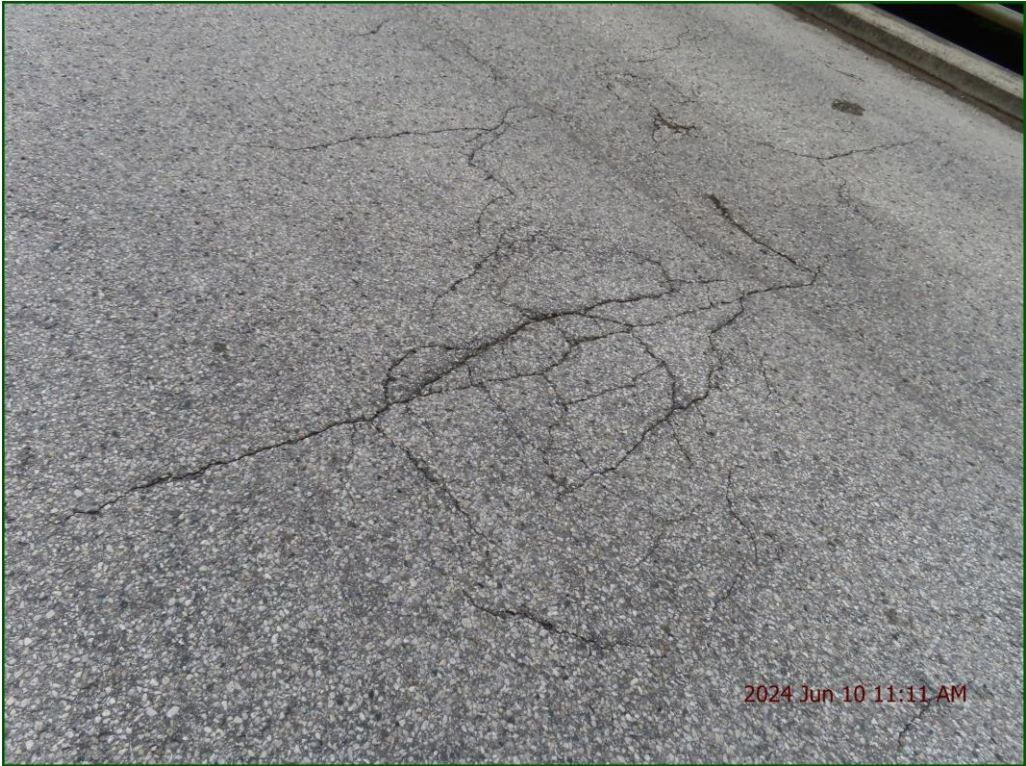
Description: Wearing Surface: Light map cracking throughout.

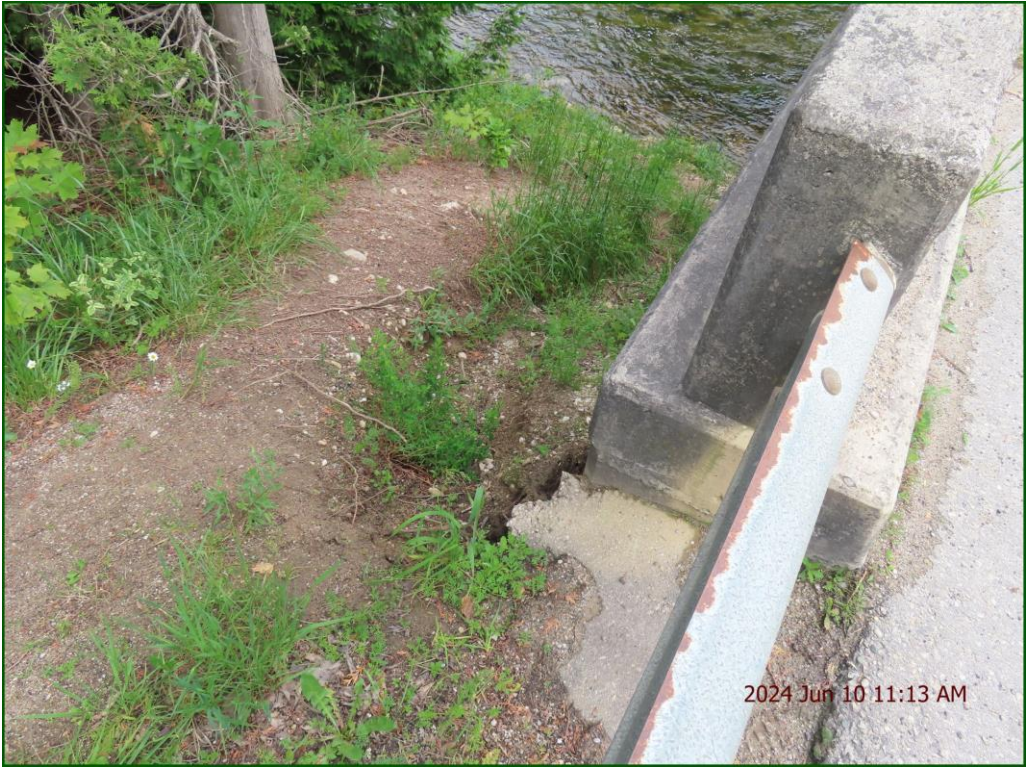
Description: Embankments: Moderate erosion on SW quadrant.

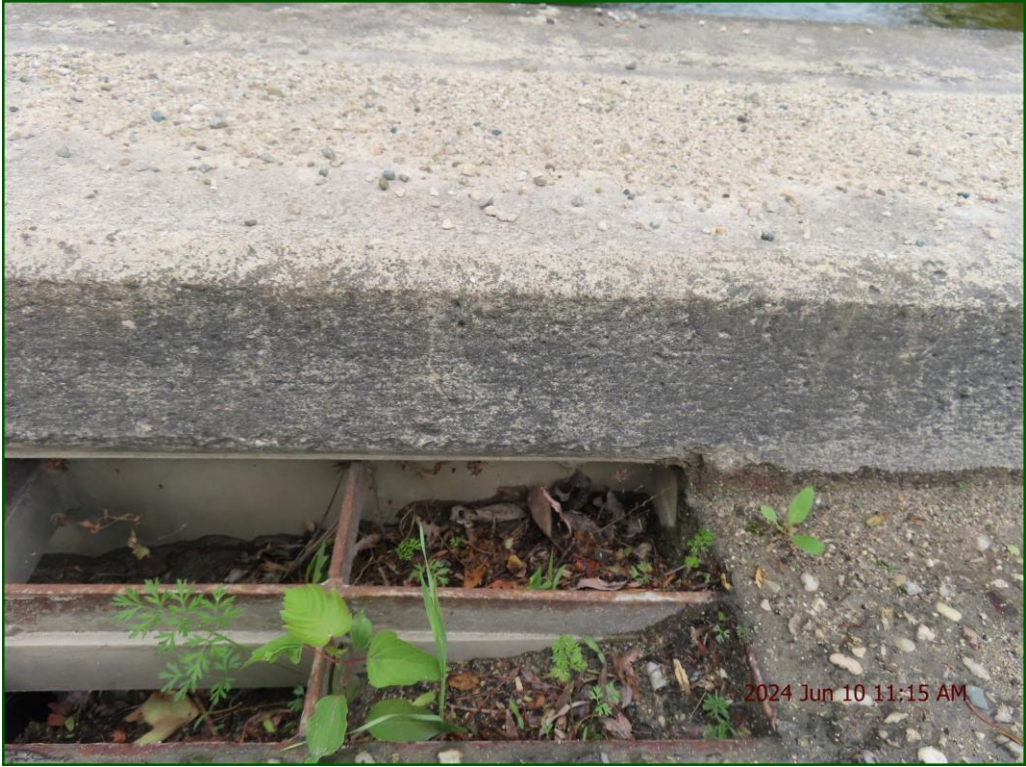
Description: Curbs: Light vertical cracks throughout.

Light vertical cracks throughout.

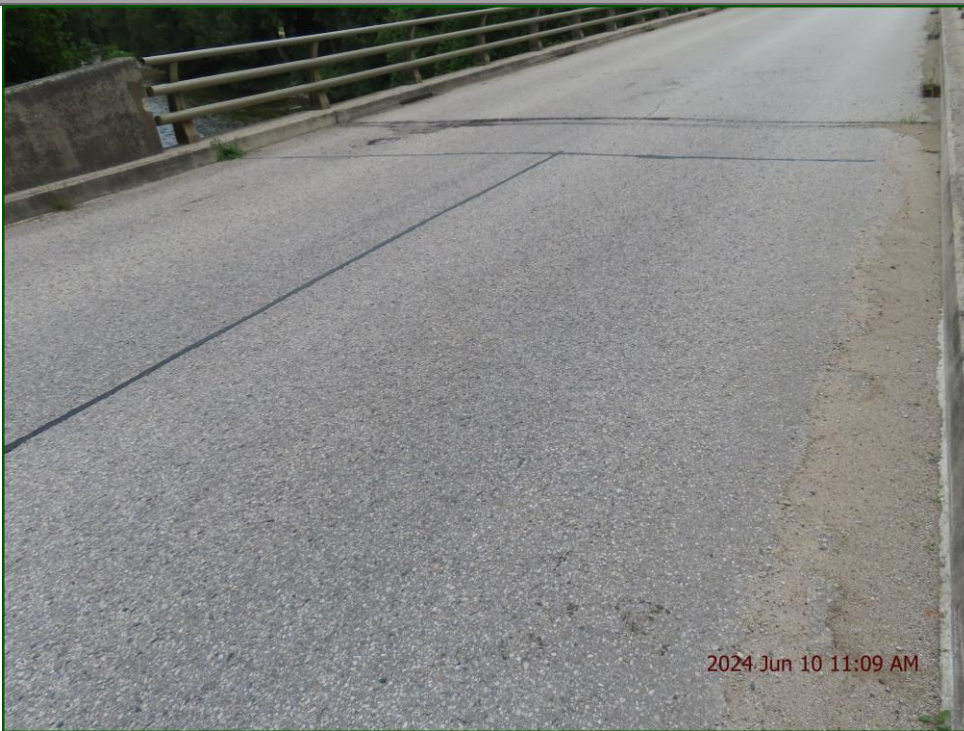
Description: Approach Wearing Surface: Joint sealing.

Joint sealing have been.
