OSIM Biennial Inspection Report

Concession 11/12, Lot 30

Burgess Engineering Inc

27-Aug-24

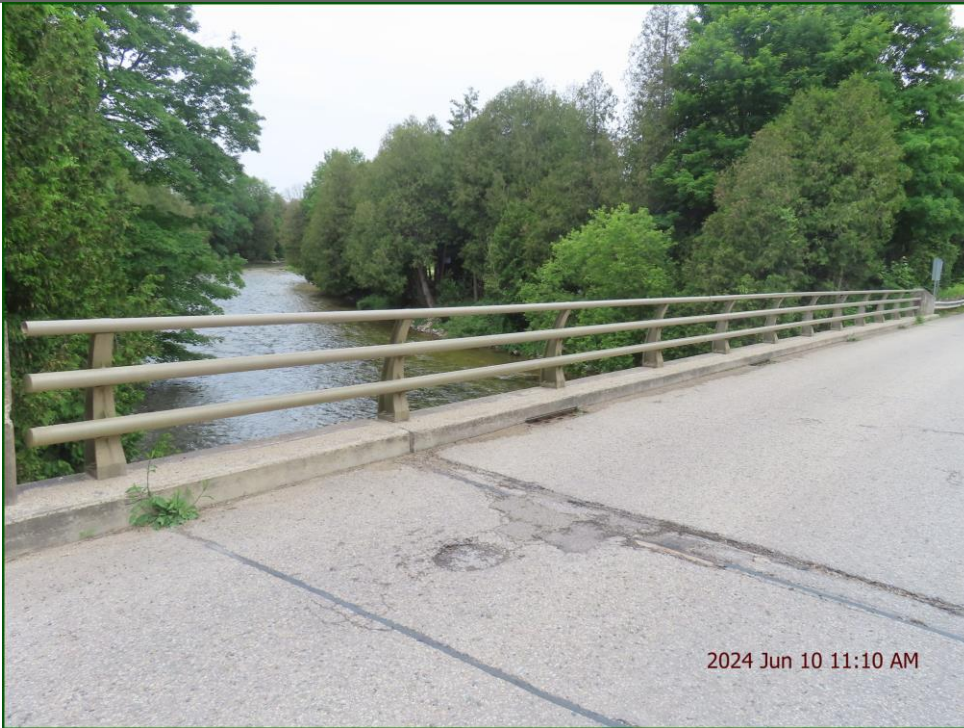
Description: Railing Systems: Minor impact damage.

Minor impact damage.

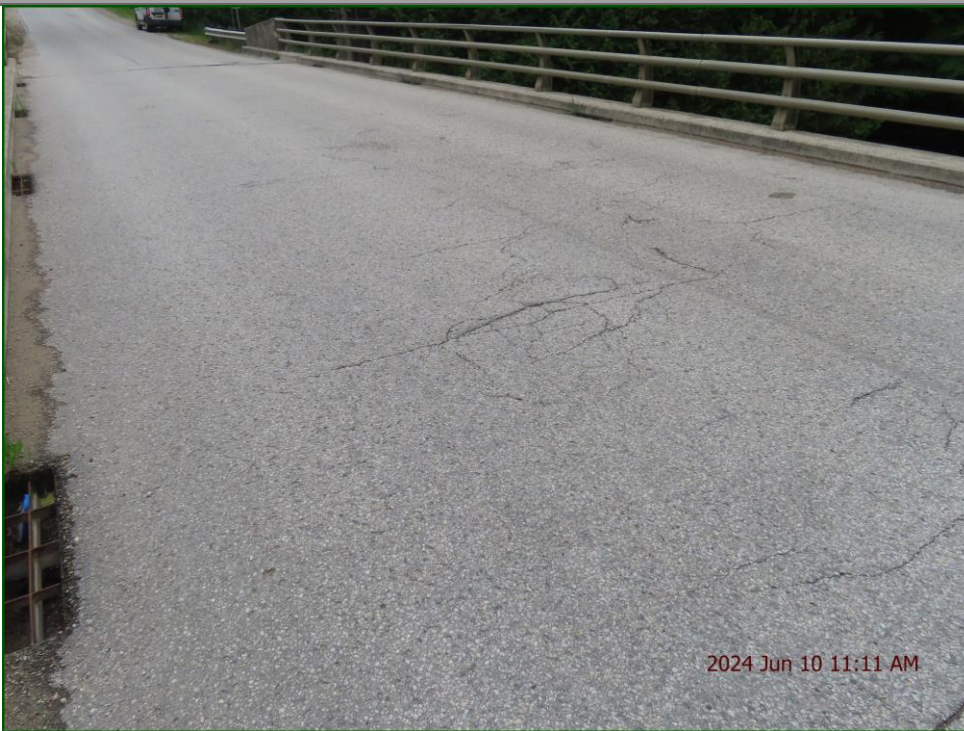
Description: Wearing Surface: Light map cracking throughout.

Description: Wearing Surface: Light to medium transverse cracking along joints.

Light map cracking throughout. Light to medium transverse cracking along joints.

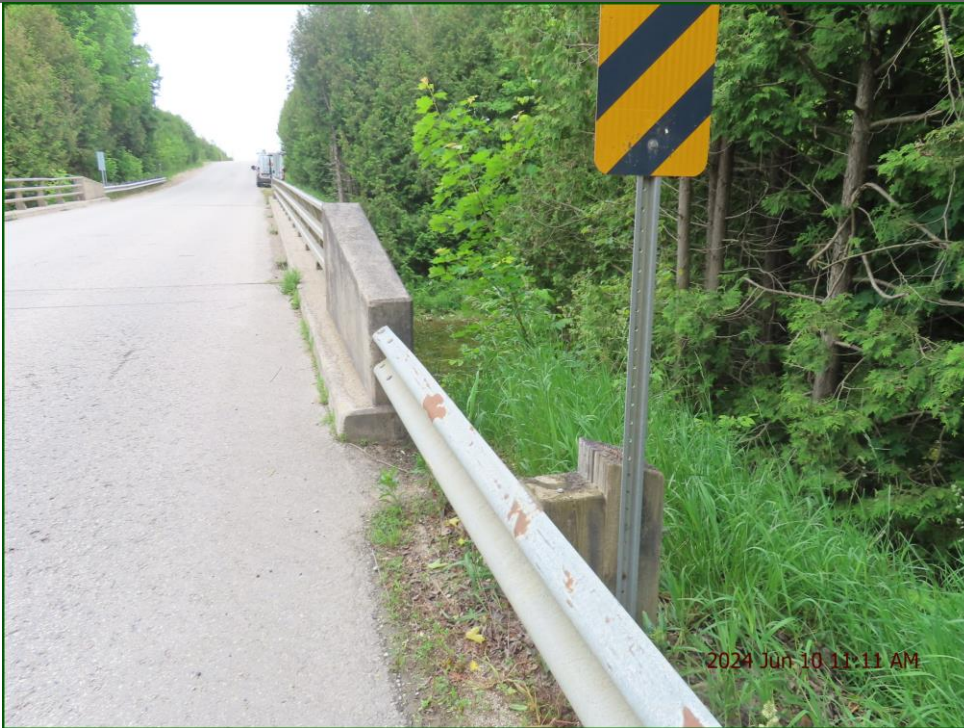
Moderate erosion on SW quadrant.

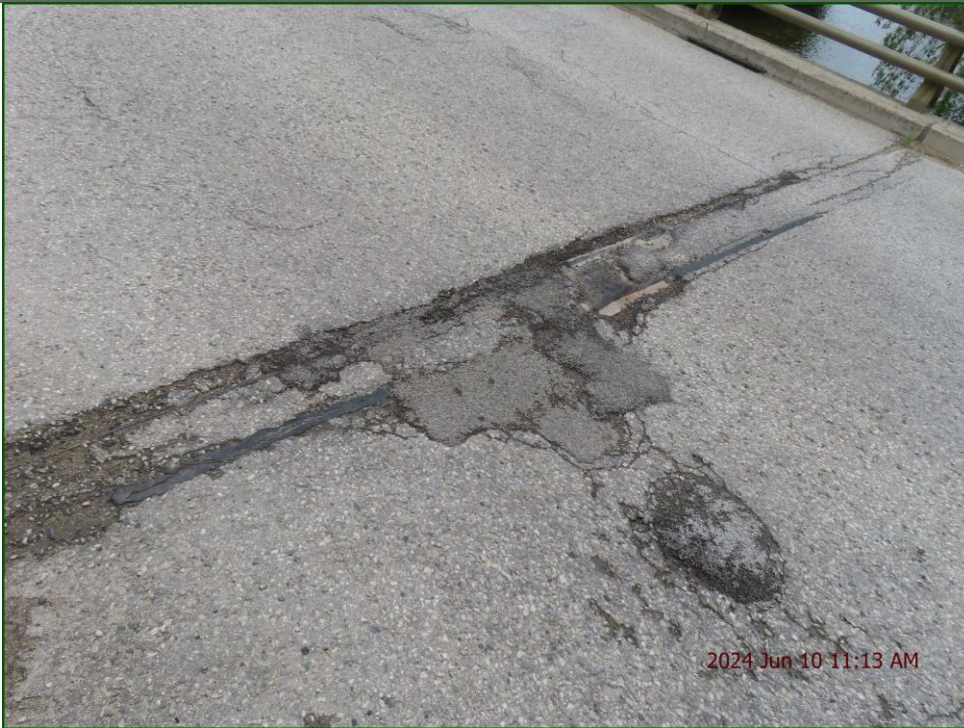
Paved over.

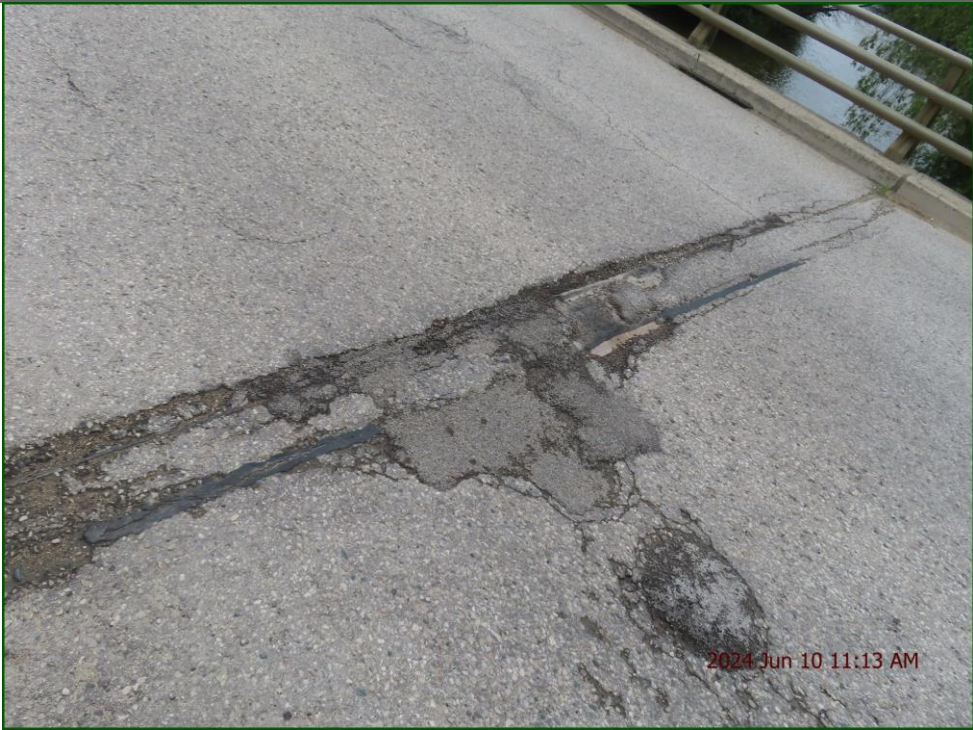
Paved over.

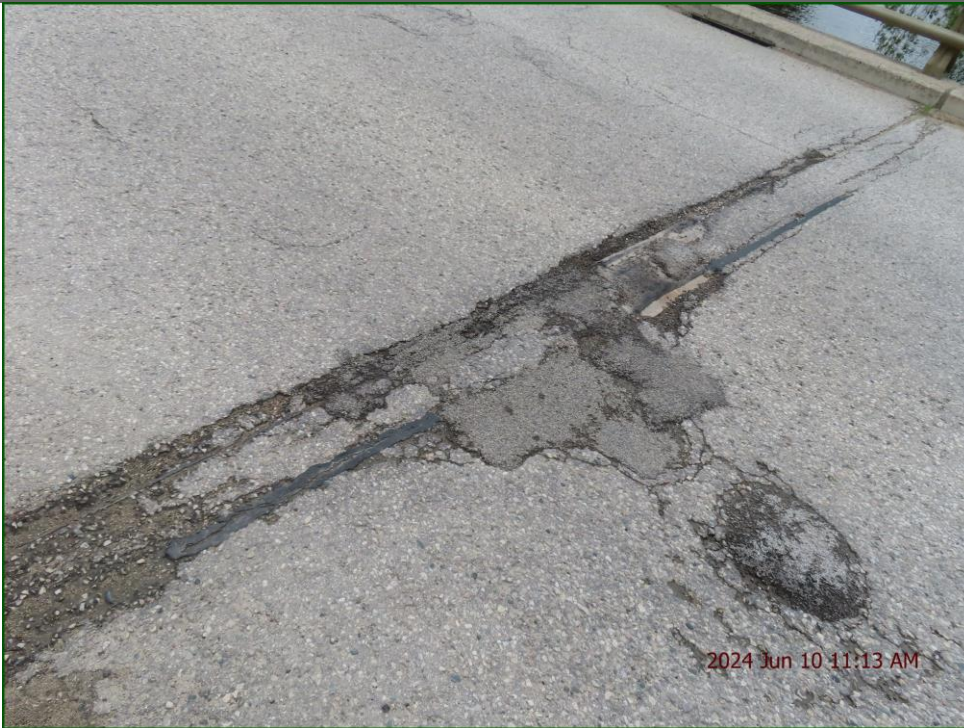
Paved over.

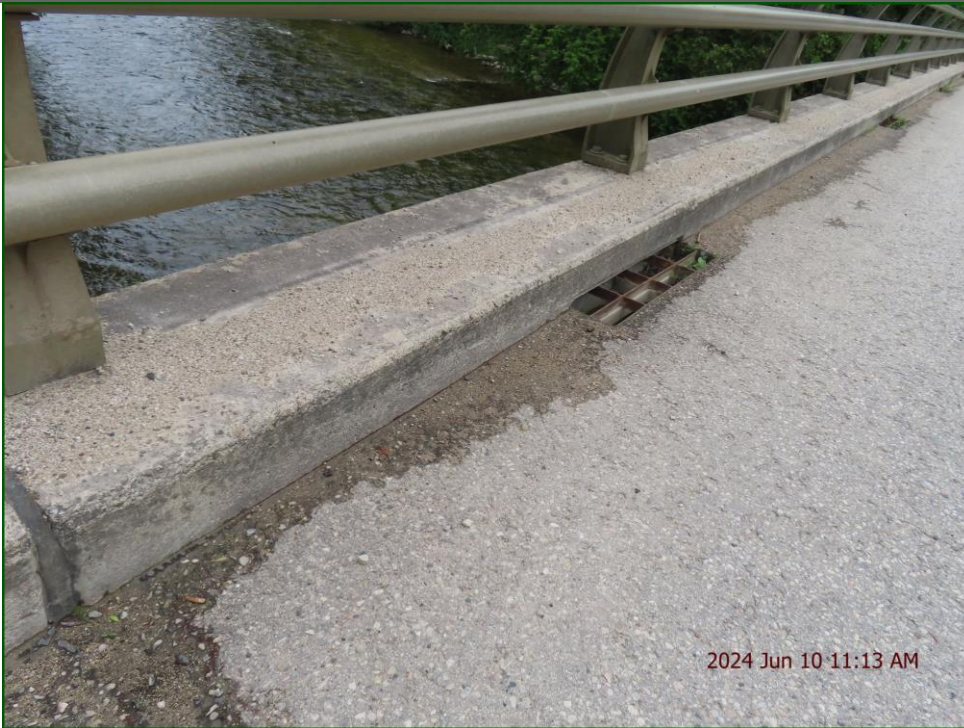
Description: Curbs: Light vertical cracks throughout.

Light vertical cracks throughout.

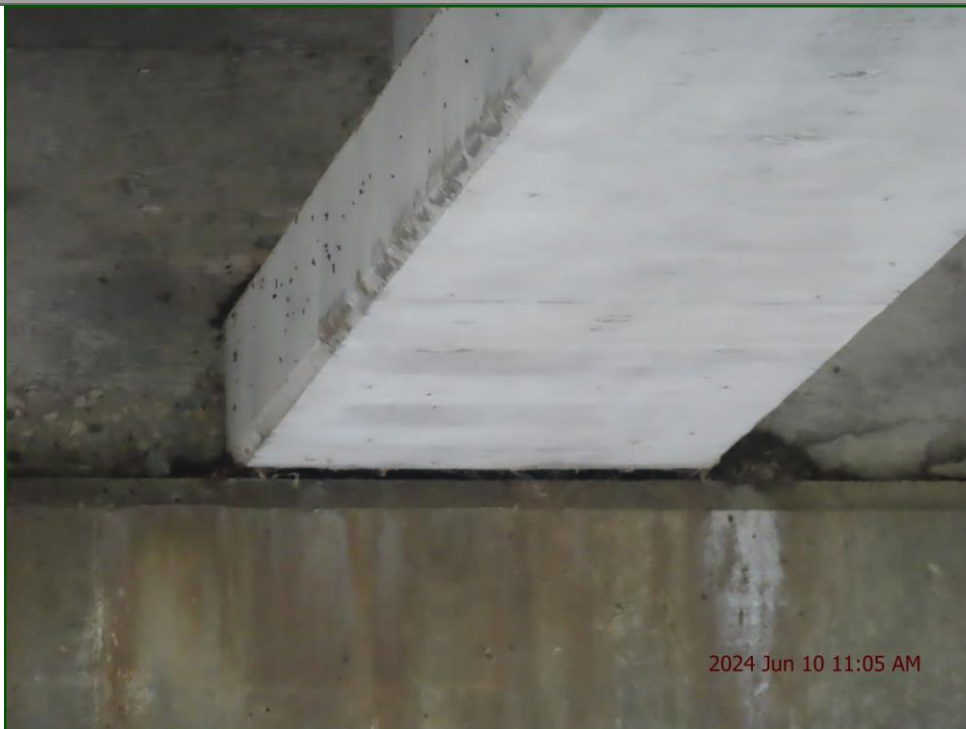
Limited inspection of bearings due to abutment elevation.

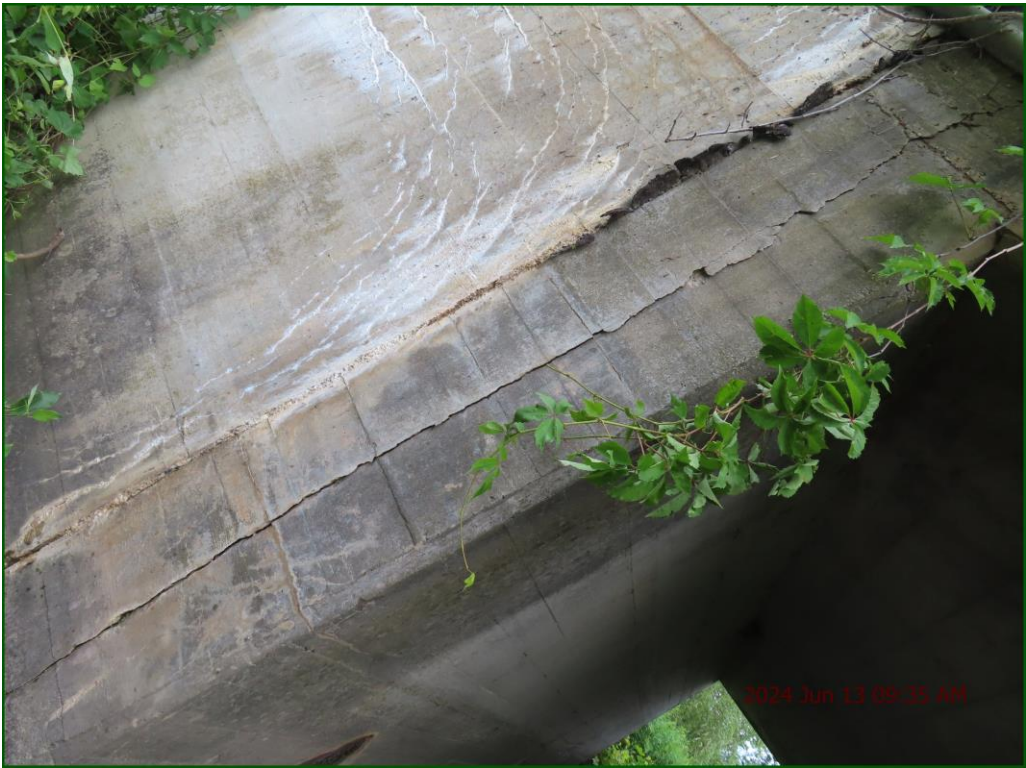
Description: Abutment walls: Wide vertical crack extending entire height of abutment at SE & SW corner (

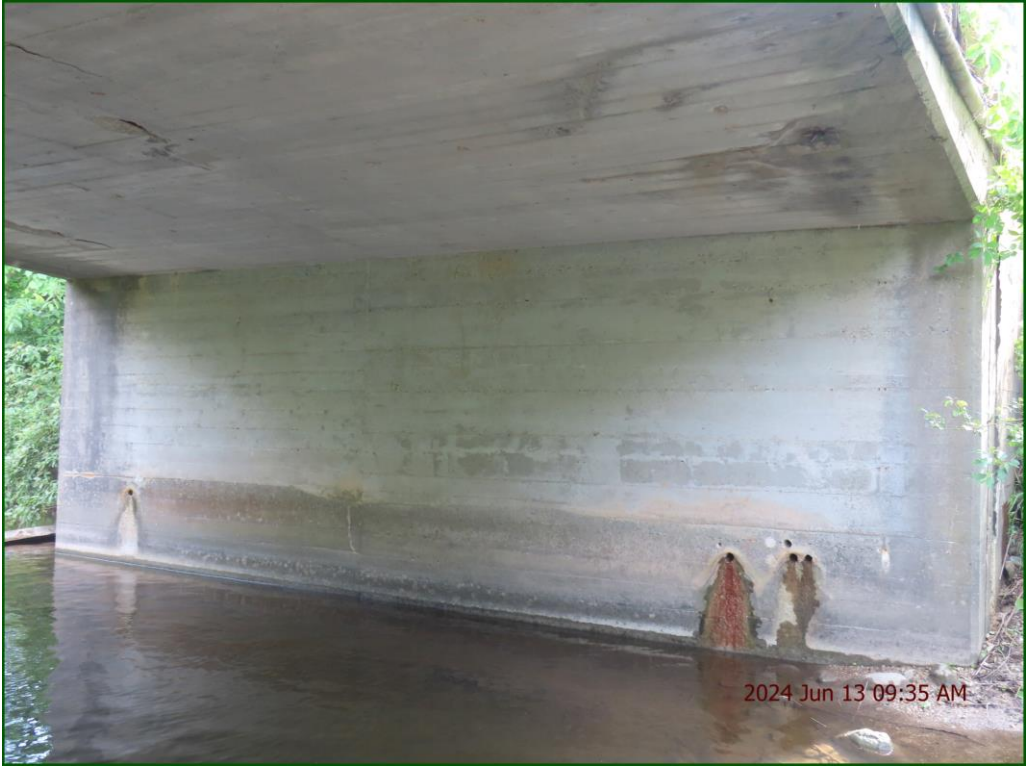
Description: Abutment Walls: Patched areas.

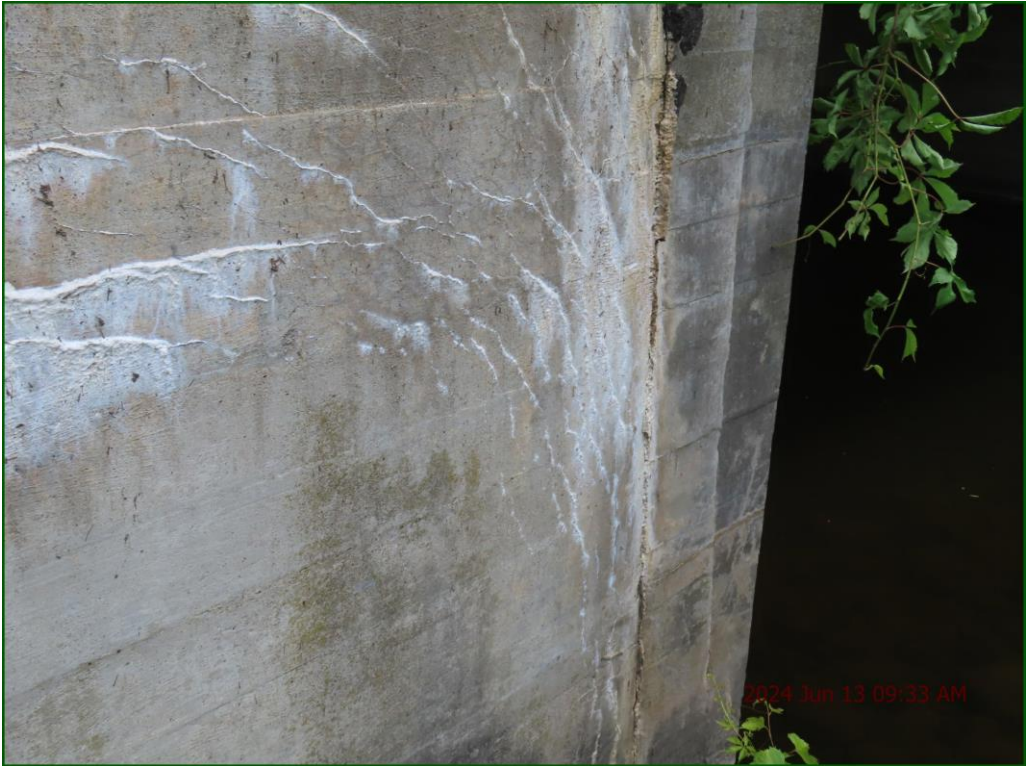
Description: Wingwalls: Light to medium vertical cracks throughout with leachate staining.

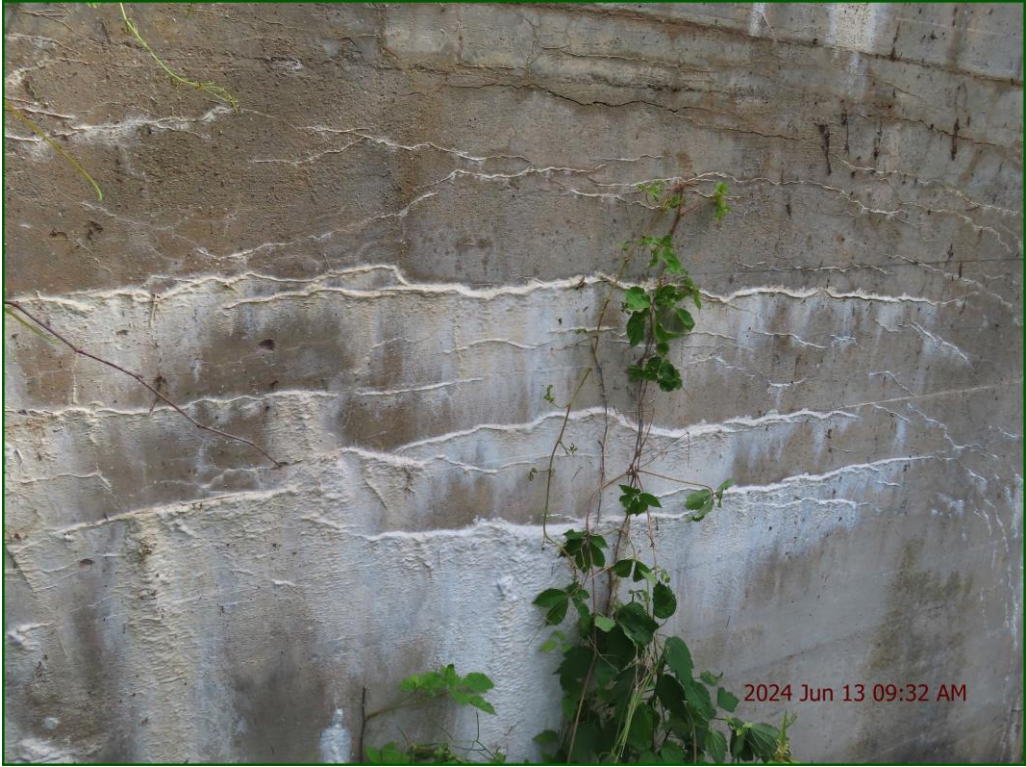
Description: Wingwalls: Medium to wide horizontal cracking throughout with leachate staining.

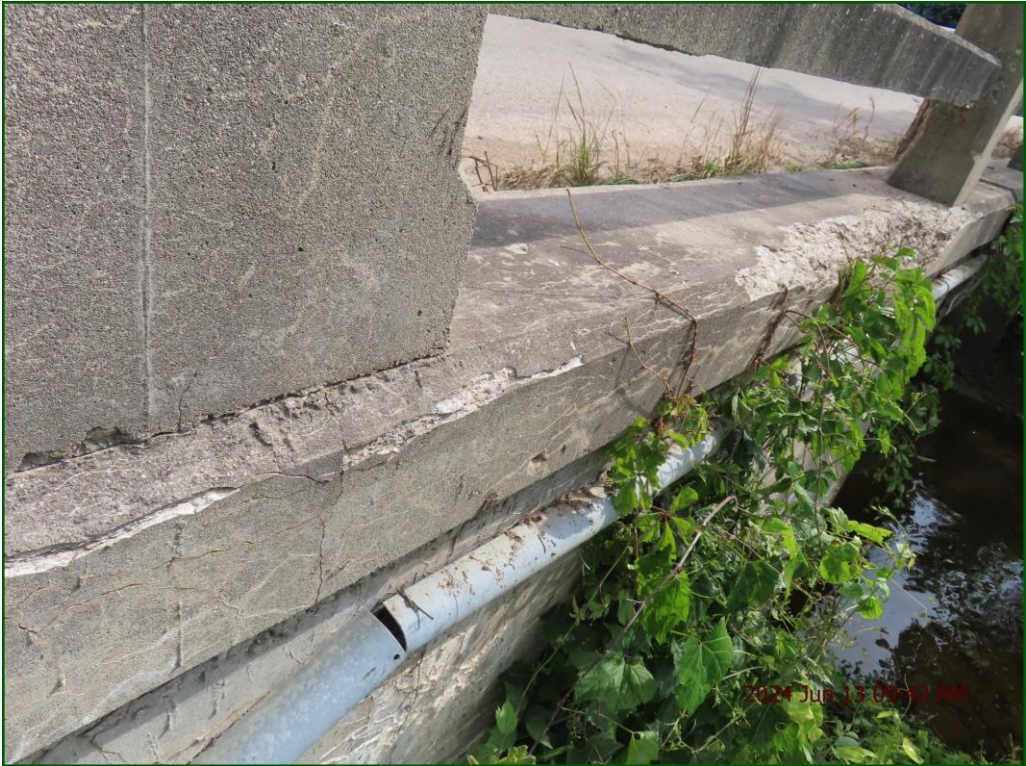
Description: Approach Curbs: Light to medium map cracking at NE quadrant.

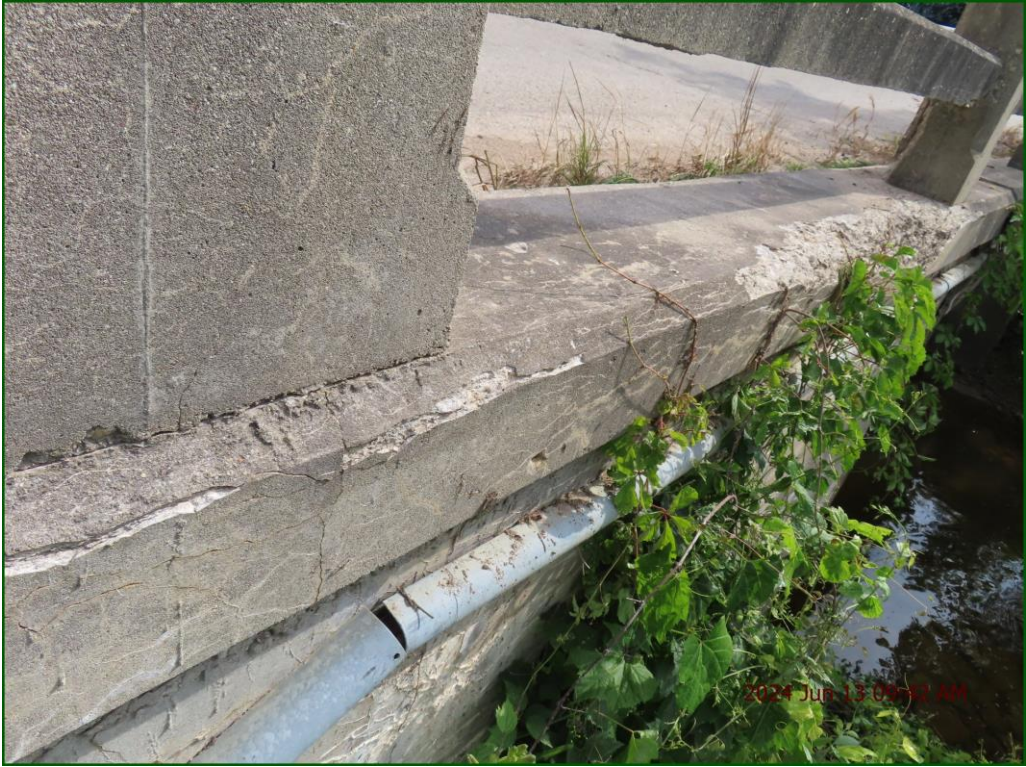
Description: Approach Curbs: Light to medium map cracking at NE quadrant.

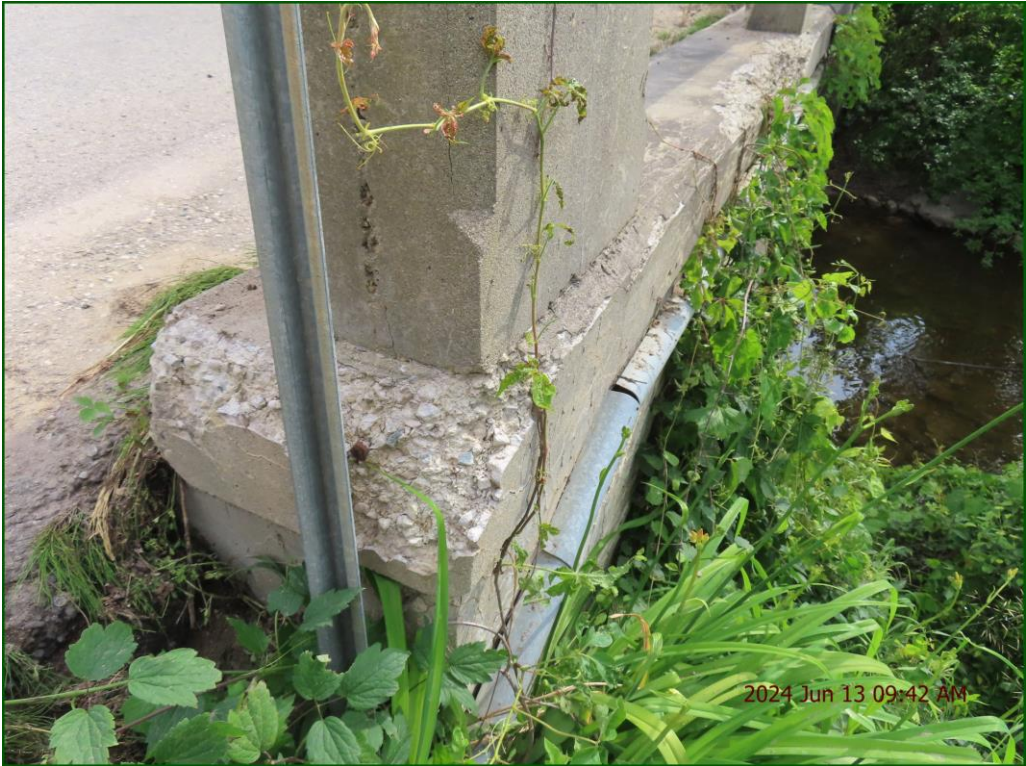
Description: Approach Curbs: Moderate disintegration on outside of SW approach.

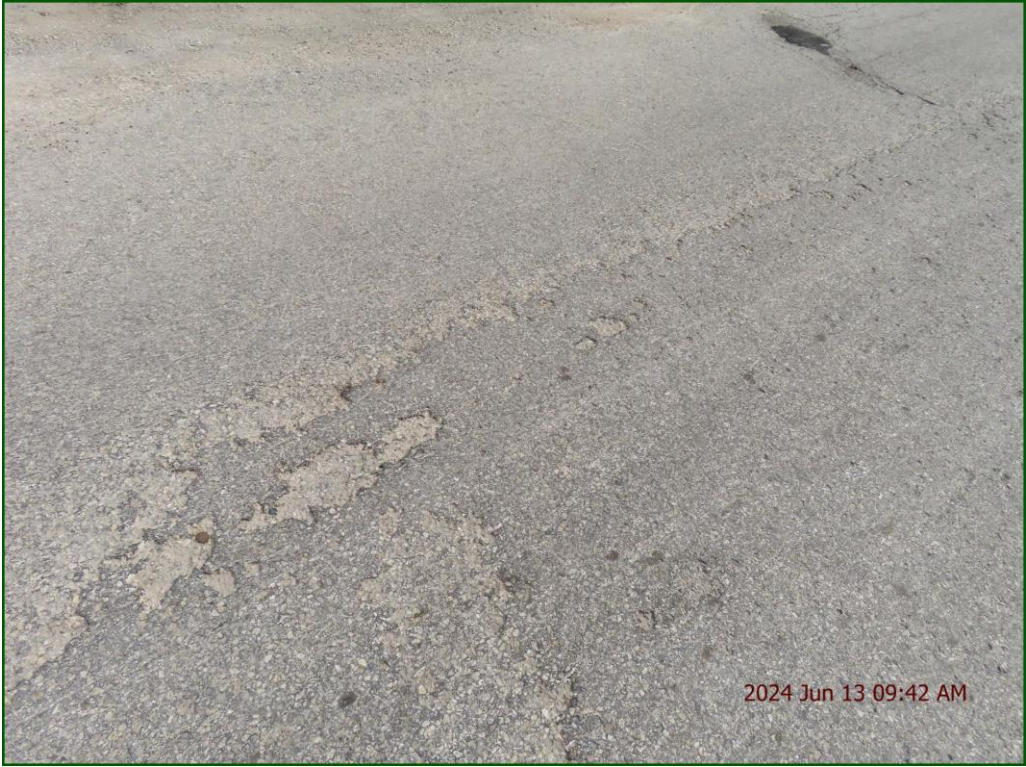
Description: Approach Wearing Surface: Medium ravelling at centreline.

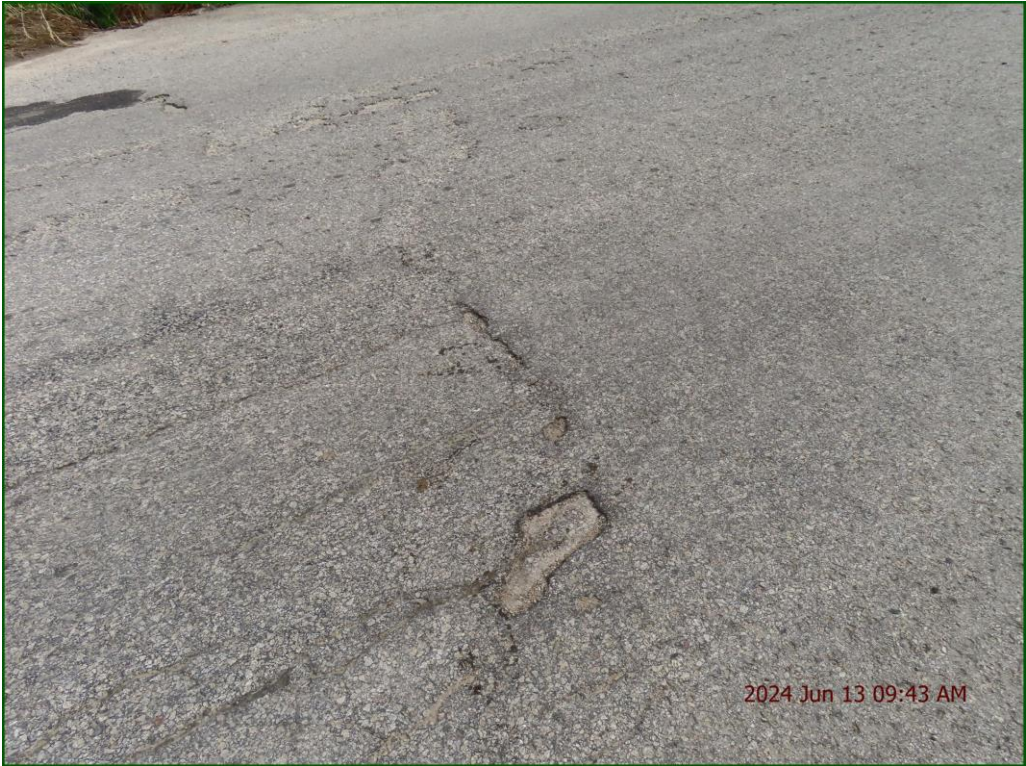
Description: Approach Wearing Surface: Moderate pothole.

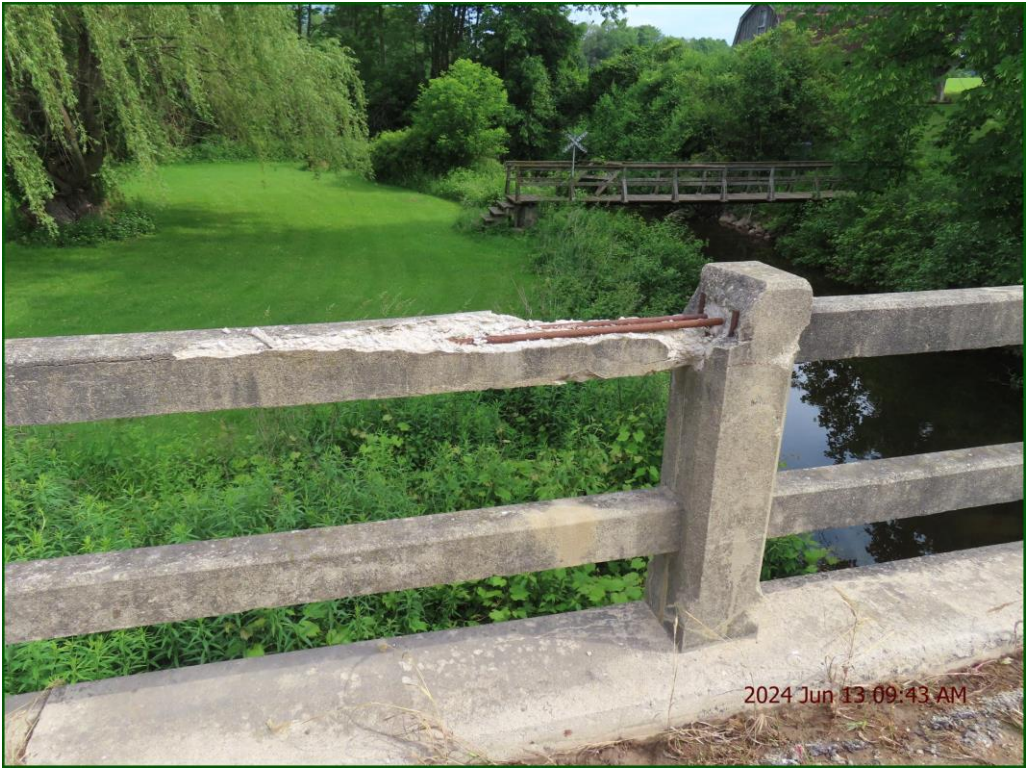
Description: Railing systems: Severe concrete disintegration with exposed reinforcing.

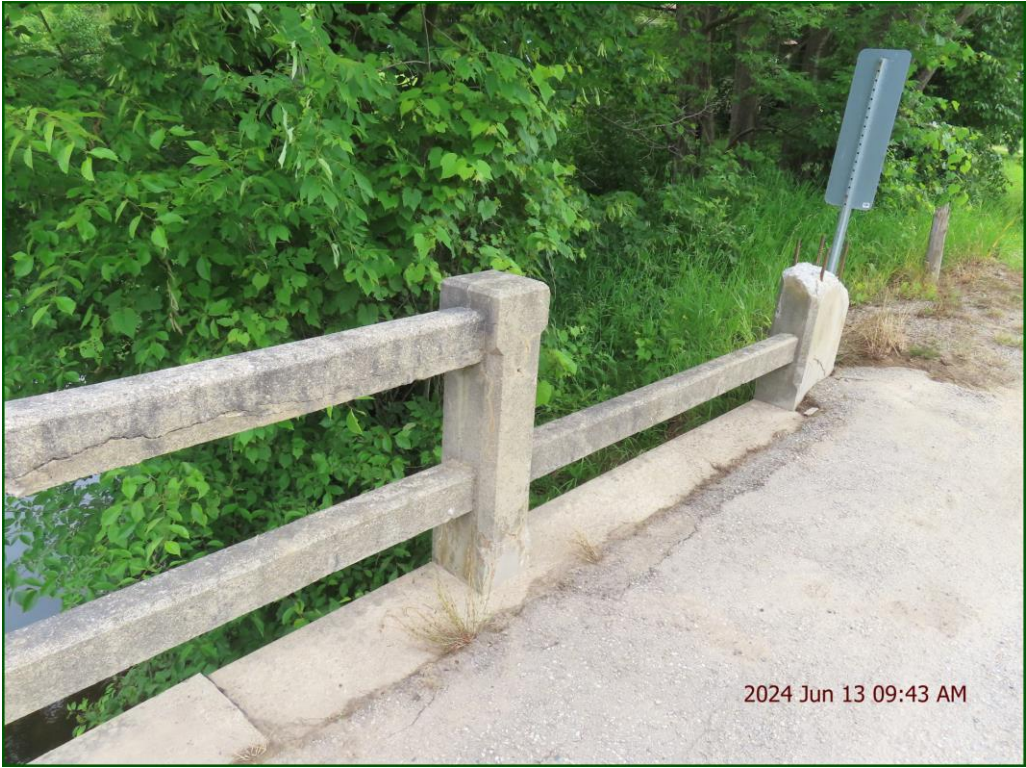
Description: Railing systems: Complete section loss at NE corner.

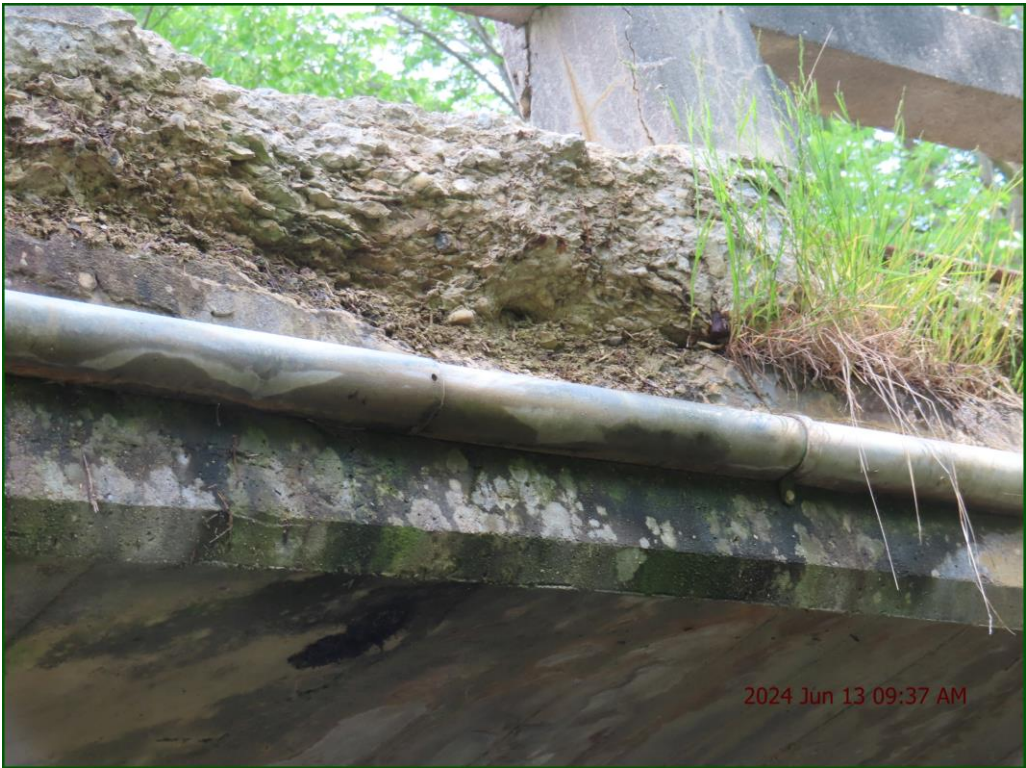
Description: Soffit (ext): Severe spall on south side.

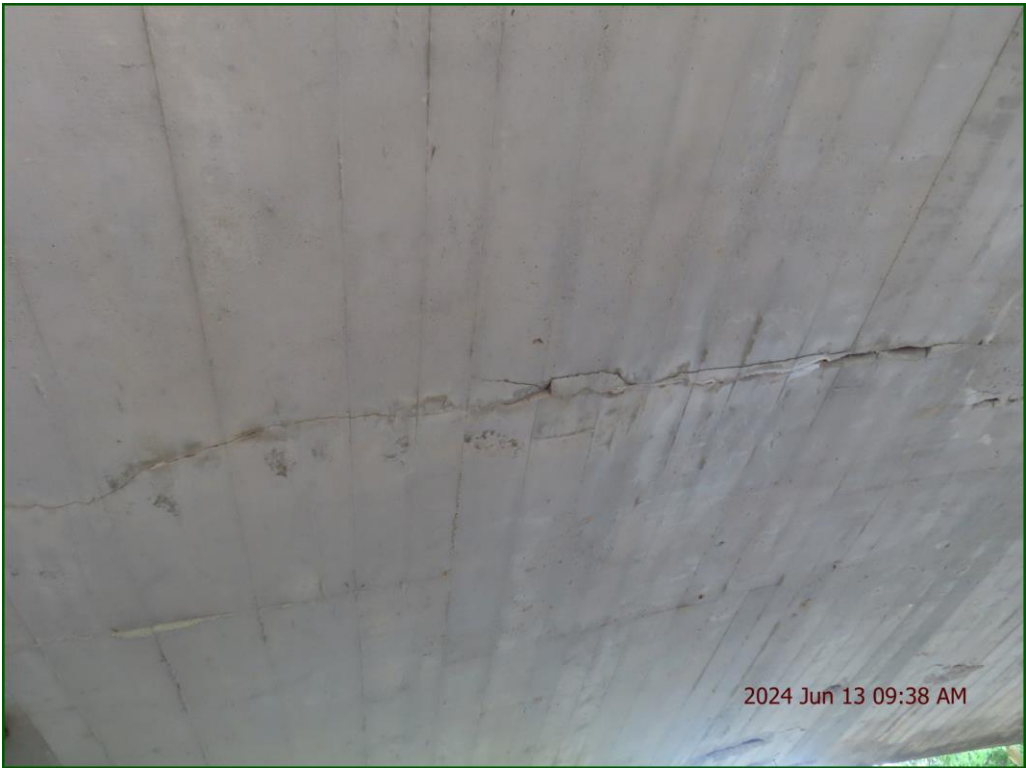
Description: Soffit (int): Medium longitudinal cracks propogating from spalls.

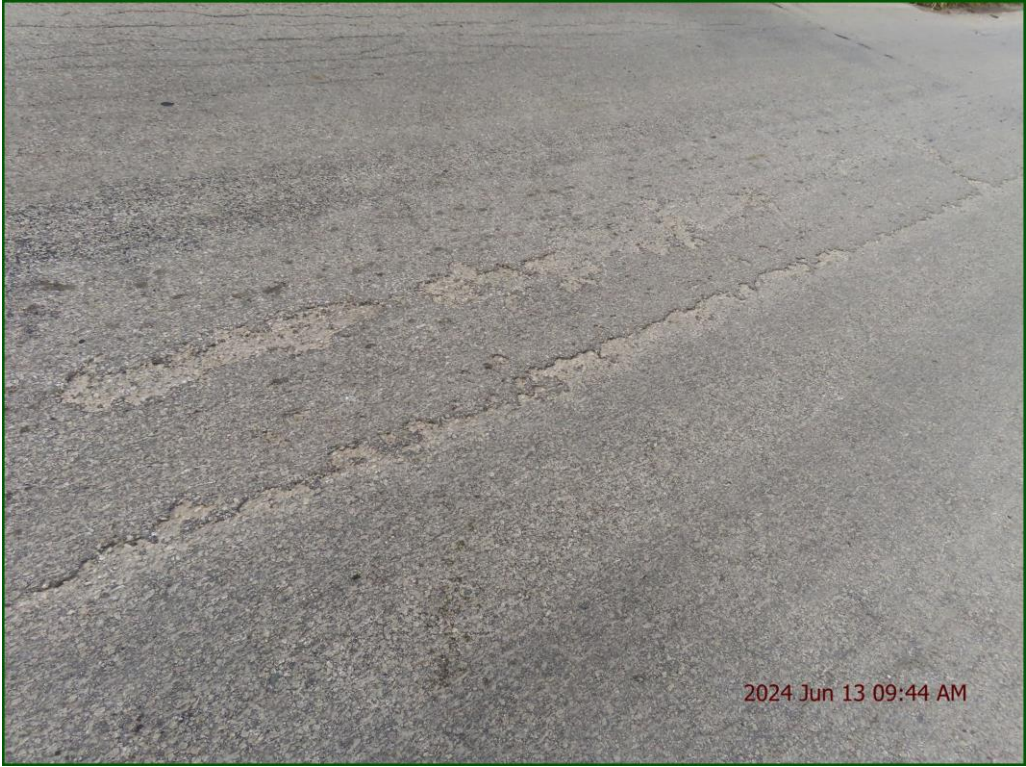
Description: Wearing Surface: Medium ravelling at centreline.

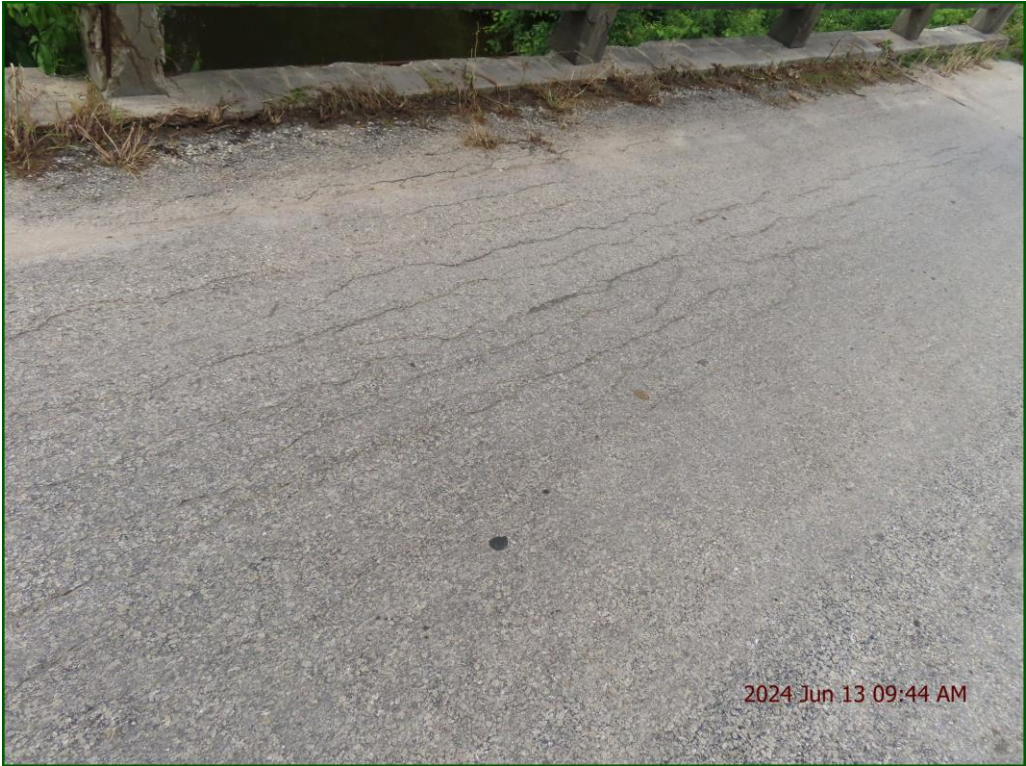
Description: Wearing Surface: Light to medium longitudinal cracking.

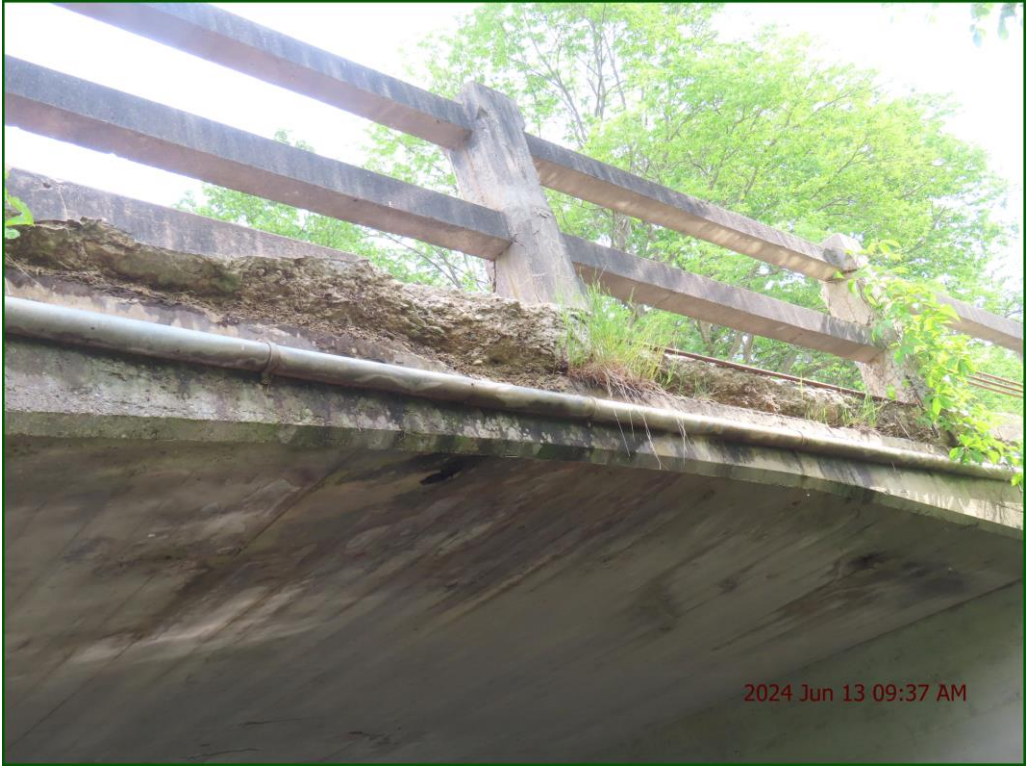
Description: Curbs: Severe spalling and disintegration on south curb.

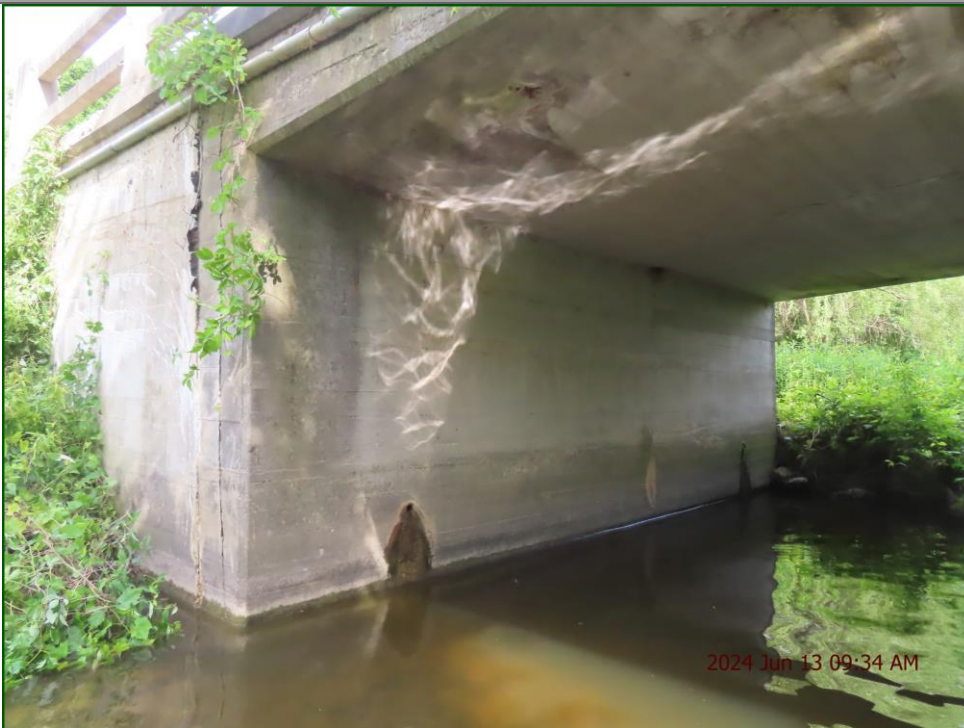
Light to medium vertical crack midspan on west abutment. Wide vertical crack extending entire height of abutment at SE & SW corner (exterior). Patched areas.

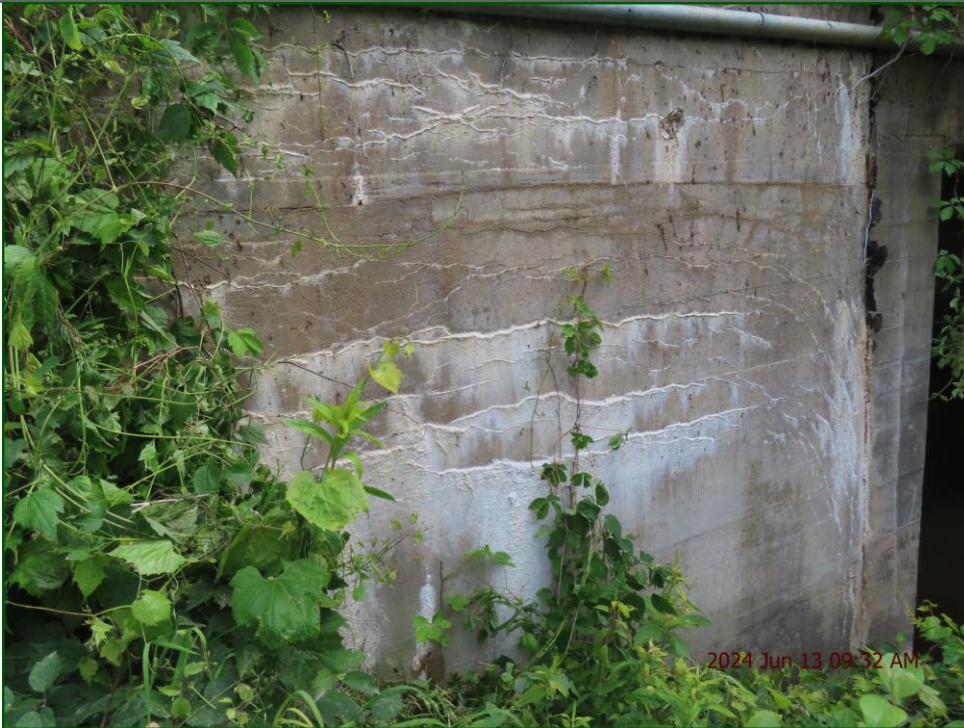
Light to medium vertical cracks throughout with leachate staining. Medium to wide horizontal cracking throughout with leachate staining. Recommend to remove vegetation.

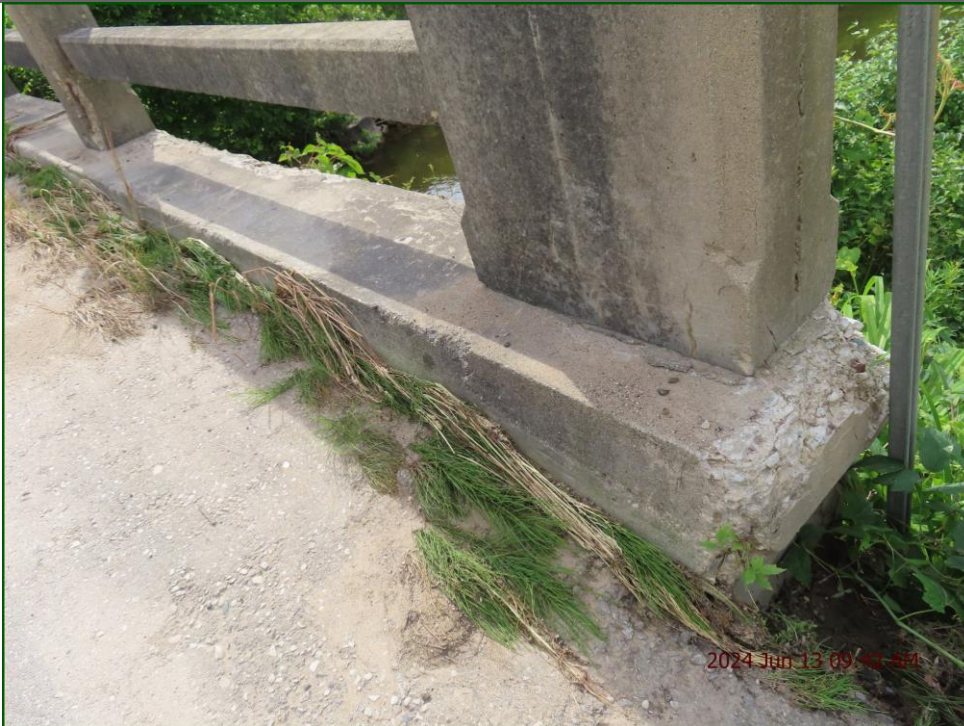
Light to medium map cracking at NE quadrant. Recommend removing vegetation. Moderate disintegration on outside of SW approach.

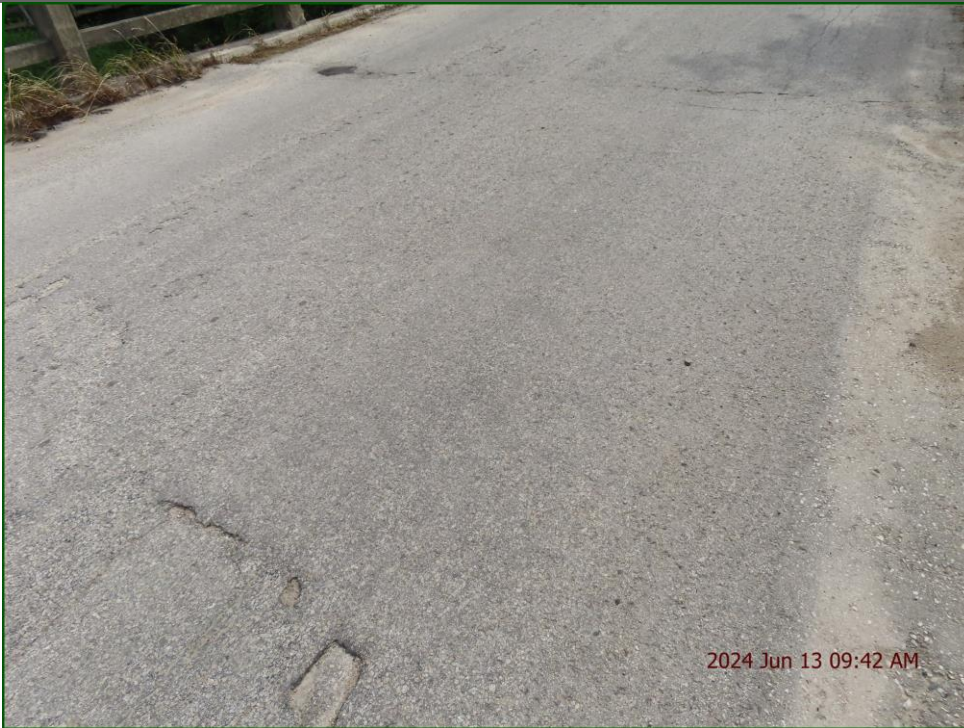
Medium ravelling at centreline. Moderate pothole.

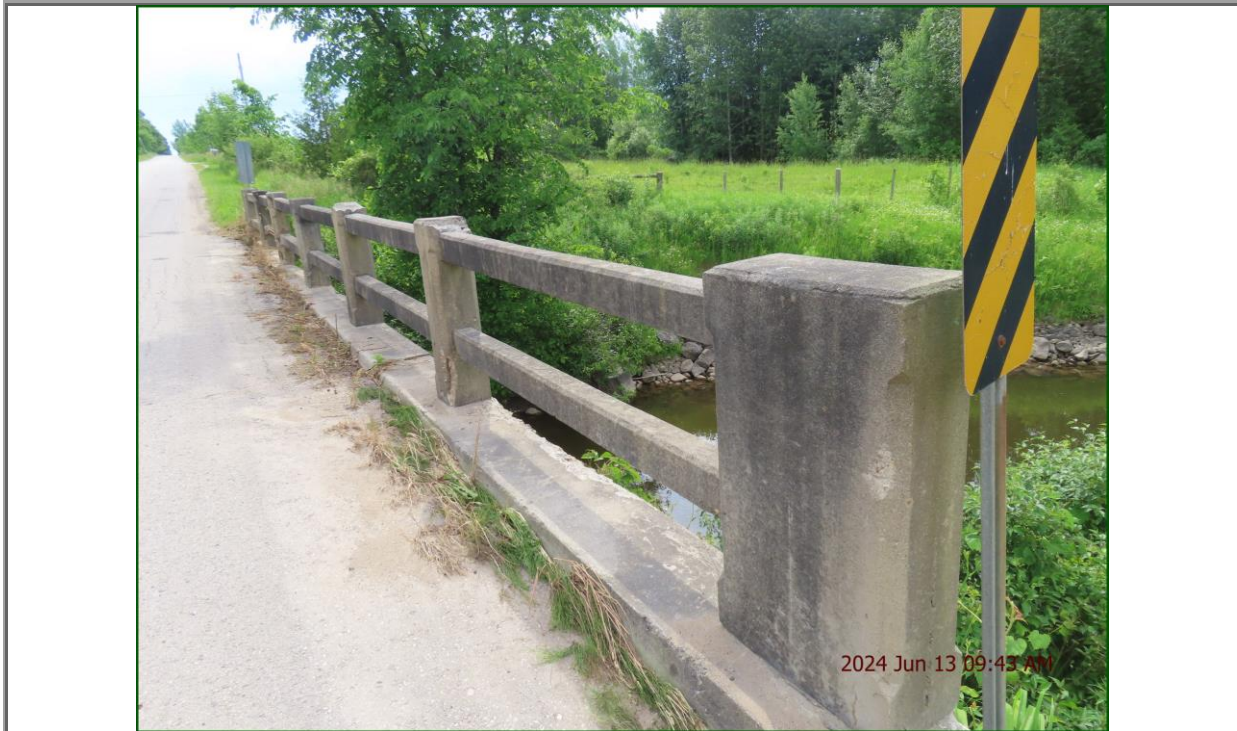
Severe concrete disintegration with exposed reinforcing. Complete section loss at NE corner.

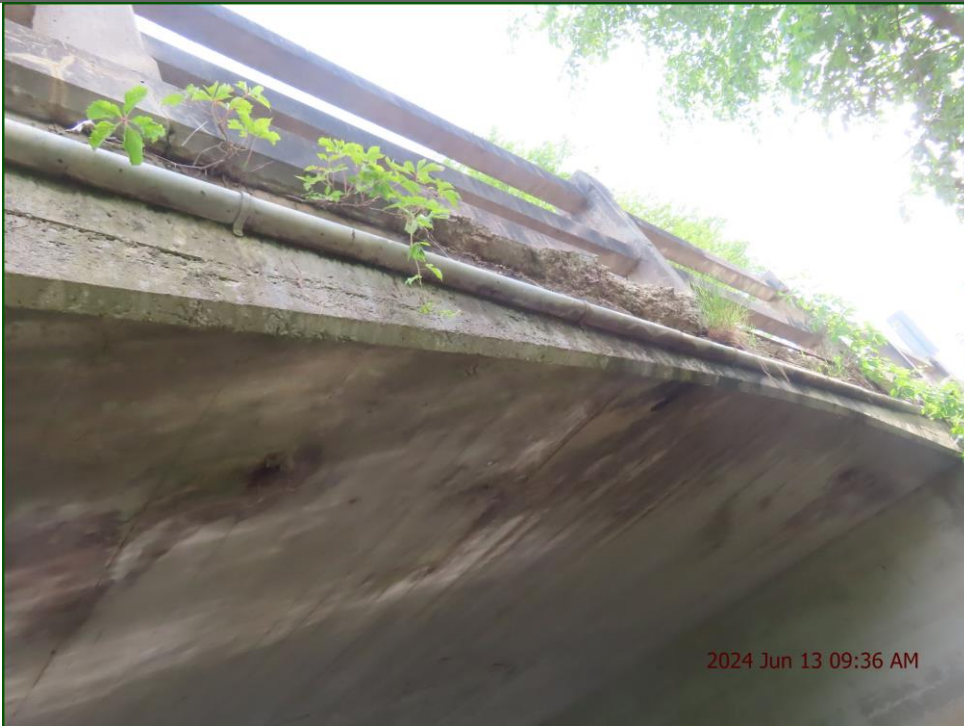
Light to medium horizontal cracks with leachate staining. Severe spall on south side.
