OSIM Biennial Inspection Report

Concession 11/12, Lot 30

Burgess Engineering Inc

27-Aug-24

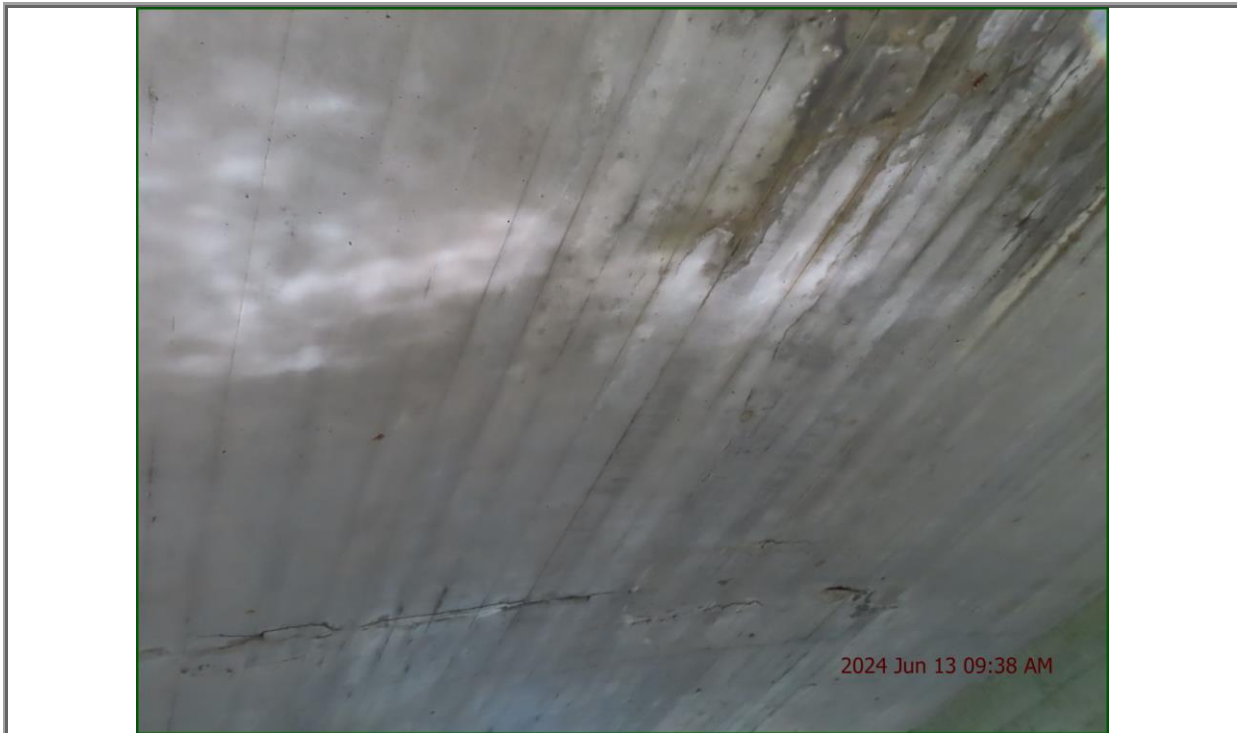
Light spalling with exposed reinforcing throughout. Medium longitudinal cracks propogating from spalls and shallow delamination at midspan.

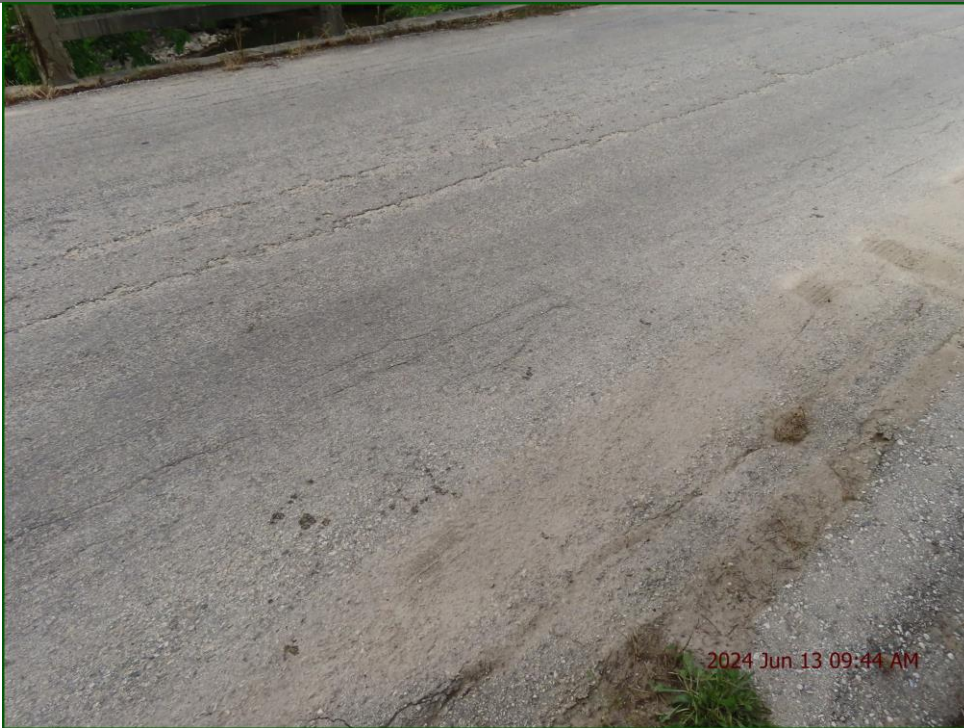
Medium ravelling at centreline. Light to medium longitudinal cracking.

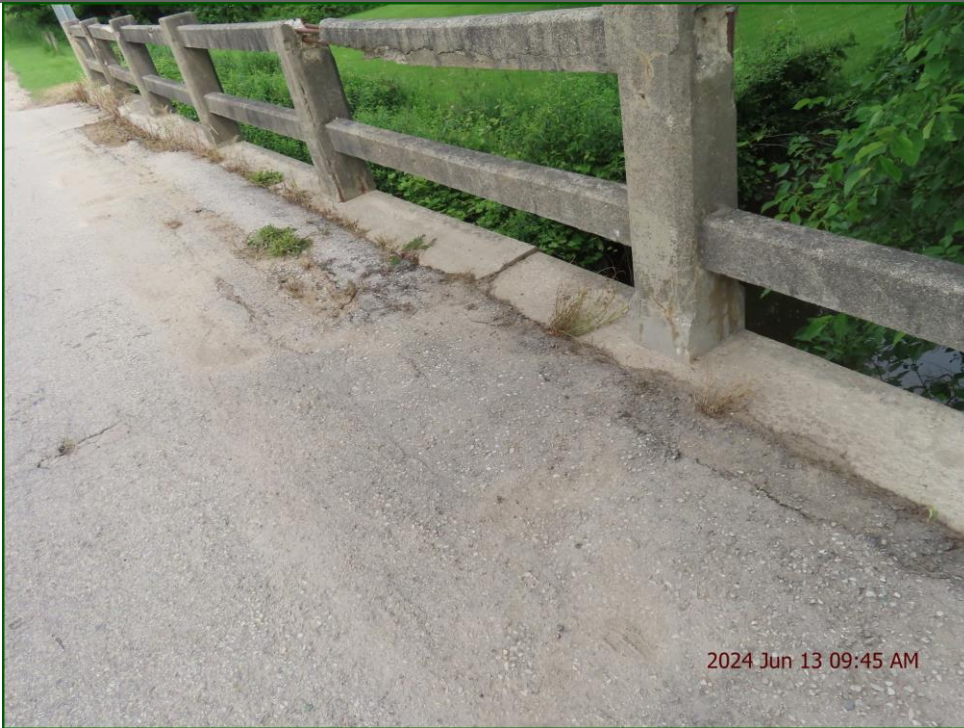
Severe spalling and disintegration on south curb.

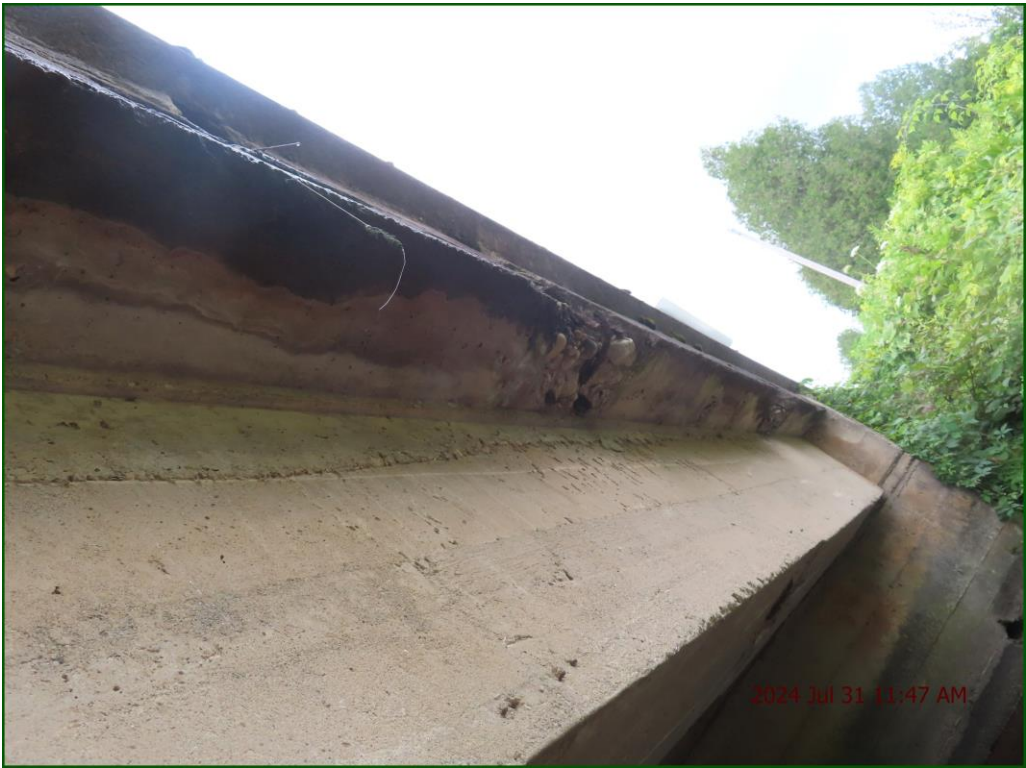
Description: Soffit: Severe spalling with exposed reinforcing.

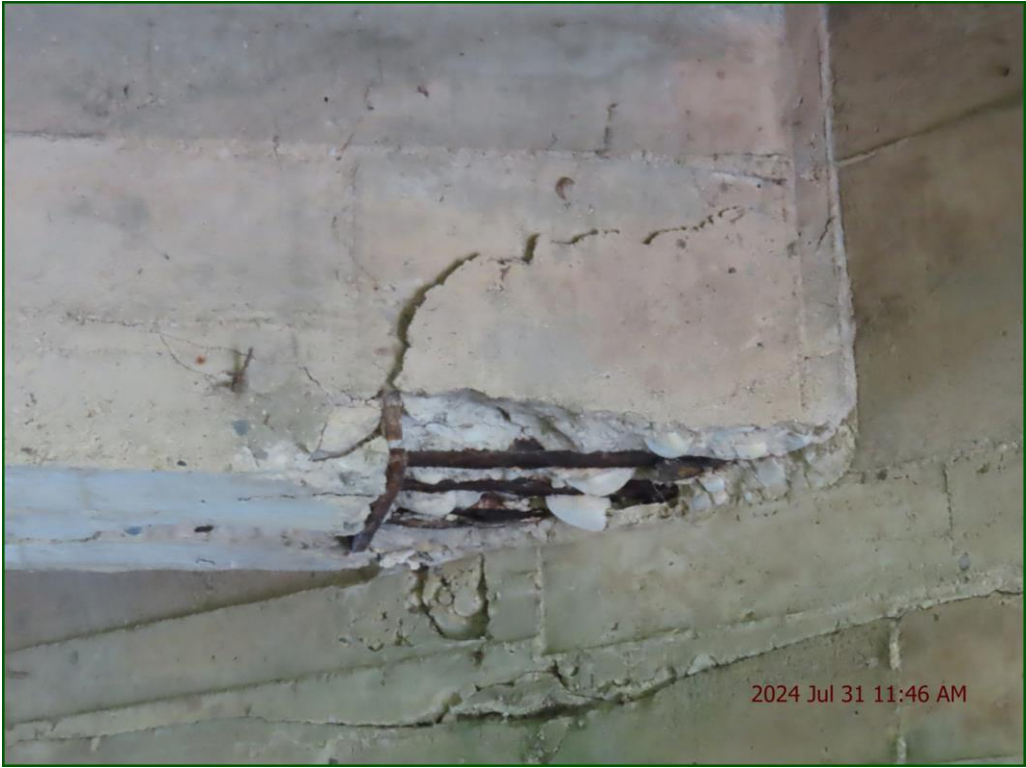
Description: Girders: Severe spalling with exposed reinforcing throughout.

Severe spalling with exposed reinforcing throughout.

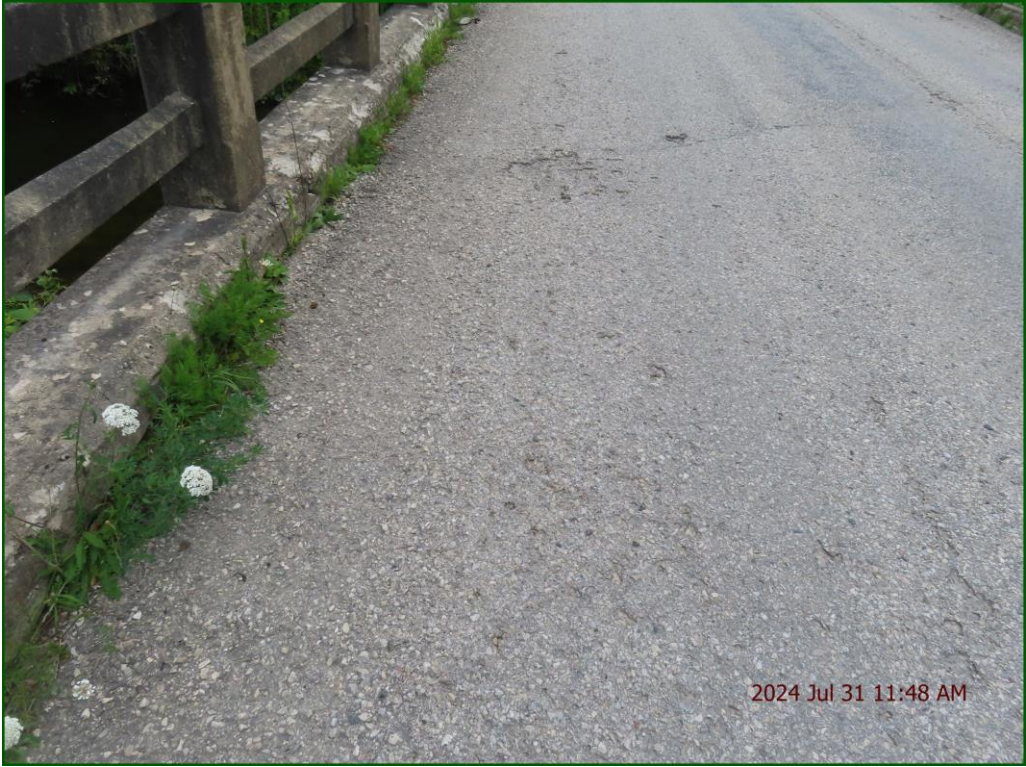
Description: Approach Wearing Surface: Moderate ravelling throughout.

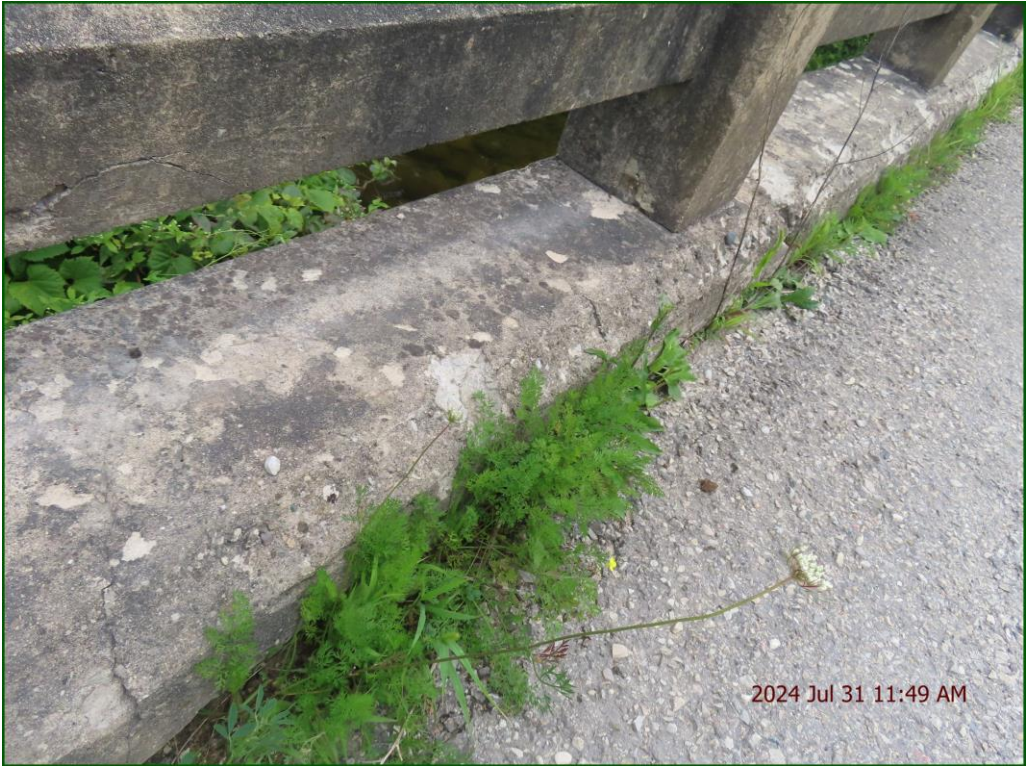
Description: Approach Curbs: Shallow popouts throughout and light spalling.

Shallow popouts throughout and light spalling.

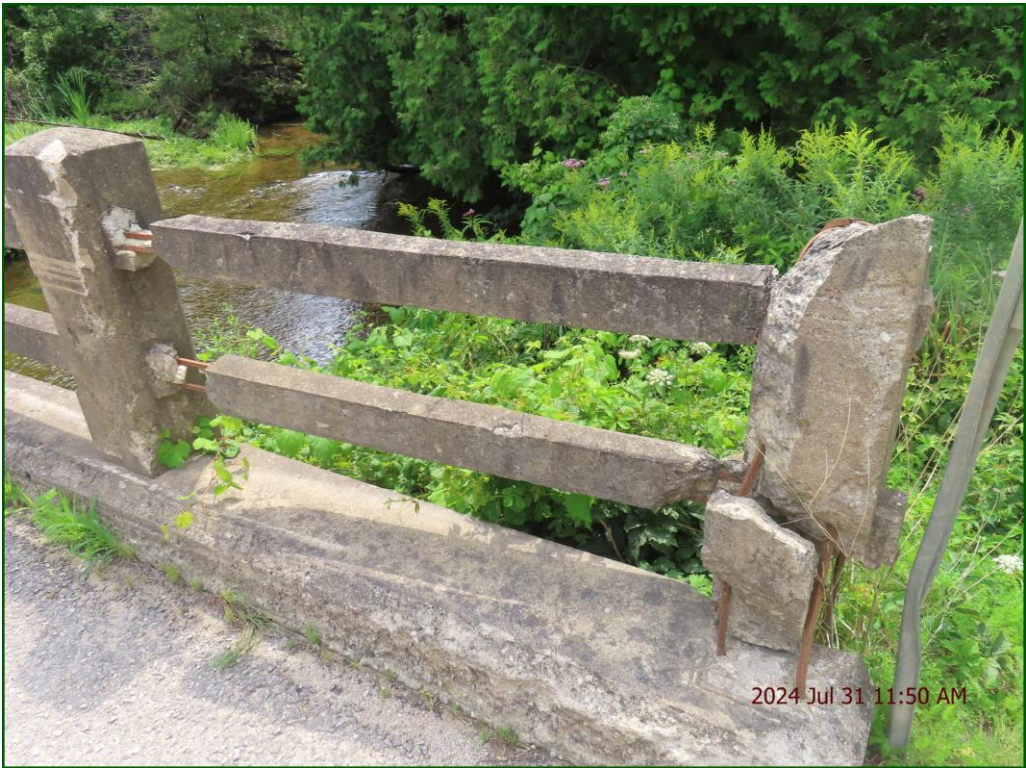
Description: Approach Railing System: Severe impact damage.

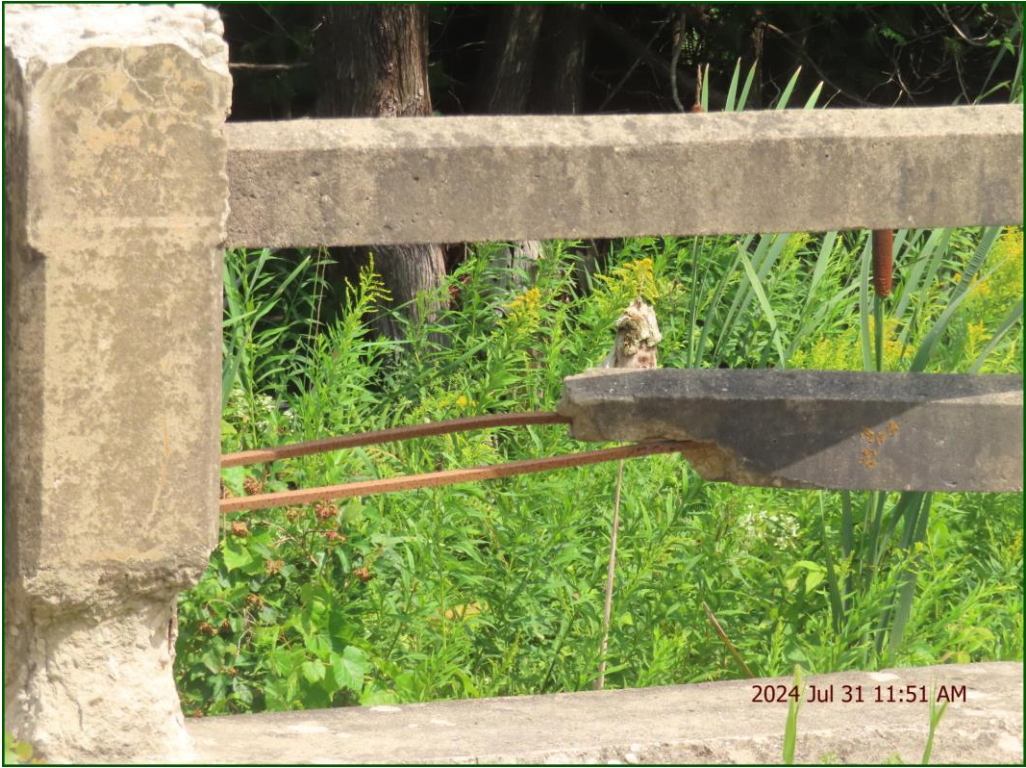
Description: Railing System: Severe impact damage.

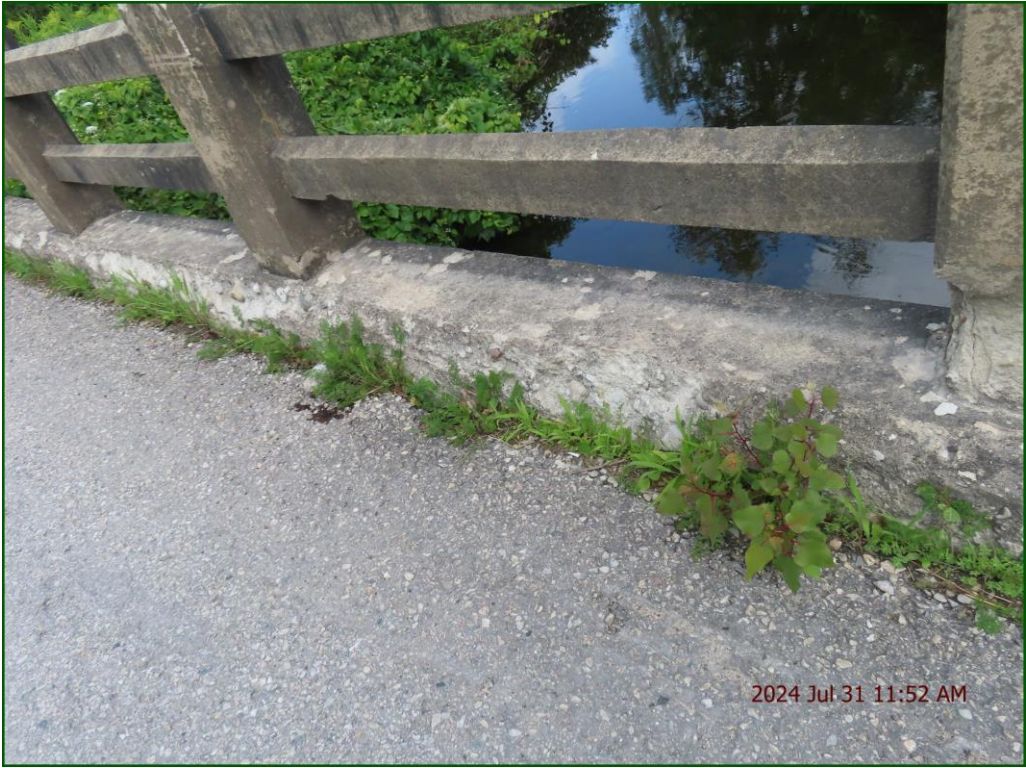
Description: Curbs: Moderate spalling and disintegration throughout.

Moderate spalling and disintegration throughout.

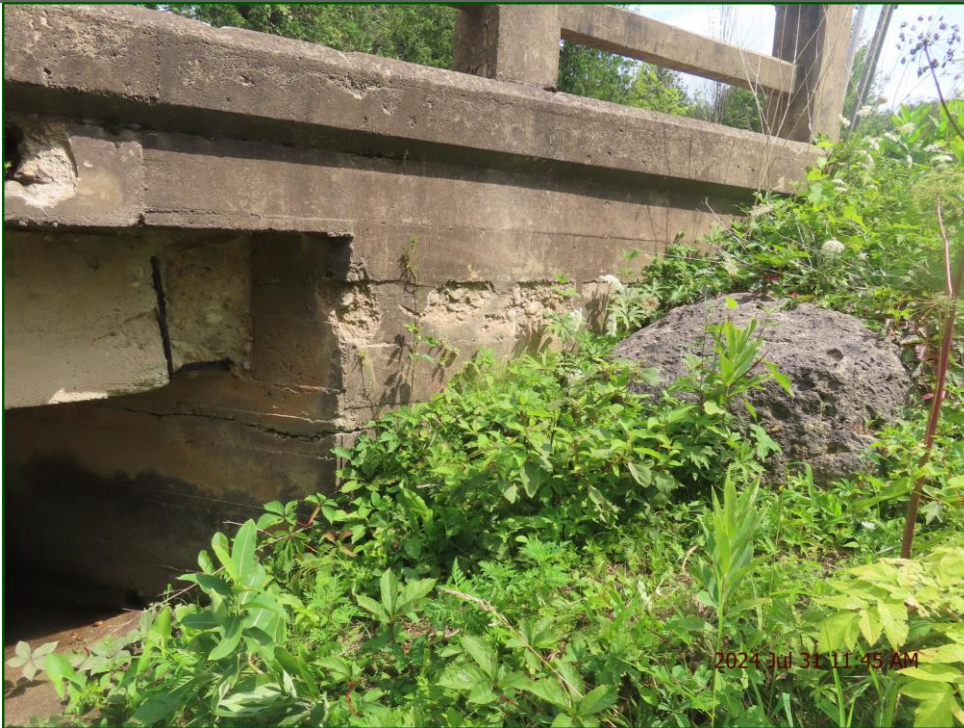
Light spalling with disintegration.

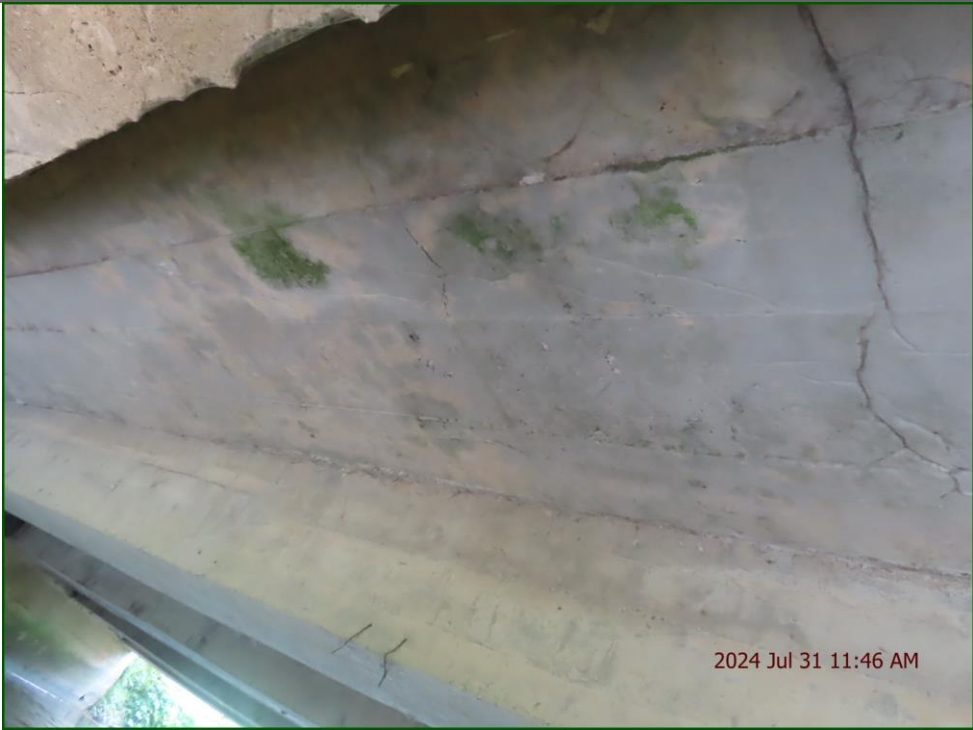
Severe spalling with exposed reinforcing. Severe spalling and disintegration with exposed reinforcing.

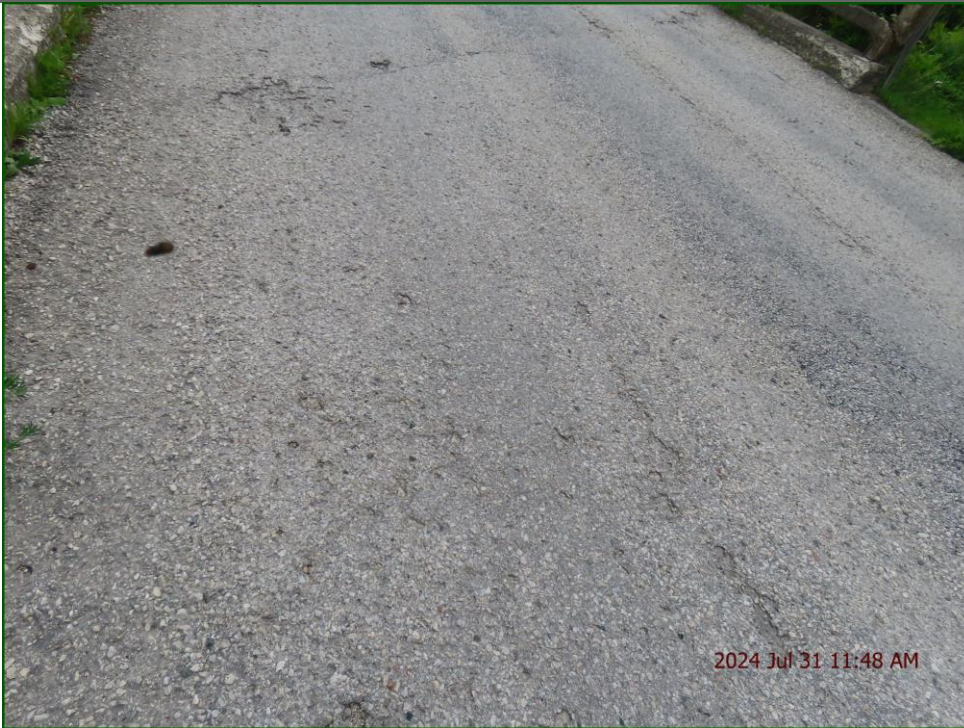
Moderate ravelling throughout.

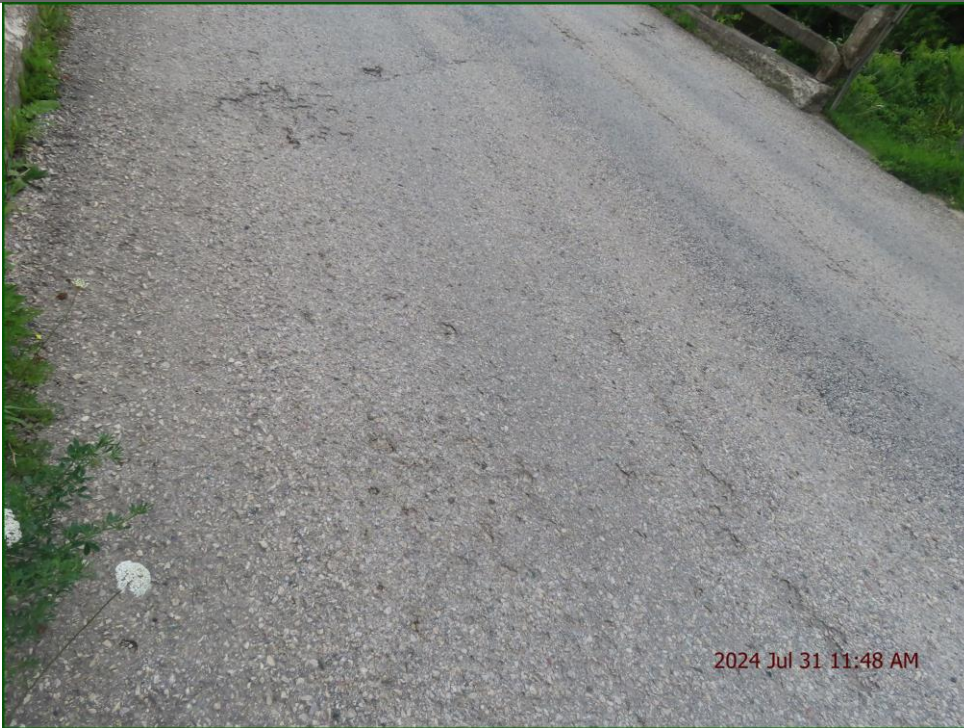
No signs of settlement.

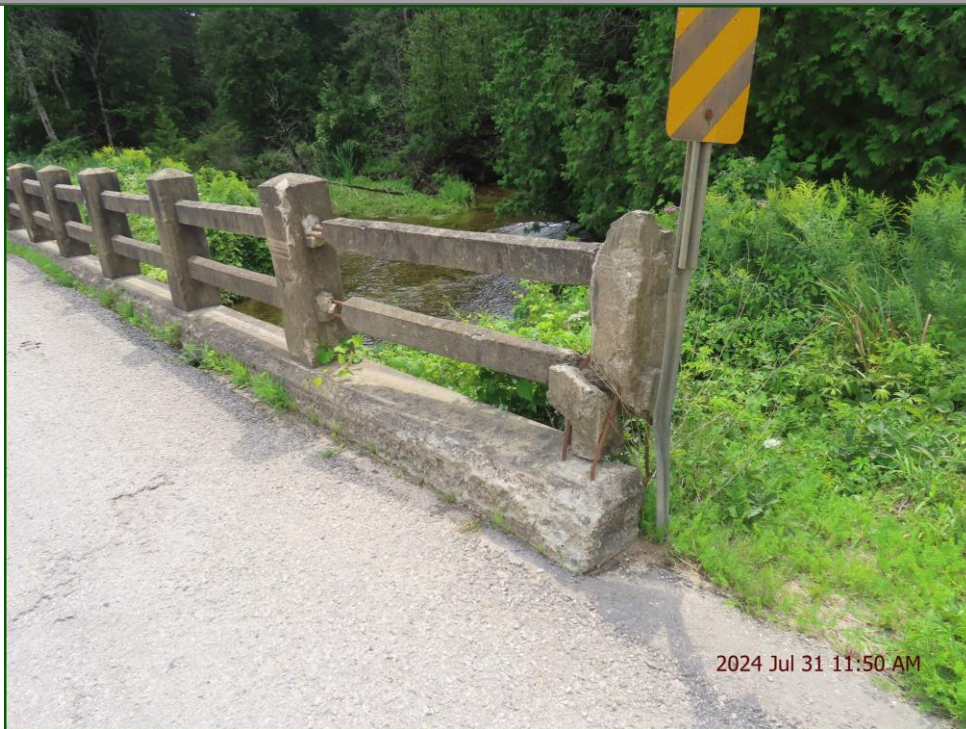
Severe spalling and disintegration at base of posts. Severe impact damage.

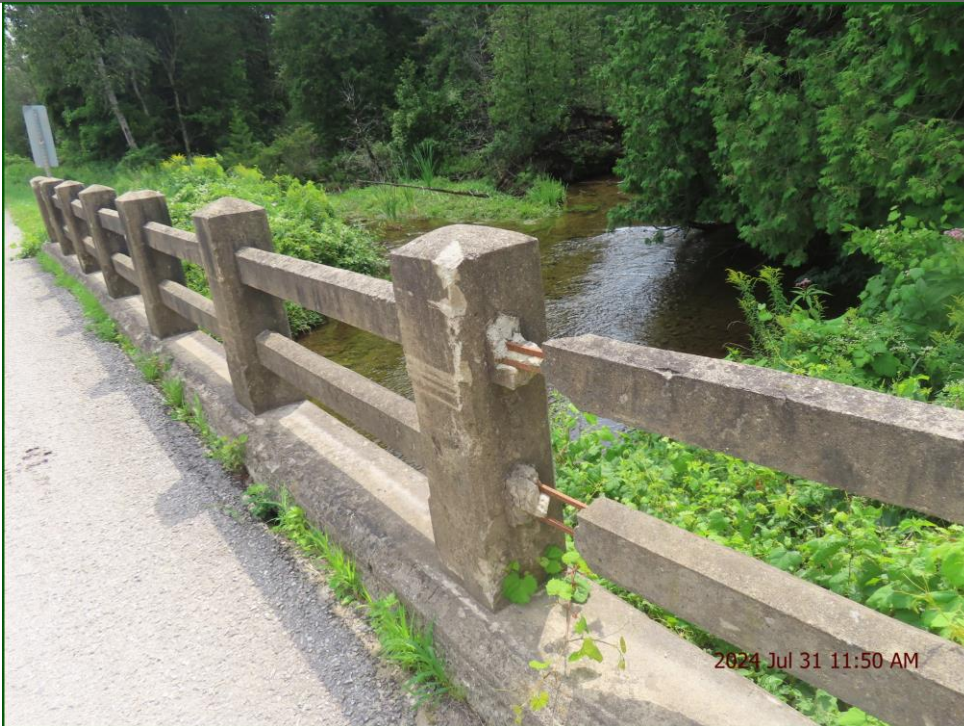
Severe spalling and disintegration of bases and railing. Severe impact damage.

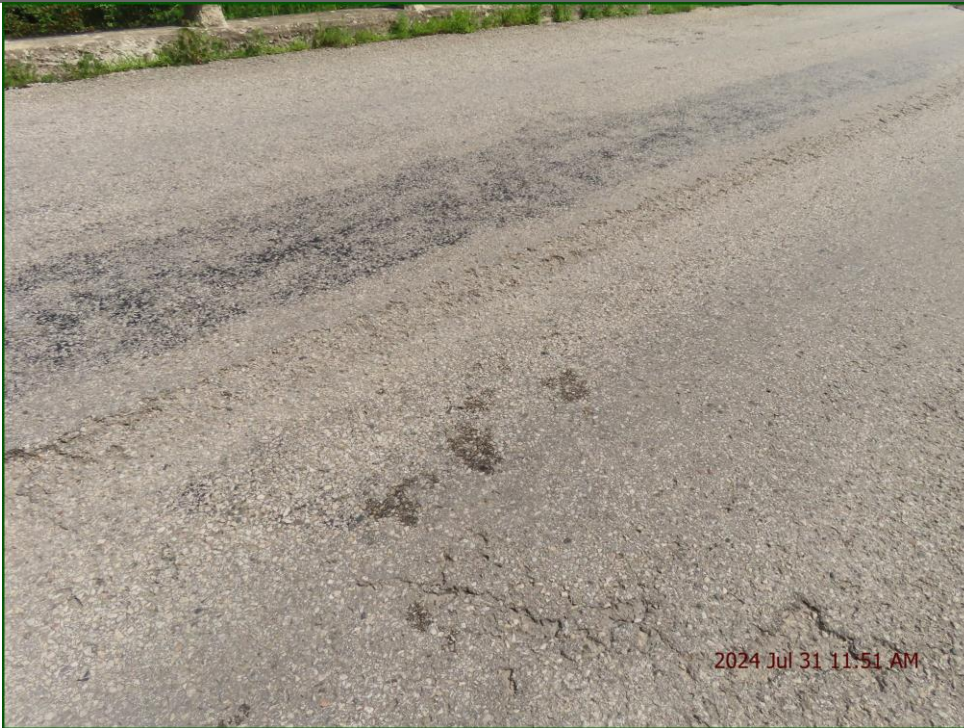
Moderate ravelling along curblines and centreline.

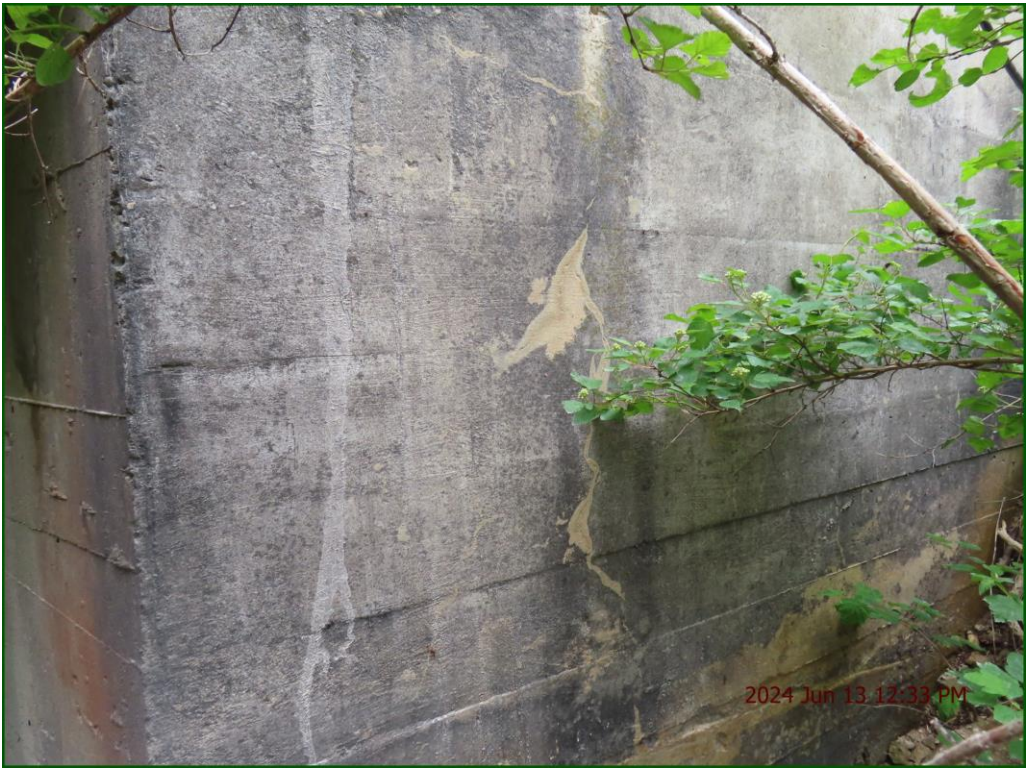
Description: Wingwalls: Medium vertical cracking with leachate staining.

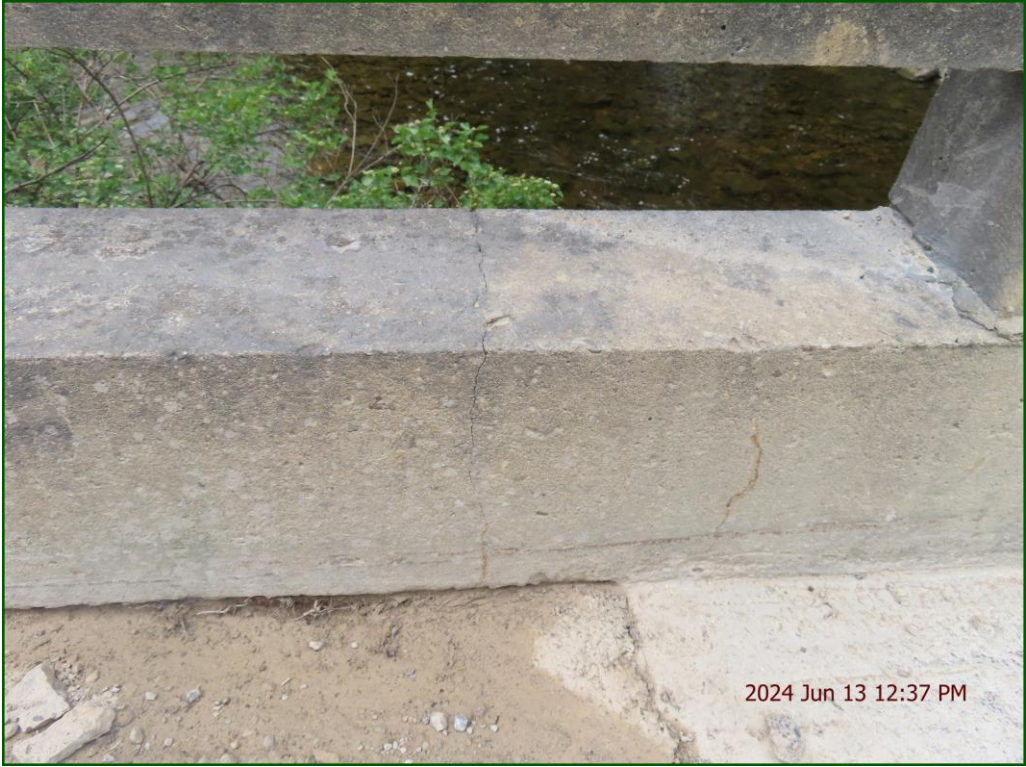
Description: Approach Curbs: Medium vertical cracking throughout.

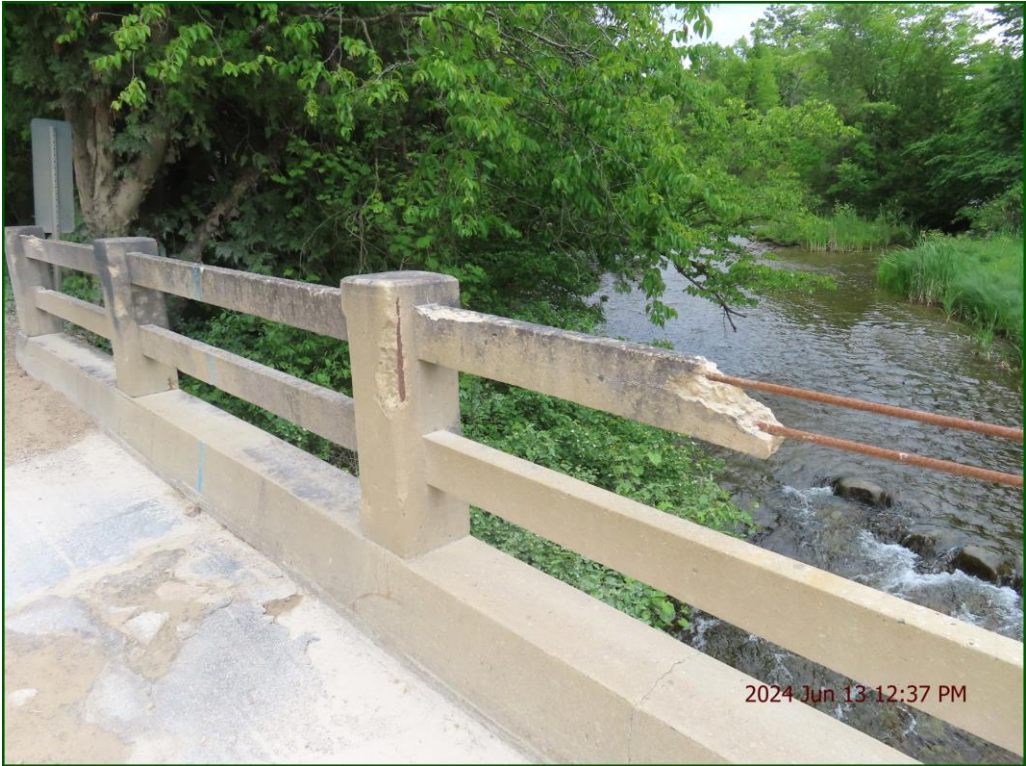
Description: Railing Systems: Severe spalling with exposed reinforcing.

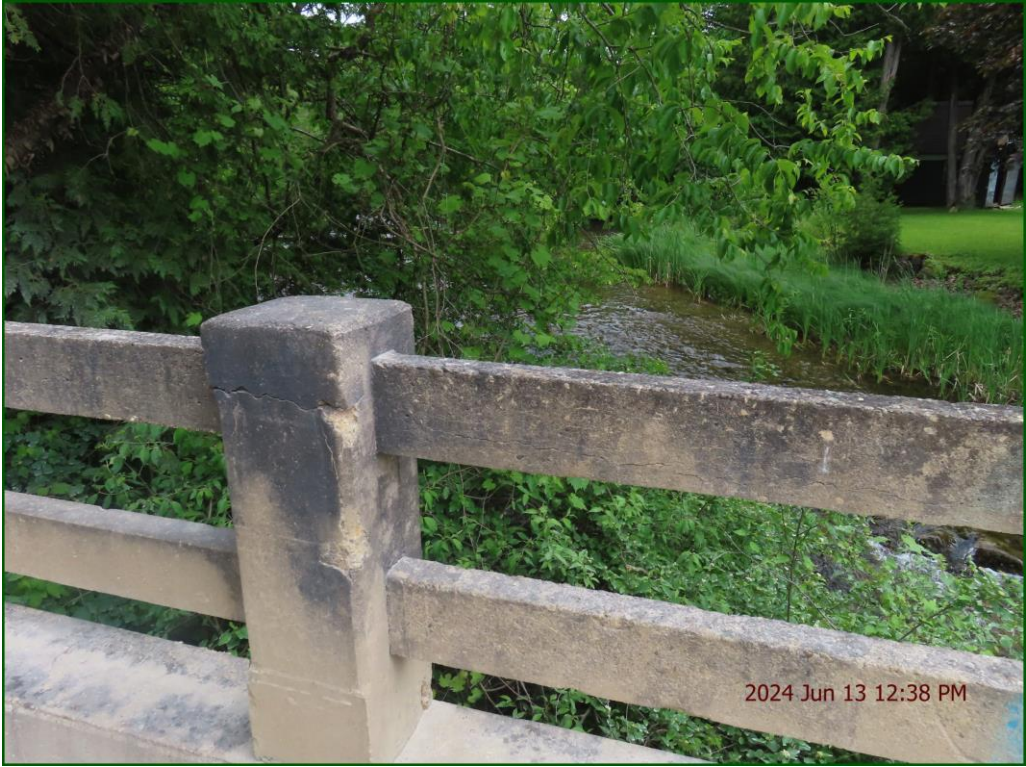
Description: Railing Systems: Medium to wide horizontal cracking.

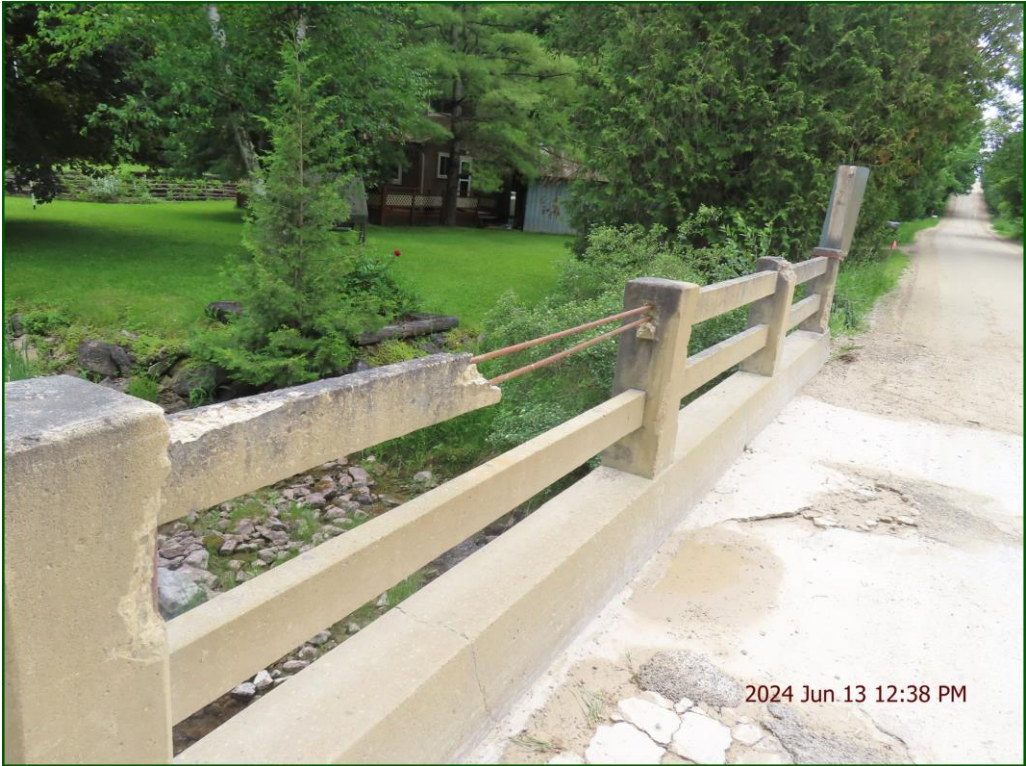
Description: Railing Systems: Localized area of 100% section loss.

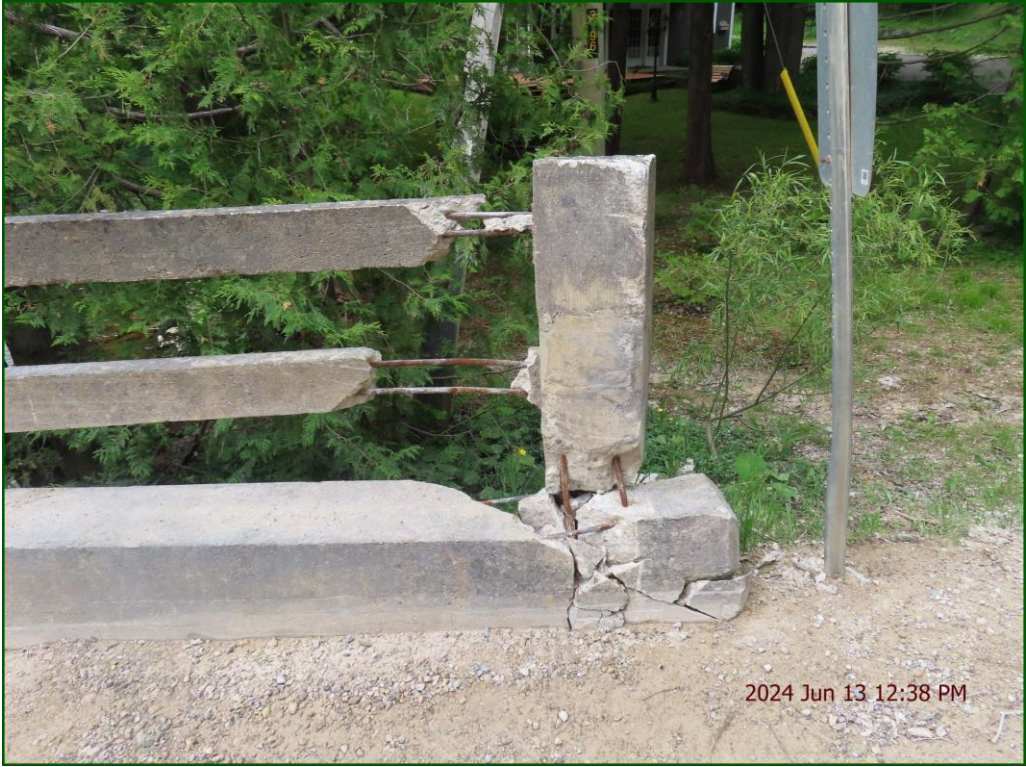
Description: Railing Systems: Severe impact damage NW corner.

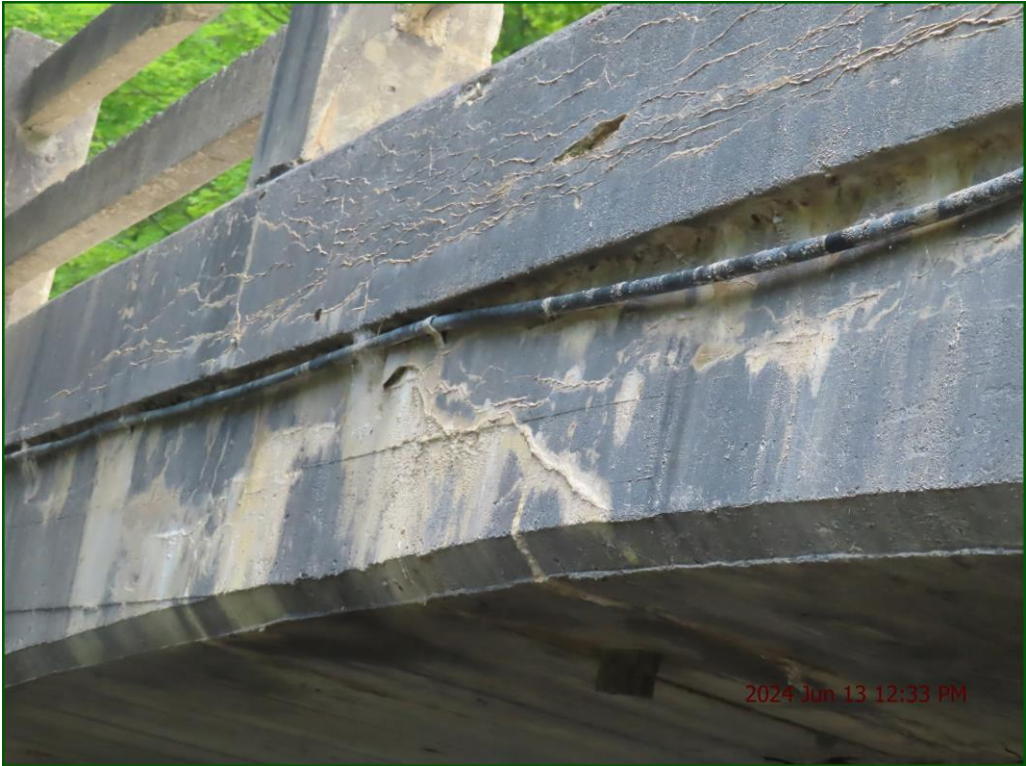
Description: Soffit (ext): Medium longitudinal cracking with leachate staining.

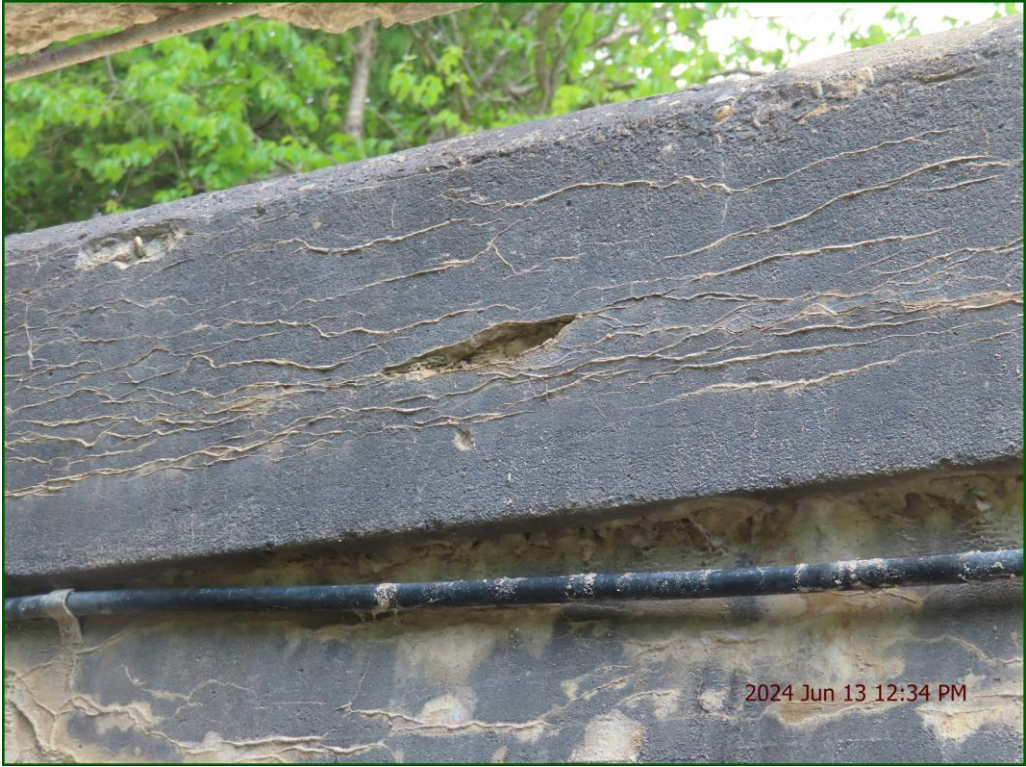
Description: Soffit (ext): Shallow delaminations with light map cracking and leachate staining.

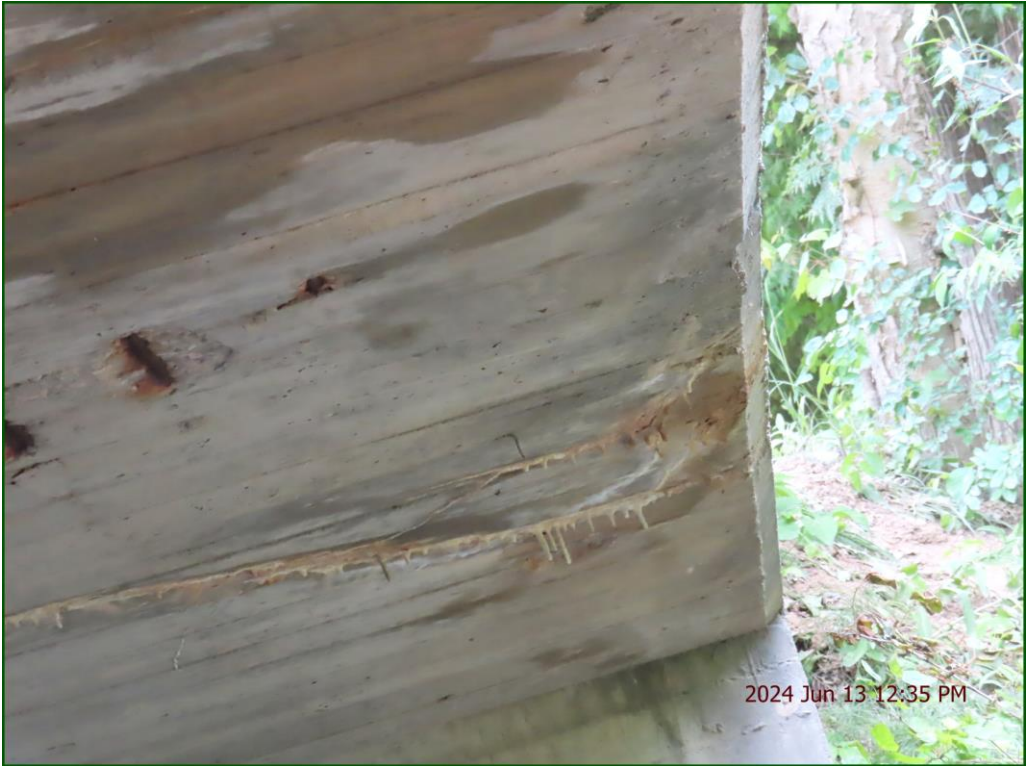
Description: Soffit (ext): Medium to wide map cracking with leachate staining and stalactite.

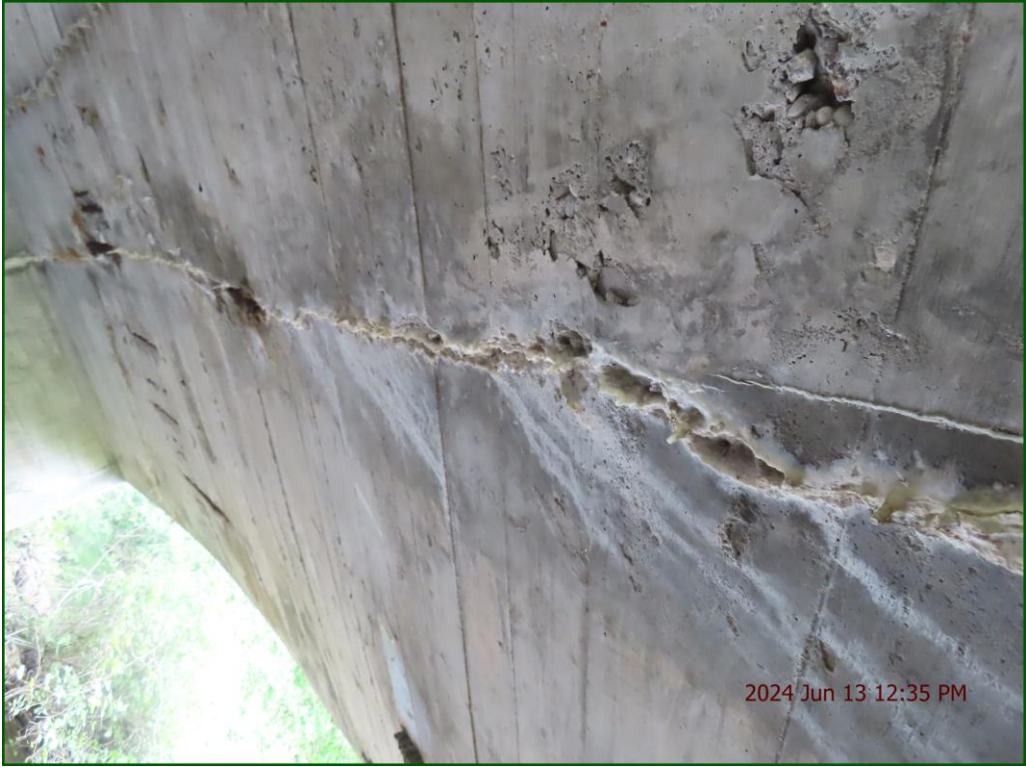
Description: Soffit (int): Medium to wide longitudinal cracking with leachate staining.

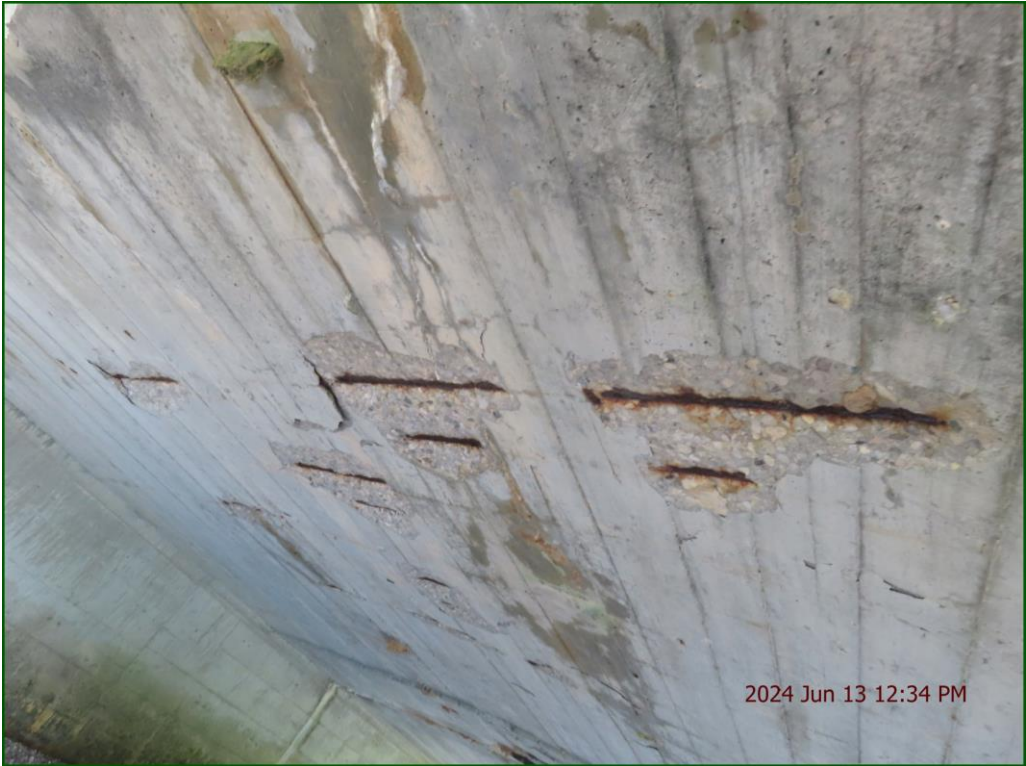
Description: Soffit (int): Medium spalling with exposed reinforcing.

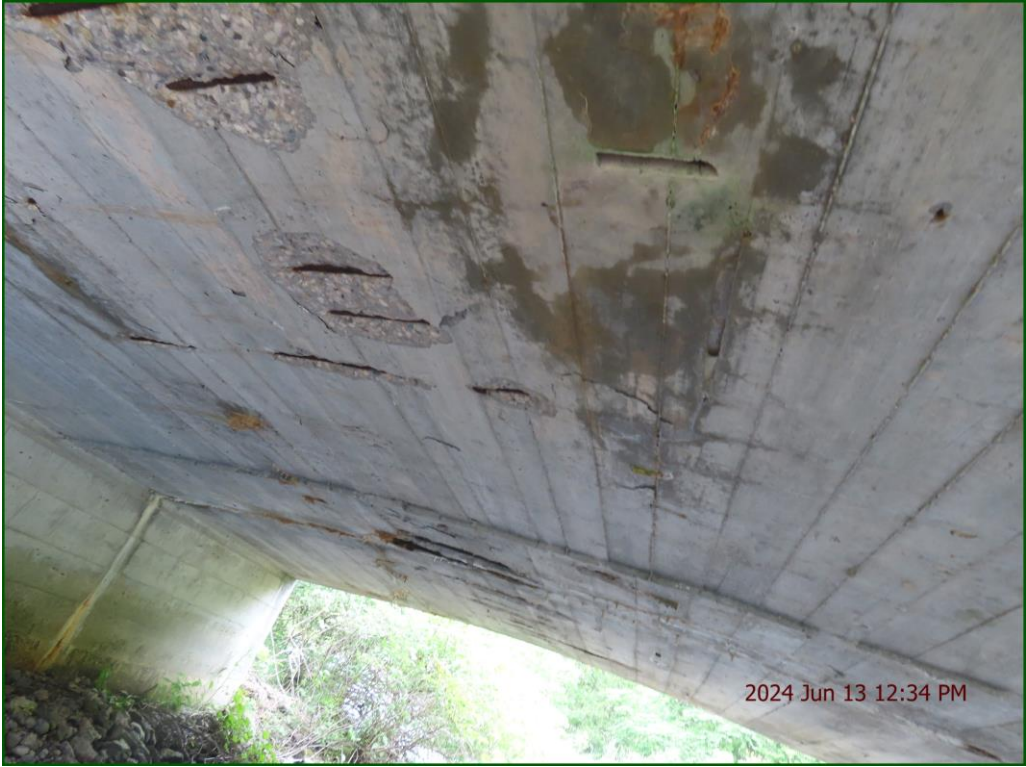
Description: Soffit (int): Severe delamination with exposed reinforcing.
