OSIM Biennial Inspection Report

Concession 11/12, Lot 30

Burgess Engineering Inc

27-Aug-24

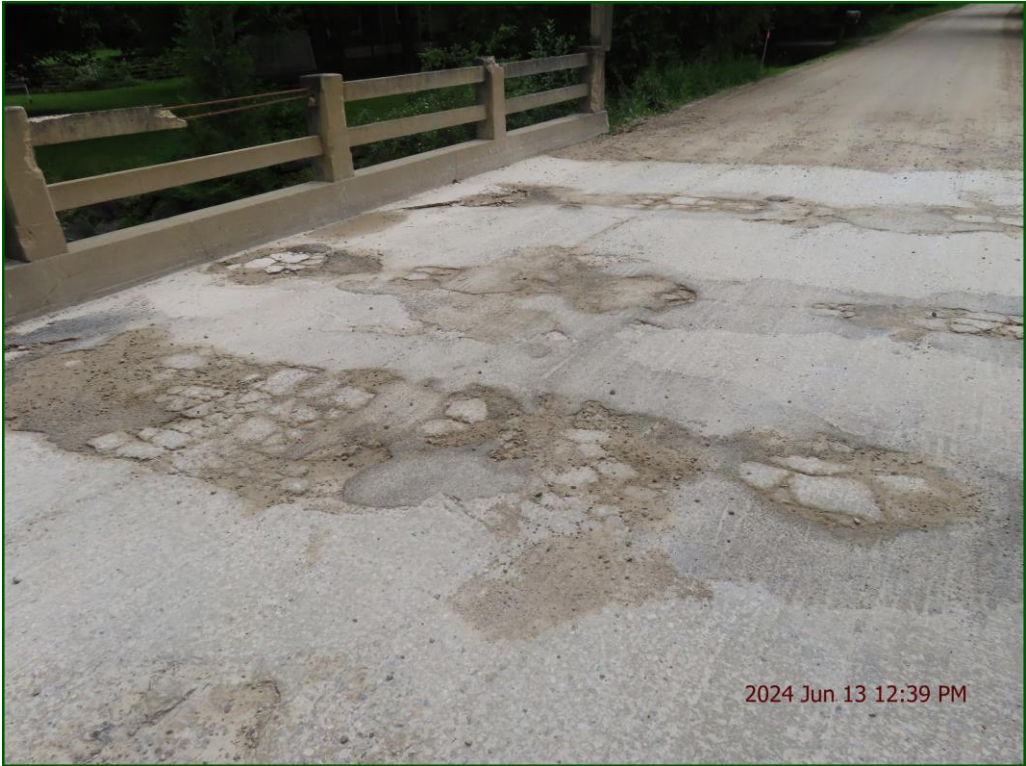
Description: Wearing Surface: Severe potholes throughout.

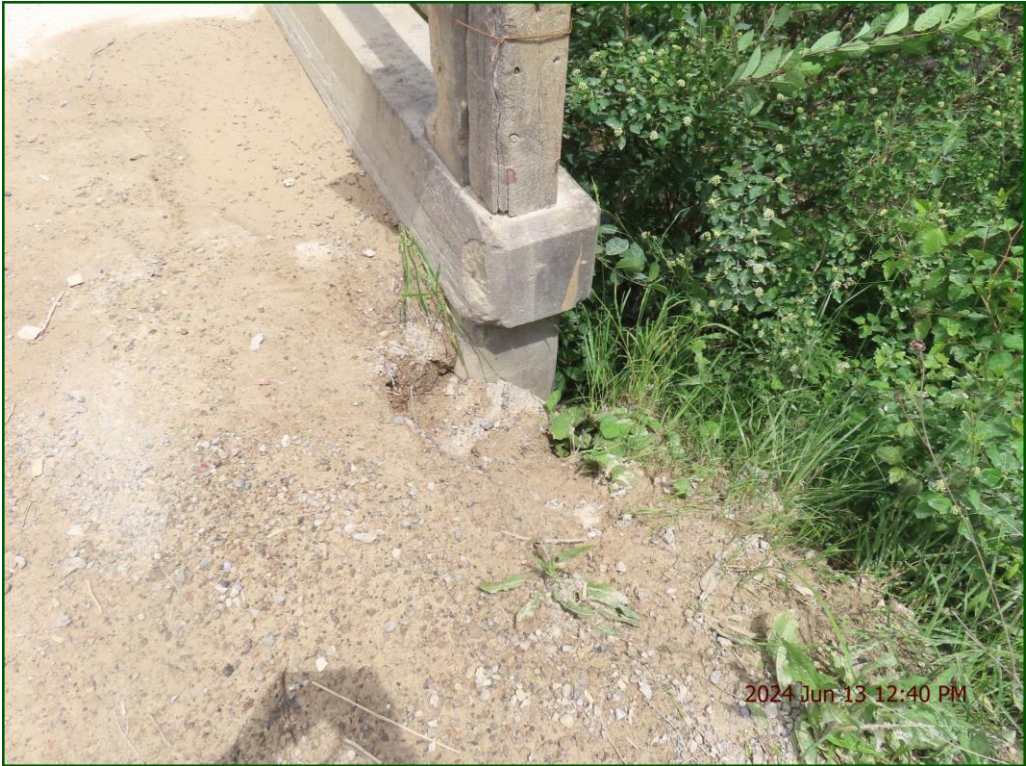
Description: Embankments: Moderate erosion beginning to encroach onto road way.

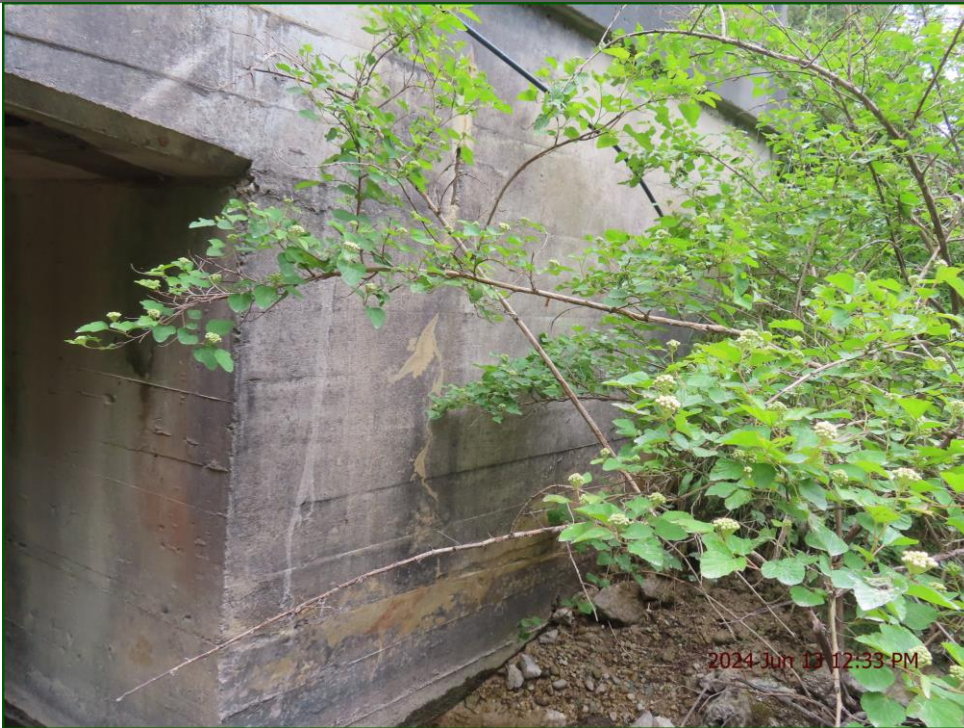
Medium vertical cracking with leachate staining.

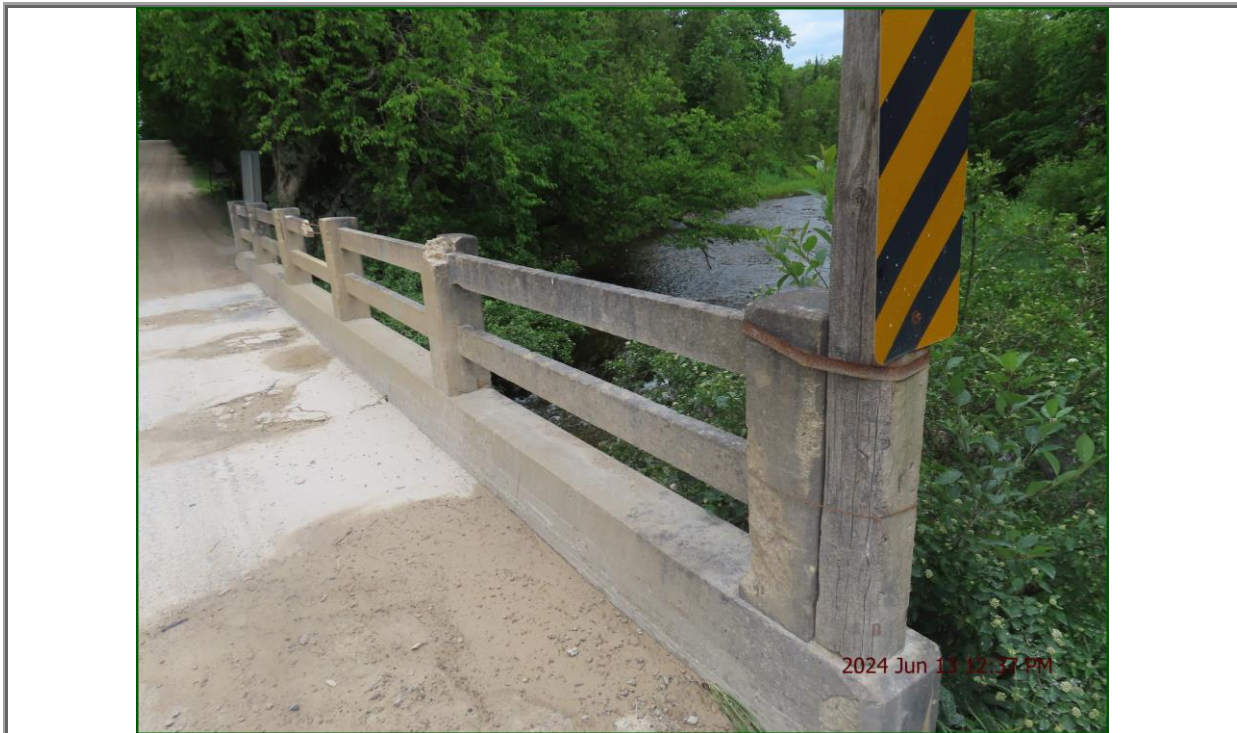
Severe spalling with exposed reinforcing. Medium to wide horizontal cracking. Localized area of 100% section loss. Severe impact damage NW corner.

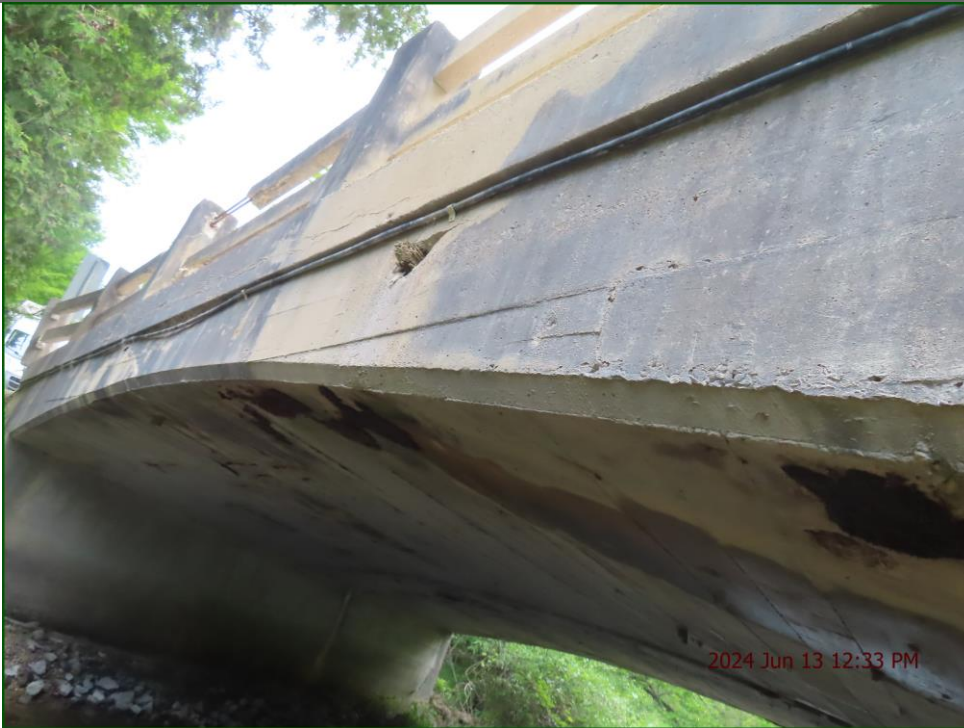
Medium longitudinal cracking with leachate staining. Shallow delaminations with light map cracking and leachate staining. Medium to wide map cracking with leachate staining and stalactite.

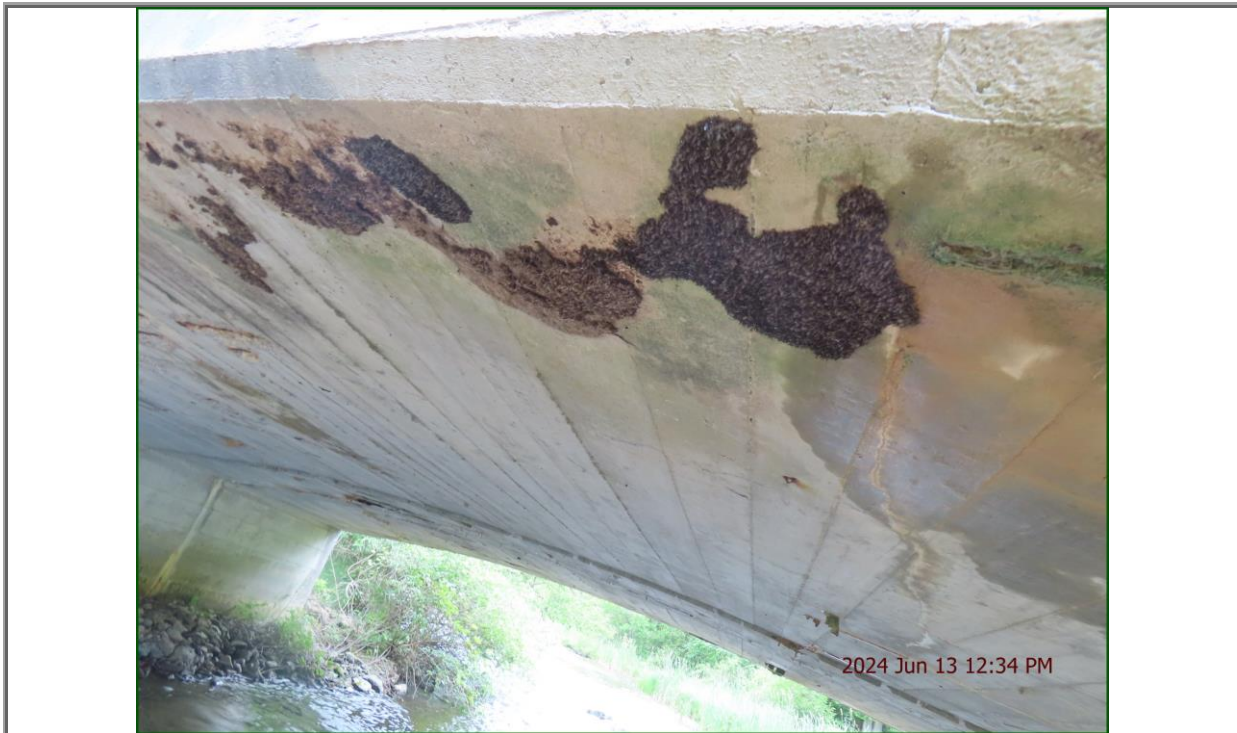
Medium to wide longitudinal cracking with leachate staining and stalactite. Medium spalling with exposed reinforcing. Severe delamination with exposed reinforcing.

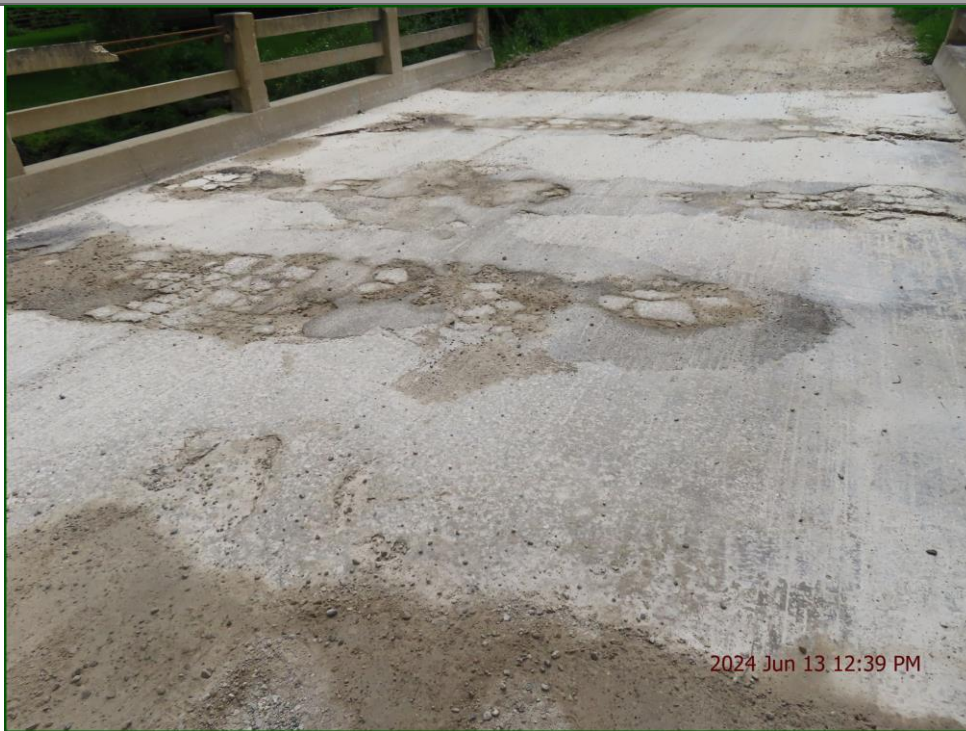
Severe potholes throughout. Severe alligator cracking throughout.

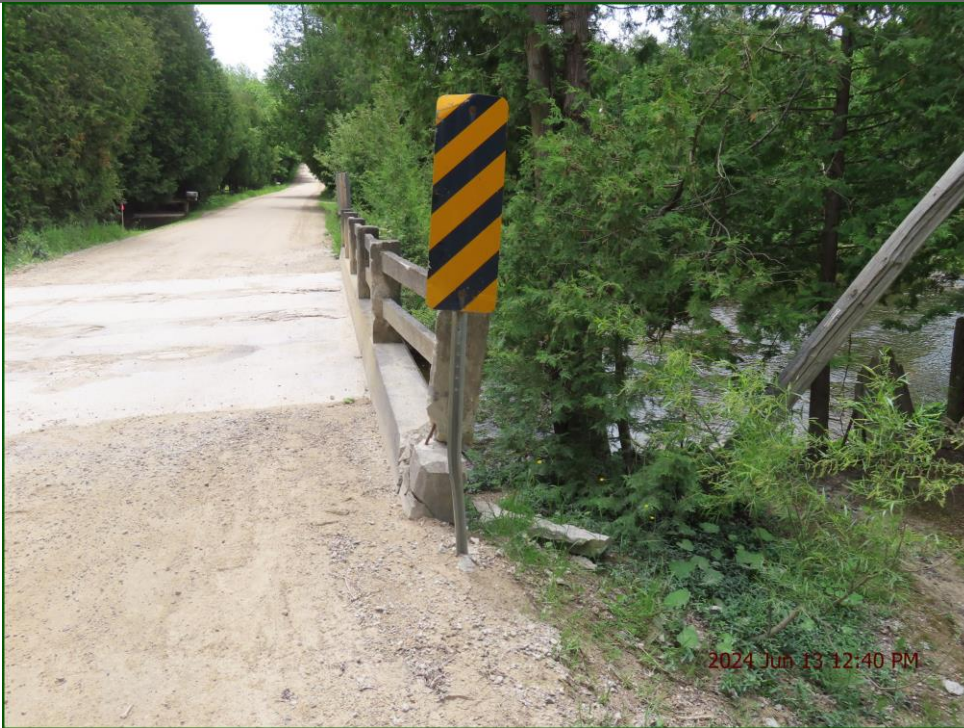
Moderate erosion beginning to encroach onto road way on north ends.

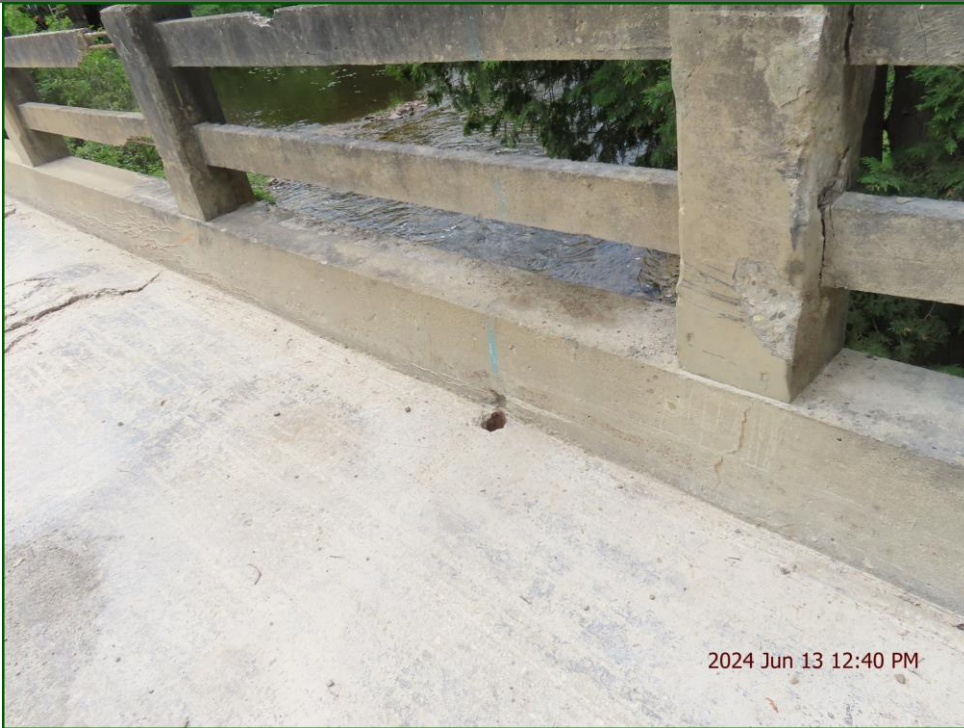
Shallow delamination with medium map cracking and leachate staining.

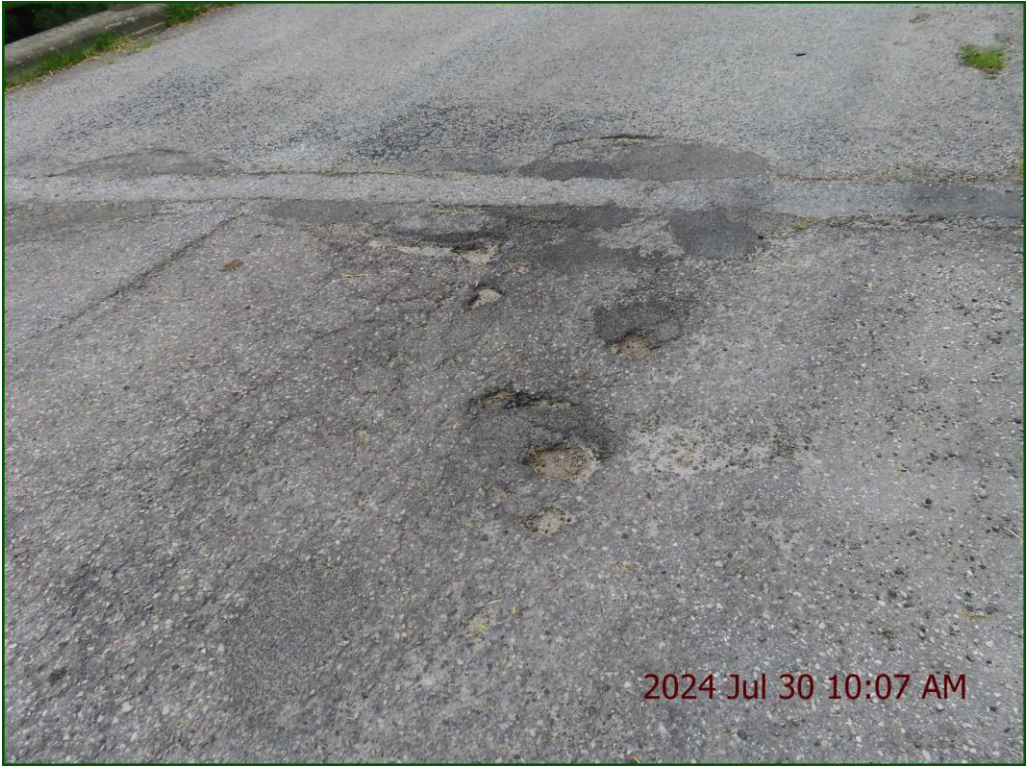
Description: Approach Wearing surface: Minor potholes throughout.

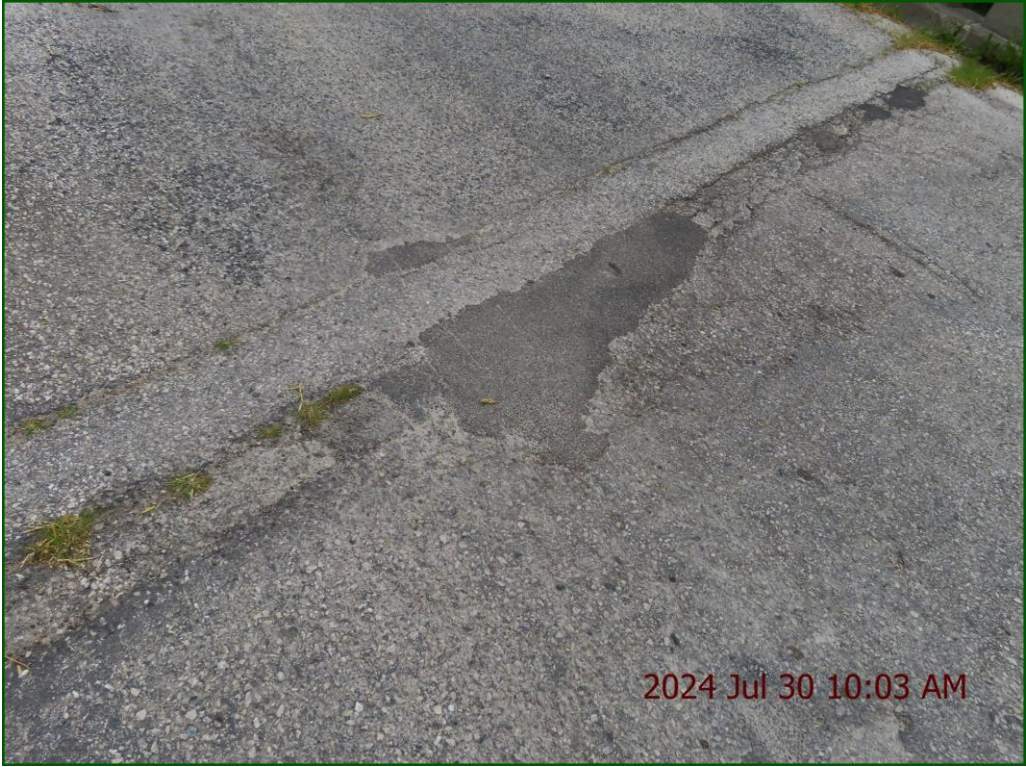
Description: Approach Wearing surface: Severe alligator cracking along joints.

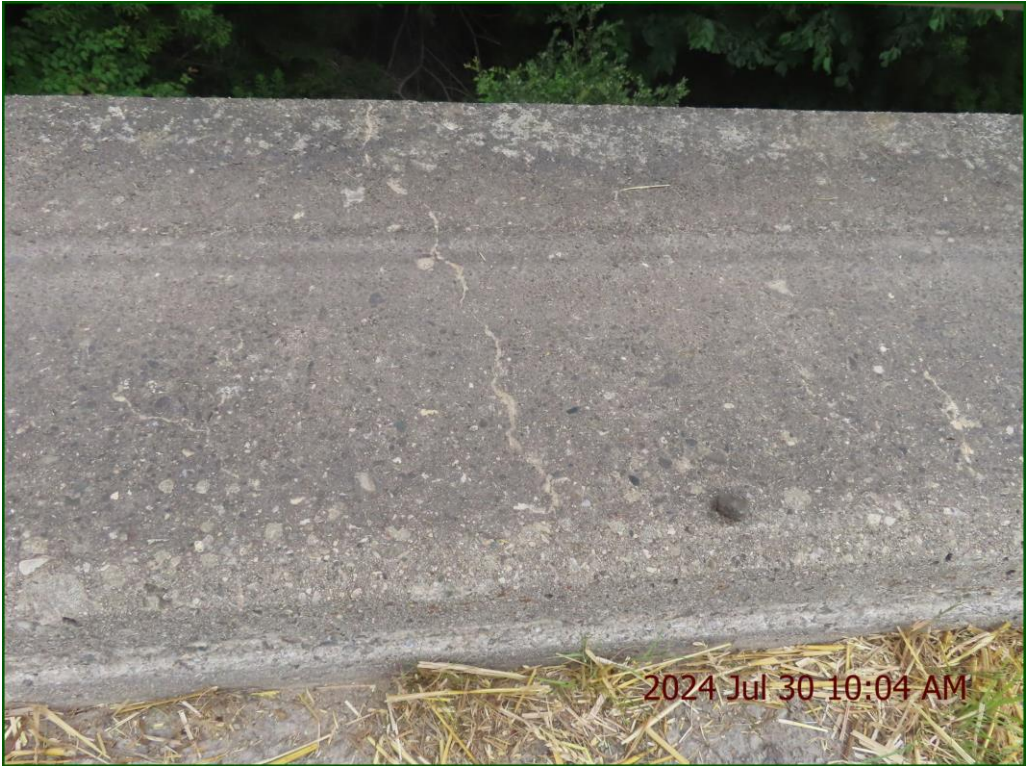
Description: Curbs: Medium to wide cracking with wetness staining throughout (1/2).

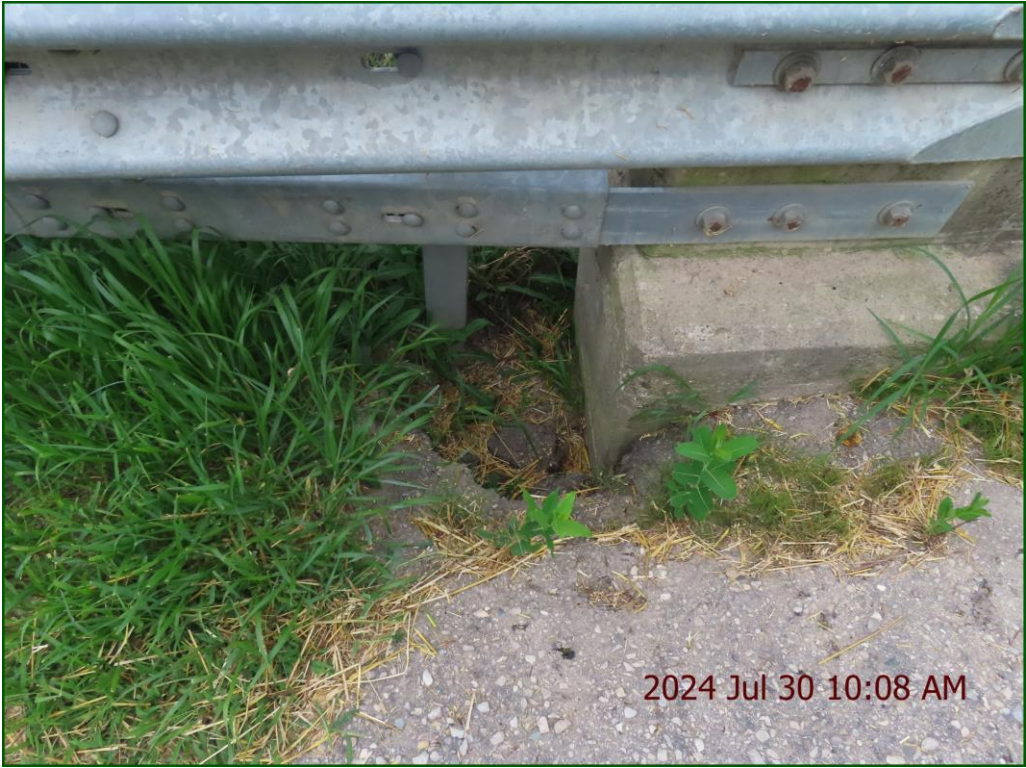
Description: Embankments: Moderate erosion at east embankments.

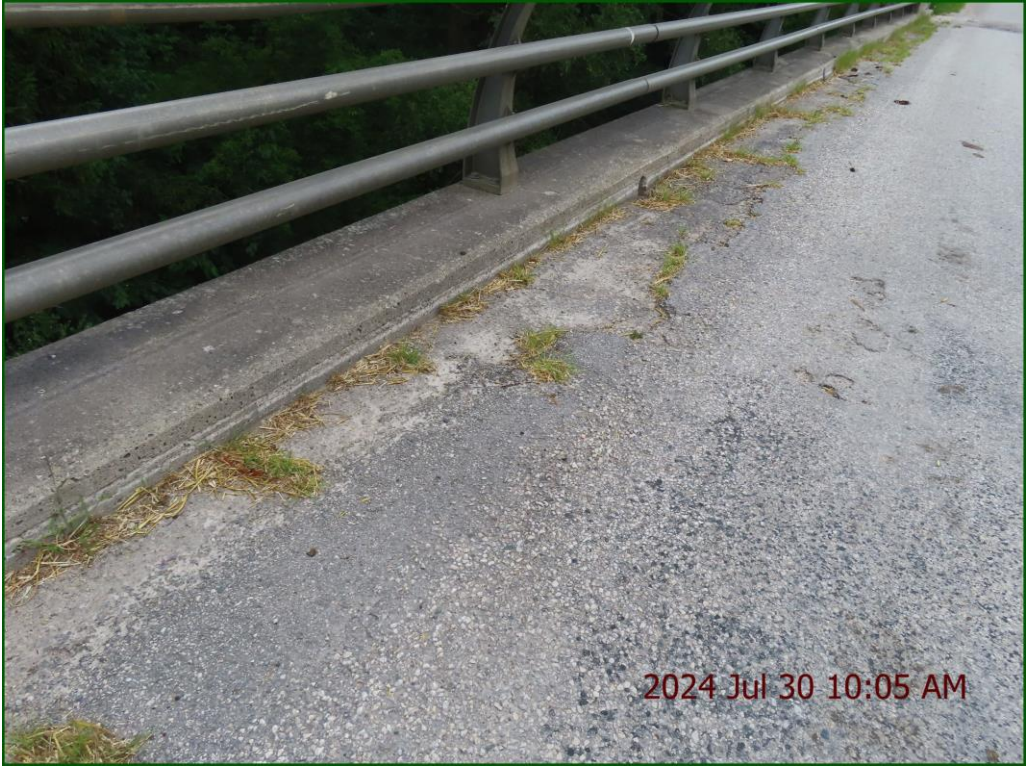
Description: Wearing surface: Minor ravelling along curbline.

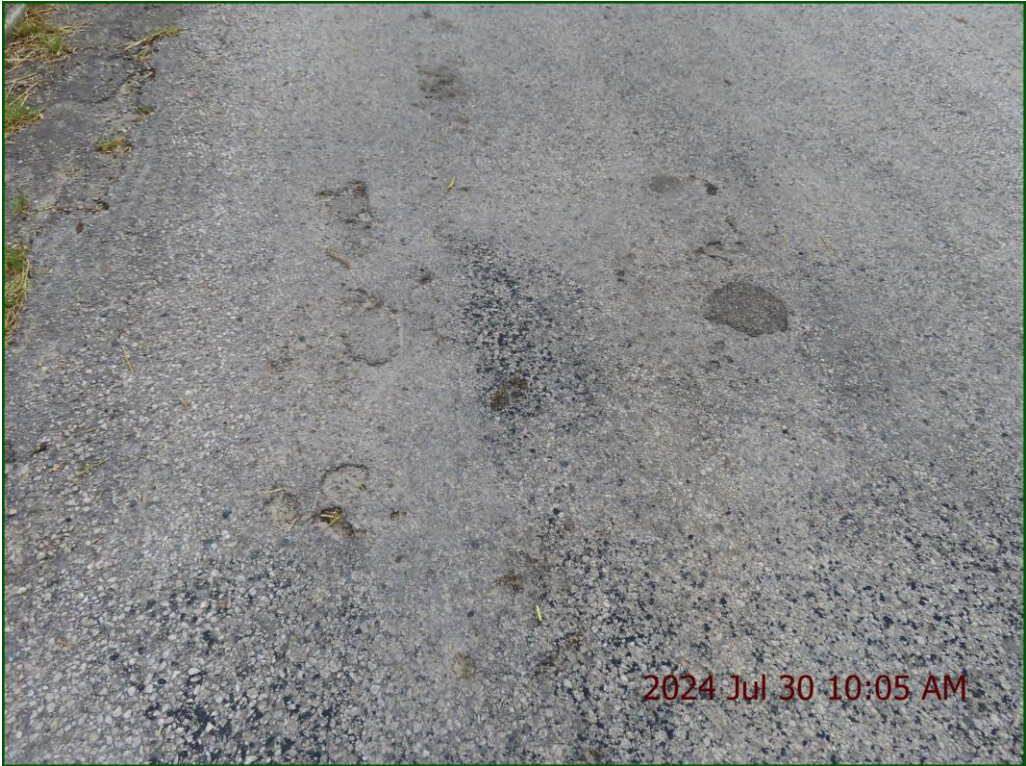
Description: Wearing surface: Minor potholing throughout.

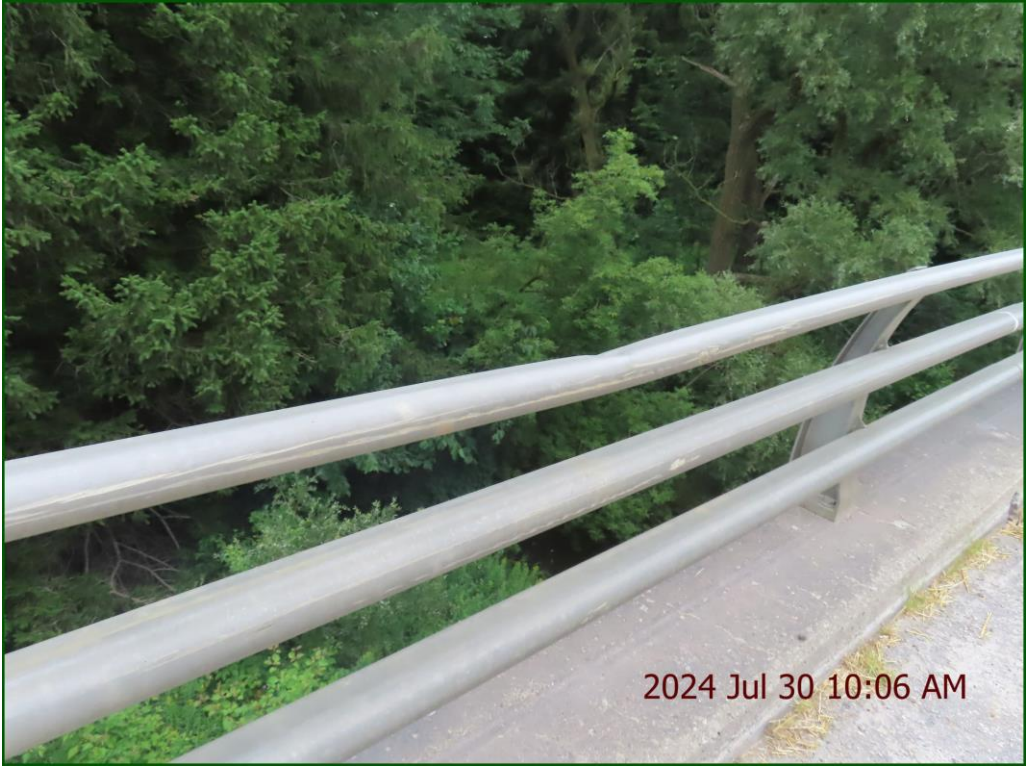
Description: Railing systems: Minor impact damage.

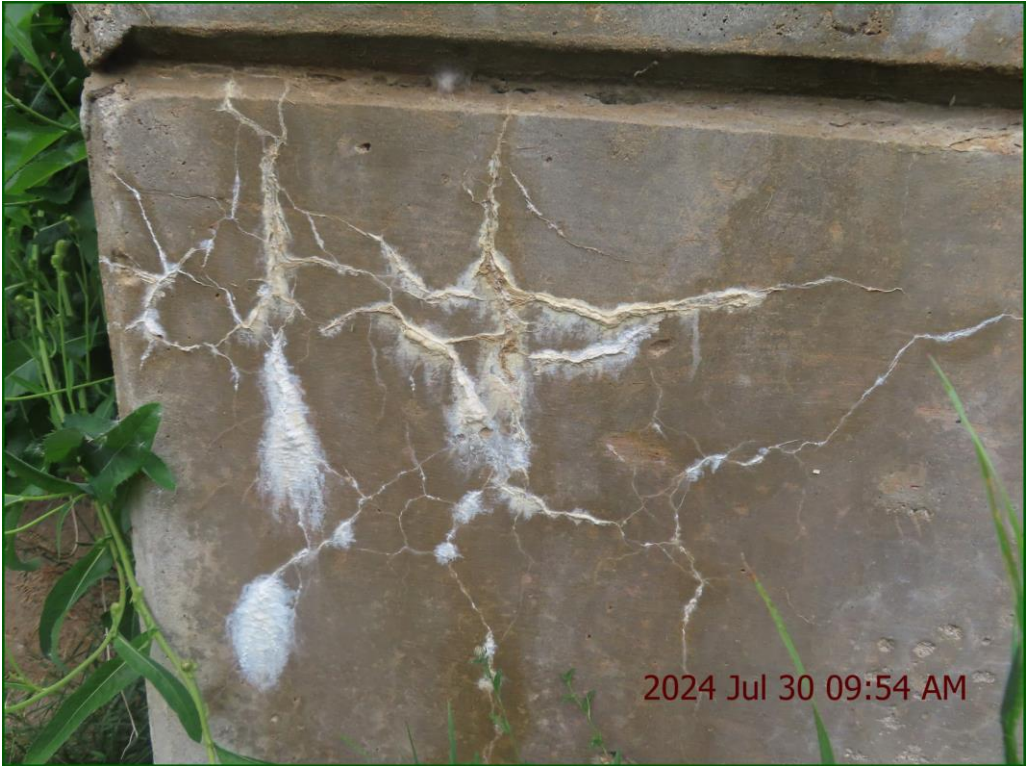
Description: Wingwalls: Light to medium map cracking with leachate staining.

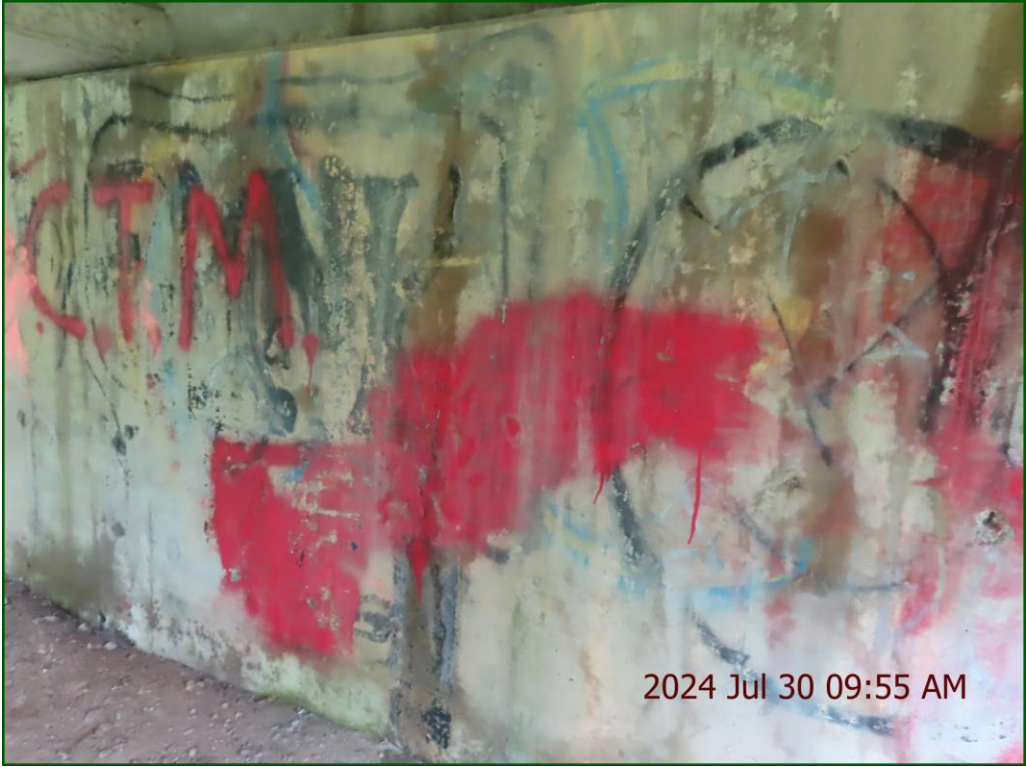
Description: Abutment walls: Medium to wide vertical crack with wetness staining.

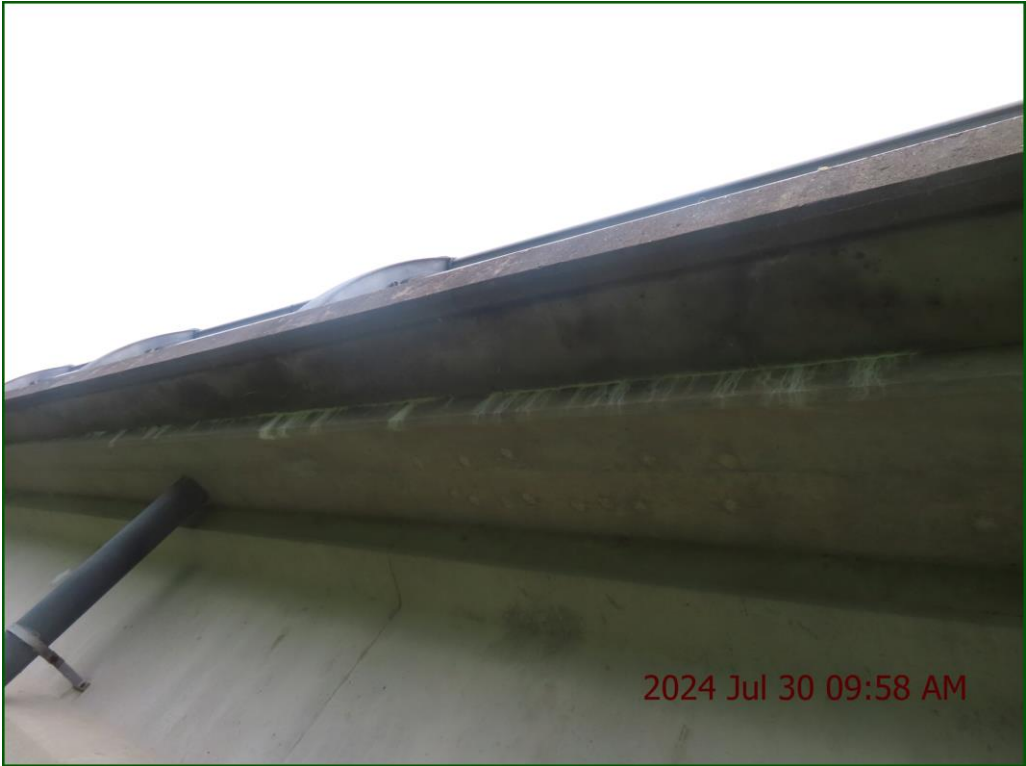
Description: Soffit (ext): Light cracking with leachate staining throughout (1/2).

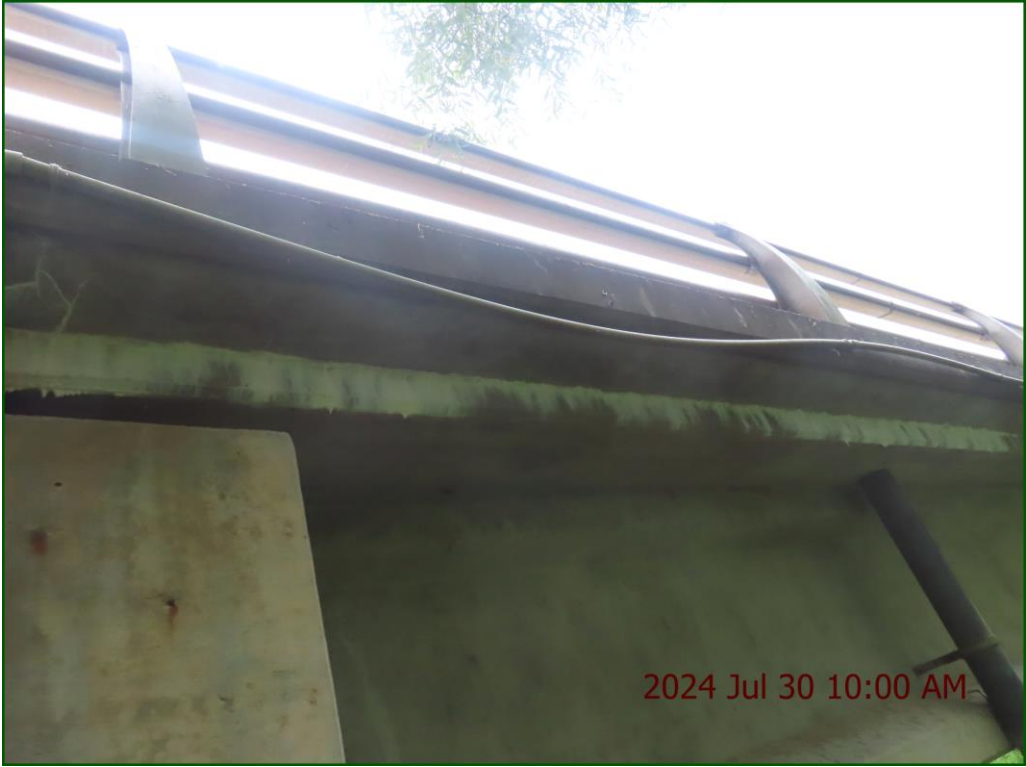
Description: Soffit (ext): Light cracking with leachate staining throughout (2/2).

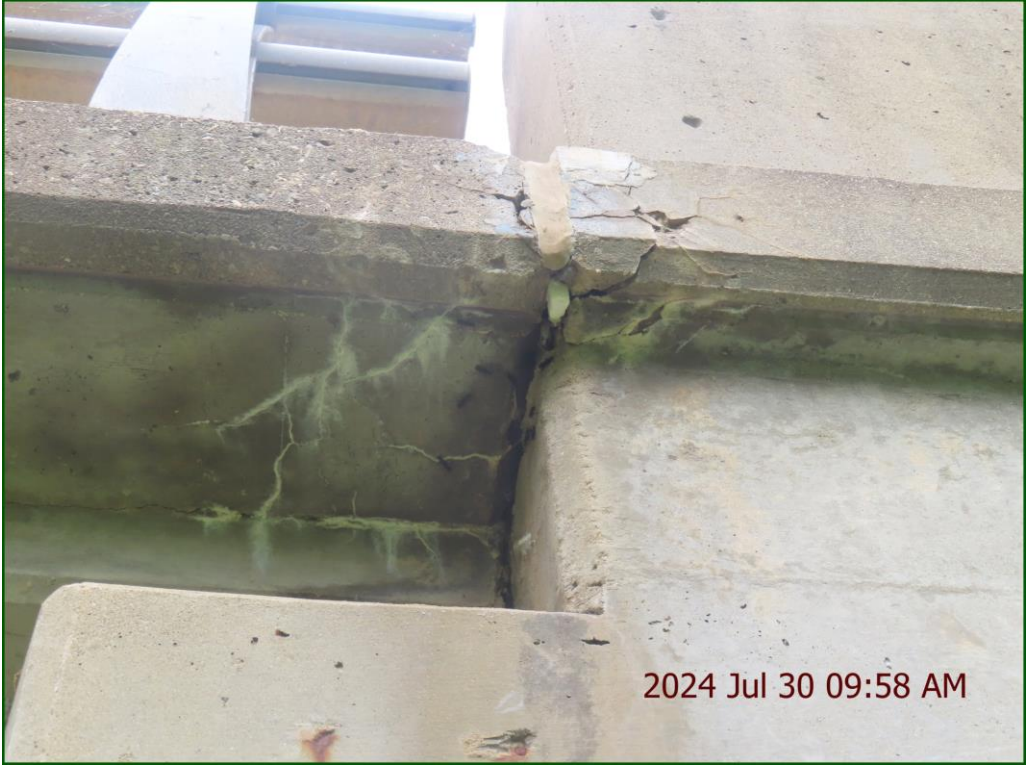
Description: Soffit (ext): Moderate crushing at south east quadrant possibly suggesting movement in brid

Light cracking with leachate staining throughout, leachate staining at construction joint. Moderate crushing at south east quadrant possibly suggesting movement in bridge.

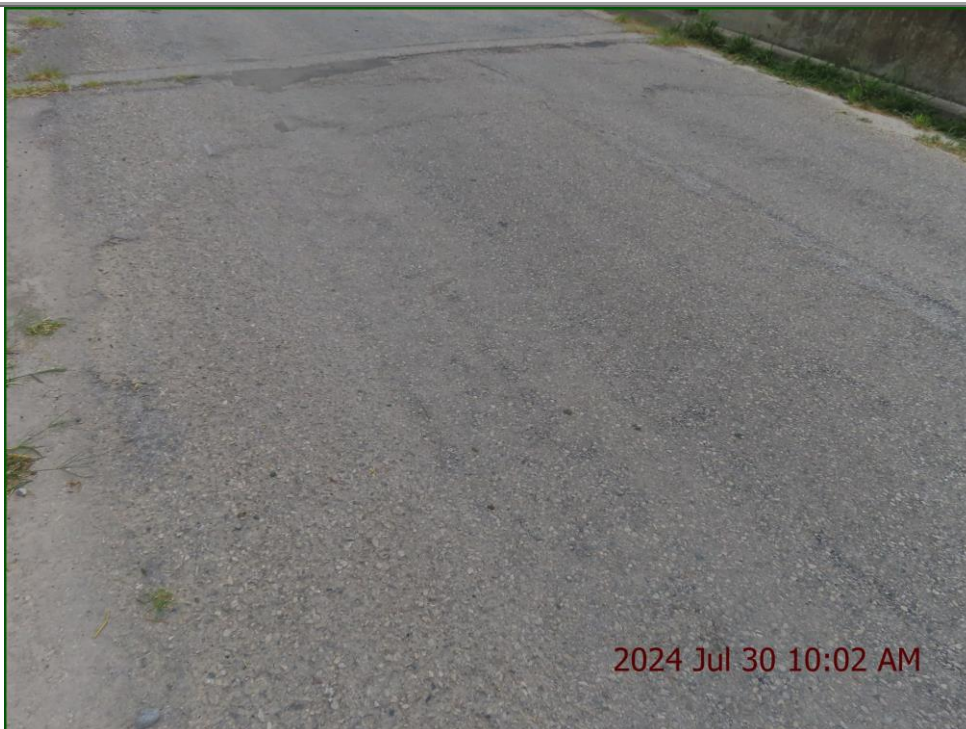
Moderate ravelling along curblines. Minor potholes throughout. Severe alligator cracking along joints.

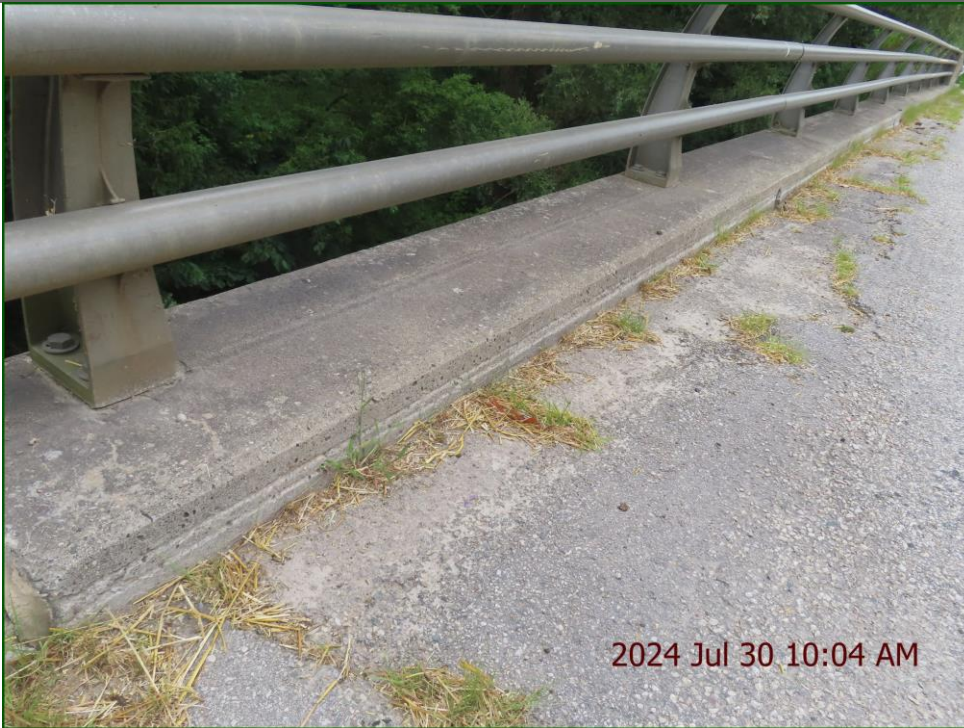
Medium to wide cracking with wetness staining throughout. Recommend removing vegetation from curbline.

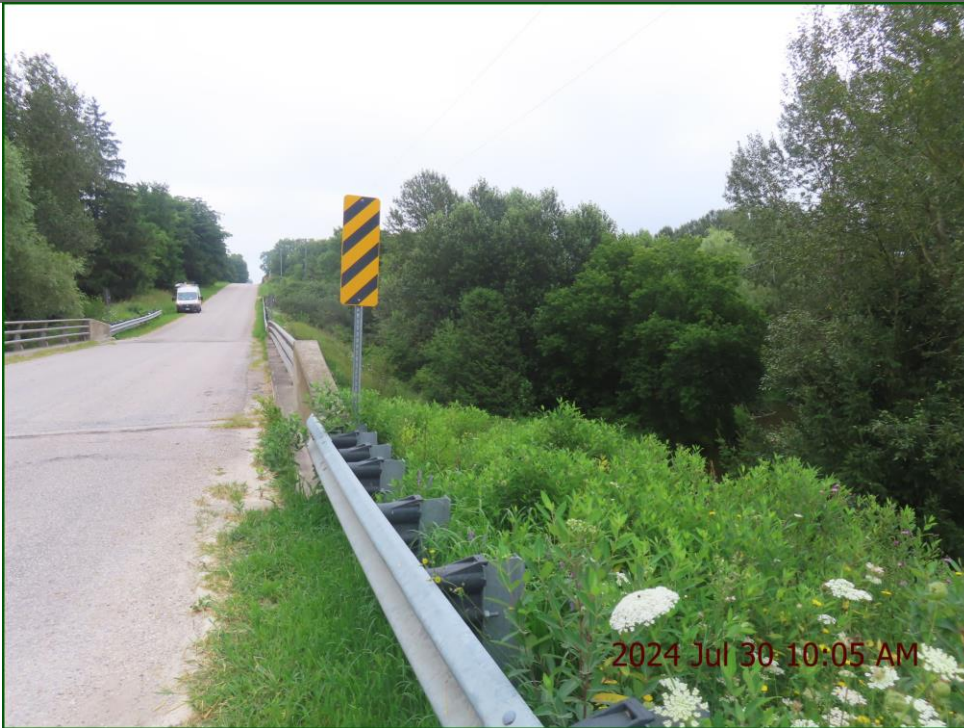
Moderate erosion at east embankments.

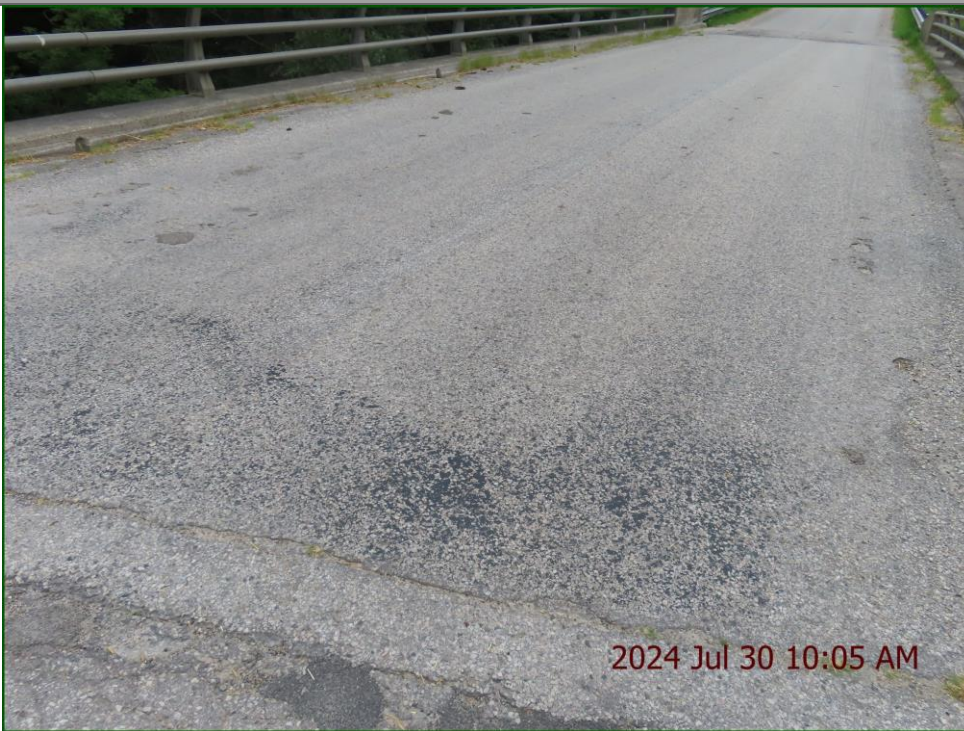
Minor ravelling along curblin. Minor potholing throughout. Recommend extending wearing surface to curblin.

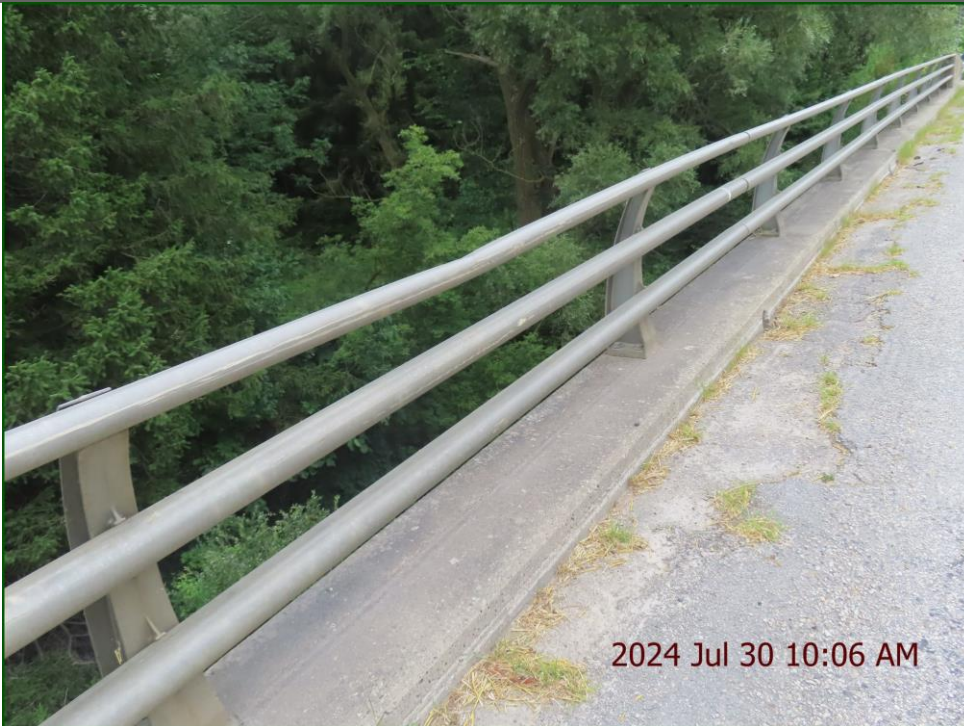
Minor impact damage.

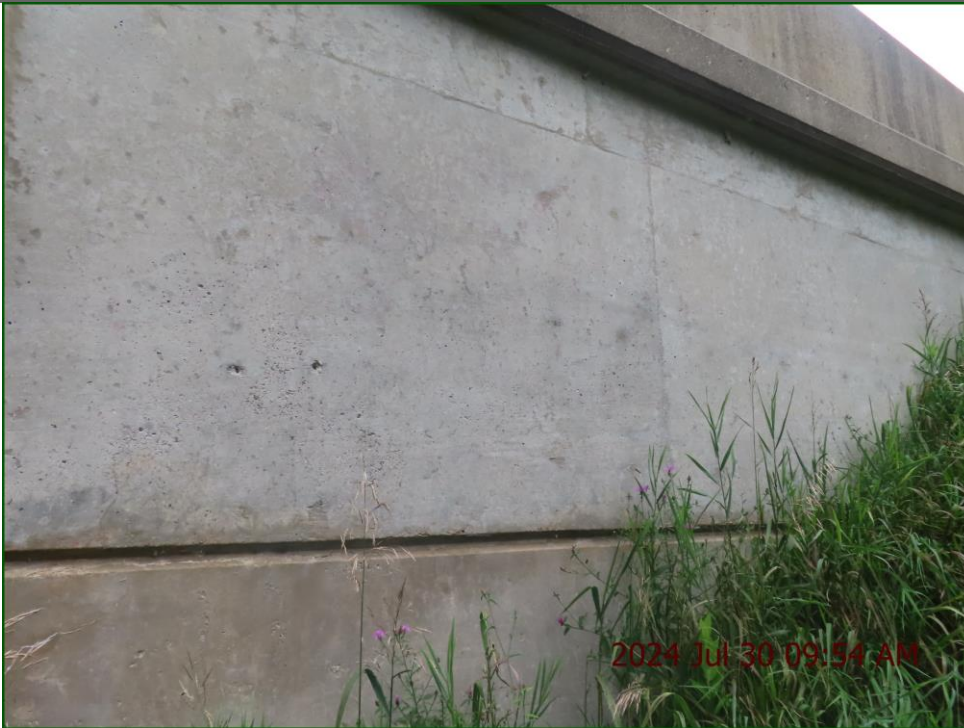
Light to medium map cracking with leachate staining.

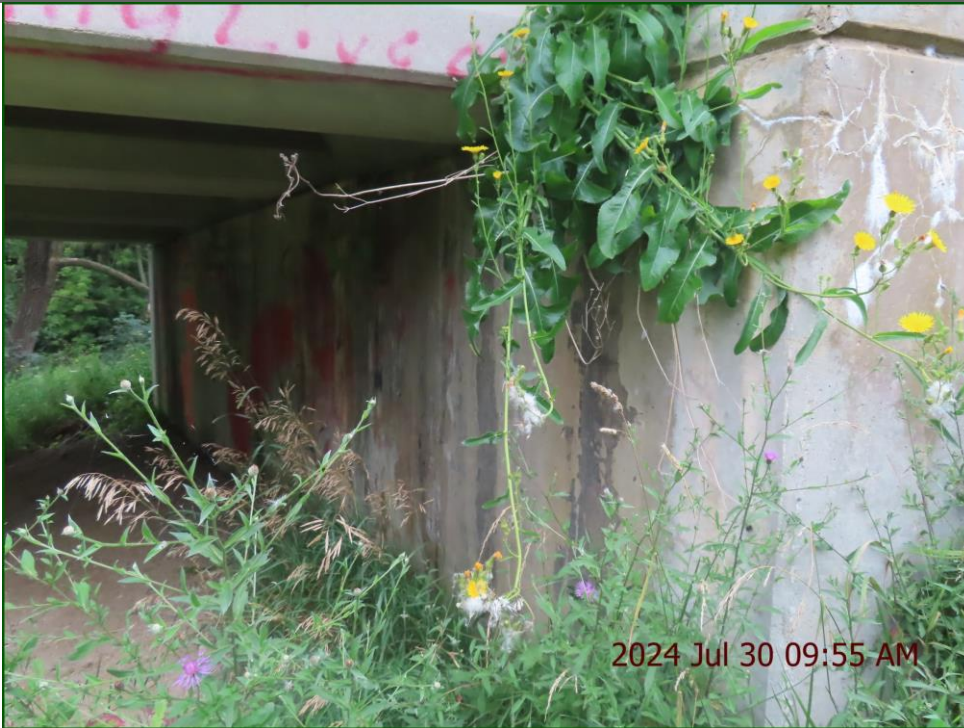
Medium to wide vertical crack with wetness staining.

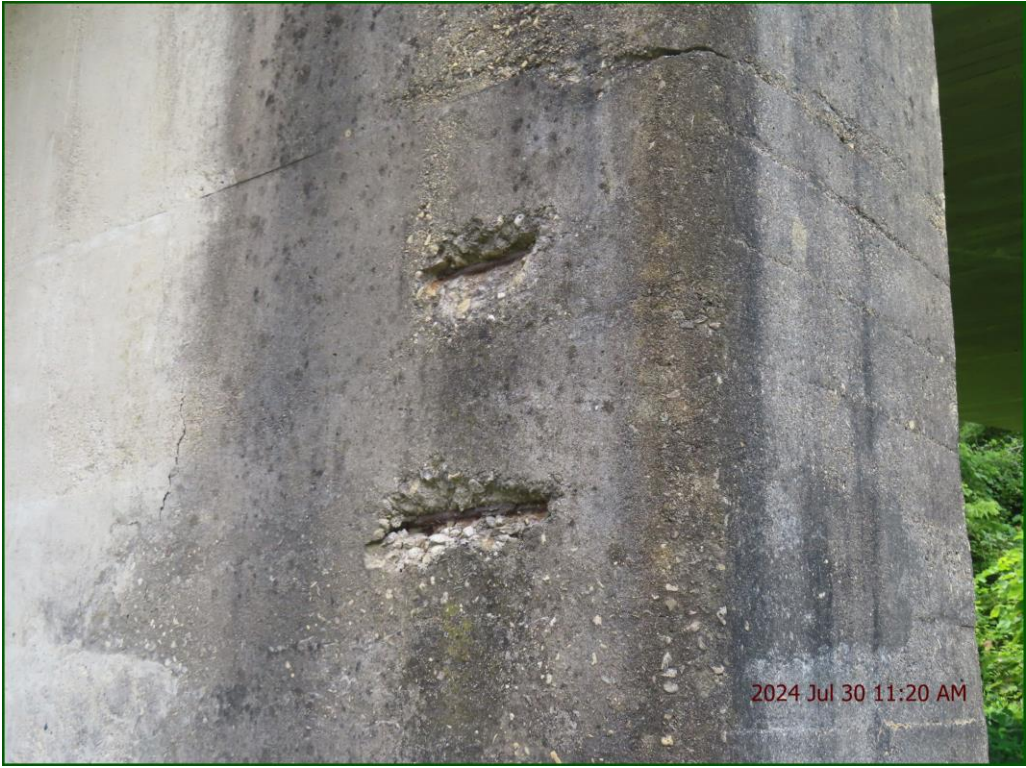
Description: Shafts/Columns/Pile Bents: Light spalling throughout.
