OSIM Biennial Inspection Report

Concession 11/12, Lot 30

Burgess Engineering Inc

27-Aug-24

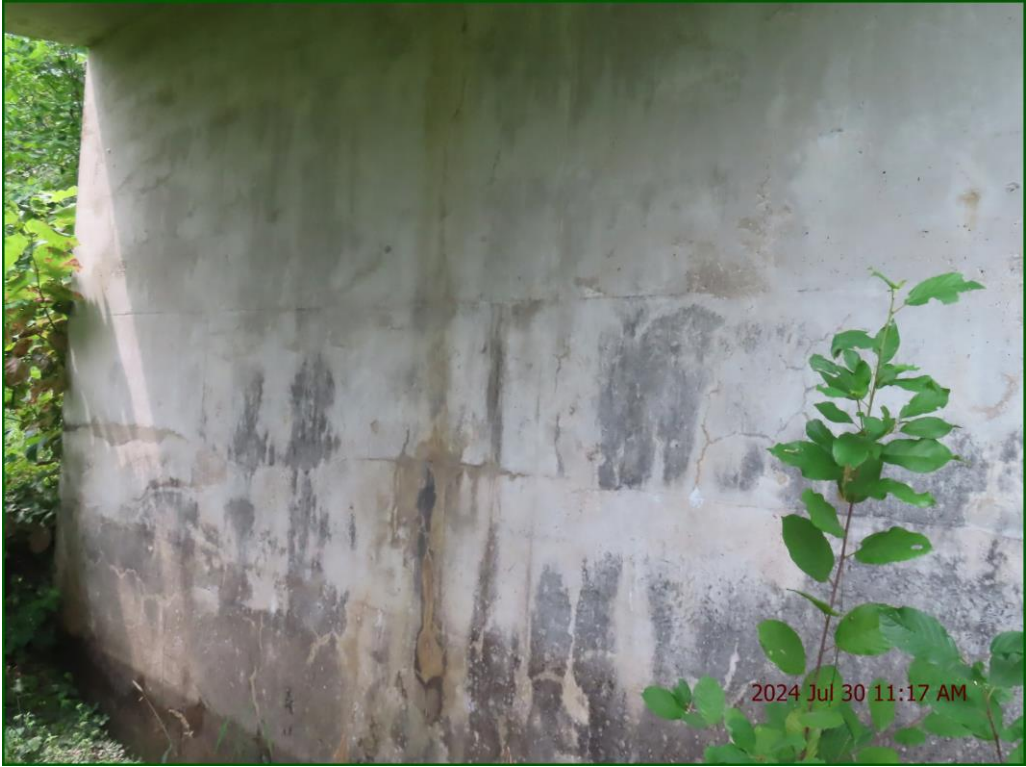
Description: Abutment Walls: Medium to wide vertical cracking with wetness staining.

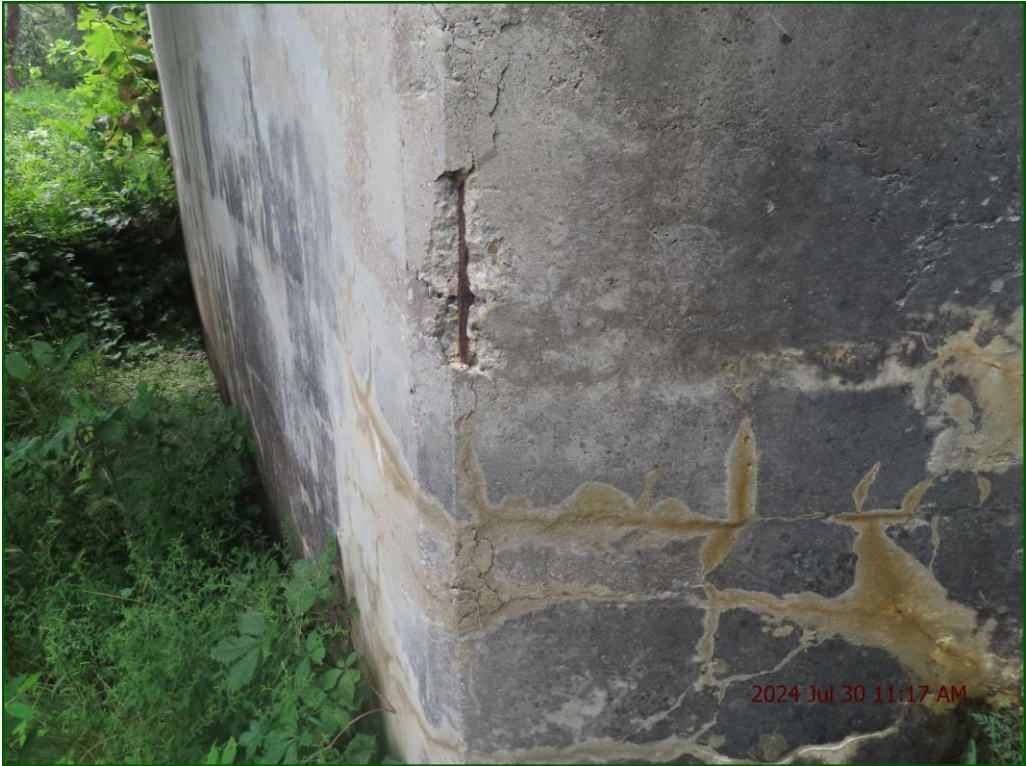
Description: Wingwalls: Light spalling with exposed reinforcing.

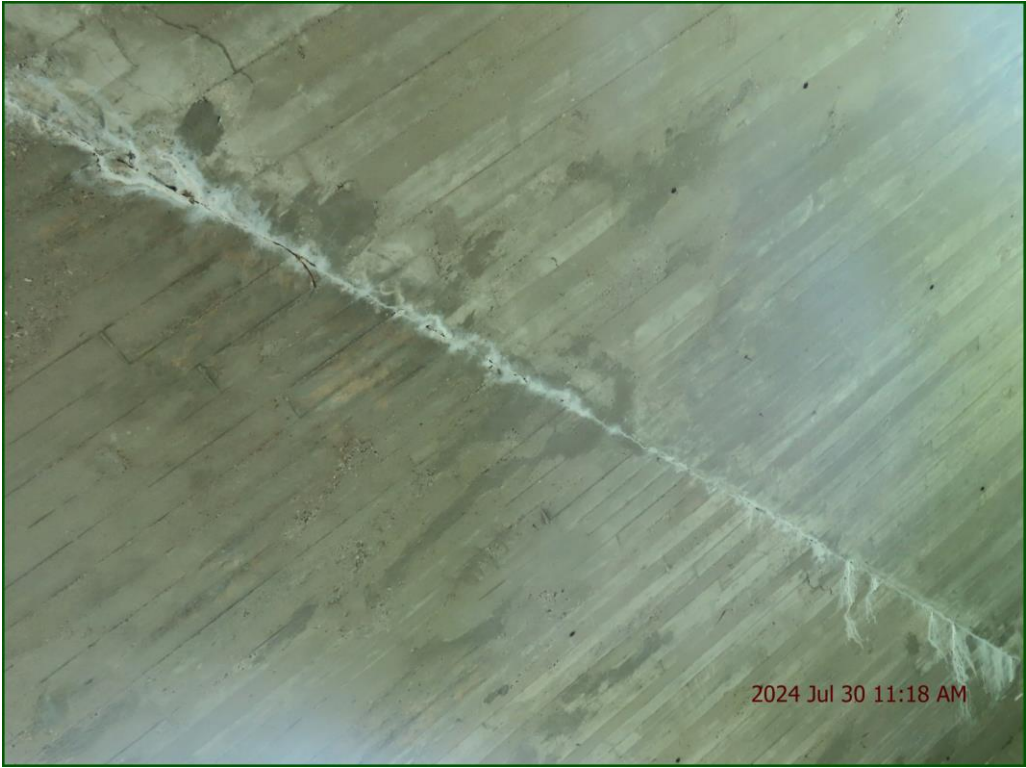
Description: Soffit (int): Wide longitudinal cracks with leachate staining.

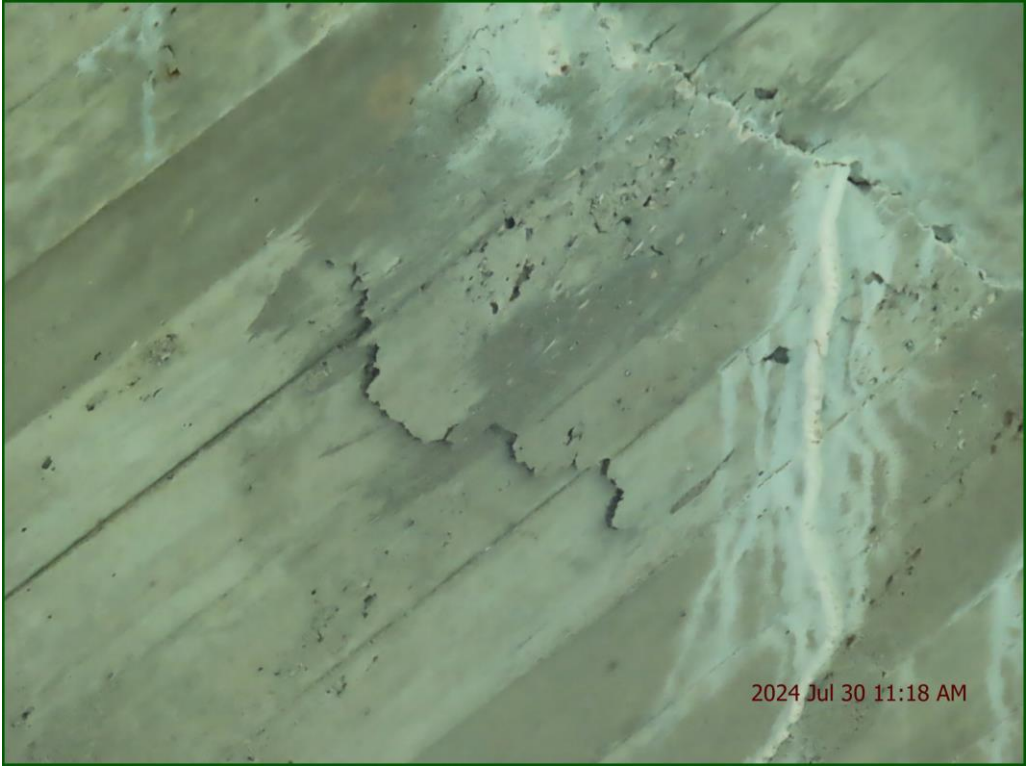
Description: Soffit (int): Light delamination.

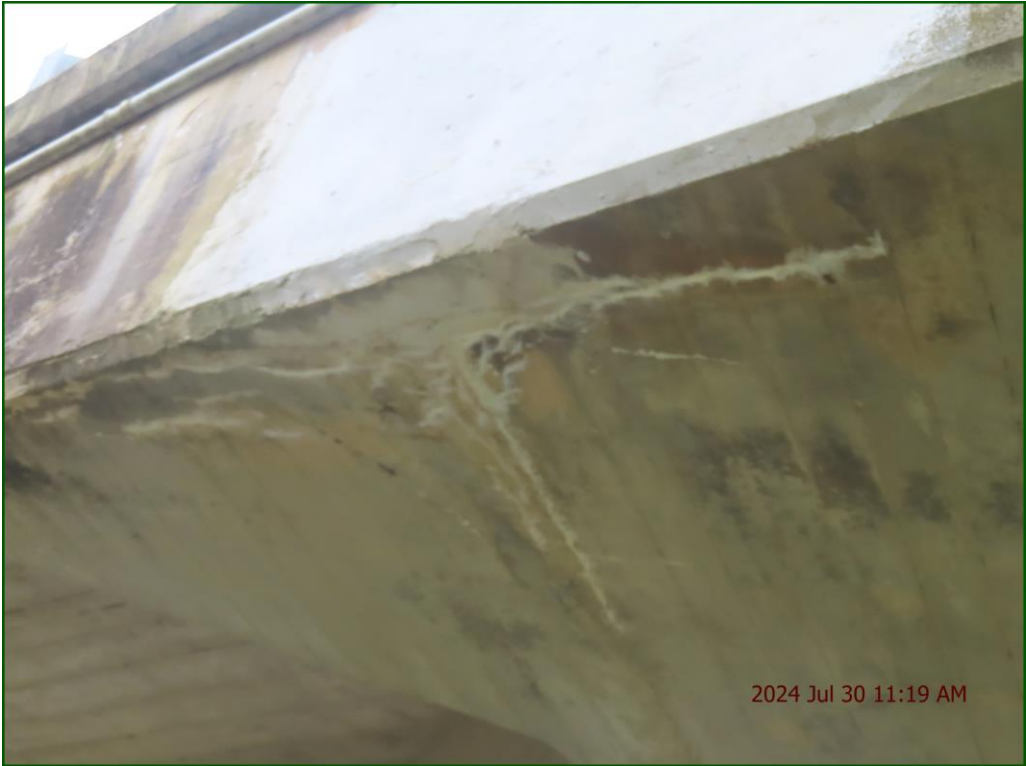
Description: Soffit (ext): Wide map cracking with leachate staining.

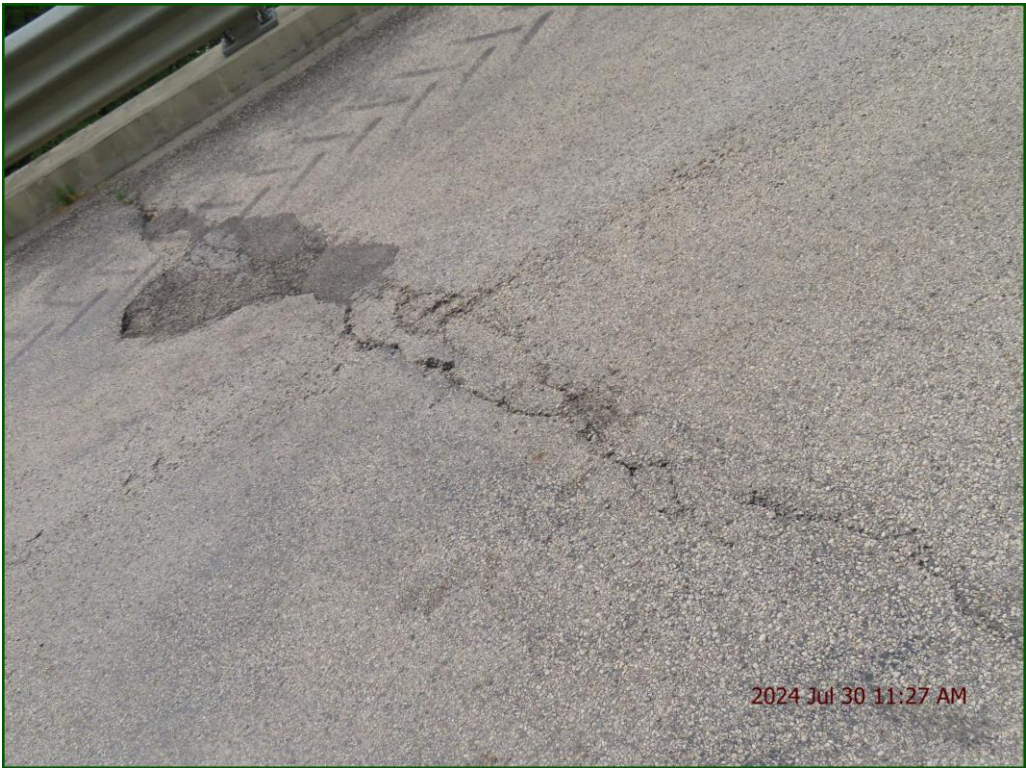
Description: Approach Wearing Surface: Wide transverse cracks.

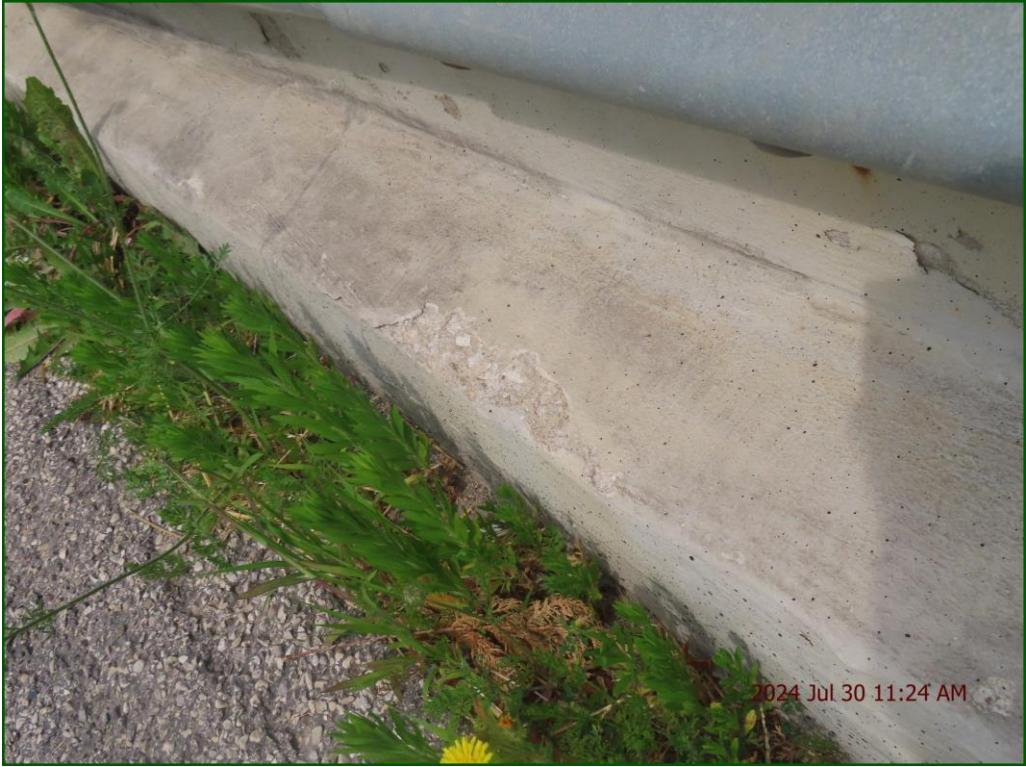
Description: Approach Curbs: Light delamination throughout.

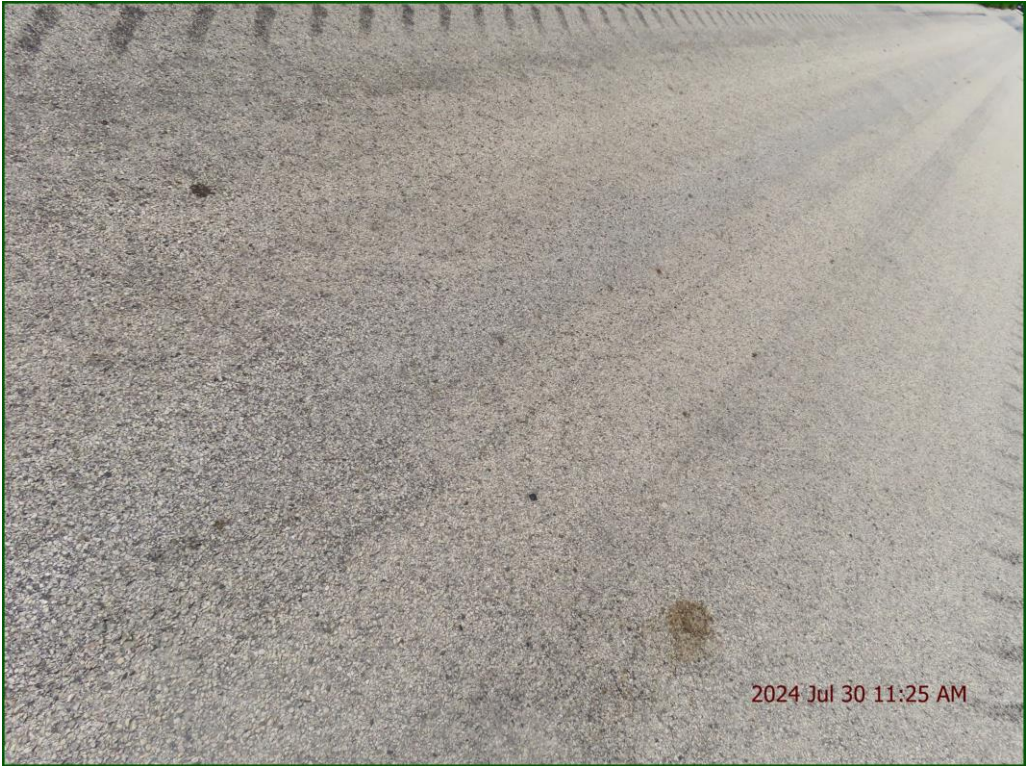
Description: Wearing Surface: Light ravelling along centreline.

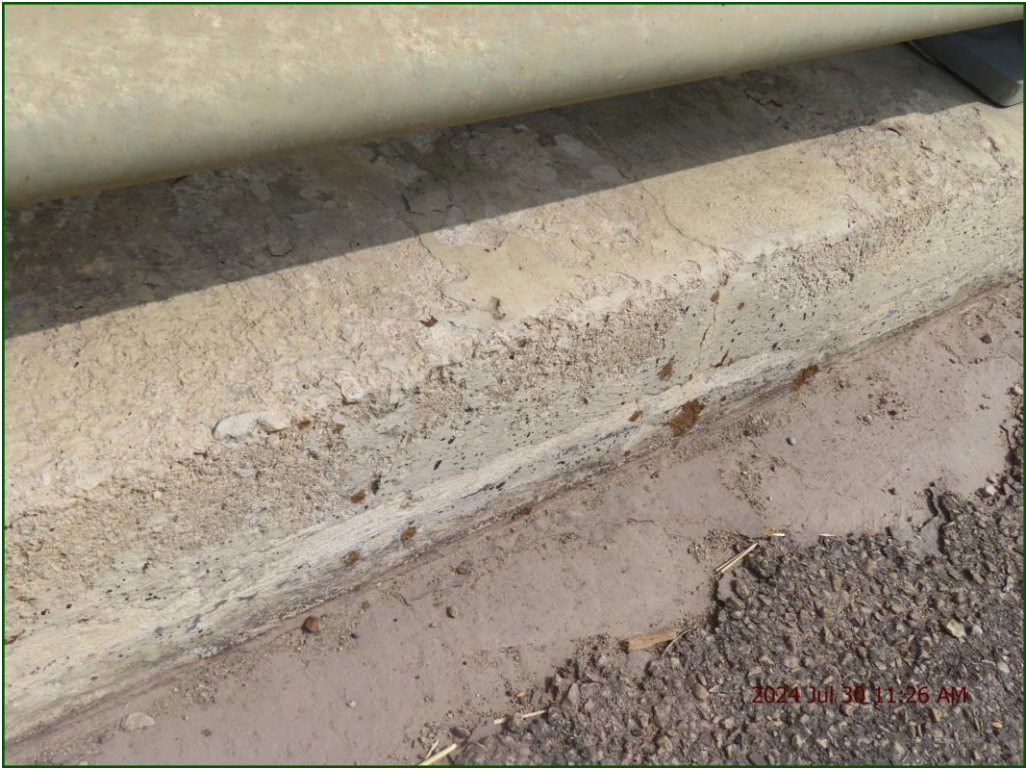
Description: Curbs: Light delamination throughout.

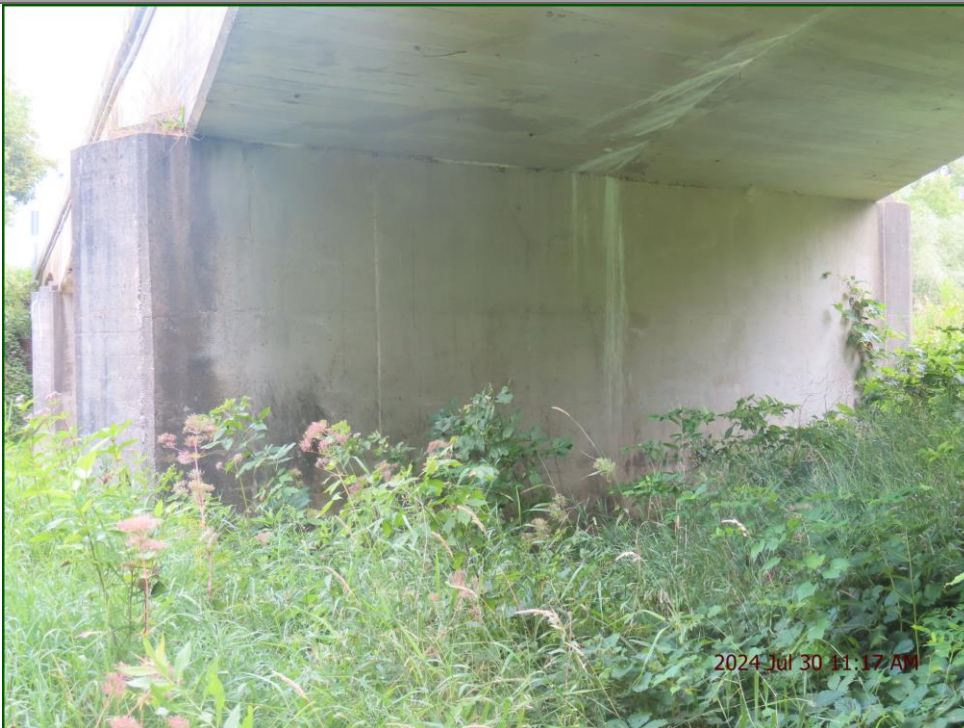
Medium to wide cracking with leachate staining throughout. Light spalling throughout.

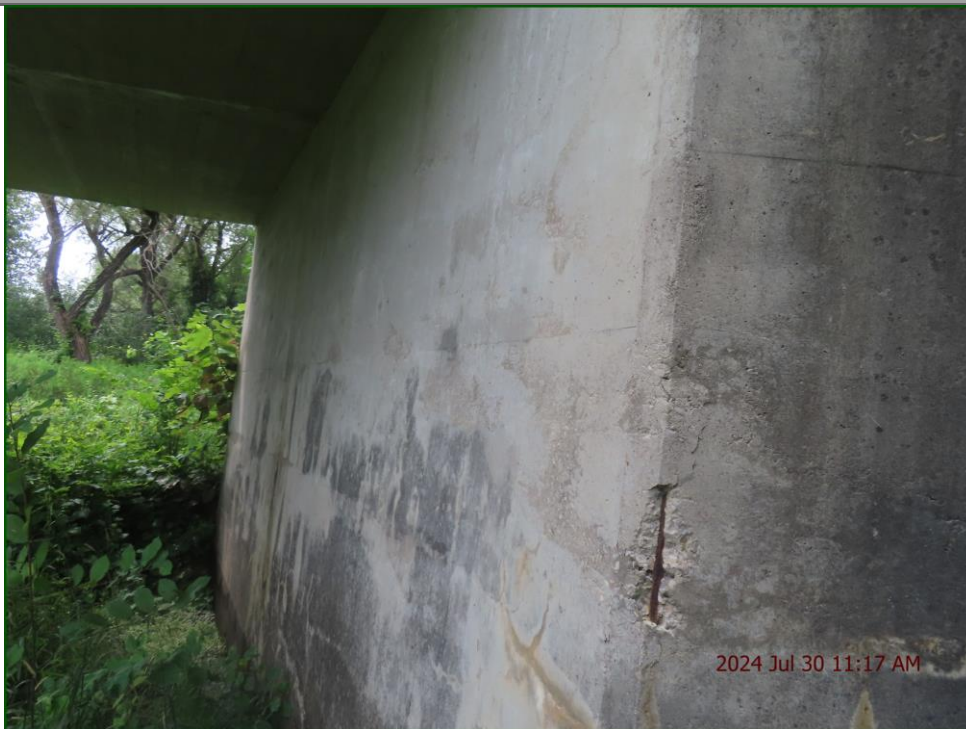
Medium to wide vertical cracking with wetness staining.

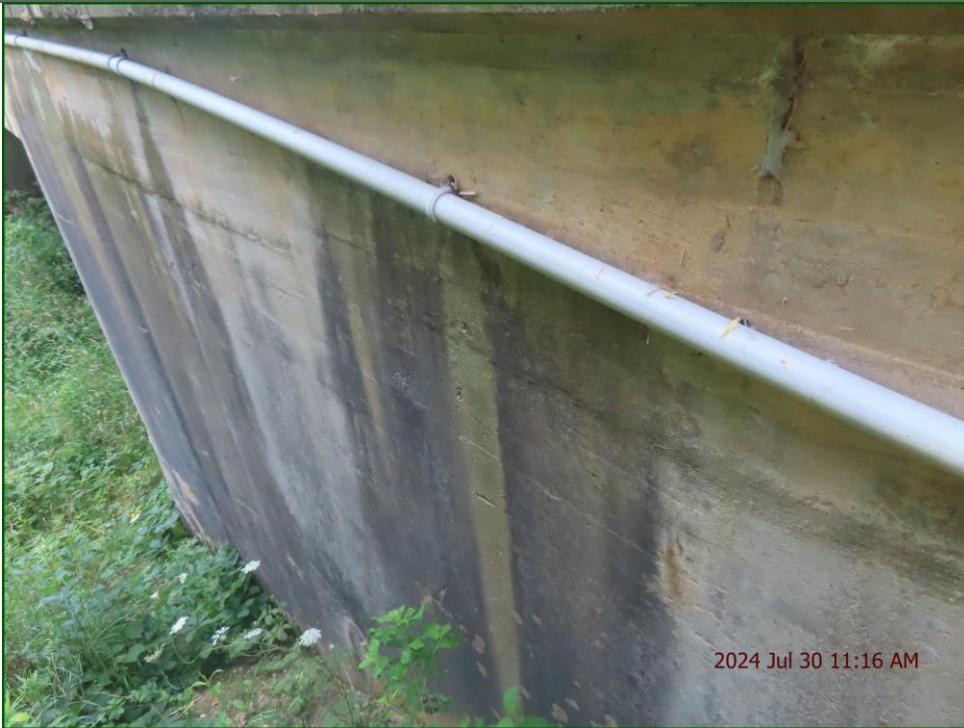
Light spalling with exposed reinforcing. Light to medium cracking with leachate staining.

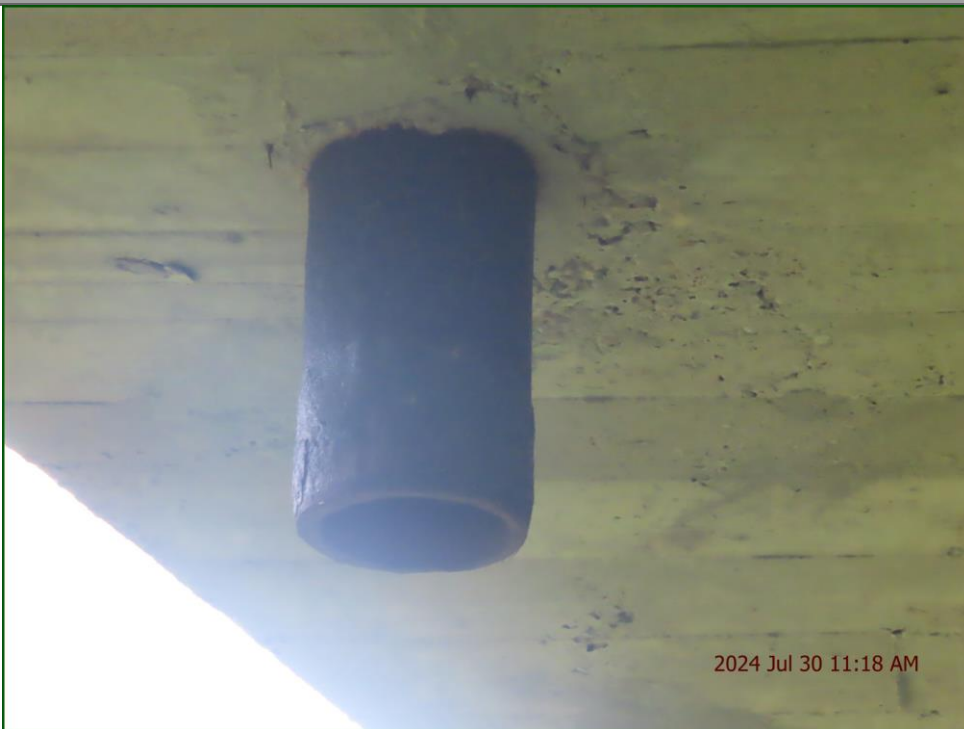
Minor corrosion throughout.

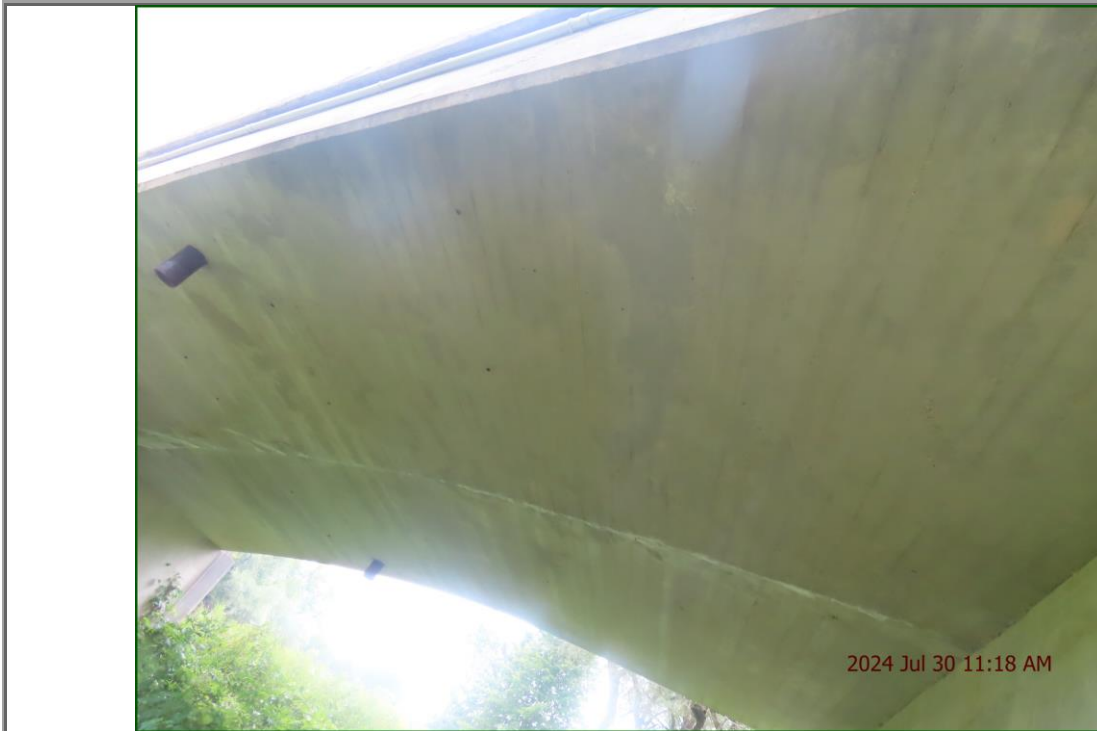
Wide longitudinal cracks with leachate staining. Light delamination.

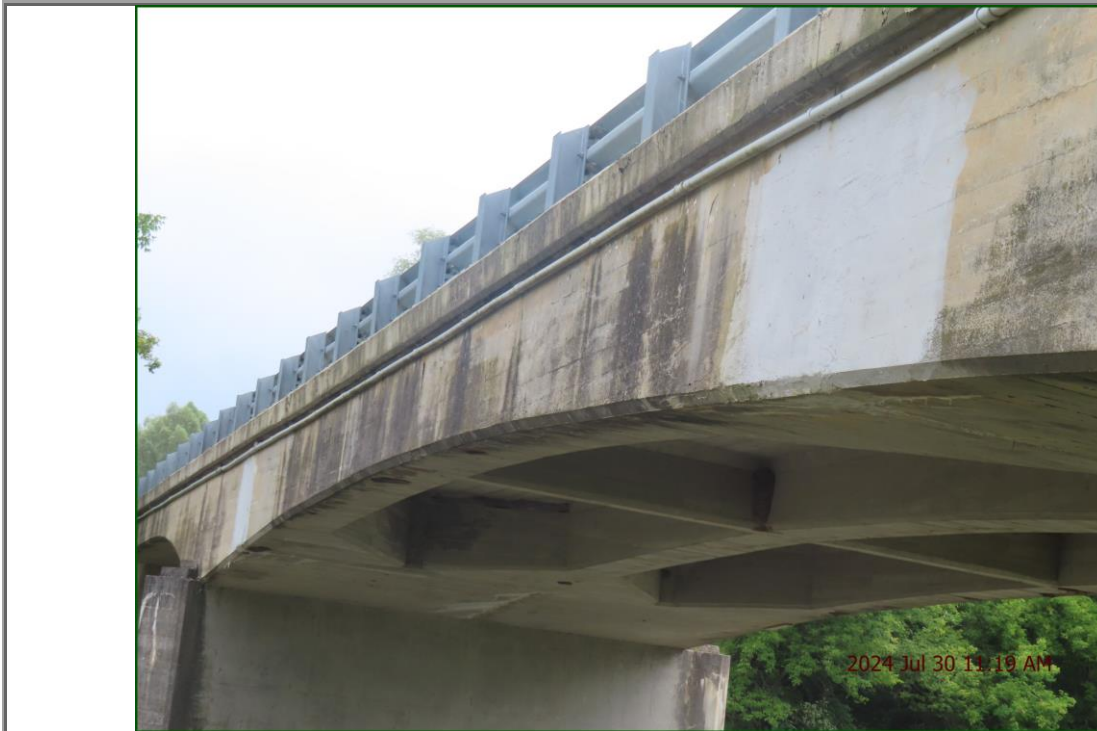
Wide map cracking with leachate staining.

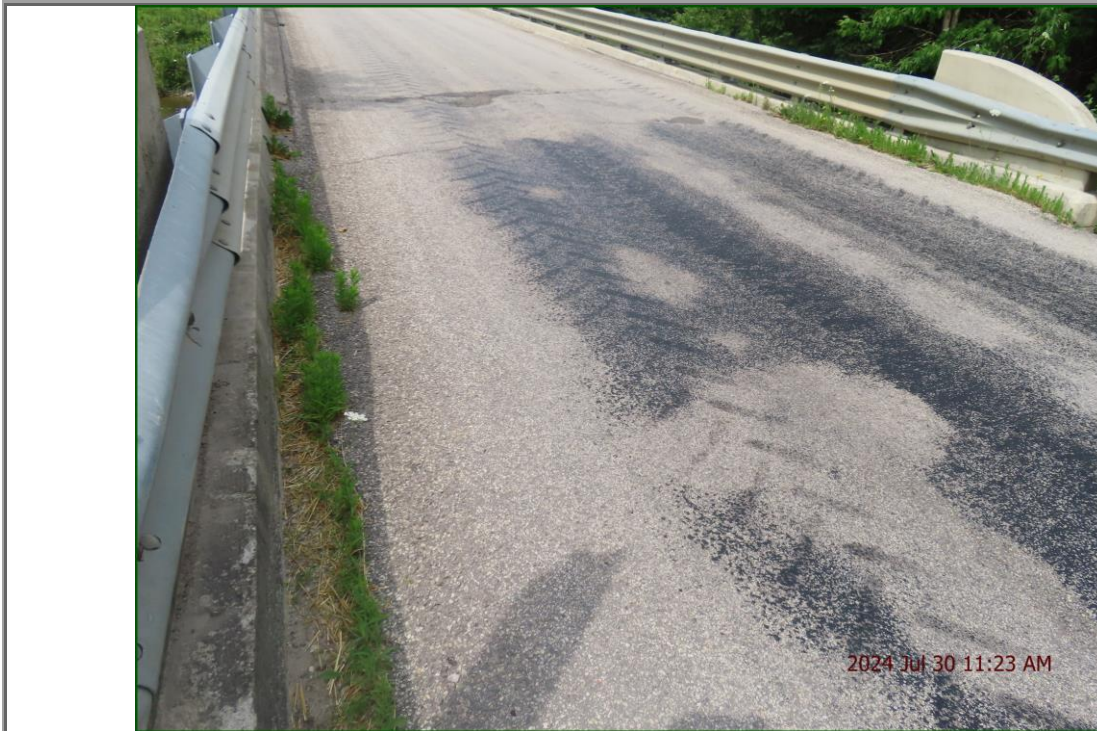
Minor potholing throughout. Wide transverse cracks.

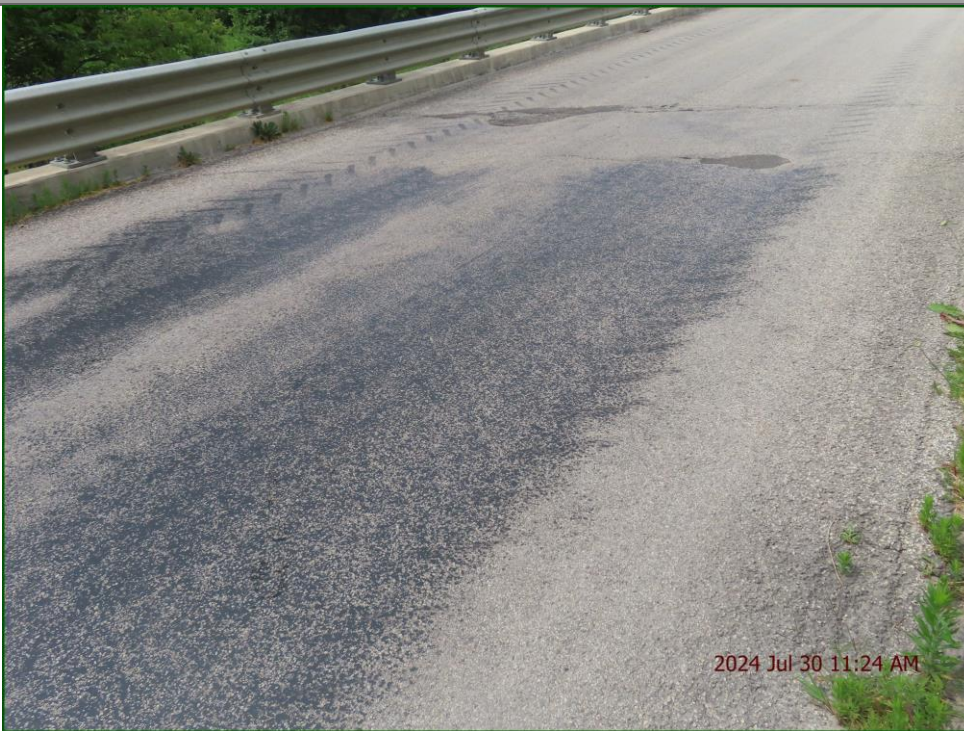
No signs of settlement.

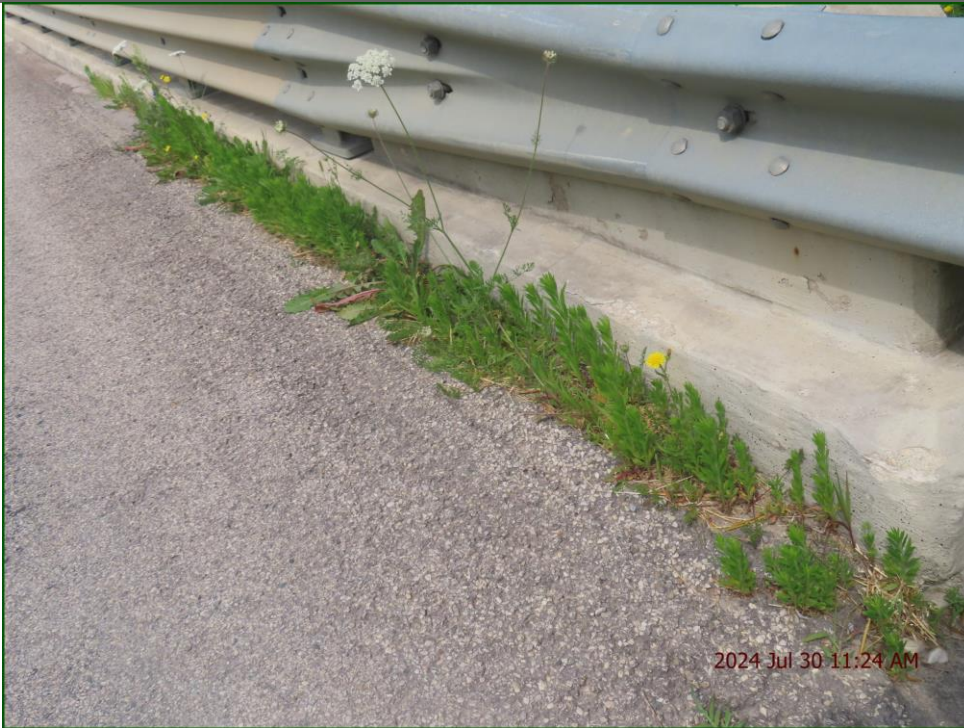
Light delamination throughout.

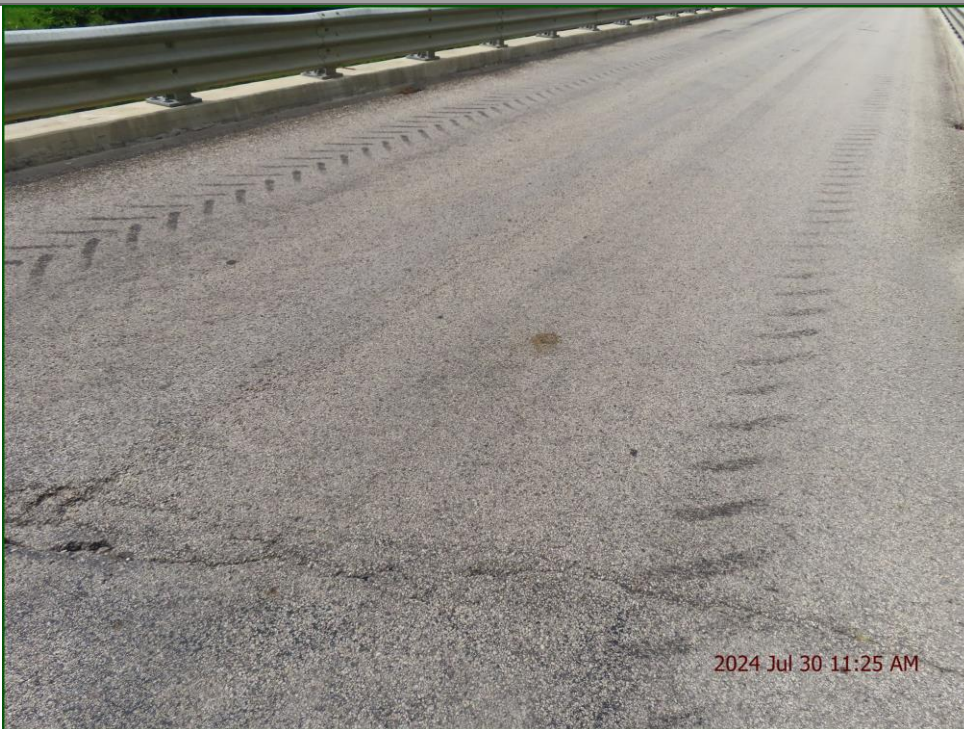
Light ravelling along centreline. Recommend extending wearing surface to curblines.

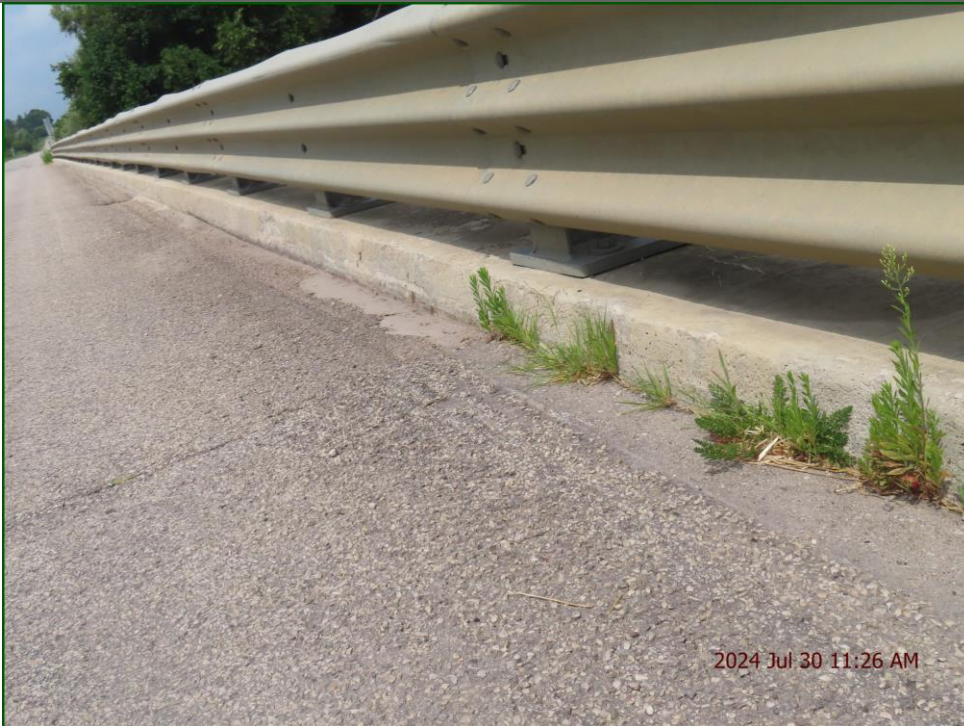
Light delamination throughout.

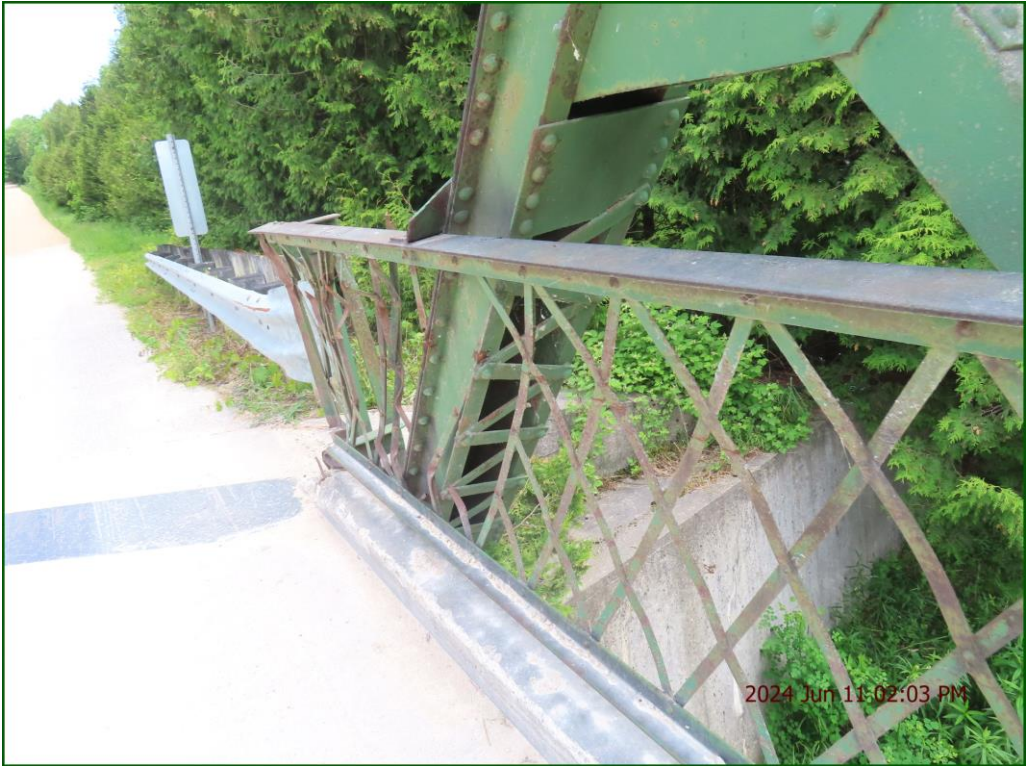
Description: Railing systems: Severe impact damage at NW corner.

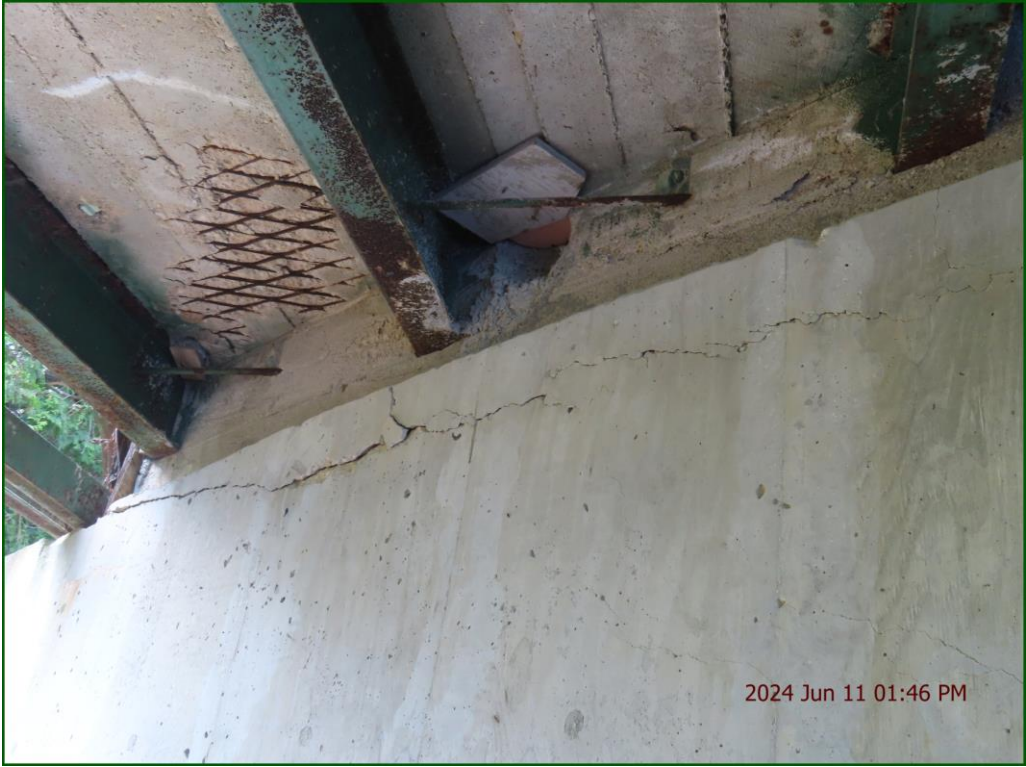
Description: Ballast walls: Moderate spall on east side.

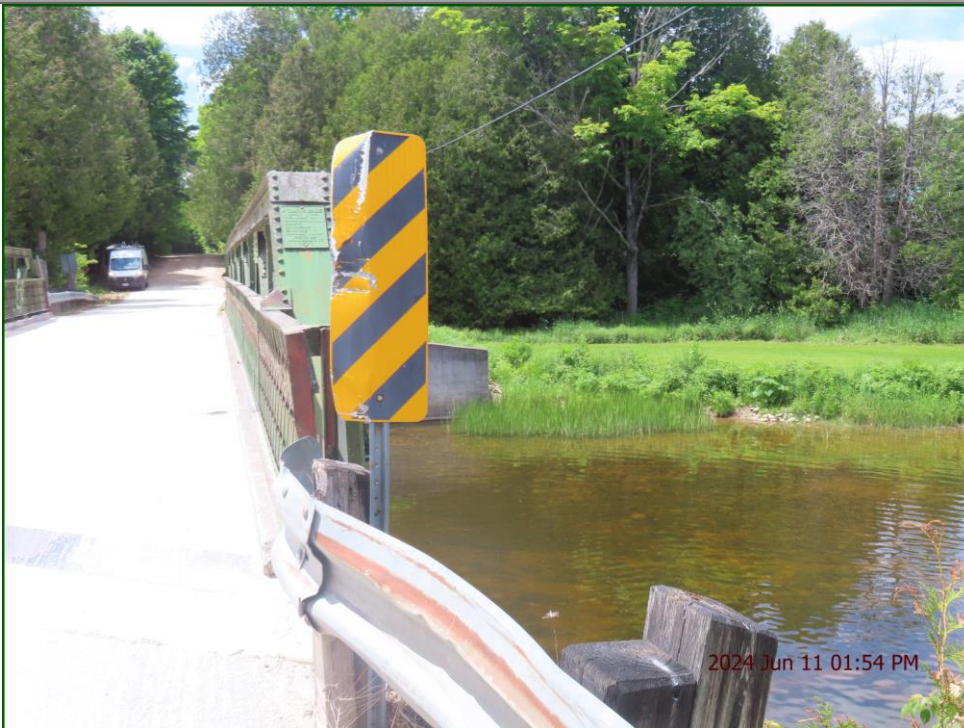
Four (4) hazard signs.

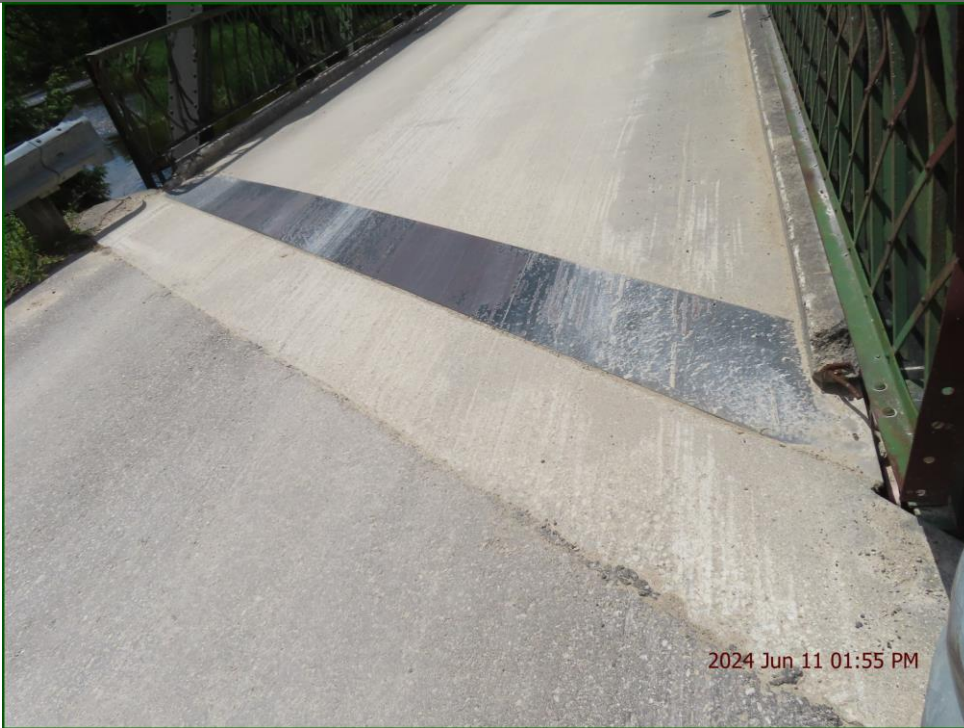
West side paved over.

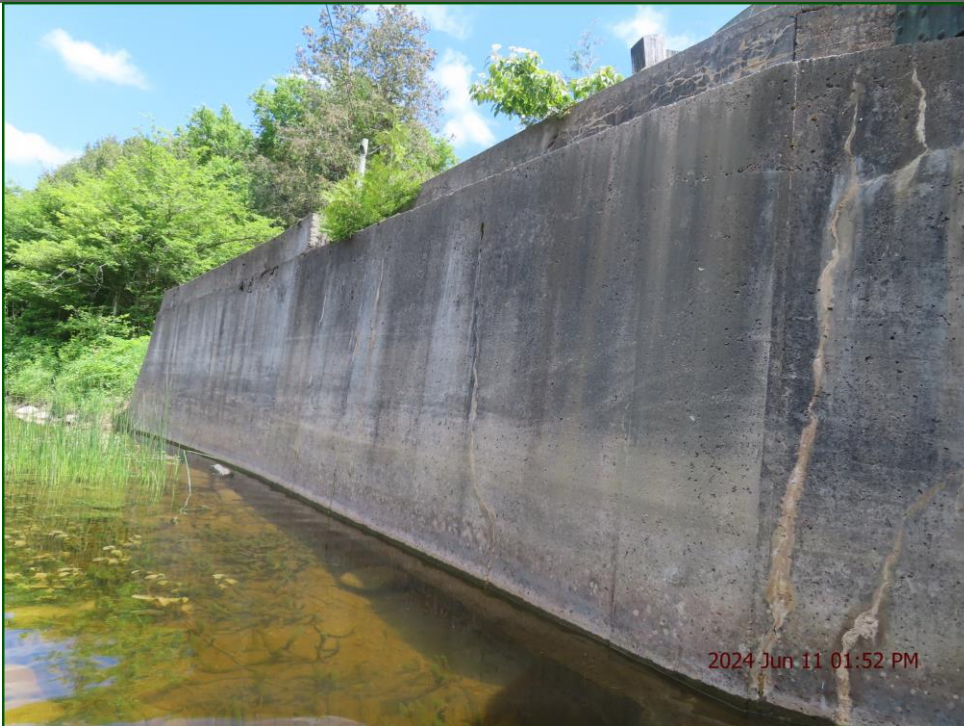
Light to medium vertical cracking with leachate staining.

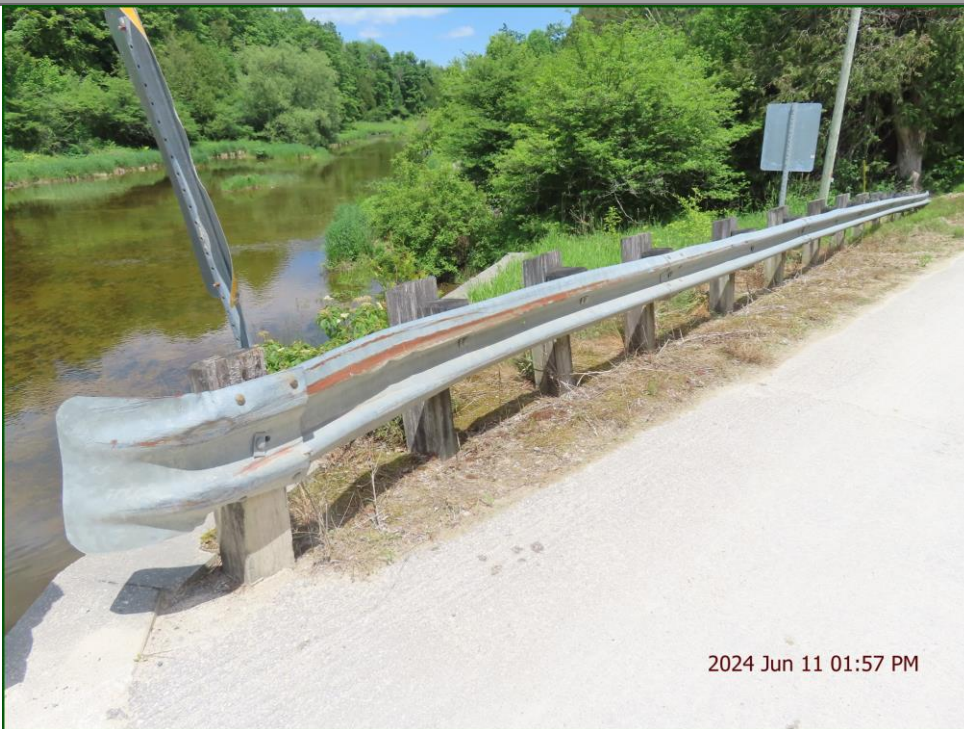
Moderate impact damage at NE quadrant.

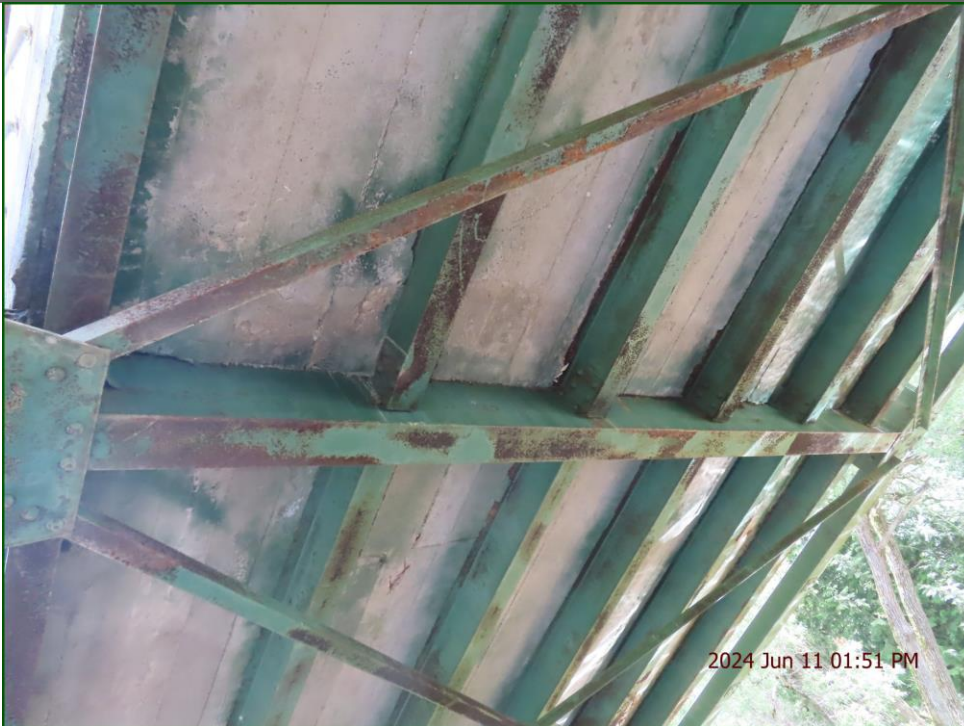
Light corrosion throughout.

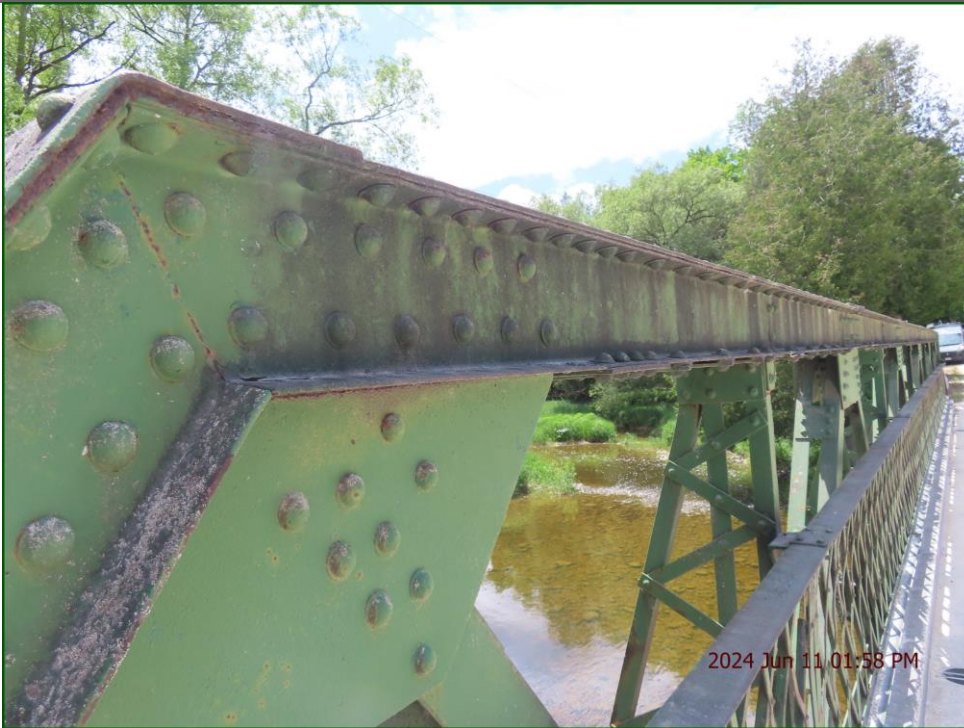
Light coating breakdown throughout.

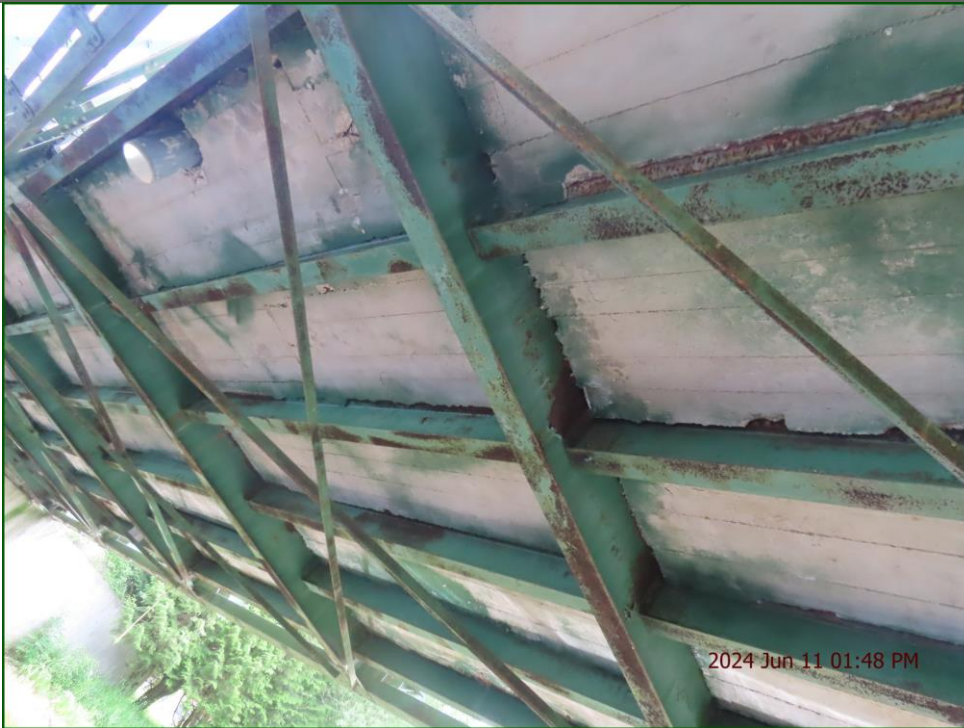
Medium to severe delaminations throughout.

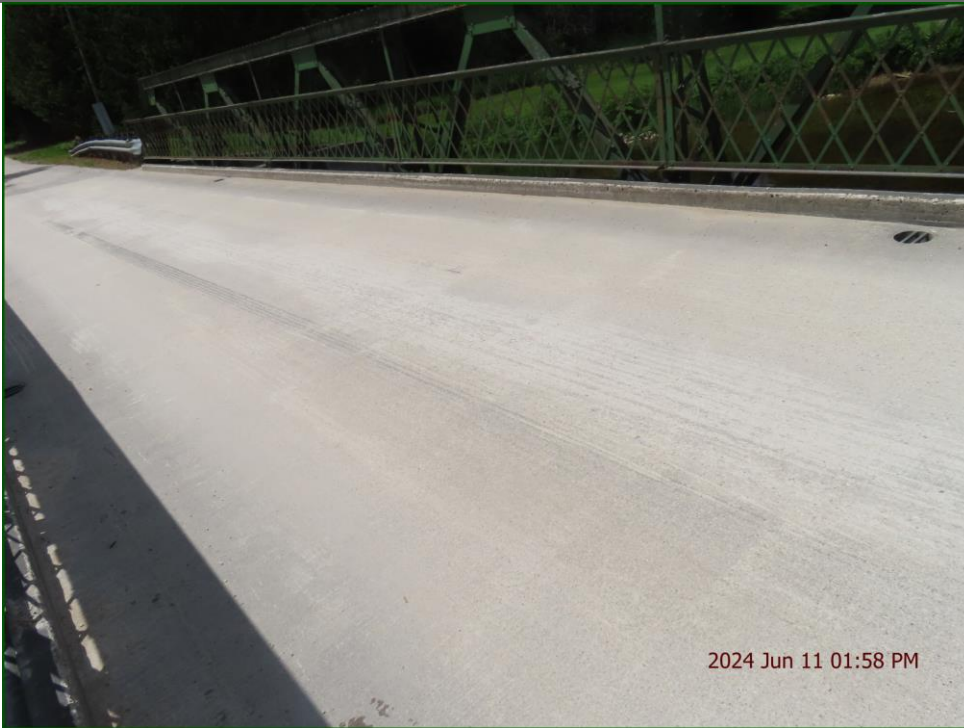
Medium transverse crack.
