OSIM Biennial Inspection Report

Concession 11/12, Lot 30

Burgess Engineering Inc

27-Aug-24

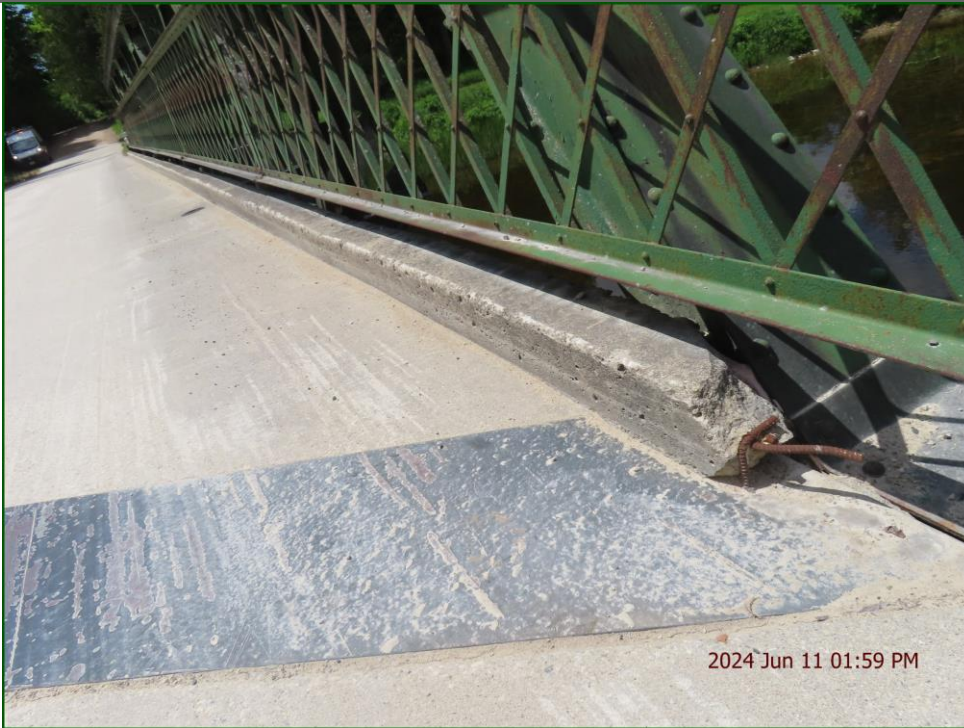
Severe spall with exposed reinforcing.

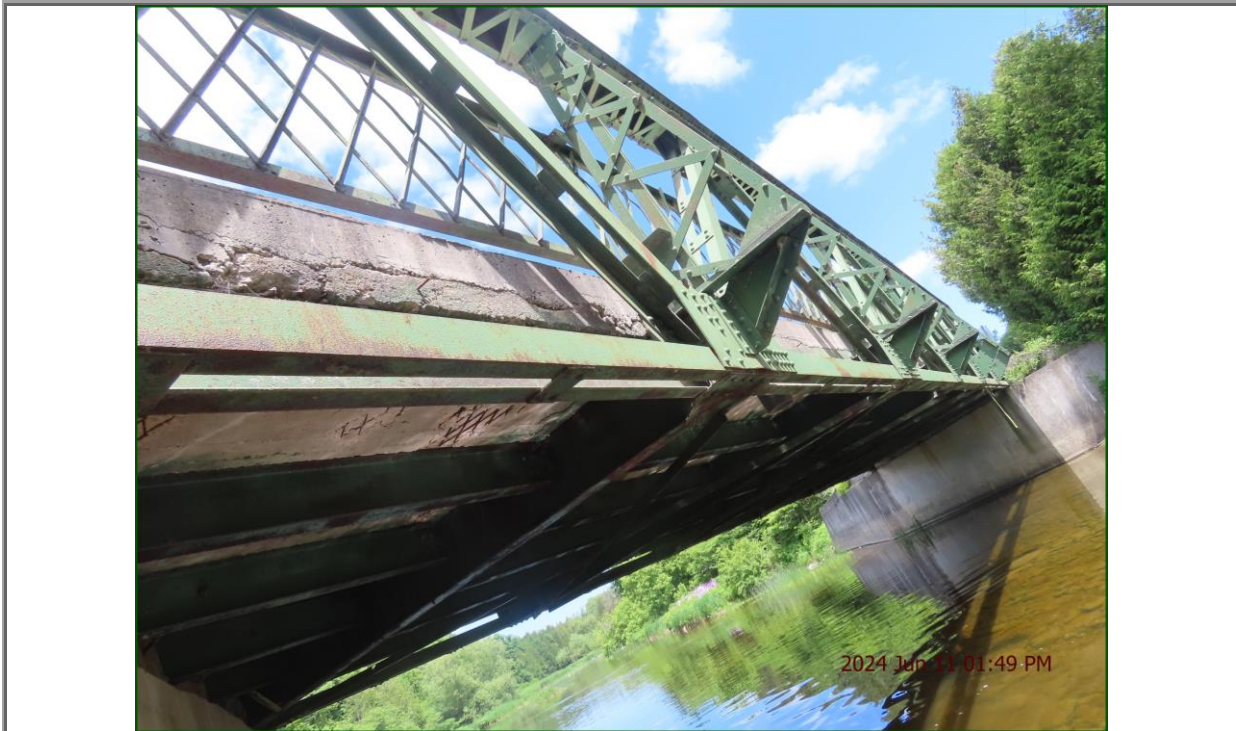
Light corrosion throughout. Severe corrosion with perforation NW corner.

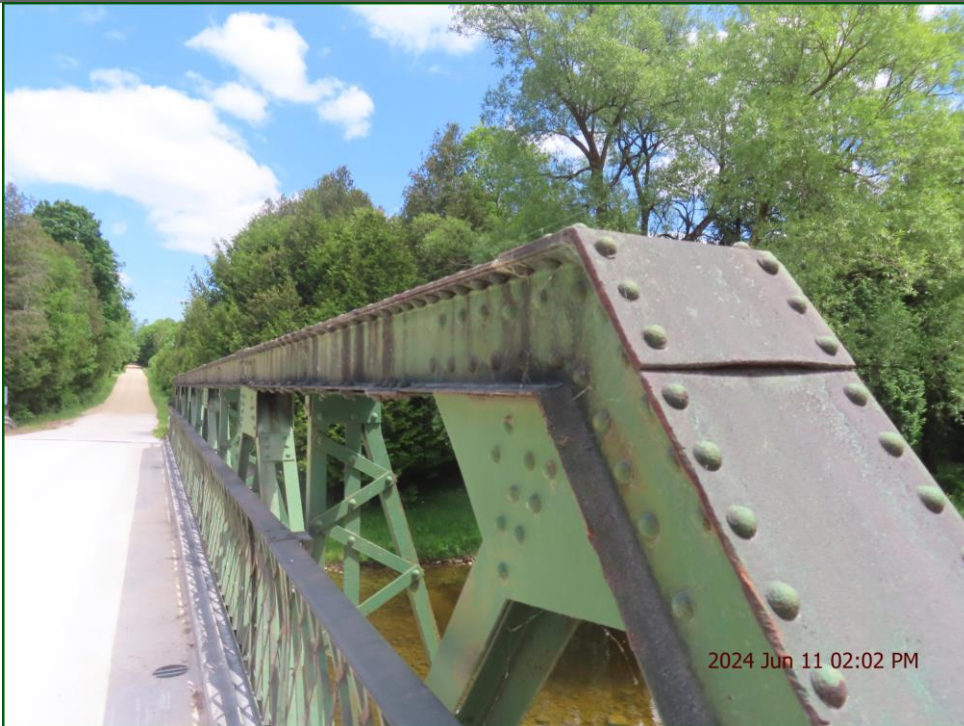
Light corrosion throughout.

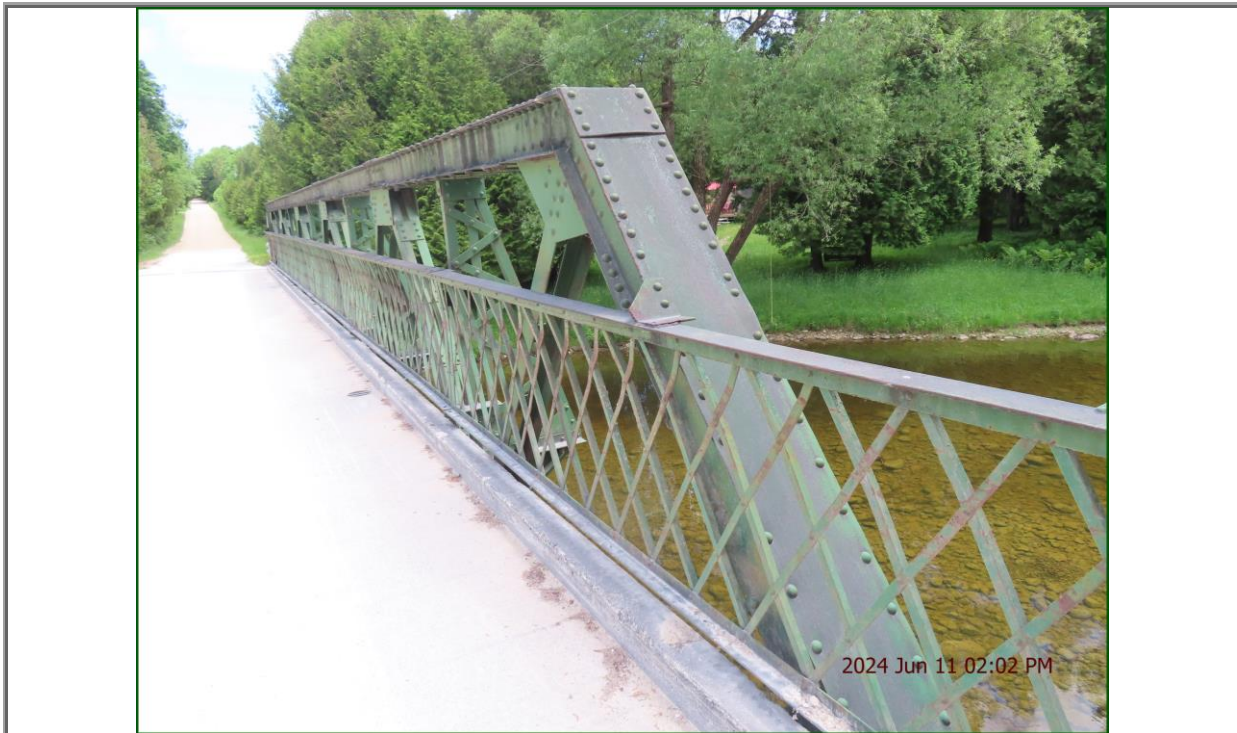
Moderate impact damage throughout. Severe impact damage at NW corner. Light corrosion throughout.

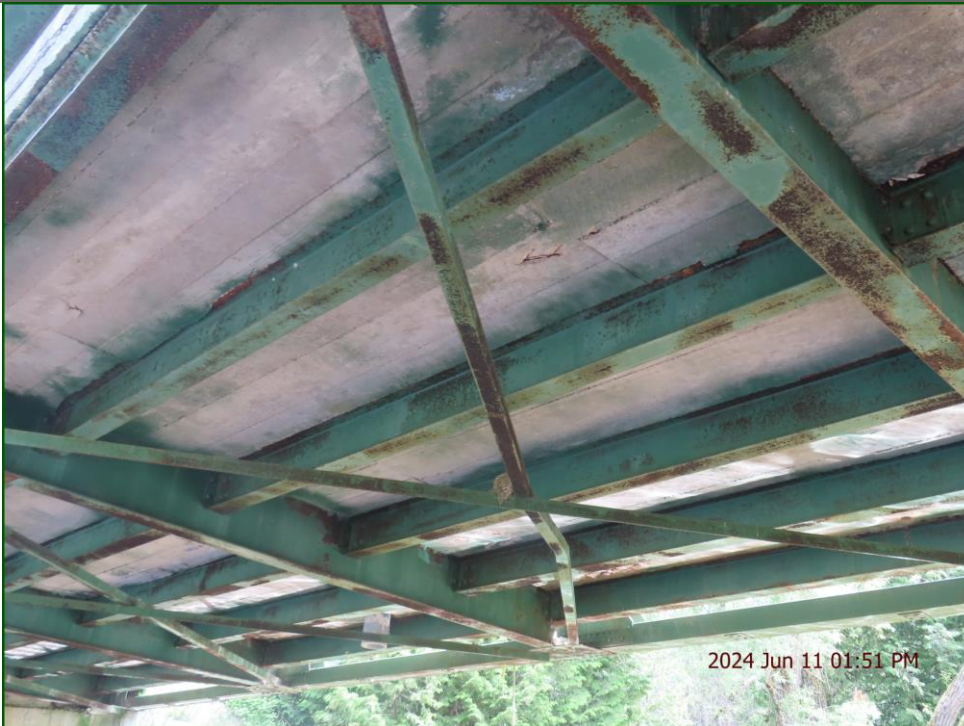
Light corrosion throughout.

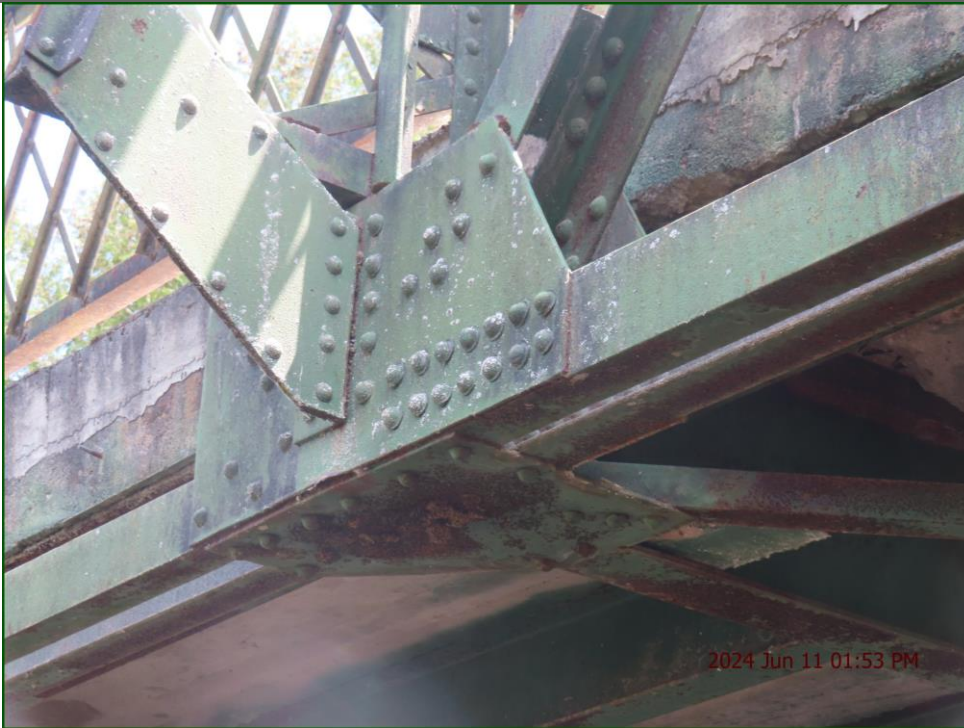
Light corrosion throughout.

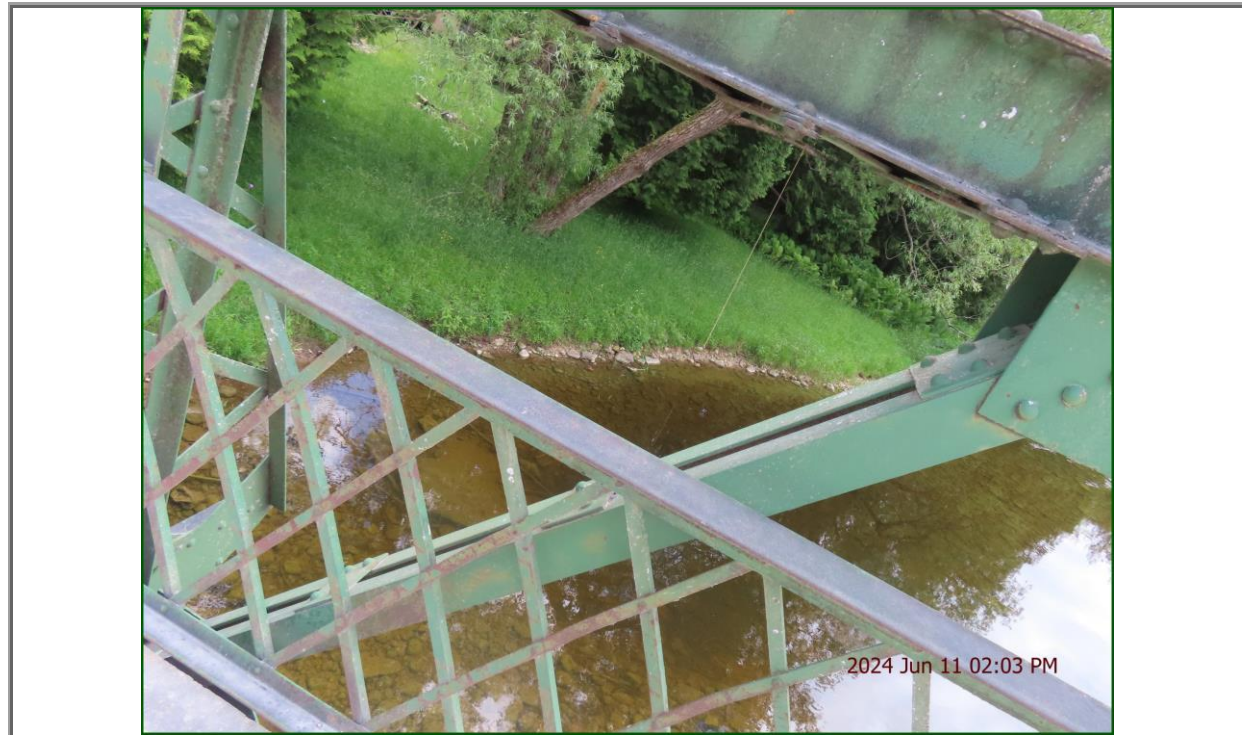
General Comments:
Light corrosion throughout.

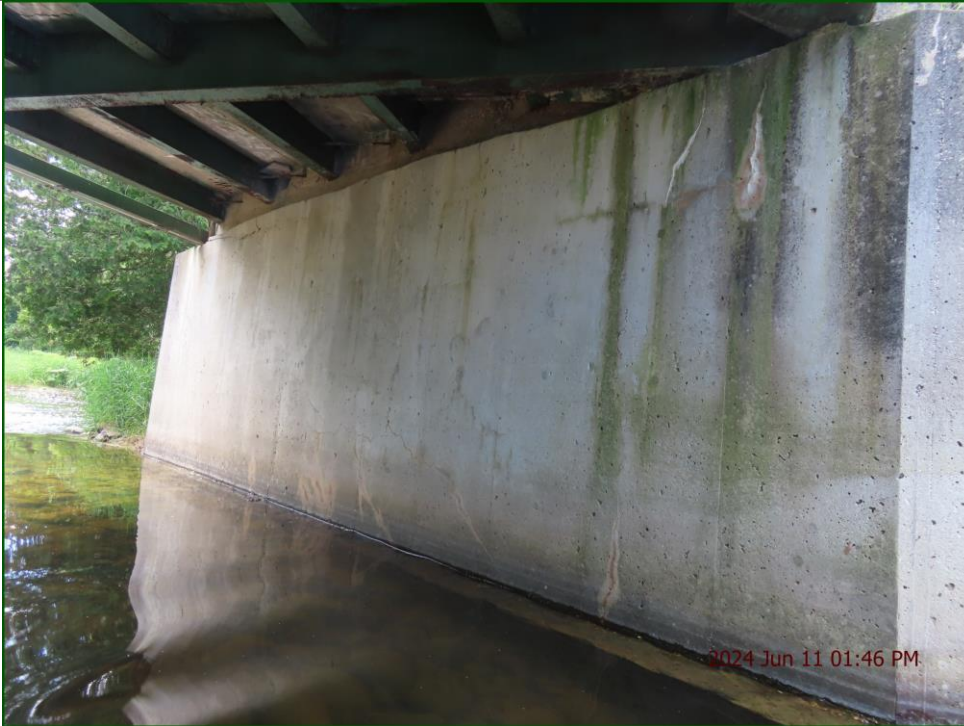
Light to medium vertical cracking throughout. Localized spalling at SW corner.

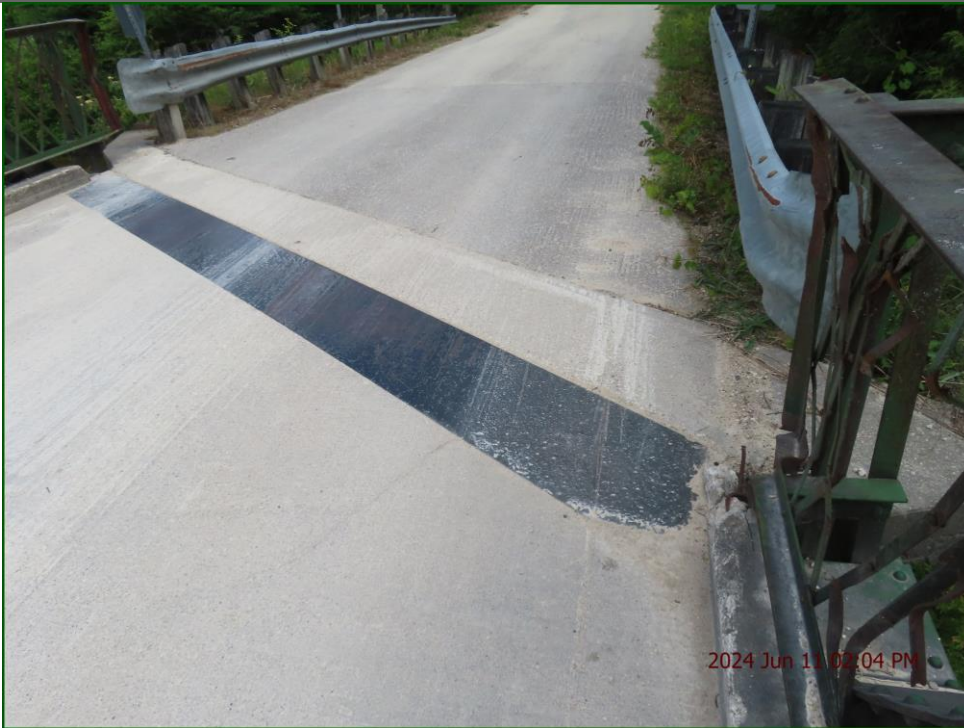
West side paved over.

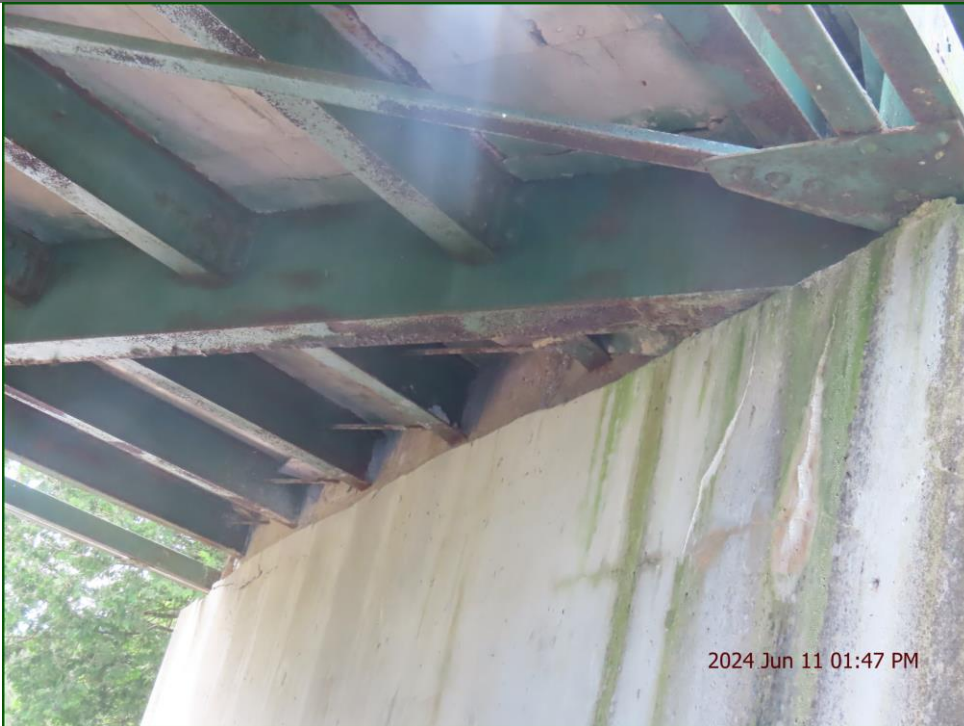
Limited inspection due to height of abutment. Moderate spall on east side.

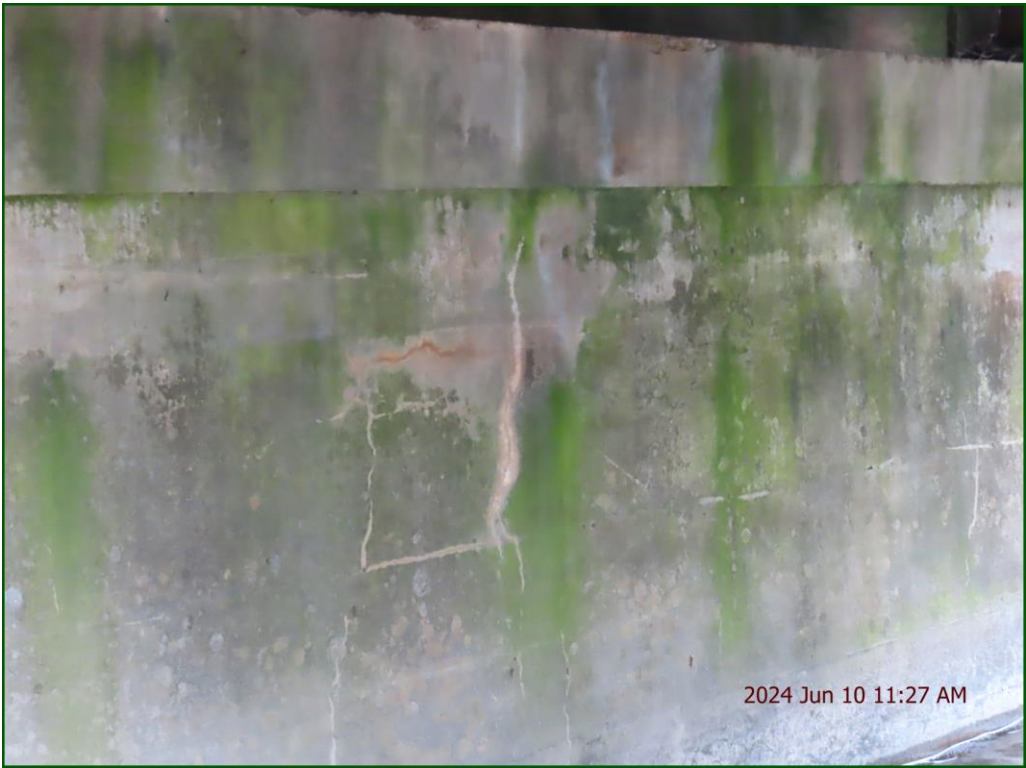
Description: Abutment Walls: Light to medium vertical cracking with leachate staining.

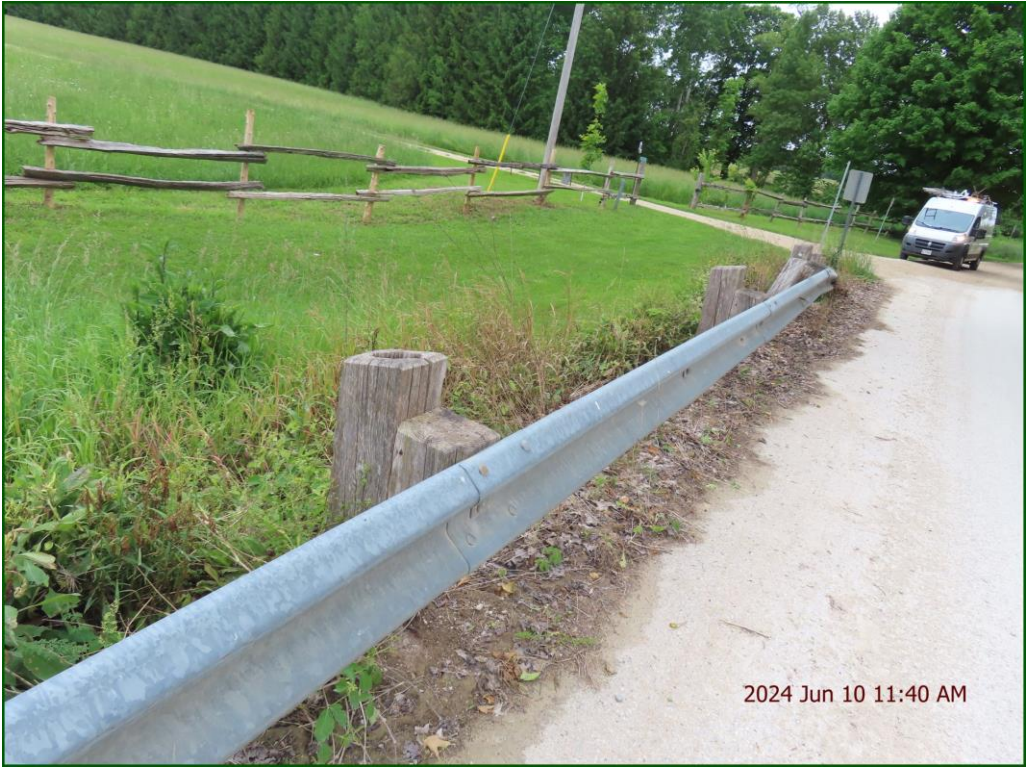
Description: Railing systems: Missing timber post on SW quadrant.

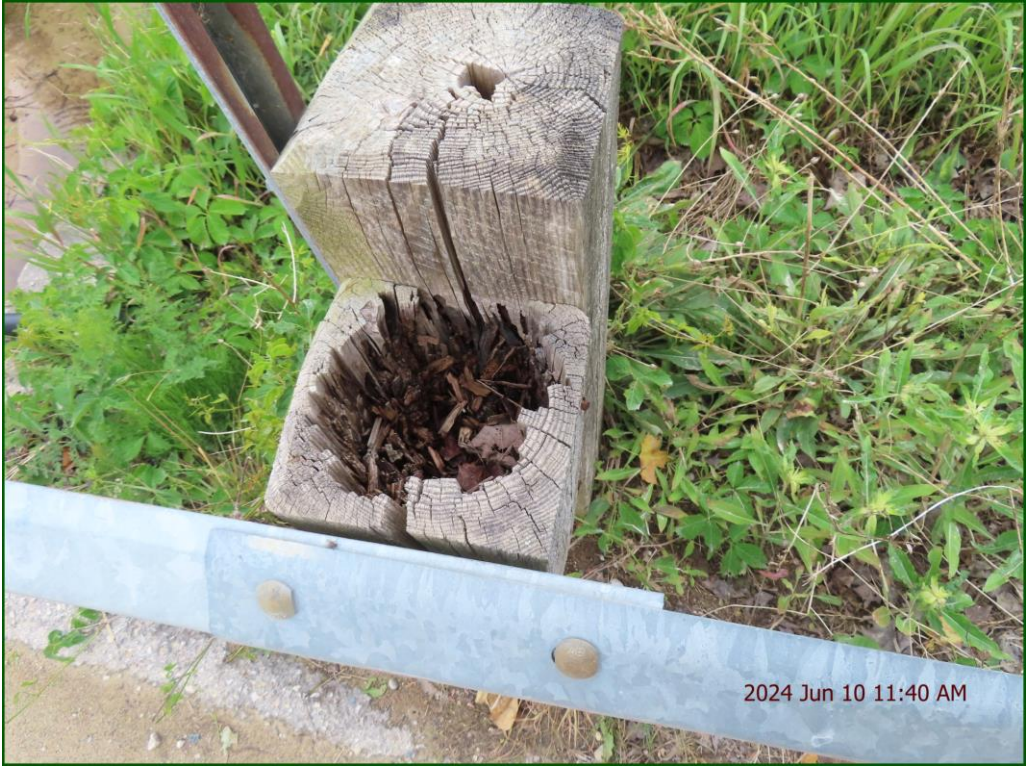
Description: Railing systems: Severe rotting.

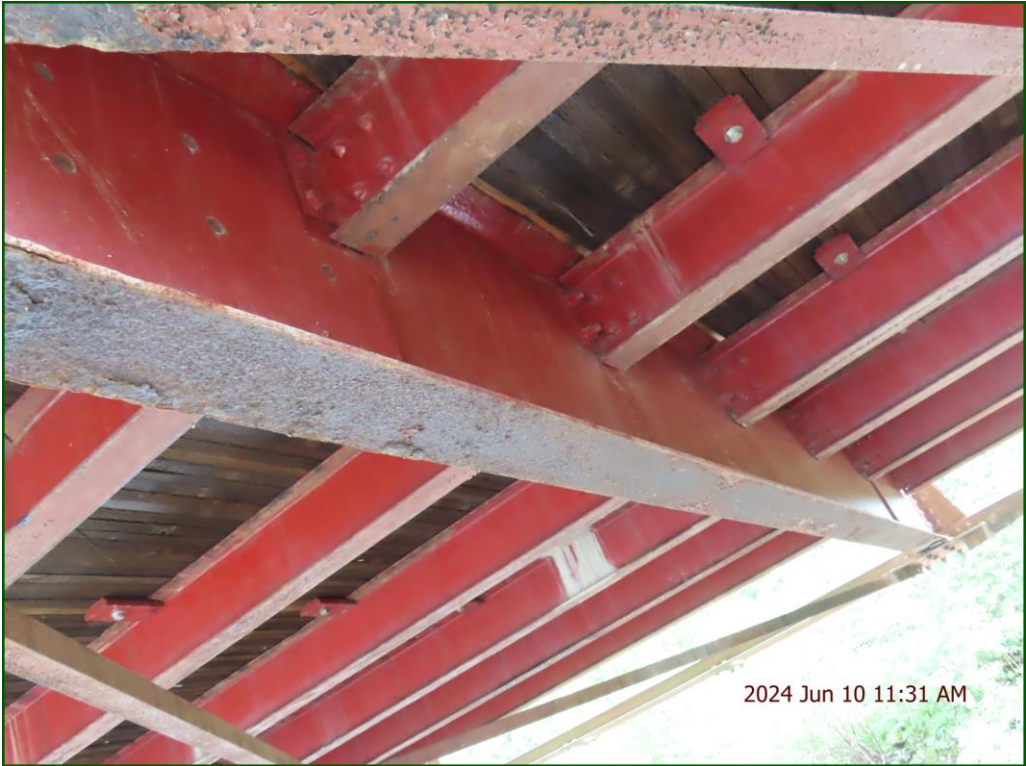
Description: Floor beams: Light corrosion throughout.

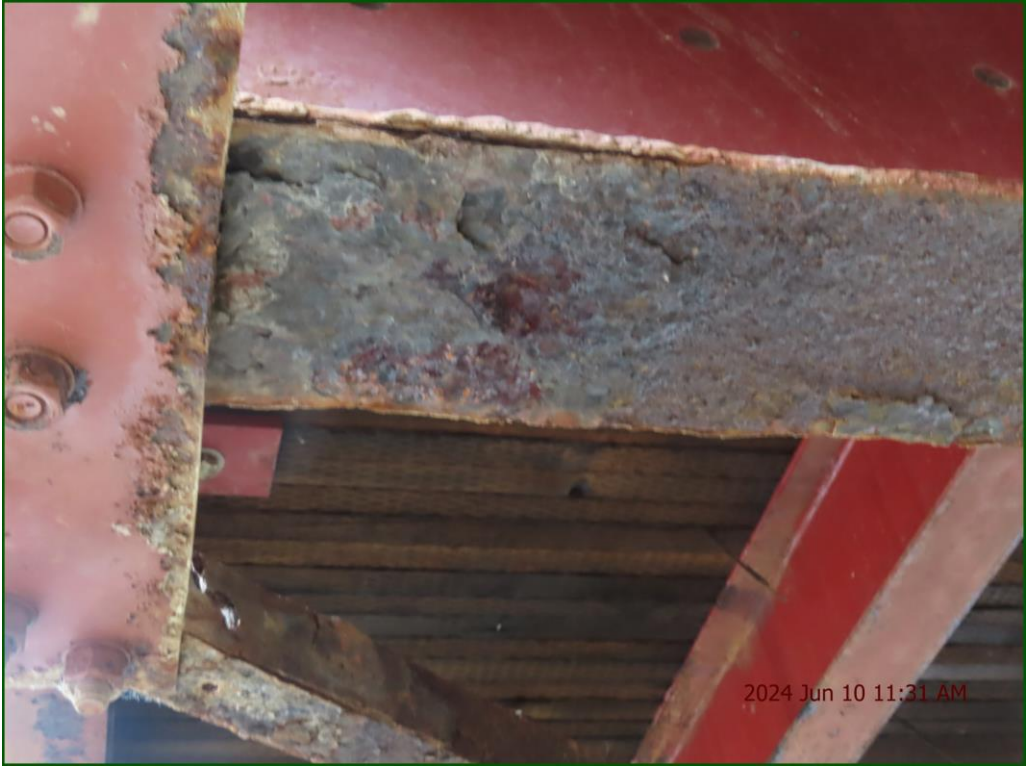
Description: Floor beams: Moderate corrosion at ends.

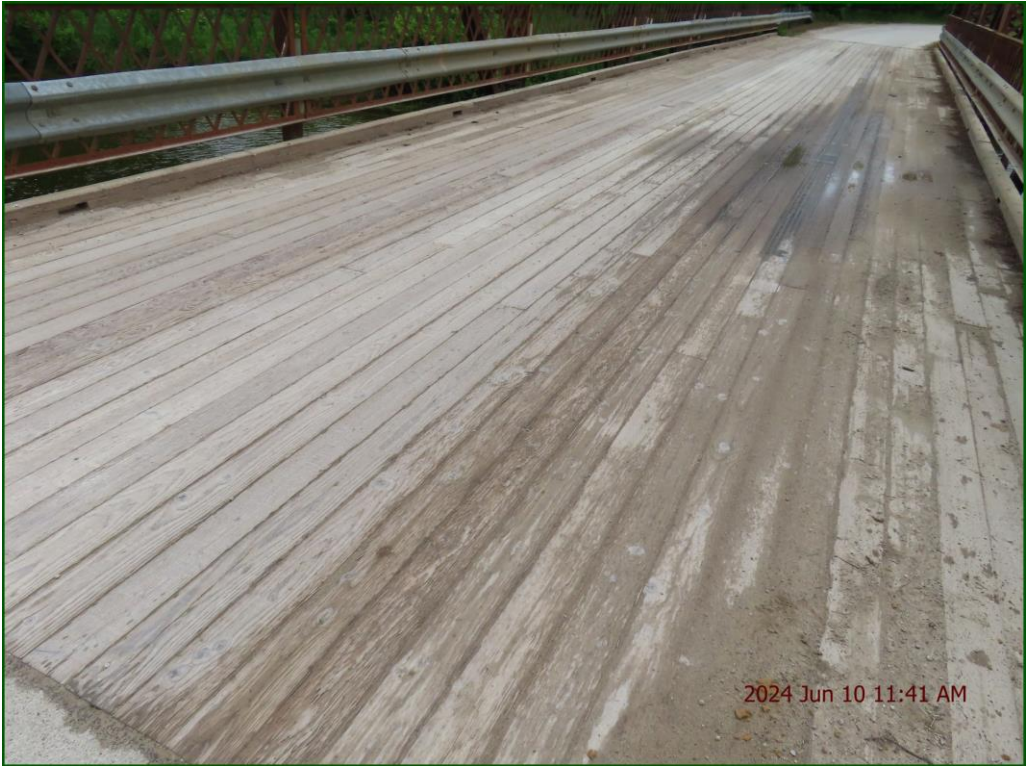
Description: Deck top: Moderate weathering throughout.

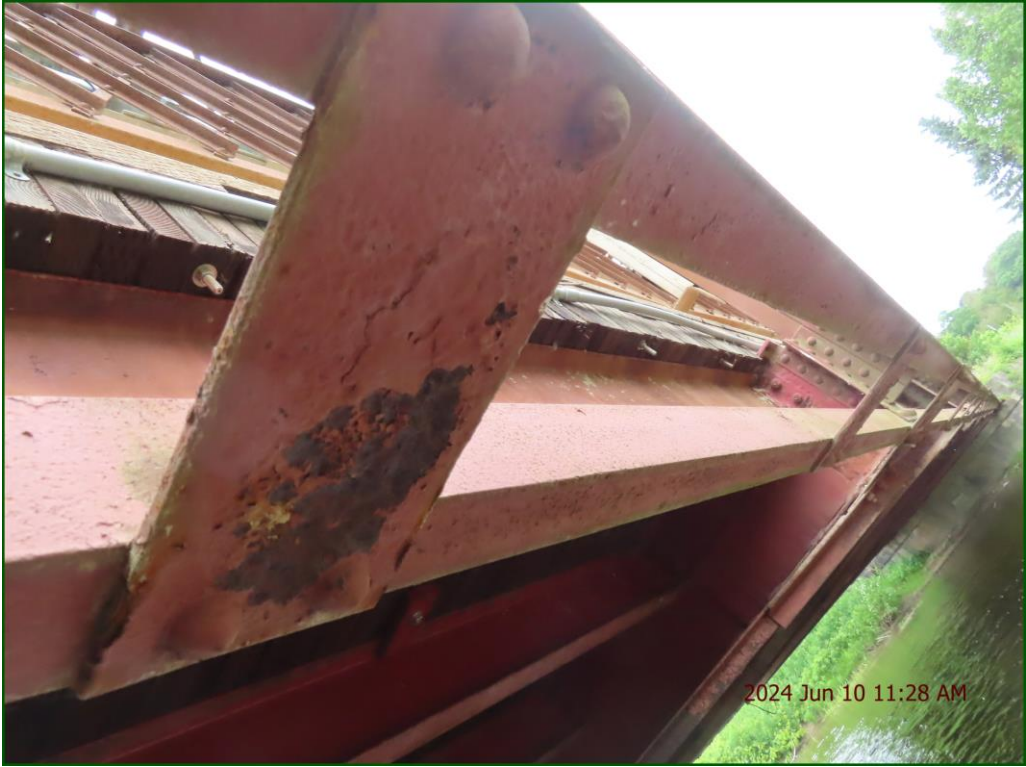
Description: Bottom chord: Light to medium corrosion throughout.

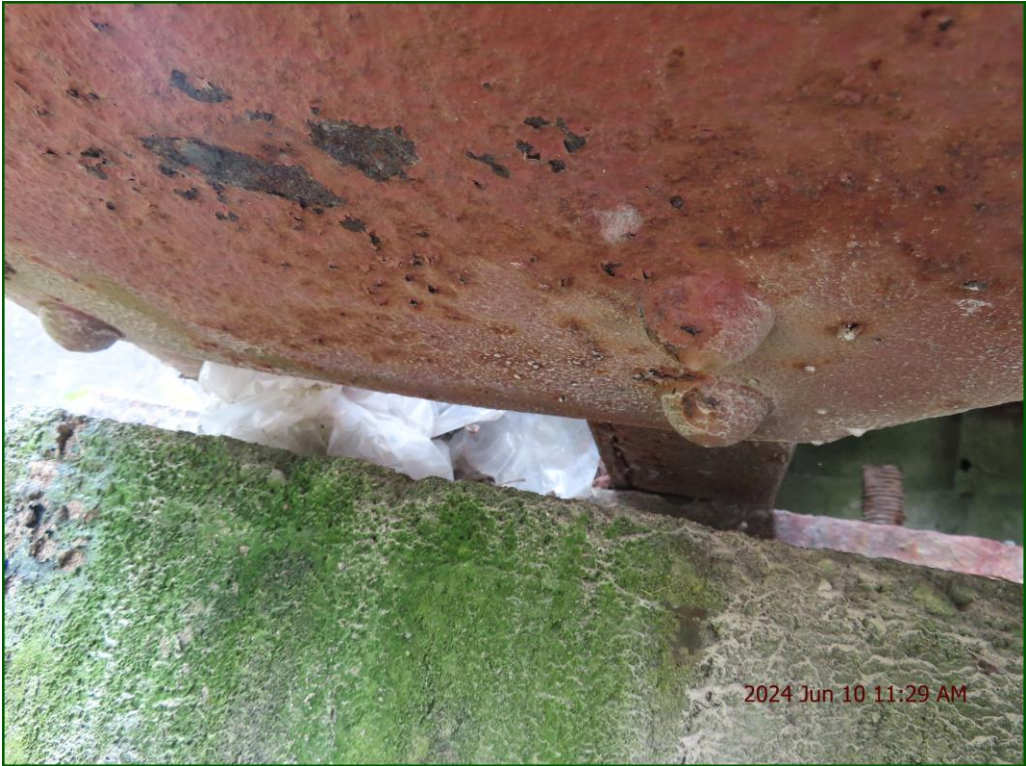
Description: Bottom chord: Moderate corrosion at ends (1/2).

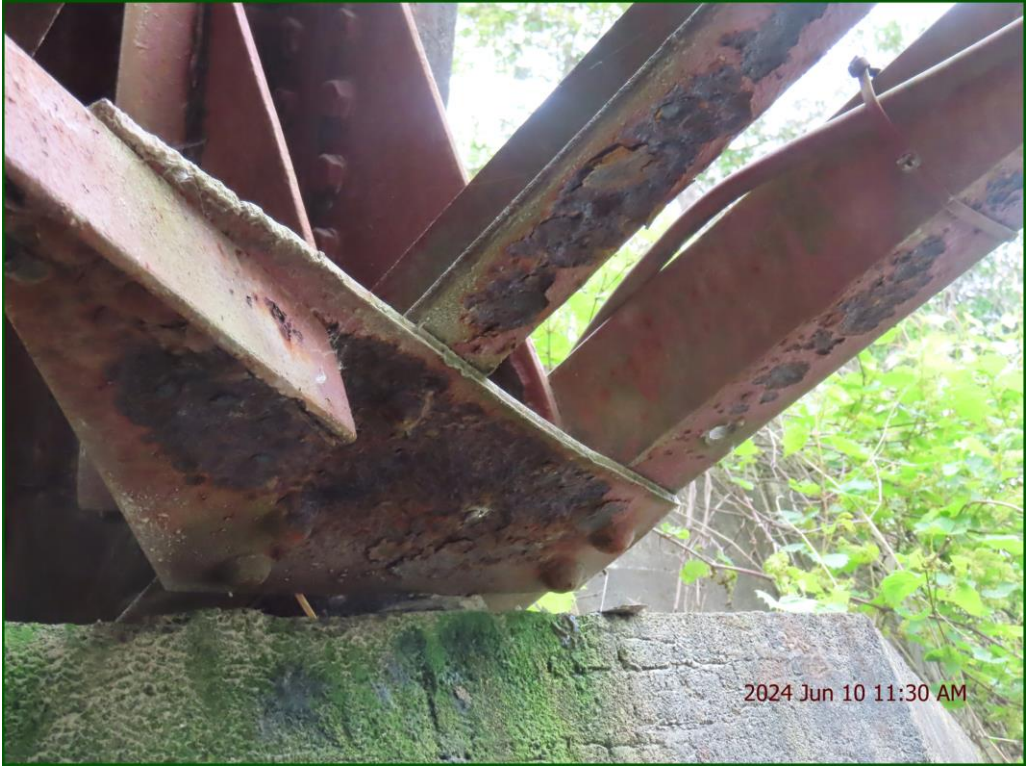
Description: Bottom chord: Moderate corrosion at ends (2/2).

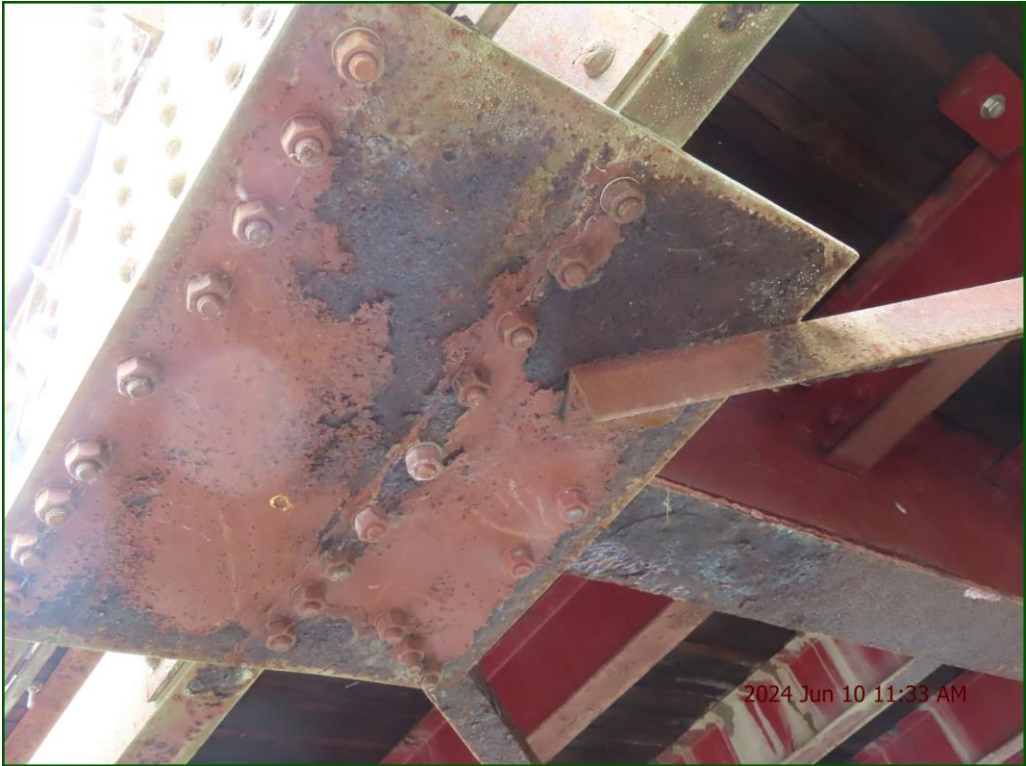
Description: Connections: Light to medium corrosion throughout.

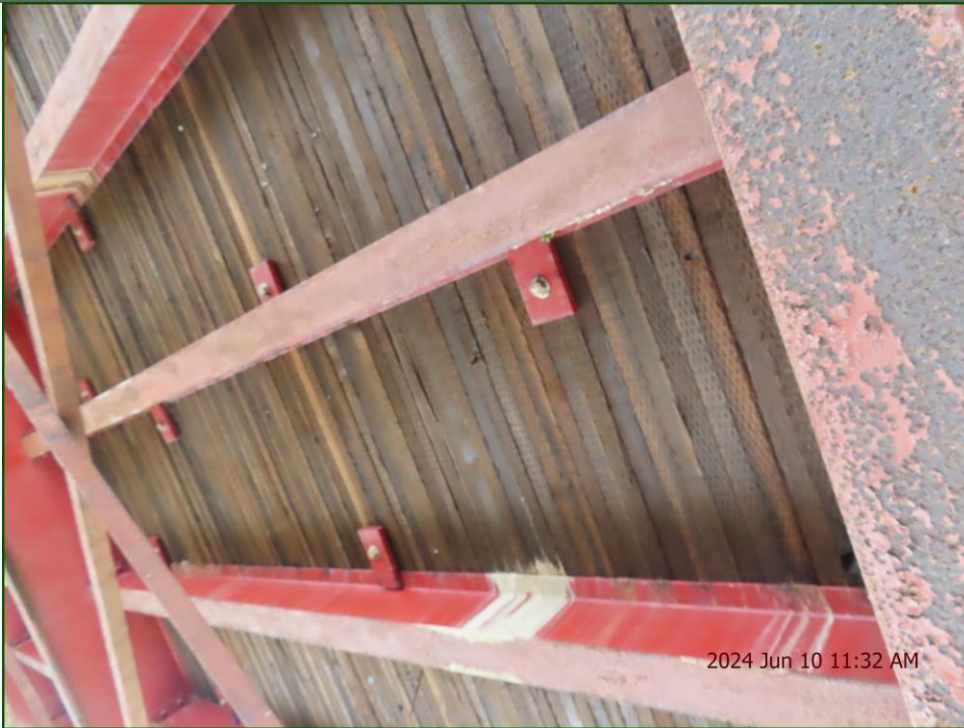
Wetness throughout.

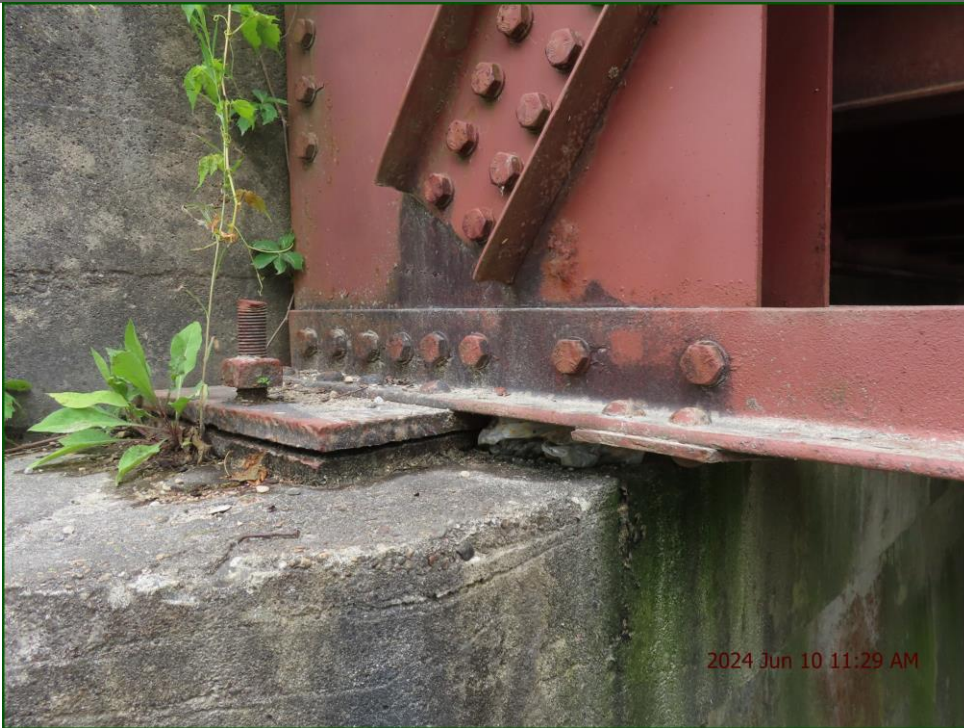
Medium corrosion at both east bearings.

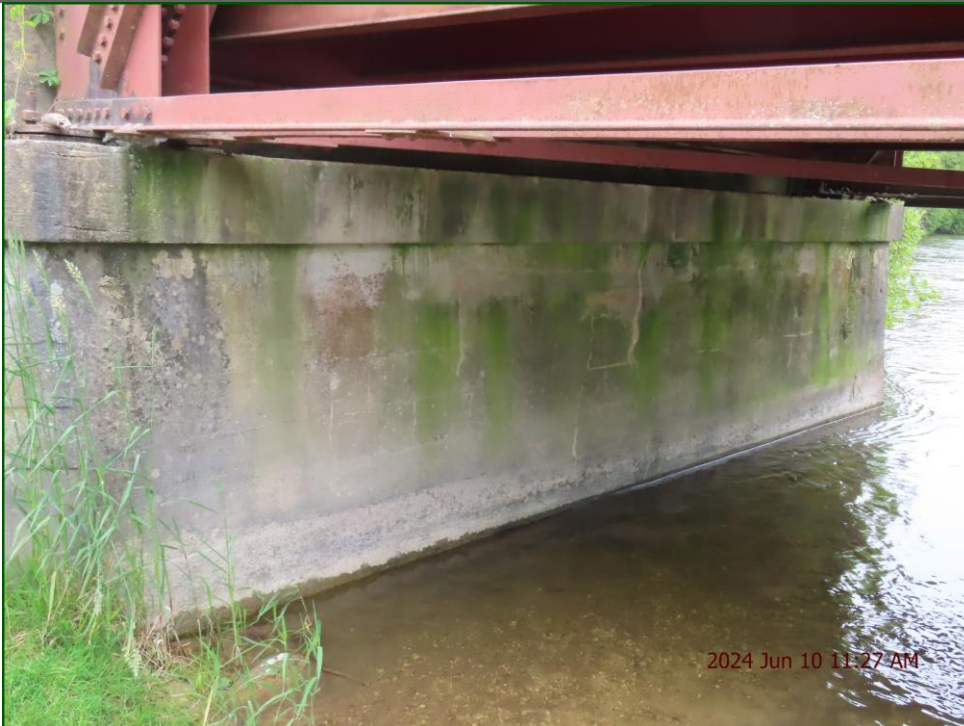
Light to medium vertical cracking with leachate staining.

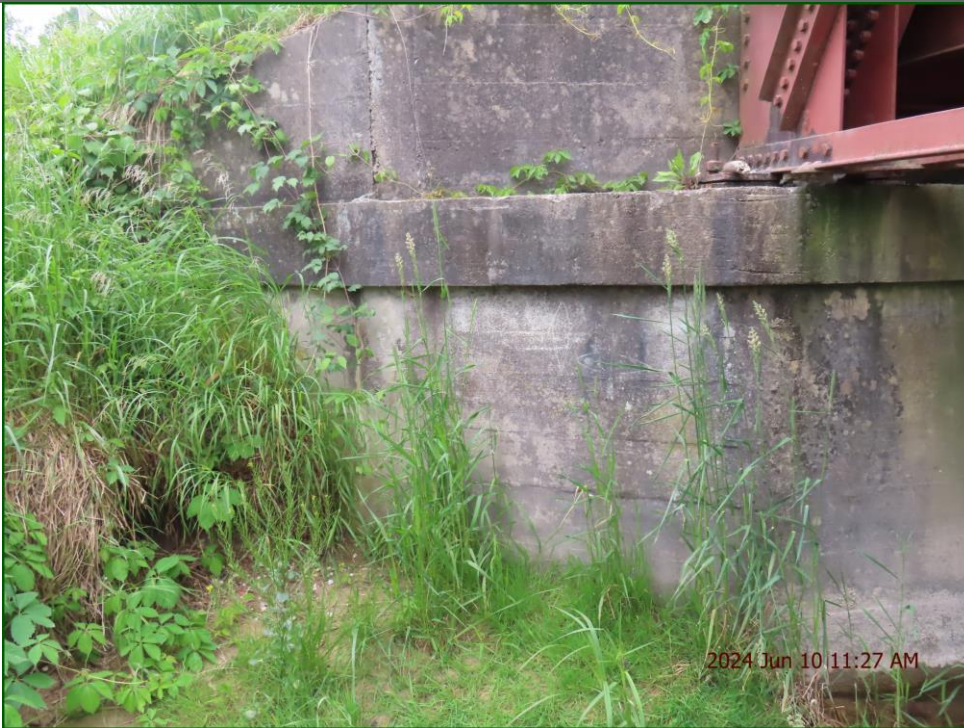
Light to medium vertical cracking with leachate staining.

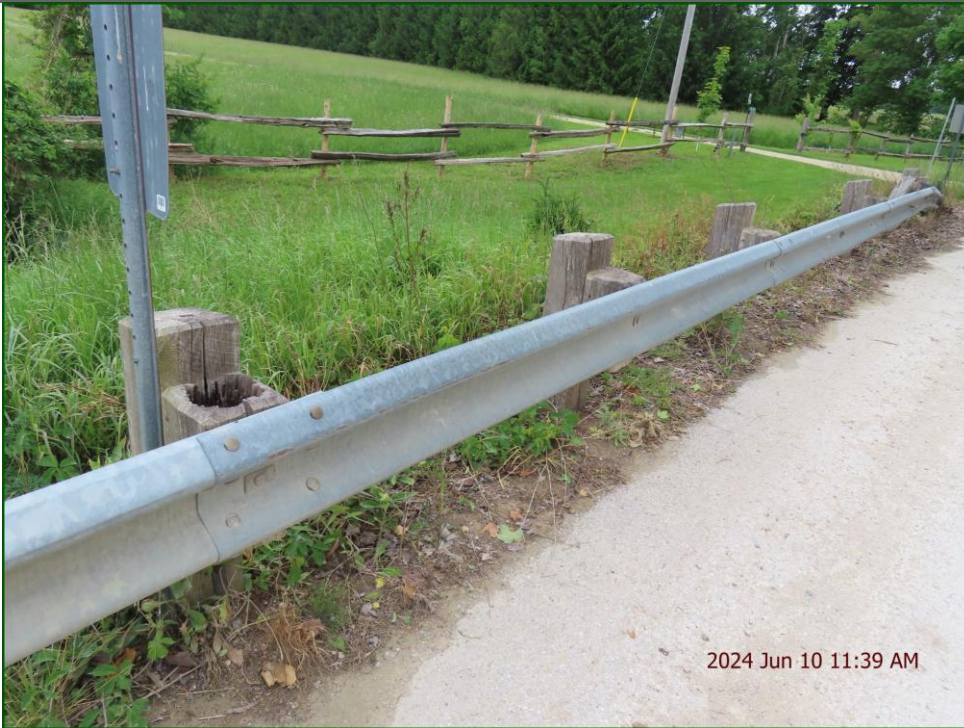
Missing timber post on SW quadrant. Severe rotting.

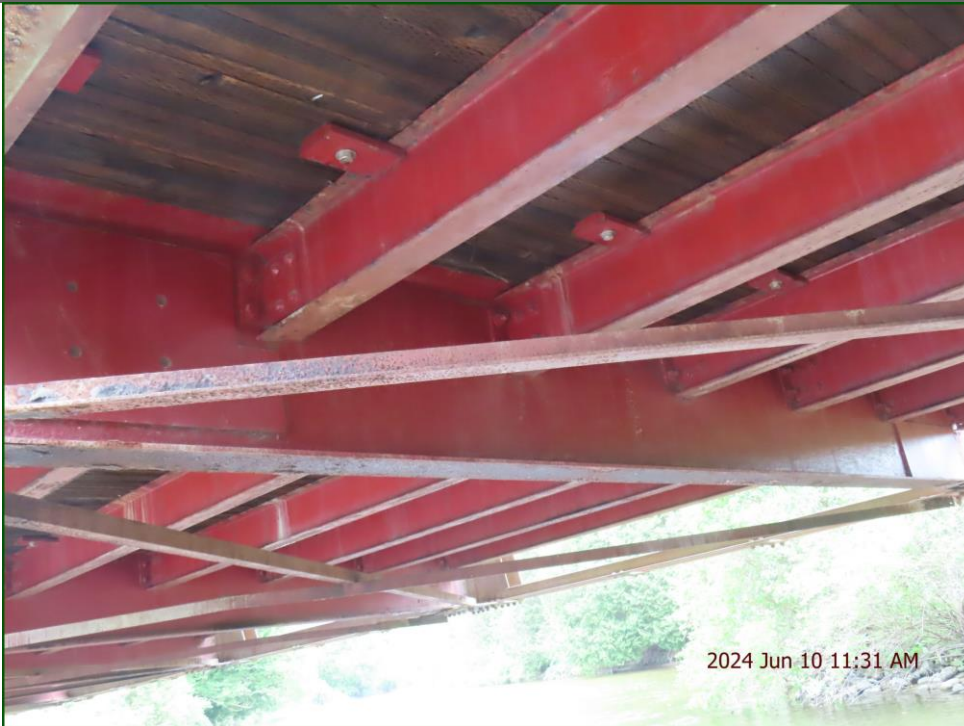
Light corrosion throughout. Moderate corrosion at ends.

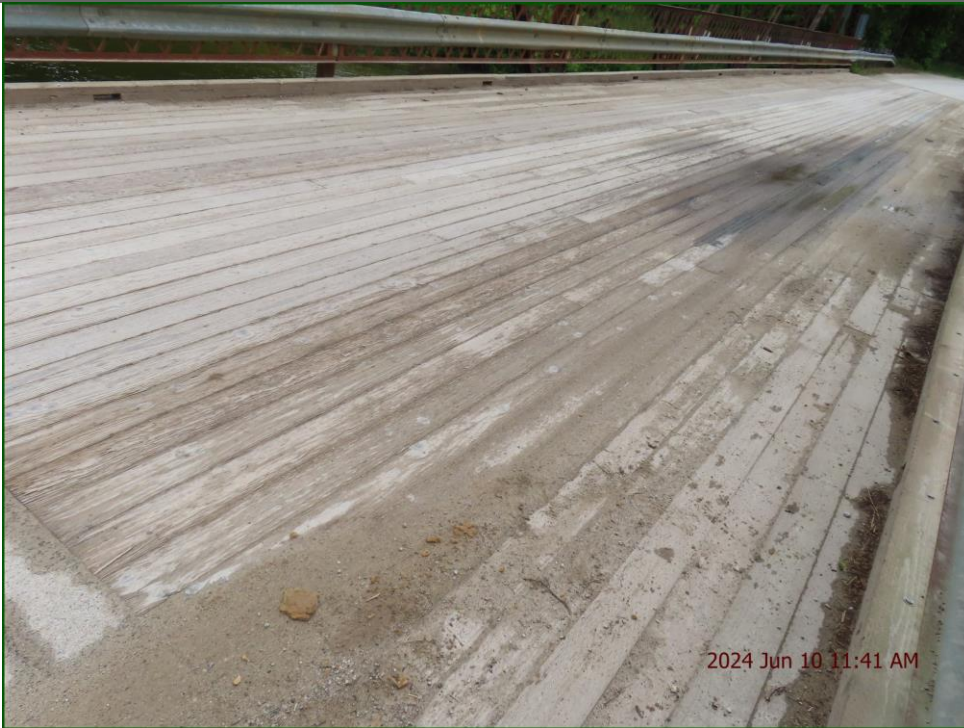
Moderate weathering throughout.

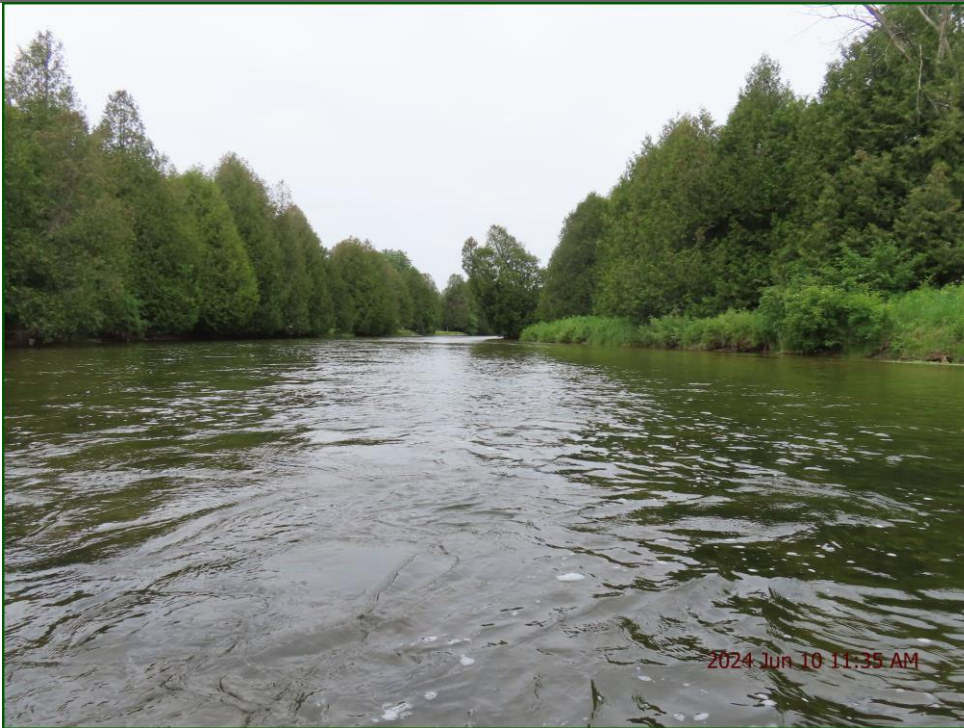
Heavy flow at time of inspection.

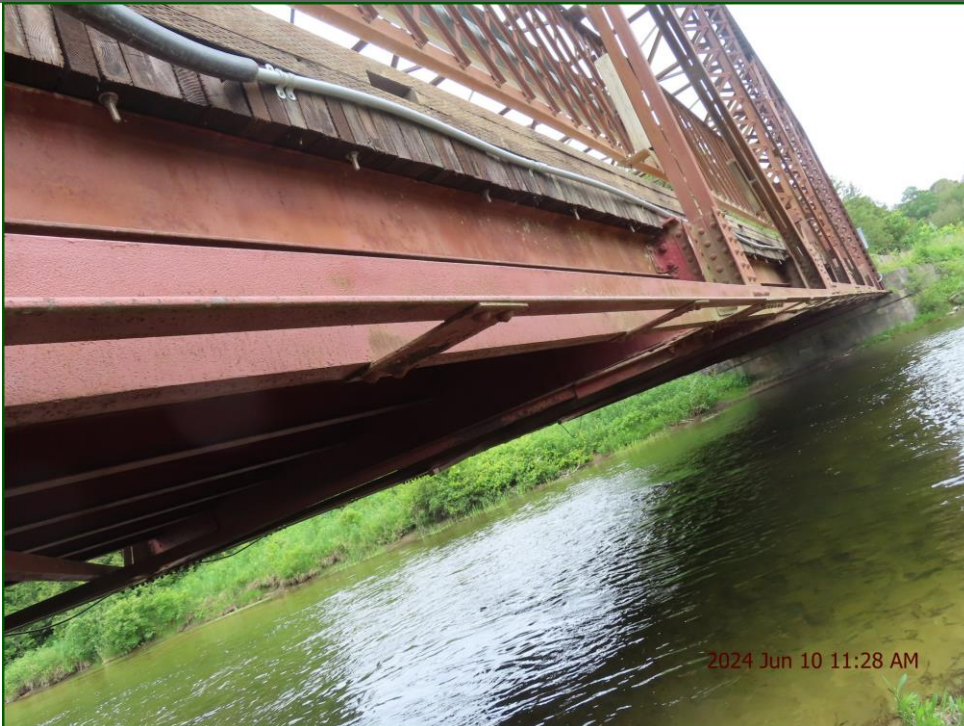
Light to medium corrosion throughout, worse at ends.

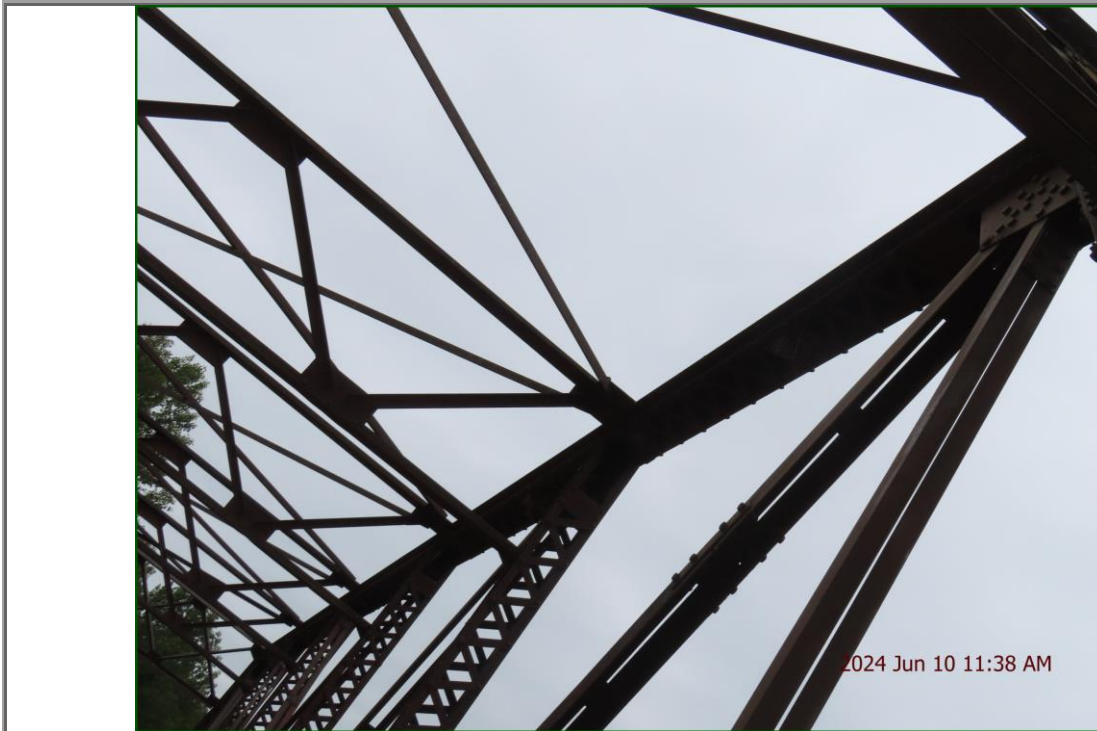
Light corrosion throughout.
