OSIM Biennial Inspection Report

Concession 11/12, Lot 30

Burgess Engineering Inc

27-Aug-24

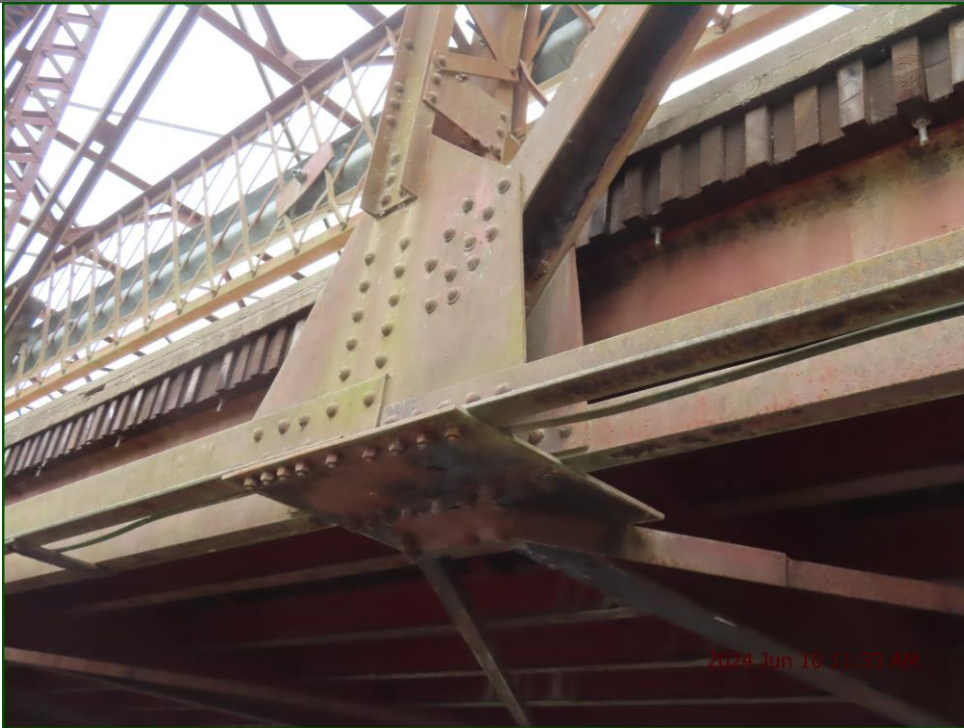
Light to medium corrosion throughout.

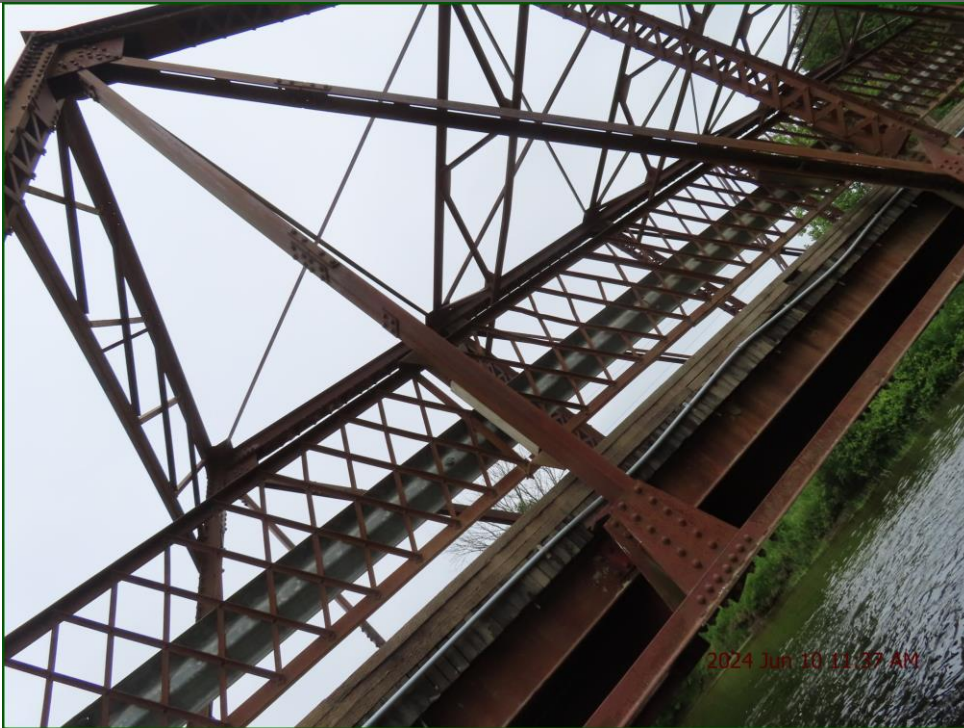
Light corrosion throughout.

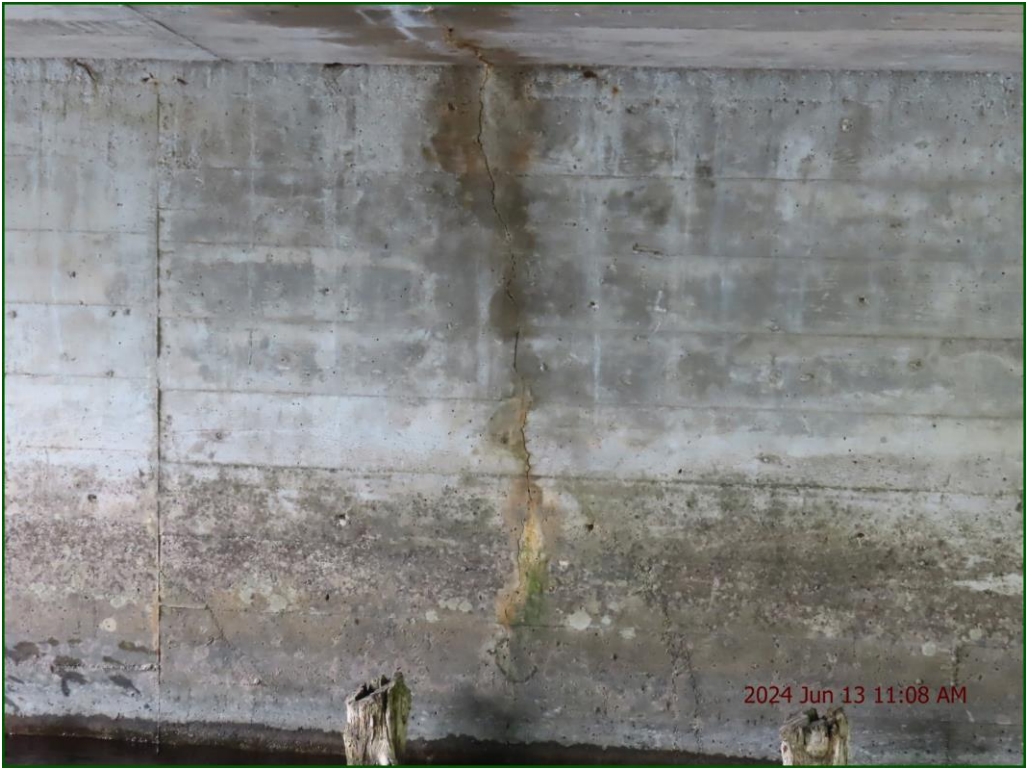
Description: Abutment walls: Medium to wide vertical cracking with leachate staining.

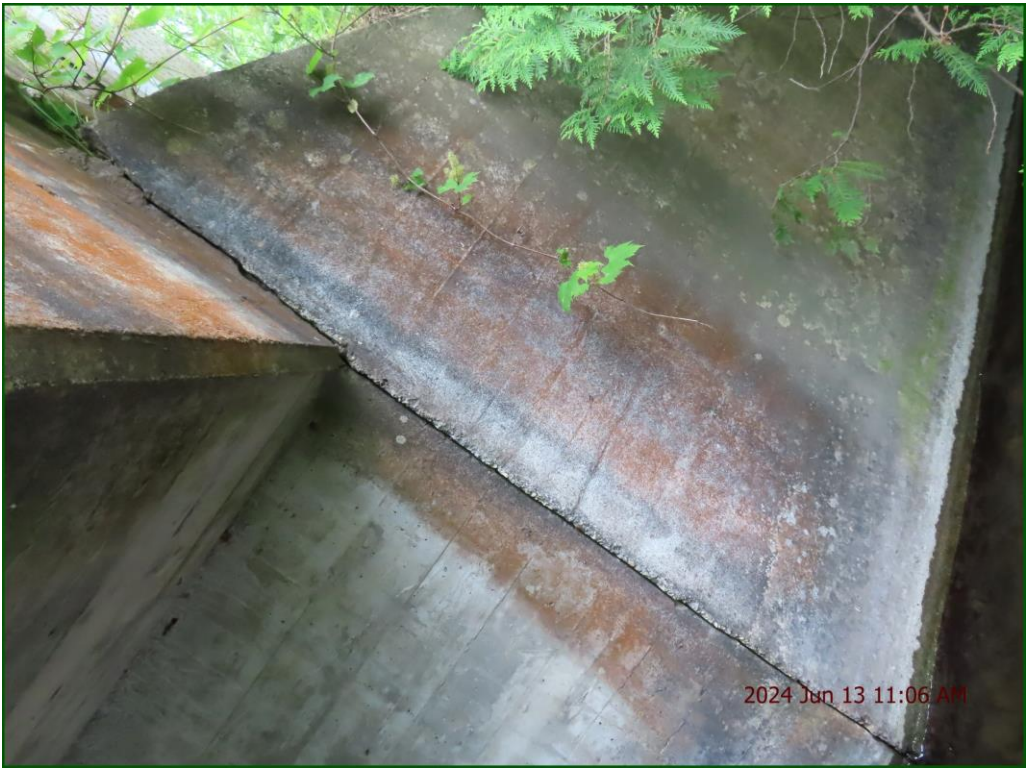
Description: Wingwalls: Possible signs of movement at SW quadrant.

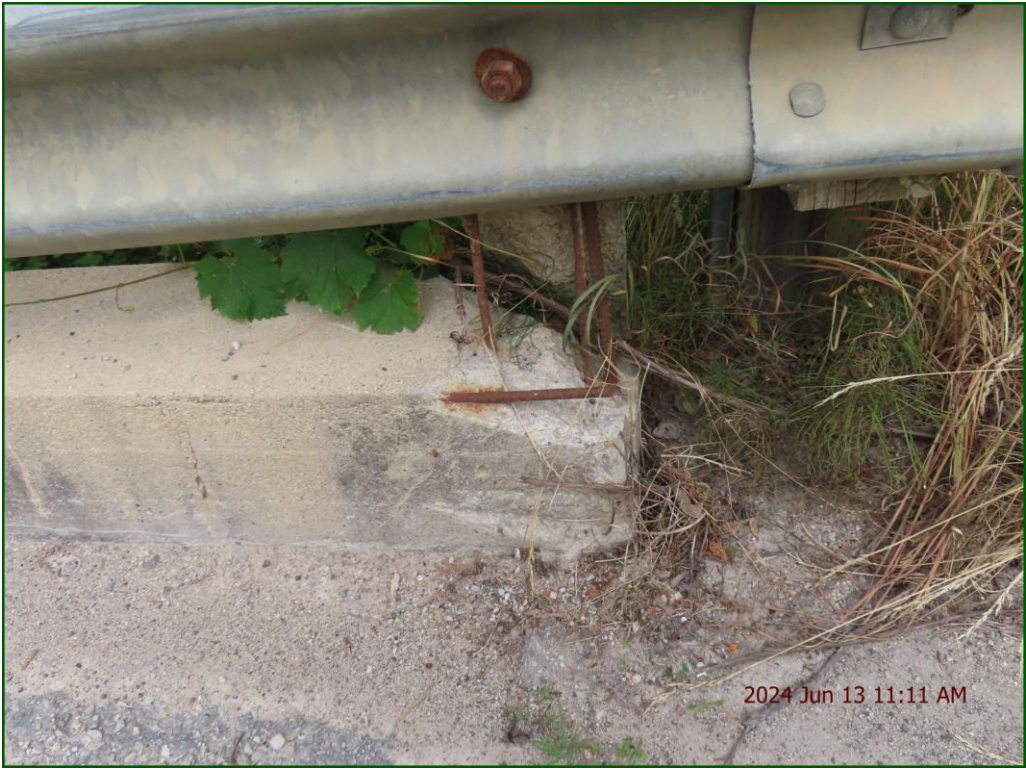
Description: Approach Curbs: Severe spalling with exposed reinforcing at NW quadrant.

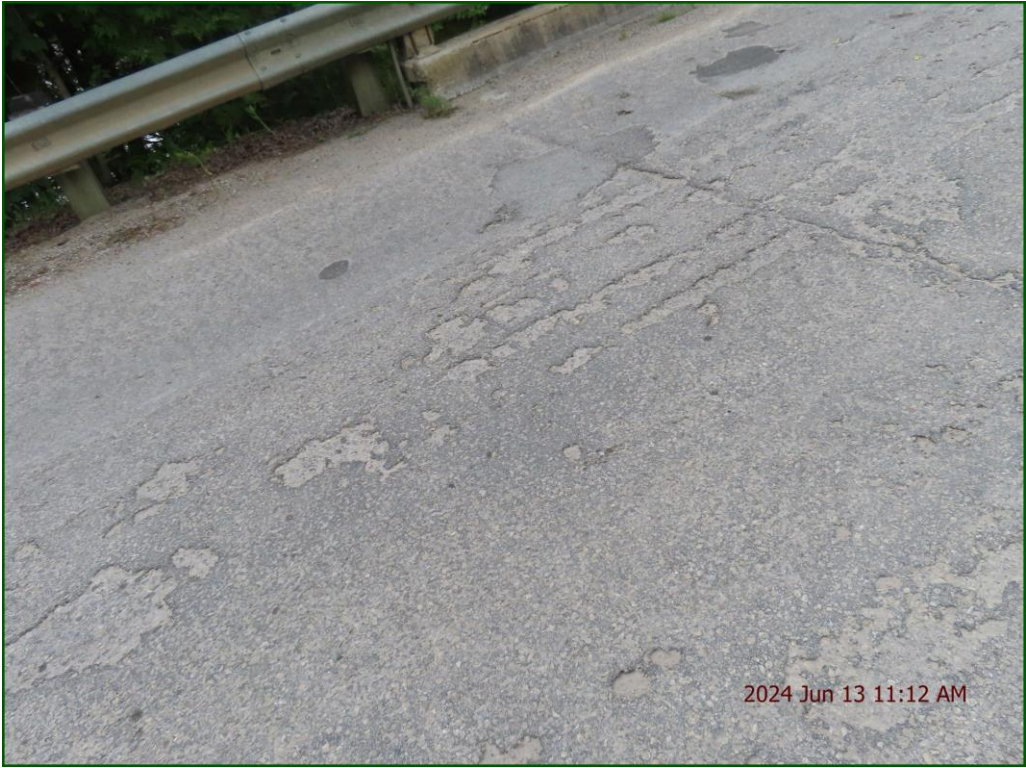
Description: Approach Wearing surface: Moderate ravelling throughout.

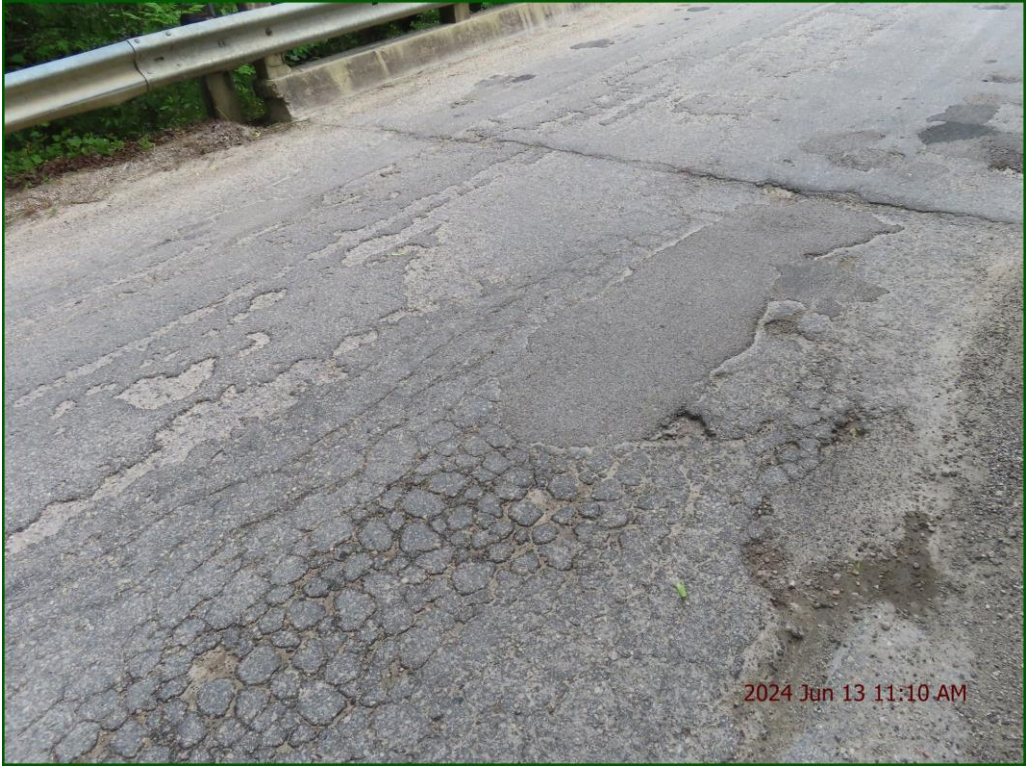
Description: Approach Wearing surface: Moderate to severe alligator cracking.

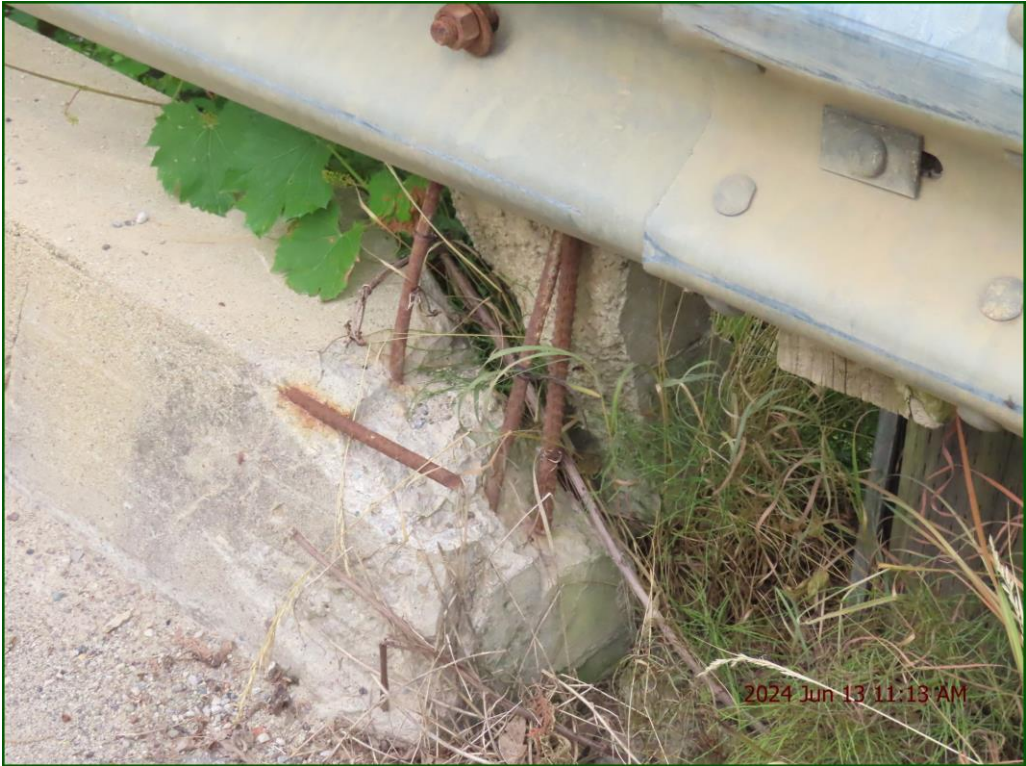
Description: Railing systems: Light spalling with exposed reinforcing.

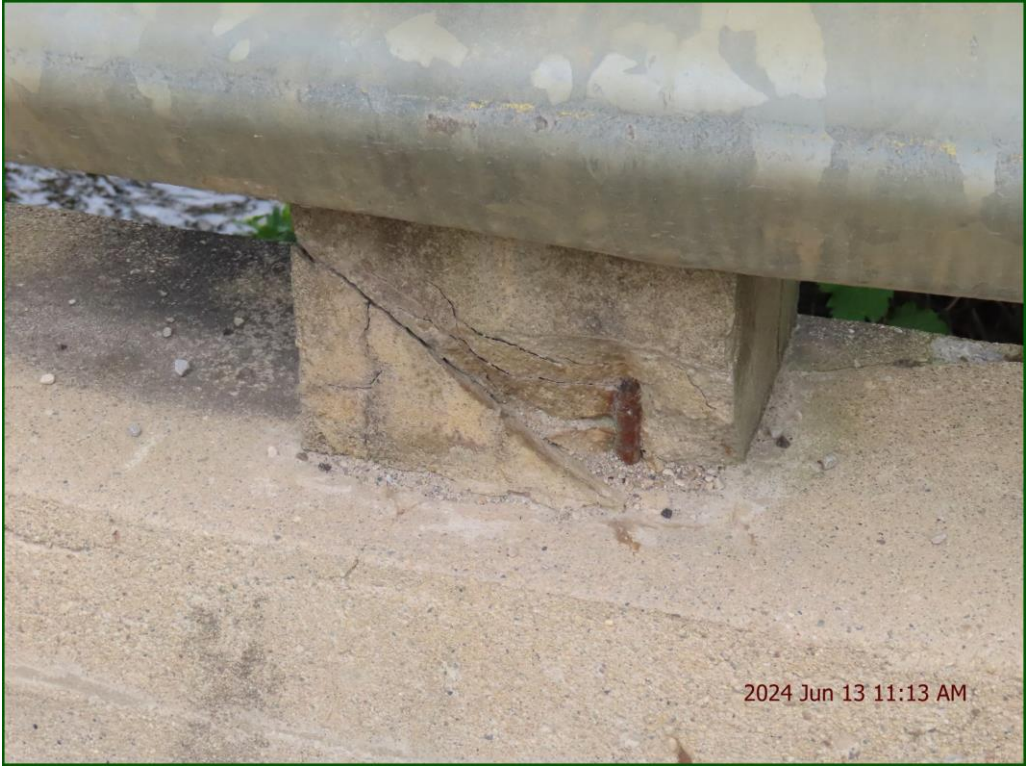
Description: Railing systems: Severe delamination with exposed reinforcing.

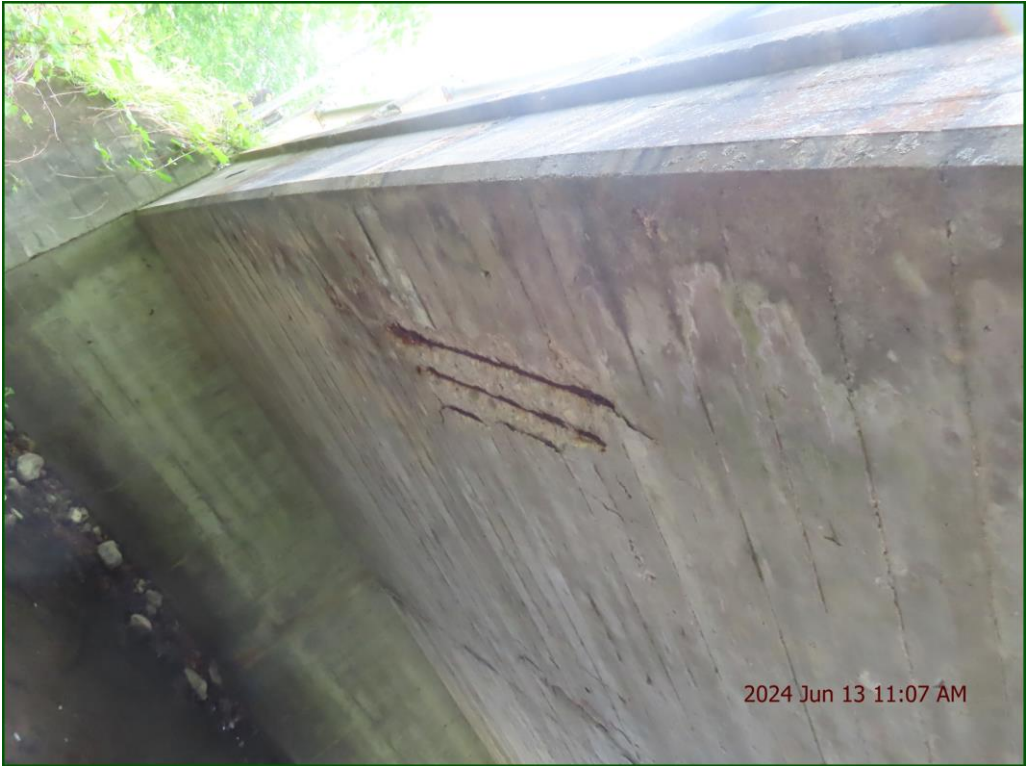
Description: Soffit (ext): Medium to severe spalling with exposed reinforcing.

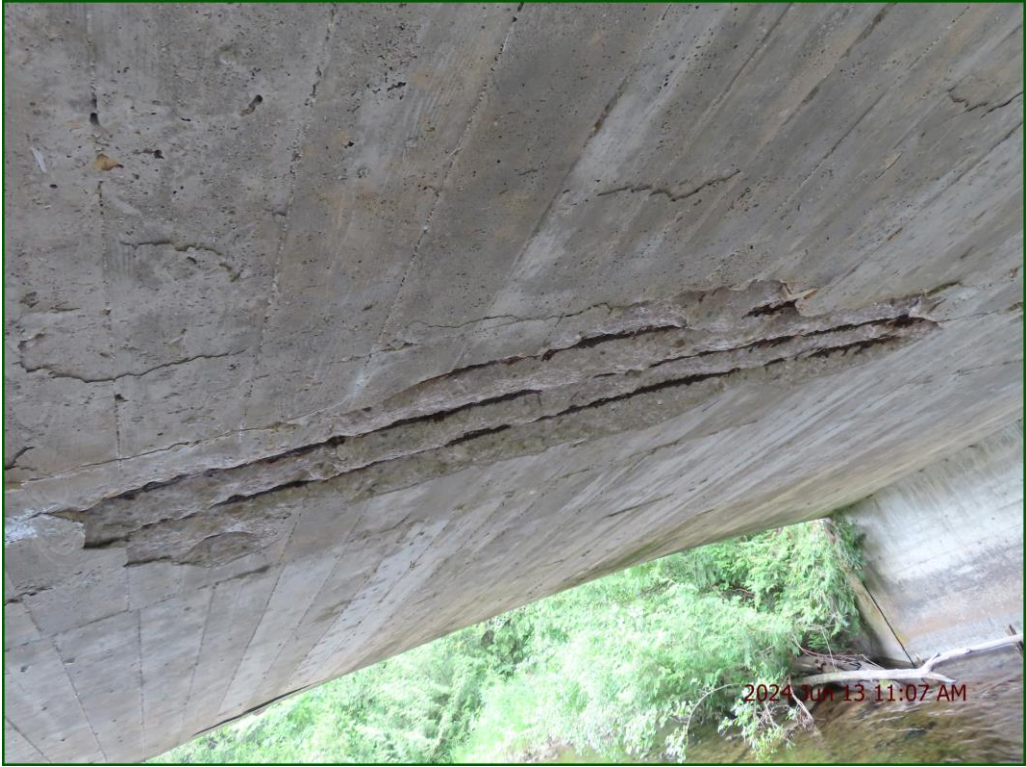
Description: Soffit (int): Severe spalling with exposed reinforcing.

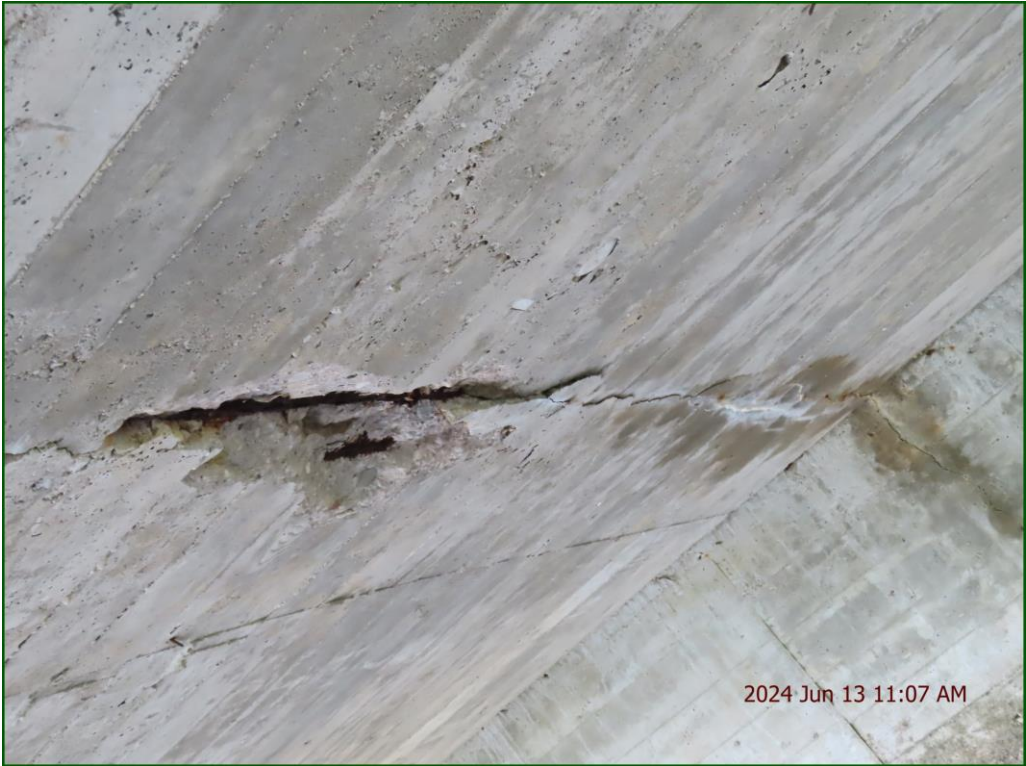
Description: Soffit (int): Medium to wide cracking with leachate staining.

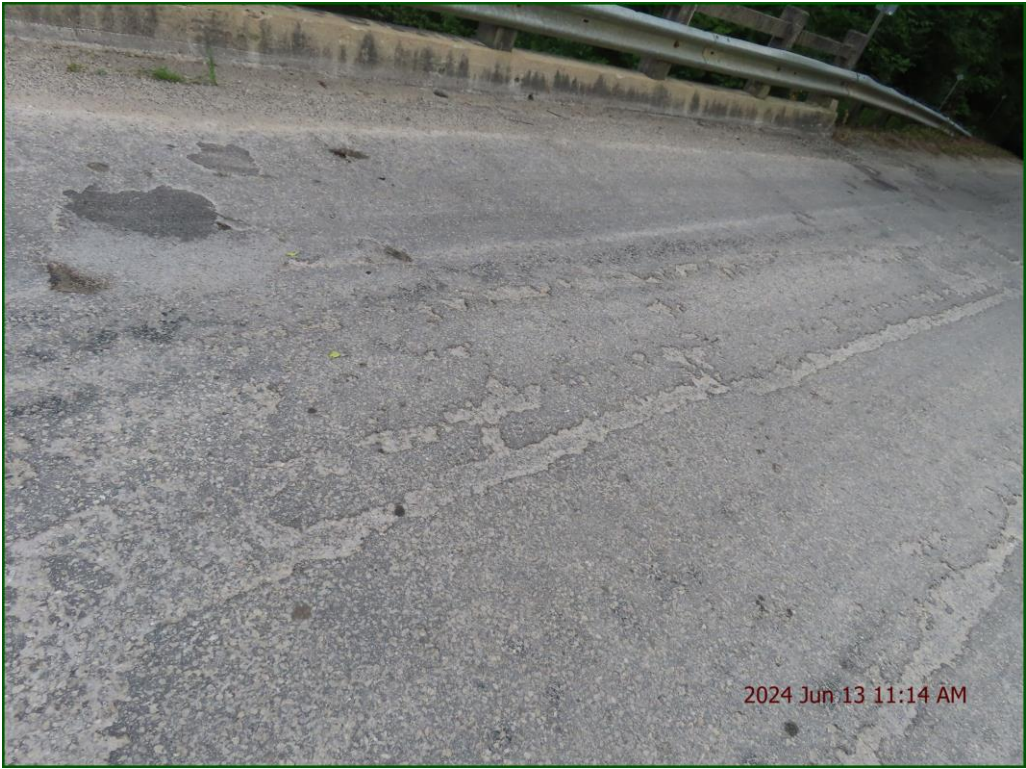
Description: Wearing Surface: Moderate ravelling along centre line.

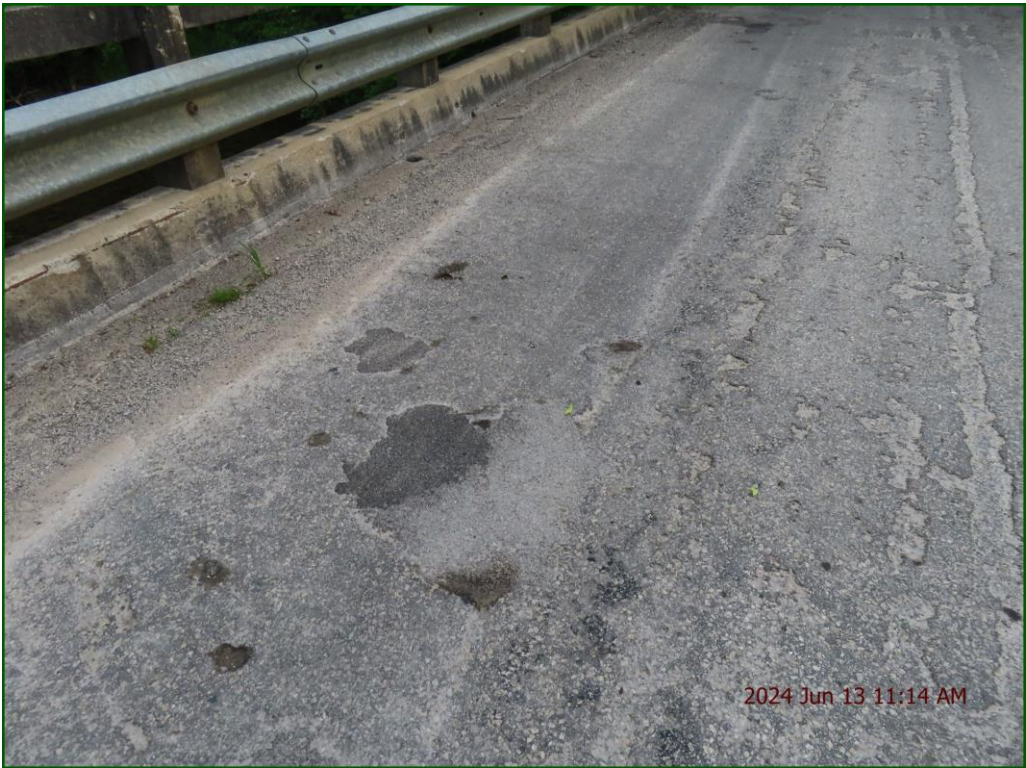
Description: Wearing Surface: Moderate potholes.

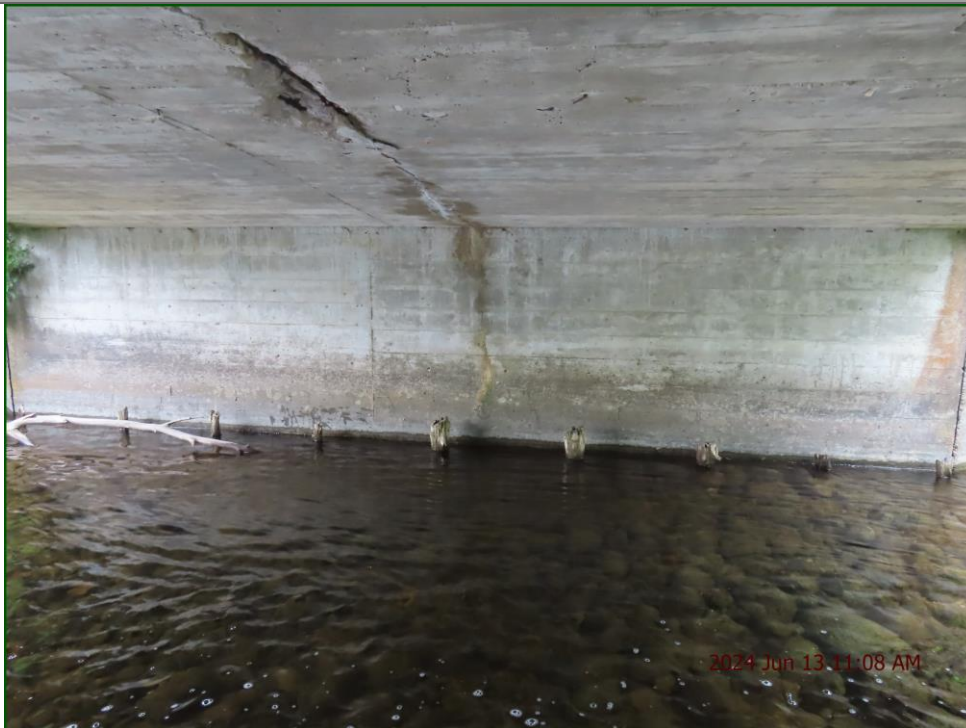
Medium to wide vertical cracking with leachate staining.

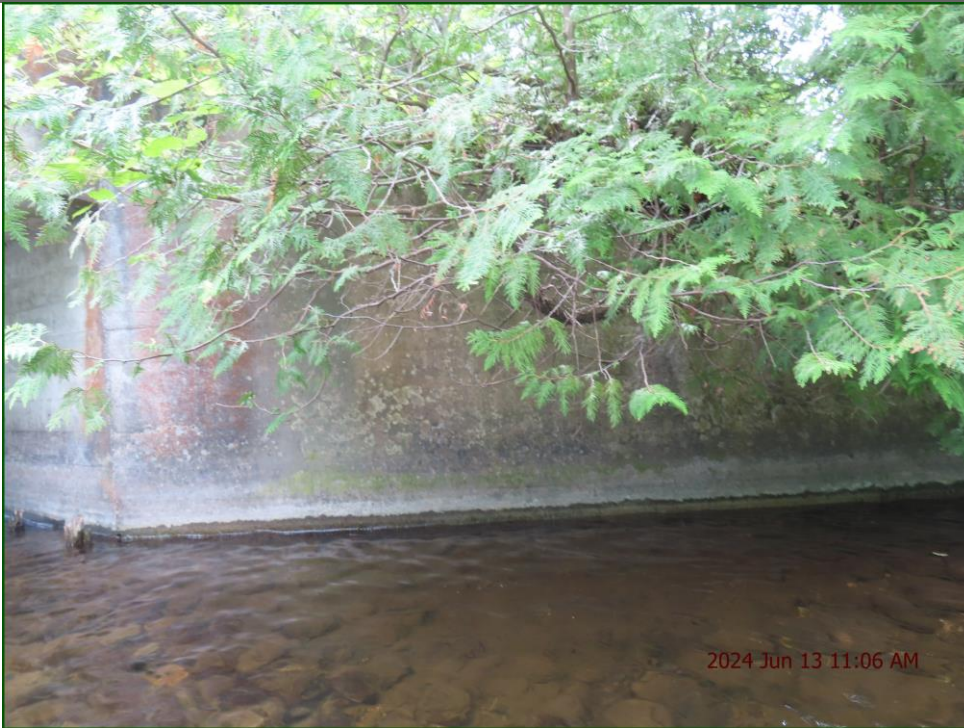
Possible signs of movement at SW quadrant, continue to monitor.

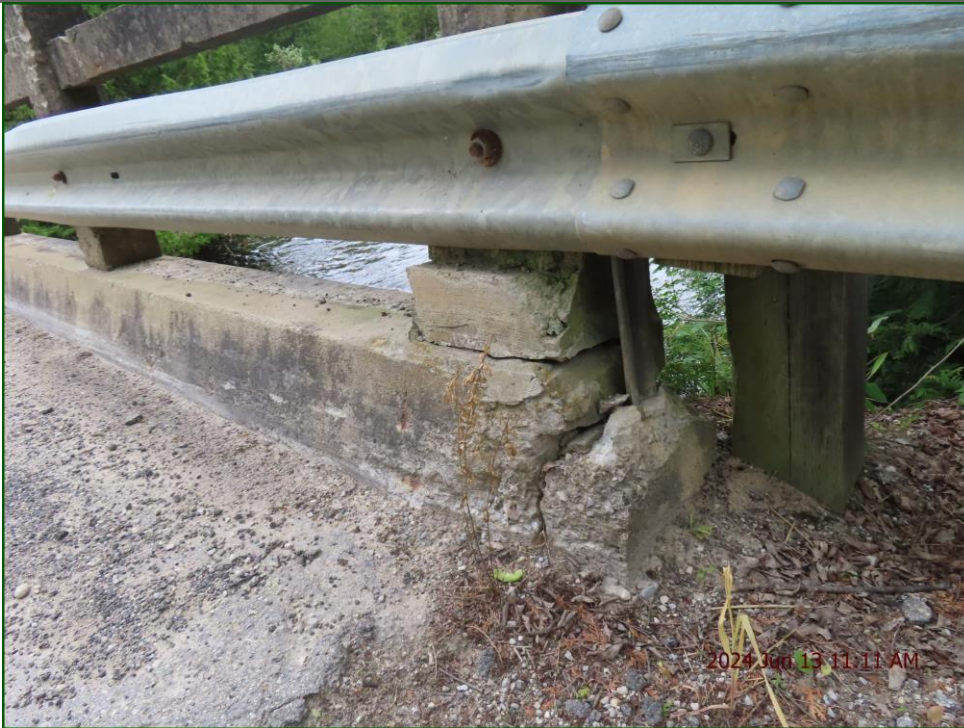
Severe spalling with exposed reinforcing at NW quadrant.

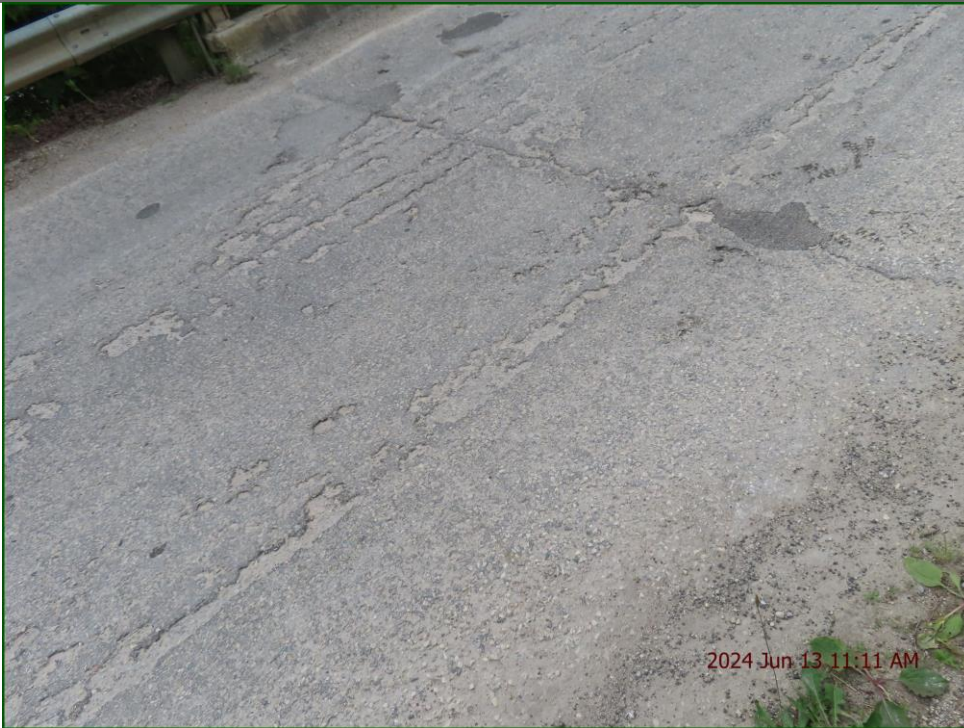
Moderate ravelling throughout. Moderate to severe alligator cracking.

Element Group:	<input type="text" value="Approaches"/>	Site Number:	<input type="text" value="B-006"/>
Element Name:	<input type="text" value="Wearing surface"/>	Width:	<input type="text" value="5.6"/> m
Element type:	<input type="text"/>	Height:	<input type="text" value="0"/> m
Sub-element:	<input type="text"/>	Length:	<input type="text" value="6.1"/> m
Material:	<input type="text" value="Asphalt"/>	Count:	<input type="text" value="2"/>
Location:	<input type="text"/>	Total Quantity:	<input type="text" value="68"/> sqm
Environment:	<input type="text" value="Severe"/>	Not inspected:	<input type="checkbox"/>
Perform. deficiencies:	<input type="text"/>	Maintenance Type:	<input type="text" value="Structural"/>
Maint needs:	<input type="text" value="Asphalt Repairs"/>	Maint. Time Period:	<input type="text" value="1 Year"/>

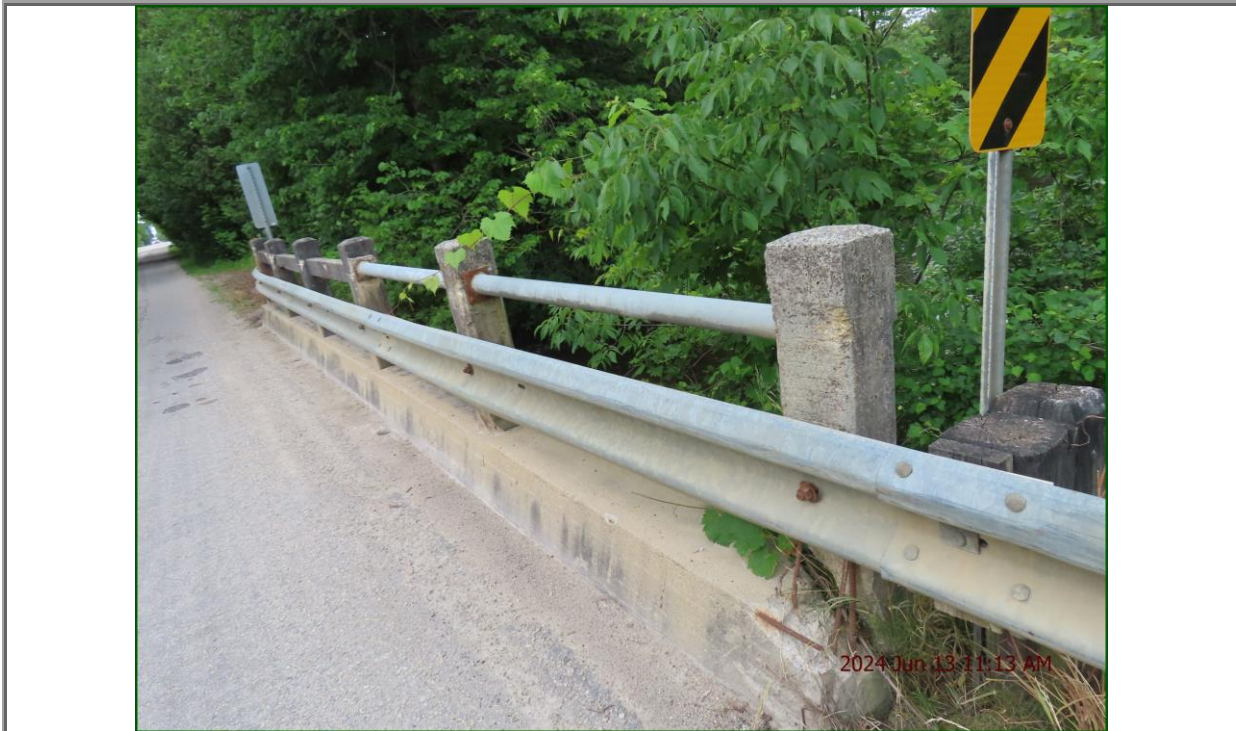
Light spalling with exposed reinforcing. Severe delamination with exposed reinforcing.

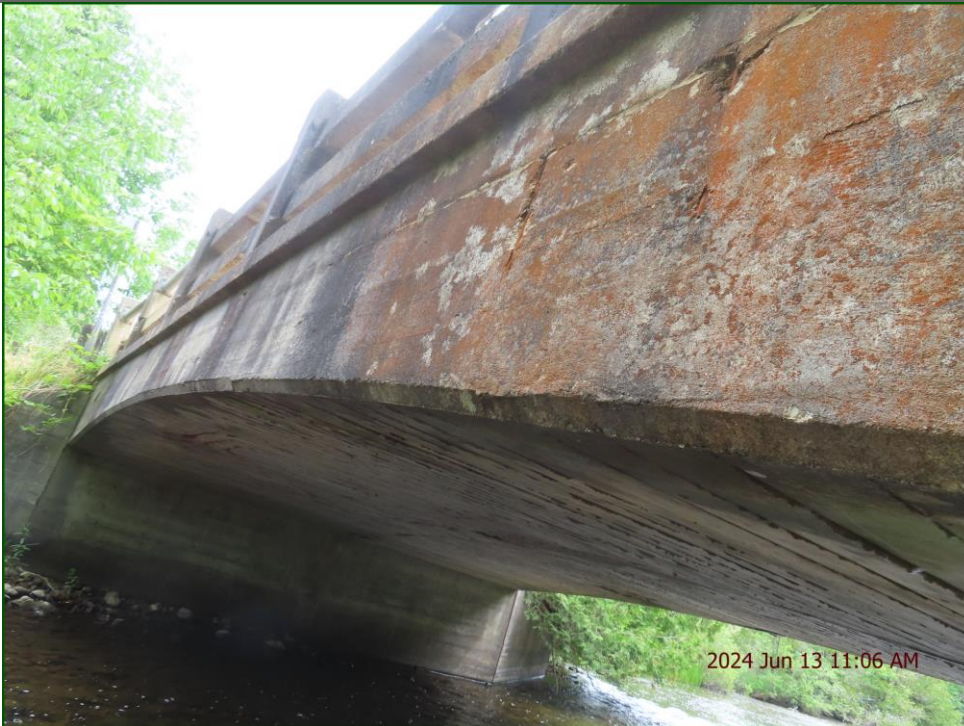
Medium to severe spalling with exposed reinforcing.

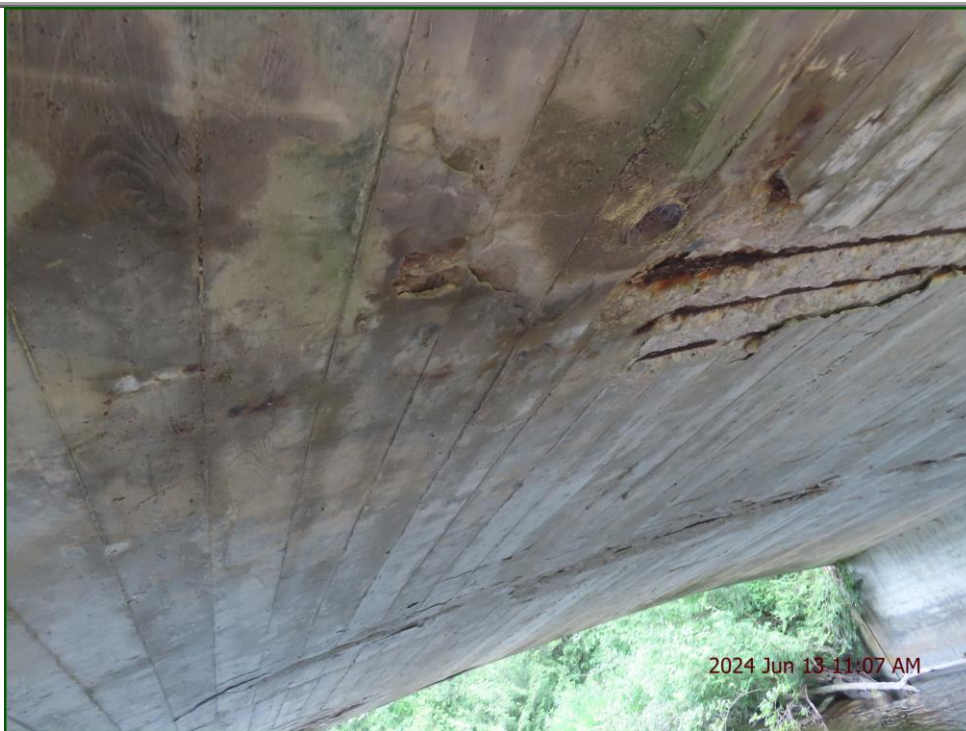
Severe spalling with exposed reinforcing. Medium to wide cracking with leachate staining.

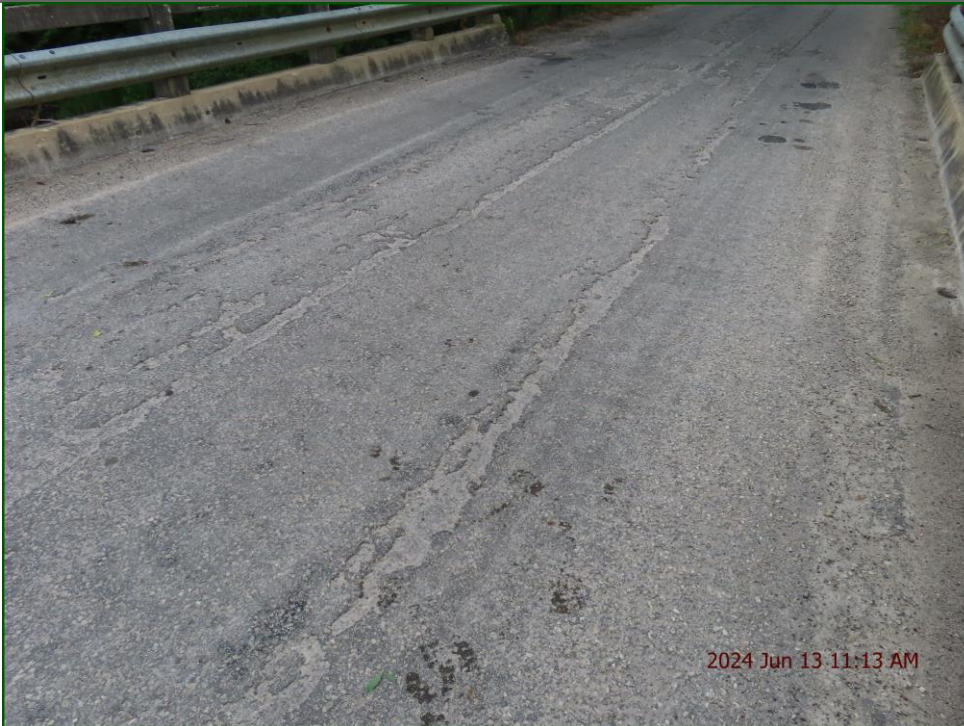
Moderate ravelling along centre line. Moderate potholes.

Element Group:	Decks	Site Number:	B-006
Element Name:	Wearing Surface	Width:	5.6 m
Element type:		Height:	0 m
Sub-element:		Length:	10.6 m
Material:	Asphalt	Count:	1
Location:		Total Quantity:	59 sqm
Environment:	Severe	Not inspected:	<input type="checkbox"/>
Perform. deficiencies:		Maintenance Type:	Structural
Maint needs:	Asphalt Repairs	Maint. Time Period:	1 Year

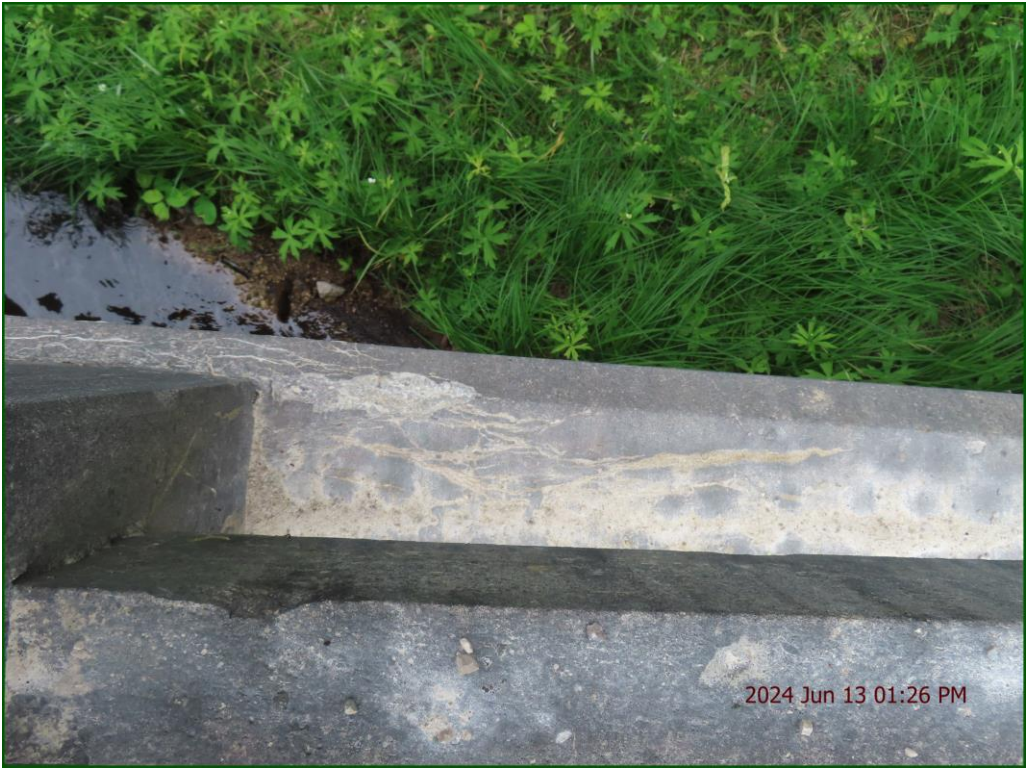
Description: Approach Curbs: Wide horizontal cracking.

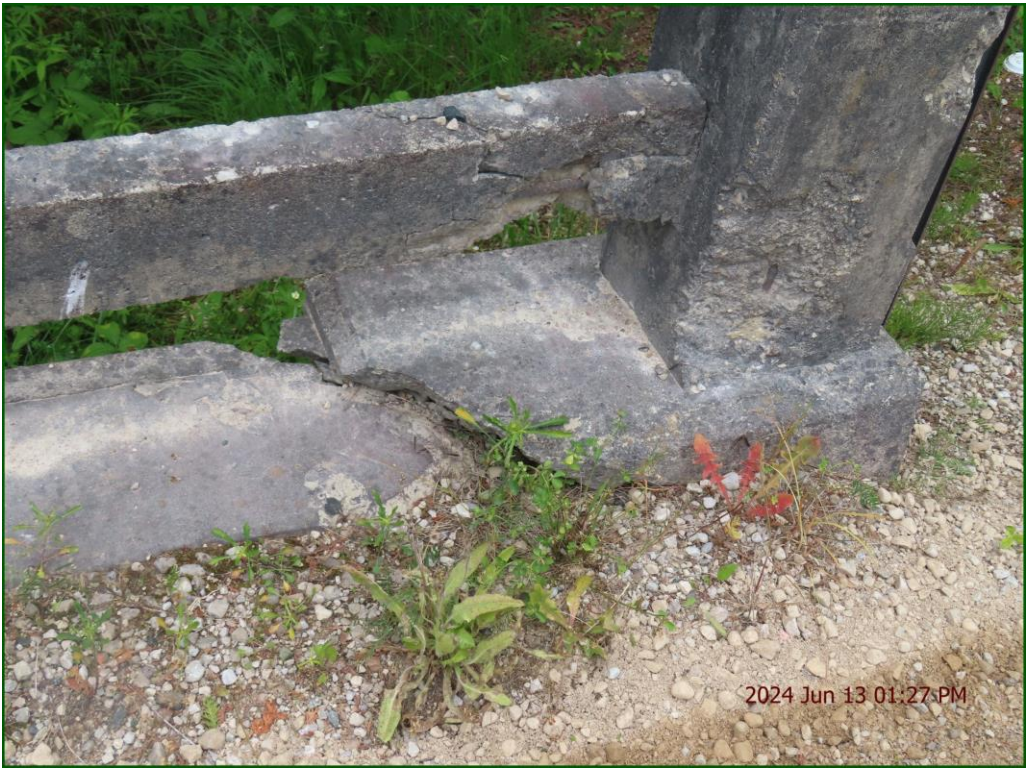
Description: Approach Curbs: Severe impact damage on SW quadrant.

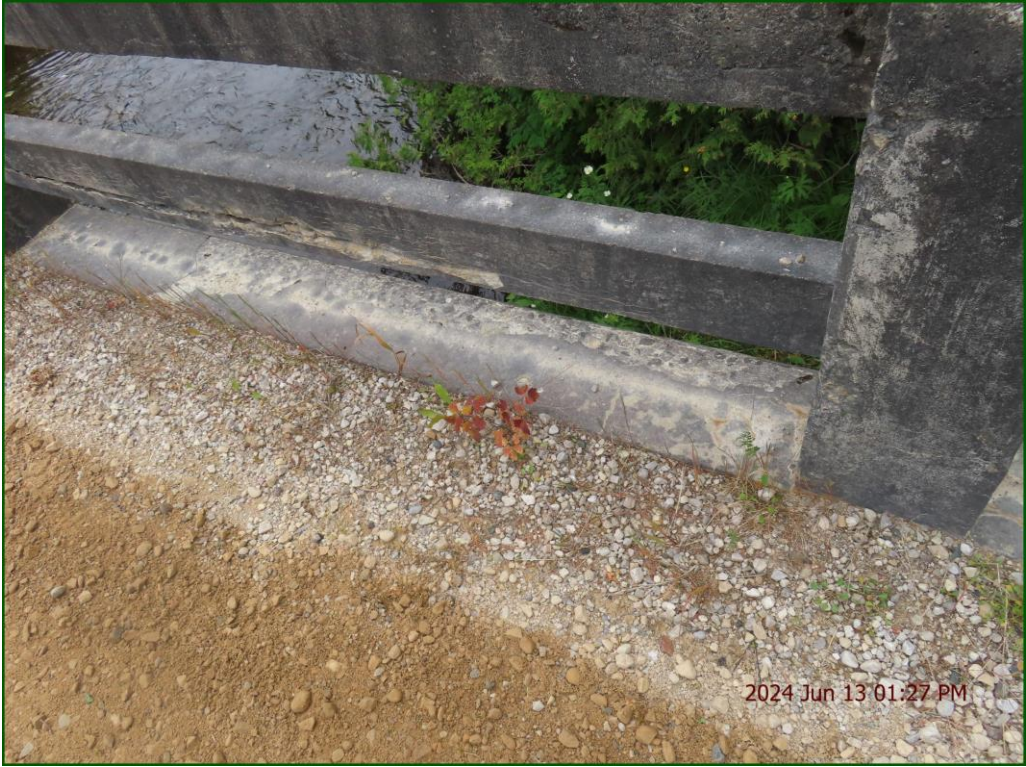
Description: Curbs: Medium scaling throughout.

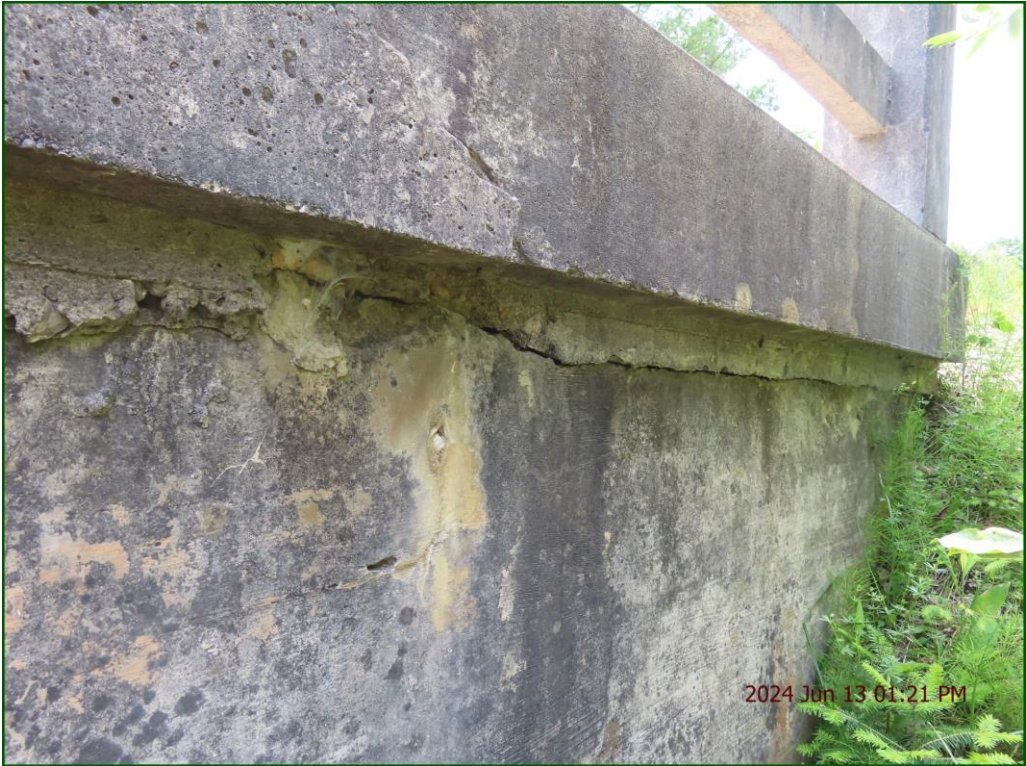
Description: Wingwalls: Medium to wide cracking at construction joints.

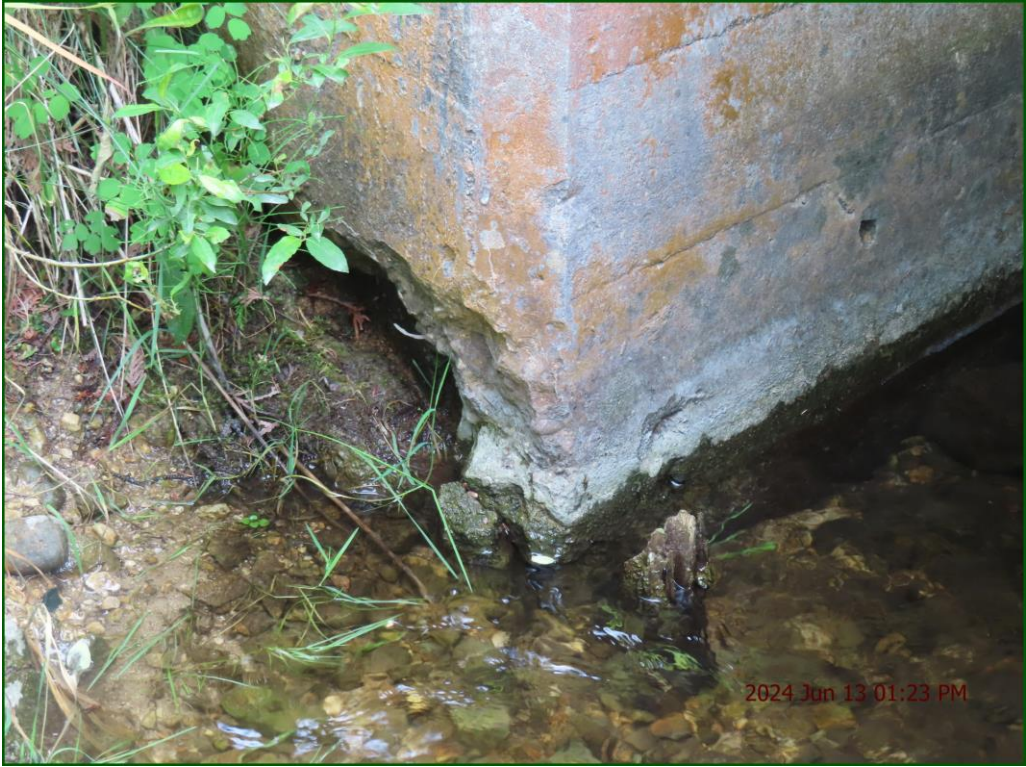
Description: Wingwalls: Medium spall on NE quadrant.

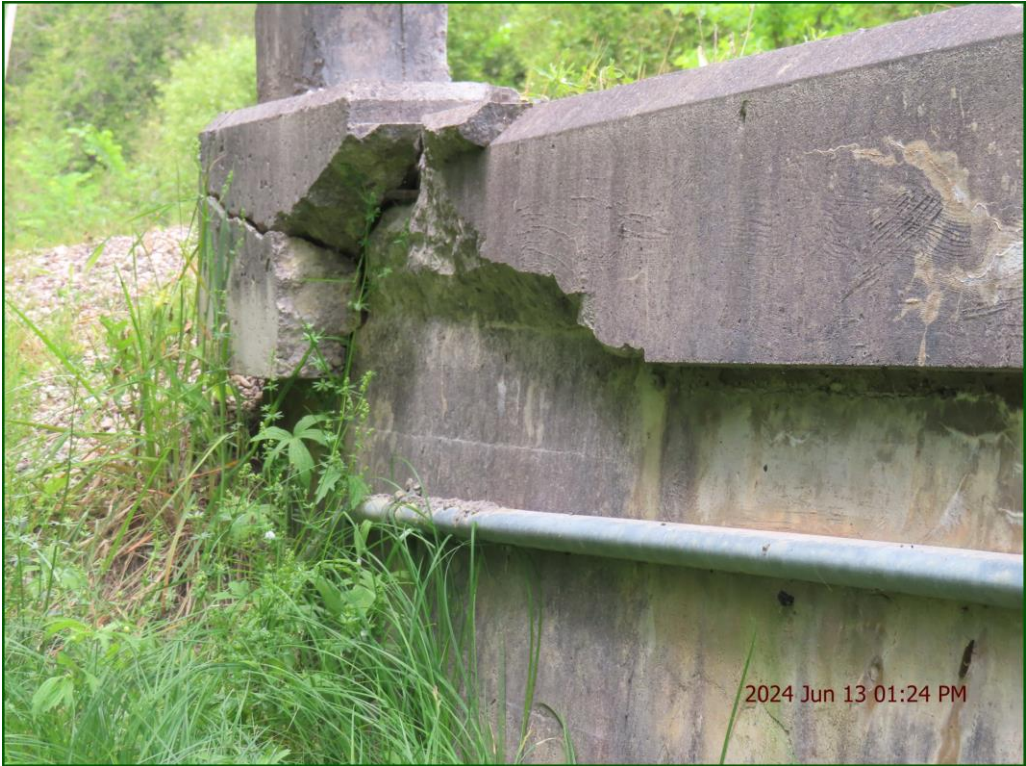
Description: Wingwalls: Severe spall on SW quadrant.

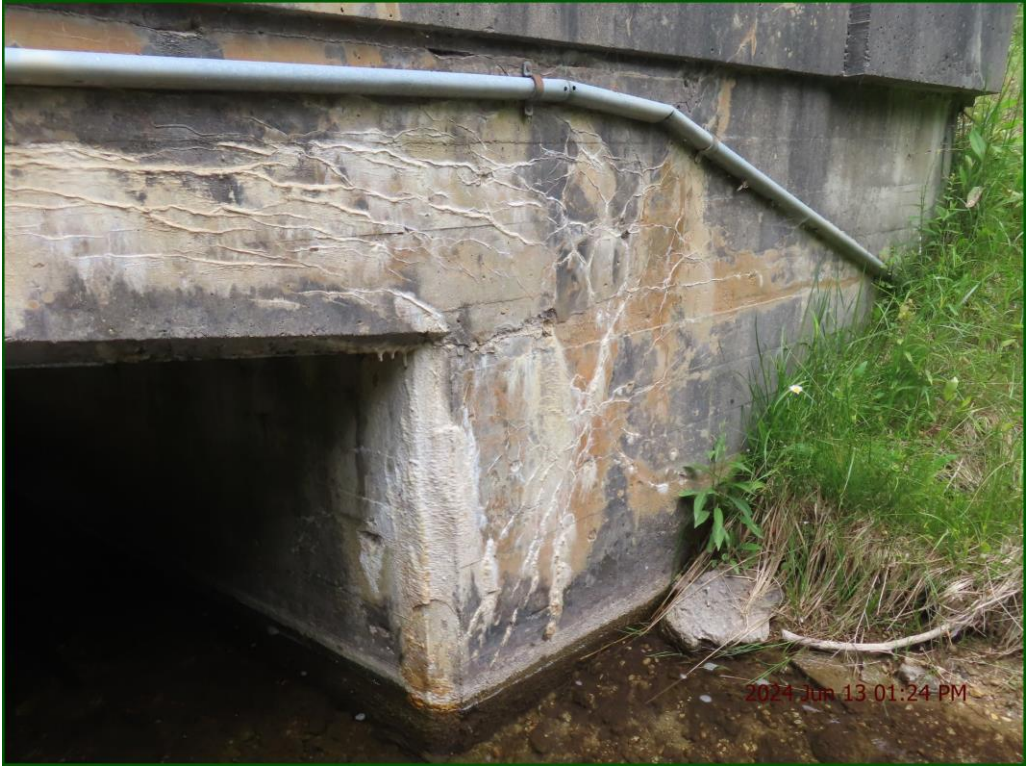
Description: Wingwalls: Light to medium map cracking with leachate staining.
