OSIM Biennial Inspection Report

Concession 11/12, Lot 30

Burgess Engineering Inc

27-Aug-24

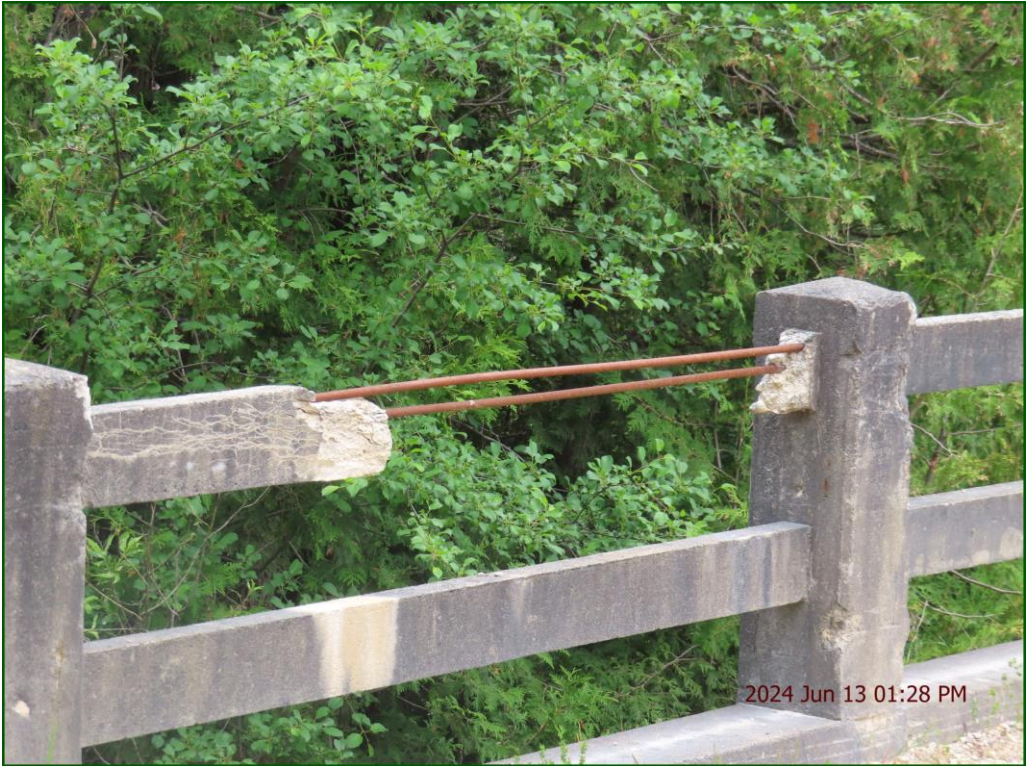
Description: Railing systems: Severe spalling throughout with areas of 100% section loss.

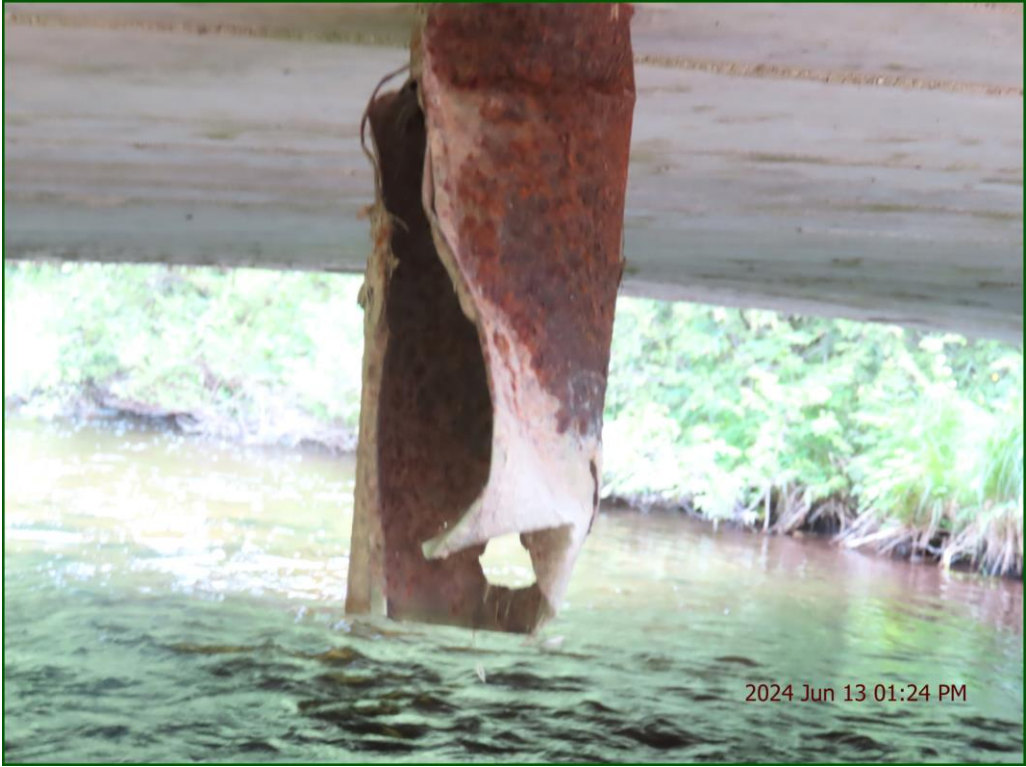
Description: Drainage System: Local severe impact damage.

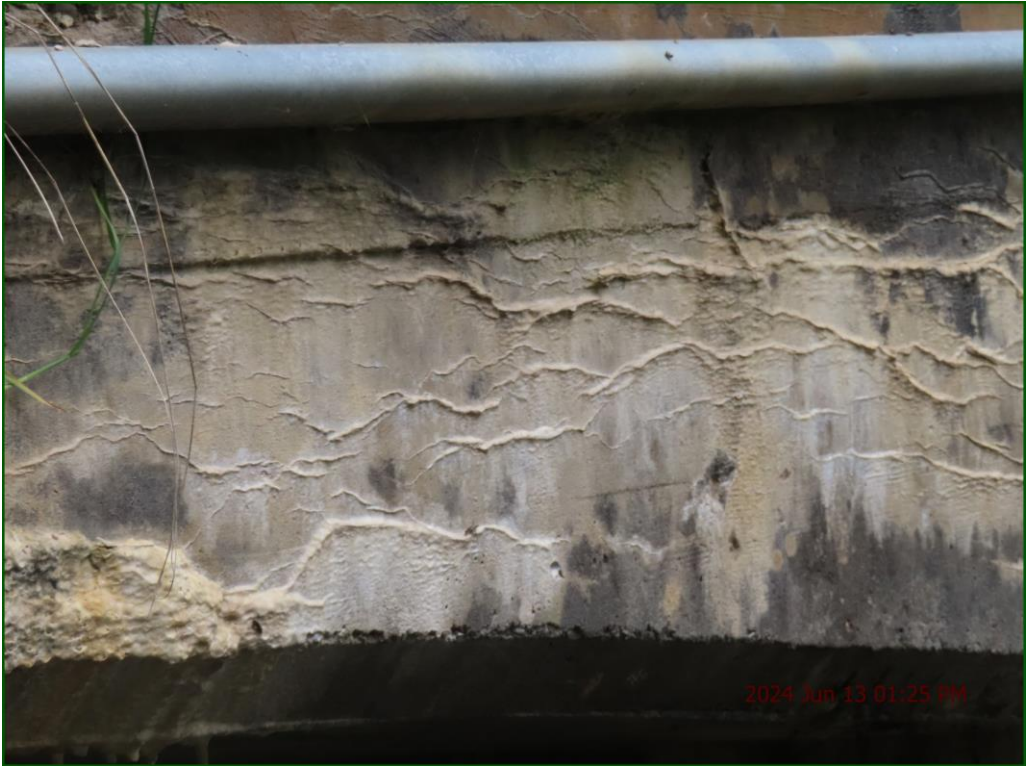
Description: Soffit (ext): Light to medium map cracking with leachate staining throughout.

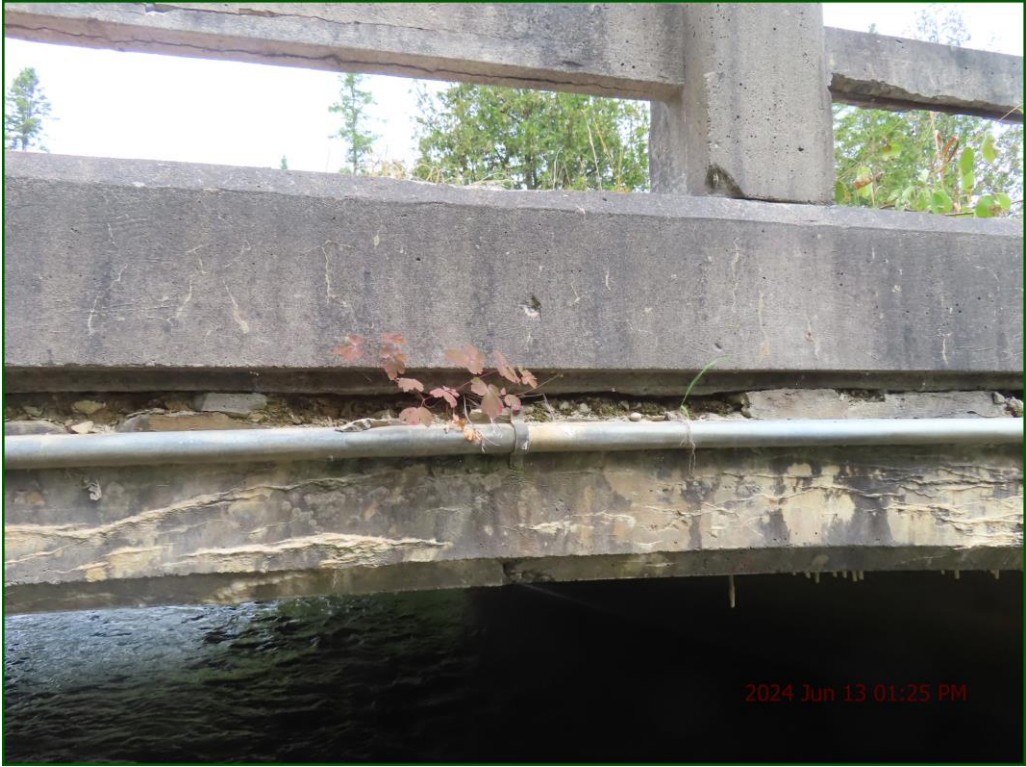
Description: Soffit (ext): Severe disintegration at construction joints.

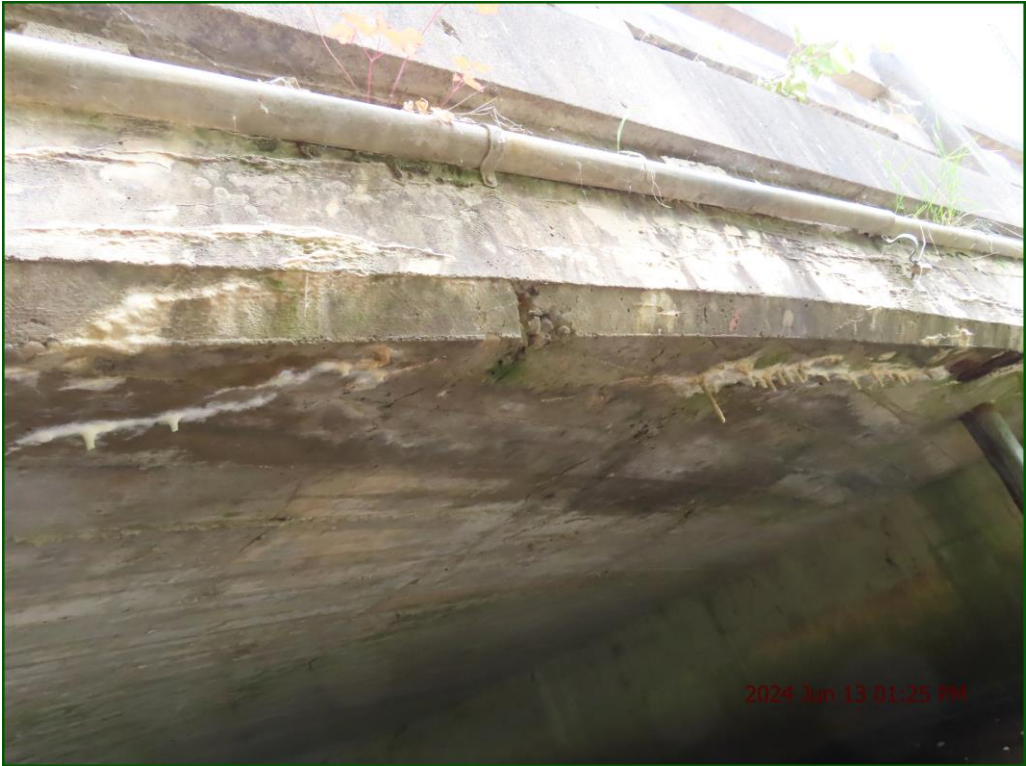
Description: Soffit (ext): Medium to wide longitudinal cracking with leachate staining.

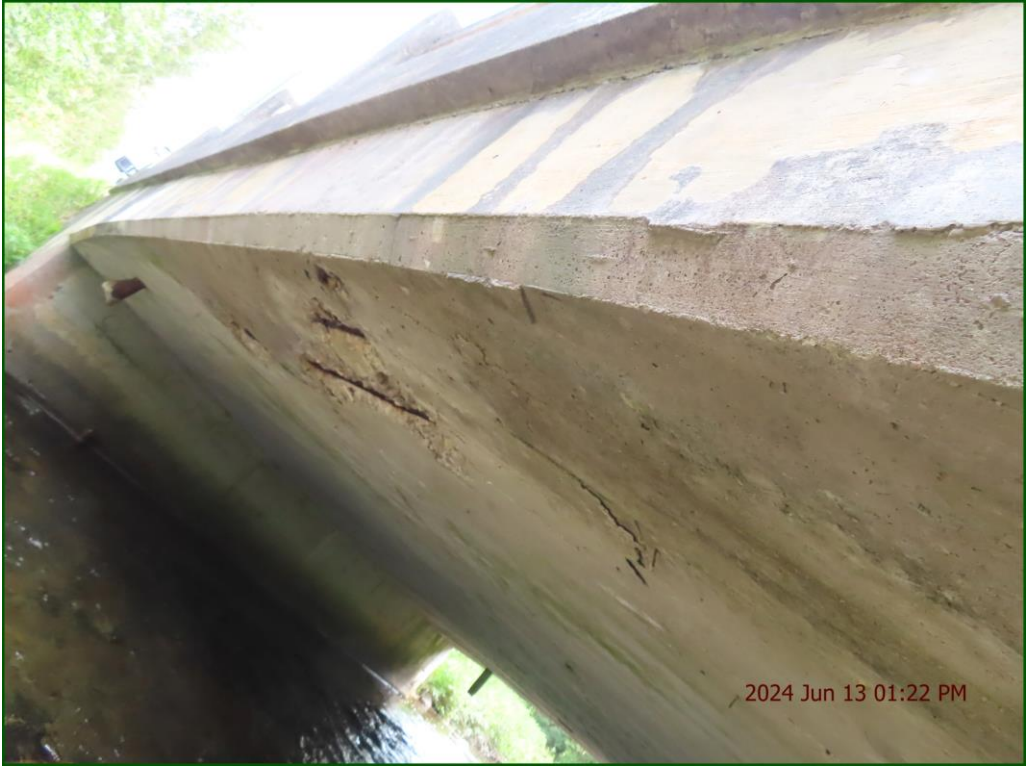
Description: Soffit (ext): Light spalling with exposed reinforcement.

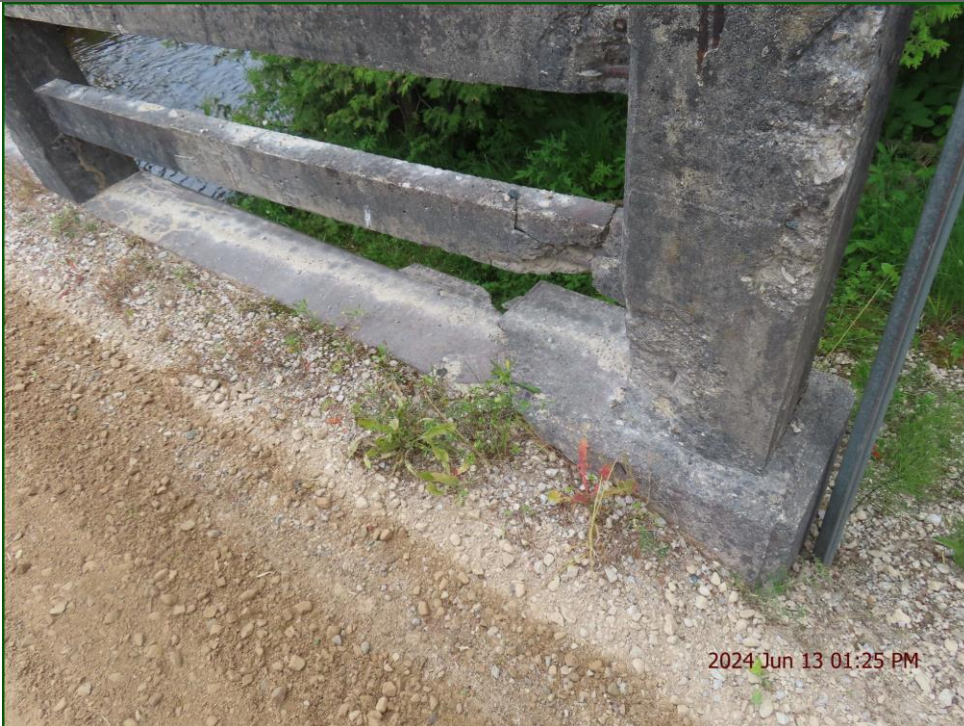
Wide horizontal cracking. Severe impact damage on SW quadrant.

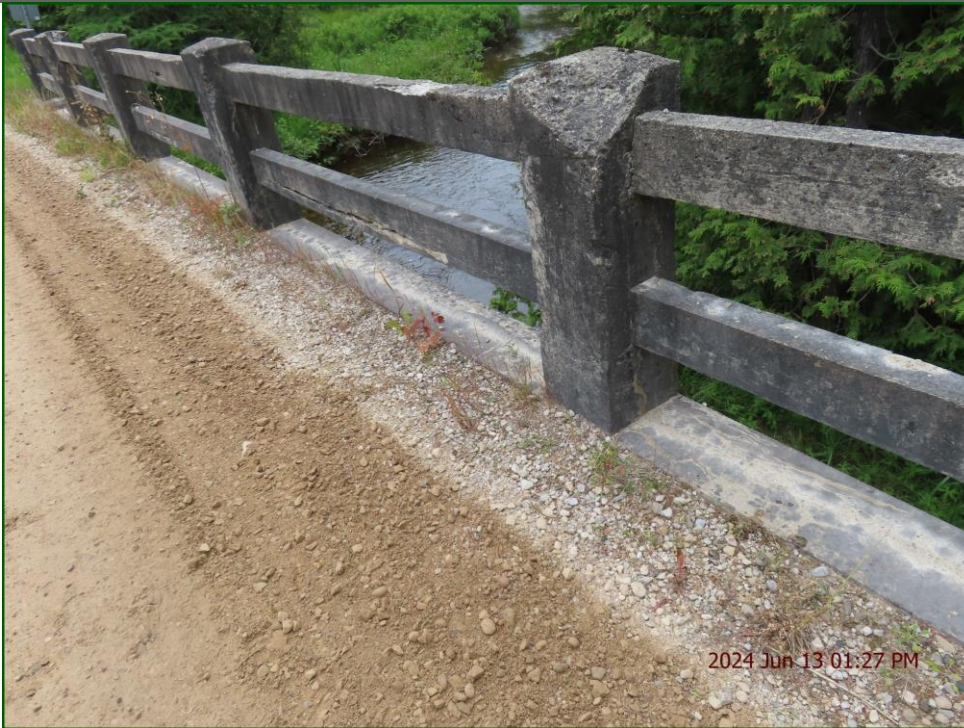
Medium scaling throughout.

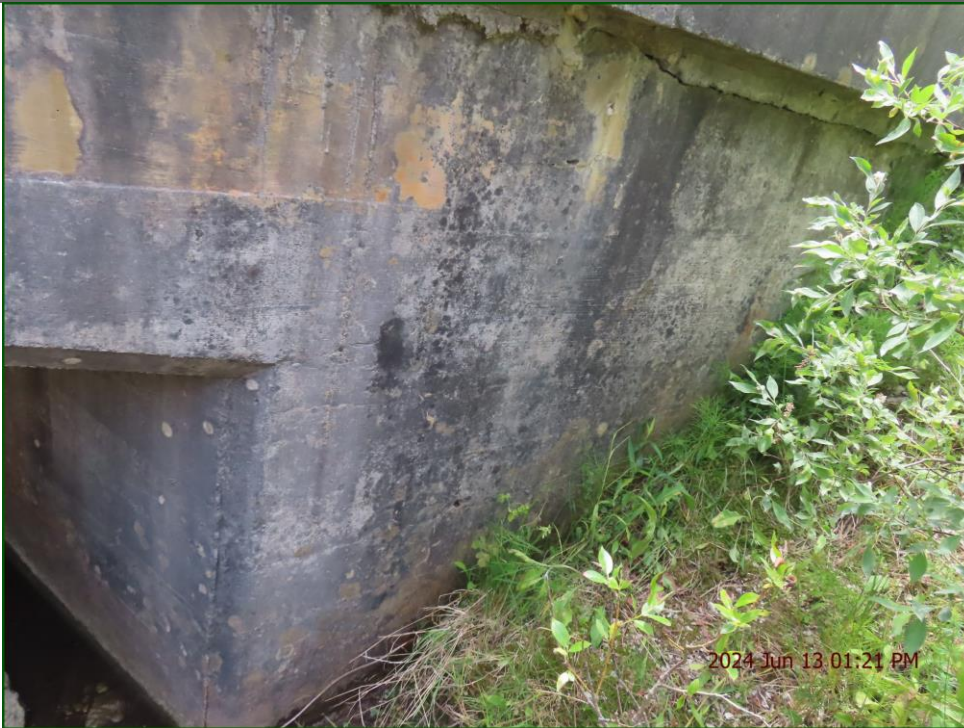
Medium to wide cracking at construction joints. Medium spall on NE quadrant. Severe spall on SW quadrant. Light to medium map cracking with leachate staining.

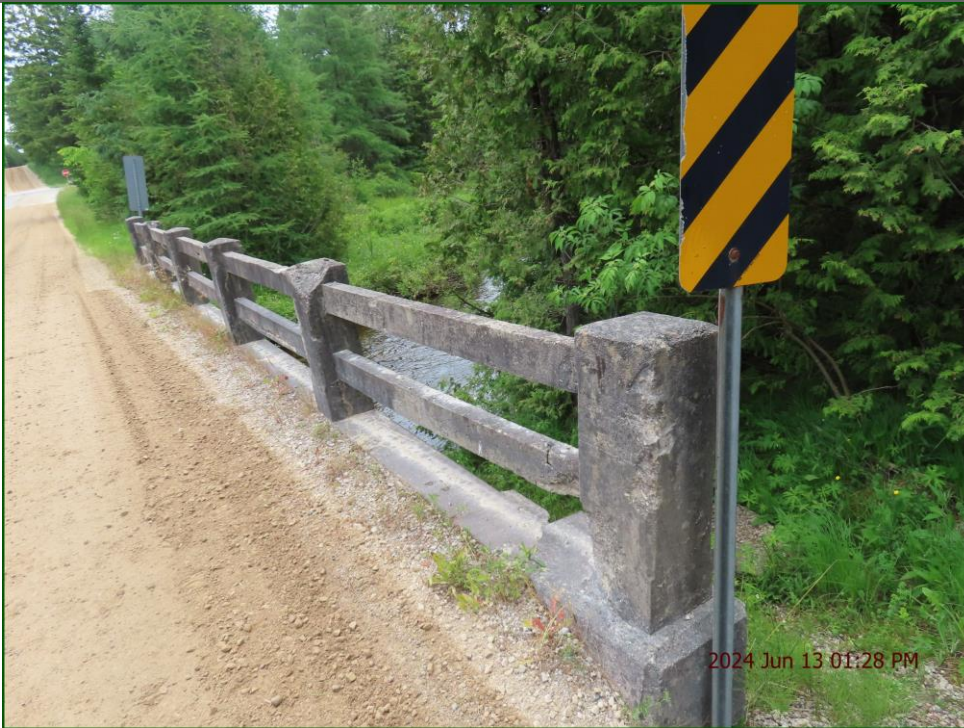
Severe spalling throughout with areas of 100% section loss.

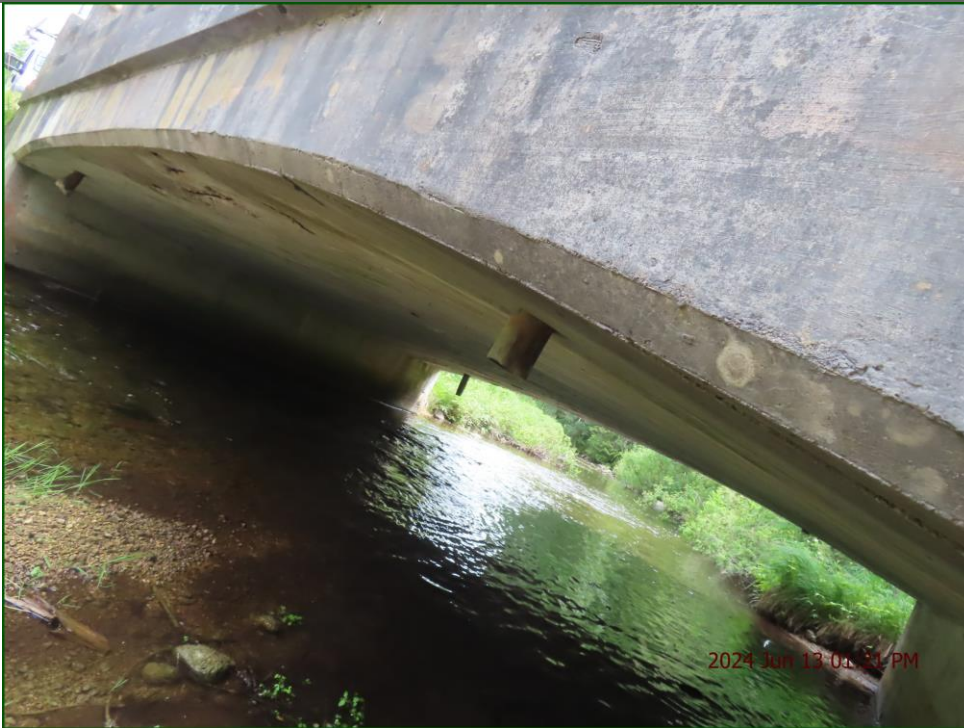
Light to medium map cracking with leachate staining throughout. Severe disintegration at construction joints. Medium to wide longitudinal cracking with leachate staining and stalactite. Light spalling with exposed reinforcement.

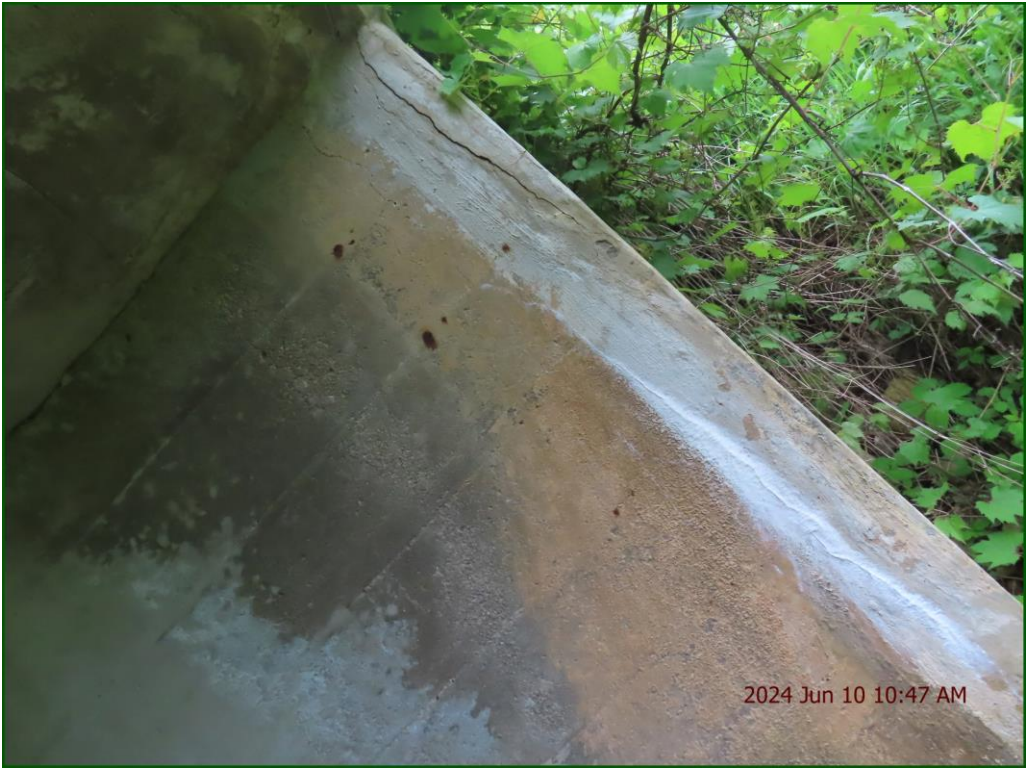
Description: Abutment walls: Medium to wide crack with leachate staining on west corners.

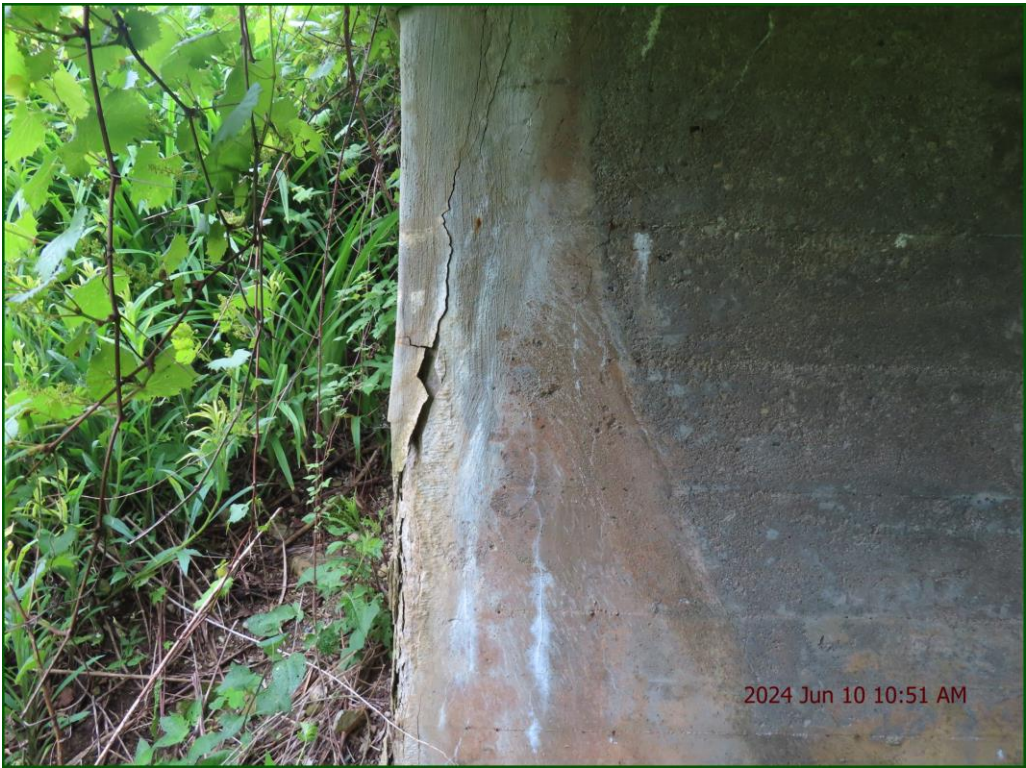
Description: Abutment walls: Light spall north west corner.

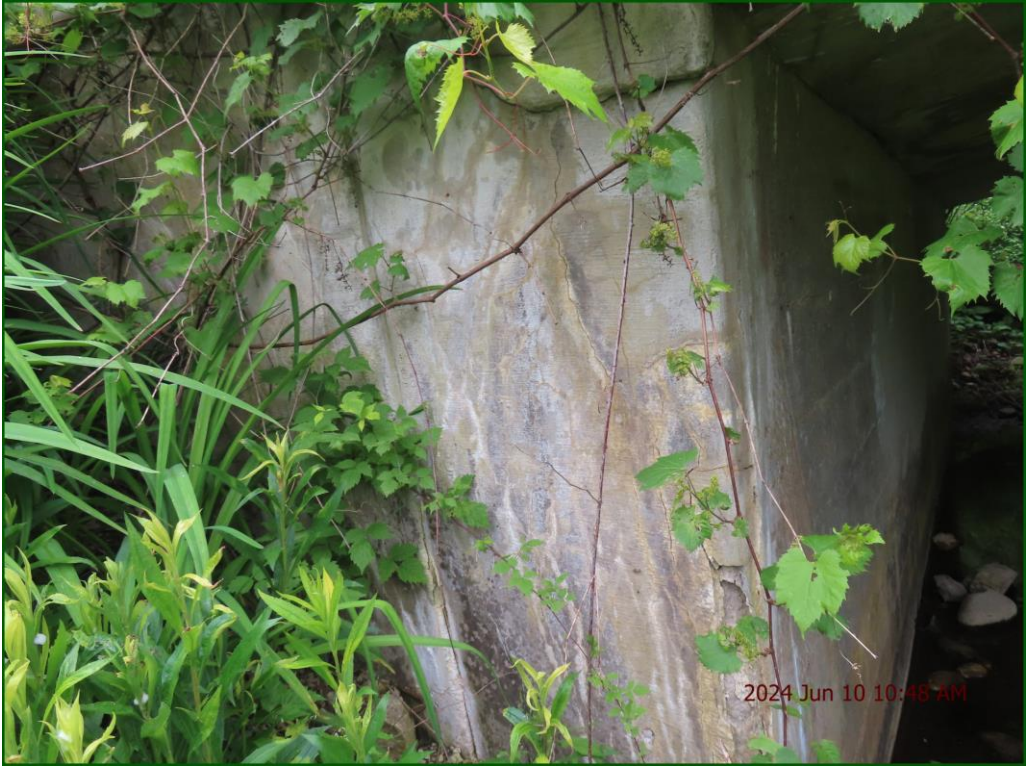
Description: Wingwalls: Light to medium map cracking with leachate staining.

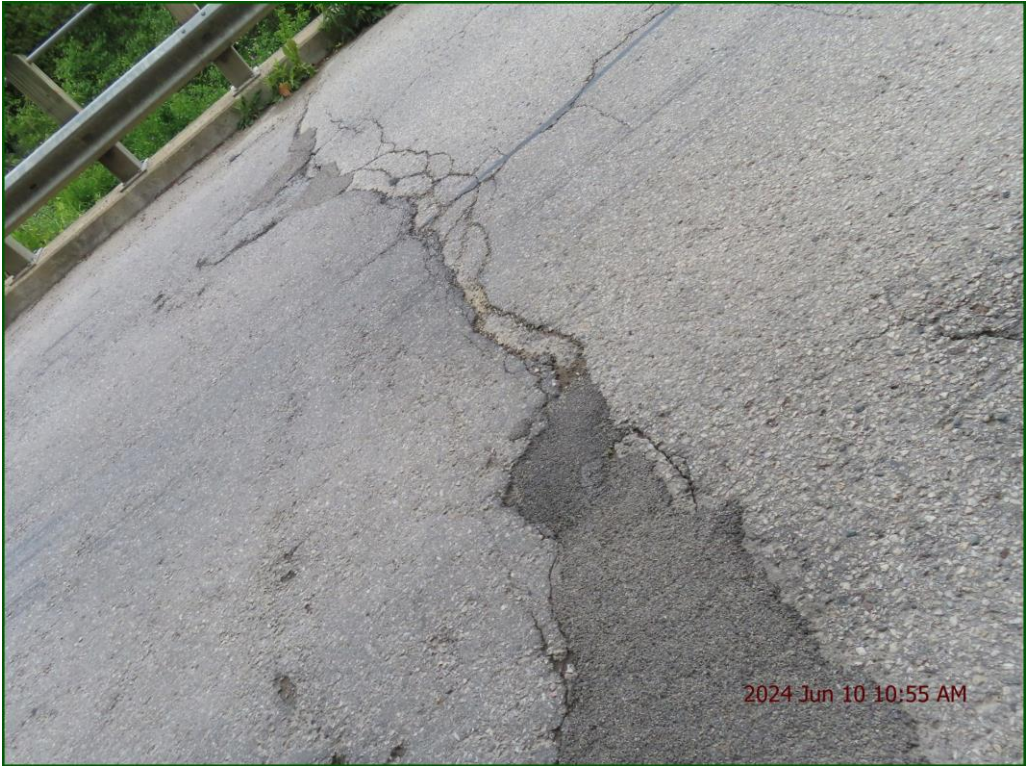
Description: Wearing surface: Light to medium map cracking.

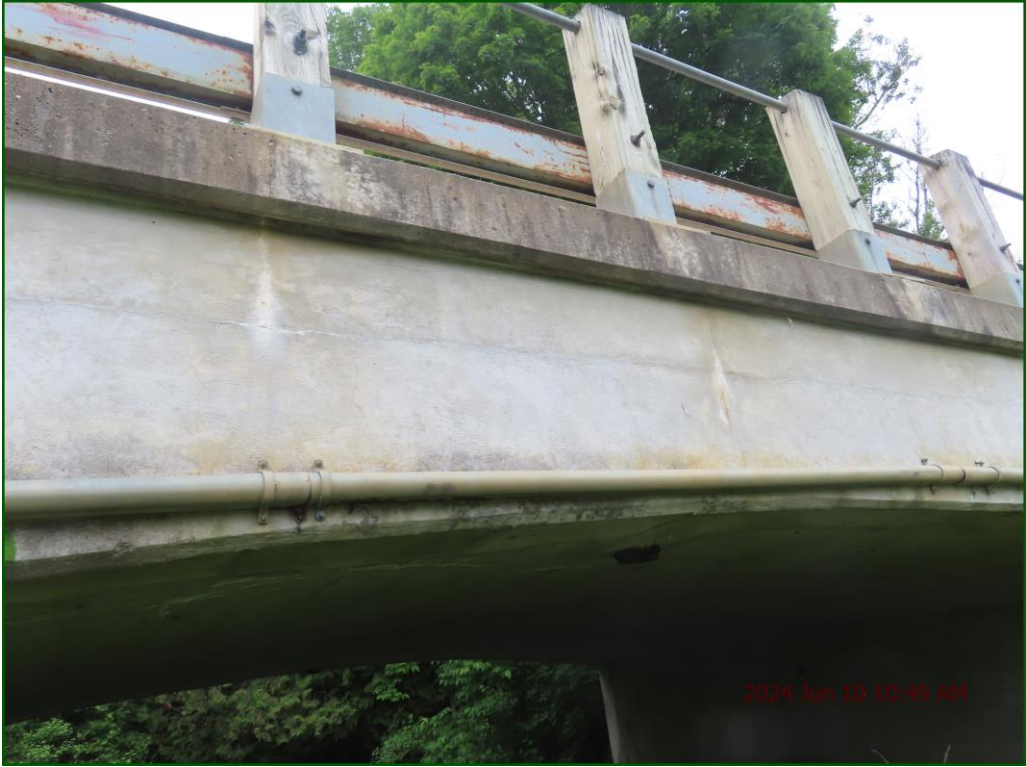
Description: Soffit (ext): Medium vertical cracks with leachate staining.

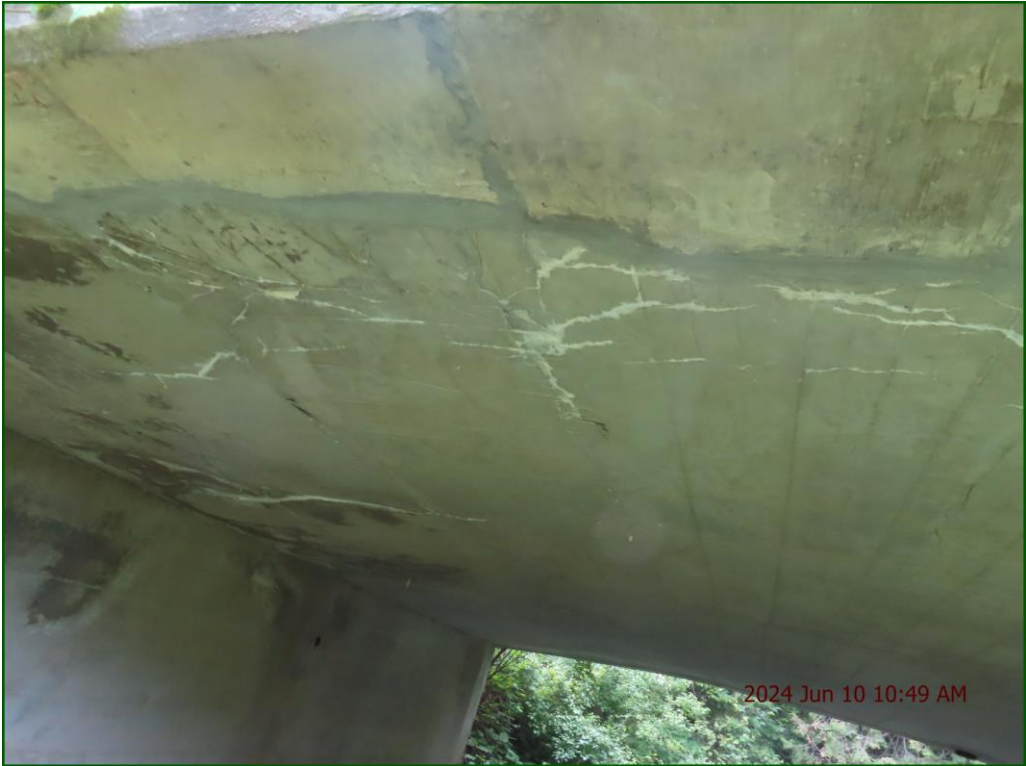
Description: Soffit (int): Medium to wide map cracking with leachate staining and stalactite.

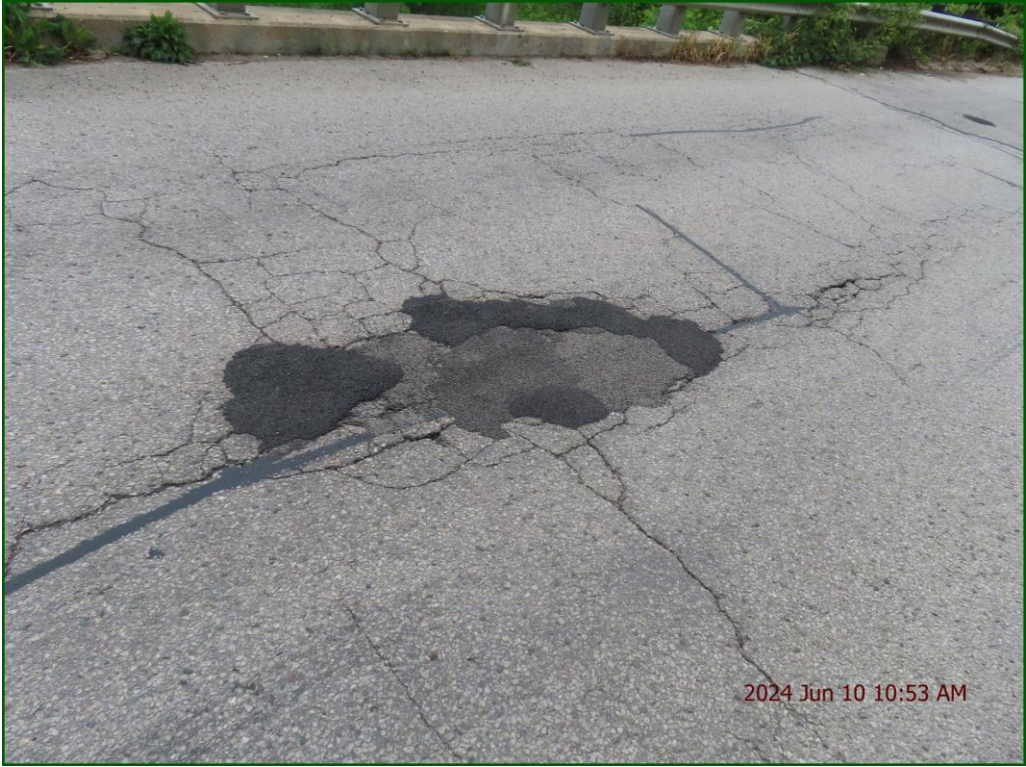
Description: Wearing surface: Light alligator cracking along centreline.

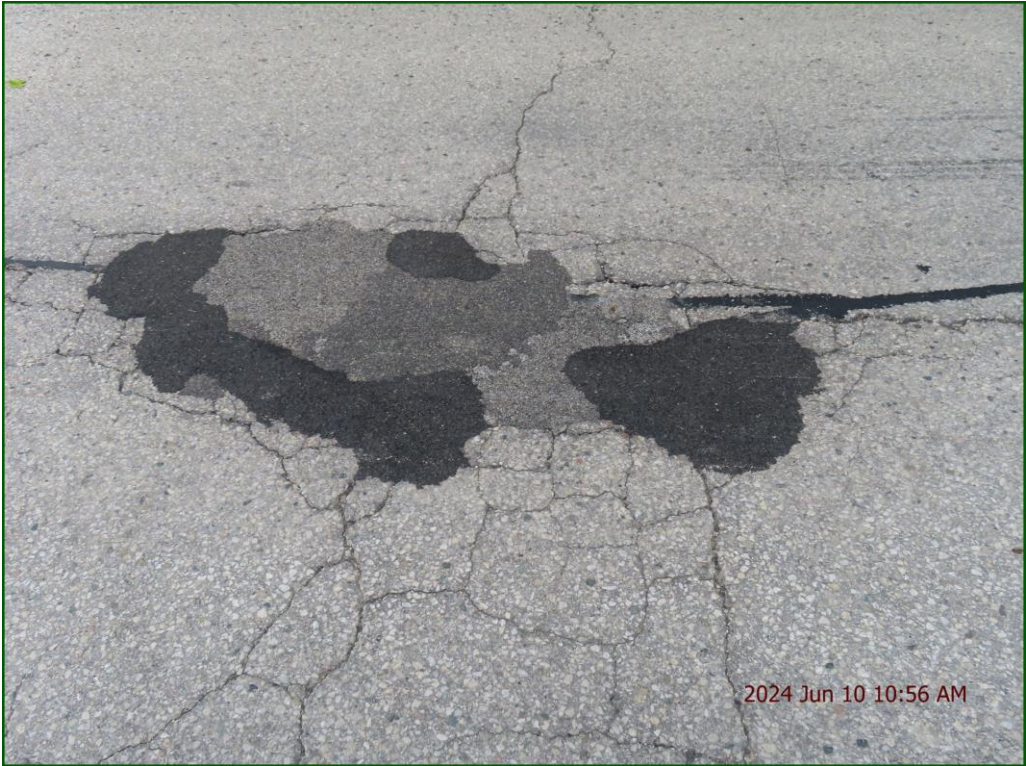
Description: Wearing surface: Cold patched potholes noted.

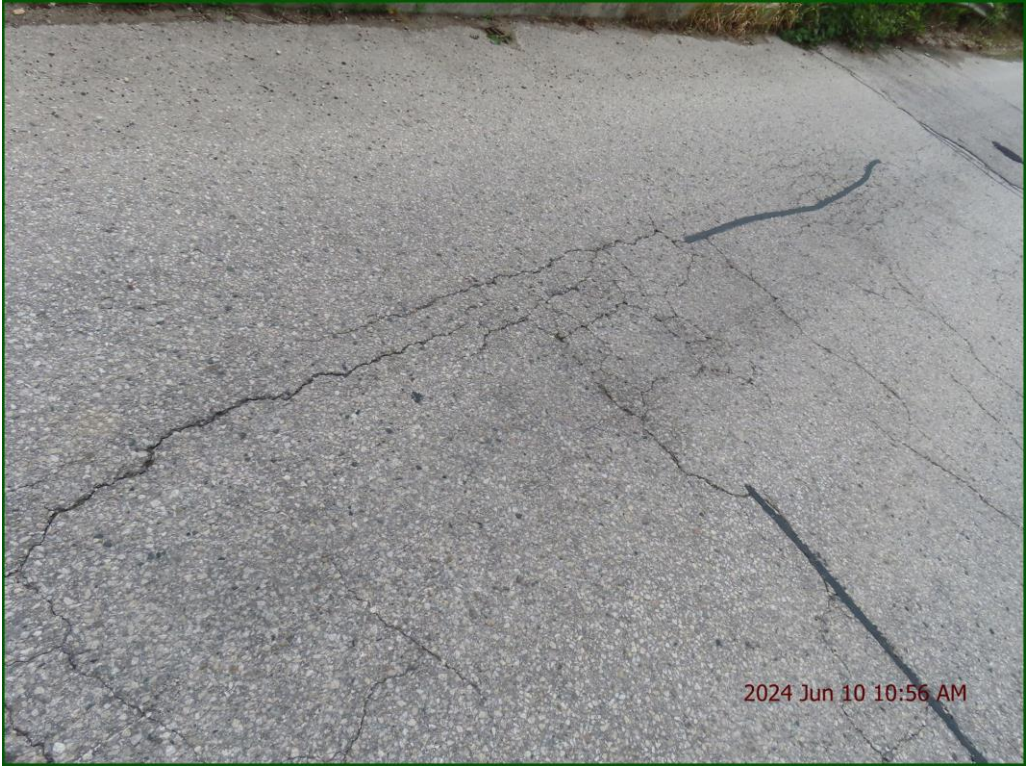
Description: Wearing surface: Light to medium map cracking.

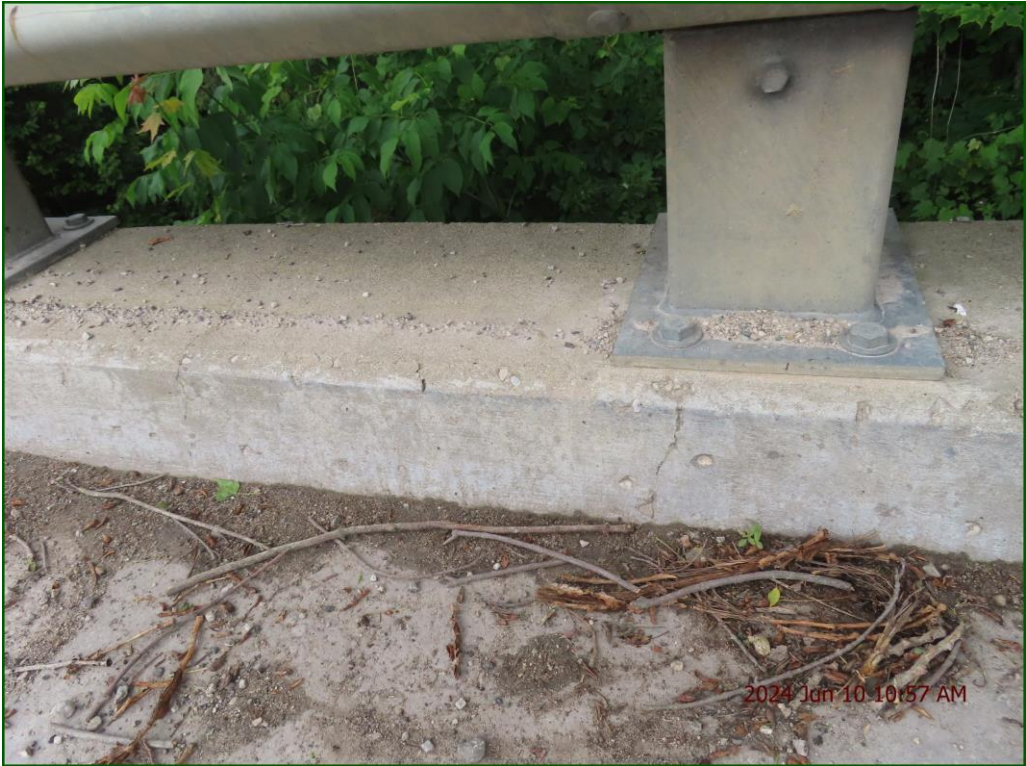
Description: Curbs: Light to medium vertical cracking throughout.

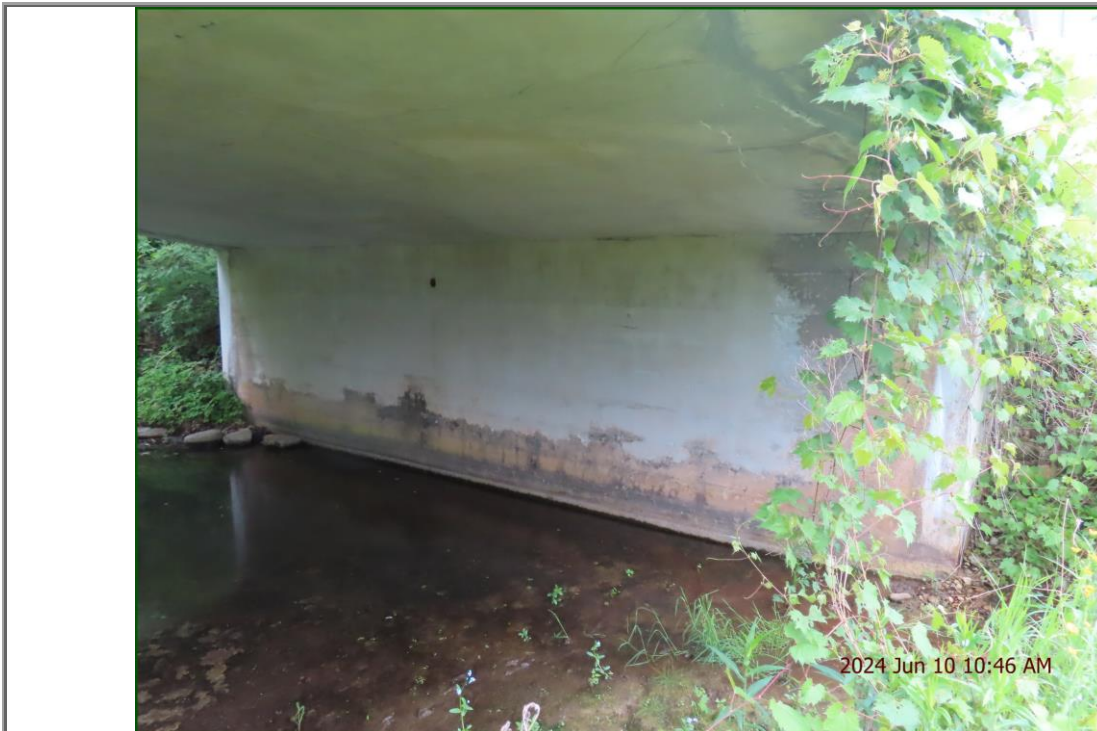
Medium to wide crack with leachate staining on west corners. Light spall north west corner.

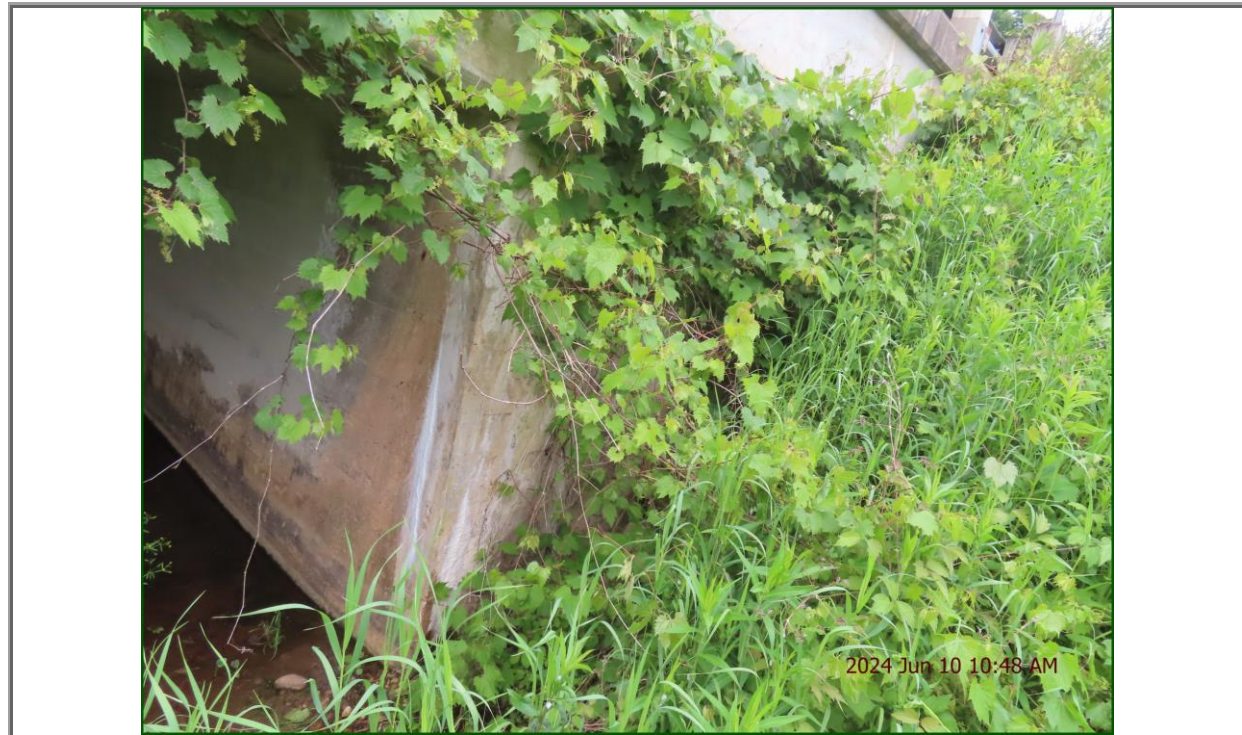
General Comments:
Light to medium map cracking with leachate staining.

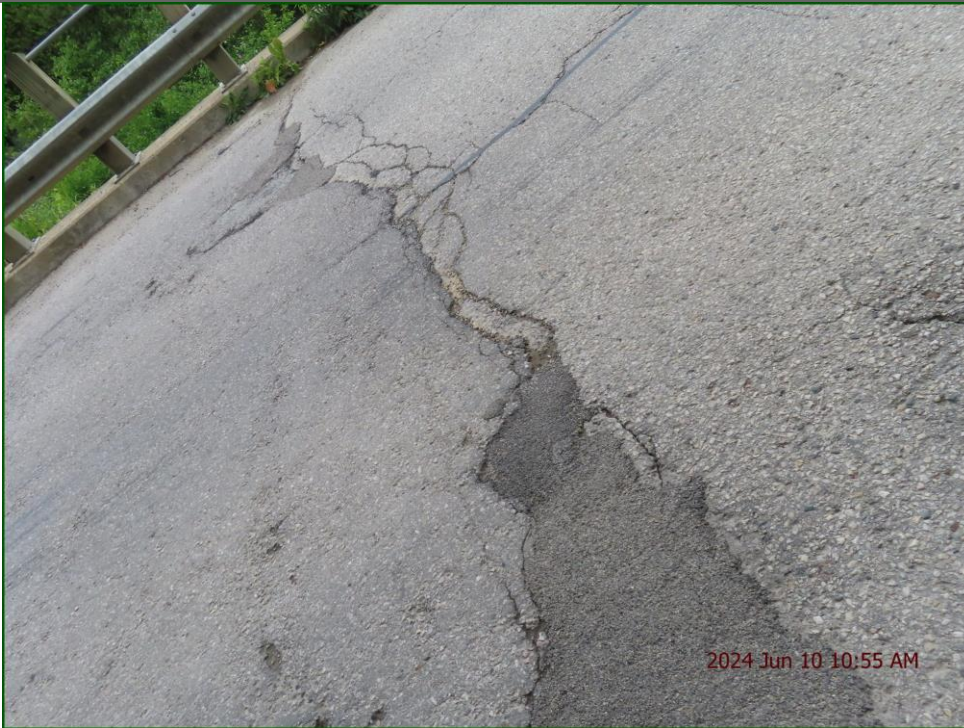
Light to medium map cracking.

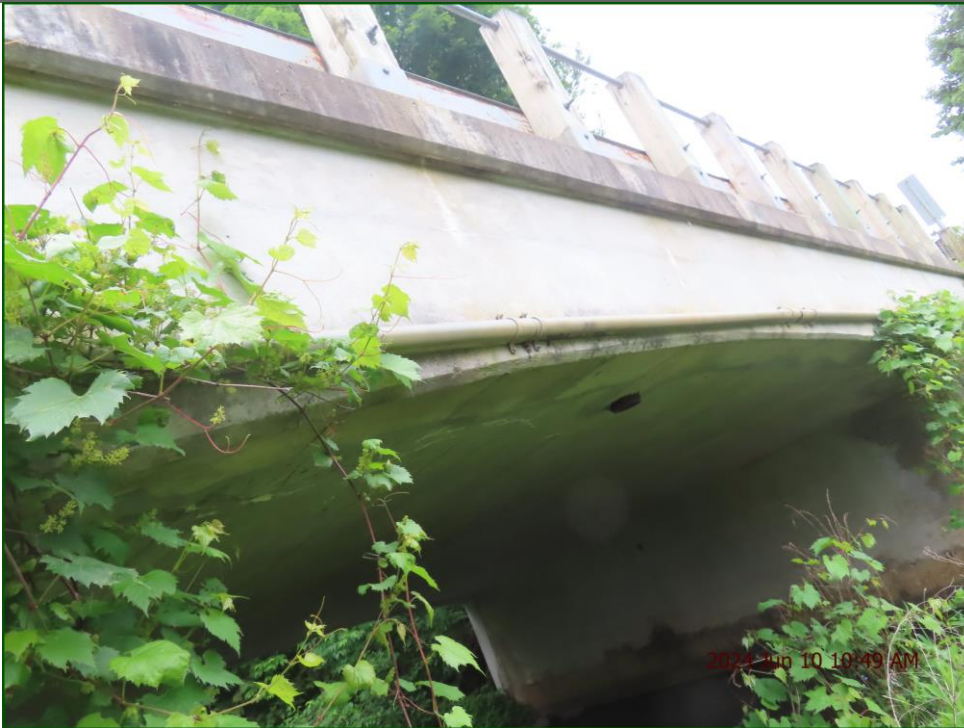
Medium vertical cracks with leachate staining.

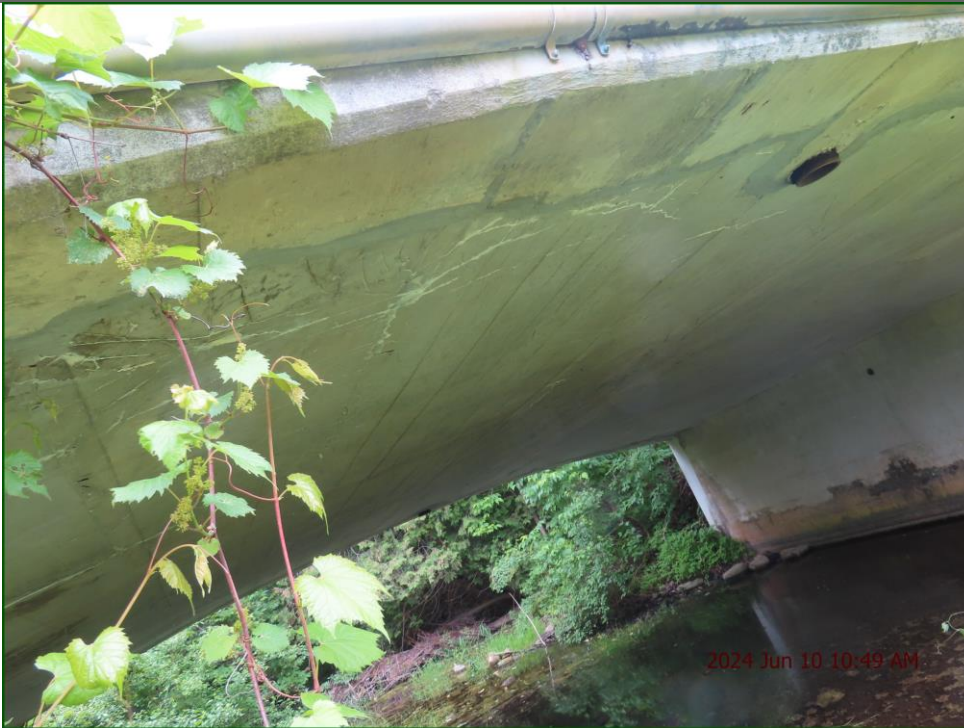
Medium to wide map cracking with leachate staining and stalactite.

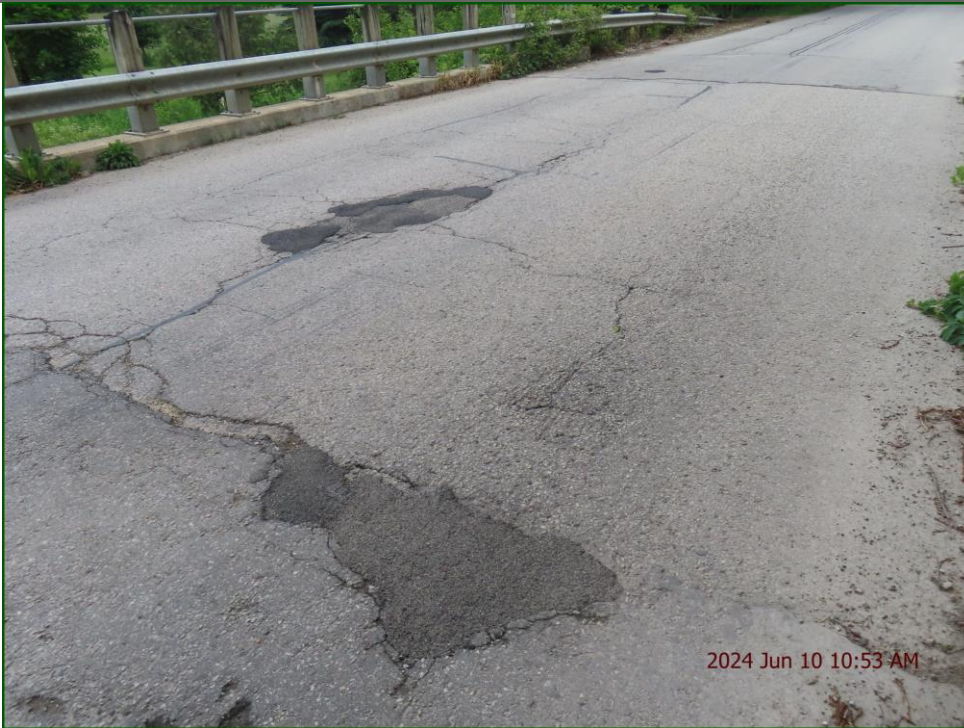
Light alligator cracking along centreline. Cold patched potholes noted. Light to medium map cracking.

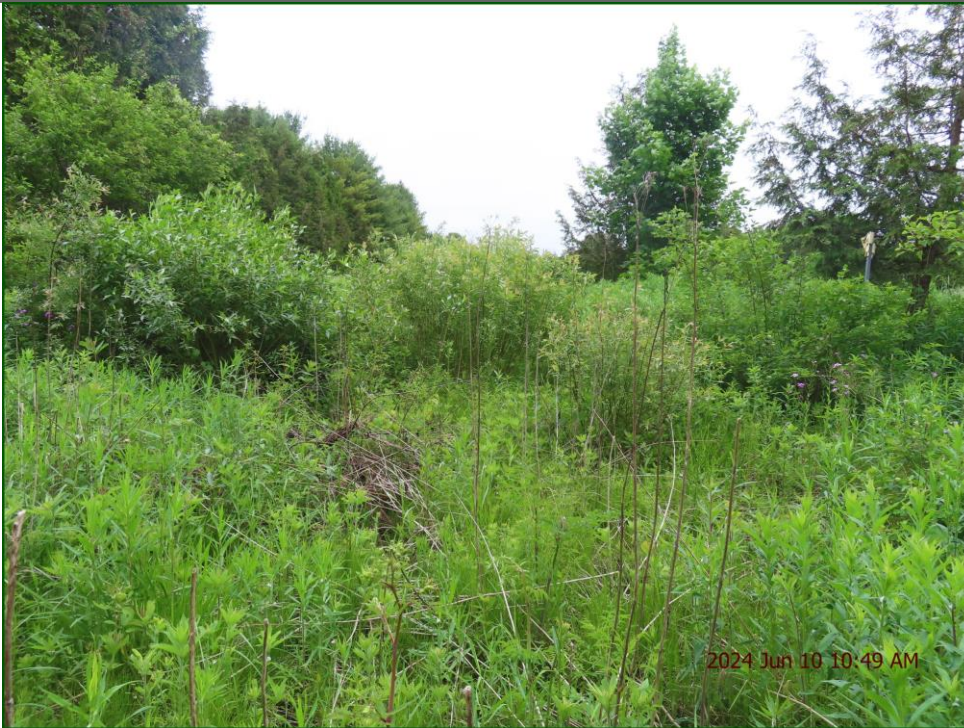
Stream dry at time of inspection.

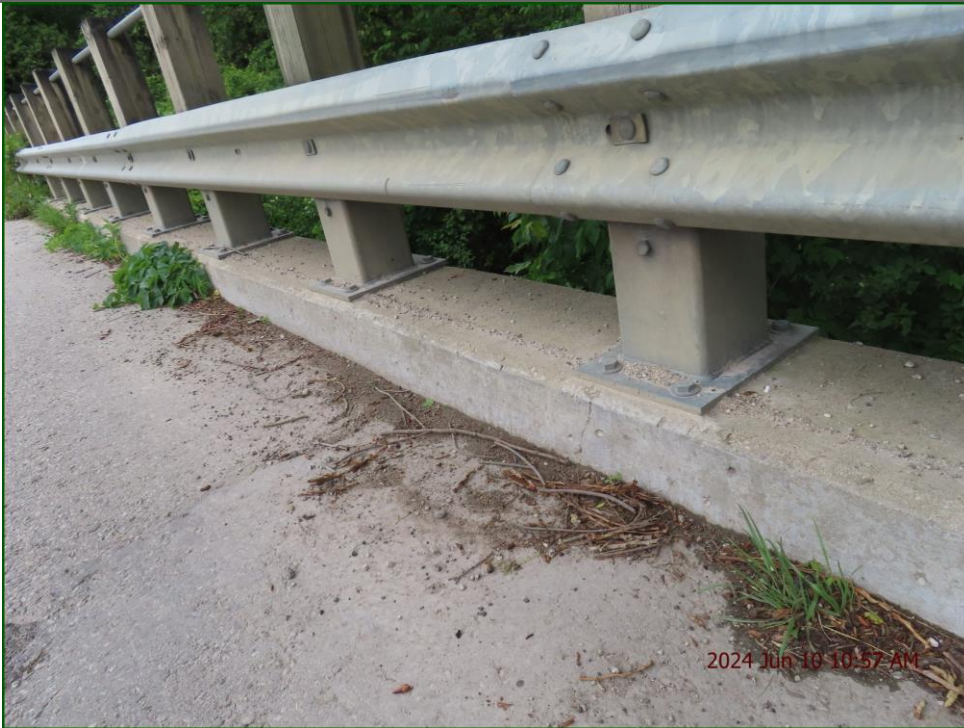
Light to medium vertical cracking throughout.
