OSIM Biennial Inspection Report

Concession 11/12, Lot 30

Burgess Engineering Inc

27-Aug-24

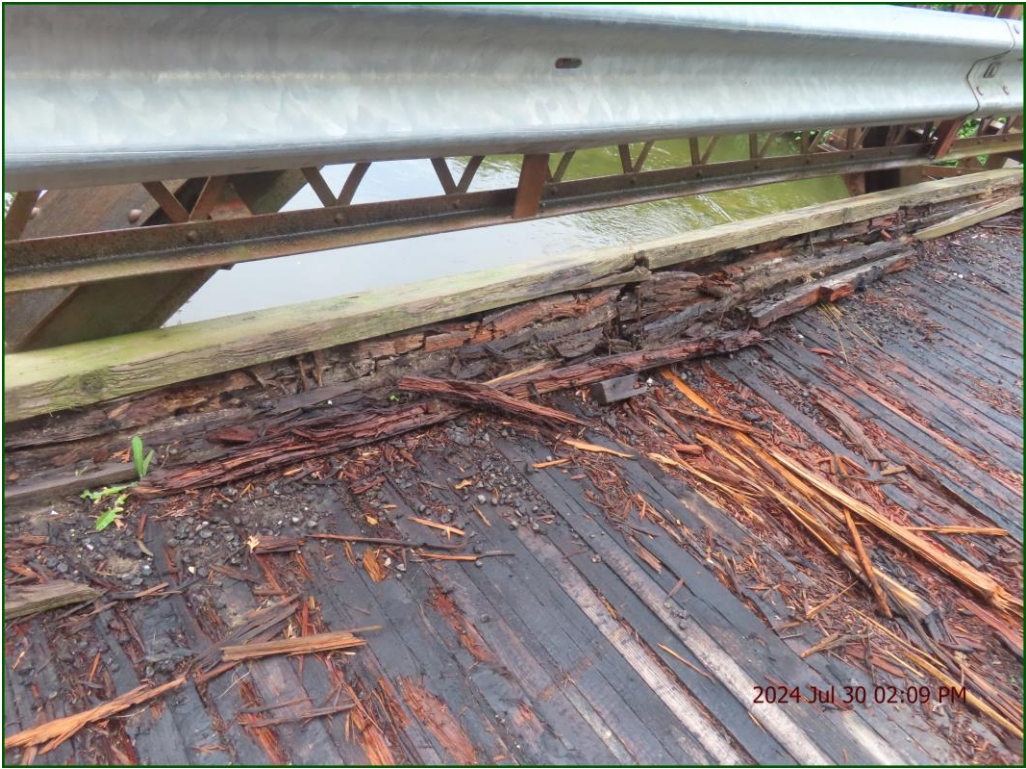
Description: Curbs: Medium to severe rotting throughout.

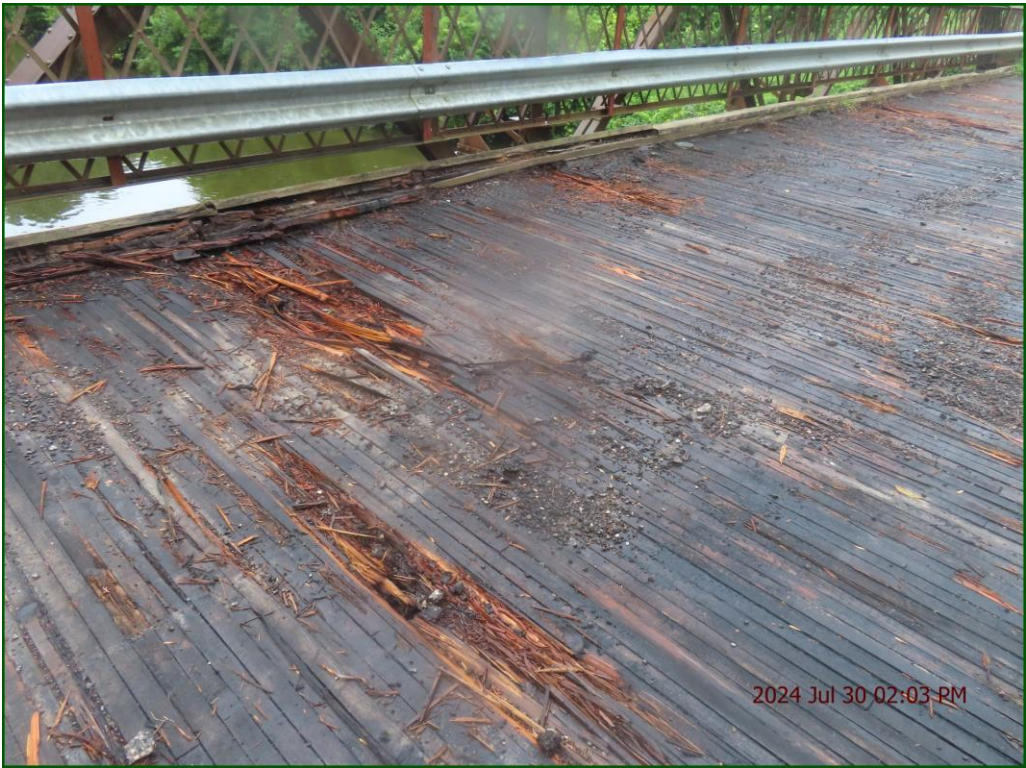
Description: Deck top: Areas of moderate to severe rot throughout (1/3).

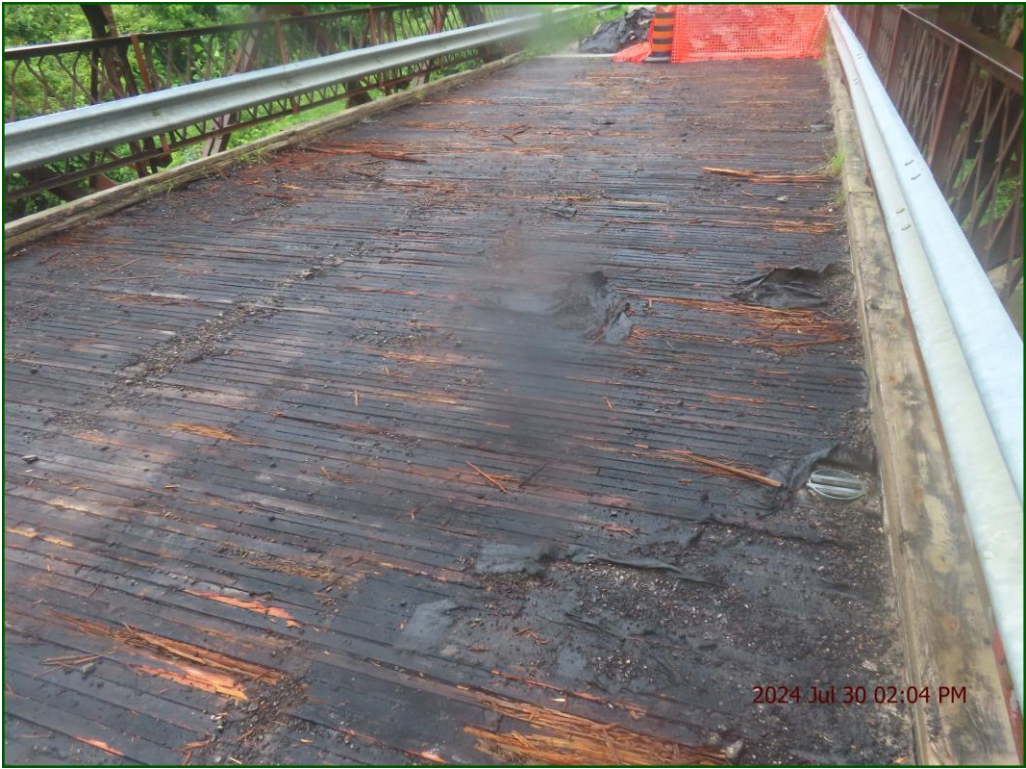
Description: Deck top: Areas of moderate to severe rot throughout (2/3).

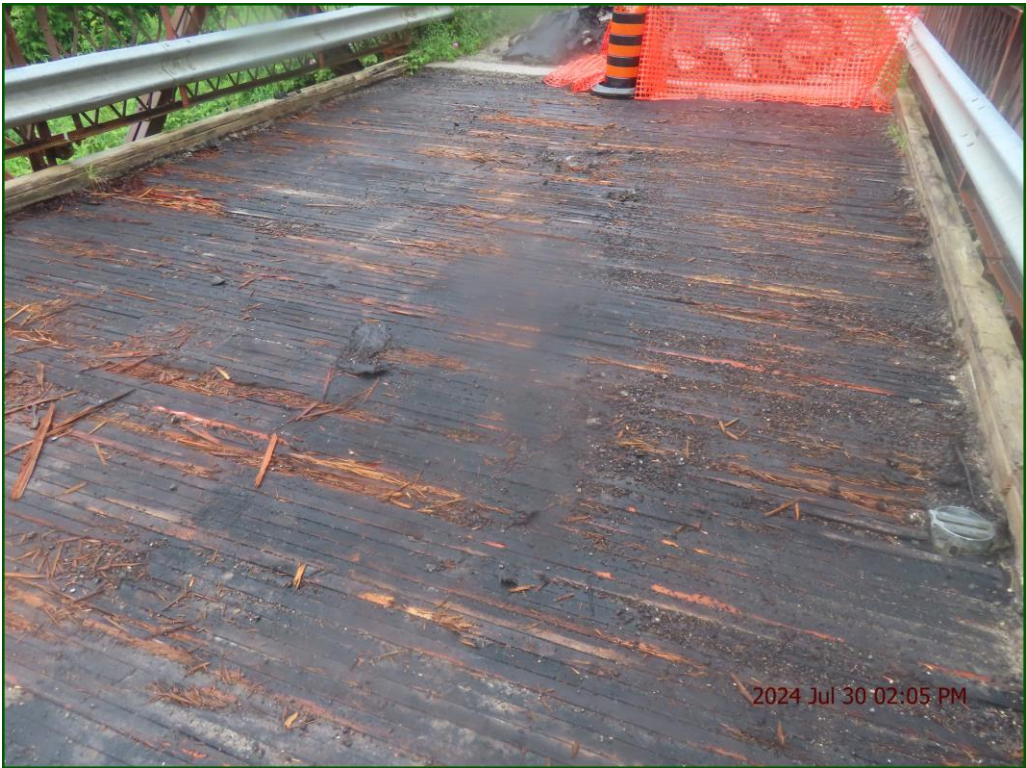
Description: Deck top: Areas of moderate to severe rot throughout (3/3).

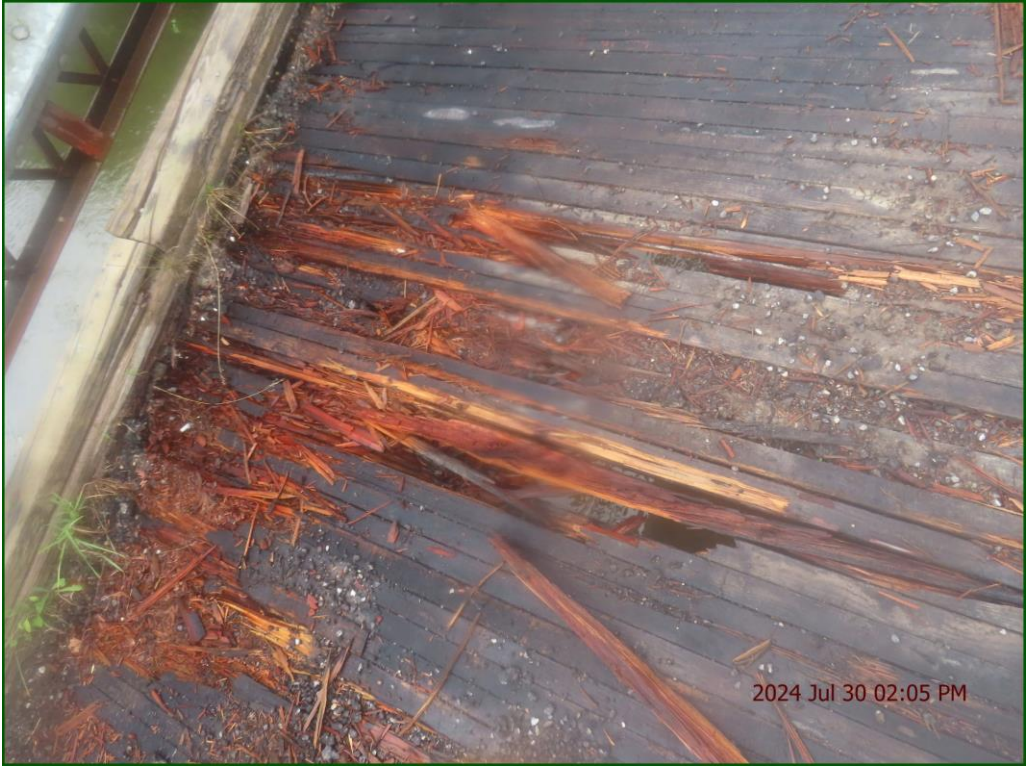
Description: Deck top: Localized areas of 100% section loss (1/2).

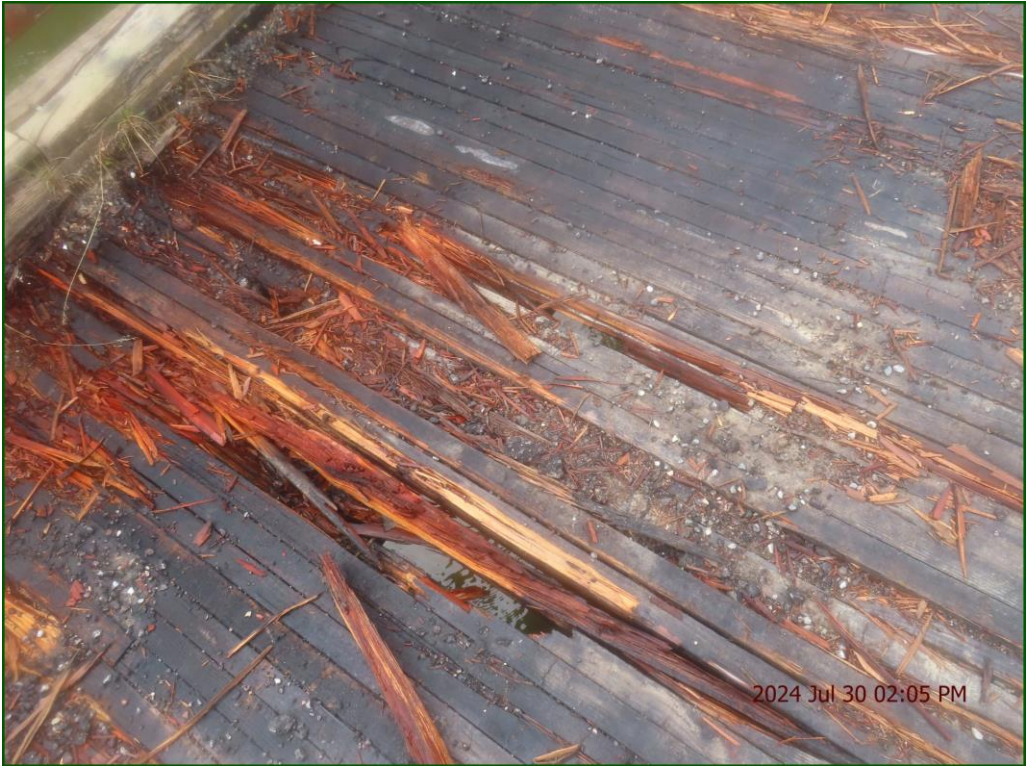
Description: Deck top: Localized areas of 100% section loss (2/2).

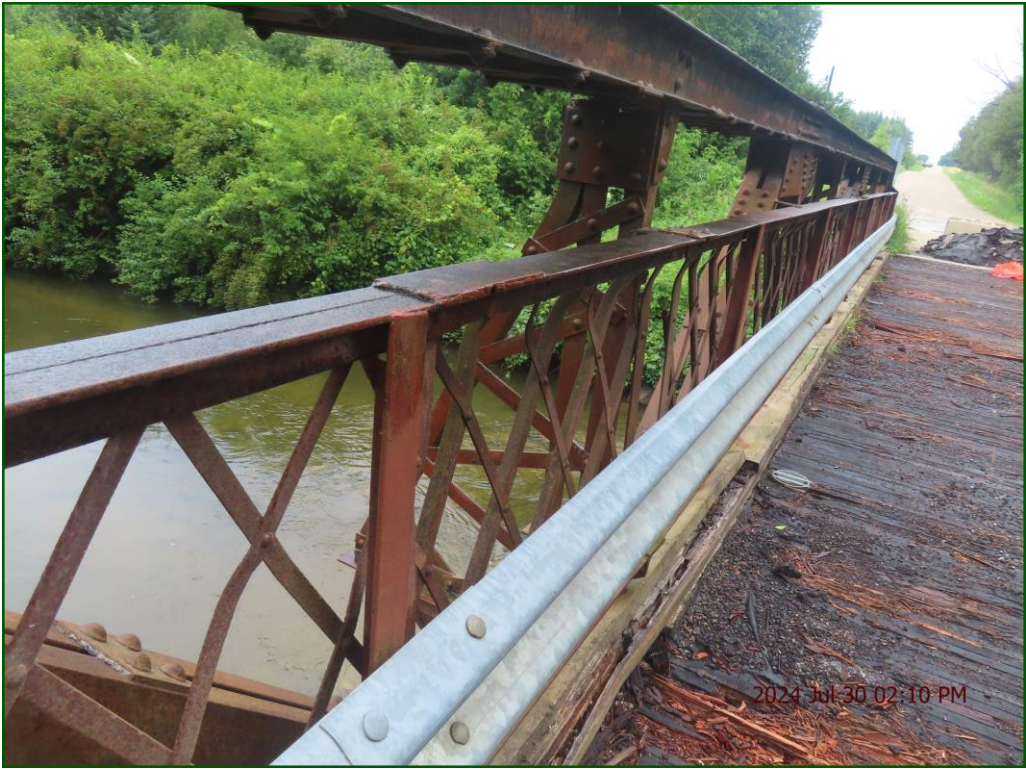
Description: Railing systems: Moderate impact damage throughout.

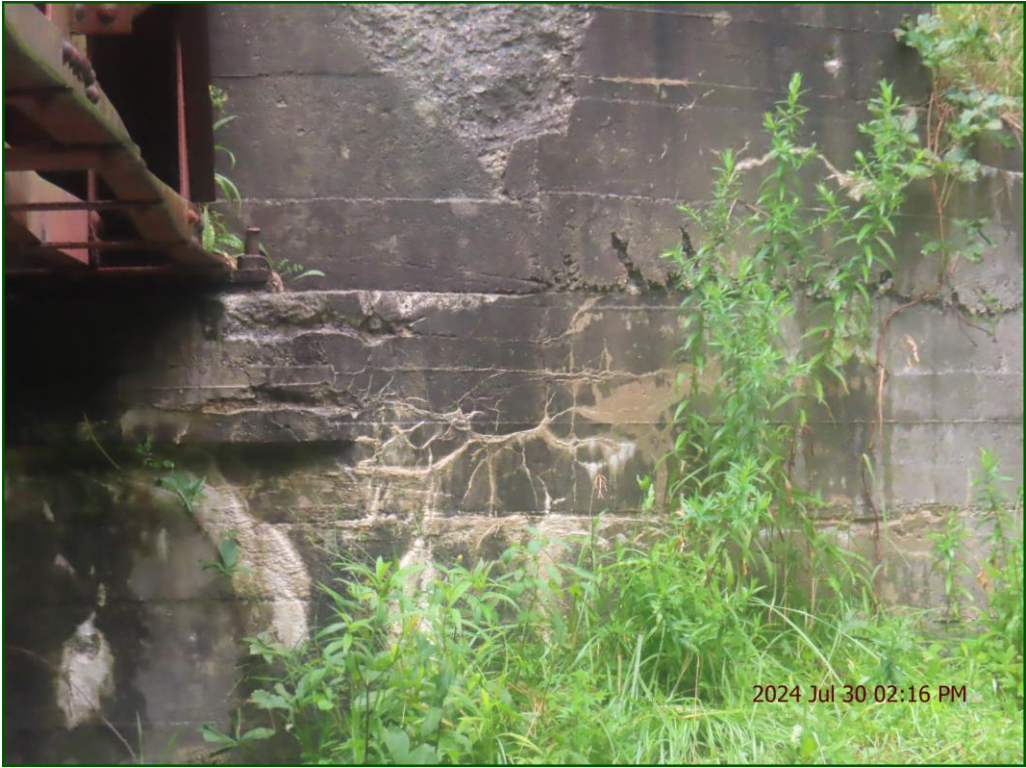
Description: Wingwalls: Medium to wide map cracking with leachate staining.

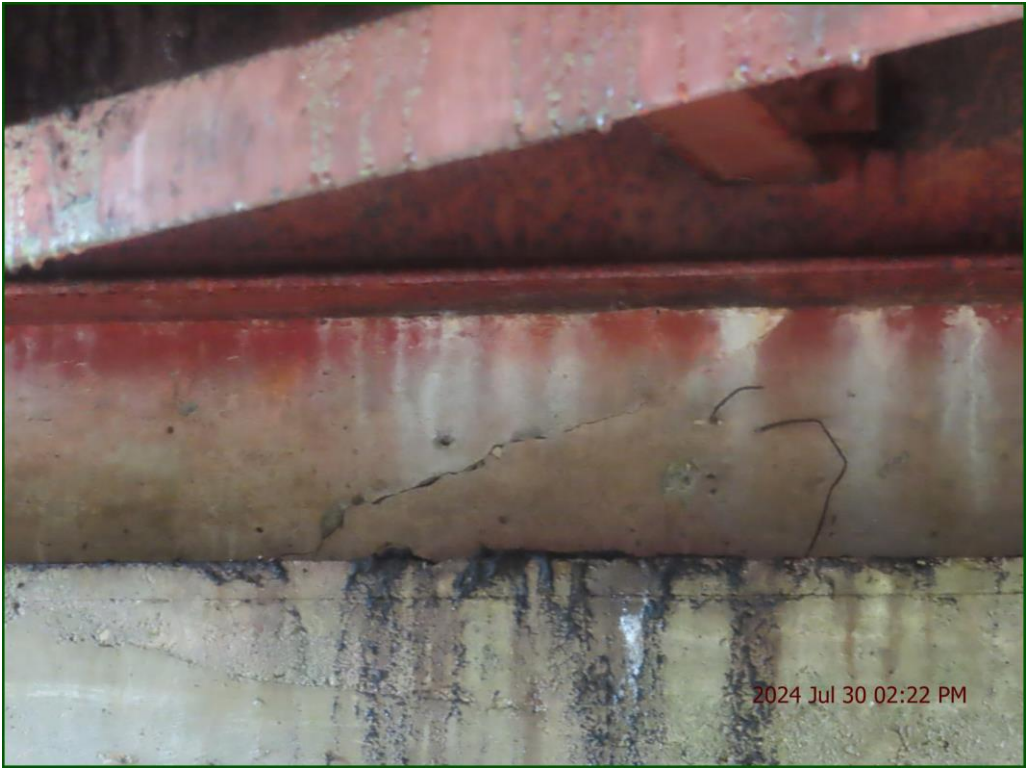
Description: Ballast Walls: Medium to wide vertical crack.

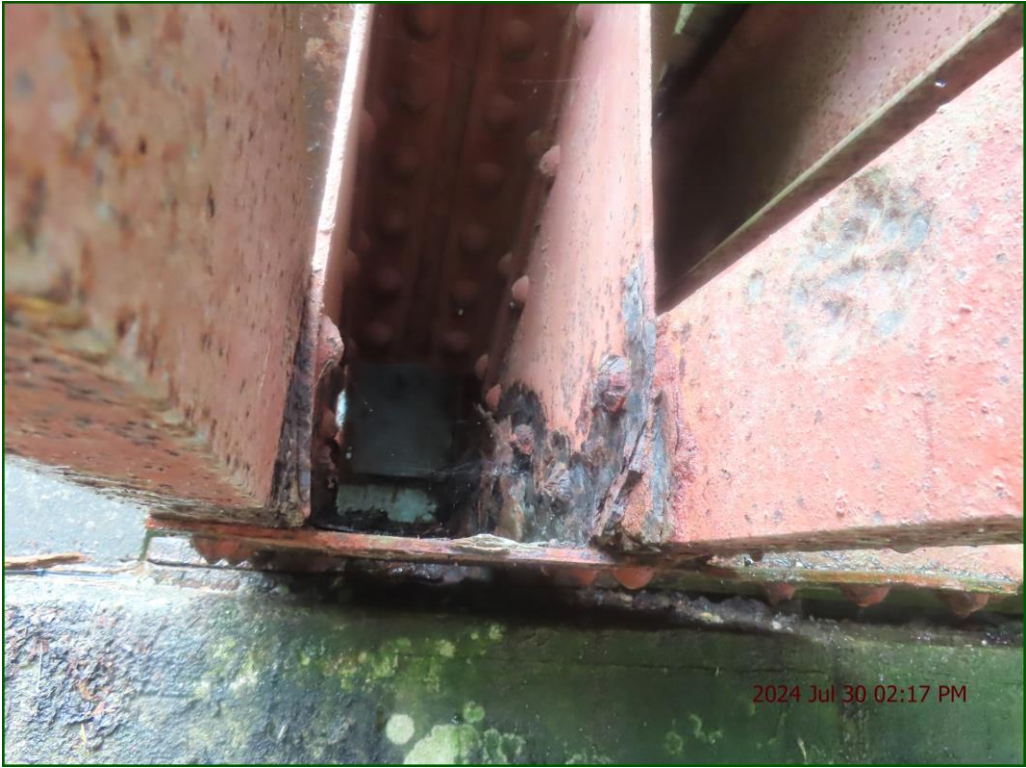
Description: Bottom Chord: Medium corrosion at ends.

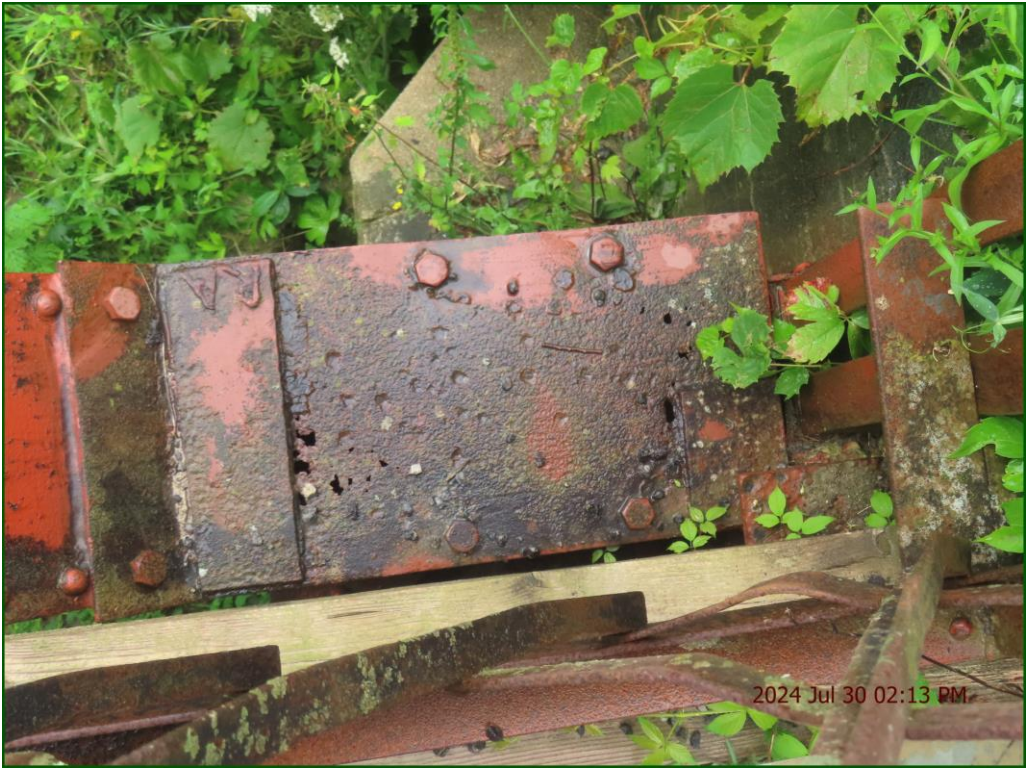
Description: Top Chords: Severe corrosion with perforations at end.

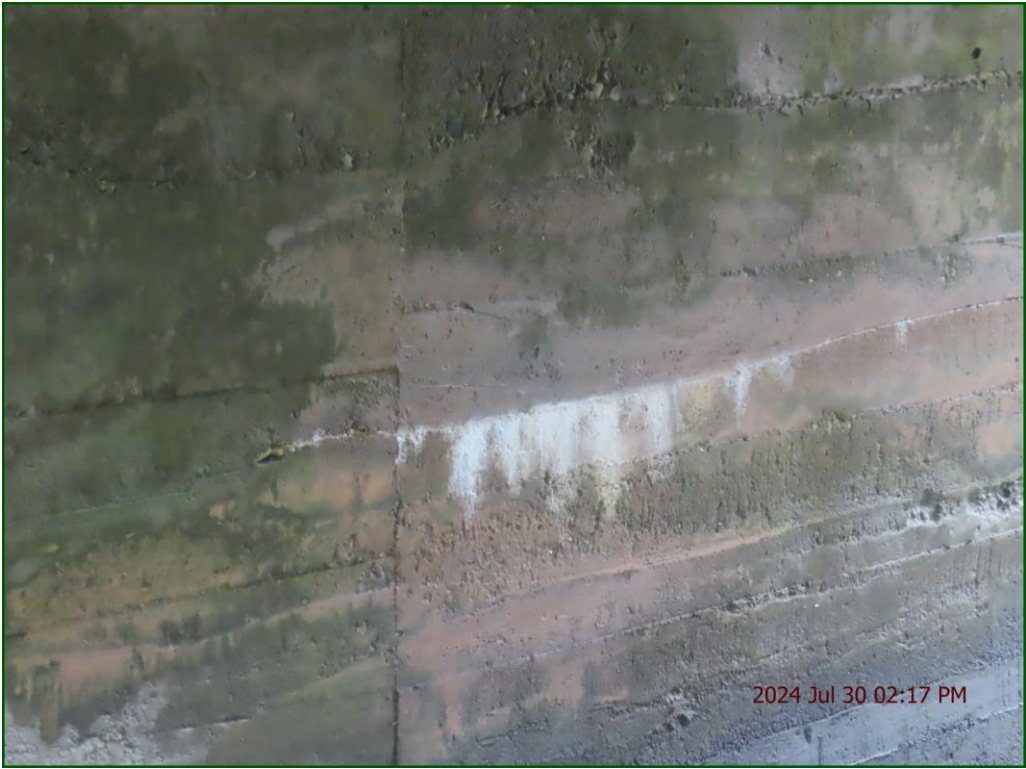
Description: Abutment Walls: Light to medium horizontal cracking with leachate staining.

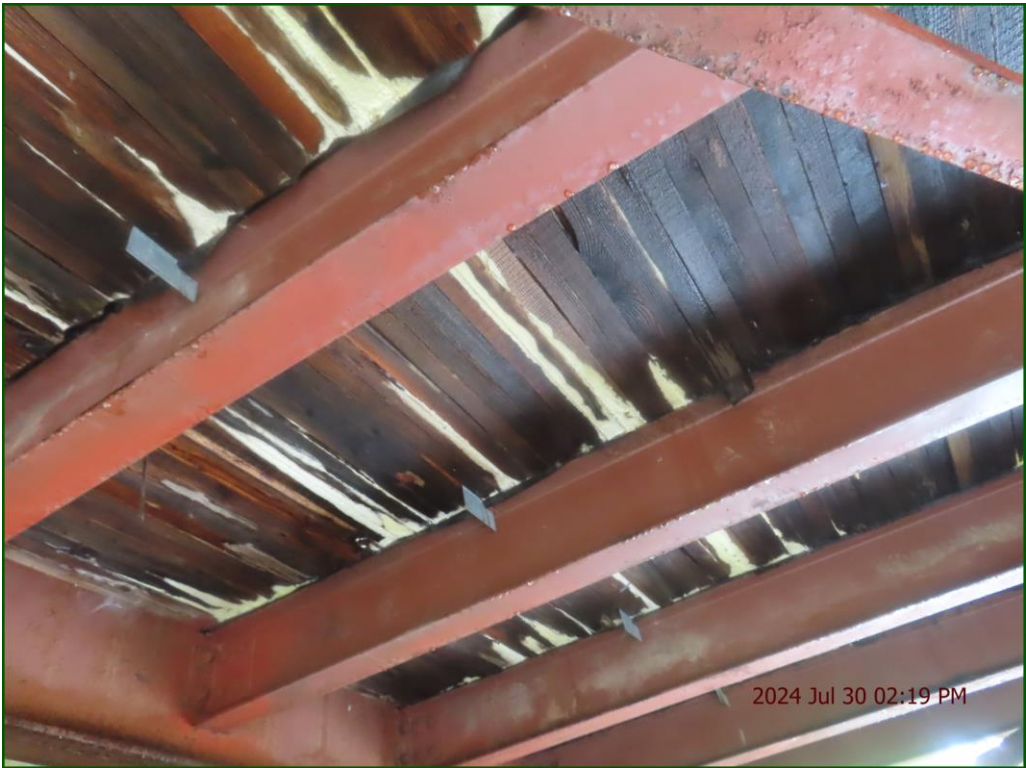
Description: Soffit: Moderate to severe rotting throughout (1/2).

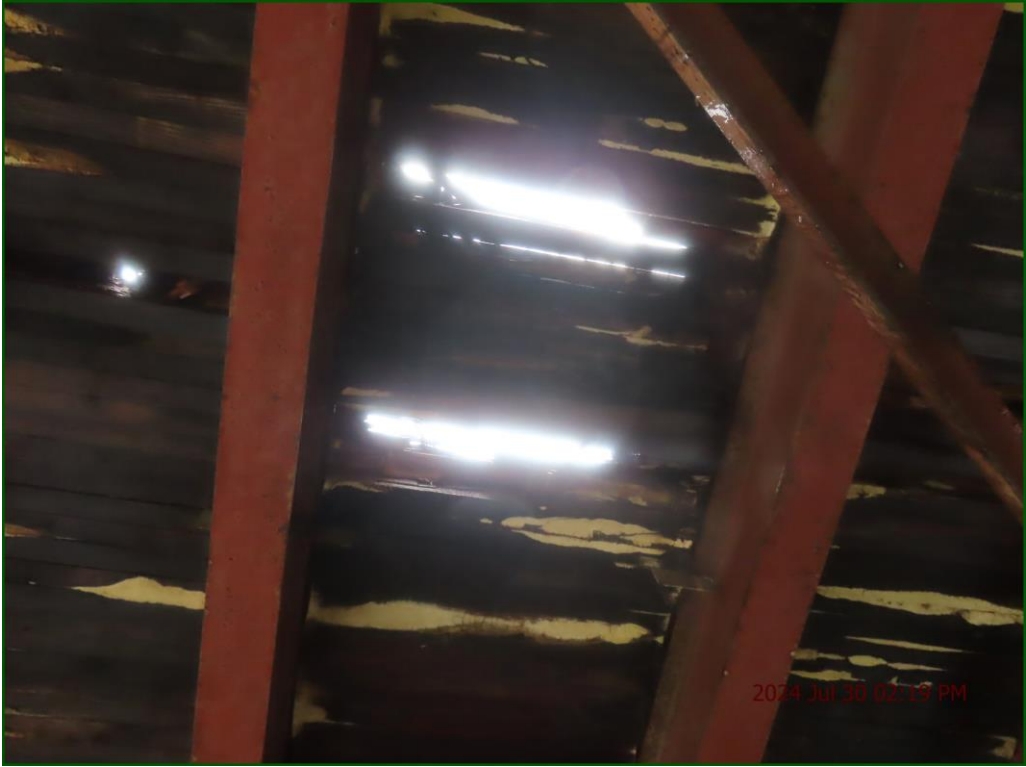
Description: Soffit: Moderate to severe rotting throughout (2/2).

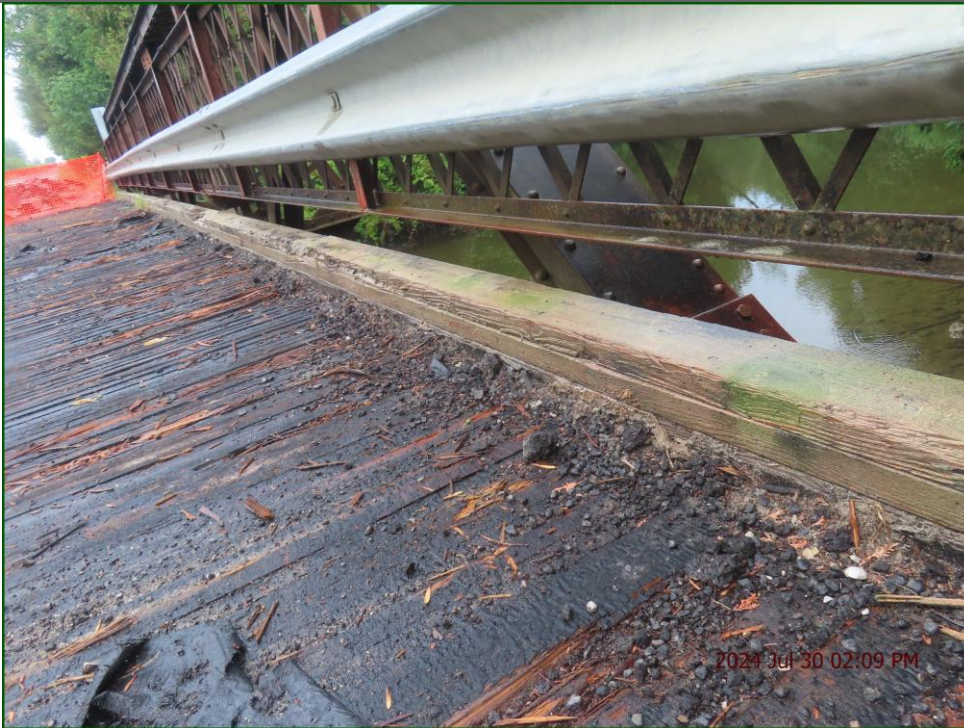
Medium to severe rotting throughout.

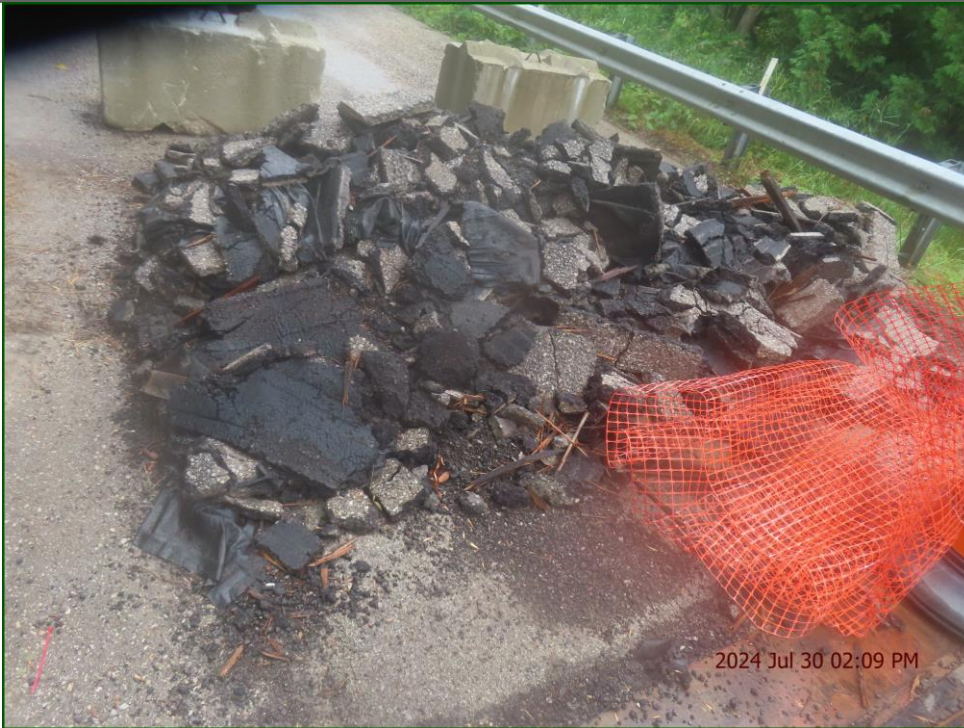
Wide transverse cracking. Covered by asphalt wearing surface debris, limited inspection.

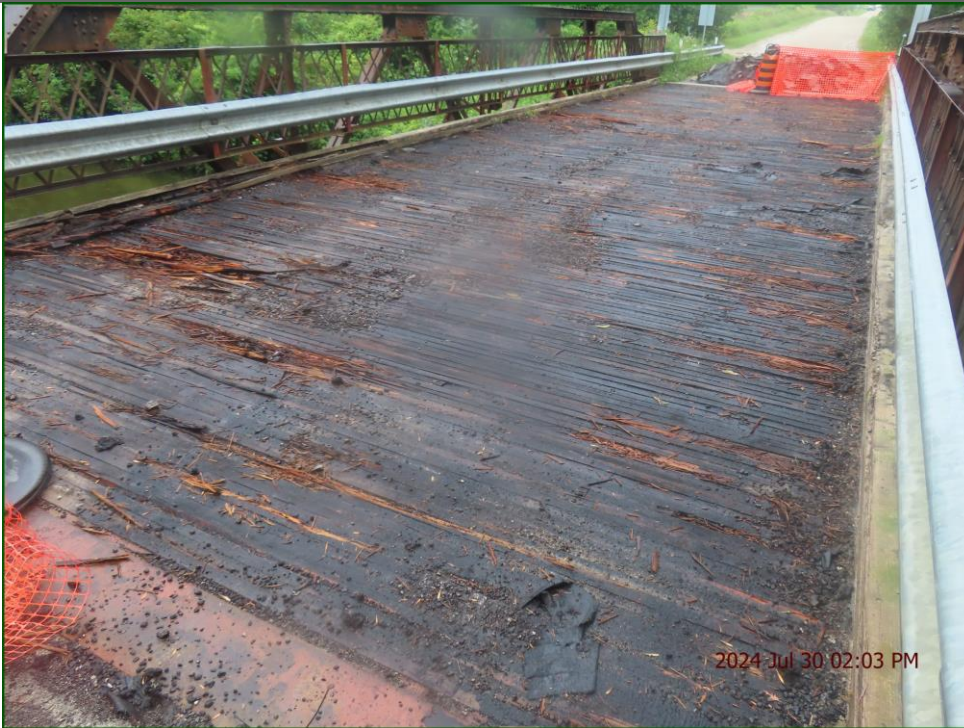
Areas of moderate to severe rot throughout. Localized areas of 100% section loss.

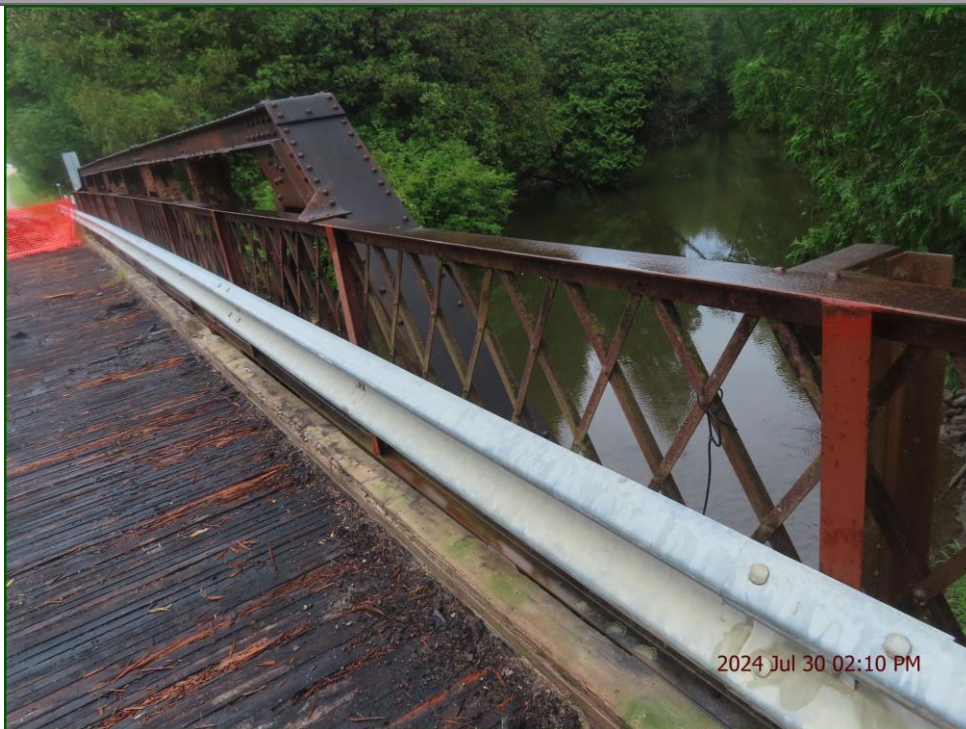
Moderate impact damage throughout.

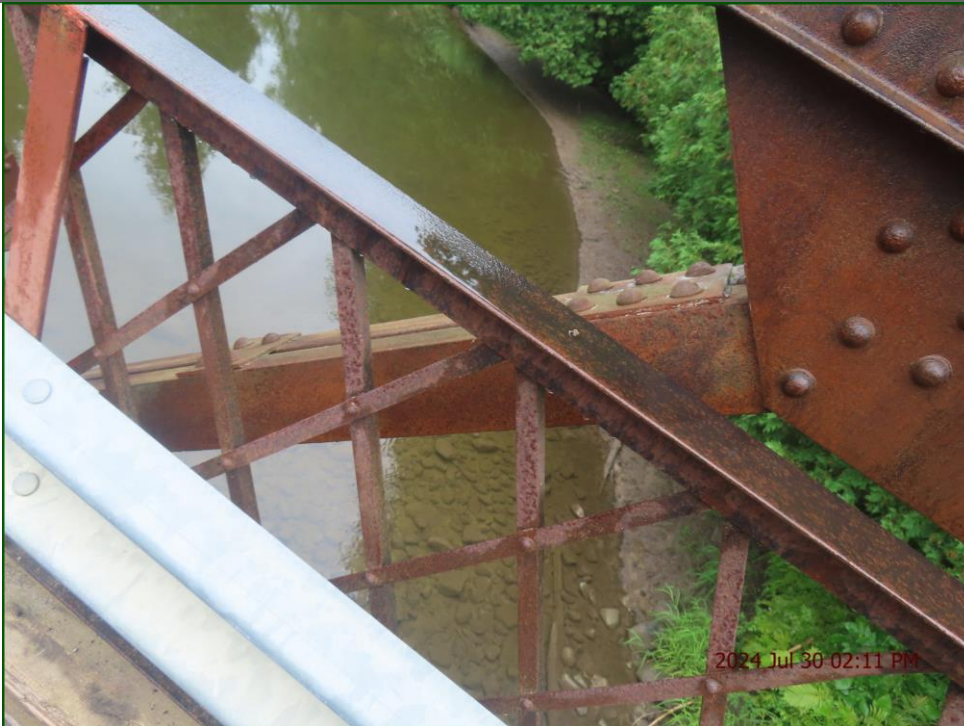
Light corrosion throughout.

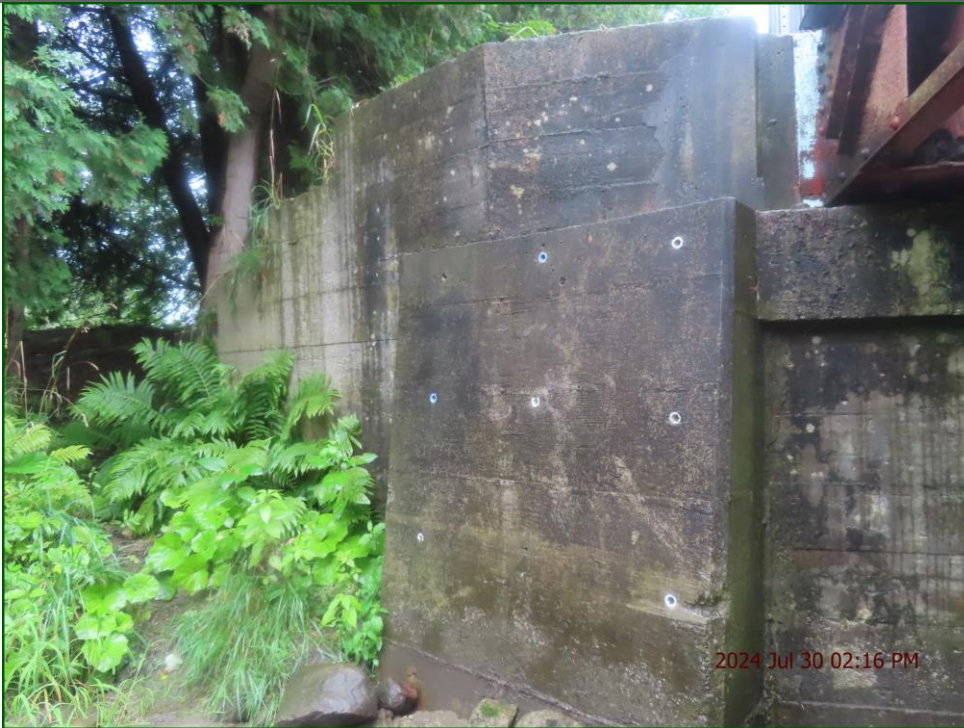
Medium to wide map cracking with leachate staining.

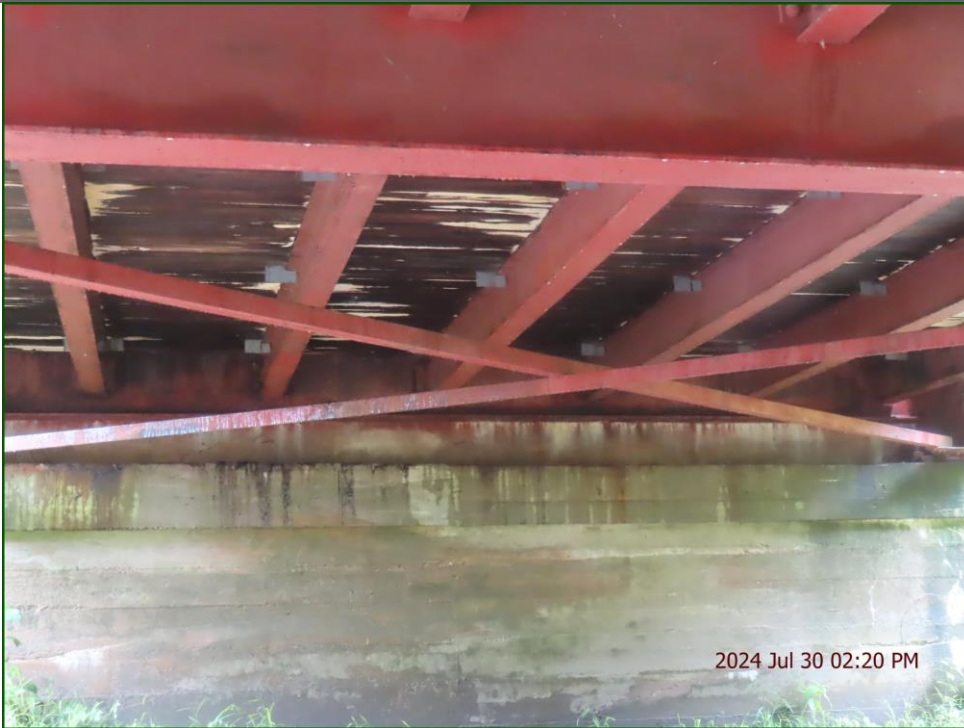
Limited inspection due to floor beams. Medium to wide vertical crack.

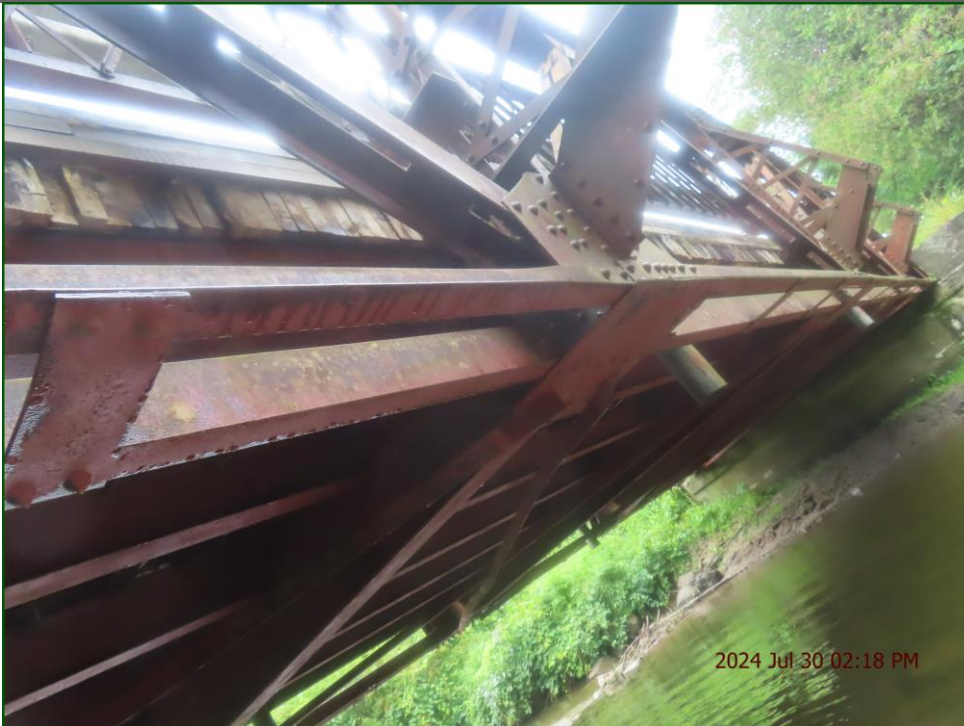
Medium corrosion at ends.

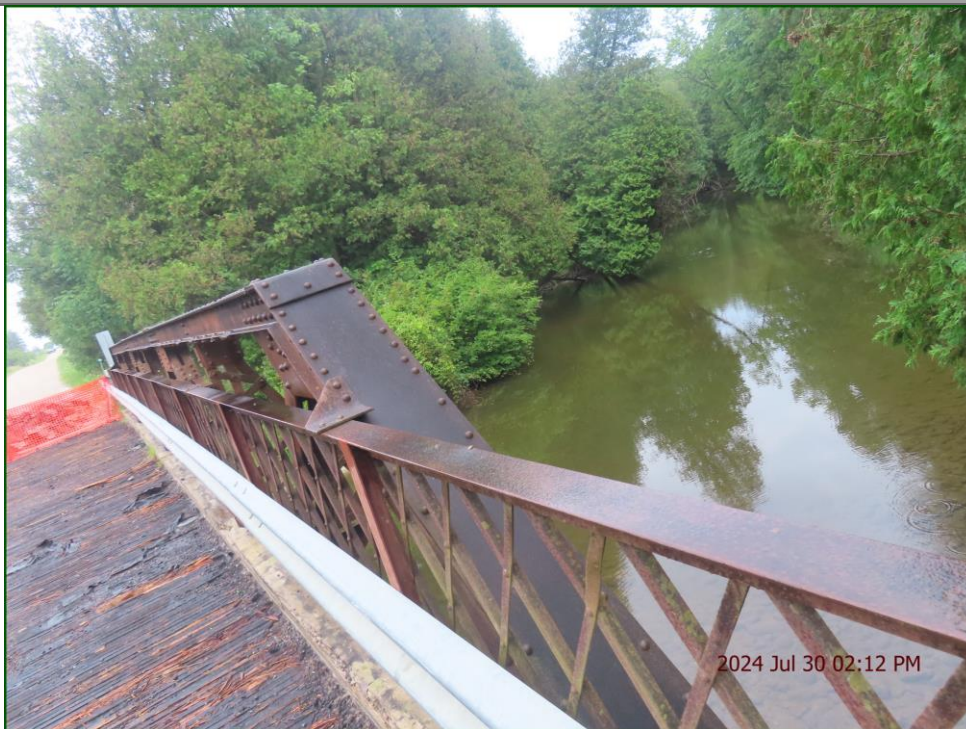
Light corrosion throughout. Severe corrosion with perforations at end.

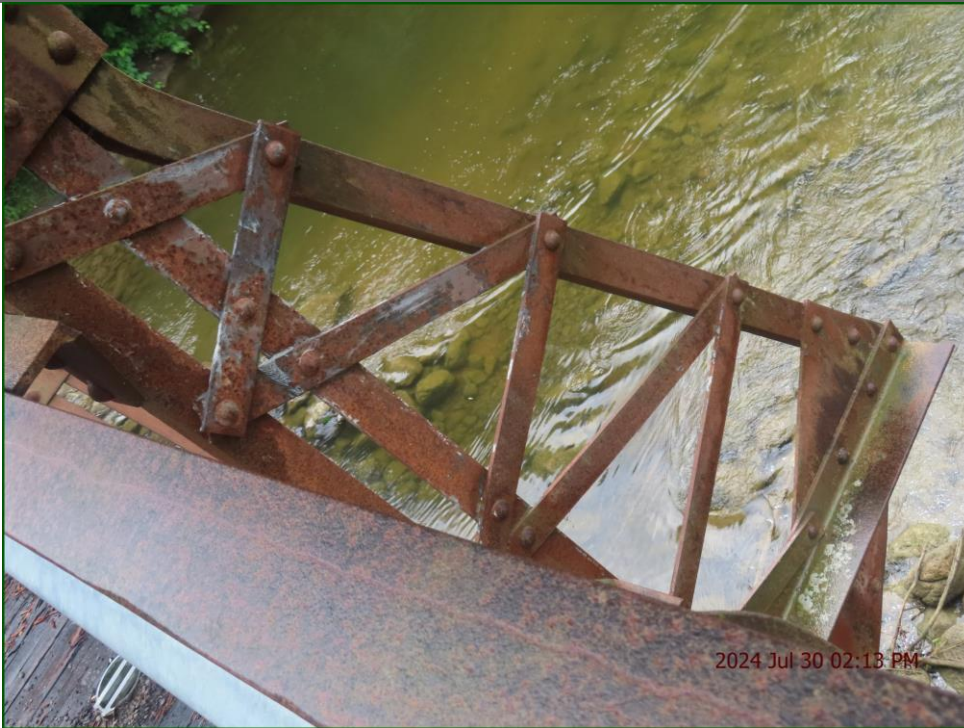
Light corrosion throughout.

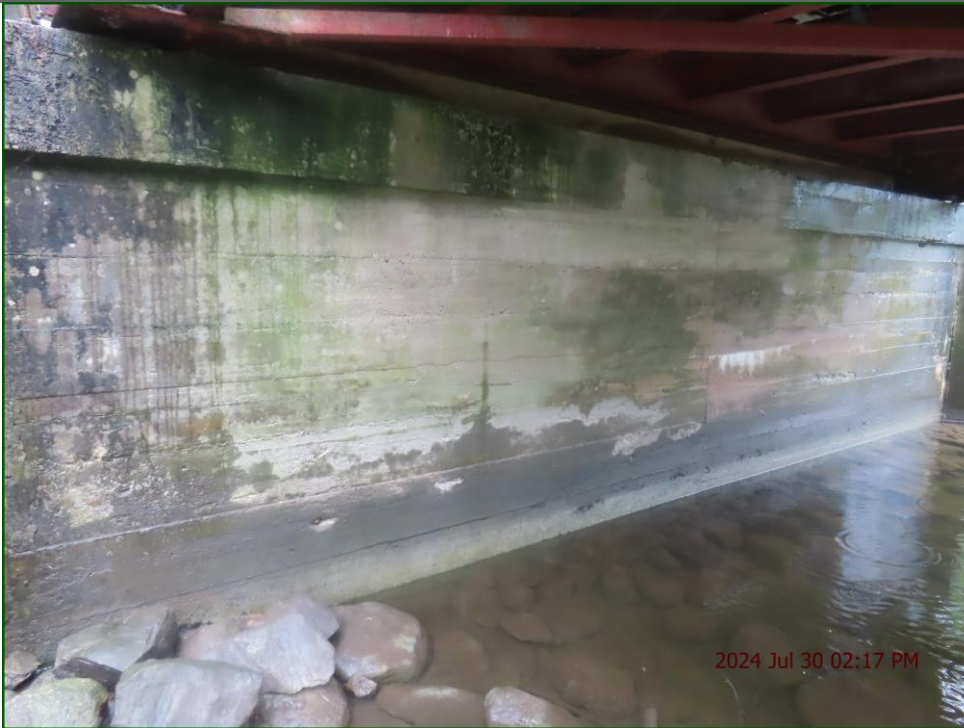
Light to medium horizontal cracking with leachate staining.

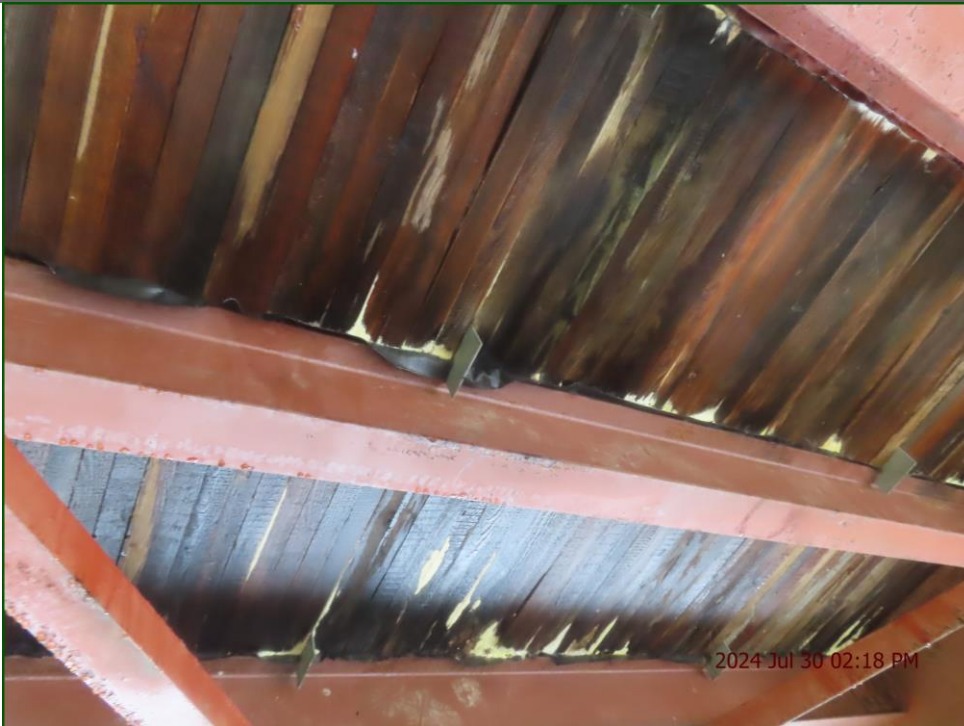
Moderate to severe rotting throughout.

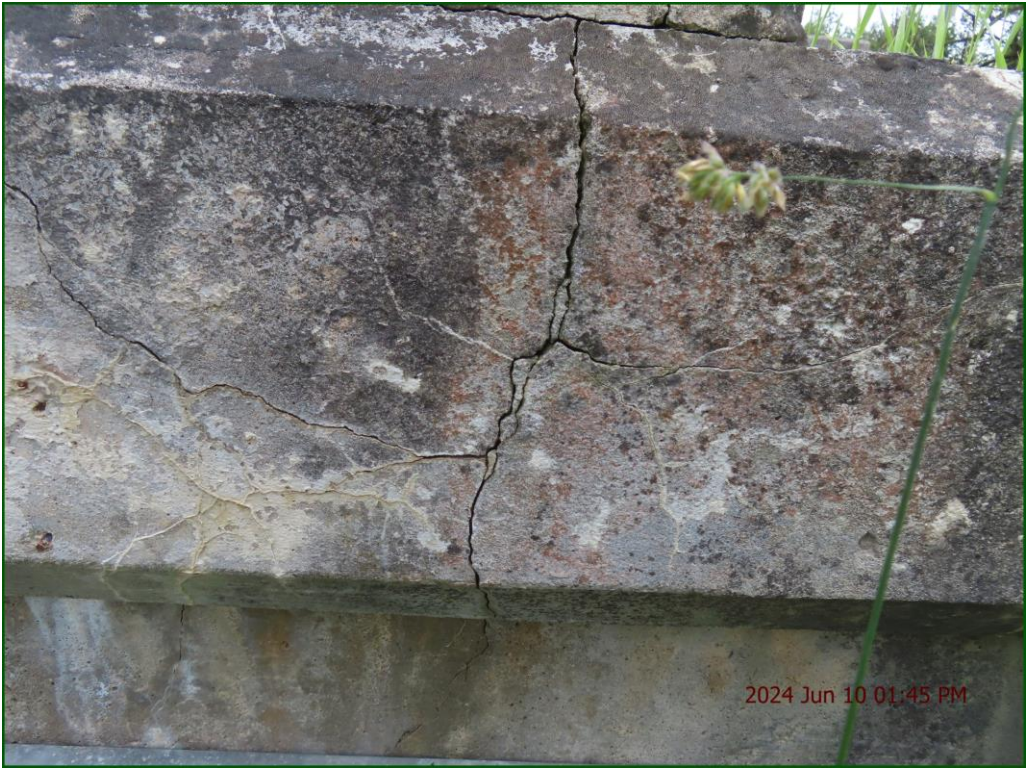
Description: Wingwalls: Light to medium map cracking with leachate staining.

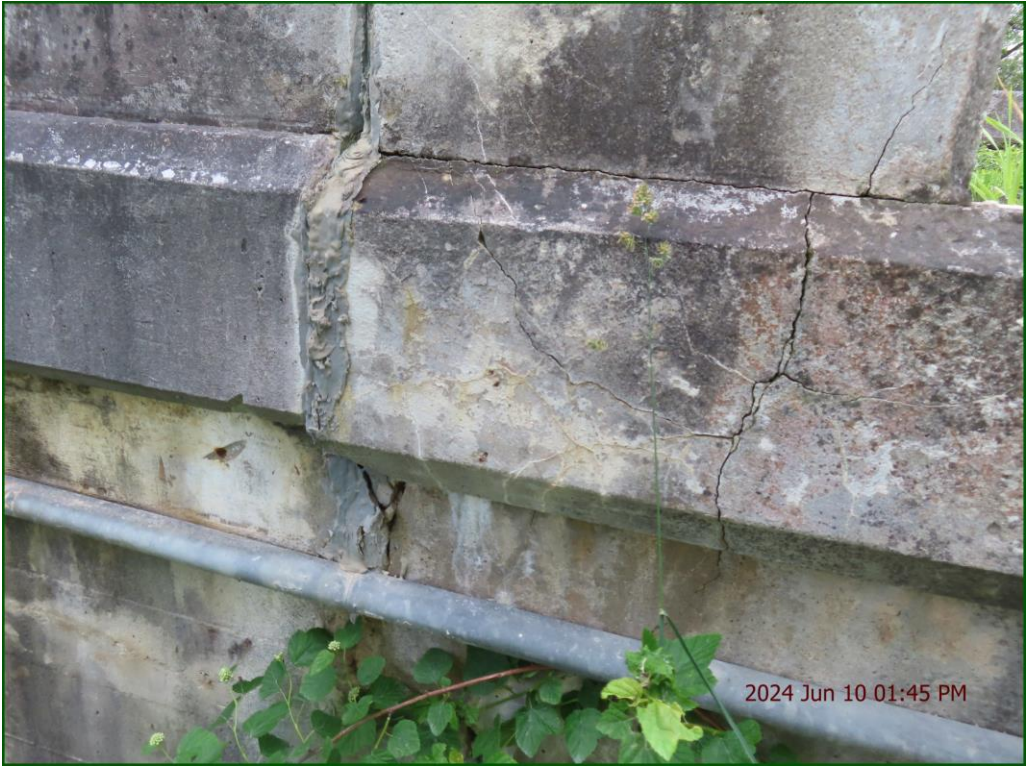
Description: Wingwalls: Light spalling at construction joint, sealing has failed.

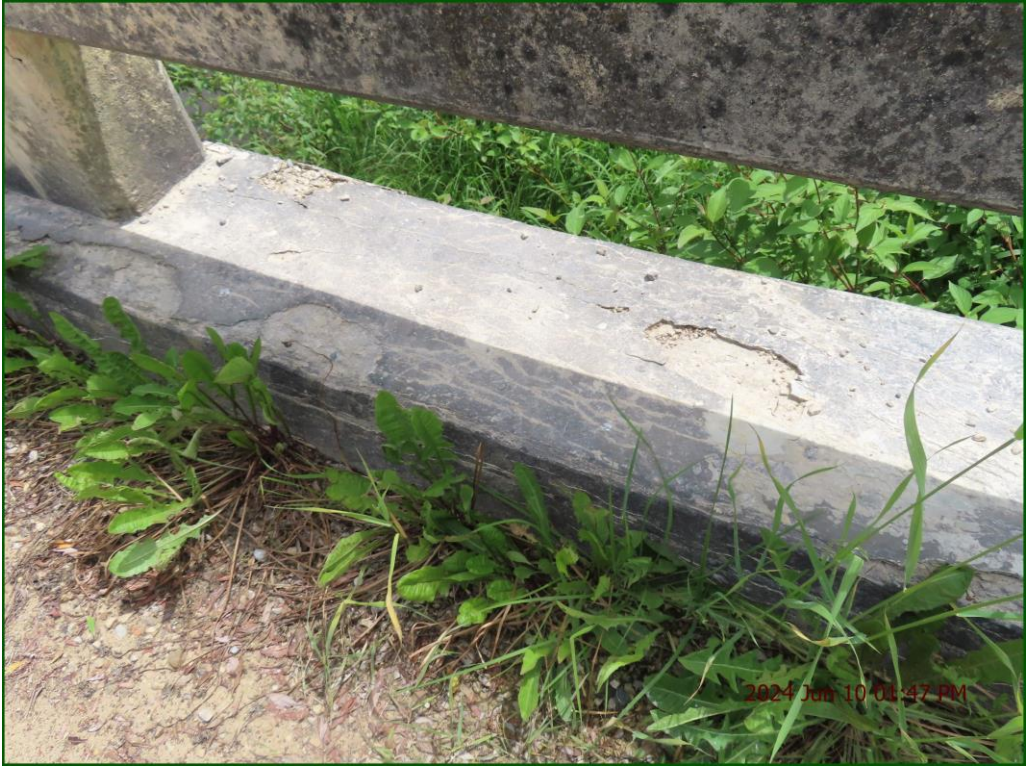
Description: Approach Curbs: Shallow delamination throughout.

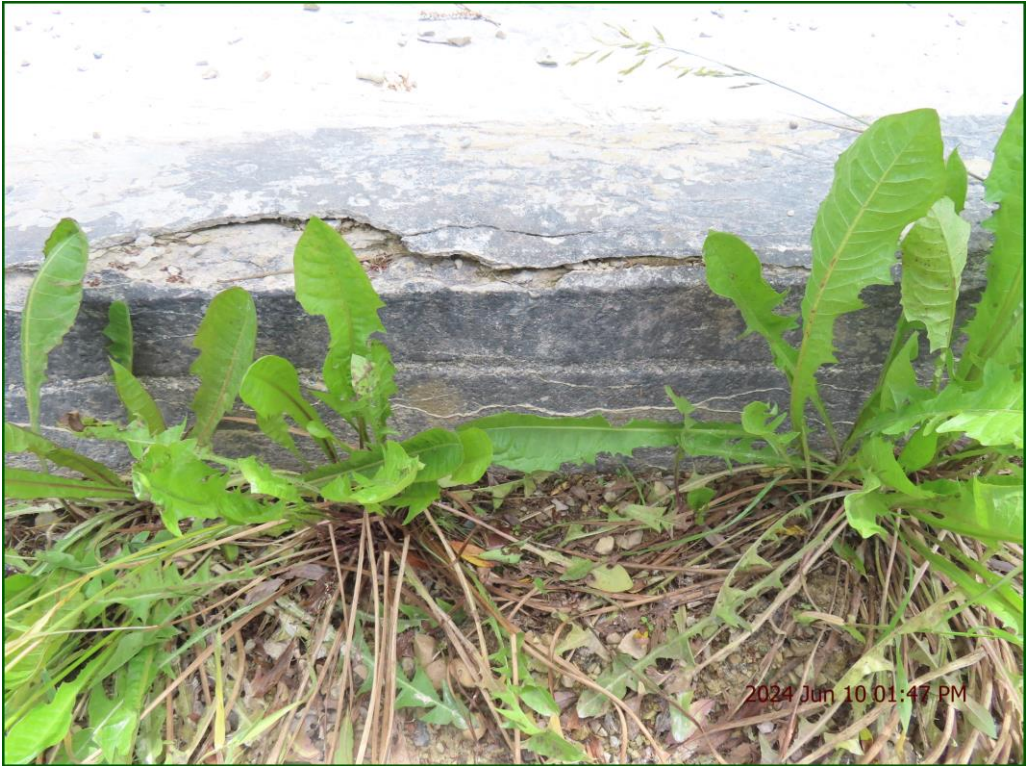
Description: Approach Curbs: Light to medium horizontal cracking with leachate staining.
