OSIM Biennial Inspection Report

Concession 11/12, Lot 30

Burgess Engineering Inc

27-Aug-24

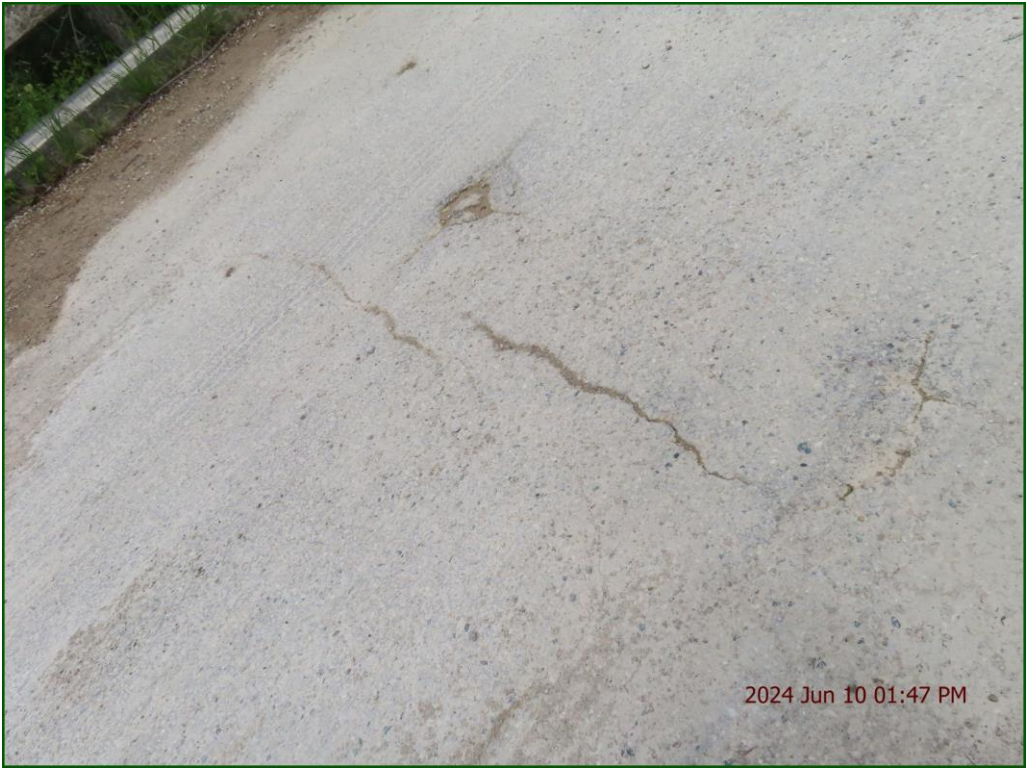
Description: Approach Wearing surface: Light to medium transverse cracks.

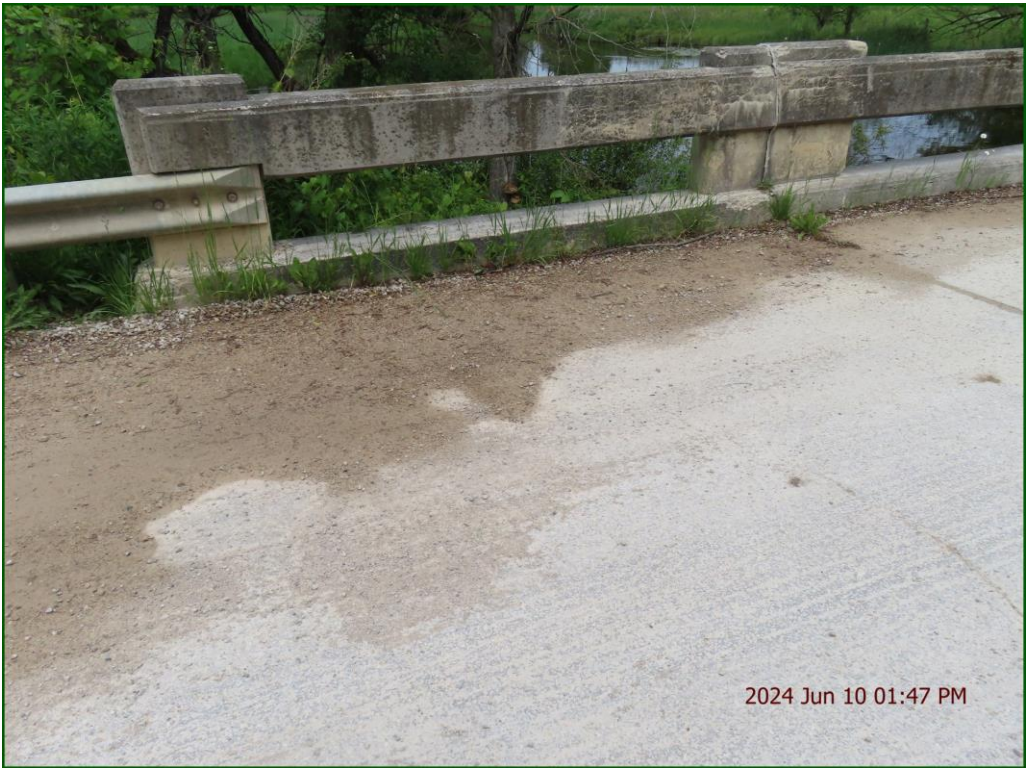
Description: Approach Wearing surface: Sediment covering entire structure.

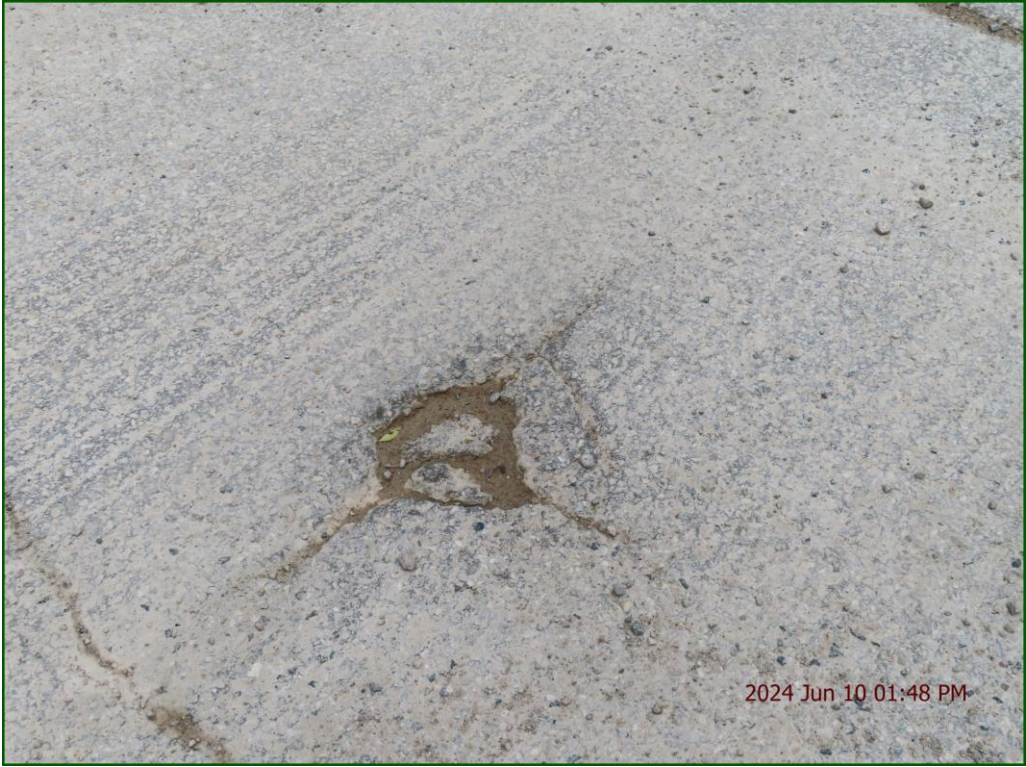
Description: Approach Wearing surface: Moderate to severe potholing throughout.

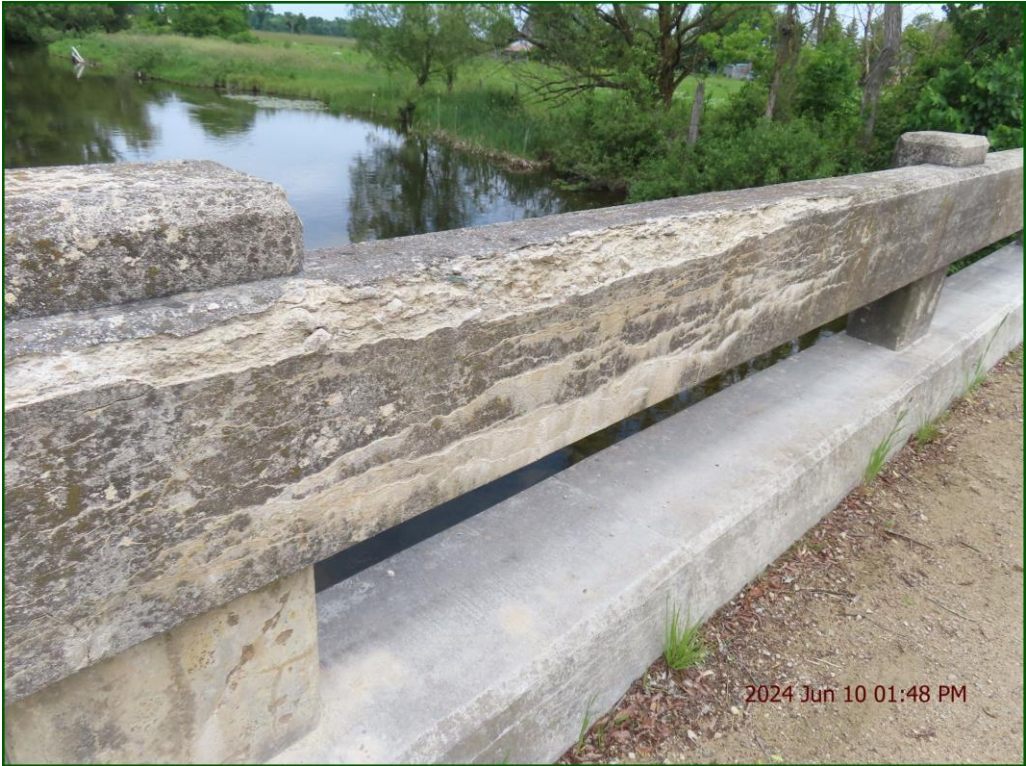
Description: Railing Systems: Medium delamination throughout.

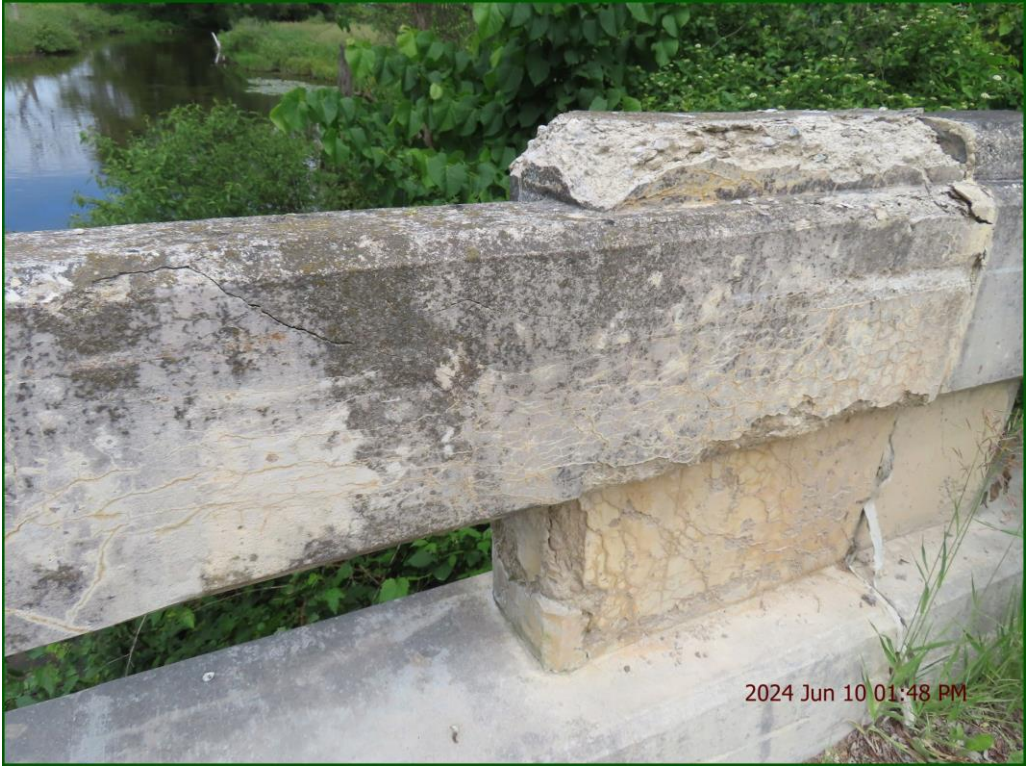
Description: Railing Systems: Light to medium map cracking with leachate staining.

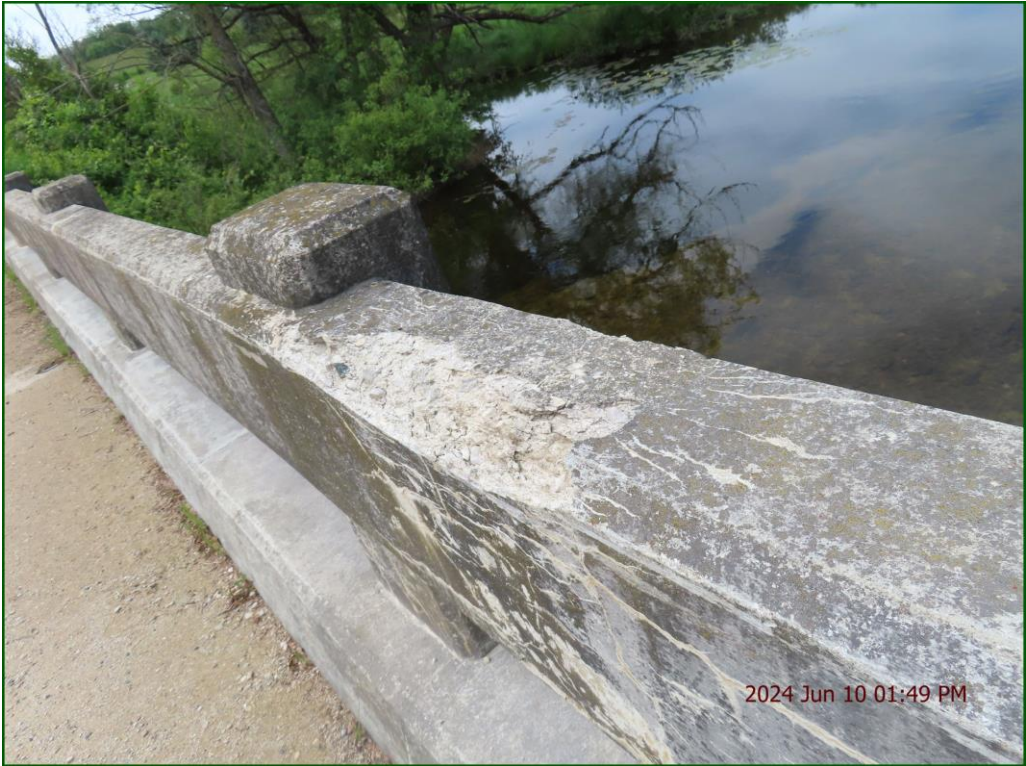
Description: Railing Systems: Light spalling with disintegration.

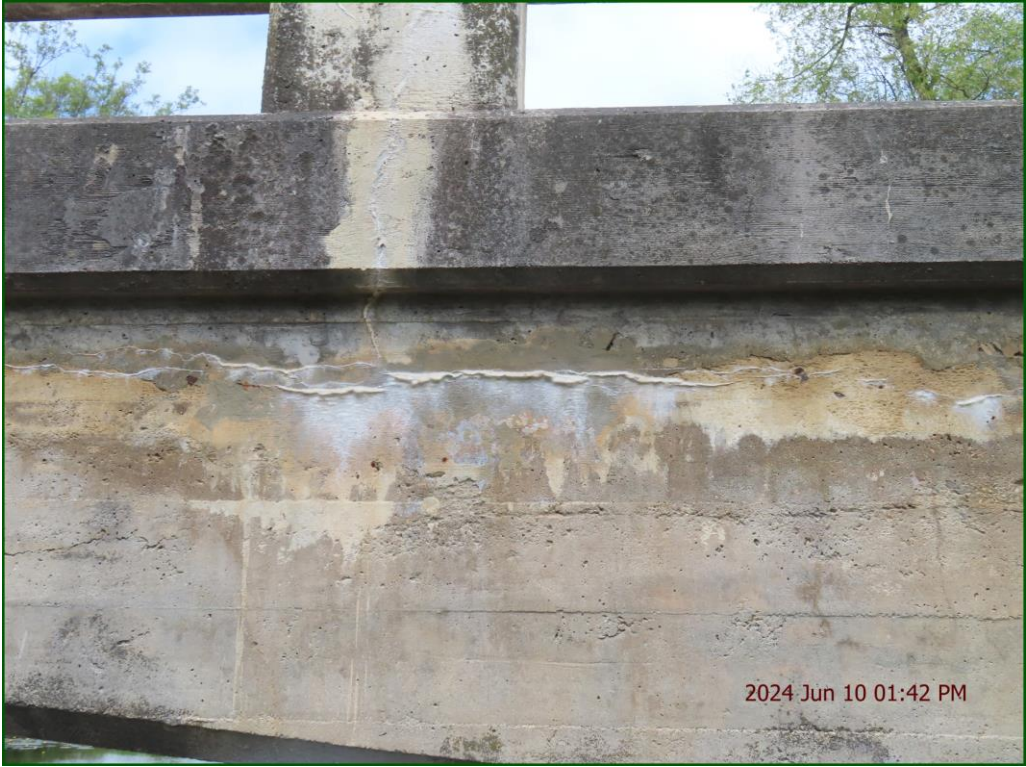
Description: Soffit (ext): Light to medium horizontal cracking with leachate staining.

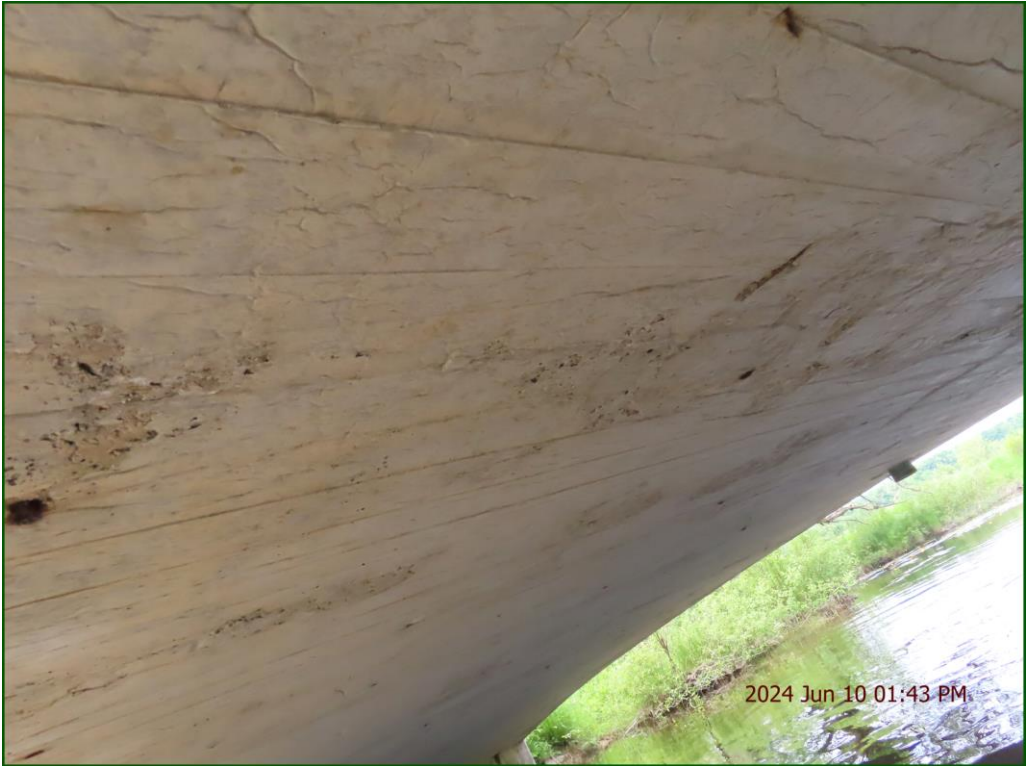
Description: Soffit (int): Patch noted at midspan. Light honeycombing at midspan.

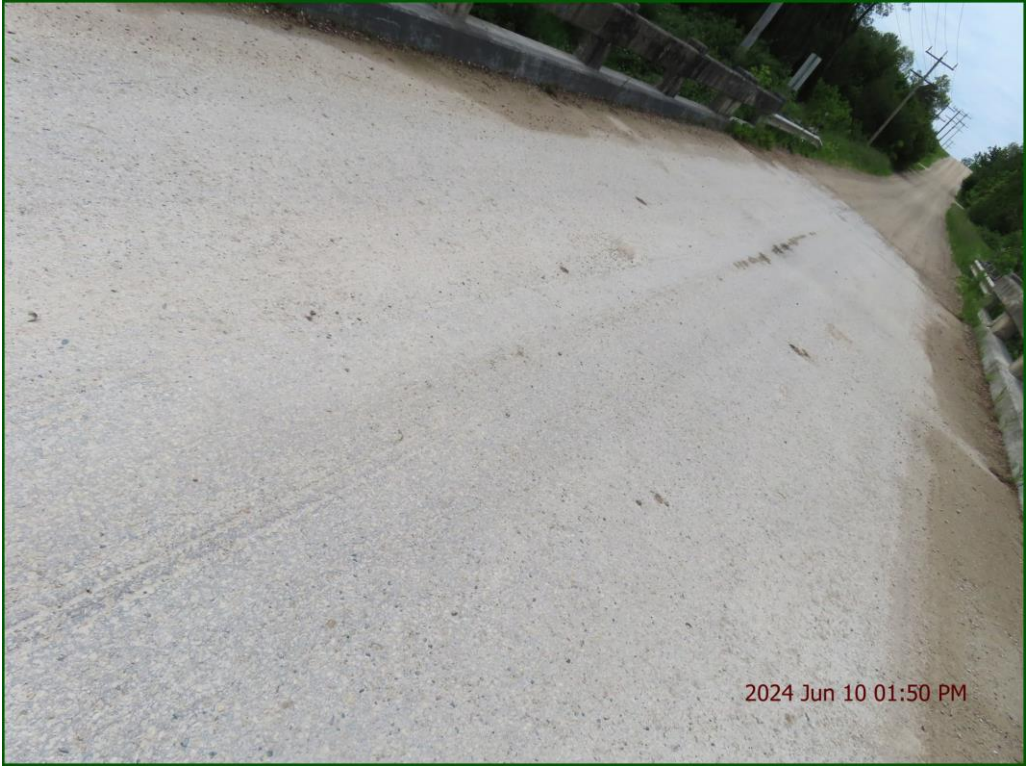
Description: Wearing Surface: Moderate ravelling along centreline.

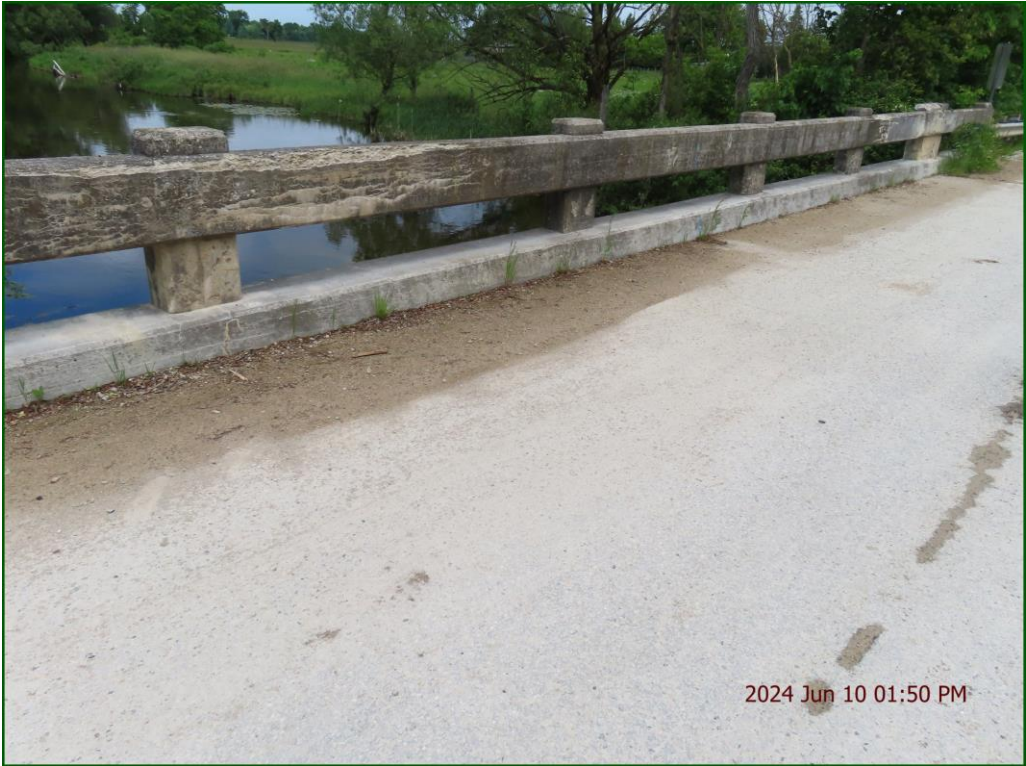
Description: Wearing Surface: Covered in sediment, limited inspection.

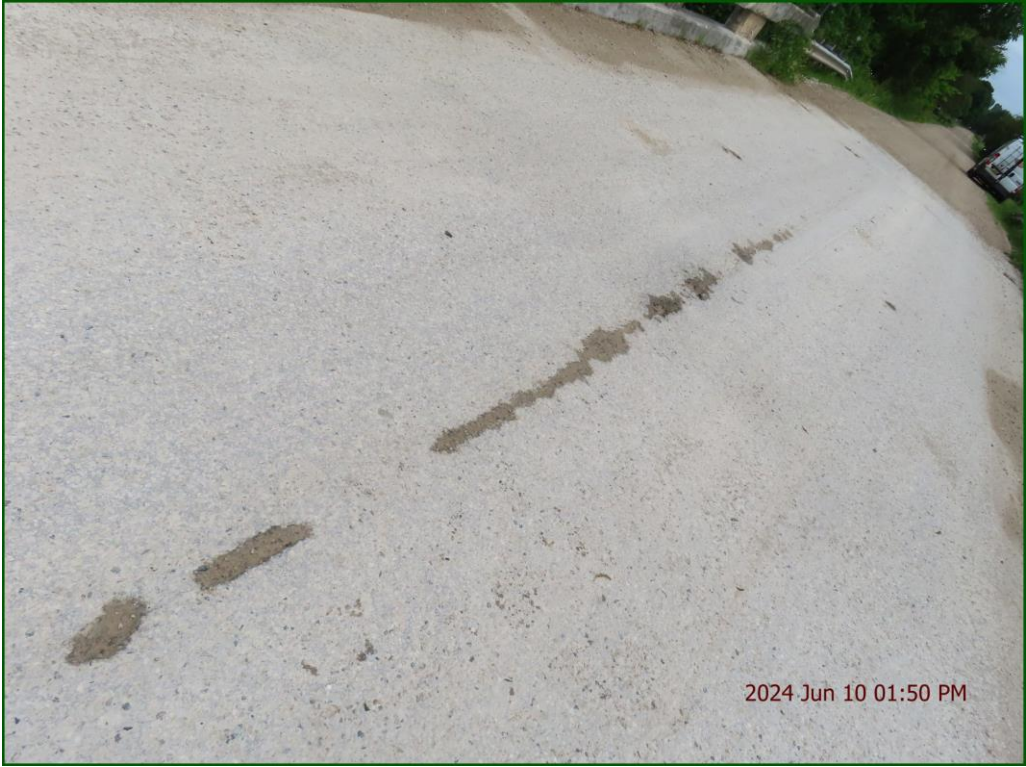
Description: Wearing Surface: Shallow to moderate potholing along centreline.

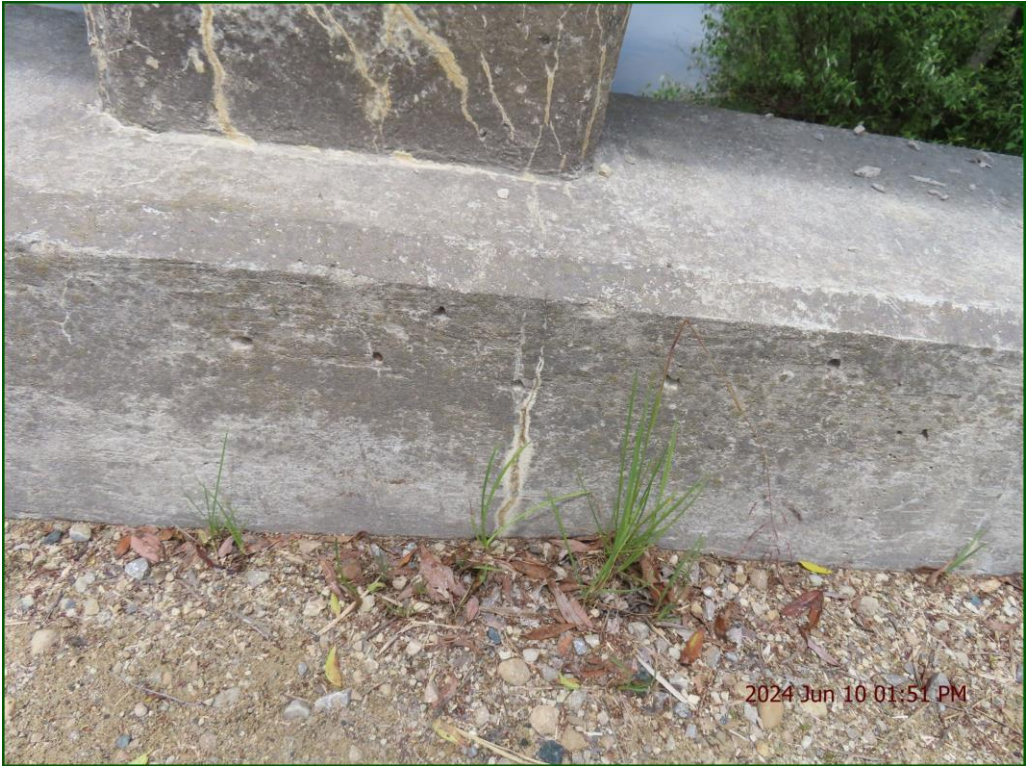
Description: Curbs: Light to medium vertical cracks with leachate staining typ. at post locations.

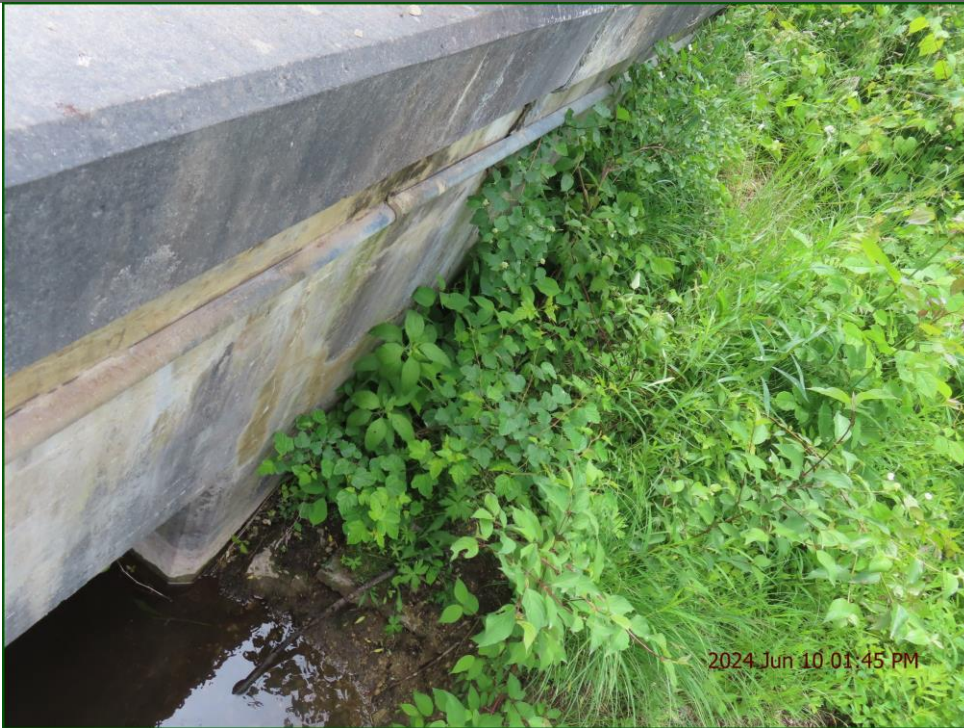
Light to medium map cracking with leachate staining. Light spalling at construction joint, sealing has failed.

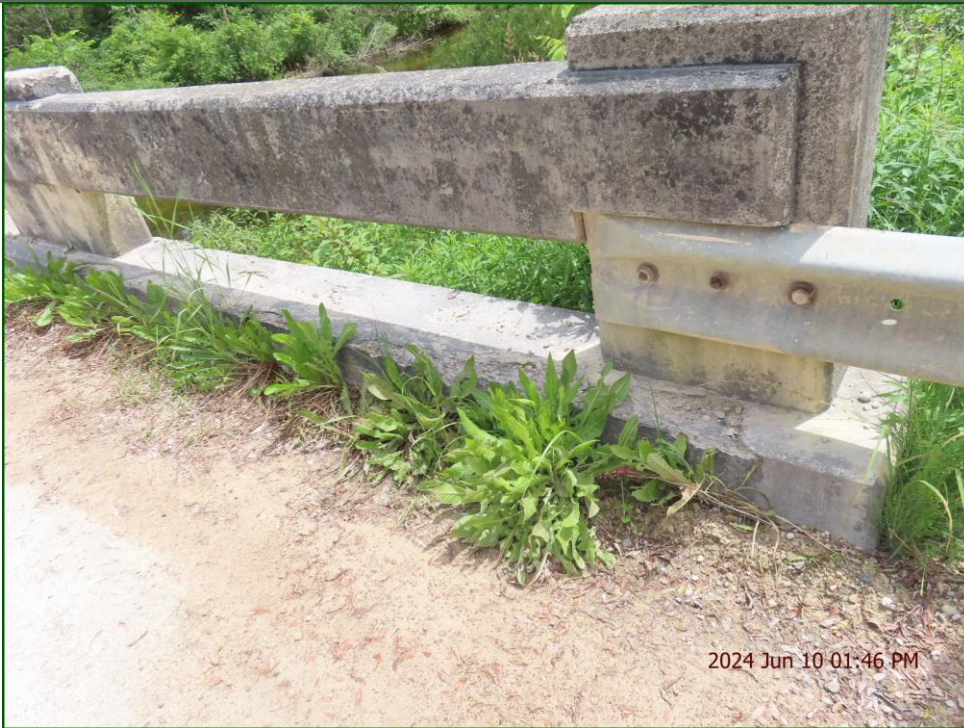
Shallow delamination throughout. Light to medium horizontal cracking with leachate staining.

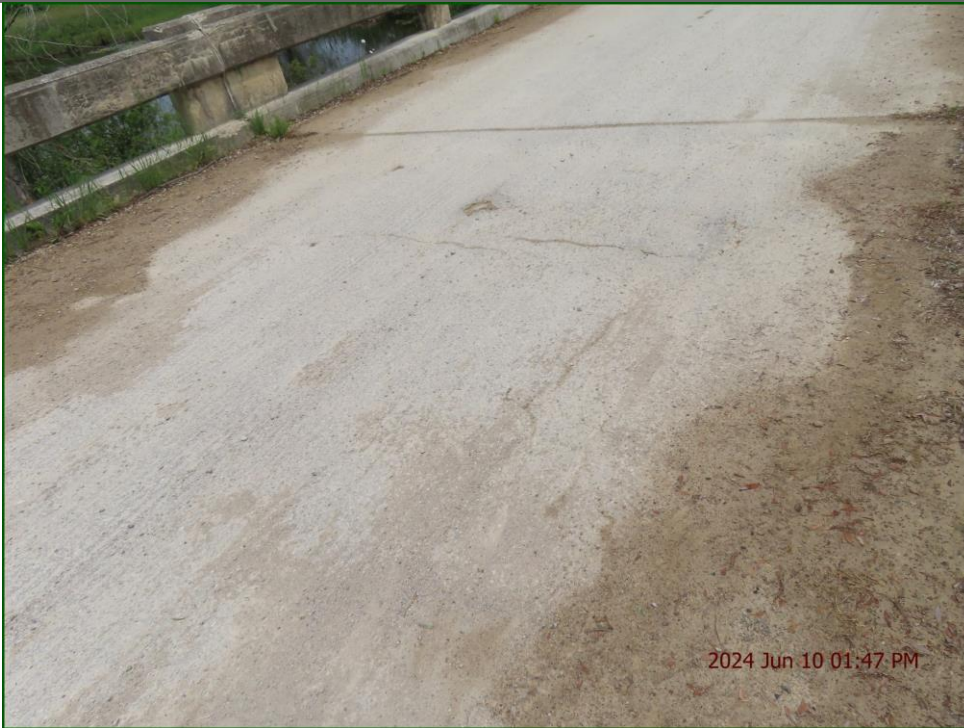
Light to medium transverse cracks. Sediment covering entire structure, limited inspection. Moderate to severe potholing throughout.

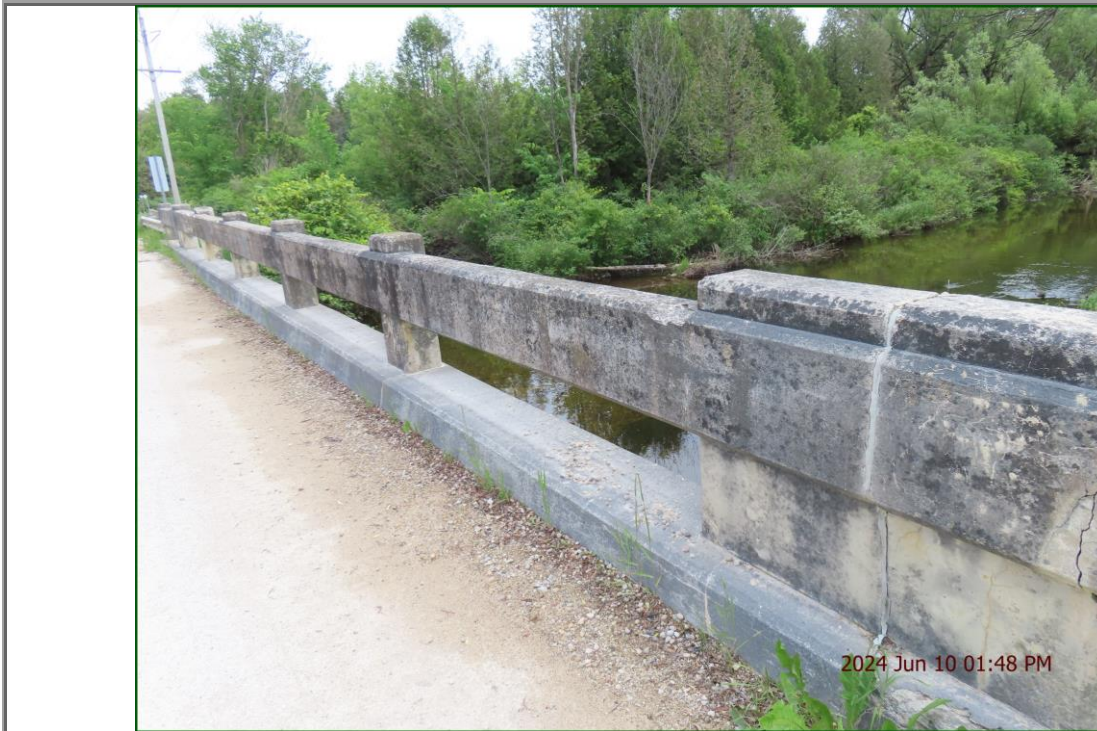
Medium delamination throughout. Light to medium map cracking with leachate staining. Light spalling with disintegration.

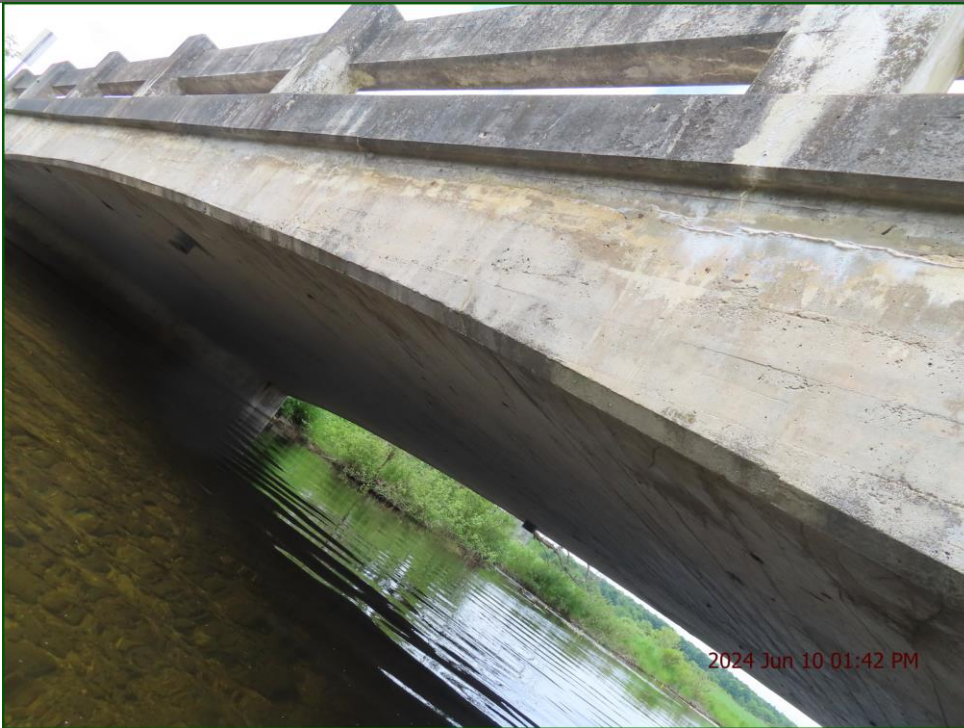
Light to medium horizontal cracking with leachate staining.

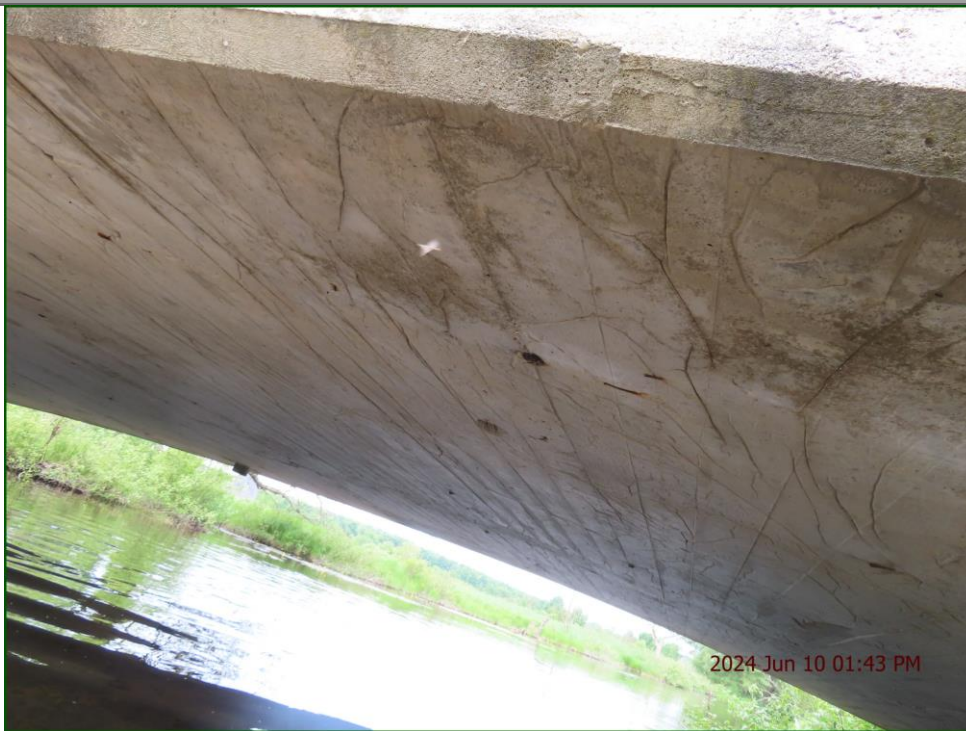
Patch noted at midspan. Light honeycombing at midspan.

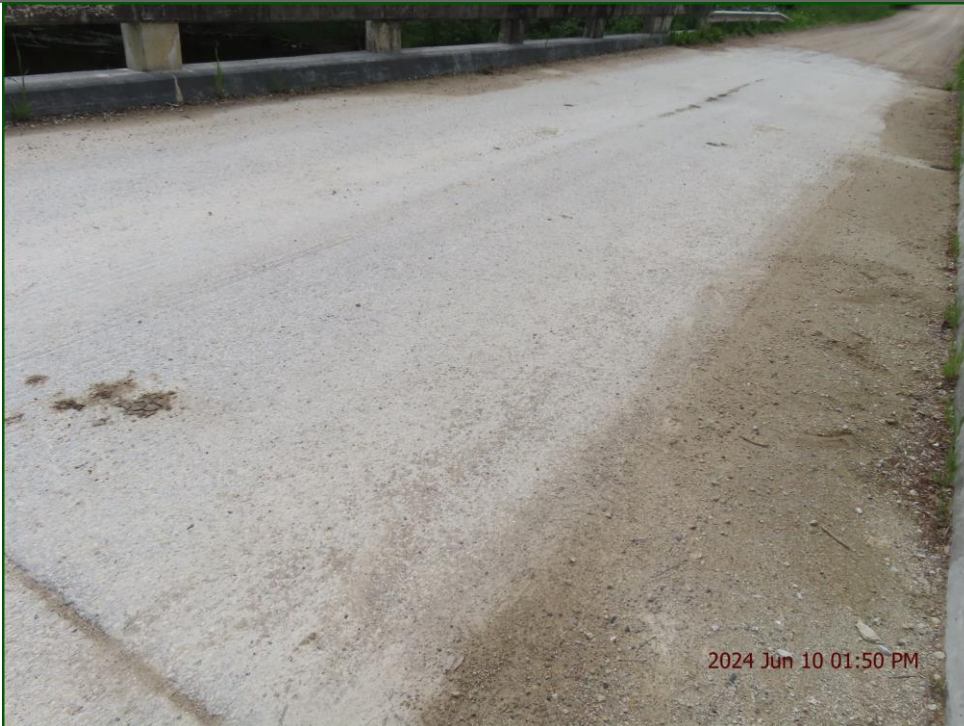
Moderate ravelling along centreline. Covered in sediment, limited inspection. Shallow to moderate potholing along centreline.

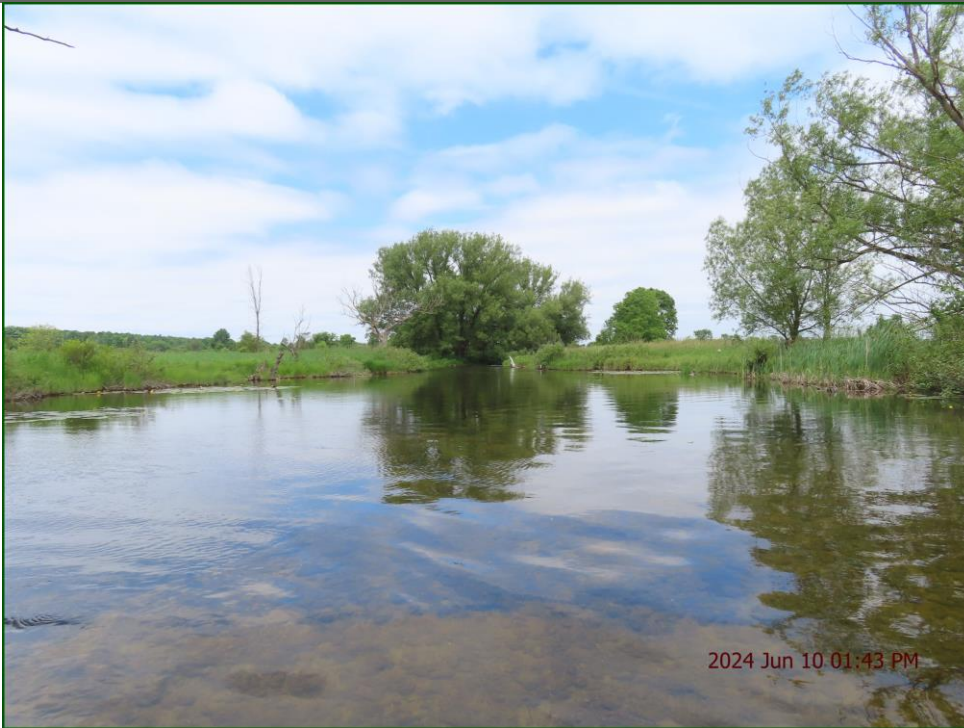
High water level at time of inspection.

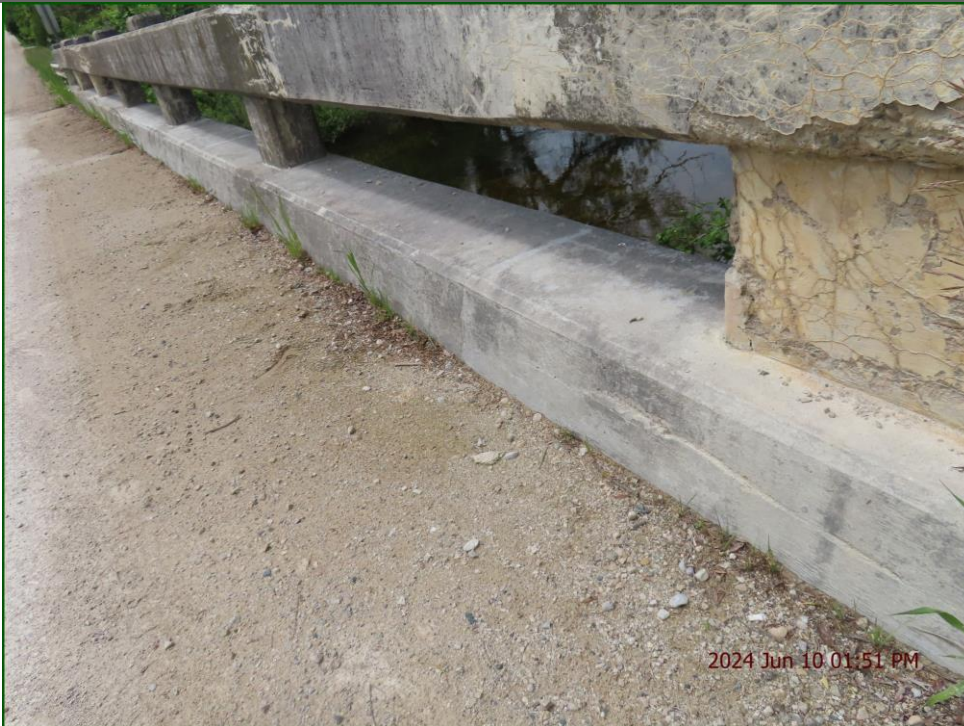
Light to medium vertical cracks with leachate staining typ. at post locations.

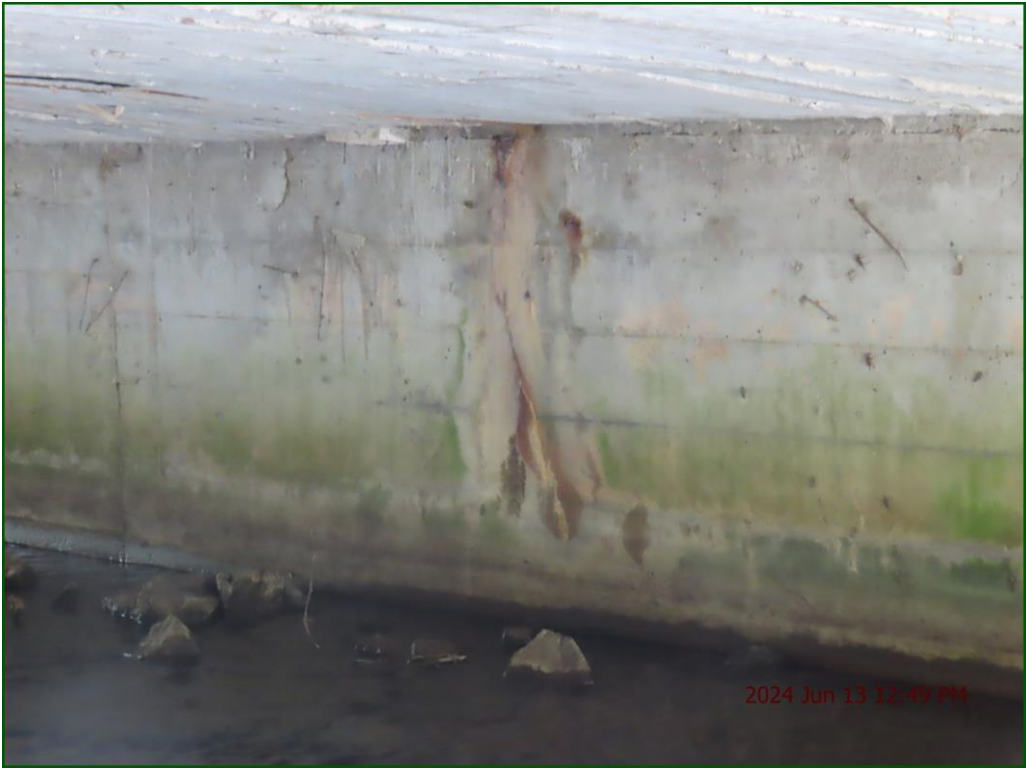
Description: Abutment walls: Medium to wide vertical cracking with leachate staining.

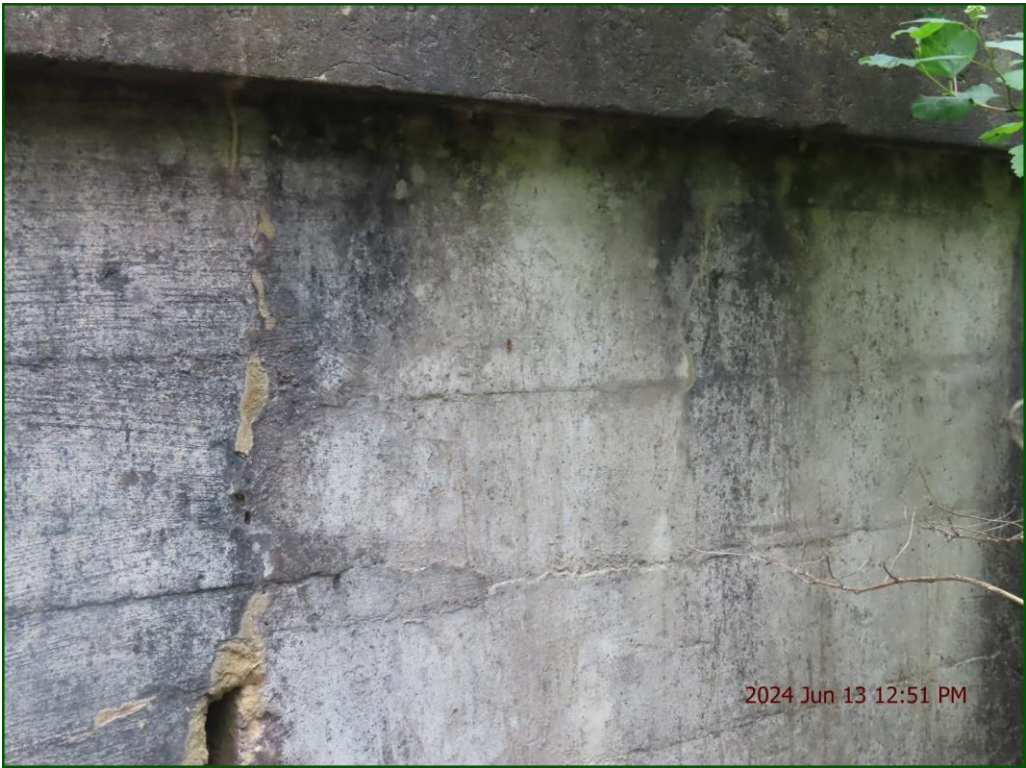
Description: Wingwalls: Light vertical cracking with leachate and wetness staining.

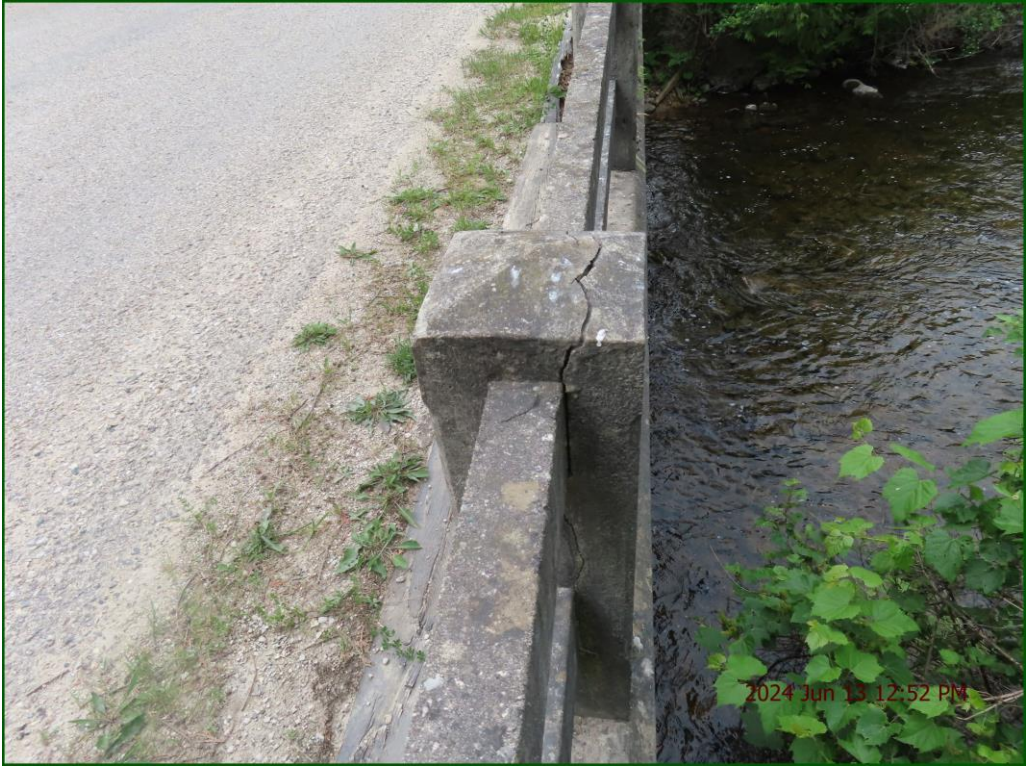
Description: Railing Systems: Medium to wide vertical cracking throughout.

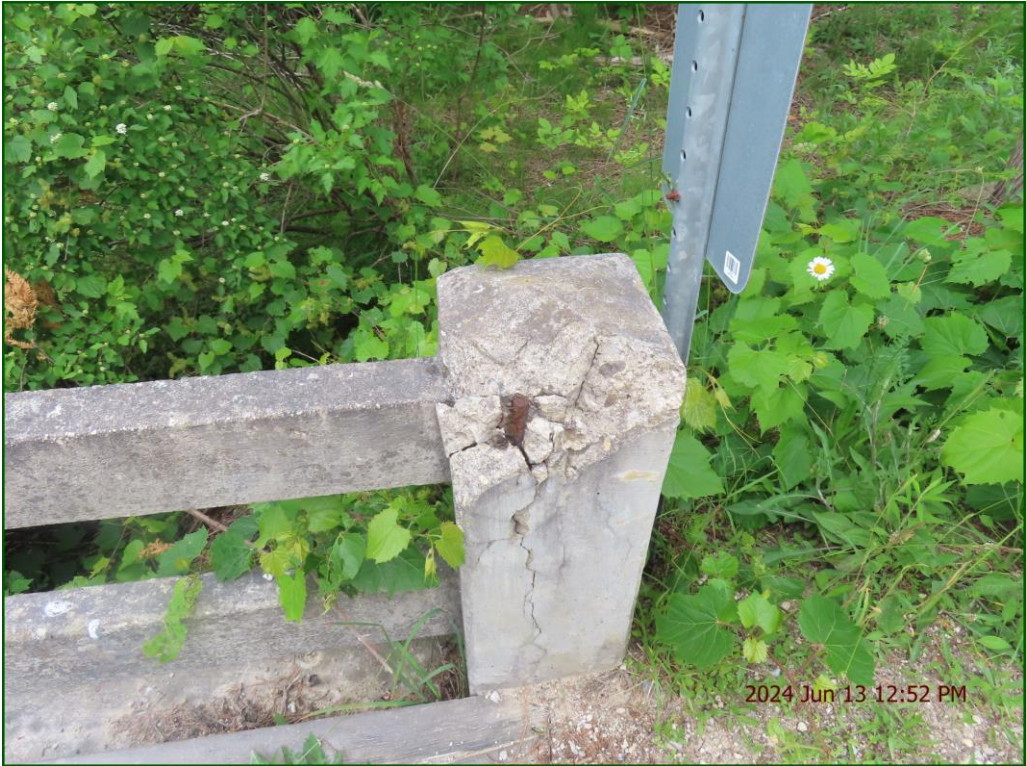
Description: Railing Systems: Shallow spall with exposed reinforcing.

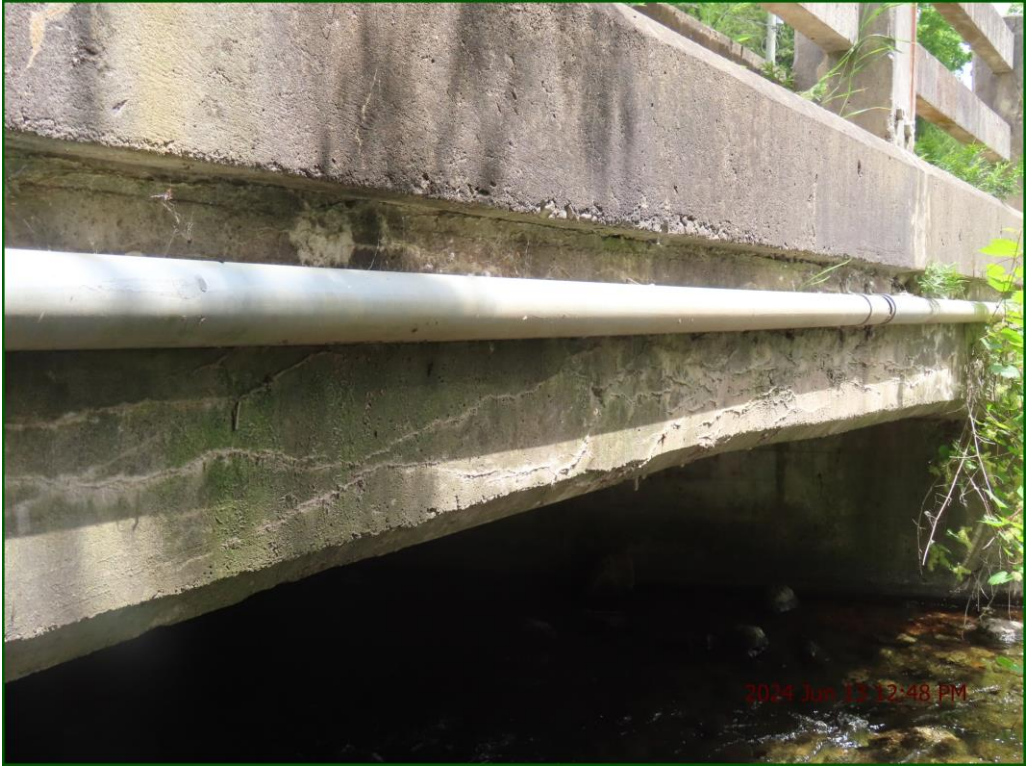
Description: Soffit (ext): Light to medium map cracking with leachate staining throughout.

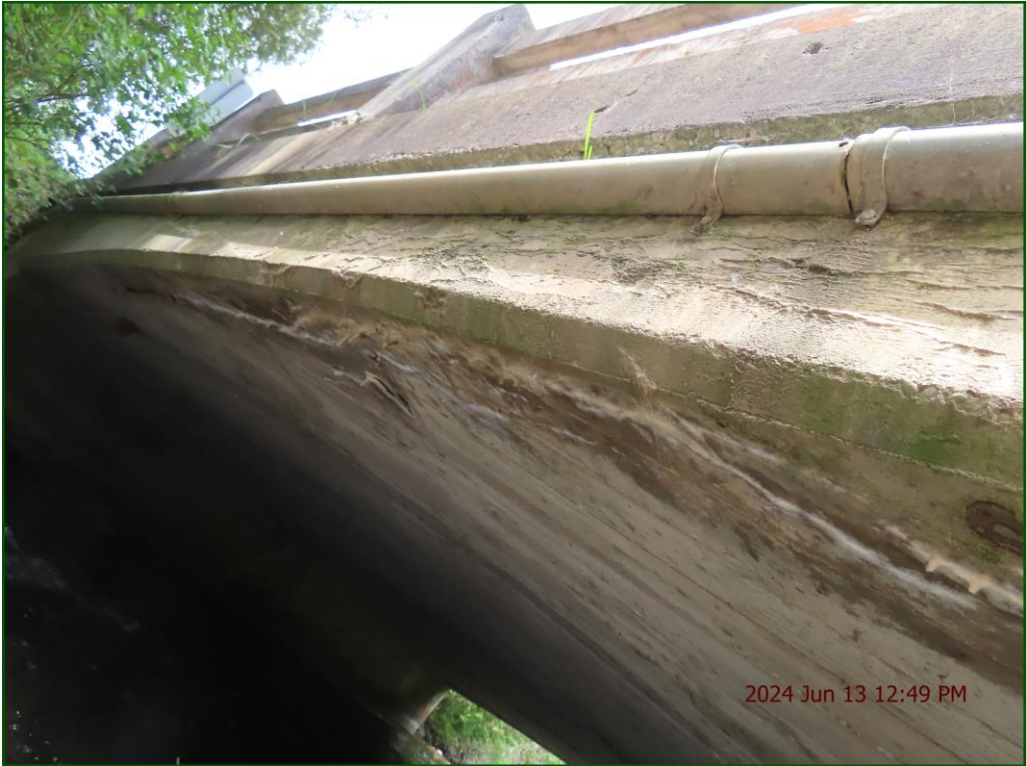
Description: Soffit (ext): Light to medium longitudinal cracking with leachate staining.

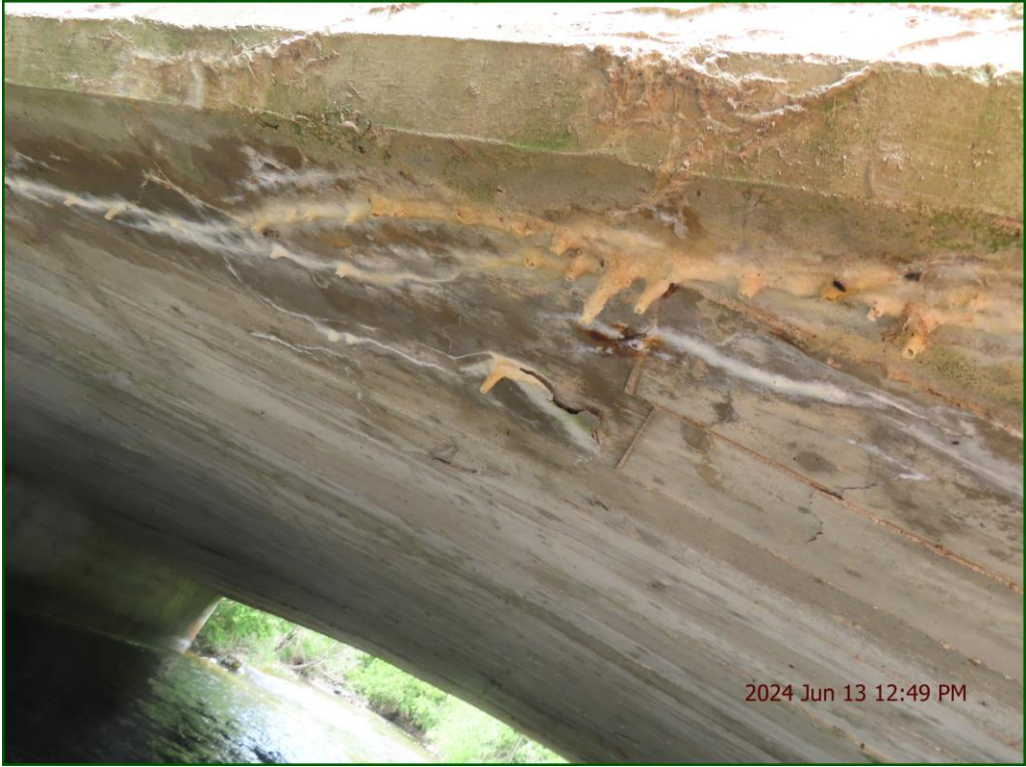
Description: Soffit (ext): Moderate delamination with exposed reinforcing.

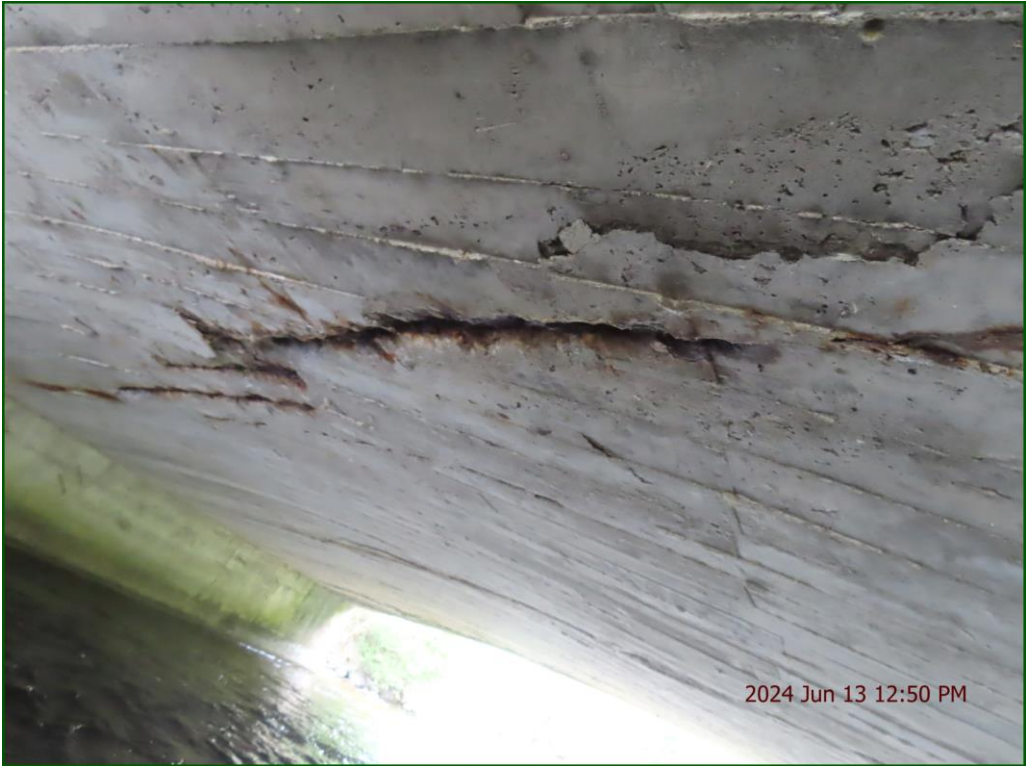
Description: Soffit (int): Moderate to severe delamination with exposed reinforcing throughout.
