OSIM Biennial Inspection Report

Concession 11/12, Lot 30

Burgess Engineering Inc

27-Aug-24

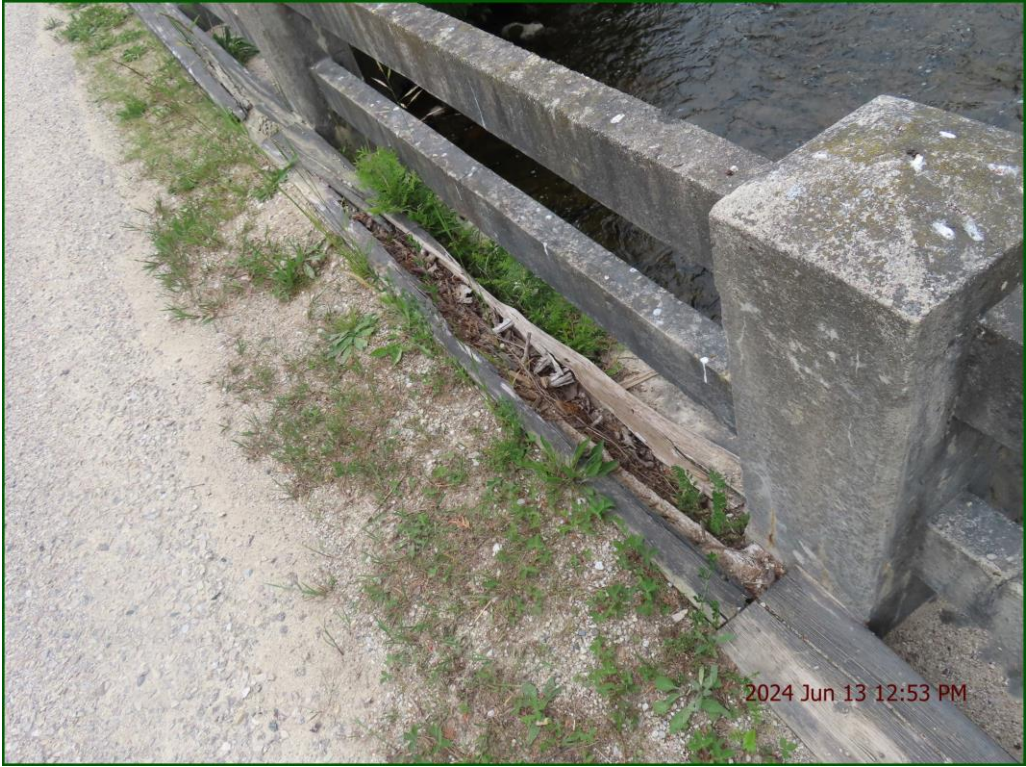
Description: Curbs: Severe localized rot.

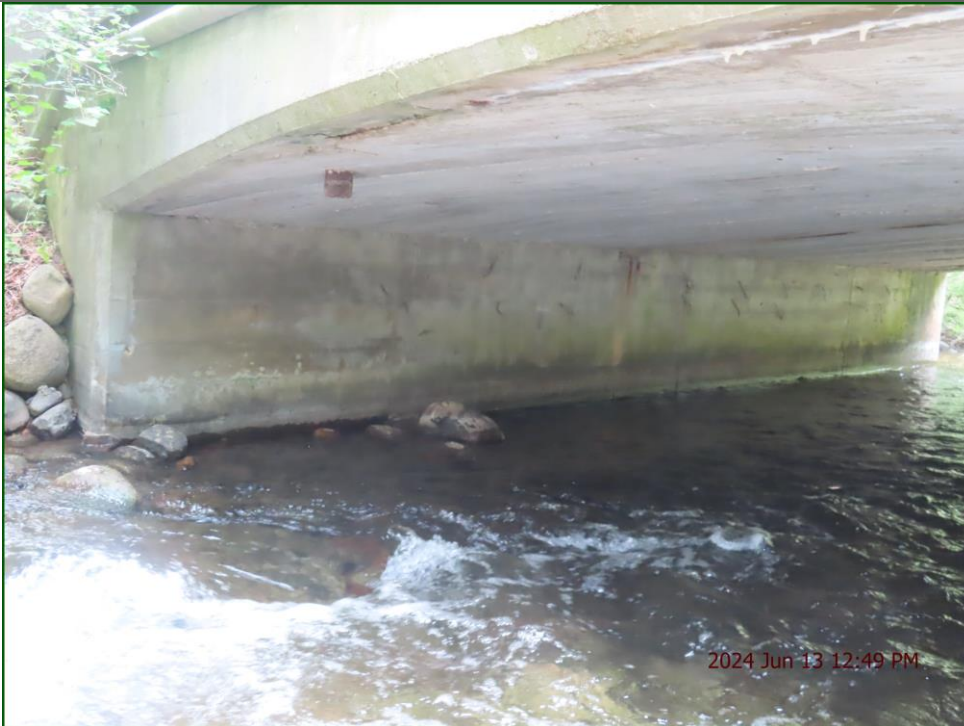
Medium to wide vertical cracking with leachate staining.

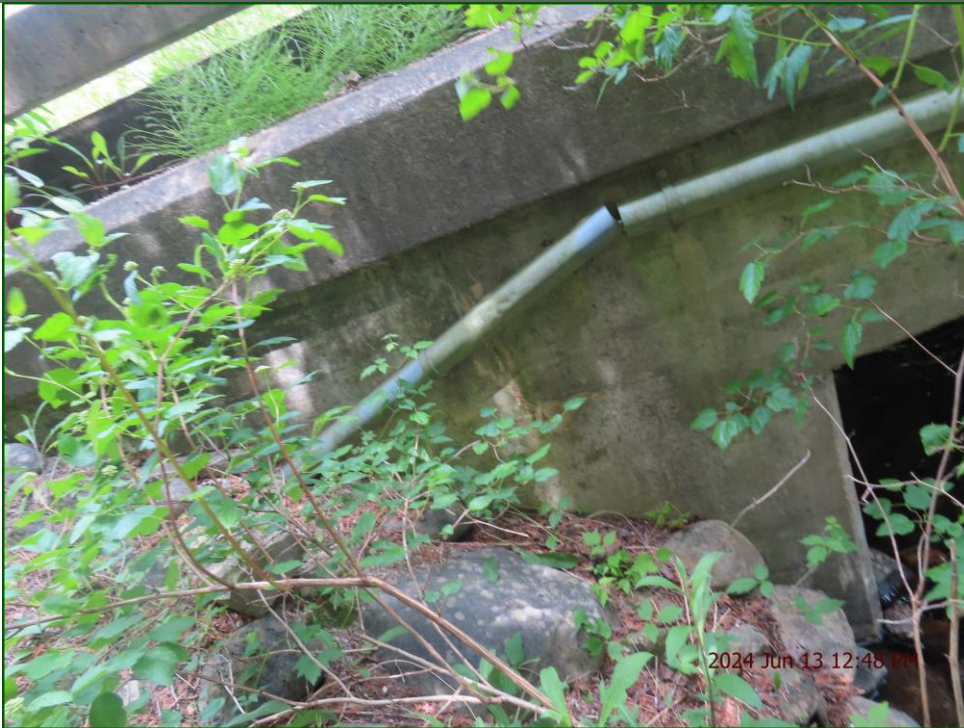
Light vertical cracking with leachte and wetness staining.

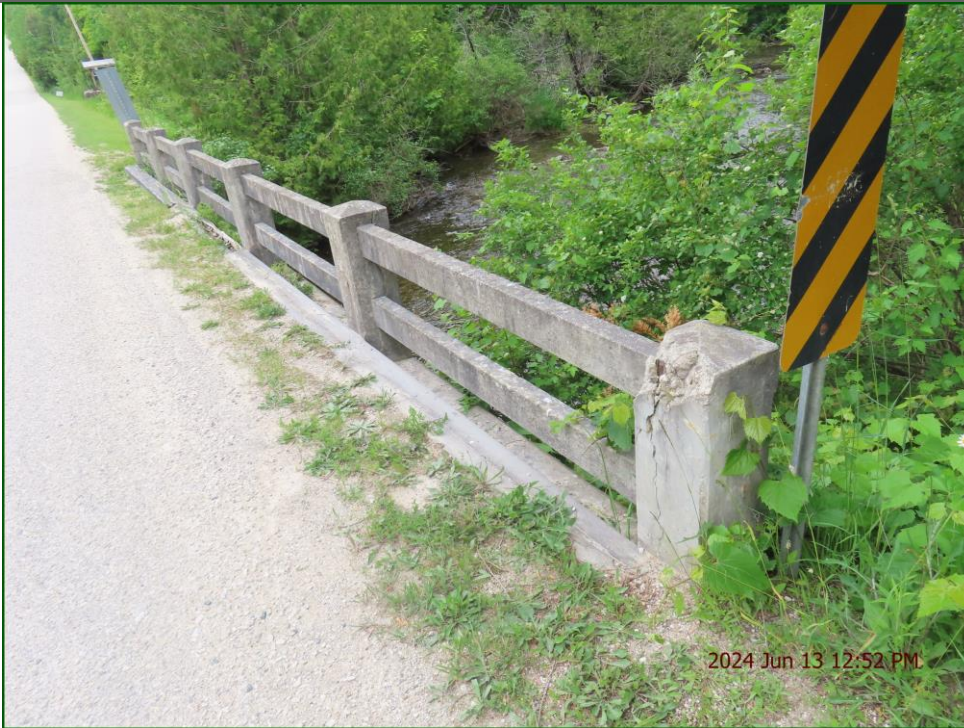
Medium to wide vertical cracking throughout. Shallow spall with exposed reinforcing.

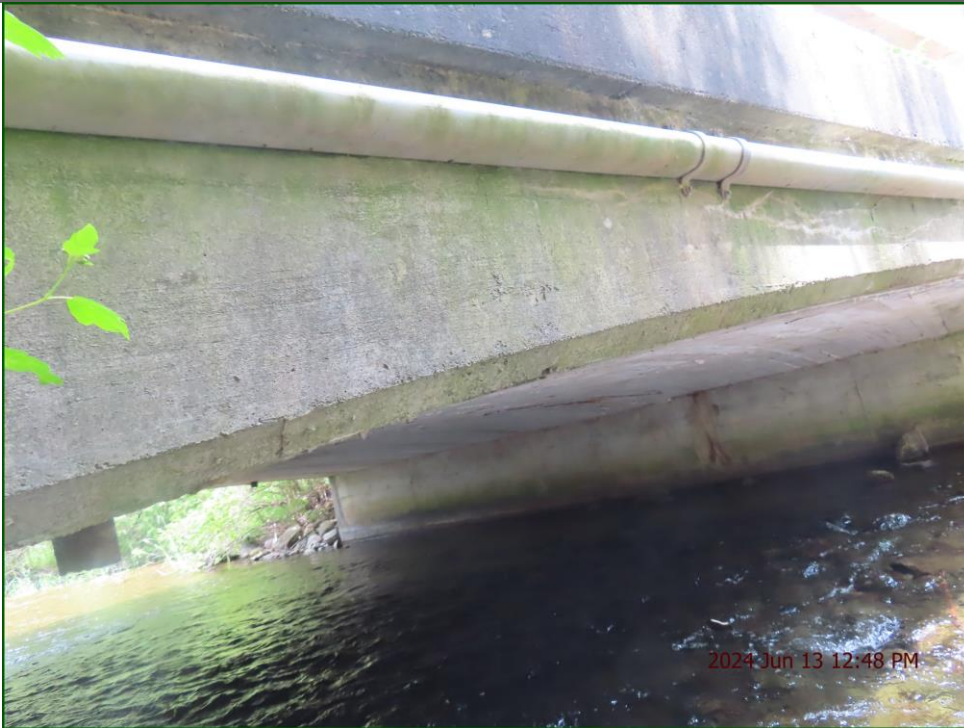
Light to medium map cracking with leachate staining throughout. Light to medium longitudinal cracking with leachate staining. Moderate delamination with exposed reinforcing.

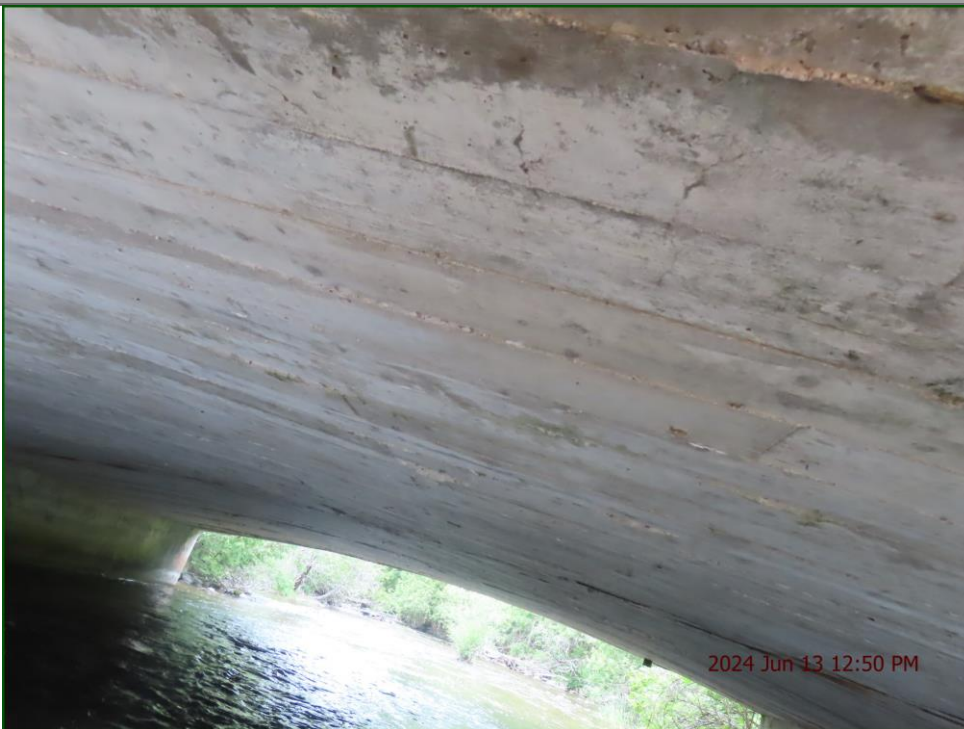
Moderate to severe delamination with exposed reinforcing throughout.

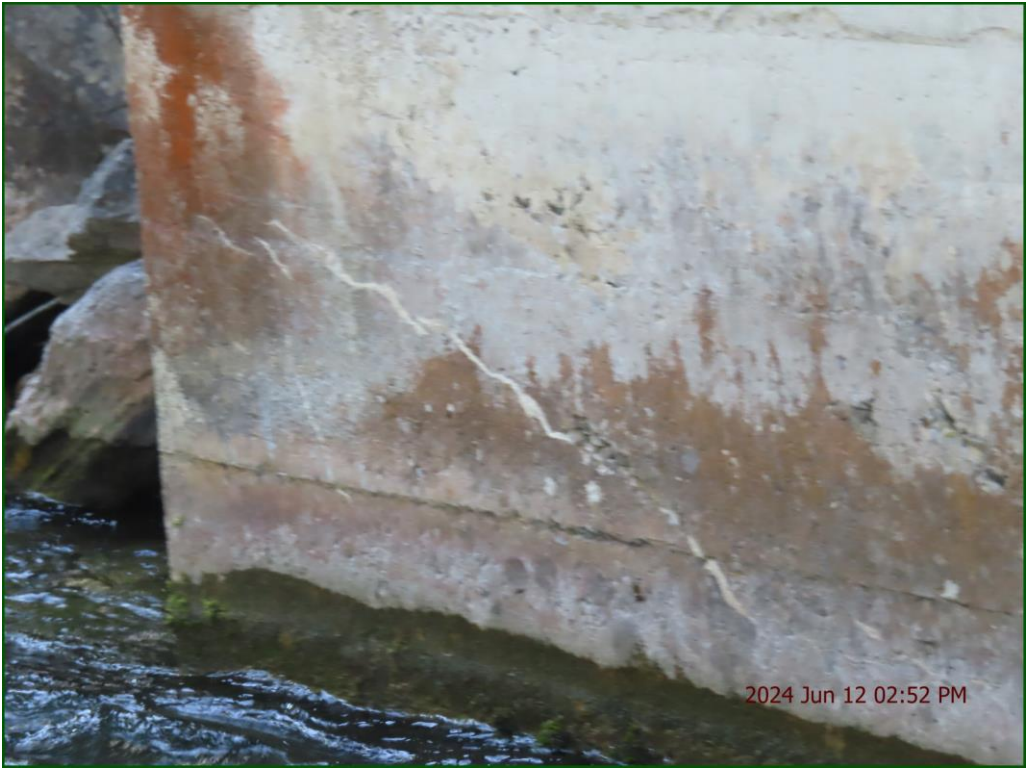
Description: Abutment walls: Light scaling throughout.

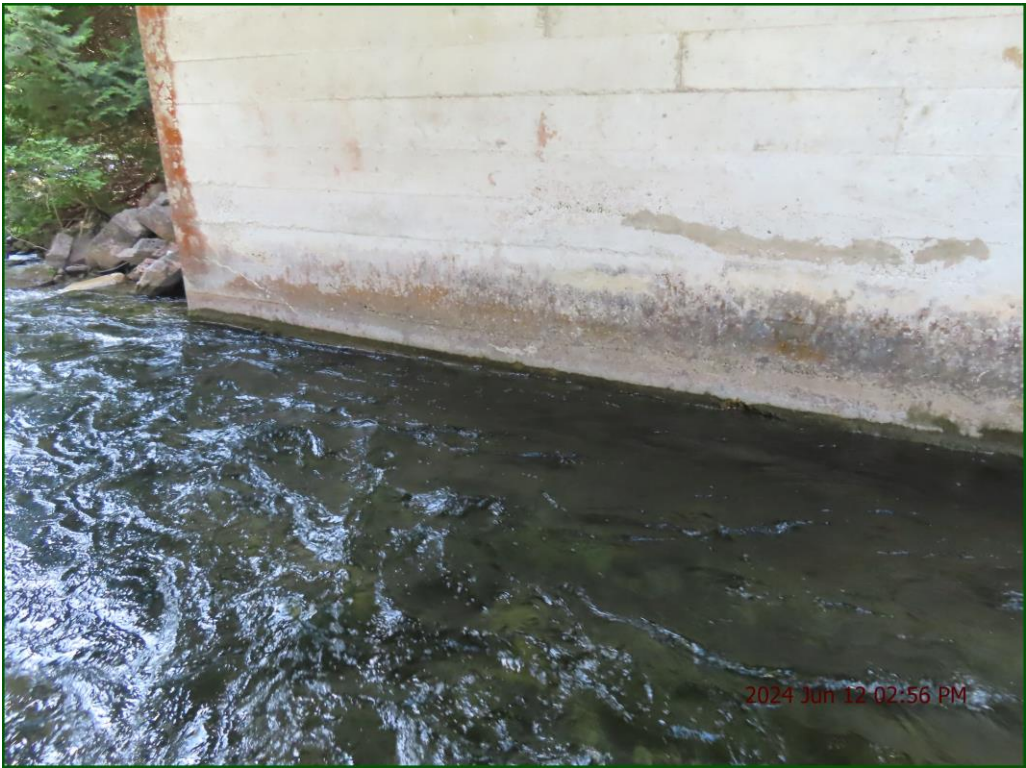
Description: Abutment walls: Moderate scouring on west abutment, under water.

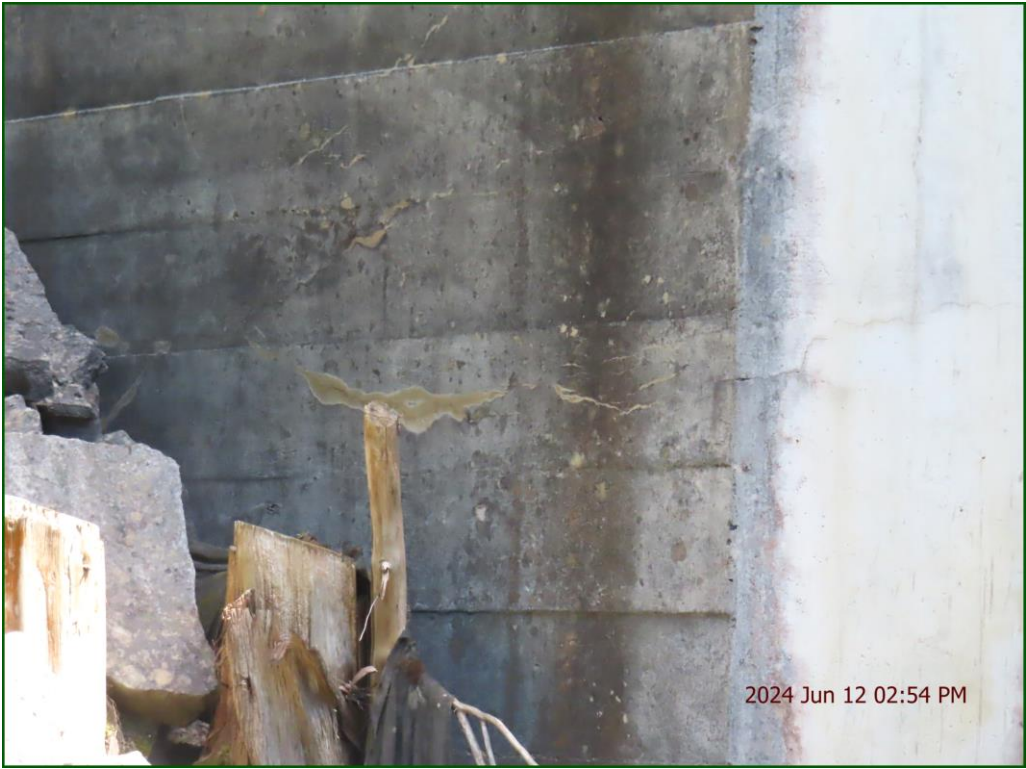
Description: Wingwalls: Light to medium horizontal cracking with leachate staining.

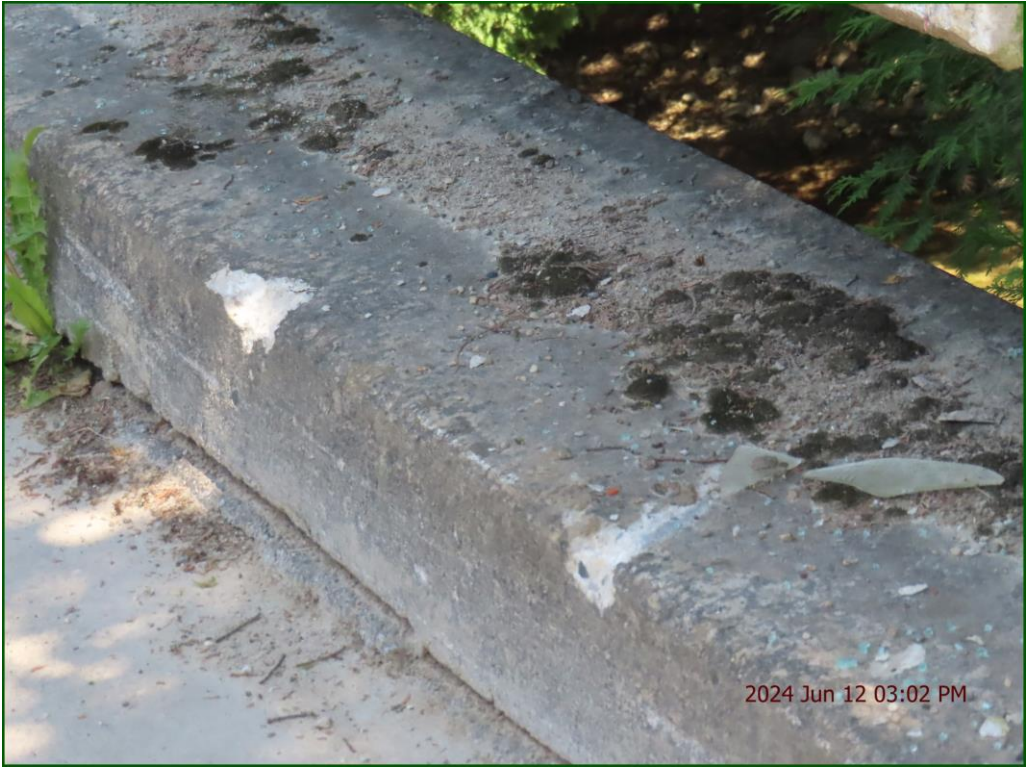
Description: Approach Curbs: Shallow delaminations throughout.

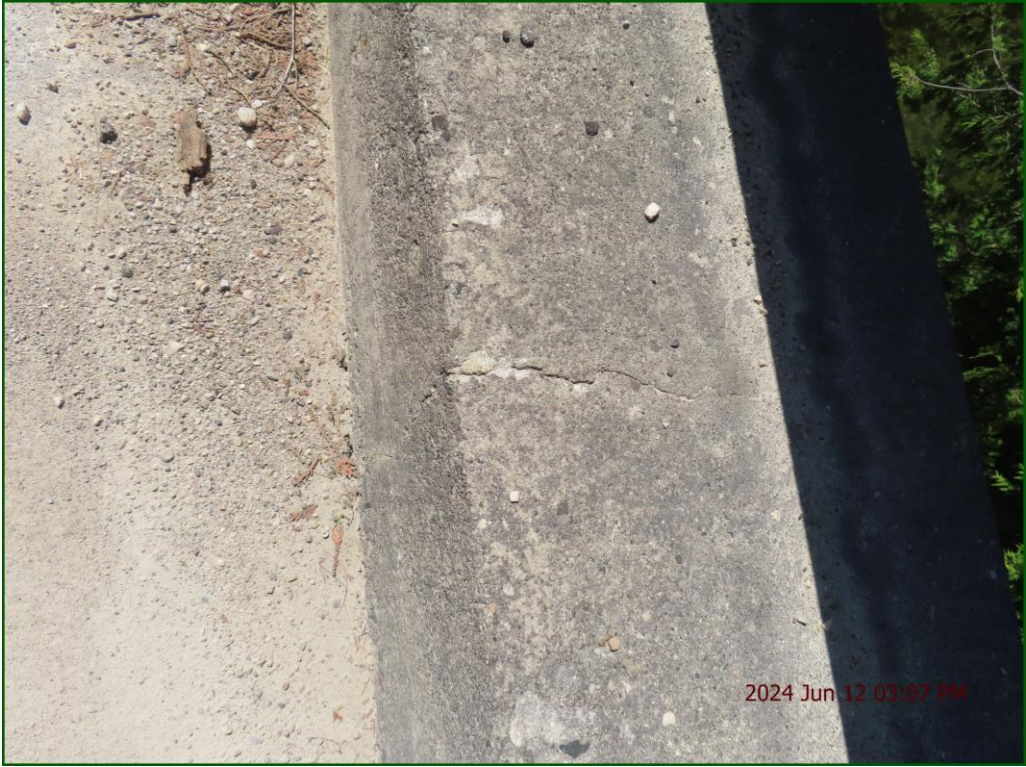
Description: Approach Curbs: Medium transverse cracking throughout.

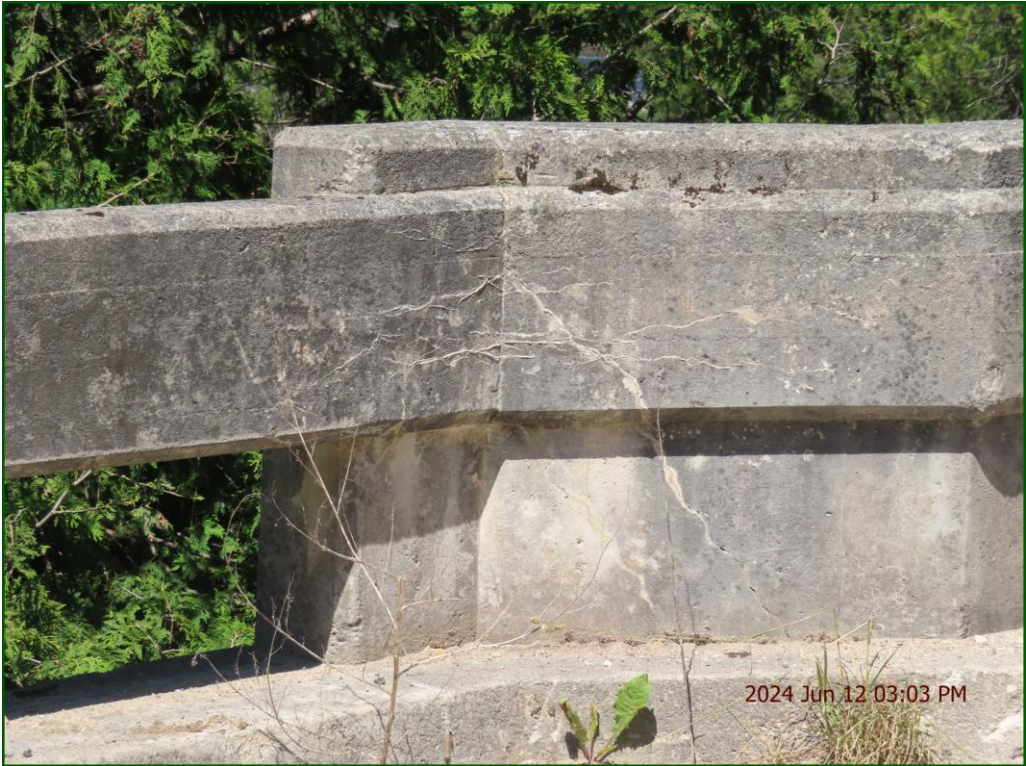
Description: Railing systems: Light to medium map cracking with leachate staining.

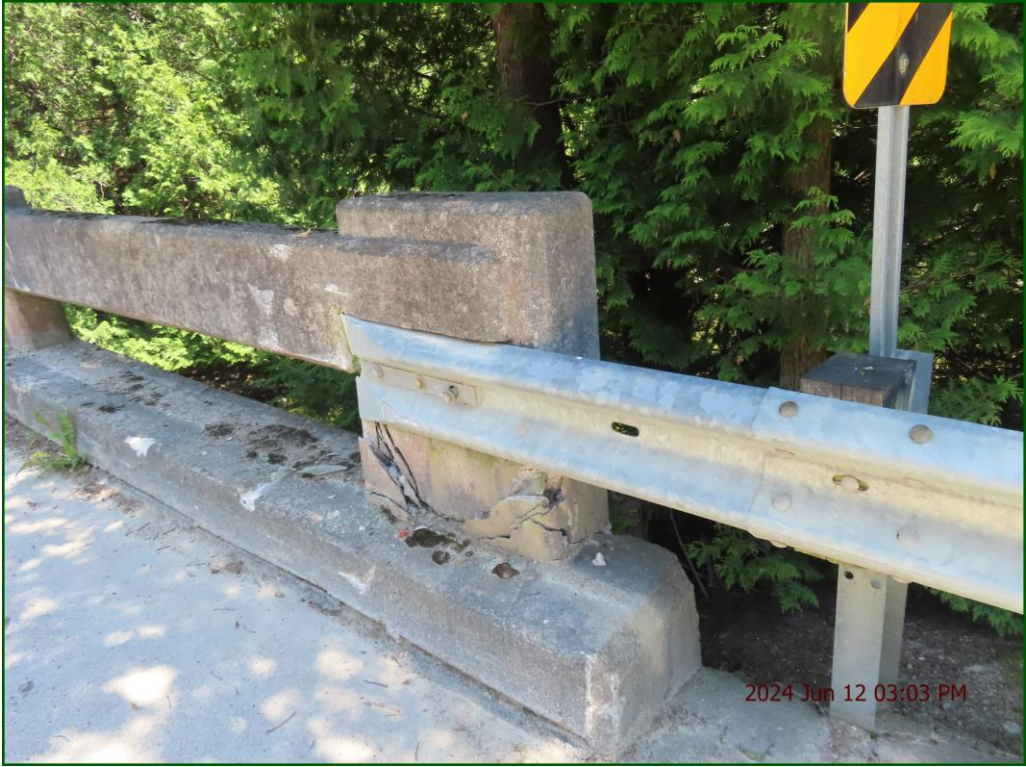
Description: Railing systems: Severe impact damage at south west corner.

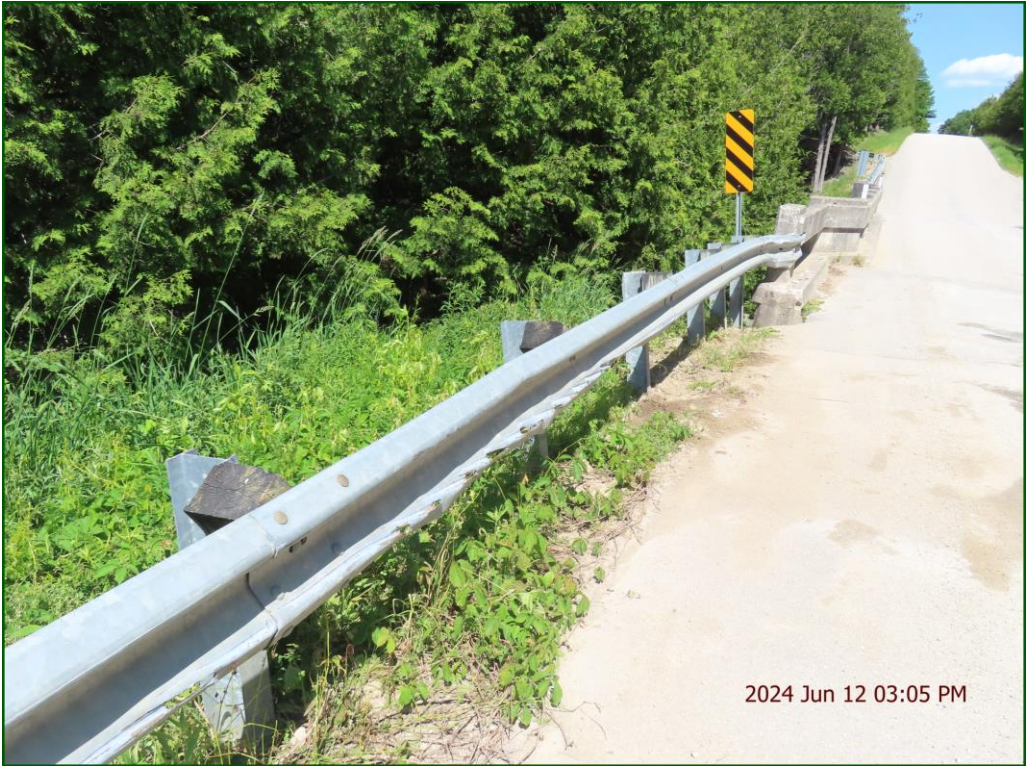
Description: Railing Systems: Severe impact damage at north west bridge connection.

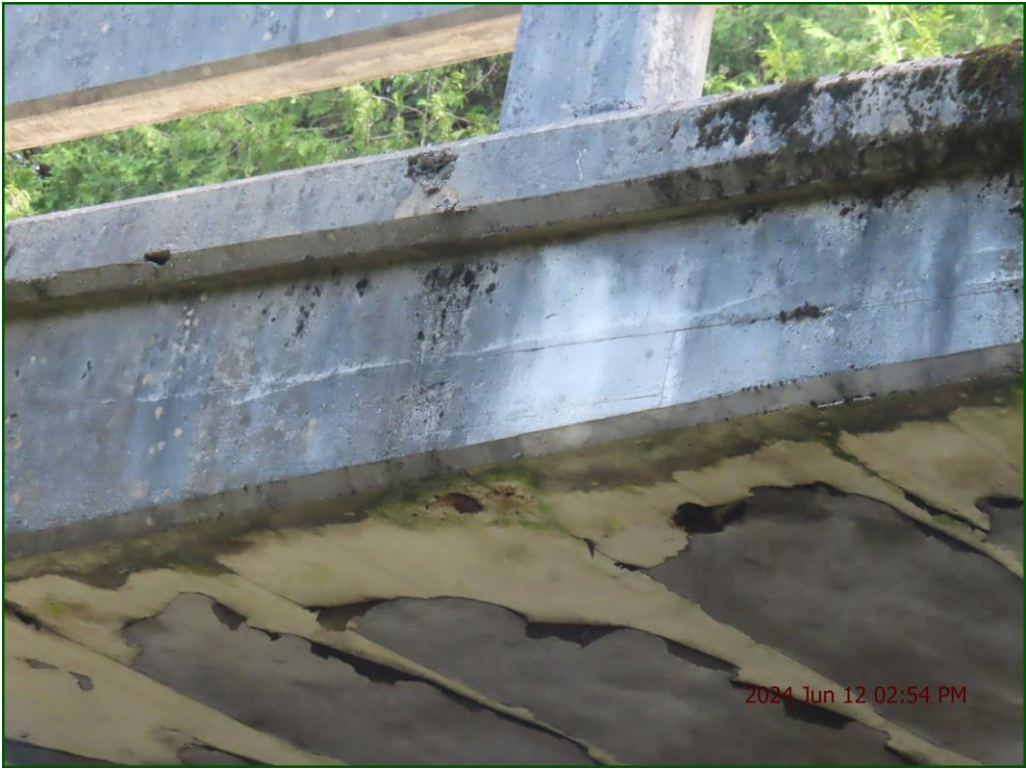
Description: Soffit (ext): Light to medium horizontal cracking and leachate staining.

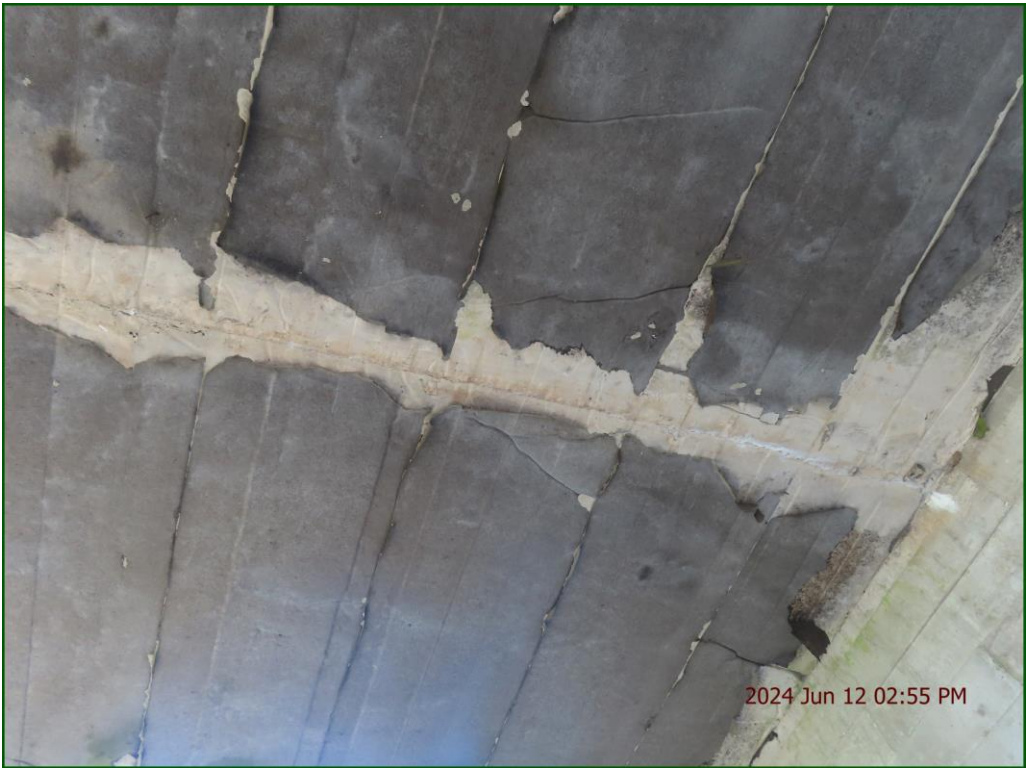
Description: Soffit (int): Light to medium longitudinal cracking with leachate staining along construction jo

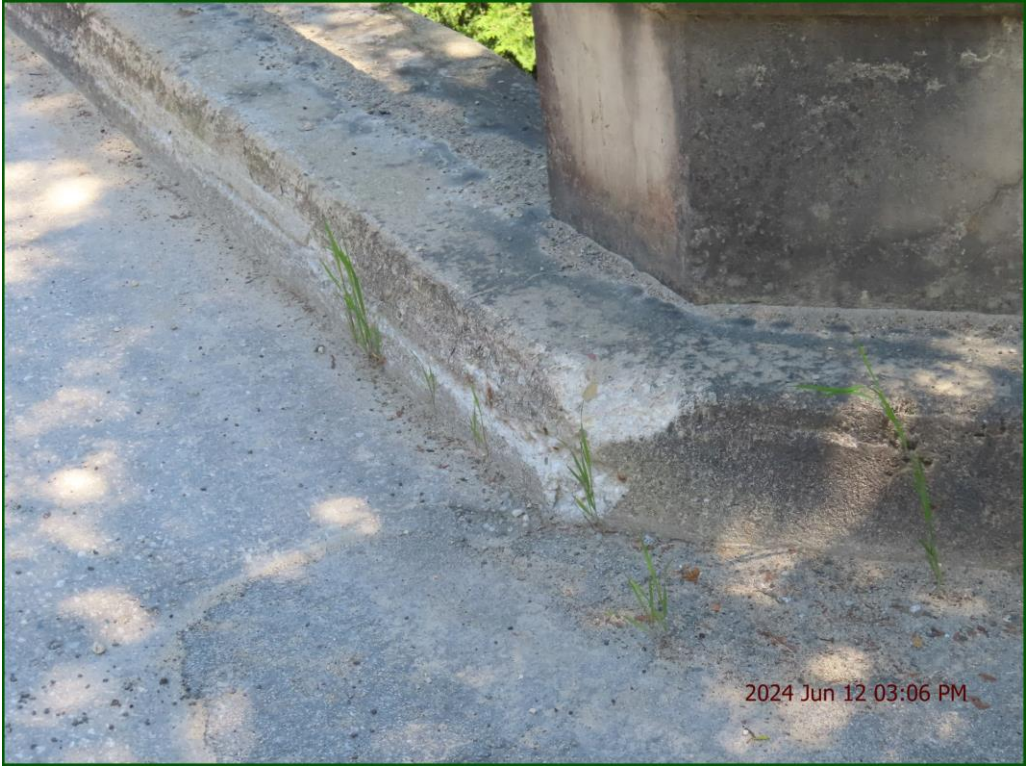
Description: Curbs: Shallow delaminations throughout.

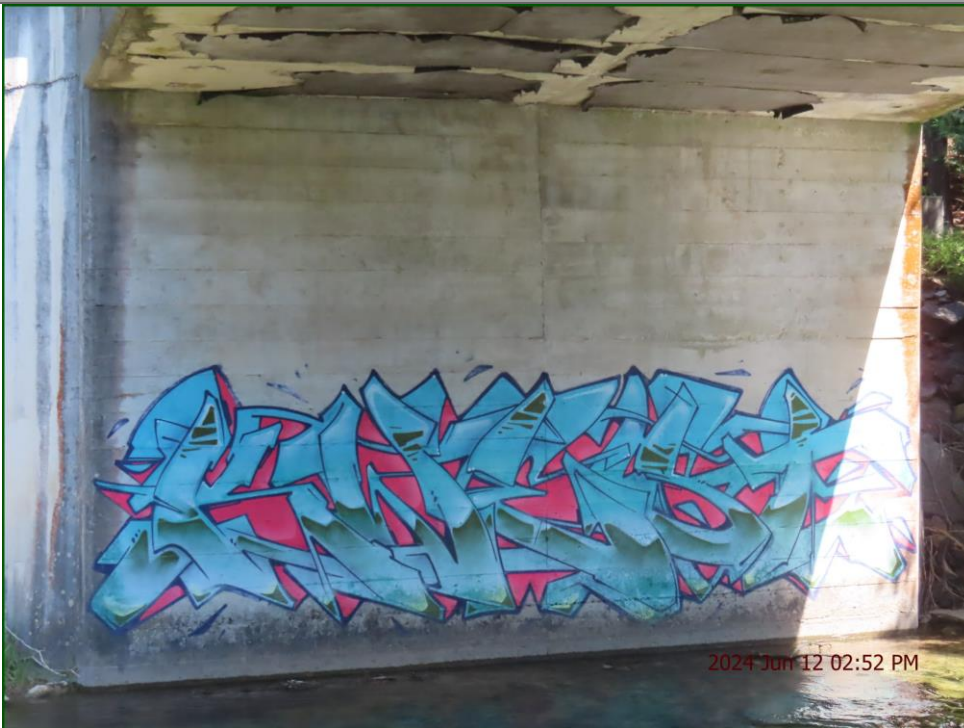
Light scaling throughout. Moderate scouring on west abutment, under water.

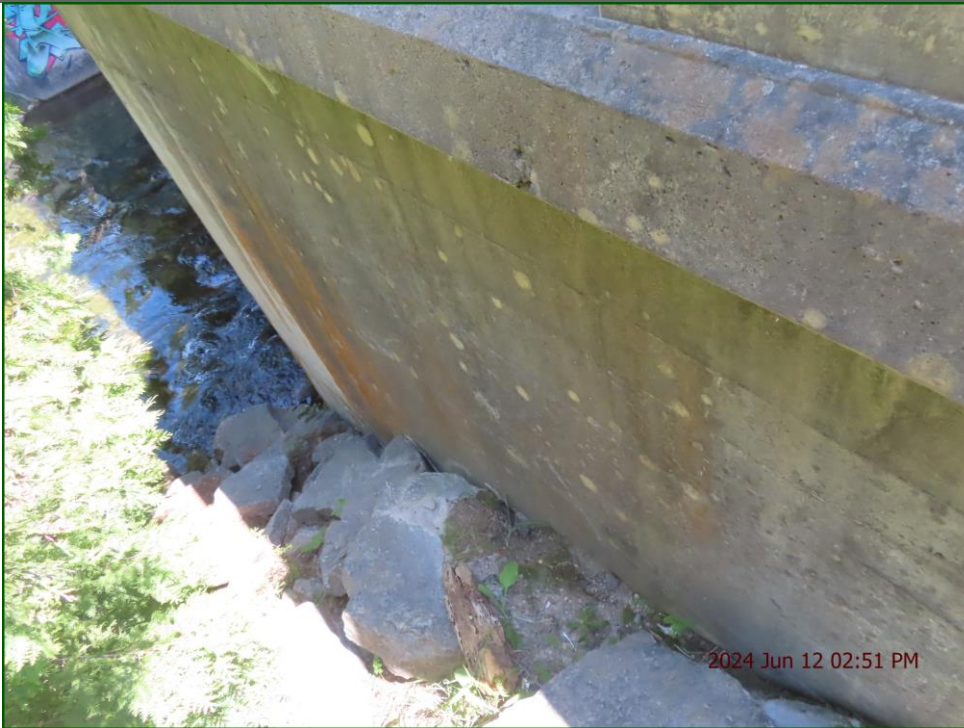
Light to medium horizontal cracking with leachate staining.

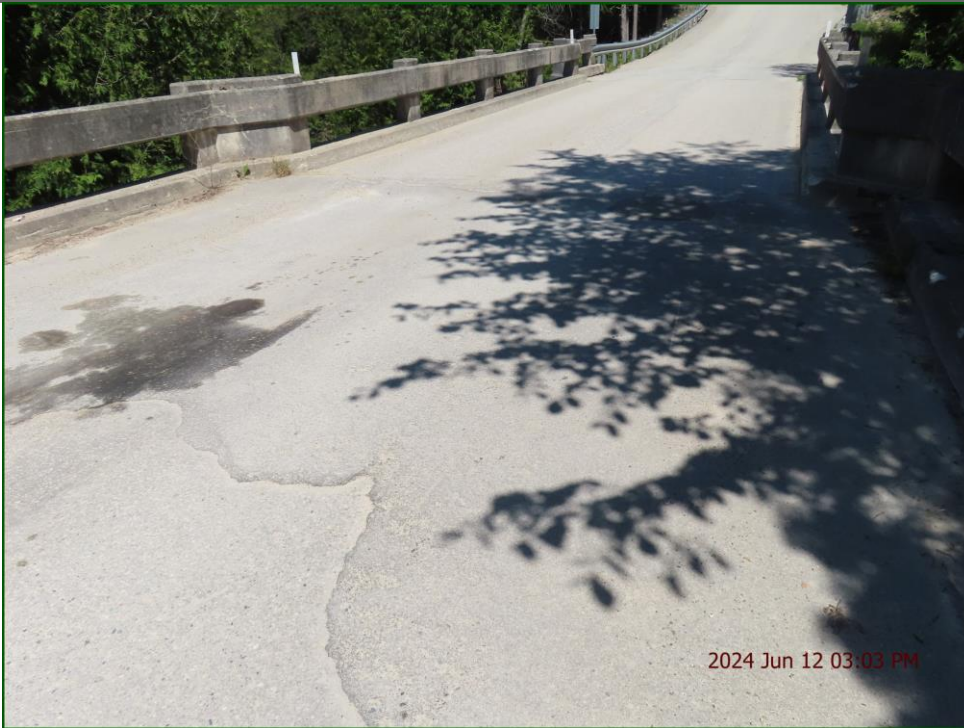
Approaches appear to have been repaved.

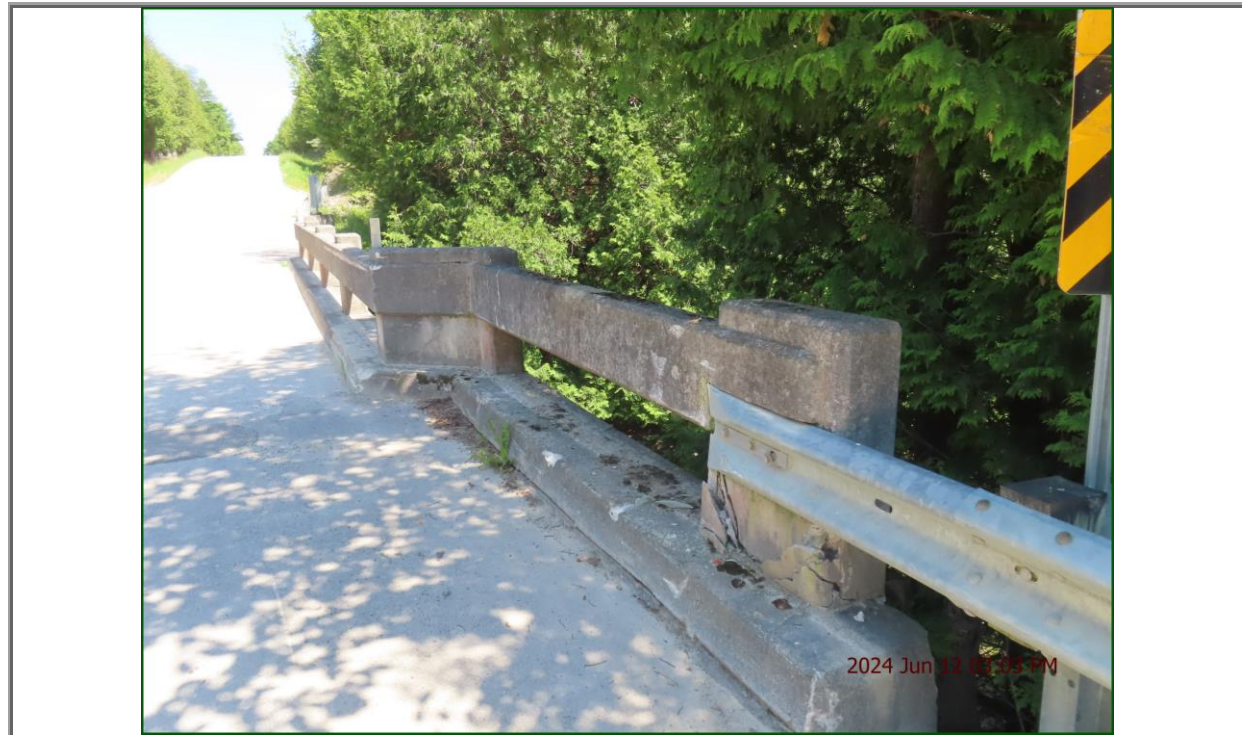
General Comments:
Light to medium map cracking with leachate staining. Severe impact damage at south west corner.

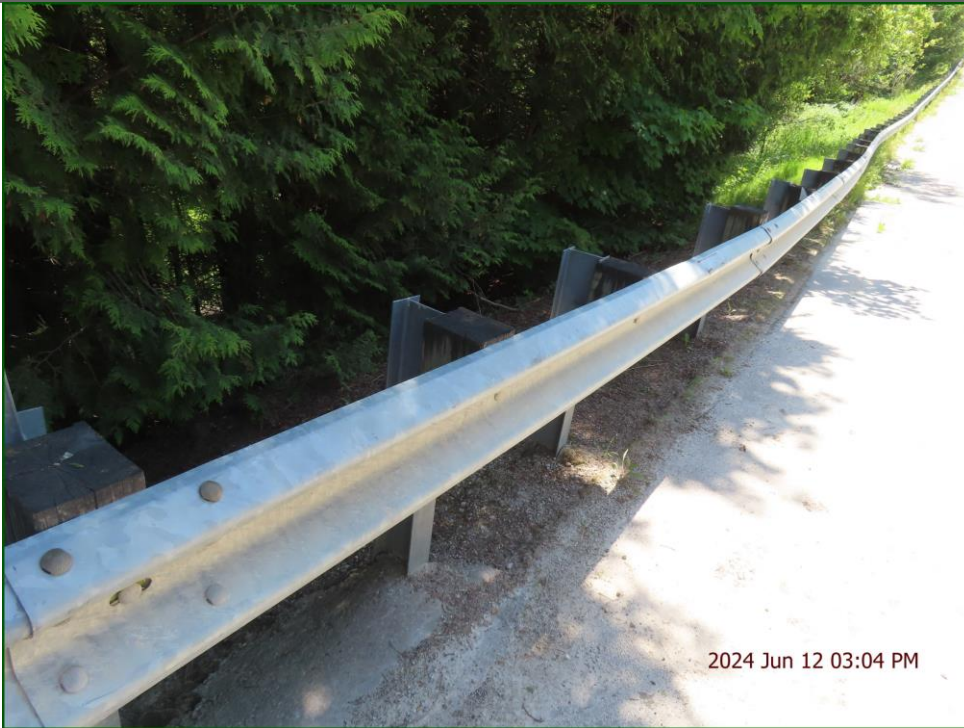
Severe impact damage at north west bridge connection.

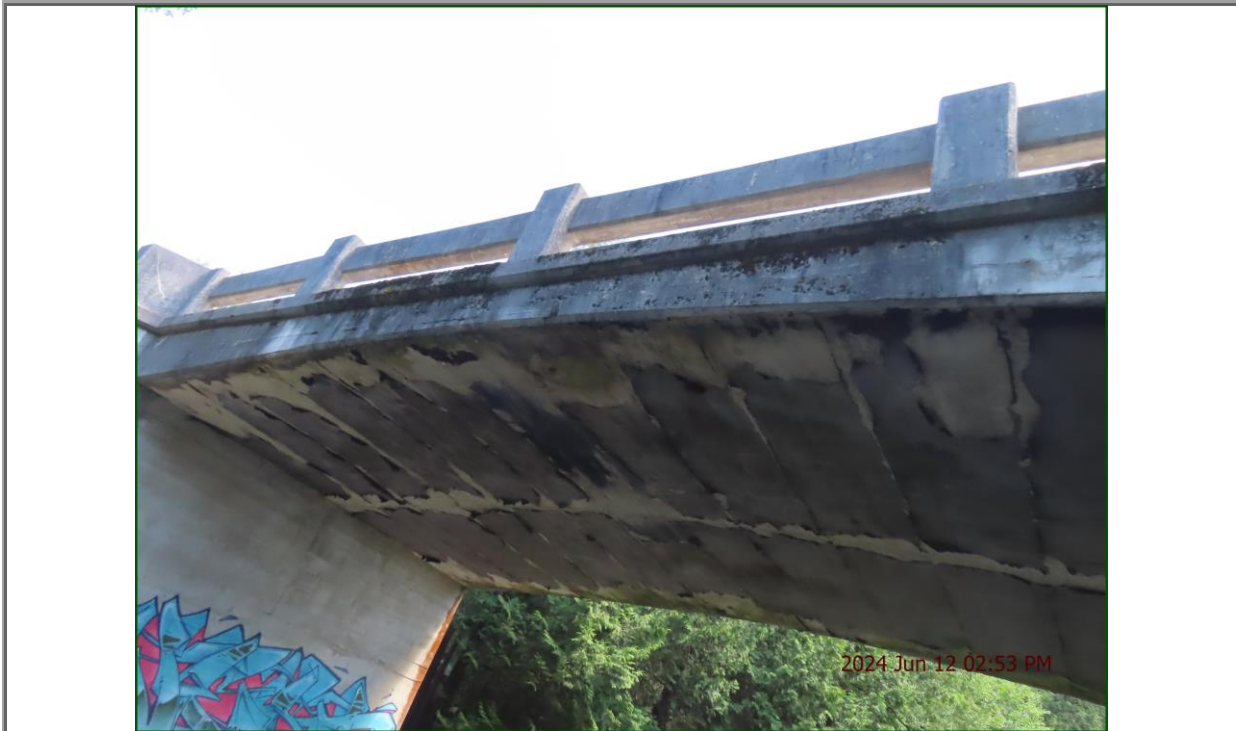
Light to medium horizontal cracking and leachate staining.

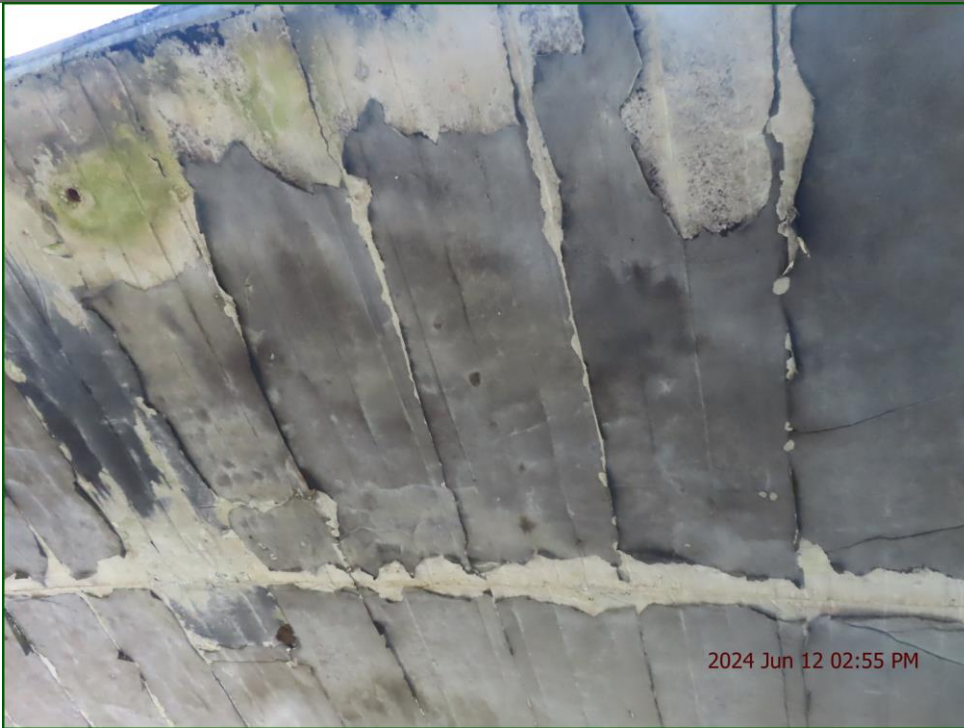
Light to medium longitudinal cracking with leachate staining along construction joint.

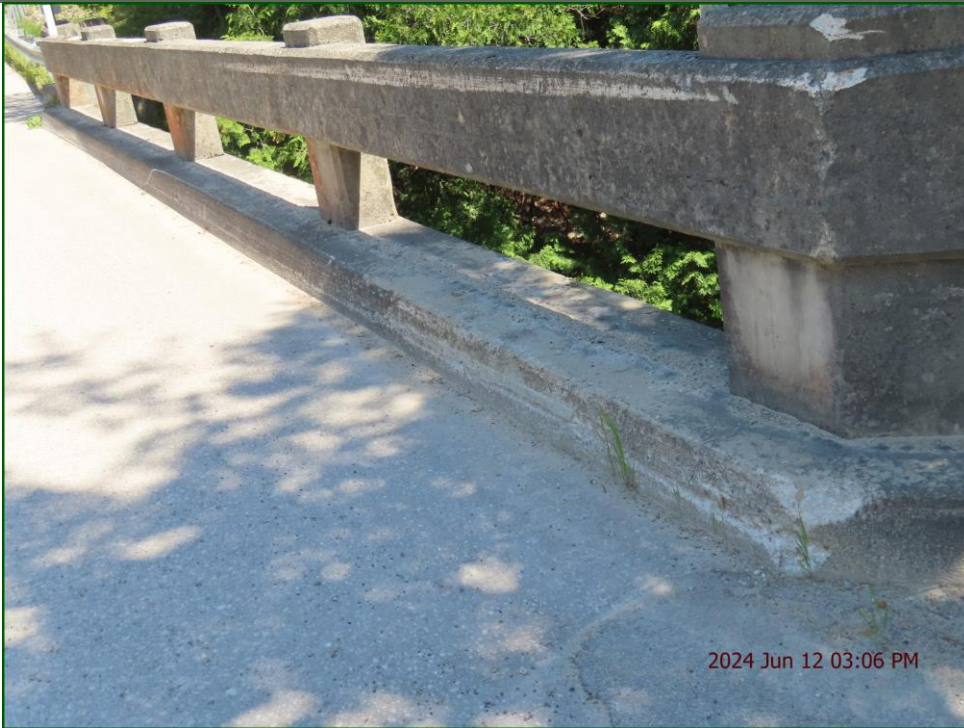
Shallow delaminations throughout.

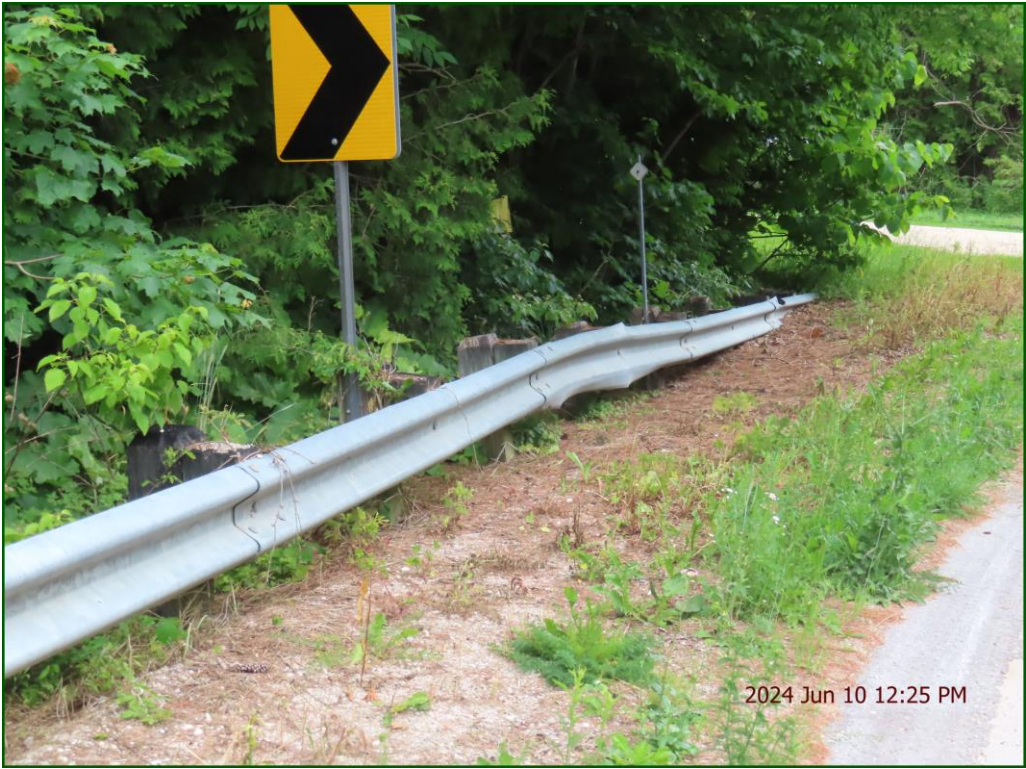
Description: Railing systems: Severe impact damage.

Description: Railing systems: Recommend mounting flexi beam to face of post and rail.

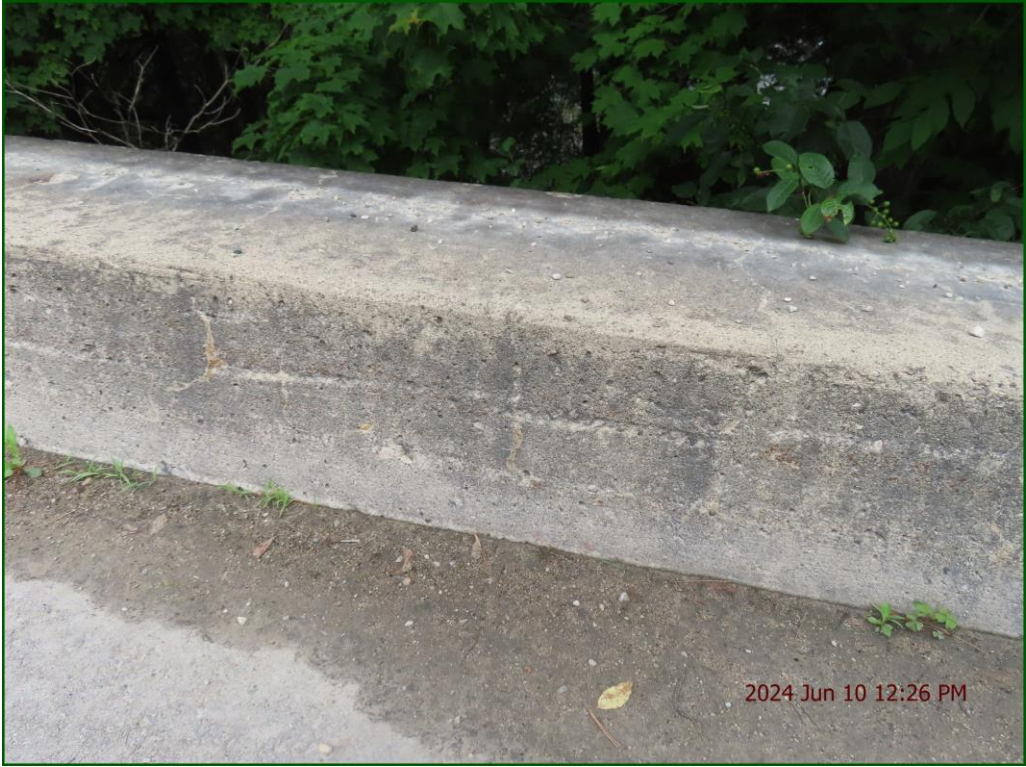
Description: Approach Curbs: Light to medium vertical cracking throughout.

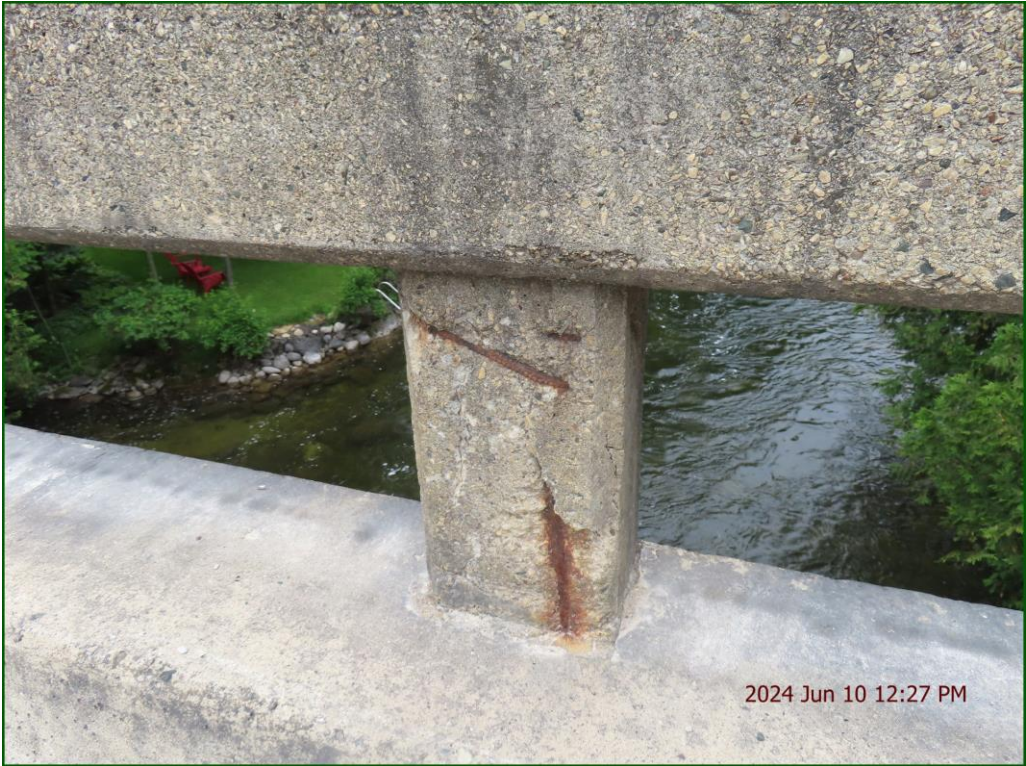
Description: Railing systems: Moderate spalls with exposed reinforcing throughout.

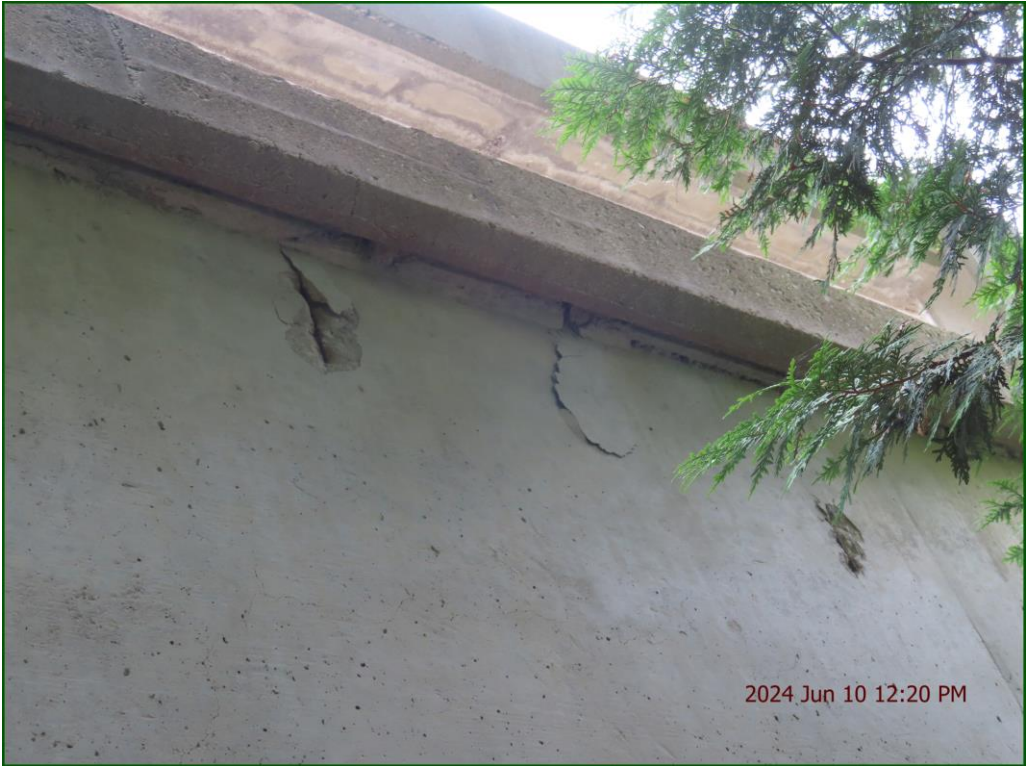
Description: Soffit (ext): Minor popout with exposed reinforcing.
