OSIM Biennial Inspection Report

Concession 11/12, Lot 30

Burgess Engineering Inc

27-Aug-24

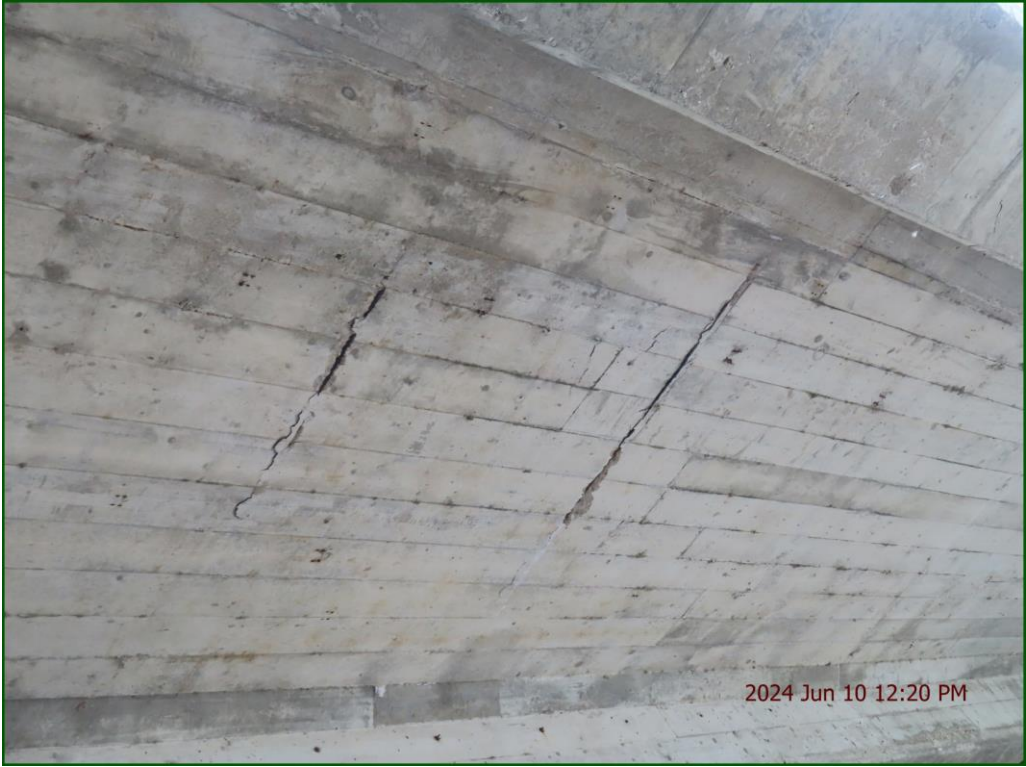
Description: Soffit (int): Light spalling with exposed reinforcing.

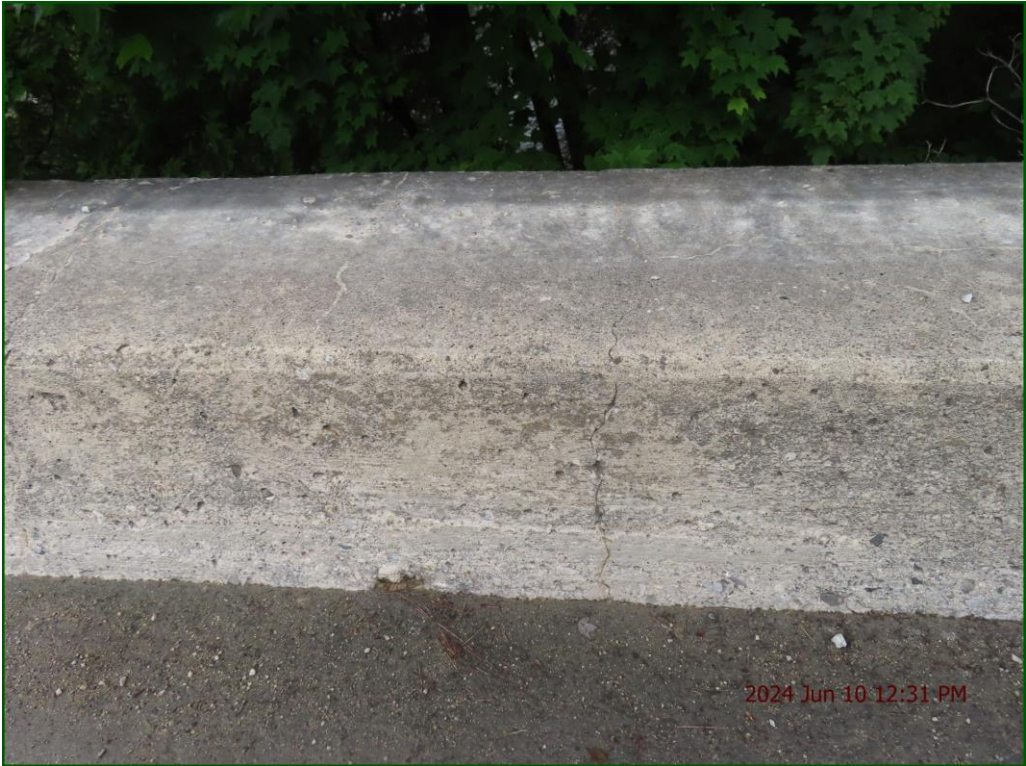
Description: Curbs: Light to medium vertical cracks throughout.

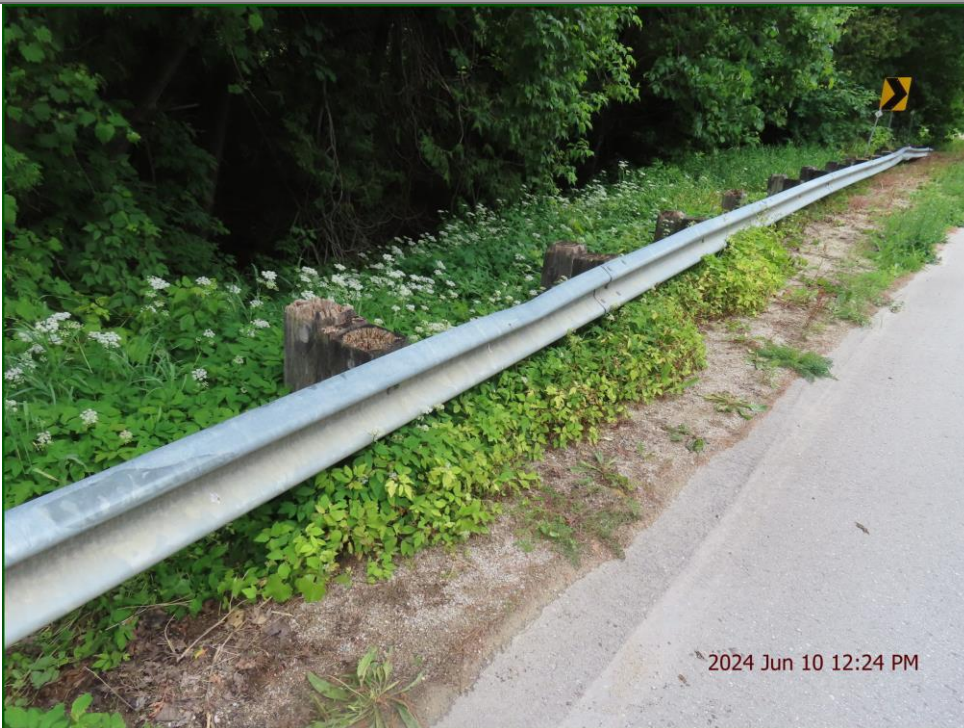
Element Group:	Barriers	Site Number:	B-018
Element Name:	Railing systems	Width:	0 m
Element type:	Flexi beam with timber posts	Height:	0 m
Sub-element:		Length:	18 m
Material:	Steel	Count:	4
Location:	Approaches	Total Quantity:	72 m
Environment:	Severe	Not inspected:	<input type="checkbox"/>
Perform. deficiencies:		Maintenance Type:	Structural
Maint needs:	Barrier/railing system repair	Maint. Time Period:	1 Year

Severe impact damage. Recommend mounting flexi beam to face of post and rail.
