Element Inspection

Date of Inspection:	31-Jul-24
Name of Inspector:	Andrew Burgess, P.Eng. & Joel Ziegler CET
Equipment Used:	Sounding hammer, measuring equipment, GPS
Weather Conditions:	Sunny
Temperature:	23
Special Notes:	Bridge is in good condition, showing no signs of structural distress.

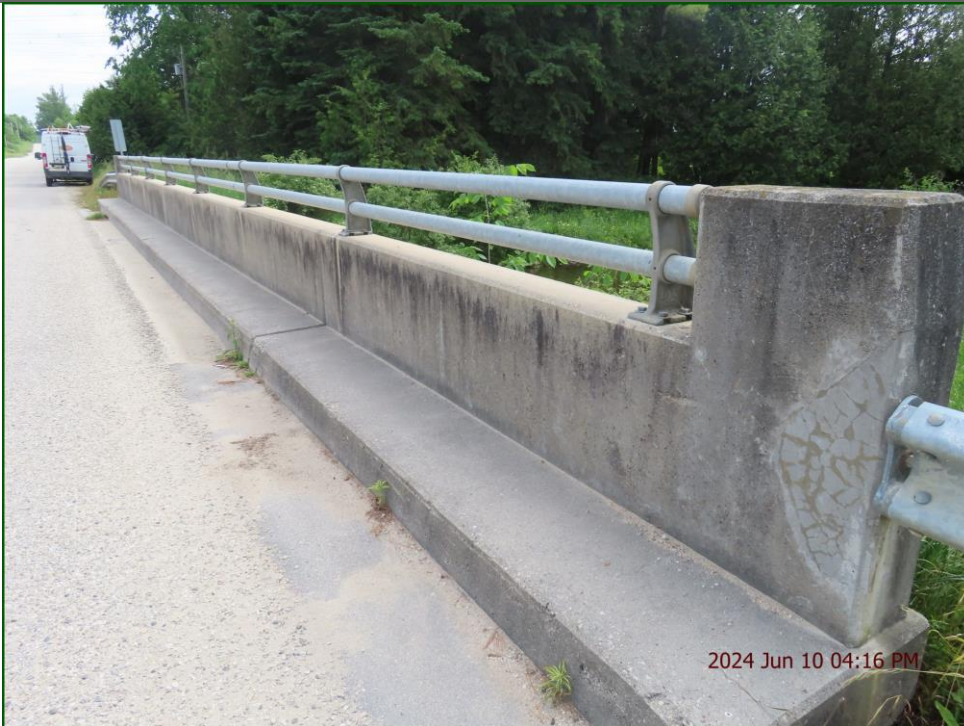
Light localized map cracking at connection to guide rail.

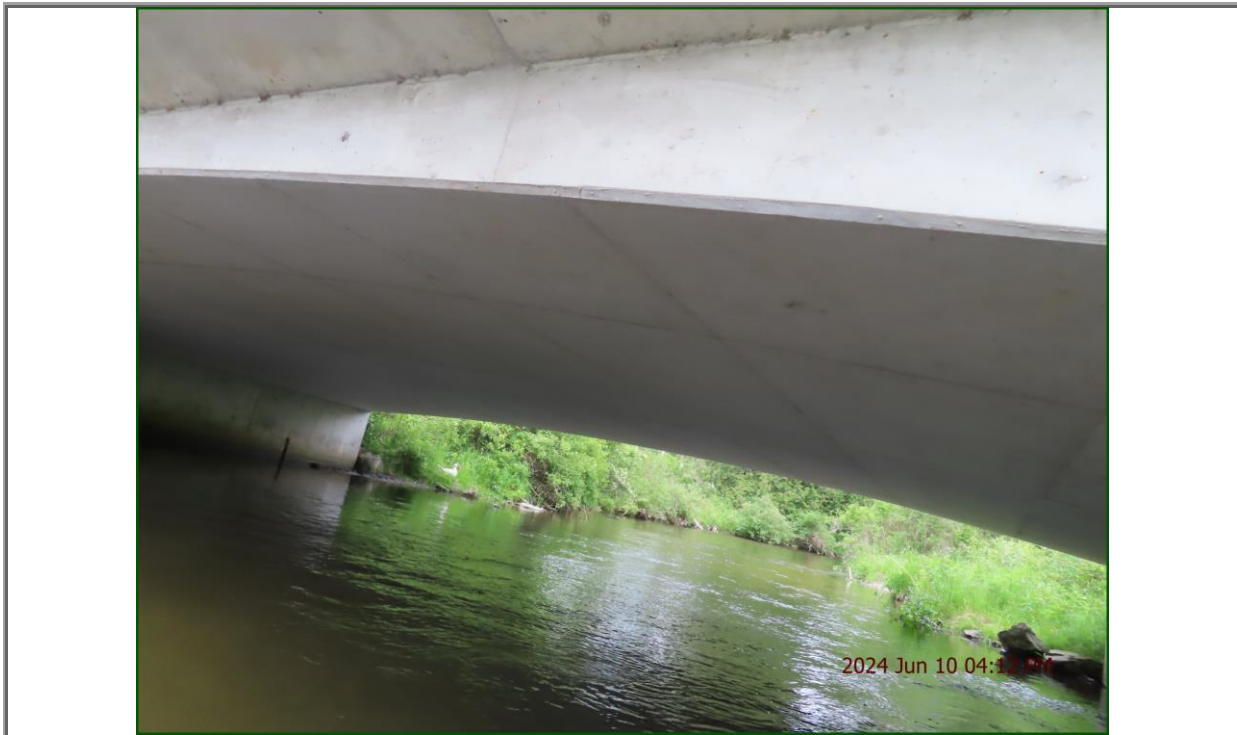
Medium to wide cracking with leachate staining.

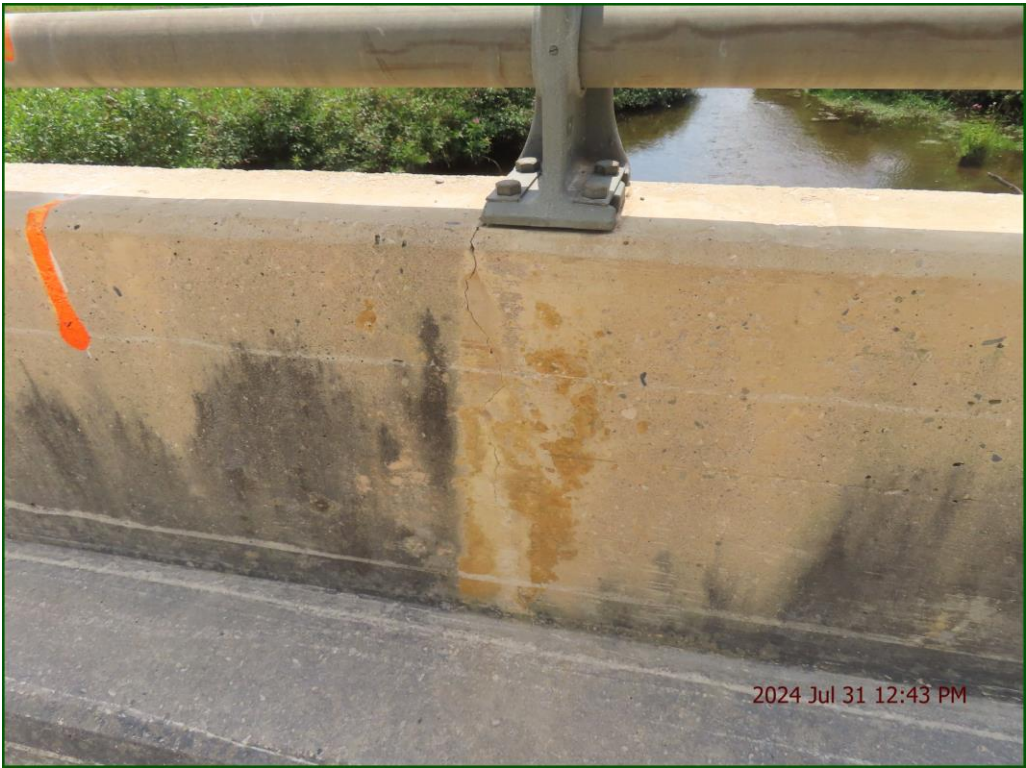
Description: Barrier/Parapet walls (int): Medium to wide vertical cracking.

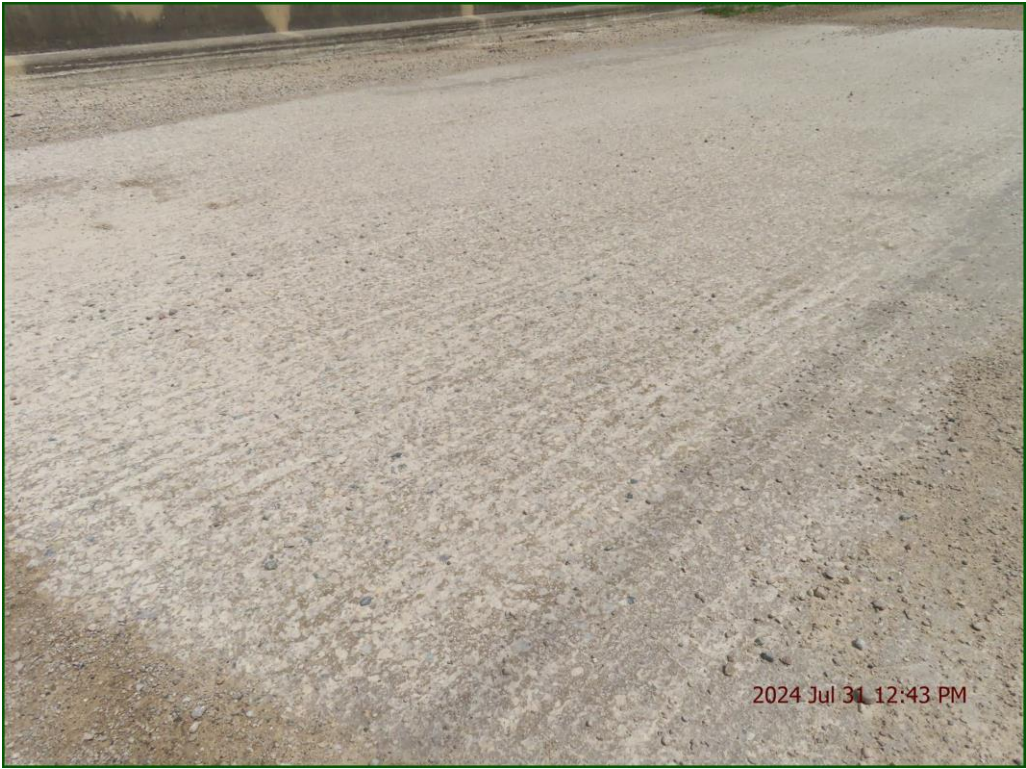
Description: Deck top: Minor abrasions throughout.

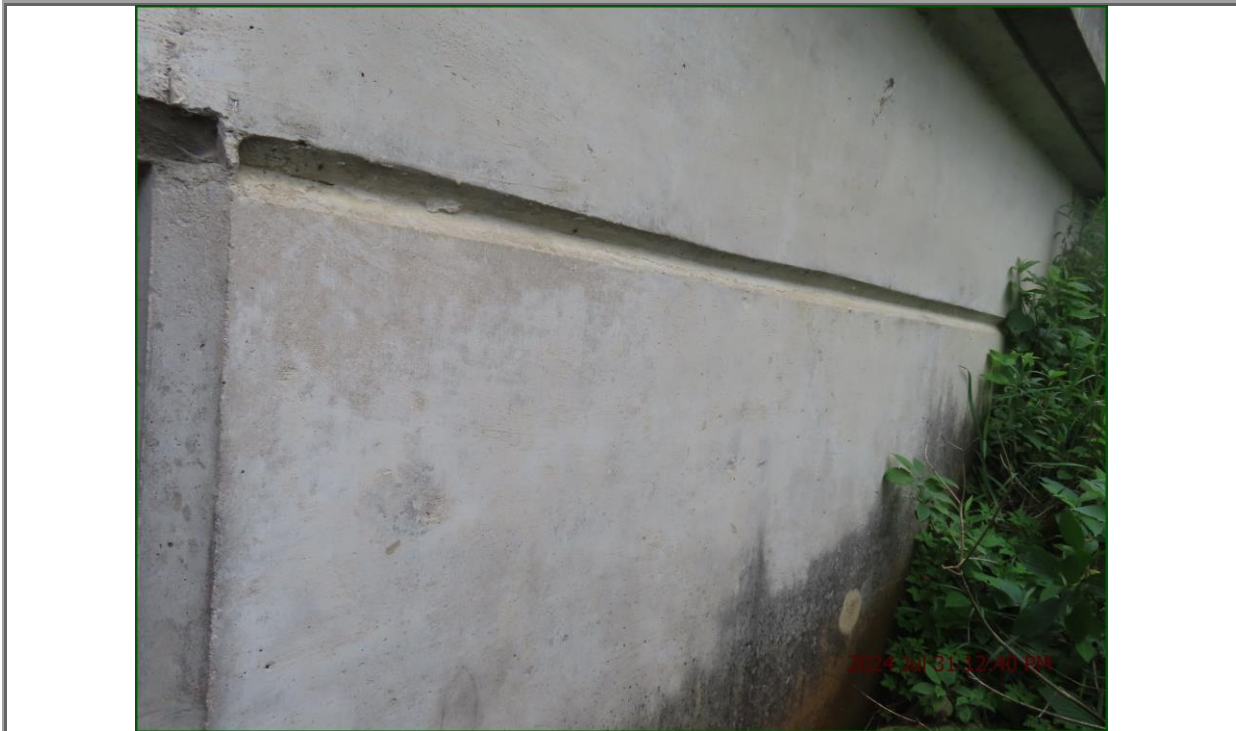
Description: Abutment Walls: Light to medium vertical cracking with leachate staining.

Light to medium vertical cracking with leachate staining.

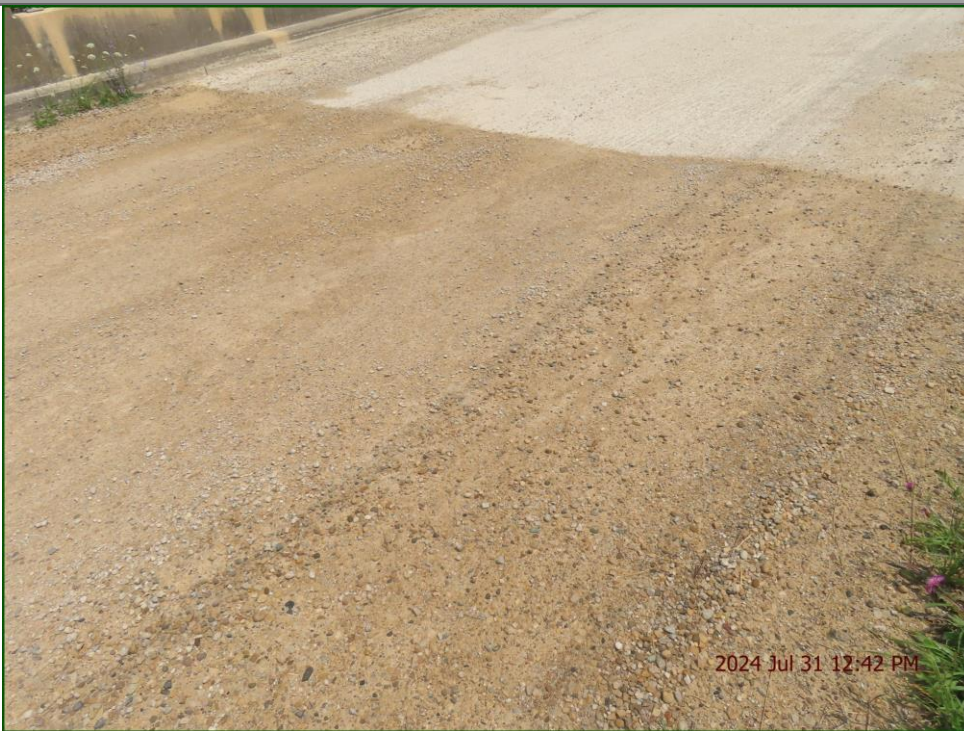
No signs of settlement.

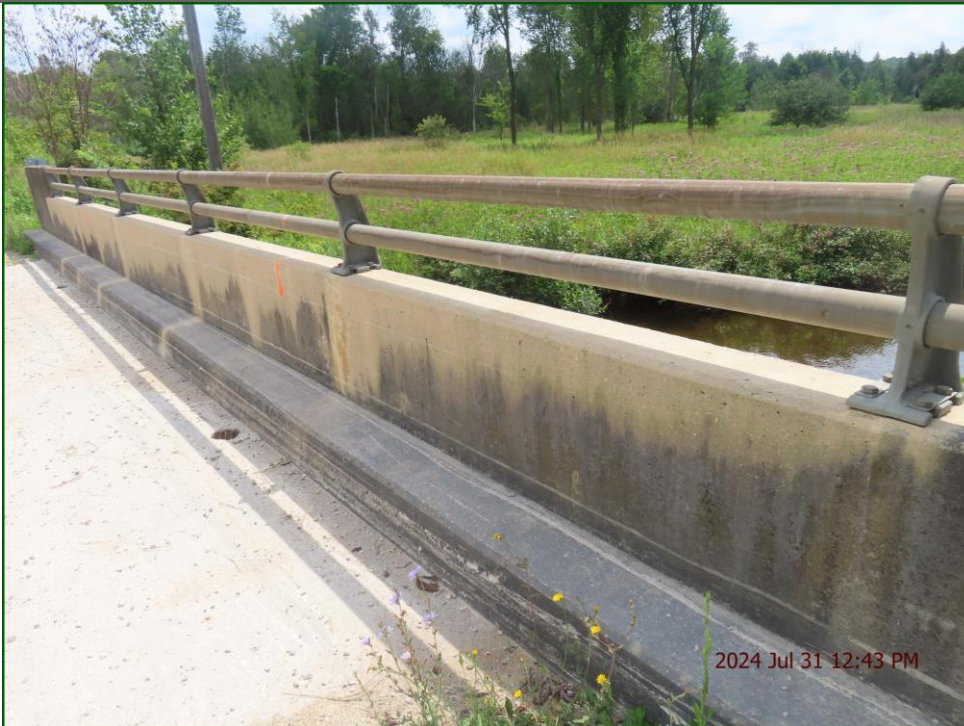
Medium to wide vertical cracking.

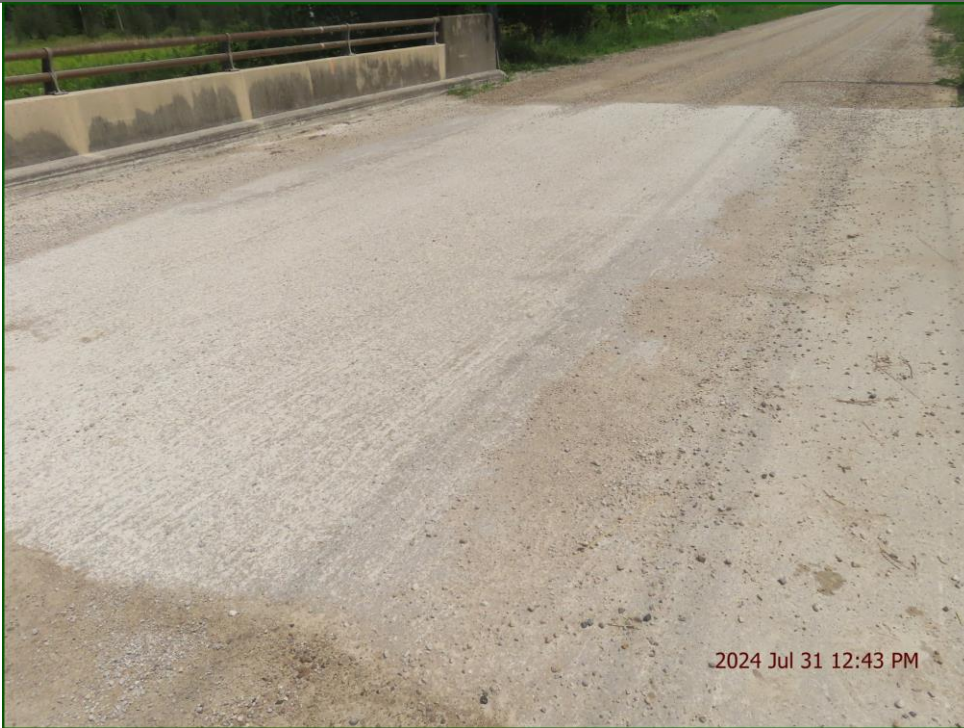
Minor abrasions throughout.

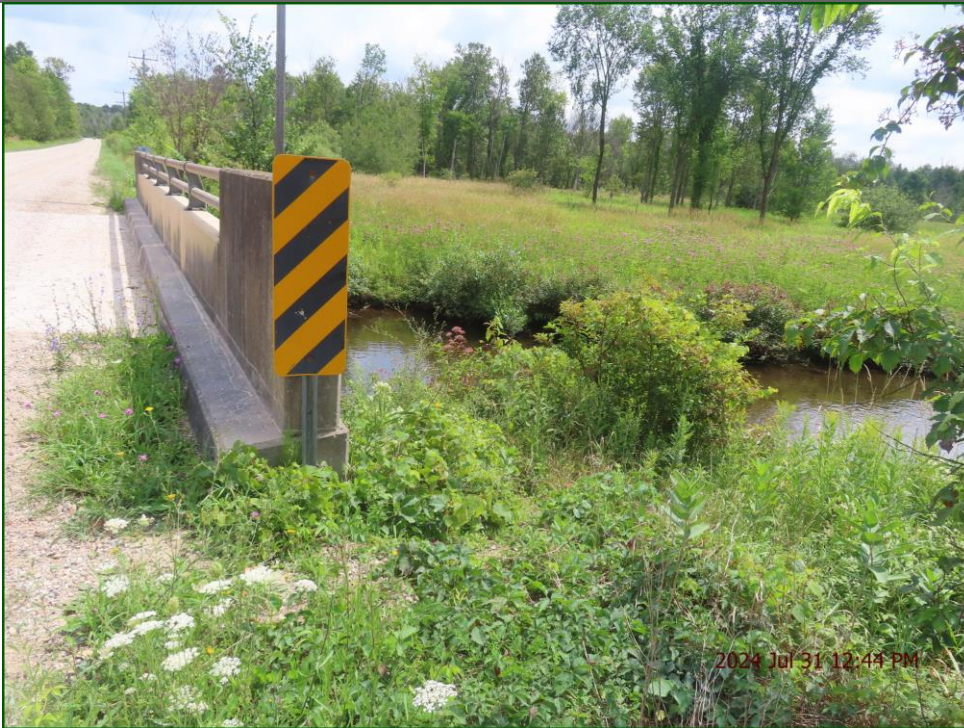
Steep embankments, recommend approach protection.

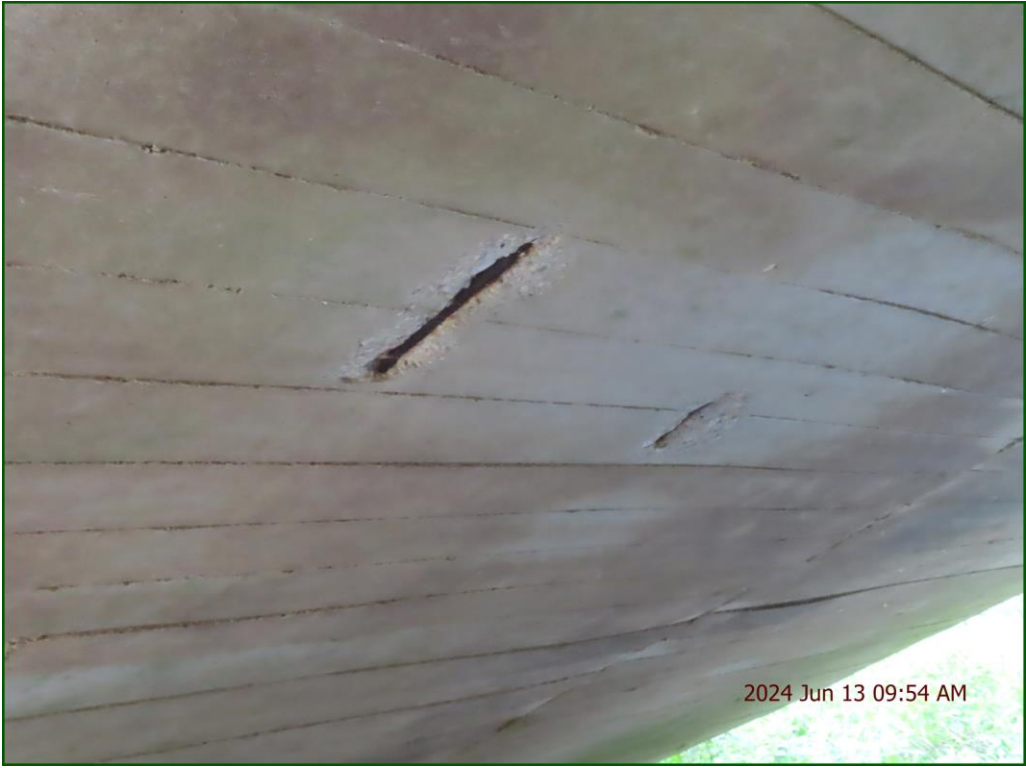
Description: Barrel: Minor spall with exposed reinforcing at midspan.

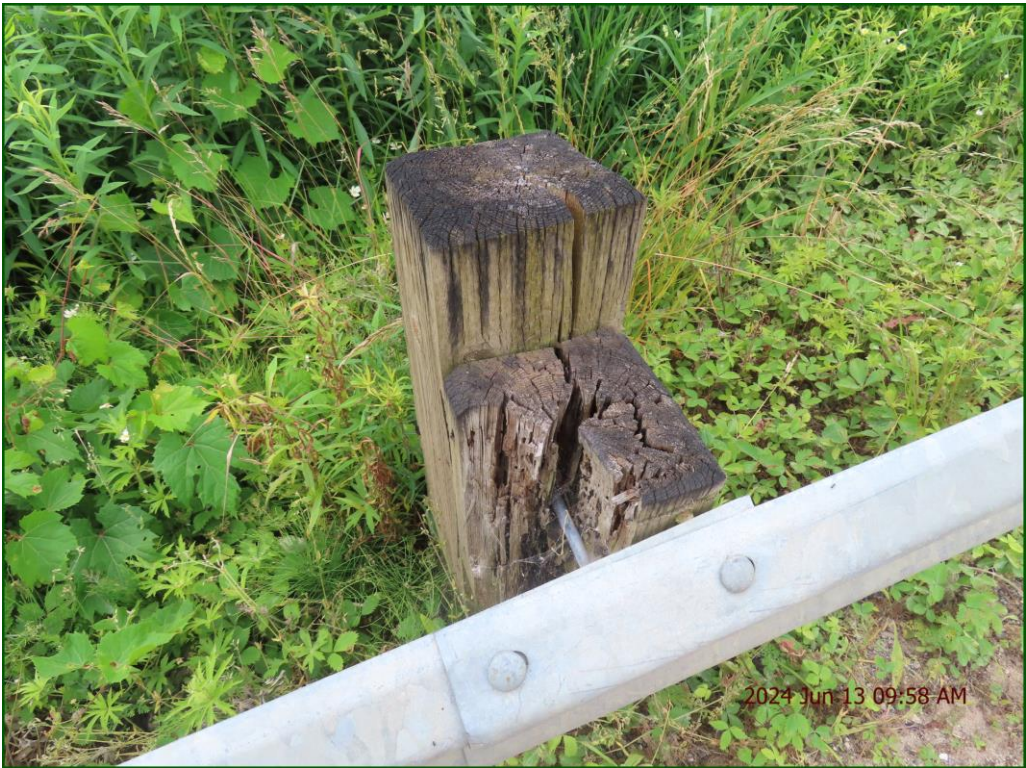
Description: Railing Systems: Severe rotting at SE quadrant.

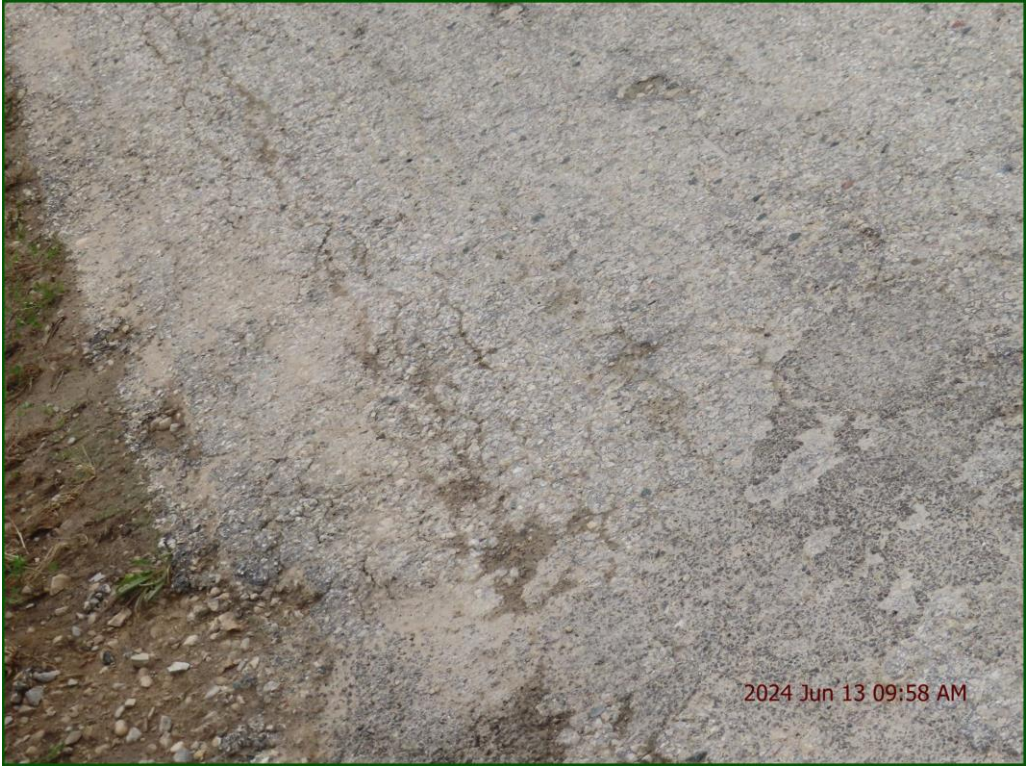
Description: Wearing Surface: Light to medium map cracking.

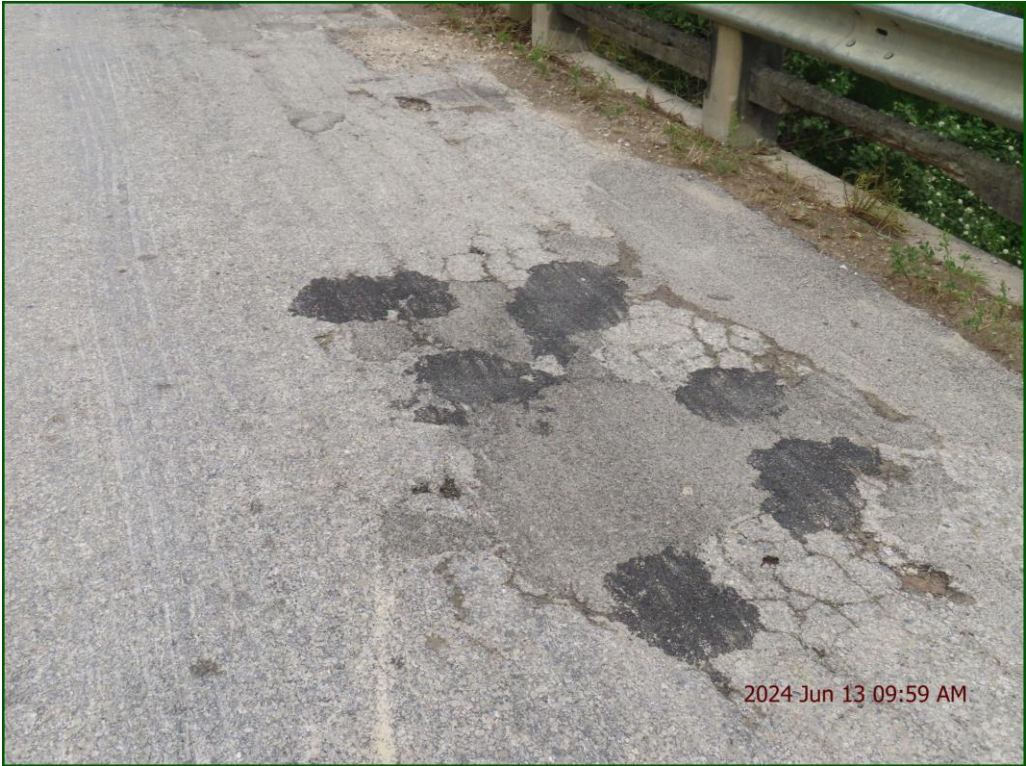
Description: Wearing Surface: Minor potholes throughout have been filled with cold patch.

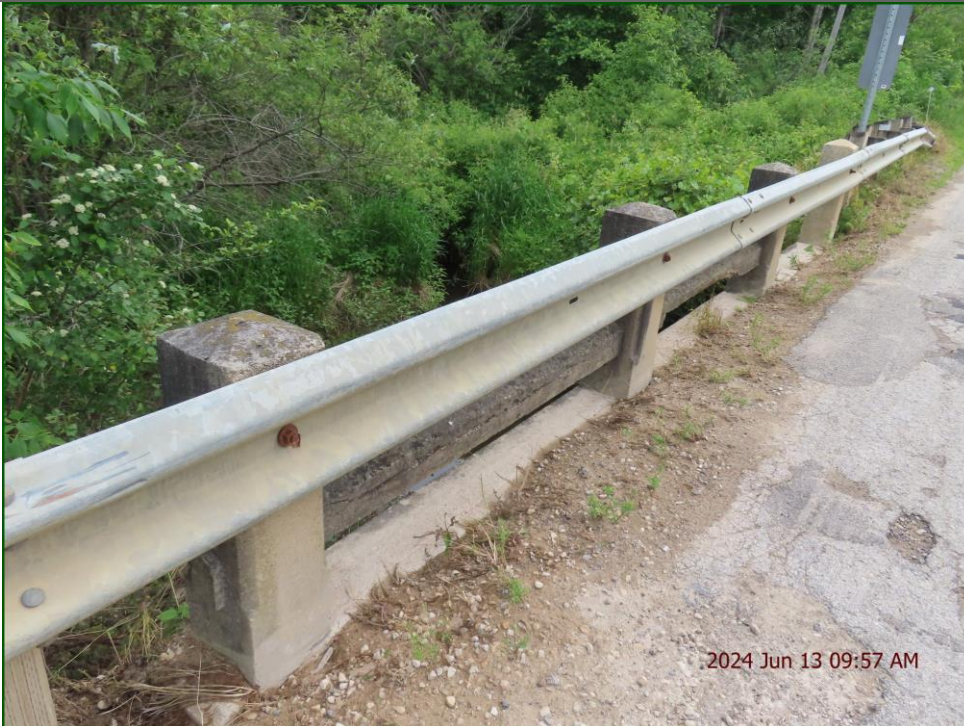
Flexi beam mounted to original, concrete post and rail, railing system. Original rail disintegration with areas of 100% section loss.

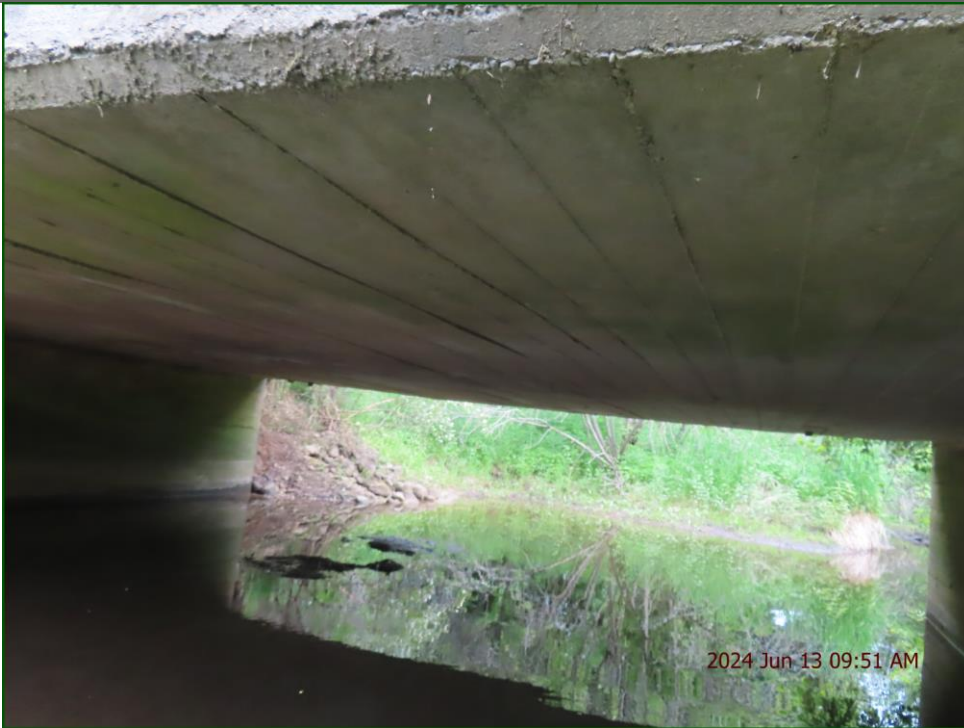
Minor spall with exposed reinforcing at midspan.

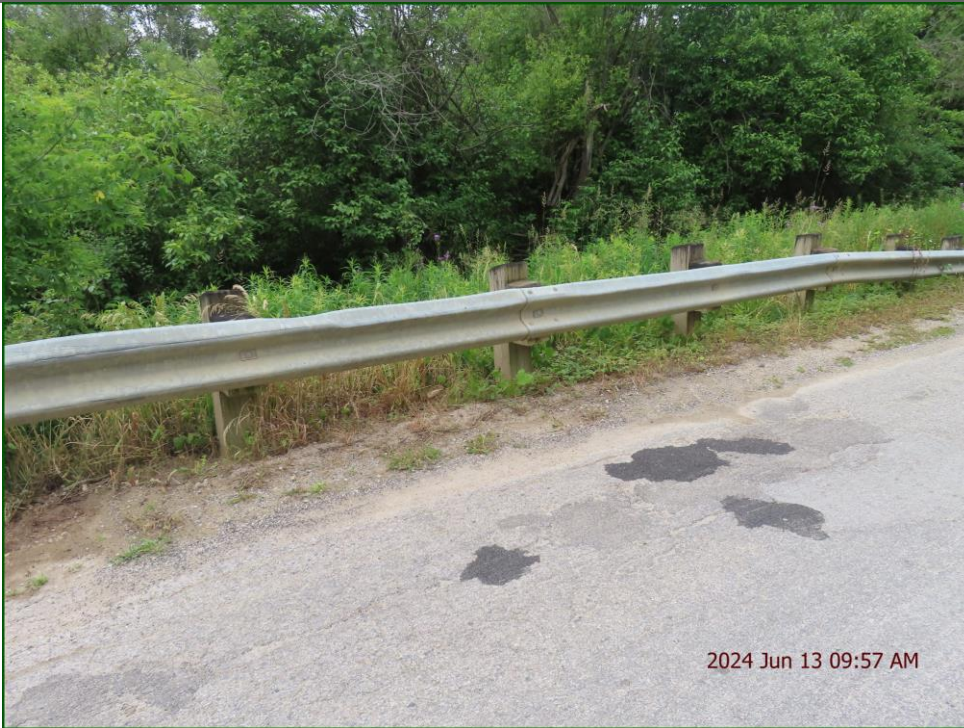
Moderate impact damage at NE quadrant. Severe rotting at SE quadrant.

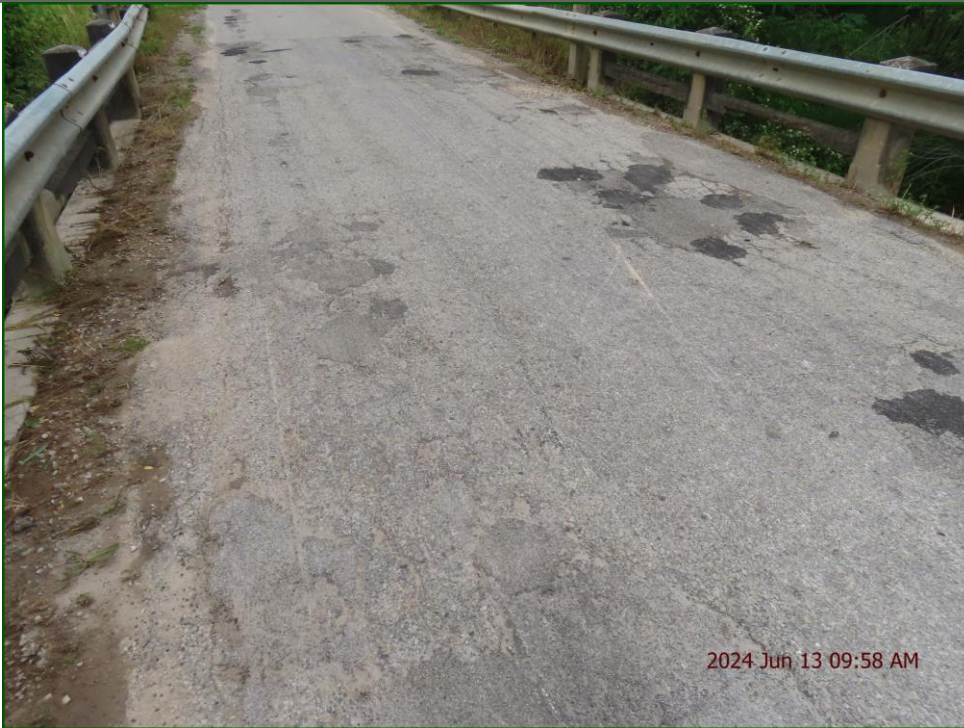
Light to medium map cracking. Minor potholes throughout have been filled with cold patch.

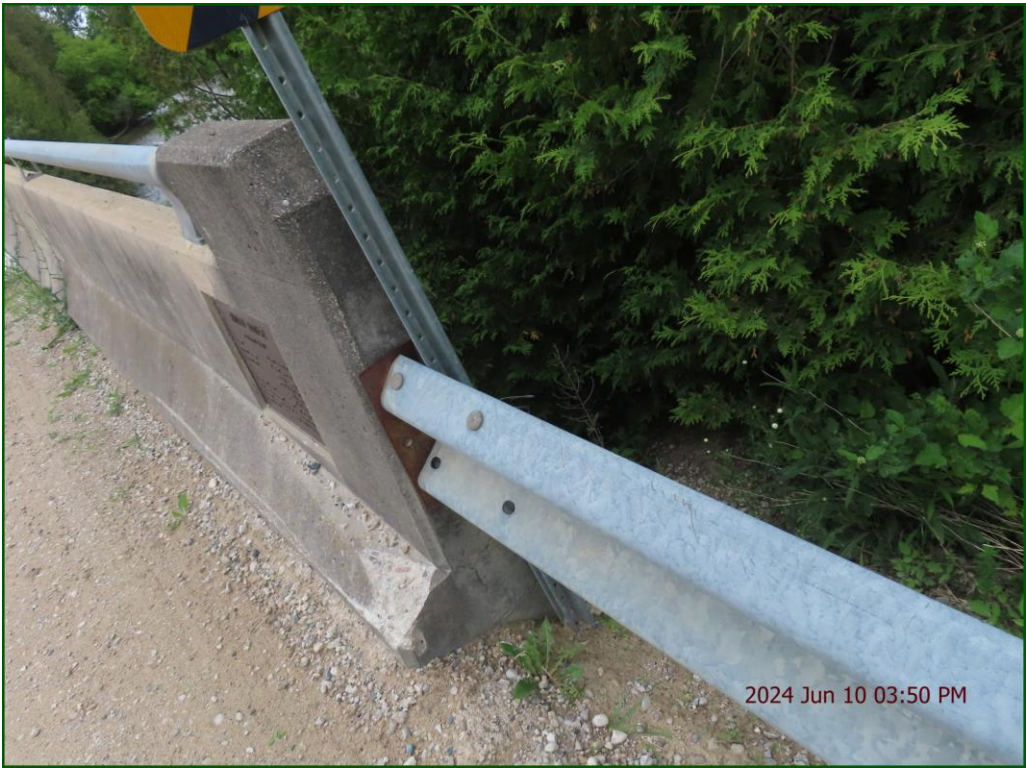
Description: Railing Systems: Wrong connection to barrier wall.

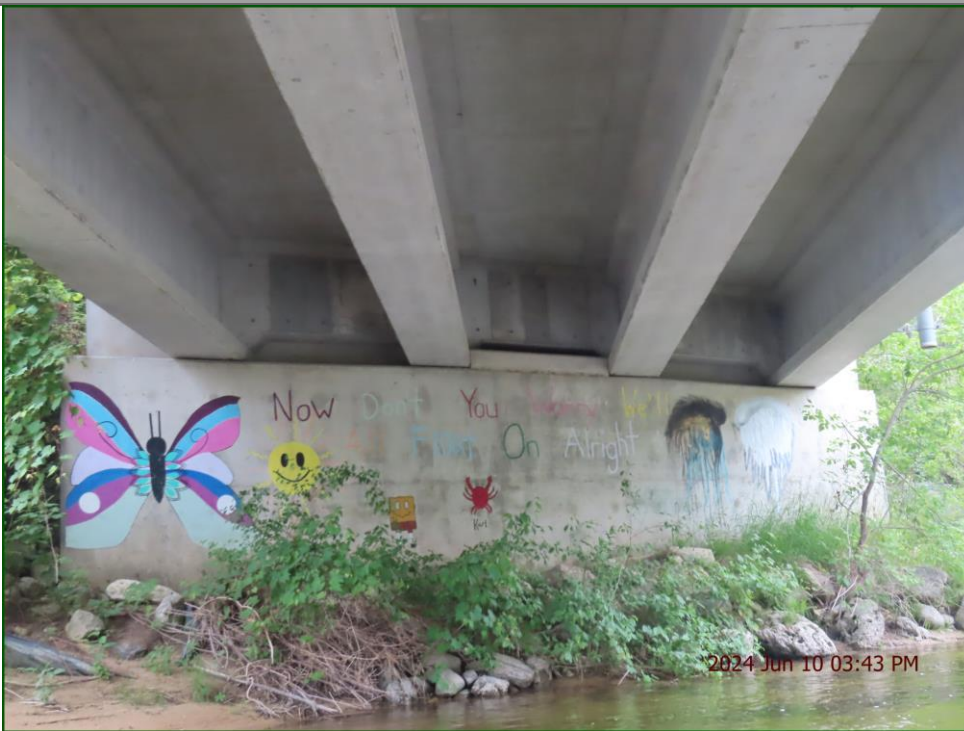
Limited inspection due to height of abutments.

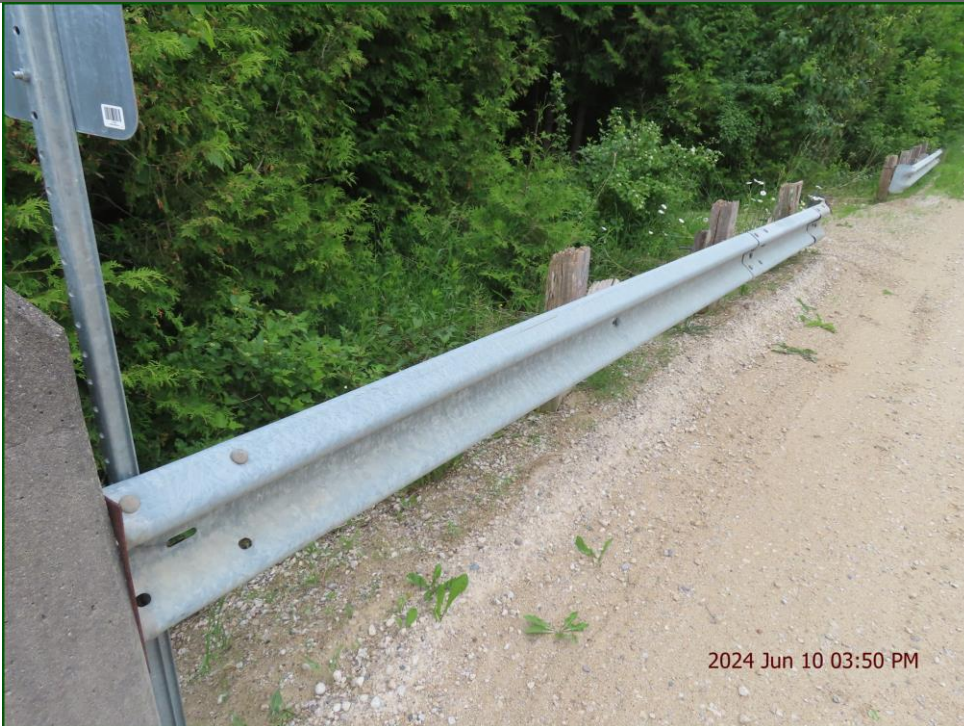
Moderate to severe rotting in timber posts. Wrong connection to barrier wall.

Element Group:	Barriers	Site Number:	B-022
Element Name:	Railing Systems	Width:	0 m
Element type:	Flexi beam with timber posts	Height:	0.8 m
Sub-element:		Length:	6 m
Material:	Steel	Count:	4
Location:	Approaches	Total Quantity:	24 m
Environment:	Severe	Not inspected:	<input type="checkbox"/>
Perform. deficiencies:		Maintenance Type:	Structural
Maint needs:	Barrier/railing system repair	Maint. Time Period:	1 Year

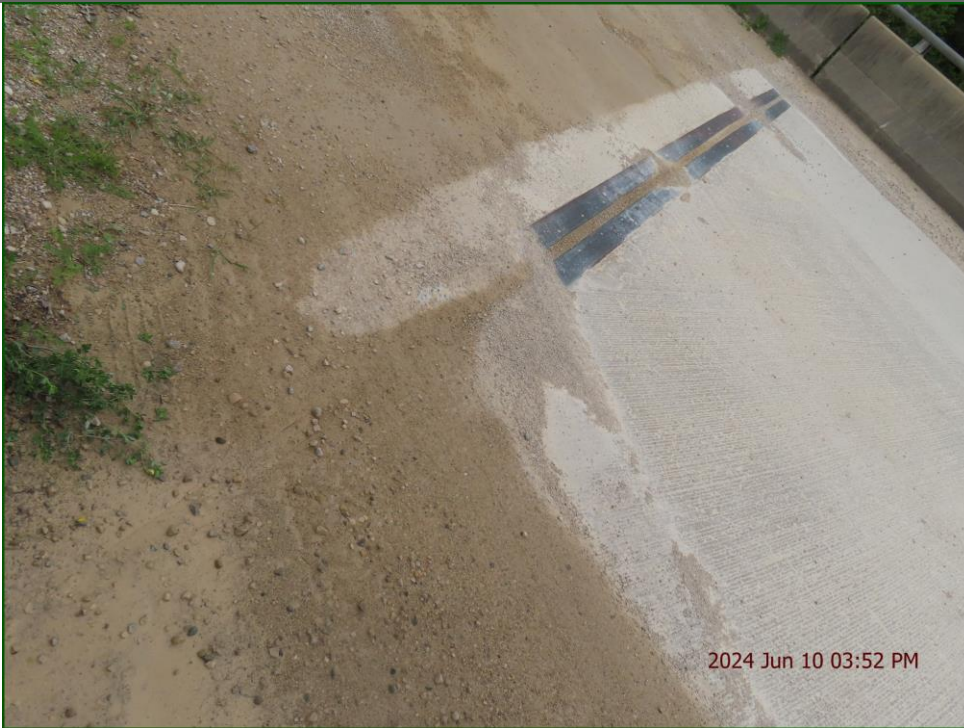
Seals full of gravel.

Element Group:	<input type="text" value="Joints"/>	Site Number:	<input type="text" value="B-022"/>
Element Name:	<input type="text" value="Seals (strip)"/>	Width:	<input type="text" value="0"/> m
Element type:	<input type="text"/>	Height:	<input type="text" value="0"/> m
Sub-element:	<input type="text"/>	Length:	<input type="text" value="8.5"/> m
Material:	<input type="text" value="Rubber"/>	Count:	<input type="text" value="2"/>
Location:	<input type="text"/>	Total Quantity:	<input type="text" value="2"/> each
Environment:	<input type="text" value="Severe"/>	Not inspected:	<input type="checkbox"/>
Perform. deficiencies:	<input type="text"/>	Maintenance Type:	<input type="text" value="Routine"/>
Maint needs:	<input type="text" value="Bridge cleaning"/>	Maint. Time Period:	<input type="text" value="1 Year"/>

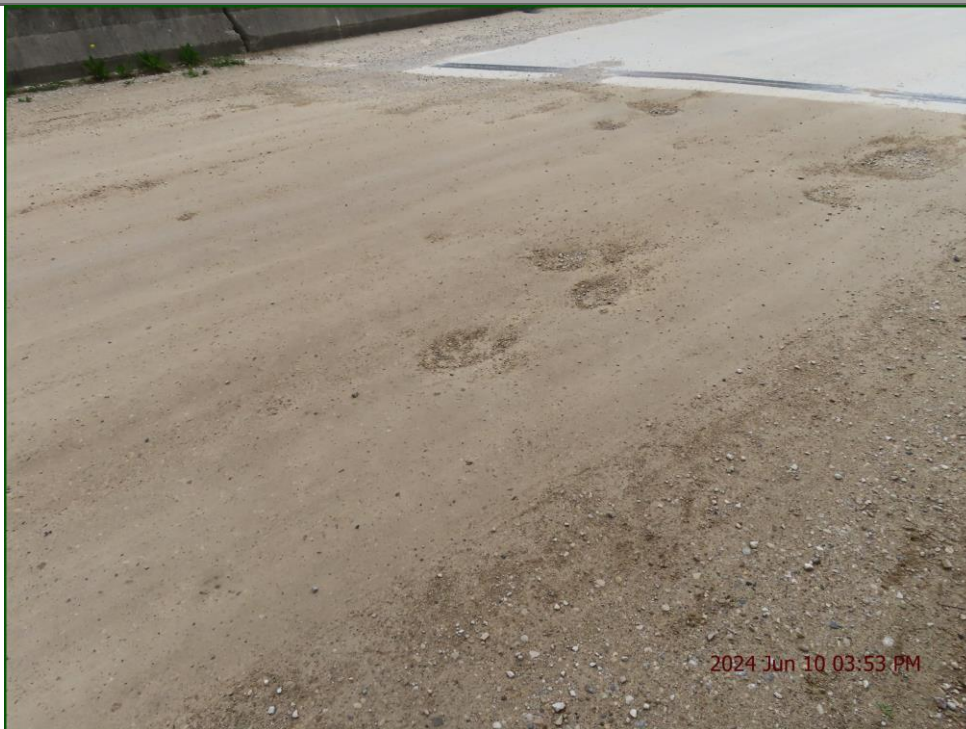
Description: Approach Wearing surface: Moderate to severe potholing throughout.

Moderate to severe potholing throughout.

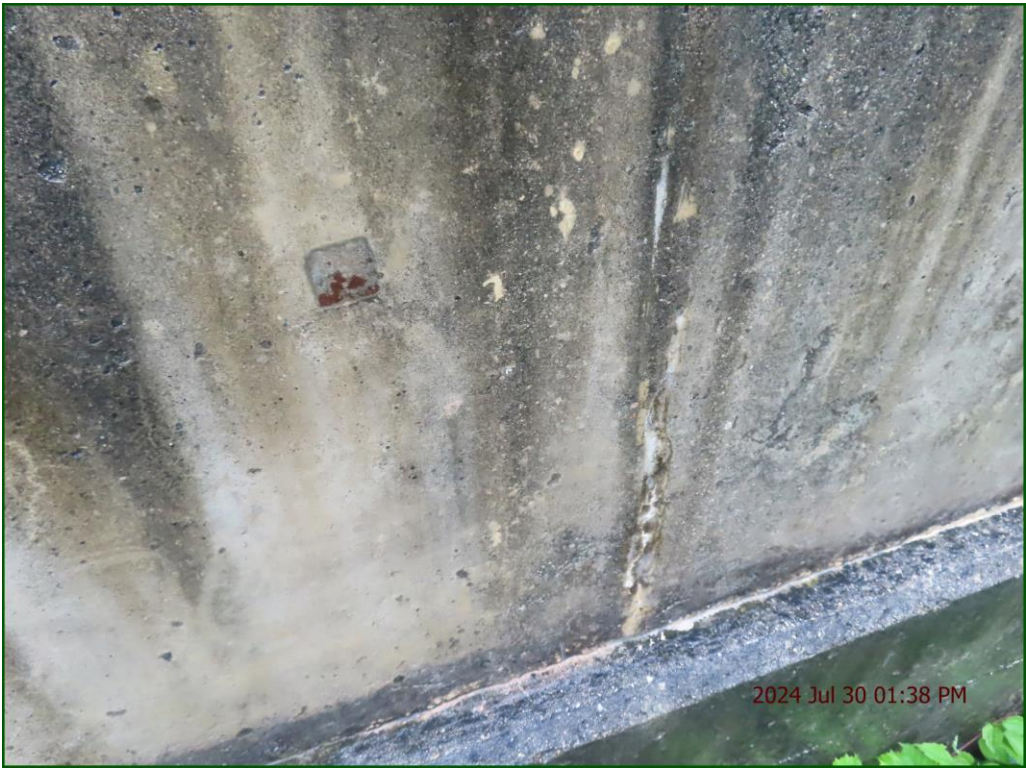
Description: Barrier/Parapet walls (ext): Light to medium vertical crack with wetness and leachate stainin

Light to medium vertical crack with wetness and leachate staining.

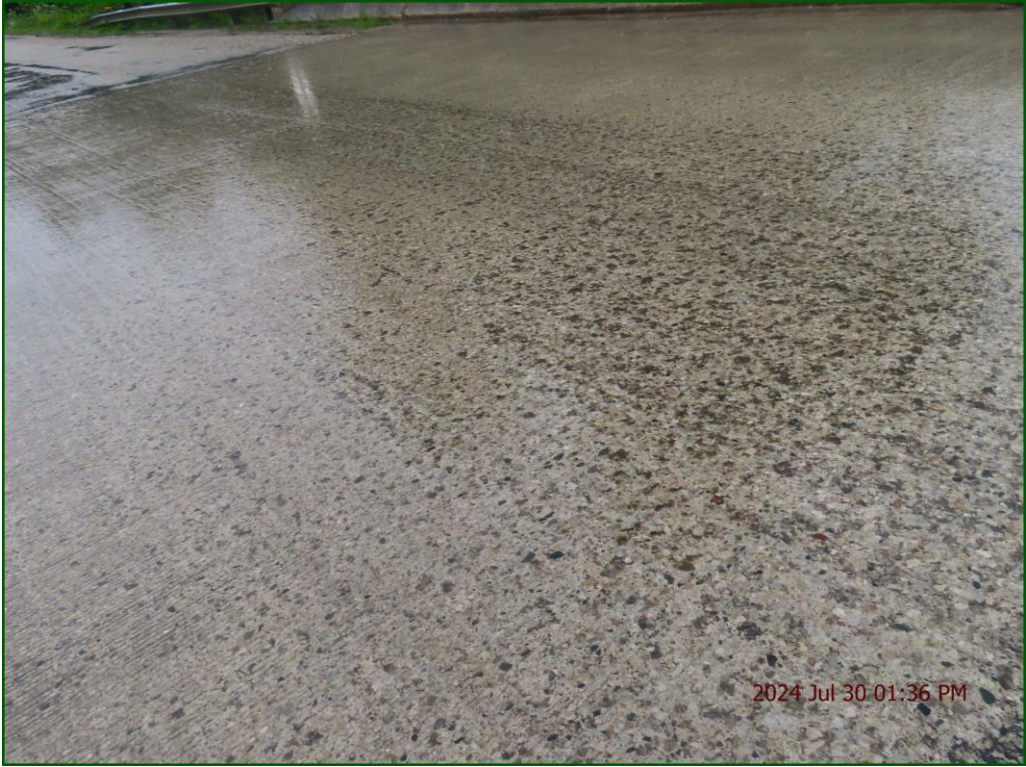
Description: Deck top: Shallow popouts throughout.

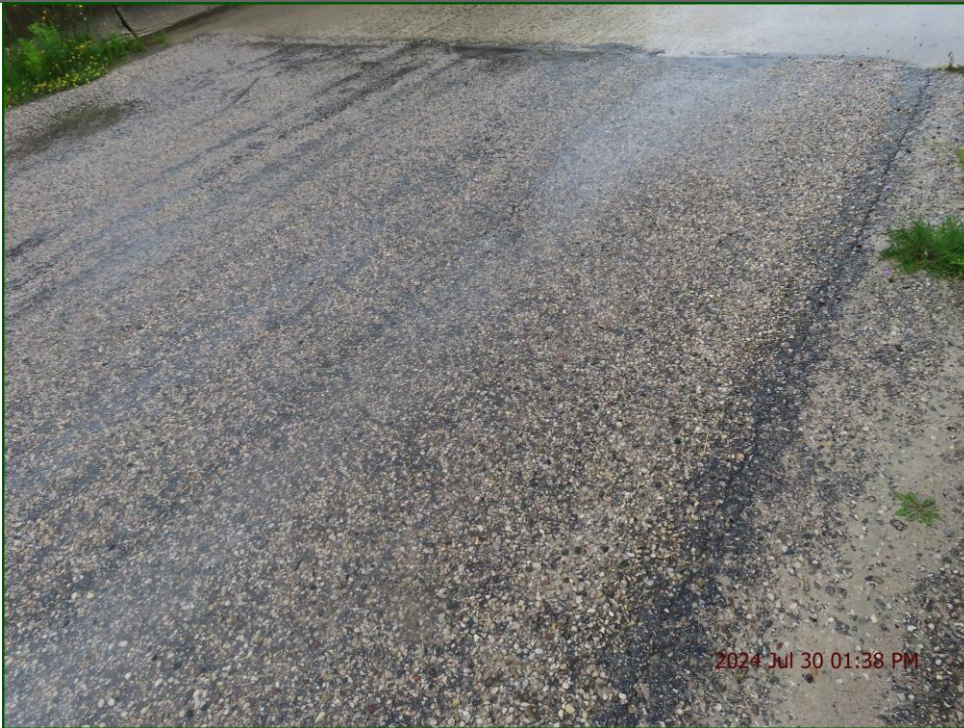
No signs of settlement.

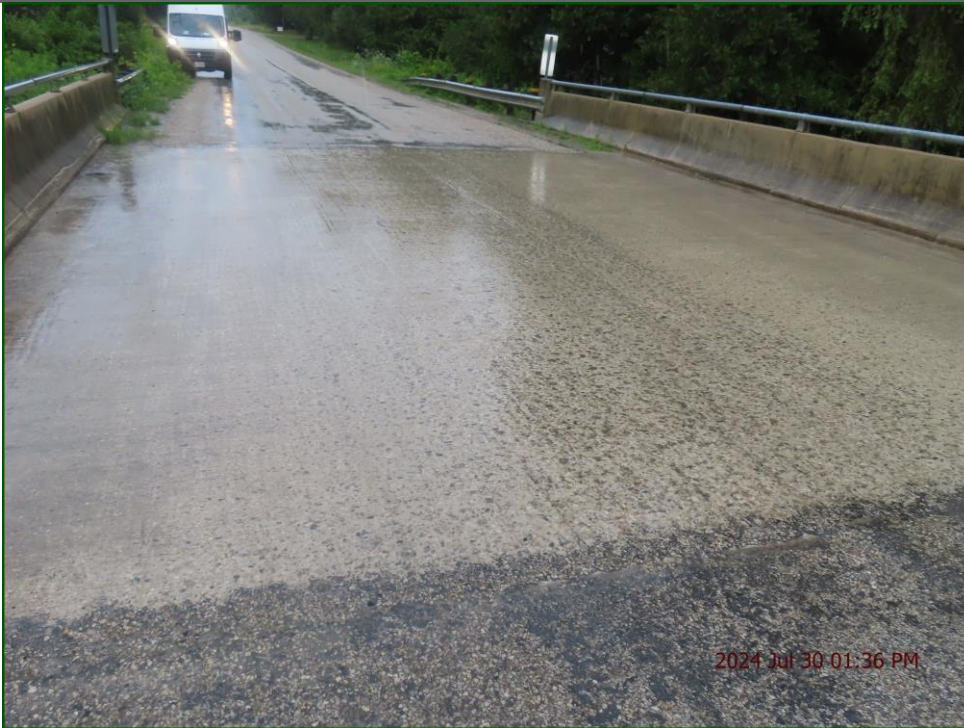
Shallow popouts throughout.

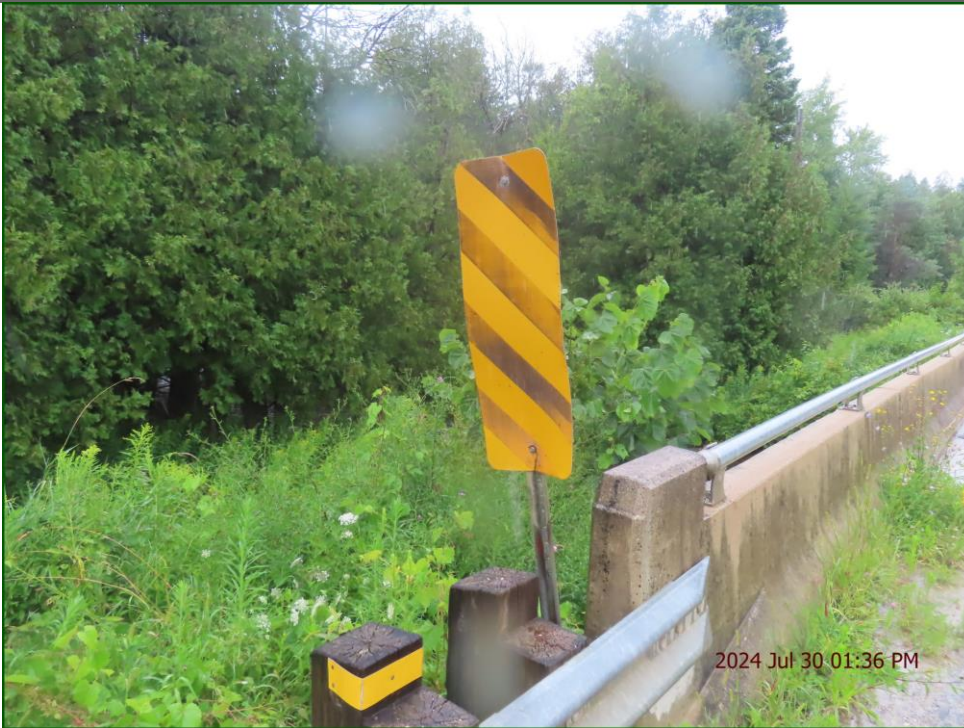
Faded signs, recommend replacement.

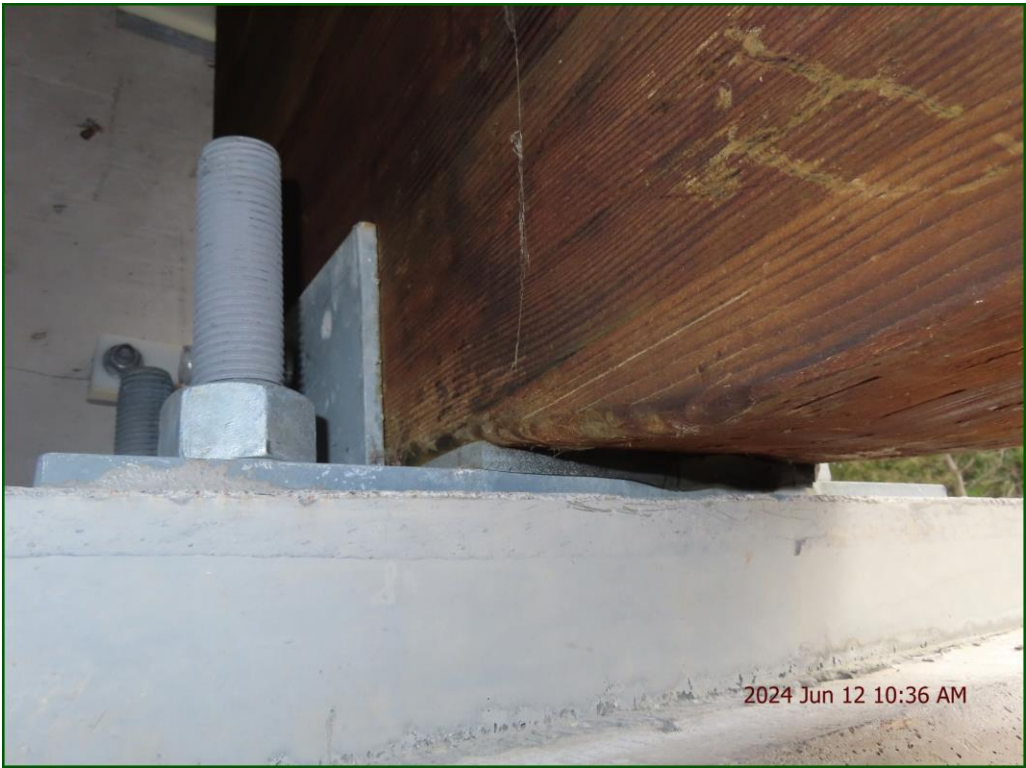
Description: Bearings: Possible flattening of elastomeric bearings (minor).

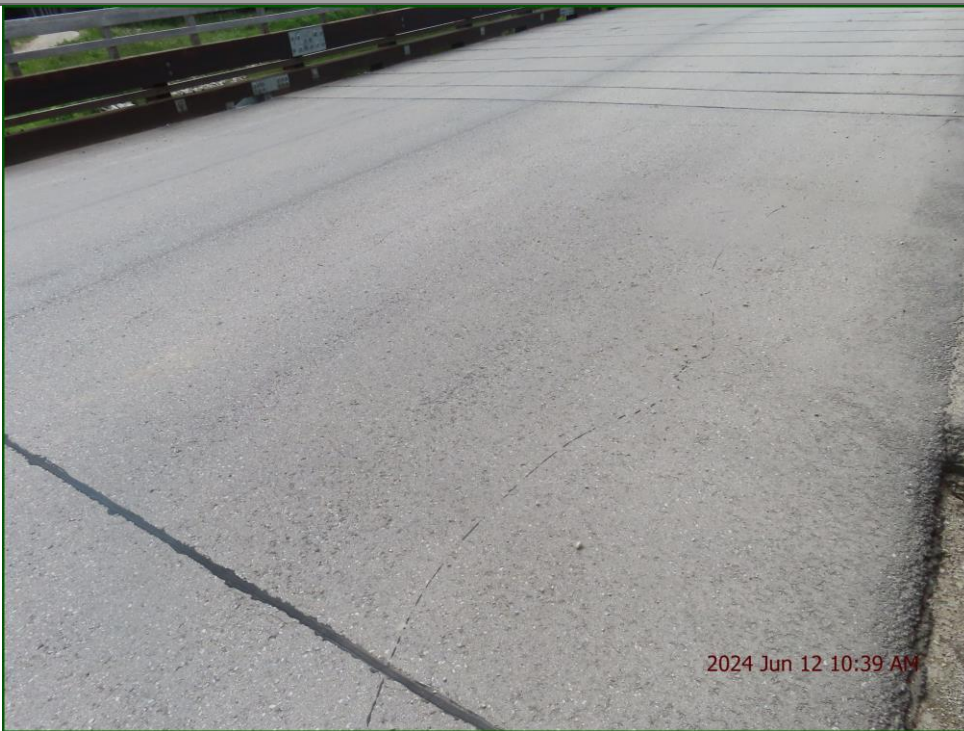
Narrow transverse crack.
