Element Inspection

Date of Inspection:	31-Jul-24
Name of Inspector:	Andrew Burgess, P.Eng. & Joel Ziegler CET
Equipment Used:	Sounding hammer, measuring equipment, GPS
Weather Conditions:	Sunny
Temperature:	23
Special Notes:	Bridge is in good condition, showing no signs of structural distress.

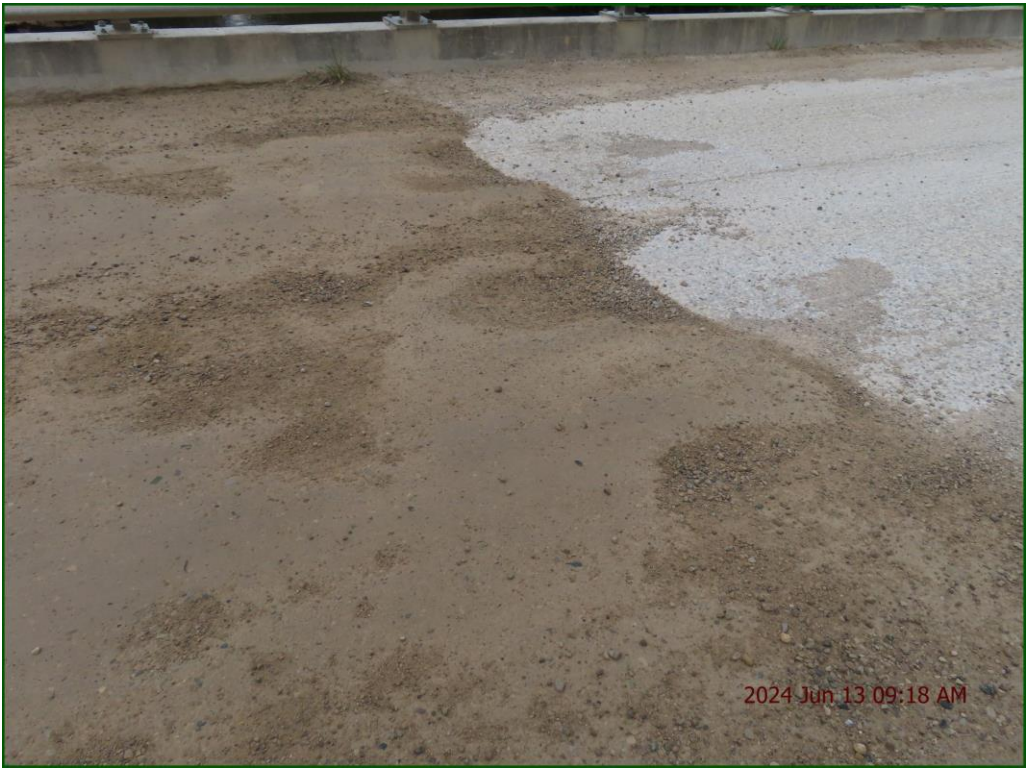
Description: Approach Wearing Surface: Moderate to severe potholes throughout.

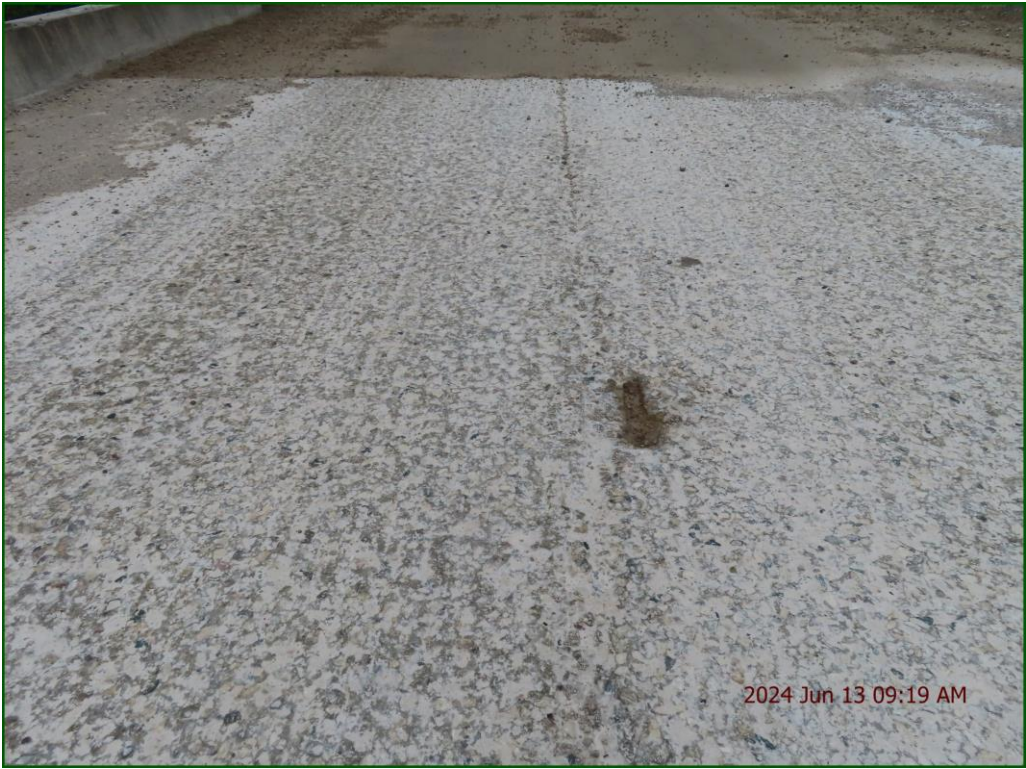
Description: Deck top: Shallow to moderate pop outs throughout.

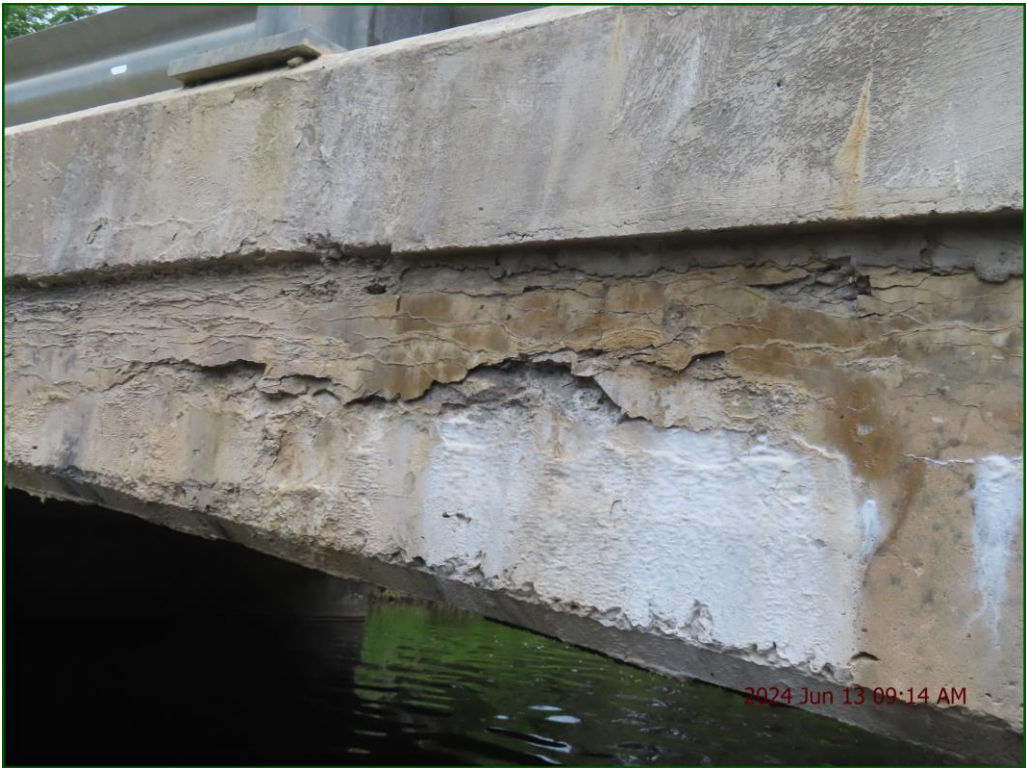
Description: Soffit (ext): Moderate to severe delamination throughout.

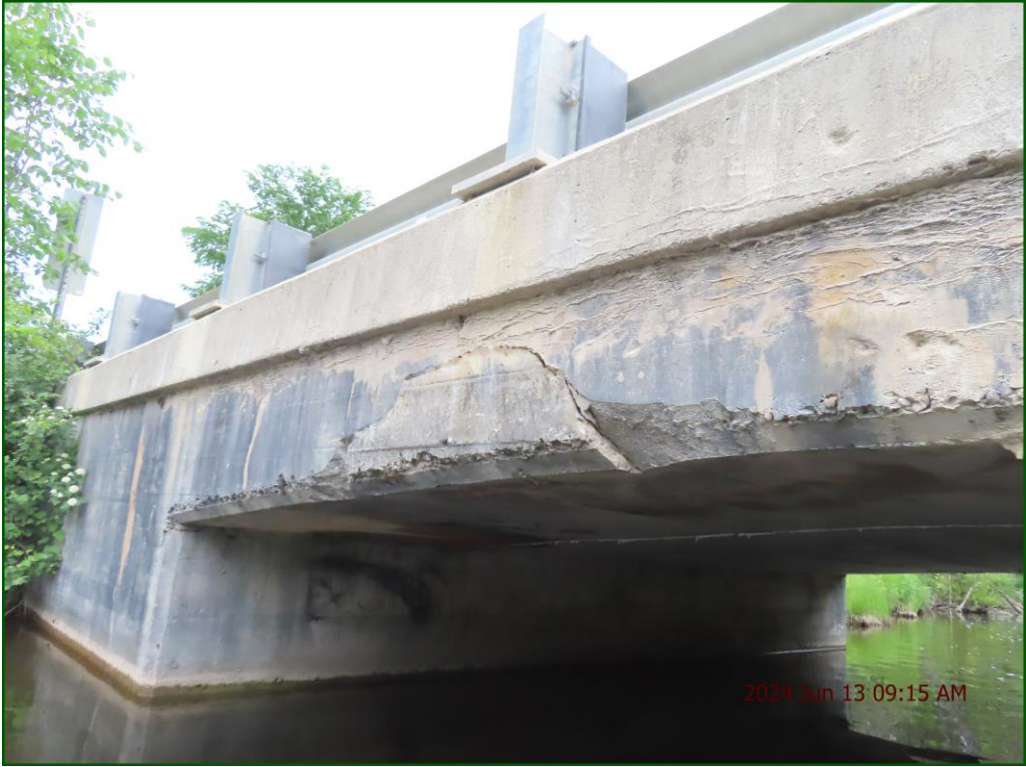
Description: Soffit (ext): Severe spalling on south.

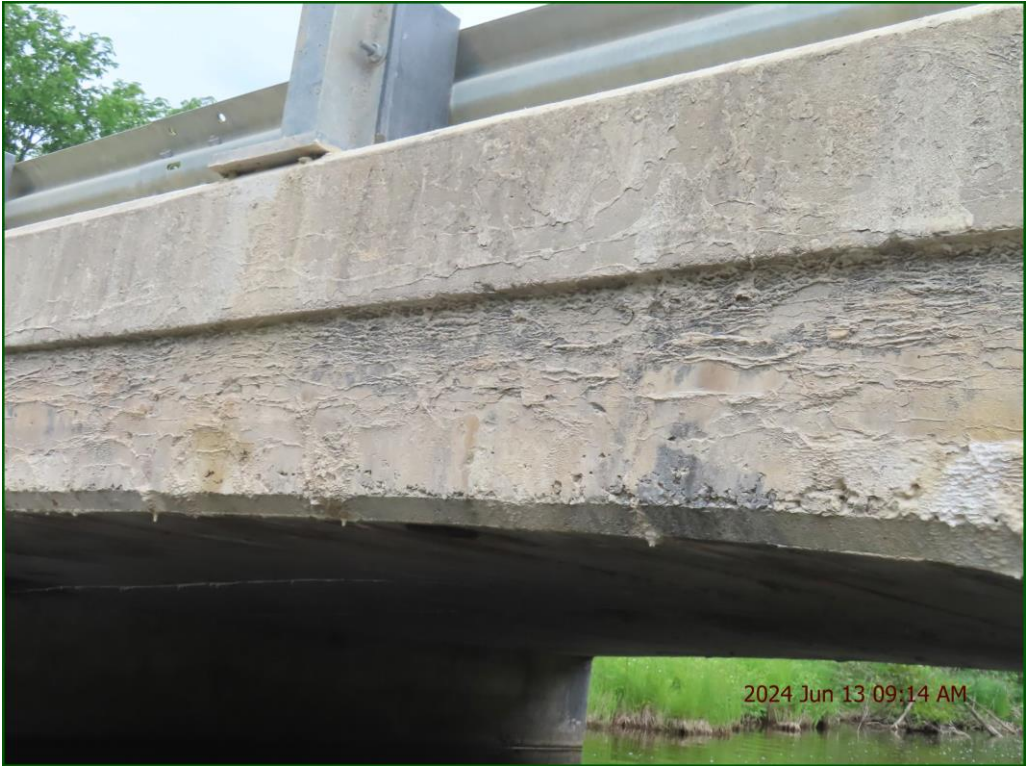
Description: Soffit (ext): Light to medium horizontal cracking with leachate staining.

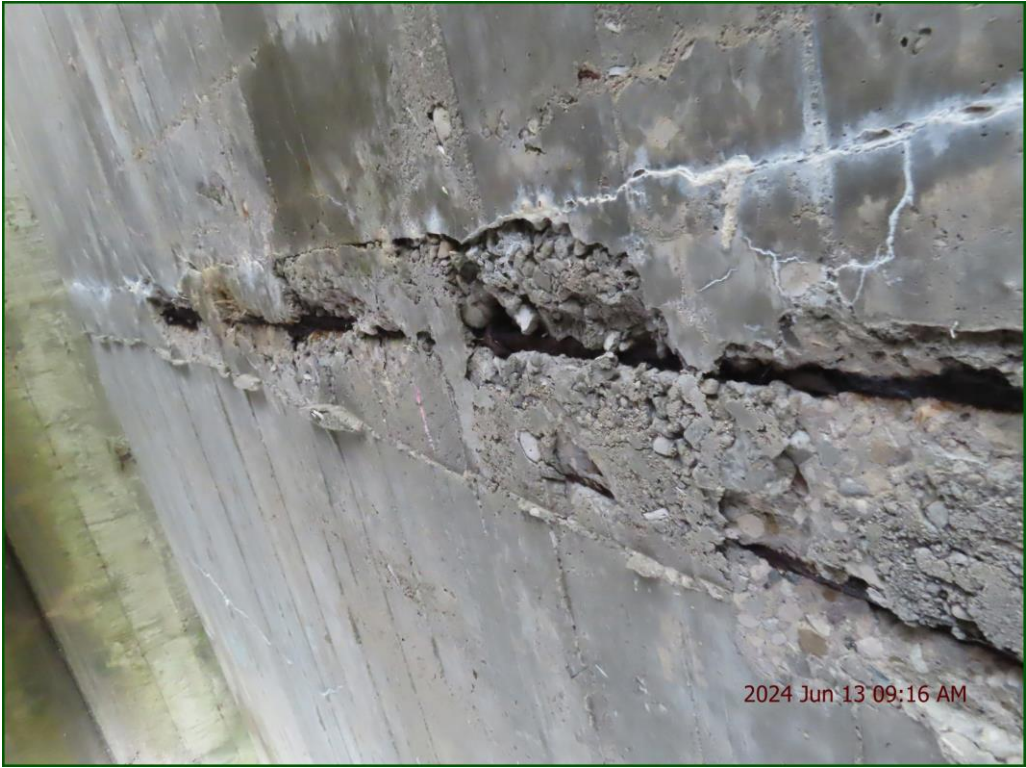
Description: Soffit (int): Severe spalling with exposed reinforcing throughout.

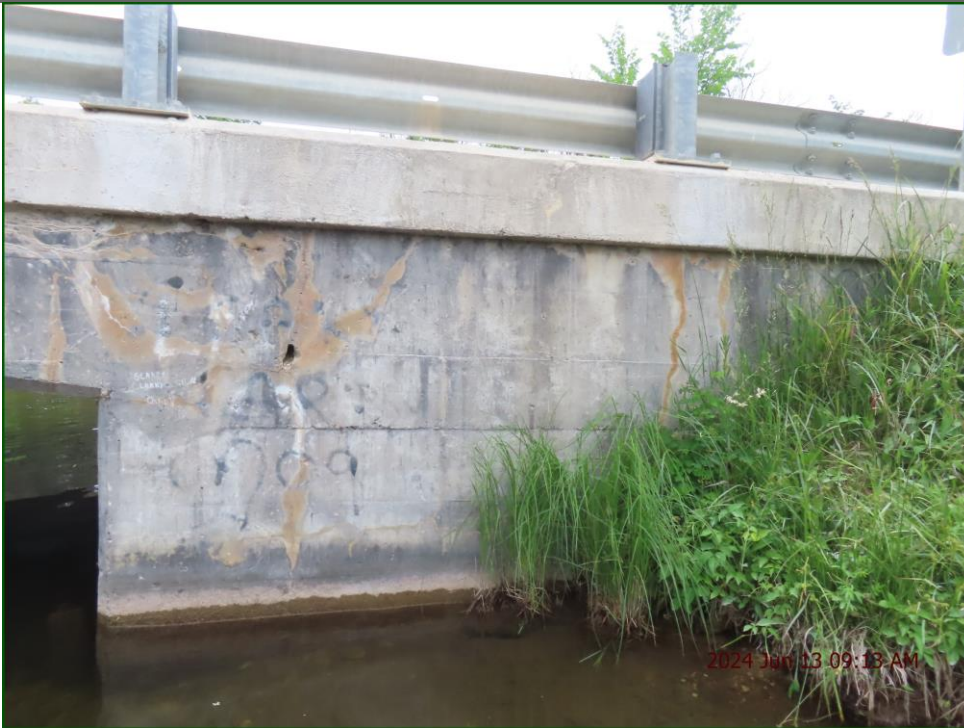
Light to medium vertical cracking with leachate staining.

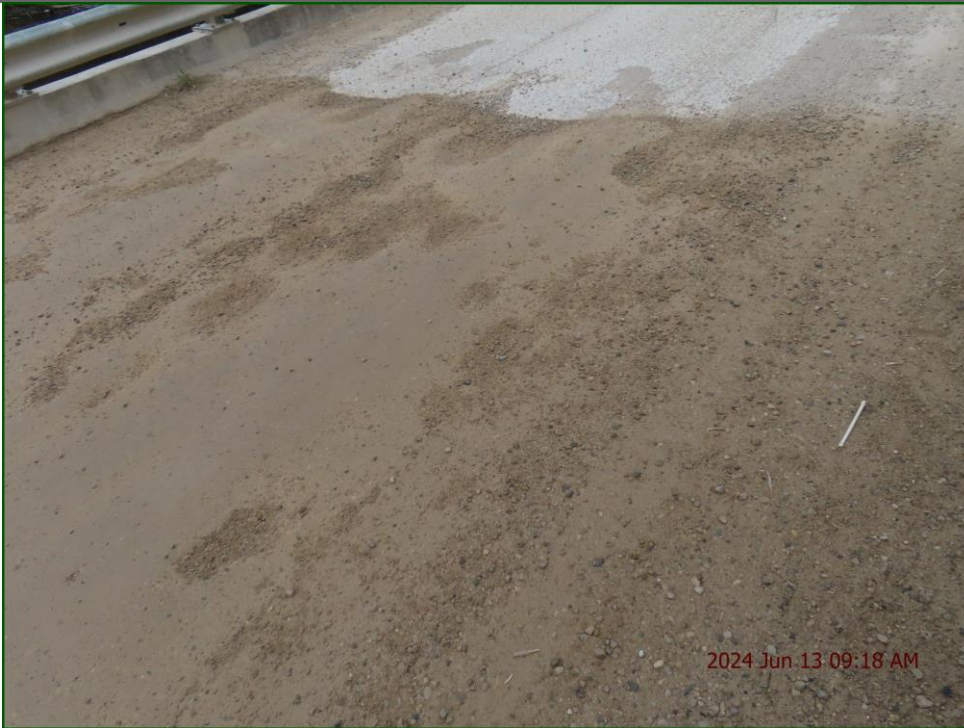
Moderate to severe potholes throughout.

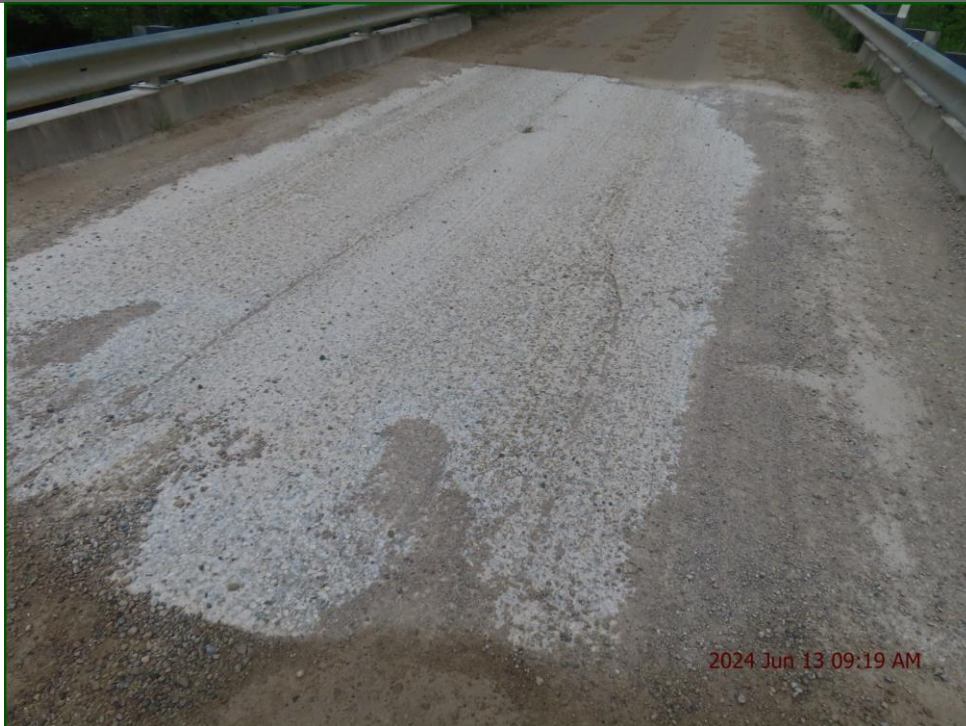
Shallow to moderate pop outs throughout. Sediment on bridge at time of inspection, limited inspection.

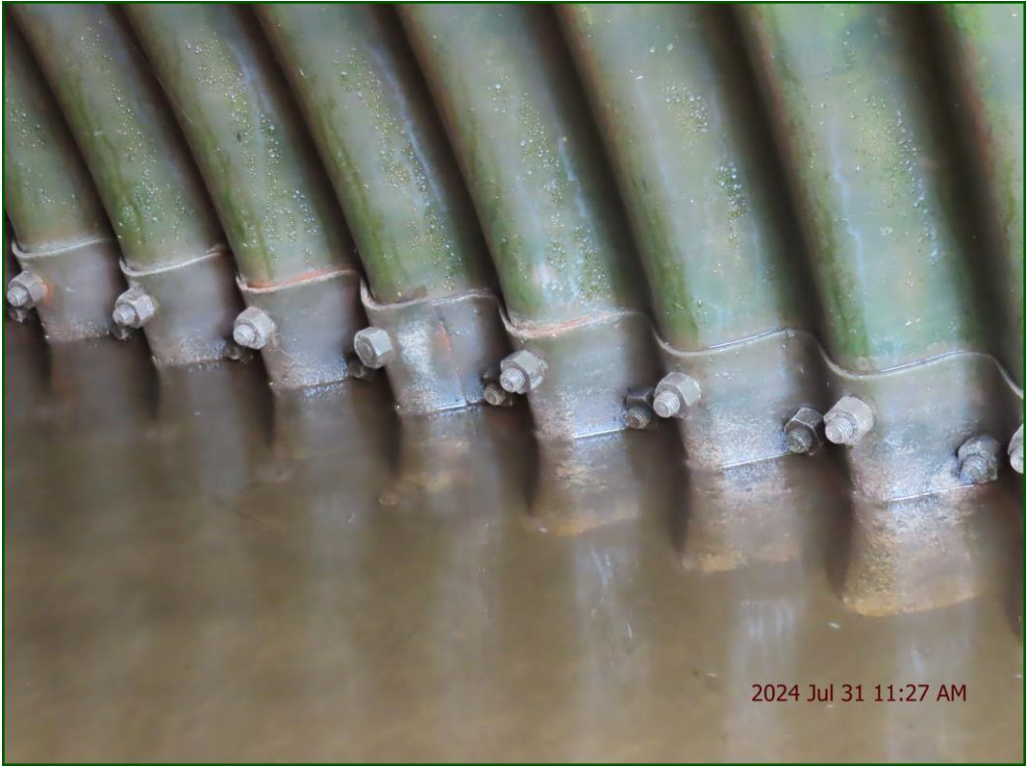
Description: Barrel: Improper splice bolt pattern, no signs of cracking.

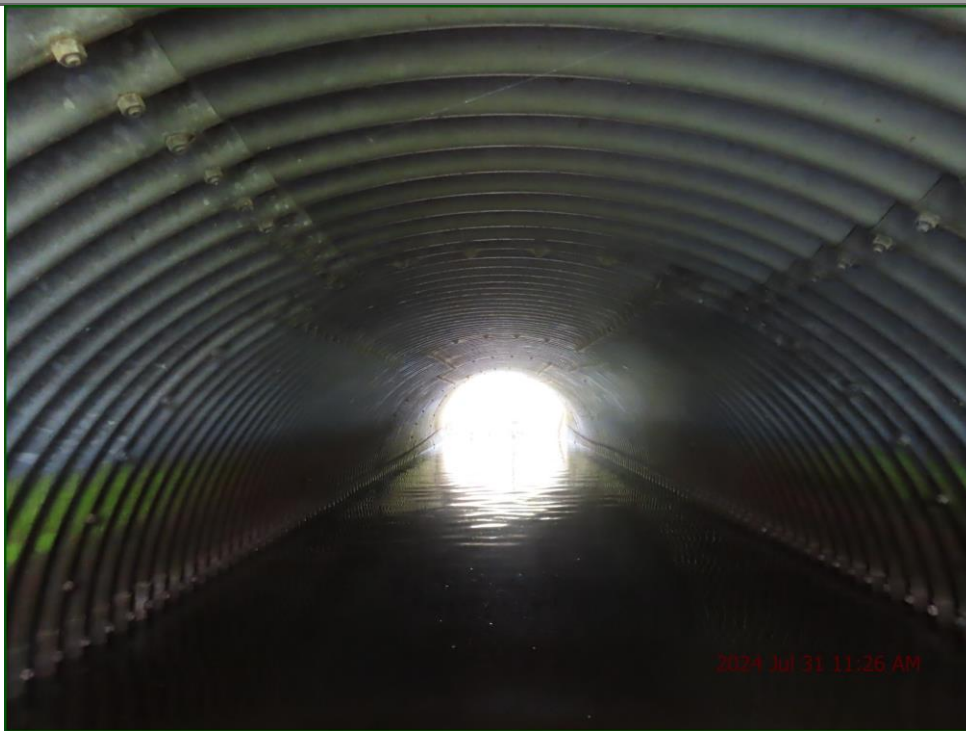
Improper splice bolt pattern, no signs of cracking.

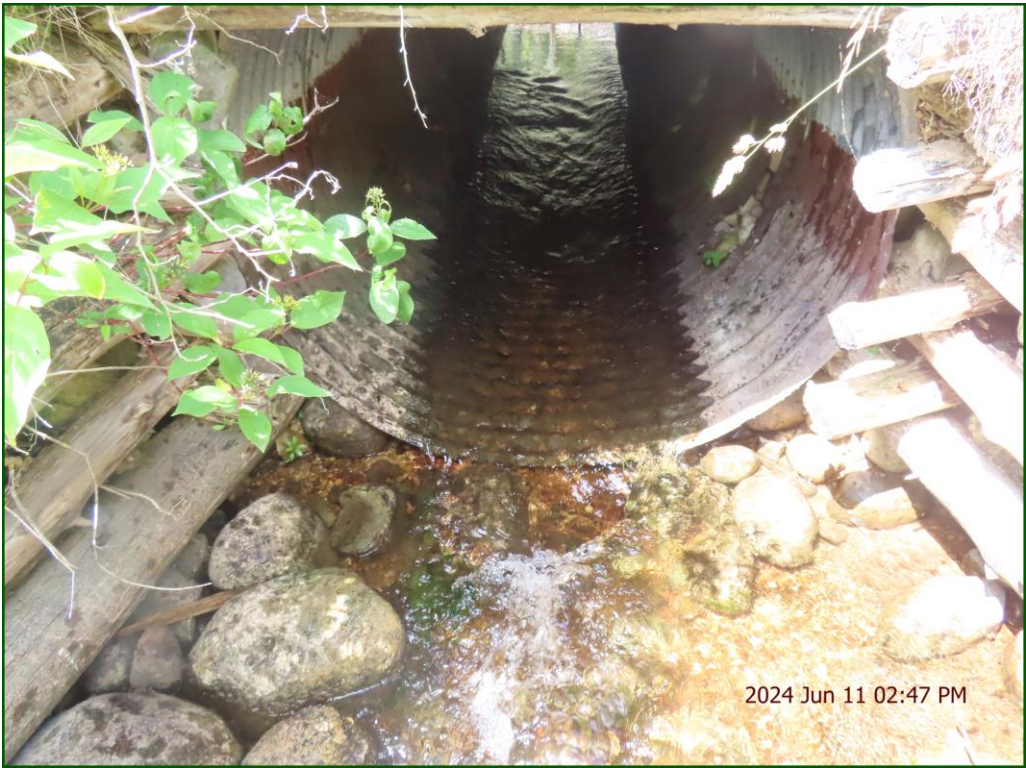
Description: Outlet: Minor scouring.

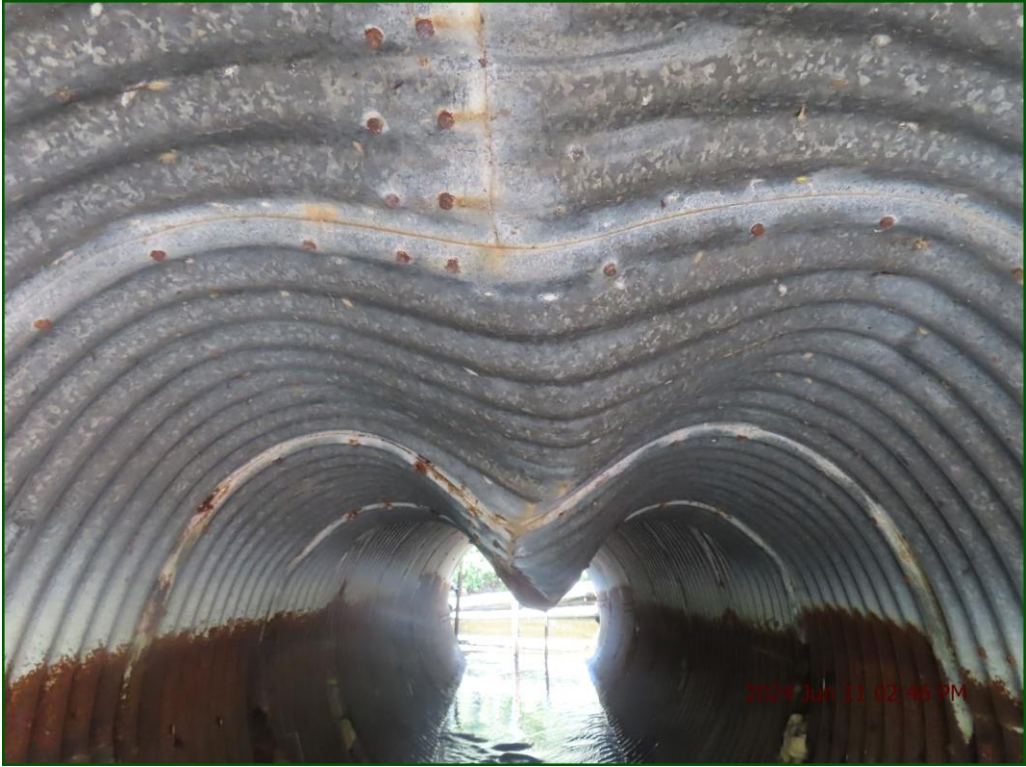
Description: Barrel: Severe sag in south side.

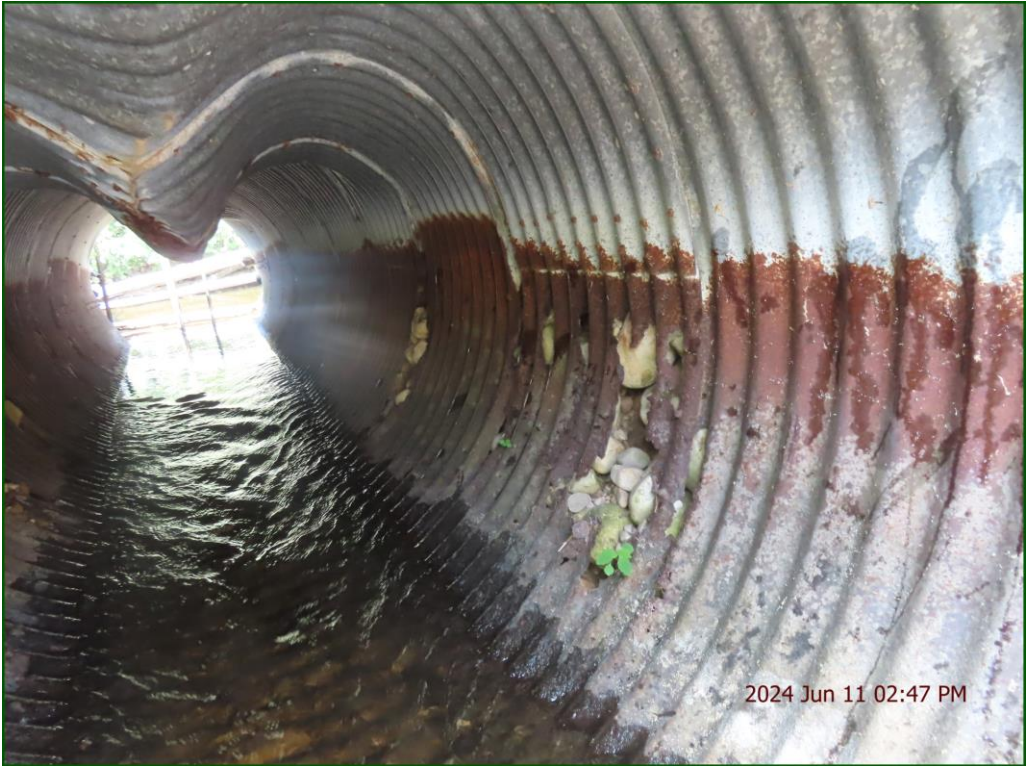
Description: Barrel: Severe corrosion and perforations throughout.

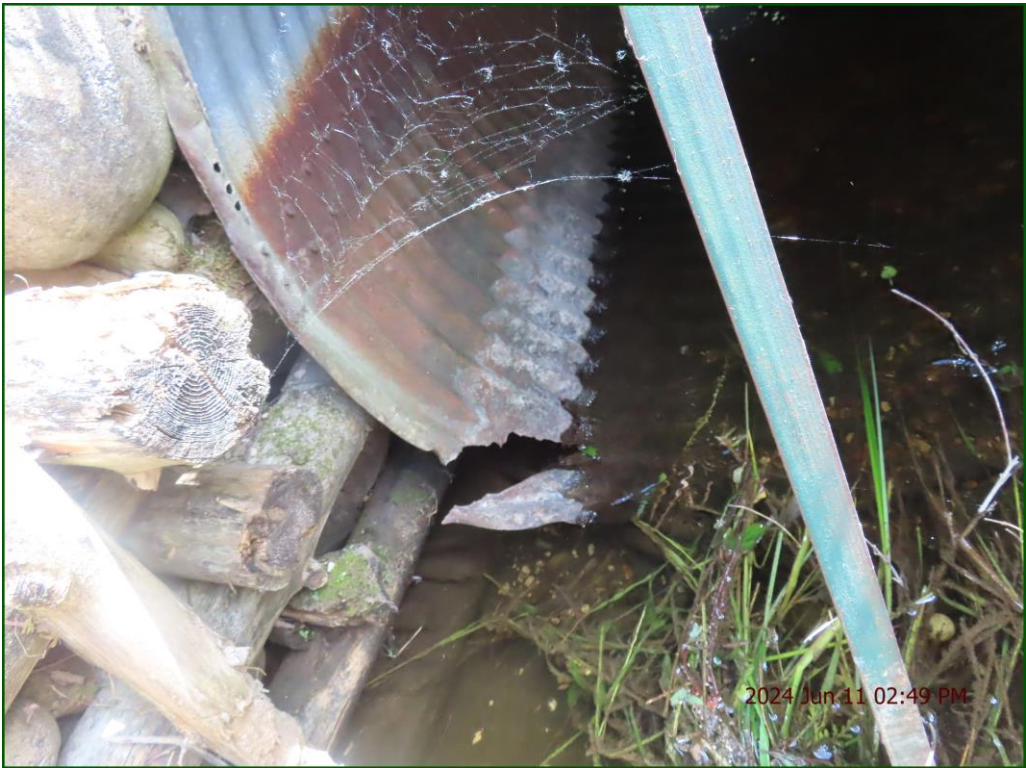
Description: Inlet: Light corrosion and perforation.

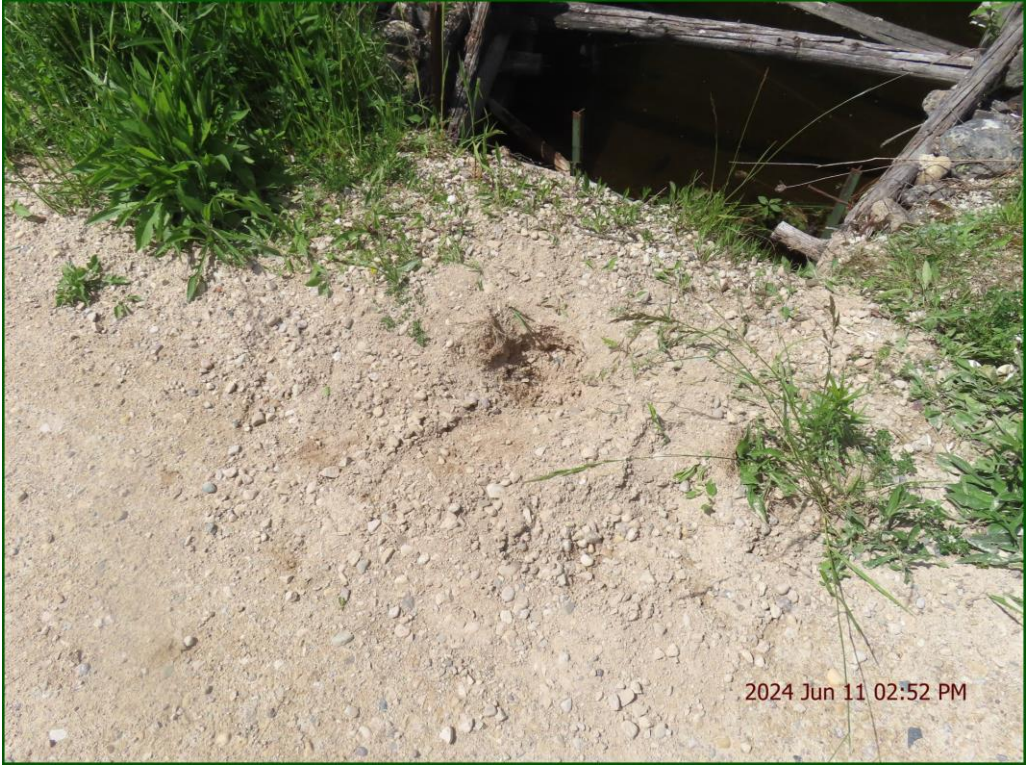
Description: Embankments: Severe pothole forming above sag location.

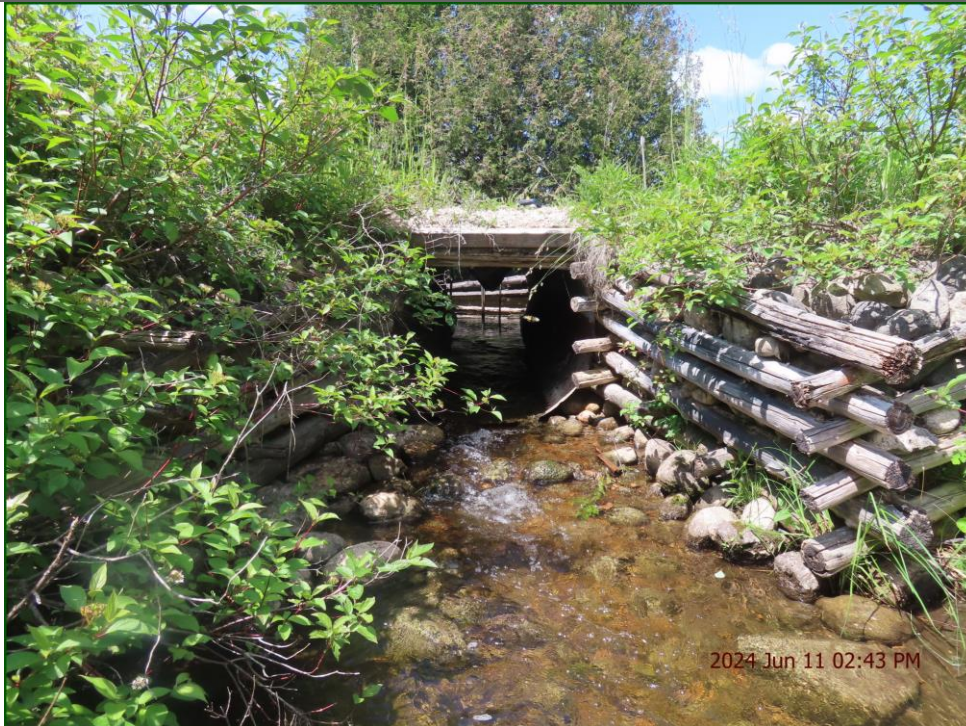
Minor scouring.

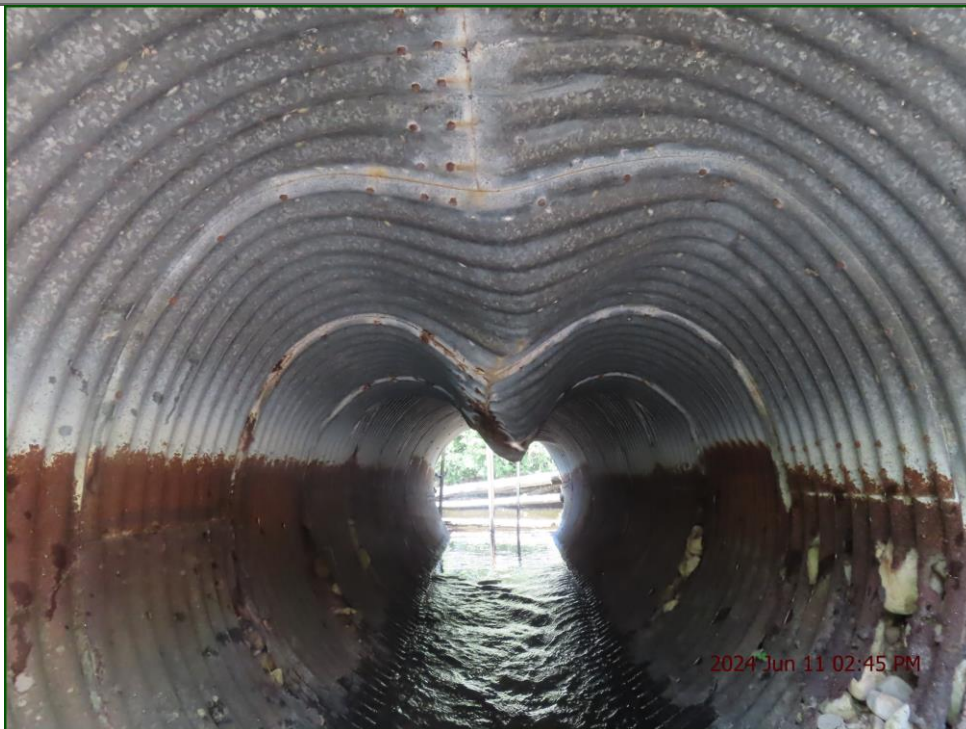
Severe sag in south side. Severe corrosion and perforations throughout. Severe sag at mid barrel and north side of barrel.

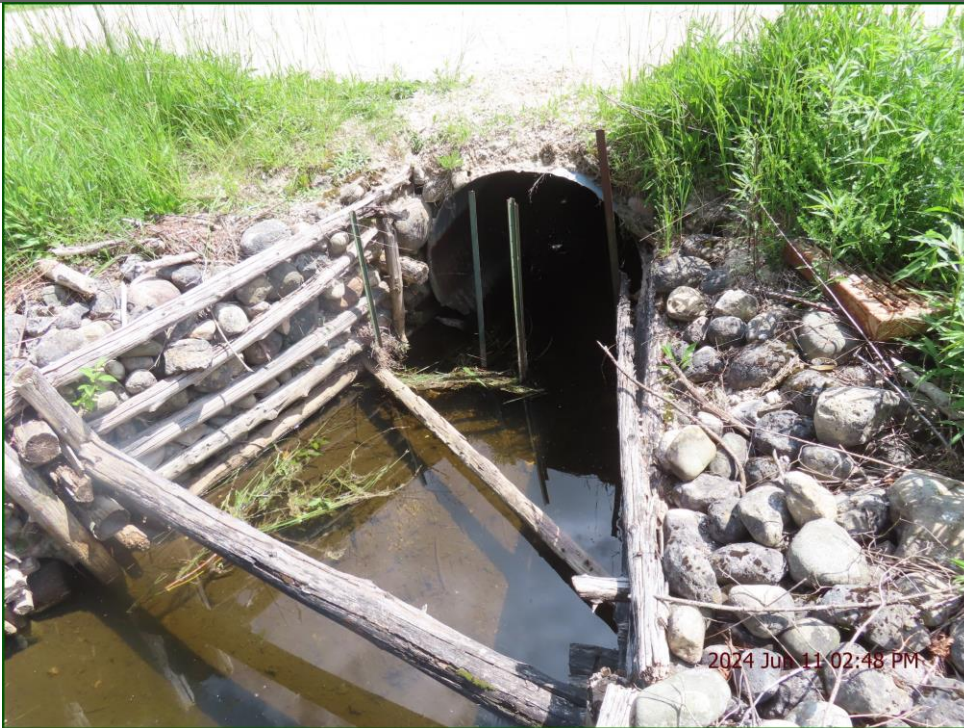
Corrosion and perforation.

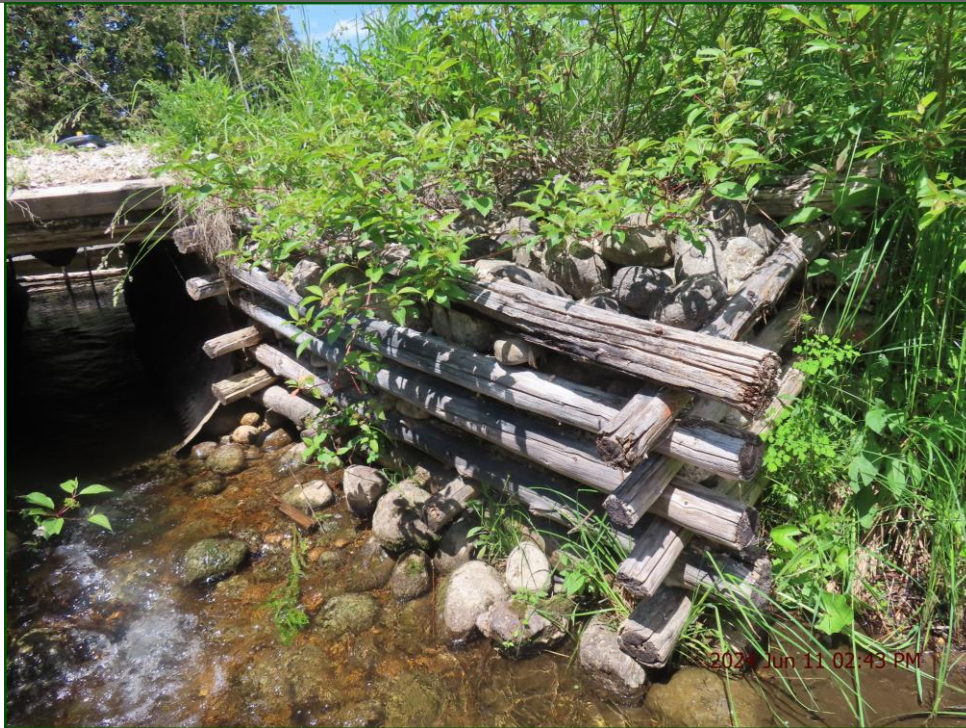
Gabian stone held back by timber. Retaining walls on south side appear stable.

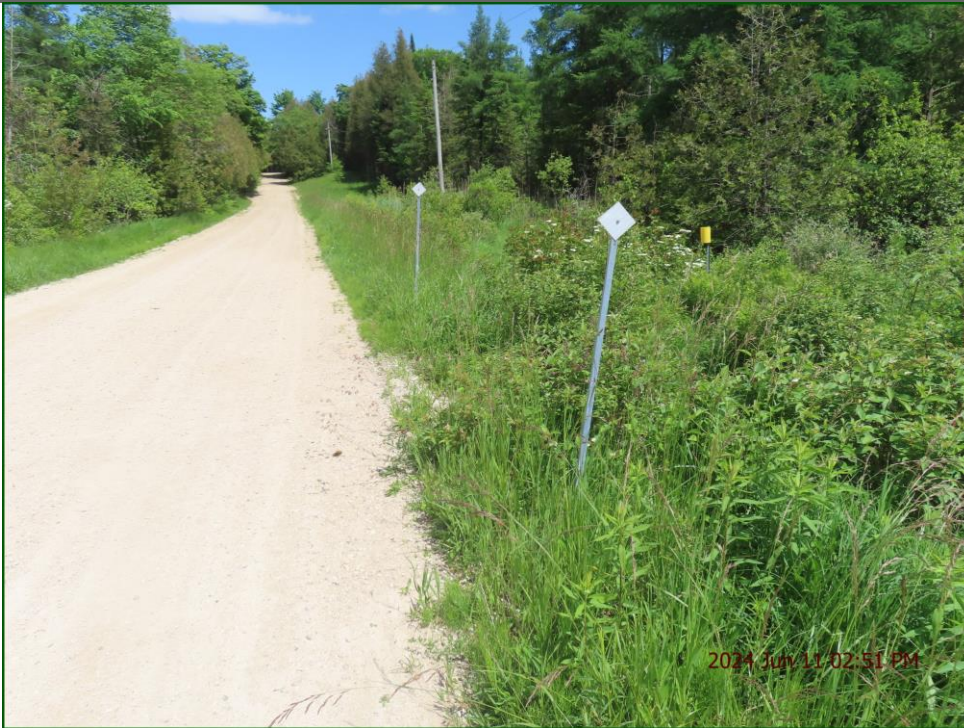
Severe pothole forming above sag location.

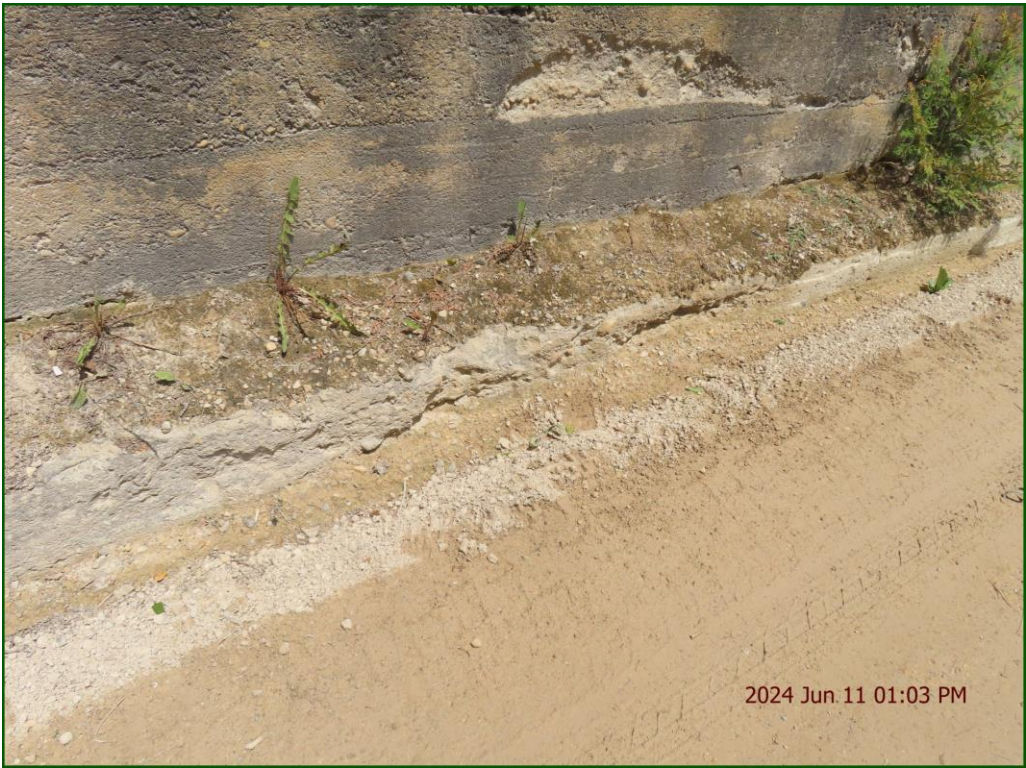
Description: Curbs: Severe spalling throughout.

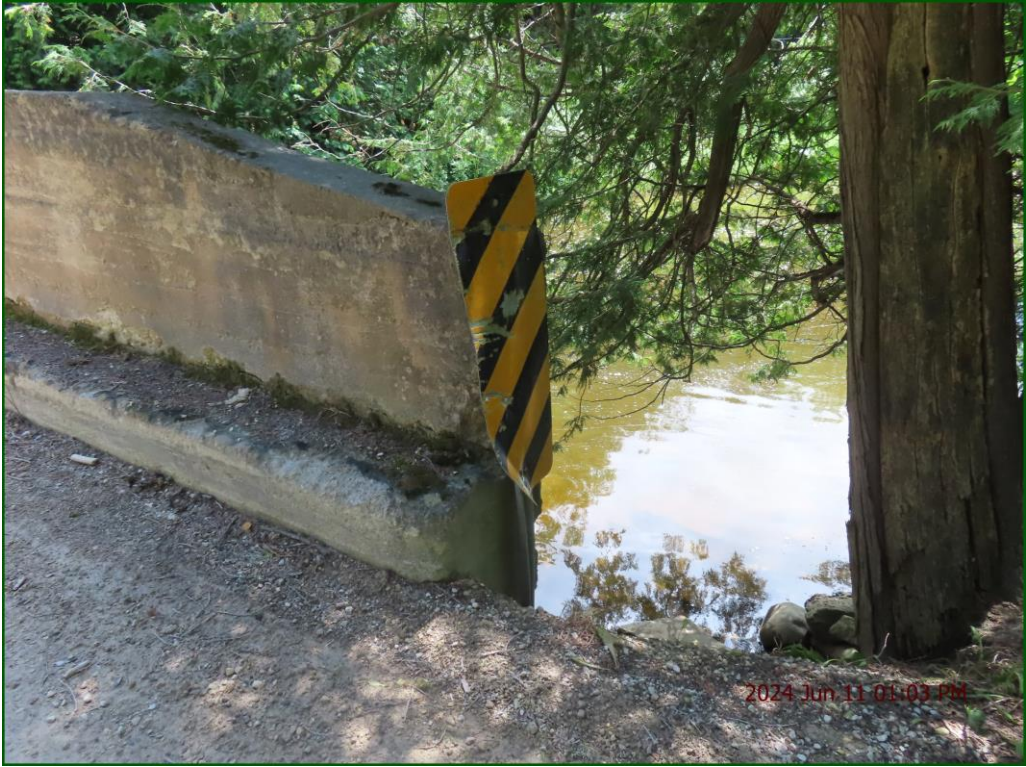
Description: Signs: Impact damage on south west (minor).

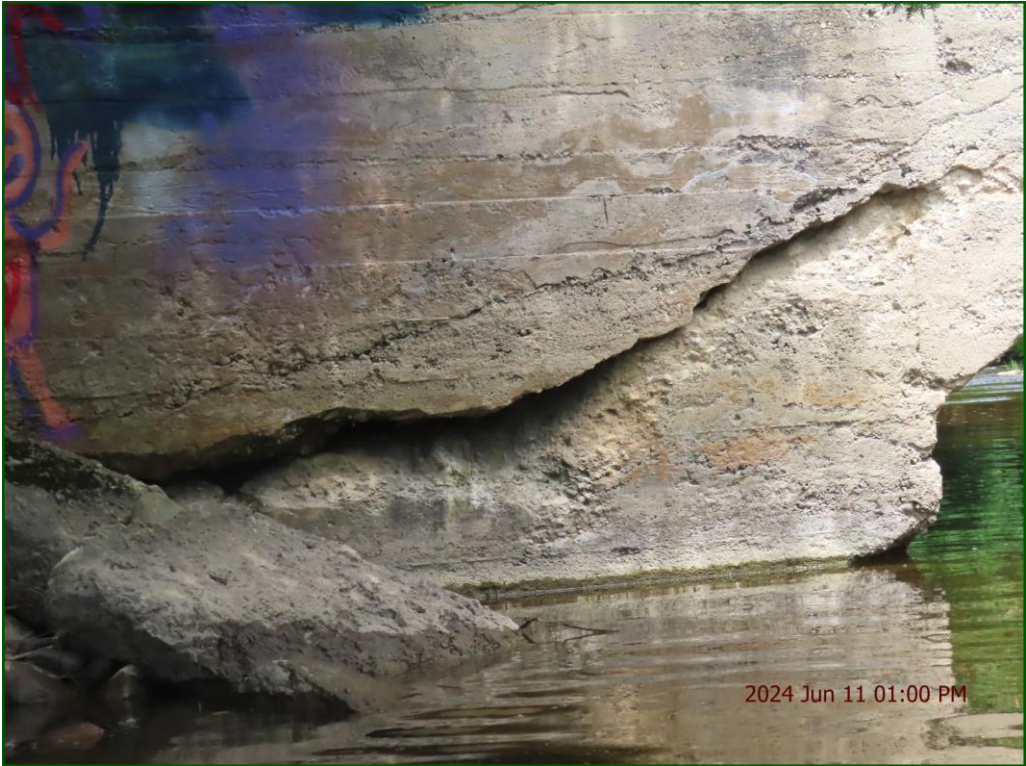
Description: Inlet: Severe spalling and disintegration throughout.

Severe spalling and disintegration throughout.

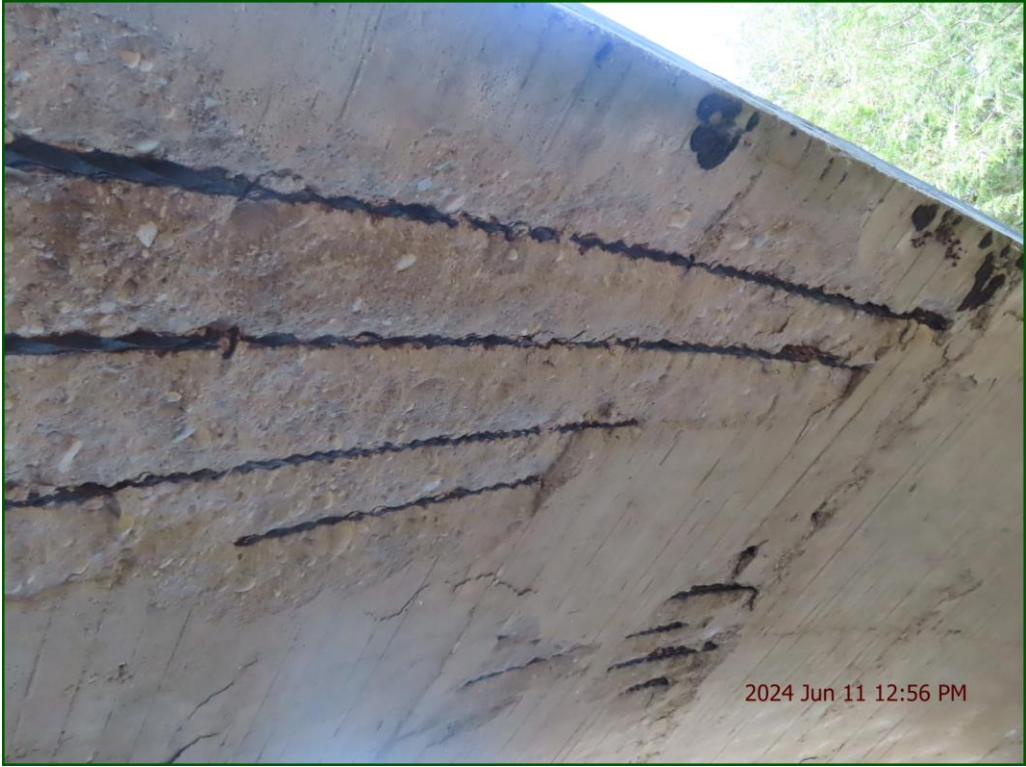
Description: Barrel: Severe spalling with exposed reinforcing throughout.

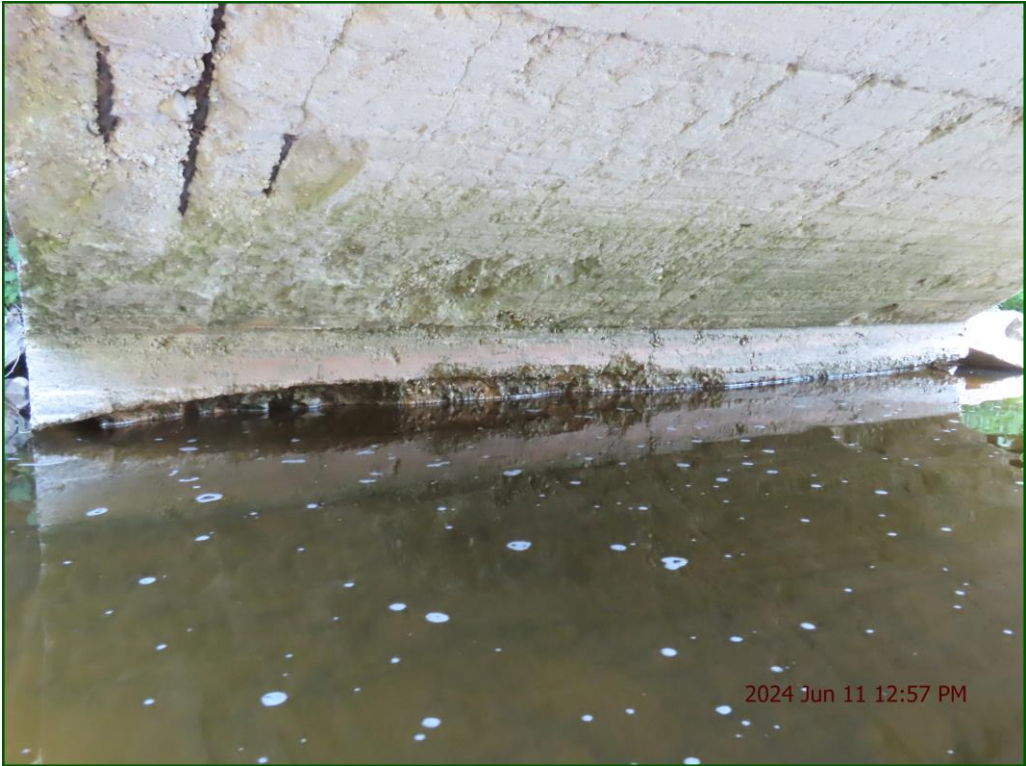
Description: Barrel: Severe scouring and disintegration at waterline at both ends.

Severe spalling with exposed reinforcing throughout. Severe scouring and disintegration at waterline at both ends, under water. Scouring around waterline beginning to undermine structure.

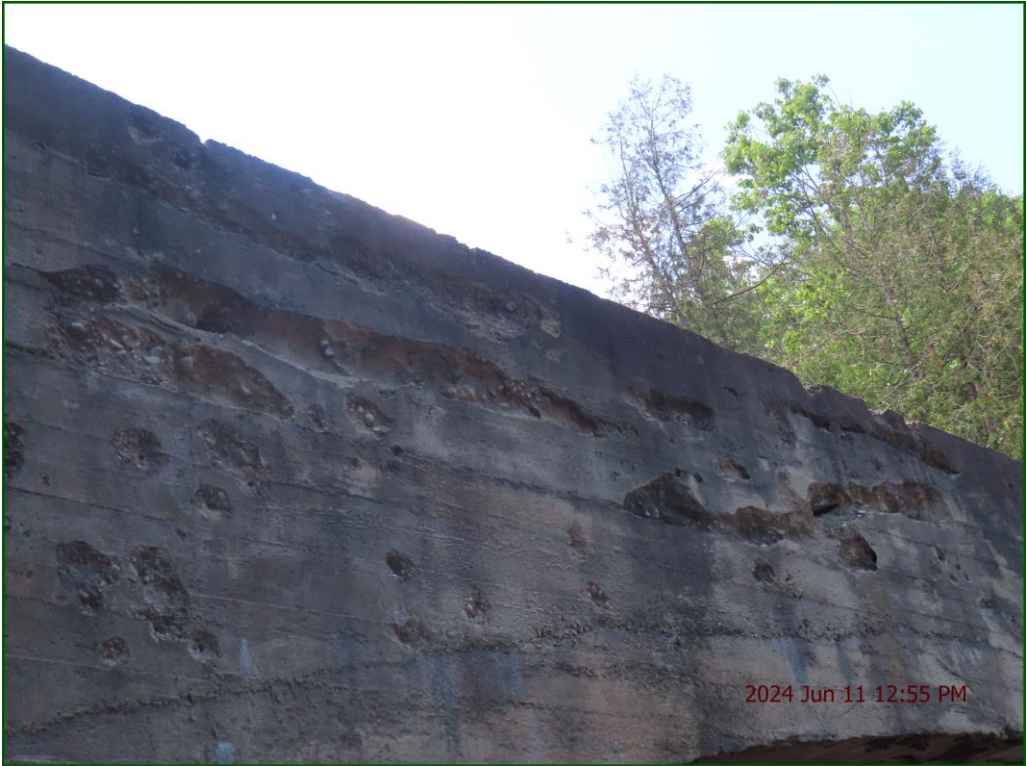
Description: Outlet: Severe spalling and disintegration throughout.

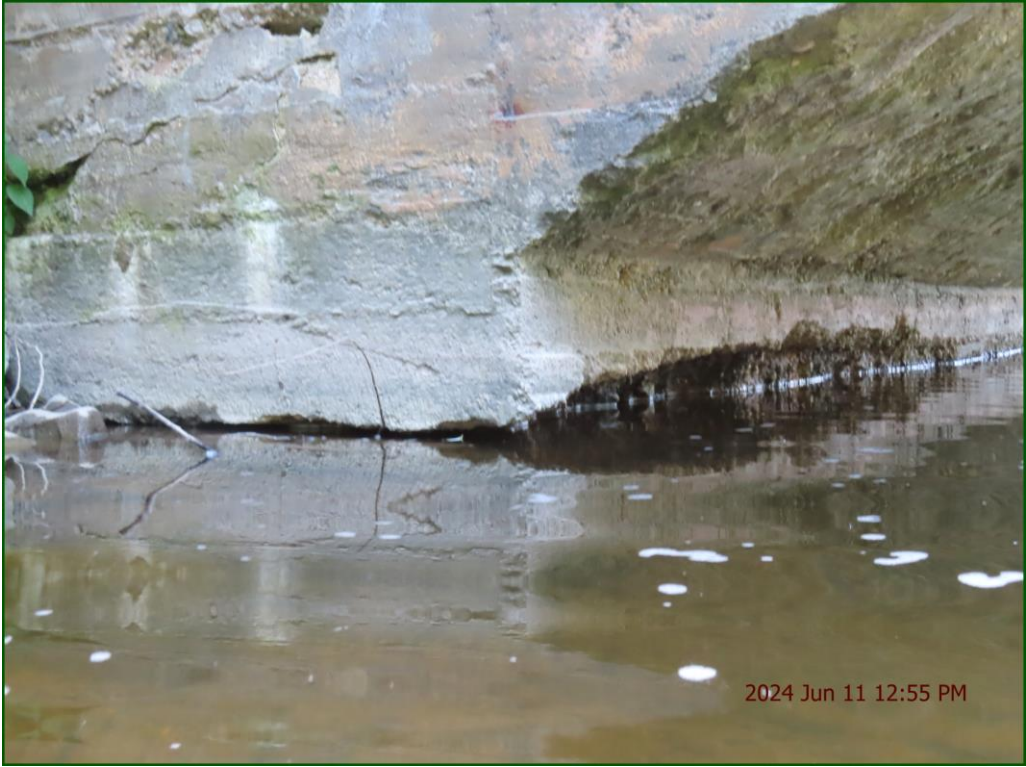
Description: Outlet: Severe scouring at waterline resulting in undermined structure.

Severe spalling and disintegration throughout. Severe scouring at waterline resulting in undermined structure, partially under water.

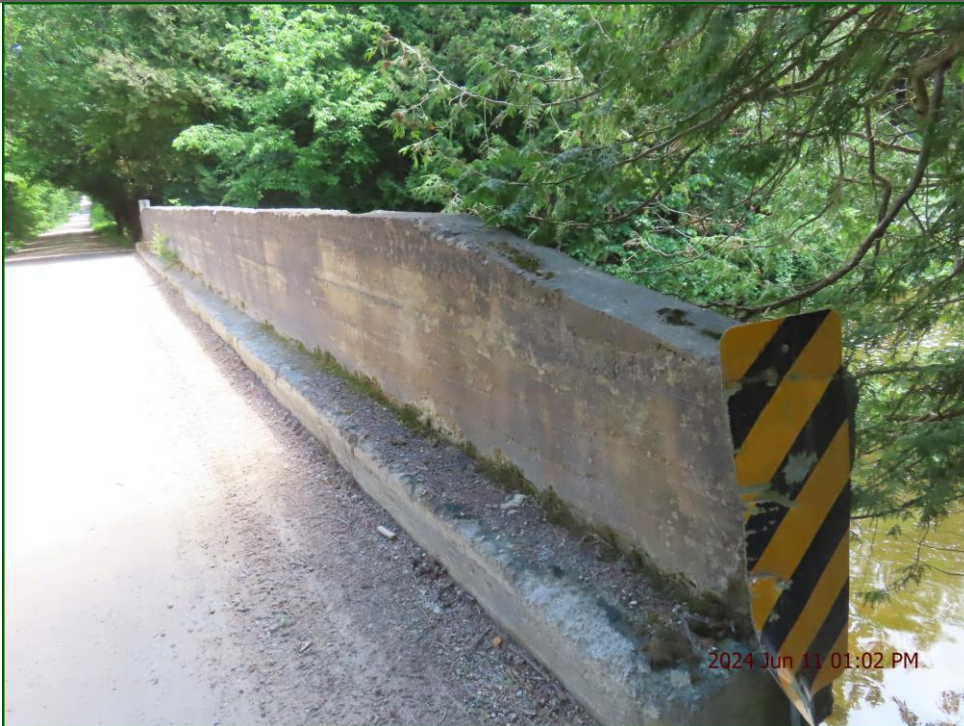
Severe spalling and disintegration throughout.

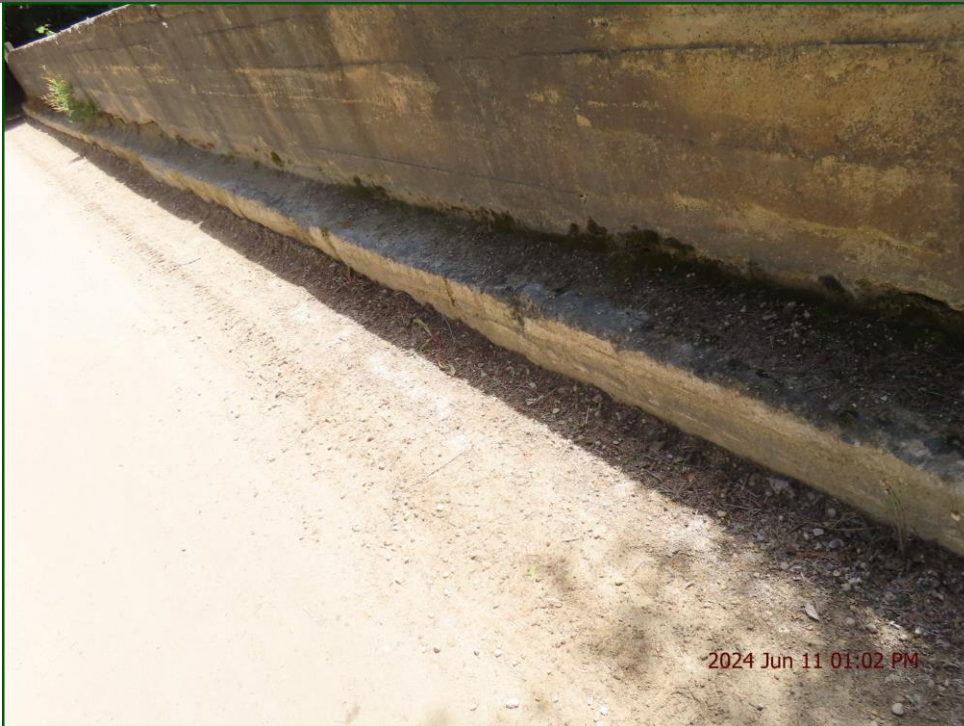
Severe spalling throughout. Partially covered in sediment.
