Element Inspection

Date of Inspection:	31-Jul-24
Name of Inspector:	Andrew Burgess, P.Eng. & Joel Ziegler CET
Equipment Used:	Sounding hammer, measuring equipment, GPS
Weather Conditions:	Sunny
Temperature:	23
Special Notes:	Bridge is in good condition, showing no signs of structural distress.

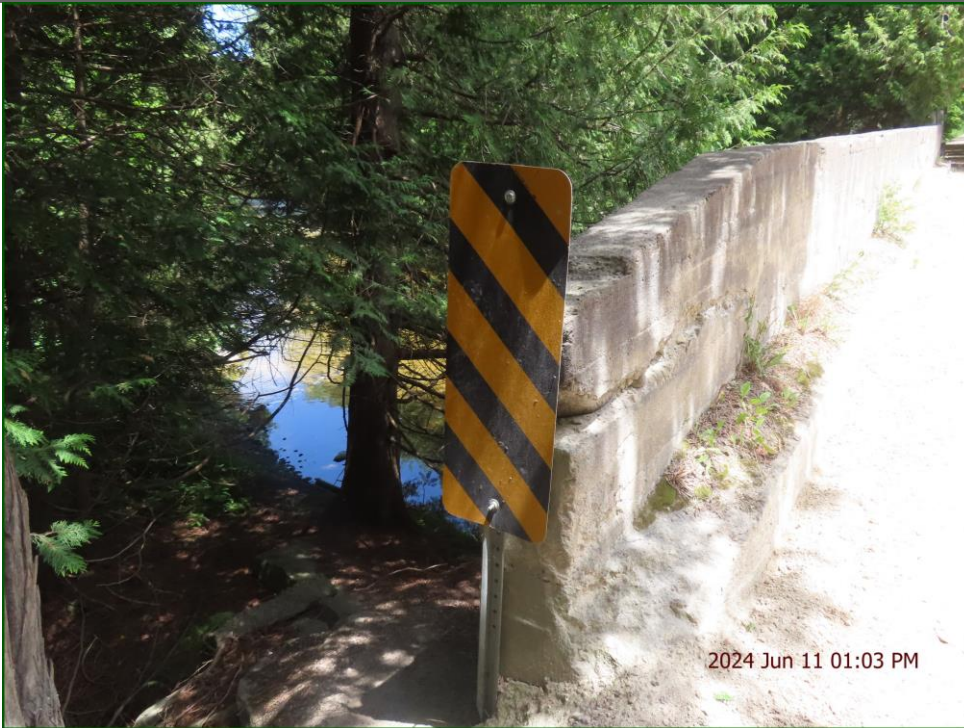
Impact damage on south west (minor).

Element Group:	Accessories	Site Number:	G-044
Element Name:	Signs	Width:	0 m
Element type:		Height:	0 m
Sub-element:		Length:	0 m
Material:		Count:	4
Location:		Total Quantity:	4 each
Environment:	Severe	Not inspected:	<input type="checkbox"/>
Perform. deficiencies:		Maintenance Type:	Routine
Maint needs:	Sign Repair	Maint. Time Period:	1 Year

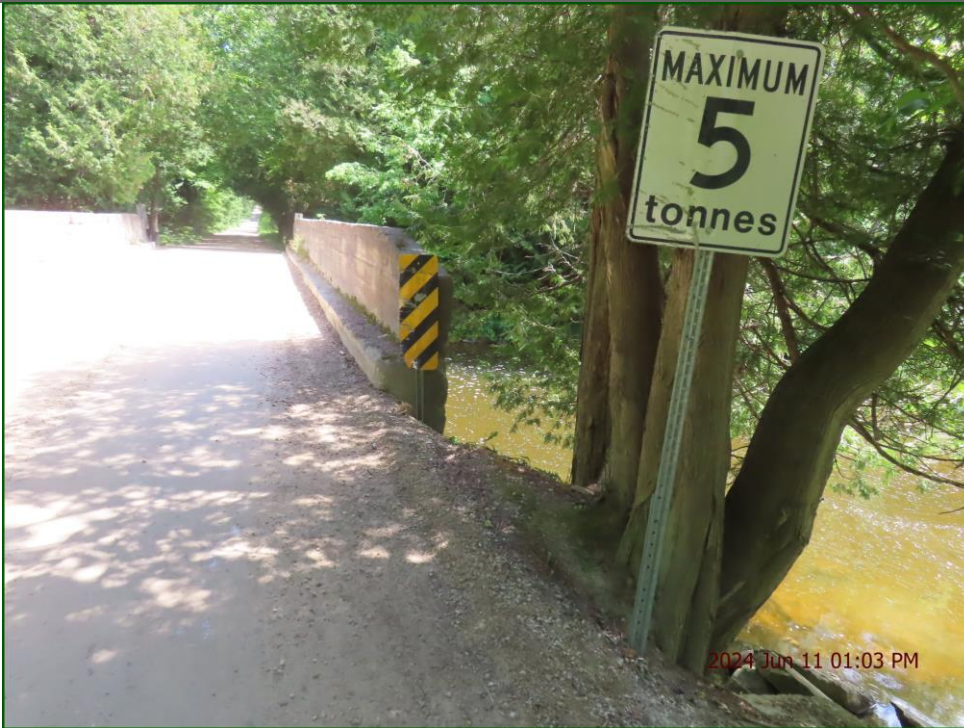
Very steep embankments, recommend approach protection.

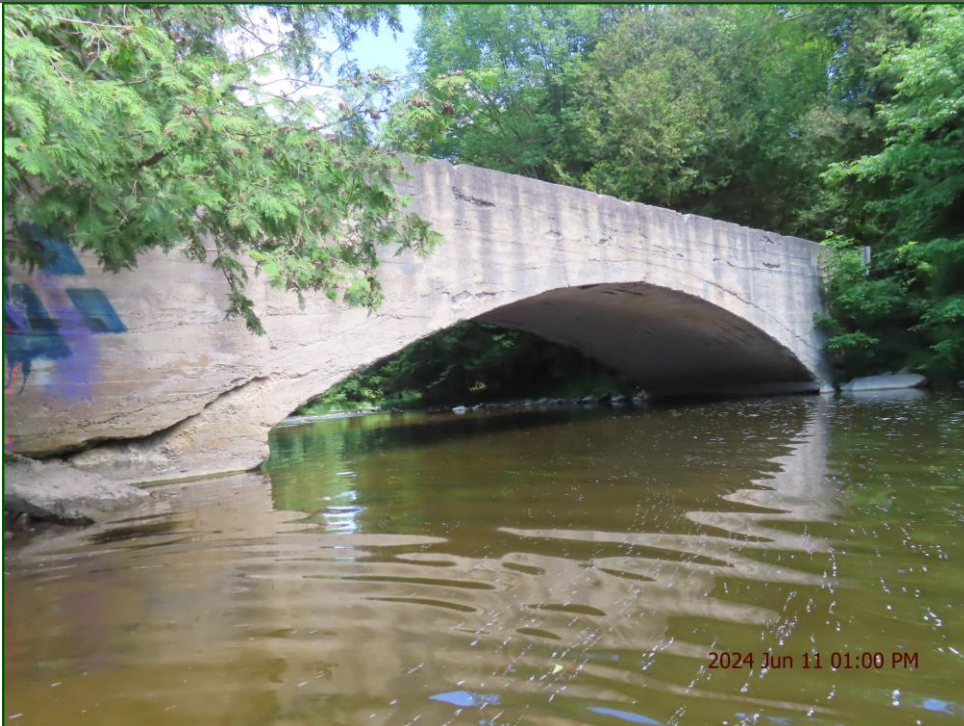
Severe spalling and disintegration throughout.

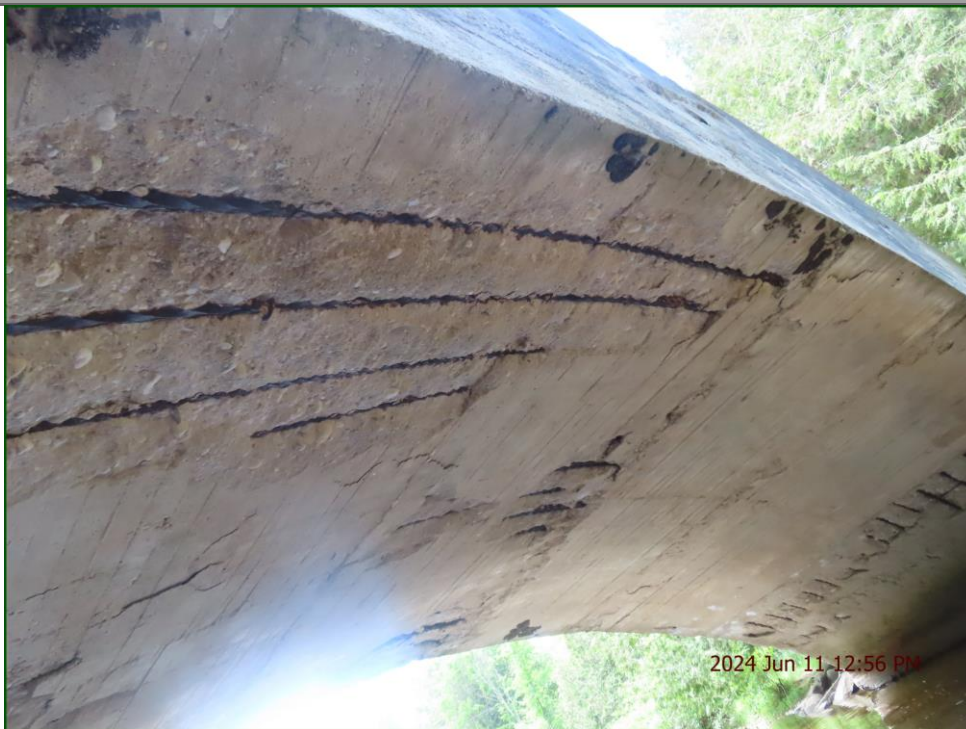
Severe spalling with exposed reinforcing throughout. Severe scouring and disintegration at waterline at both ends, under water. Scouring around waterline beginning to undermine structure.

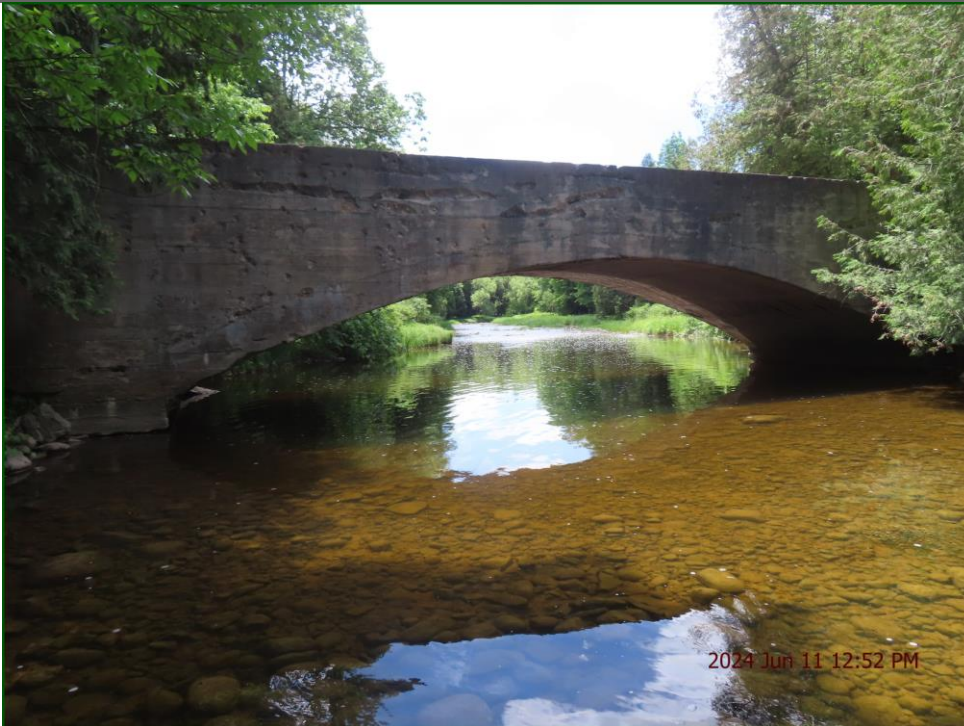
Severe spalling and disintegration throughout. Severe scouring at waterline resulting in undermined structure, partially under water.

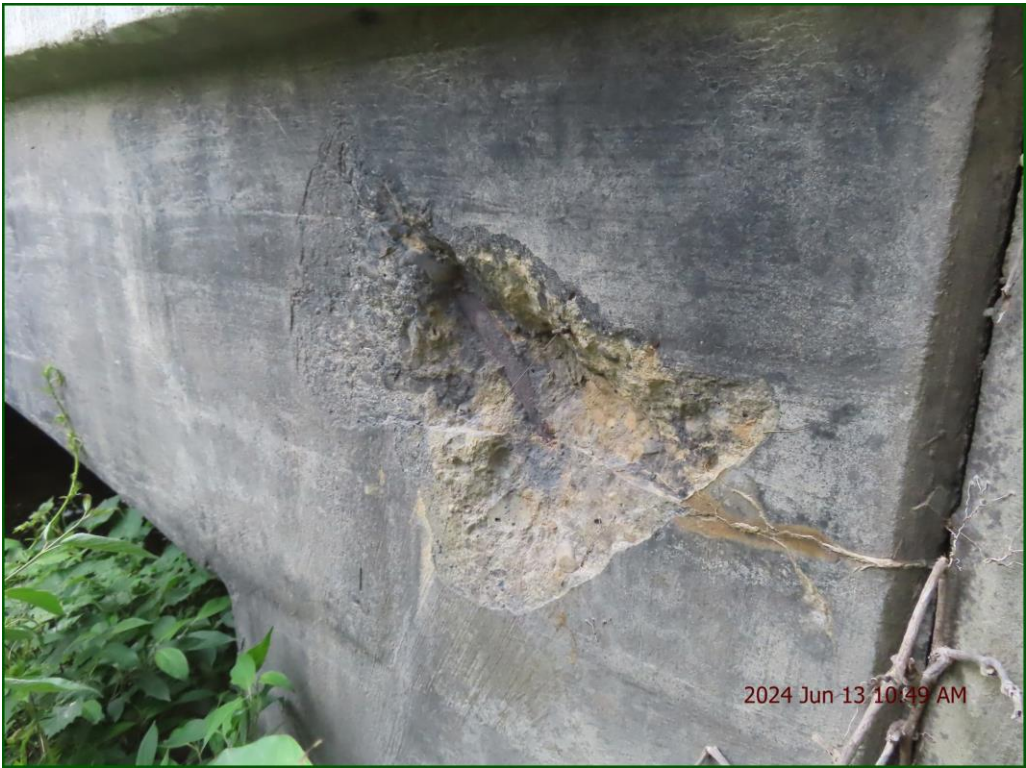
Description: Wingwalls: Large localized spall with exposed reinforcing at SE quadrant.

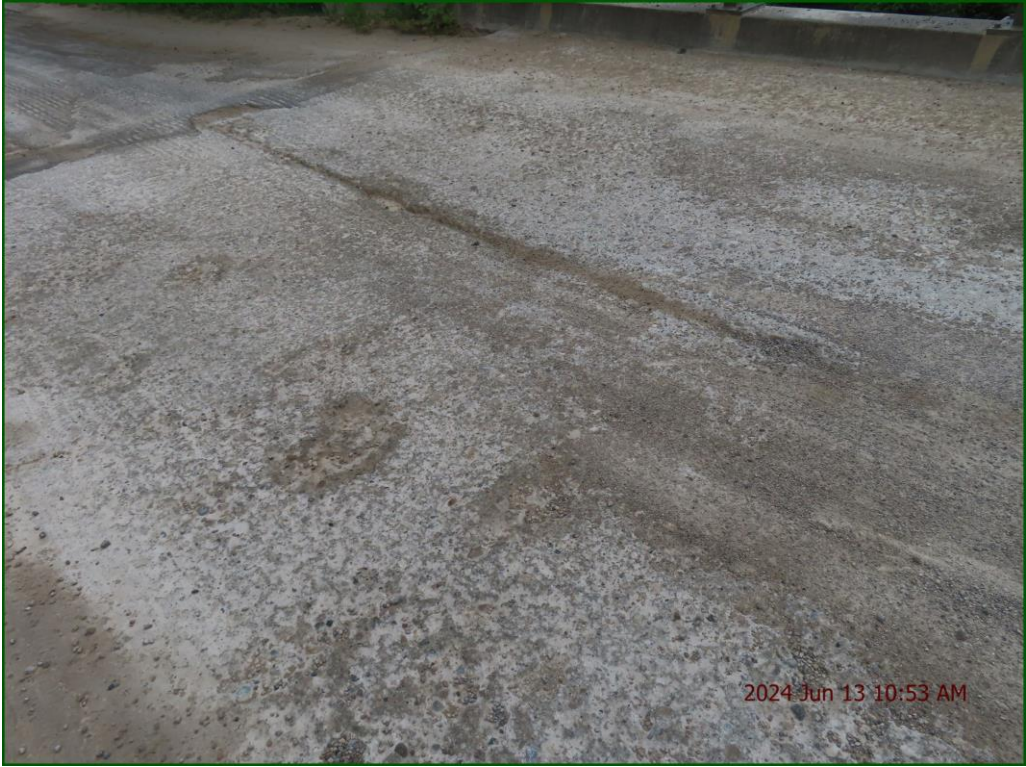
Description: Wearing surface: Moderate potholes throughout.

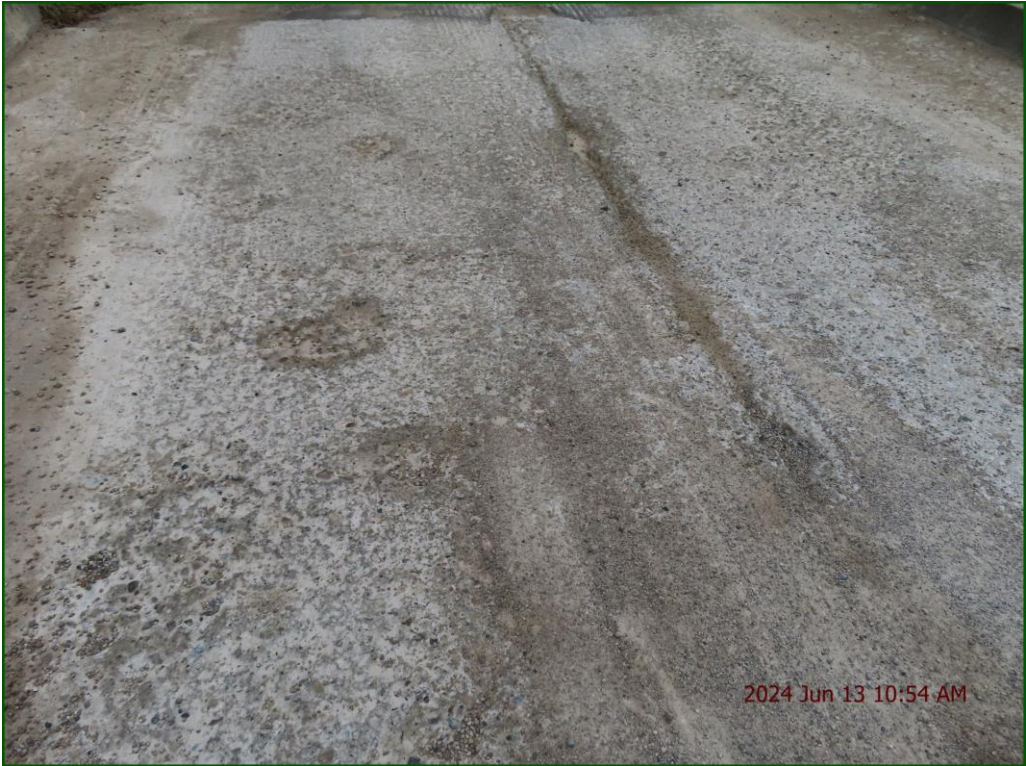
Description: Deck top: Light to medium spalling throughout.

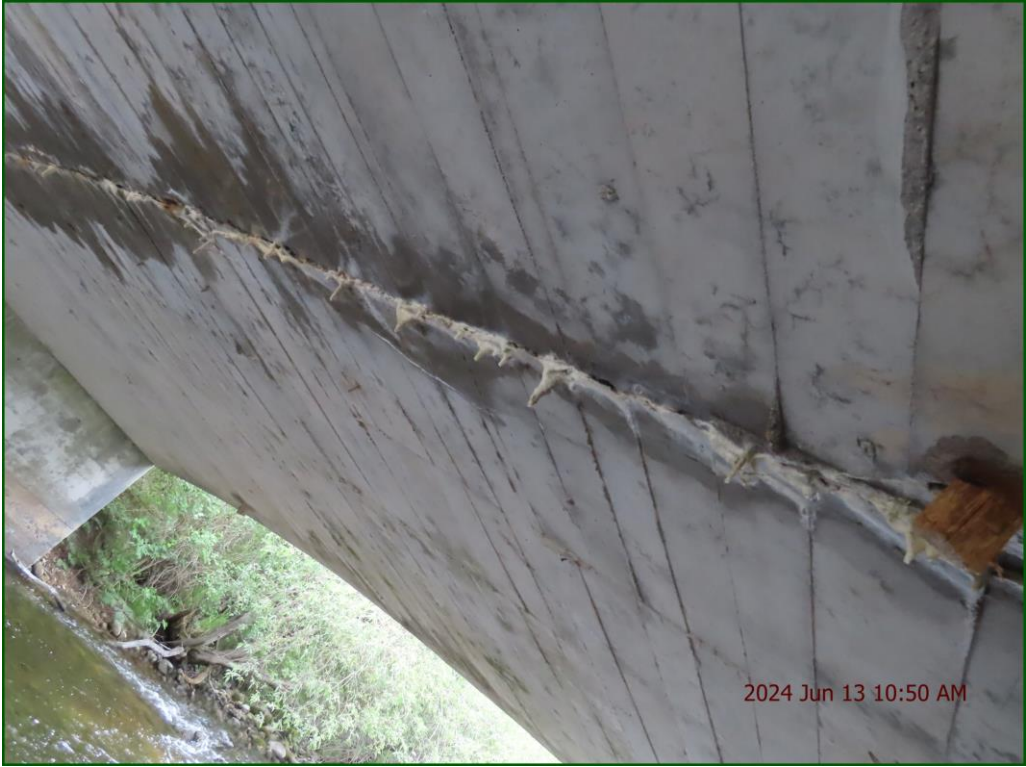
Description: Soffit (int): Medium longitudinal cracking with leachate staining and stalactite.

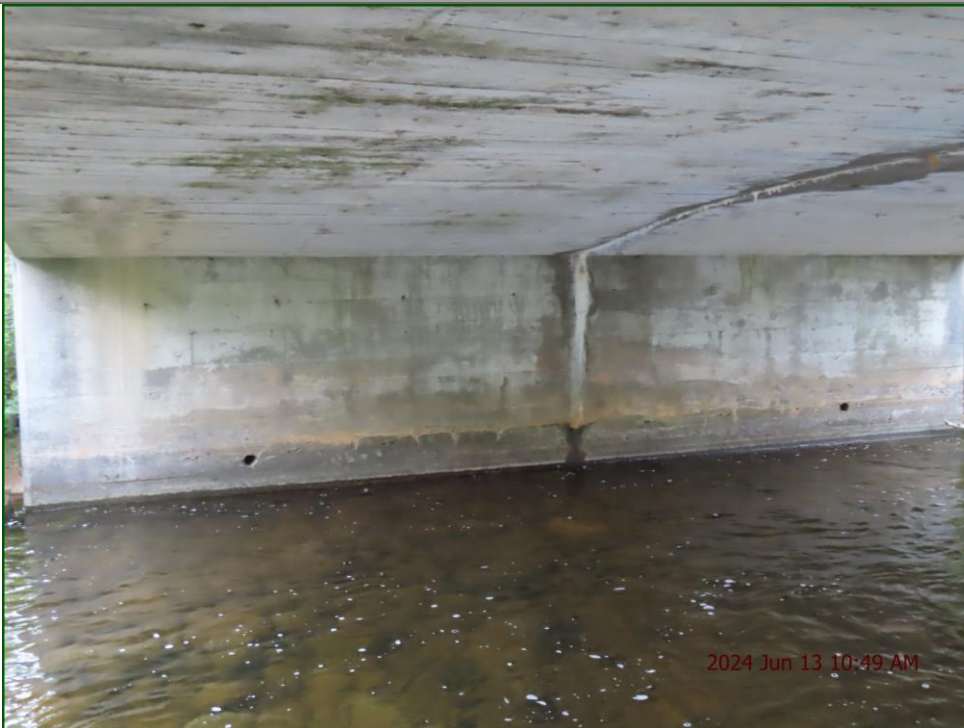
Light to medium vertical cracking with leachate staining.

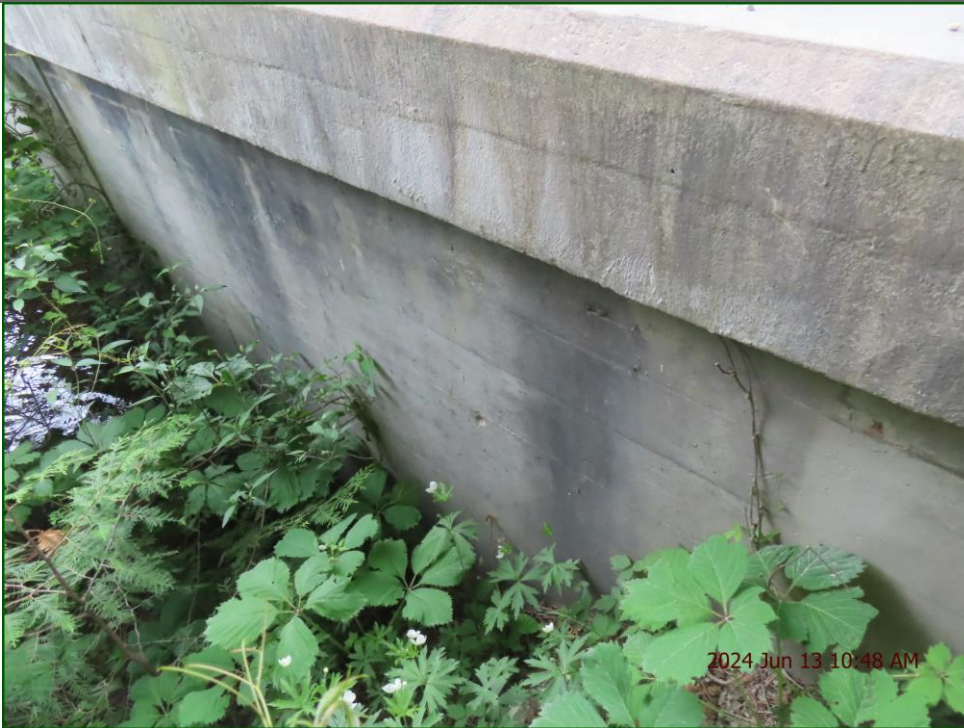
Large localized spall with exposed reinforcing at SE quadrant.

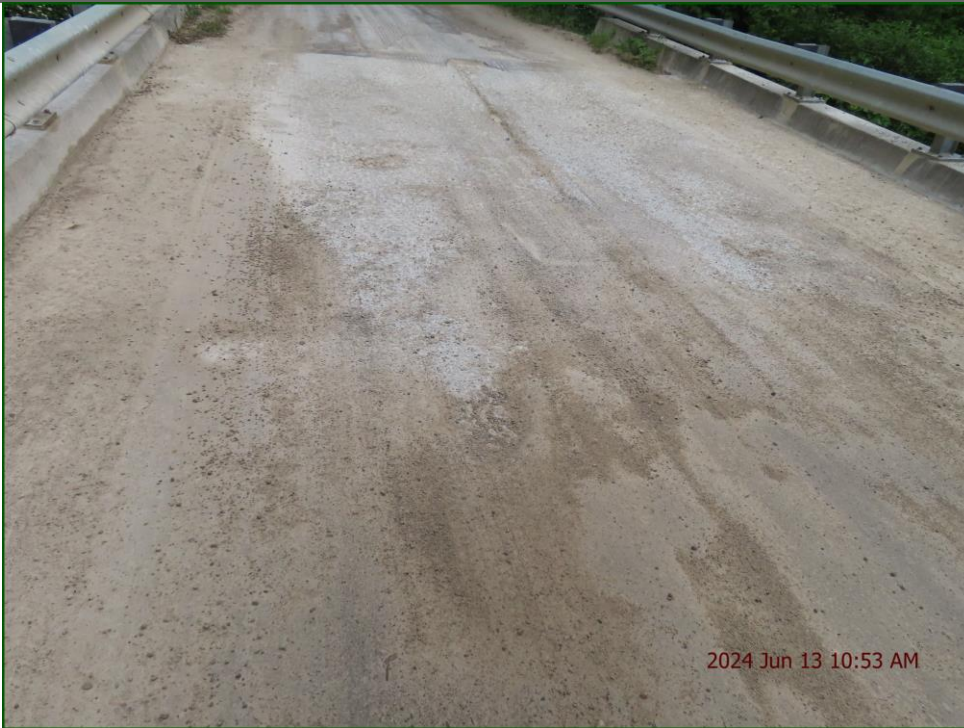
Moderate potholes throughout.

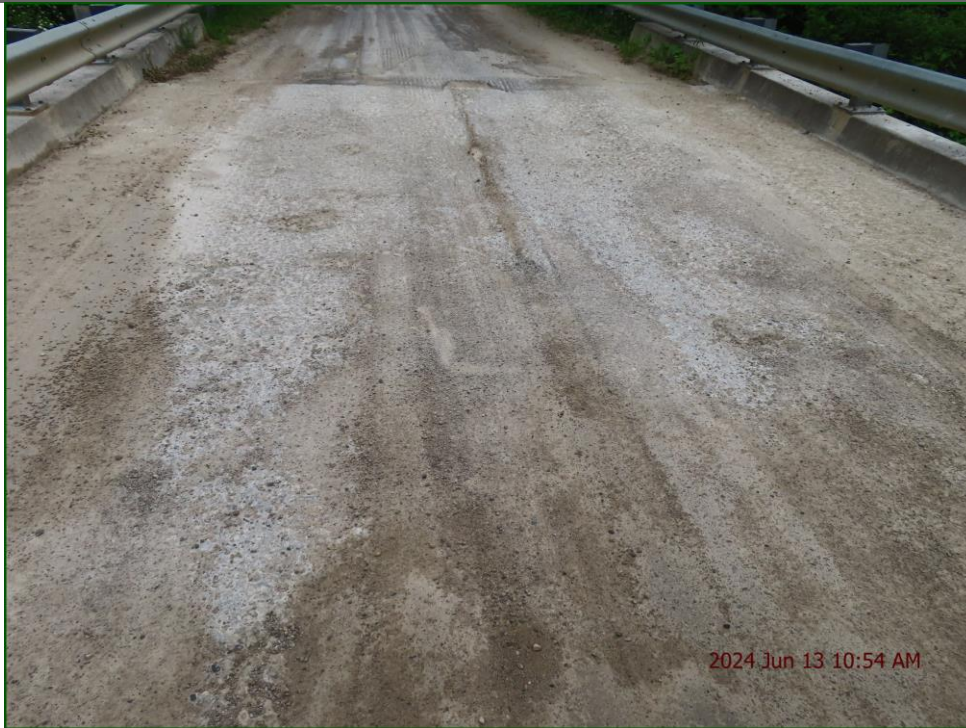
Light to medium spalling throughout.

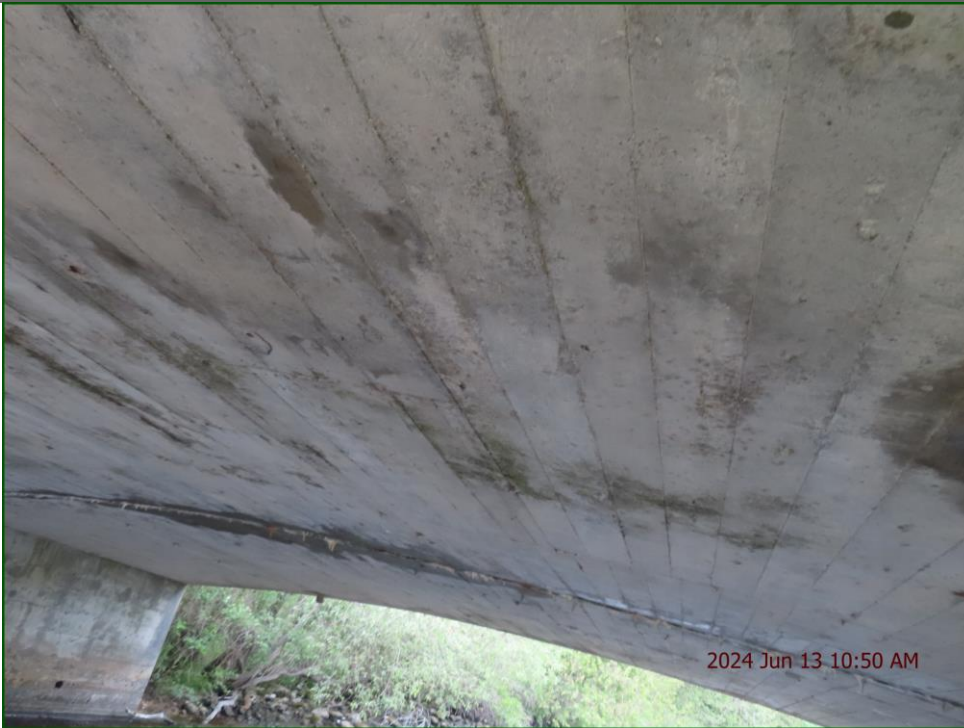
Medium longitudinal cracking with leachate staining and stalactite at construction joint.

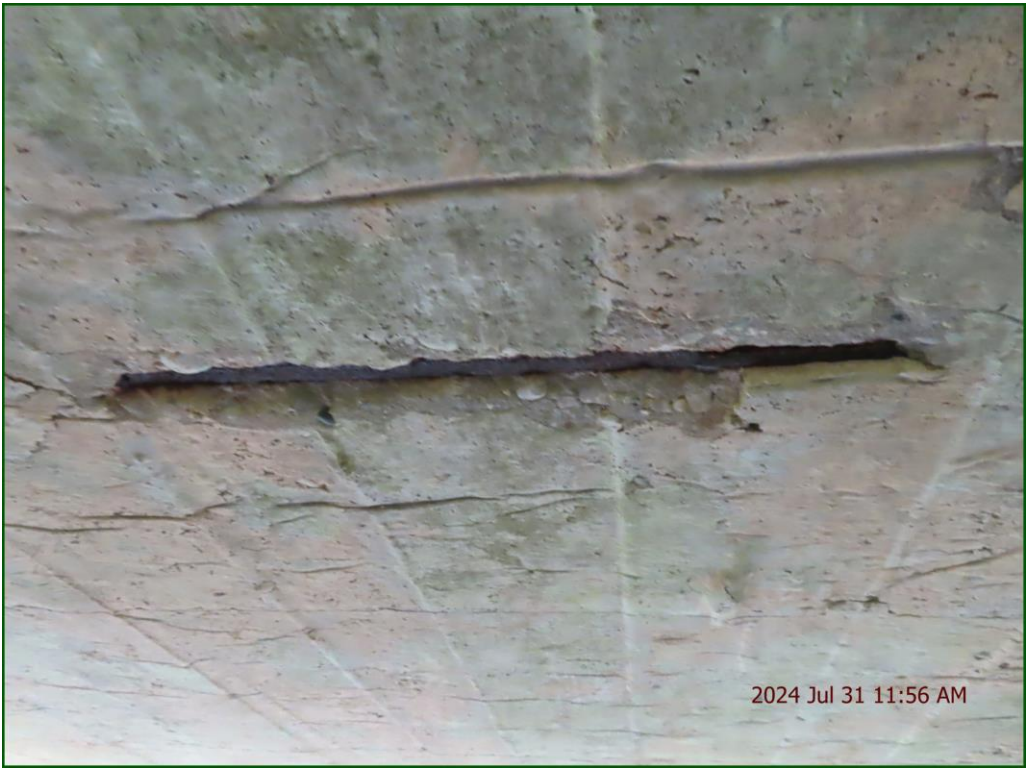
Description: Barrel: Severe delamination with exposed reinforcing.

Moderate delamination. Severe delamination with exposed reinforcing.

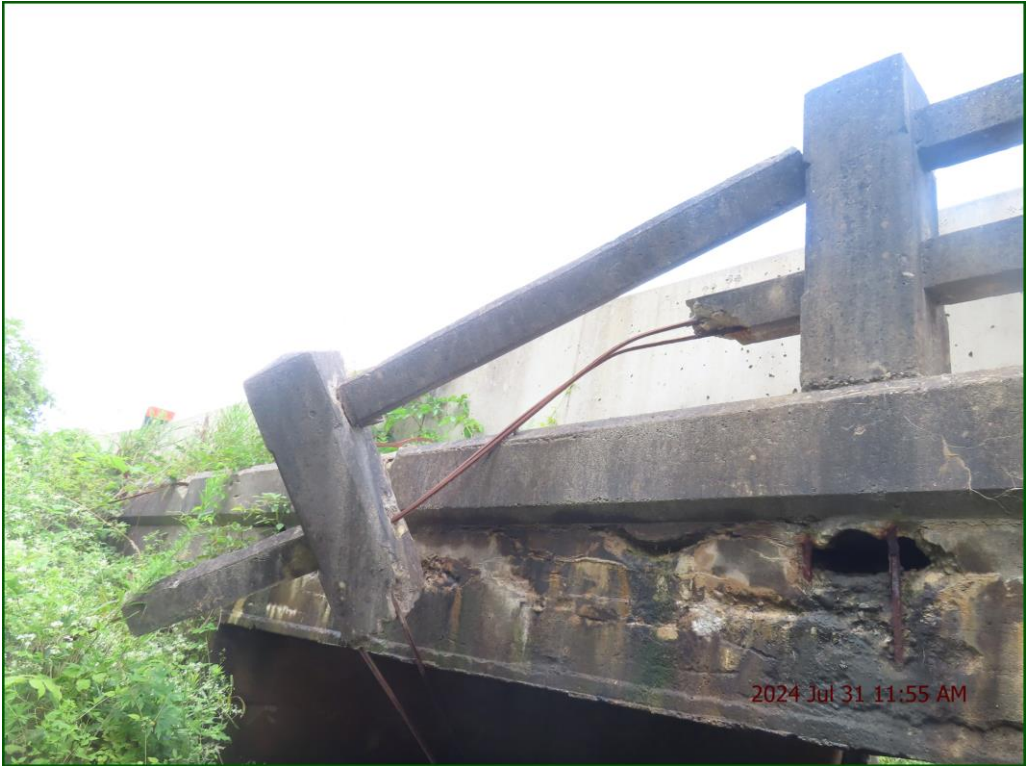
Description: Barrier/Parapet walls: Existing cast in place concrete barrier has failed.

Temporary concrete barrier has replaced existing railing system on both sides. Existing cast in place concrete barrier has failed, temporary concrete barrier in place.

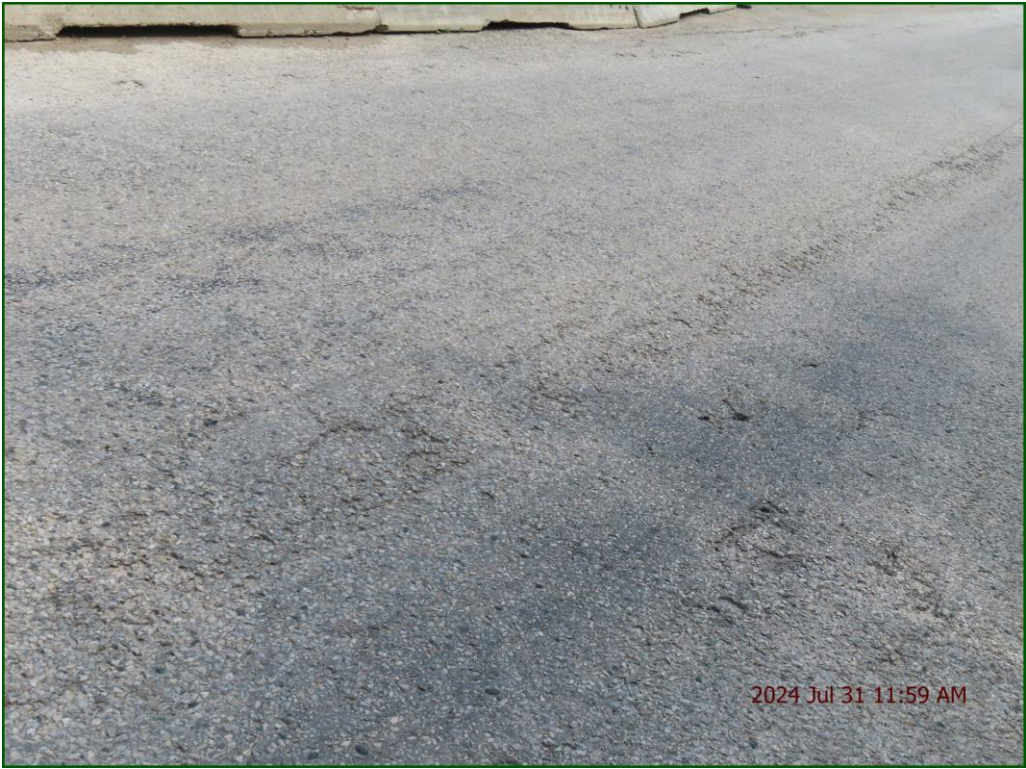
Description: Wearing Surface: Moderate ravelling along curbline.

Moderate ravelling along curblines. Medium to wide longitudinal cracking.

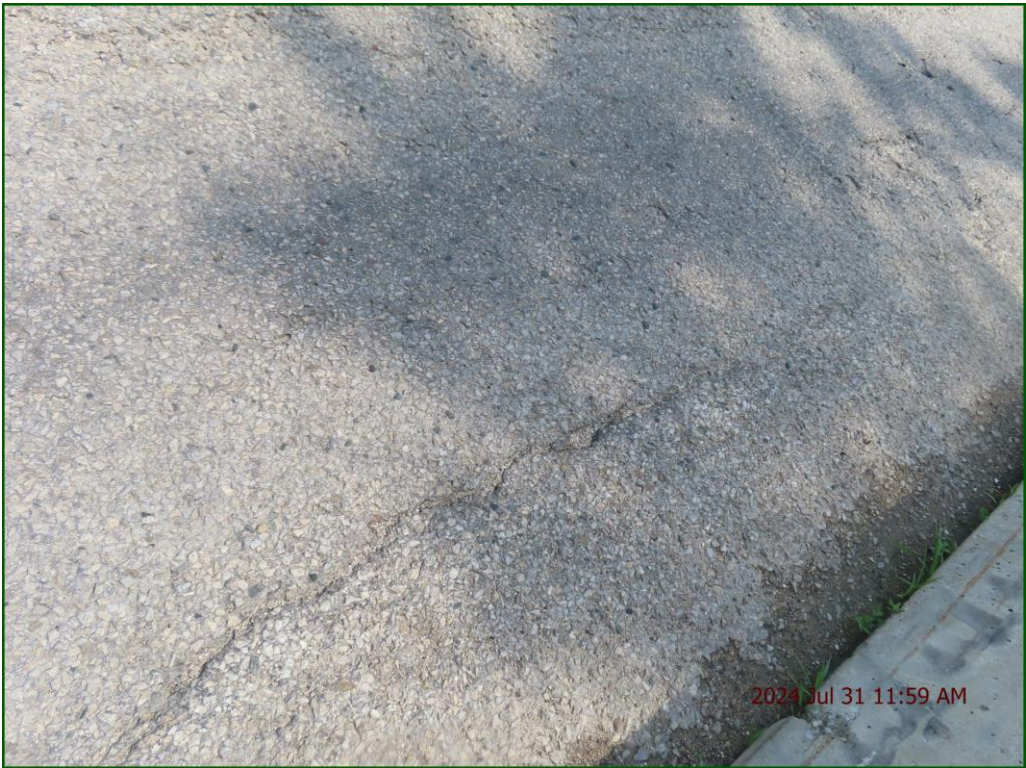
Description: Wearing Surface: Medium to wide longitudinal cracking.

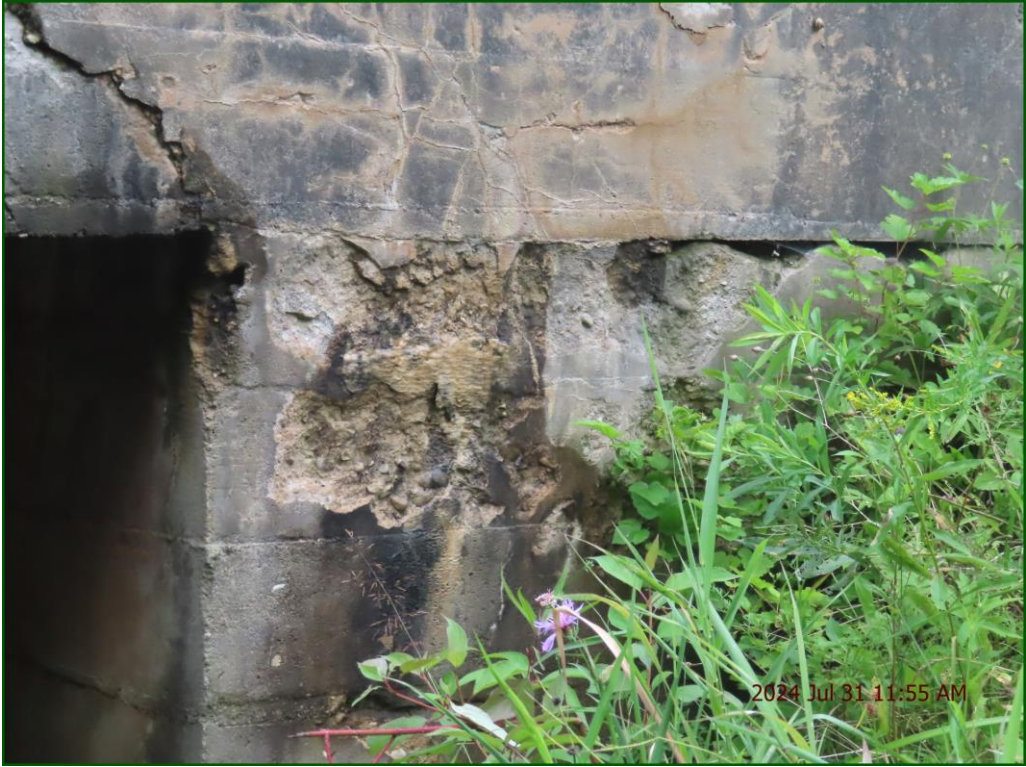
Description: Outlet: Severe delamination and disintegration.

Severe delamination and disintegration. Medium to wide cracking with leachate staining.

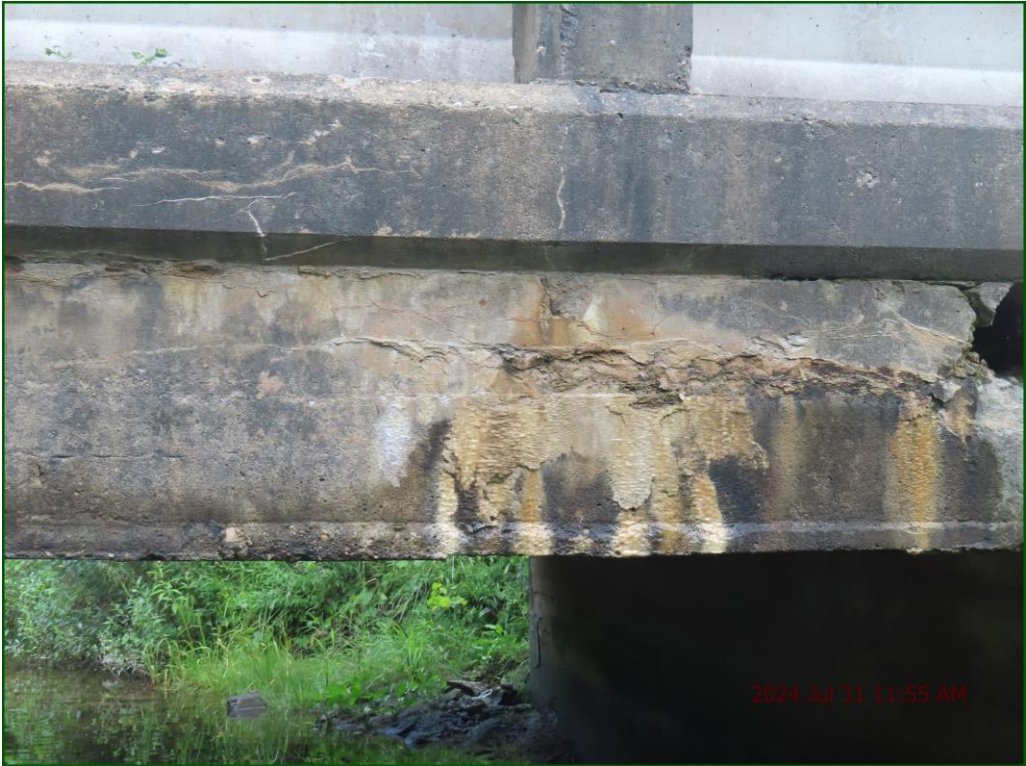
Description: Outlet: Medium to wide cracking with leachate staining.

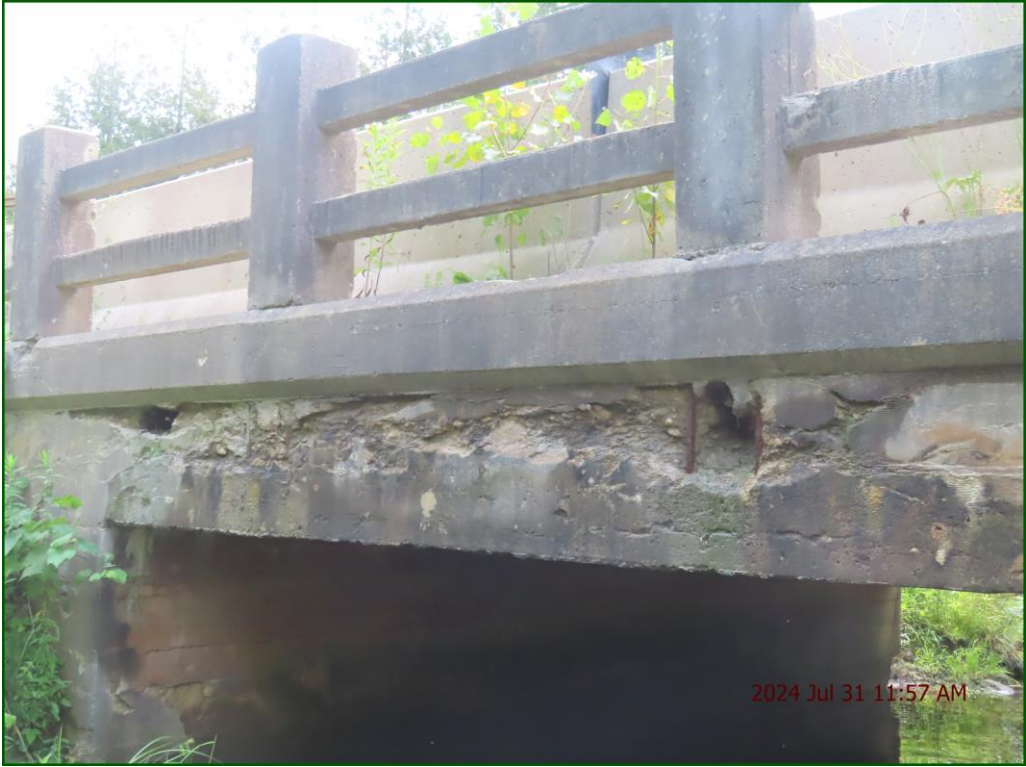
Description: Inlet: Severe spalling and disintegration with exposed reinforcing.

Severe spalling and disintegration with exposed reinforcing.

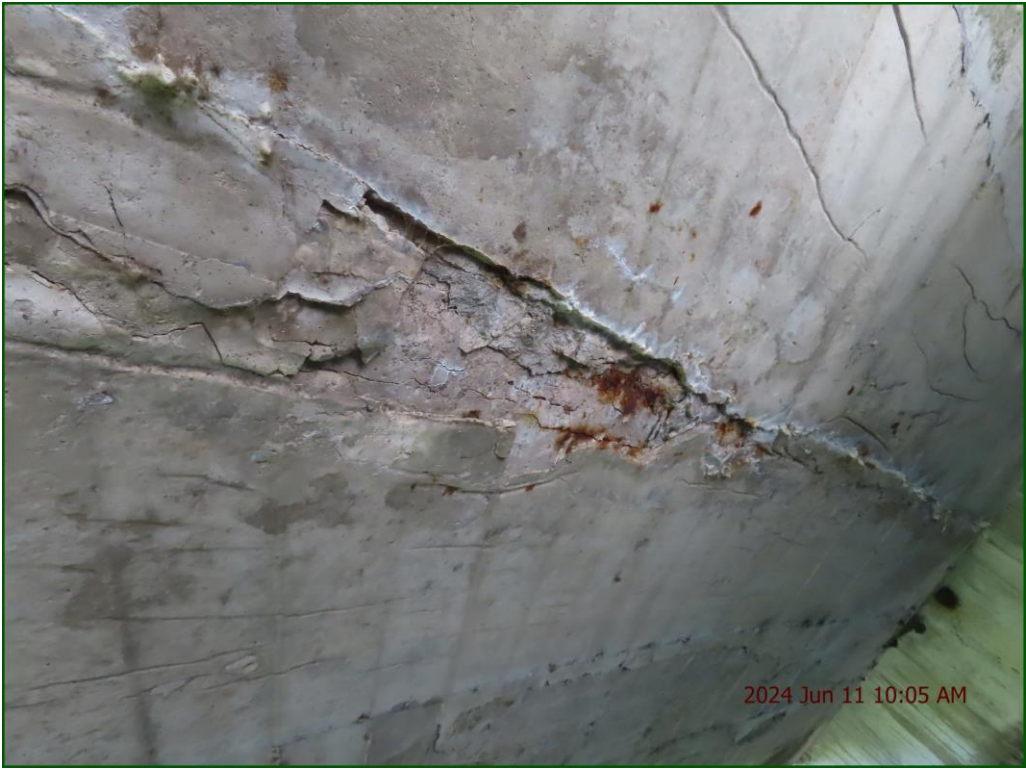
Description: Soffit (int): Severe delamination along construction joints (1/2).

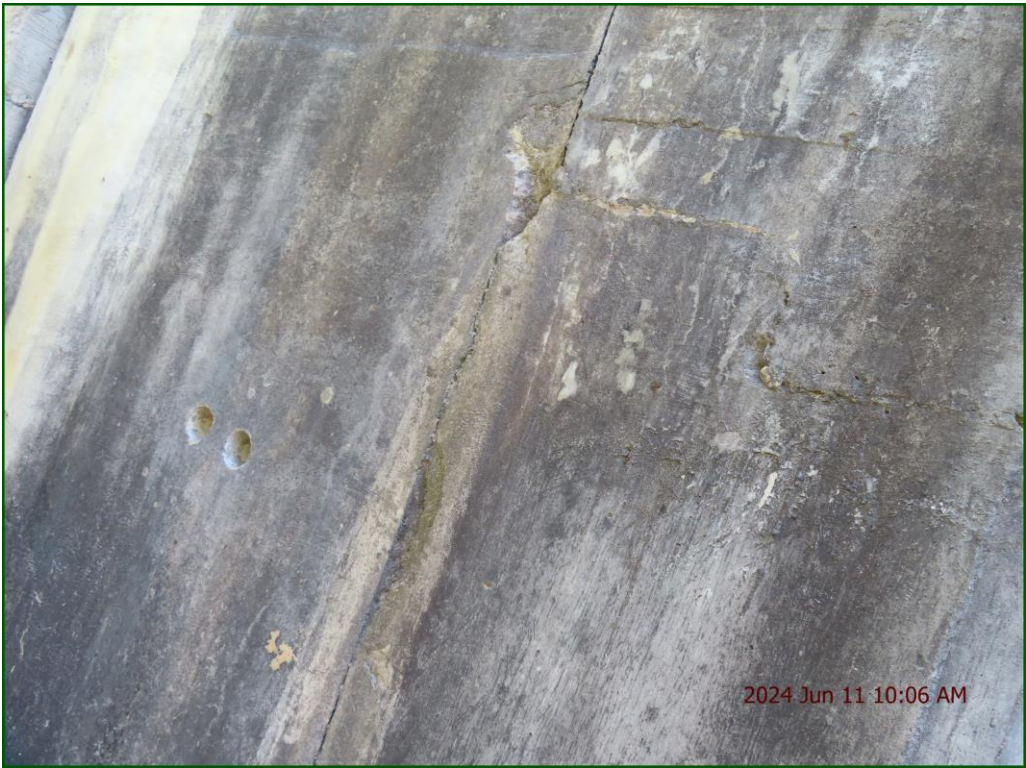
Description: Soffit (int): Severe delamination along construction joints (2/2).

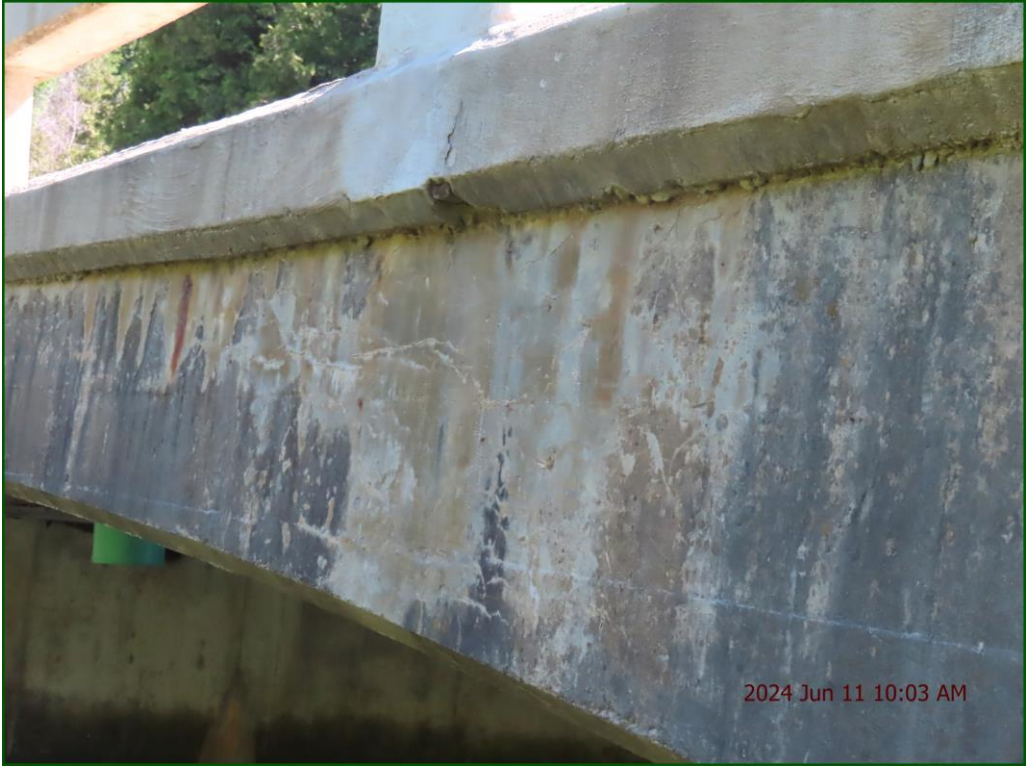
Description: Soffit (ext): Light to medium cracking with leachate staining throughout.

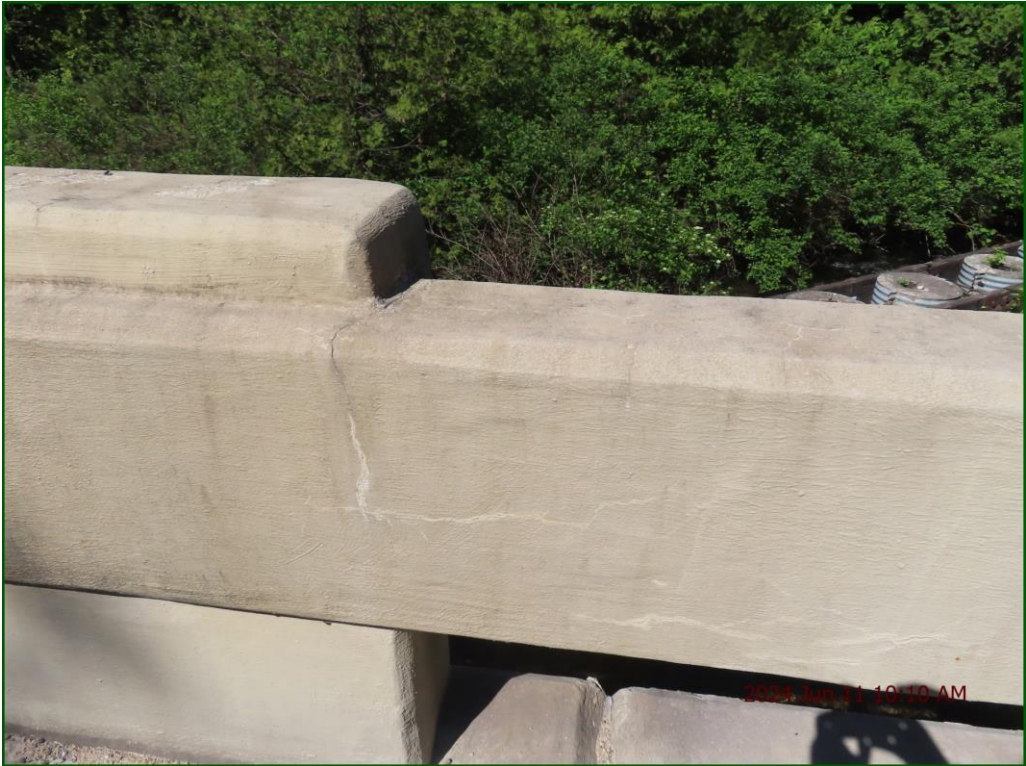
Description: Railing system: Narrow to medium cracking throughout.

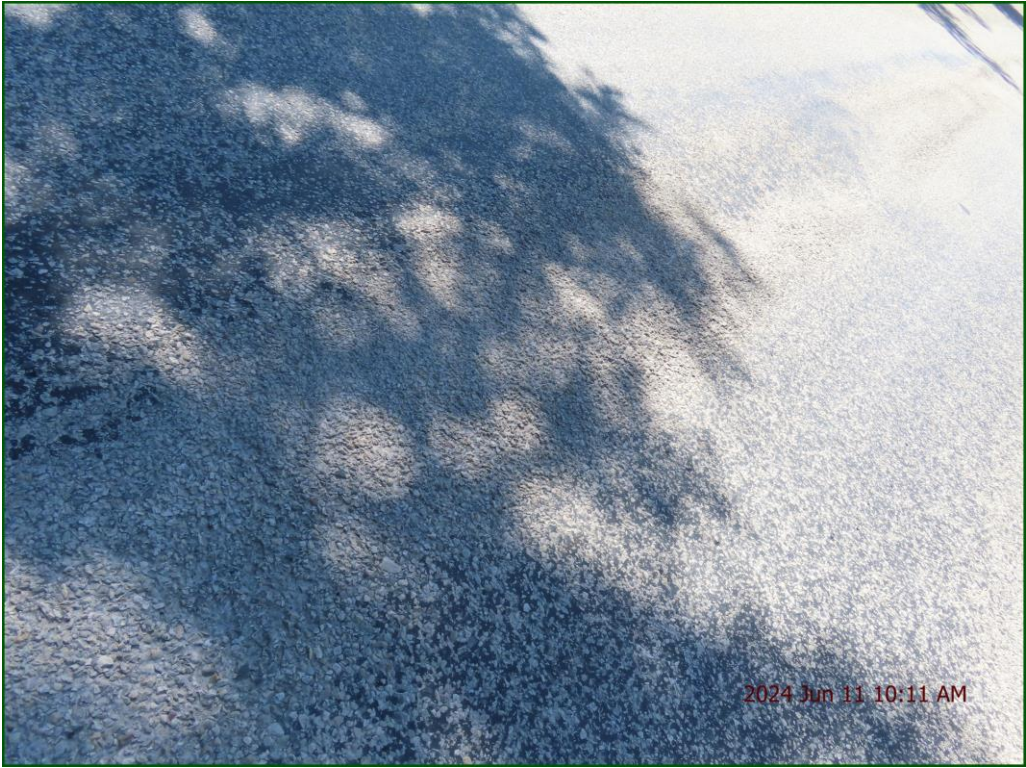
Description: Wearing surface: Severe ravelling along centreline.

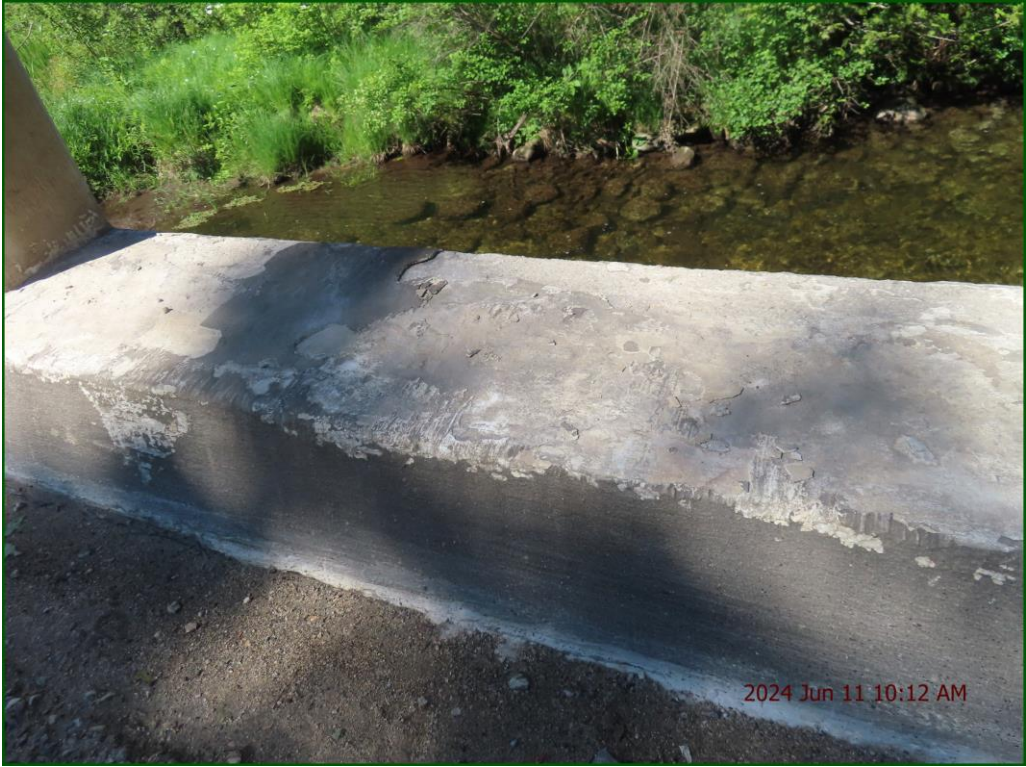
Description: Curbs: Shallow delamination throughout.

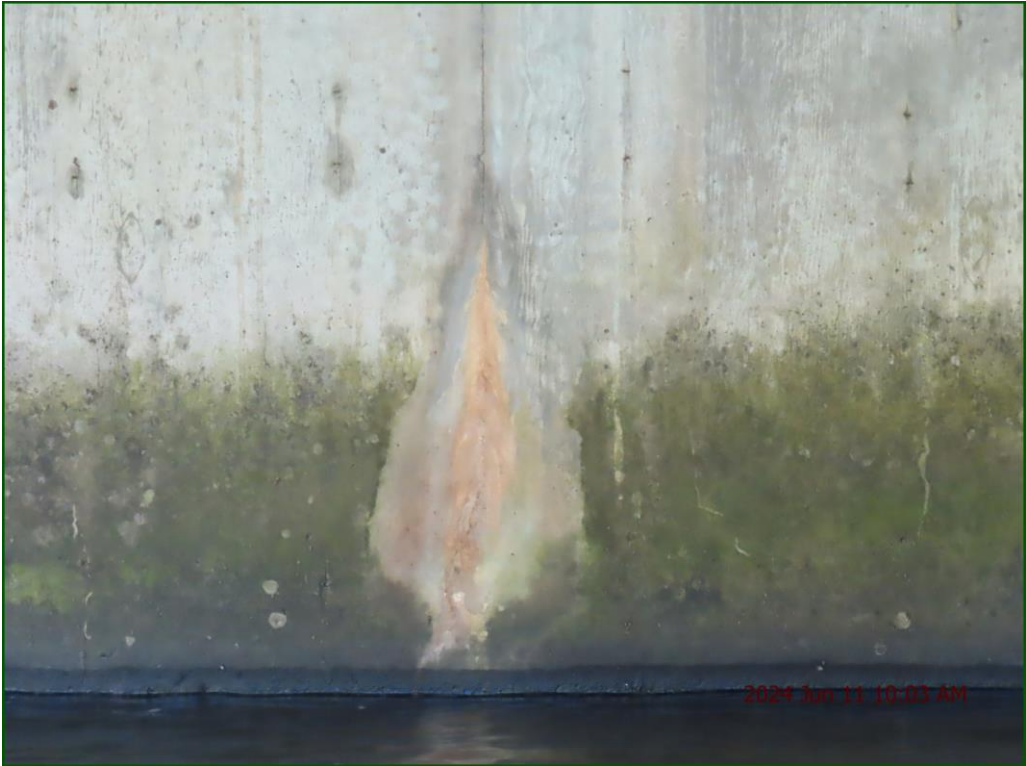
Description: Abutment walls: Medium to wide vertical crack with leachate and wetness staining.

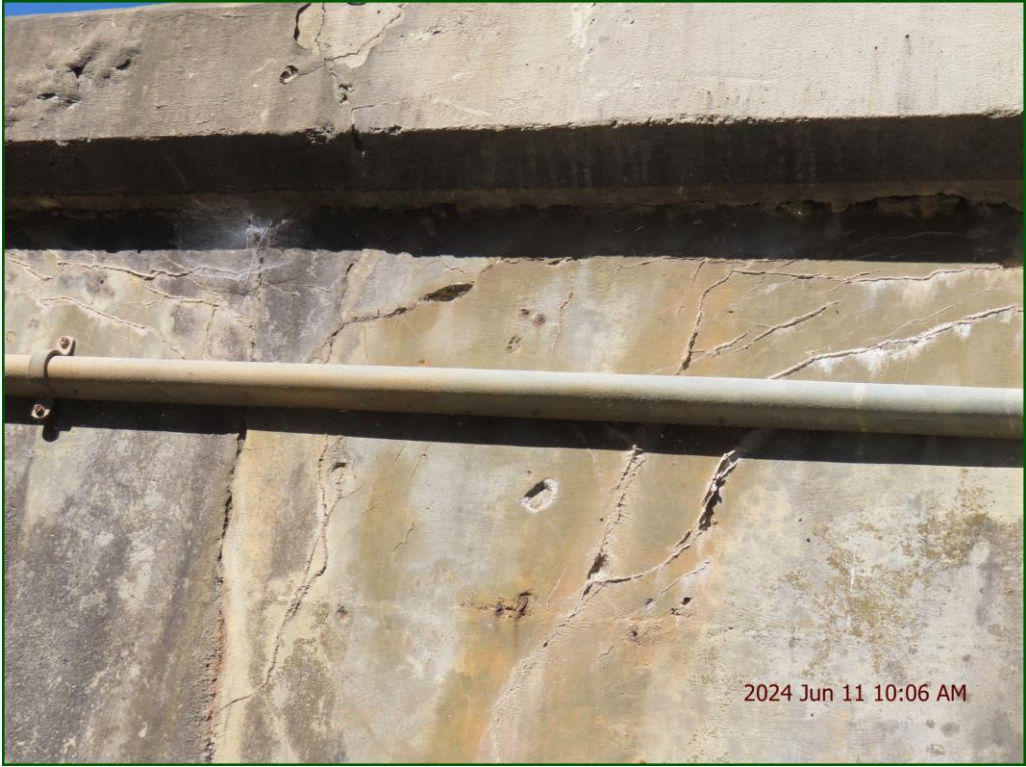
Description: Wingwalls: Medium to wide cracking with leachate staining.
