Element Inspection

Date of Inspection:	31-Jul-24
Name of Inspector:	Andrew Burgess, P.Eng. & Joel Ziegler CET
Equipment Used:	Sounding hammer, measuring equipment, GPS
Weather Conditions:	Sunny
Temperature:	23
Special Notes:	Bridge is in good condition, showing no signs of structural distress.

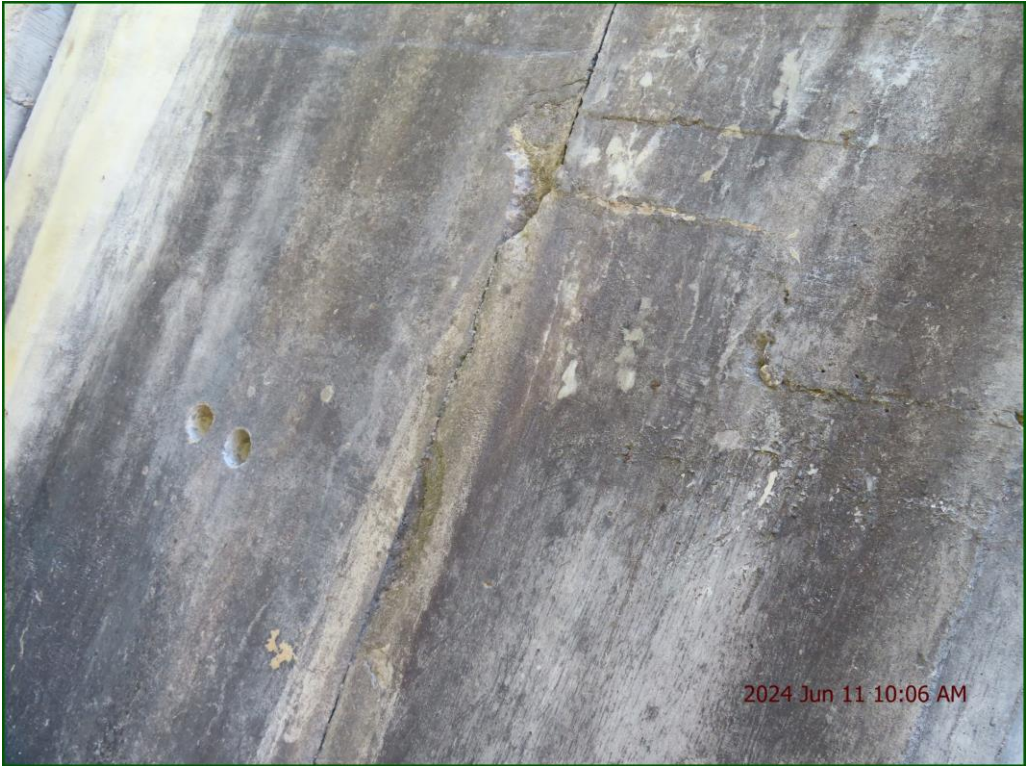
Description: Wingwalls: Minor spalling at construction joint.

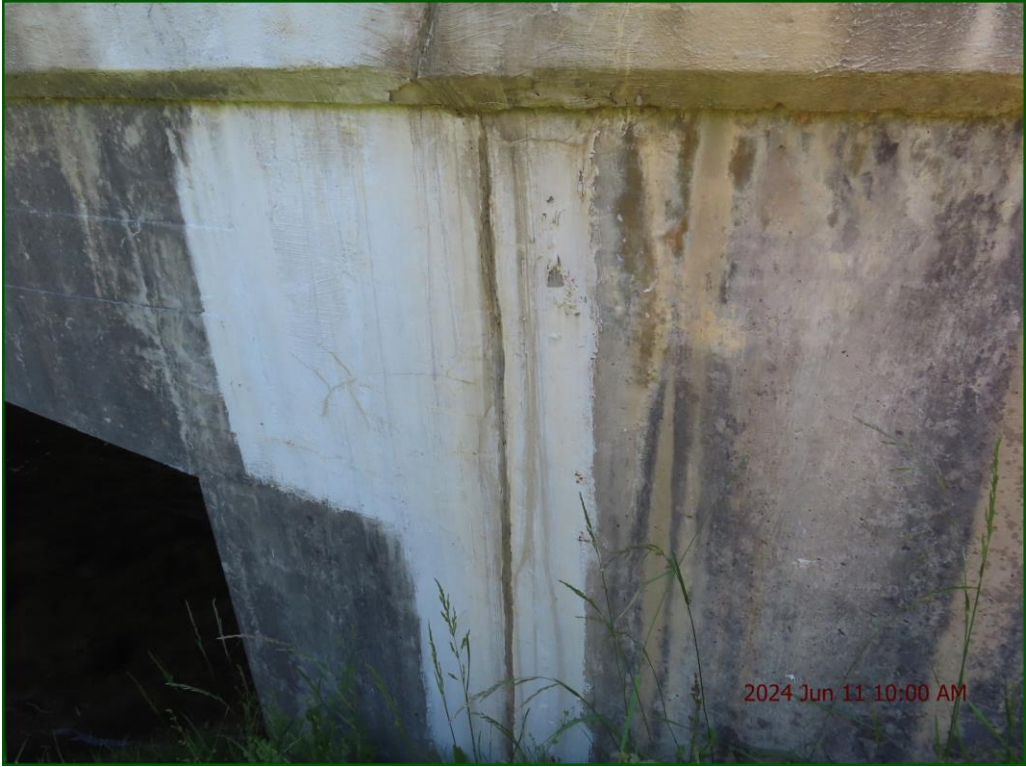
Description: Wingwalls: Patchwork noted.

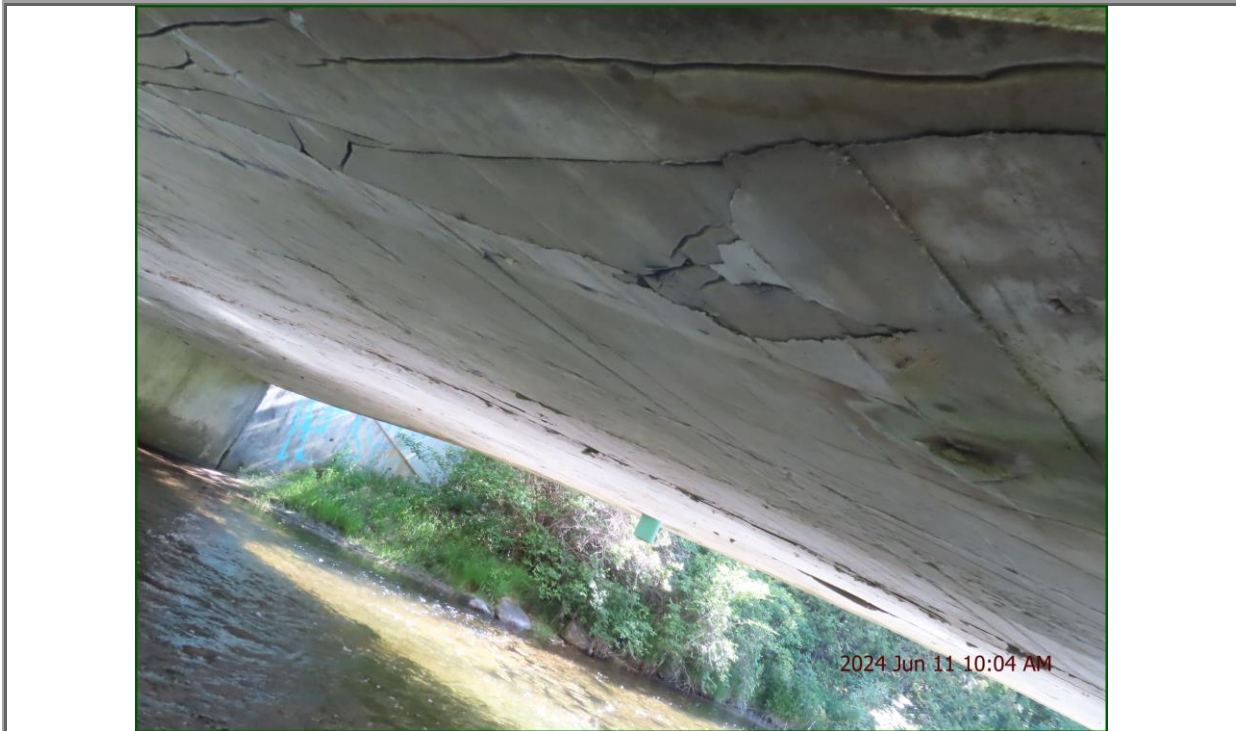
Severe delamination along construction joints.

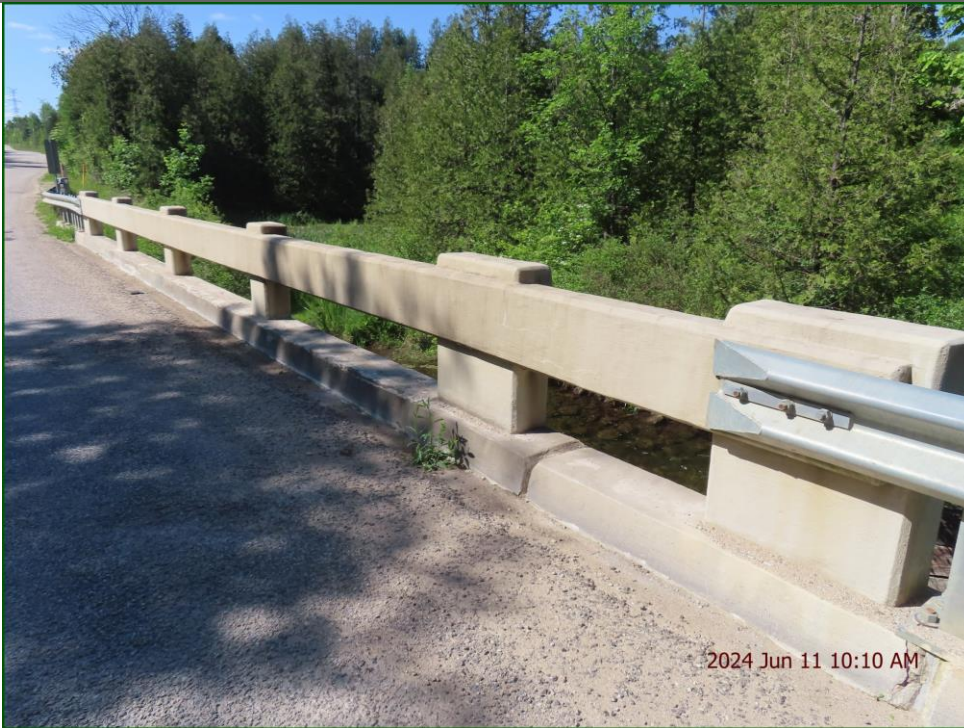
Narrow to medium cracking throughout.

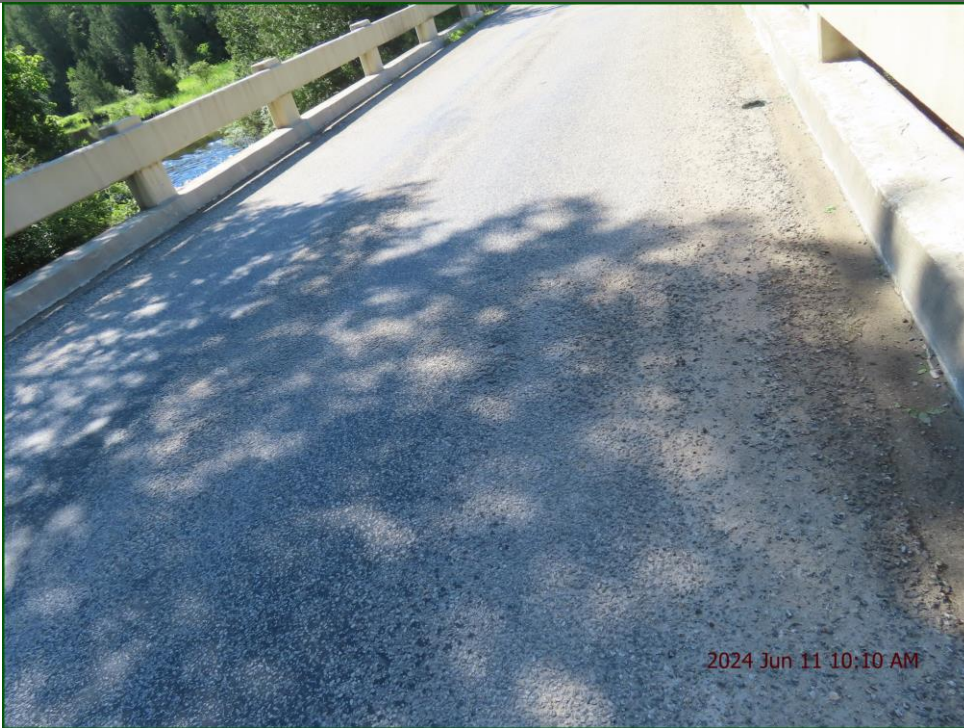
Severe ravelling along centreline.

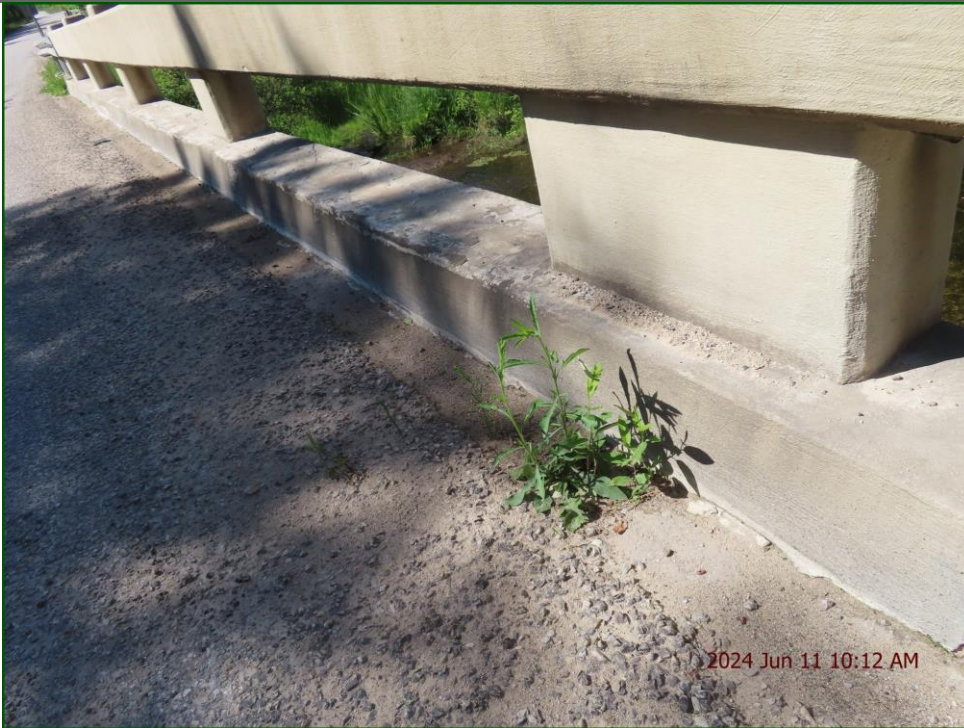
Shallow delamination throughout.

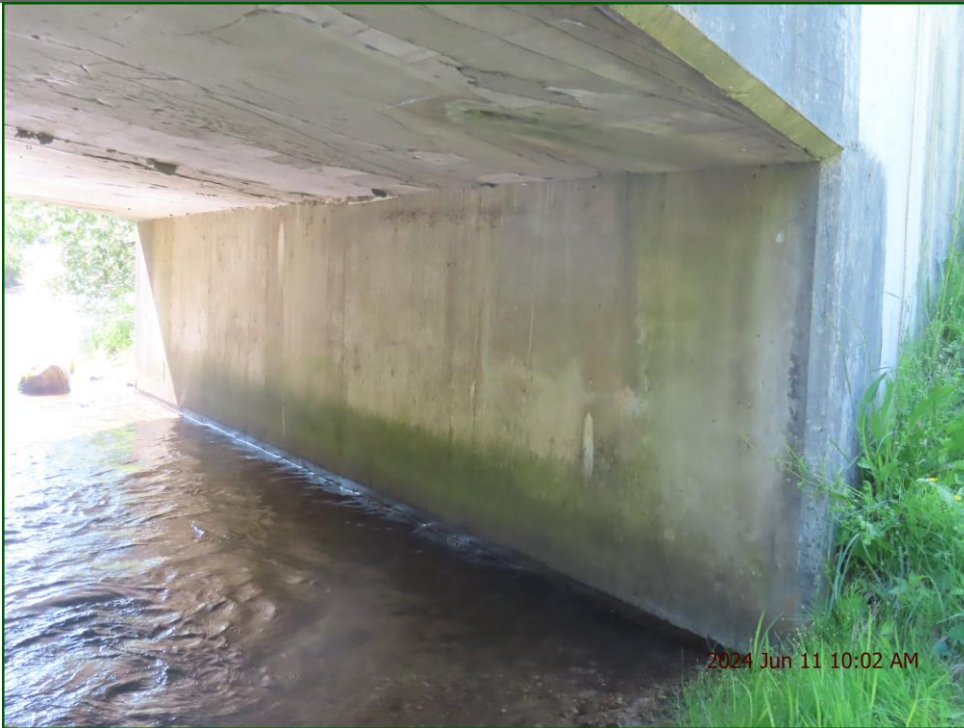
Medium to wide vertical crack with leachate and wetness staining.

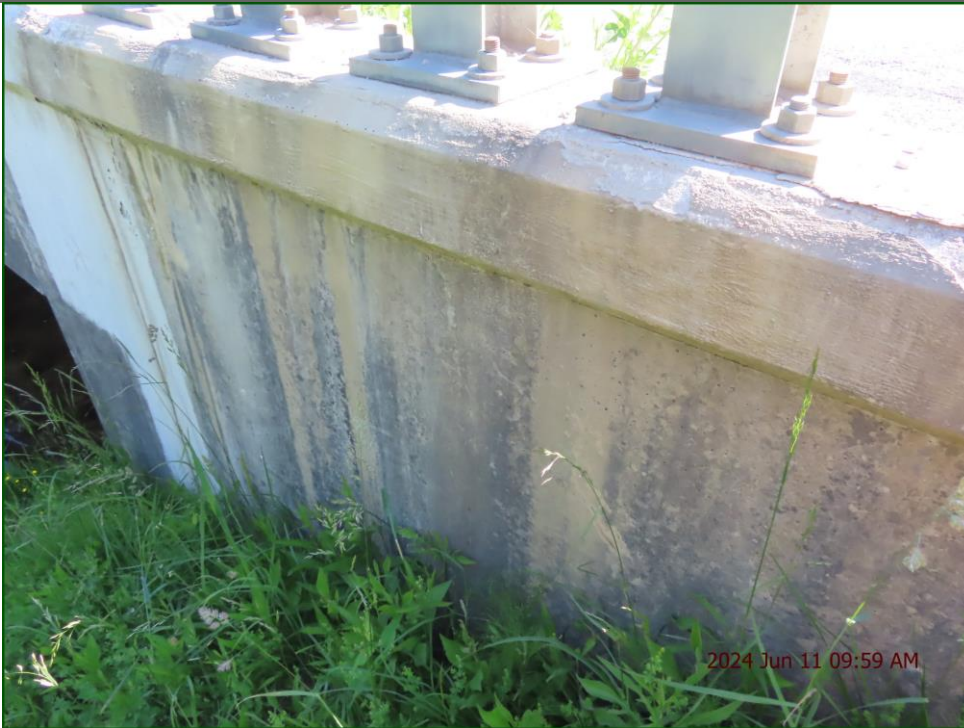
Medium to wide cracking with leachate staining. Minor spalling at construction joint. Patchwork noted.

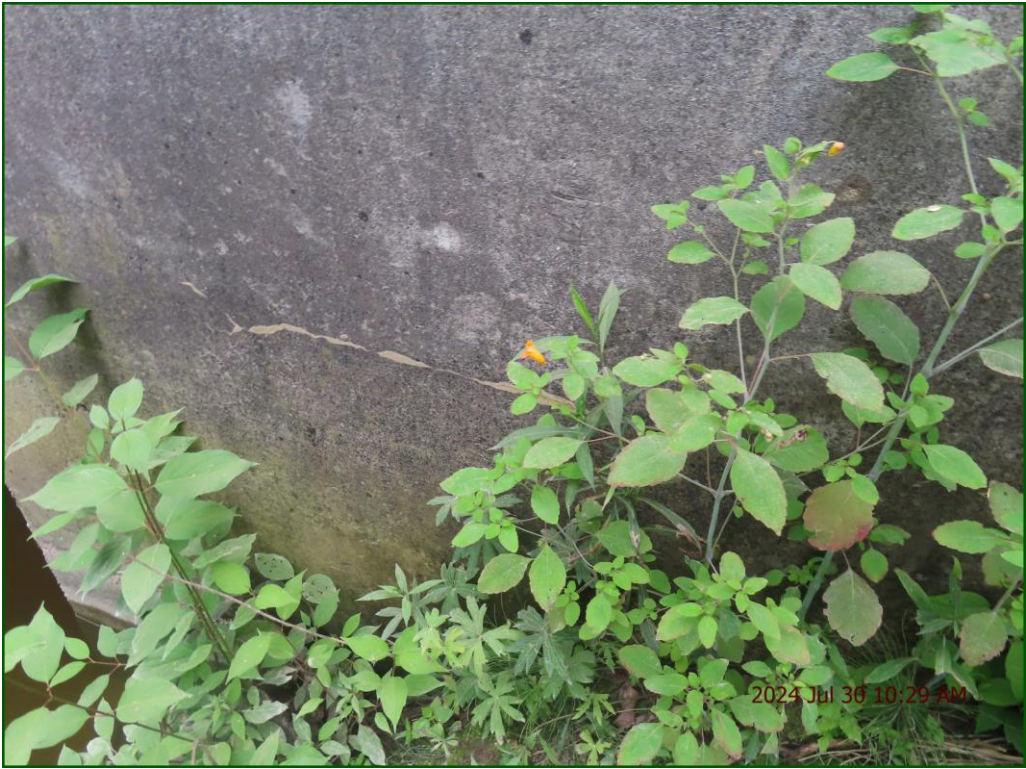
Description: Wingwalls: Light horizontal cracking.

Light horizontal cracking.

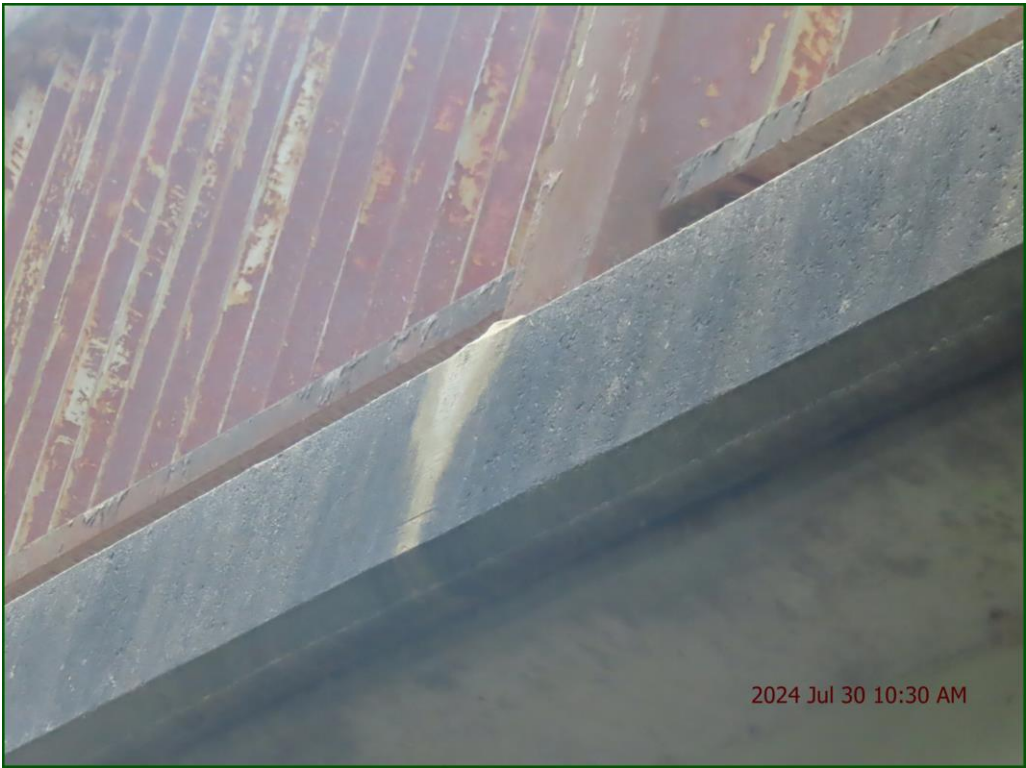
Description: Soffit (ext): Light to medium cracking with leachate staining at posts locations.

Light to medium cracking with leachate staining at posts locations.

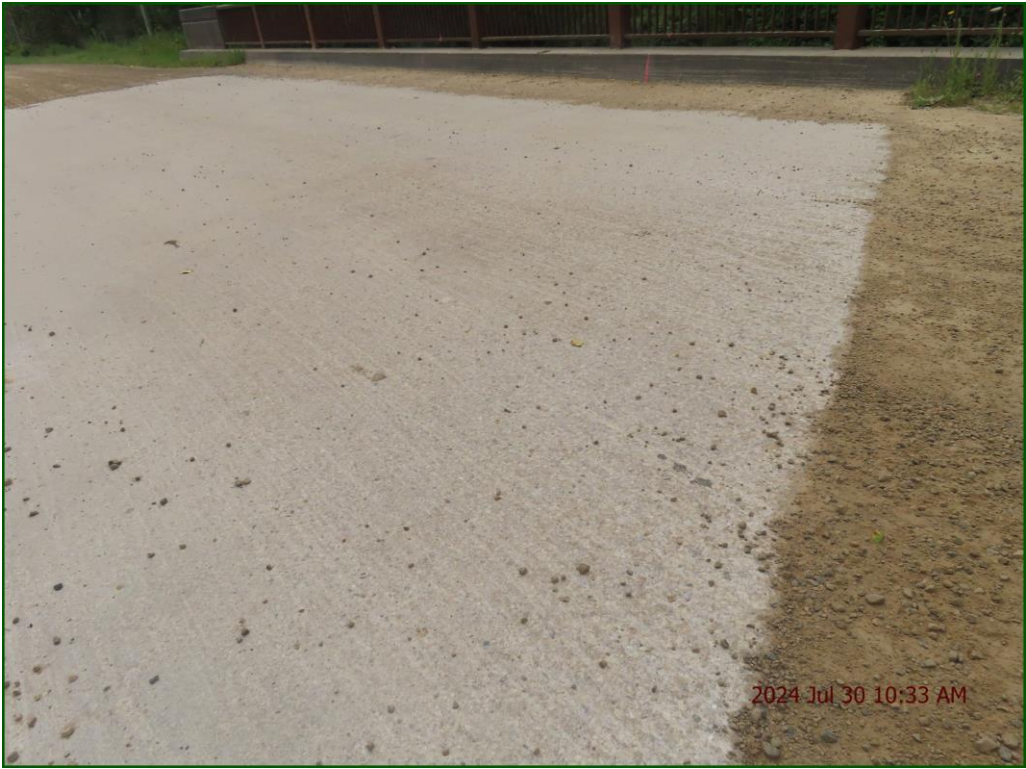
Description: Deck top: Minor abrasains throughout.

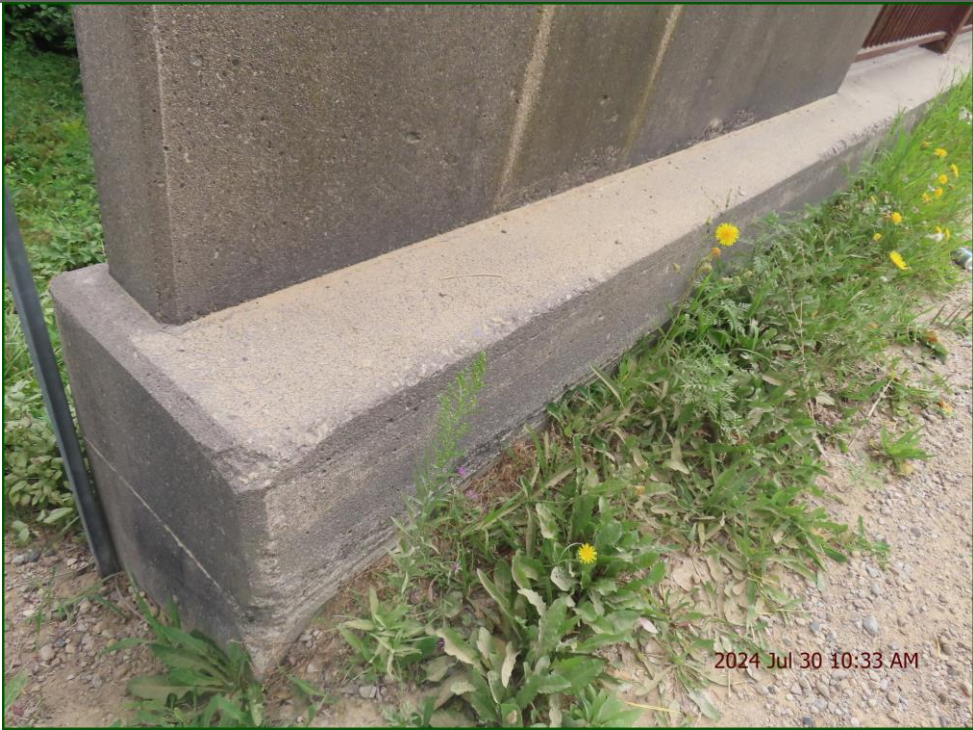
No signs of settlement.

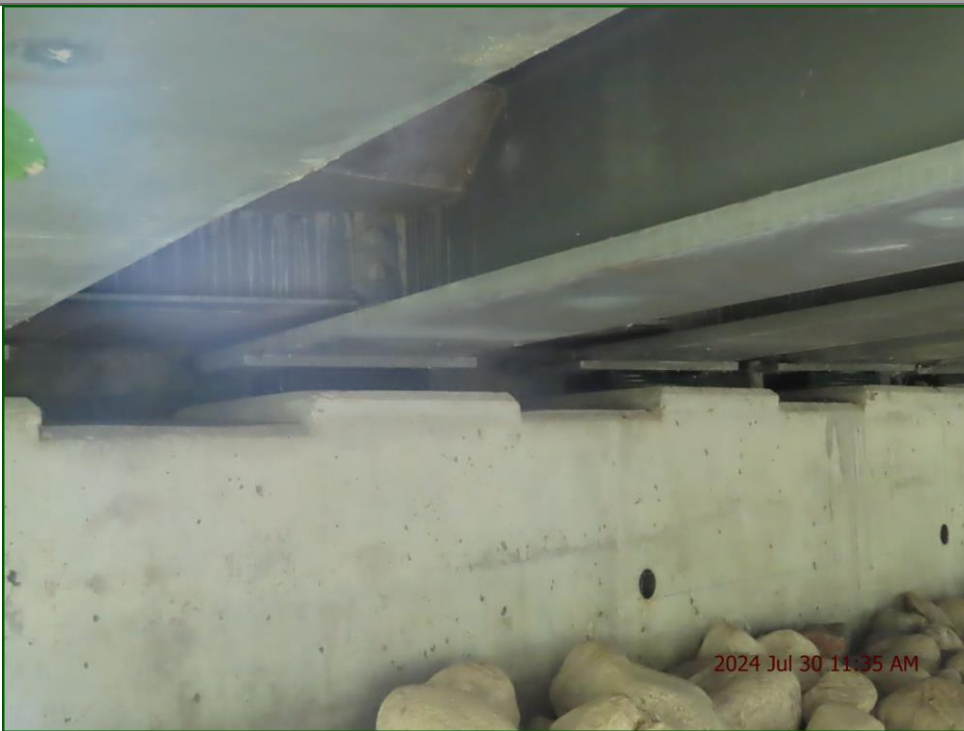
Limited inspection due to diaphragms.

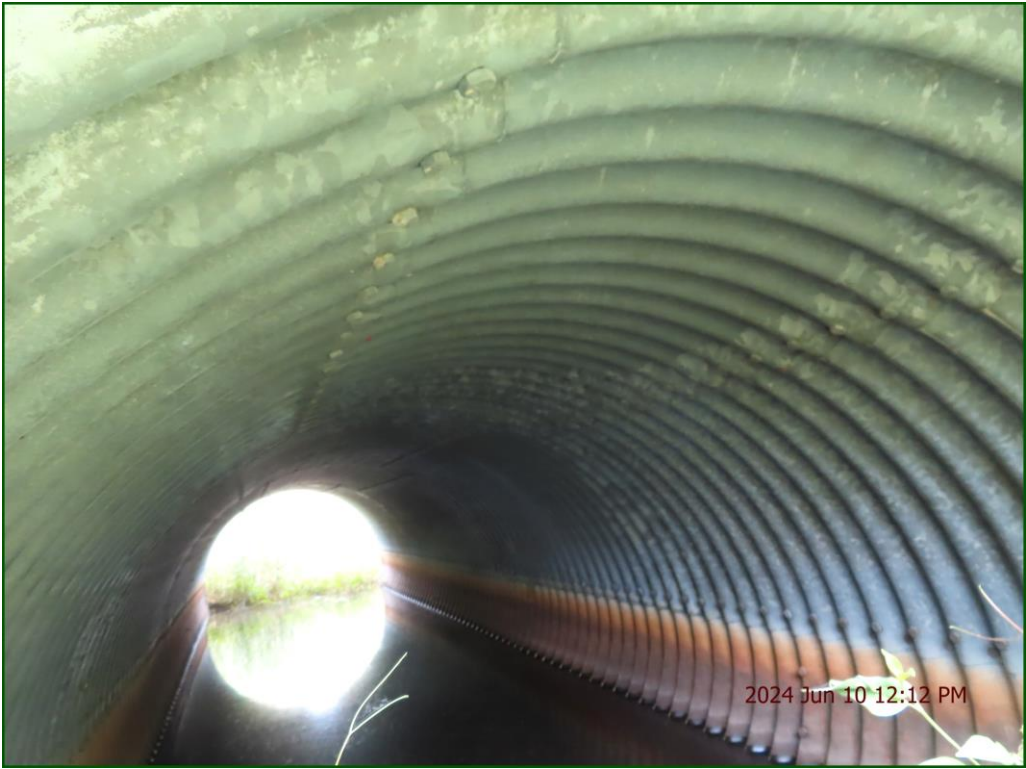
Description: North barrel: View from east.

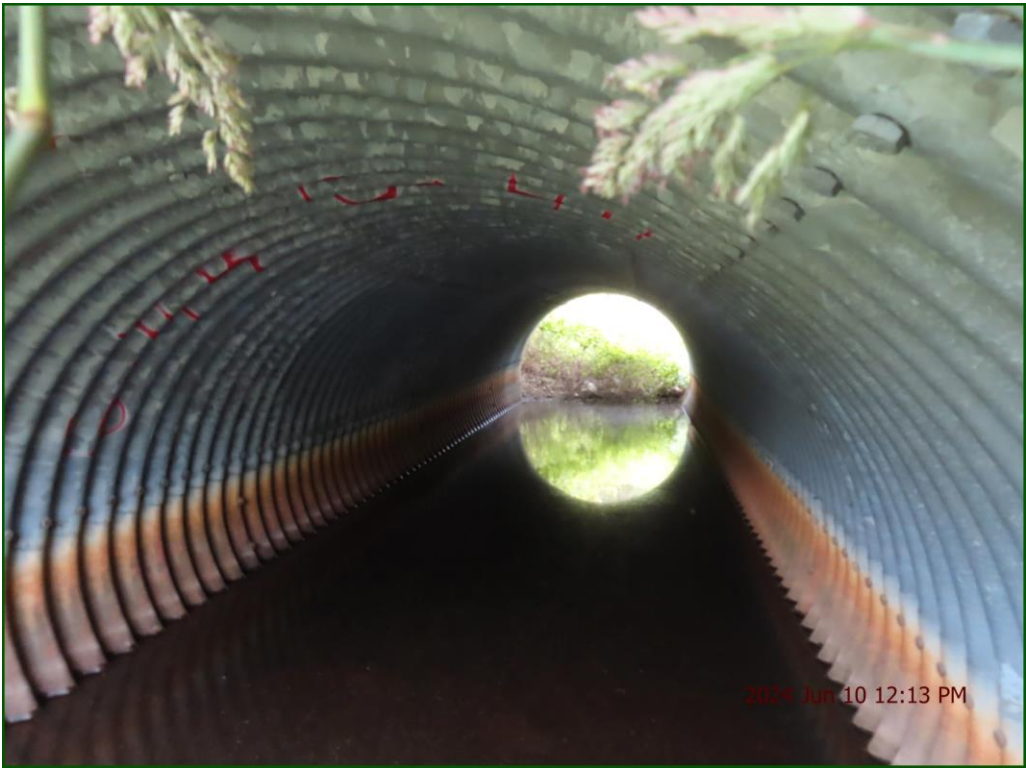
Description: North barrel: View from west.

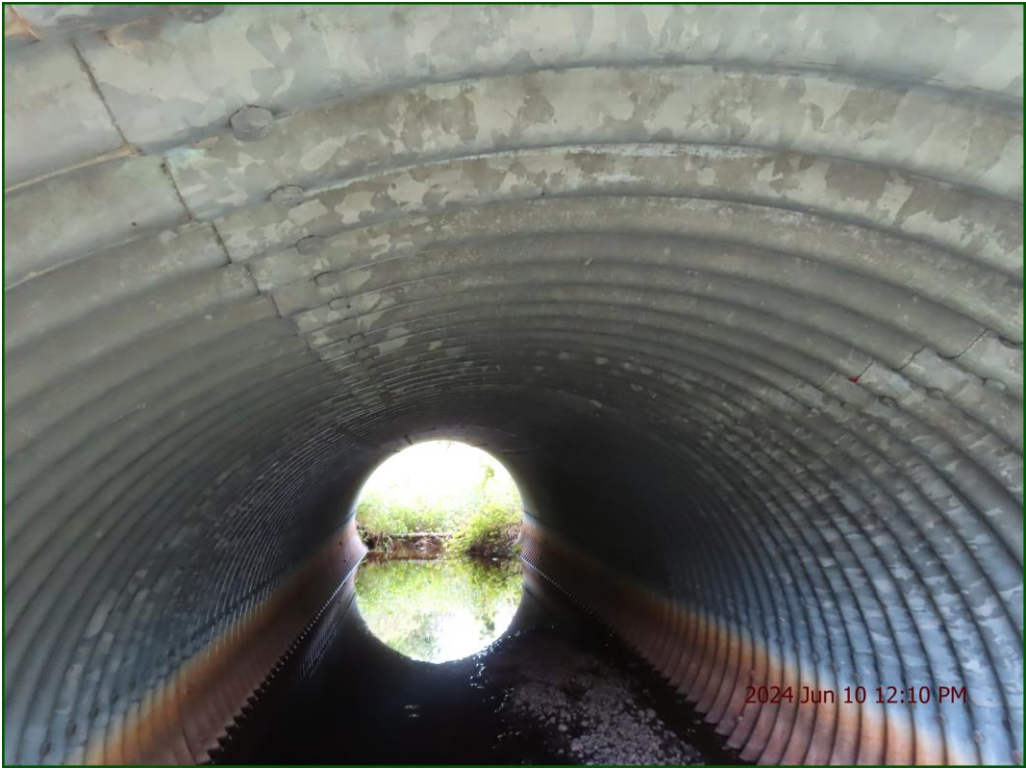
Description: South barrel: View from west.

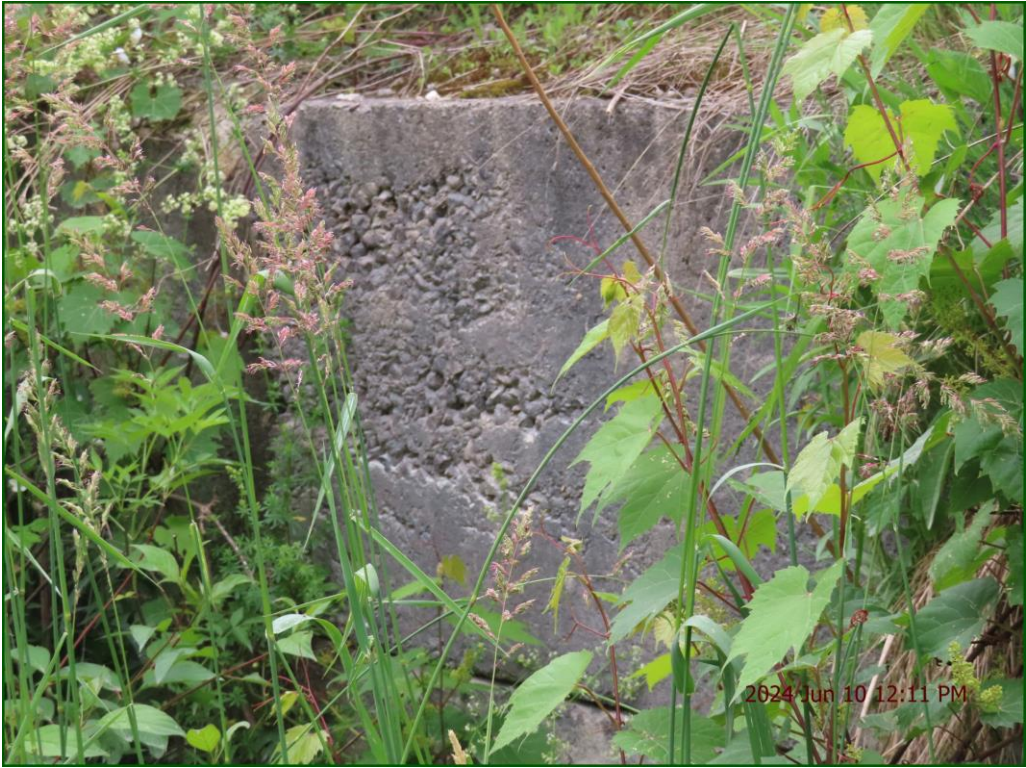
Description: Inlet: Light to medium honeycombing.

Light to medium honeycombing.

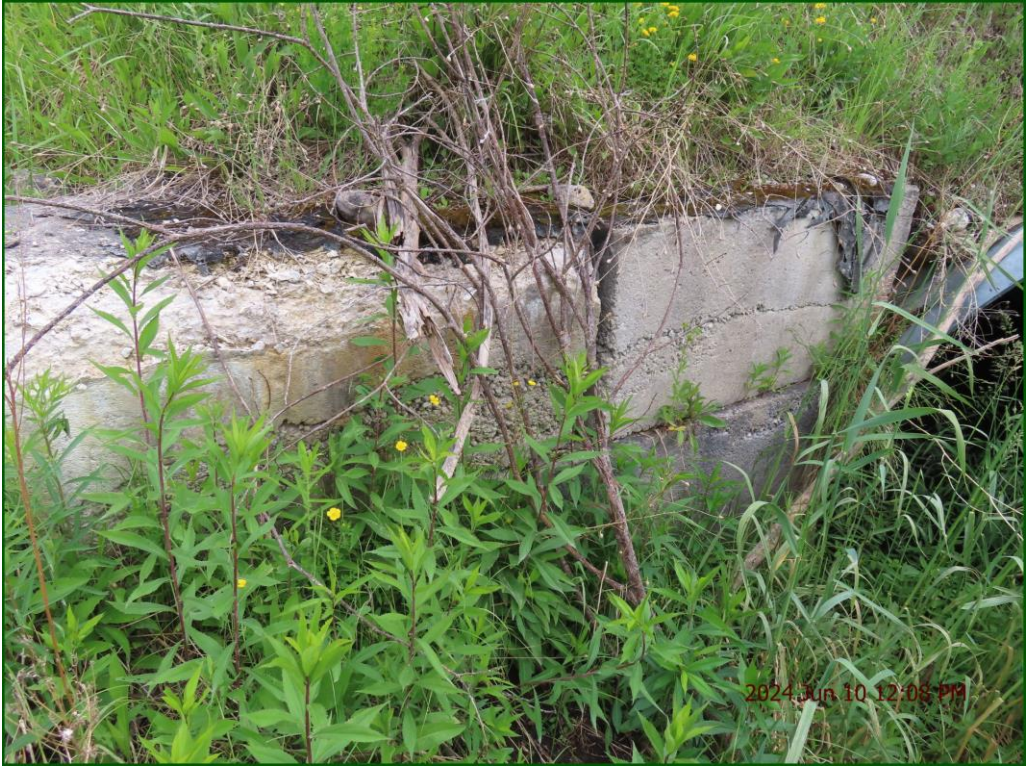
Description: Outlet: Light to medium honeycombing.

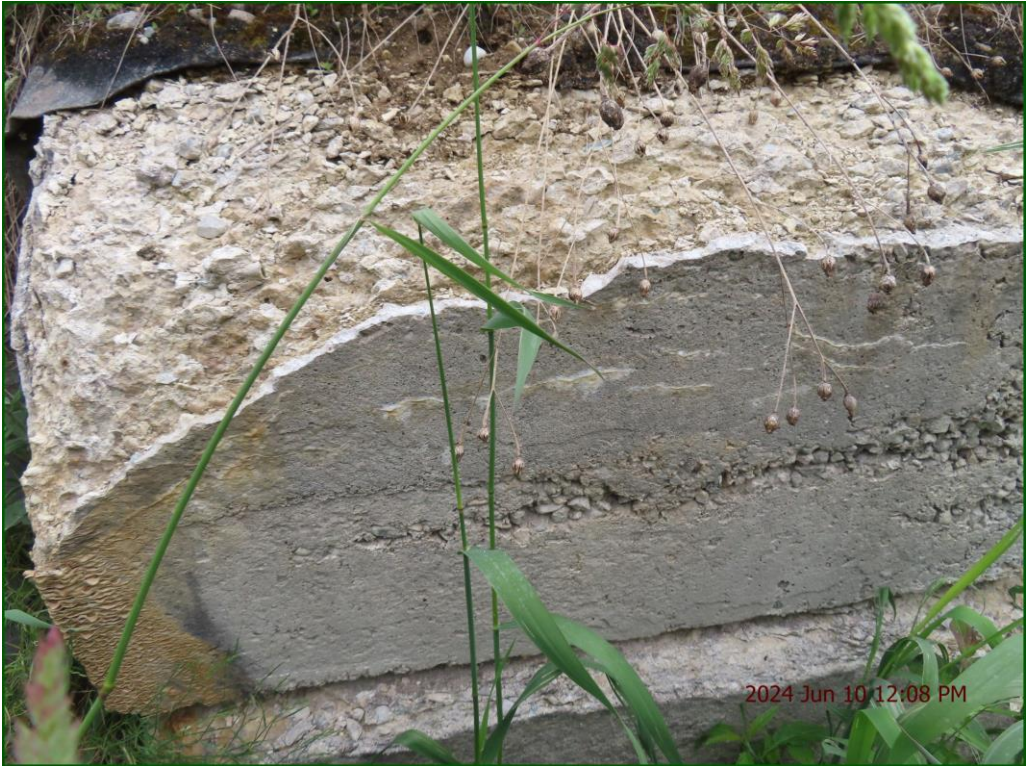
Description: Outlet: Light horizontal cracking with leachate staining.

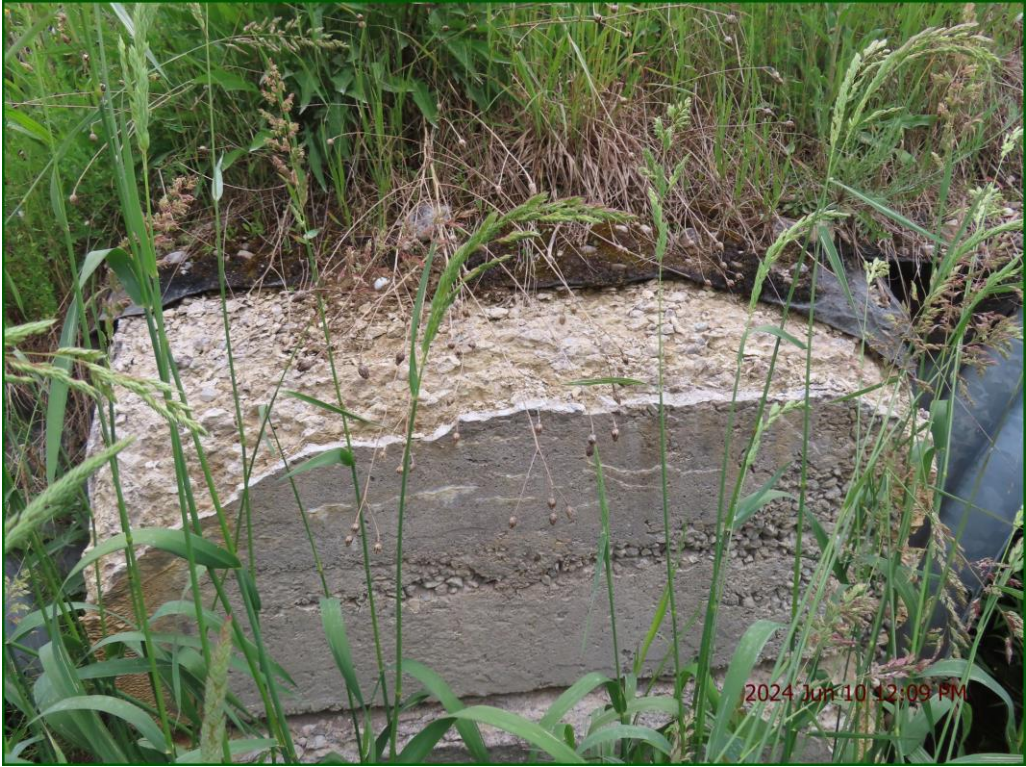
Description: Outlet: Medium to severe disintegration.

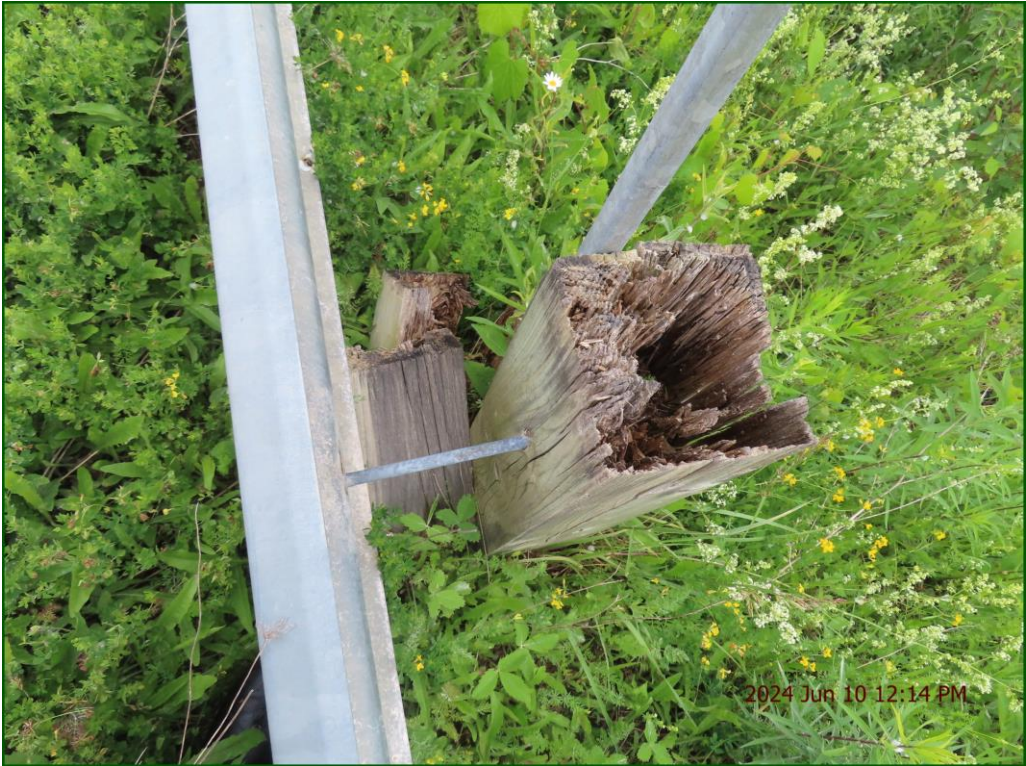
Description: Railing systems: Moderate to severe rot with localized 100% section loss.

Moderate to severe rot with localized 100% section loss.

Element Group:	Barriers	Site Number:	B-104
Element Name:	Railing systems	Width:	0 m
Element type:	Flexi beam with timber posts	Height:	0.9 m
Sub-element:		Length:	24 m
Material:	Steel	Count:	2
Location:		Total Quantity:	48 m
Environment:	Severe	Not inspected:	<input type="checkbox"/>
Perform. deficiencies:		Maintenance Type:	Structural
Maint needs:	Barrier/railing system repair	Maint. Time Period:	2 Year

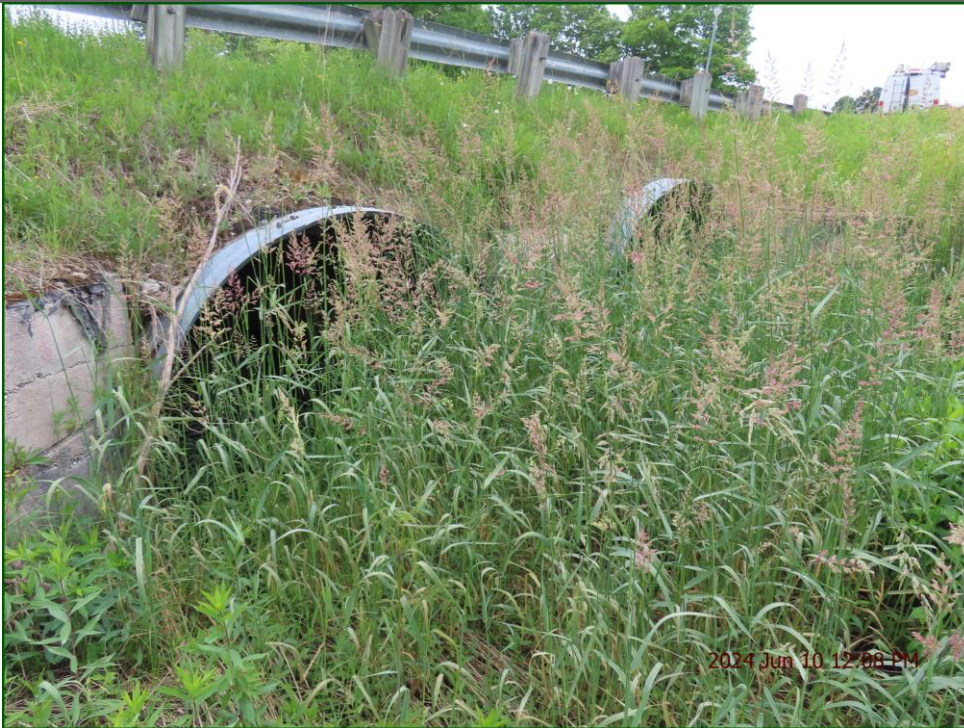
Light to medium honeycombing. Light horizontal cracking with leachate staining. Medium to severe disintegration.

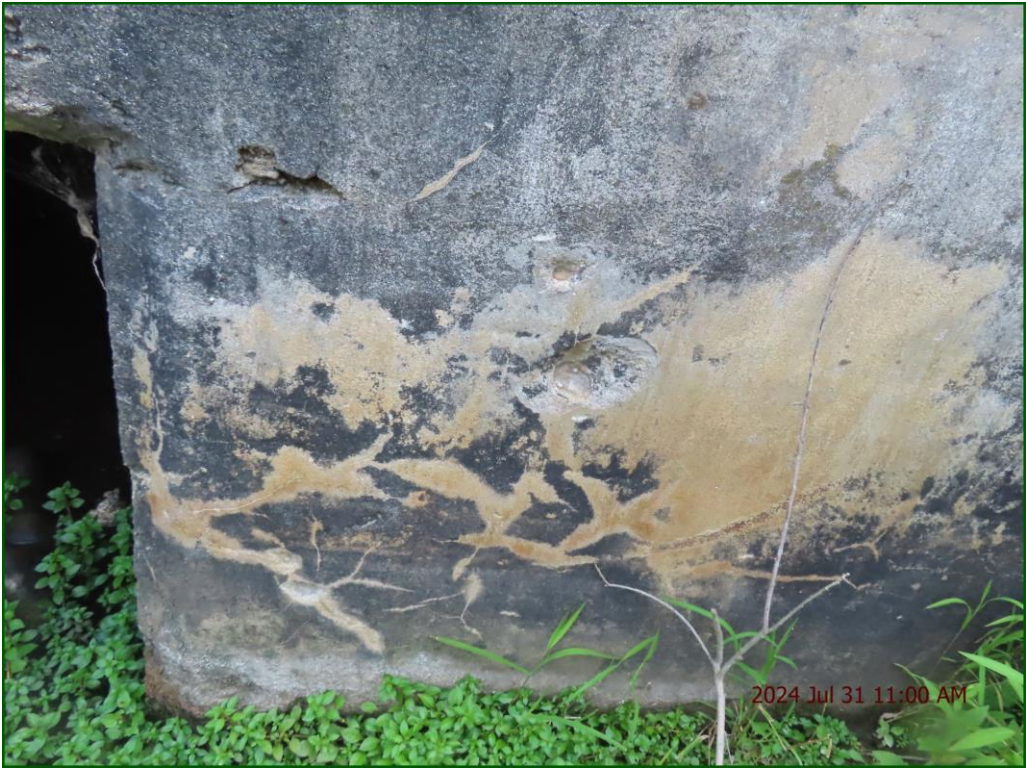
Description: Inlet: Light to medium cracking with leachate staining.

Light to medium cracking with leachate staining.

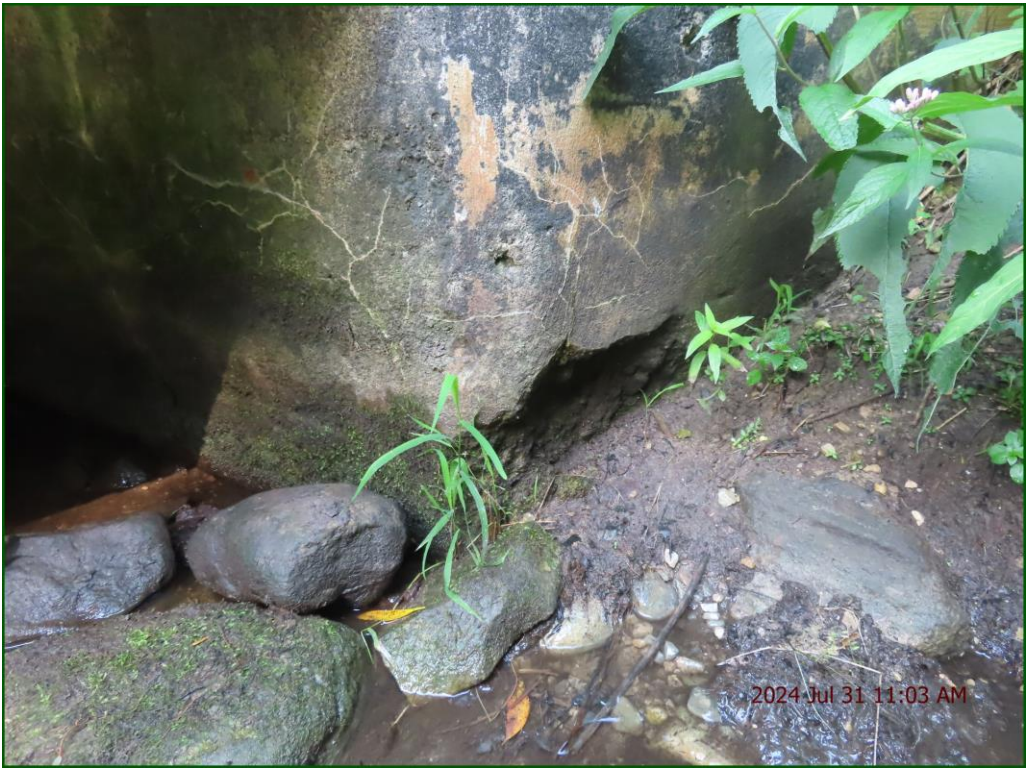
Description: Outlet: Light spalling with exposed reinforcing throughout.

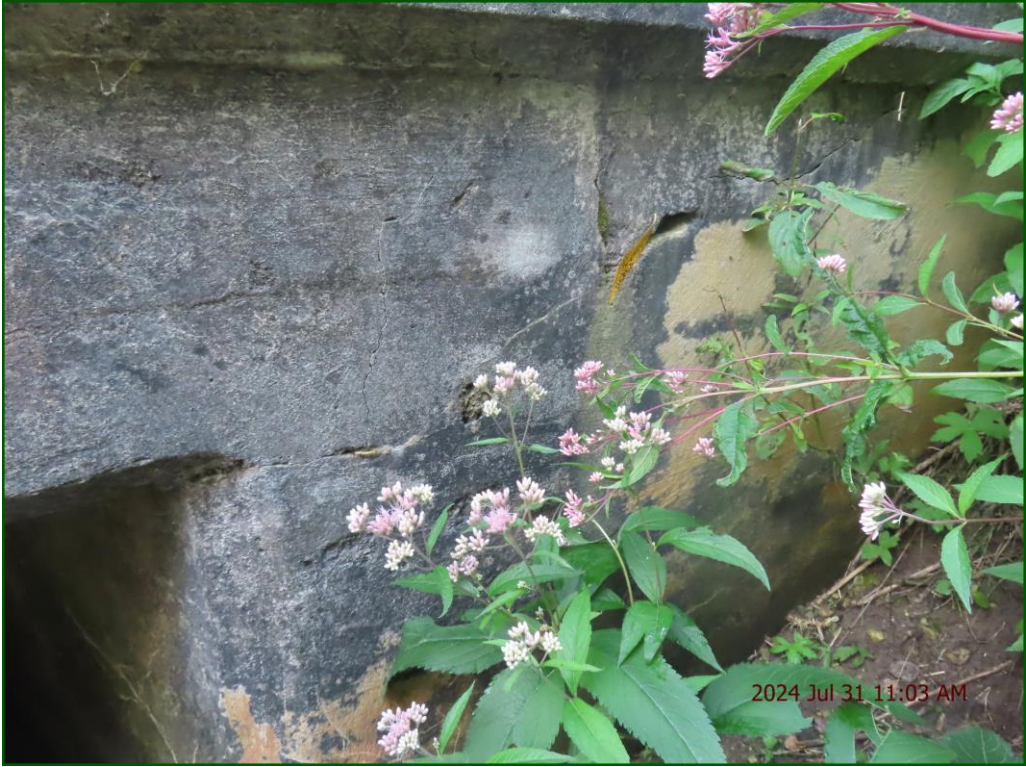
Description: Outlet: Medium to wide cracking.

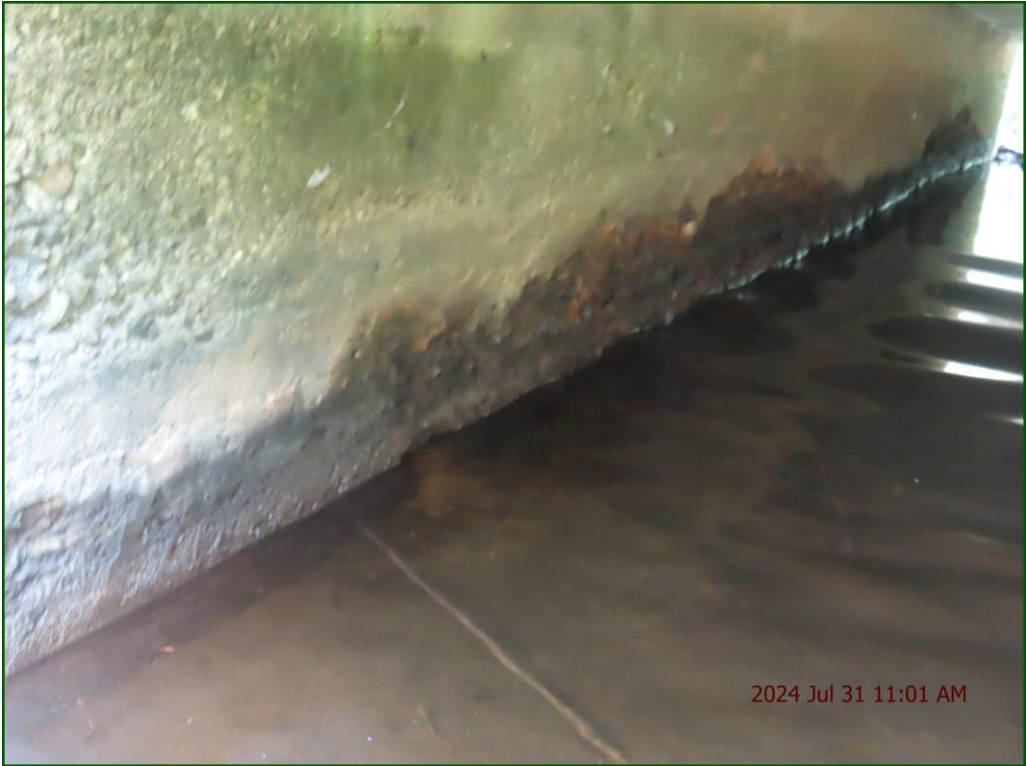
Description: Barrel: Light spalling and disintegration along waterline.

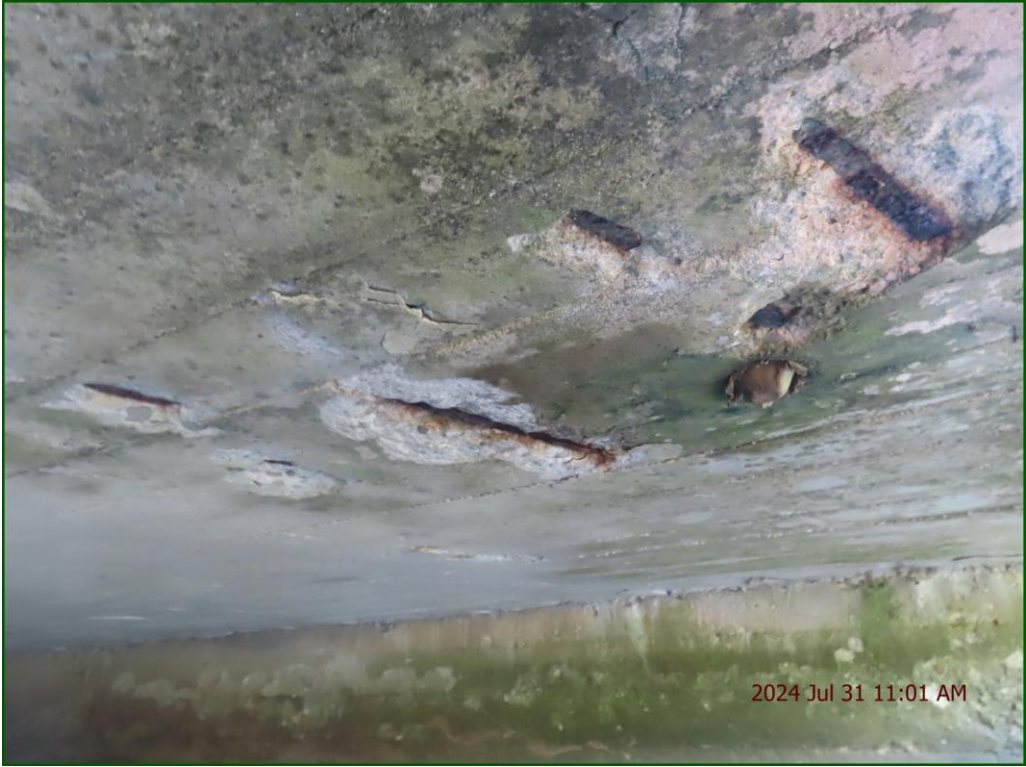
Description: Barrel: Severe delamination with exposed reinforcing on soffit.

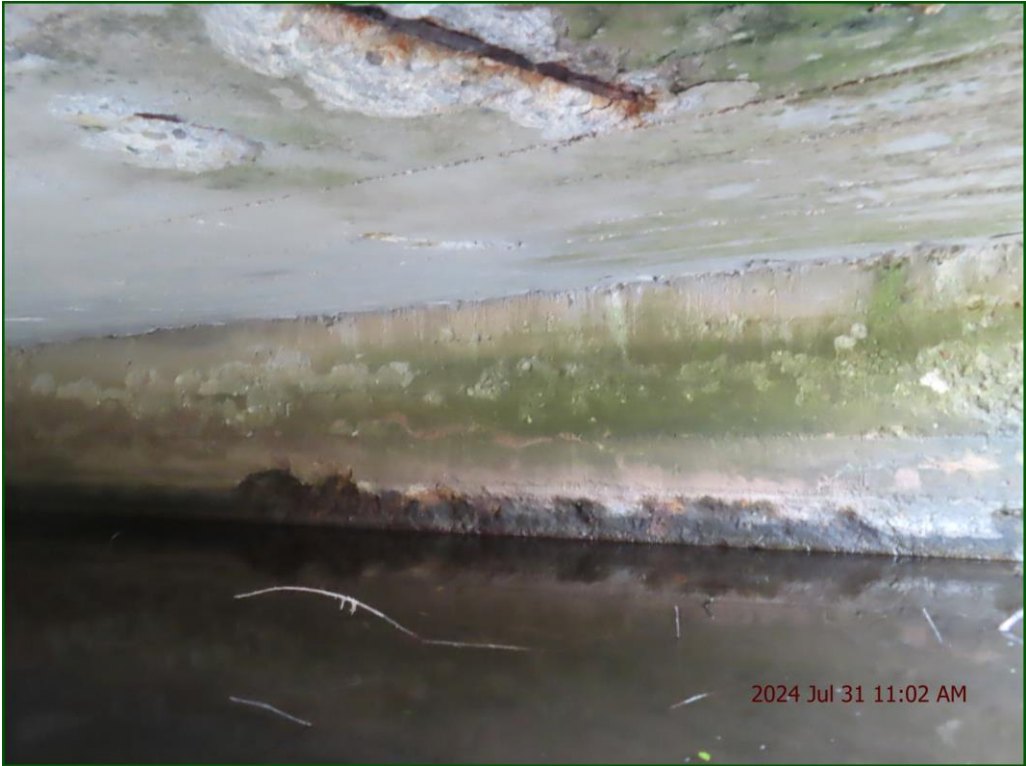
Description: Barrel: Moderate scaling throughout.

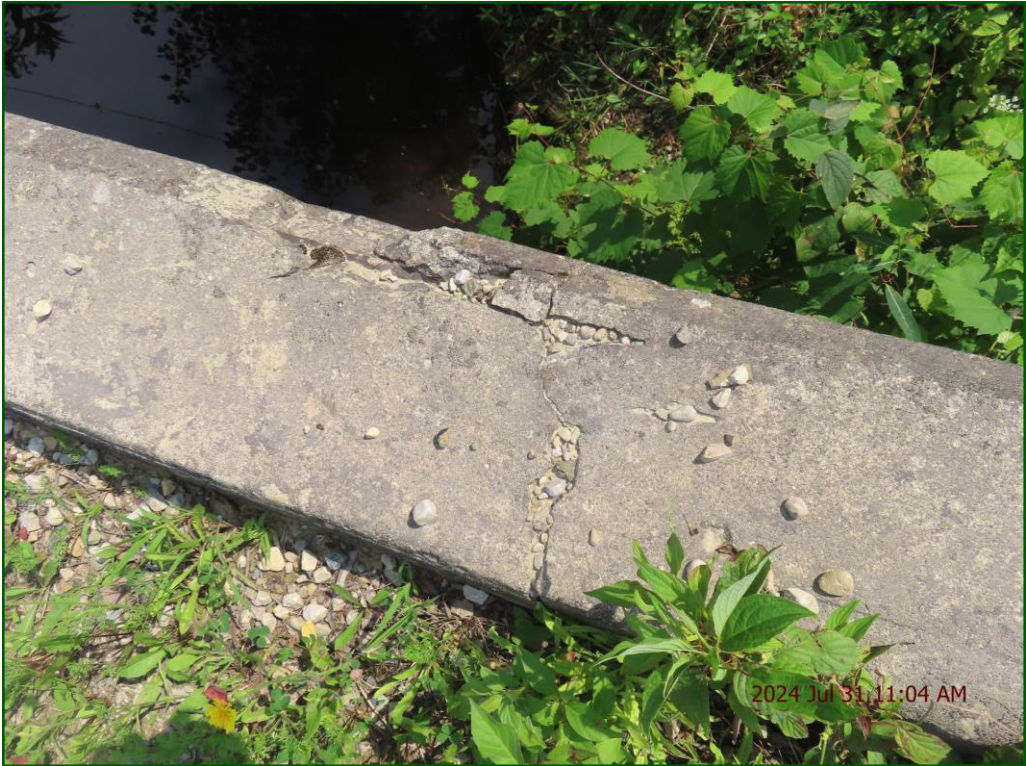
Description: Curbs: Wide cracking and spalling with exposed reinforcing.
