Element Inspection

Date of Inspection:	31-Jul-24
Name of Inspector:	Andrew Burgess, P.Eng. & Joel Ziegler CET
Equipment Used:	Sounding hammer, measuring equipment, GPS
Weather Conditions:	Sunny
Temperature:	23
Special Notes:	Bridge is in good condition, showing no signs of structural distress.

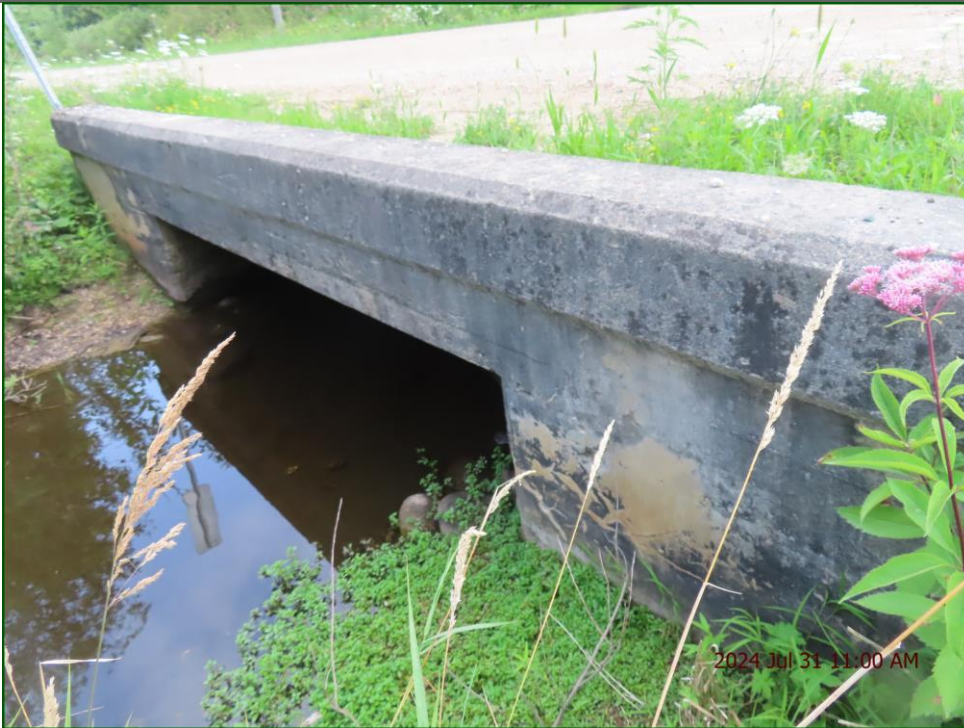
Light to medium cracking with leachate staining.

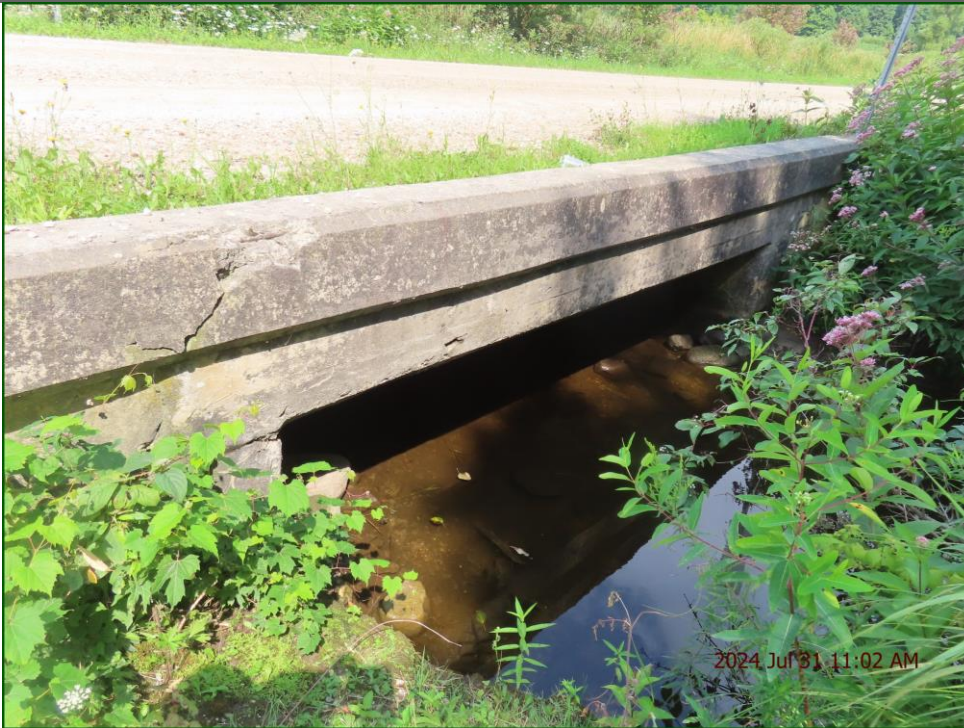
Light spalling with exposed reinforcing throughout. Medium to wide cracking.

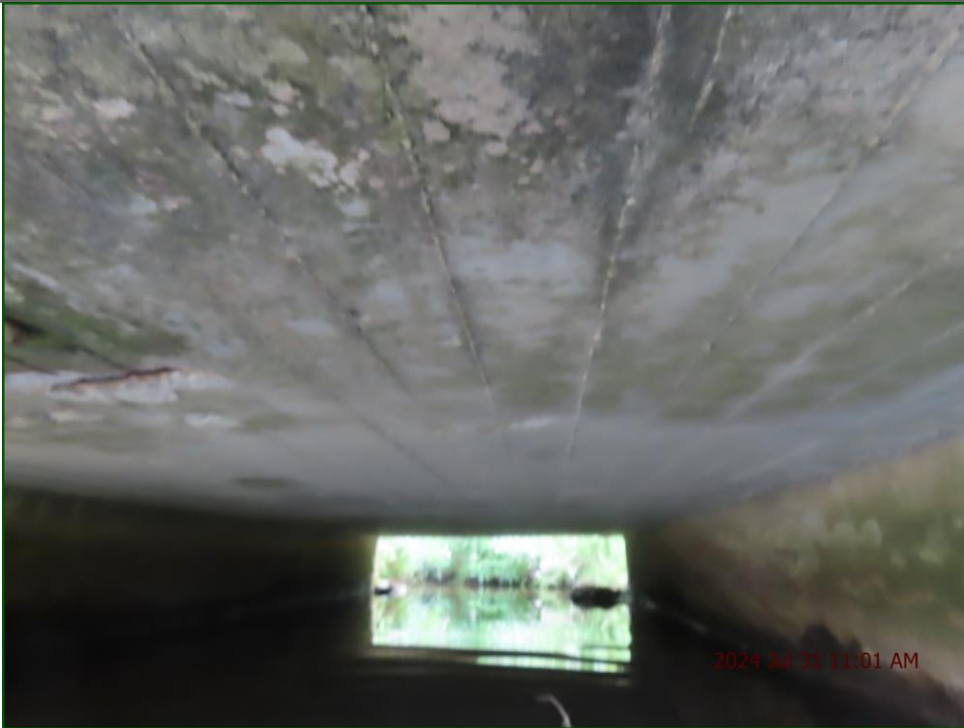
Light spalling and disintegration along waterline. Severe delamination with exposed reinforcing on soffit. Moderate scaling throughout.

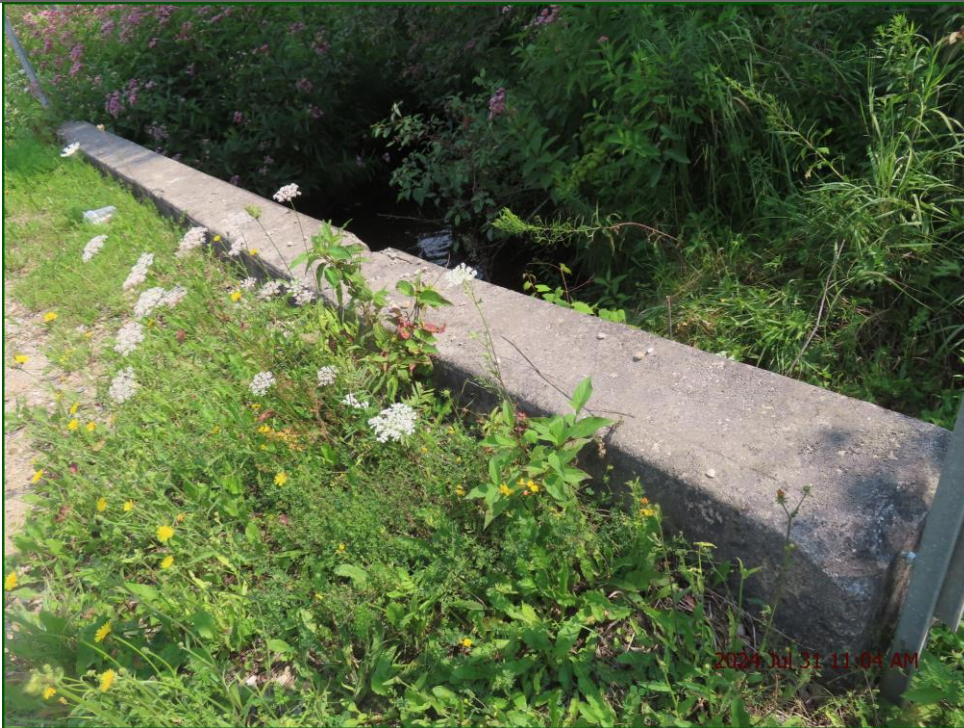
Wide cracking and spalling with exposed reinforcing.

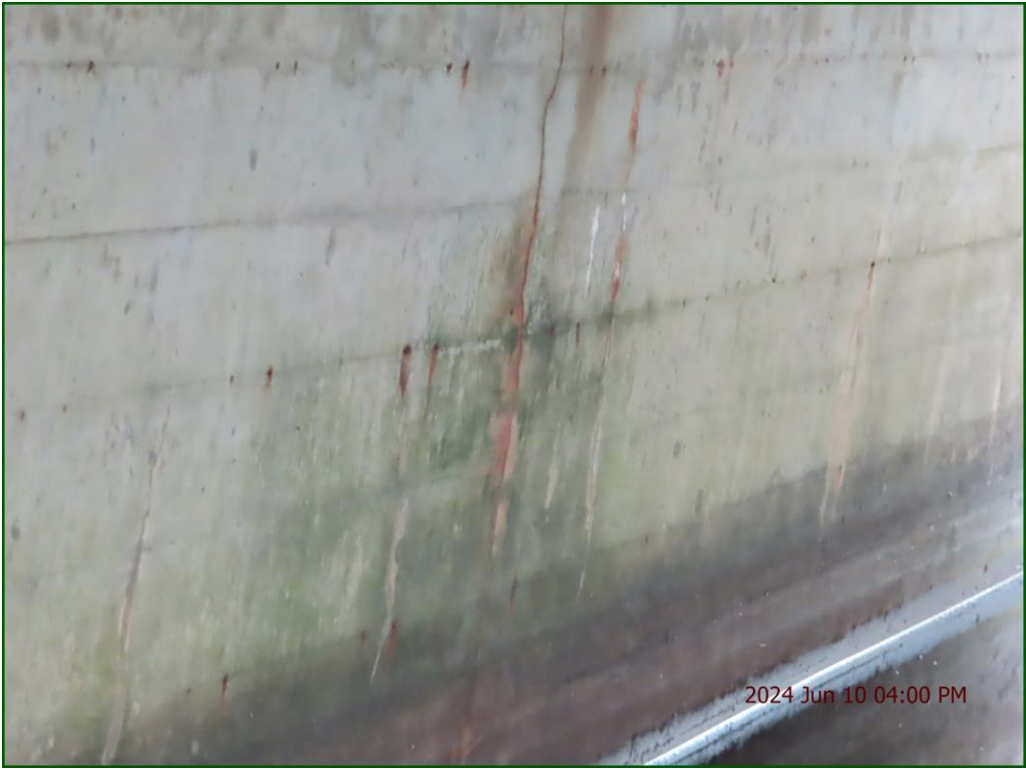
Description: Abutment walls: Medium to wide vertical cracking with wetness and rust staining.

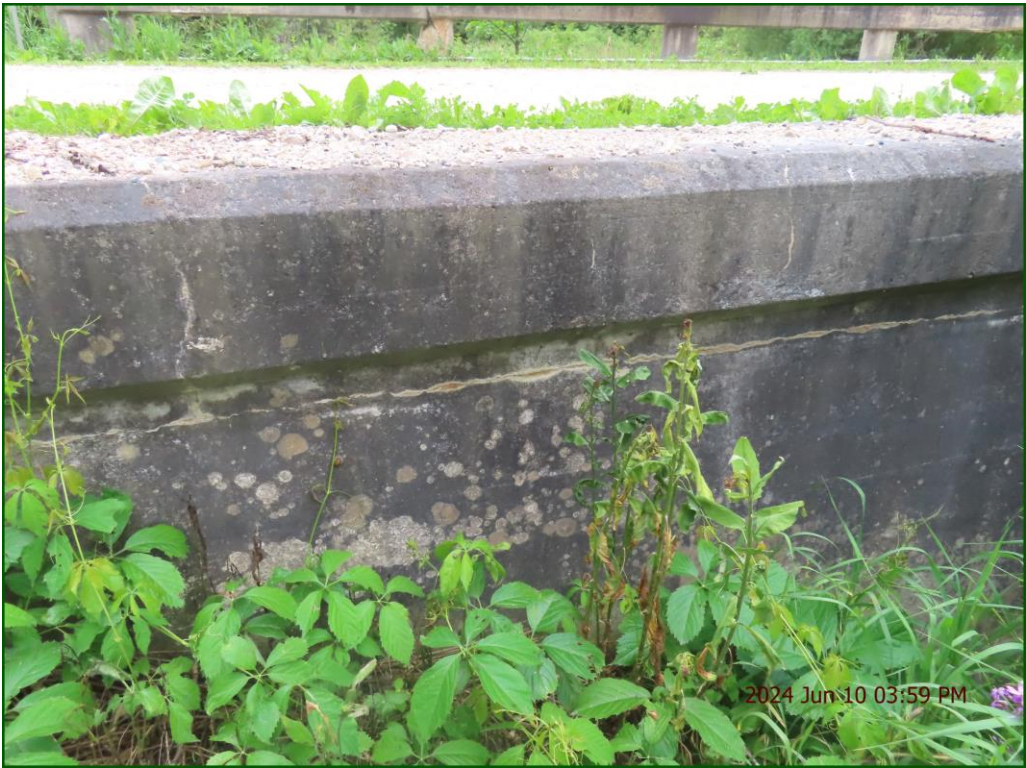
Description: Wingwalls: Light to medium horizontal cracking with leachate staining.

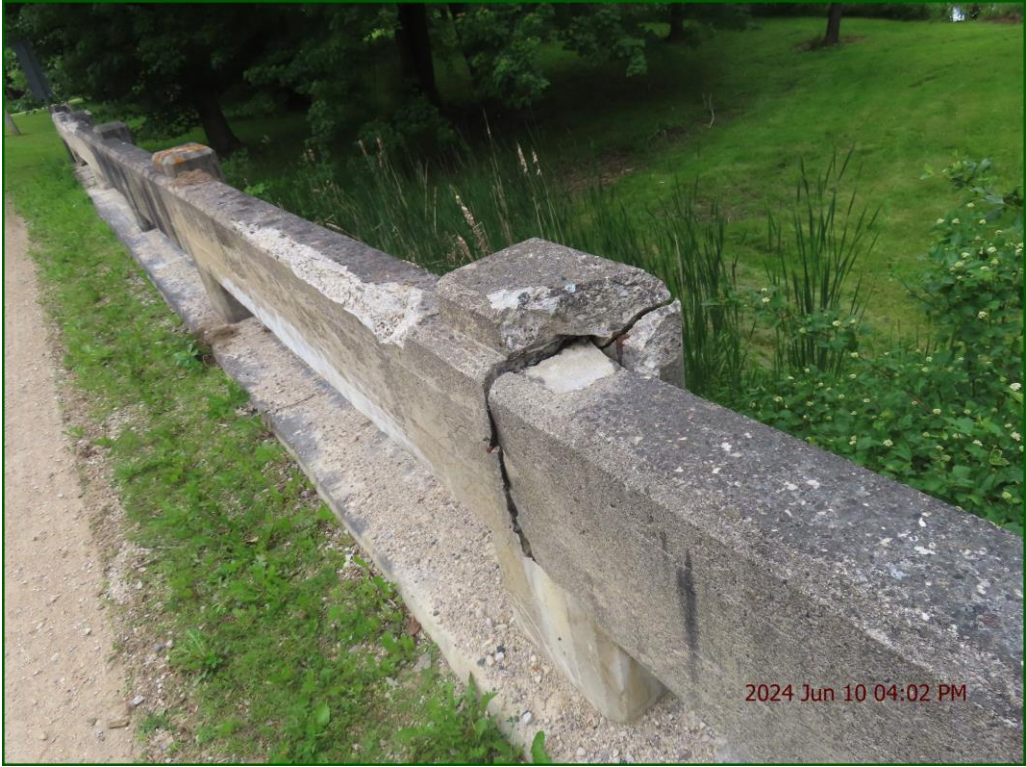
Description: Railing Systems: Medium to severe spalling and disintegration throughout.

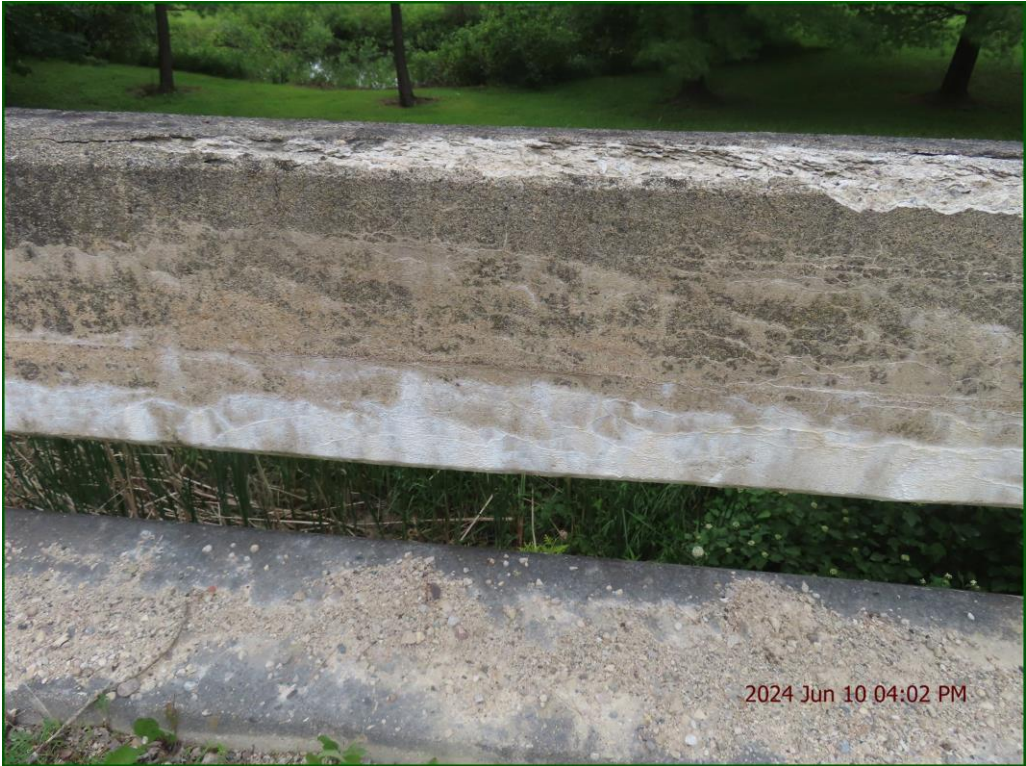
Description: Railing Systems: Light to medium map cracking with leachate staining.

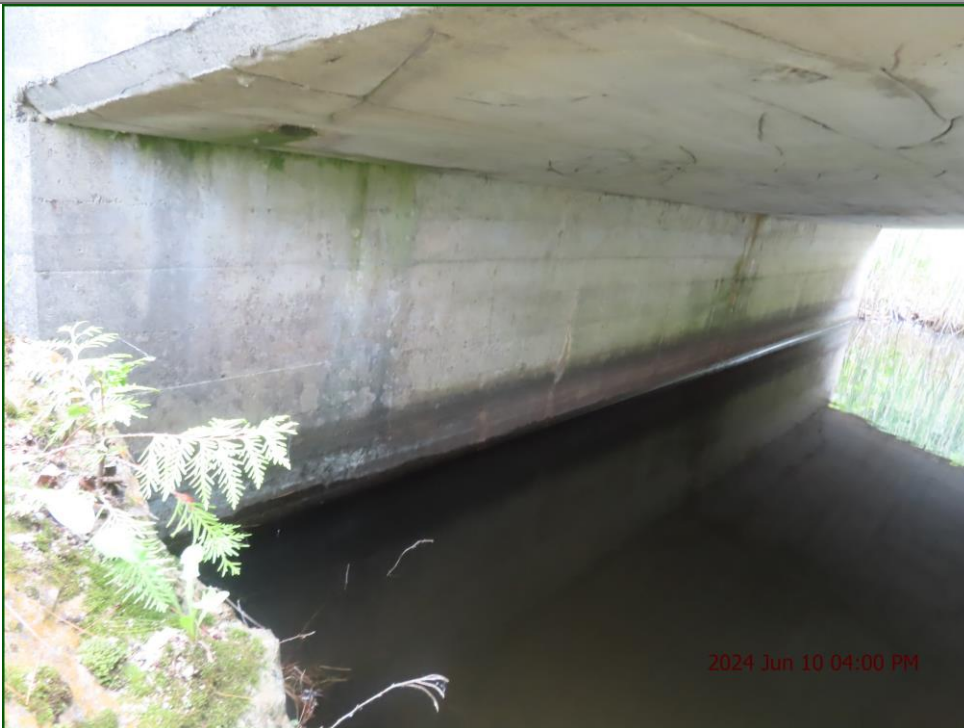
Medium to wide vertical cracking with wetness and rust staining.

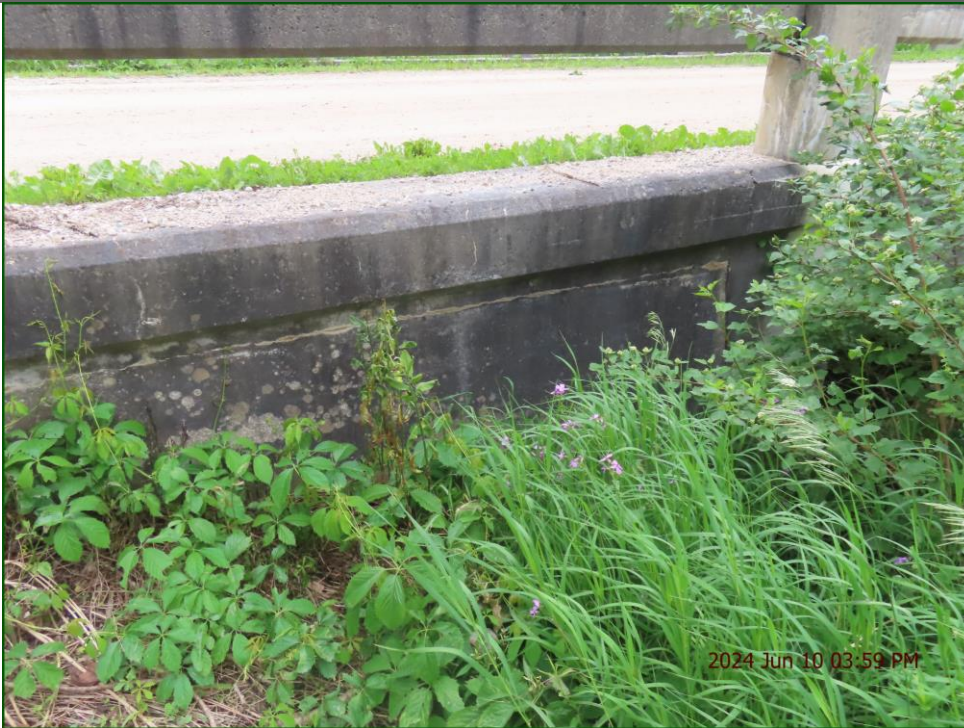
Light to medium horizontal cracking with leachate staining.

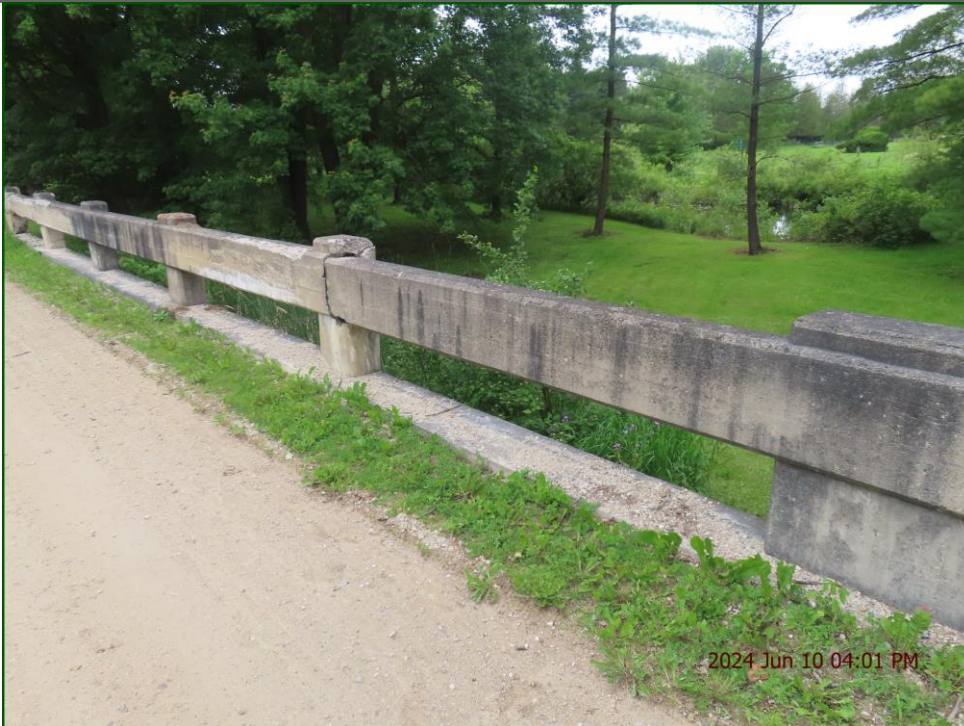
Medium to severe spalling and disintegration throughout with exposed reinforcing. Light to medium map cracking with leachate staining.

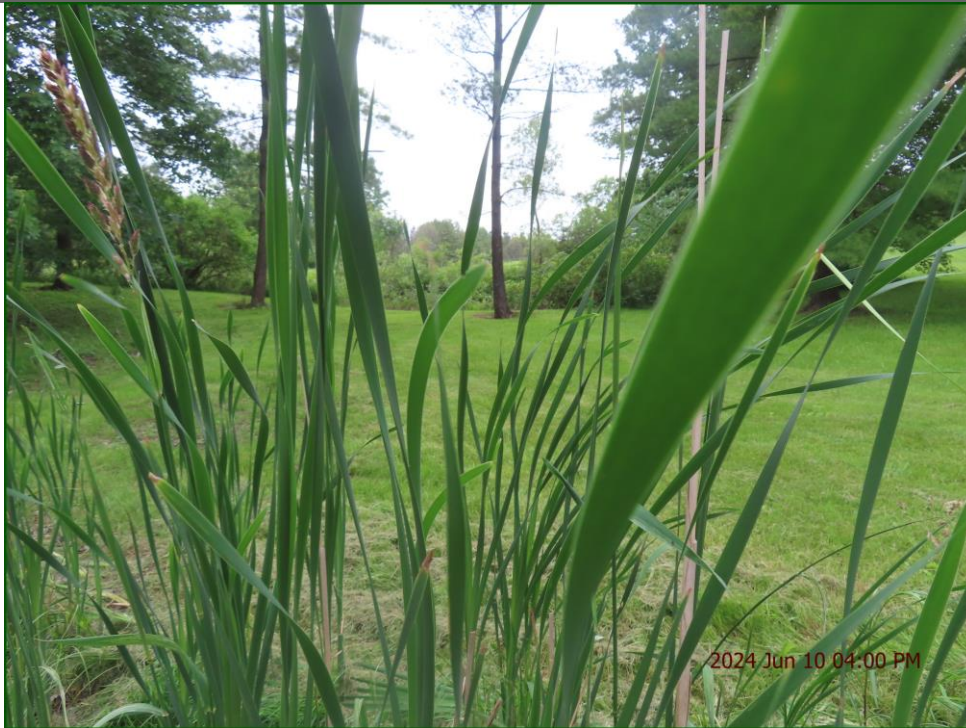
Stream dry at time of inspection.

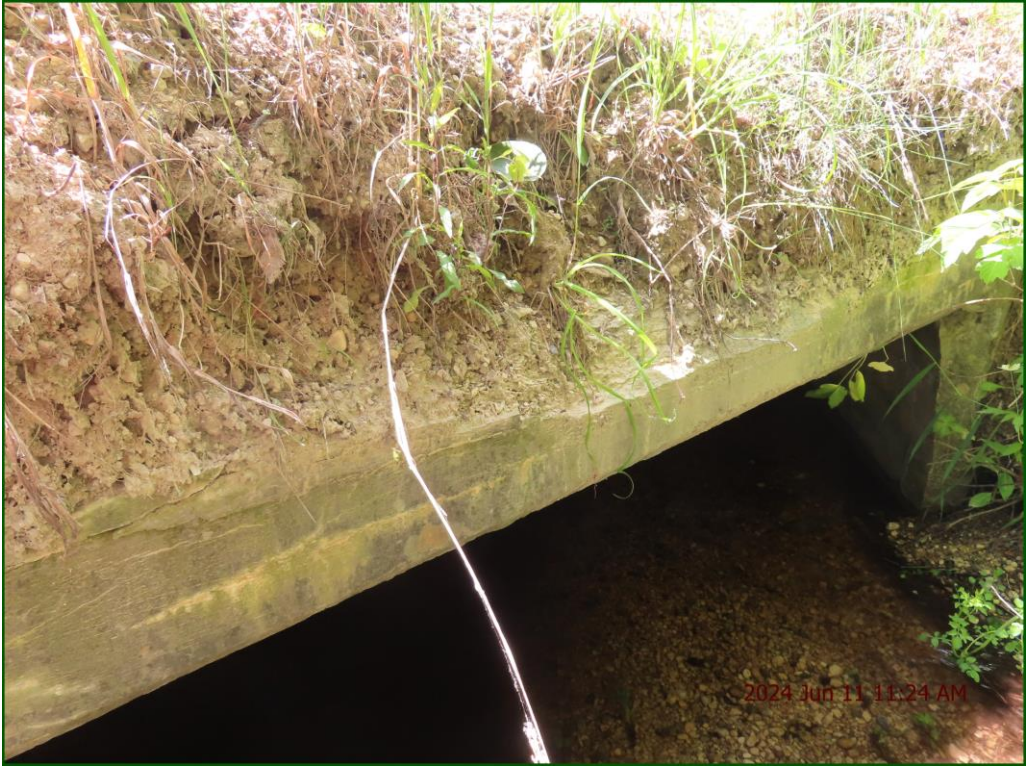
Description: Inlet: Severe spalling and disintegration throughout.

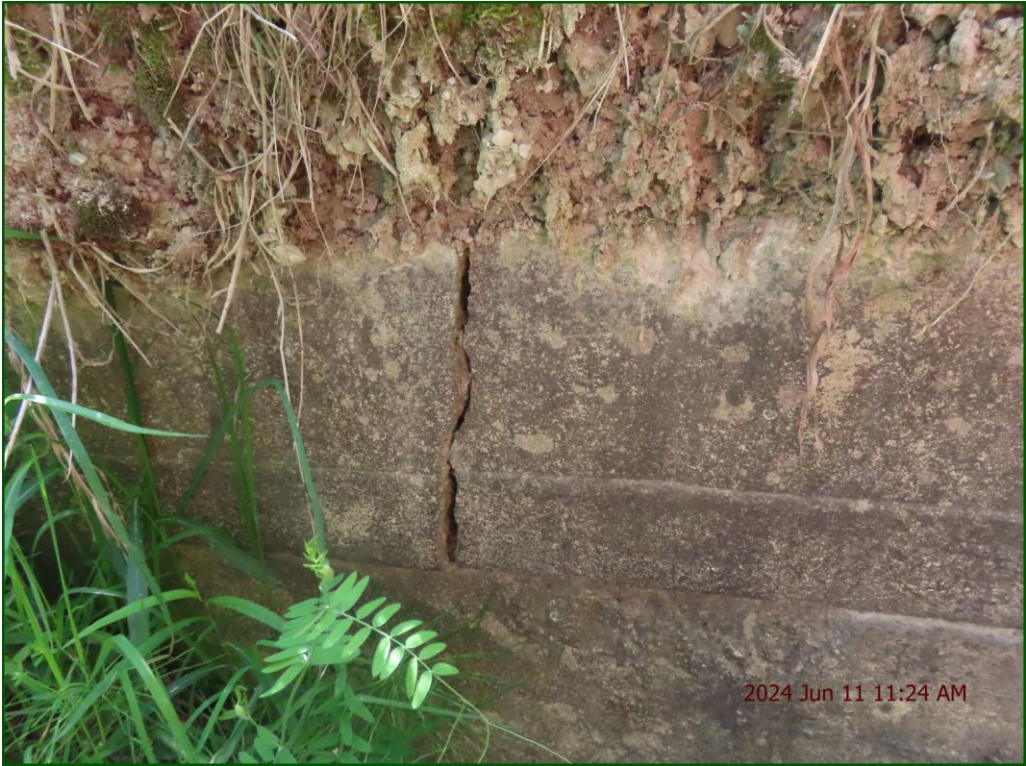
Description: Inlet: Very wide crack.

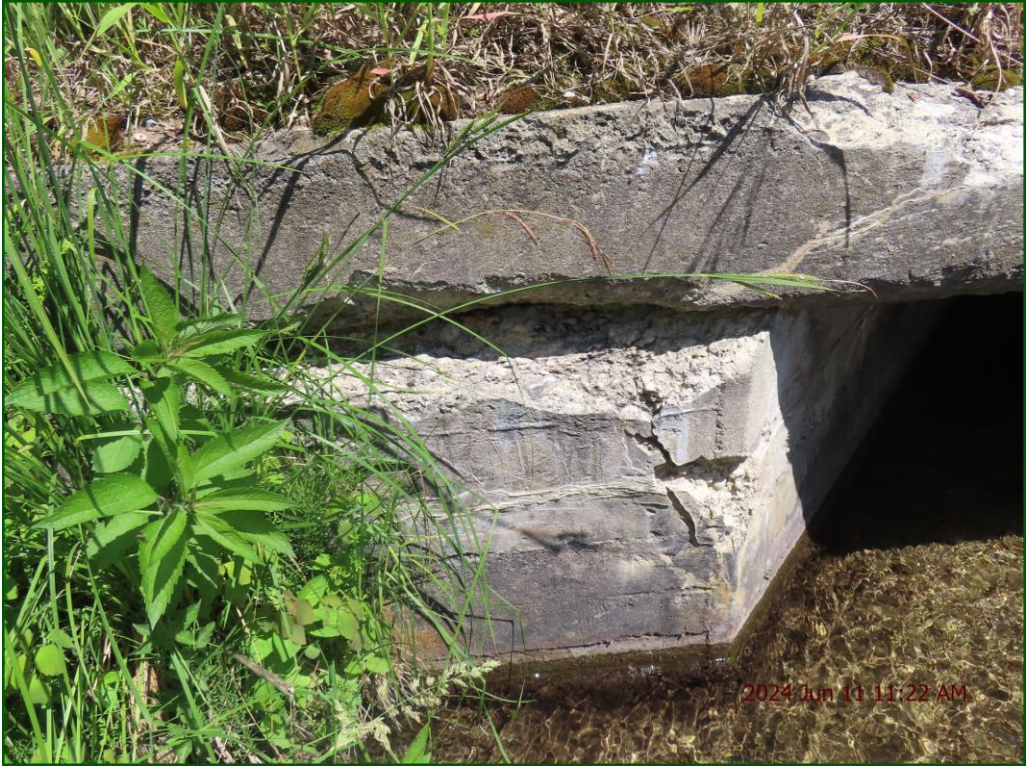
Description: Outlet: Severe spalling and disintegration throughout.

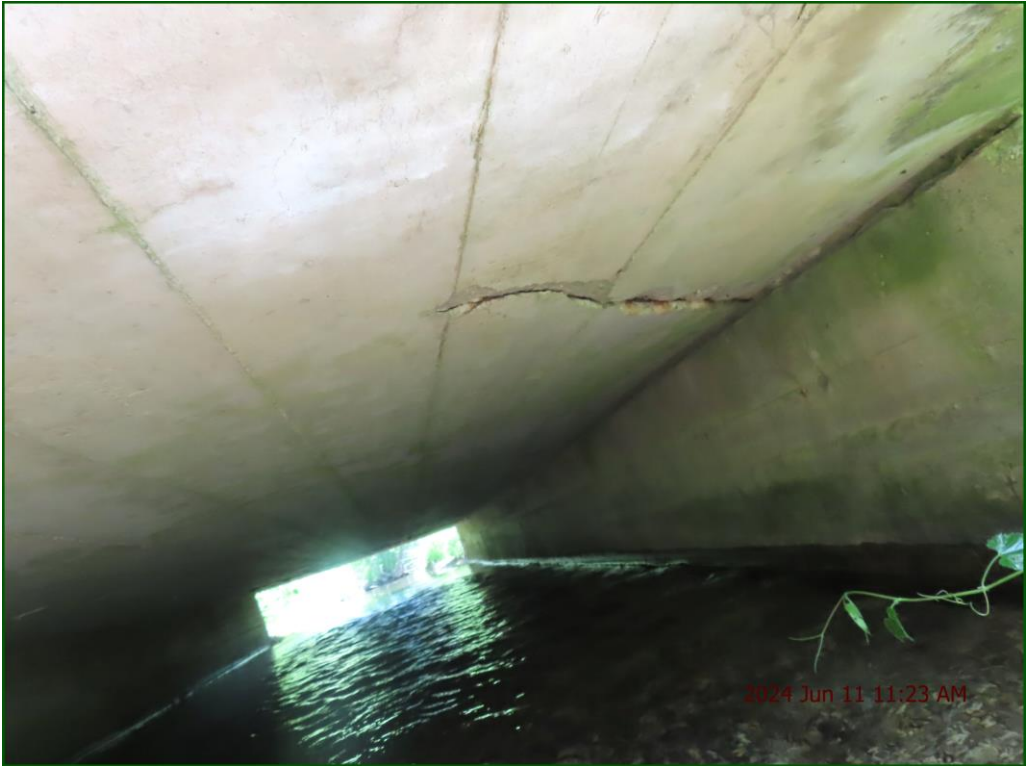
Description: Barrel: Moderate spall with exposed reinforcing (1/2).

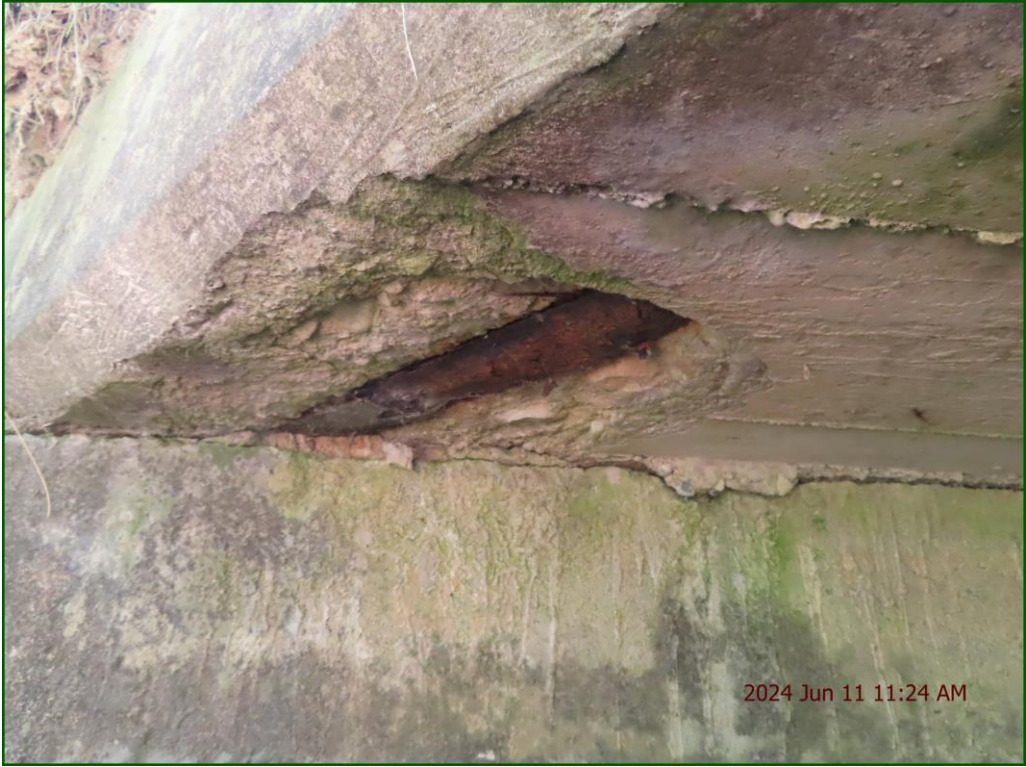
Description: Moderate spall wwith exposed reinforcing (2/2).

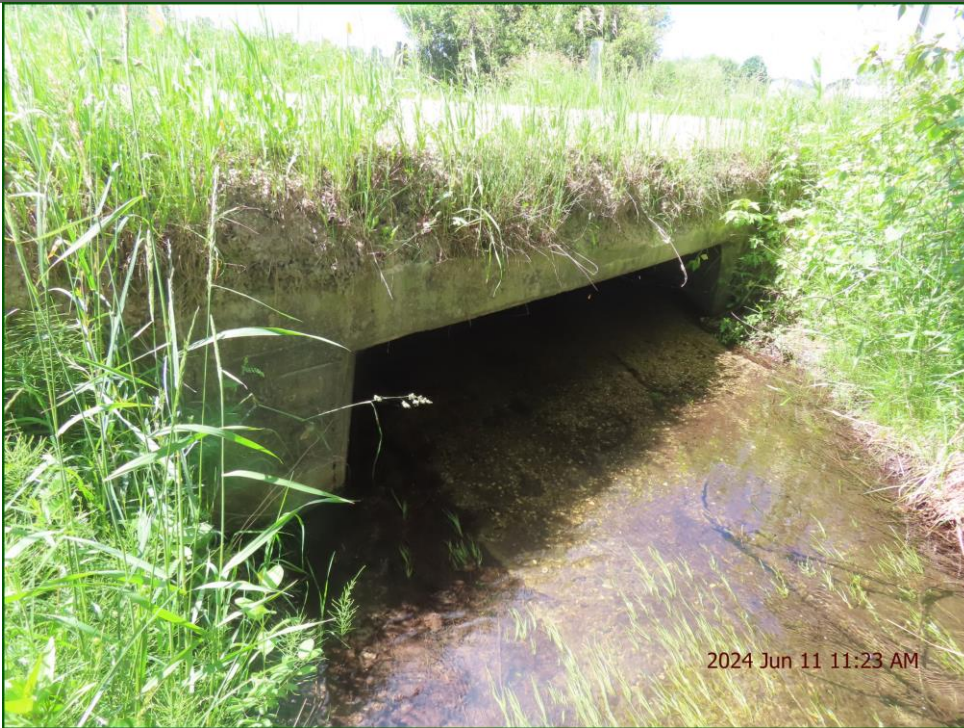
Severe spalling and disintegration throughout. Very wide crack.

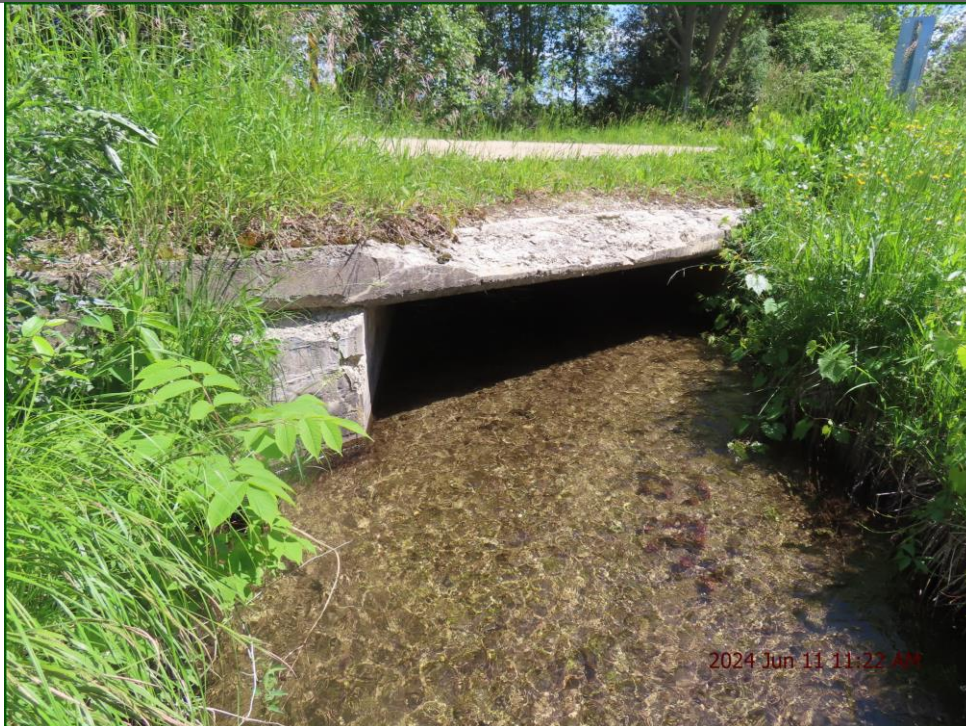
Severe spalling and disintegration throughout.

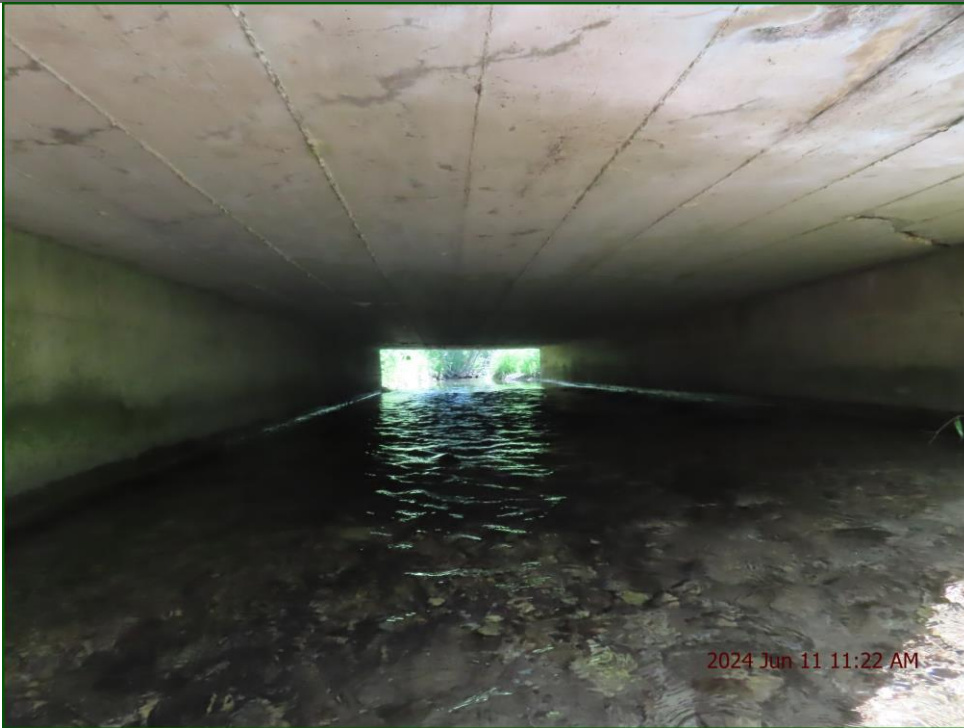
Moderate spall with exposed reinforcing.

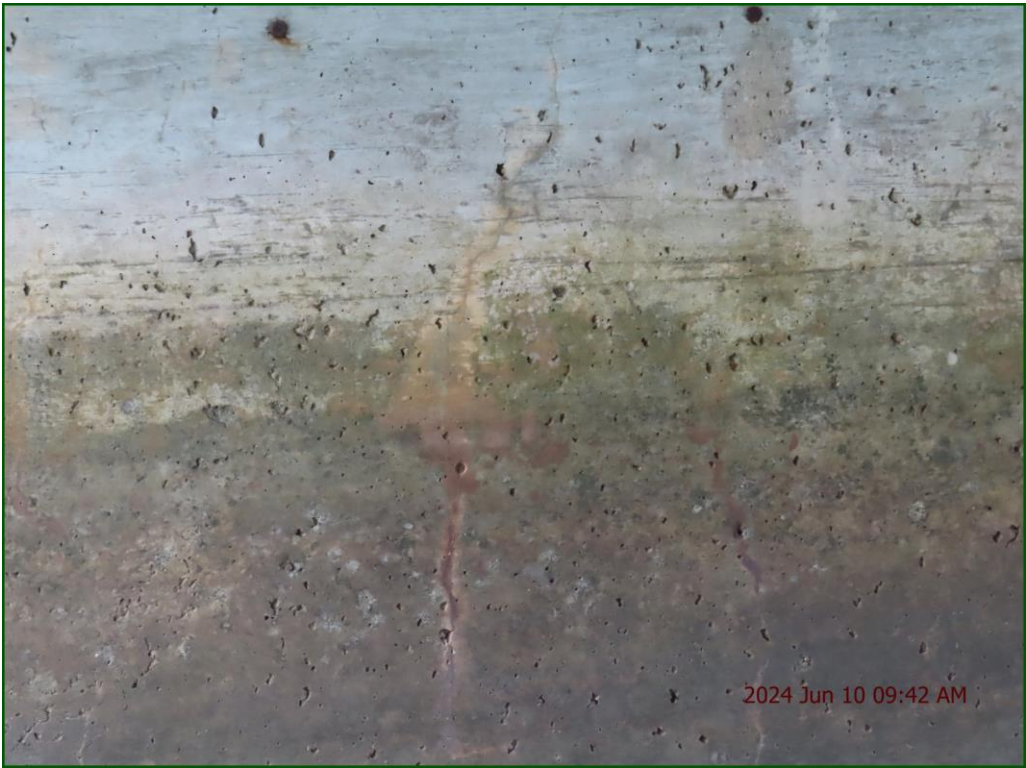
Description: Barrel: Light cracking and wetness staining.

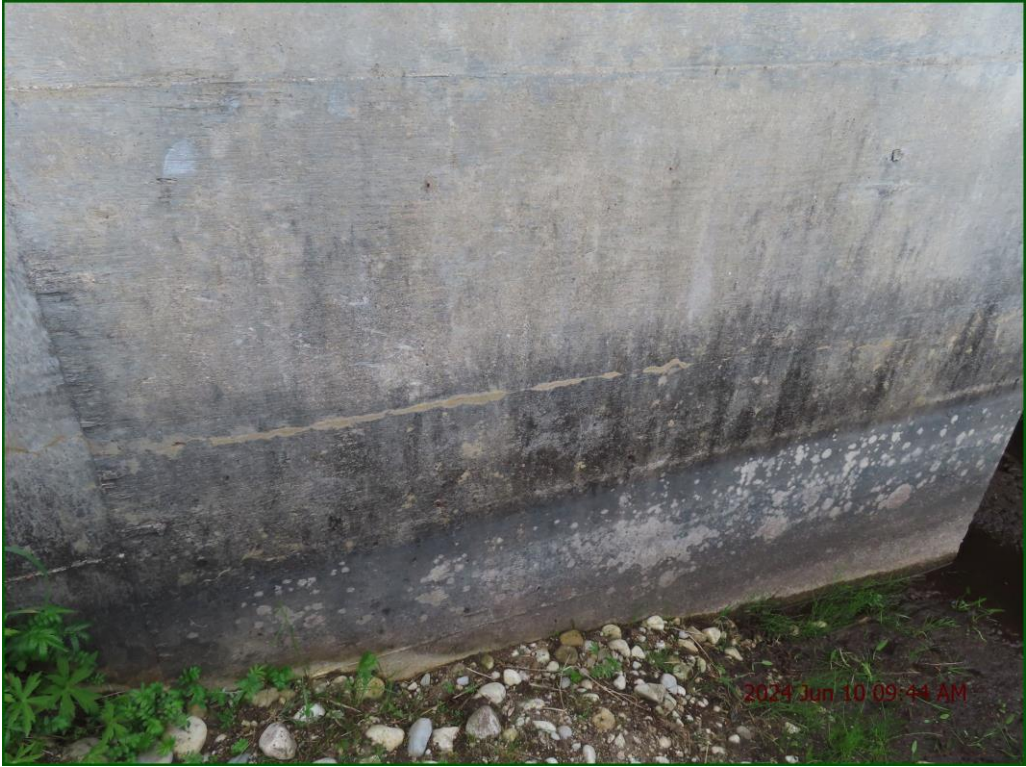
Description: Inlet: Light cracking with leachate staining.

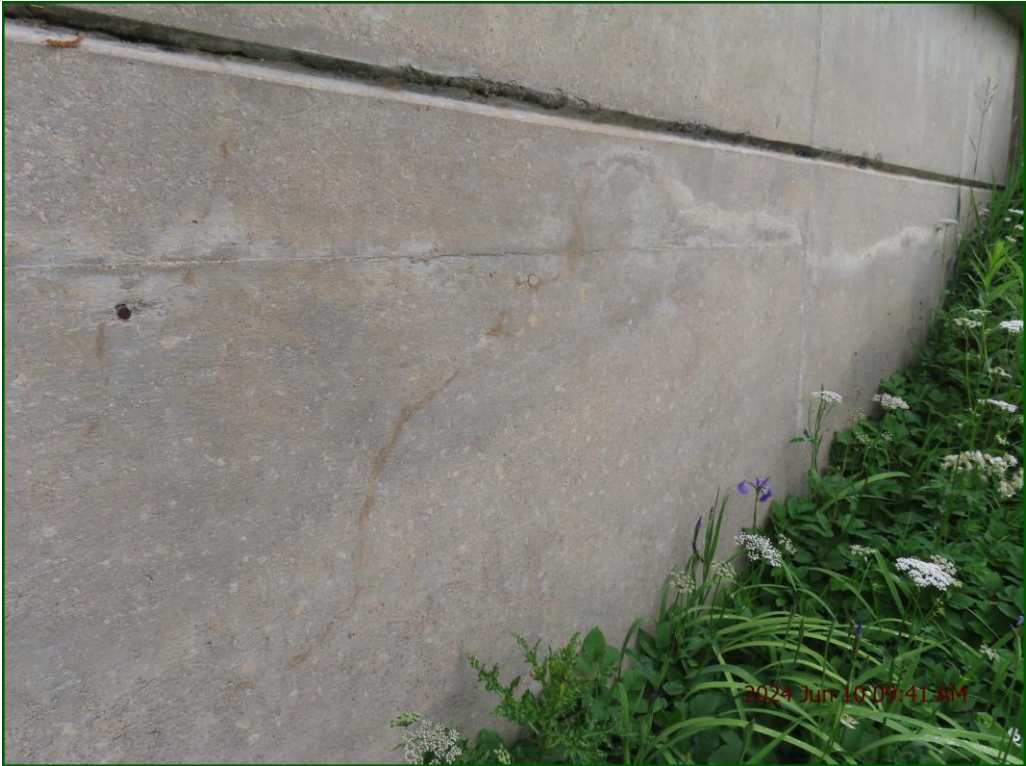
Description: Outlet: Light cracking with wetness staining.

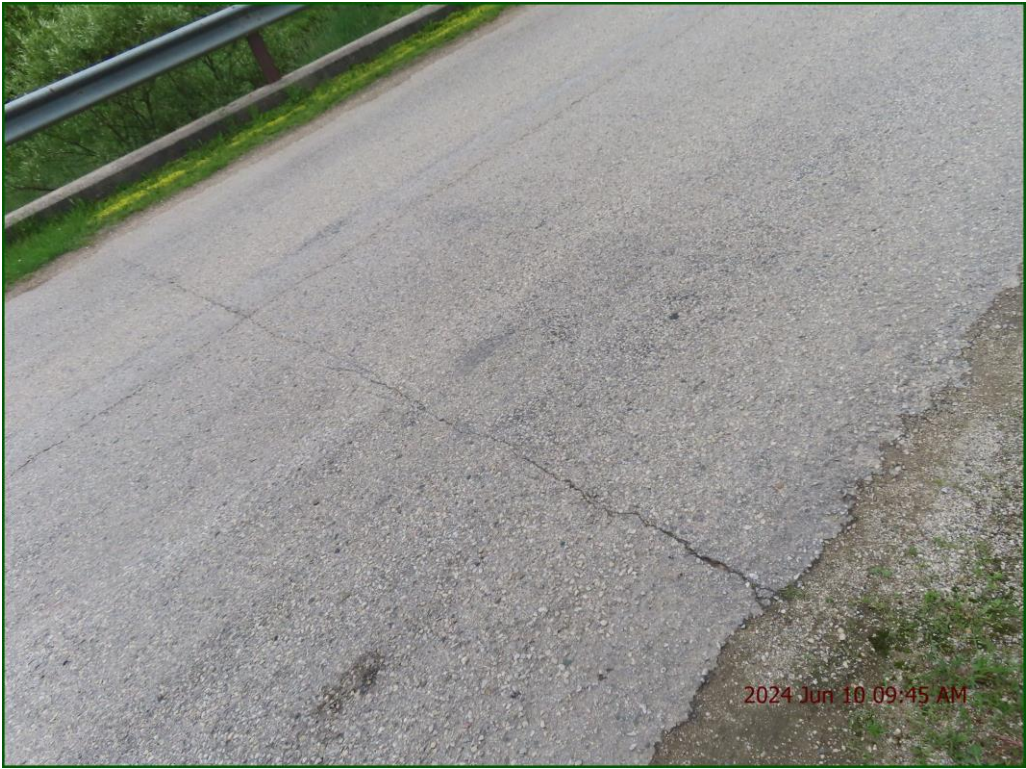
Description: Wearing surface: Light transverse cracking.

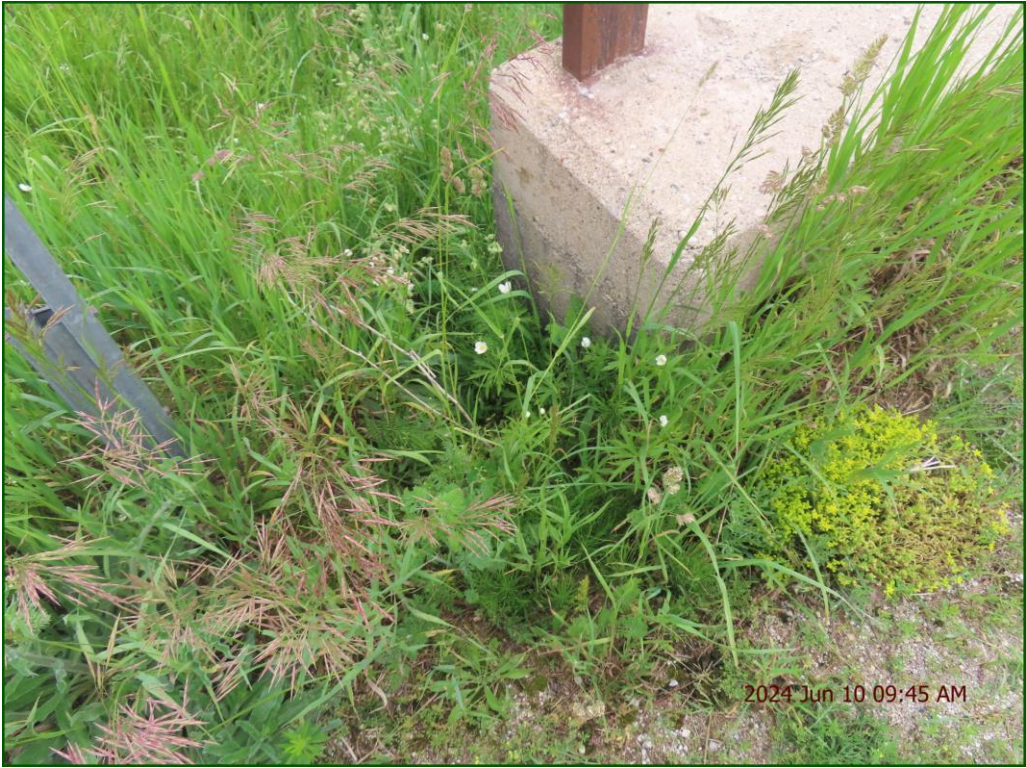
Description: Embankments: Moderate erosion at NW and NE corner.

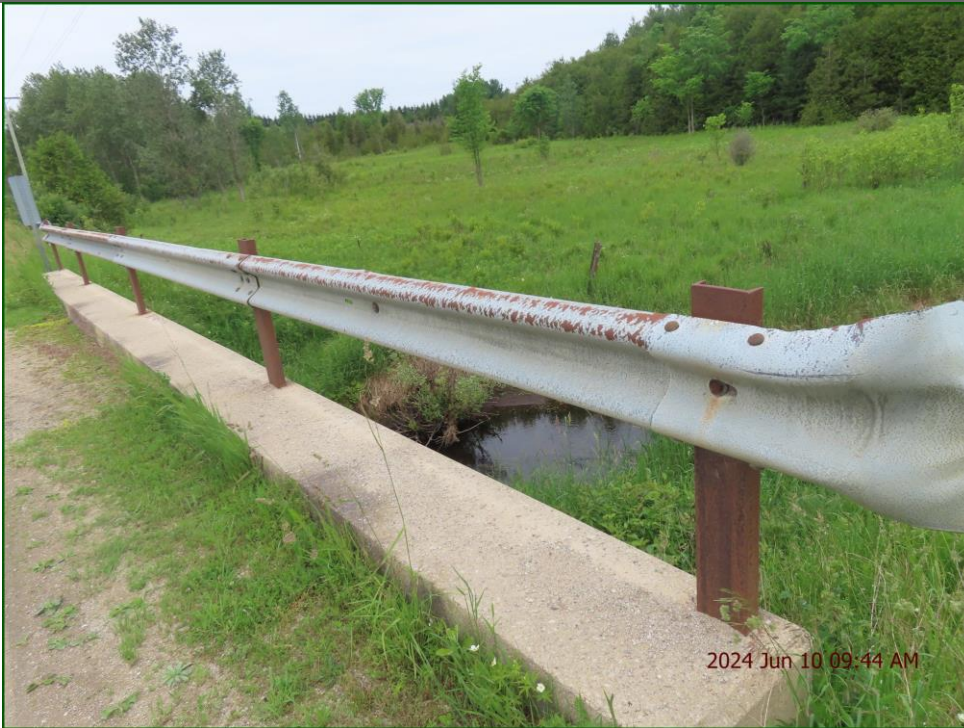
Light design, recommend upgrade.

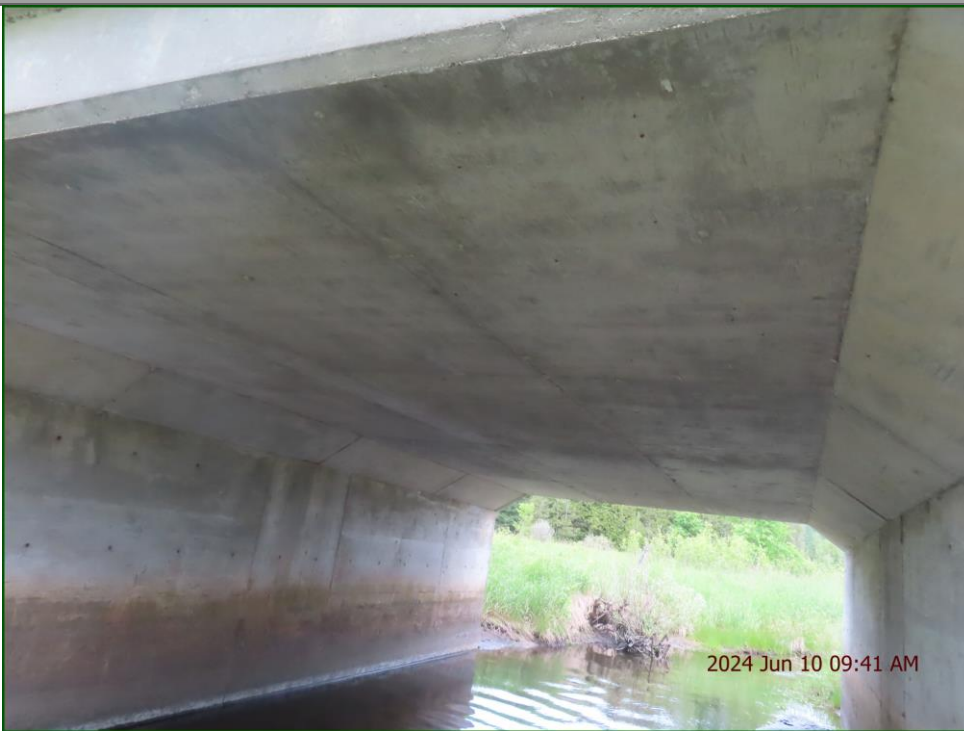
Light cracking and wetness staining.

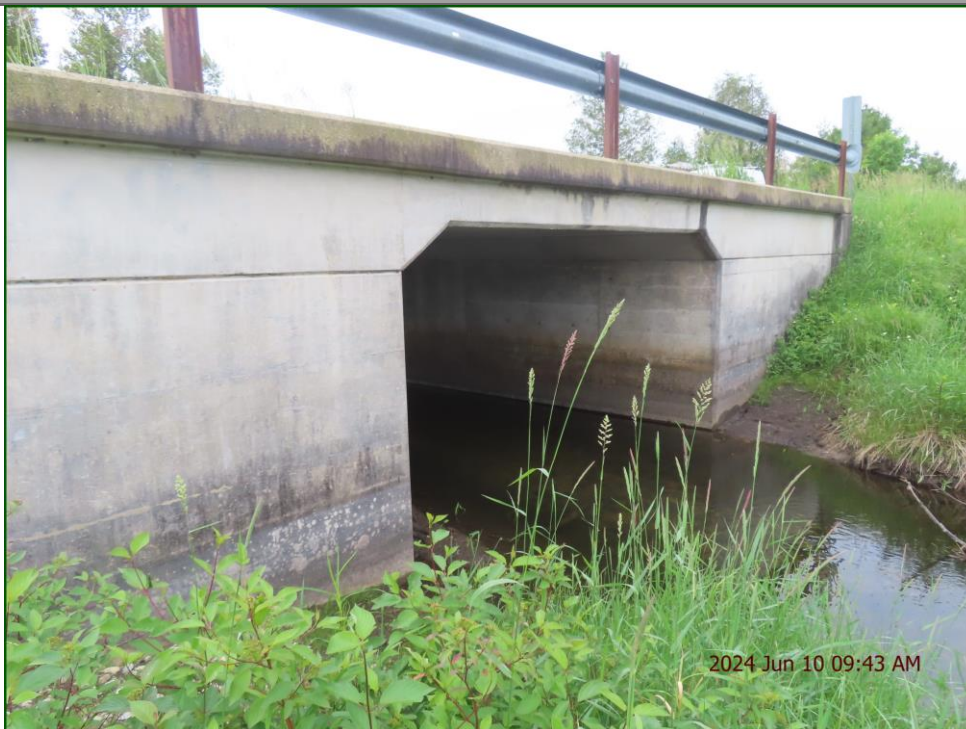
Light cracking with leachate staining.

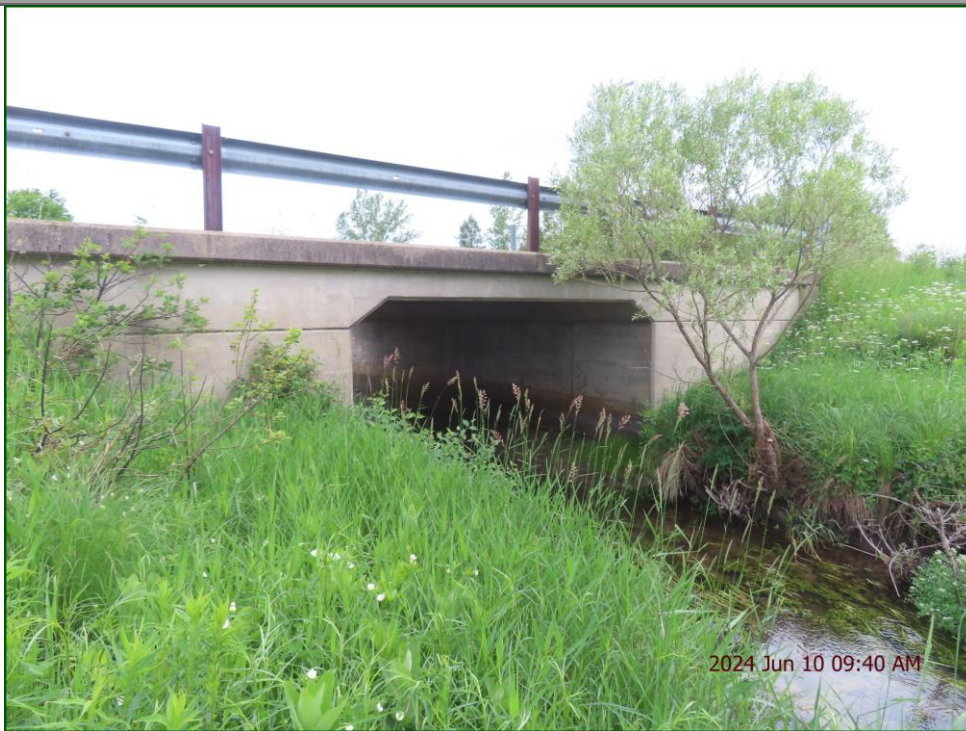
Light cracking with wetness staining.

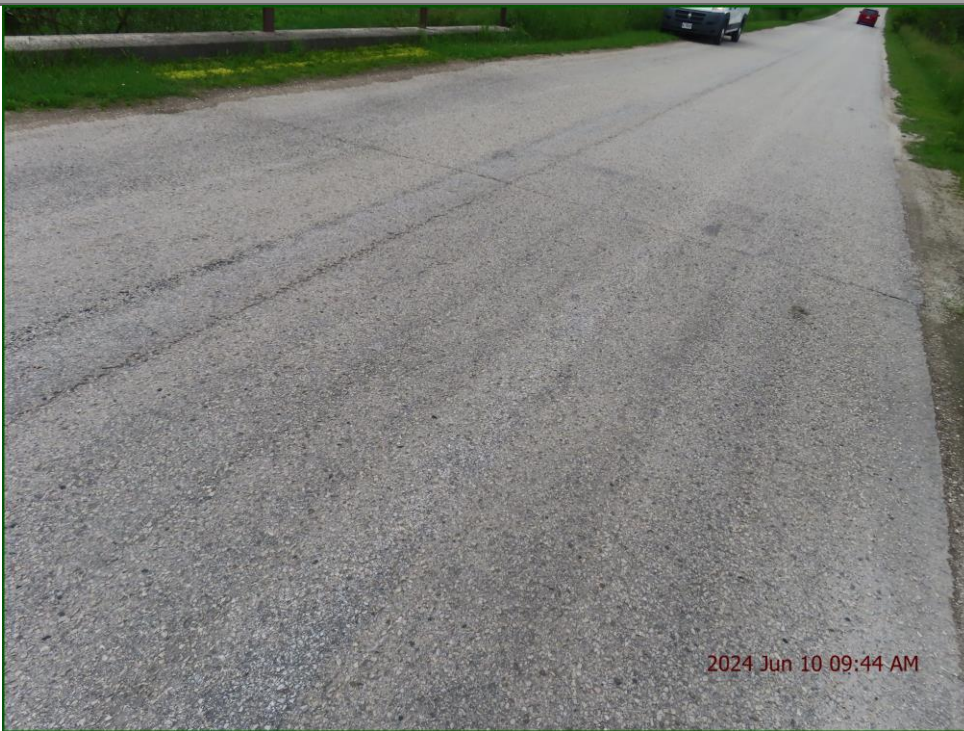
Light transverse cracking.
