Element Inspection

Date of Inspection:	31-Jul-24
Name of Inspector:	Andrew Burgess, P.Eng. & Joel Ziegler CET
Equipment Used:	Sounding hammer, measuring equipment, GPS
Weather Conditions:	Sunny
Temperature:	23
Special Notes:	Bridge is in good condition, showing no signs of structural distress.

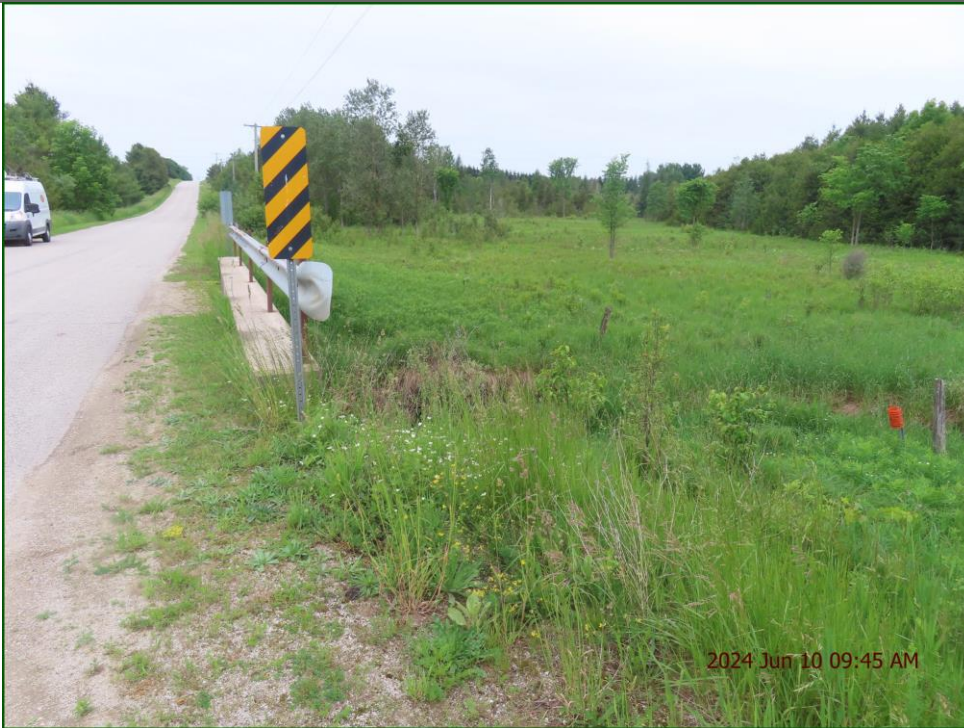
Moderate erosion at NW and NE corner.

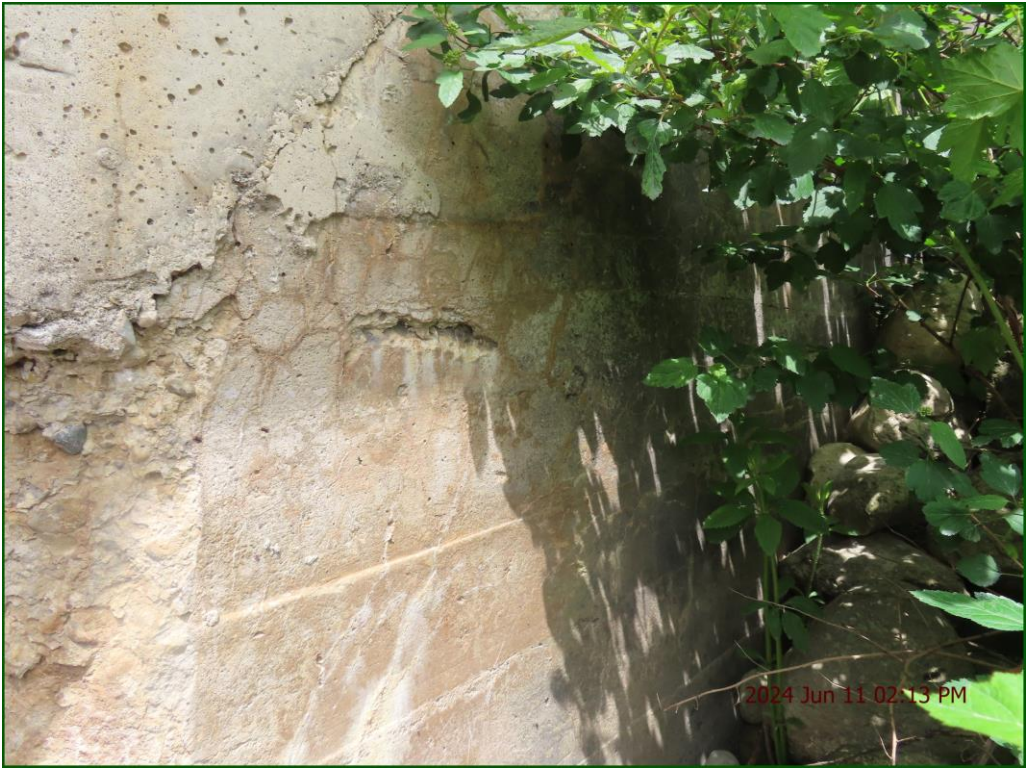
Description: Wingwalls: Medium to wide vertical cracking with wetness and leachate staining.

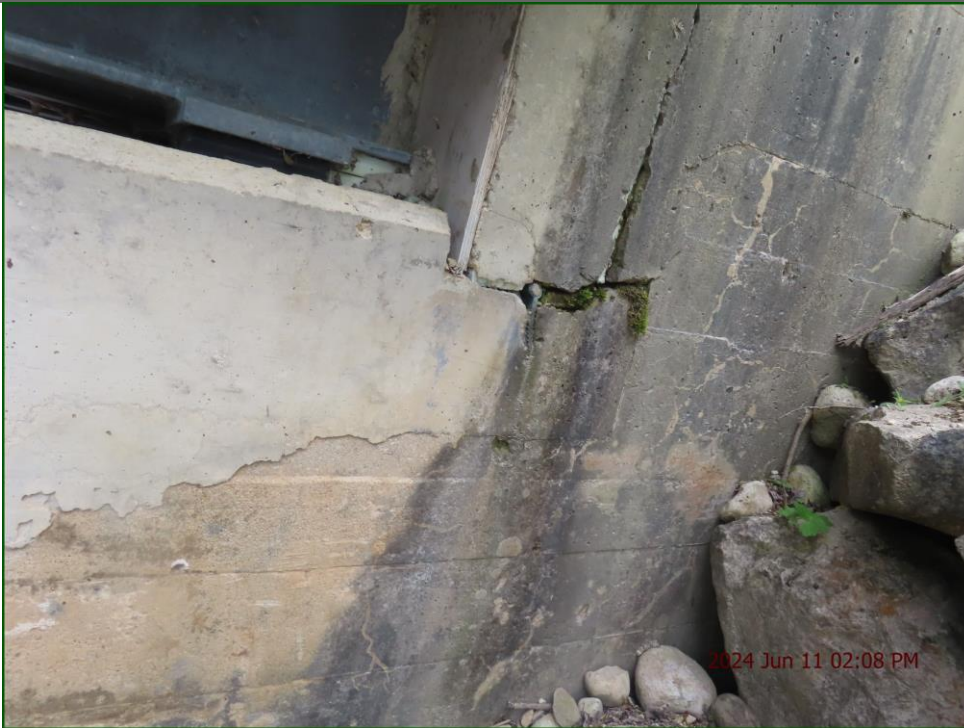
Medium to wide vertical cracking with wetness and leachate staining.

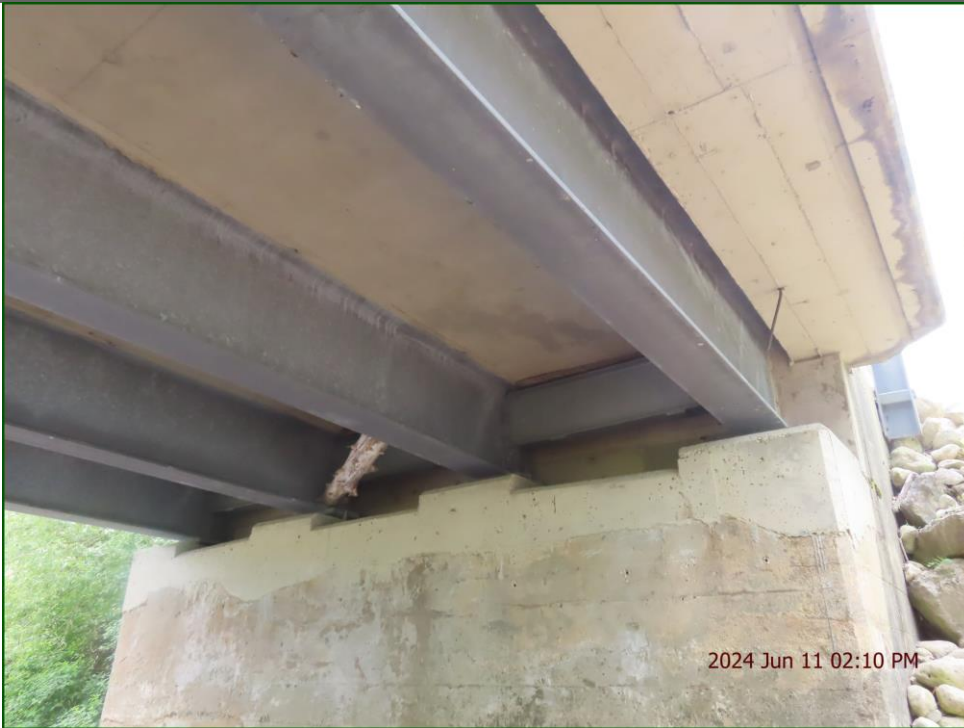
Limited inspection due to height of abutment.

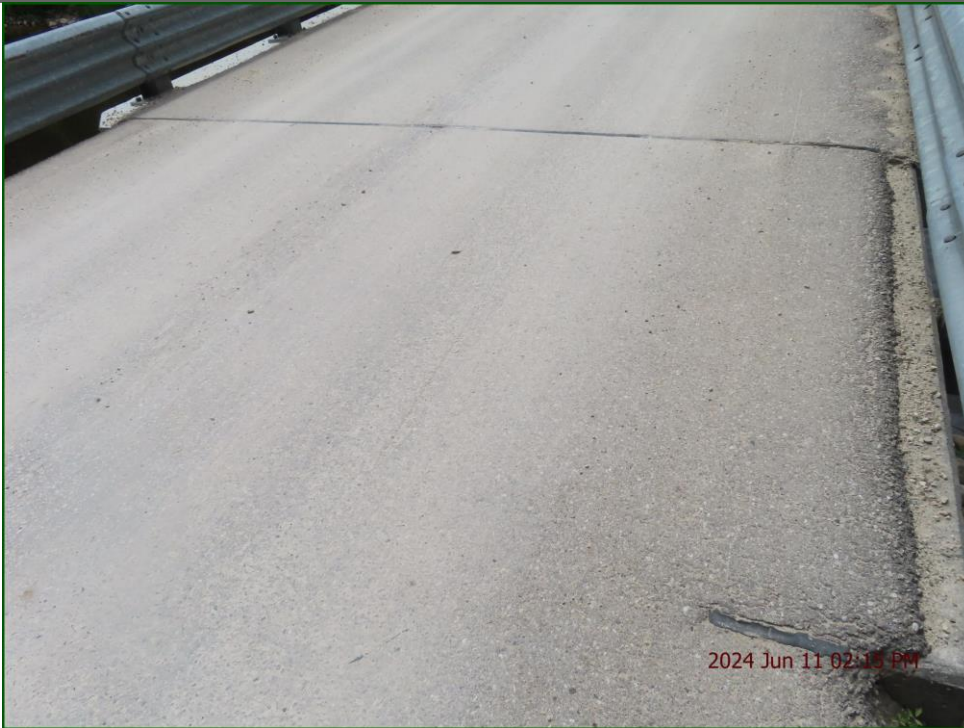
No signs of settlement.

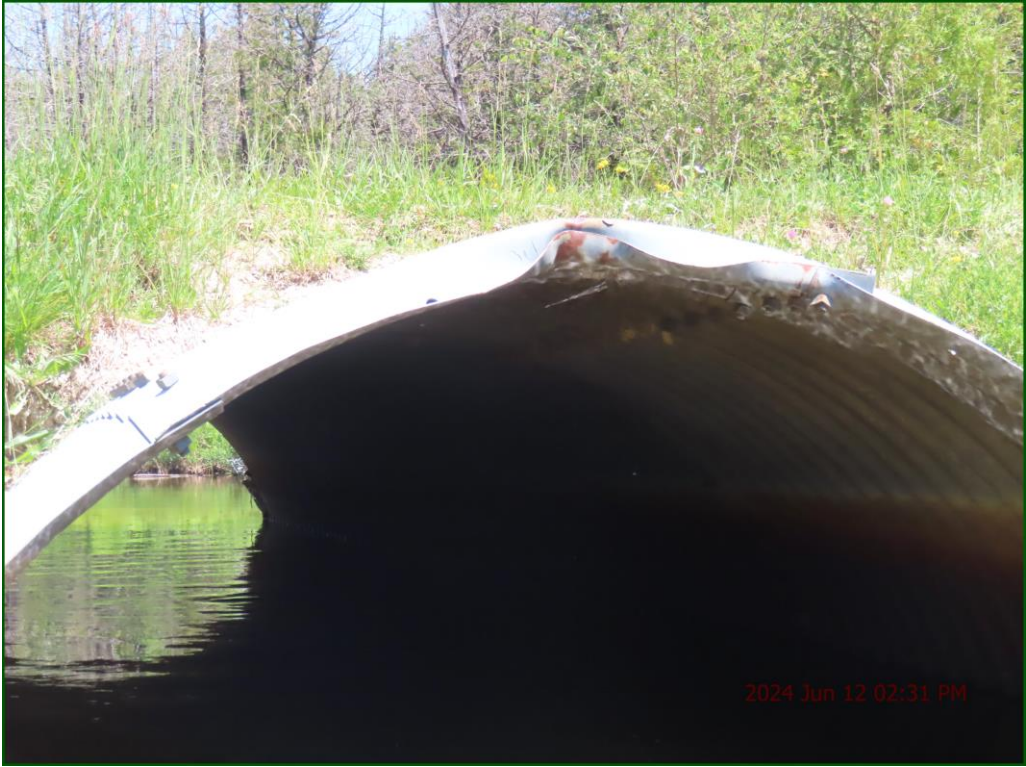
Description: Outlet: Minor impact damage.

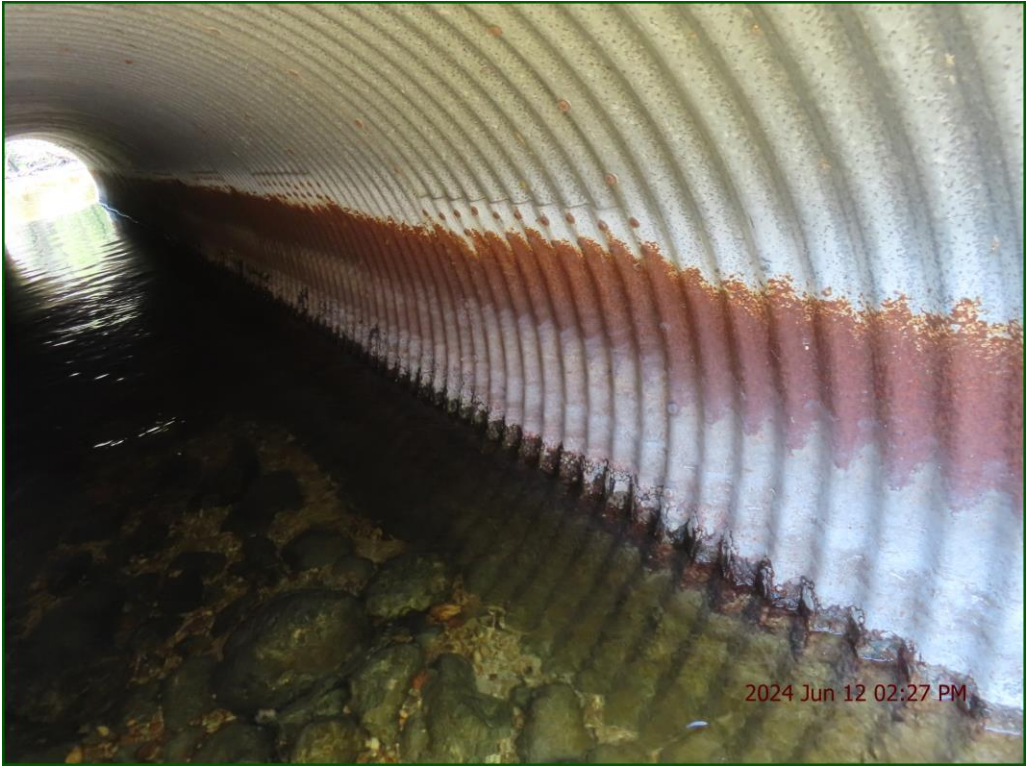
Description: Barrel: Light corrosion at water line.

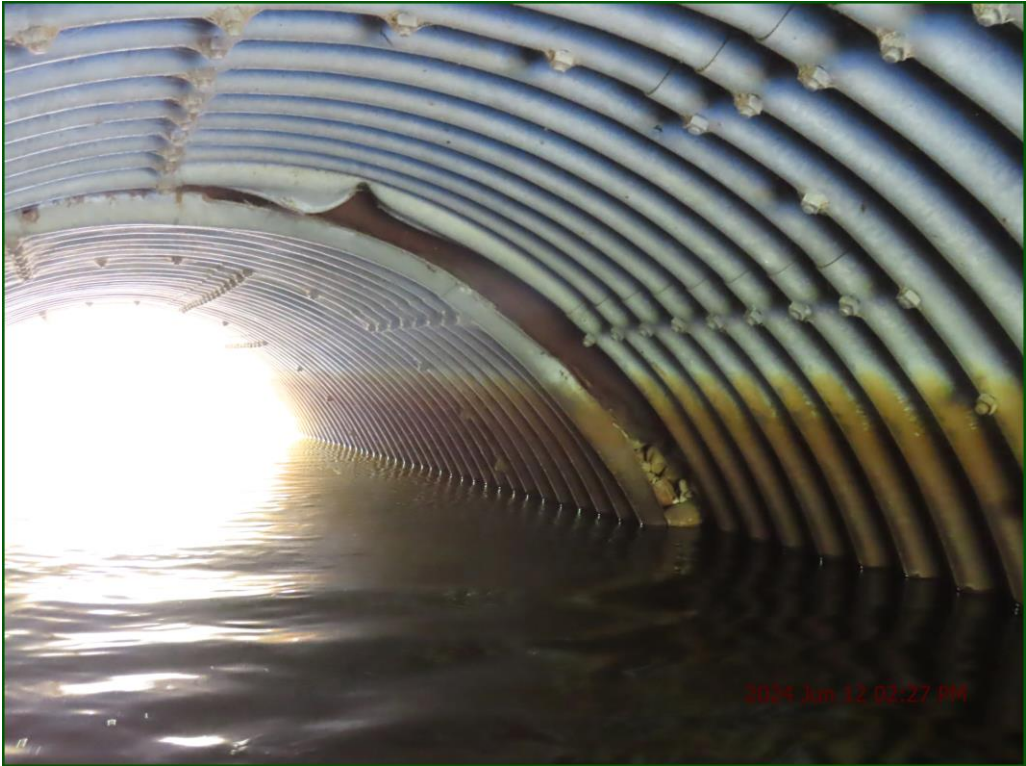
Description: Barrel: Separation of sections at mid point of south barrel.

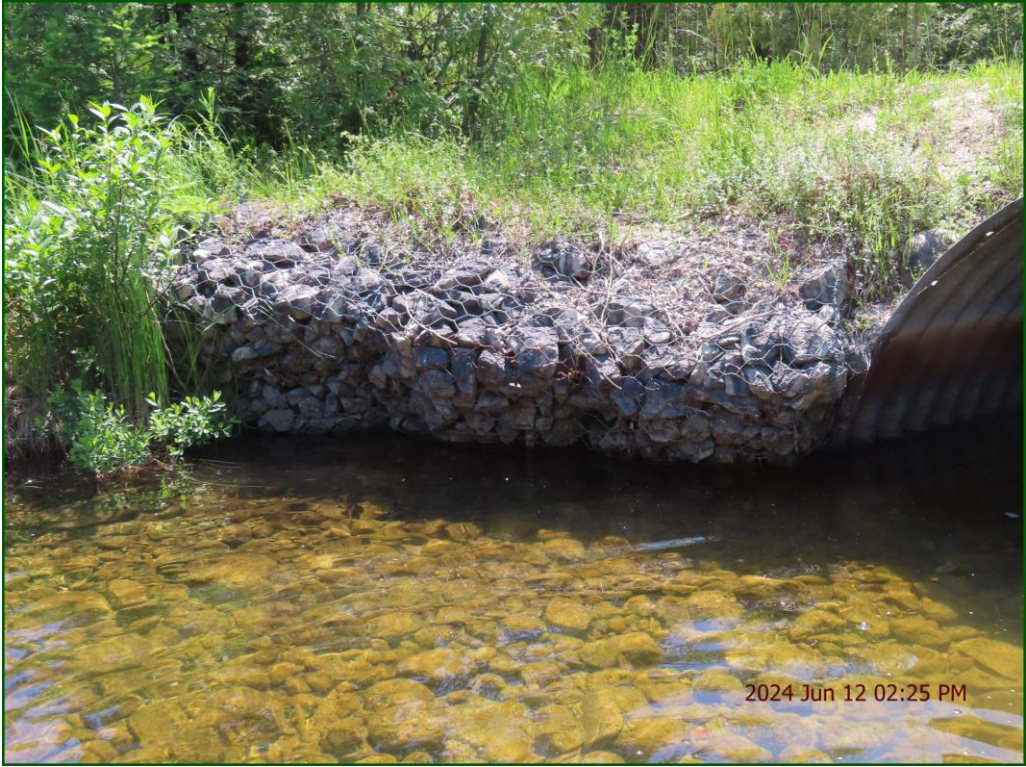
Description: Inlet: South gabion basket is leaning into river, monitor.

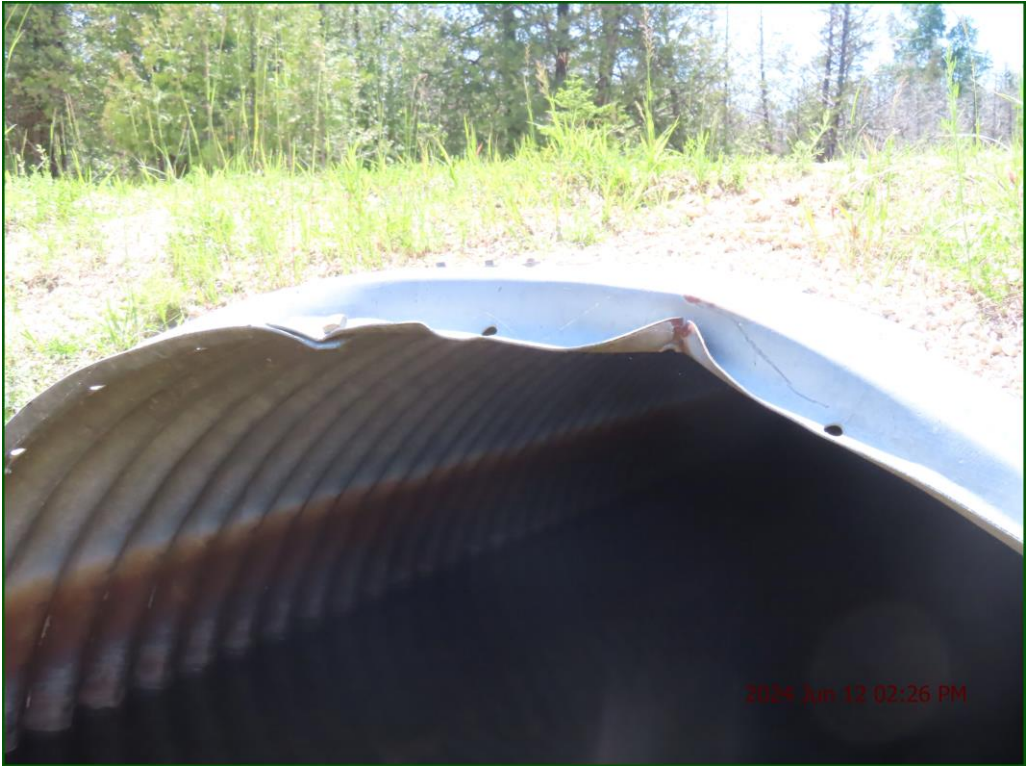
Description: Inlet: Minor impact damage.

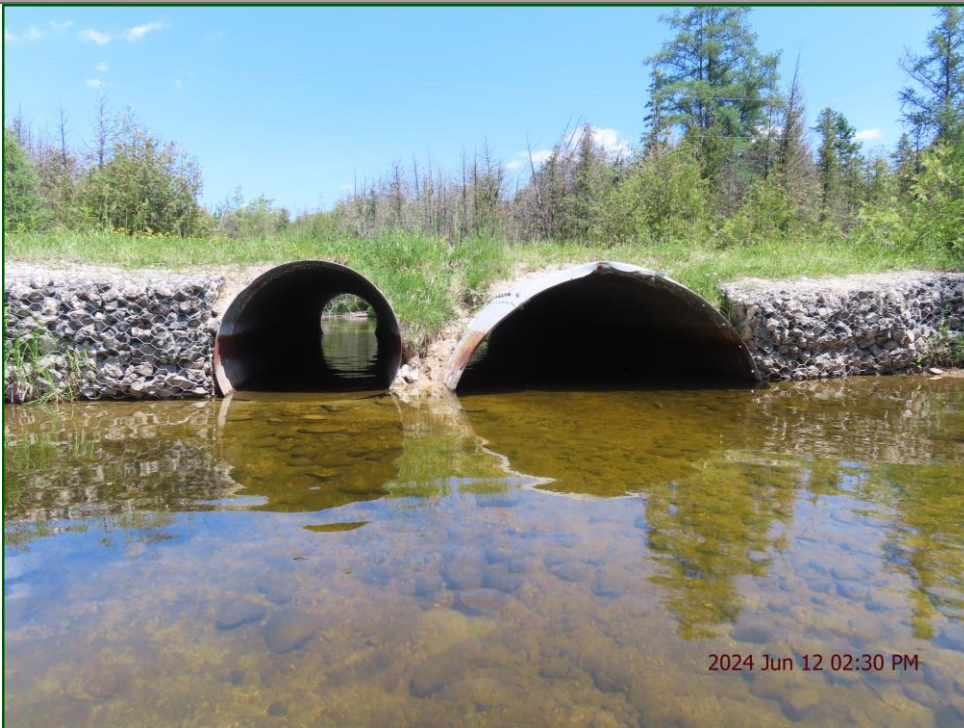
Minor impact damage.

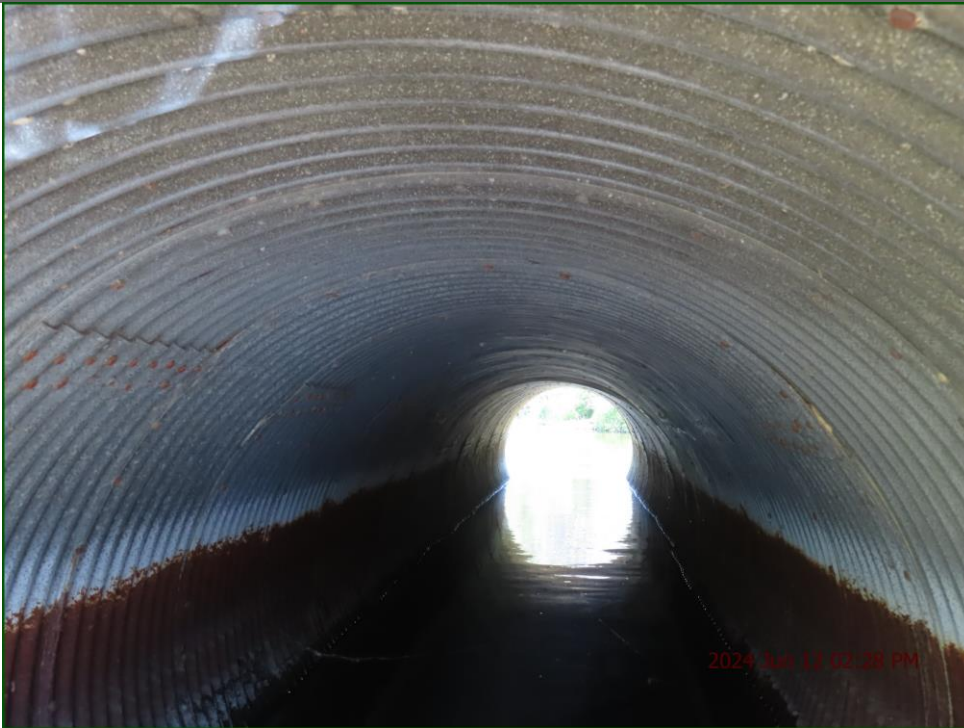
Light corrosion at water line. Separation of sections at mid point of south barrel.

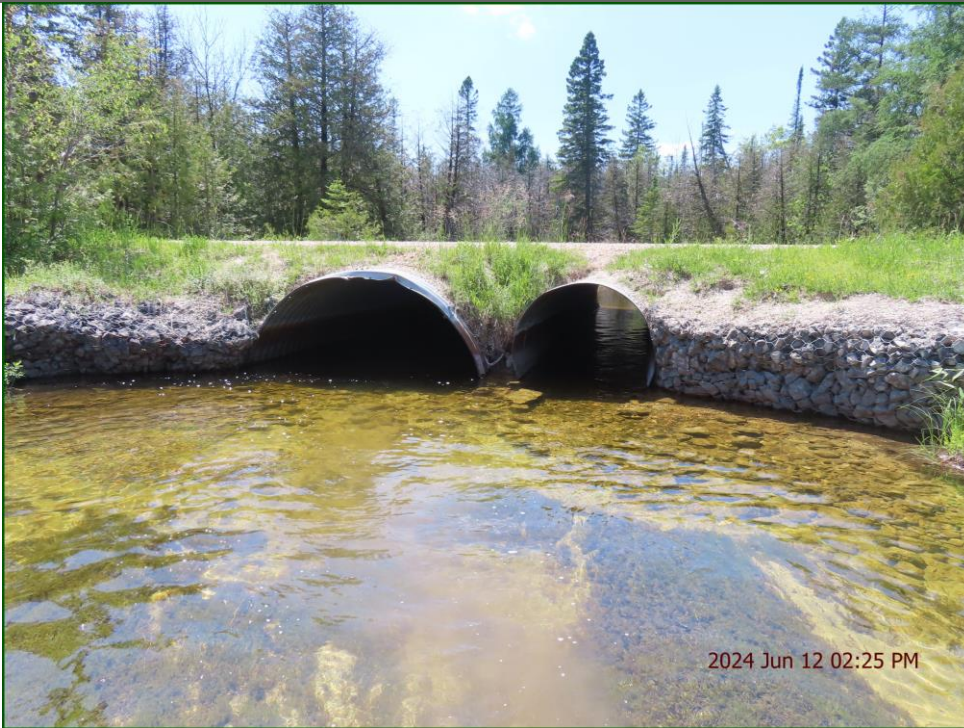
South gabion basket is leaning into river, monitor. Minor impact damage.

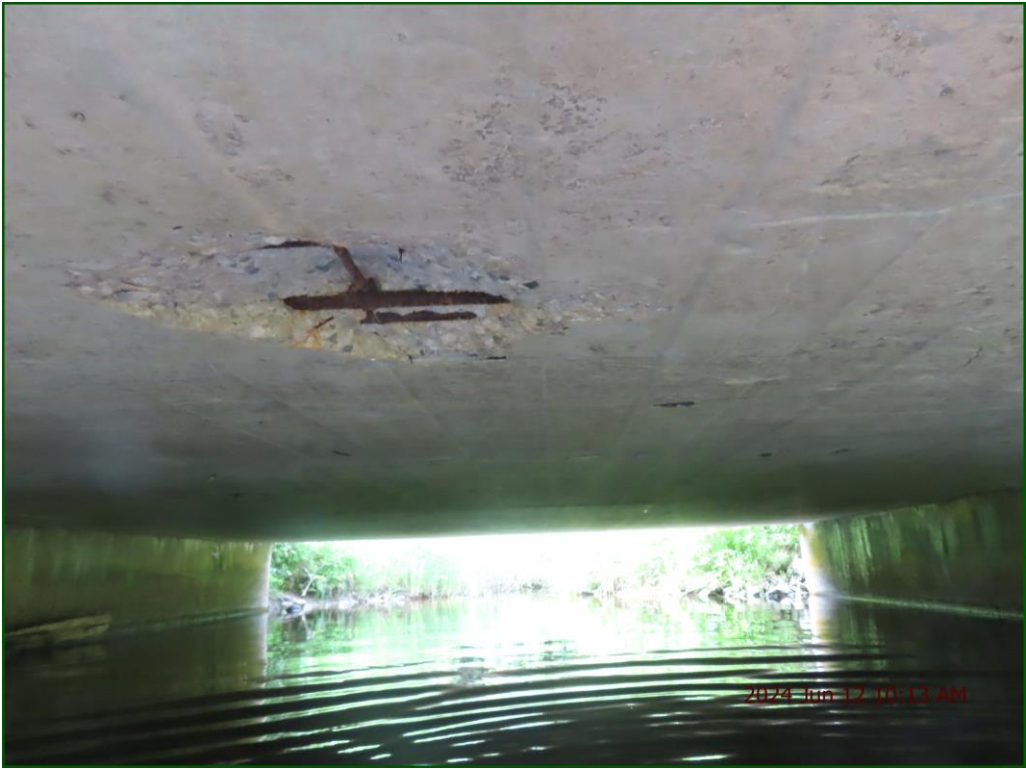
Description: Barrel: Severe localized spall with exposed reinforcing.

Severe localized spall with exposed reinforcing.

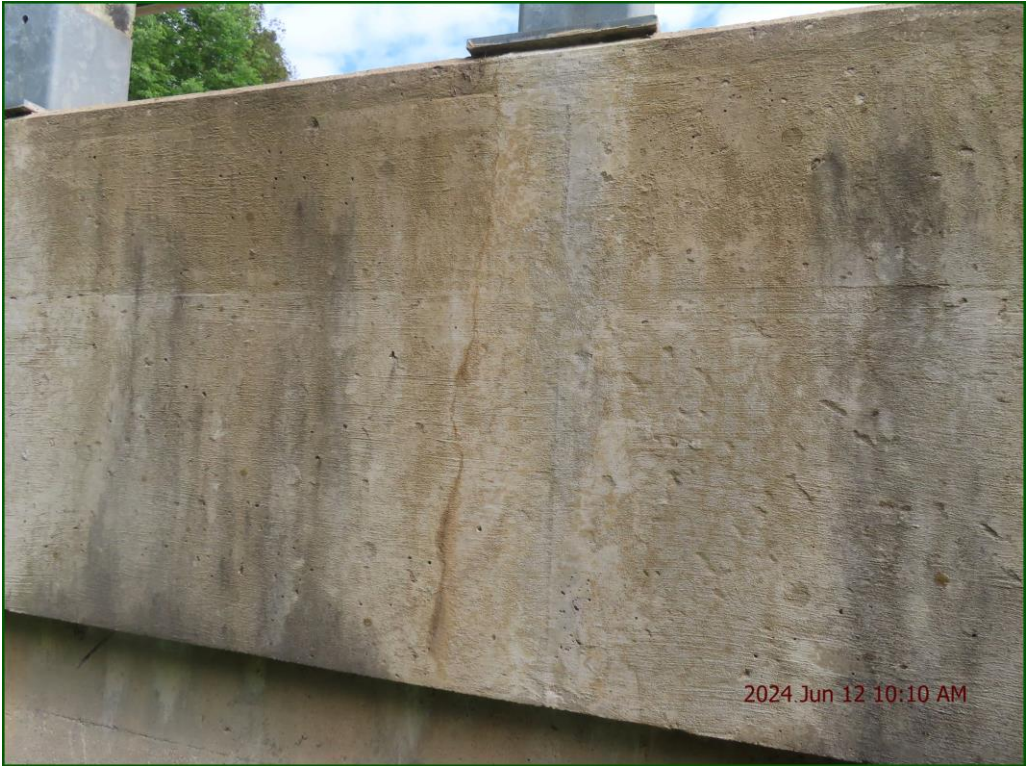
Description: Inlet: Light to medium vertical cracking with wetness staining.

Light to medium vertical cracking with wetness staining, typical by post locations.

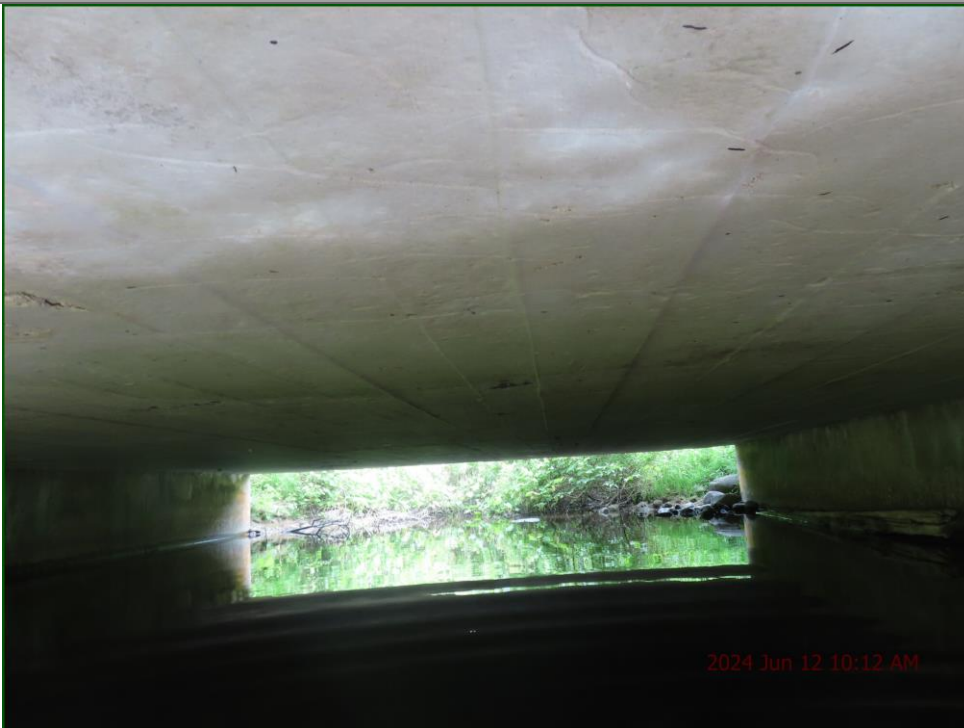
Light to medium horizontal cracking with leachate staining at corners. Light vertical cracking throughout, typical at post locations.

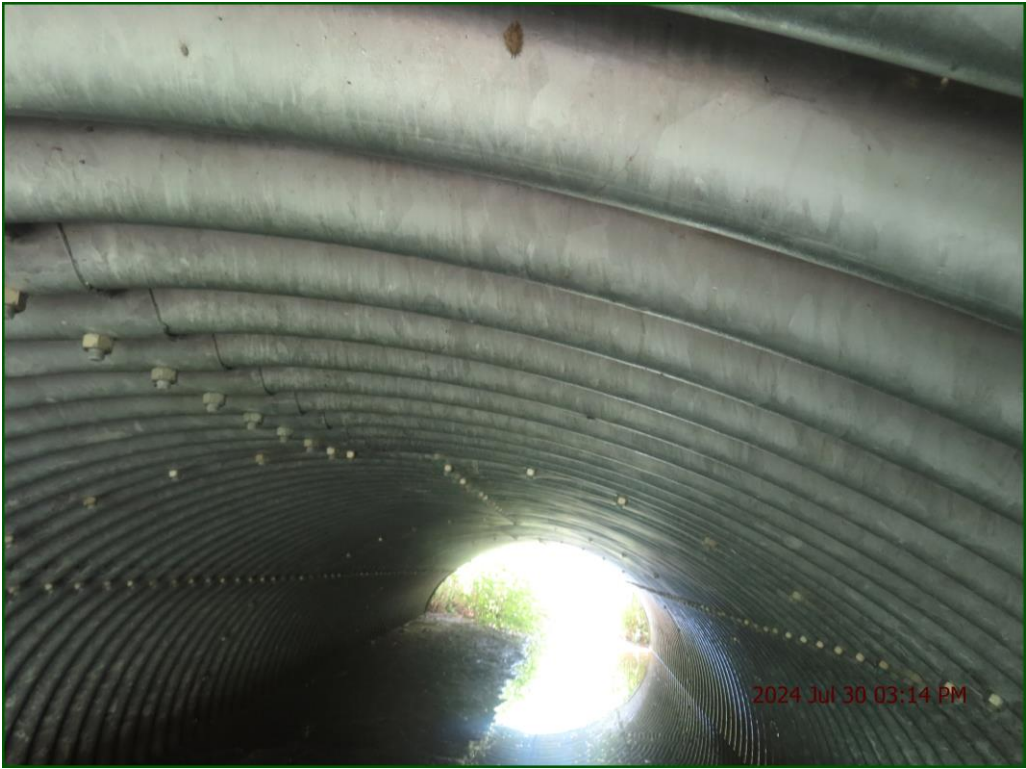
Description: Barrel: View from west.

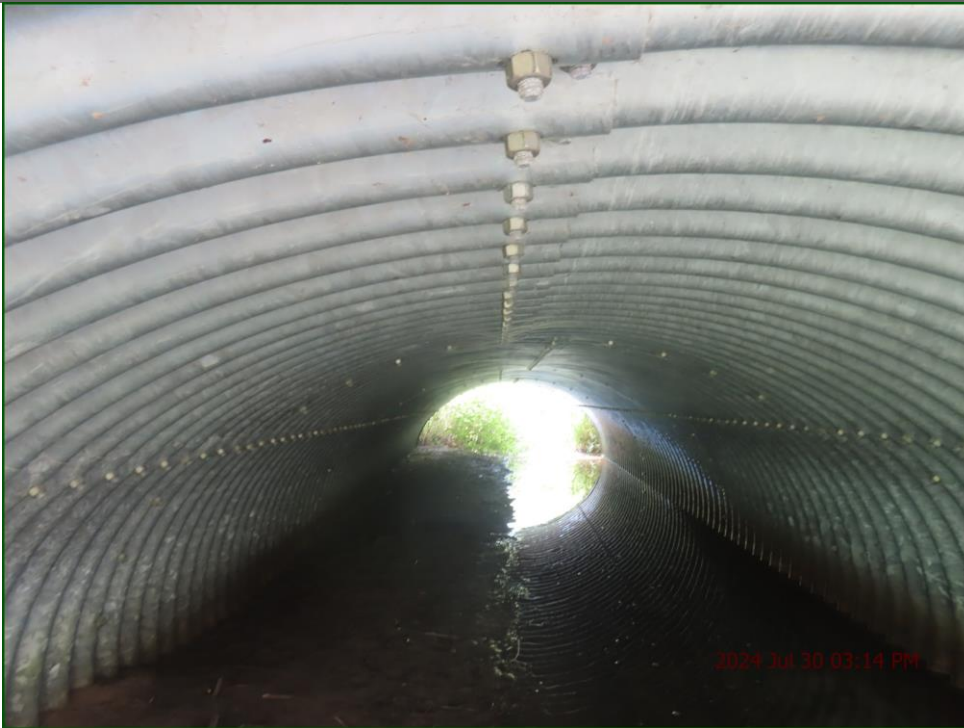
Minor deformations.

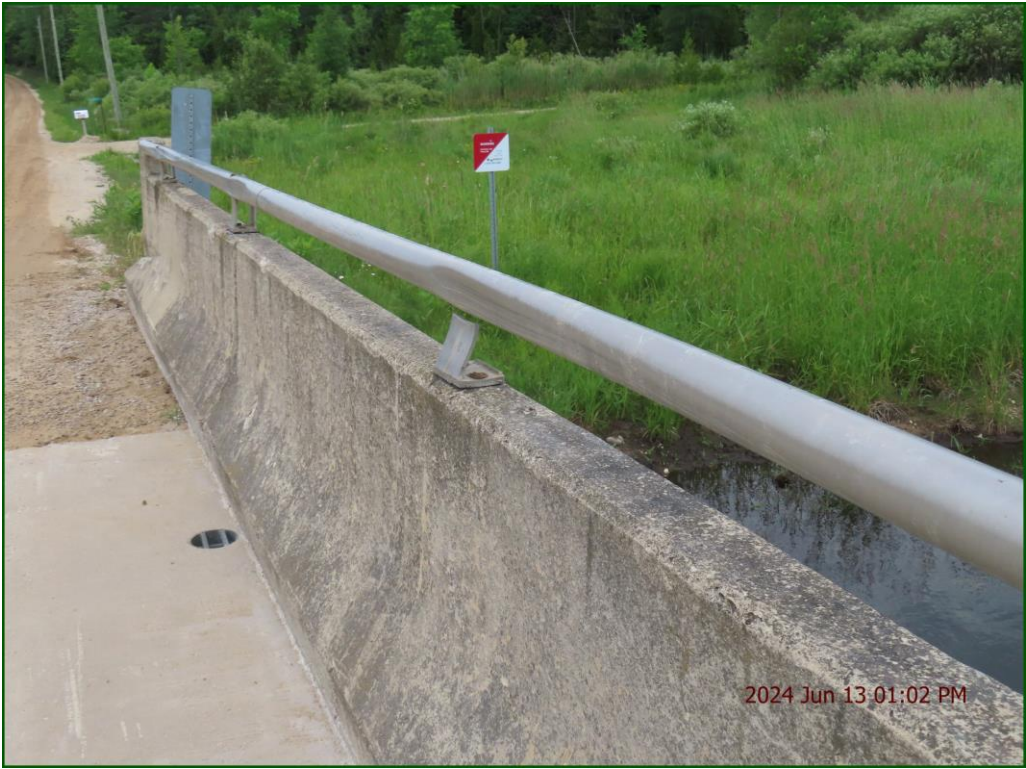
Description: Barrier/Parapet Walls: Shallow spall on NE corner.

Severe impact damage throughout. Shallow spall on NE corner.

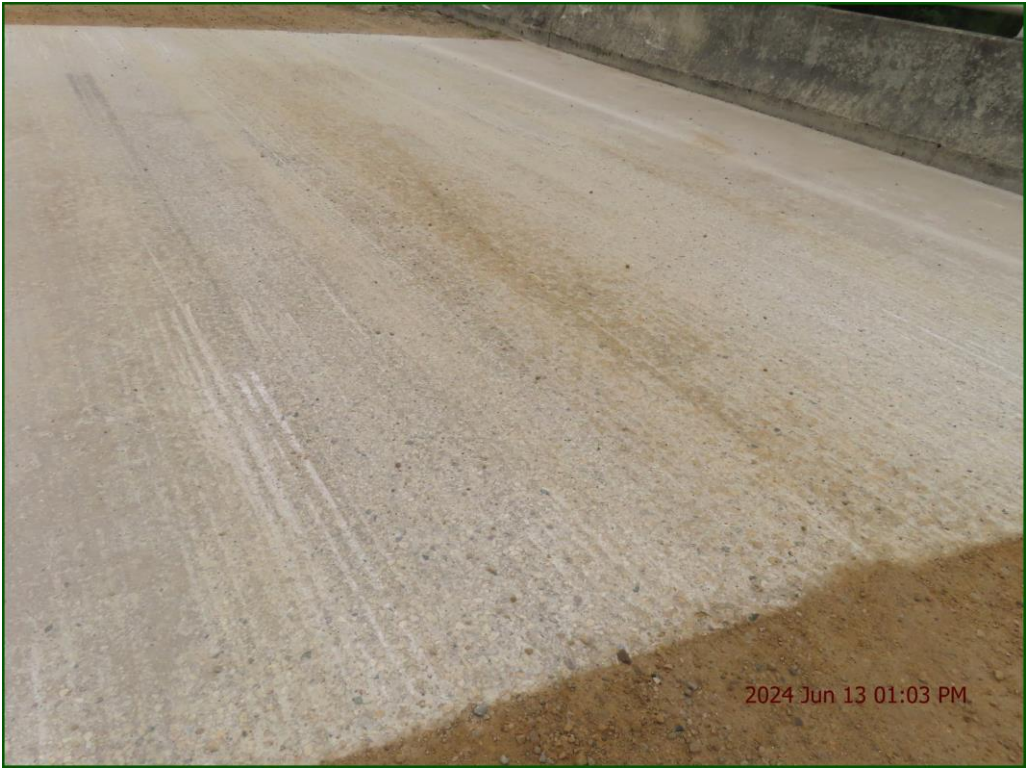
Description: Deck top: Light scaling throughout.

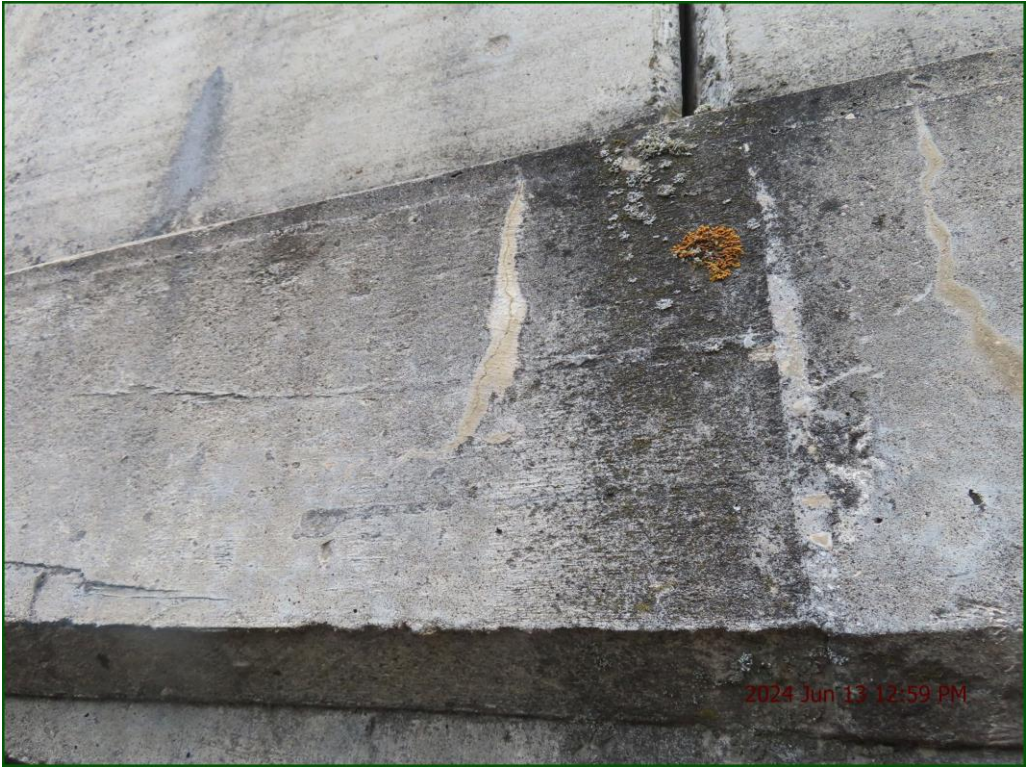
Description: Soffit (ext): Light vertical cracking with leachate staining throughout.

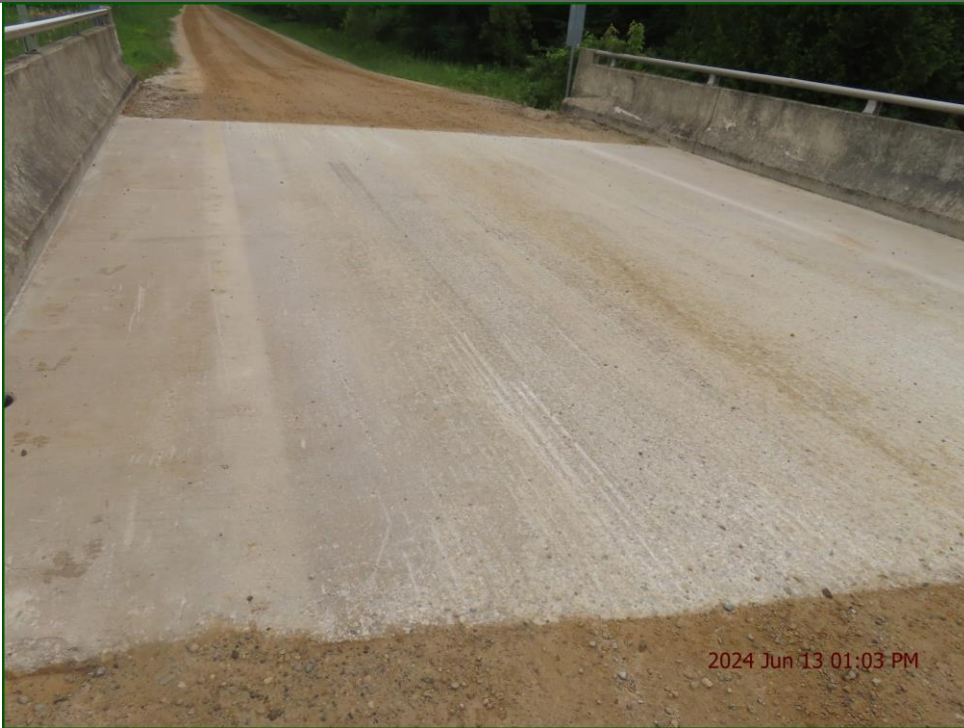
Light scaling throughout.

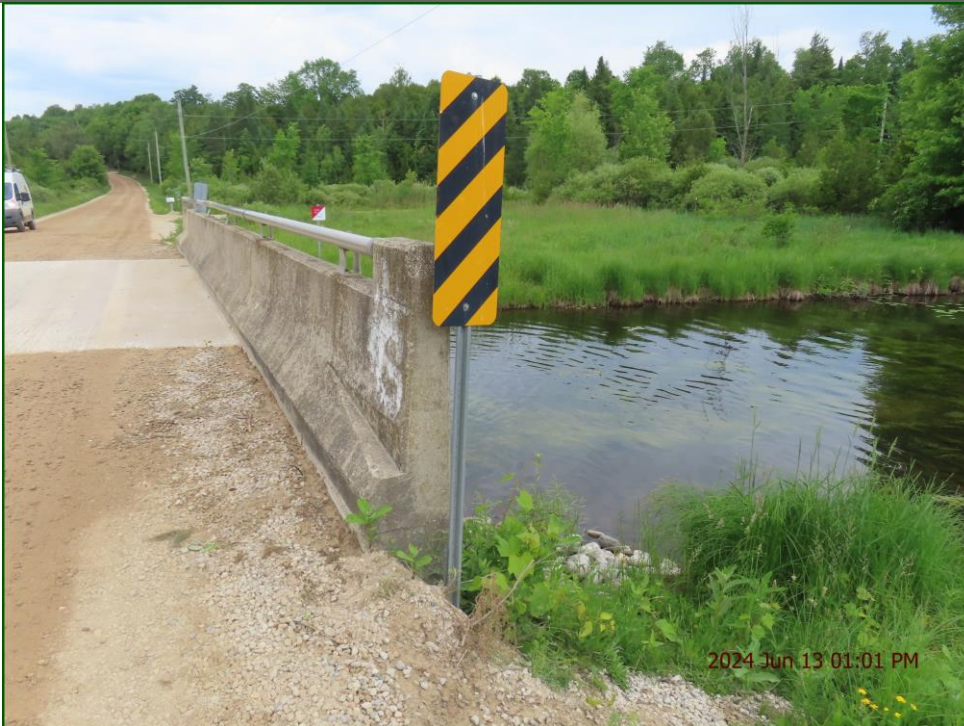
Steep embankments recommend approach protection.

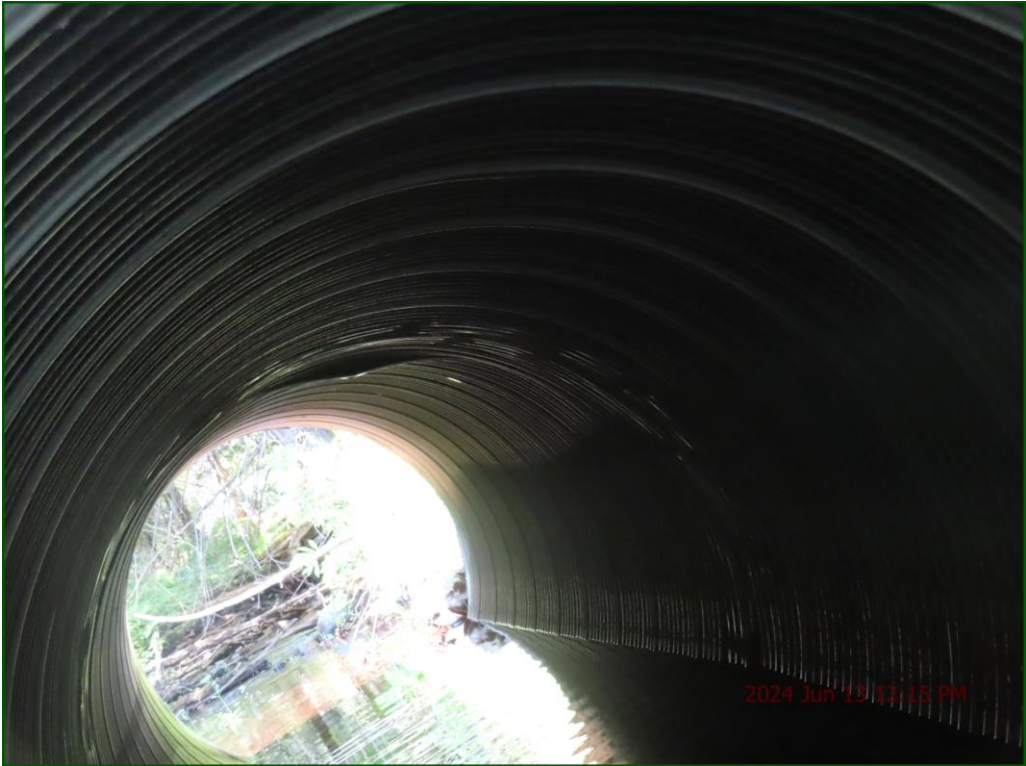
Description: Barrel: Minor deformations throughout.
