Final Dam Inspection Report

Durham Upper Dam and Dyke

**Municipality of West Grey,
County of Grey, Ontario**

D.M. Wills Project Number 22-5540

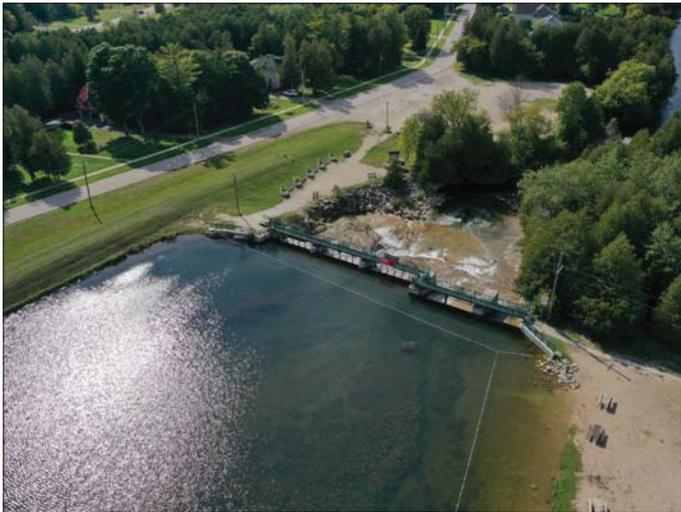
Photo 1 - September 19, 2022
Durham Upper Dam and Dyke
Aerial View of Upstream Side of Dam

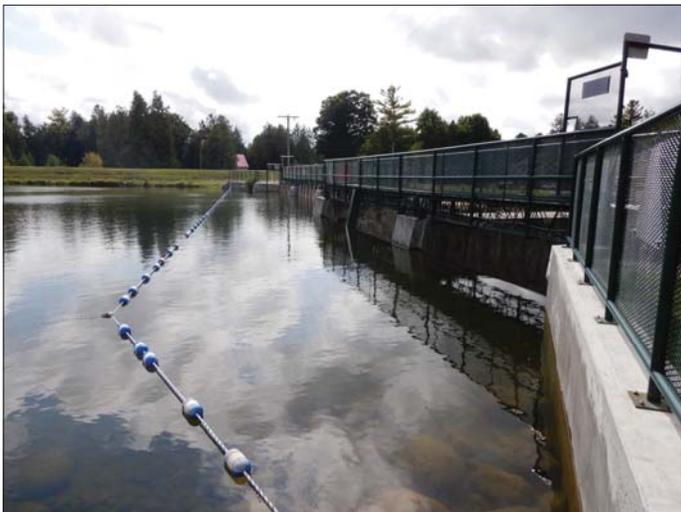
Photo 5 - September 19, 2022
Durham Upper Dam and Dyke
Buoy Line from Left Bank

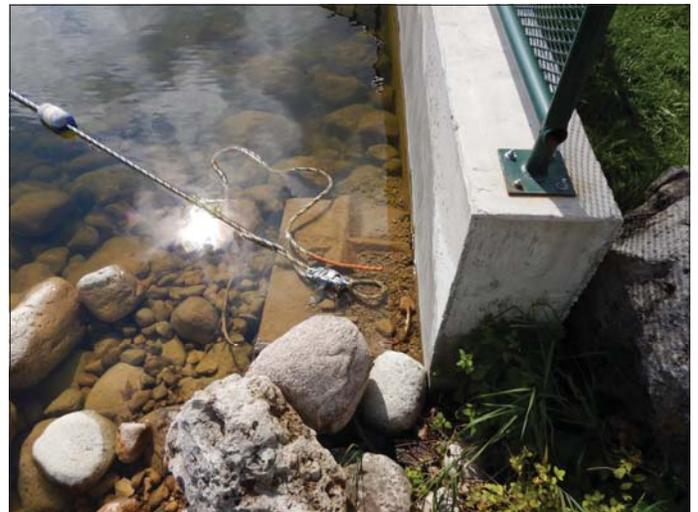
Photo 6 - September 19, 2022
Durham Upper Dam and Dyke
Left Side Buoy Line Anchor

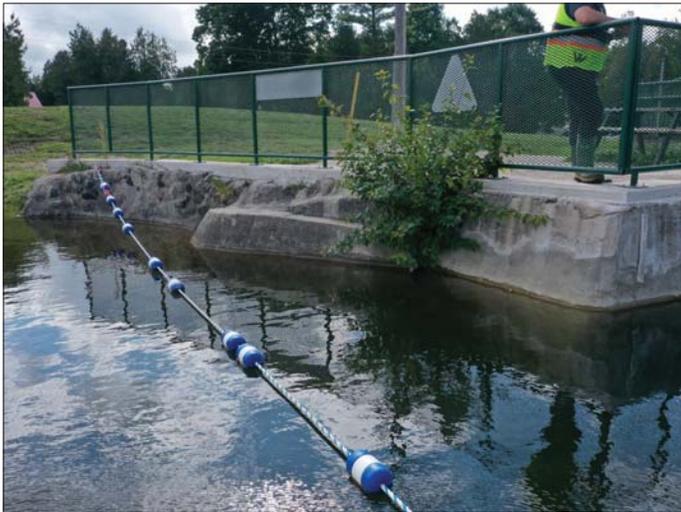
Photo 7 - September 19, 2022
Durham Upper Dam and Dyke
Upstream Right Wingwall

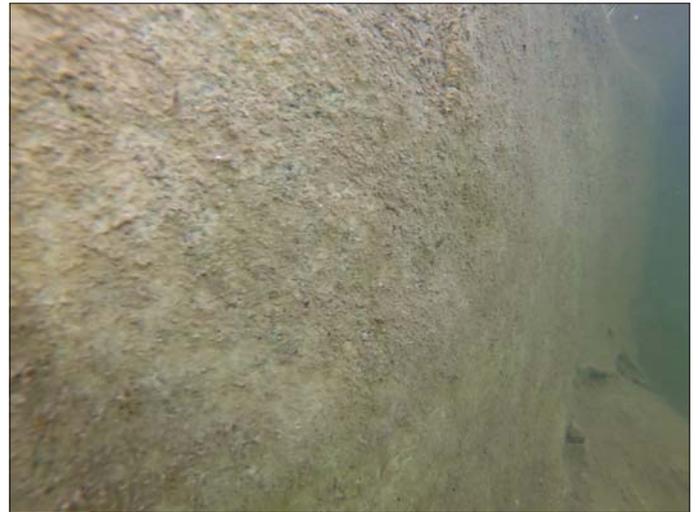
Photo 8 - September 19, 2022
Durham Upper Dam and Dyke
Upstream Right Wingwall

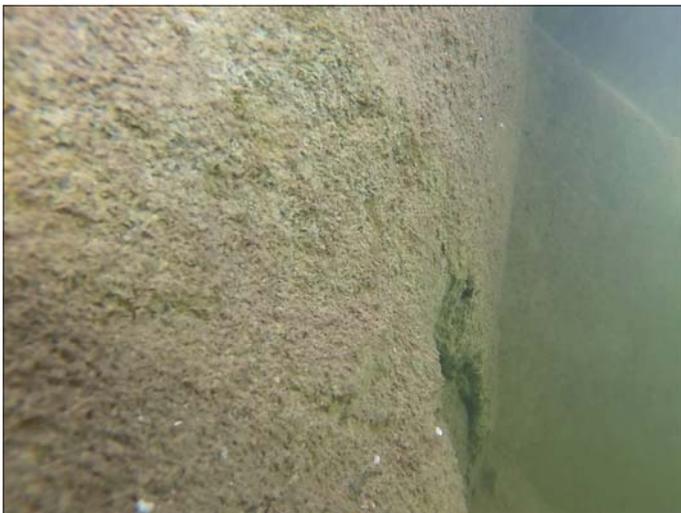
Photo 9 - September 19, 2022
Durham Upper Dam and Dyke
Upstream Right Wingwall

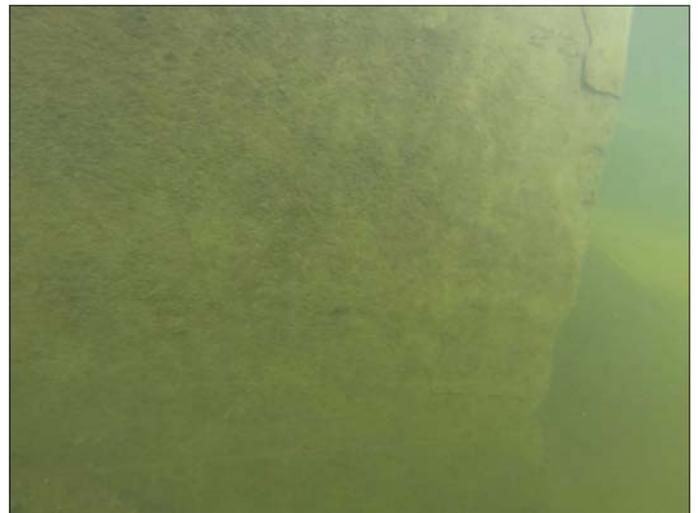
Photo 10 - September 19, 2022
Durham Upper Dam and Dyke
Upstream Right Wingwall

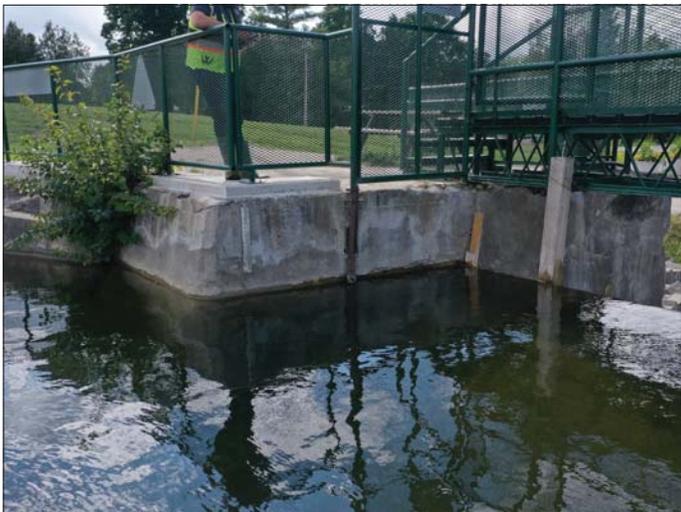
Photo 11 - September 19, 2022
Durham Upper Dam and Dyke
Left Side of Pier 6

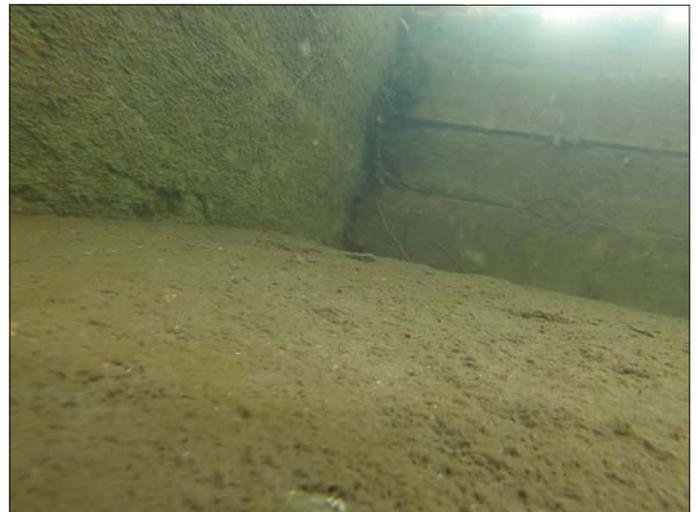
Photo 12 - September 19, 2022
Durham Upper Dam and Dyke
Sluice 5 at Right Abutment

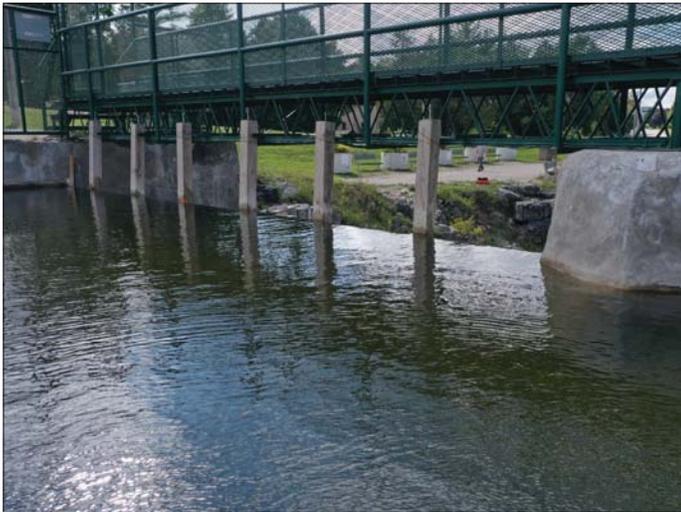
Structure	Location	Deficiency / Description	Condition Rating	Risk Rating
Spillways	Downstream	None (Photos: 53, 57, 61, 66, 70)	4	1
Wooden and Metal Structures				
Pedestrian Bridge	Above	Some degree of corrosion, recently recoated. Needs to be constantly repaired due to ice loading (Photos: 83, 85, 86-87)	3	2
Railings	Throughout	None (Photos: 43, 79, 86)	4	1
Flow Control Equipment				
Stoplogs	Sluiceway 1	4-ply 2x10s bending severely (Photos: 38-39)	1	3
	Sluiceway 2	None (Photo: 34)	4	1
Flashboards	Sluiceways 3, 4, 5	None (Photos: 13-14, 19-20, 25-26)	4	1

Photo 13 - September 19, 2022
Durham Upper Dam and Dyke
Upstream Side of Sluiceway 5

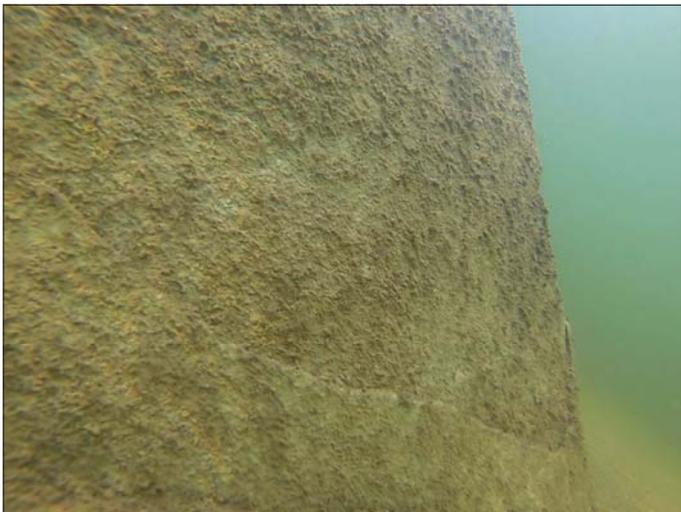
Photo 17 - September 19, 2022
Durham Upper Dam and Dyke
Upstream Side of Pier 4

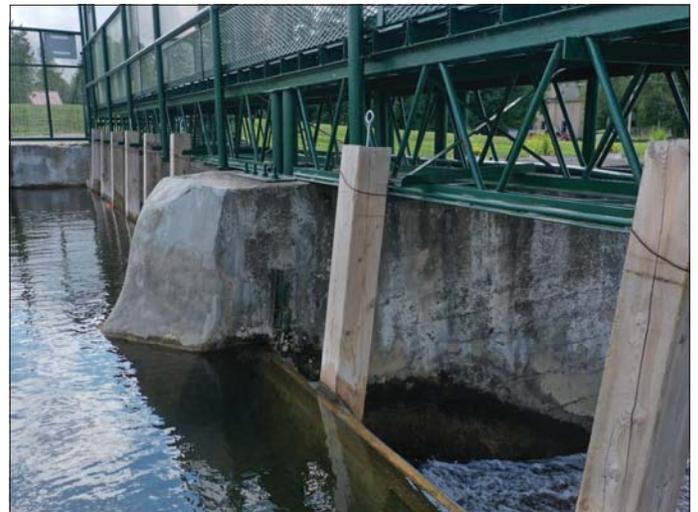
Photo 18 - September 19, 2022
Durham Upper Dam and Dyke
Left Side of Pier 4

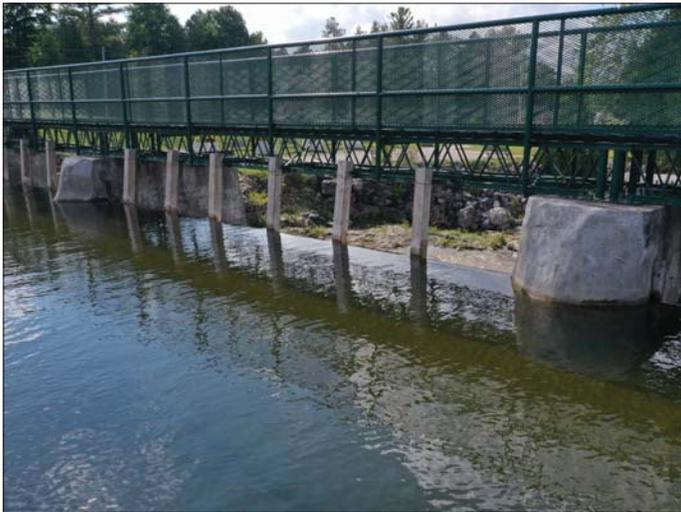
Photo 19 - September 19, 2022
Durham Upper Dam and Dyke
Upstream Side of Sluiceway 4

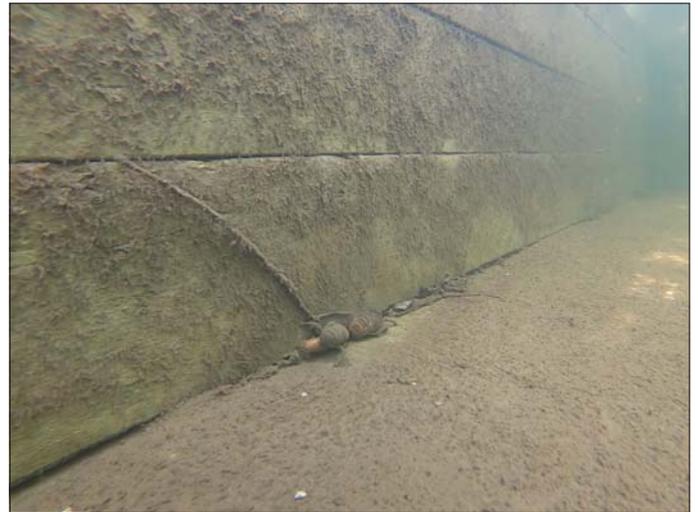
Photo 20 - September 19, 2022
Durham Upper Dam and Dyke
Stoplogs in Sluiceway 4

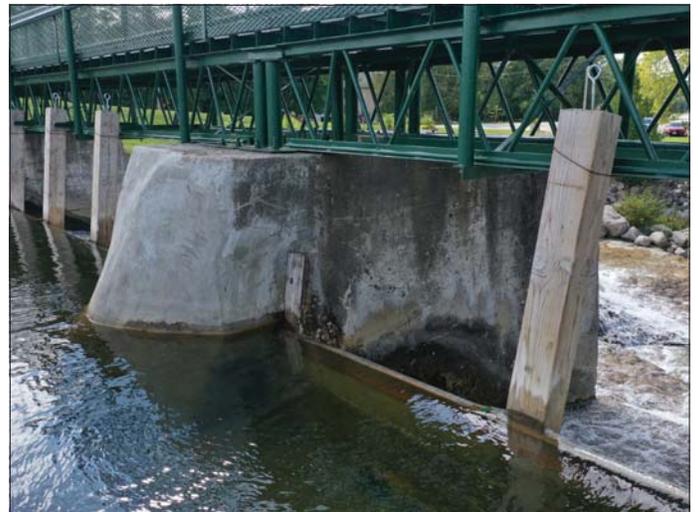
Structure	Location	Deficiency / Description	Condition Rating	Risk Rating
Earth Embankment				
Earth Embankments	Flood Dyke	Steep slopes on the left side of the embankment, grass cut short exposing bare soil, Concrete culverts through dyke partially filled with sediment (Photos: 97-106)	4	1
	Right Embankment	None (Photo: 49)	4	1
	Left Embankment	None (Photo: 95)	4	1
Concrete Structures				
Abutment	Left Abutment	Light scaling and cracking. Localized spalling (Photos: 40, 70-71)	4	1
	Right Abutment	Repaired area has delaminated. Moss growth, severe scaling, large spall. Seepage through abutment, exiting through concrete block retaining wall. (Photos: 11, 12, 49, 50, 52)	2	1
Piers	Pier 1	Medium scaling. Cracking with efflorescence along cold joint (Photos: 35-38, 67-69)	3	1
	Pier 2	Medium scaling, large spalling. Medium to wide cracking (Photos: 28-32, 63-65)	3	1
	Pier 3	Medium scaling, localized spalling (Photos; 21-24, 58-60)	3	1

Photo 24 - September 19, 2022
Durham Upper Dam and Dyke
Left Side of Pier 3

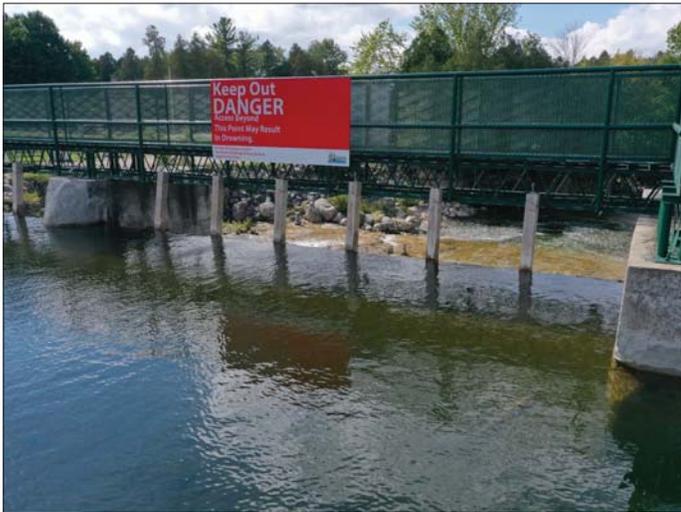
Photo 25 - September 19, 2022
Durham Upper Dam and Dyke
Upstream Side of Sluiceway 3

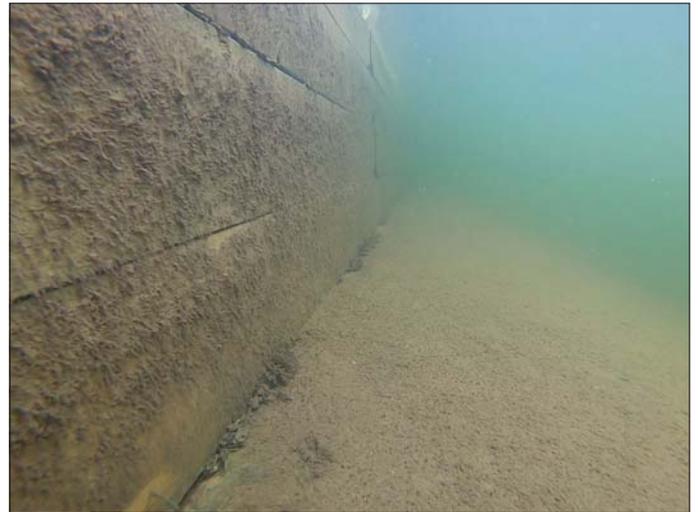
Photo 26 - September 19, 2022
Durham Upper Dam and Dyke
Stoplogs in Sluiceway 3

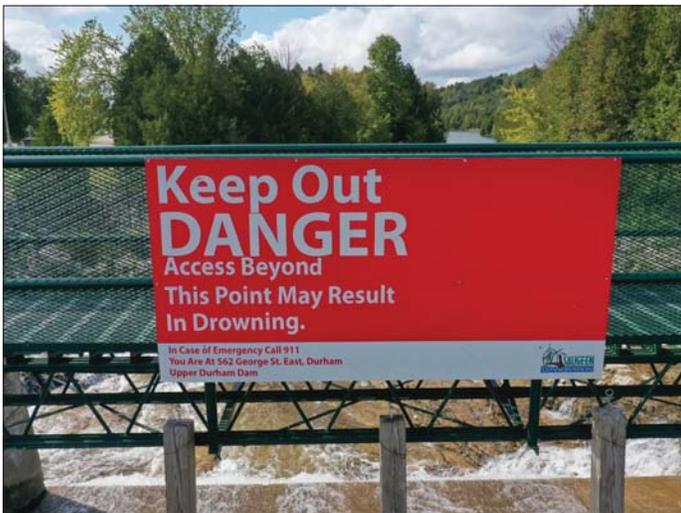
Photo 27 - September 19, 2022
Durham Upper Dam and Dyke
Upstream Facing Public Safety Sign

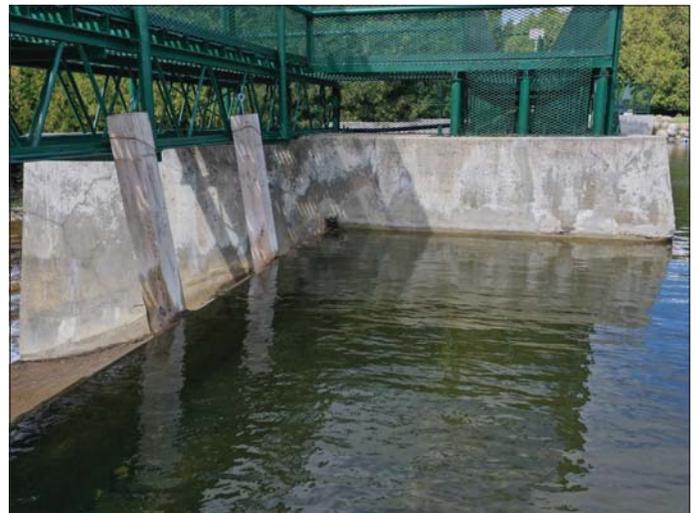
Photo 28 - September 19, 2022
Durham Upper Dam and Dyke
Right Side of Pier 2

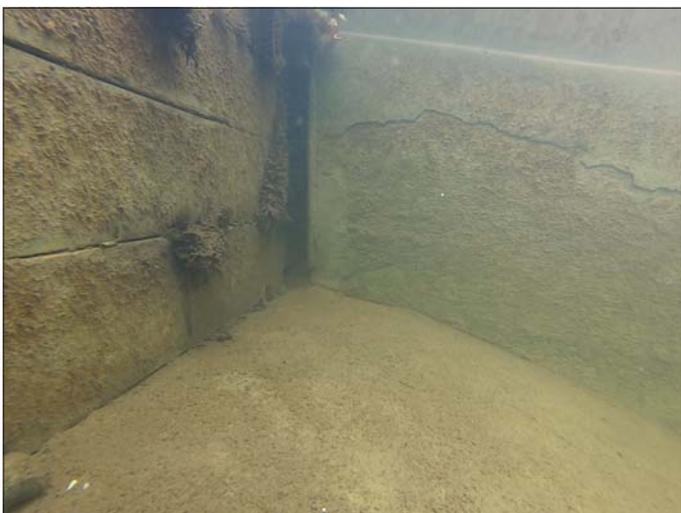
Photo 29 - September 19, 2022
Durham Upper Dam and Dyke
Right Side of Pier 2

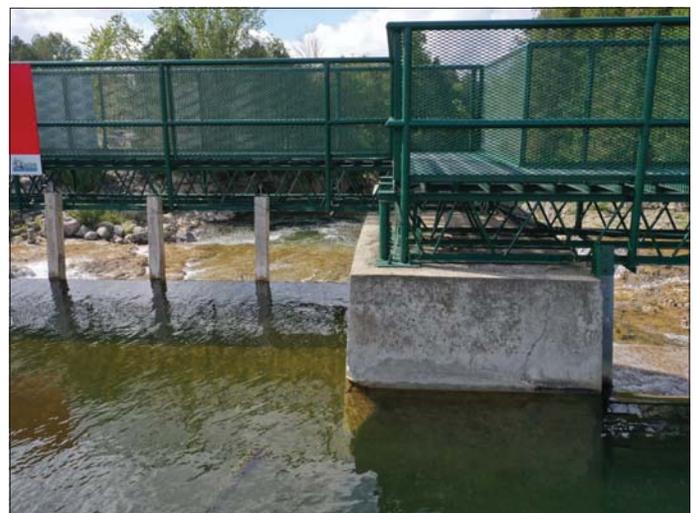
Photo 30 - September 19, 2022
Durham Upper Dam and Dyke
Upstream Side of Pier 2

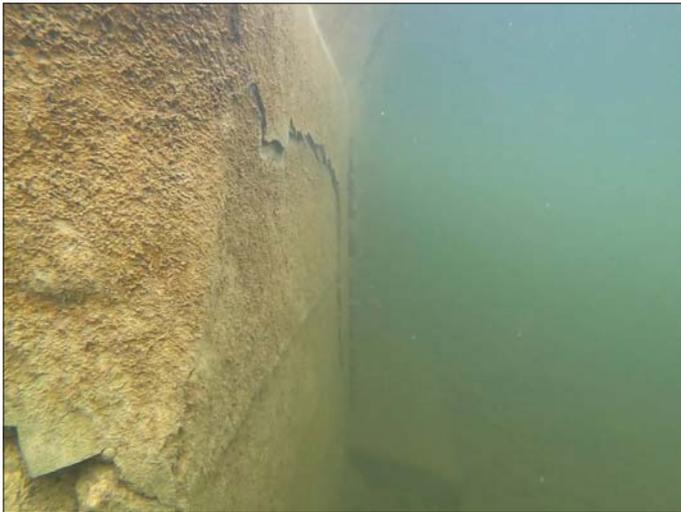
Photo 31 - September 19, 2022
Durham Upper Dam and Dyke
Upstream Side of Pier 2

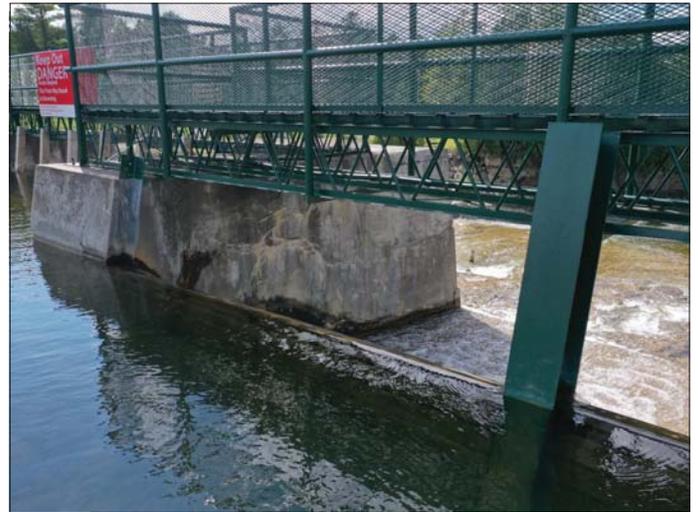
Photo 32 - September 19, 2022
Durham Upper Dam and Dyke
Left Side of Pier 2

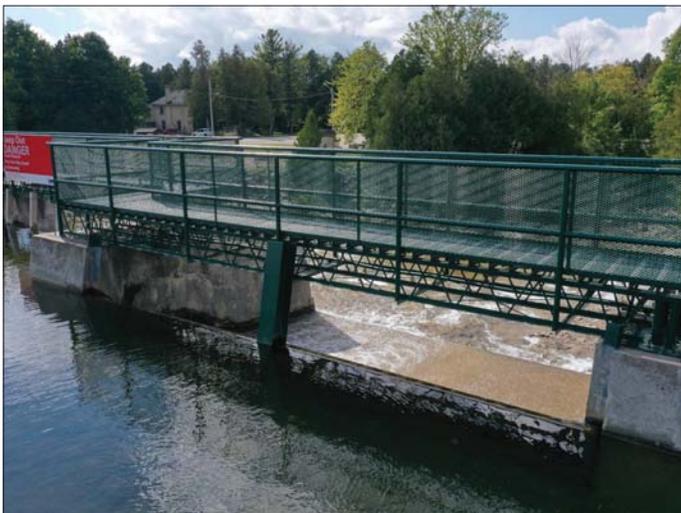
Photo 33 - September 19, 2022
Durham Upper Dam and Dyke
Upstream Side of Sluiceway 2

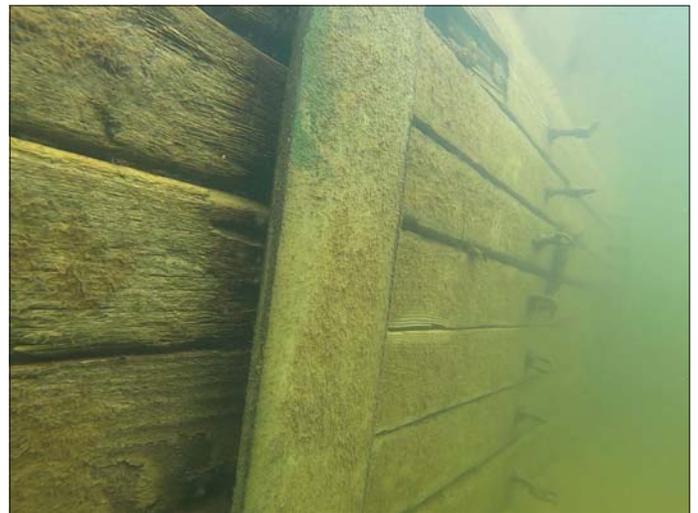
Photo 34 - September 19, 2022
Durham Upper Dam and Dyke
Stoplogs in Sluiceway 2

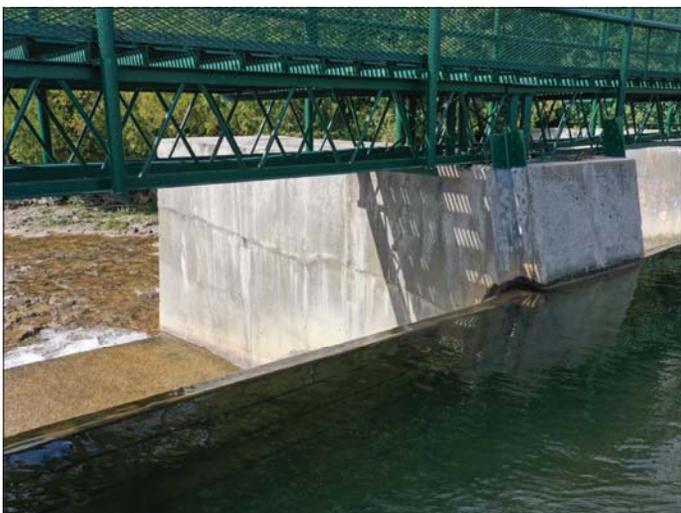
Photo 35 - September 19, 2022
Durham Upper Dam and Dyke
Right Side of Pier 1

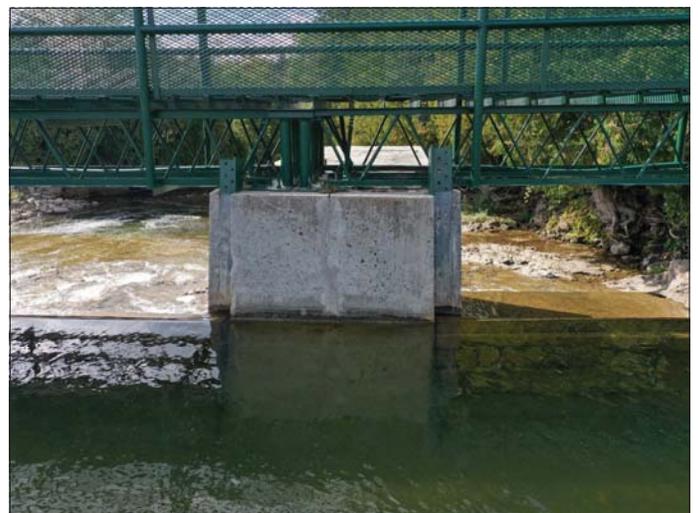
Photo 36 - September 19, 2022
Durham Upper Dam and Dyke
Upstream Side of Pier 1

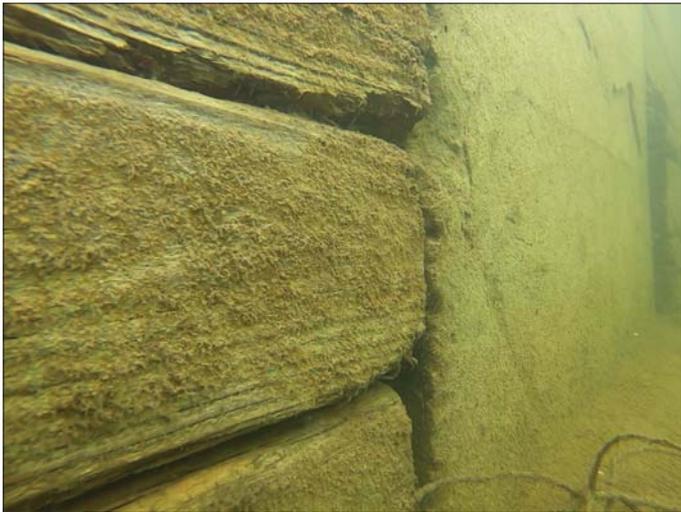
Photo 37 - September 19, 2022
Durham Upper Dam and Dyke
Upstream Side of Pier 1

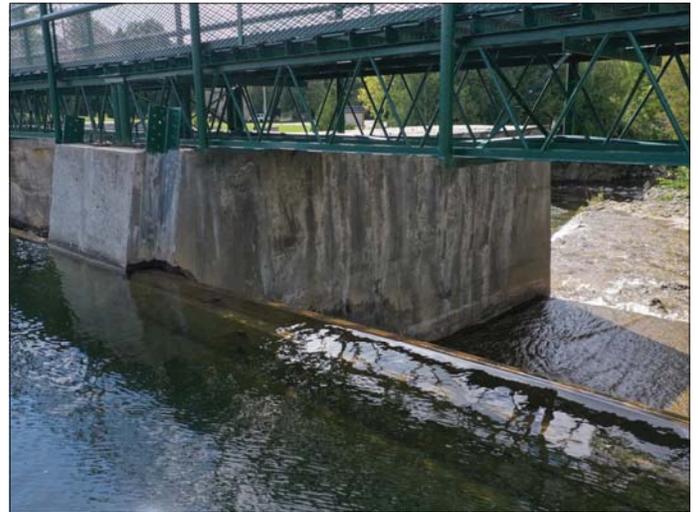
Photo 38 - September 19, 2022
Durham Upper Dam and Dyke
Left Side of Pier 1

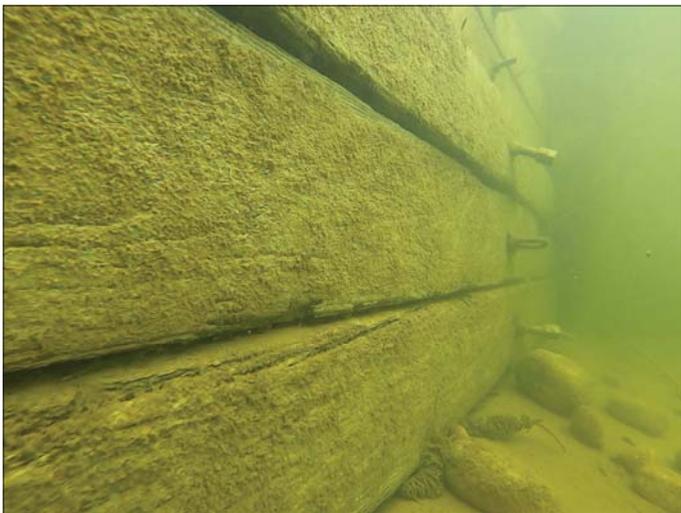
Photo 39 - September 19, 2022
Durham Upper Dam and Dyke
Stoplogs in Sluiceway 1

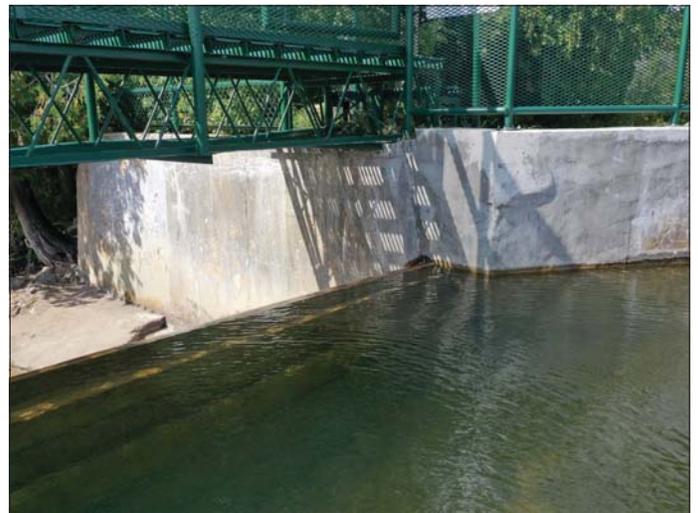
Photo 40 - September 19, 2022
Durham Upper Dam and Dyke
Right Side of Left Abutment

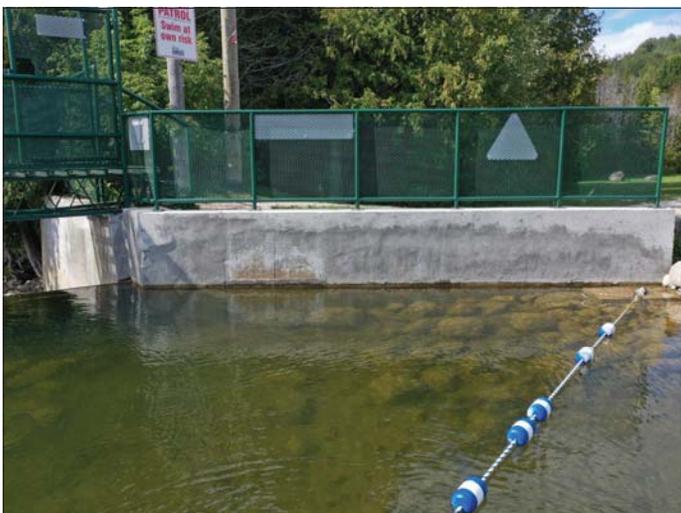
Photo 41 - September 19, 2022
Durham Upper Dam and Dyke
Upstream Left Wingwall

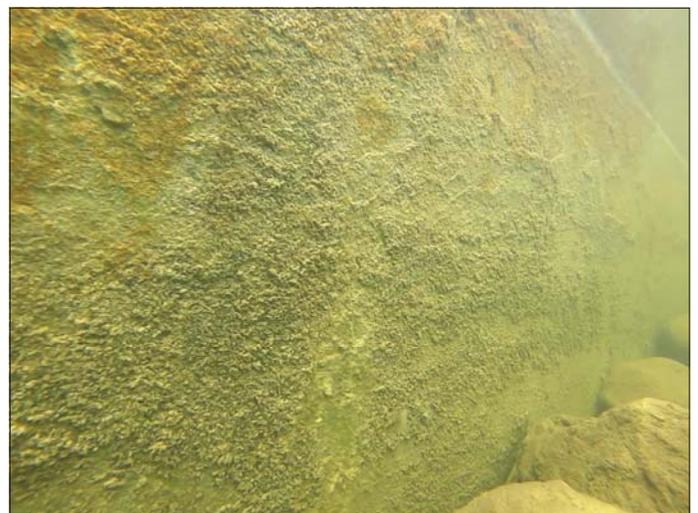
Photo 42 - September 19, 2022
Durham Upper Dam and Dyke
Upstream Left Wingwall

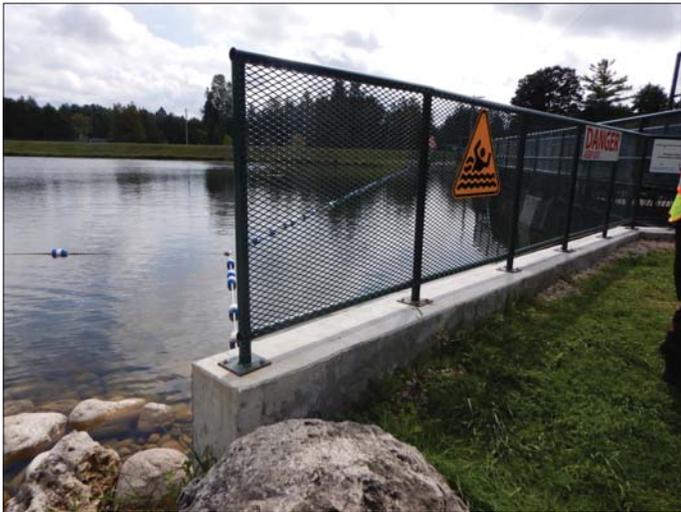
Photo 43 - September 19, 2022
Durham Upper Dam and Dyke
Railing on Upstream Left Wingwall

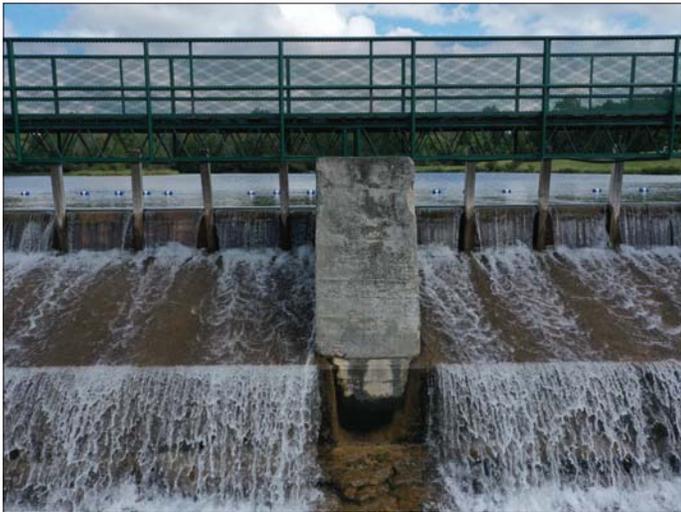
Photo 54 - September 19, 2022
Durham Upper Dam and Dyke
Right Side of Pier 4

Pier 4 – Pier 4 (first from the right abutment) has cracking with efflorescence on the inside, outside and downstream faces. There are also two areas of spalling on the corners towards the tops of the piers. There is medium scaling at the base of the pier on both sides.

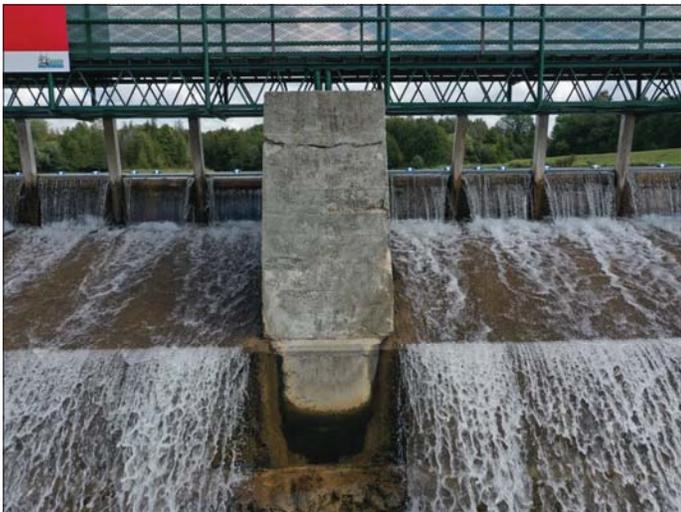
Photo 58 - September 19, 2022
Durham Upper Dam and Dyke
Right Side of Pier 3

Pier 3 – There is medium scaling at the base of the pier on both sides and a wide crack on the downstream face of the pier with a localized spall along the crack.

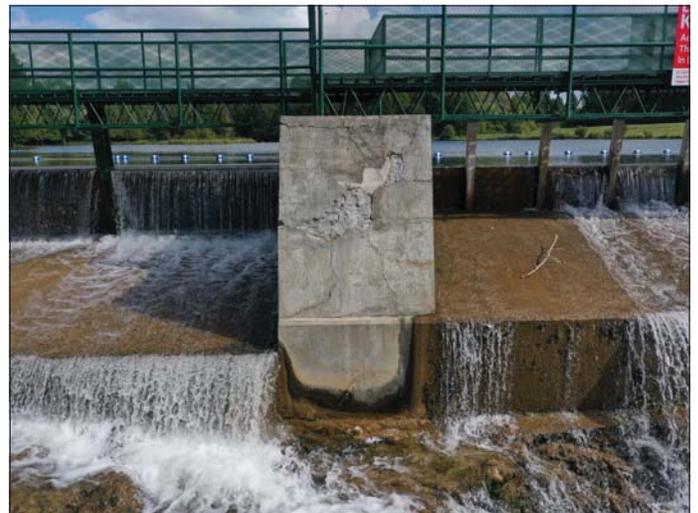
Photo 63 - September 19, 2022
Durham Upper Dam and Dyke
Right Side of Pier 2

Pier 2 – There is medium scaling at the base of the pier on both sides and a large area of spalling in the center of the downstream face. From this area of spalling propagates a wide crack that extends along the length of the right inside face of the pier. There is also medium to wide cracking on the left inside face of the pier.

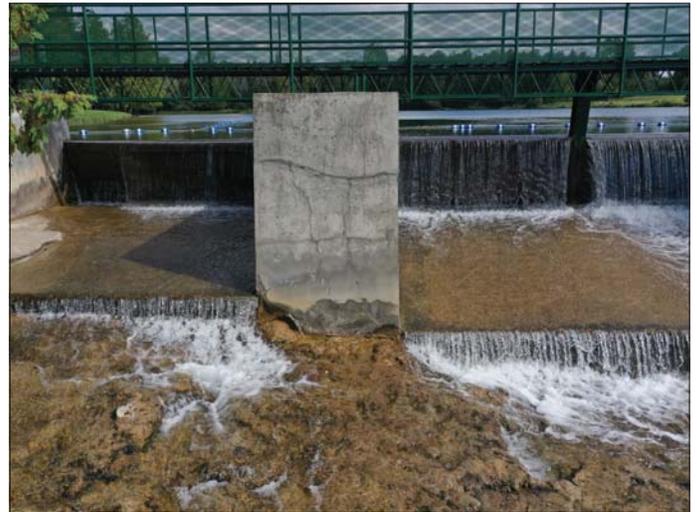
Photo 67 - September 19, 2022
Durham Upper Dam and Dyke
Right Side of Pier 1

Pier 1 – There is medium scaling at the base of the pier and there is horizontal cracking with efflorescence along apparent cold joints.

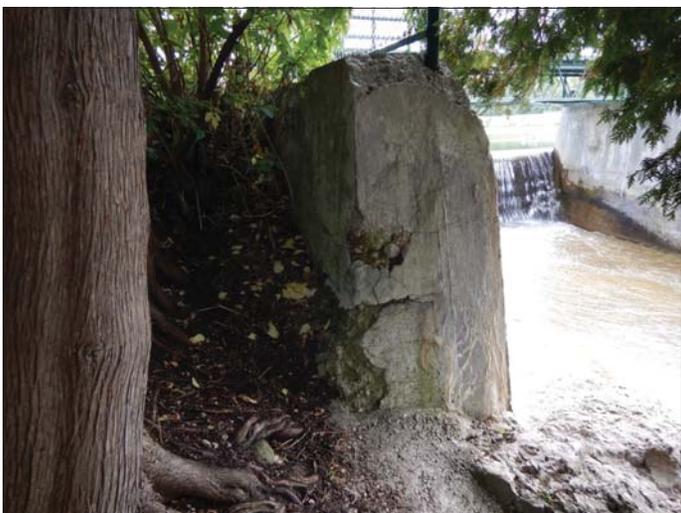
Photo 70 - September 19, 2022
Durham Upper Dam and Dyke
Right Side of Left Abutment

Left Abutment – The left abutment has light scaling at the base, cracking with efflorescence concentrated to the top half of the wall with some localized spalling on the corner of the top and inside face, and small pop-outs and spalls throughout the wall face.

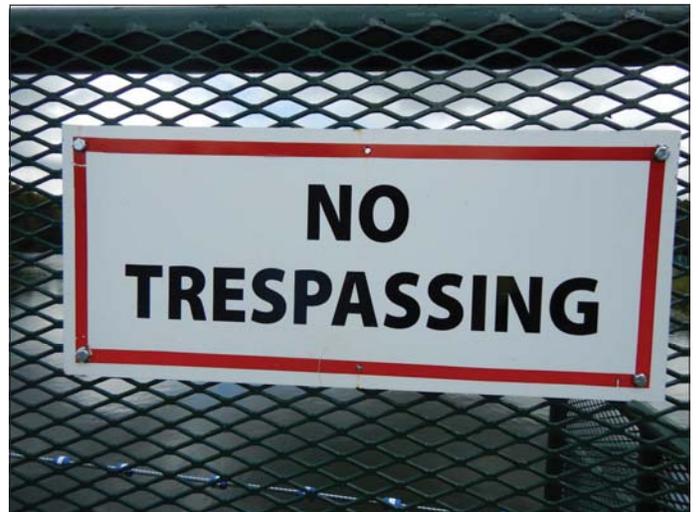
Photo 83 - September 19, 2022
Durham Upper Dam and Dyke
Right Side of Pedestrian Walkway

Dam Deck / Pedestrian Bridge – A steel deck/pedestrian bridge sits atop the abutments and piers to provide operator access to the various parts of the dam and allow members of the public to cross the dam. The structure is constructed with open web steel joists as the main girders with various steel angles acting as sway bracing and lateral bracing. The wearing surface consists of individual steel sections welded to the girders. The structure is in fair to good condition although SVCA staff explained that the structure was recently recoated and may be hiding some deficiencies that were visible before recoating. Upon inspection, the majority of the steel appears to be experiencing some degree of corrosion. It is difficult to determine the extent of corrosion due to the recent coating but there are some members where the cross section of steel observed was thin, which would indicate corrosion of the steel. The bridge is anchored into each pier and abutment with steel base plates and anchors. The plates are in good condition and the number of anchors seem adequate for the current use of the bridge. The grating on the structure generally appears to be in good condition.

It was noted by SVCA staff that ice sometimes comes into contact with the girders on the underside of the structure, causing the girders to deform, needing repairs. This deformation may also be due to the fact that the supports for the flashboards and stoplogs rely on the dam deck/pedestrian bridge structure to provide lateral support and when the ice is pushed downstream it causes excessive lateral stresses that cannot be absorbed by the dam deck/pedestrian bridge structure without deforming.

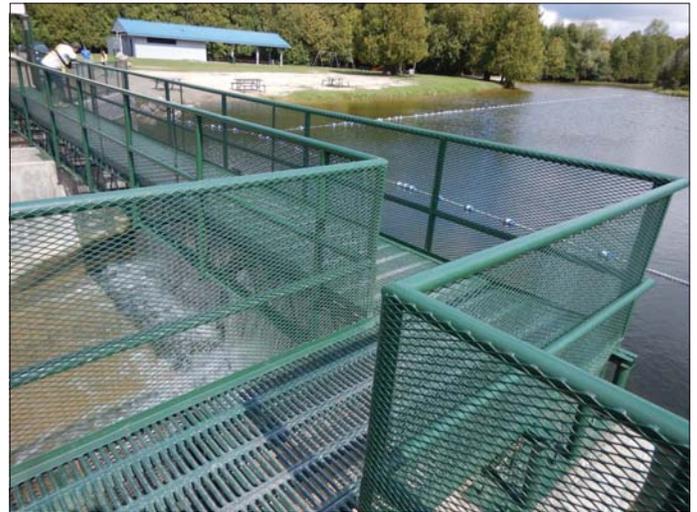
Photo 85 - September 19, 2022
Durham Upper Dam and Dyke
Pedestrian Walkway

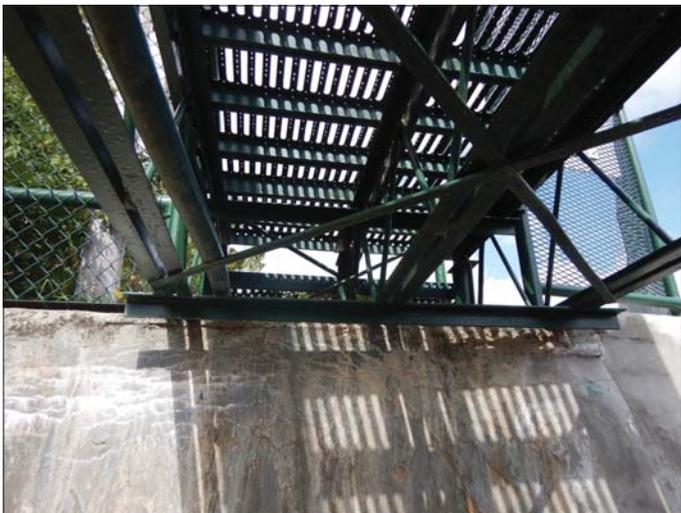
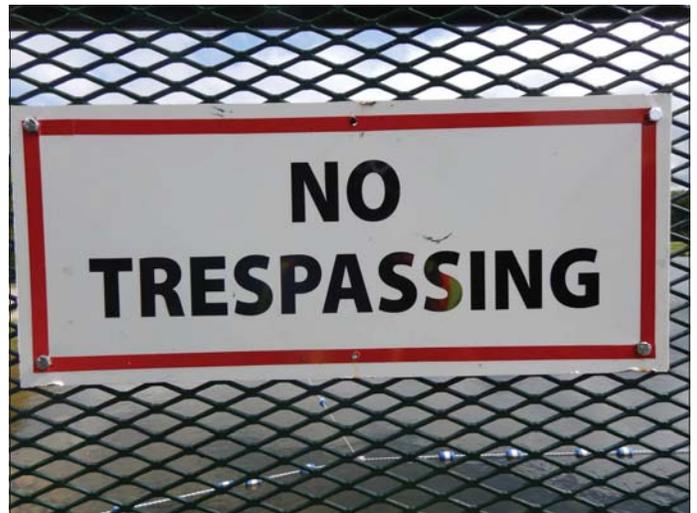
Photo 86 - September 19, 2022
Durham Upper Dam and Dyke
Pedestrian Walkway

Photo 87 - September 19, 2022
Durham Upper Dam and Dyke
Underside of Pedestrian Walkway

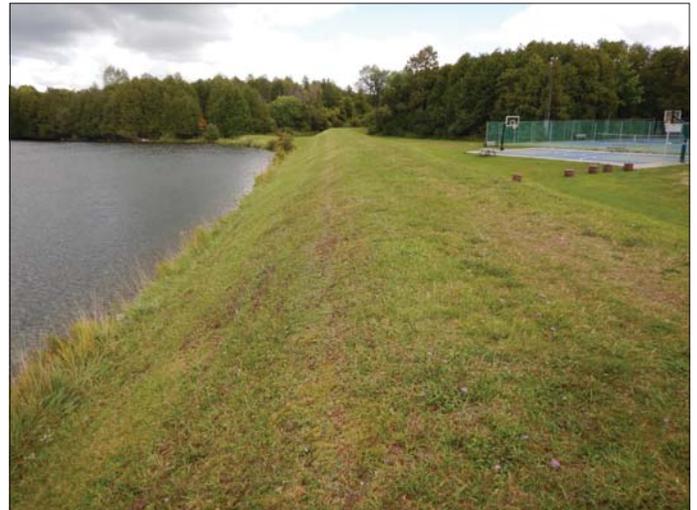
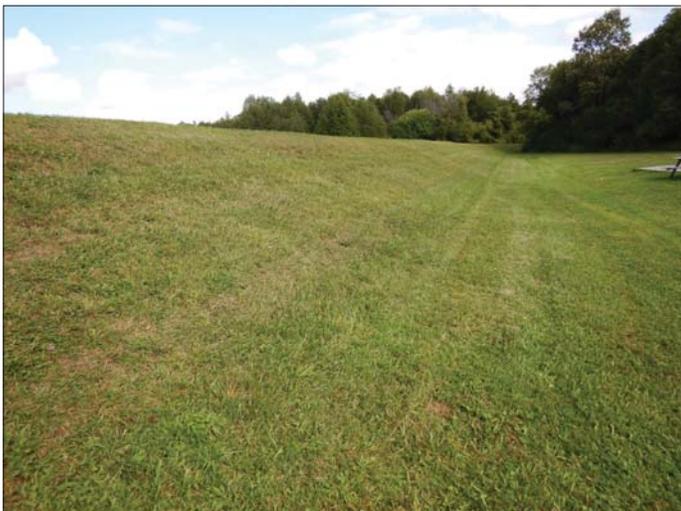
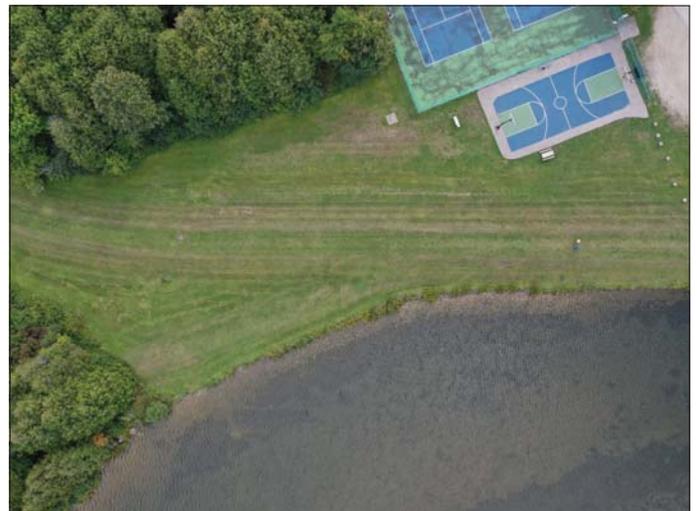
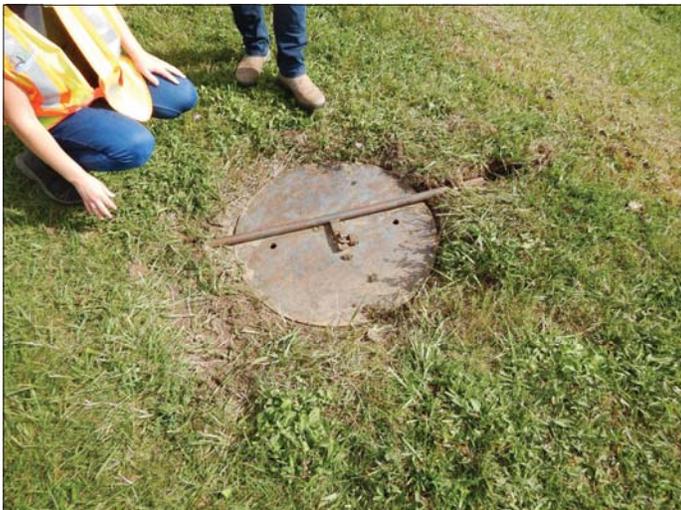
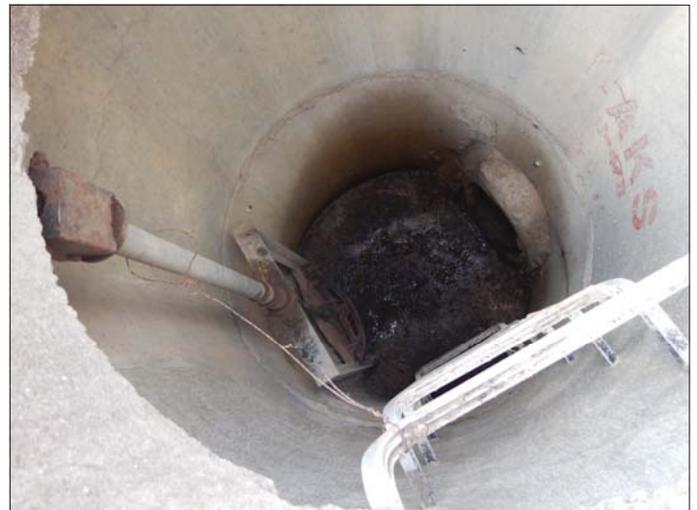
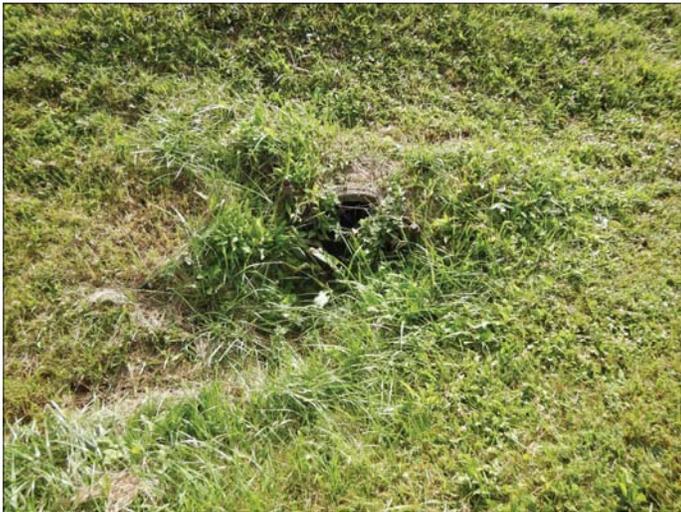
Photo 97 - September 19, 2022
Durham Upper Dam and Dyke
Left Side of Dyke

Photo 98 - September 19, 2022
Durham Upper Dam and Dyke
Crest of Dyke

Photo 99 - September 19, 2022
Durham Upper Dam and Dyke
Right Side of Dyke

Photo 100 - September 19, 2022
Durham Upper Dam and Dyke
Overhead View of Dyke

Photo 101 - September 19, 2022
Durham Upper Dam and Dyke
Manhole in Dyke

Photo 102 - September 19, 2022
Durham Upper Dam and Dyke
Manhole in Dyke

There is a manhole structure in the crest of the embankment with a steel grate that is locked shut. There are concrete culverts that lead into the manhole structure from both sides of the flood dyke. It's understood that this was installed to allow for drainage of a local development. There is a valve on the inside of the manhole structure that can be closed to prevent floodwaters from flowing through the flood dyke. The valve requires manual operation during a flood event. The concrete culverts are filled with sediment and debris but otherwise appear to be in good condition.

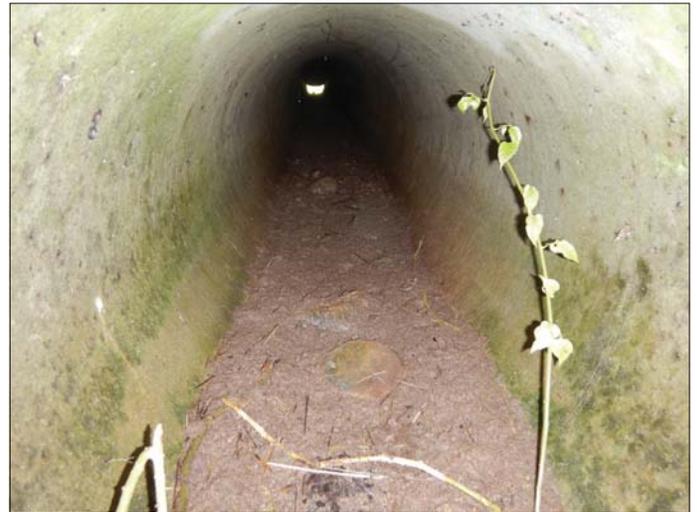
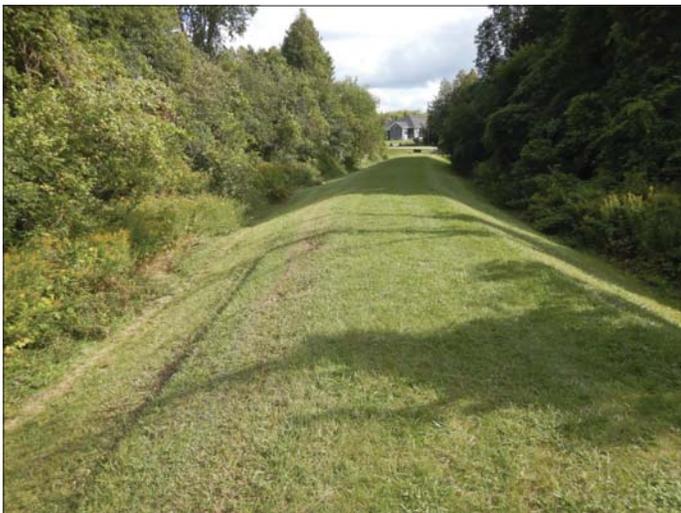
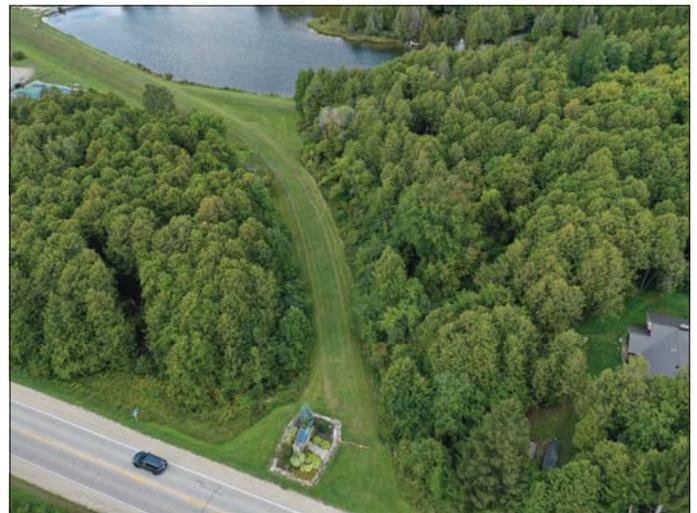
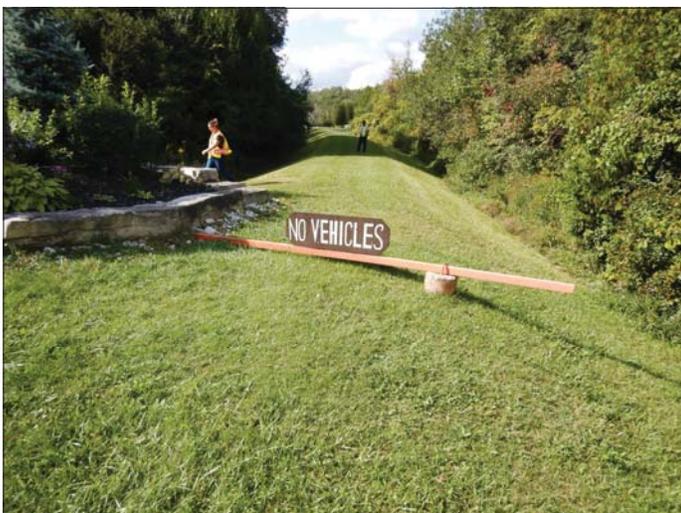
Photo 103 - September 19, 2022
Durham Upper Dam and Dyke
Outlet Pipe in Dyke

Photo 104 - September 19, 2022
Durham Upper Dam and Dyke
Inside Outlet Pipe

Photo 105 - September 19, 2022
Durham Upper Dam and Dyke
Crest of Dyke

Photo 106 - September 19, 2022
Durham Upper Dam and Dyke
Aerial View of Dyke
