Final Dam Inspection Report

Durham Lower Dam and Dyke

**Municipality of West Grey,
County of Grey, Ontario**

D.M. Wills Project Number 22-5540

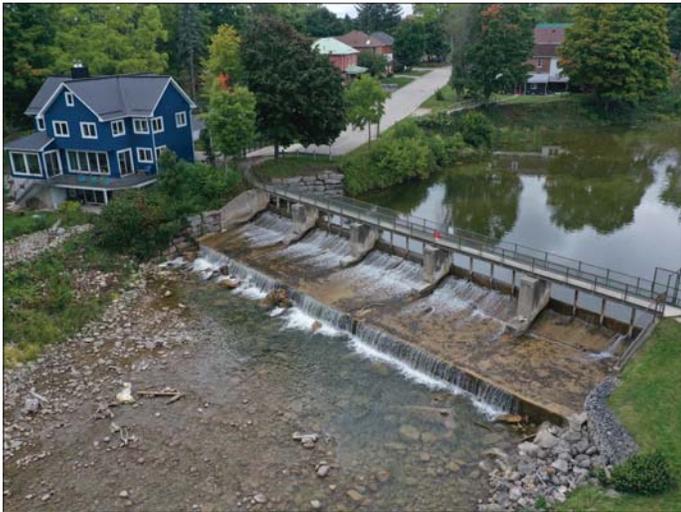
Photo 1 - September 19, 2022
Durham Lower Dam and Dyke

Aerial View of Downstream Side of Dam

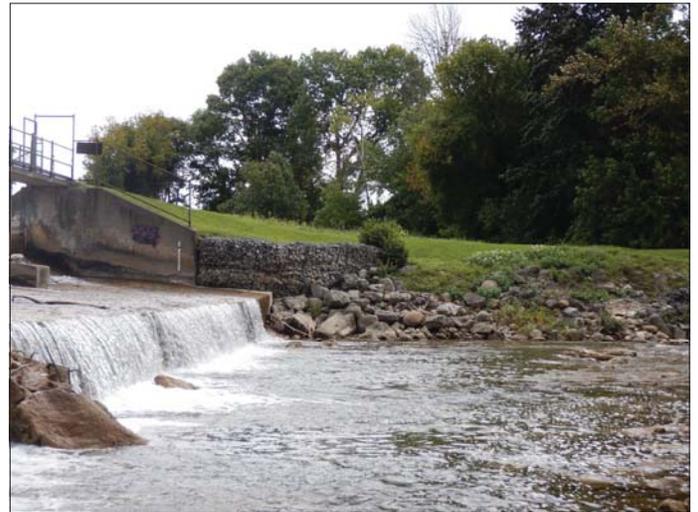
Photo 2 - September 19, 2022
Durham Lower Dam and Dyke

Downstream Right Side of Dam

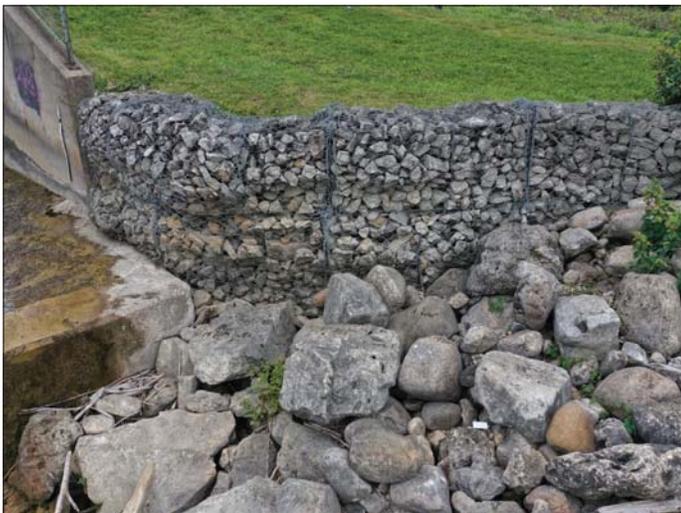
Photo 3 - September 19, 2022
Durham Lower Dam and Dyke

Gabion Baskets on Downstream Right Side of Dam

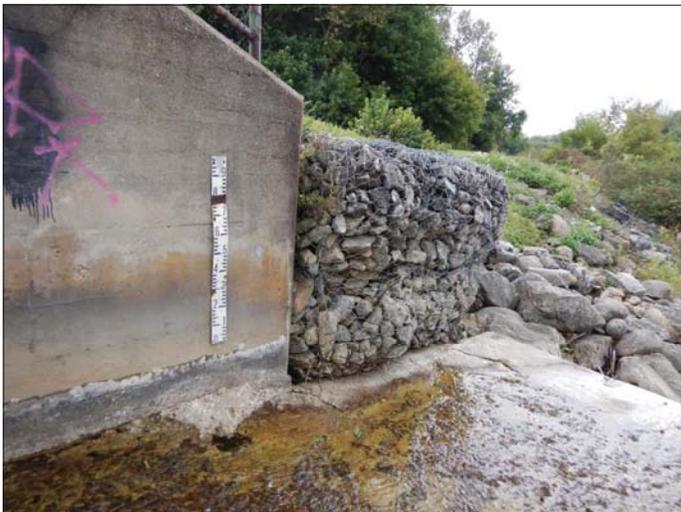
Photo 5 - September 19, 2022
Durham Lower Dam and Dyke

Staff Gauge on Downstream Right Wingwall

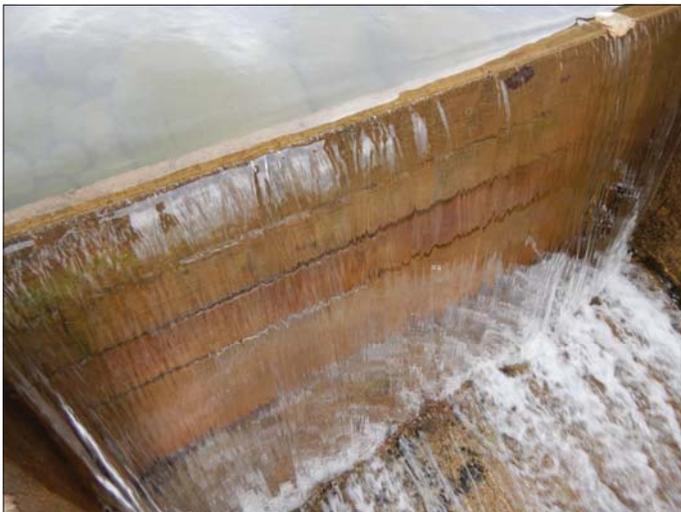
Photo 11 - September 19, 2022
Durham Lower Dam and Dyke
Stoplogs in Sluiceway 4

Structure	Location	Deficiency / Description	Condition Rating	Risk Rating
Wooden and Metal Structures				
Retaining Walls	Upstream Left	Armour stone retaining wall in good condition with possibly some movement (Photo: 64)	3	1
	Downstream Left	Armour stone retaining wall in good condition with possibly some movement, undercutting at the downstream end and vegetation growth behind (Photo: 27)	3	1
	Downstream Right	Gabion baskets are corroded and the ballast is being displaced. The top course of the wall is overturning as middle of wall settles (Photo: 3)	3	2
Walkway Railing	Throughout	Extensive coating loss, light to medium corrosion. Broken and damaged sections of chain link (Photos: 78-80)	3	2
Flow Control Equipment				
Stop logs and Reinforcing Posts	Throughout	Light weathering, rot and decay of the stoplogs (Photos: 11, 37, 43, 55)	3	1

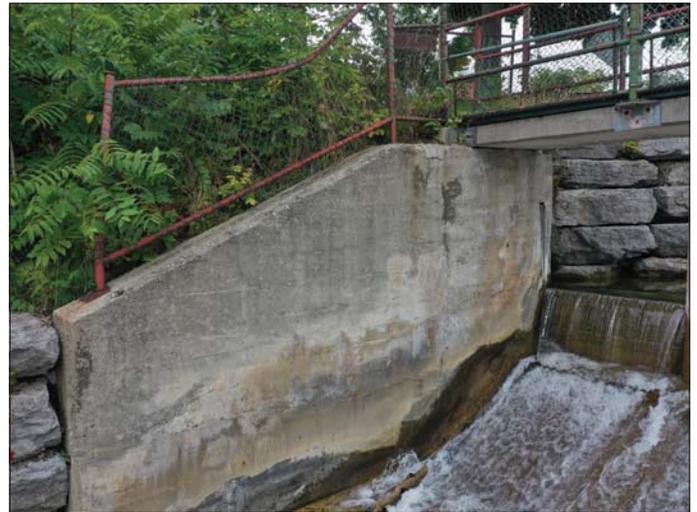
Photo 26 - September 19, 2022
Durham Lower Dam and Dyke
Right Side of Pier 1 and Downstream Left Wingwall

Structure	Location	Deficiency / Description	Condition Rating	Risk Rating
Earth Embankment				
Earth Embankment	Upstream Slope	None (Photos: 86, 88)	4	1
	Downstream Slope	Some sections are heavily treed with exposed soils on steep slopes (Photos: 89-90)	3	1
Concrete Structures				
Piers	Pier 1	Medium to severe scaling, efflorescence staining and wide cracking (Photos: 26, 62)	3	1
	Pier 2	Medium to severe scaling, efflorescence staining and wide cracking (Photos: 22-24, 56-59)	3	1
	Pier 3	Scouring, localized spalling and concrete disintegration (Photos: 18-20, 50-53)	3	2
	Pier 4	Scouring, localized spalling and concrete disintegration (Photos: 13-15, 44-47)	3	2
Deck/Soffit	Top of Deck	Minor weathering and staining. Longitudinal efflorescence-stained cracks (Photos: 75, 77)	4	1
	Soffit	Wet staining and efflorescence adjacent to the fascia (Photo: 76)	3	1
Abutments	Top of Abutments at Deck Soffit	Wide cracking and spalling (Photos: 4, 26)	3	1

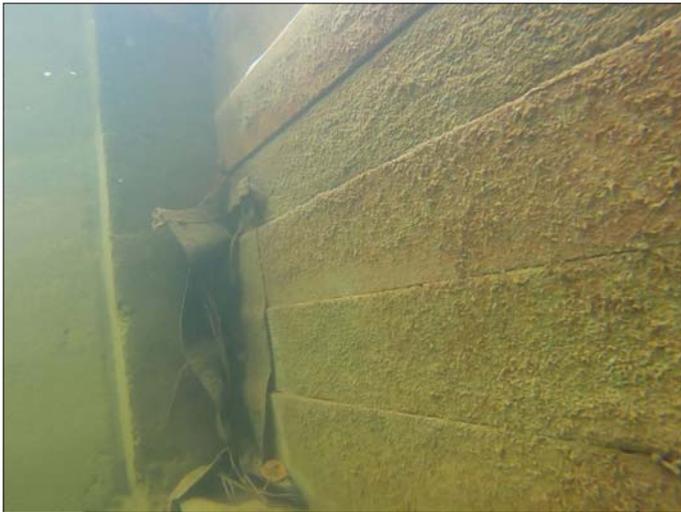
Photo 37 - September 19, 2022
Durham Lower Dam and Dyke

Stoplogs on Upstream Side of Sluiceway 5

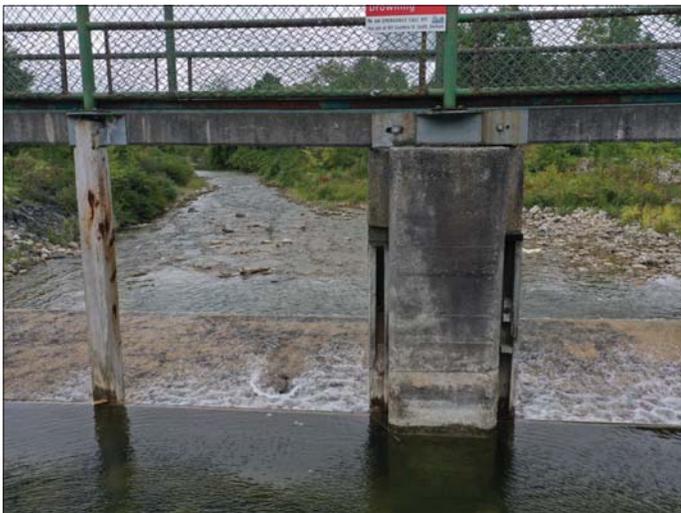
Photo 44 - September 19, 2022
Durham Lower Dam and Dyke

Right Side of Pier 4

Piers/Abutments – Water levels and the sill configuration allowed full access to the concrete piers. A sounding hammer was used in conjunction with visual inspection to determine concrete condition and map deterioration. The pier faces are all experiencing similar deterioration patterns. Medium to severe scaling is noted towards the bottom of all piers at the apparent high-water line, efflorescence staining above the waterline and wide cracking and spalling at the top of the pier adjacent to the walkway are also present. Piers 3 and 4 are exhibiting areas of scouring and

concrete disintegration at the base. These same piers have localized areas of spalling. The pier toes on all piers are in fair to poor condition. Generally, they are showing spalling and delamination, severe scaling with some concrete disintegration and various cracking.

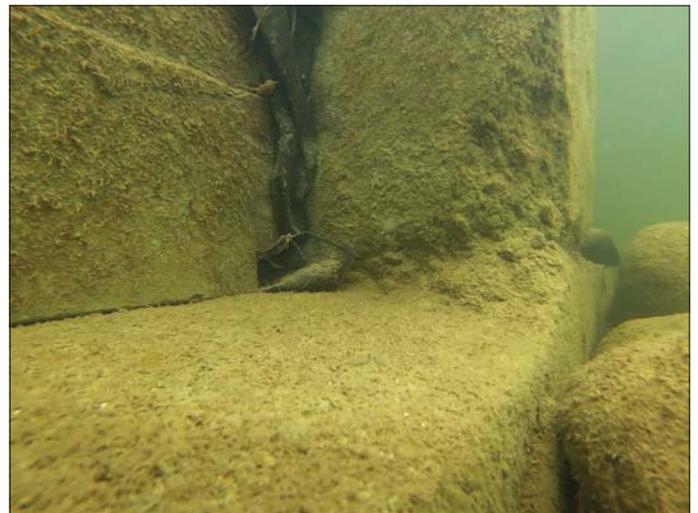
Photo 45 - September 19, 2022
Durham Lower Dam and Dyke

Upstream Side of Pier 4

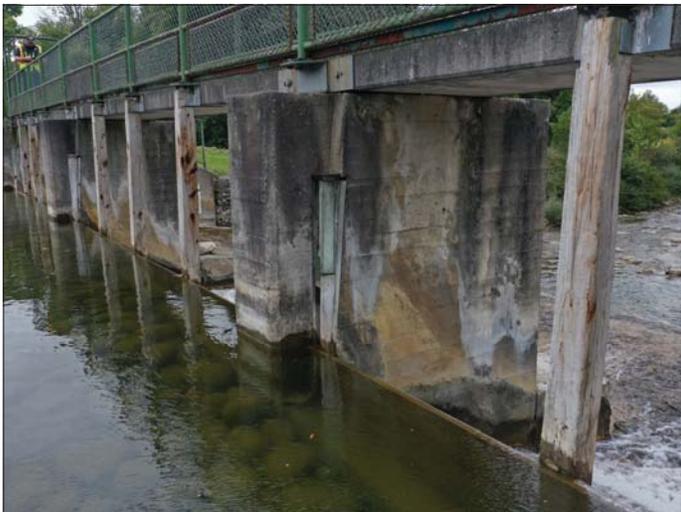
Photo 46 - September 19, 2022
Durham Lower Dam and Dyke

Upstream Side of Pier 4

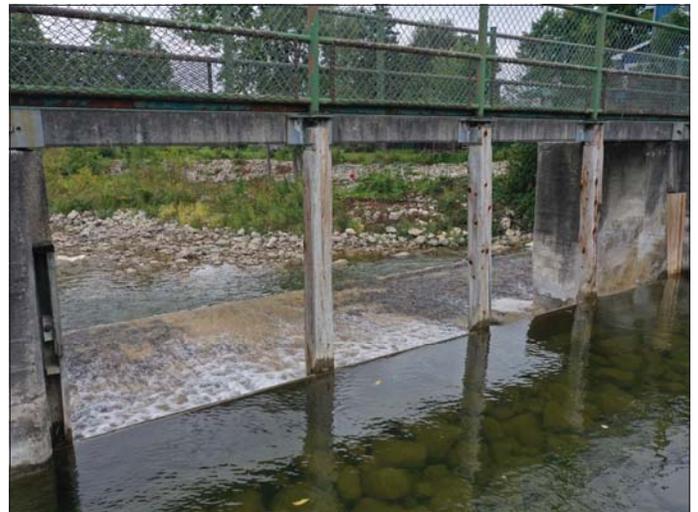
Photo 47 - September 19, 2022
Durham Lower Dam and Dyke

Left Side of Pier 4

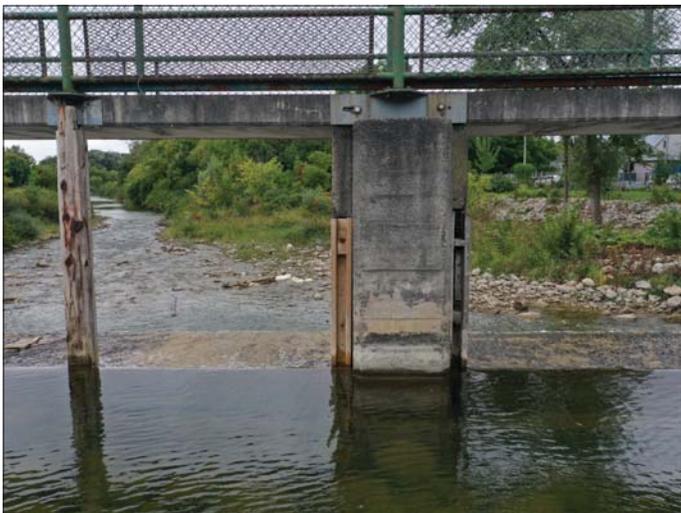
Photo 50 - September 19, 2022
Durham Lower Dam and Dyke

Right Side of Pier 3

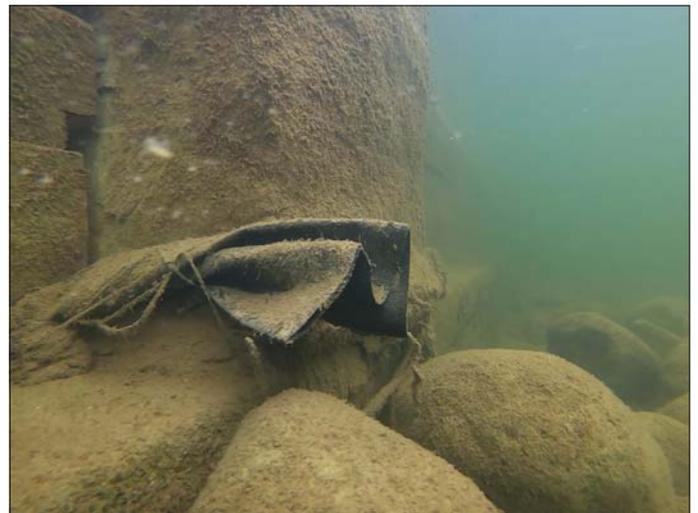
Photo 51 - September 19, 2022
Durham Lower Dam and Dyke

Upstream Side of Pier 3

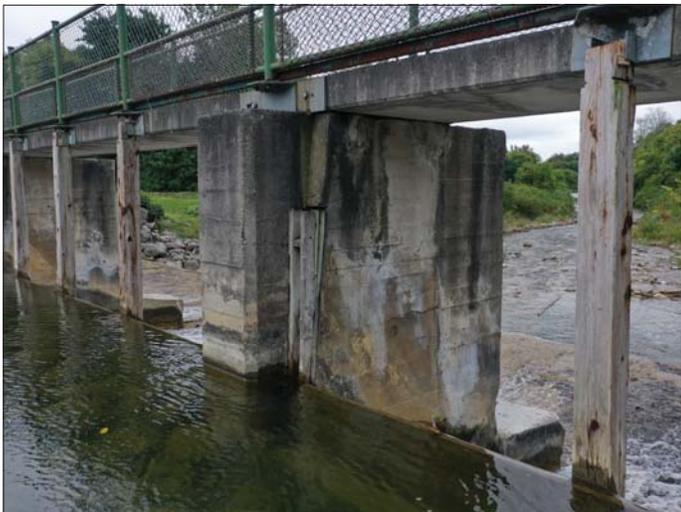
Photo 52 - September 19, 2022
Durham Lower Dam and Dyke

Upstream Side of Pier 3

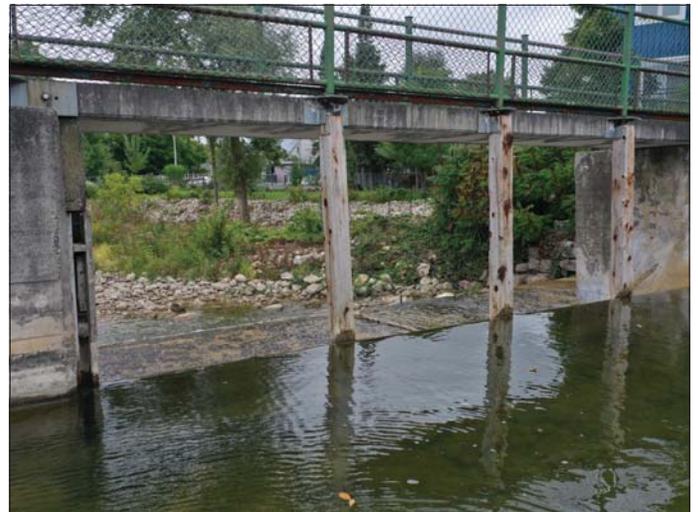
Photo 53 - September 19, 2022
Durham Lower Dam and Dyke

Left Side of Pier 3

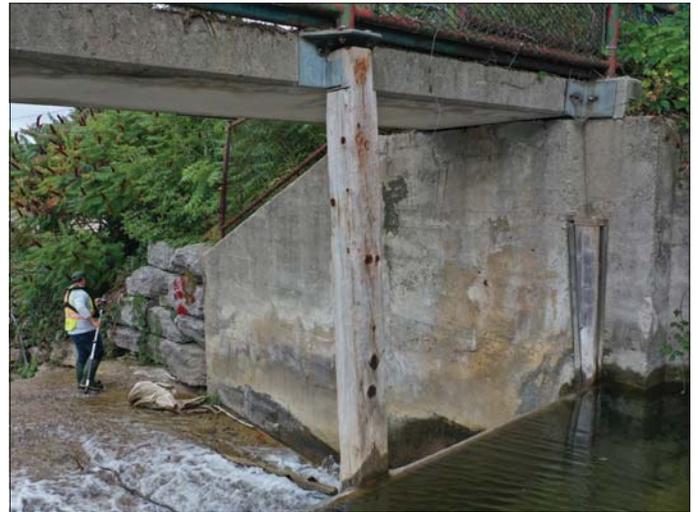
Photo 61 - September 19, 2022
Durham Lower Dam and Dyke

Stoplogs on Upstream Side of Sluiceway 1

stoplogs. The stoplogs and posts are exhibiting light weathering, rot, and decay, consistent with the environment in which they are being used.

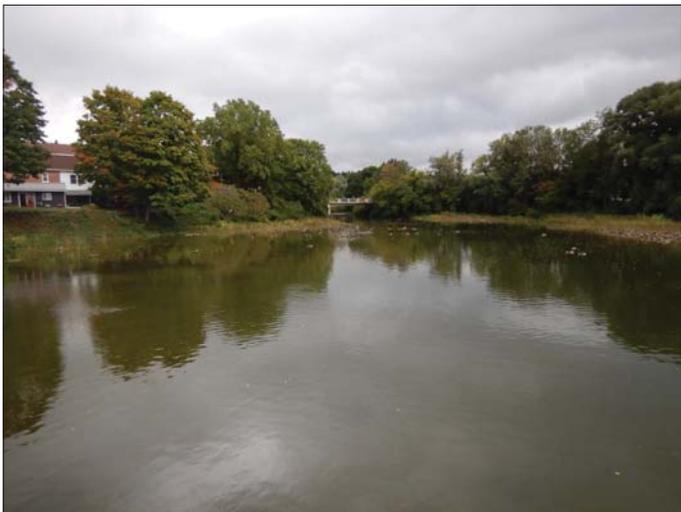
Photo 64 - September 19, 2022
Durham Lower Dam and Dyke

Stone Retaining Wall on Upstream Left Bank

Retaining Walls – Armour stone retaining walls exist on the left abutment, on the upstream and downstream sides of the control structure. The stone units appear to be square and no settlement or overturning is present. There is a gabion basket retaining wall on the downstream right side of the control structure between the overflow spillway and the edge of the watercourse. The bottom course of gabion baskets are corroded and ballast is being displaced. The top course of the wall is overturning as the middle of the wall is settling.

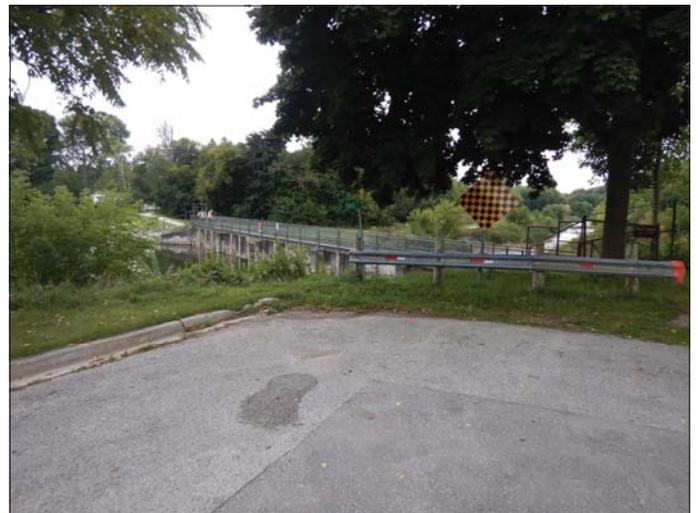
Photo 81 - September 19, 2022
Durham Lower Dam and Dyke
Left Facing Public Safety Sign

There are small (18 inch by 24 inch) public safety signs mounted to the railings on the upstream and downstream sides of the dam. The signs read “DANGER, NO TRESPASSING, Access Beyond This Point May Result in Drowning” and includes the old SVCA logo as well as the address of the dam and instructions to call 911 in an emergency. The signs are in good condition; however, they are not the correct signs for facing upstream and downstream.

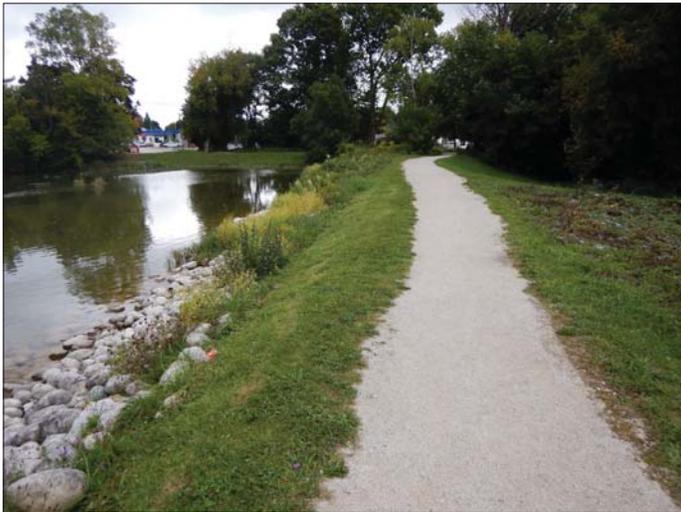
Photo 85 - September 19, 2022
Durham Lower Dam and Dyke
Crest of Dyke

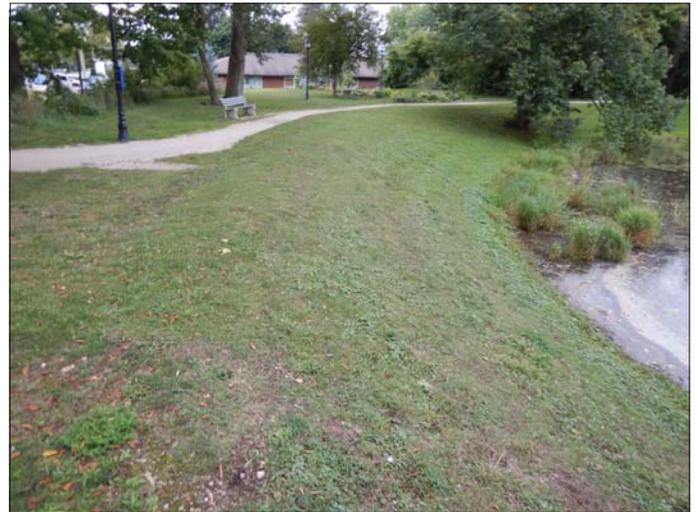
Photo 86 - September 19, 2022
Durham Lower Dam and Dyke
Upstream Side of Dyke

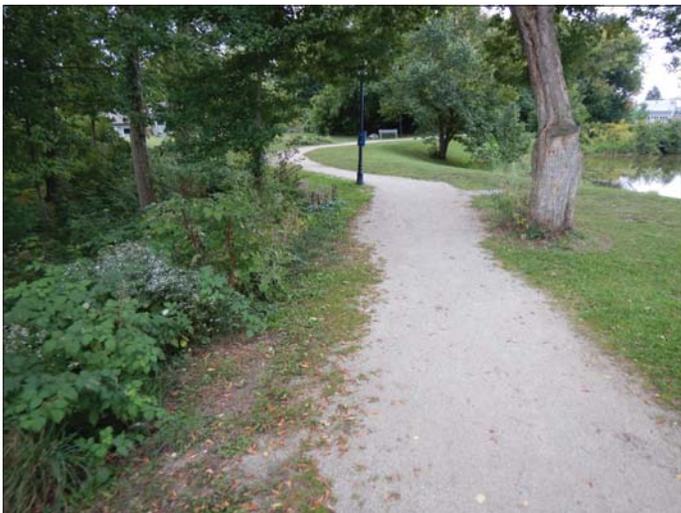
The upstream side of the embankment is gently sloped and consists of various types of vegetation, grasses, and trees towards the parking area. Towards the control structure, there is round rip-rap placed on the upstream side of the embankment that extends into the watercourse. Some larger round rocks are also present on the upstream side. A granular path runs along the crest of the embankment to provide access across the dam. The path is in good condition with no apparent areas of erosion.

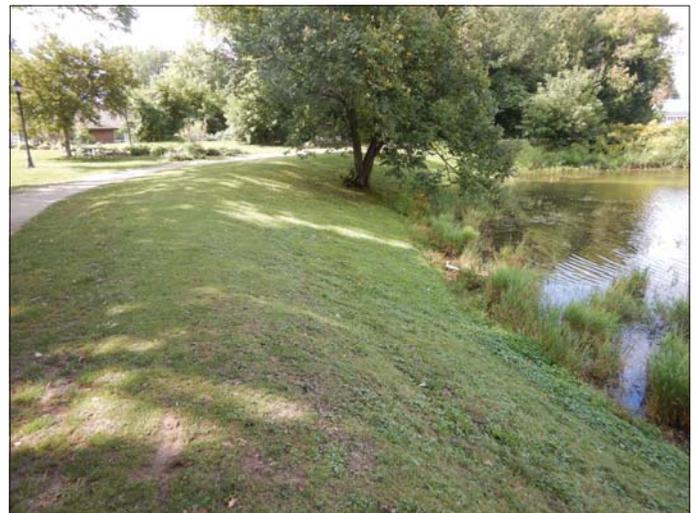
Photo 88 - September 19, 2022
Durham Lower Dam and Dyke
Upstream Side of Dyke

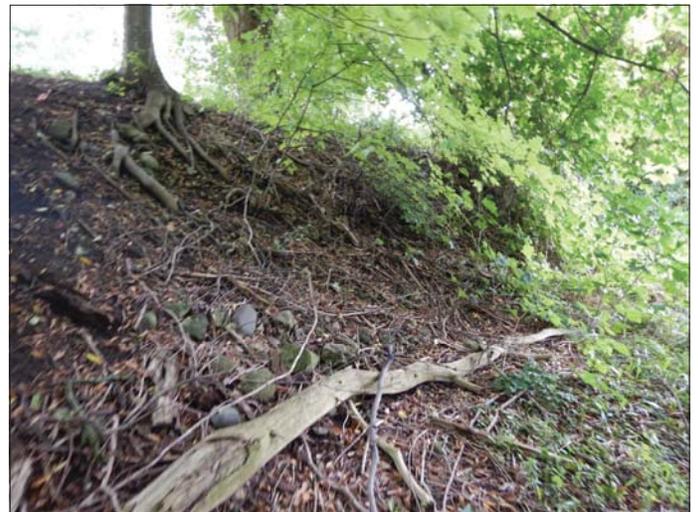
Photo 89 - September 19, 2022
Durham Lower Dam and Dyke
Downstream Side of Dyke

The downstream side of the embankment is generally covered in closely cut grass; however, there are some sections of the downstream slope that are heavily treed with exposed soil on the steep slopes. Adjacent to the control structure, there is an emergency spillway. The spillway has angular rip-rap beside the crest of embankment. At the end of the spillway, towards the watercourse, an articulating block system is implemented. Grass is growing between the articulating concrete units. No erosion was observed in the emergency spillway area.

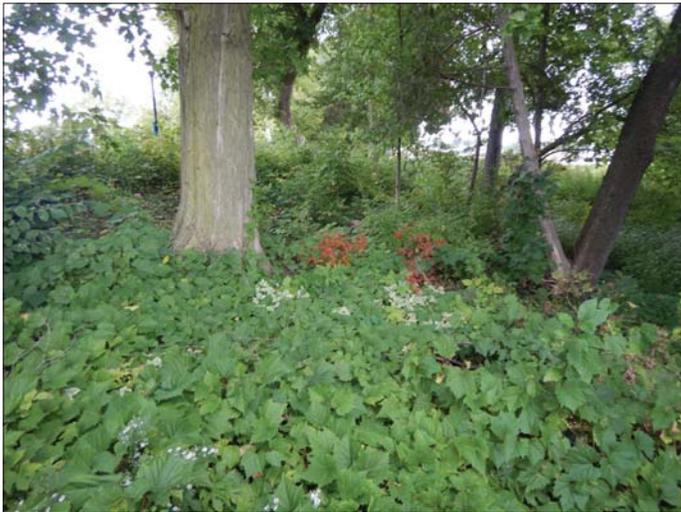
Photo 90 - September 19, 2022
Durham Lower Dam and Dyke
Downstream Side of Dyke

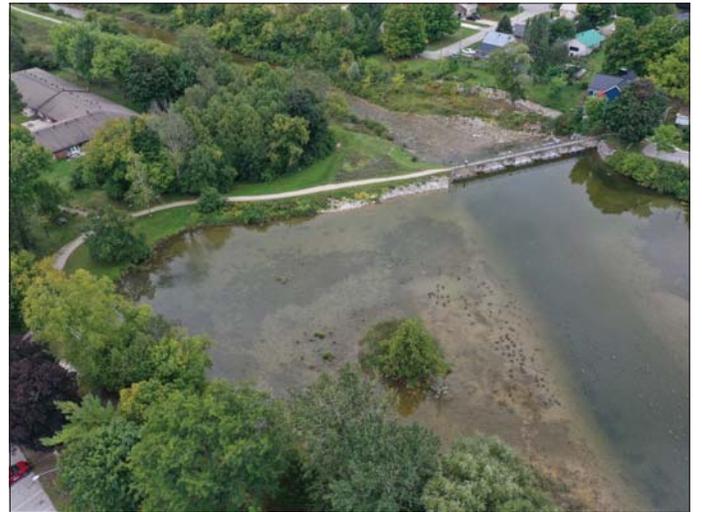
Photo 92 - September 19, 2022
Durham Lower Dam and Dyke
Aerial View of Upstream Side of Dam and Dyke
