Date of Inspection:	30-Jul-24
Name of Inspector:	Andrew Burgess, P.Eng. & Joel Ziegler CET
Equipment Used:	Sounding hammer, measuring equipment, GPS
Weather Conditions:	Cloudy
Temperature:	23
Special Notes:	Bridge is in good condition, showing no signs of structural distress.

Year Built:	1979	Contract Number When Built:	
Latest Biennial Inspection:	September 14, 2022	Latest Specialized Inspection:	
Latest Structure Rating:	75.0	Latest Structure Condition:	
RehabHistory:			
Regional Priority Number:		Programmed Work Year:	
NatureOfProgramWork:

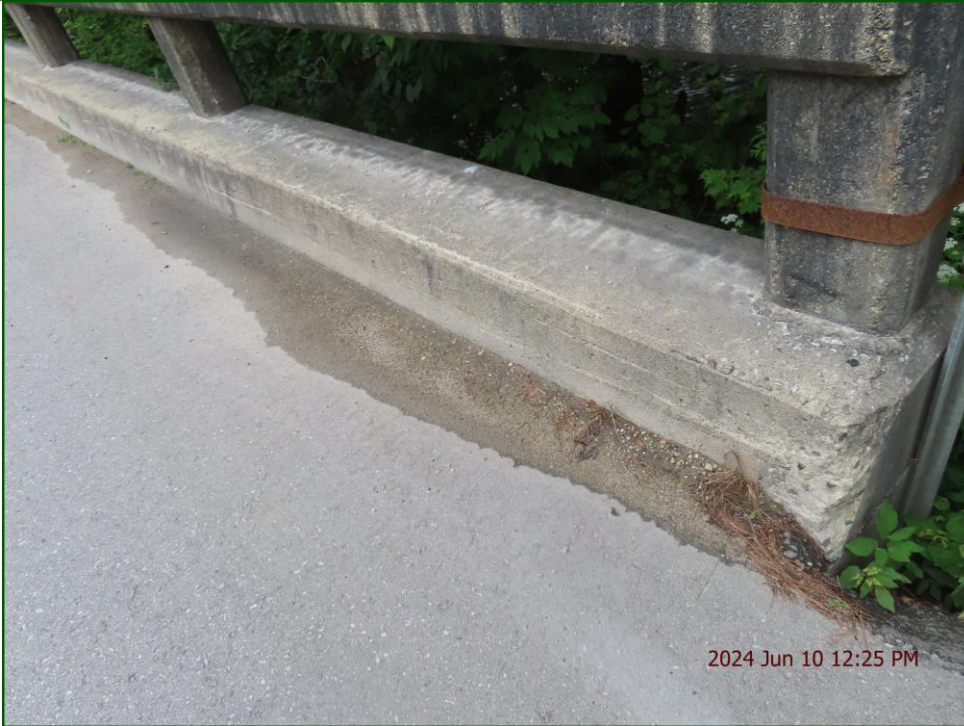
Light to medium vertical cracking throughout.

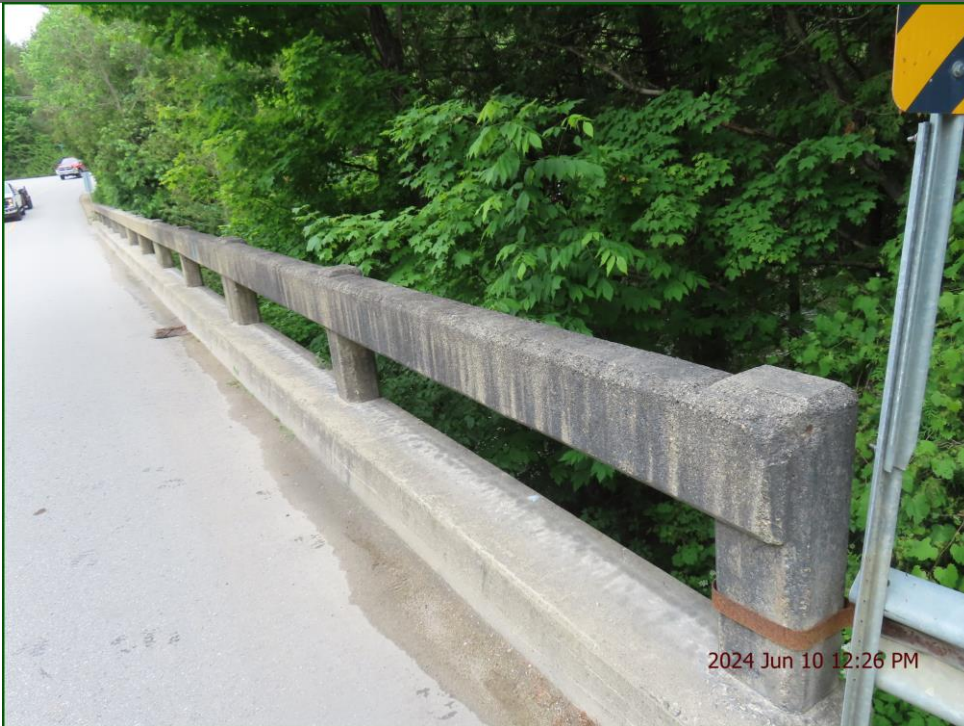
Moderate spalls with exposed reinforcing throughout.

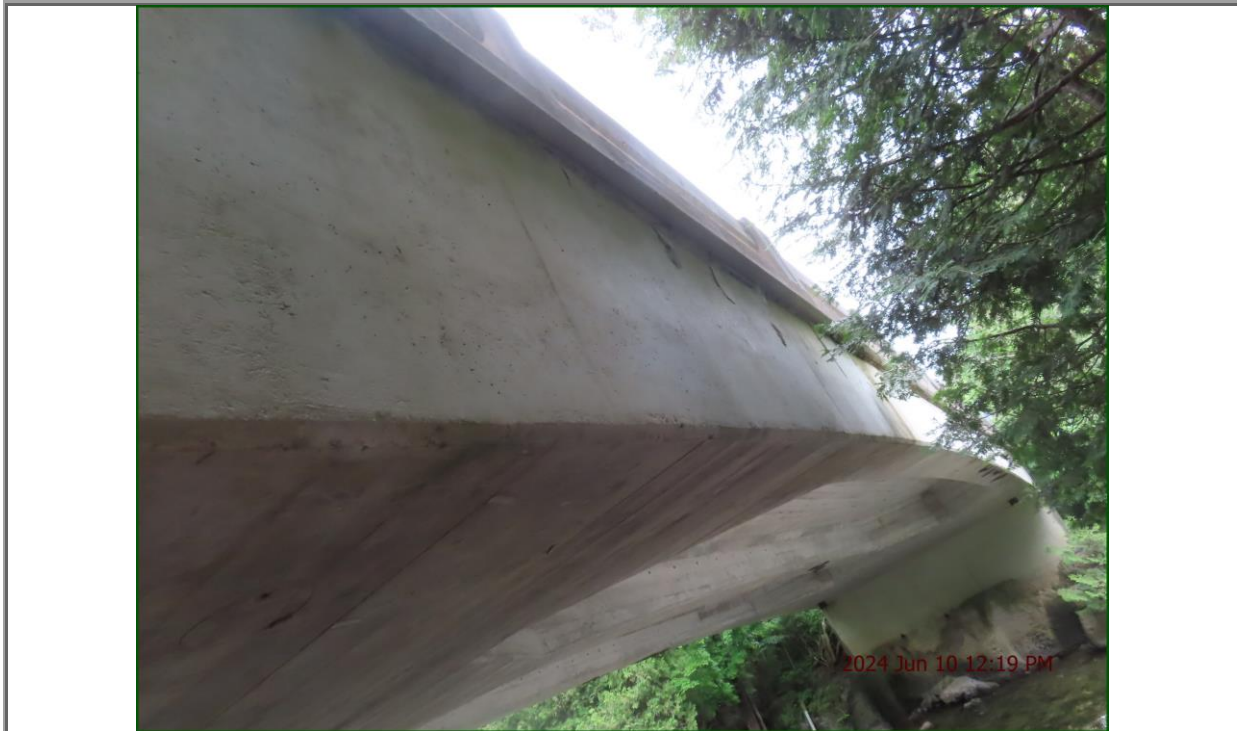
Minor popout with exposed reinforcing.

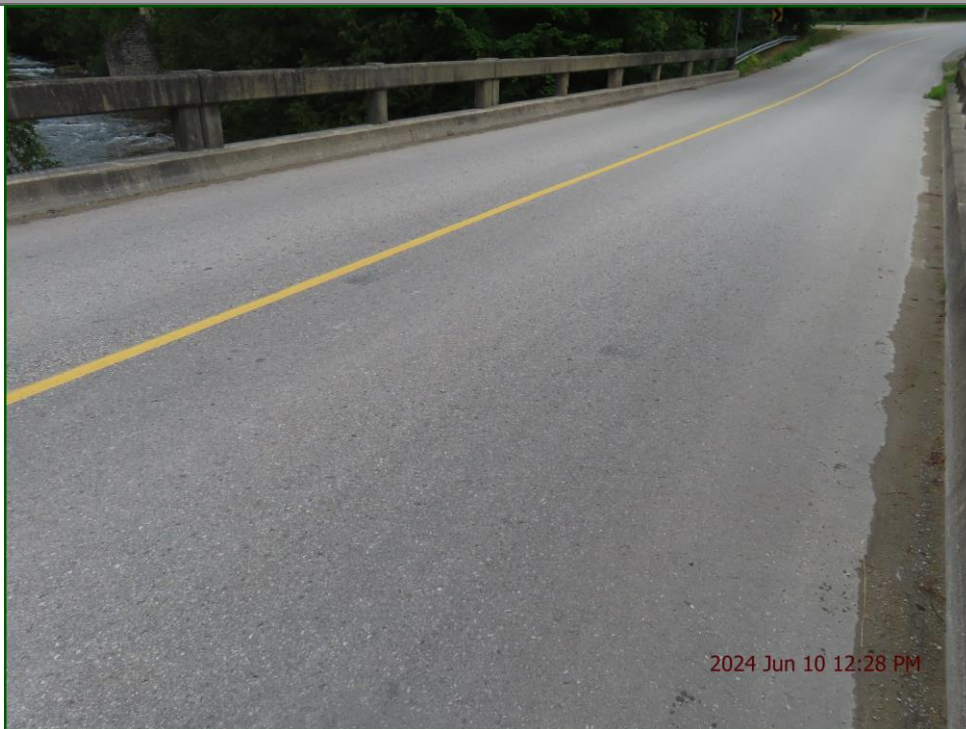
Moderate ravelling along edges.

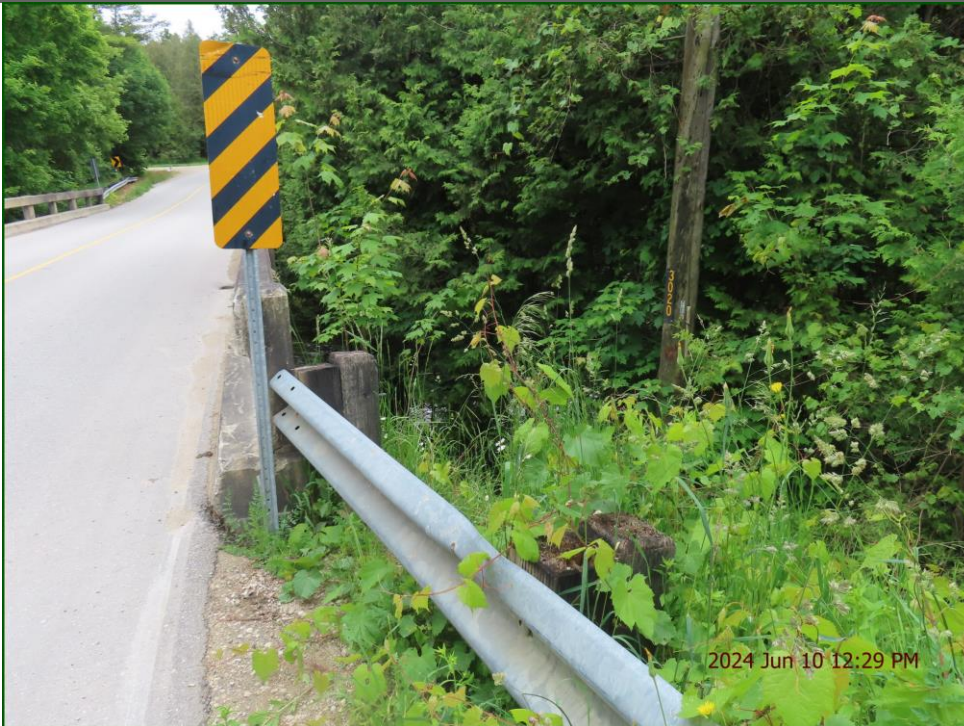
Moderate erosion on E quadrants.

Element Group:	Embankments & Streams	Site Number:	B-018
Element Name:	Embankments	Width:	0 m
Element type:		Height:	0 m
Sub-element:		Length:	0 m
Material:		Count:	4
Location:		Total Quantity:	4 each
Environment:	Moderate	Not inspected:	<input type="checkbox"/>
Perform. deficiencies:		Maintenance Type:	Routine
Maint needs:	Erosion control	Maint. Time Period:	2 Year

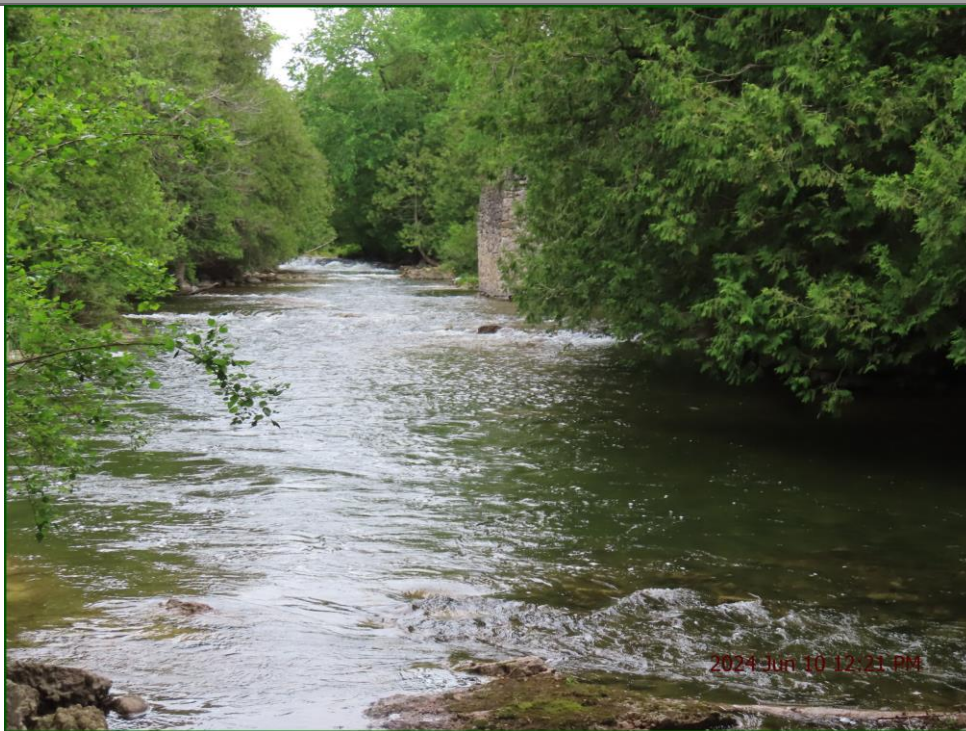
Heavy flow at time of inspection.

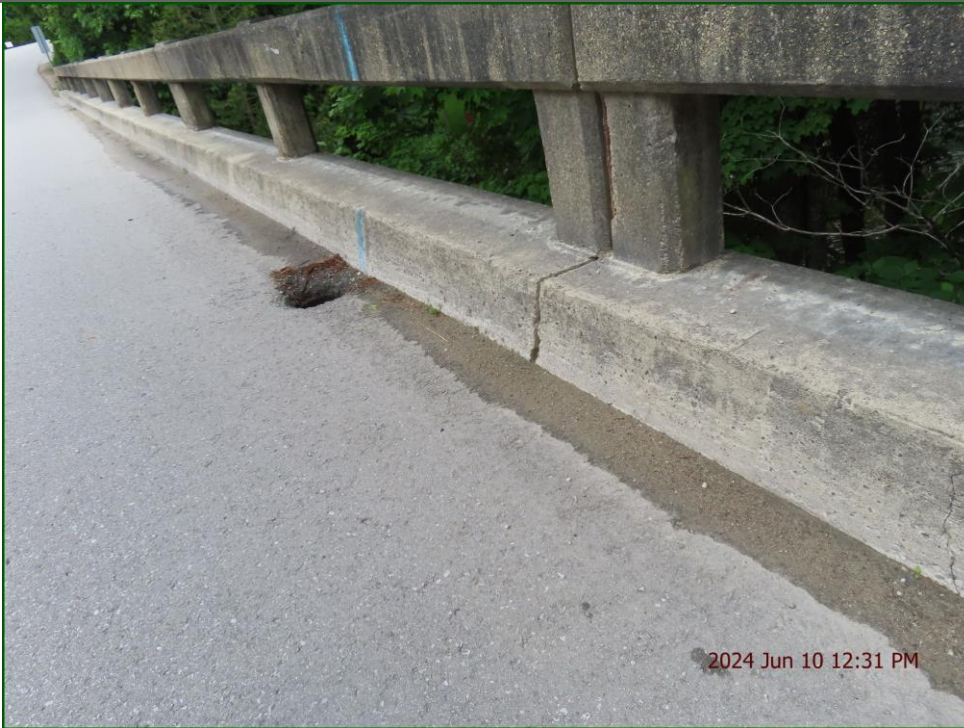
Light to medium vertical cracks throughout.

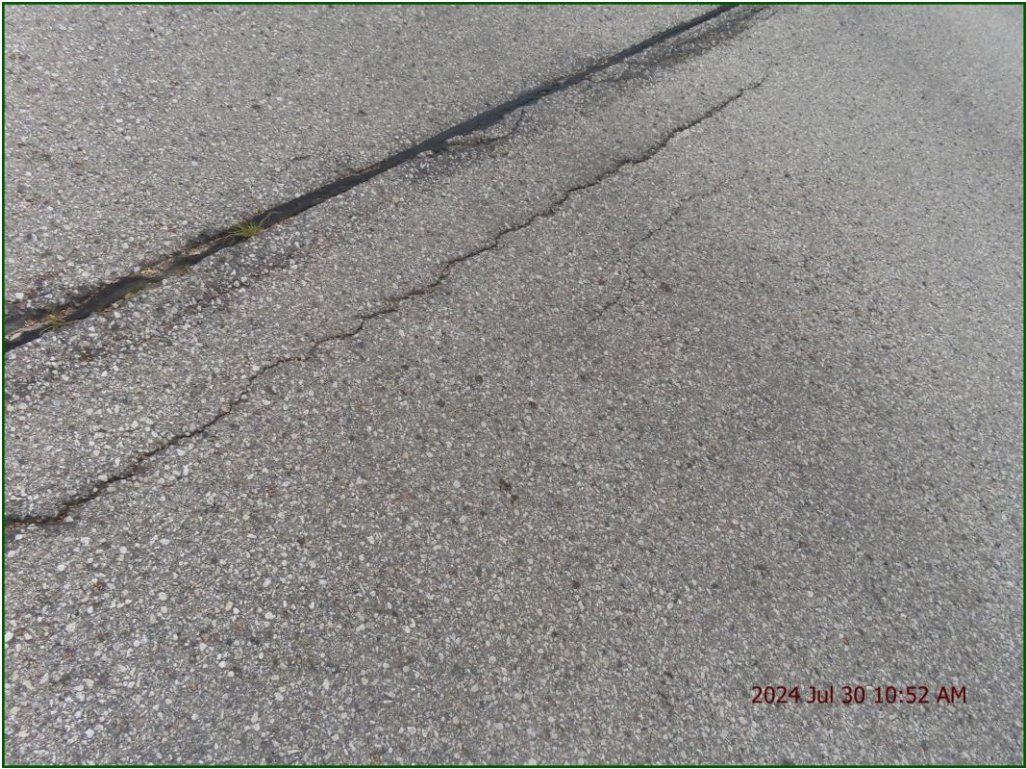
Description: Approach Wearing Surface: Wide transverse crack.

Wide transverse crack.

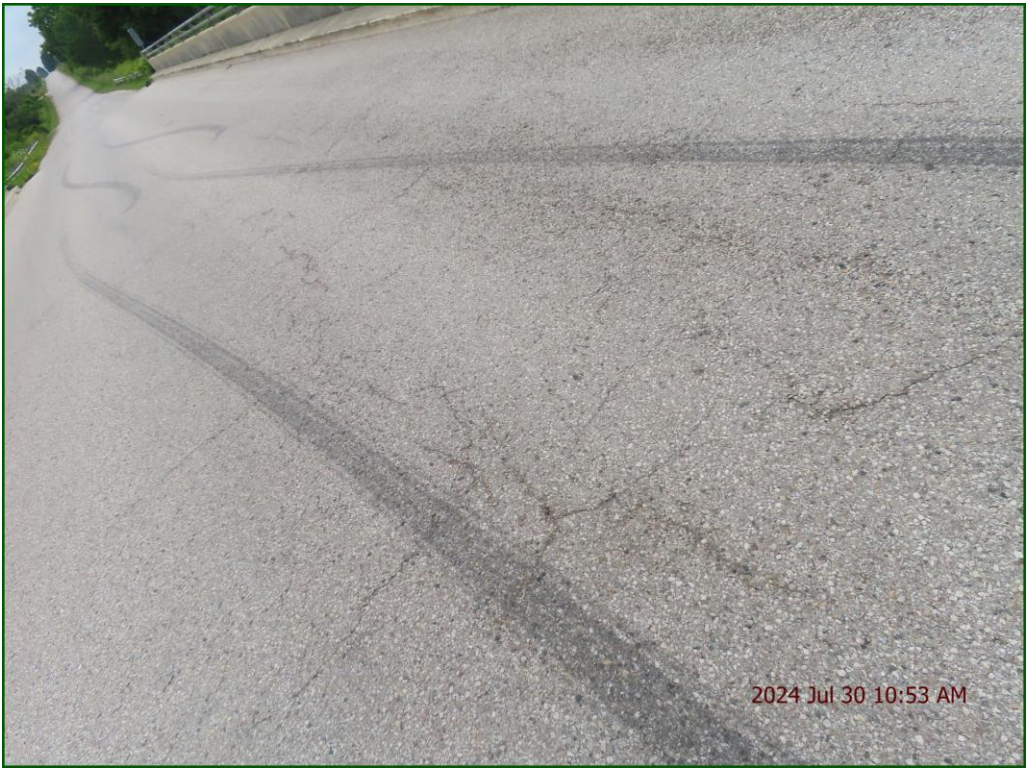
Description: Wearing Surface: Light to medium map cracking.

Light to medium map cracking.

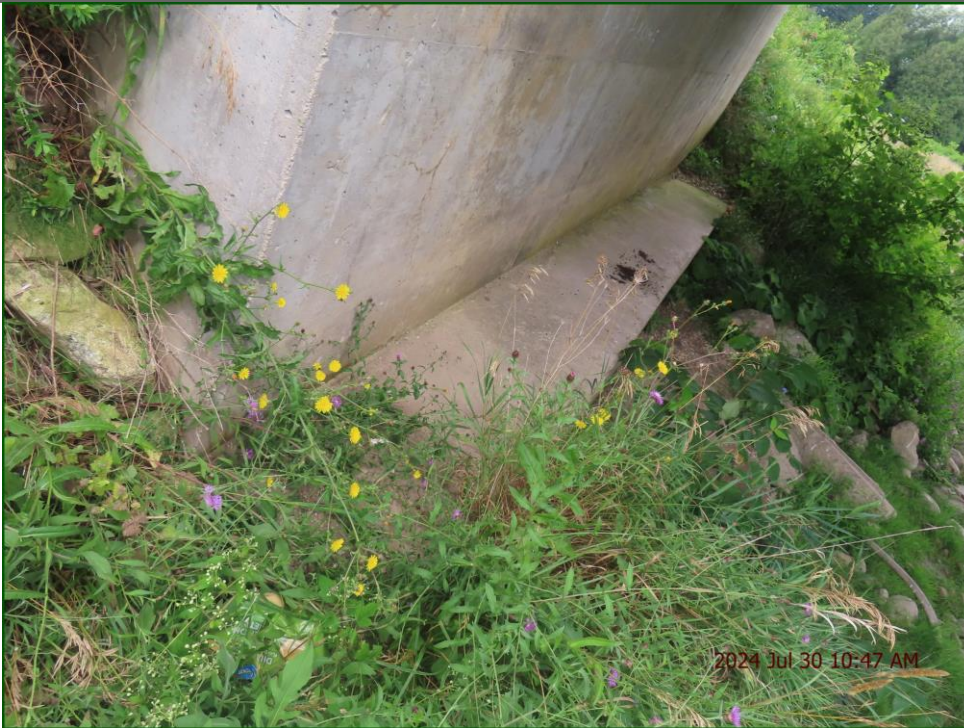
No signs of settlement.

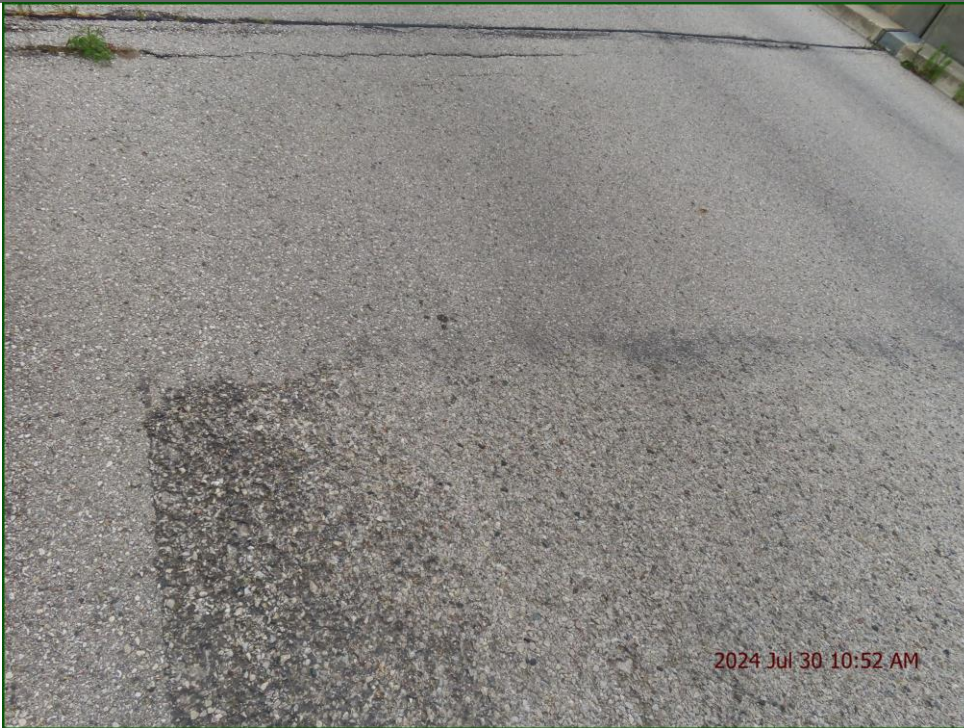
No signs of settlement.

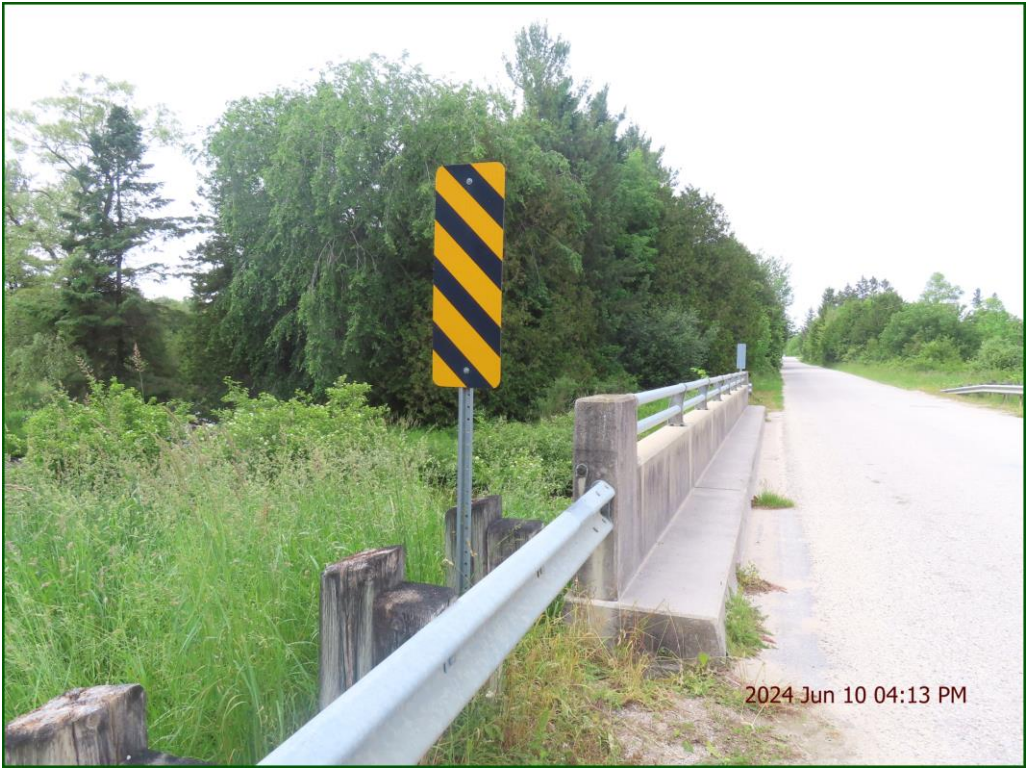
Description: Abutment walls: Light vertical cracking with leachate staining.

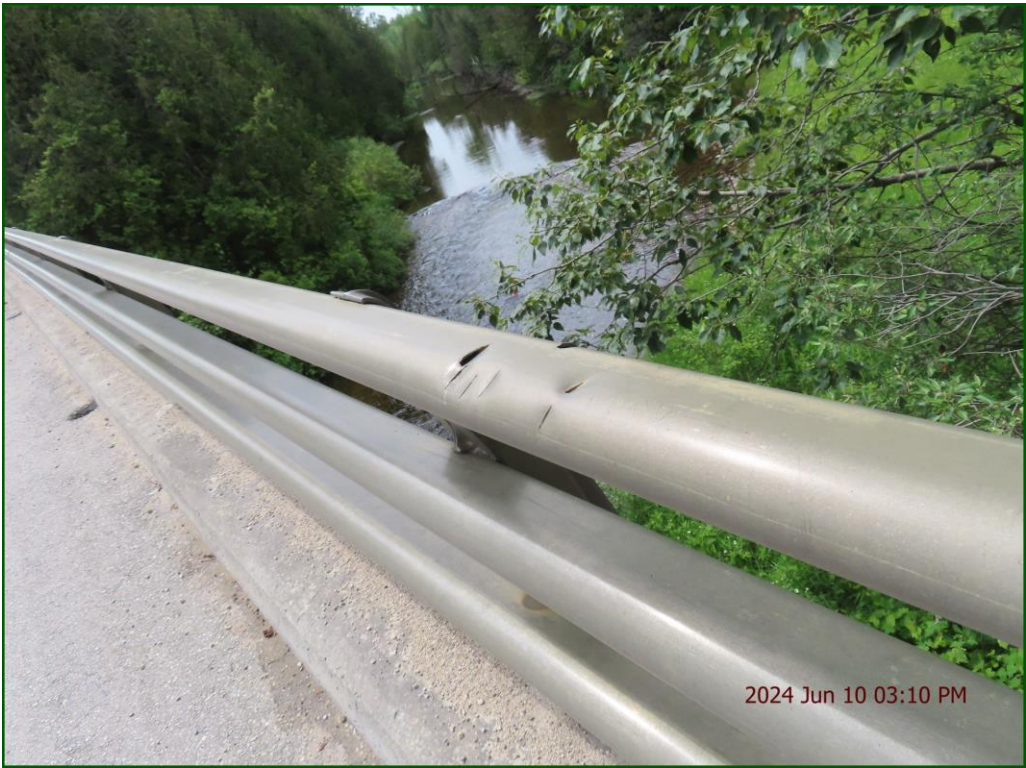
Description: Railing Systems: Minor impact damage.

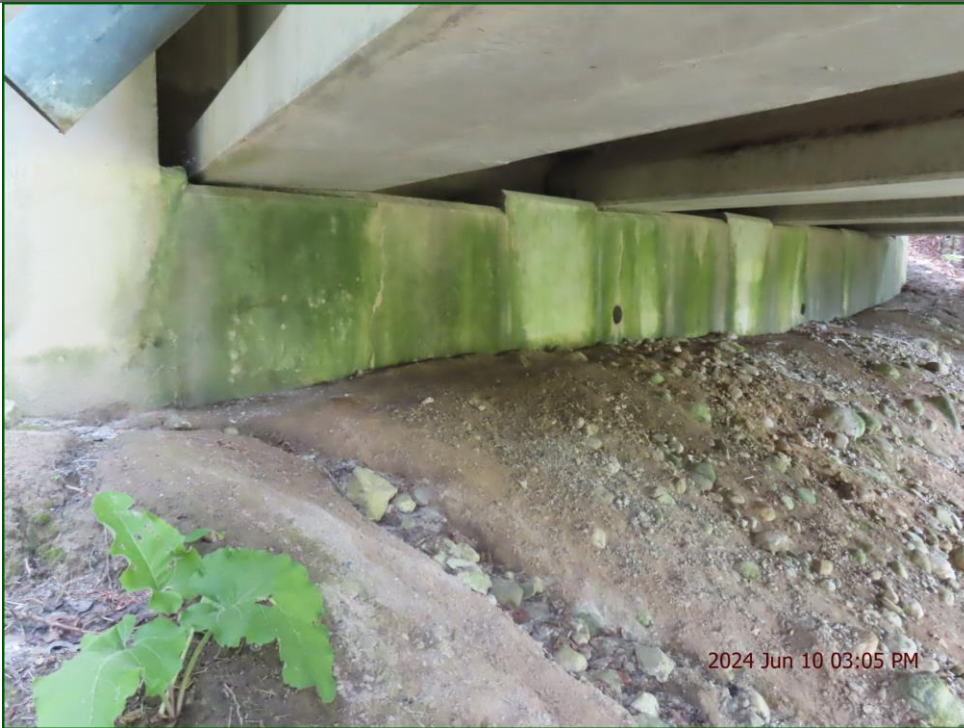
Light vertical cracking with leachate staining.

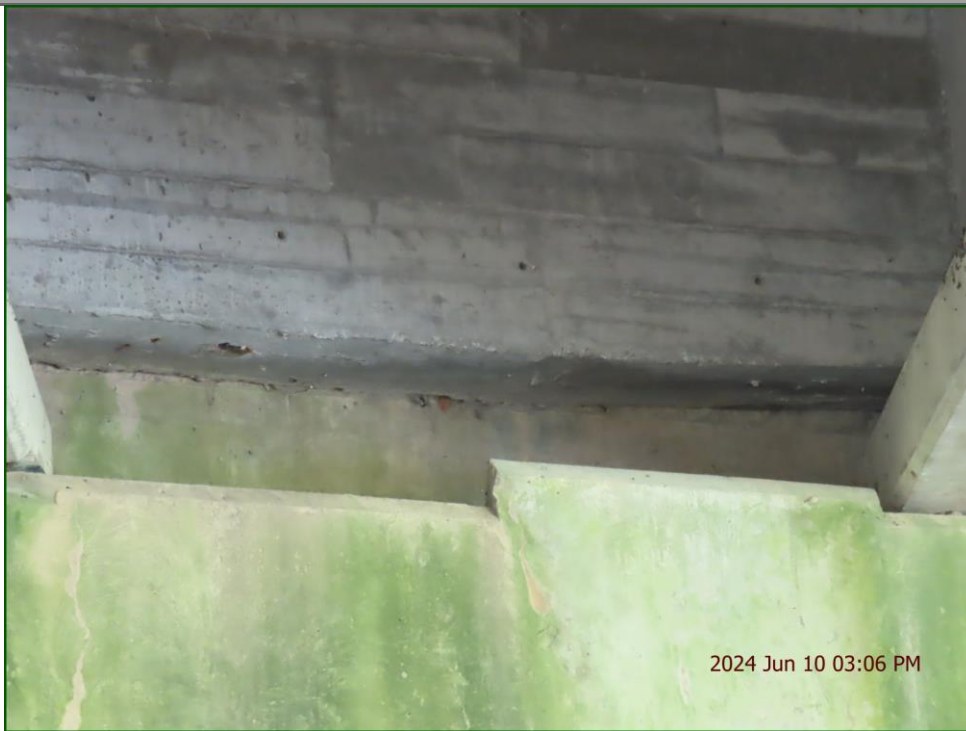
Limited inspection due to diaphragms.

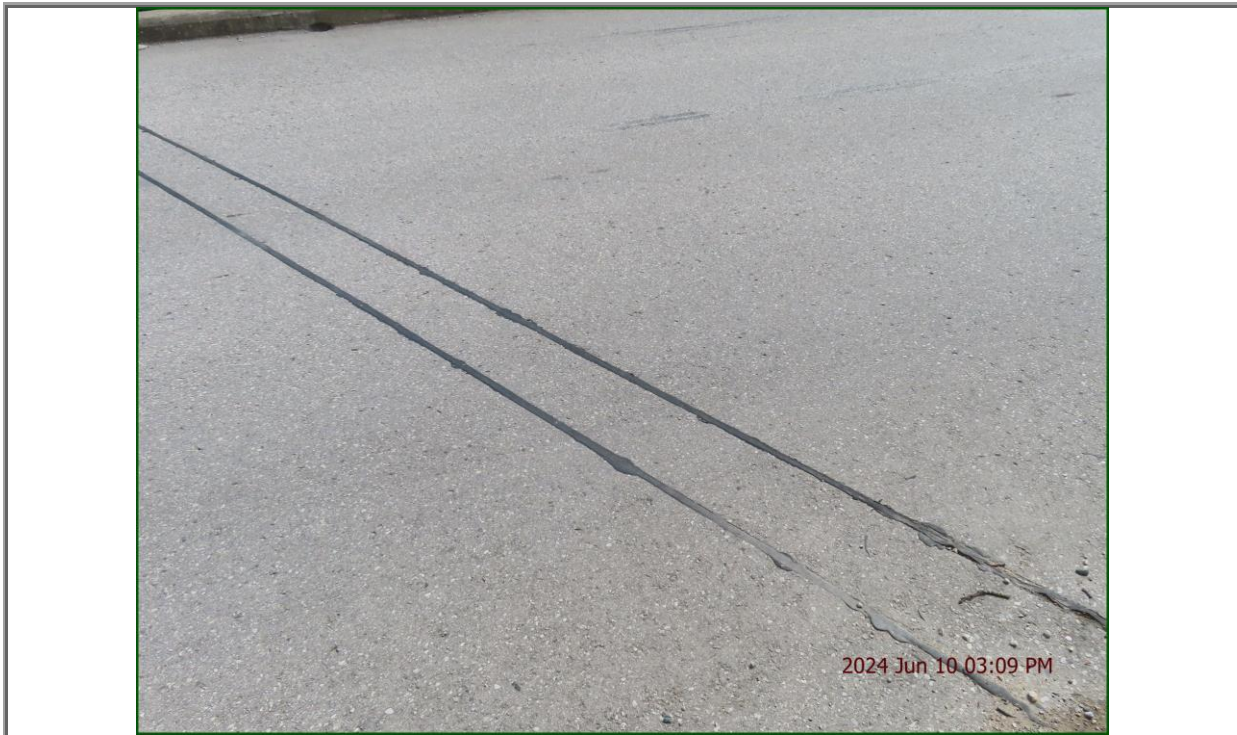
Paved over.

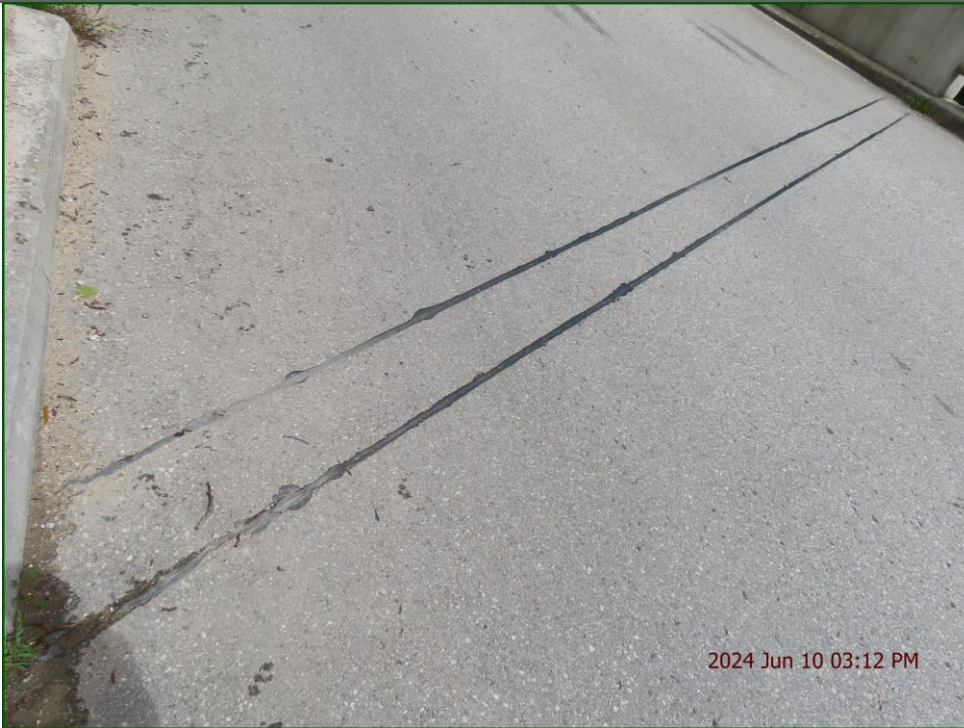
Paved over.

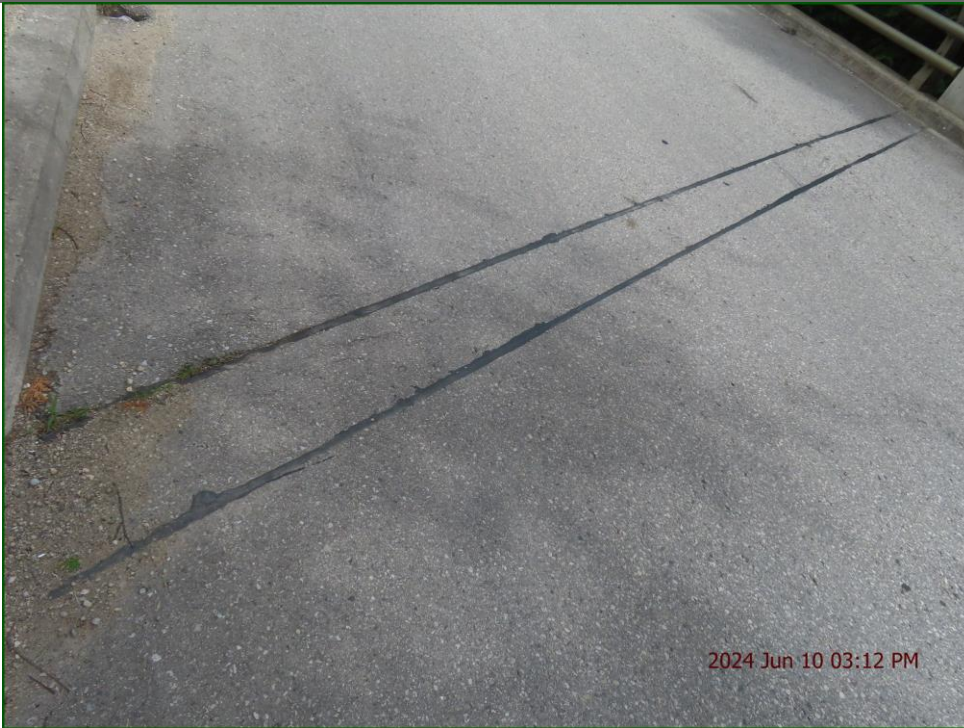
Paved over.

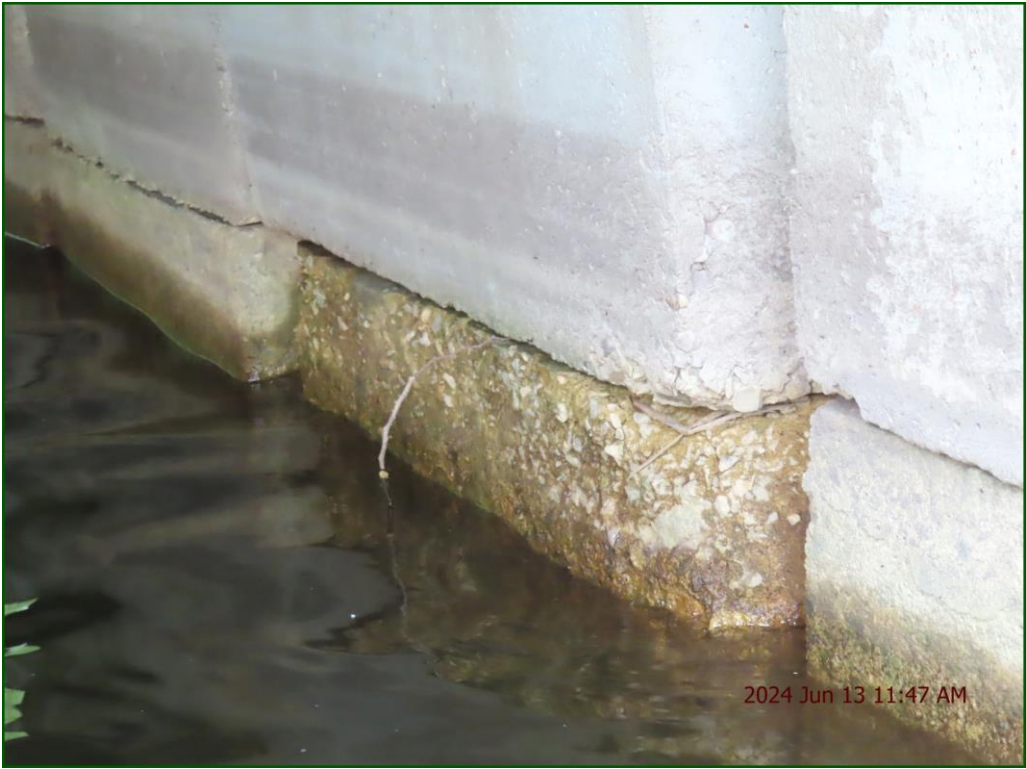
Description: Shafts/Columns/Pile Bents: Light spalling throughout.

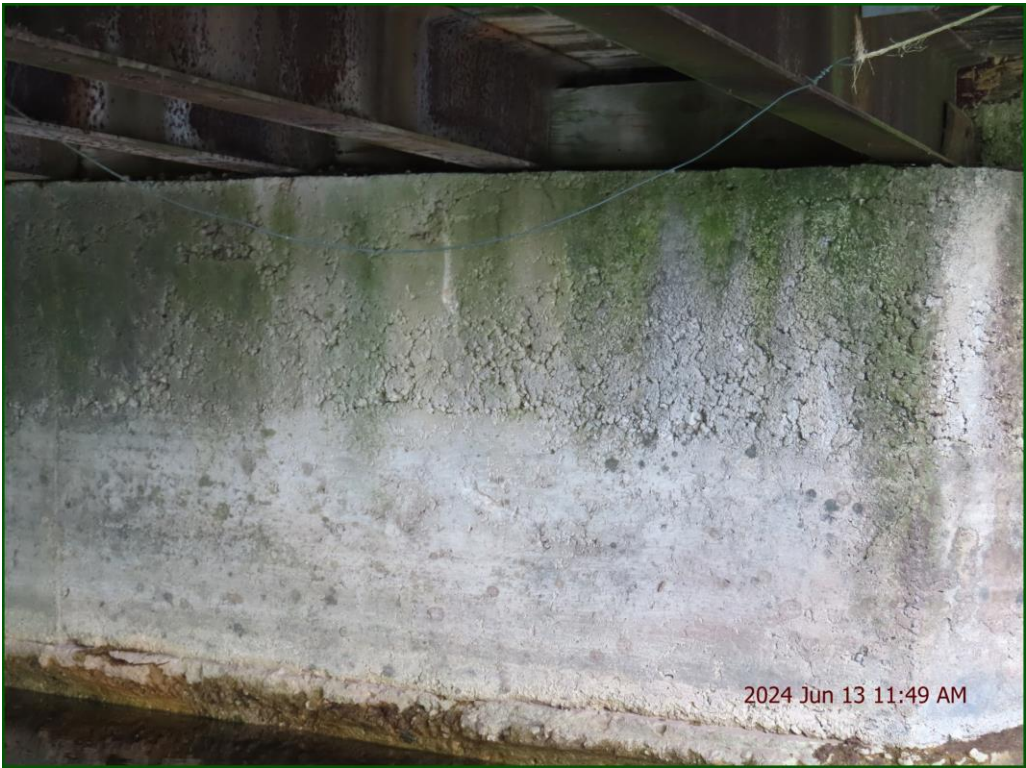
Description: Abutment walls: Medium honeycombing throughout.

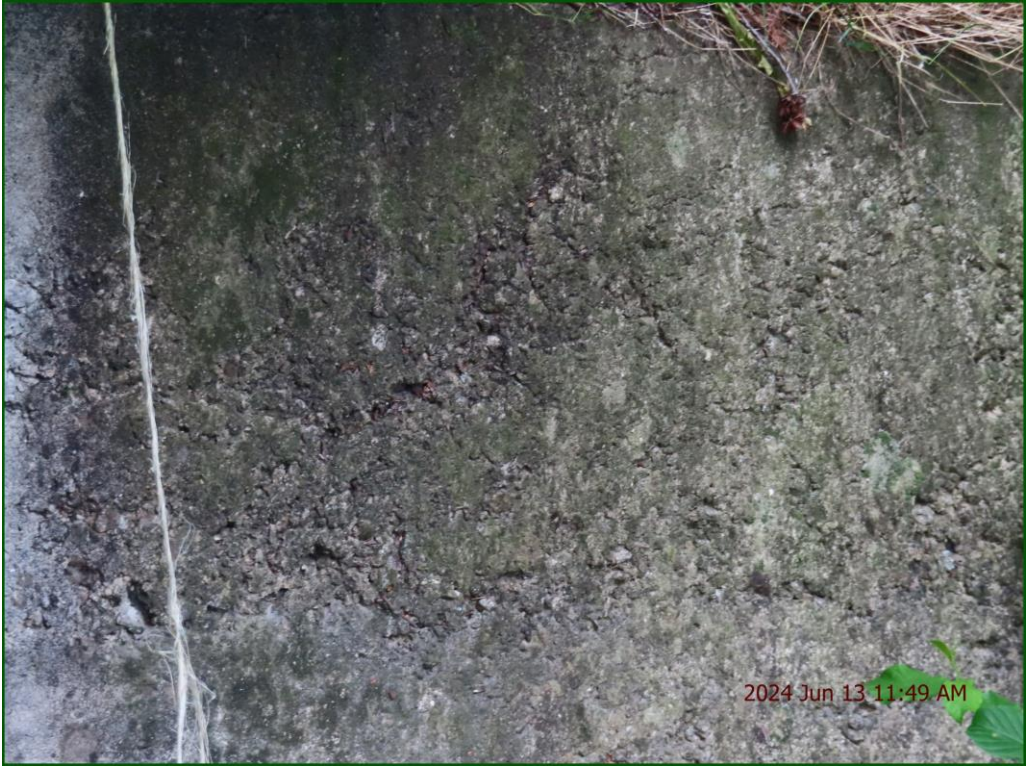
Description: Wingwalls: Medium honeycombing throughout.

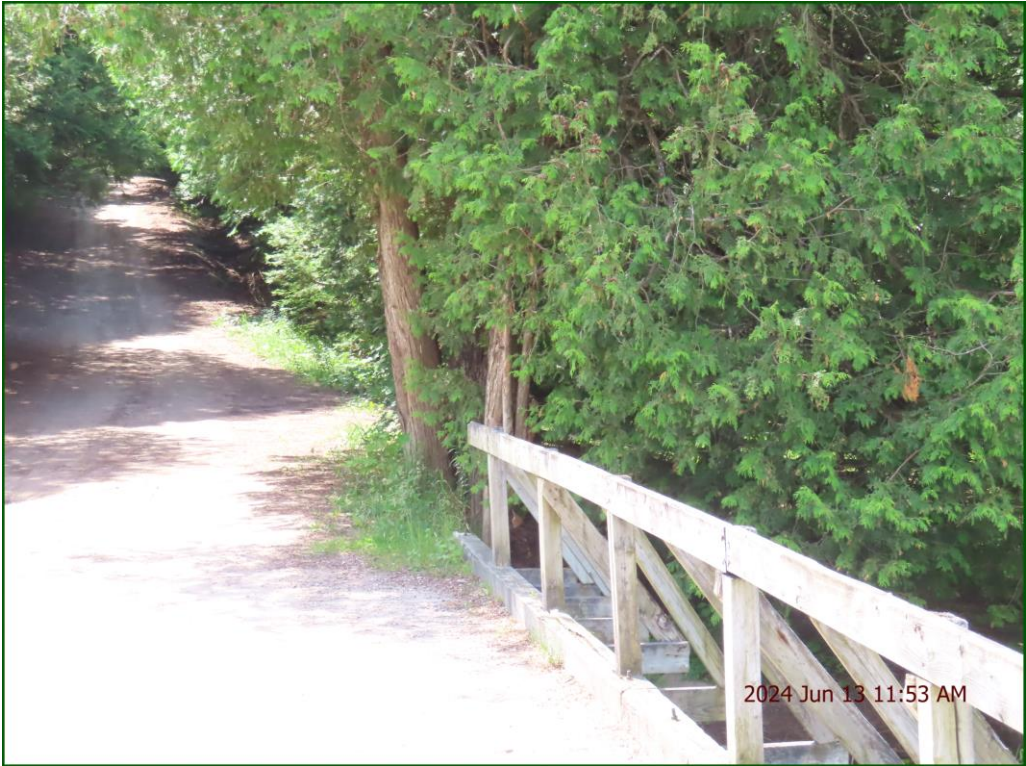
Description: Signs: Missing hazard sign at SW quadrant.

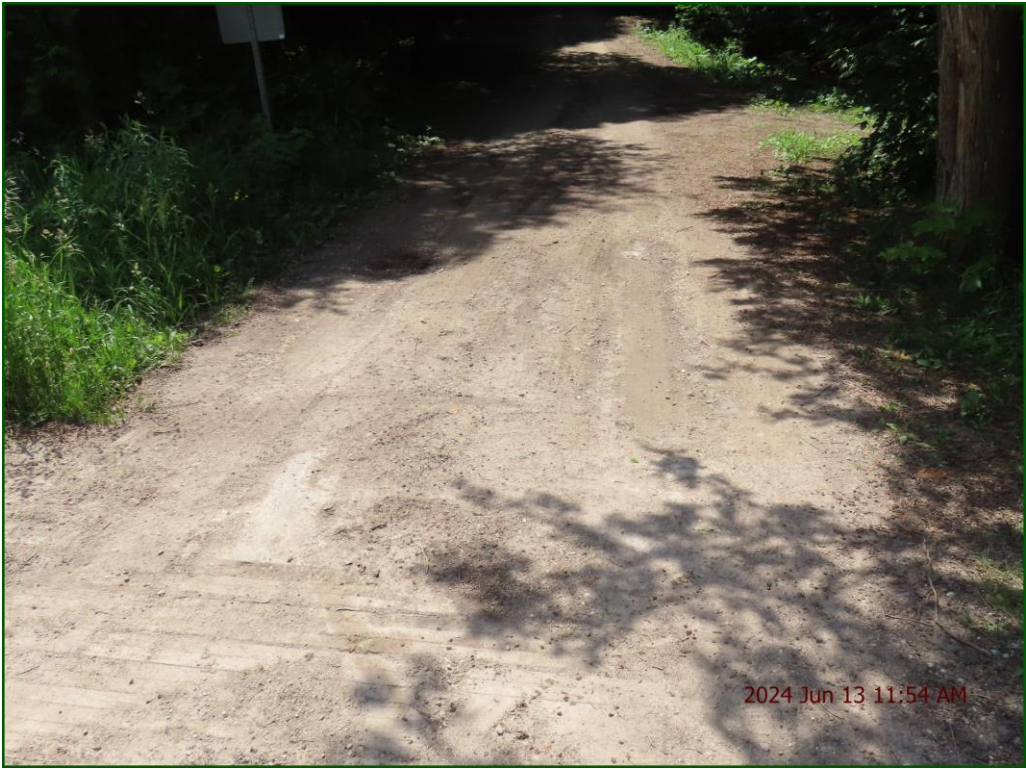
Description: Approach Wearing surface: Light rutting on south side.

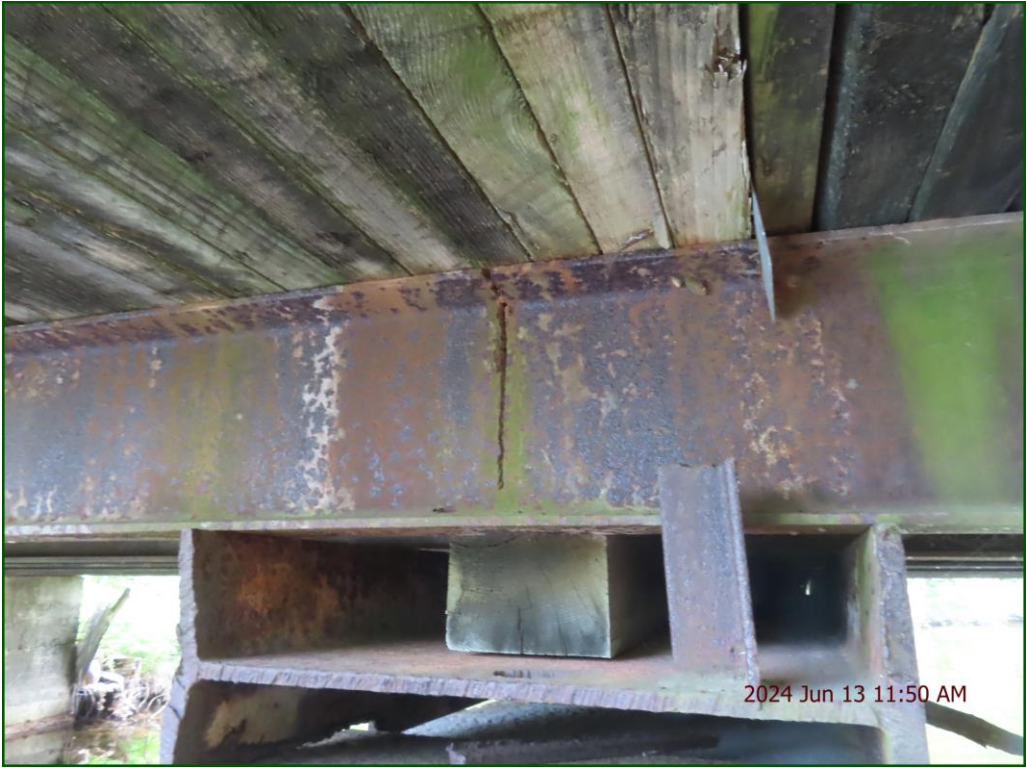
Description: Girders: Very wide vertical crack in west girder above pier.

Light corrosion throughout. Very wide vertical crack in west girder above pier, not critical.

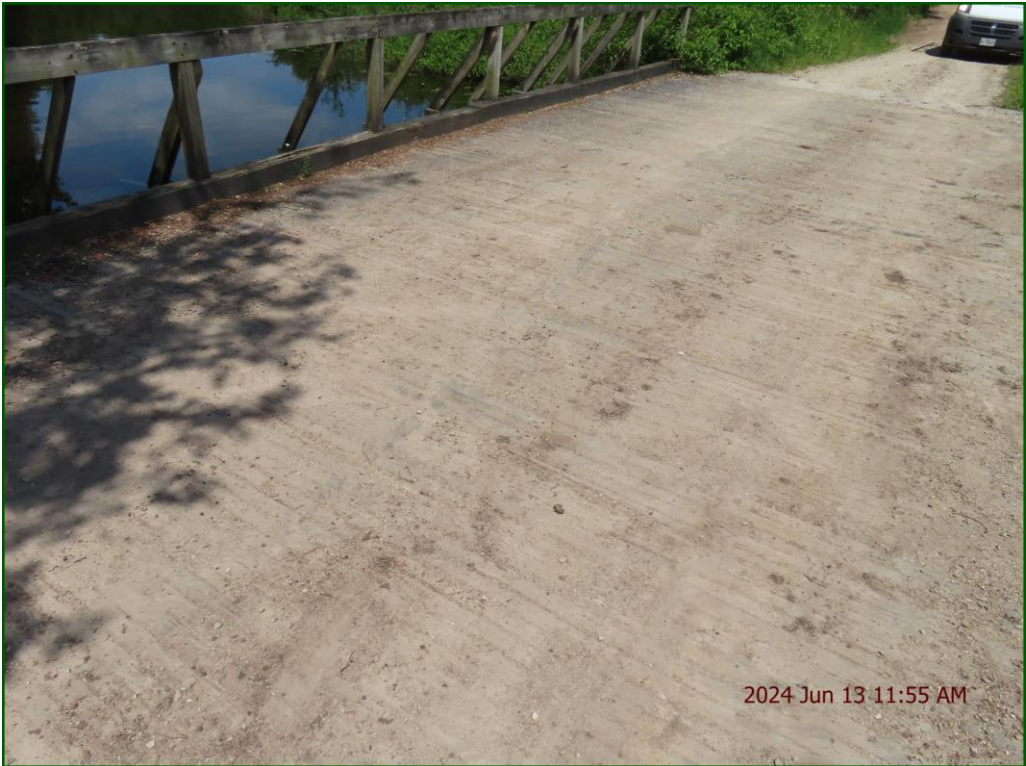
Description: Deck top: Light to medium weathering throughout.

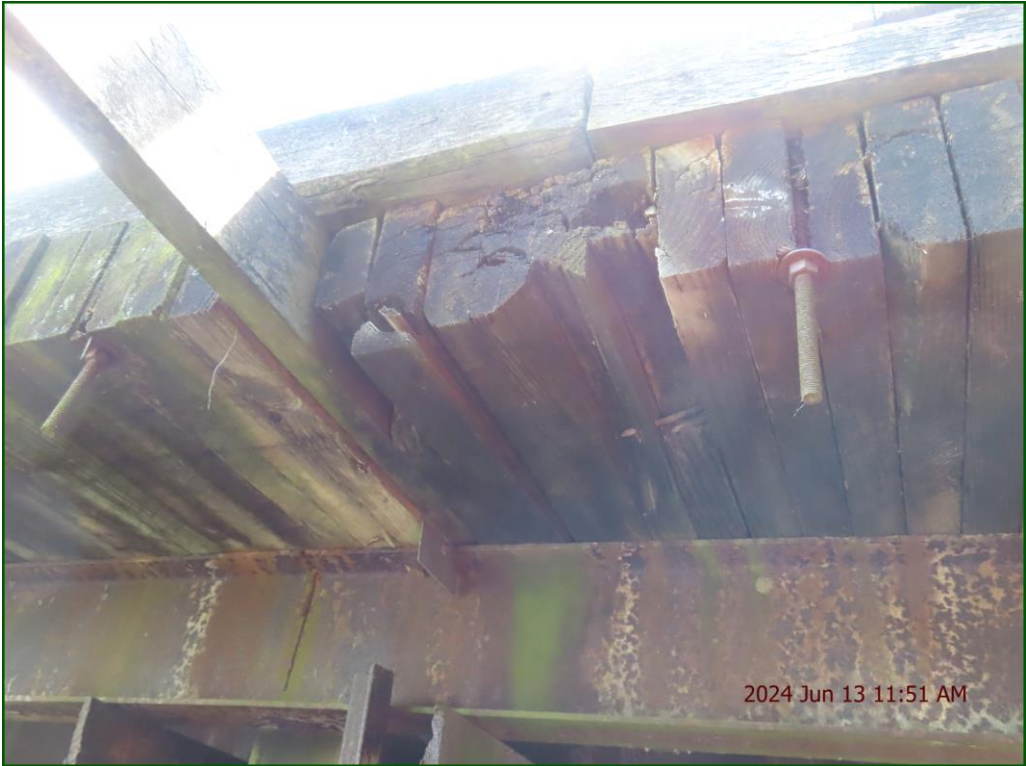
Description: Soffit (ext): Medium to severe rotting throughout.

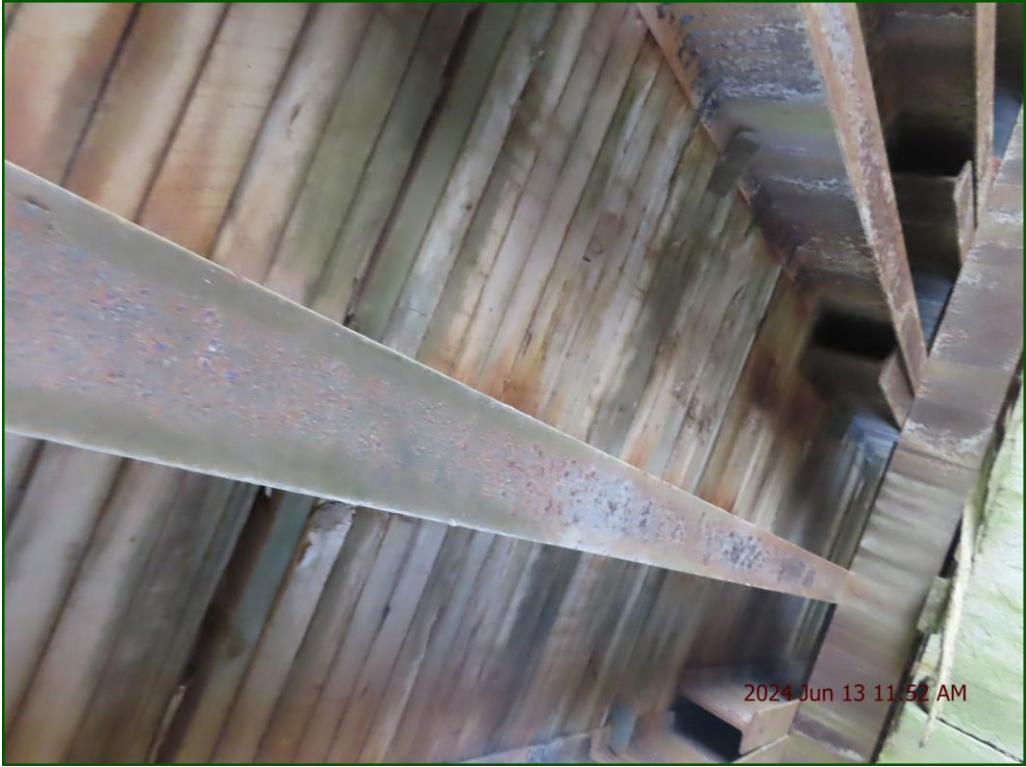
Description: Soffit (int): Light weathering.

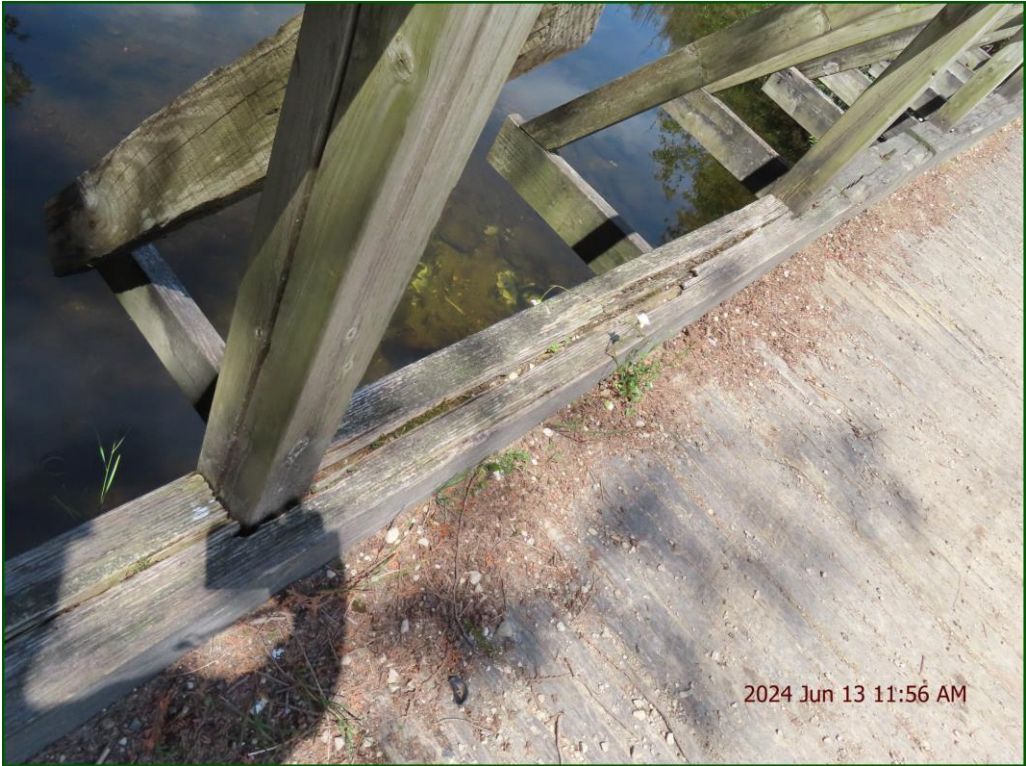
Description: Curbs: Light weathering and light rot throughout.

Light weathering and light rot throughout.

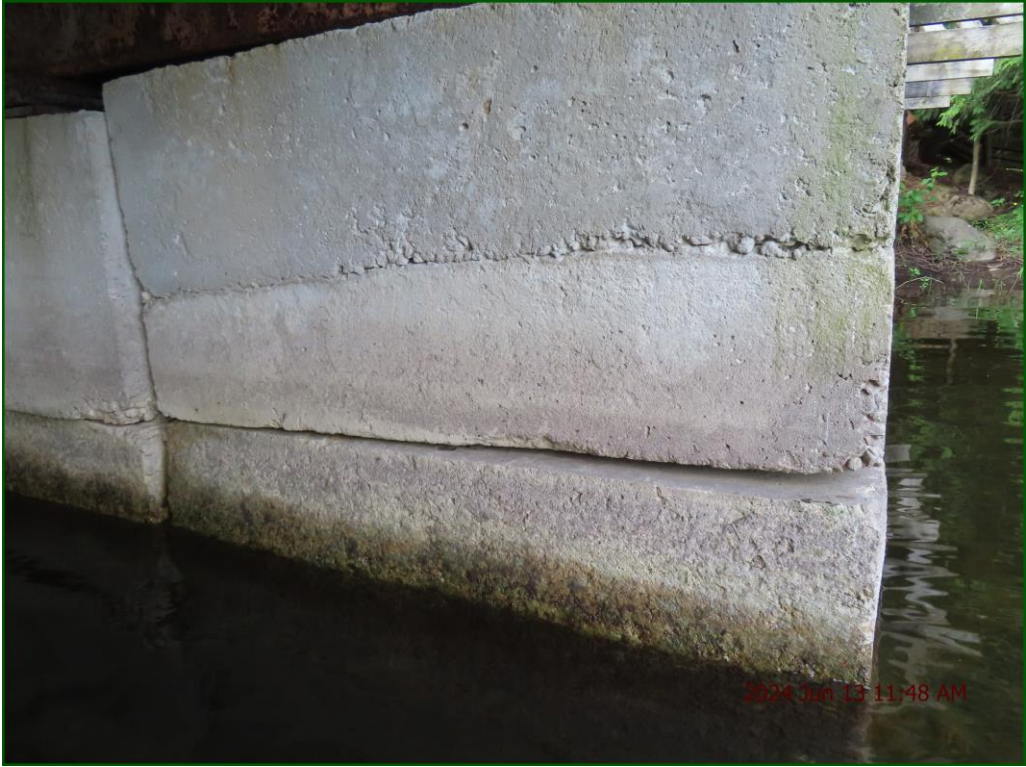
Description: Shafts/Columns/Pile Bents: Light to medium honeycombing throughout.
