Date of Inspection:	30-Jul-24
Name of Inspector:	Andrew Burgess, P.Eng. & Joel Ziegler CET
Equipment Used:	Sounding hammer, measuring equipment, GPS
Weather Conditions:	Cloudy
Temperature:	23
Special Notes:	Bridge is in good condition, showing no signs of structural distress.

Year Built:	1979	Contract Number When Built:	
Latest Biennial Inspection:	September 14, 2022	Latest Specialized Inspection:	
Latest Structure Rating:	75.0	Latest Structure Condition:	
RehabHistory:			
Regional Priority Number:		Programmed Work Year:	
NatureOfProgramWork:

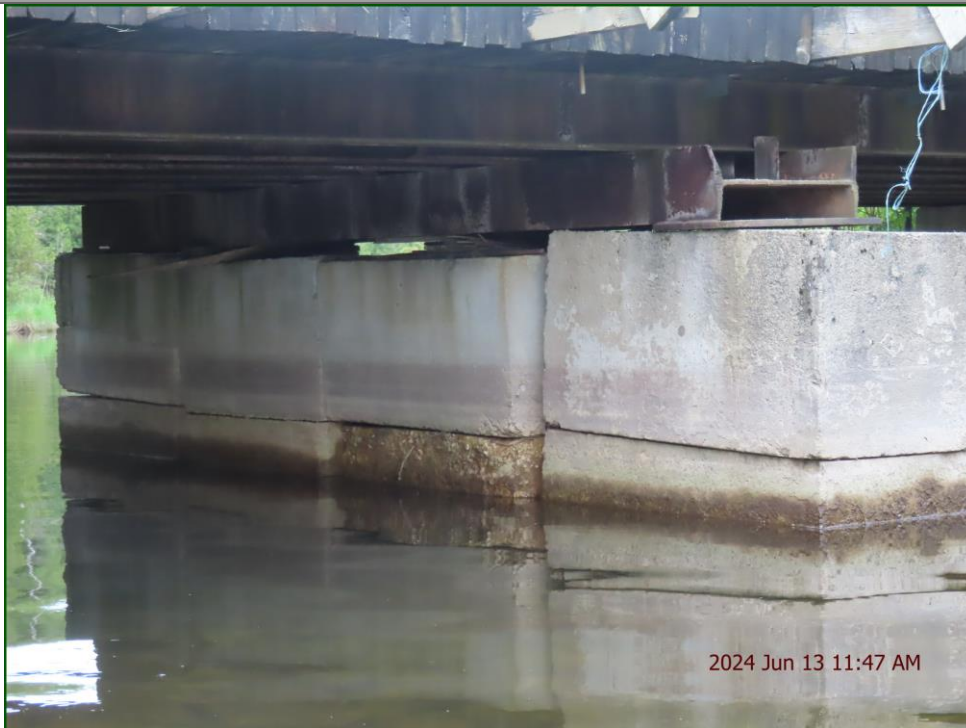
Light to medium honeycombing throughout. Light spalling throughout. High water level at time of inspection.

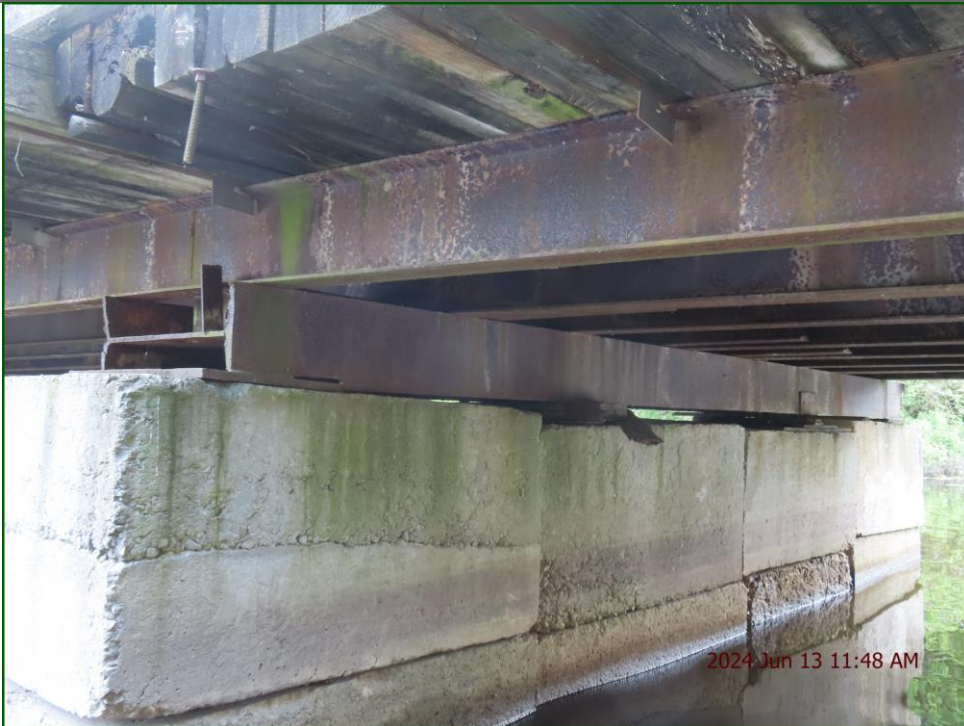
Light corrosion throughout. Cap is Steel I-beam.

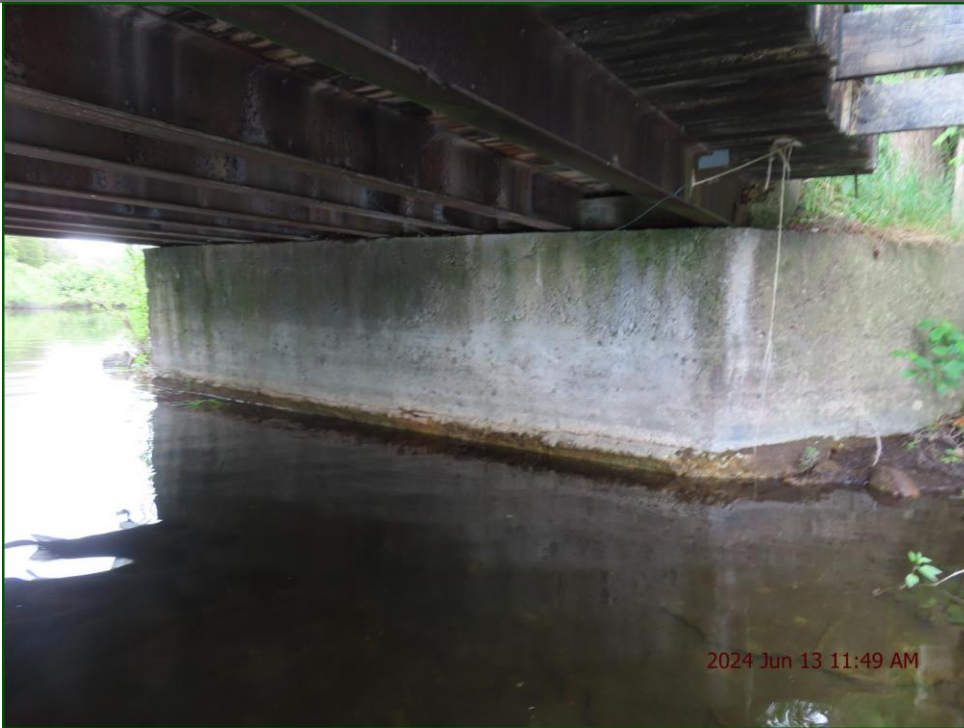
Medium honeycombing throughout.

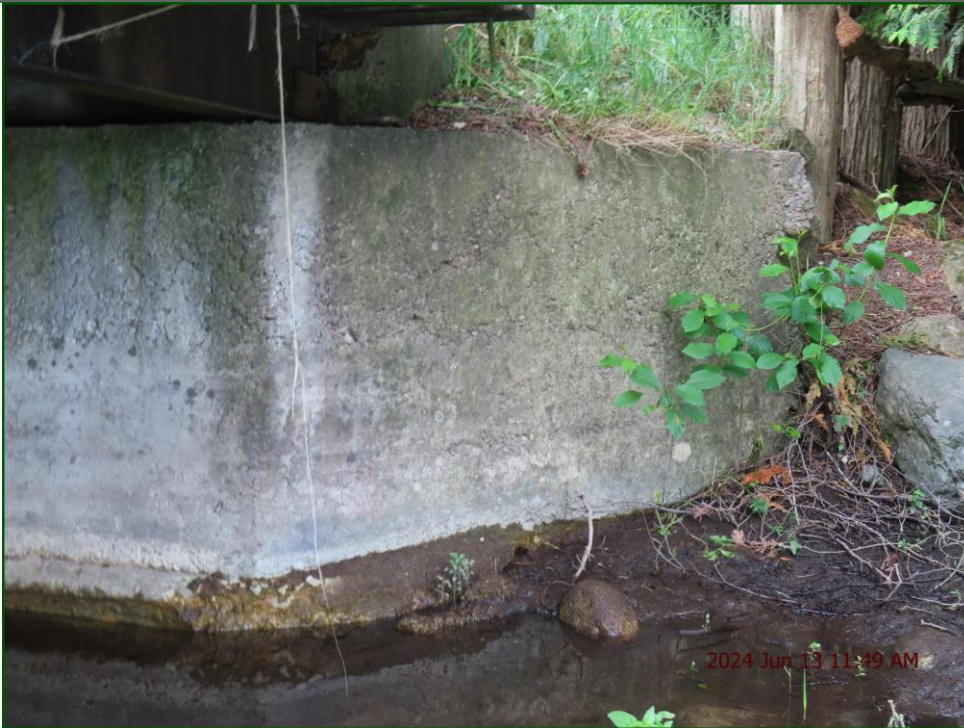
Medium honeycombing throughout.

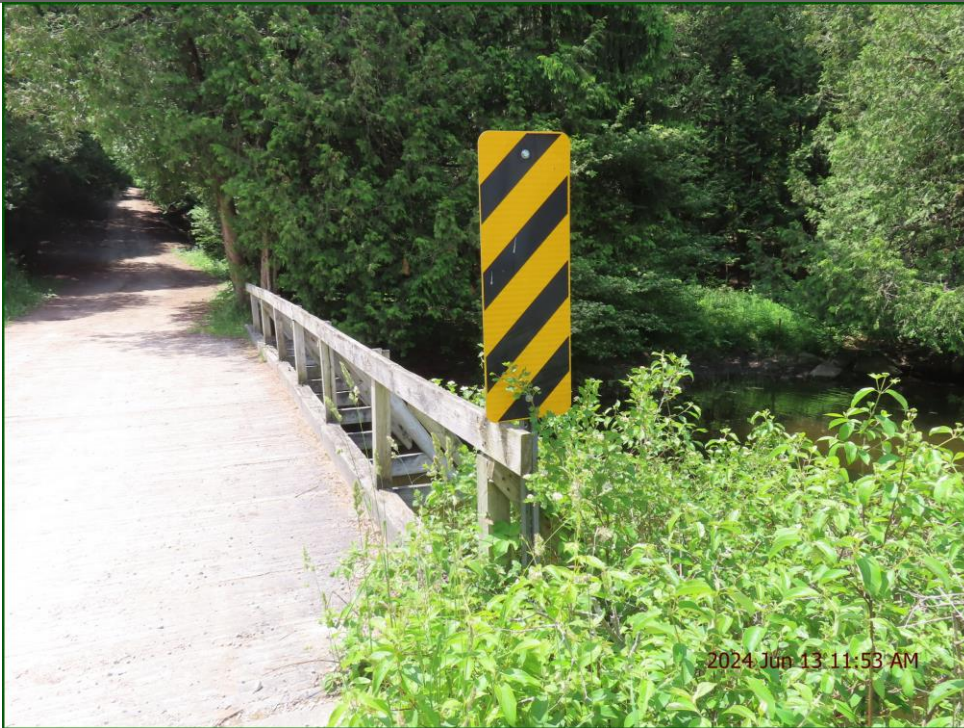
Description: Signs: Missing hazard sign at SW quadrant.

Missing hazard sign at SW quadrant.

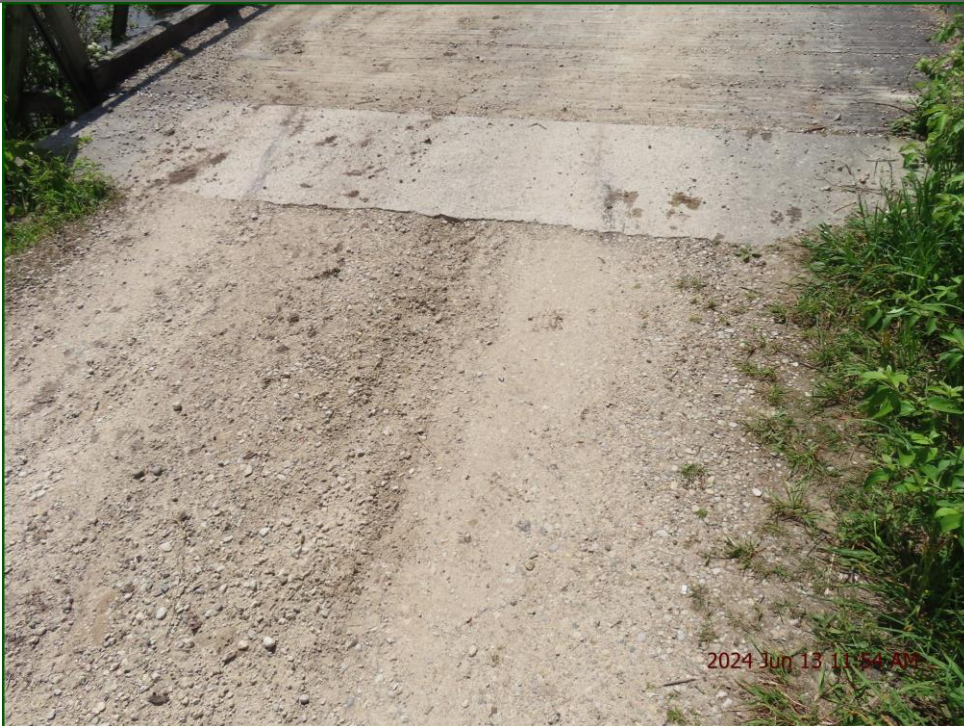
Description: Approach Wearing surface: Light rutting on south side.

Light rutting on south side.

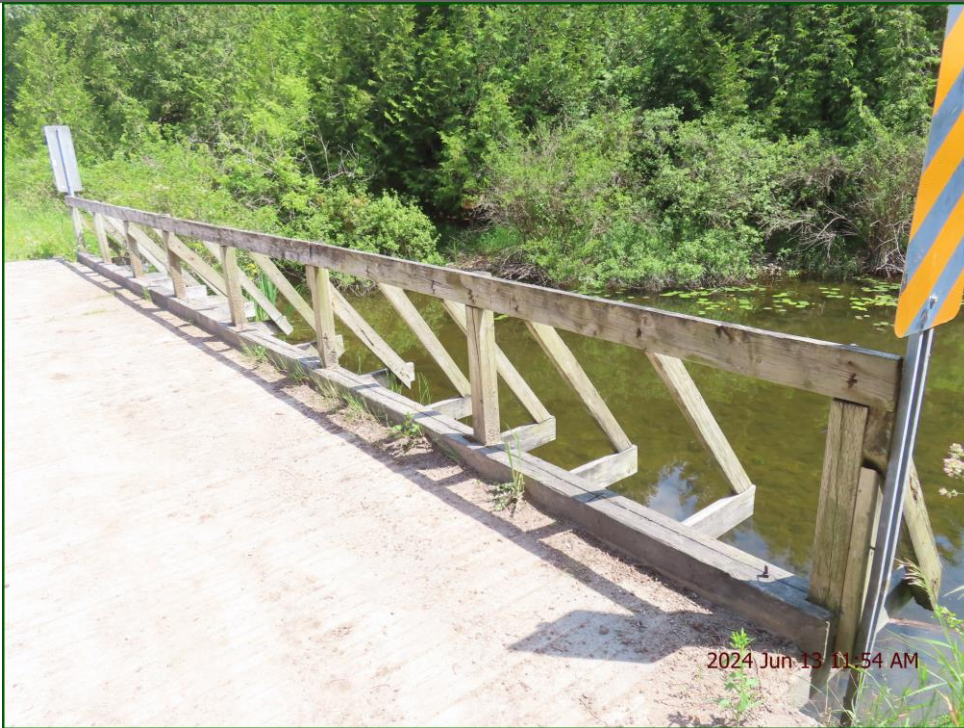
Light weathering throughout. Very light design.

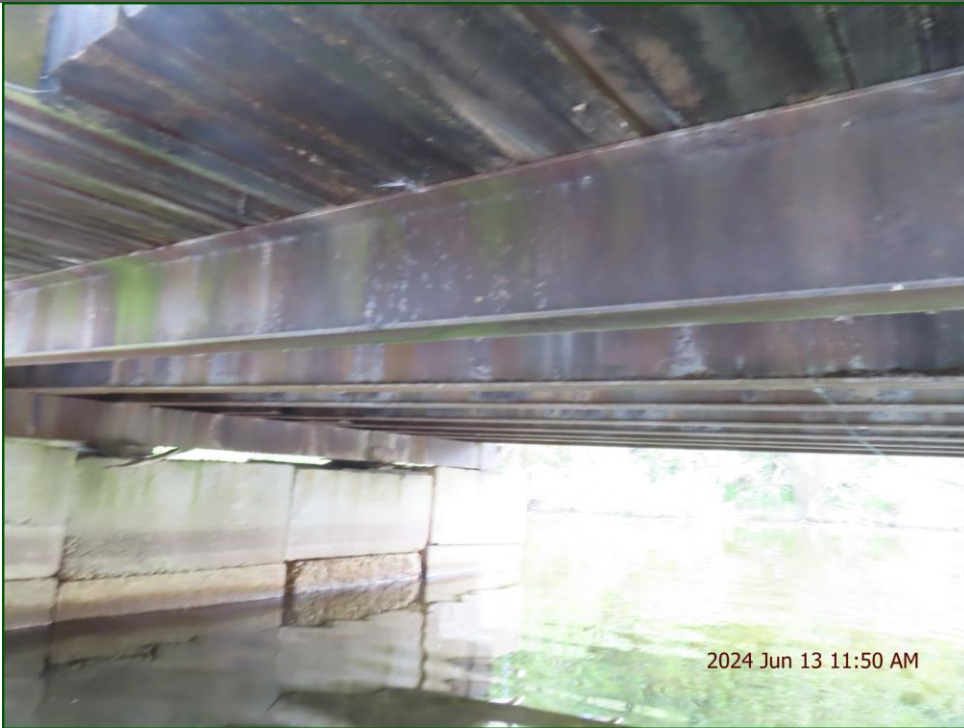
Description: Girders: Very wide vertical crack in west girder above pier.

Light corrosion throughout. Very wide vertical crack in west girder above pier, not critical.

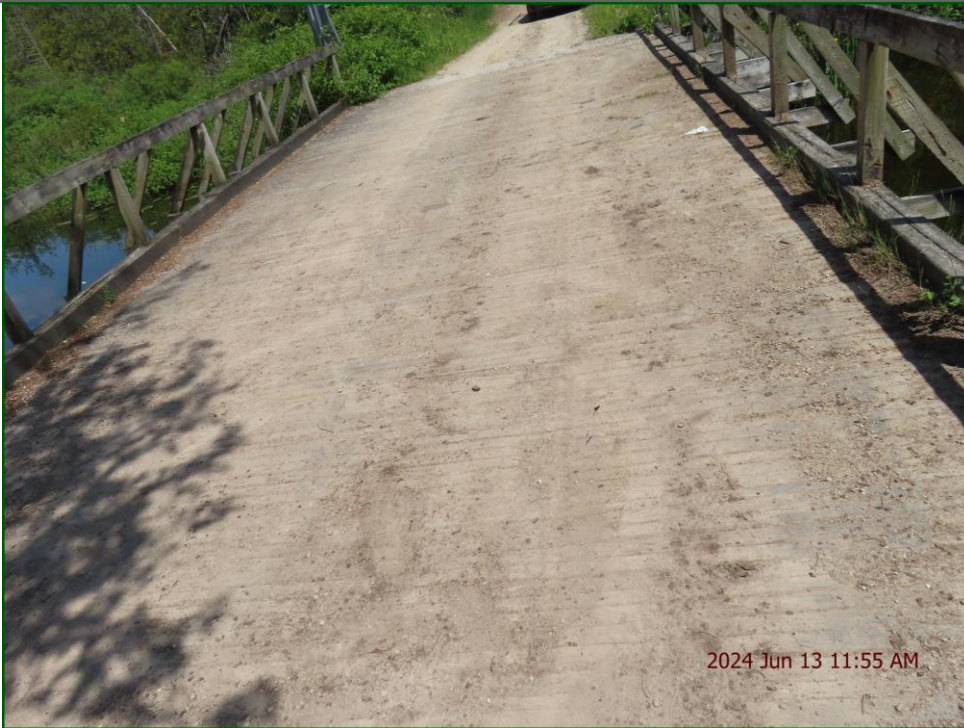
Light to medium weathering throughout.

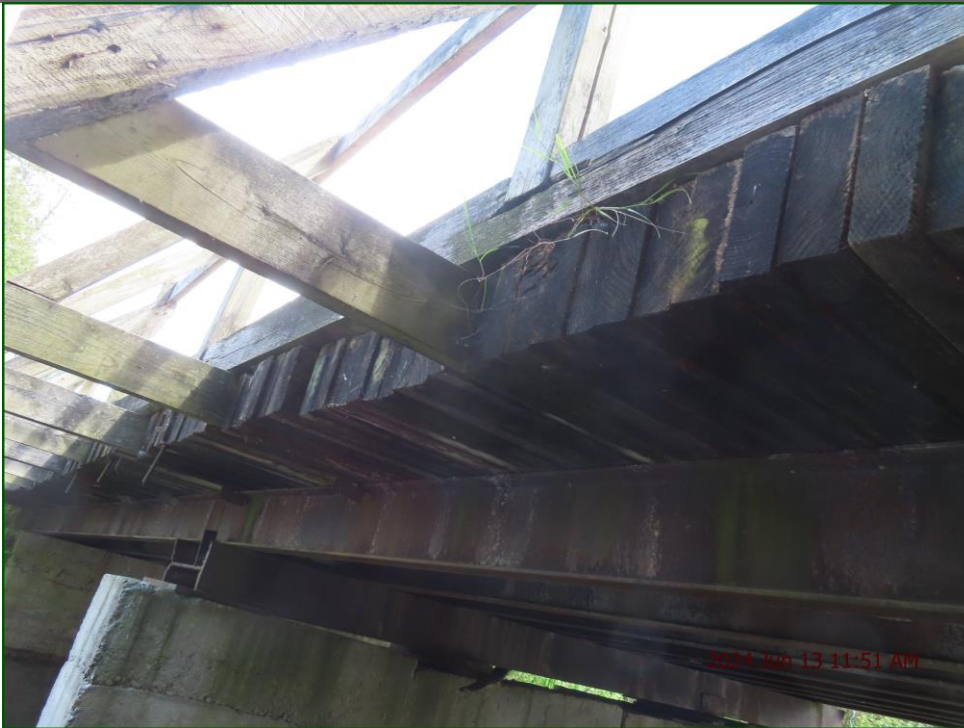
Medium to severe rotting throughout.

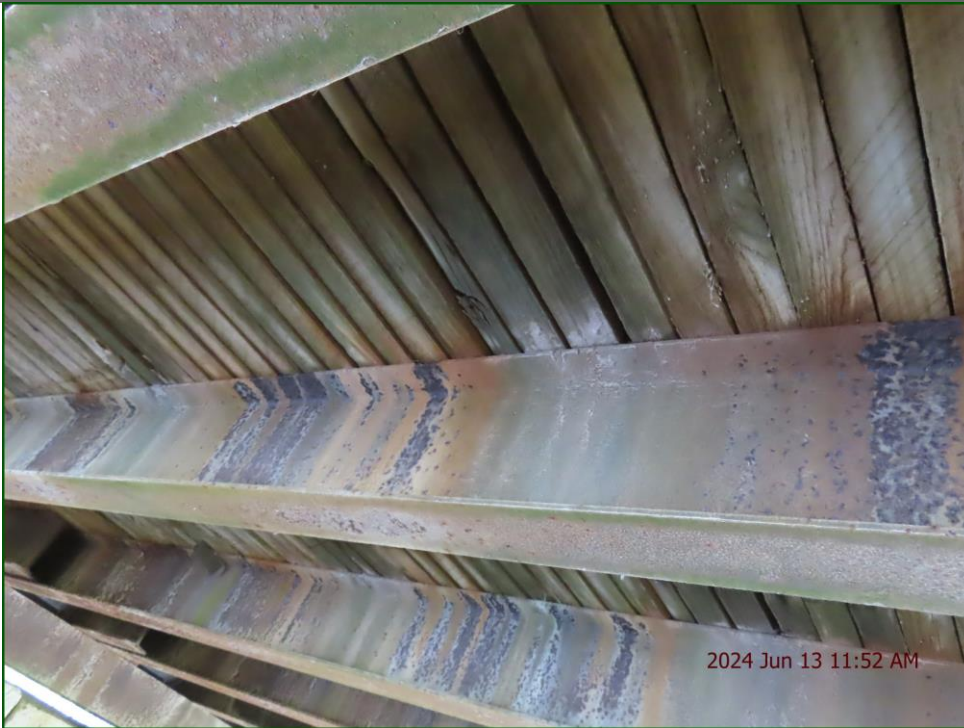
Light weathering.

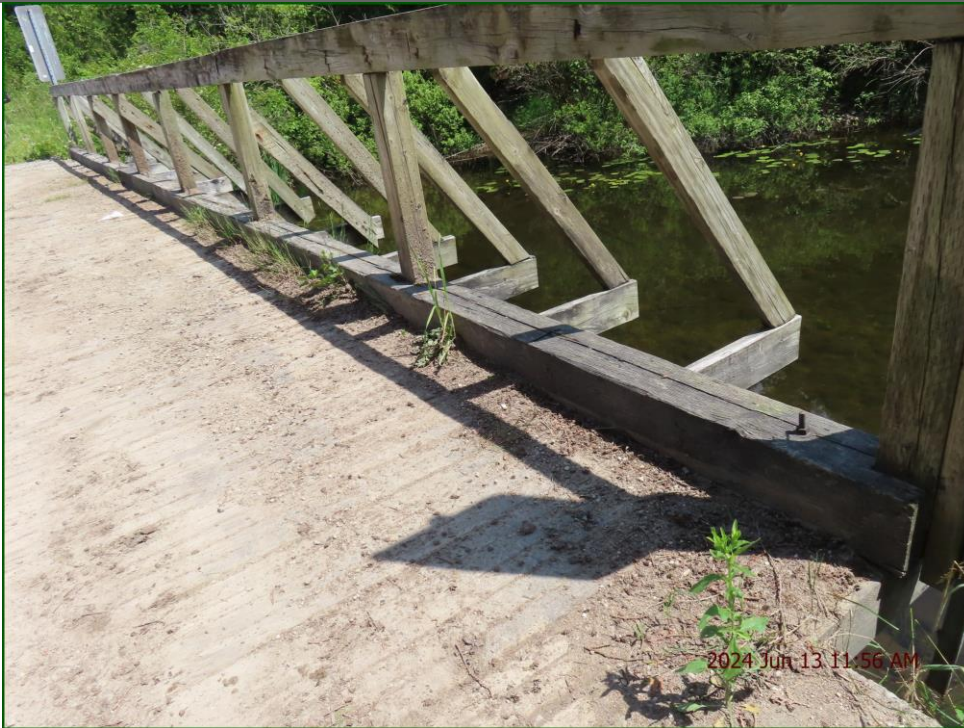
Light weathering and light rot throughout.

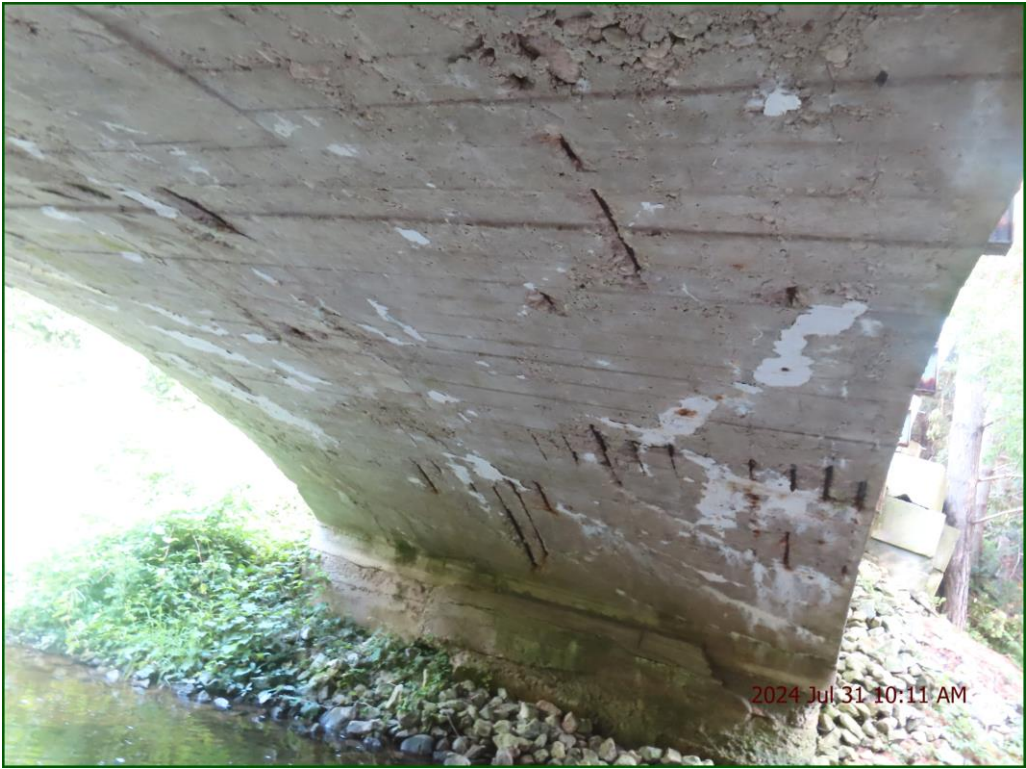
Description: Barrel: Severe spalling with exposed reinforcing throughout.

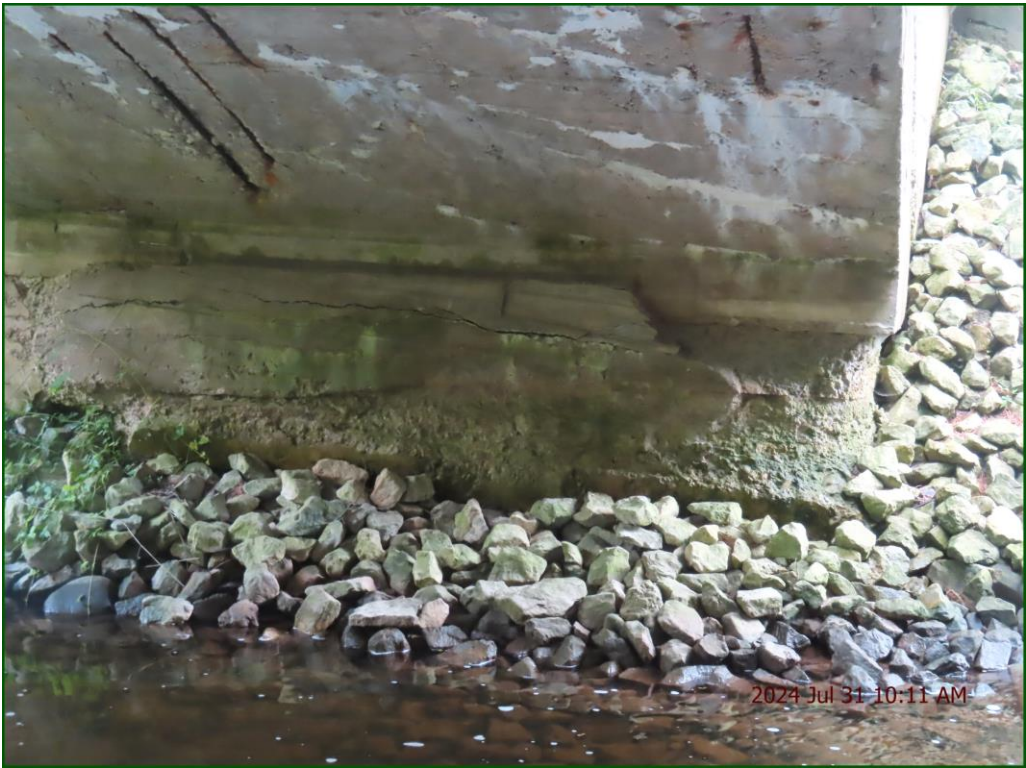
Description: Barrel: Severe spalling and disintegration at footing on east side.

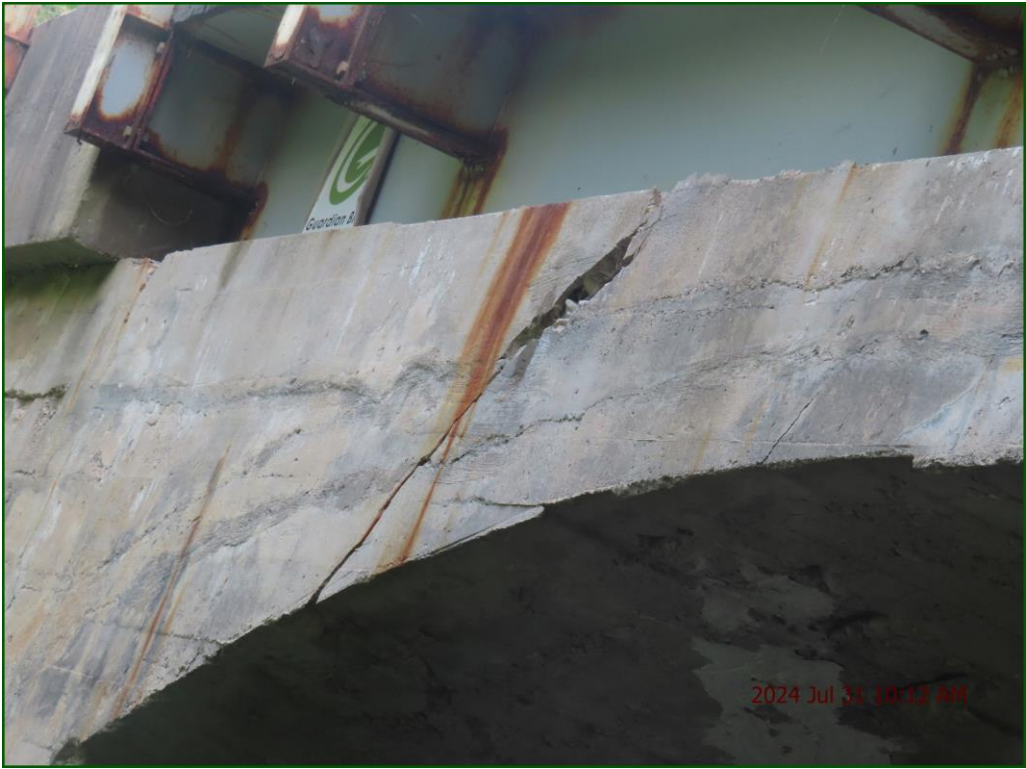
Description: Outlet: Severe spalling and cracking throughout.

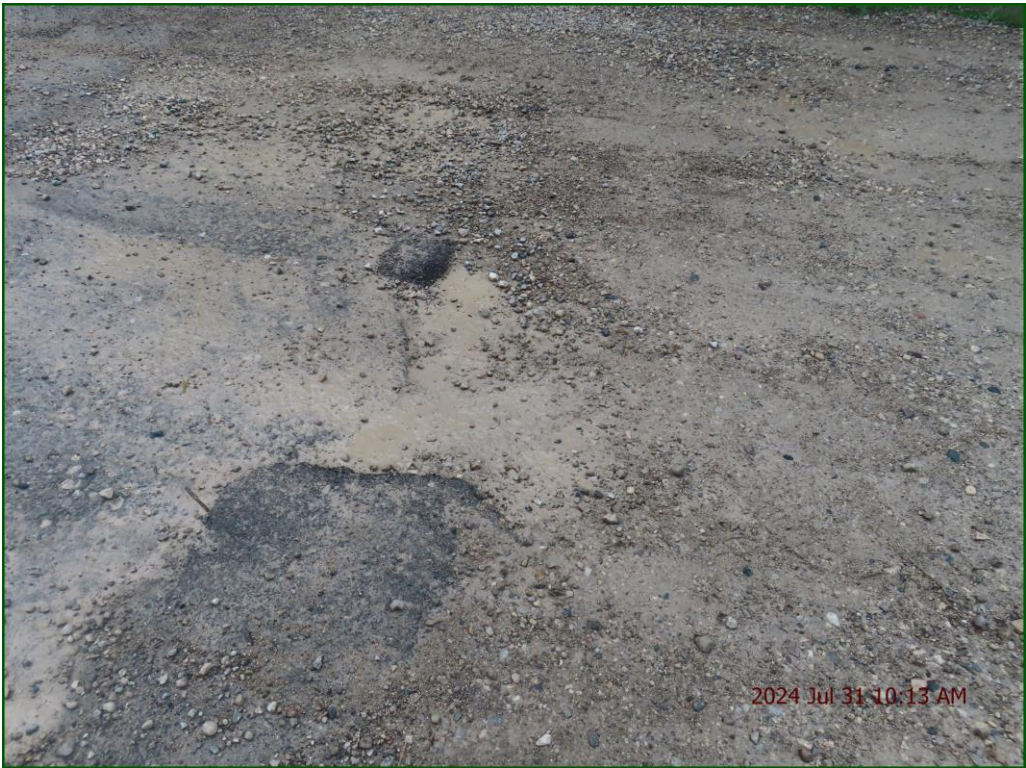
Description: Approach Wearing surface: Severe potholing throughout and possible settlement at west appr

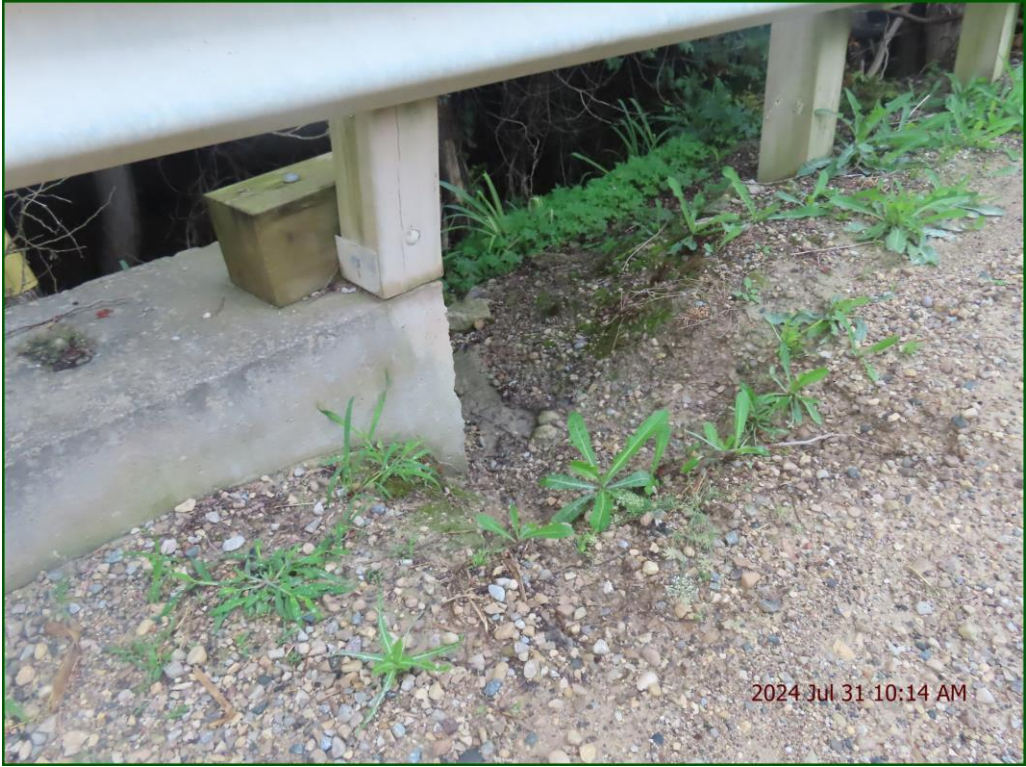
Description: Embankments: Severe erosion on south-east quadrant around retaining wall.

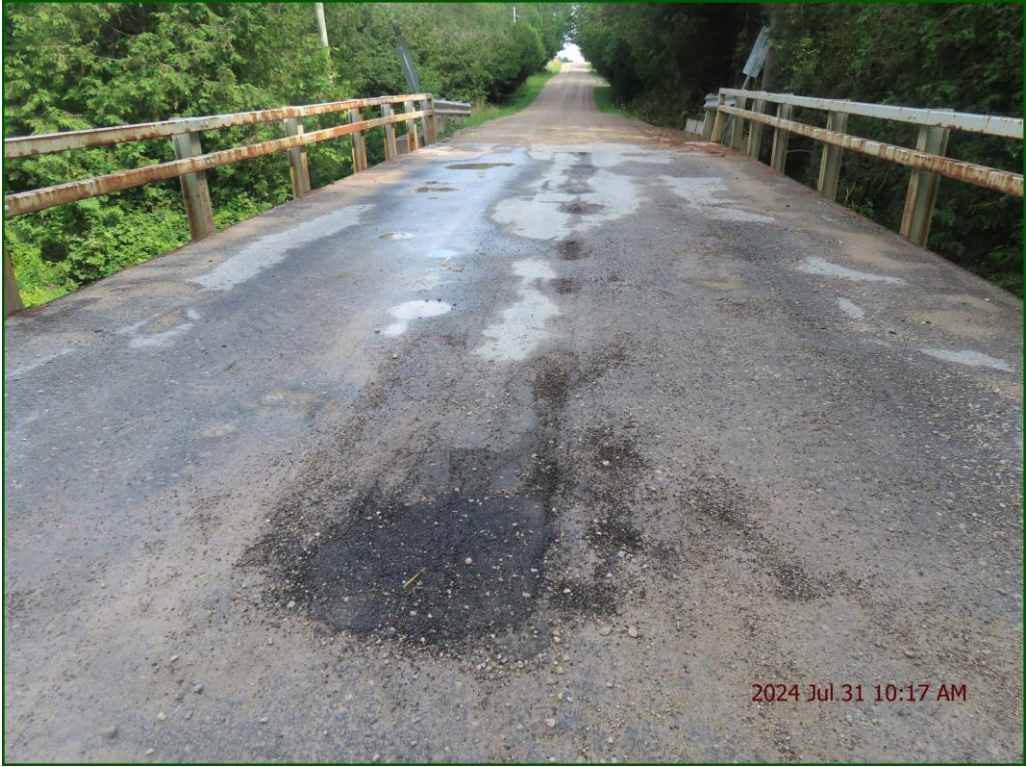
Description: Wearing surface: Moderate potholing throughout.

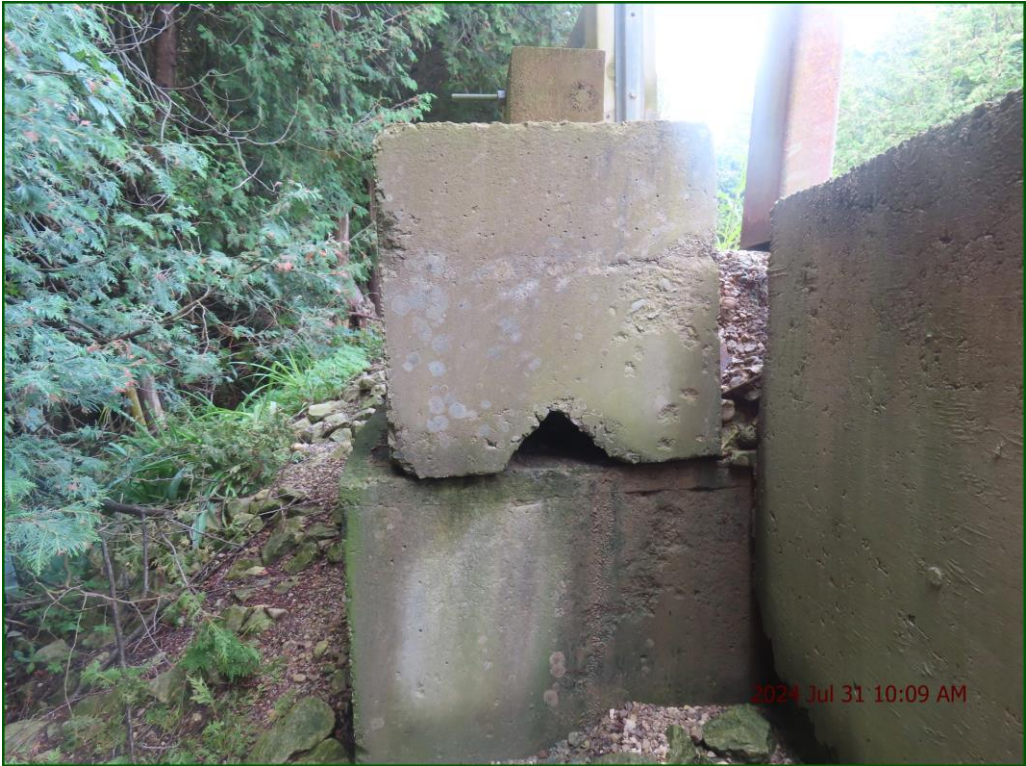
Description: Retaining Walls: Retaining walls on east side and north west quadrant starting to push outwa

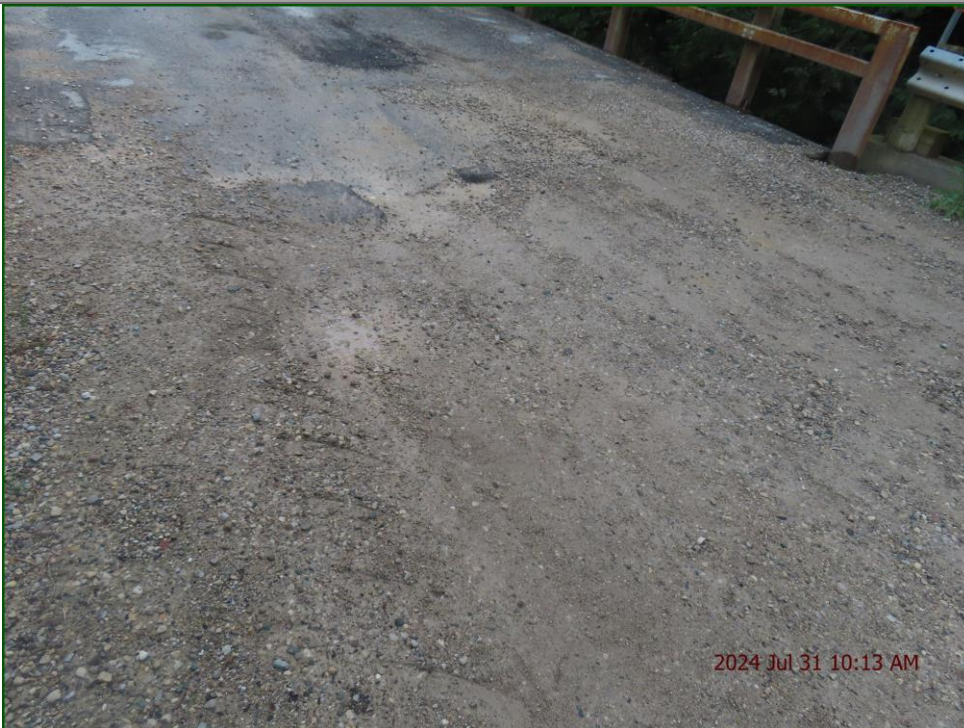
Severe potholing throughout and possible settlement at west approach.

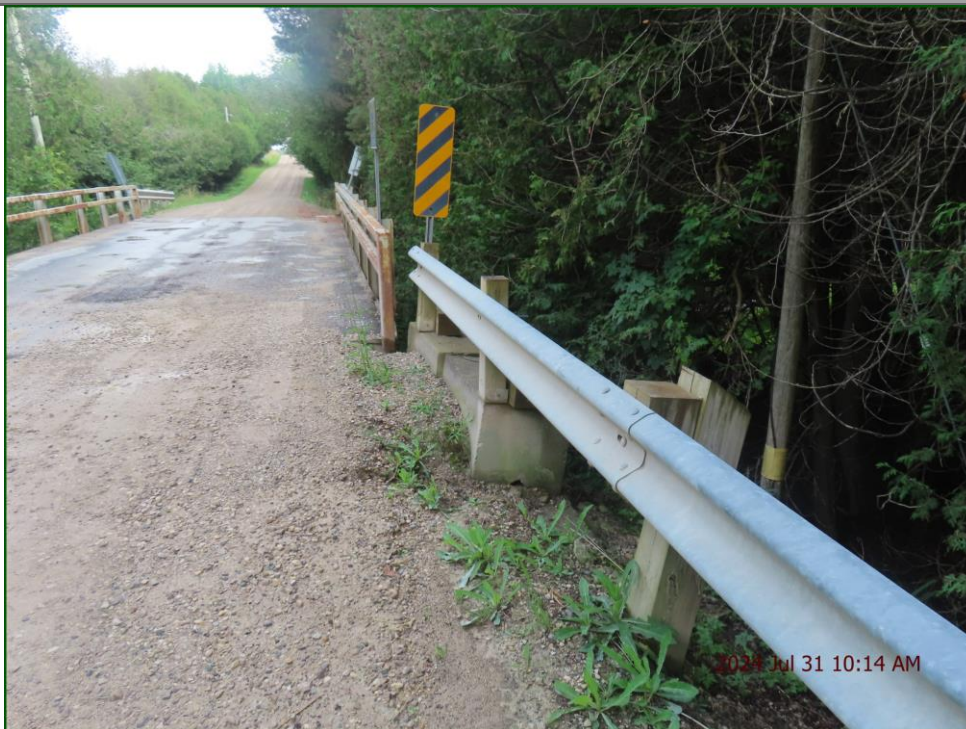
Severe erosion on south-east quadrant around retaining wall.

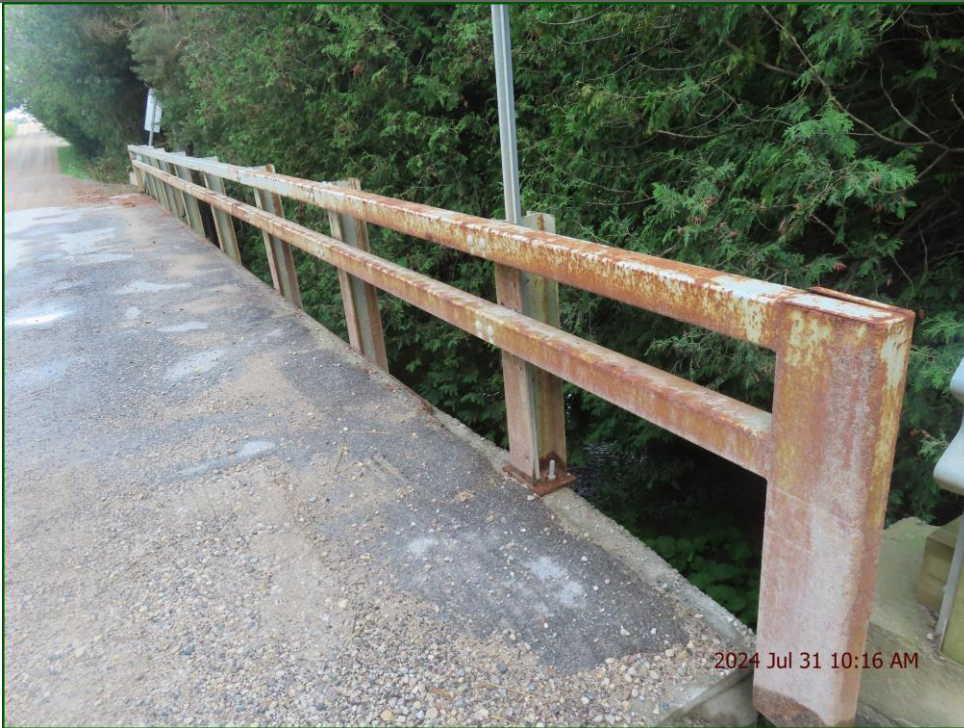
Light corrosion throughout.

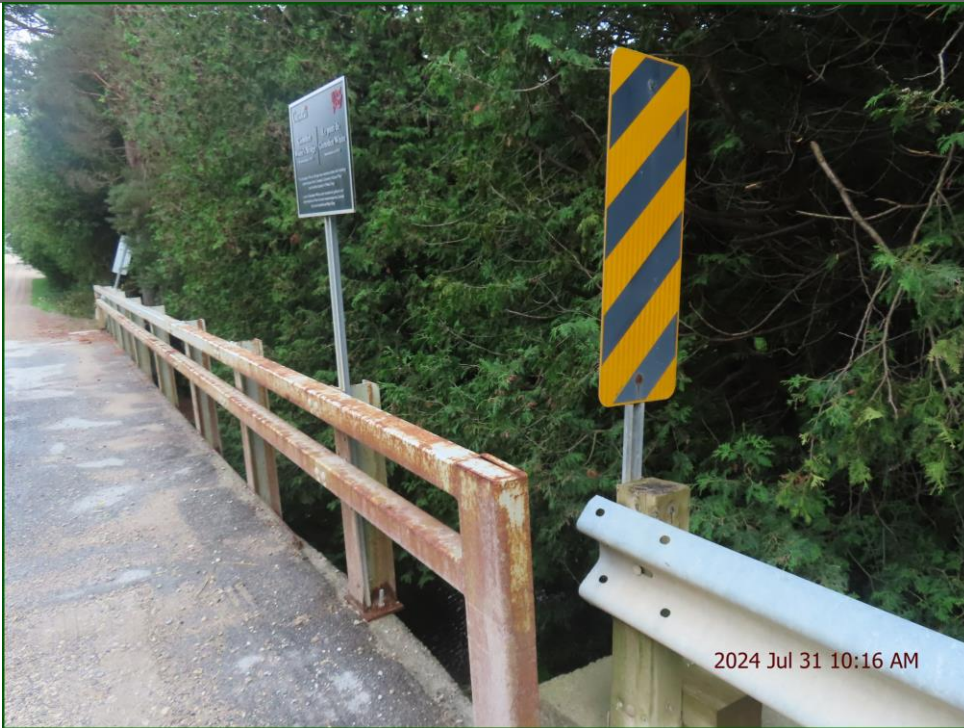
North signs both very bent.

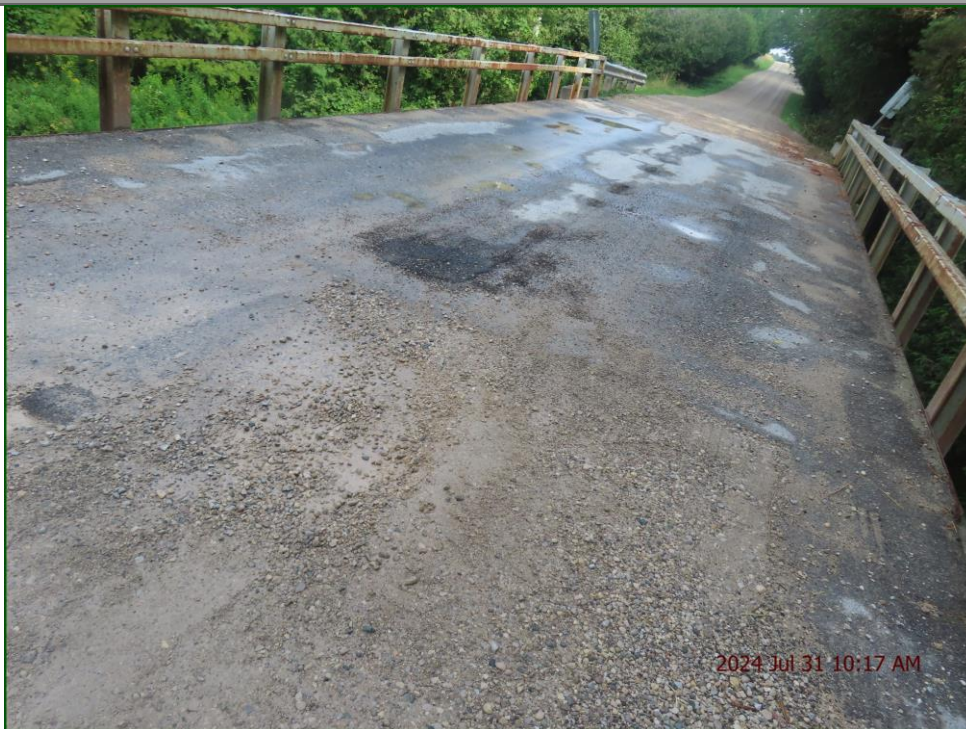
Moderate potholing throughout.

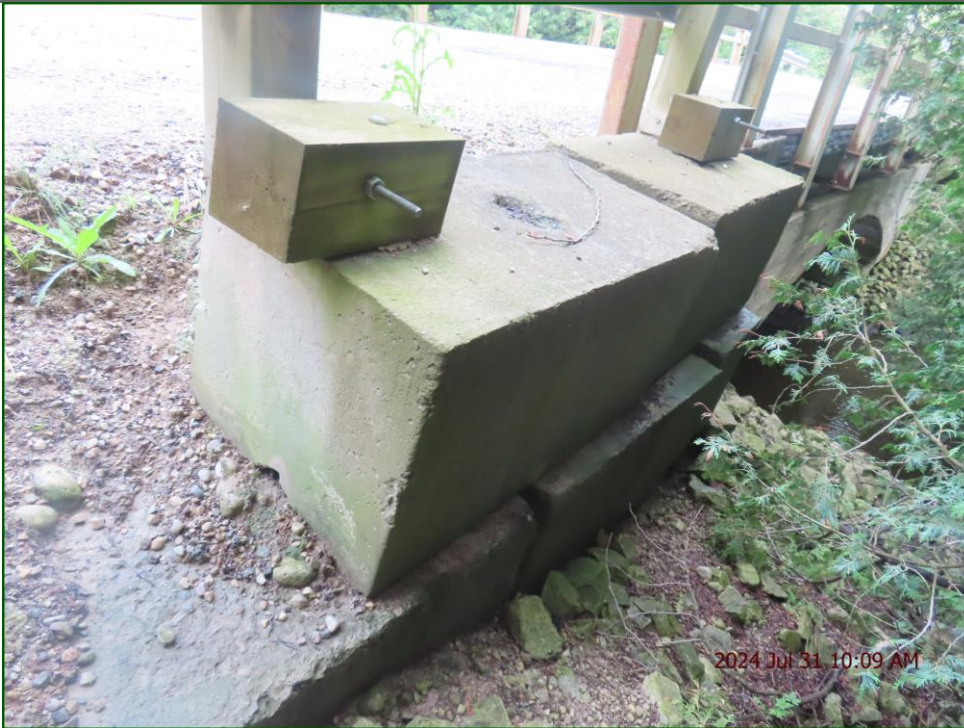
Retaining walls on east side and north west quadrant starting to push outwards. Monitor further movement.

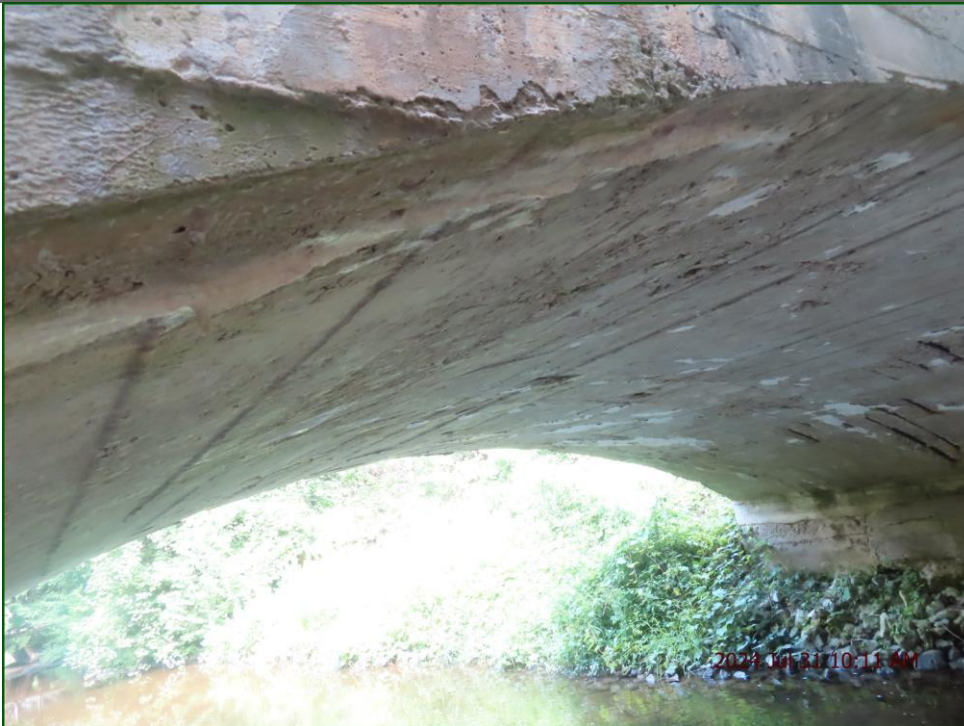
Not current structure. Severe spalling with exposed reinforcing throughout. Severe spalling and disintegration at footing on east side.

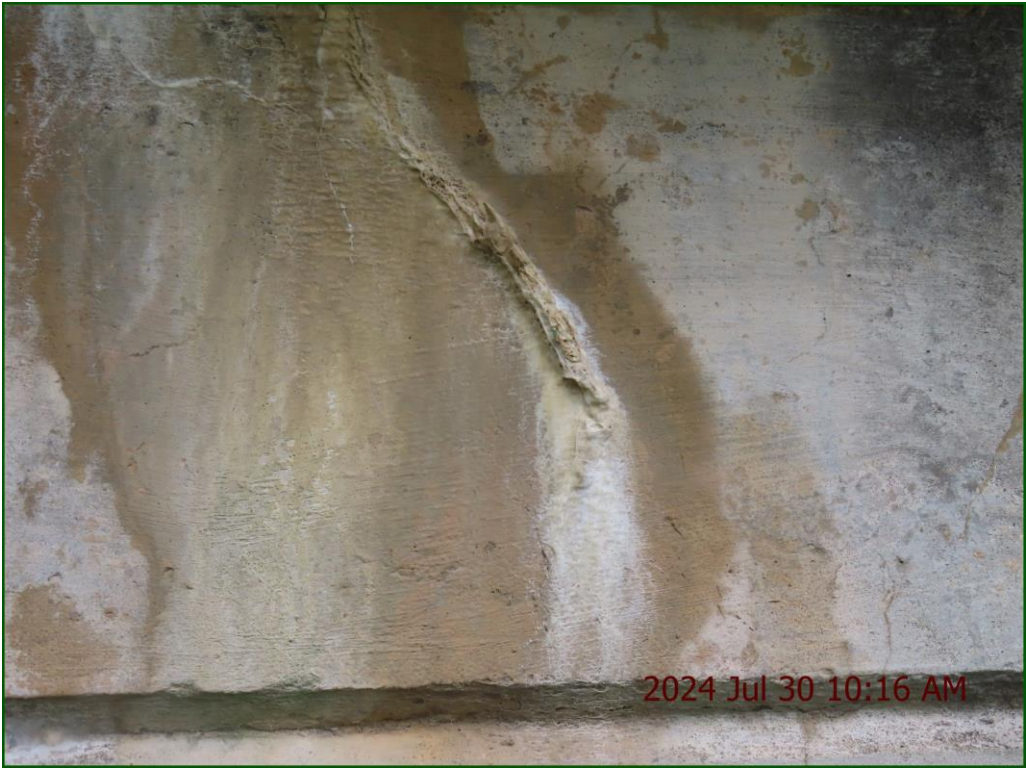
Description: Wingwalls: Medium to wide vertical cracking with leachate staining.

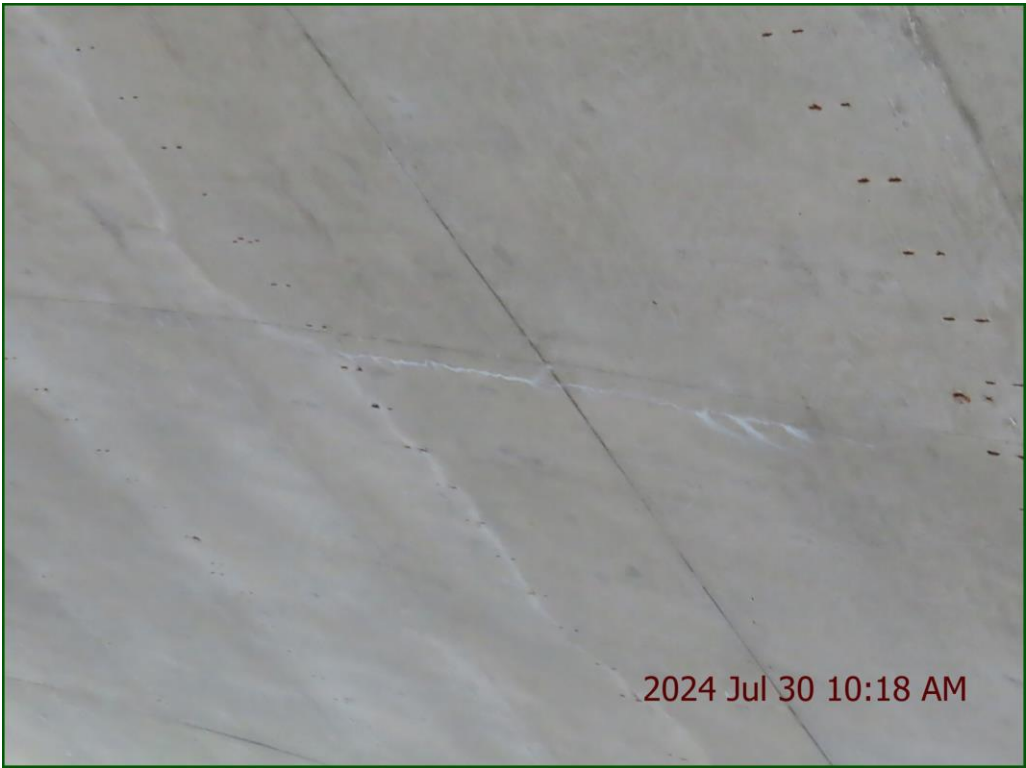
Description: Soffit (int): Light to medium longitudinal crack with leachate staining.

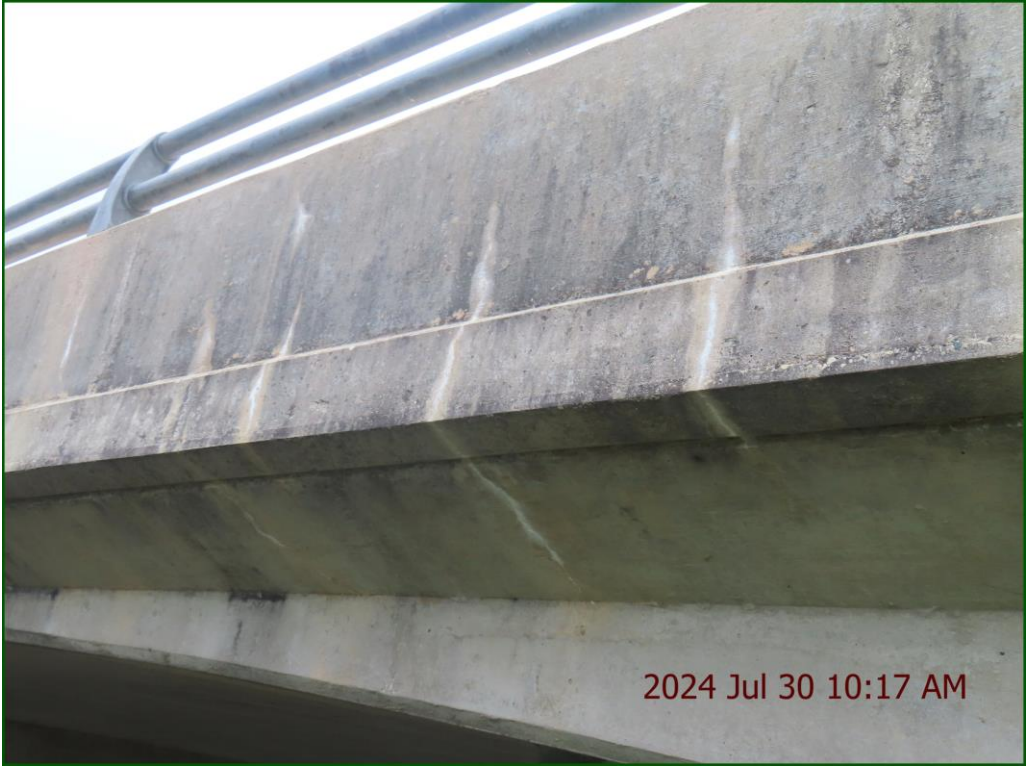
Description: Soffit (ext): Light to medium transverse crack.

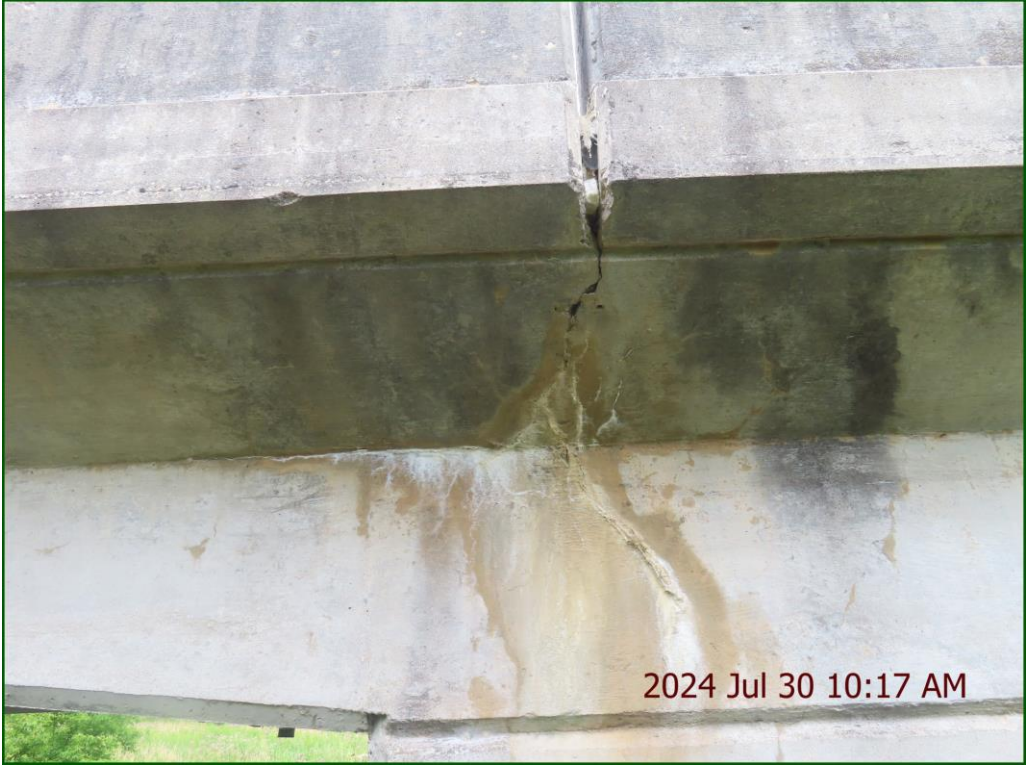
Description: Soffit (ext): Medium to wide cracking at construction joint.
