Date of Inspection:	30-Jul-24
Name of Inspector:	Andrew Burgess, P.Eng. & Joel Ziegler CET
Equipment Used:	Sounding hammer, measuring equipment, GPS
Weather Conditions:	Cloudy
Temperature:	23
Special Notes:	Bridge is in good condition, showing no signs of structural distress.

Year Built:	1979	Contract Number When Built:	
Latest Biennial Inspection:	September 14, 2022	Latest Specialized Inspection:	
Latest Structure Rating:	75.0	Latest Structure Condition:	
RehabHistory:			
Regional Priority Number:		Programmed Work Year:	
NatureOfProgramWork:

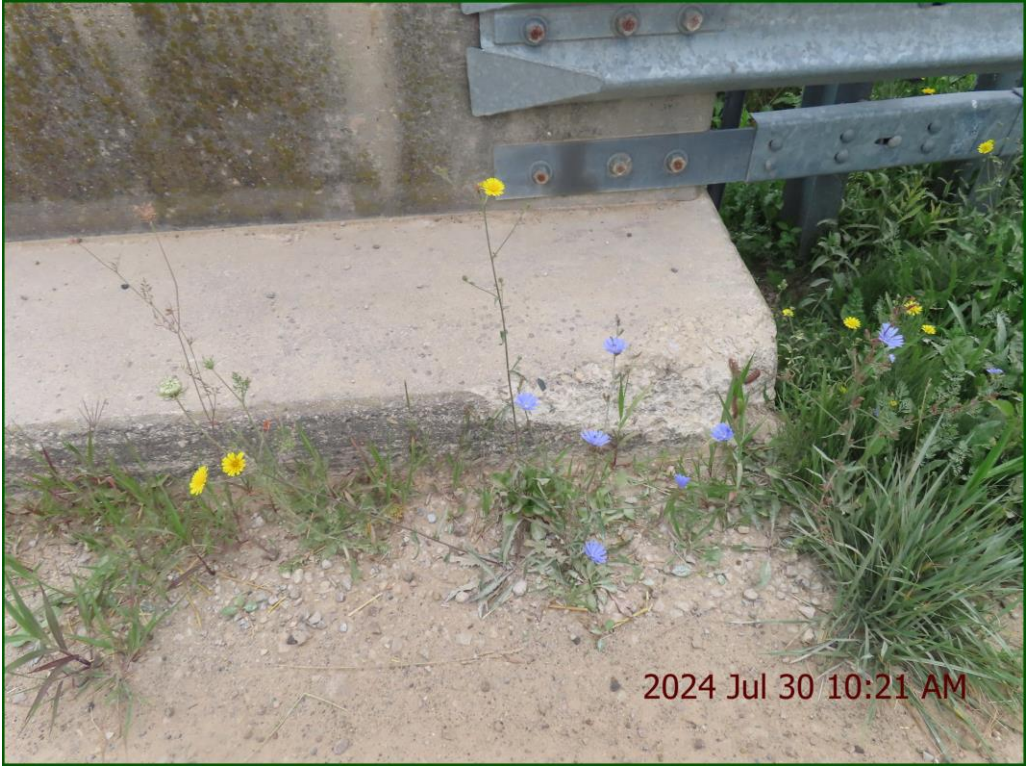
Description: Approach curbs: Light spalling throughout.

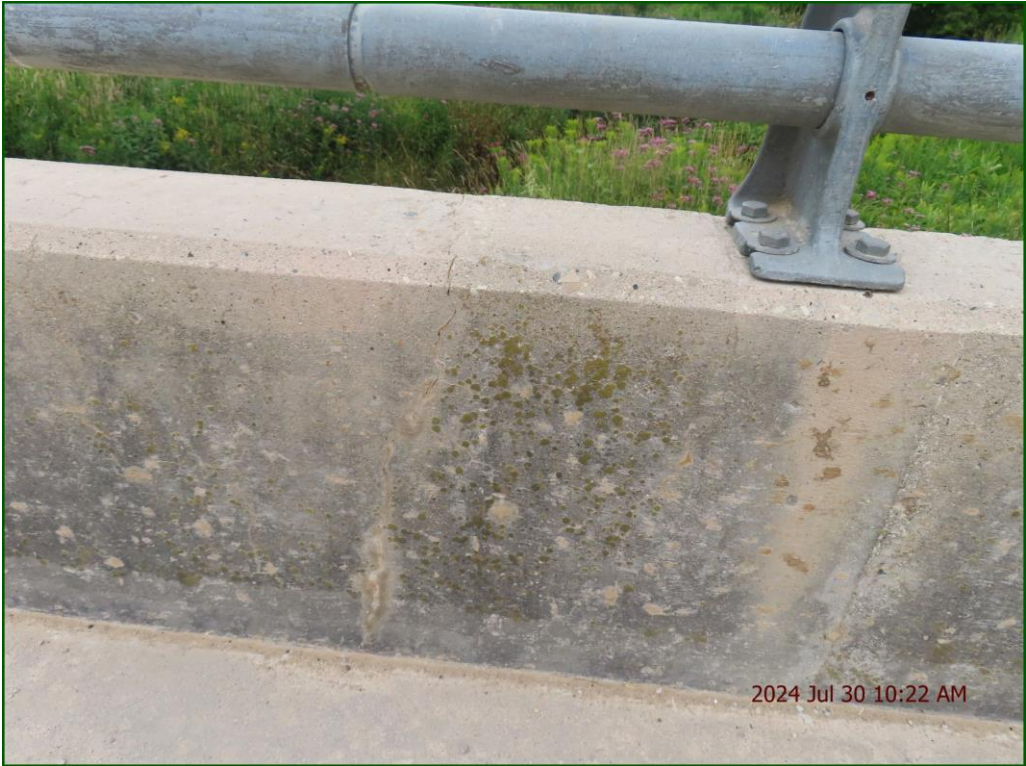
Description: Barrier/Parapet walls: Light to medium vertical cracking with wetness staining.

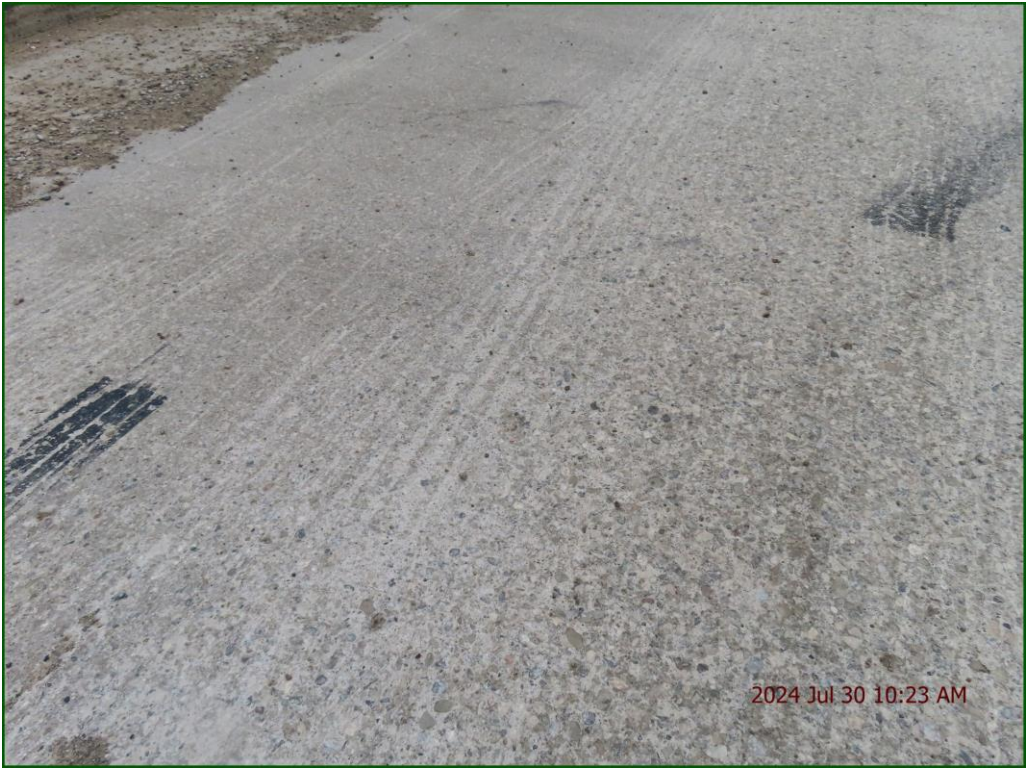
Description: Deck top: Shallow popouts throughout.

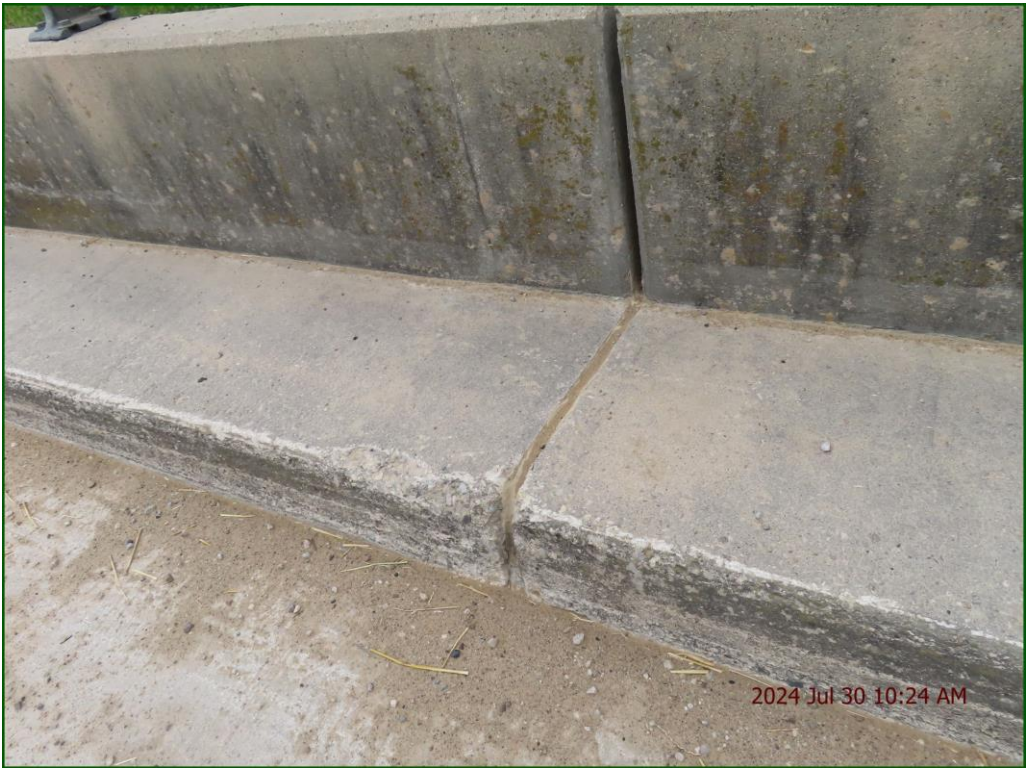
Description: Curbs: Light spalling throughout.

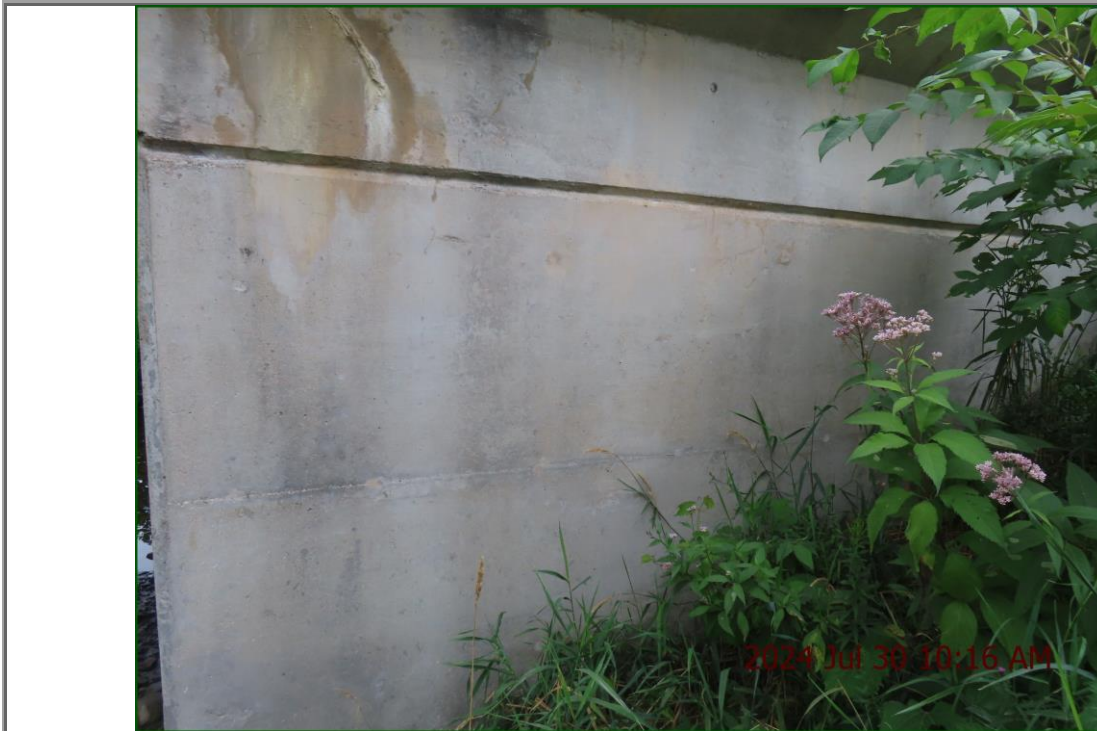
Medium to wide vertical cracking with leachate staining.

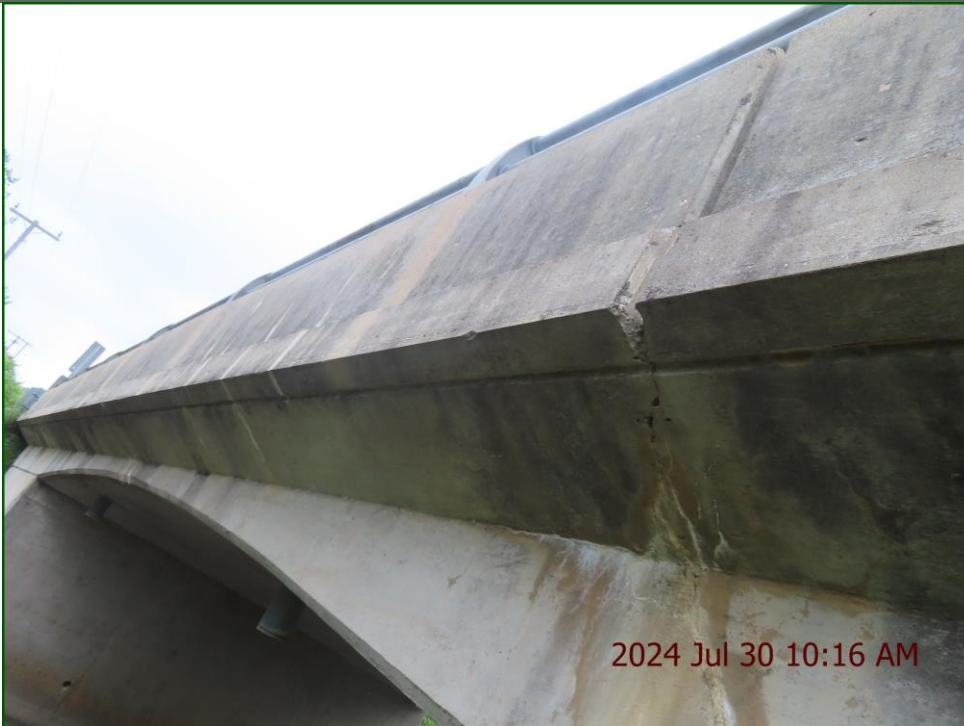
Light to medium transverse crack. Medium to wide cracking at construction joint.

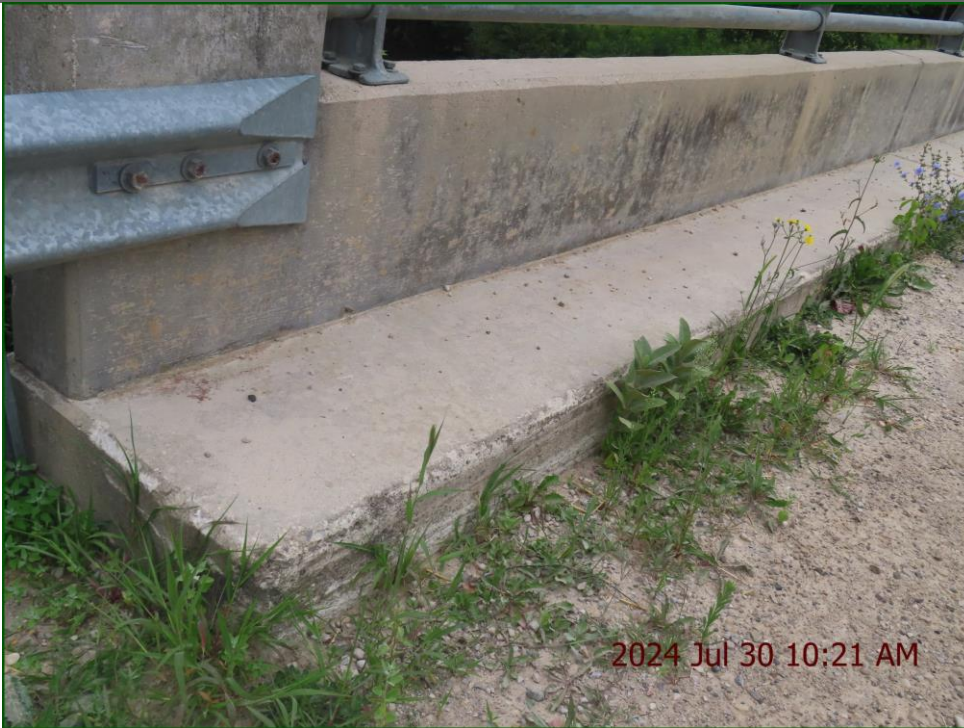
Light spalling throughout.

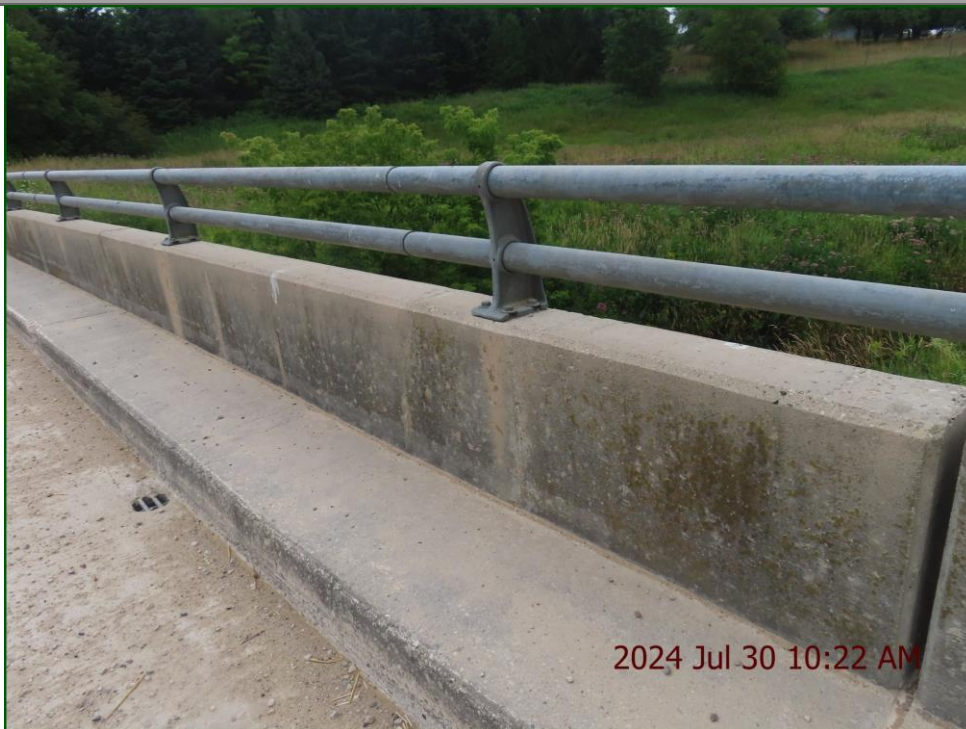
Light to medium vertical cracking with wetness staining.

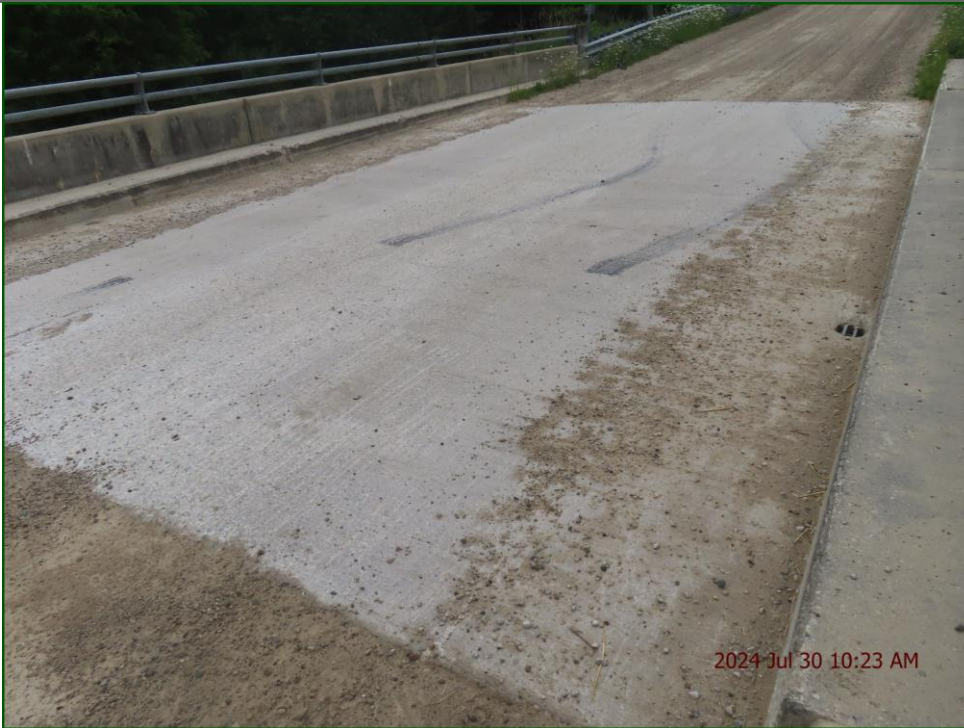
Shallow popouts throughout.

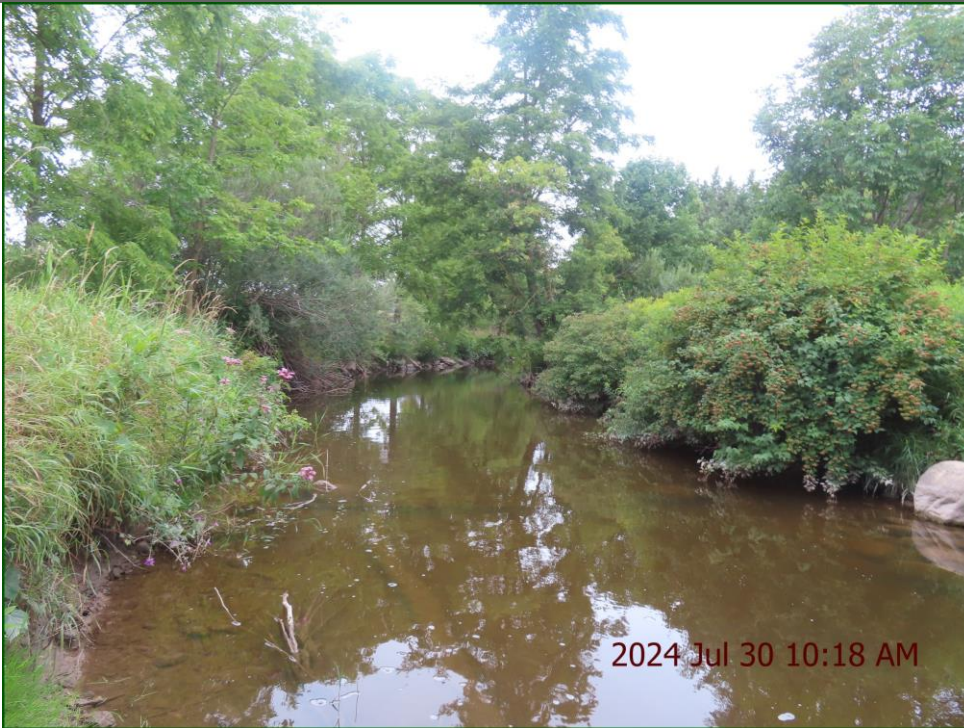
Build up of sediment on south side has diverted river to north abutment.

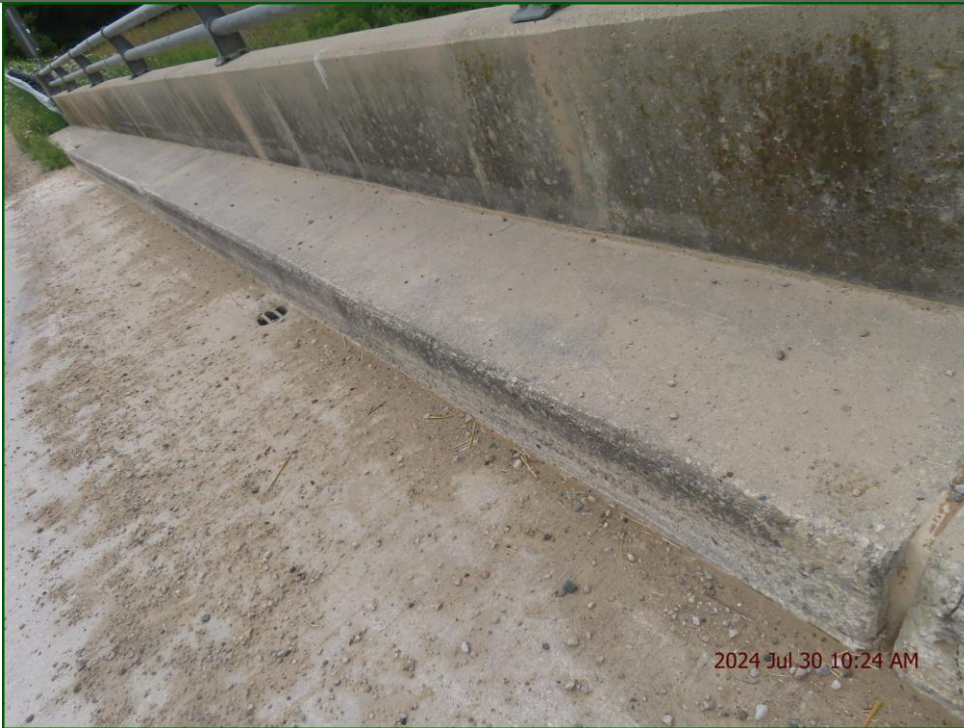
Light spalling throughout.

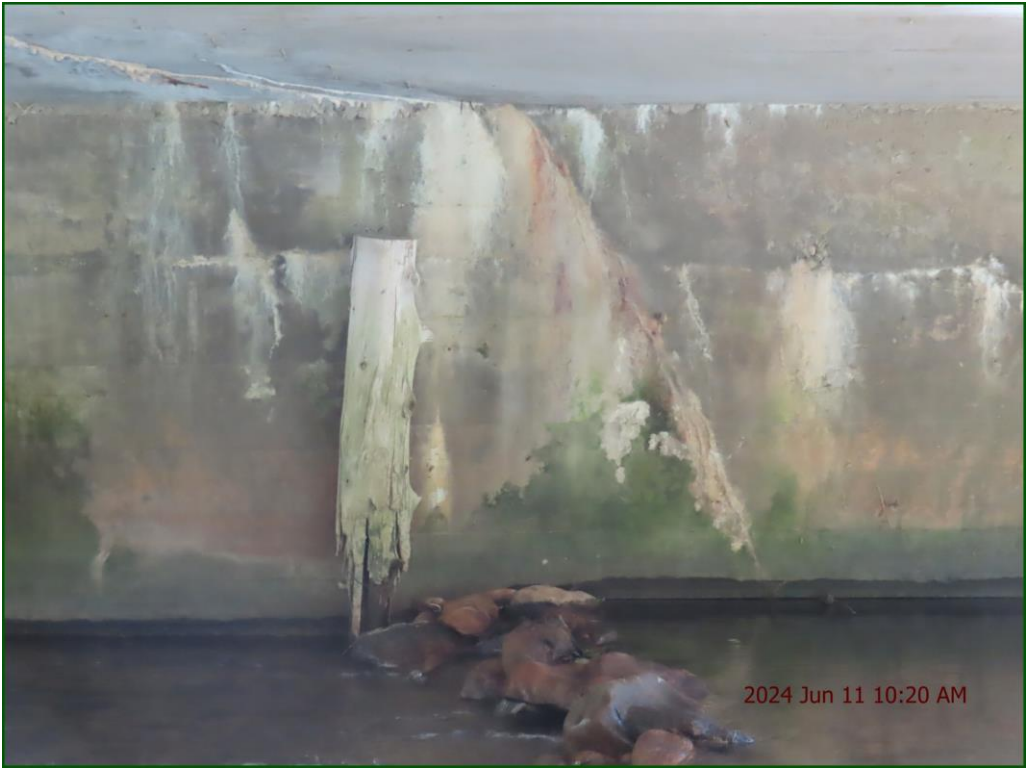
Description: Abutment walls: Wide vertical cracking with leachate staining.

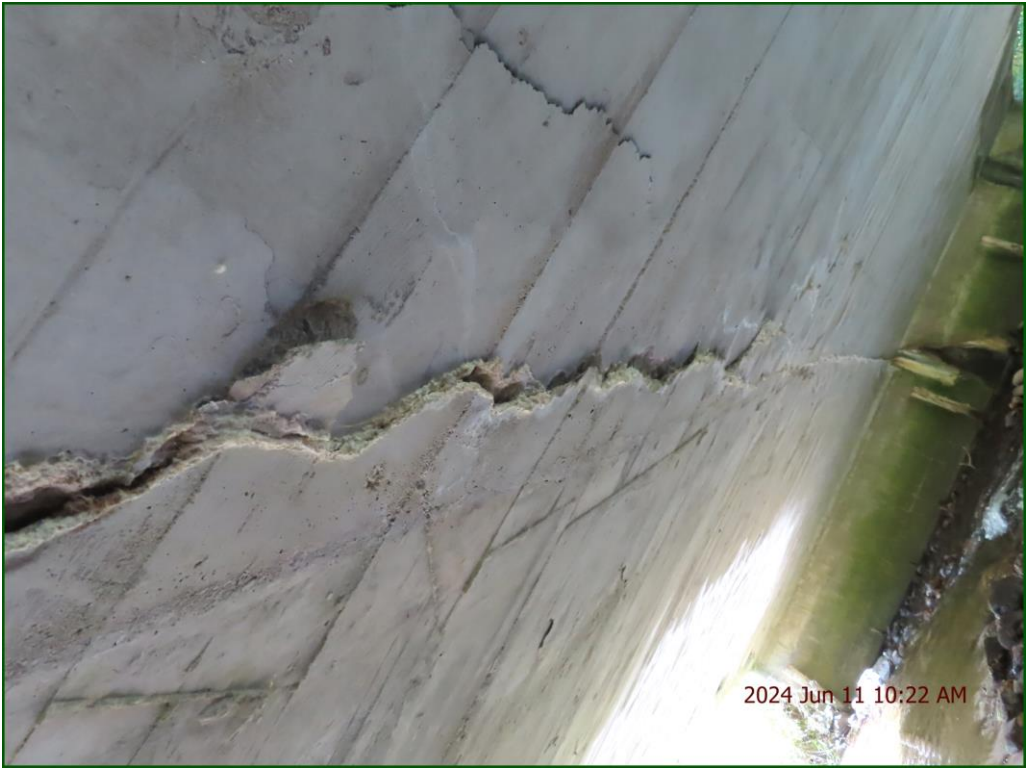
Description: Soffit (int): Medium to wide transverse crack with leachate staining.

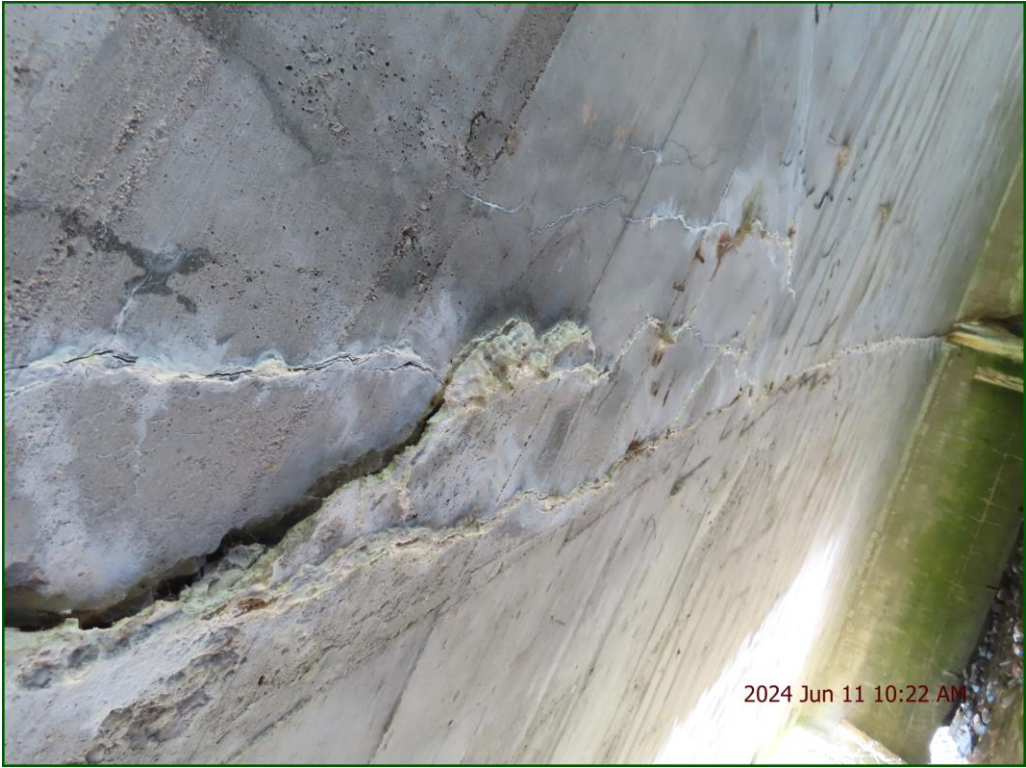
Description: Soffit (int): Shallow delamination along construction joint.

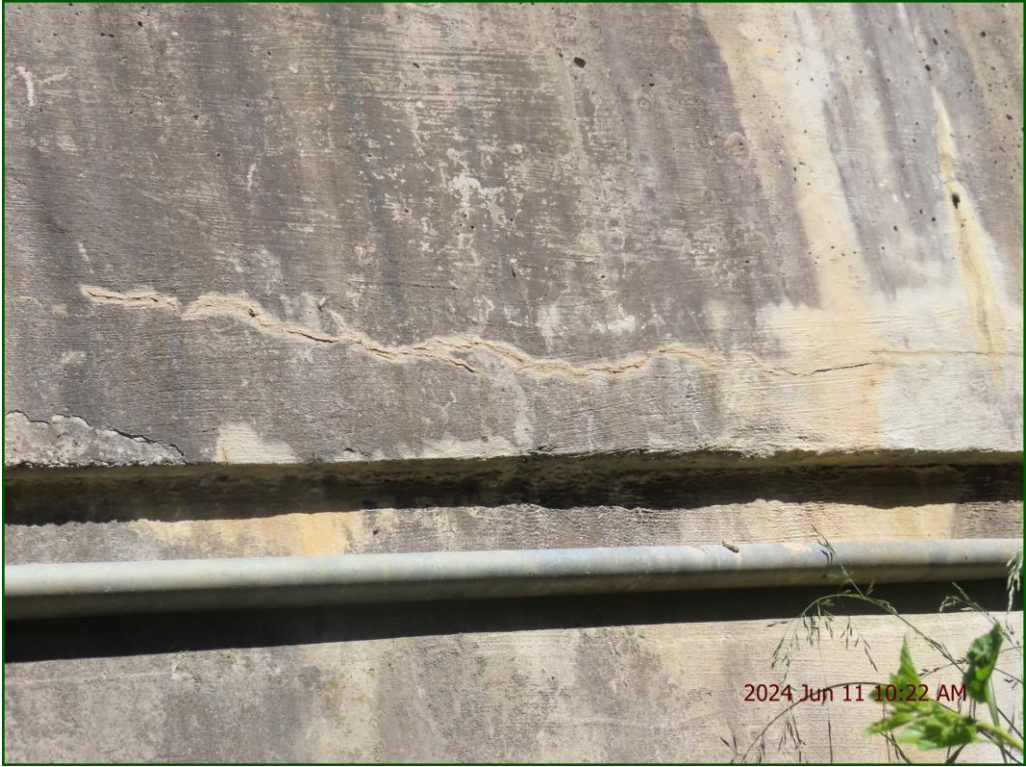
Description: Soffit (ext): Light to medium cracking with leachate staining.

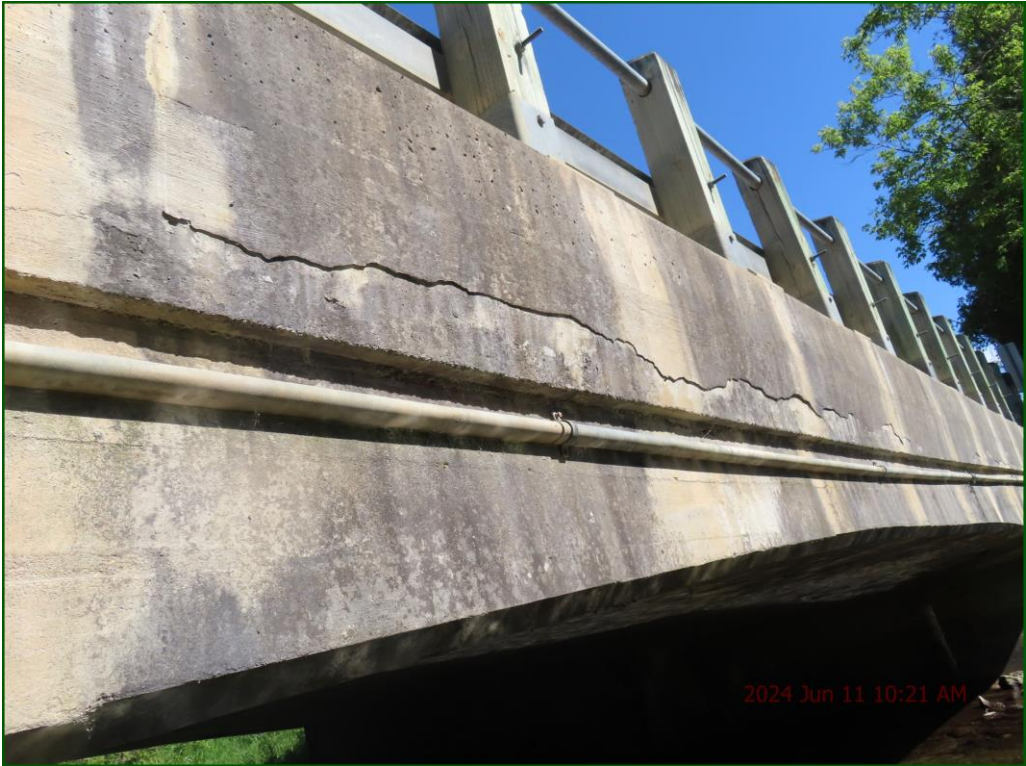
Description: Soffit (ext): Light to moderate delamination.

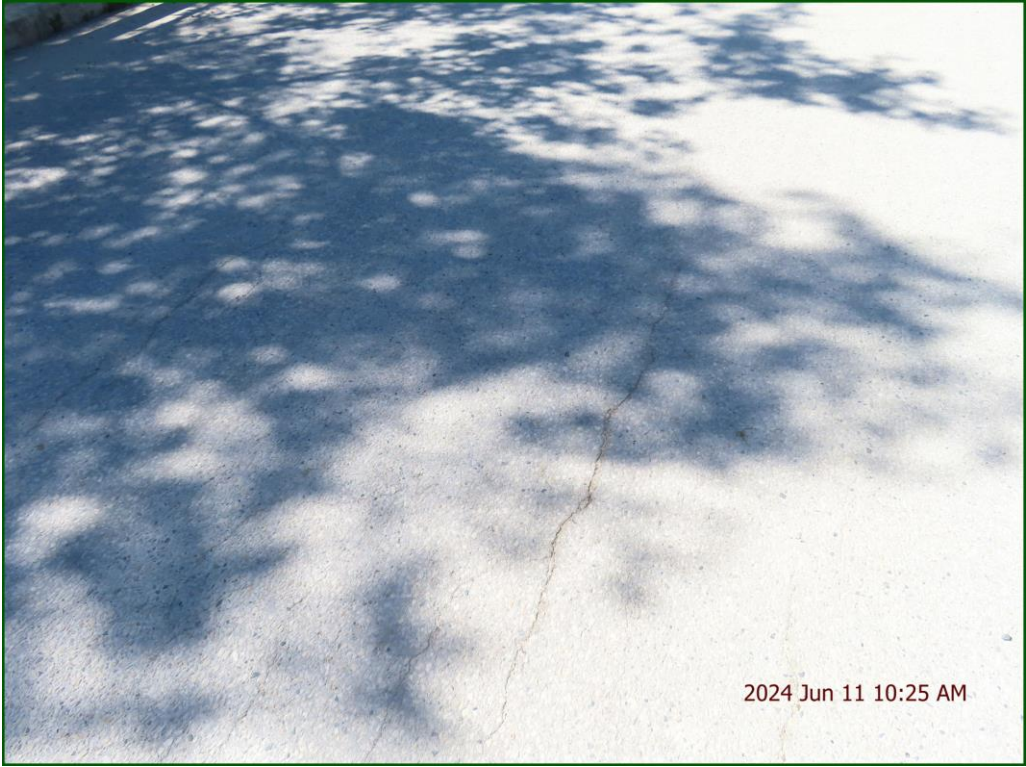
Description: Approach Wearing surface: Narrow to medium transverse and longitudinal cracks.

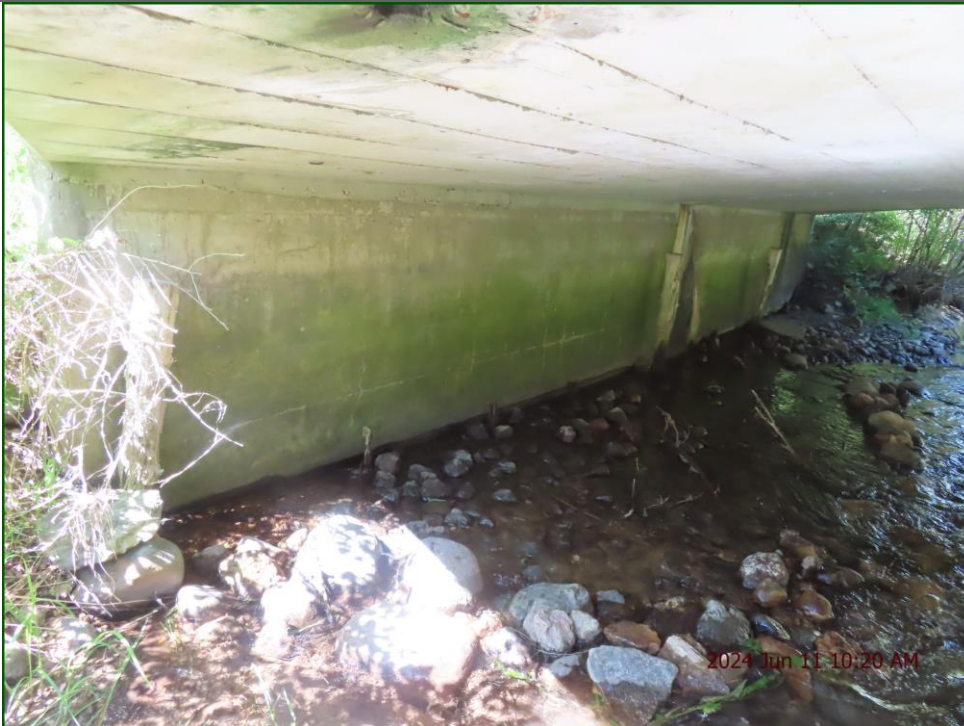
Wide vertical cracking with leachate staining.

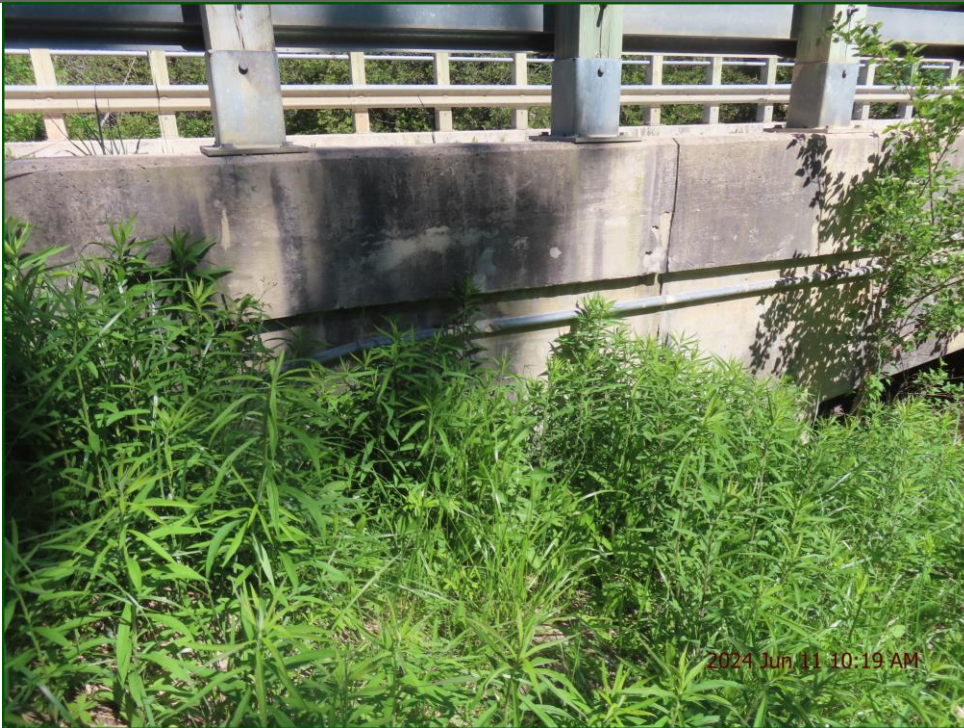
Shallow delamination throughout.

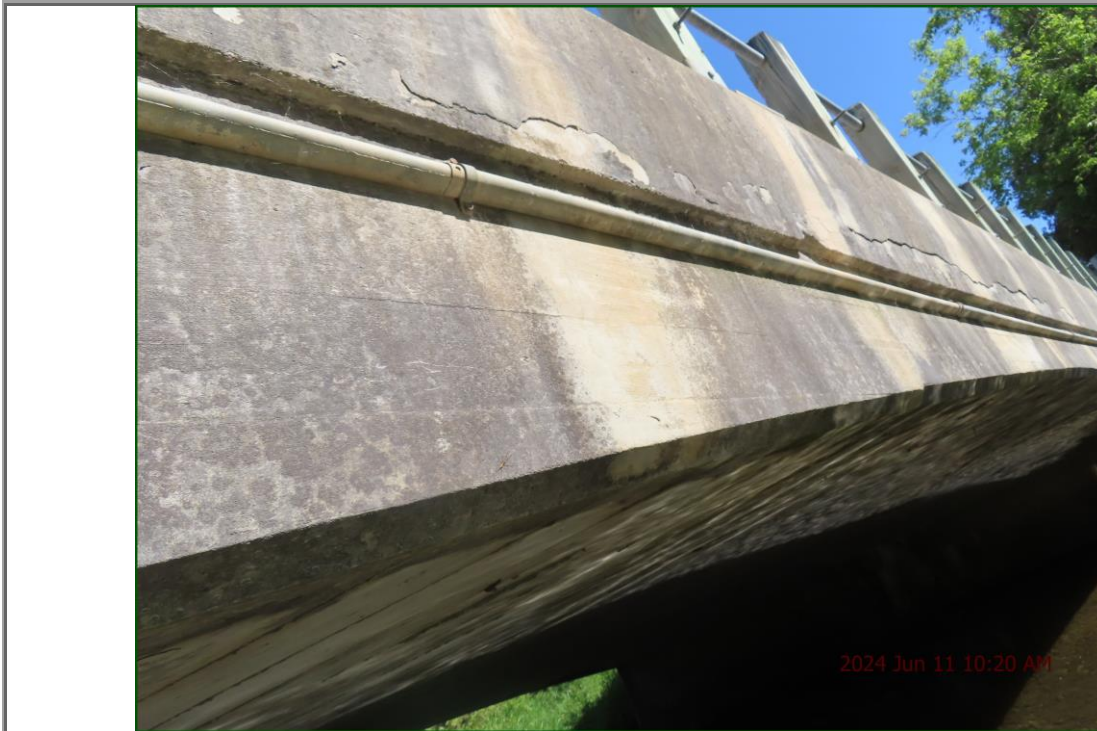
Light to medium cracking with leachate staining. Light to moderate delamination.

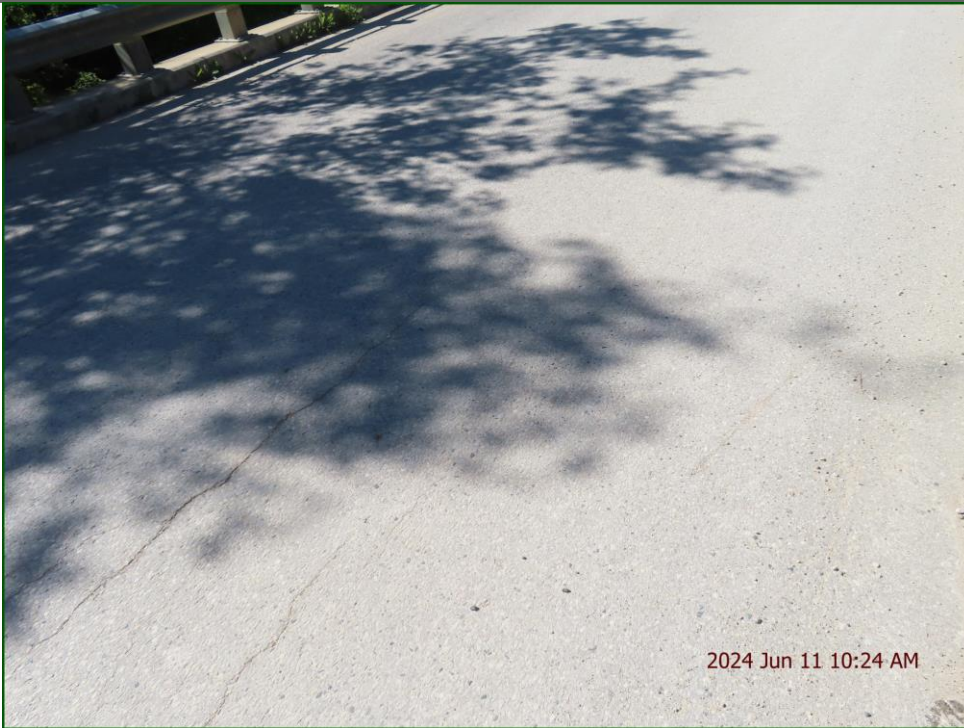
Narrow to medium transverse and longitudinal cracks.

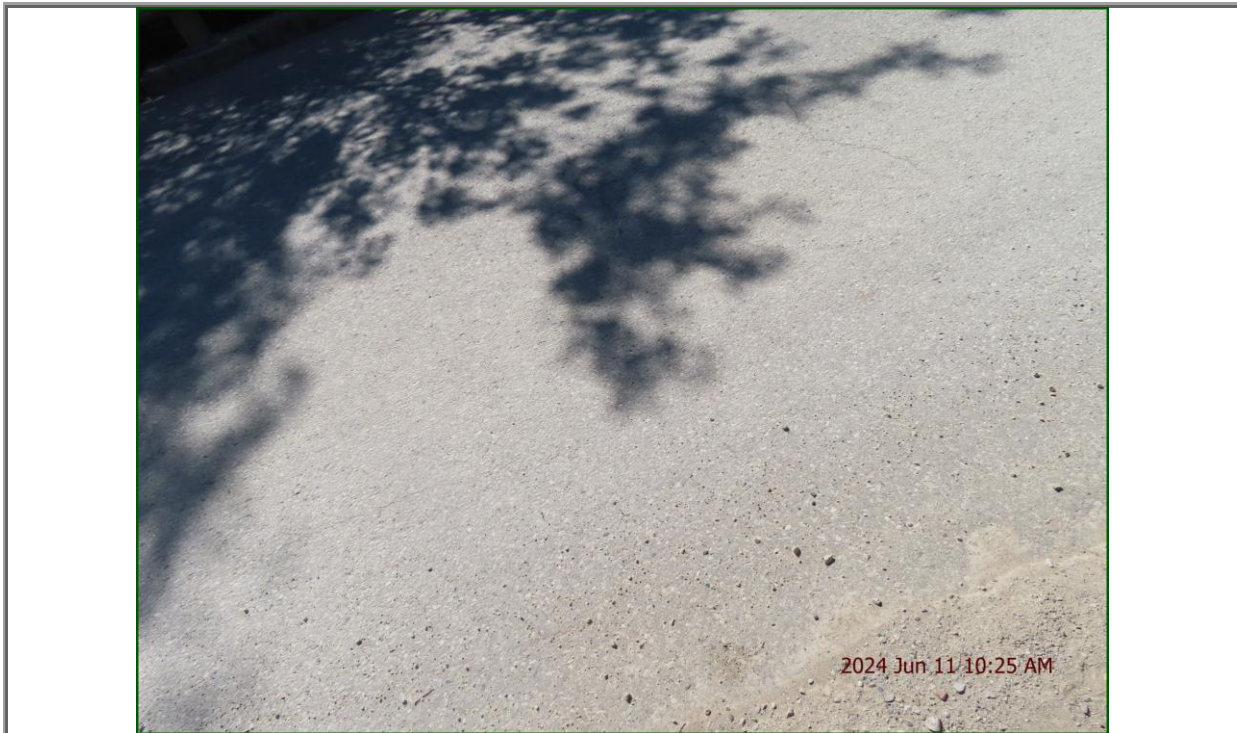
No signs of settlement.

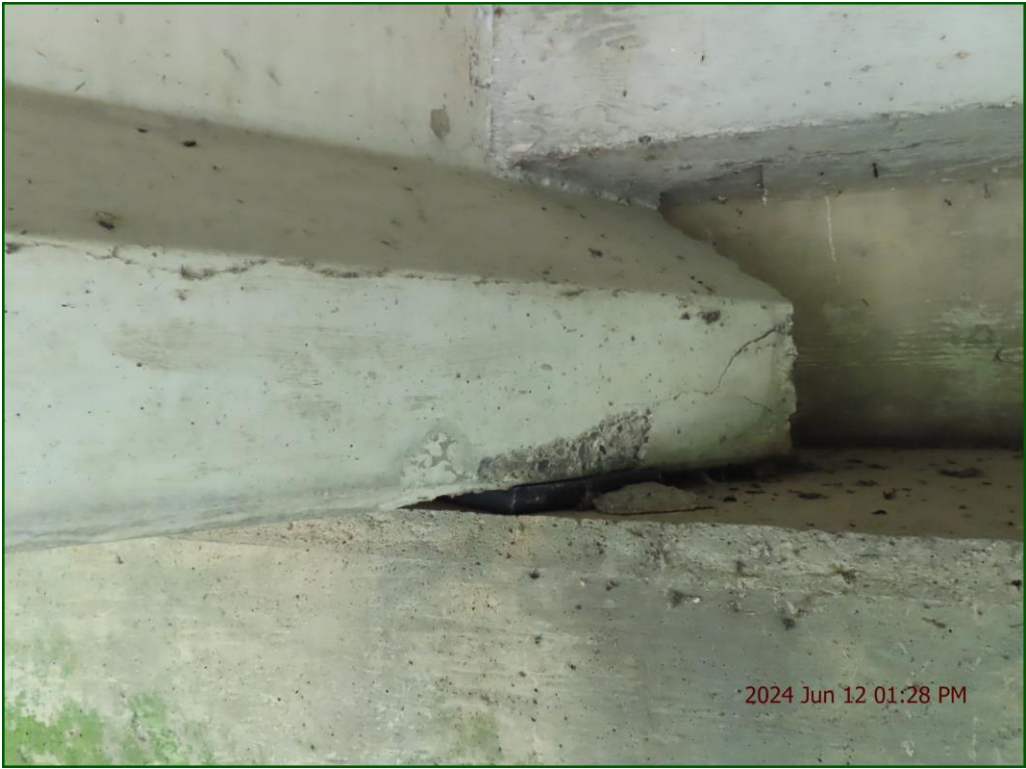
Description: Girders: Moderate delamination at girder ends.

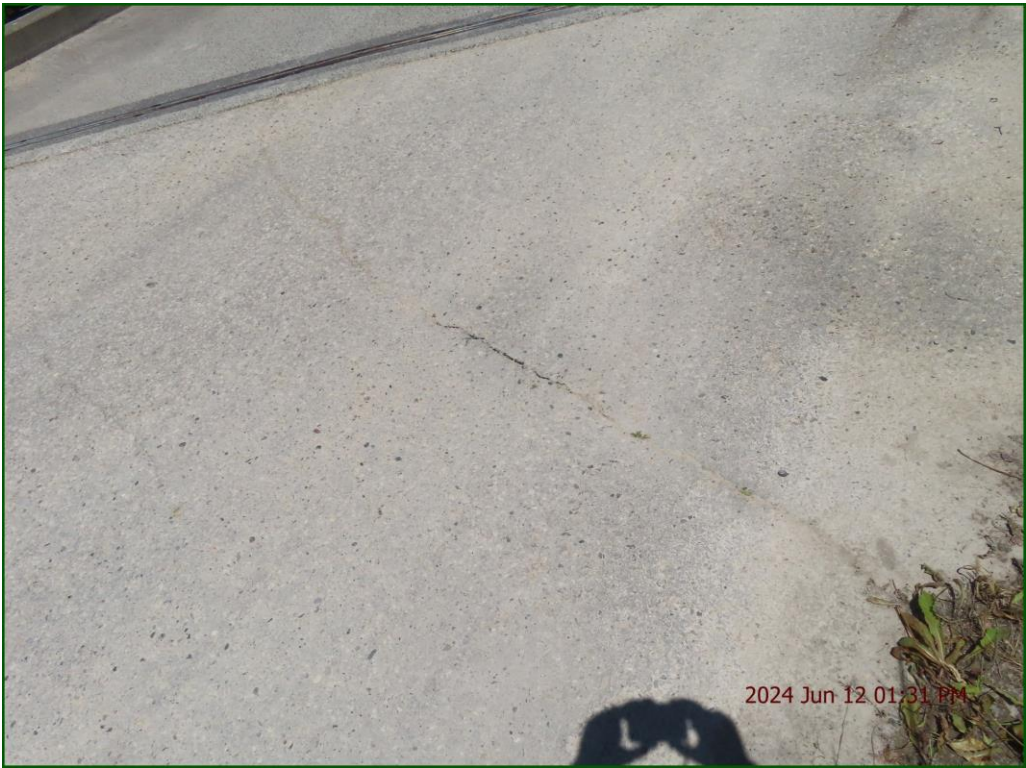
Description: Approach Wearing surface: Medium transverse crack.

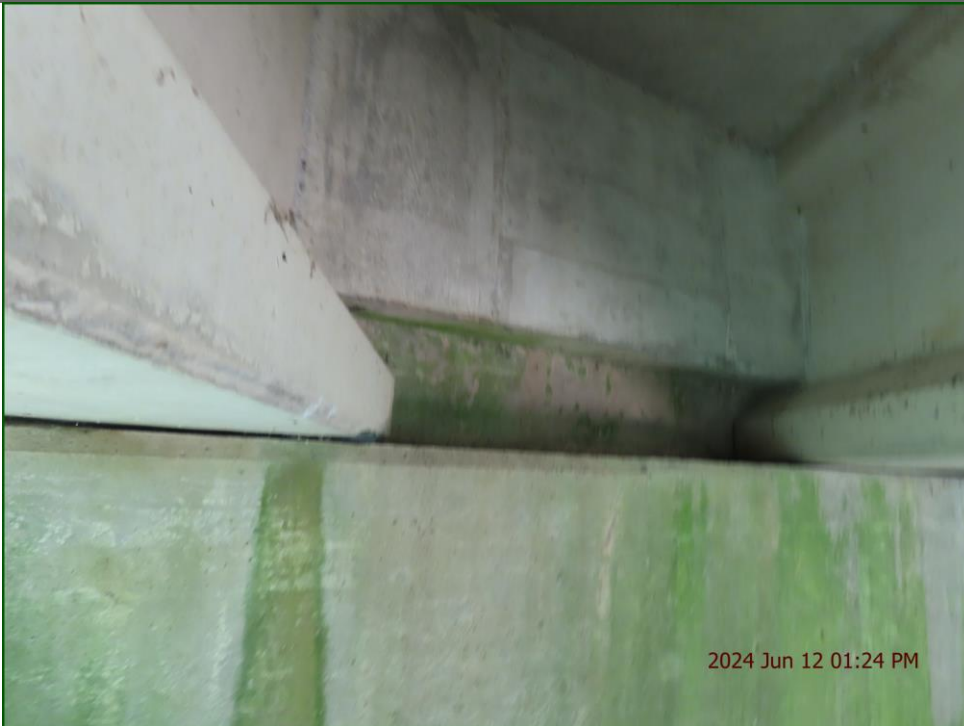
Limited inspection due to diaphragms.

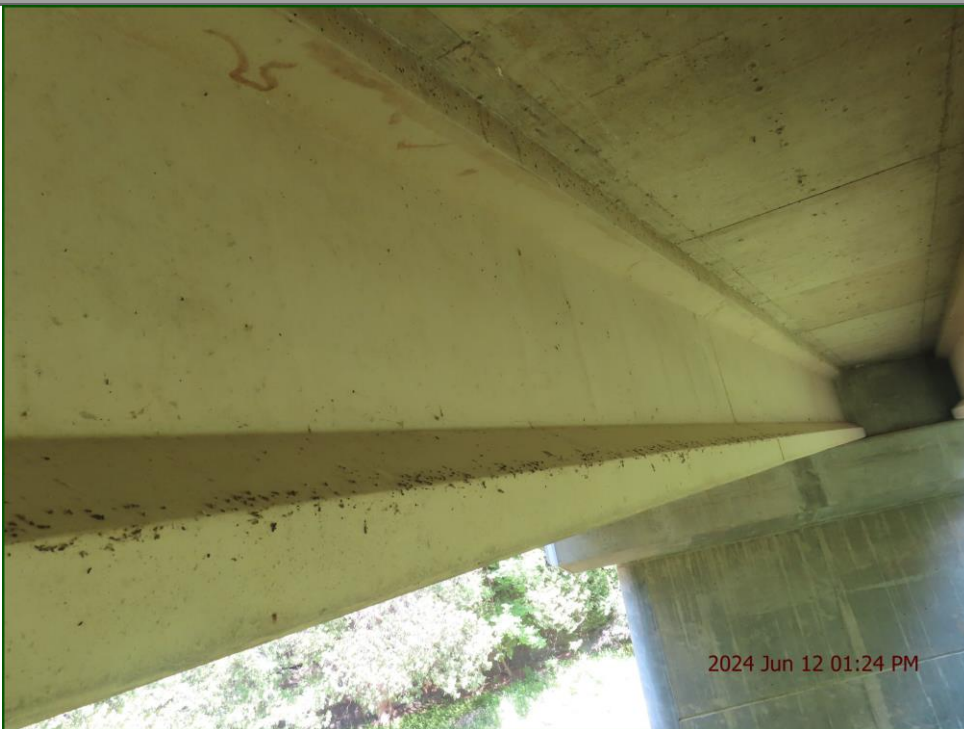
Moderate delamination at girder ends.

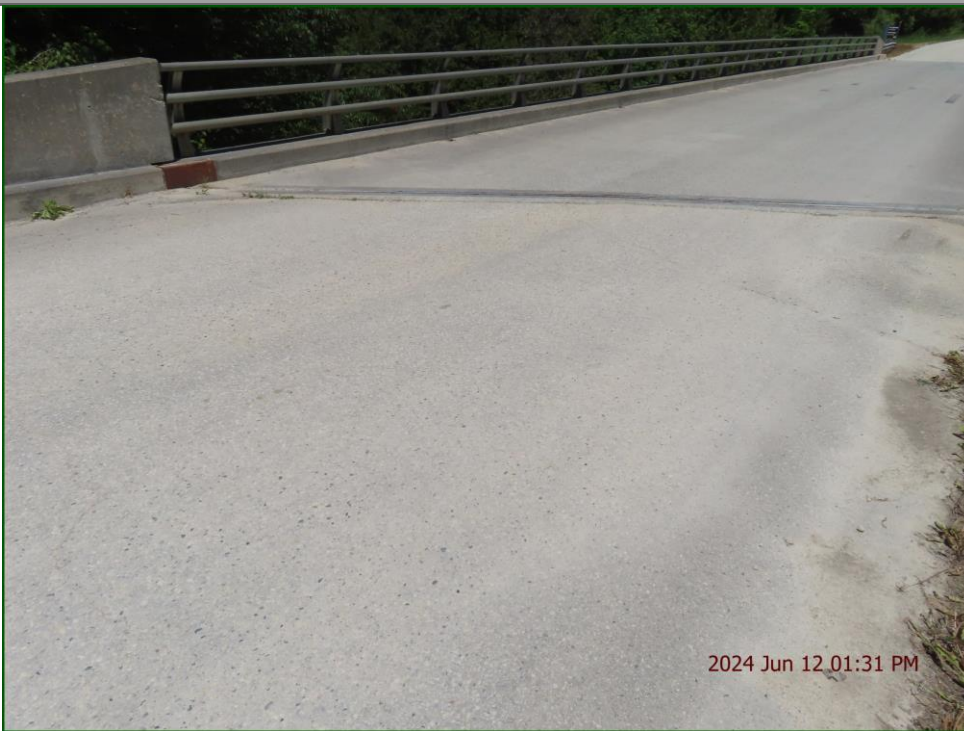
Medium transverse crack.

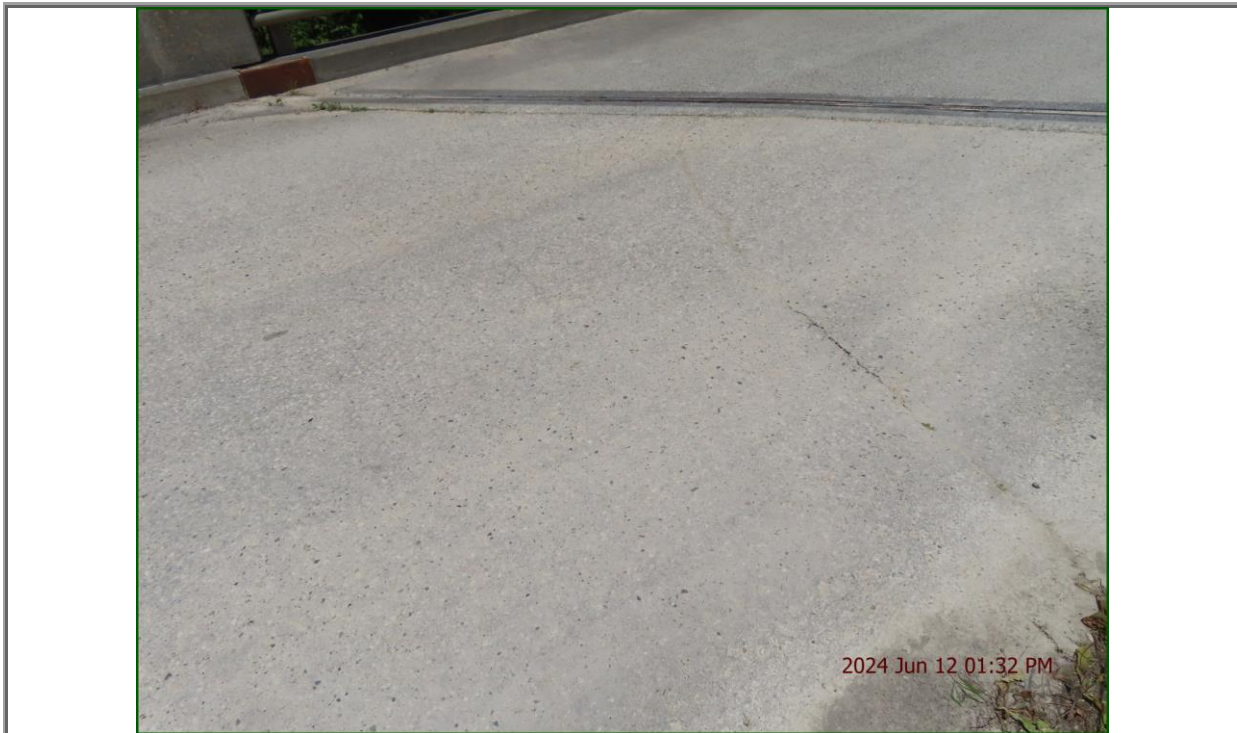
No signs of settlement.

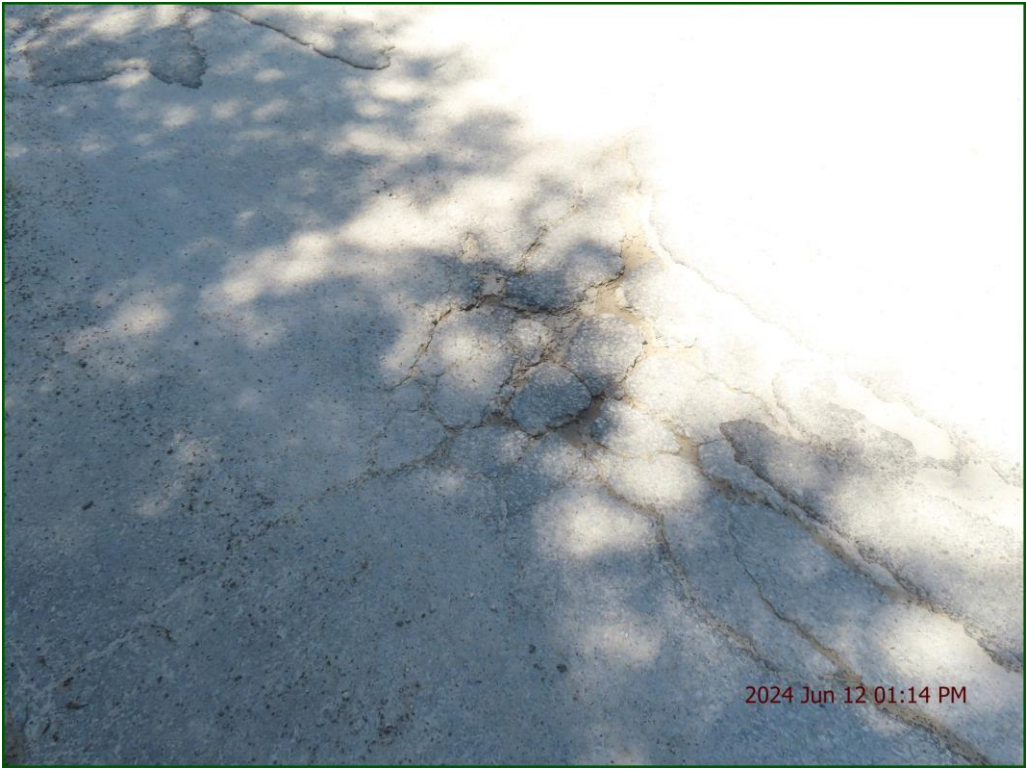
Description: Approach Wearing surface: Localized alligator cracking.
