Date of Inspection:	30-Jul-24
Name of Inspector:	Andrew Burgess, P.Eng. & Joel Ziegler CET
Equipment Used:	Sounding hammer, measuring equipment, GPS
Weather Conditions:	Cloudy
Temperature:	23
Special Notes:	Bridge is in good condition, showing no signs of structural distress.

Year Built:	1979	Contract Number When Built:	
Latest Biennial Inspection:	September 14, 2022	Latest Specialized Inspection:	
Latest Structure Rating:	75.0	Latest Structure Condition:	
RehabHistory:			
Regional Priority Number:		Programmed Work Year:	
NatureOfProgramWork:

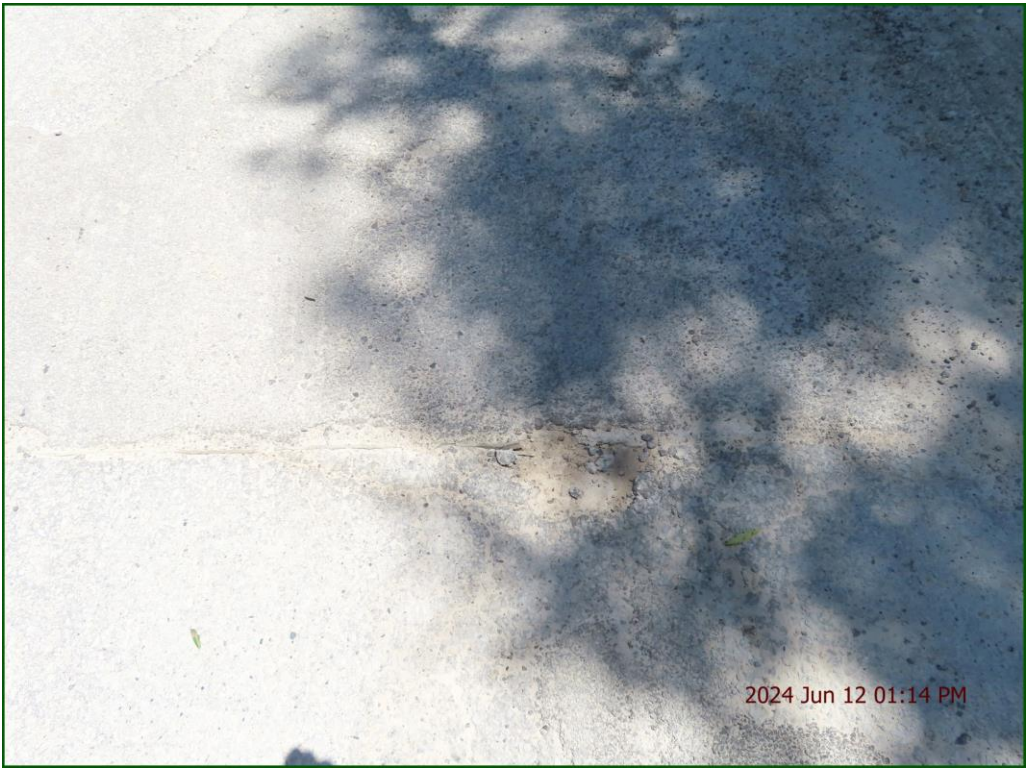
Description: Approach Wearing surface: Moderate pothole on east approach.

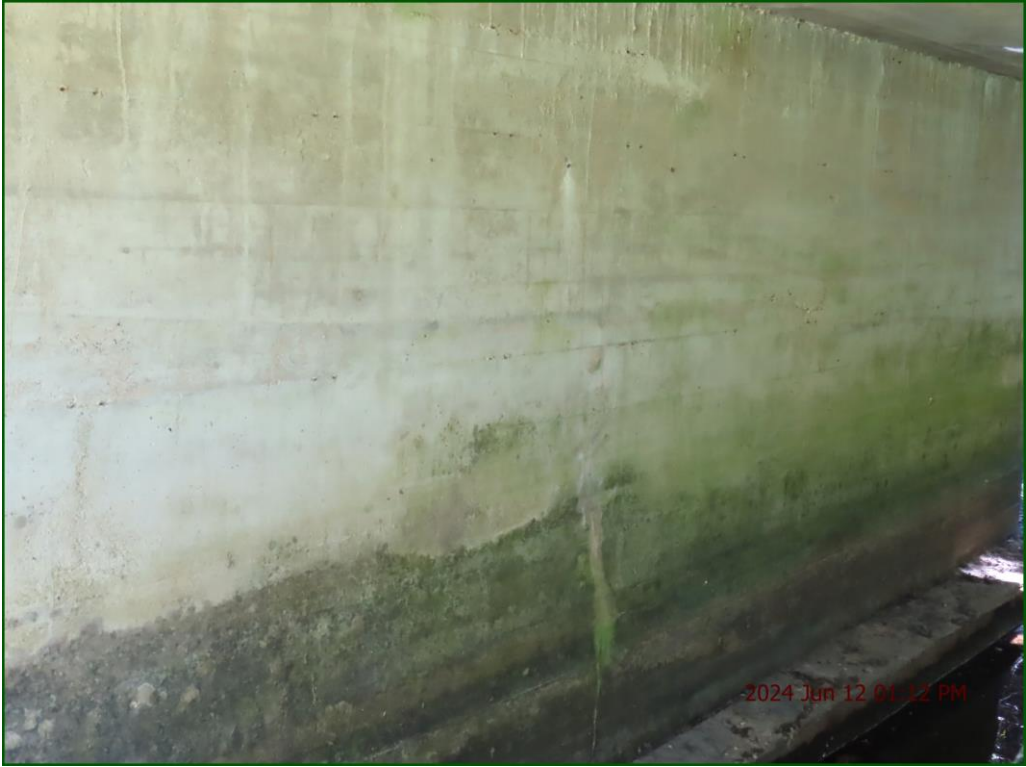
Description: Abutment walls: Medium vertical cracking with leachate staining.

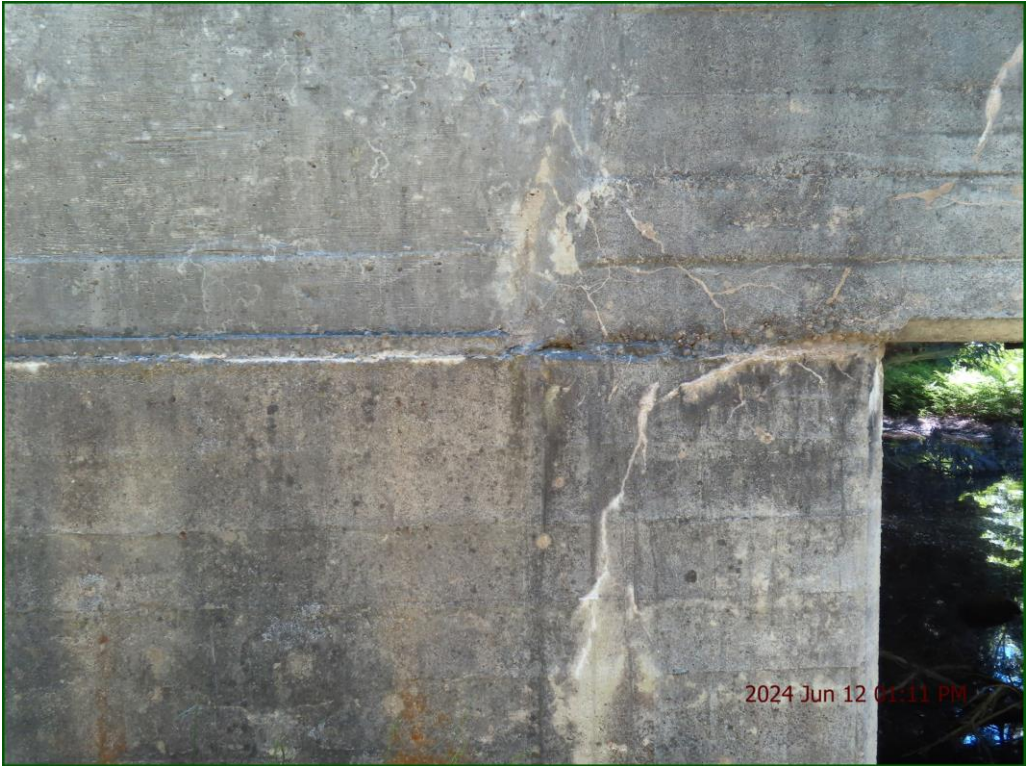
Description: Wingwalls: Light to medium map cracking with leachate staining throughout.

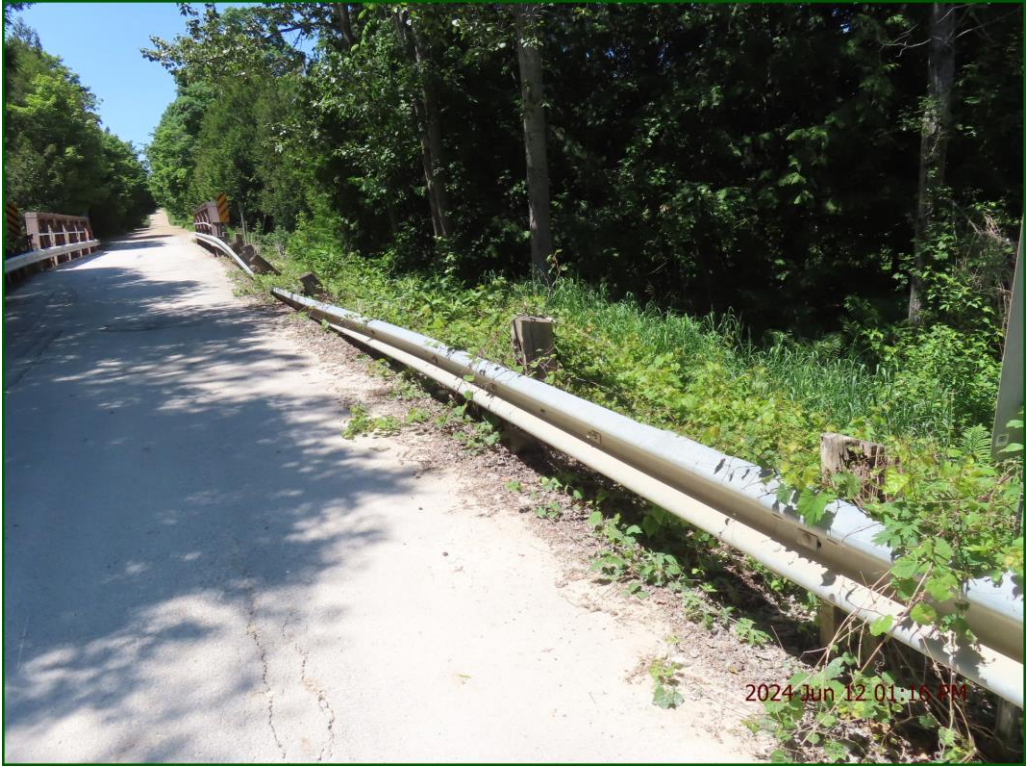
Description: Railing systems: Severe impact damage on NW quadrant.

Date of Inspection:	12-Jun-24
Name of Inspector:	A. Burgess P.Eng. & J. Ziegler CET
Equipment Used:	Sounding hammer, measuring equipment, GPS
Weather Conditions:	Sunny
Temperature:	22
Special Notes:	Bridge is in fair condition, showing no signs of structural distress. Recommend railing system repair.

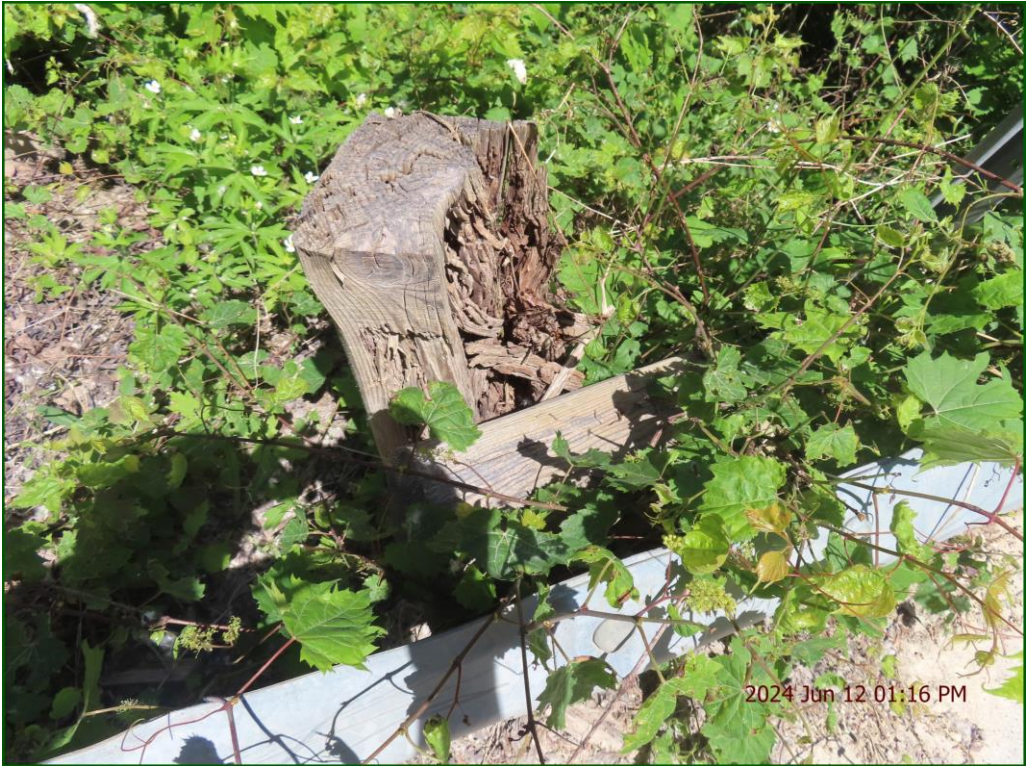
Description: Railing systems: Severe rot.

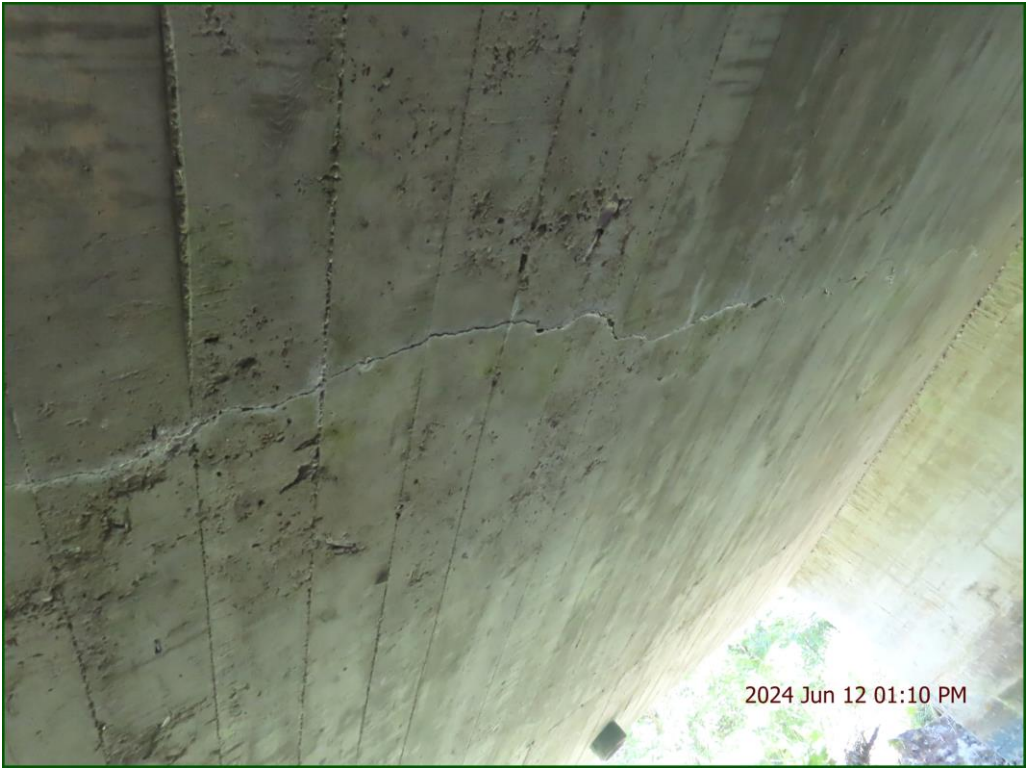
Description: Soffit (int): Medium to wide longitudinal cracking with leachate staining.

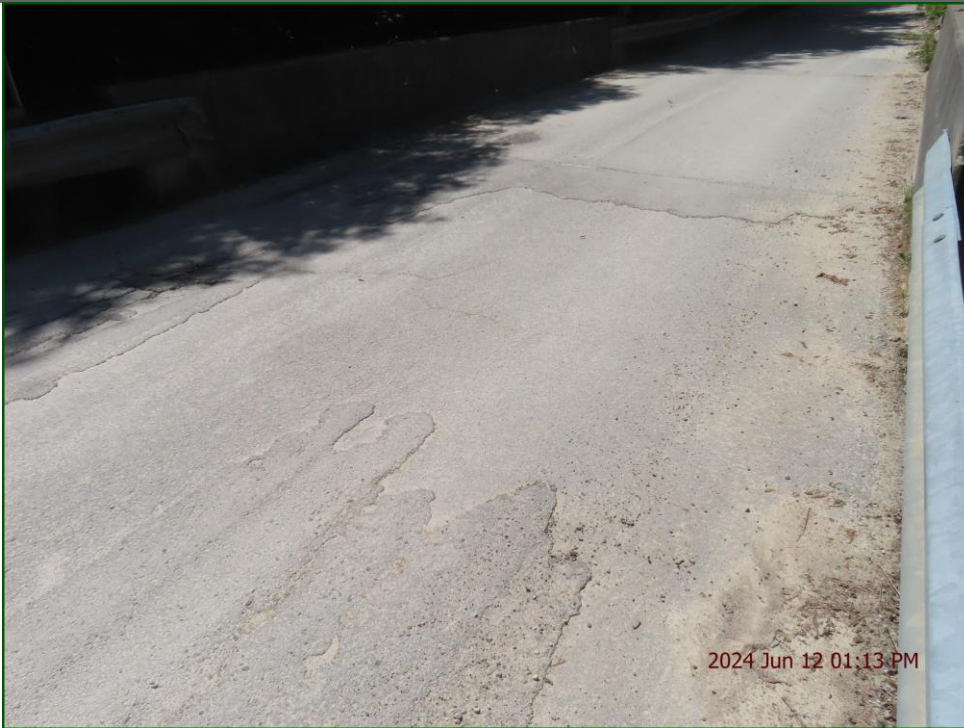
Localized alligator cracking. Moderate pothole on east approach.

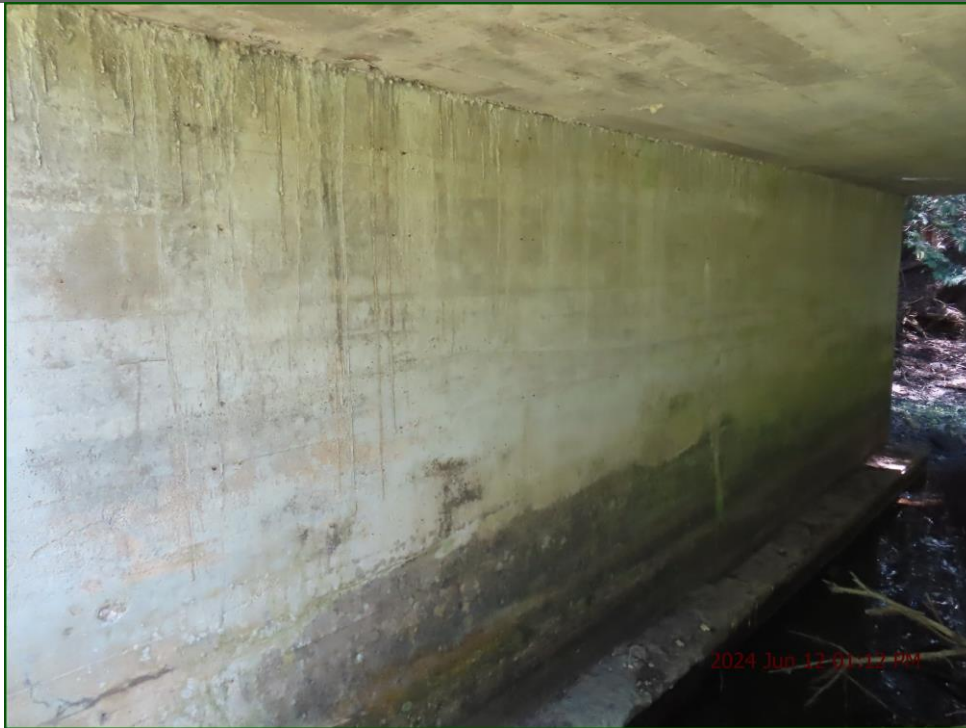
Medium vertical cracking with leachate staining.

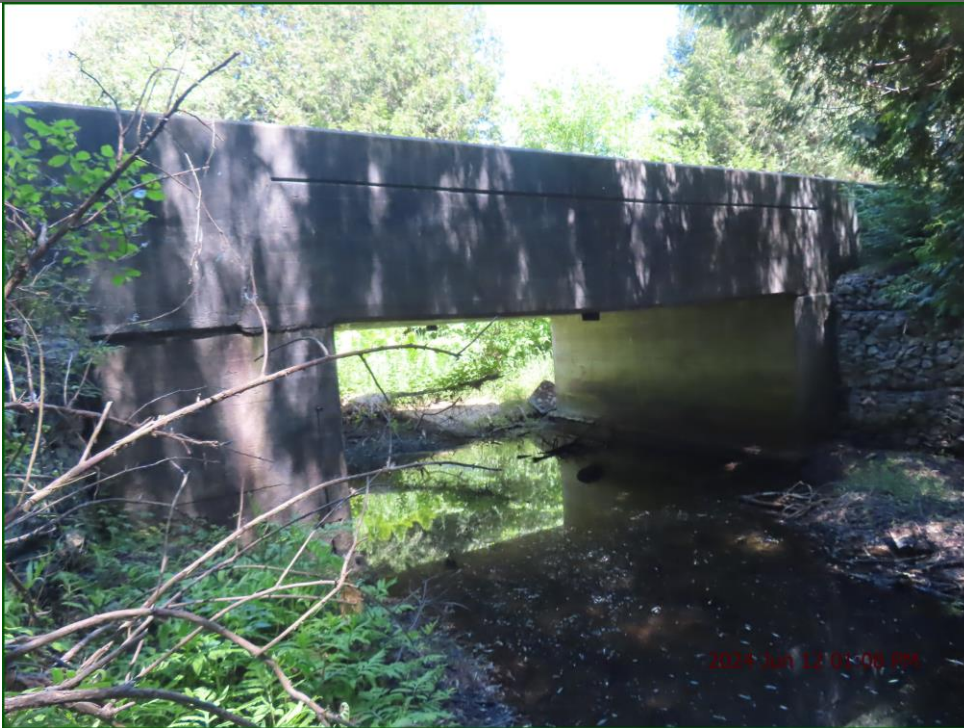
Light to medium map cracking with leachate staining throughout.

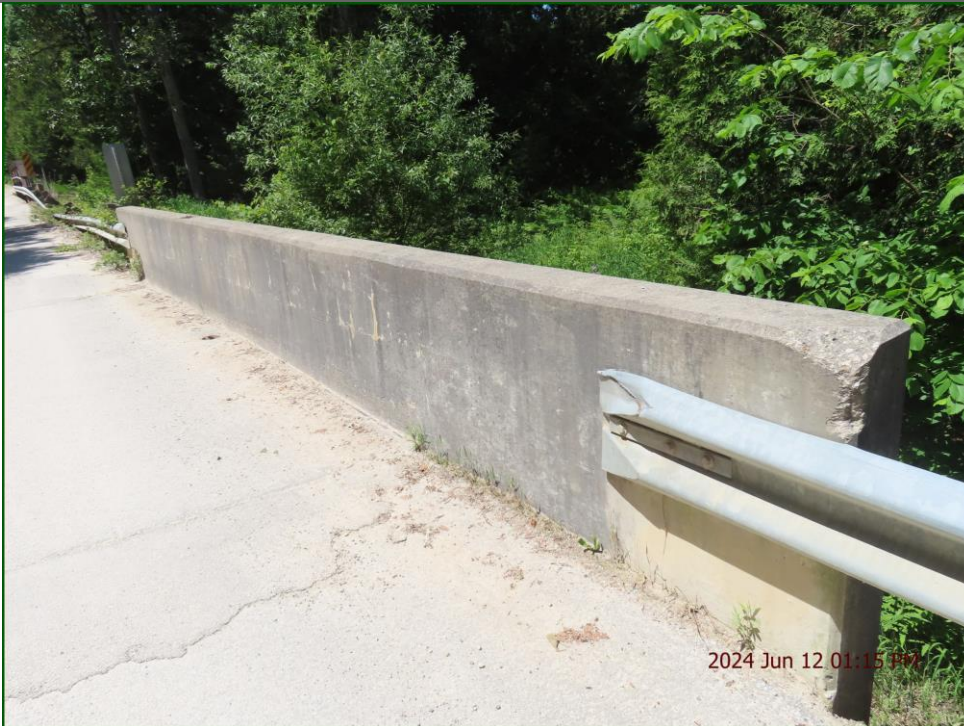
Light to medium vertical cracks with leachate staining.

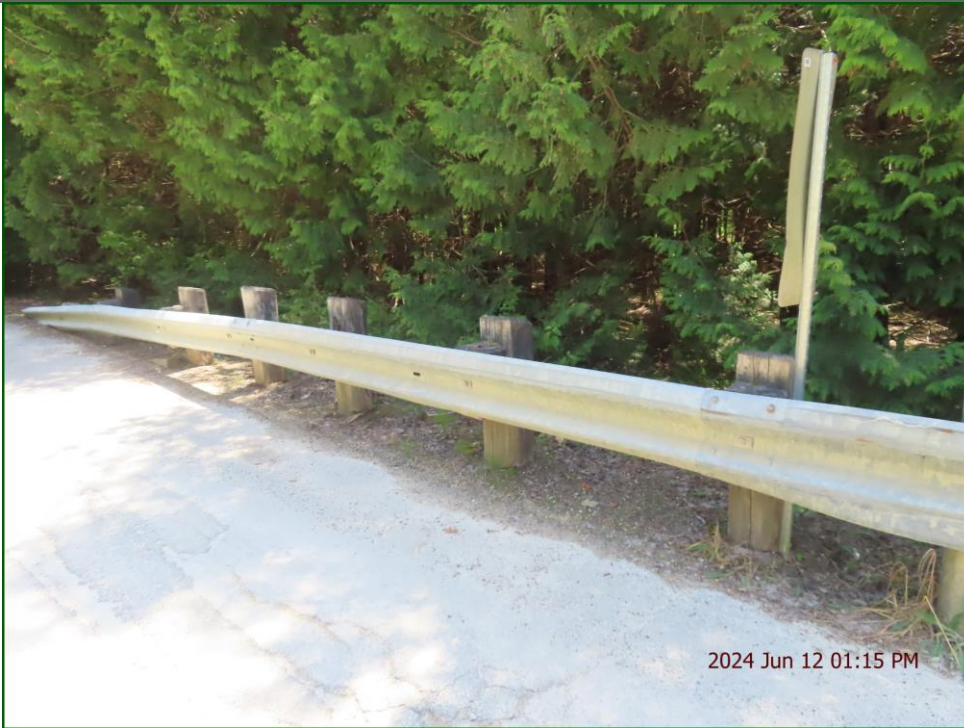
Severe impact damage on NW quadrant. Severe rot.

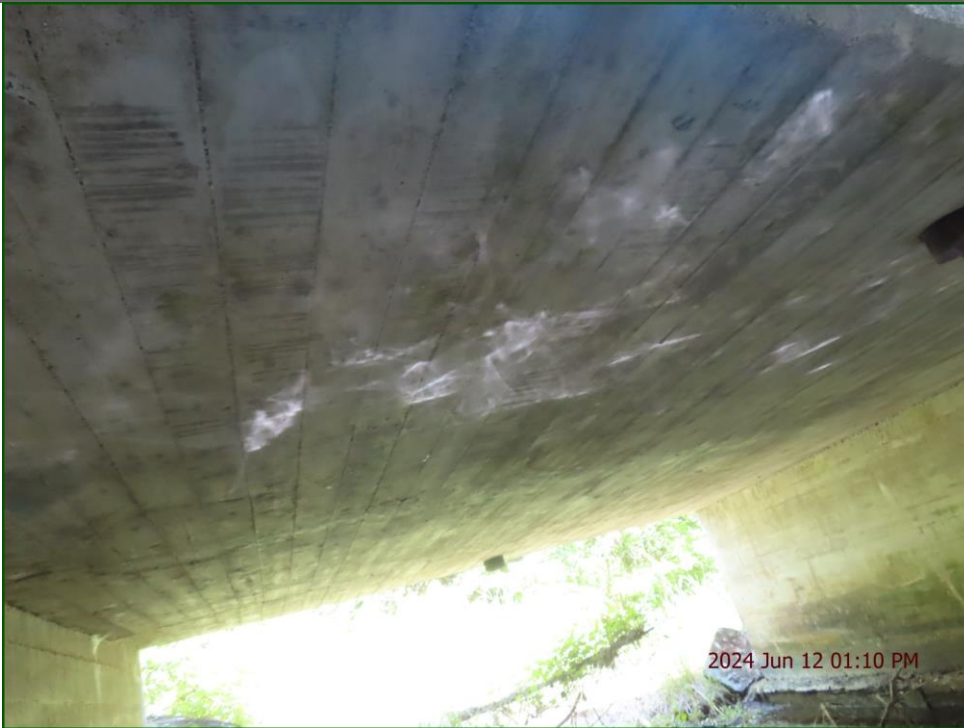
Medium to wide longitudinal cracking with leachate staining.

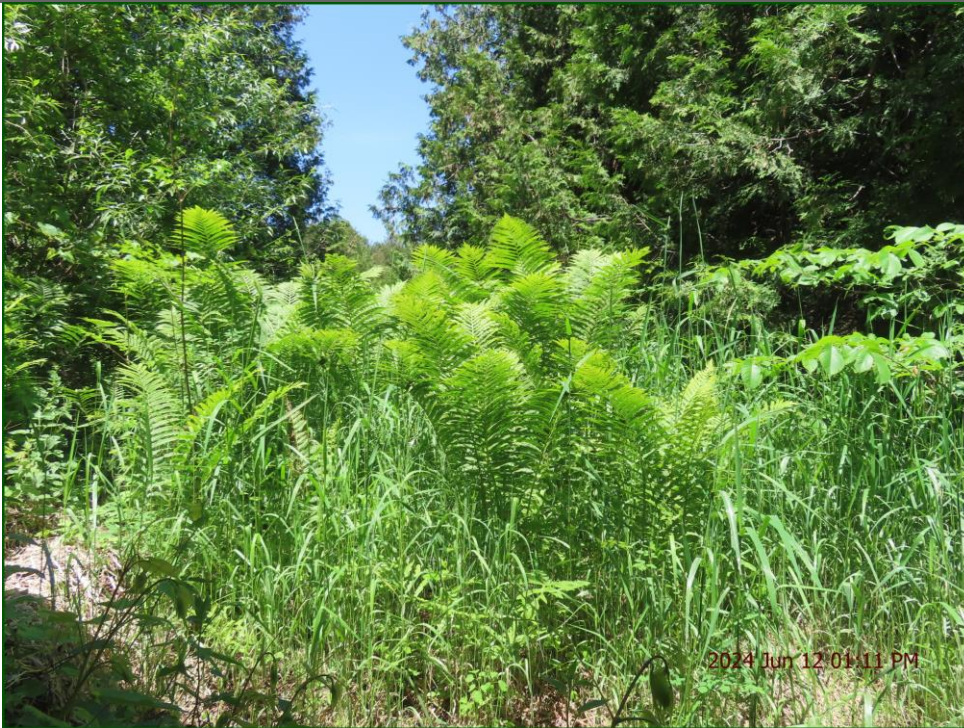
Stream dry at time of inspection.

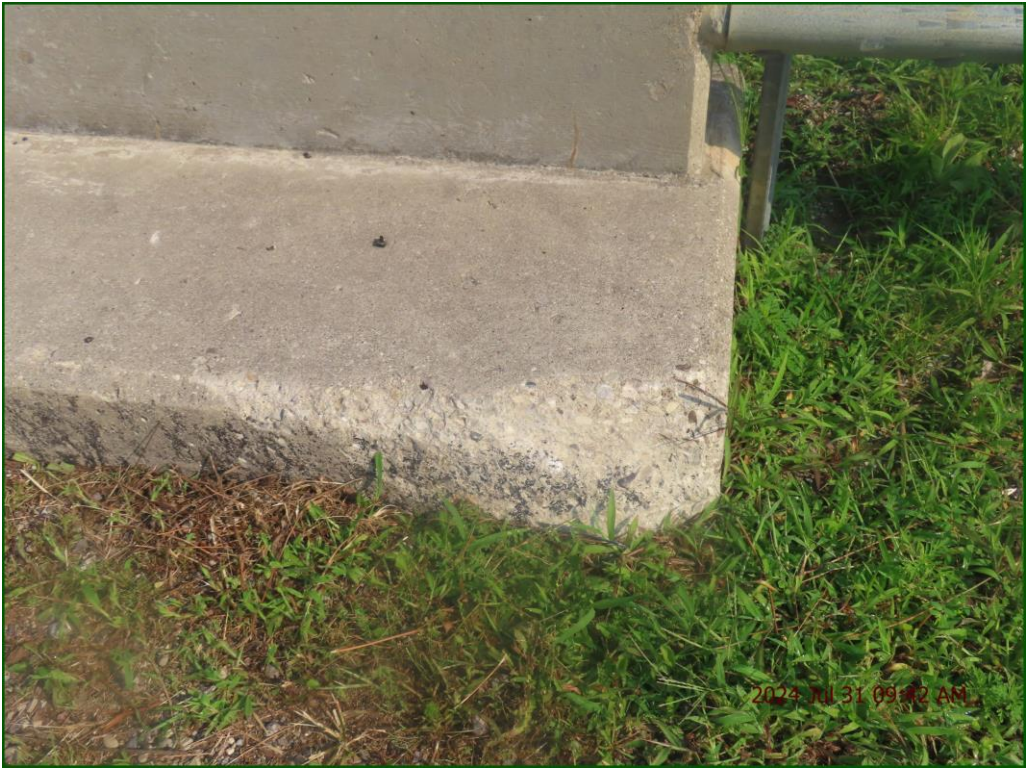
Description: Approach curbs: Light spalling at corners.

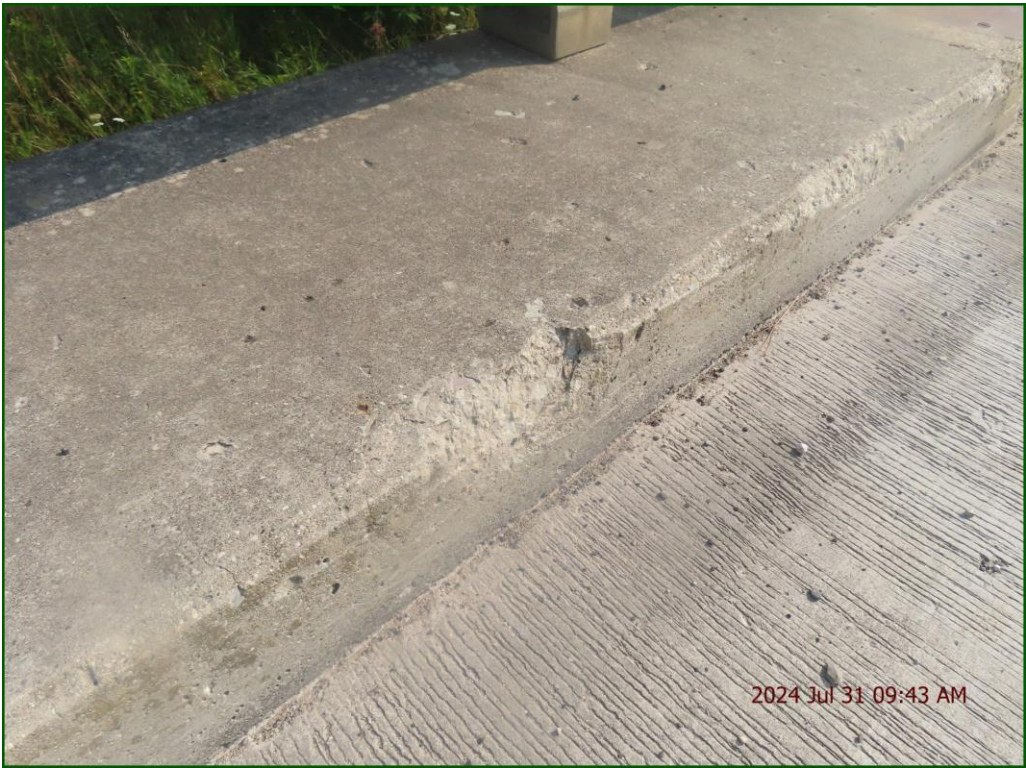
Description: Curbs: Minor abrasions along curblines.

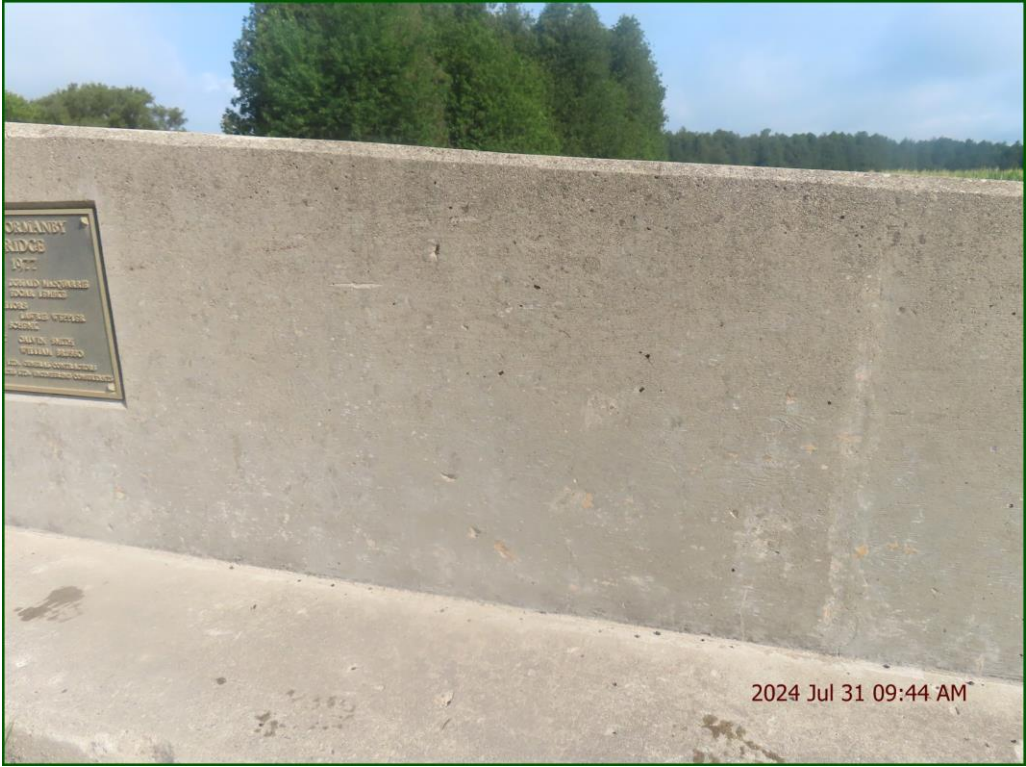
Description: Barrier/Parapet walls (int): Light to medium map cracking with wetness staining throughout.

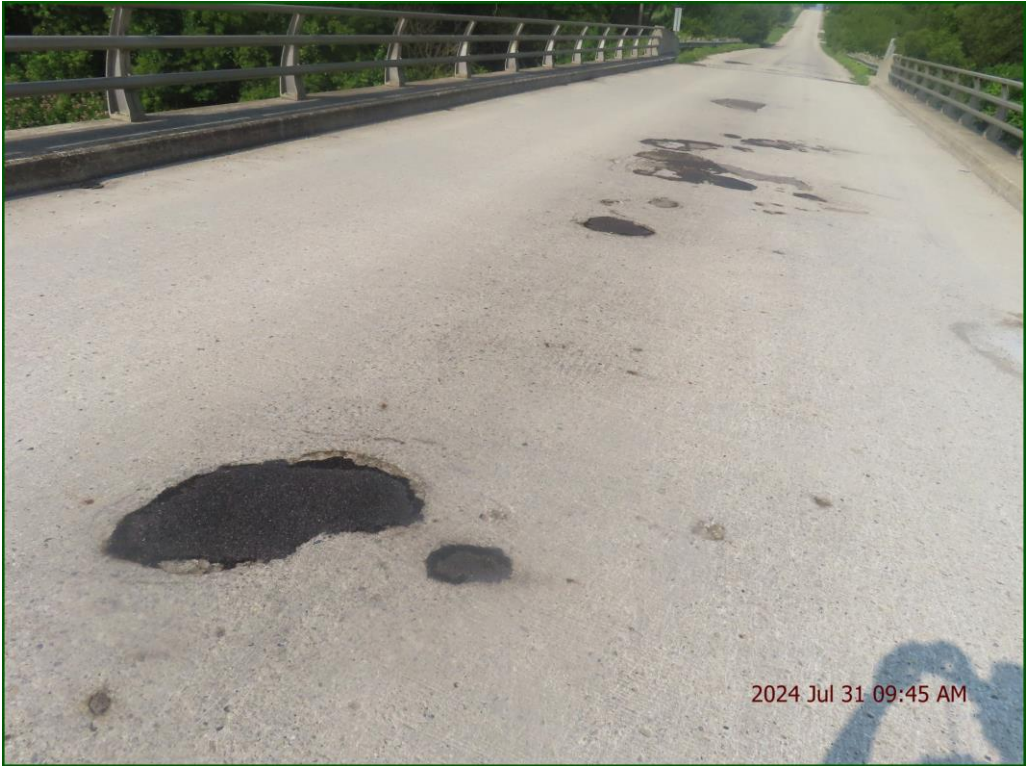
Description: Deck top: Moderate to severe spalling throughout has been patched using cold patch.

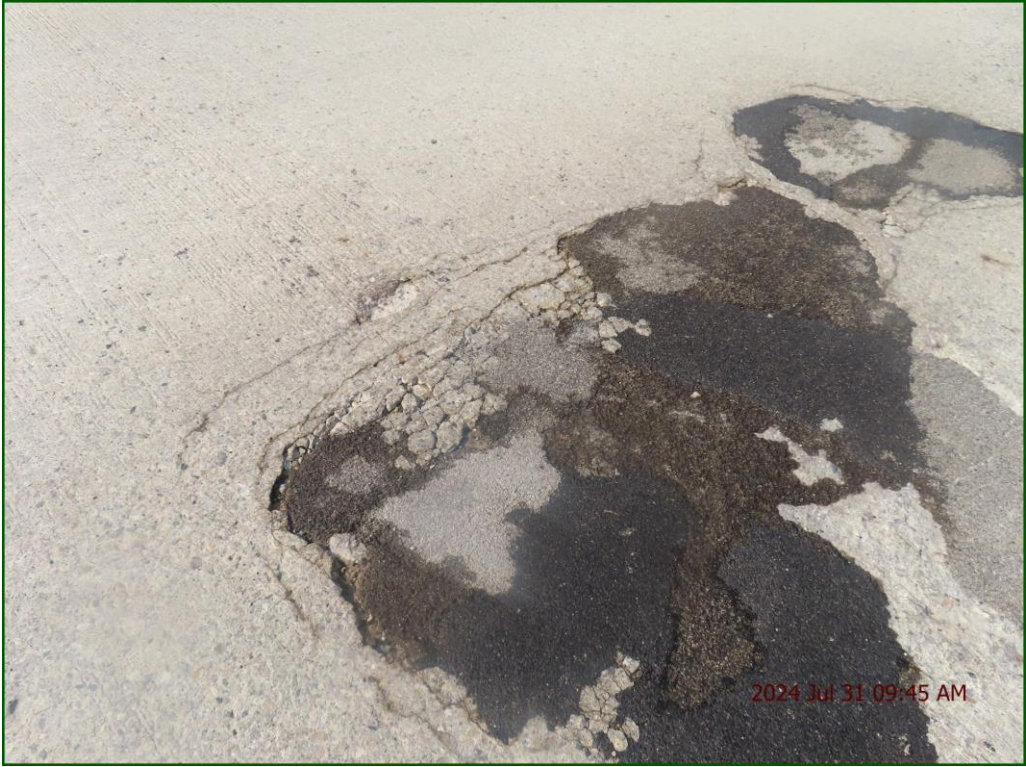
Description: Deck top: Various locations still have alligator cracking around patching.

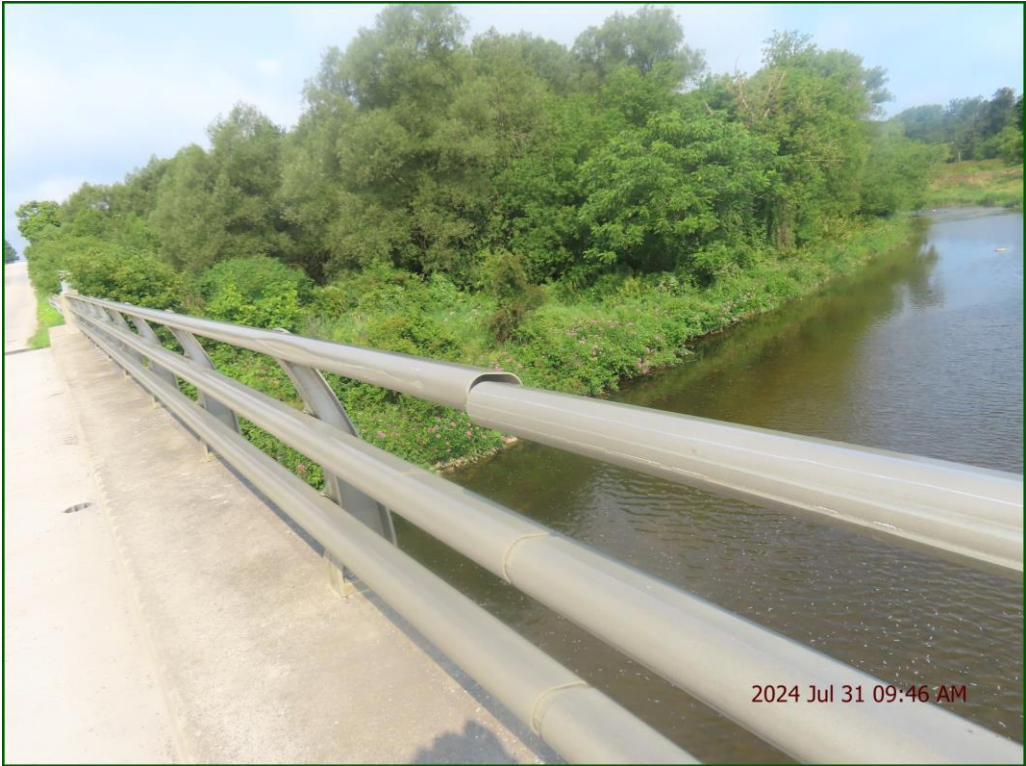
Description: Railing system: Minor impact damage throughout.

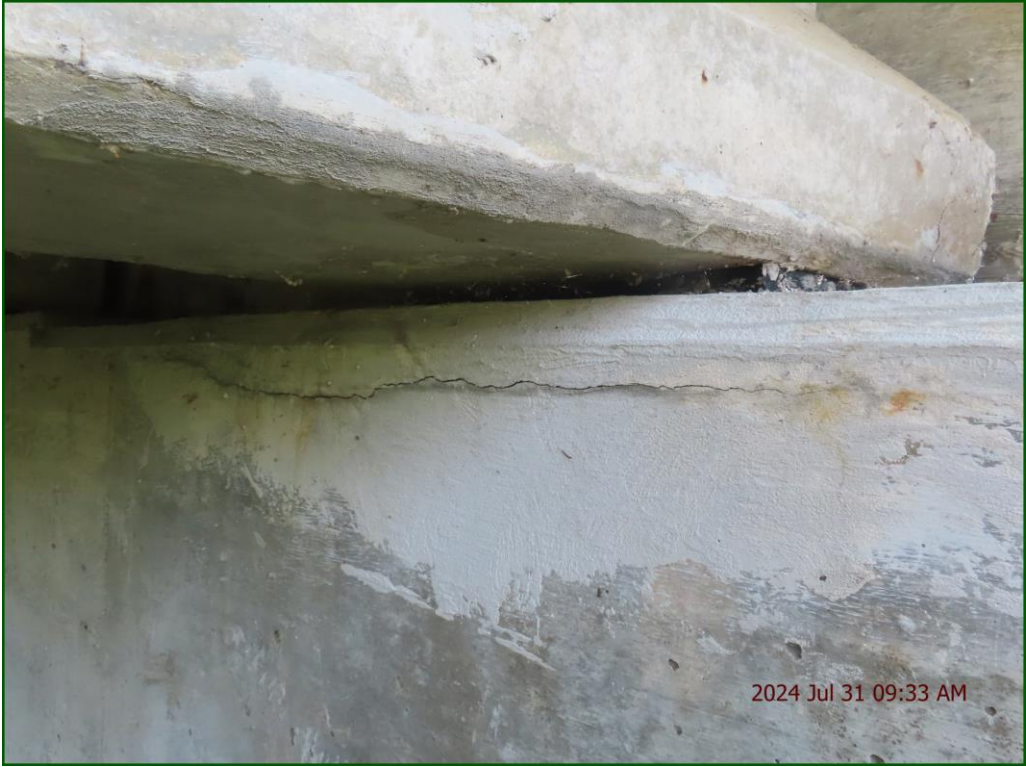
Description: Abutment walls: Medium to wide horizontal crack in previously patched area below girder. 5

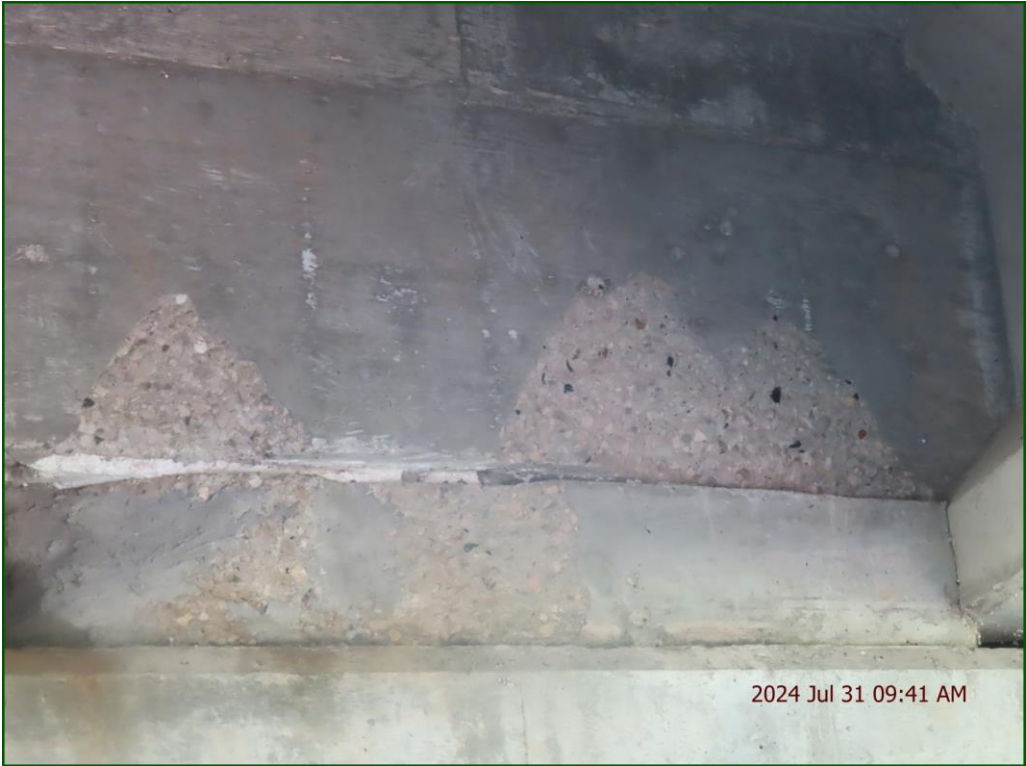
Description: Diaphragms: Light localized spalling on one diaphragm.

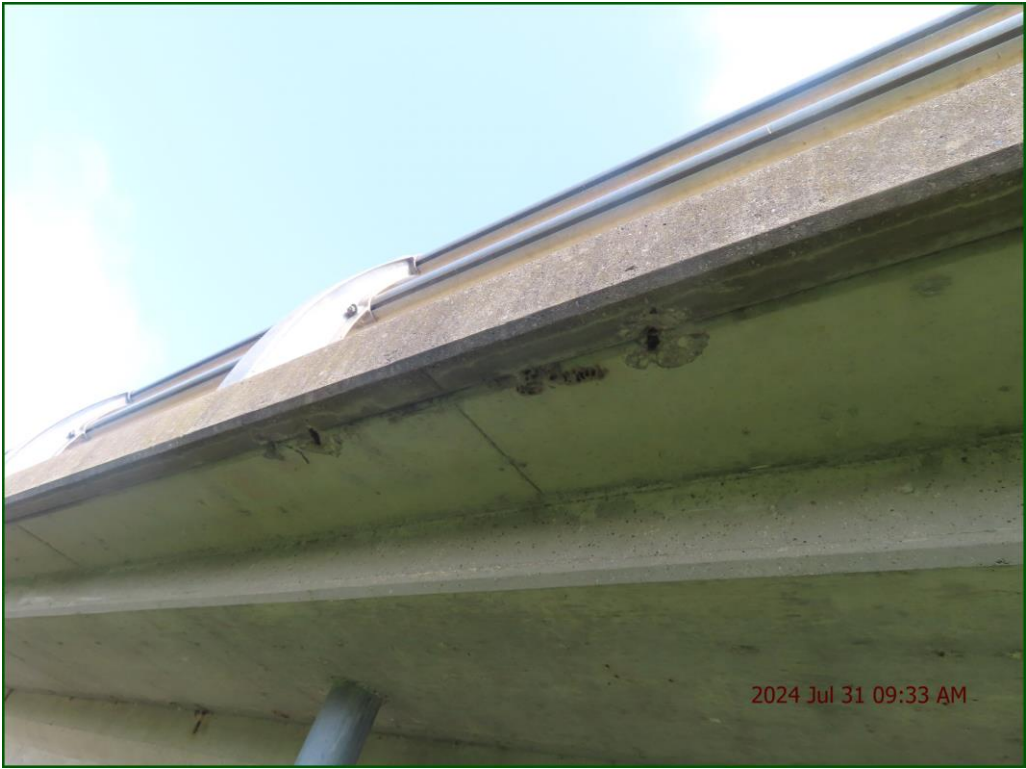
Description: Soffit (ext): Shallow spall with exposed reinforcing.

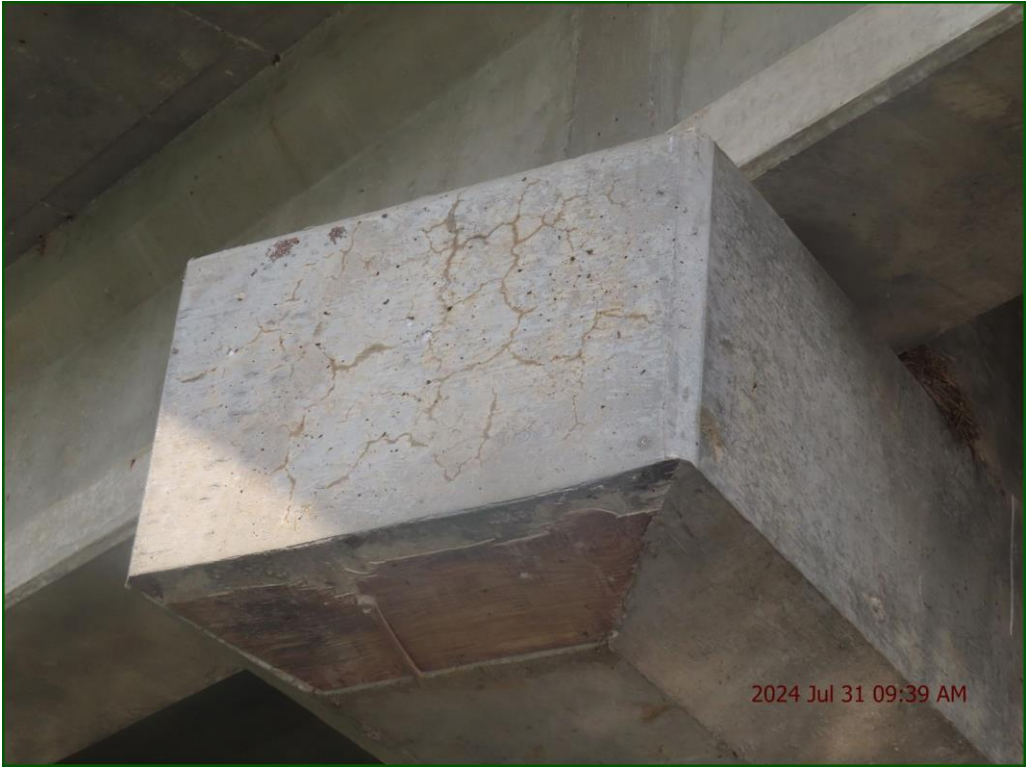
Description: Caps: Light map cracking with wetness staining.

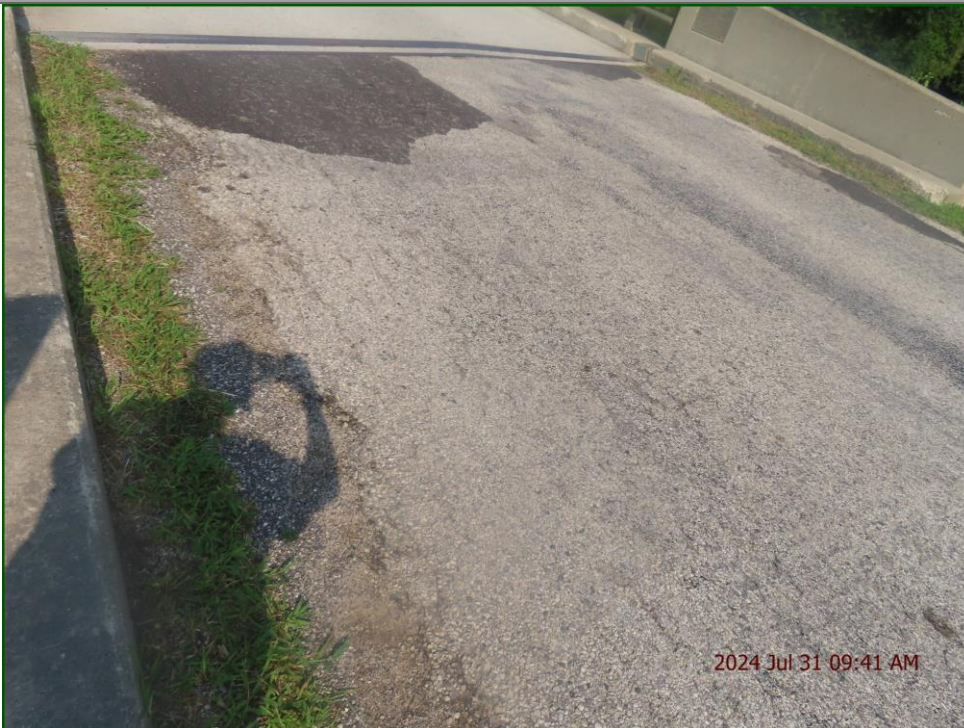
Moderate alligator cracking at joint.

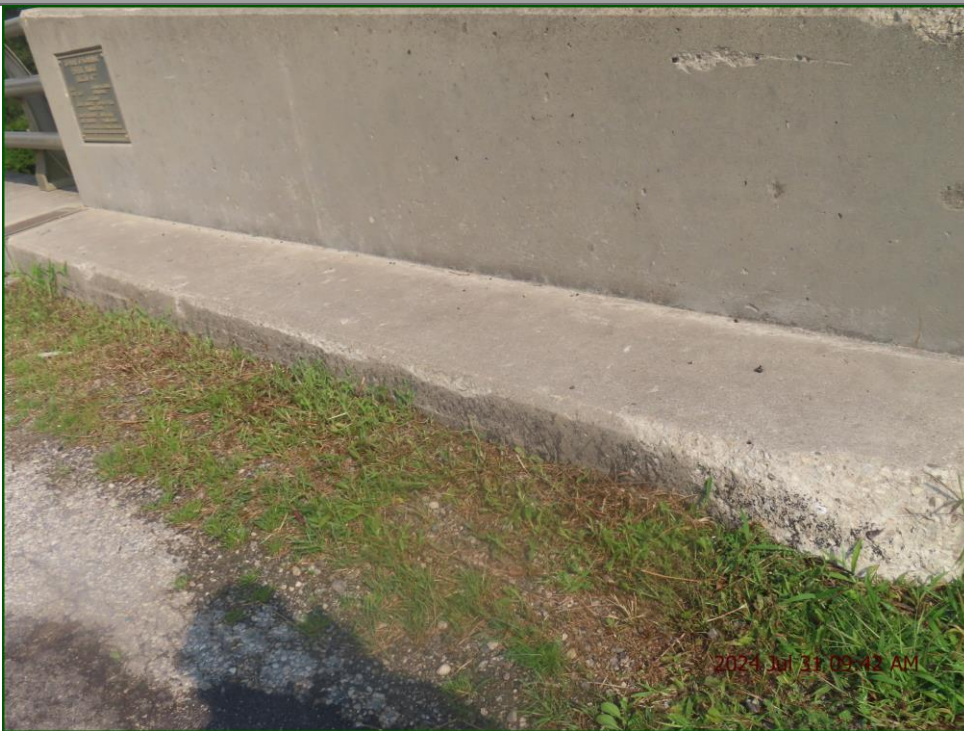
Light spalling at corners.

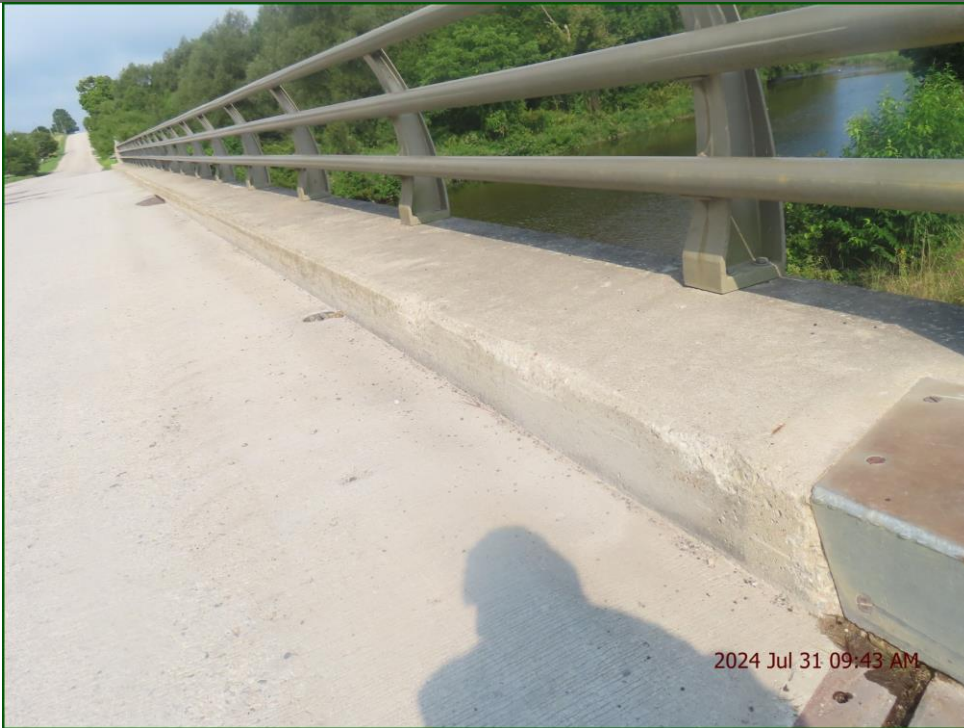
Minor abrasians along curblines.

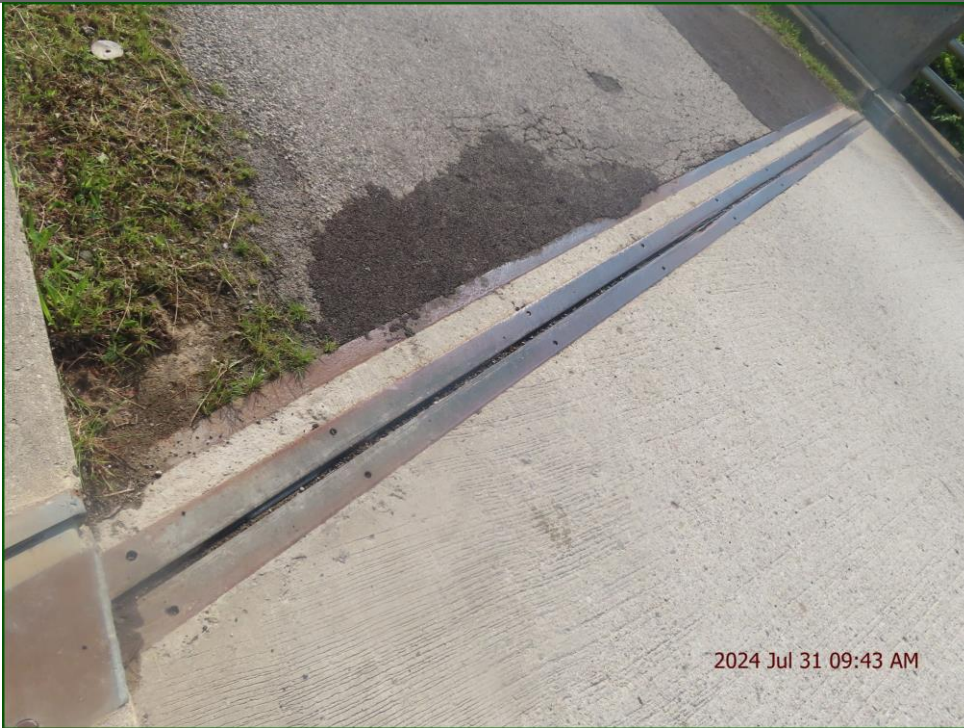
Light corrosion.

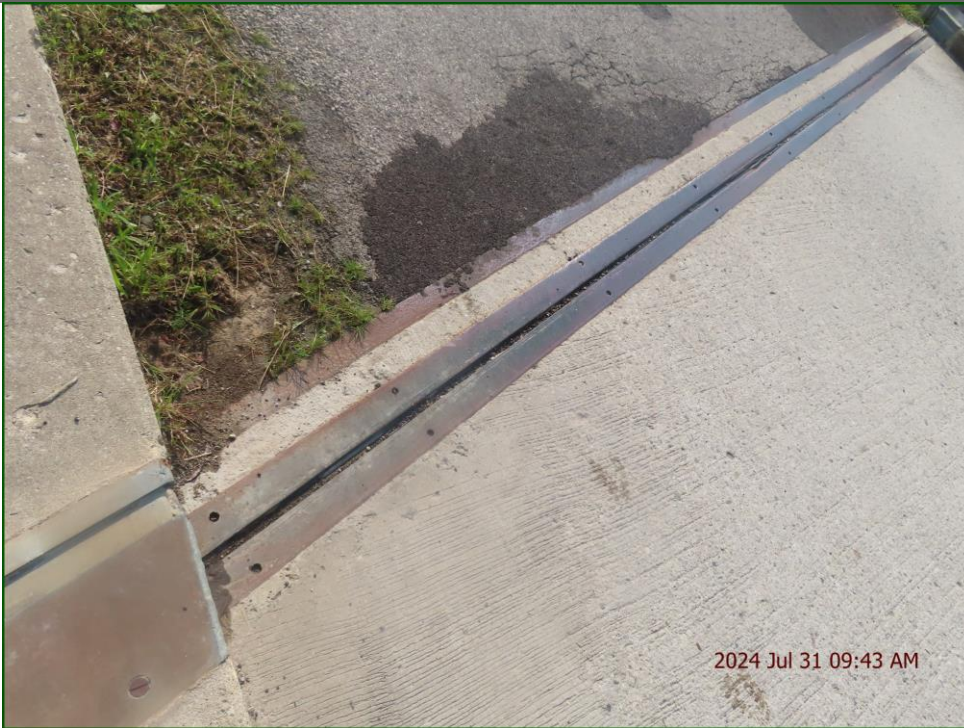
Seals beginning to fail. Seals filled with debris.

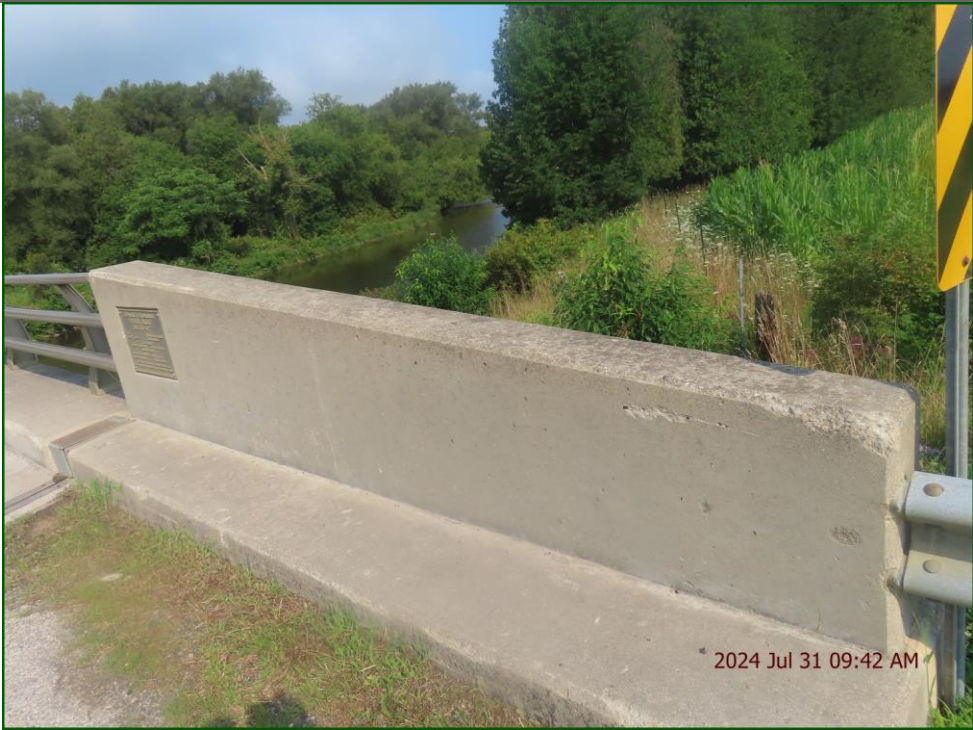
Light to medium map cracking with wetness staining throughout.

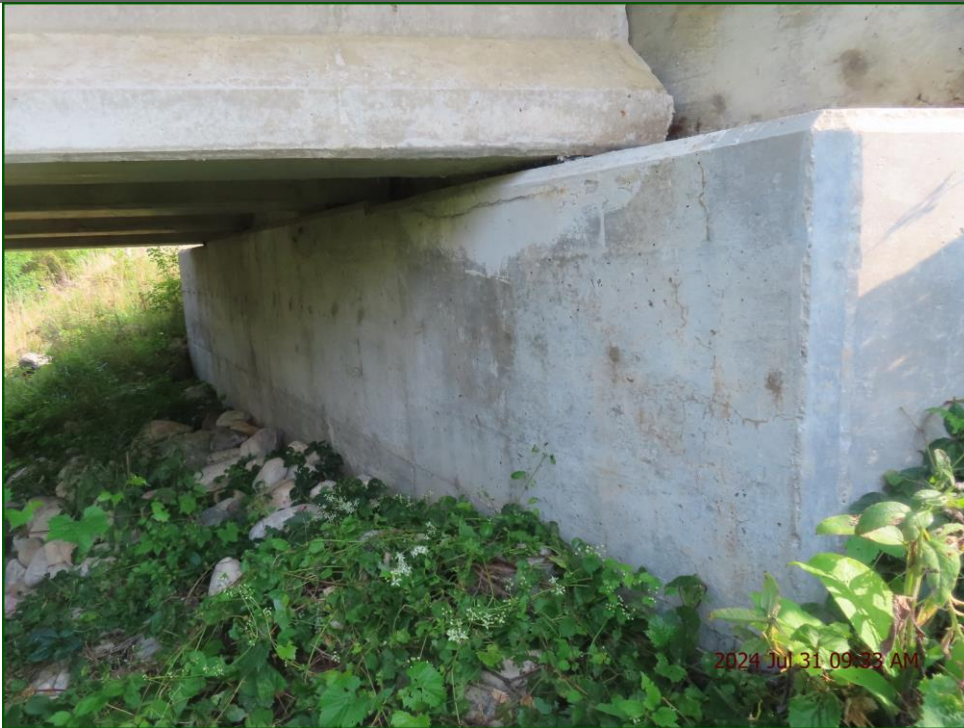
Medium to wide horizontal crack in previously patched area below girder.
