Date of Inspection:	30-Jul-24
Name of Inspector:	Andrew Burgess, P.Eng. & Joel Ziegler CET
Equipment Used:	Sounding hammer, measuring equipment, GPS
Weather Conditions:	Cloudy
Temperature:	23
Special Notes:	Bridge is in good condition, showing no signs of structural distress.

Year Built:	1979	Contract Number When Built:	
Latest Biennial Inspection:	September 14, 2022	Latest Specialized Inspection:	
Latest Structure Rating:	75.0	Latest Structure Condition:	
RehabHistory:			
Regional Priority Number:		Programmed Work Year:	
NatureOfProgramWork:

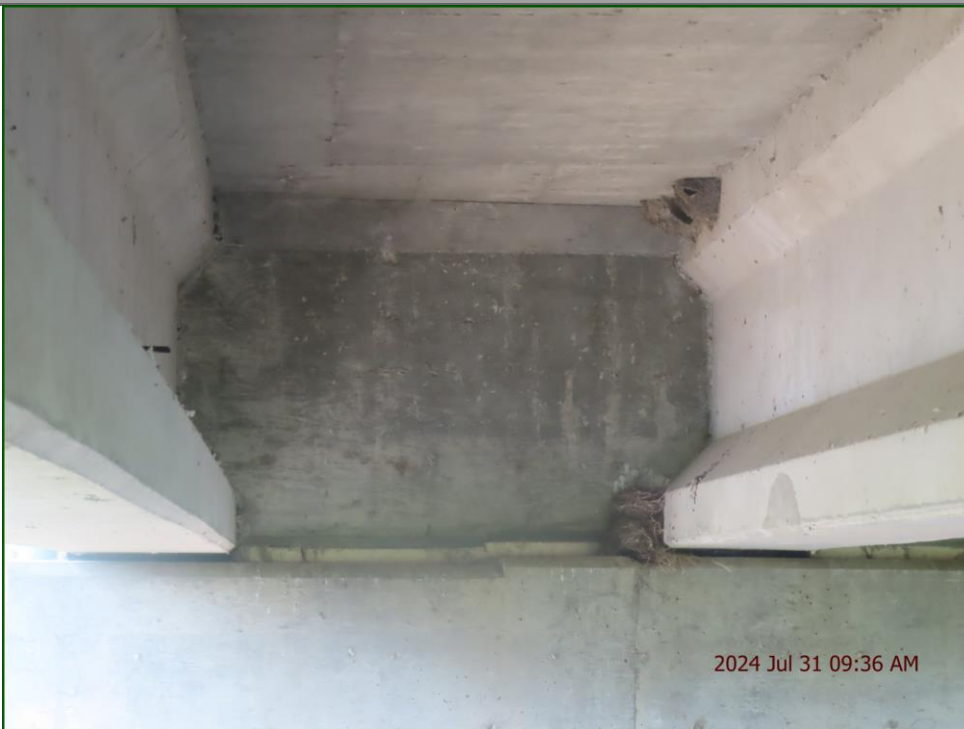
Description: Diaphragms: Light localized spalling on one diaphragm.

Light localized spalling on one diaphragm.

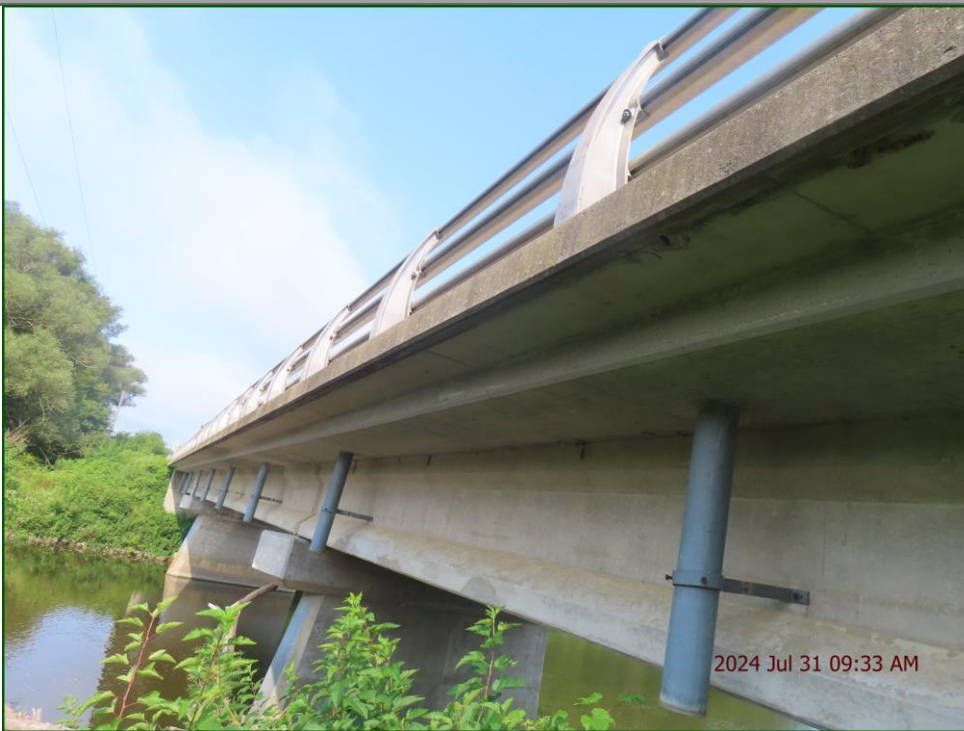
Description: Soffit (ext): Shallow spall with exposed reinforcing.

Shallow spall with exposed reinforcing.

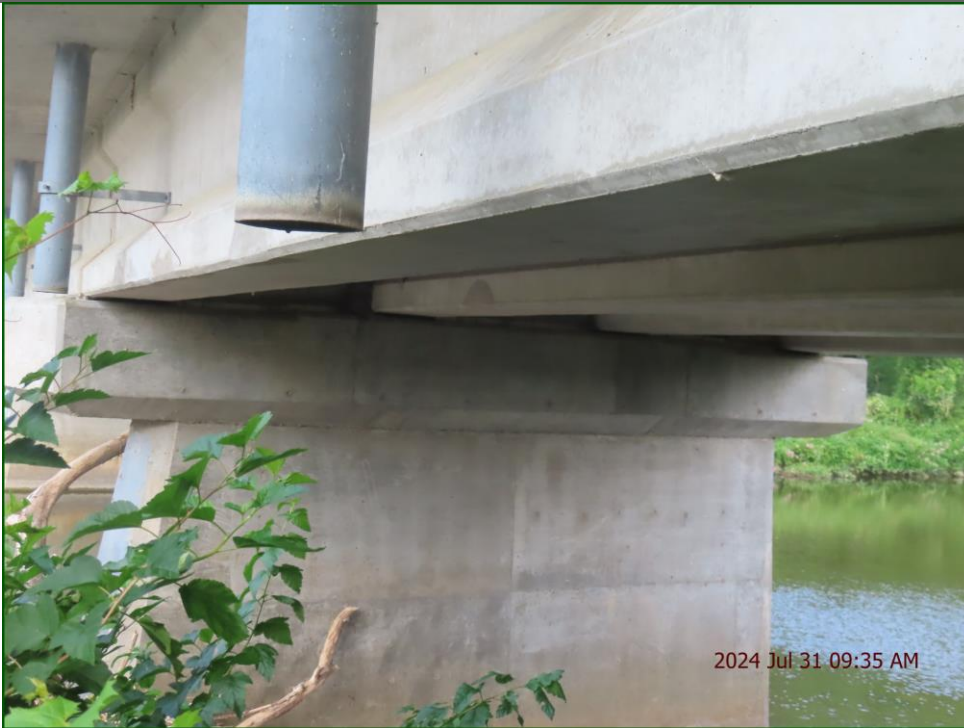
Description: Caps: Light map cracking with wetness staining.

Light map cracking with wetness staining.

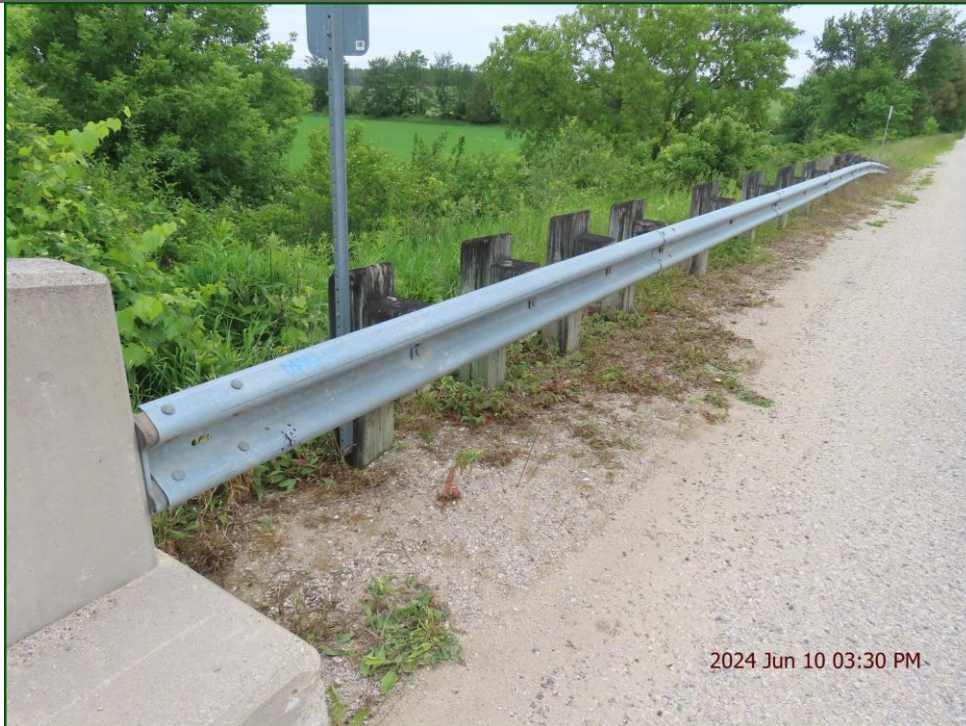
Improper connection to bridge.

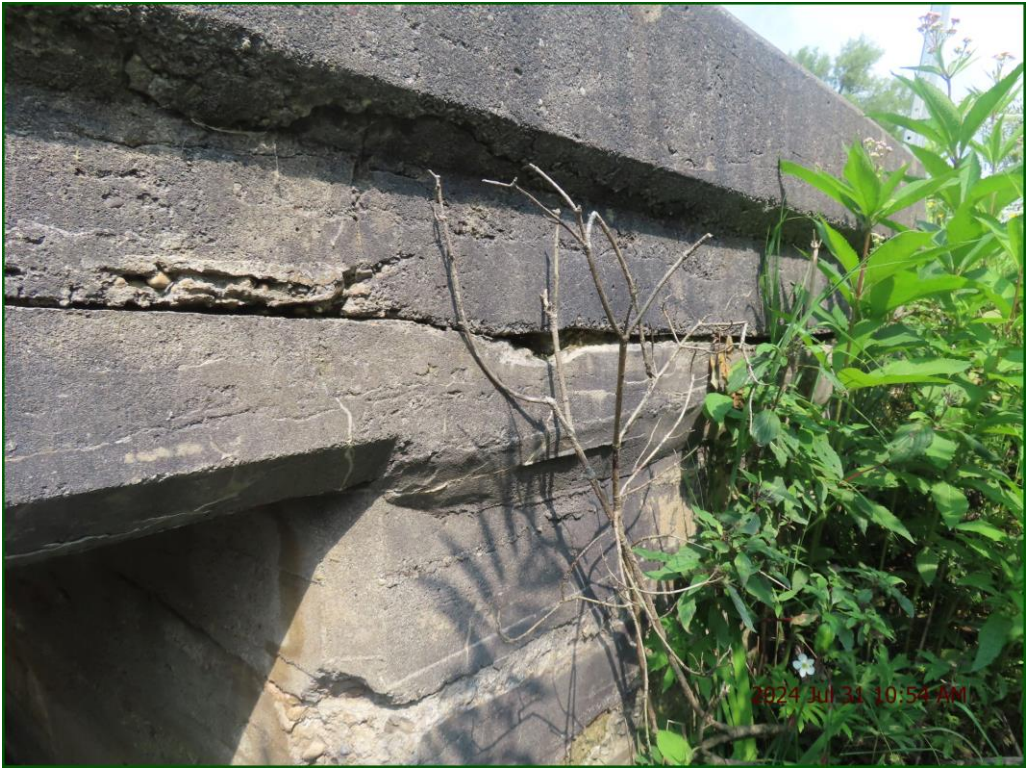
Description: Inlet: Wide cracking at construction joint.

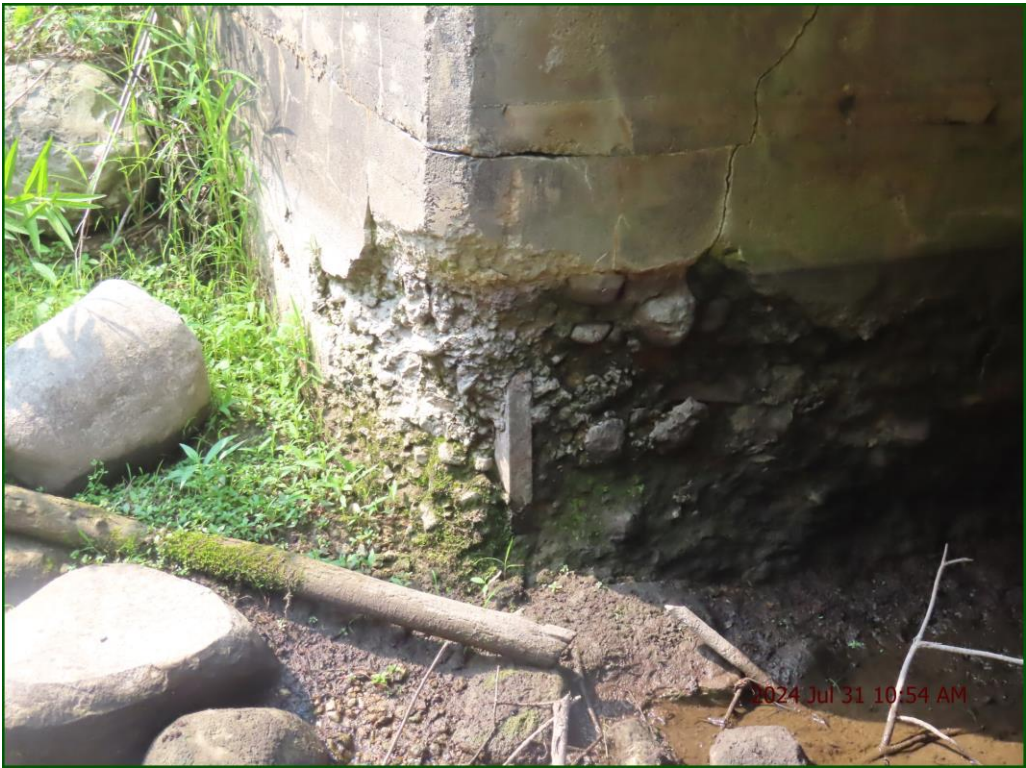
Description: Inlet: Severe spalling and disintegration.

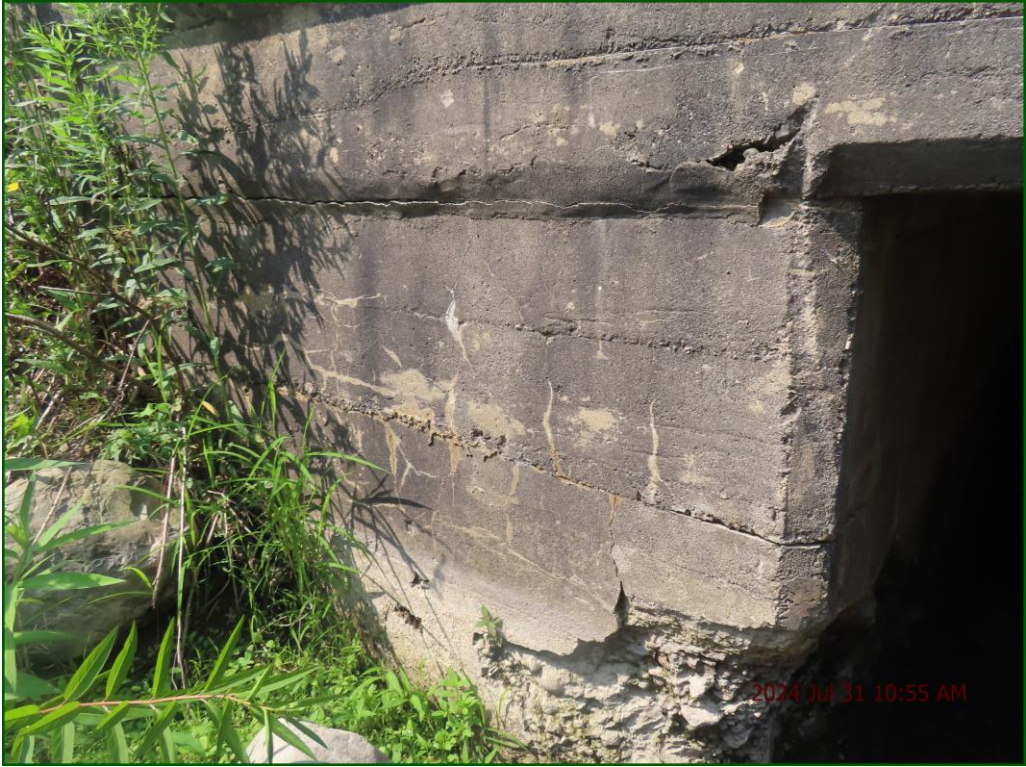
Description: Inlet: Light to medium map cracking with leachate staining.

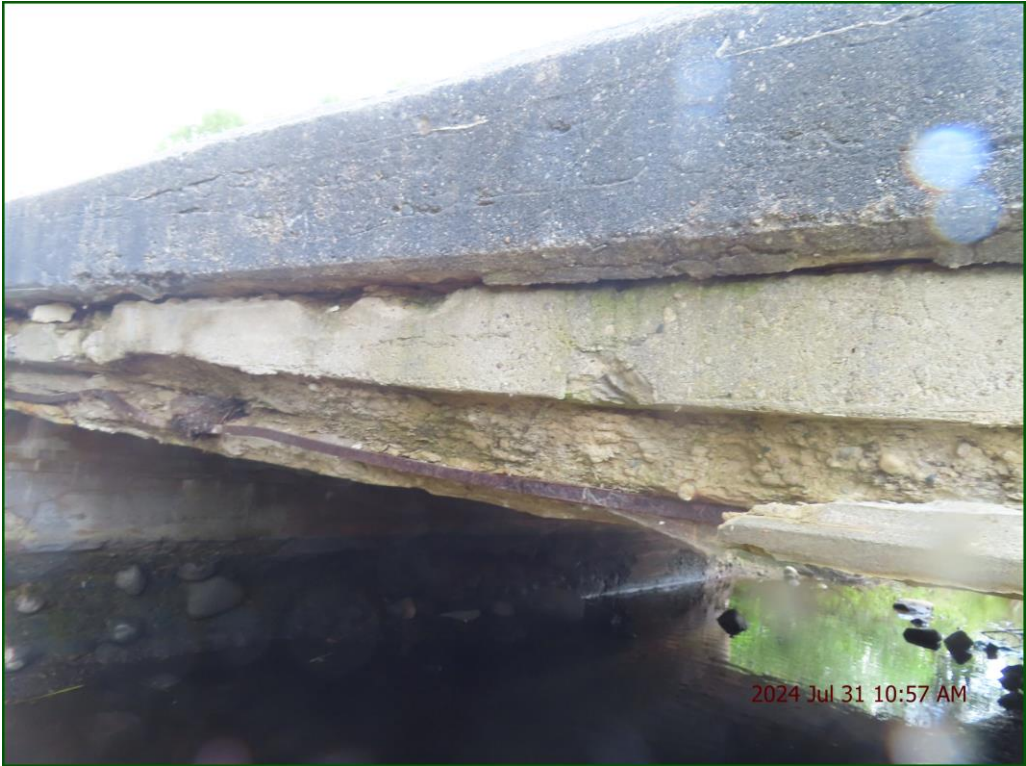
Description: Outlet: Severe disintegration along fascia with exposed reinforcing.

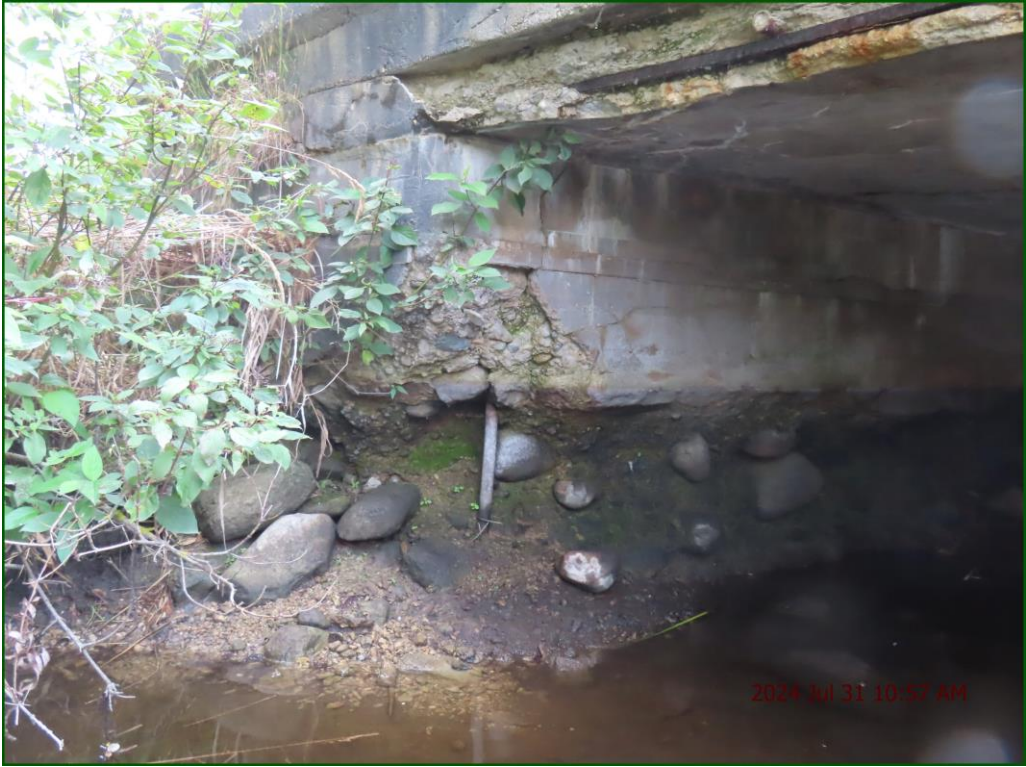
Description: Outlet: Severe disintegration at waterline, undermining culvert.

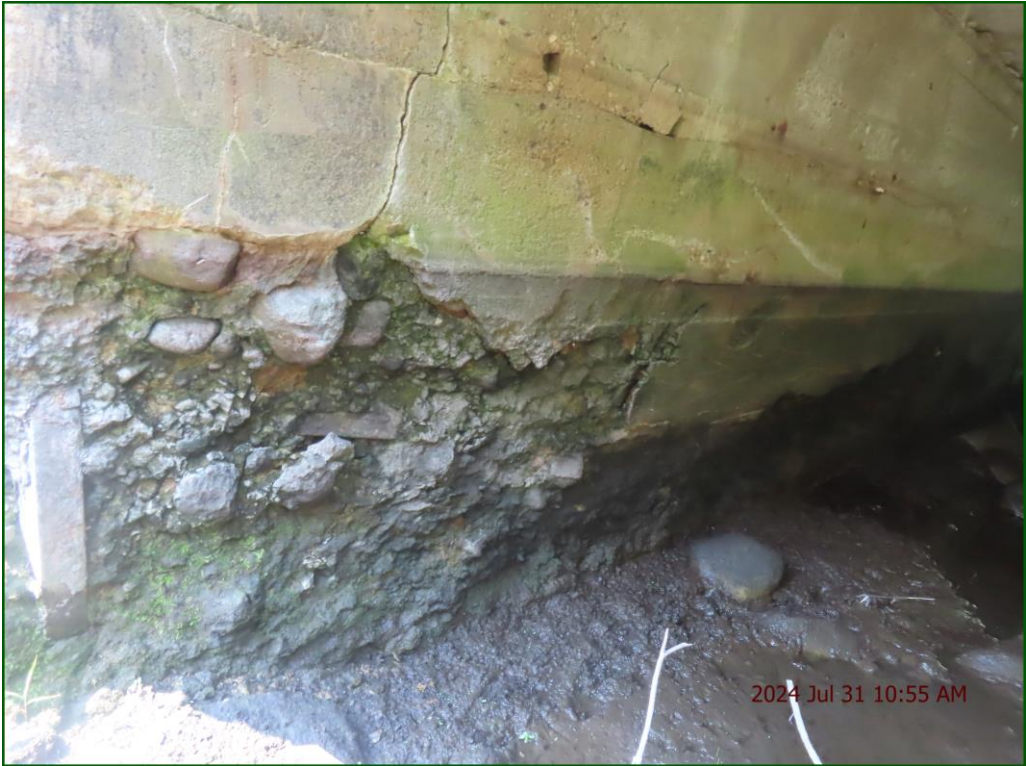
Description: Barrel: Severe spalling with exposed reinforcing throughout.

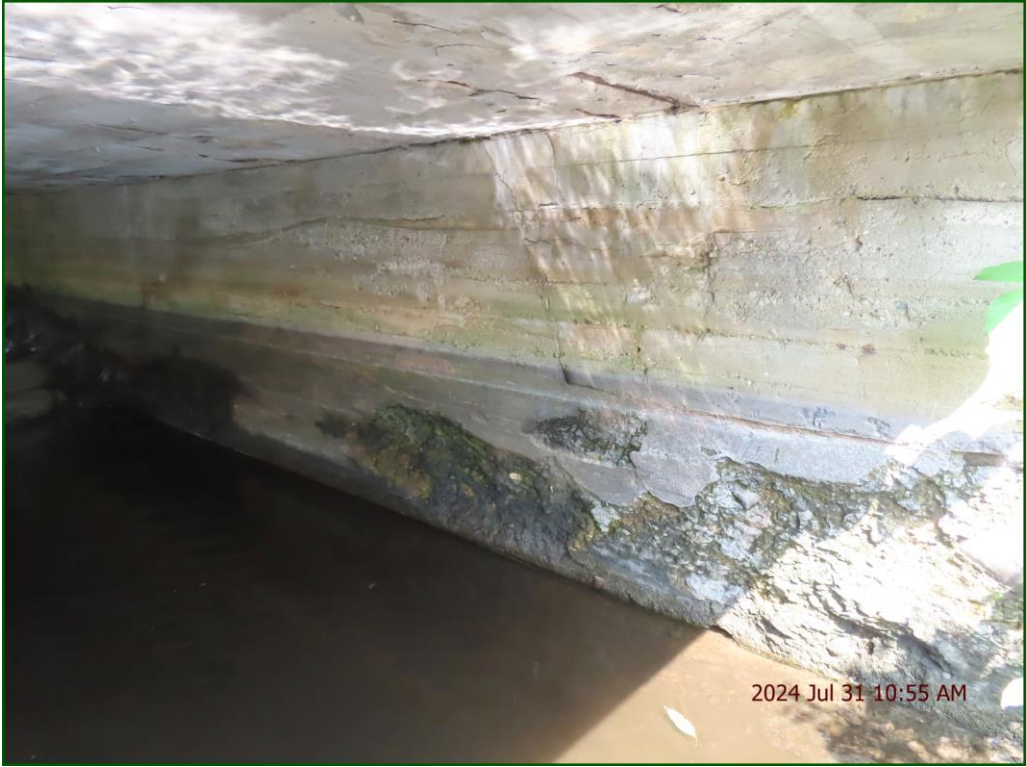
Description: Barrel: Severe scaling.

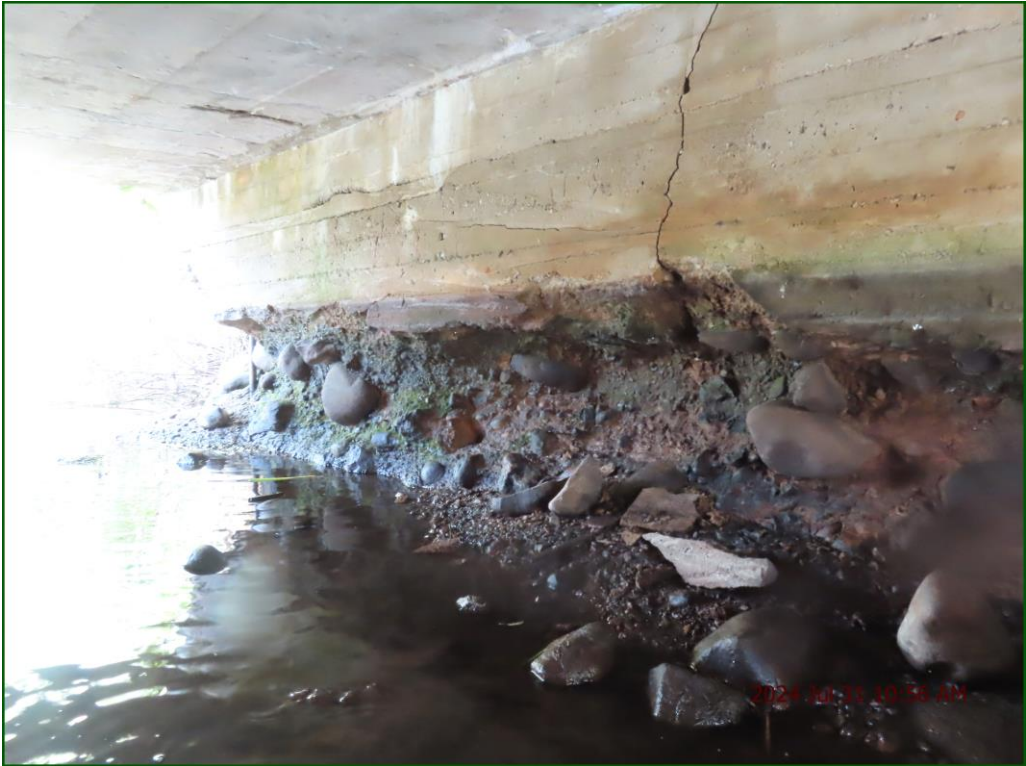
Description: Barrel: Severe disintegration along waterline, has undermined culvert.

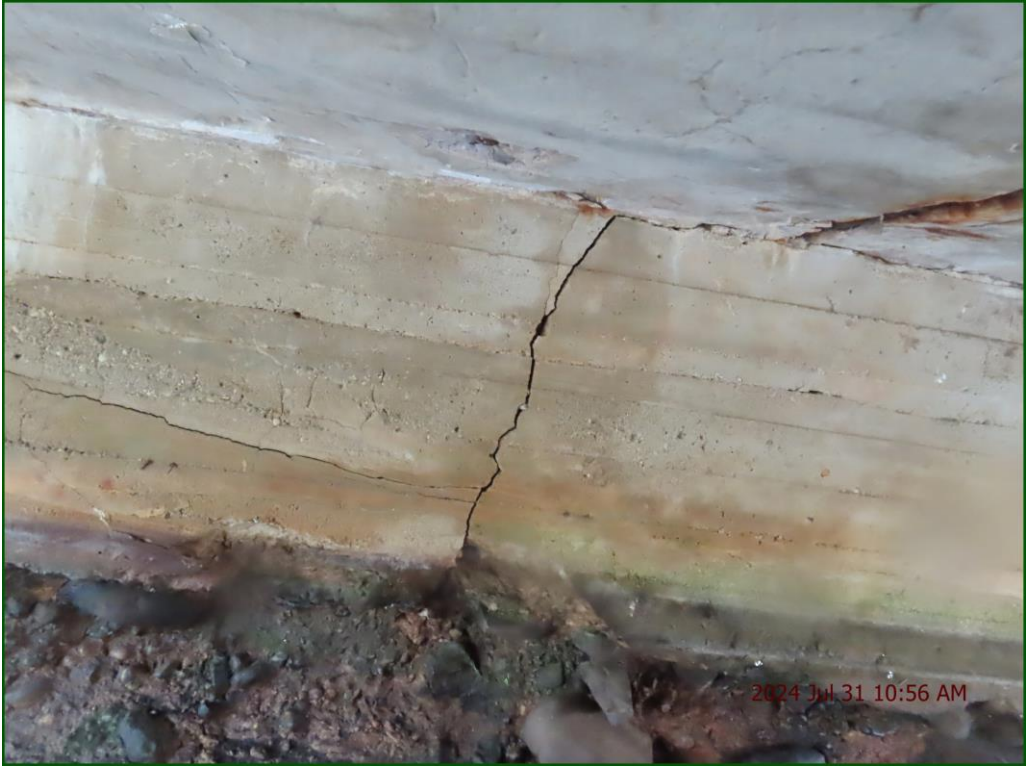
Description: Barrel: Wide vertical cracks propegating from spalling.

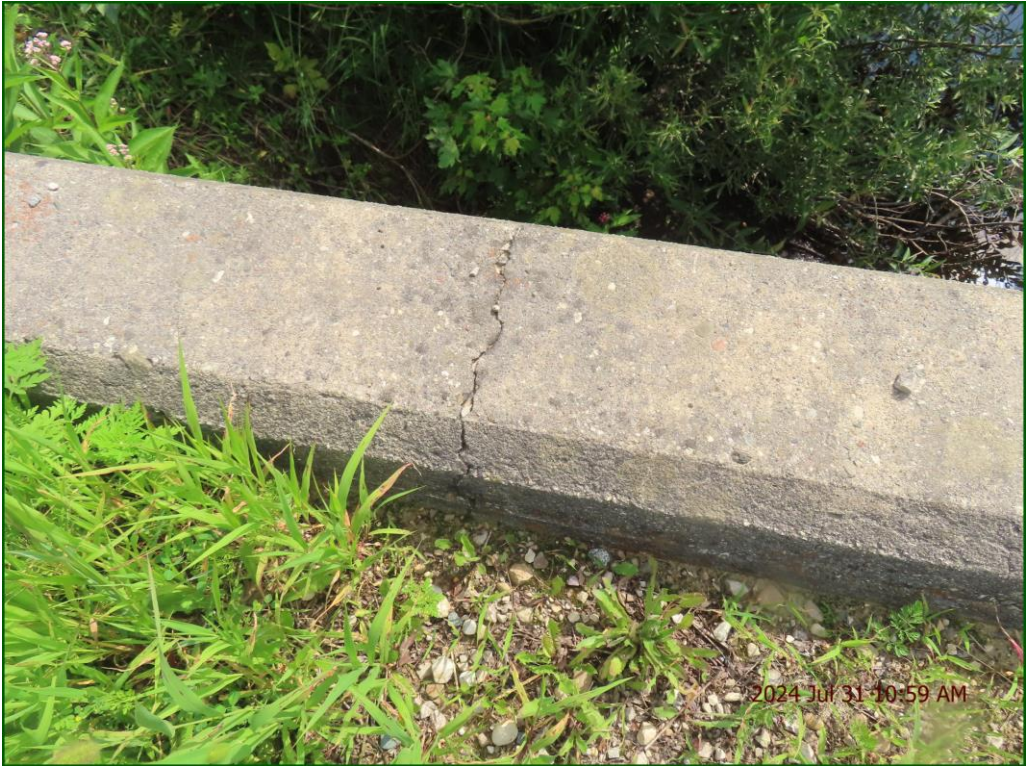
Description: Curbs: Medium to wide cracking throughout.

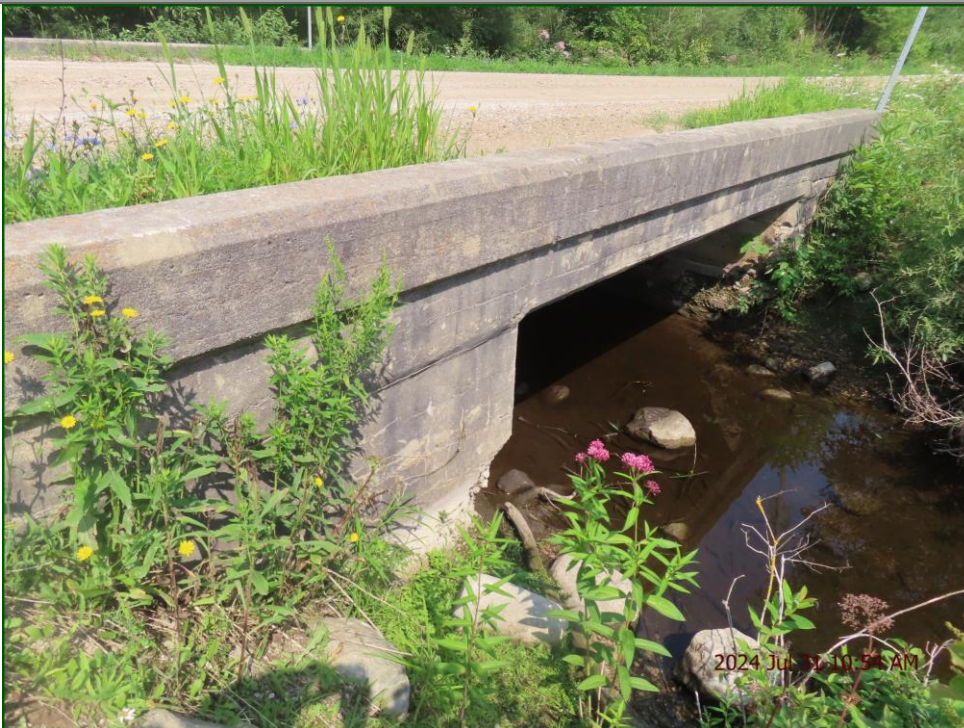
Date of Inspection:	31-Jul-24
Name of Inspector:	Andrew Burgess, P.Eng. & Joel Ziegler CET
Equipment Used:	Sounding hammer, measuring equipment, GPS
Weather Conditions:	Sunny
Temperature:	22
Special Notes:	Culvert is in poor condition. Schedule for closure and complete follow up inspection in 1 year.

Rehab Needs:	<input type="text" value="Replace with Culvert (concrete)"/>	Unit Cost:	<input type="text" value="\$5600 / sq.m"/>
Rehab time period:	<input type="text" value="1 - 5 Years"/>	Estimated Cost:	<input type="text" value="\$224,000"/>
Quantity:	<input type="text" value="40"/> sq.m

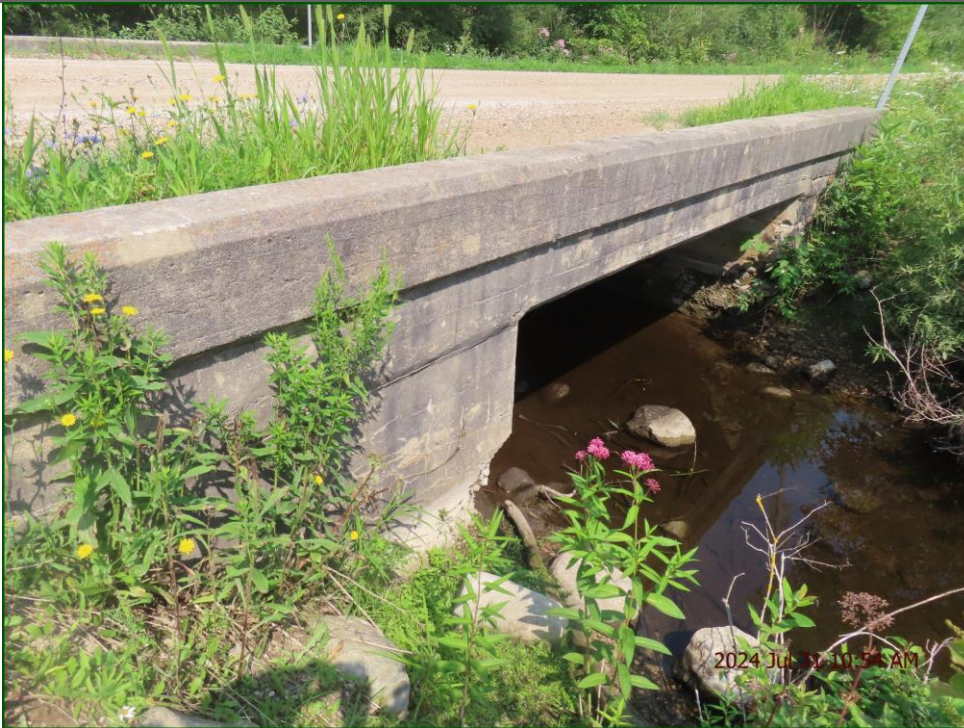
Wide cracking at construction joint. Severe spalling and disintegration. Light to medium map cracking with leachate staining.

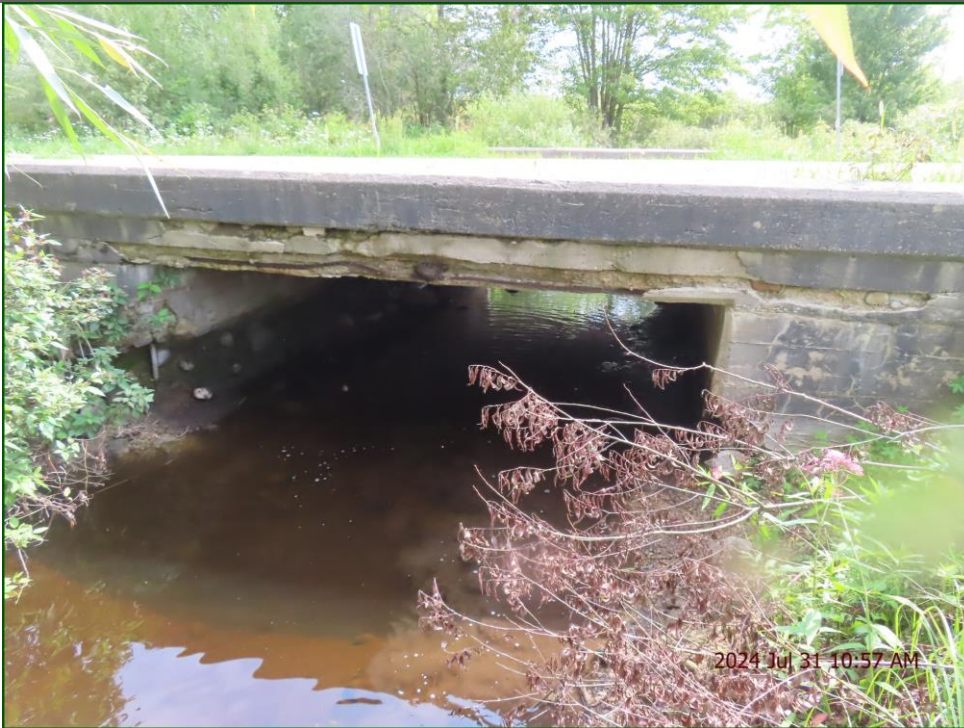
Severe disintegration along fascia with exposed reinforcing. Severe disintegration at waterline, undermining culvert.

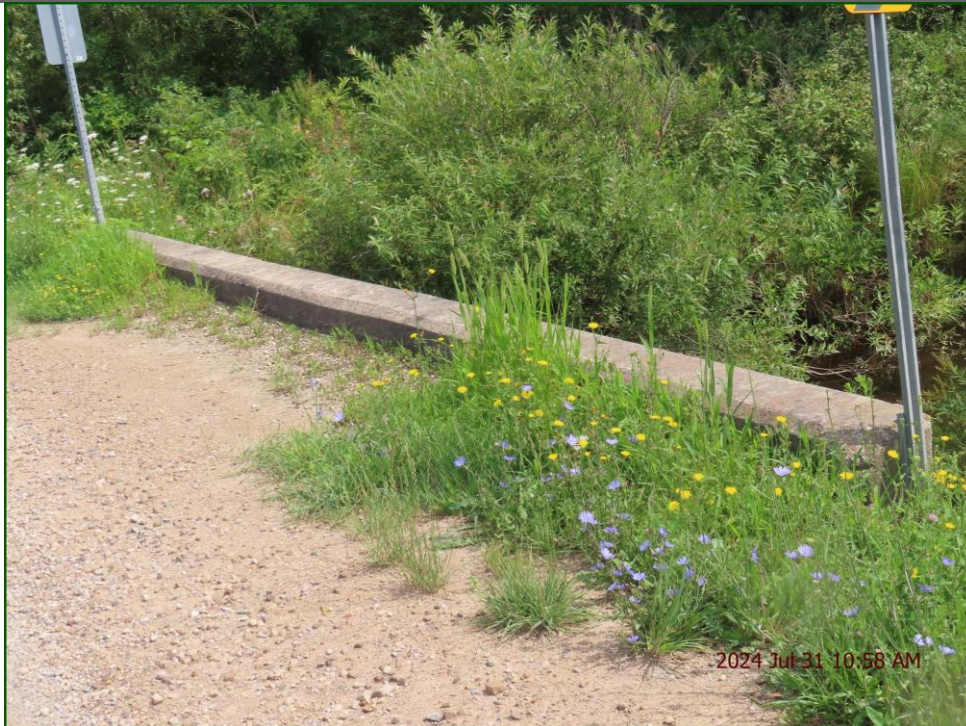
Curb beginning to lean outwards. Medium to wide cracking throughout.

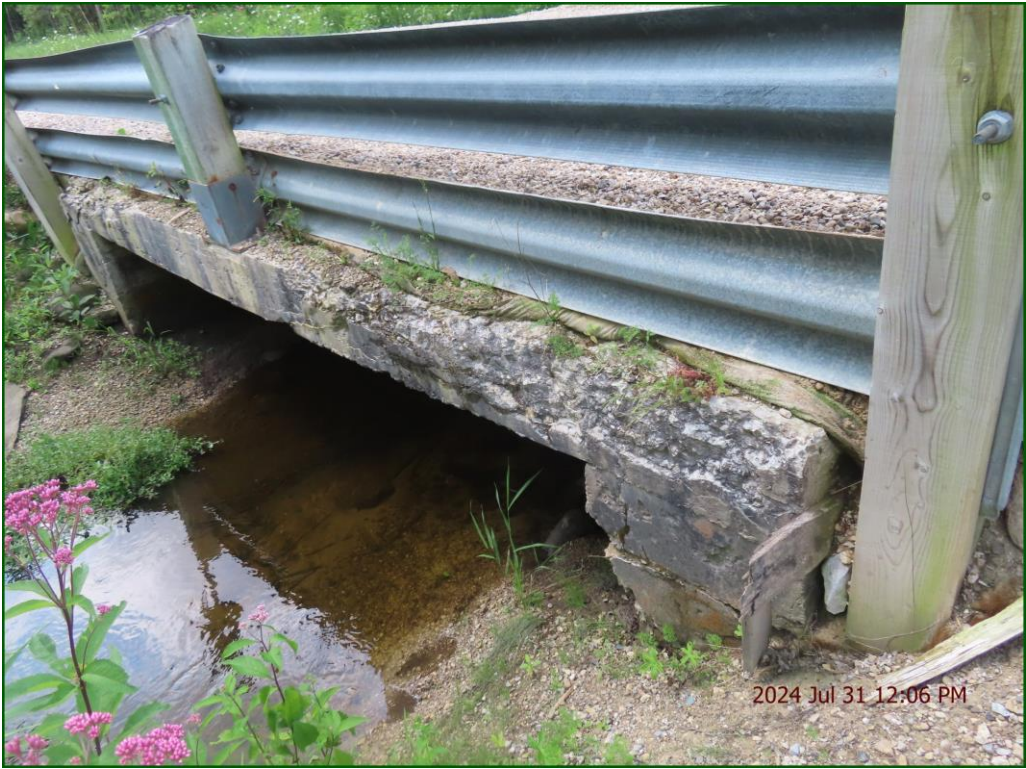
Description: Inlet: Severe spalling and disintegration.

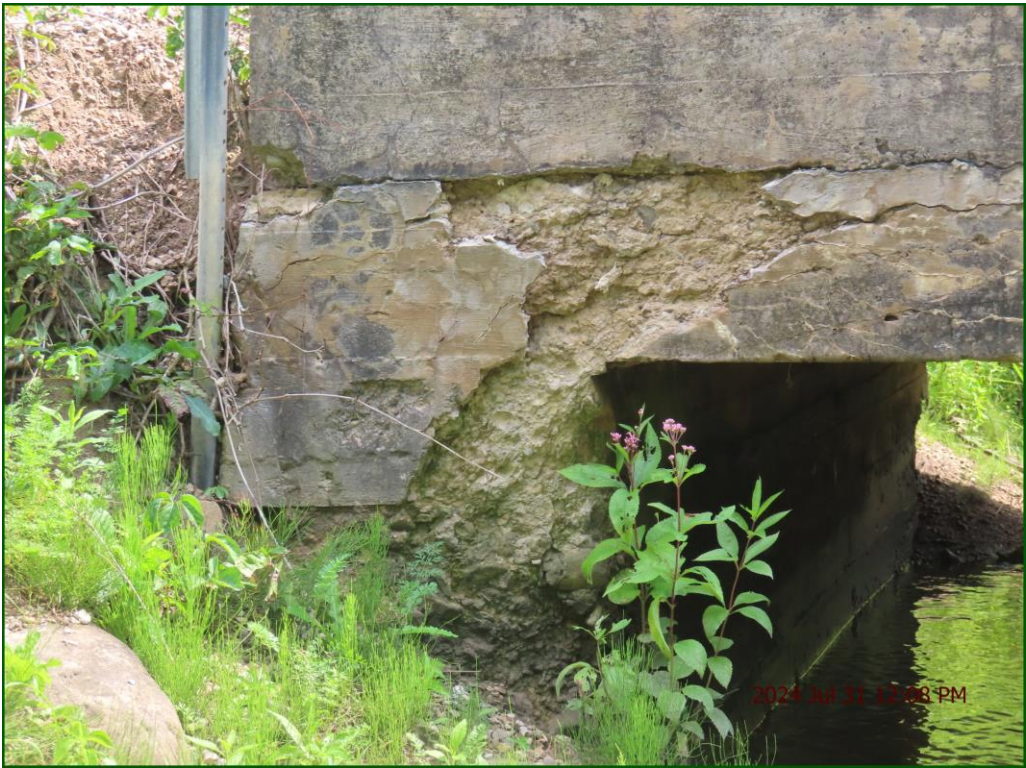
Description: Outlet: Severe spalling and disintegration.

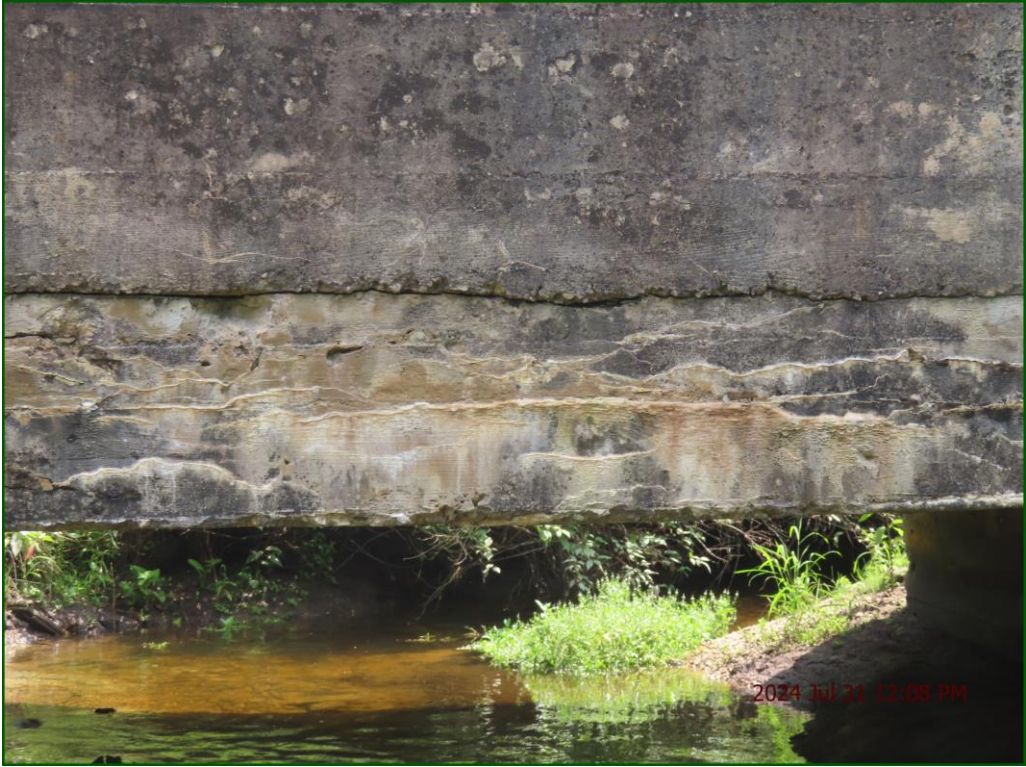
Description: Outlet: Medium to wide cracking with leachate staining throughout.

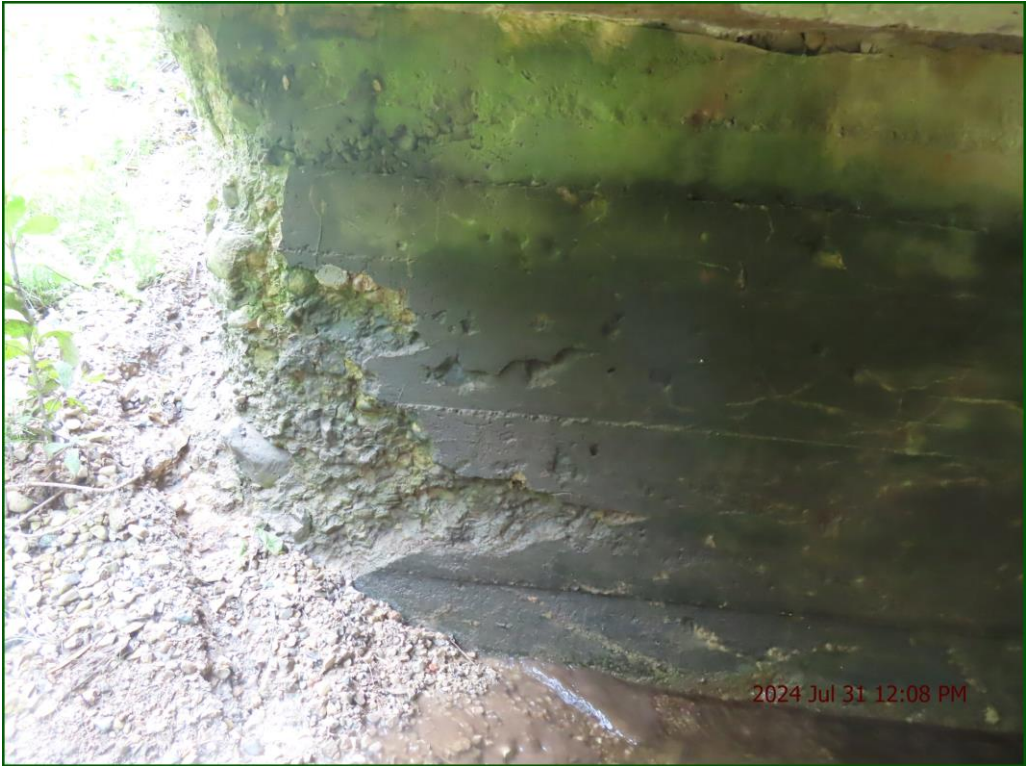
Description: Barrel: Severe spalling and disintegration.

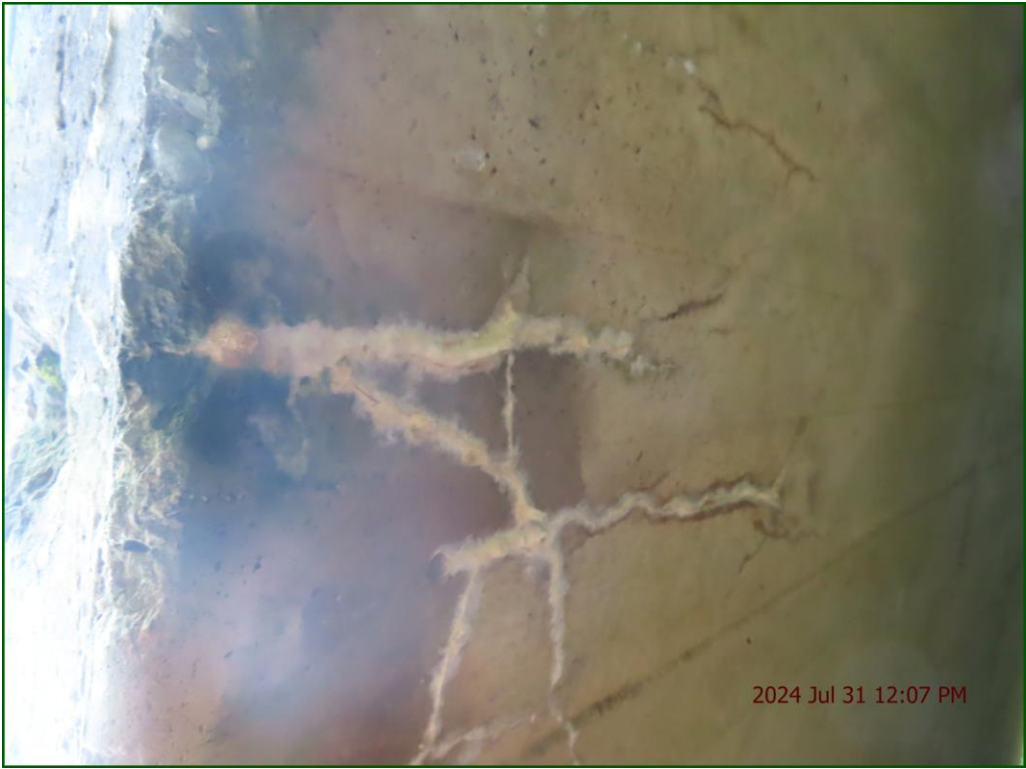
Description: Barrel: Medium to wide cracking with leachate staining throughout.

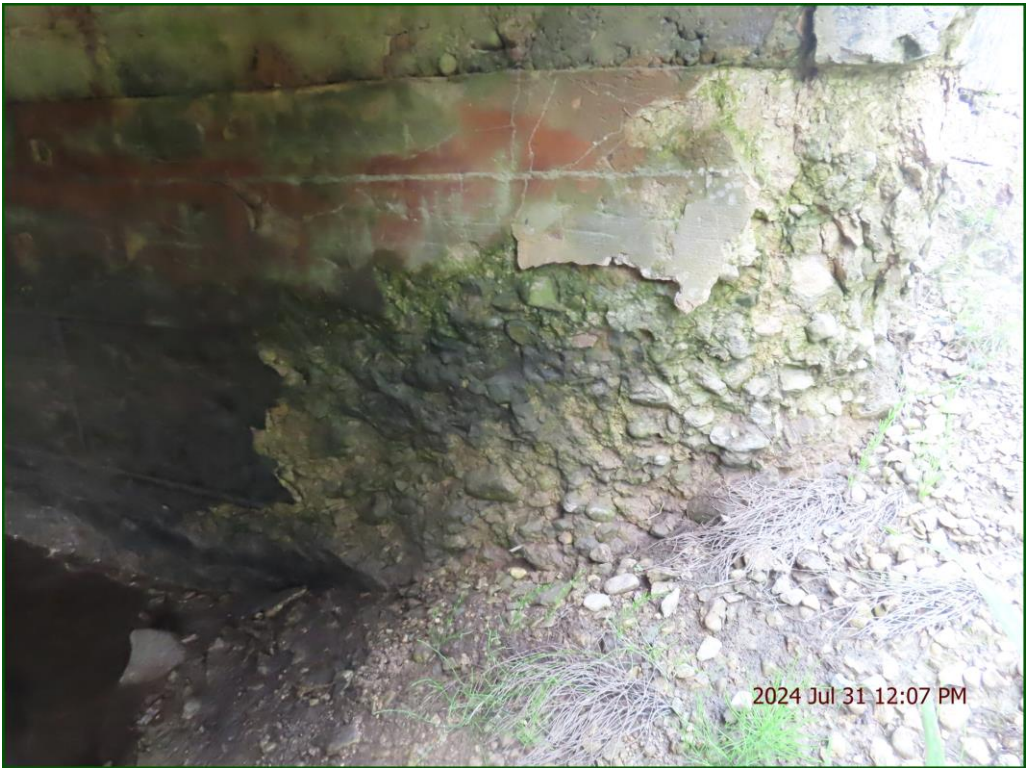
Description: Barrel: Severe spalling and disintegration (undermining).

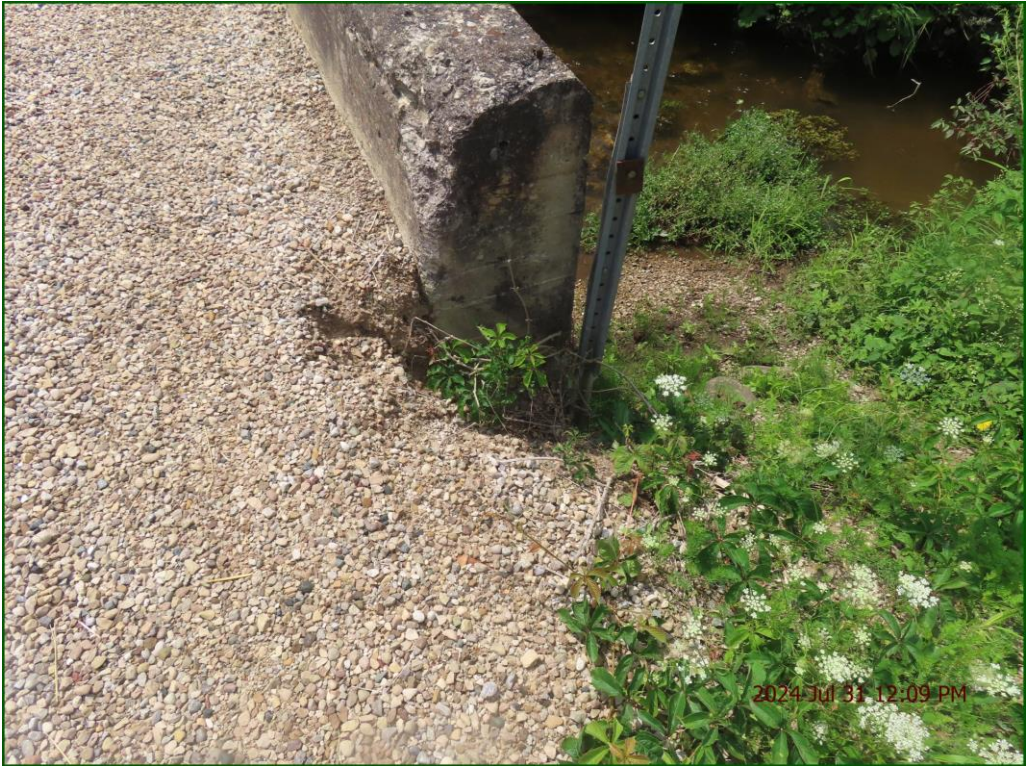
Description: Embankments: Minor erosion on north-east quadrant.

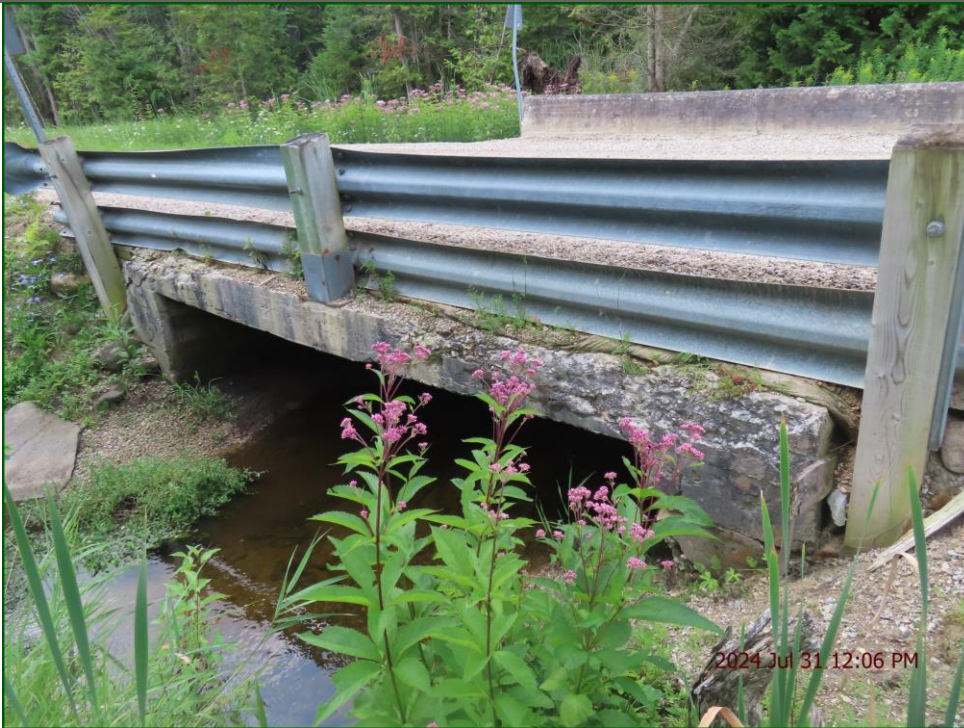
Severe spalling and disintegration.

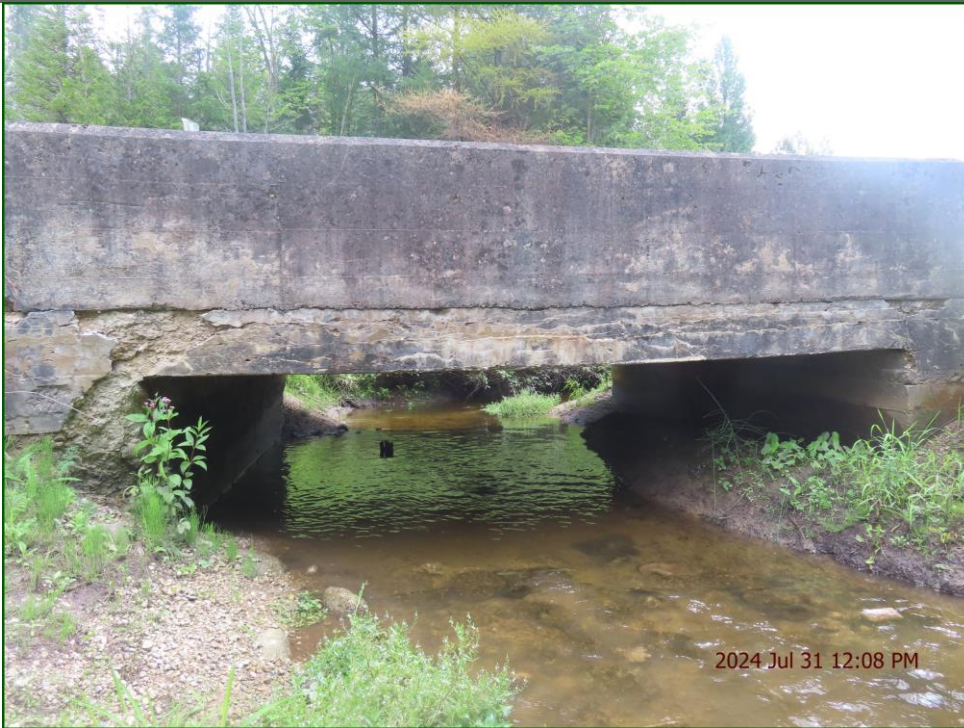
Severe spalling and disintegration. Medium to wide cracking with leachate staining throughout.

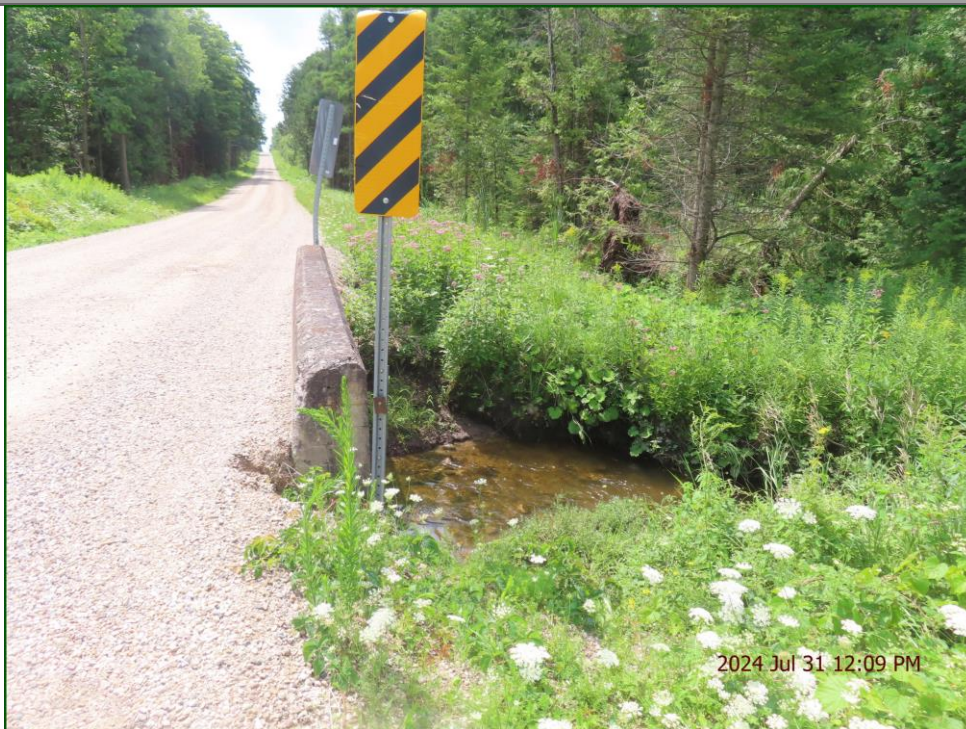
Steep embankments recommend approach protection.Minor erosion on north-east quadrant.

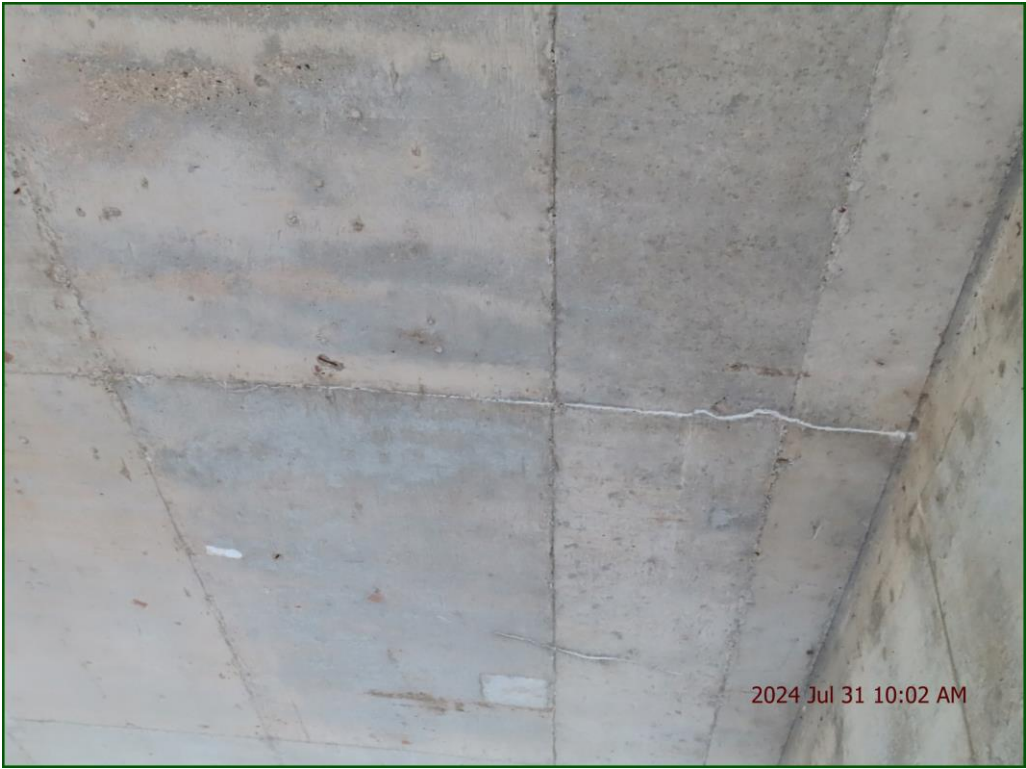
Description: Soffit (int): Light to medium longitudinal cracking with leachate staining.

Light to medium longitudinal cracking with leachate staining.
