Date of Inspection:	30-Jul-24
Name of Inspector:	Andrew Burgess, P.Eng. & Joel Ziegler CET
Equipment Used:	Sounding hammer, measuring equipment, GPS
Weather Conditions:	Cloudy
Temperature:	23
Special Notes:	Bridge is in good condition, showing no signs of structural distress.

Year Built:	1979	Contract Number When Built:	
Latest Biennial Inspection:	September 14, 2022	Latest Specialized Inspection:	
Latest Structure Rating:	75.0	Latest Structure Condition:	
RehabHistory:			
Regional Priority Number:		Programmed Work Year:	
NatureOfProgramWork:

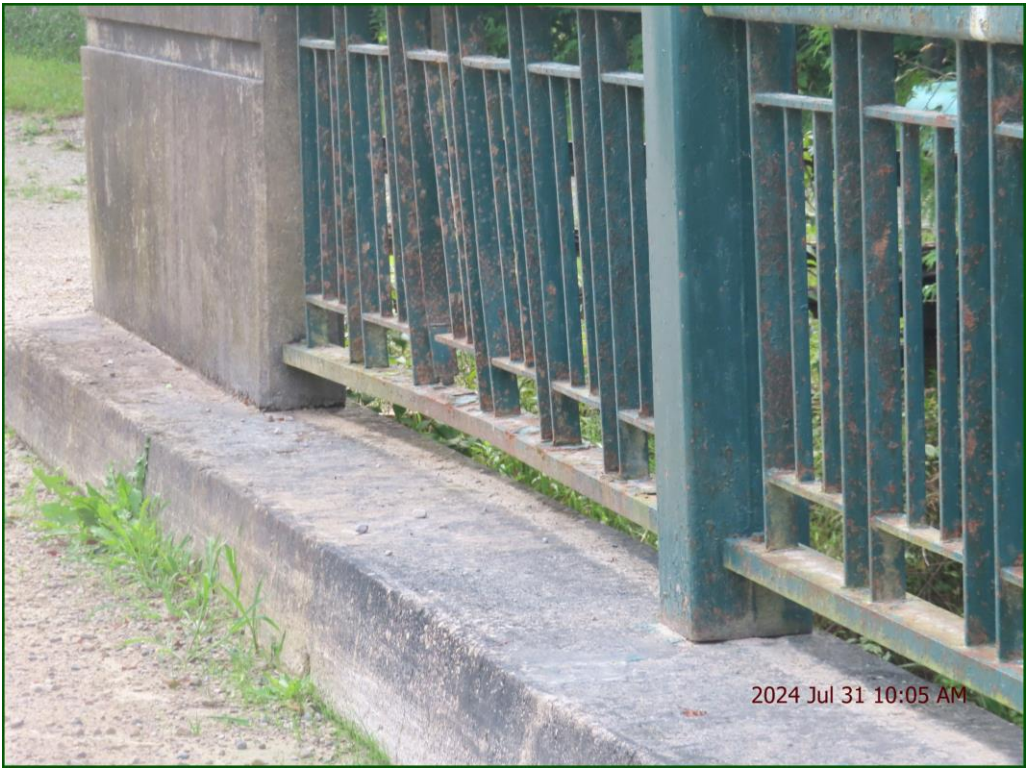
Description: Railing system: Moderate impact damage on south-east corner.

Moderate impact damage on south-east corner.

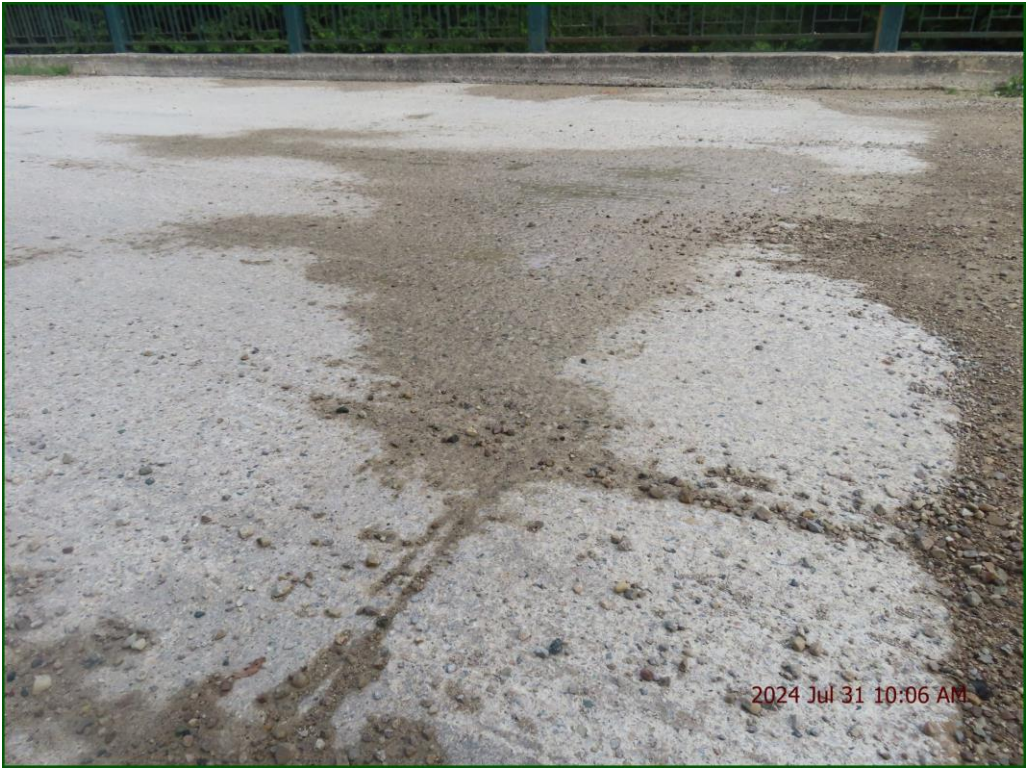
Description: Deck top: Minor abrasions throughout.

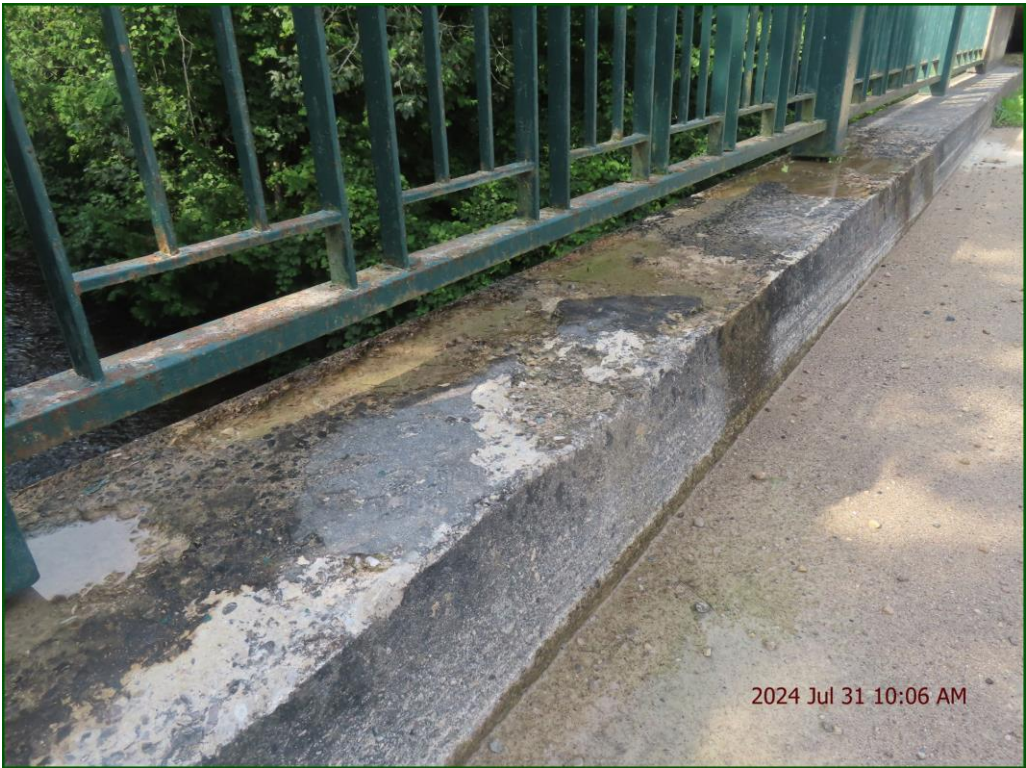
Description: Curbs: Severe delamination throughout.

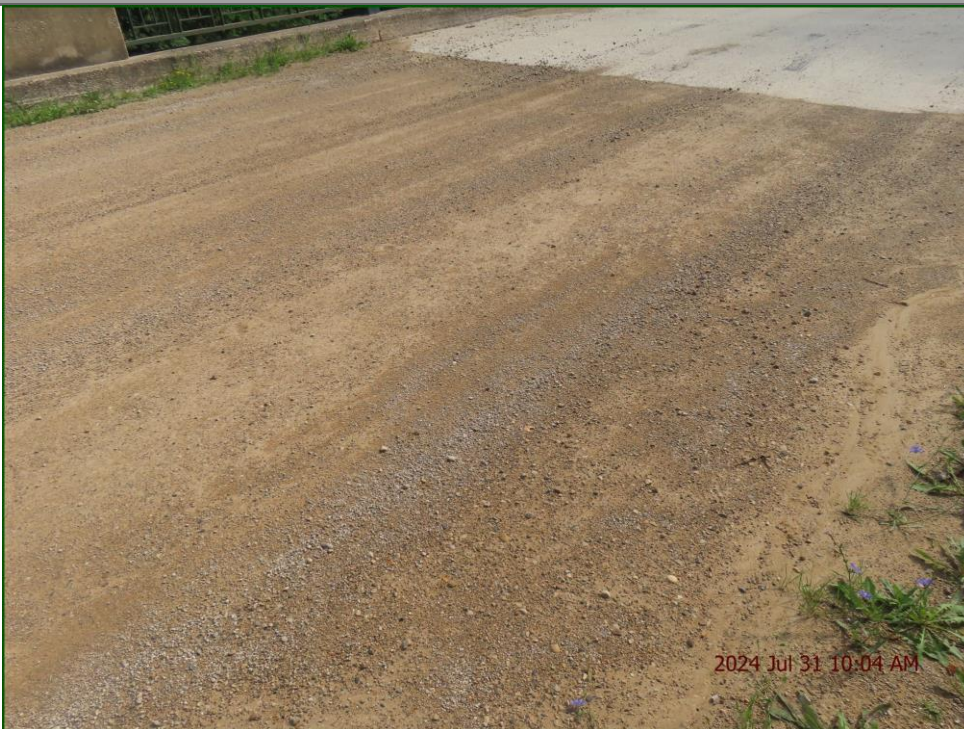
No signs of settlement.

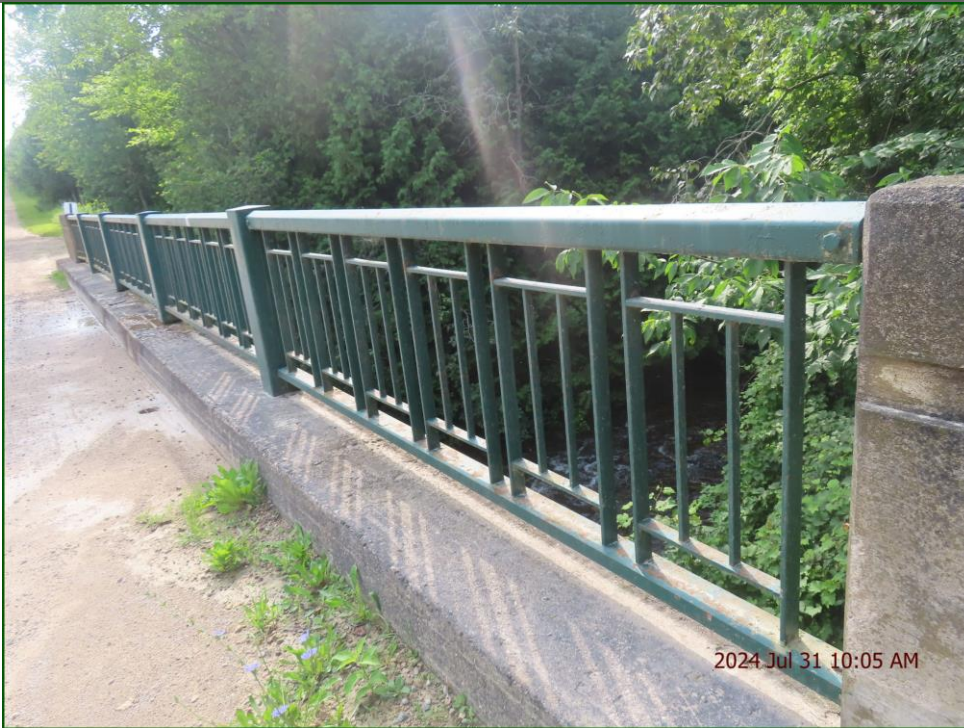
Minor abrasions throughout.

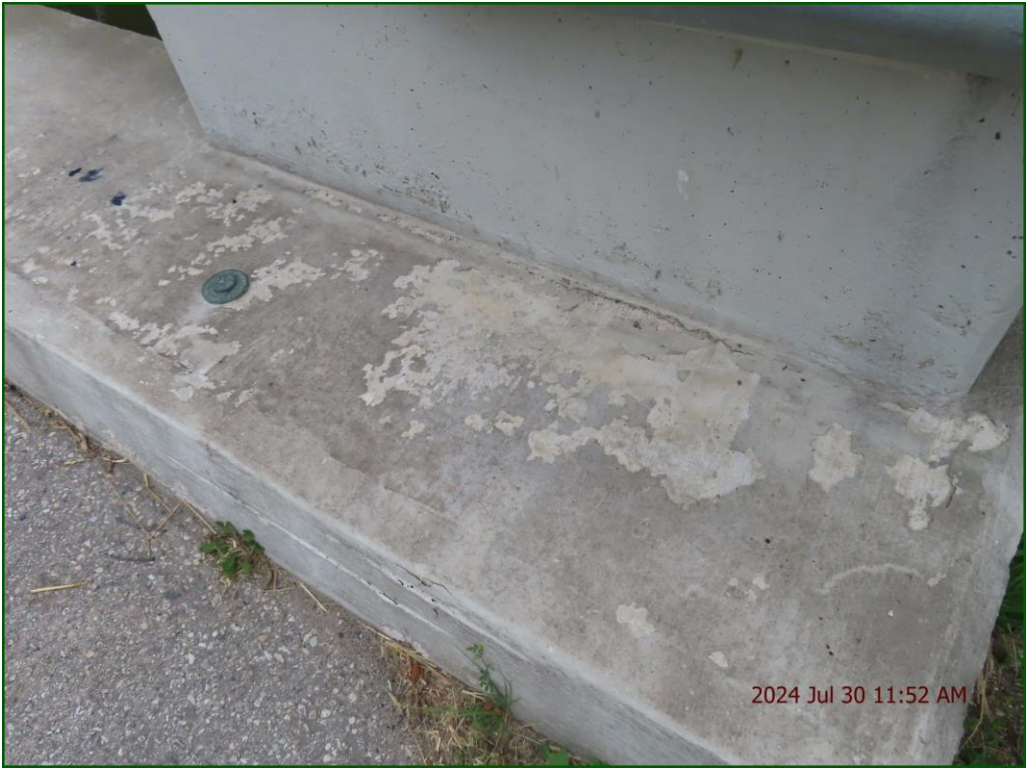
Description: Approach Curbs: Light delamination throughout.

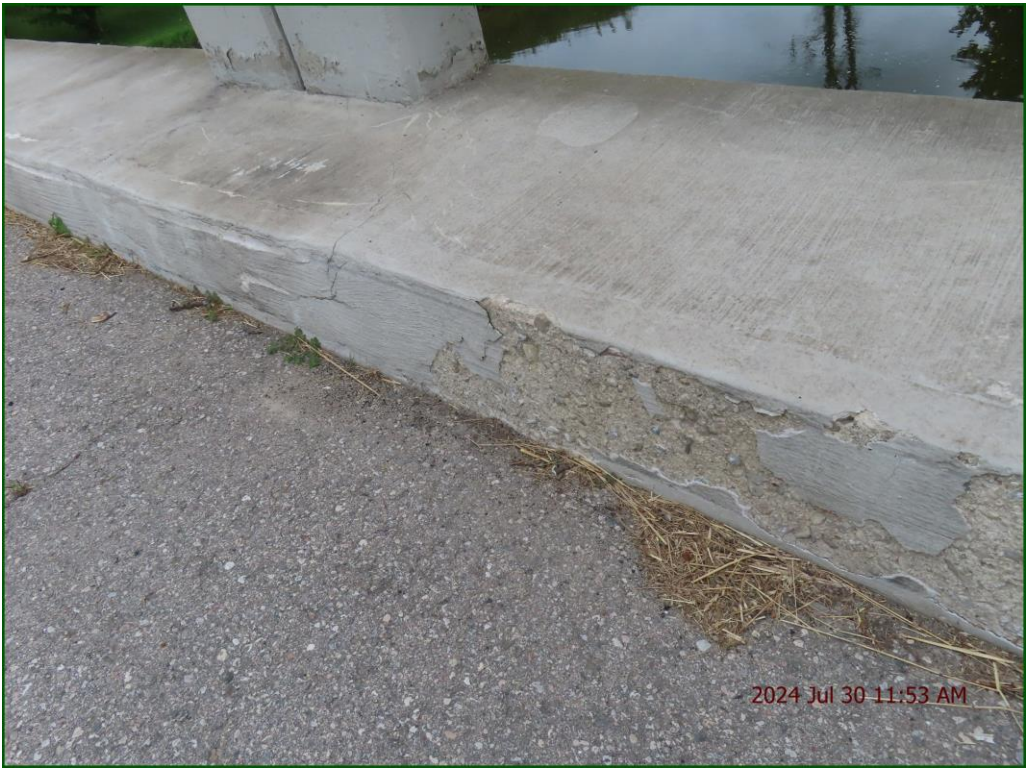
Description: Curbs: Light delamination throughout.

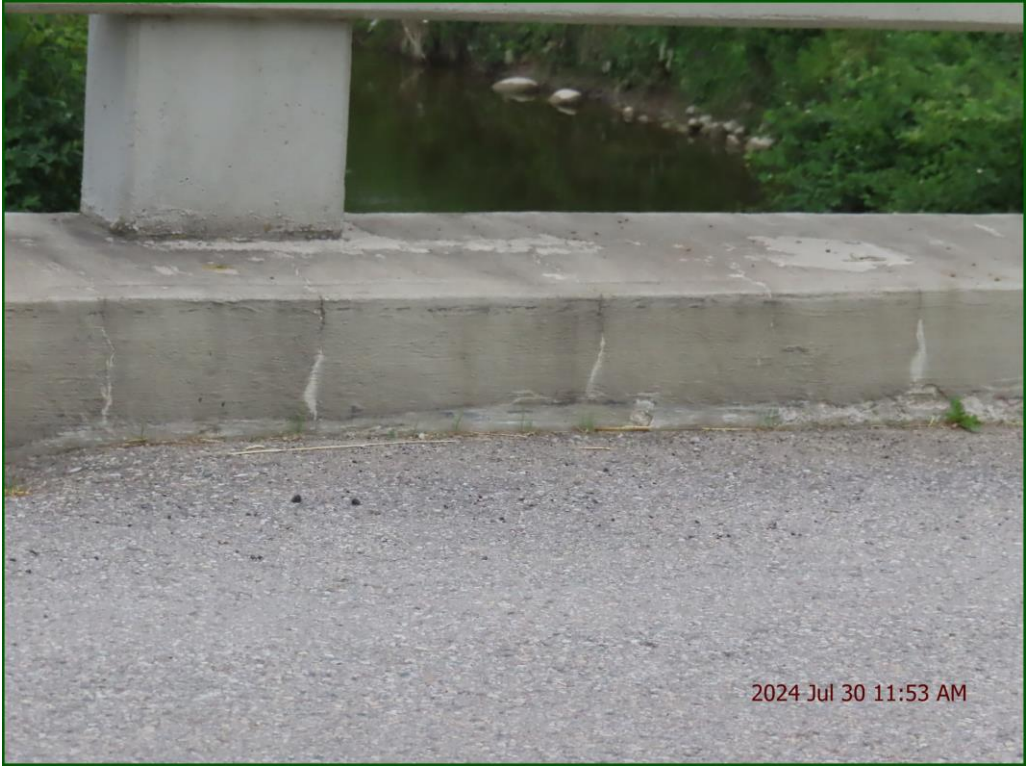
Description: Curbs: Light to medium cracking with leachate staining throughout.

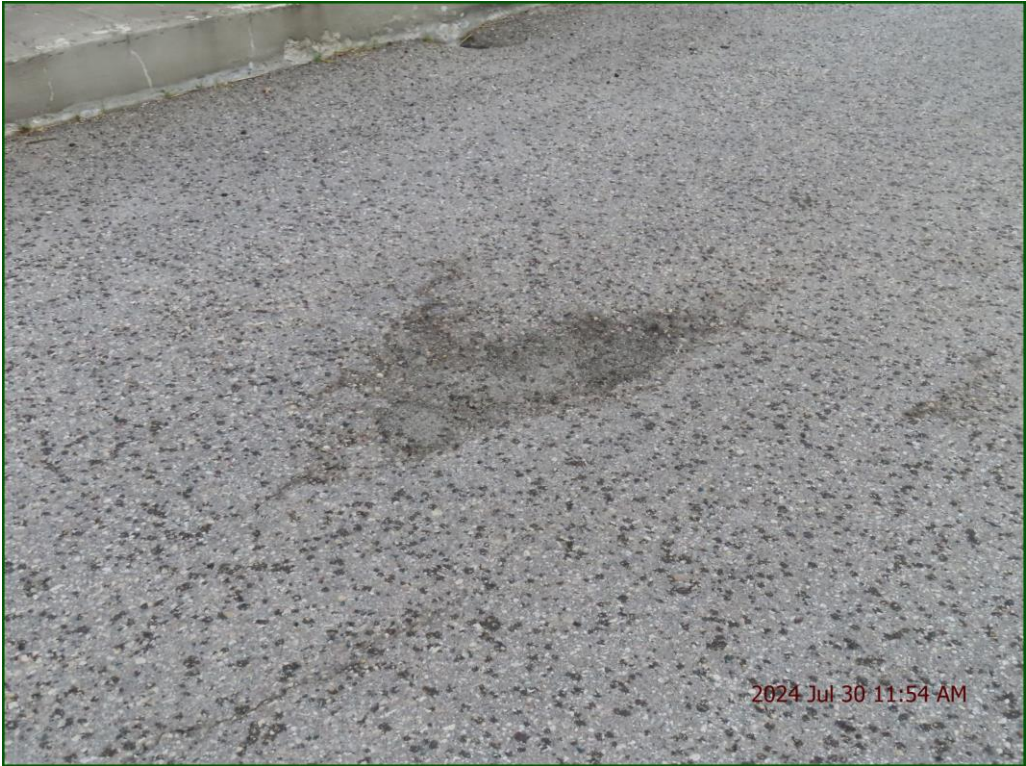
Description: Wearing Surface: Shallow pothole.

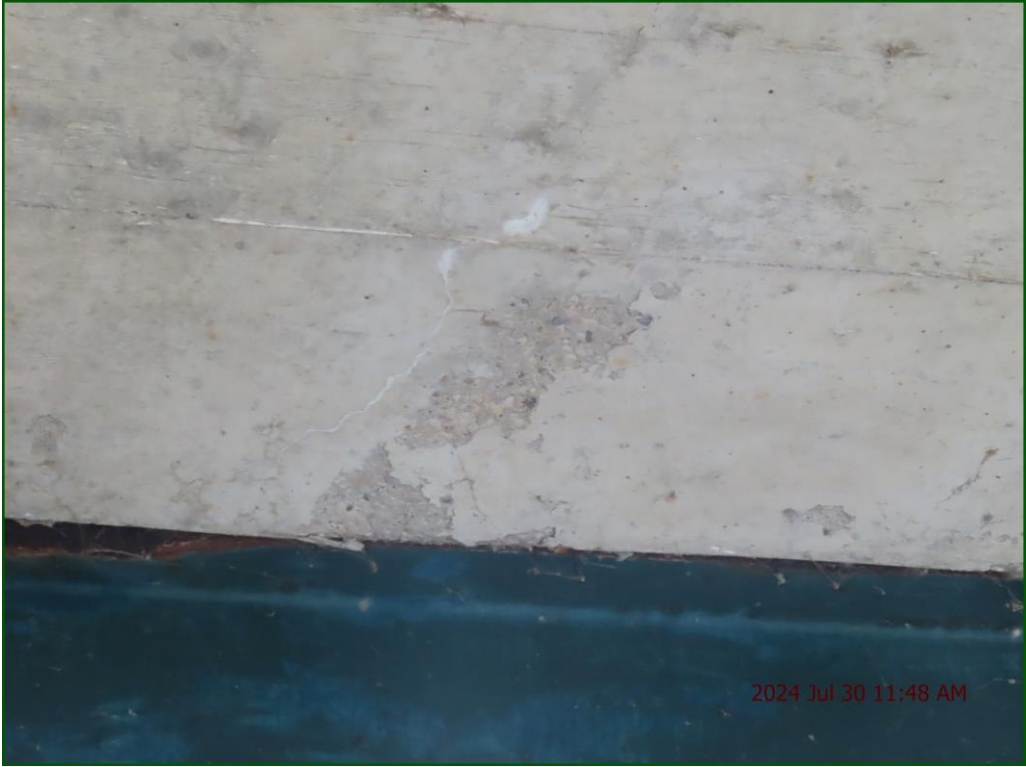
Description: Soffit (int): Shallow delamination throughout.

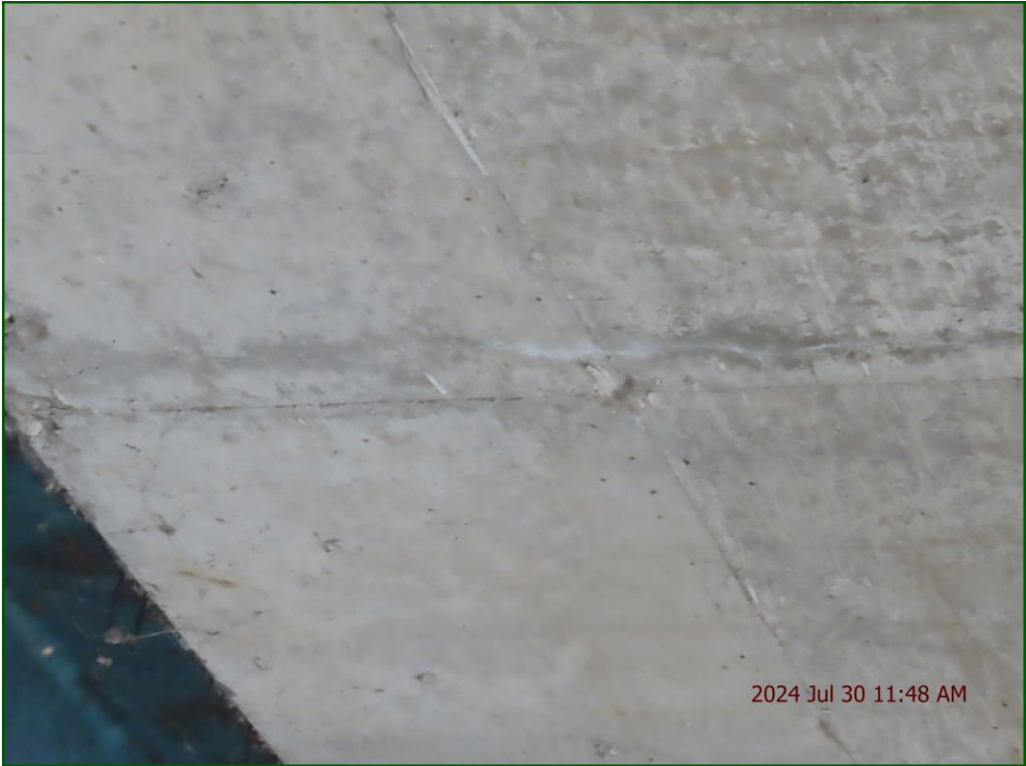
Description: Soffit (int): Light to medium crack with leachate staining.

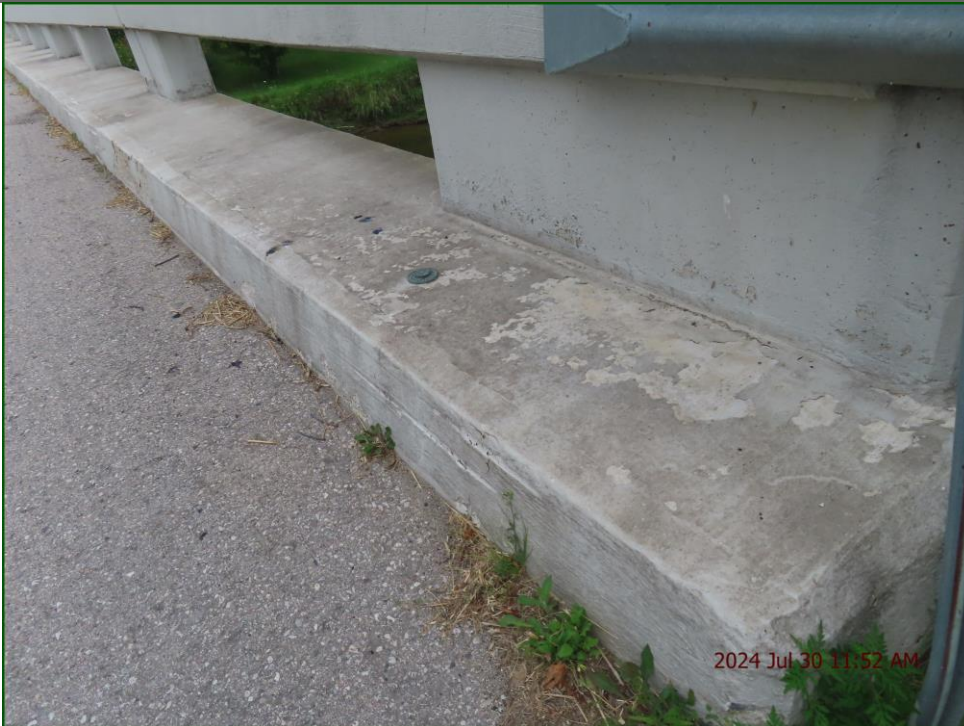
Light delamination throughout.

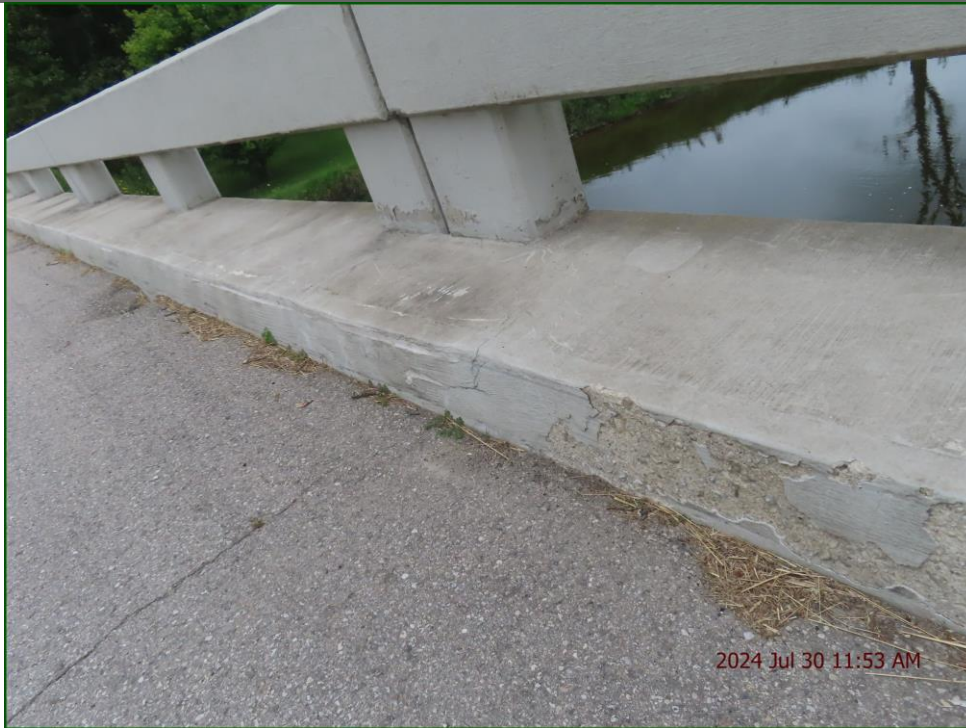
Light delamination throughout. Light to medium cracking with leachate staining throughout.

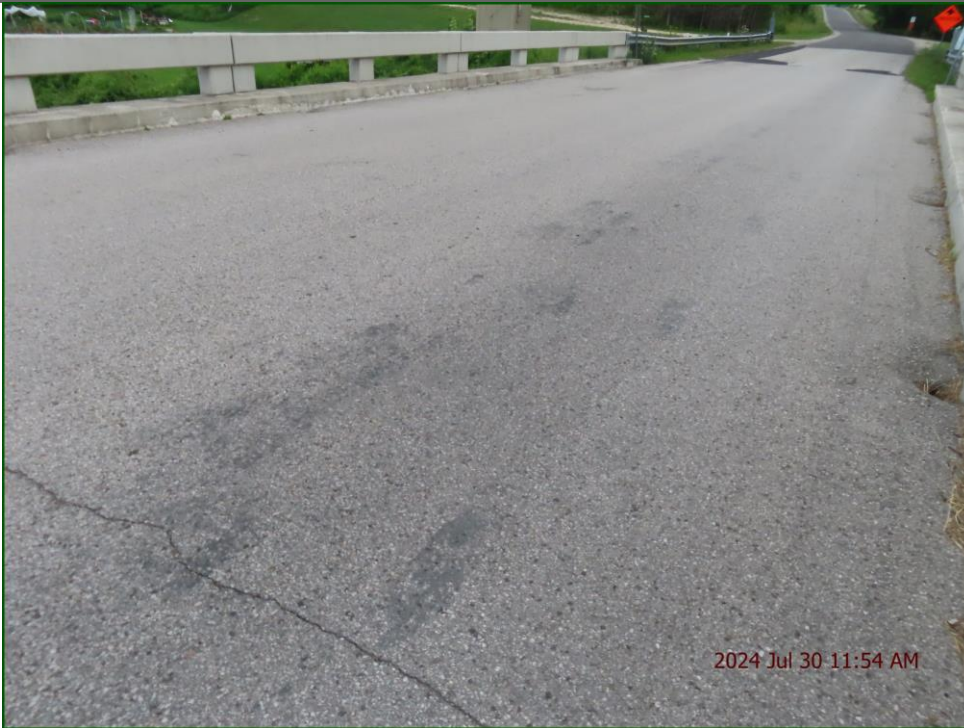
Element Group:	<input type="text" value="Decks"/>	Site Number:	<input type="text" value="N-050"/>
Element Name:	<input type="text" value="Wearing surface"/>	Width:	<input type="text" value="8.8"/> m
Element type:	<input type="text"/>	Height:	<input type="text" value="0"/> m
Sub-element:	<input type="text"/>	Length:	<input type="text" value="19.4"/> m
Material:	<input type="text" value="Asphalt"/>	Count:	<input type="text" value="0"/>
Location:	<input type="text"/>	Total Quantity:	<input type="text" value="171"/> sqm
Environment:	<input type="text" value="Severe"/>	Not inspected:	<input type="checkbox"/>
Perform. deficiencies:	<input type="text"/>	Maintenance Type:	<input type="text"/>
Maint needs:	<input type="text"/>	Maint. Time Period:	<input type="text"/>

Shallow pothole.

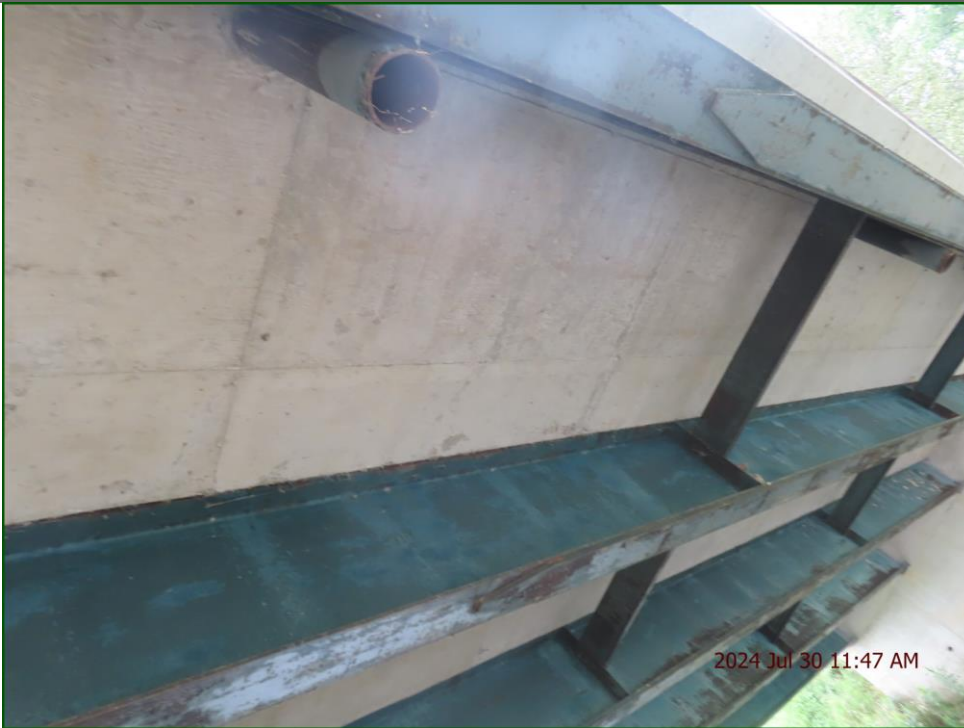
Element Group:	<input type="text" value="Decks"/>	Site Number:	<input type="text" value="N-050"/>
Element Name:	<input type="text" value="Soffit - thick slab"/>	Width:	<input type="text" value="9.4"/> m
Element type:	<input type="text"/>	Height:	<input type="text" value="0"/> m
Sub-element:	<input type="text" value="Interior"/>	Length:	<input type="text" value="19.4"/> m
Material:	<input type="text" value="Cast-in-place Concrete"/>	Count:	<input type="text" value="0"/>
Location:	<input type="text"/>	Total Quantity:	<input type="text" value="182"/> sqm
Environment:	<input type="text" value="Benign"/>	Not inspected:	<input type="checkbox"/>
Perform. deficiencies:	<input type="text"/>	Maintenance Type:	<input type="text"/>
Maint needs:	<input type="text"/>	Maint. Time Period:	<input type="text"/>

Shallow delamination throughout. Light to medium crack with leachate staining.

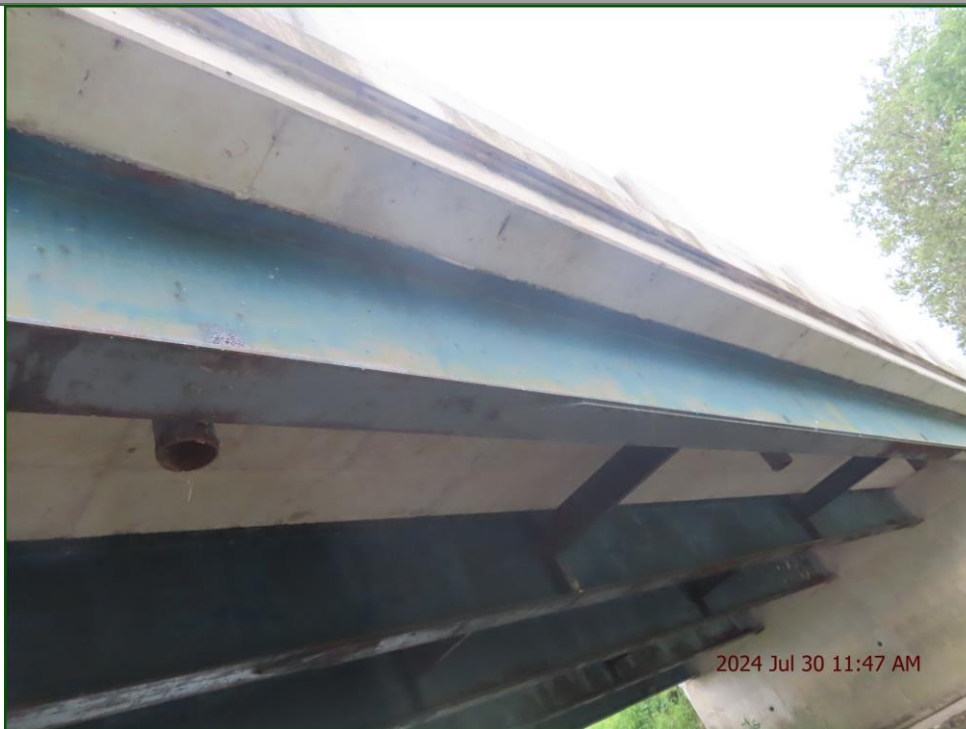
Element Group:	Beams/Main Longitudinal Elements	Site Number:	N-050
Element Name:	Girders (steel)	Width:	0.3 m
Element type:		Height:	0.85 m
Sub-element:		Length:	19.4 m
Material:	Steel	Count:	5
Location:		Total Quantity:	254 sqm
Environment:	Benian	Not inspected:	<input type="checkbox"/>
Perform. deficiencies:		Maintenance Type:	
Maint needs:		Maint. Time Period:

Areas of coating breakdown, not critical.

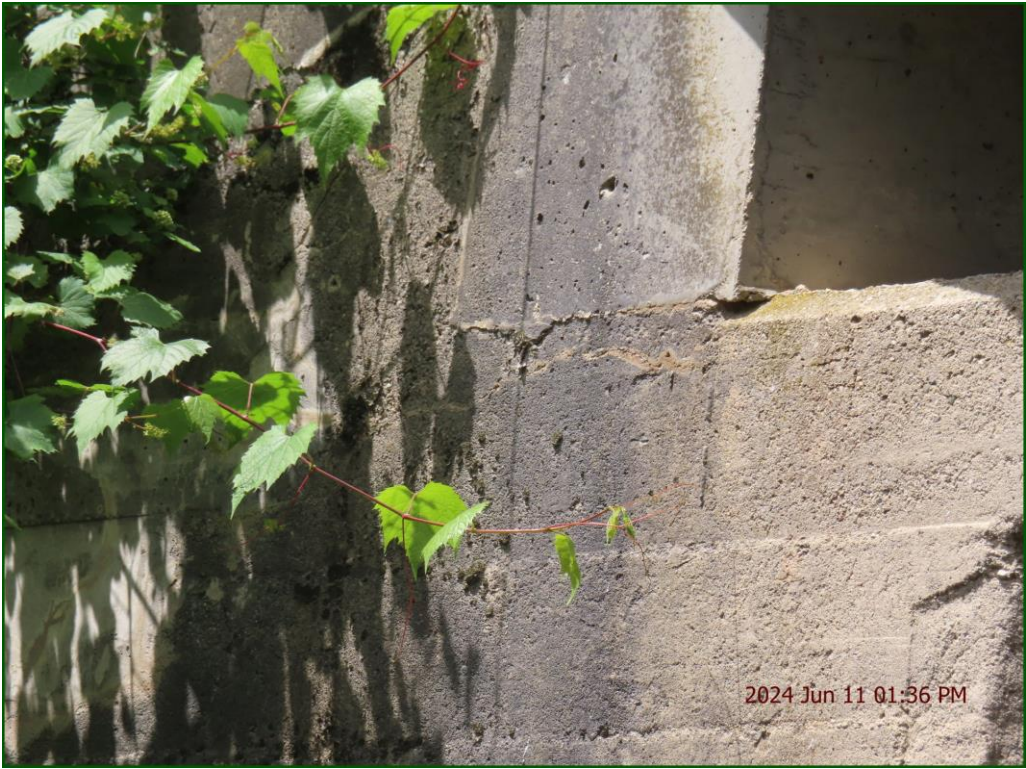
Description: Wingwalls: Light to medium horizontal cracking with leachate staining.

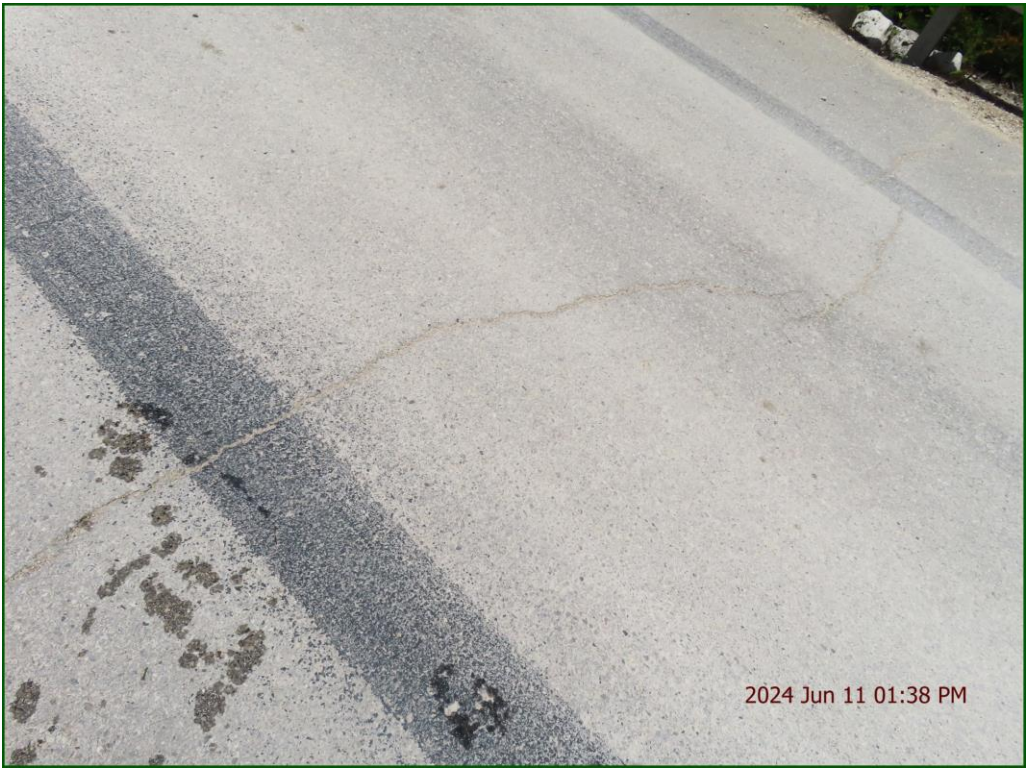
Description: Approach Wearing surface: Light transverse cracking on east approach.

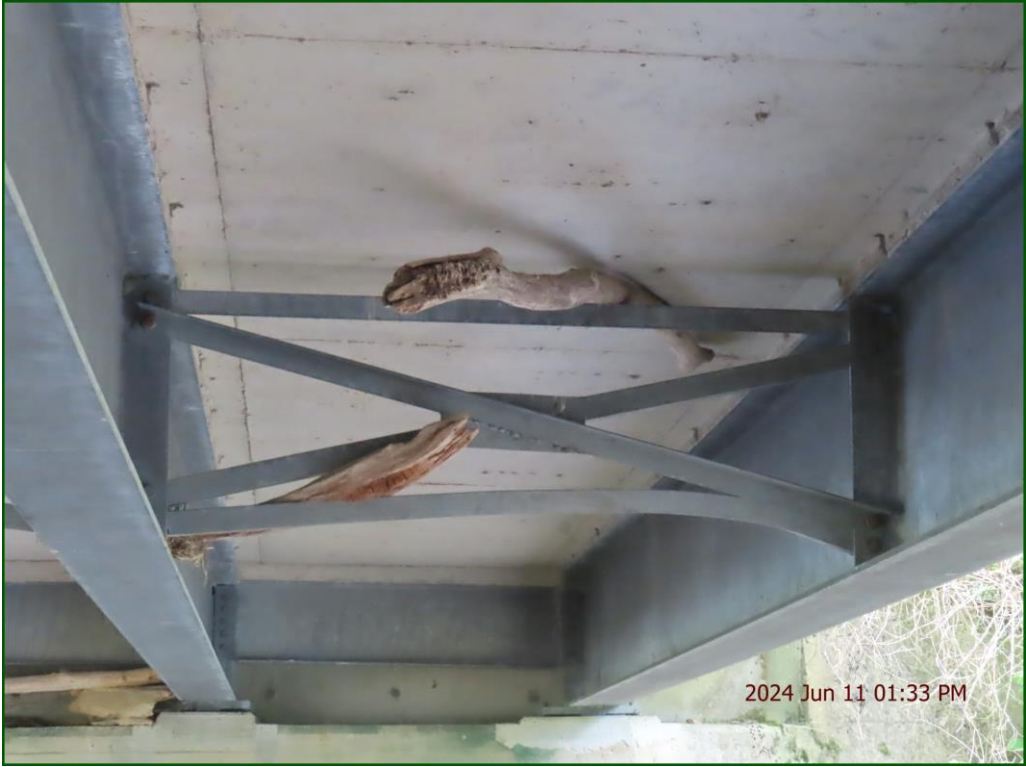
Description: Diaphragms: Impact damage.

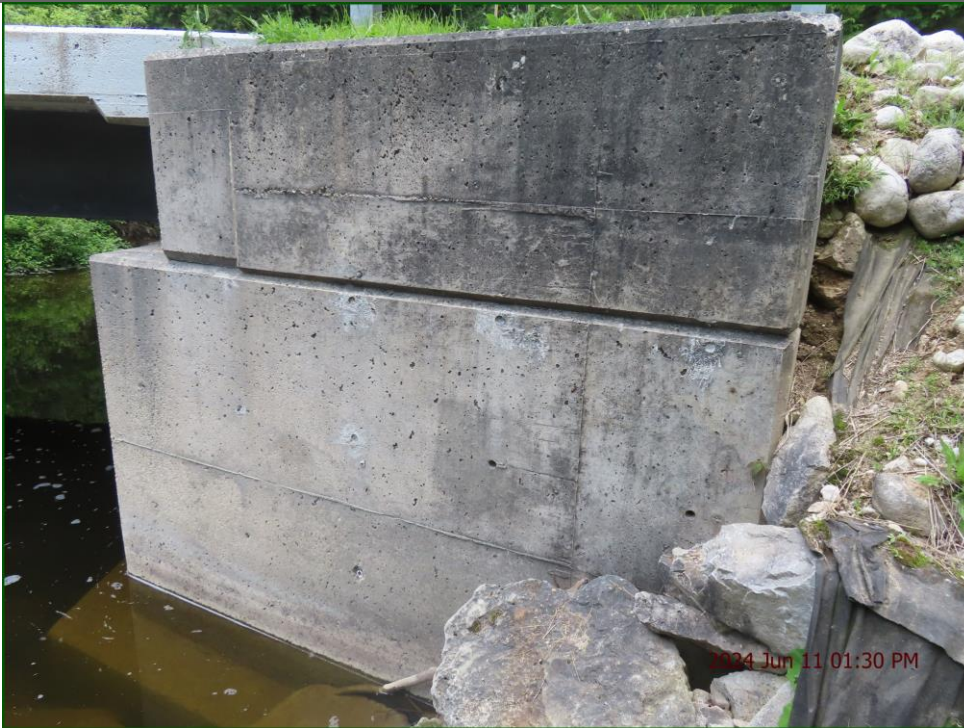
Element Group:	<input type="text" value="Abutments"/>	Site Number:	<input type="text" value="G-045"/>
Element Name:	<input type="text" value="Wingwalls"/>	Width:	<input type="text"/> m
Element type:	<input type="text"/>	Height:	<input type="text" value="2.76"/> m
Sub-element:	<input type="text"/>	Length:	<input type="text" value="2.43"/> m
Material:	<input type="text" value="Cast-in-place Concrete"/>	Count:	<input type="text" value="4"/>
Location:	<input type="text"/>	Total Quantity:	<input type="text" value="13"/> sqm
Environment:	<input type="text" value="Moderate"/>	Not inspected:	<input type="checkbox"/>
Perform. deficiencies:	<input type="text"/>	Maintenance Type:	<input type="text"/>
Maint needs:	<input type="text"/>	Maint. Time Period:	<input type="text"/>

Light to medium horizontal cracking with leachate staining.

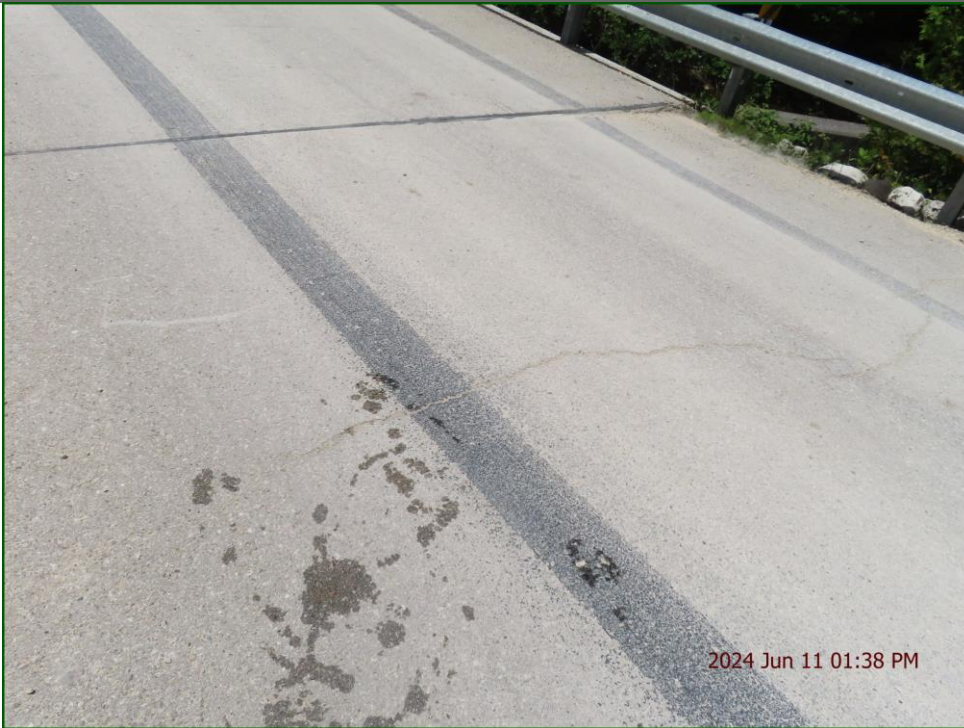
Element Group:	<input type="text" value="Approaches"/>	Site Number:	<input type="text" value="G-045"/>
Element Name:	<input type="text" value="Wearing surface"/>	Width:	<input type="text" value="6.7"/> m
Element type:	<input type="text"/>	Height:	<input type="text"/> m
Sub-element:	<input type="text"/>	Length:	<input type="text" value="6.1"/> m
Material:	<input type="text" value="Asphalt"/>	Count:	<input type="text" value="2"/>
Location:	<input type="text"/>	Total Quantity:	<input type="text" value="82"/> sqm
Environment:	<input type="text" value="Severe"/>	Not inspected:	<input type="checkbox"/>
Perform. deficiencies:	<input type="text"/>	Maintenance Type:	<input type="text"/>
Maint needs:	<input type="text"/>	Maint. Time Period:	<input type="text"/>

Light tranverse cracking on east approach.

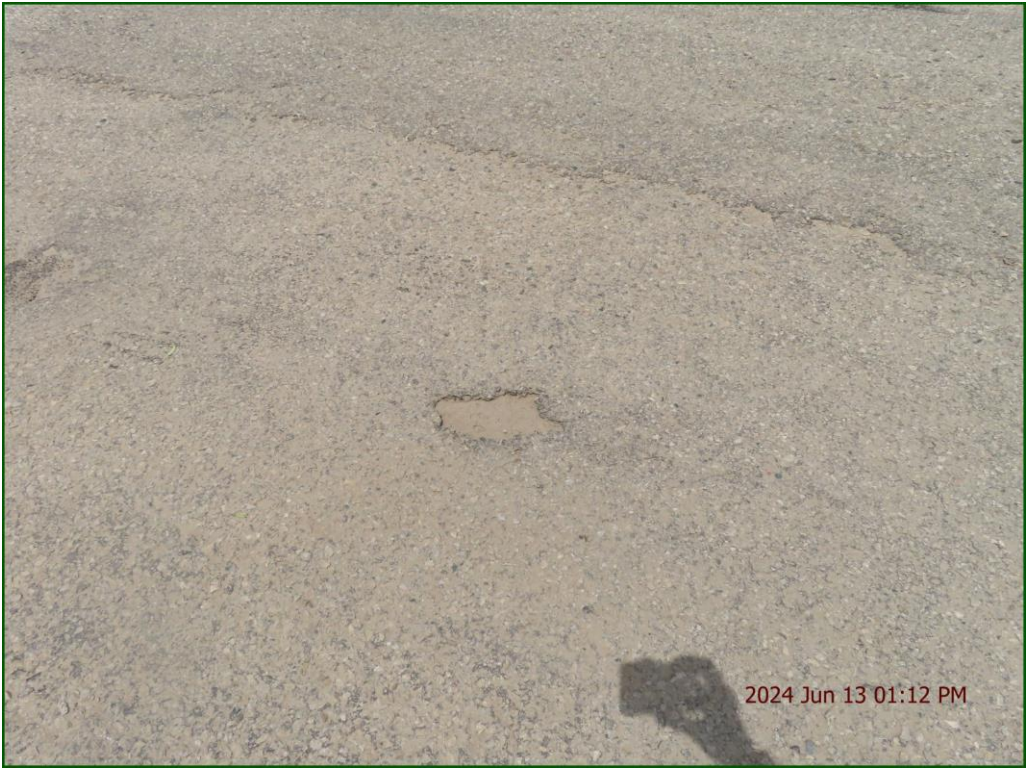
Description: Approach Wearing Surface: Shallow potholes throughout.

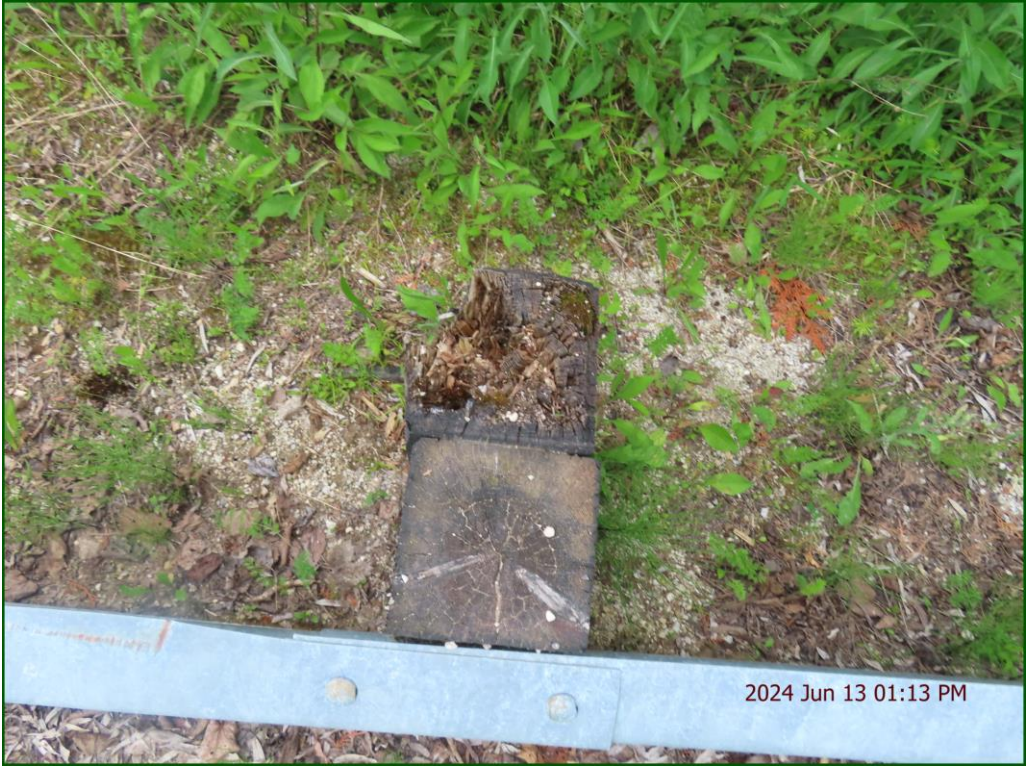
Description: Railing Systems: Severe rot throughout.

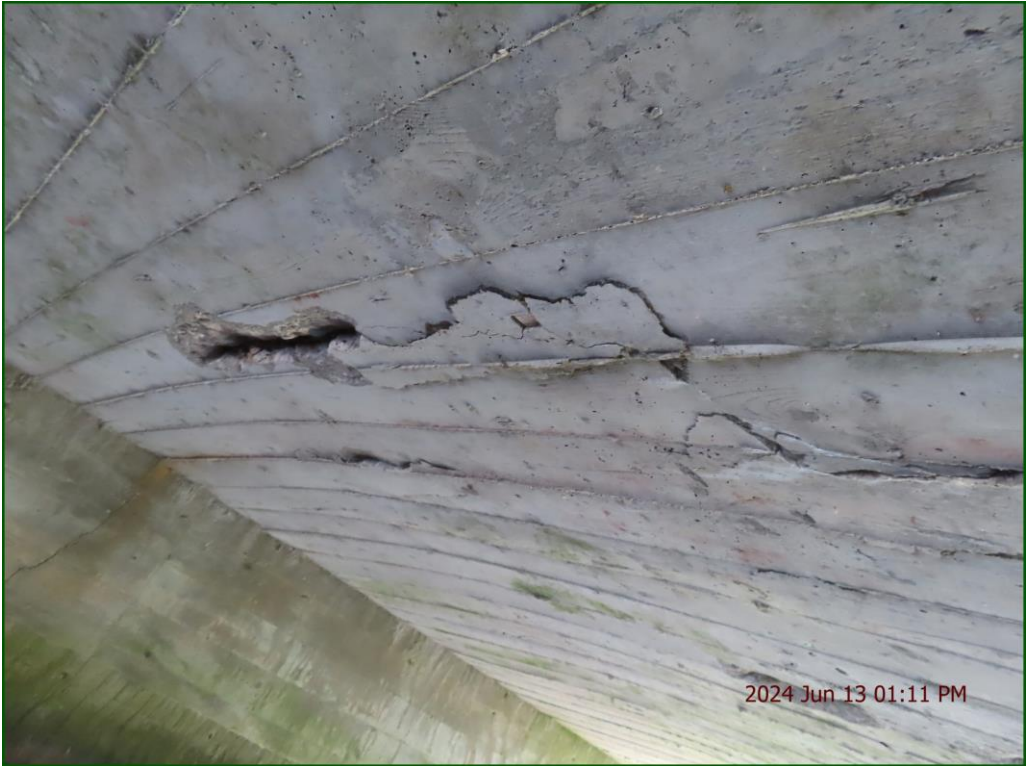
Description: Soffit (int): Shallow delaminations throughout.

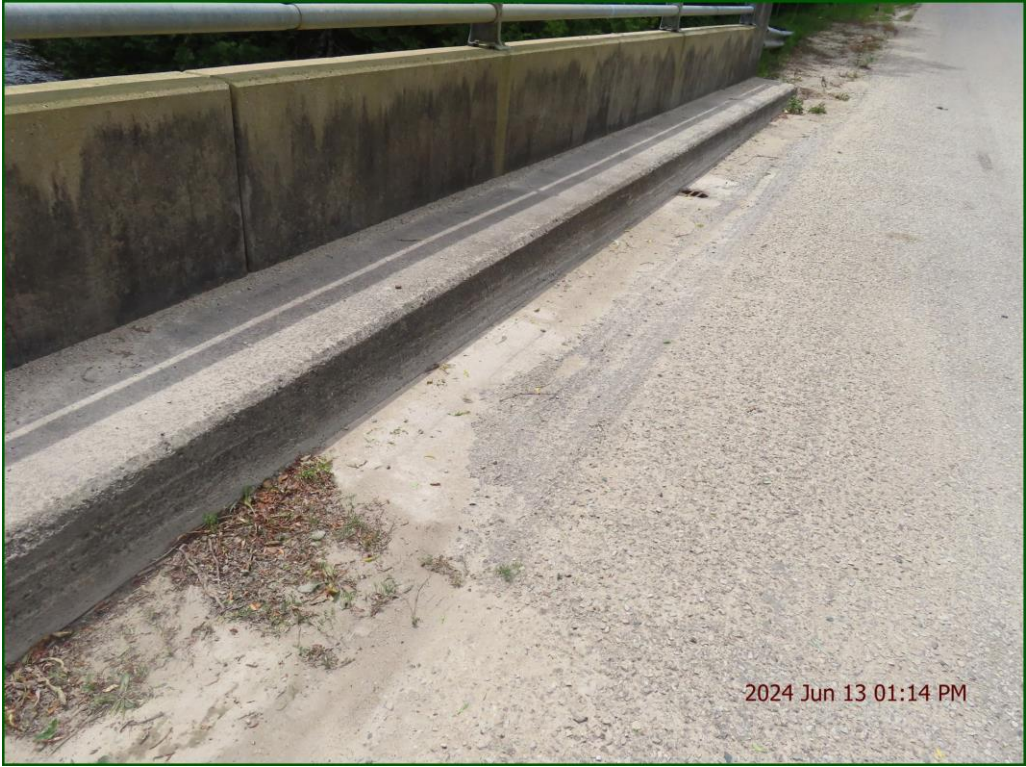
Description: Wearing Surface: Wearing surface does not extend to curblin.

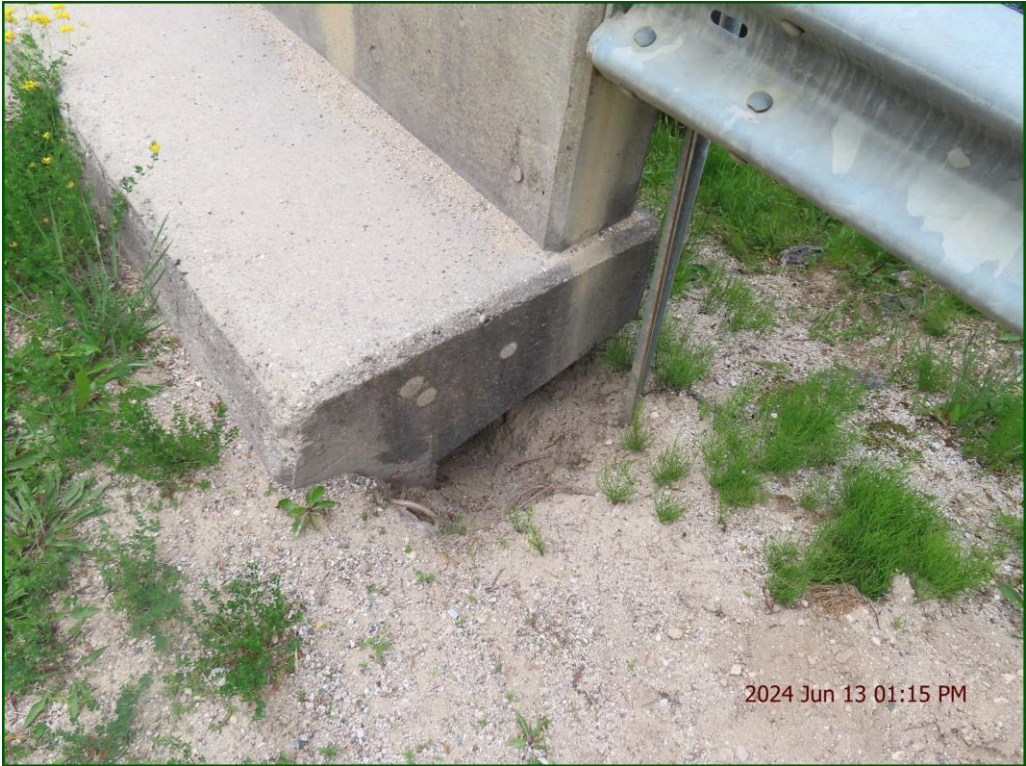
Description: Embankments: Minor erosion at NE quadrant.

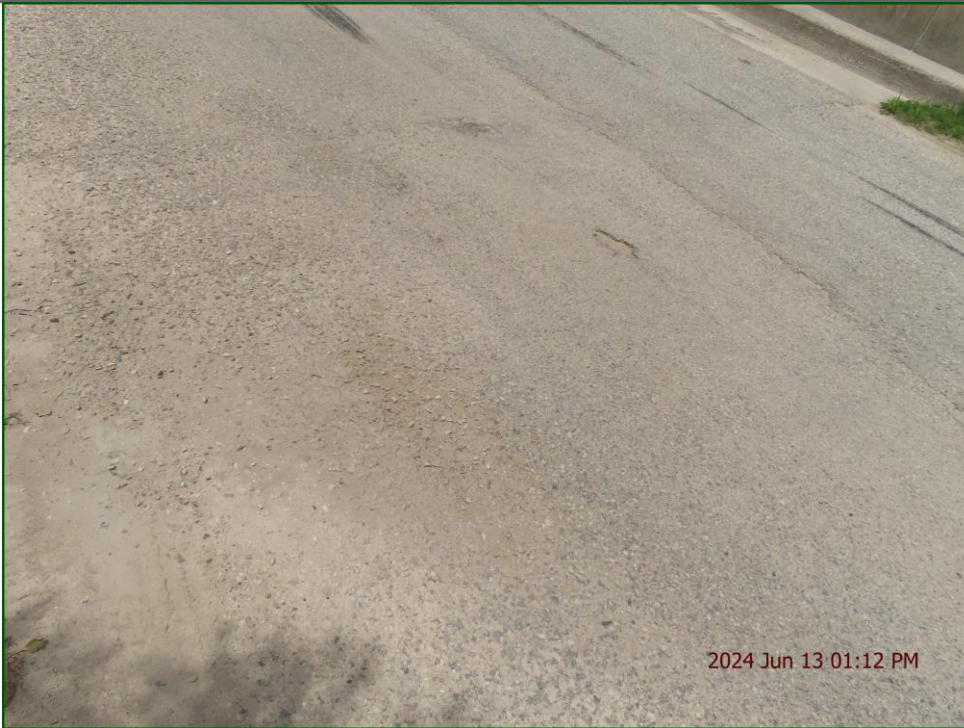
Shallow potholes throughout.

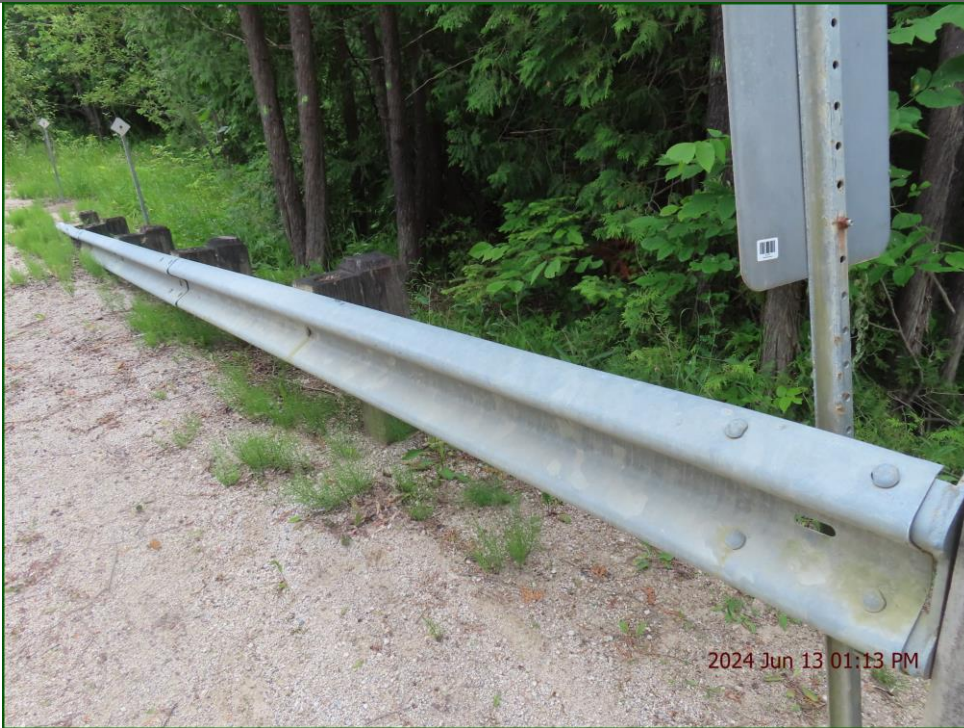
Recommend to mount flexi beam to face of parapet wall. Severe rot throughout.
