Date of Inspection:	30-Jul-24
Name of Inspector:	Andrew Burgess, P.Eng. & Joel Ziegler CET
Equipment Used:	Sounding hammer, measuring equipment, GPS
Weather Conditions:	Cloudy
Temperature:	23
Special Notes:	Bridge is in good condition, showing no signs of structural distress.

Year Built:	1979	Contract Number When Built:	
Latest Biennial Inspection:	September 14, 2022	Latest Specialized Inspection:	
Latest Structure Rating:	75.0	Latest Structure Condition:	
RehabHistory:			
Regional Priority Number:		Programmed Work Year:	
NatureOfProgramWork:

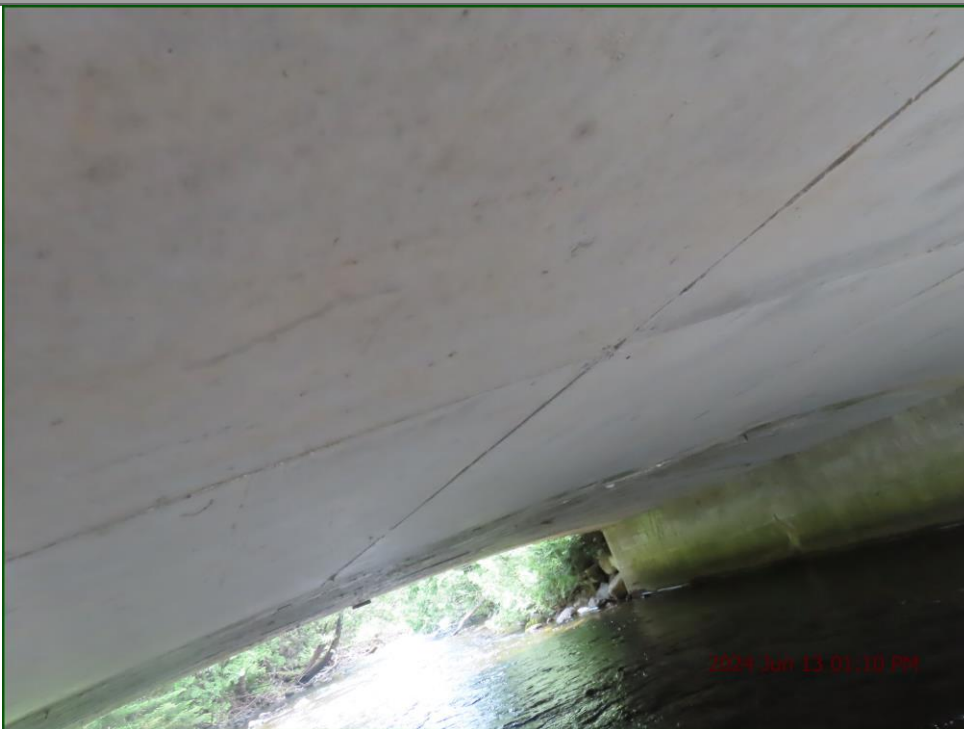
Shallow delaminations throughout.

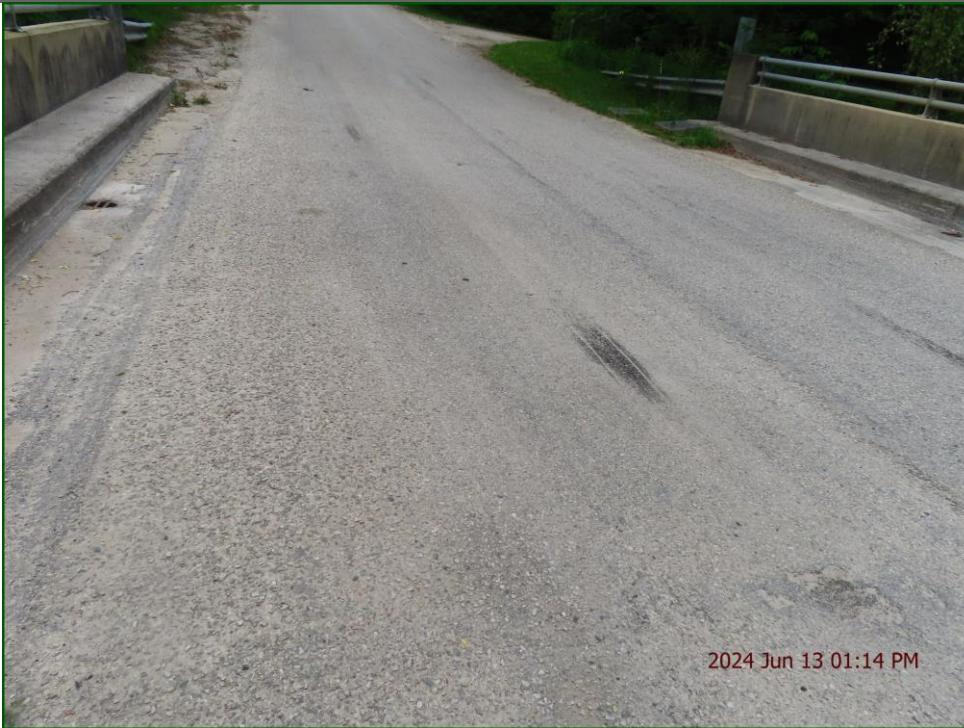
Ponding on deck in previous inspection. Wearing surface does not extend to curbline.

Element Group:	<input type="text" value="Decks"/>	Site Number:	<input type="text" value="B-012"/>
Element Name:	<input type="text" value="Wearing Surface"/>	Width:	<input type="text" value="8.47"/> m
Element type:	<input type="text"/>	Height:	<input type="text" value="0"/> m
Sub-element:	<input type="text"/>	Length:	<input type="text" value="8.8"/> m
Material:	<input type="text" value="Asphalt"/>	Count:	<input type="text" value="1"/>
Location:	<input type="text"/>	Total Quantity:	<input type="text" value="75"/> sqm
Environment:	<input type="text" value="Severe"/>	Not inspected:	<input type="checkbox"/>
Perform. deficiencies:	<input type="text"/>	Maintenance Type:	<input type="text" value="Structural"/>
Maint needs:	<input type="text" value="Asphalt Repairs"/>	Maint. Time Period:	<input type="text" value="2 Year"/>

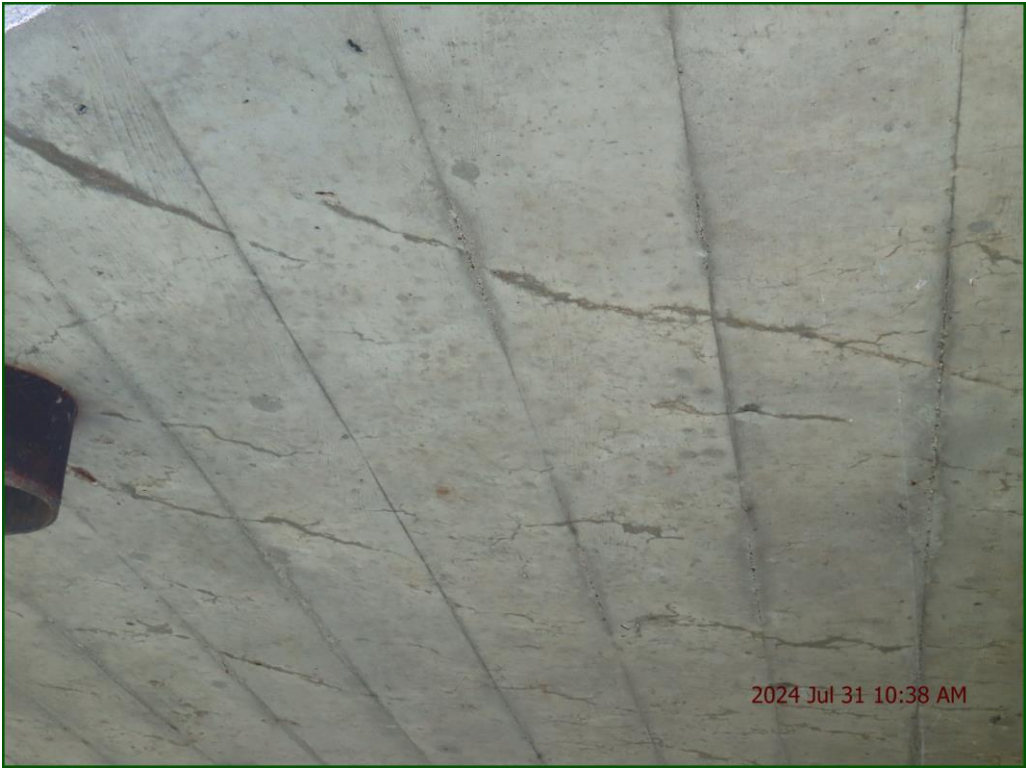
Description: Soffit (int): Various hairline cracks with wetness staining.

Various hairline cracks with wetness staining.

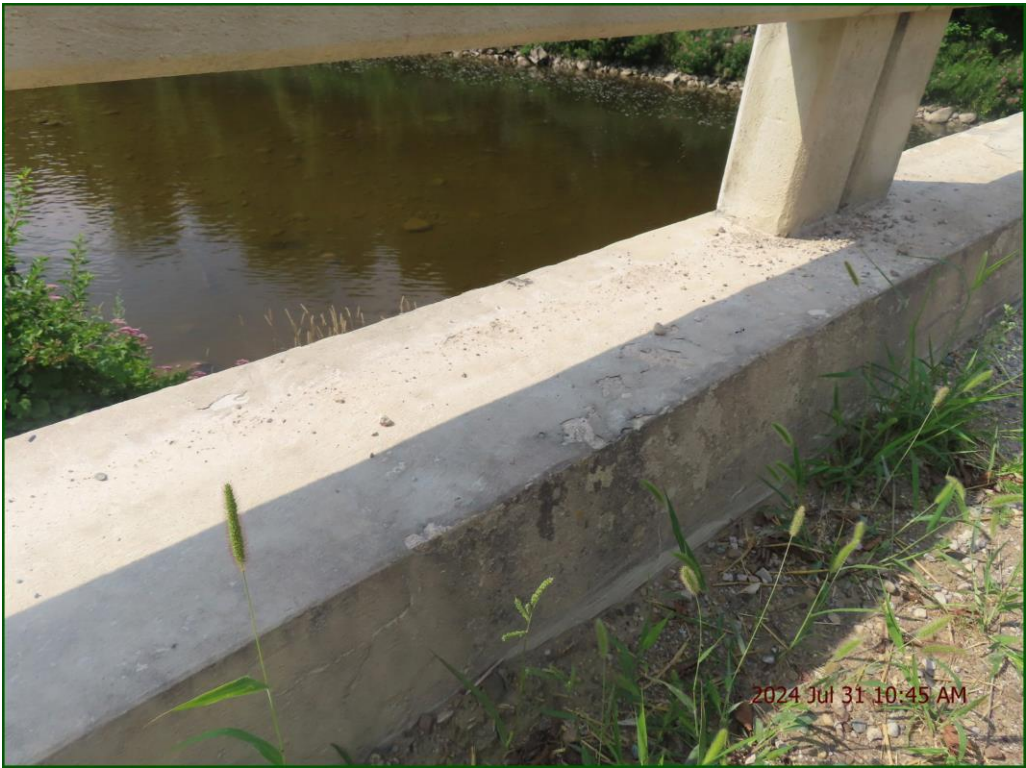
Description: Approach curbs: Shallow delamination throughout.

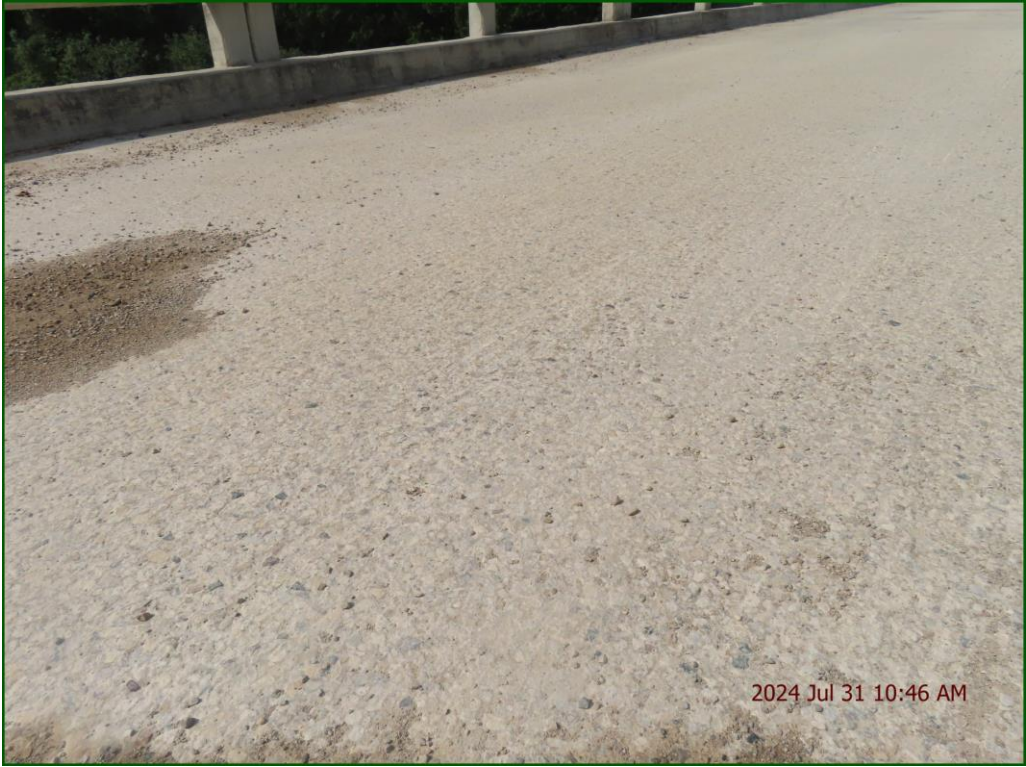
Description: Deck top: Minor abrasions throughout.

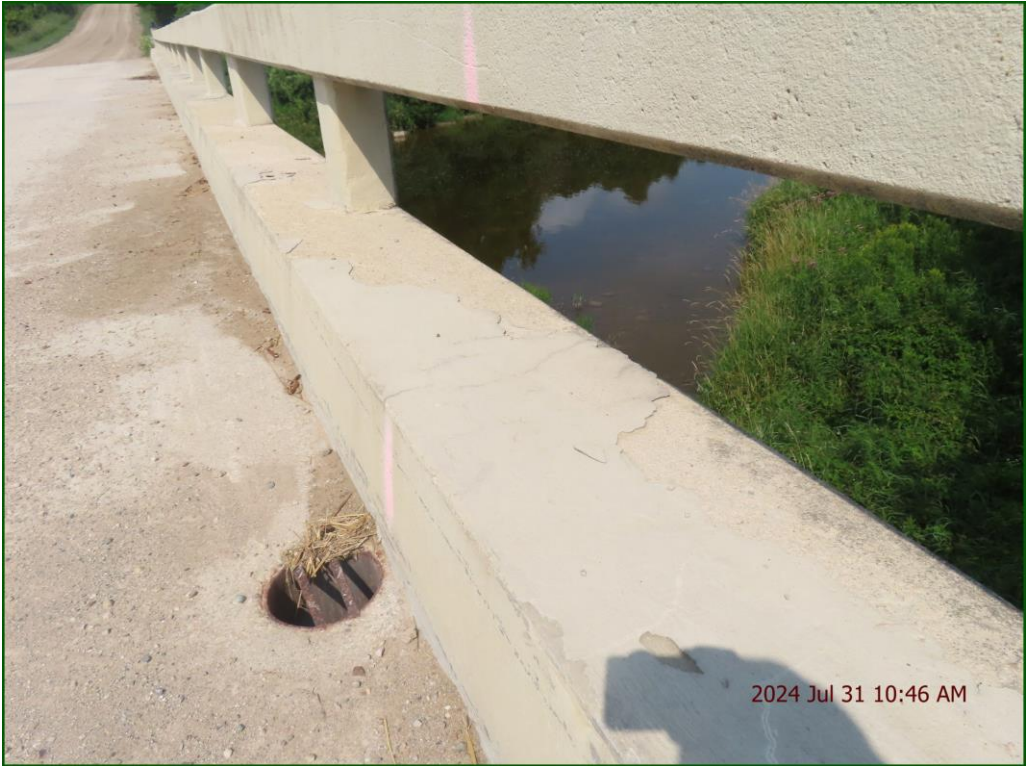
Description: Curbs: Shallow delaminations throughout.

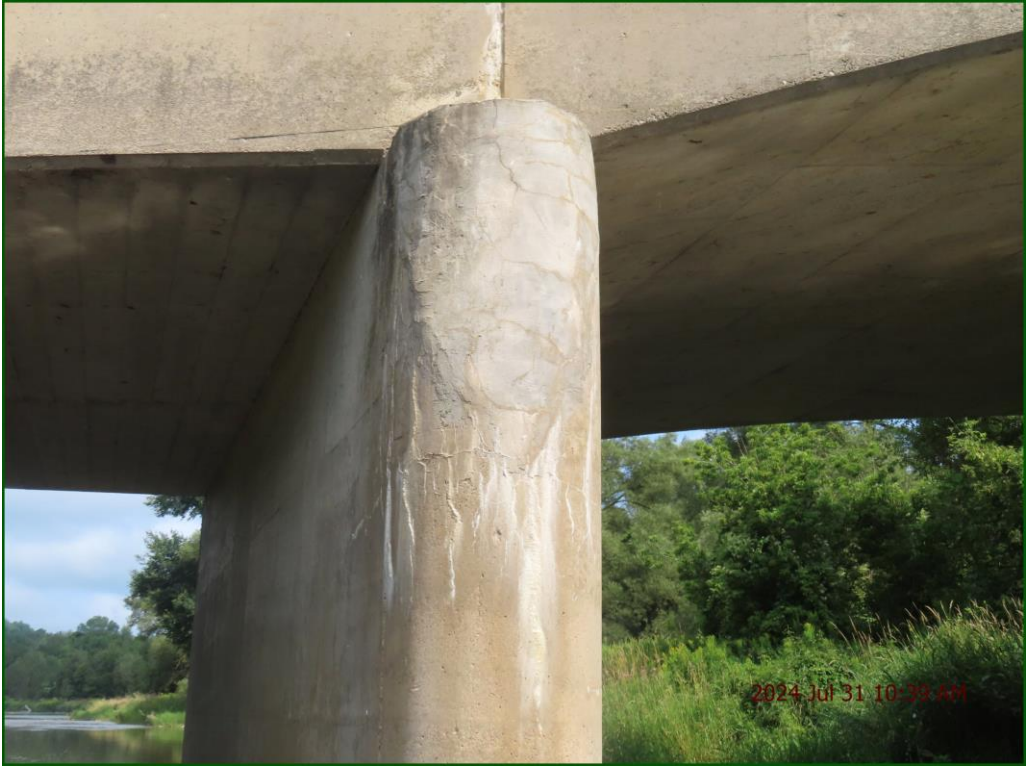
Description: Shafts/Columns/Pile Bents: Medium to wide cracking with leachate staining.

Medium to wide cracking with leachate staining coming from rehabed location.

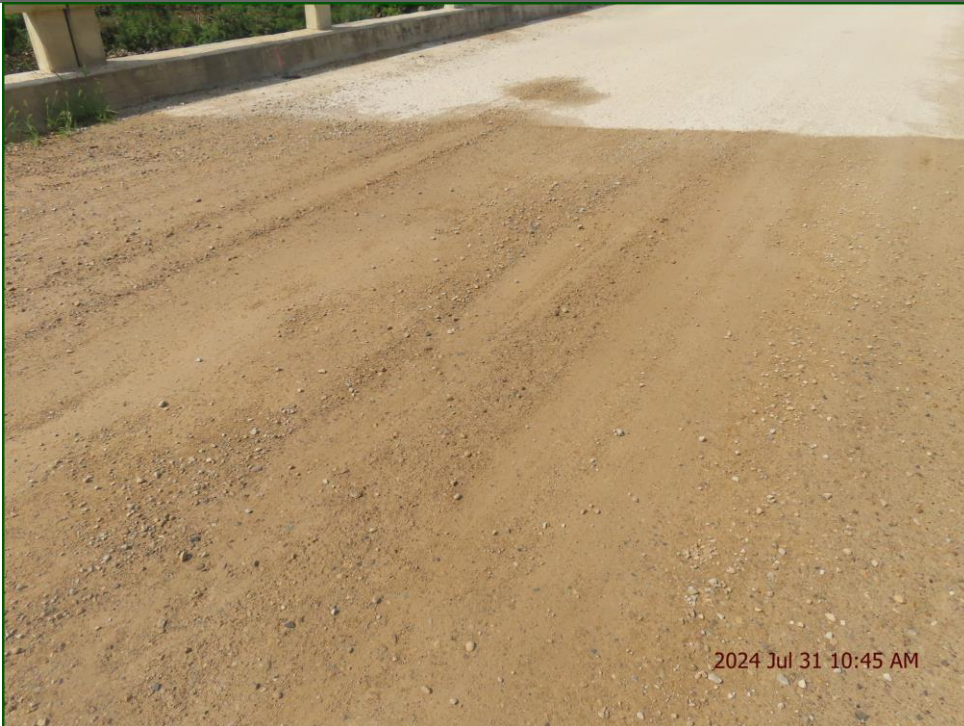
No signs of settlement.

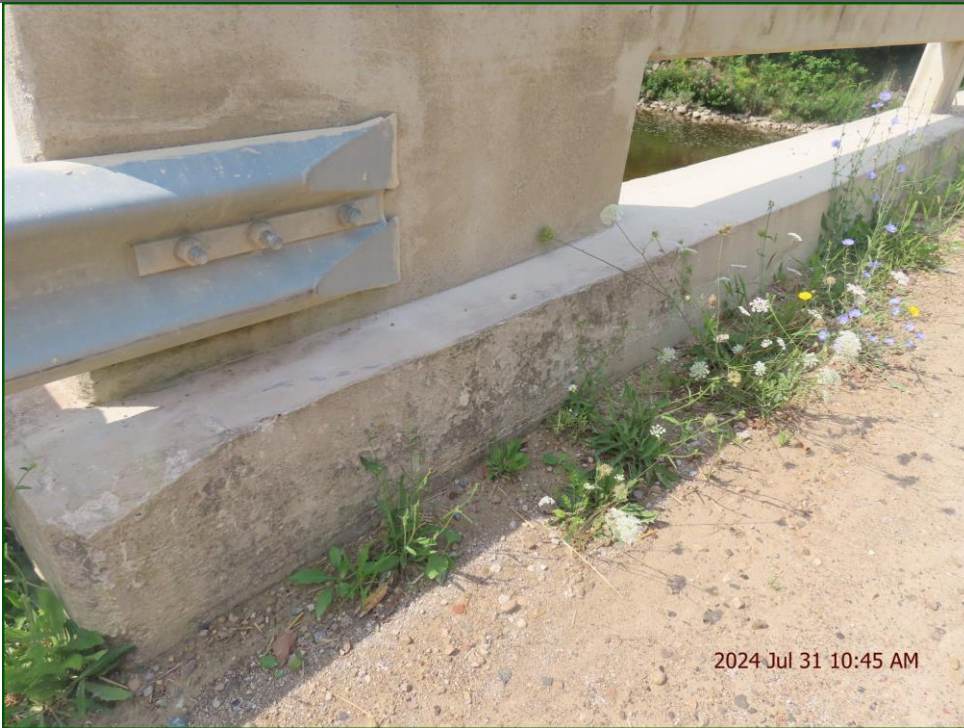
Shallow delamination throughout.

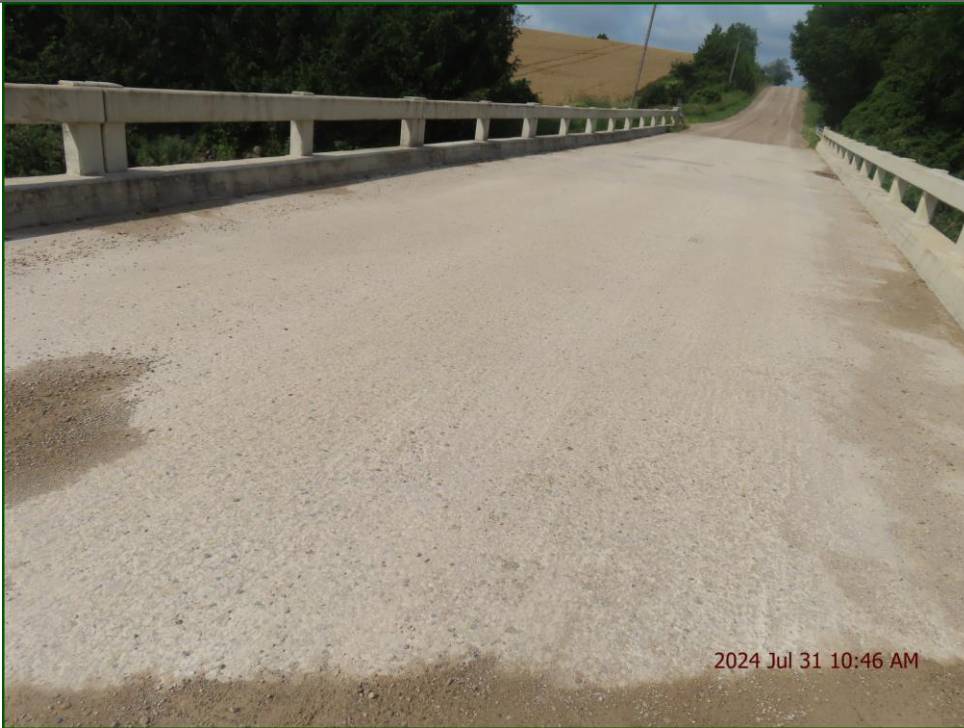
Minor abrasions throughout.

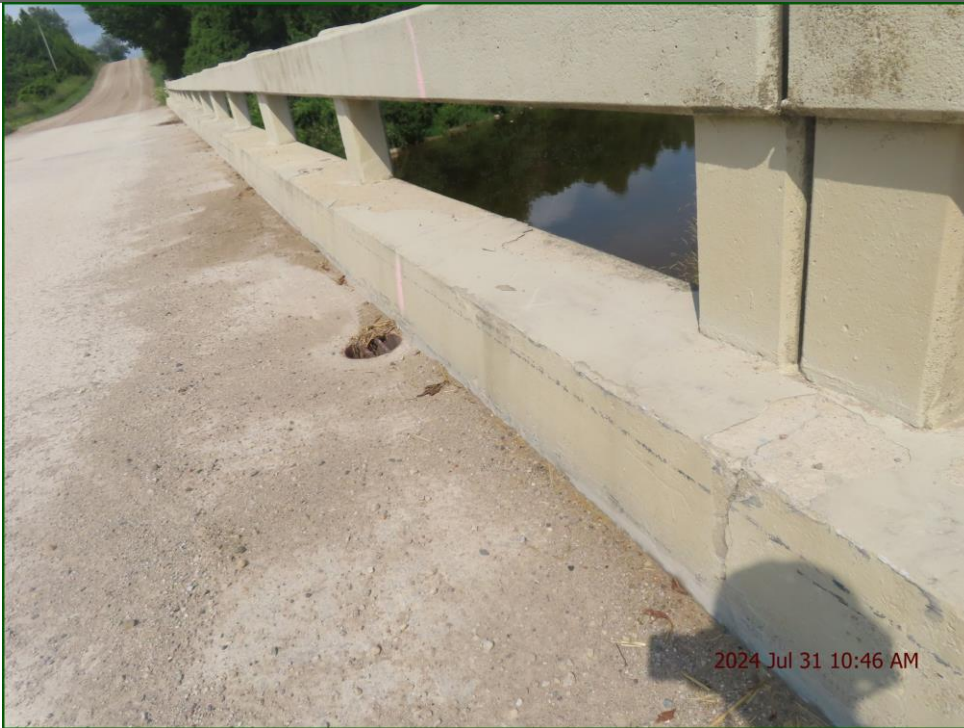
Shallow delaminations throughout.

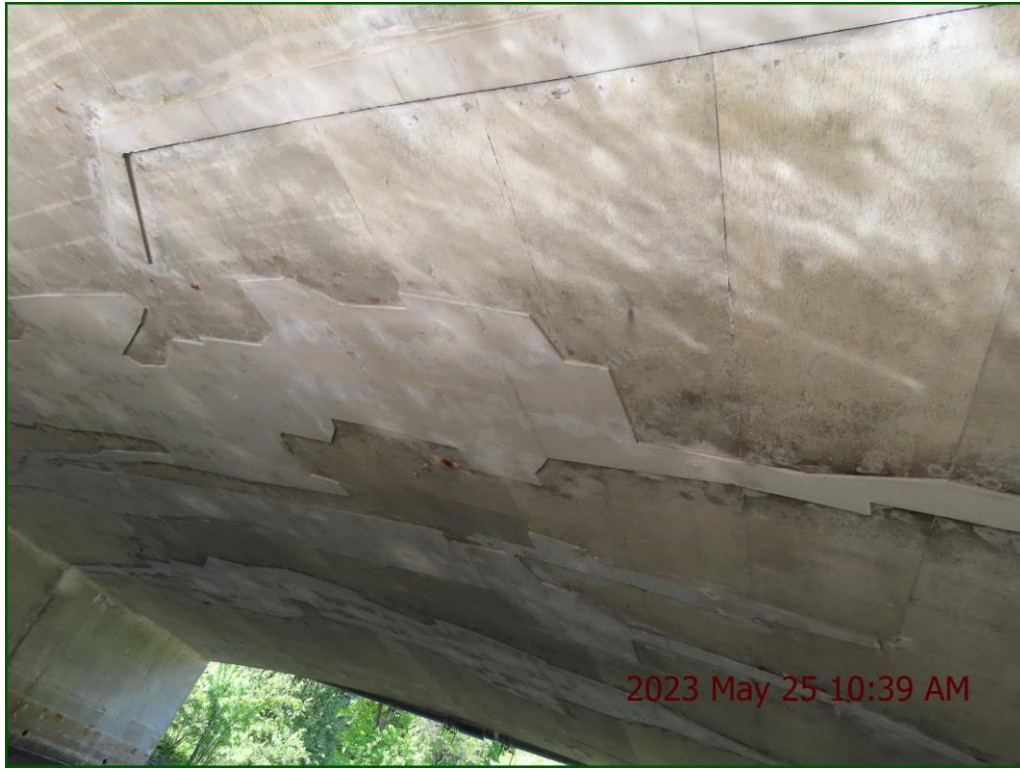
Description: Soffit (int): Patch work appears dry and sound.

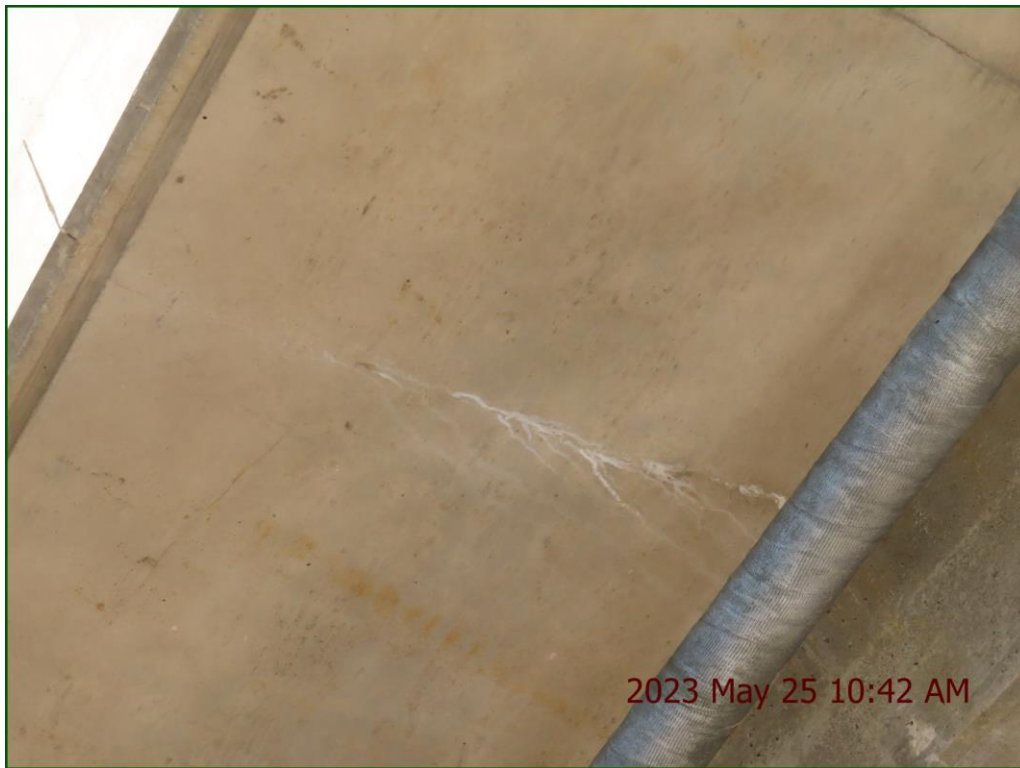
Description: Soffit (ext): Light cracking with leachate staining throughout.

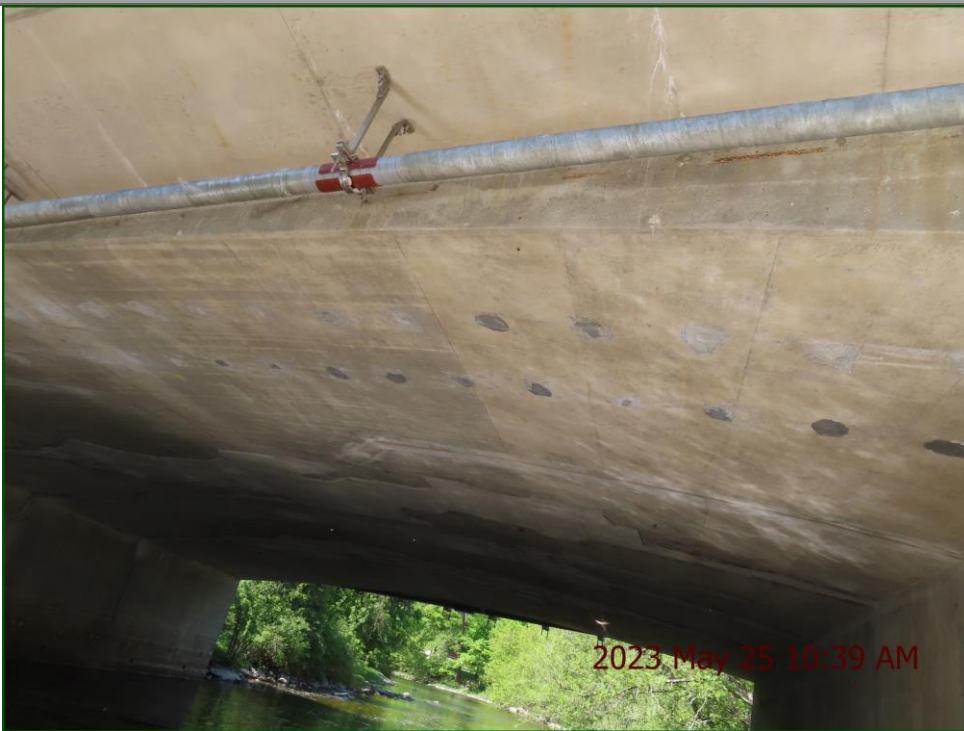
Patch work appears dry and sound.

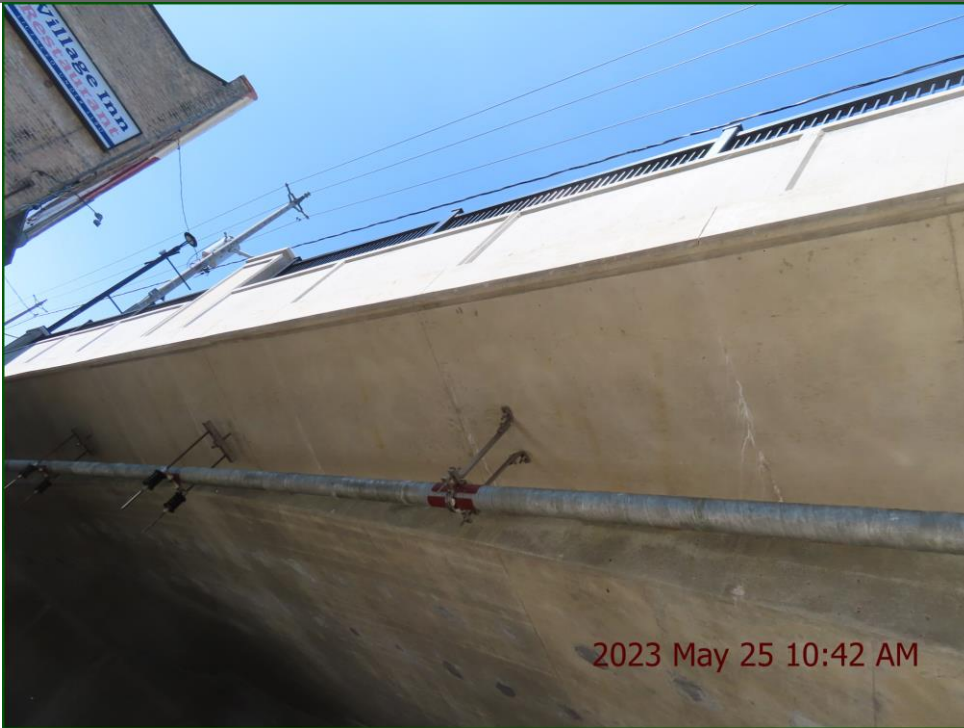
Light cracking with leachate staining throughout.

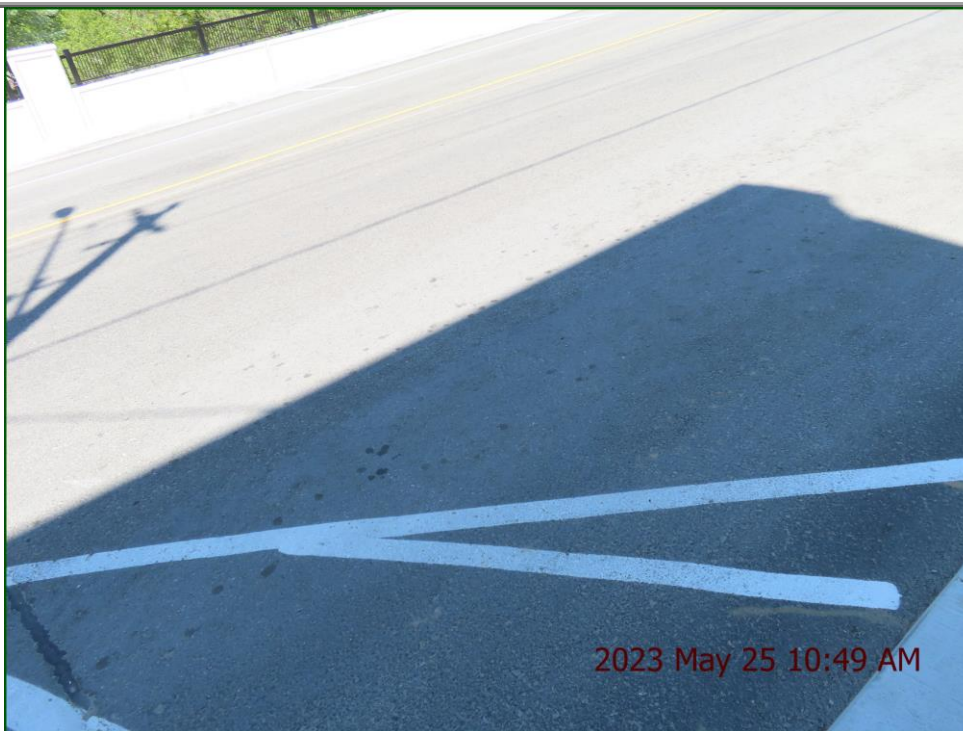
No signs of settlement.

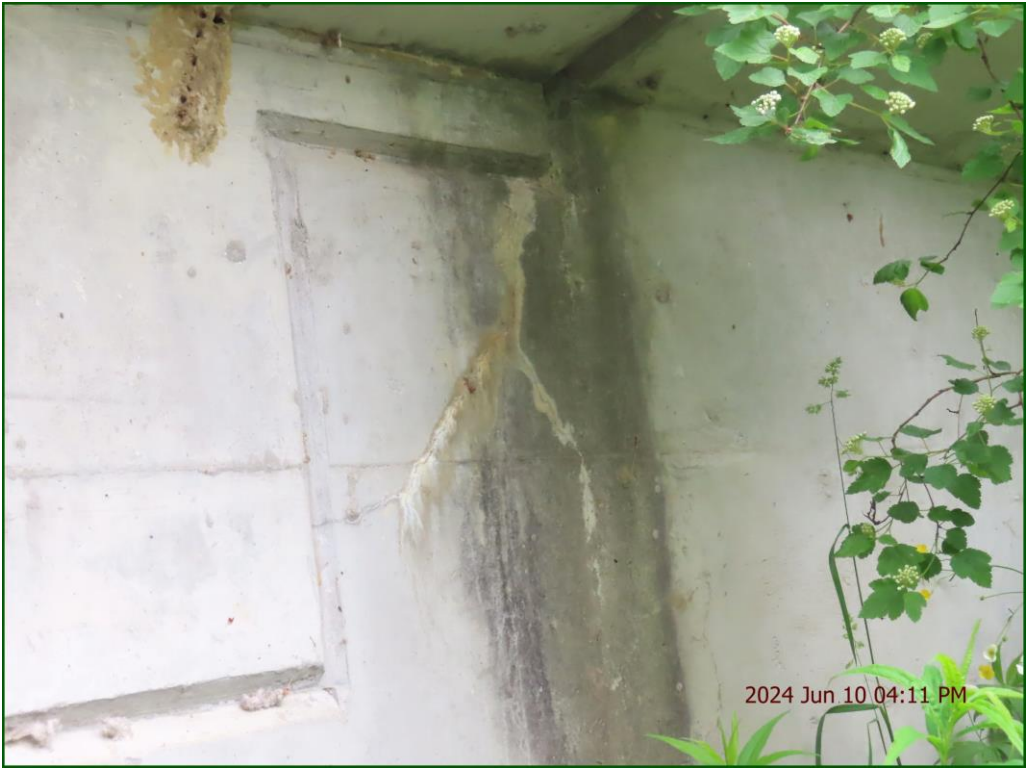
Description: Wingwalls: Medium to wide cracking with leachate staining.

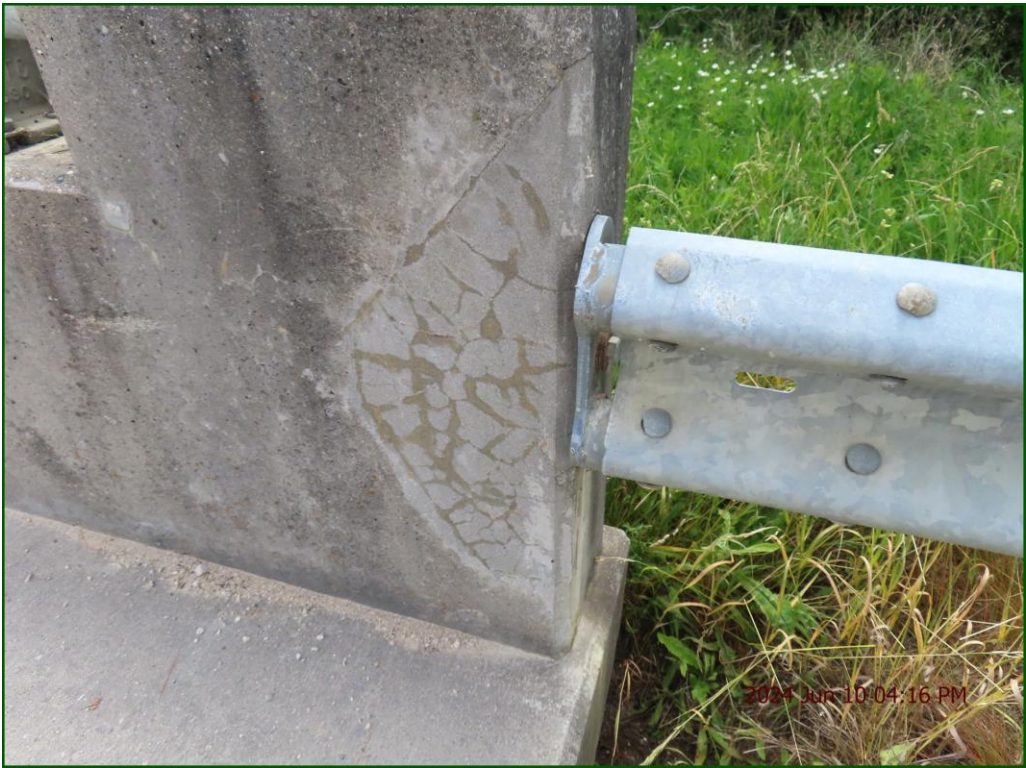
Description: Barrier/Parapet walls: Light localized map cracking at connection to guide rail.

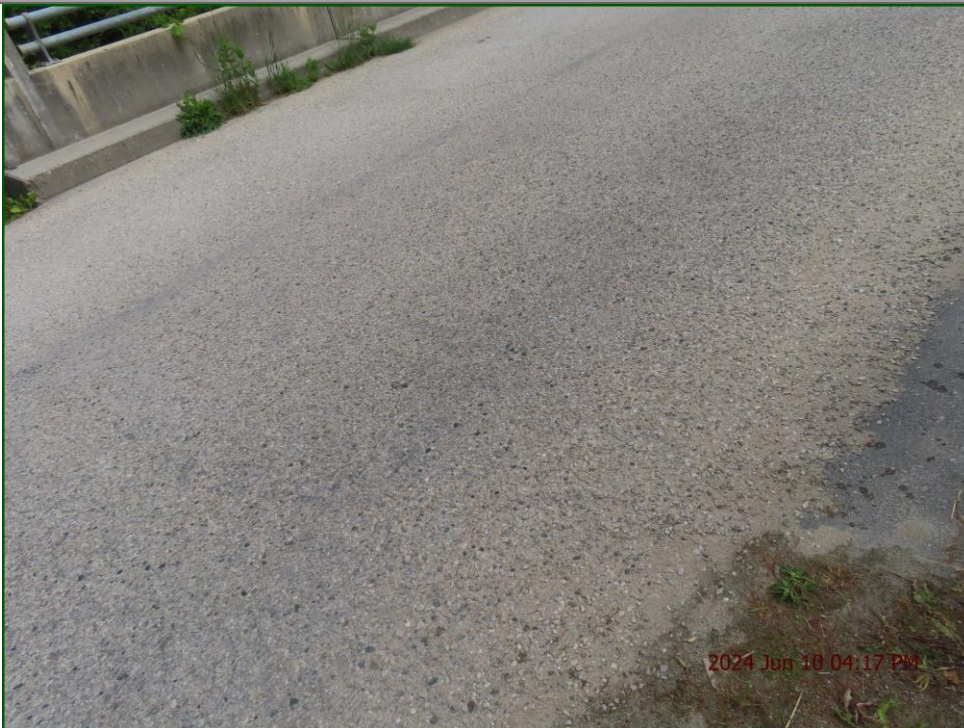
No signs of settlement.
